**Request for Proposal #21-37333
Sportspark Renovation Multi-Phase Project**

ADDENDUM #02

LIMITED ASBESTOS INSPECTION REPORT

Re: Asbestos Inspection RIOC Sportspark – 250 Main Street, Roosevelt Island, NY 10044

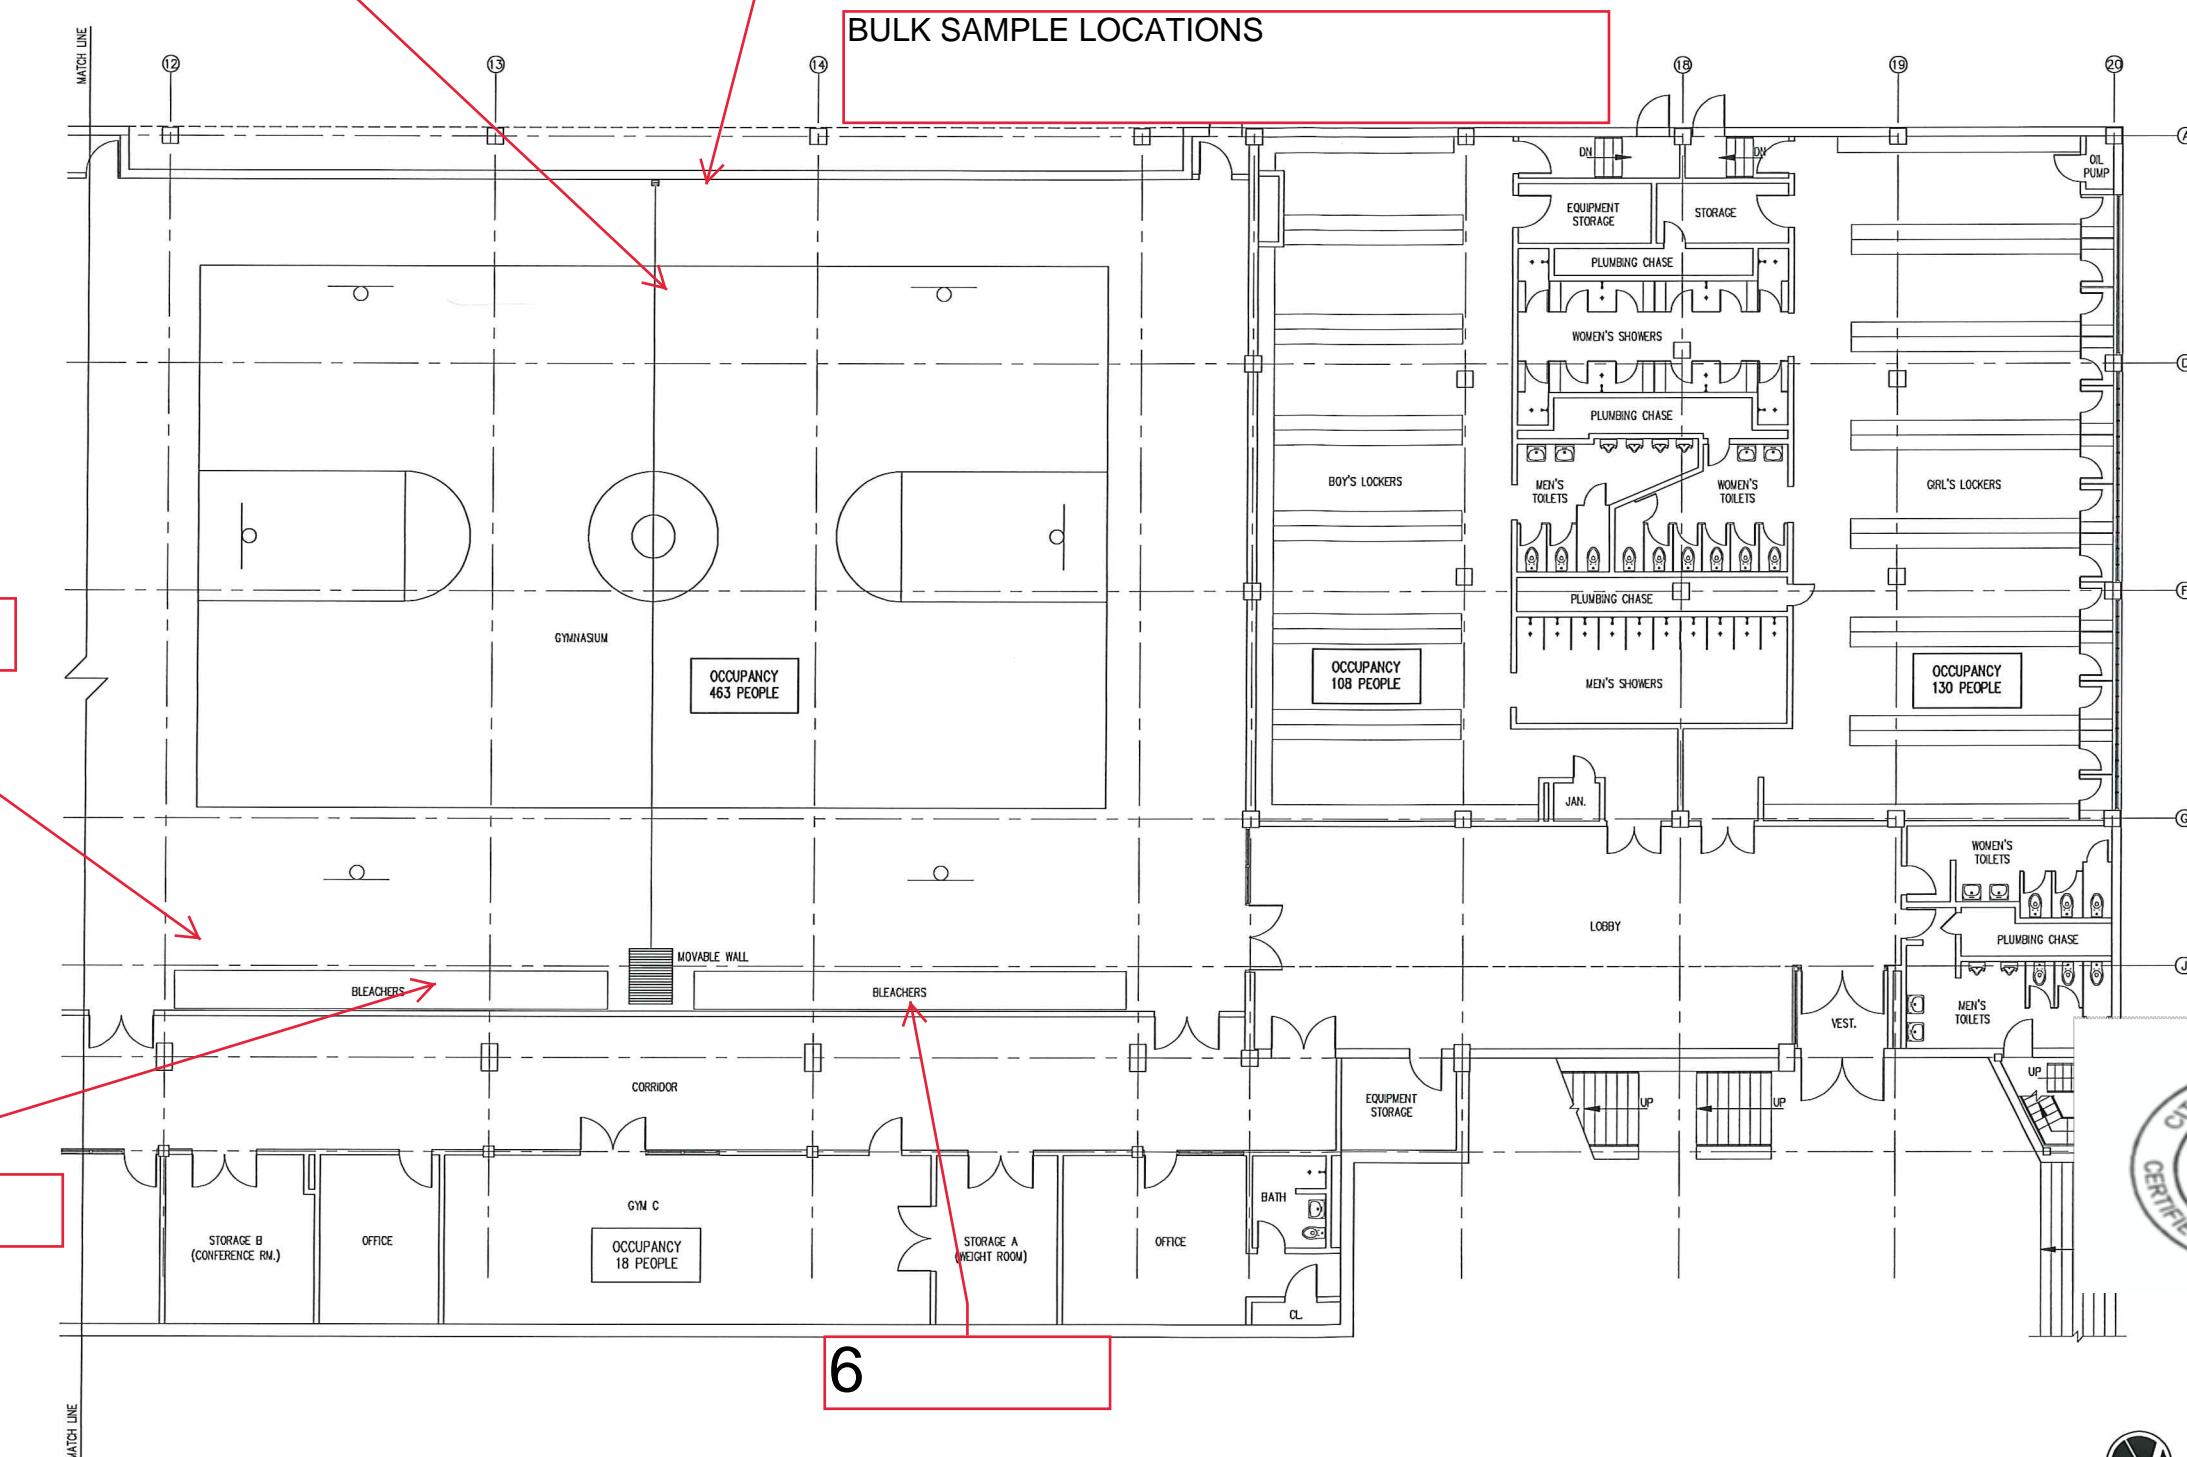
1 EXISTING LOWER WEST FLOOR PLAN

BULK SAMPLE LOCATIONS

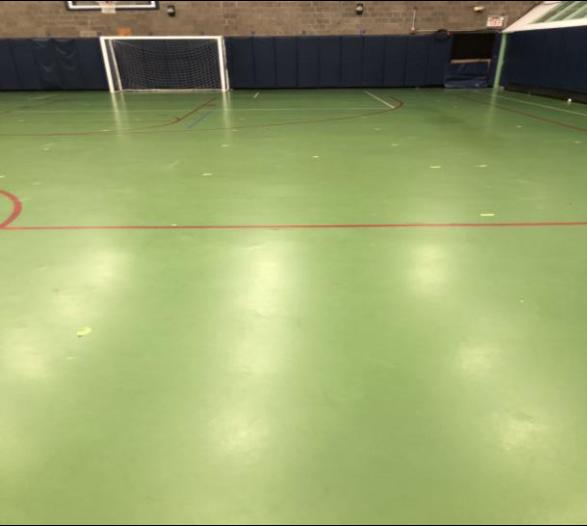
PIC.1 – Flooring in the Gym	PIC.2 – Cove base around the floor

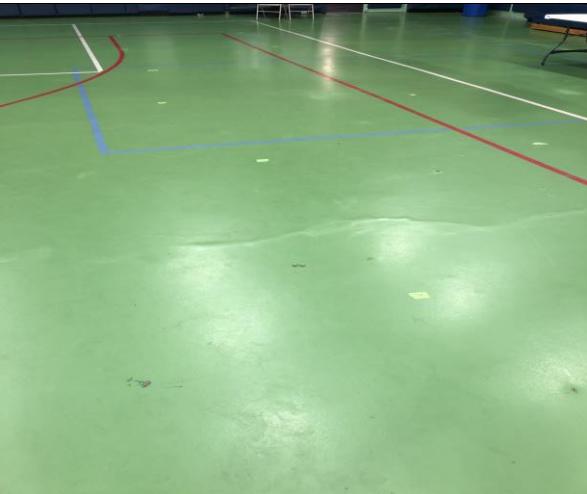
PIC.3 – Visible damaged on the floor	PIC.4 – Black foam under rubber floor - on concrete floor

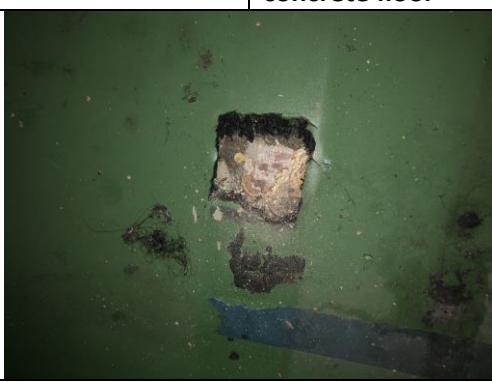
PIC.5 – Mastic under black foam on concrete floor
