TITLE:
PHOTO SURVEY -
MASONRY & SITE
CONDITIONS

LIGHTHOUSE

LIGHTHOUSE PARK,
ROOSEVELT ISLAND, NY 10044

TITLE:
PHOTO SURVEY -
LANTERN & OBSERVATION
DECK CONDITIONS

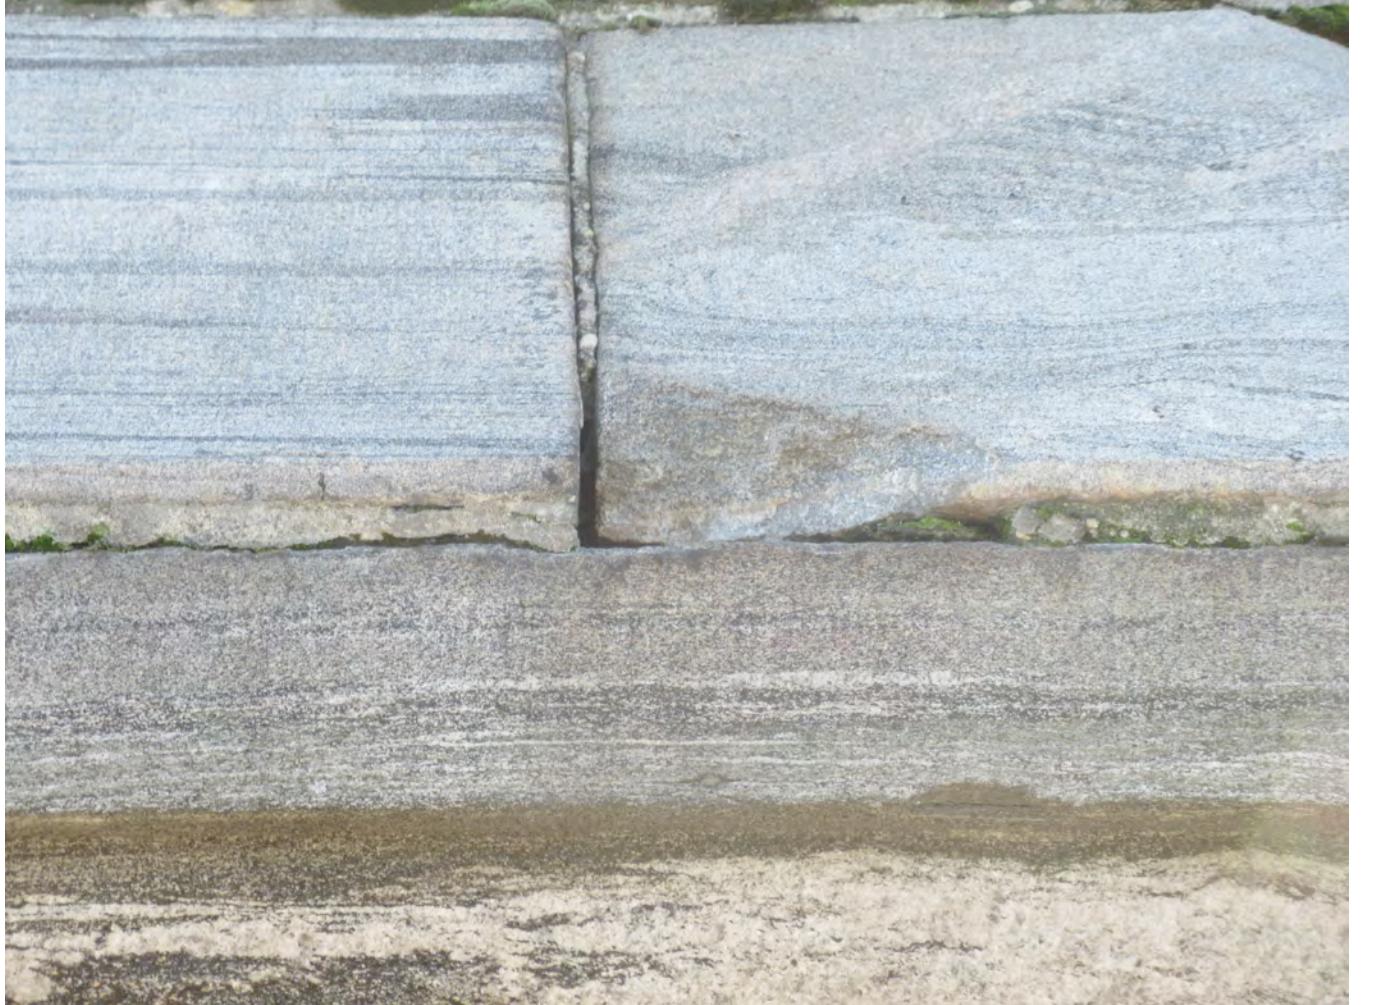
5 STONE SPALL at MOLDING
BASE at DISPARATE LOCATIONS

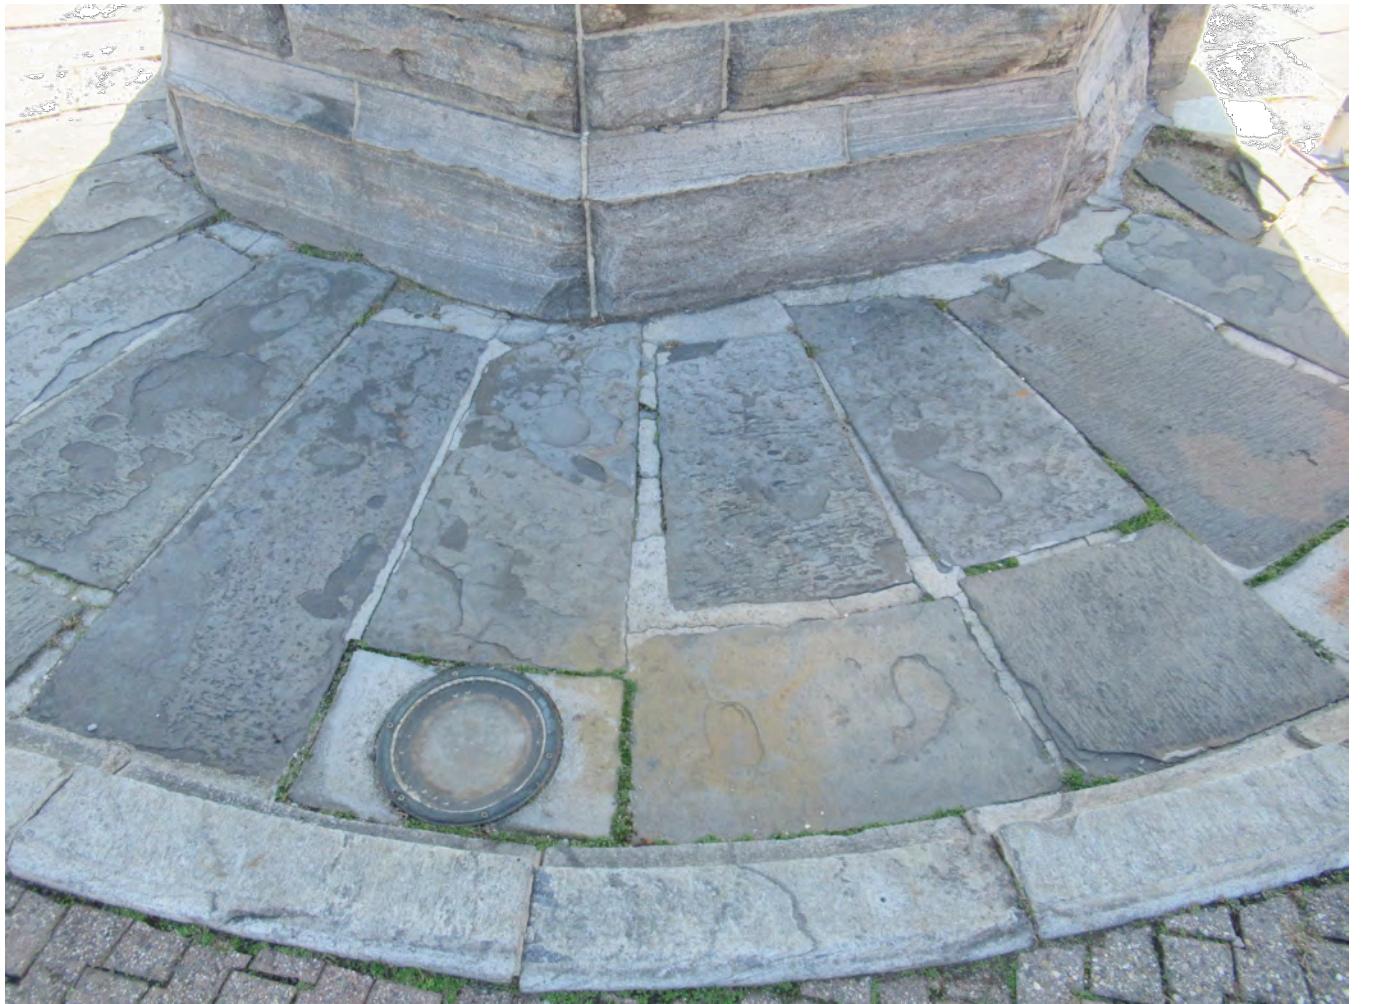
13 DISPLACED, SKEWED, ERODED & SPALLED FLAGSTONES / INCOMPATIBLE PATCHING MATERIAL
DEPRESSED PAVED AREA

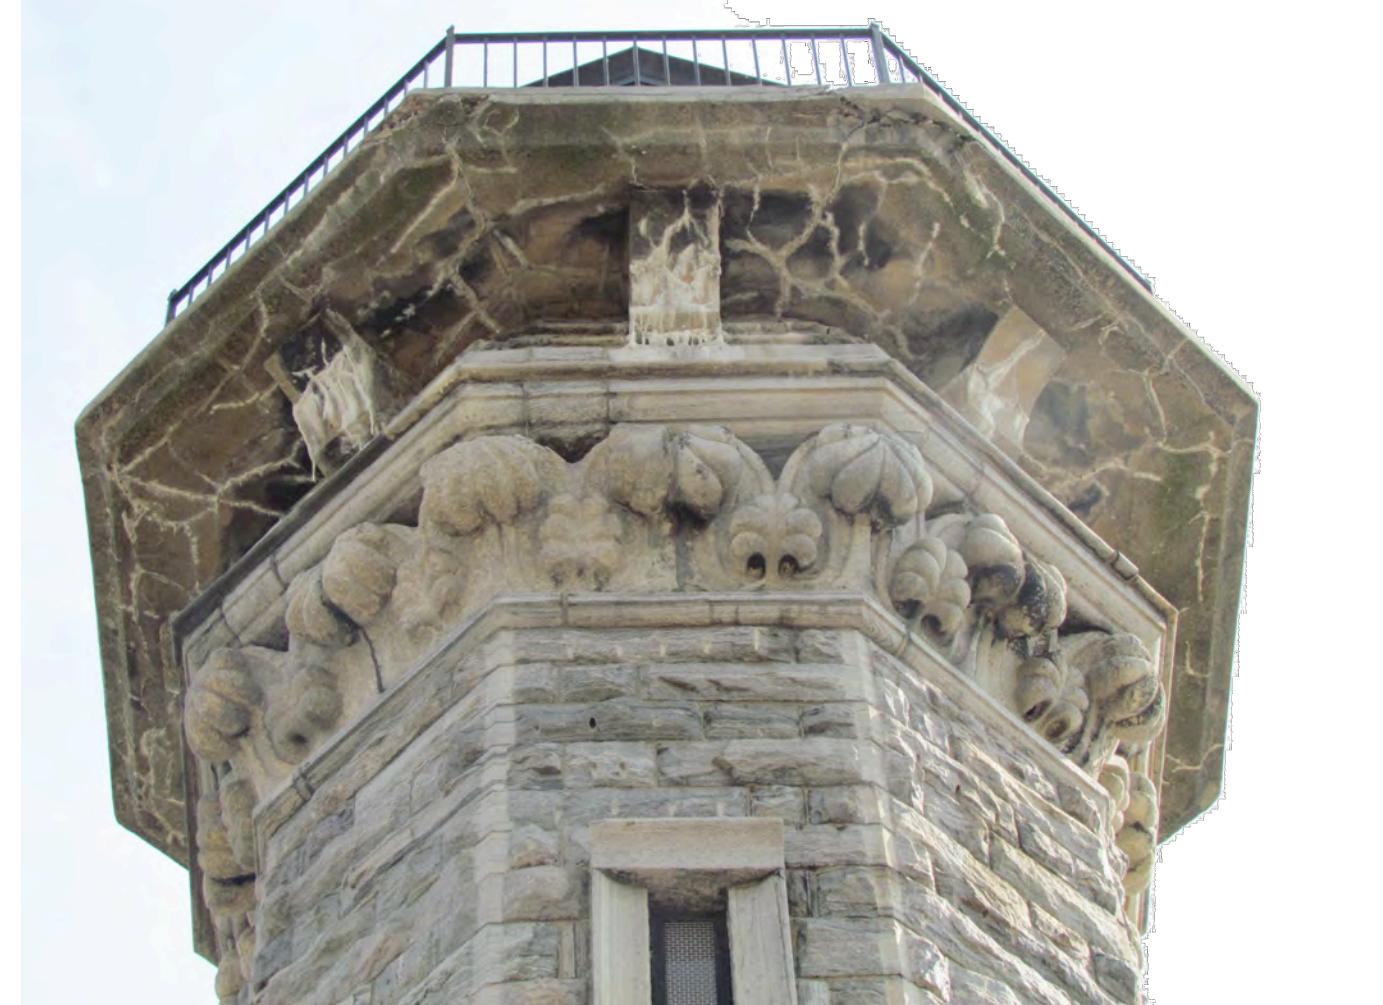
6 DETERIORATED, NON-ORIGINAL CONCRETE DECK
ALL ELEVATIONS, TYPICAL CONDITION

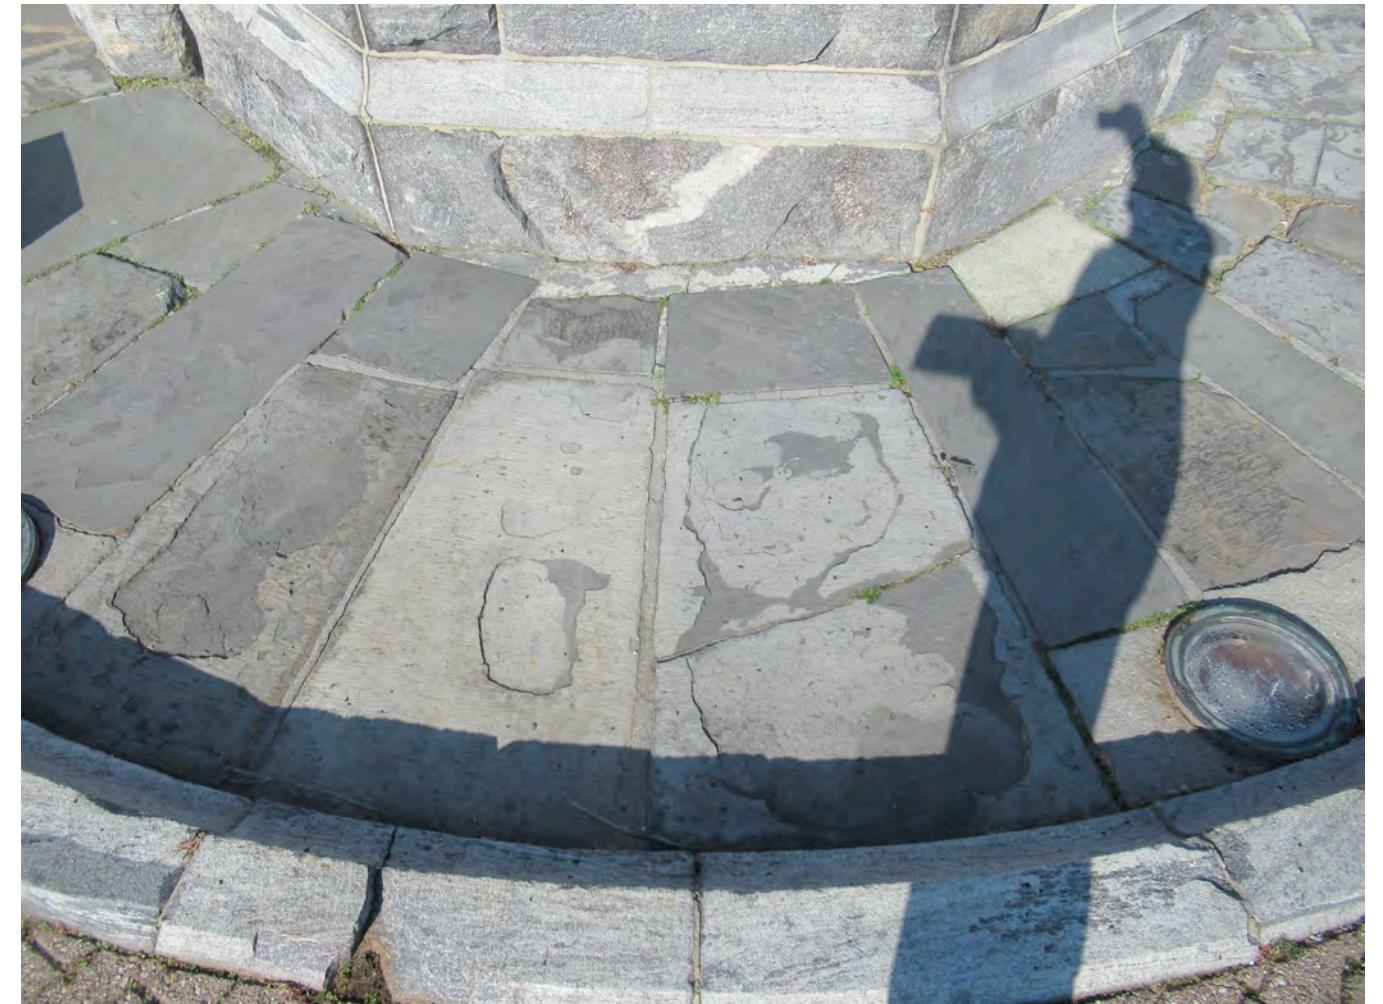
14 DISPLACED, SKEWED, ERODED & SPALLED FLAGSTONES / INCOMPATIBLE PATCHING MATERIAL
DEPRESSED PAVED AREA

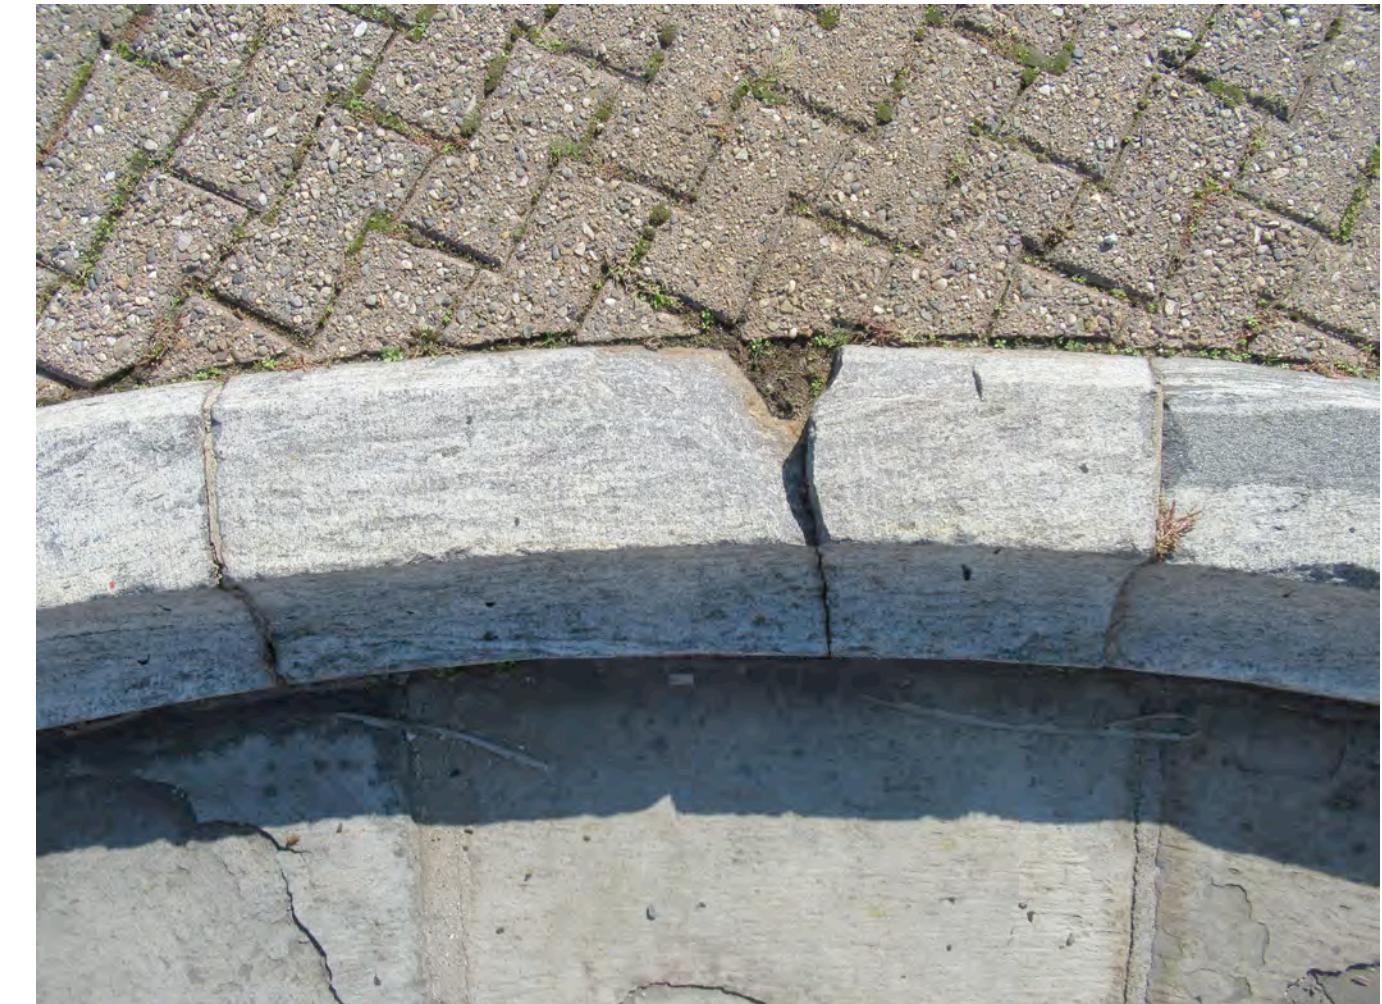
15 CRACK at STONE CURB
DEPRESSED PAVED AREA

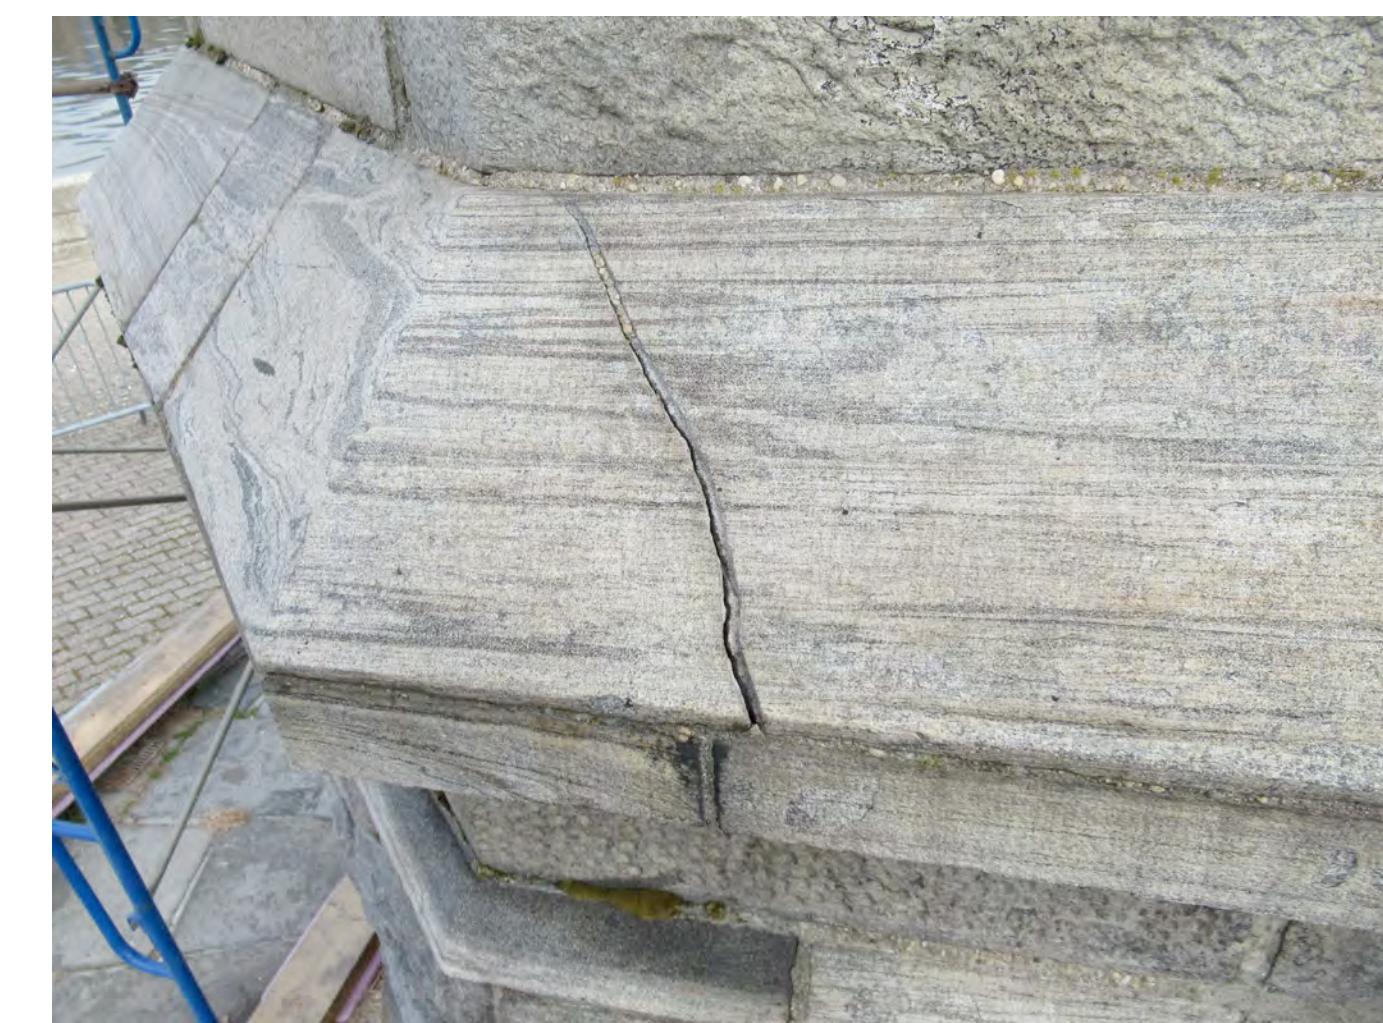
4 STONE CRACKING at MOLDING
BASE at DISPARATE LOCATIONS

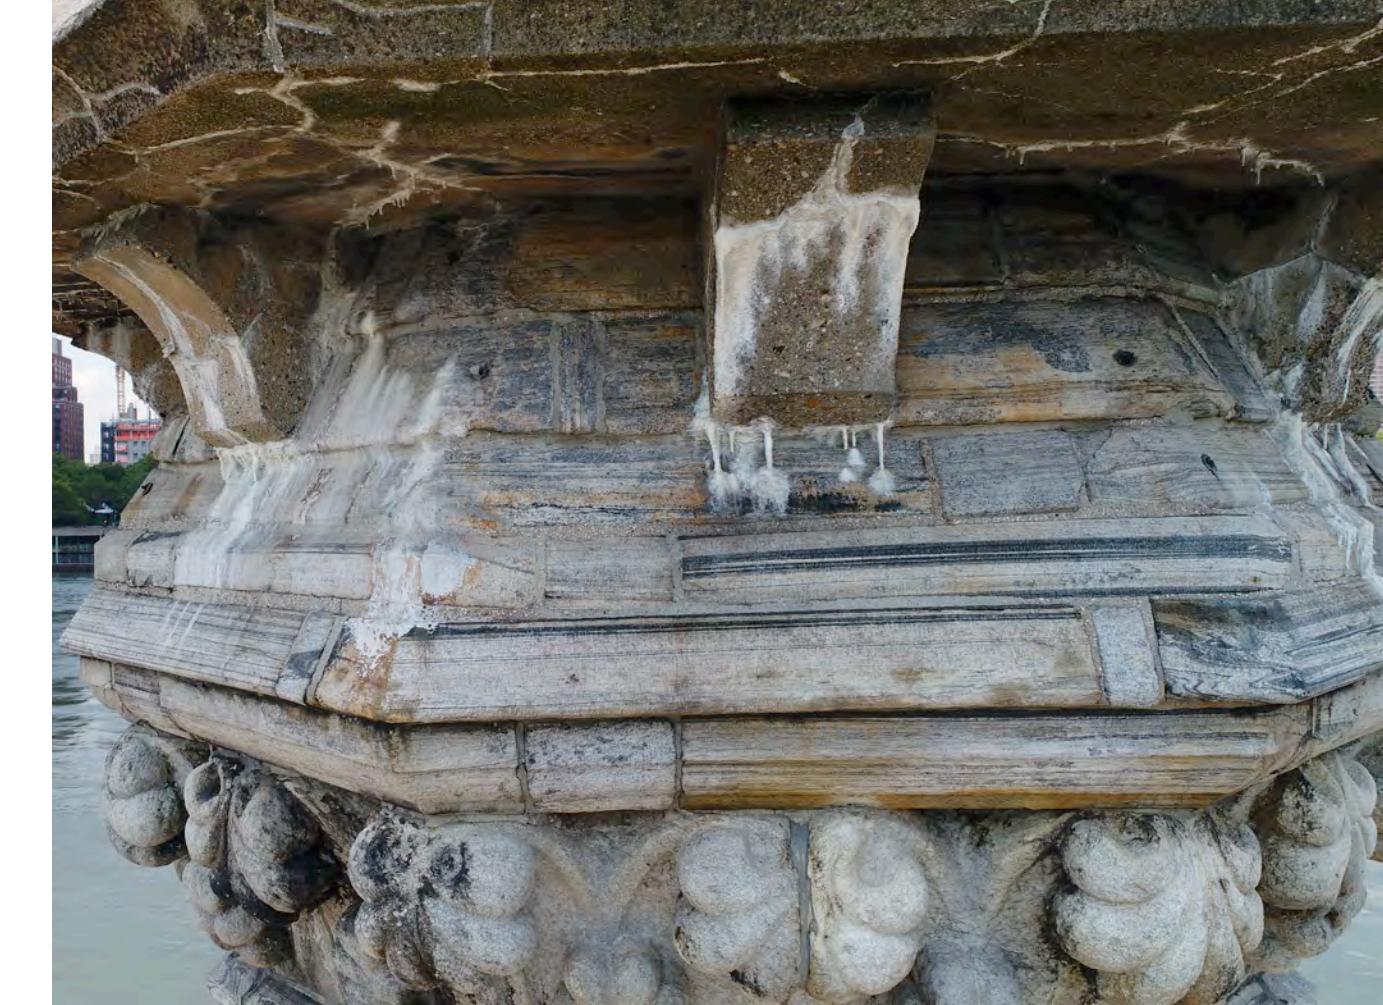
8 REMNANT OF METAL BRACKET ANCHORAGE
STEPPED STONE PROFILE at CAPITAL, EACH OUTSIDE CORNER OF THE OCTAGONAL TOWER

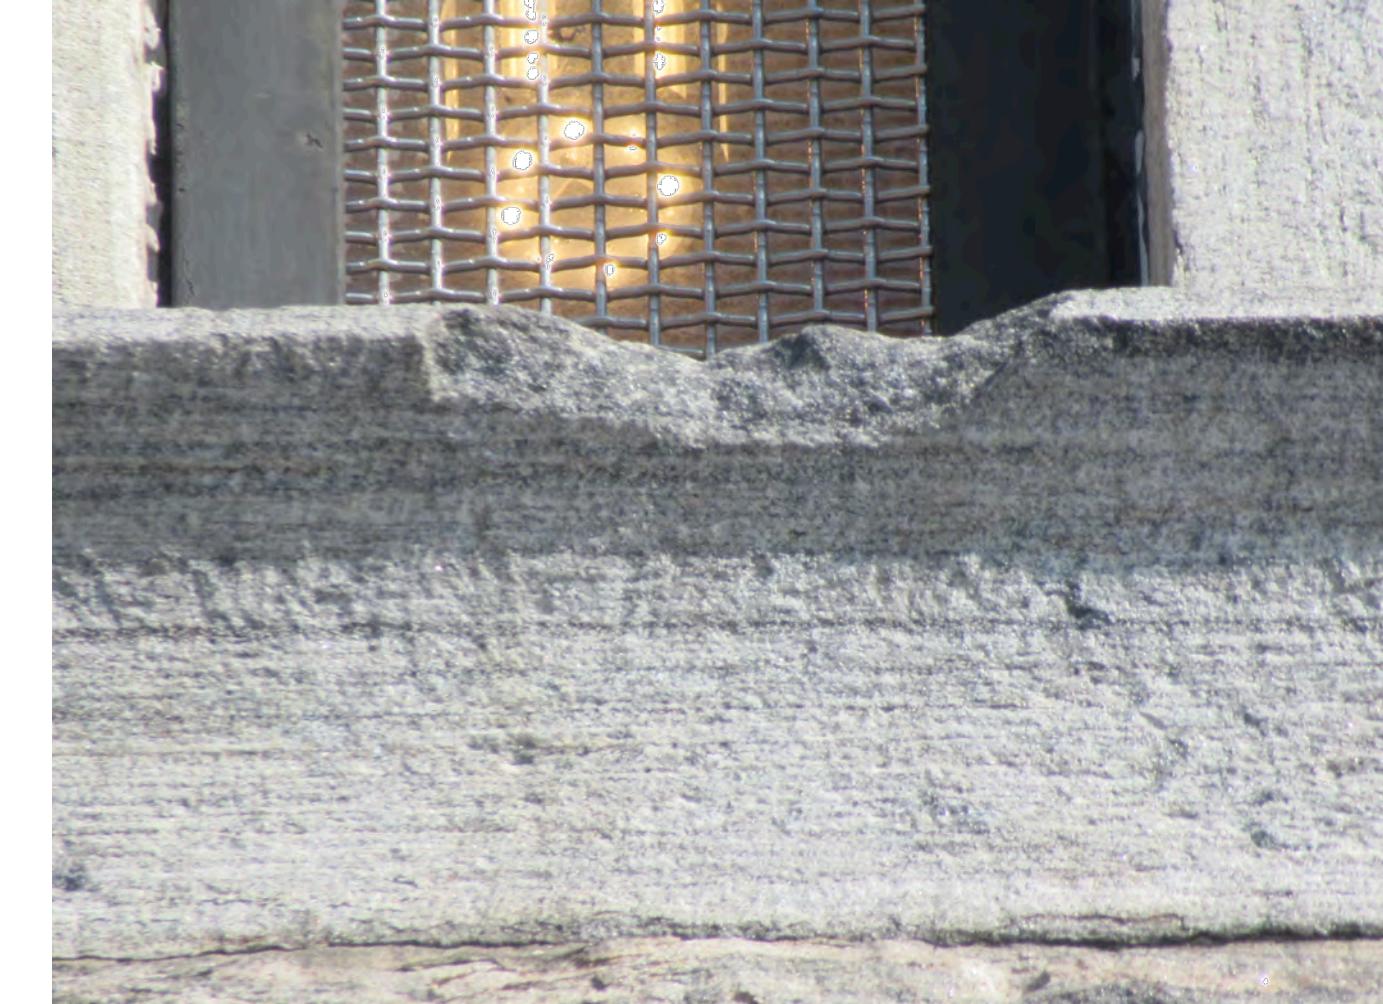
12 STONE SPALL
WINDOW SURROUND, TYPICAL CONDITION

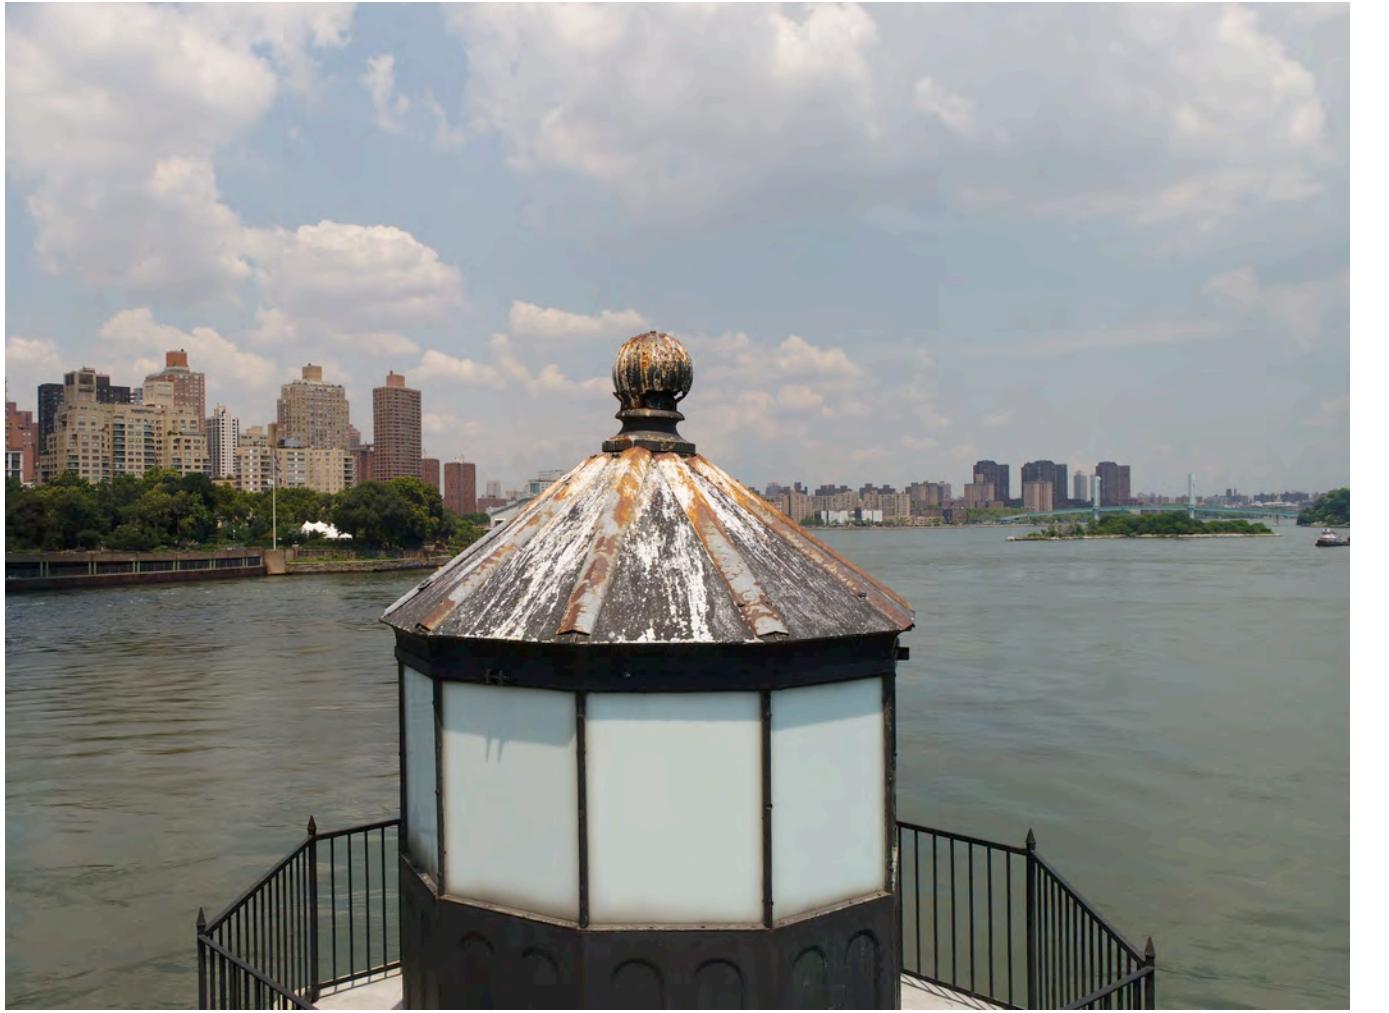
1 PAINT FAILURE, CORROSION OF METAL JOINT COVER & DISPLACED SECTIONS OF CAST IRON
LANTERN ROOF

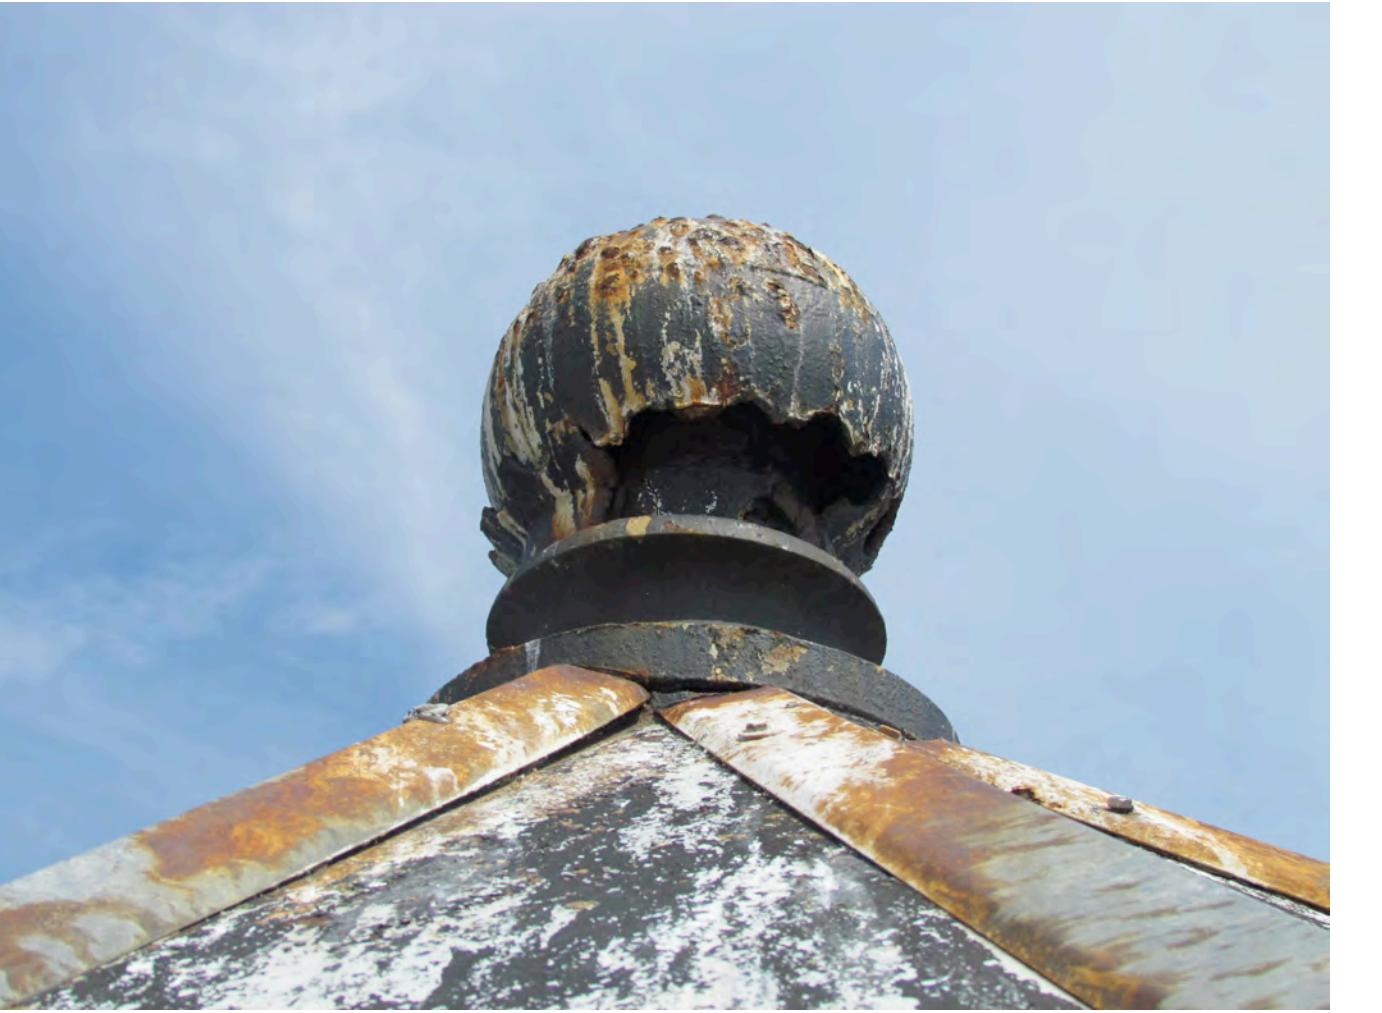
2 FRACTURED CAST IRON VENTILATOR ORB
LANTERN ROOF

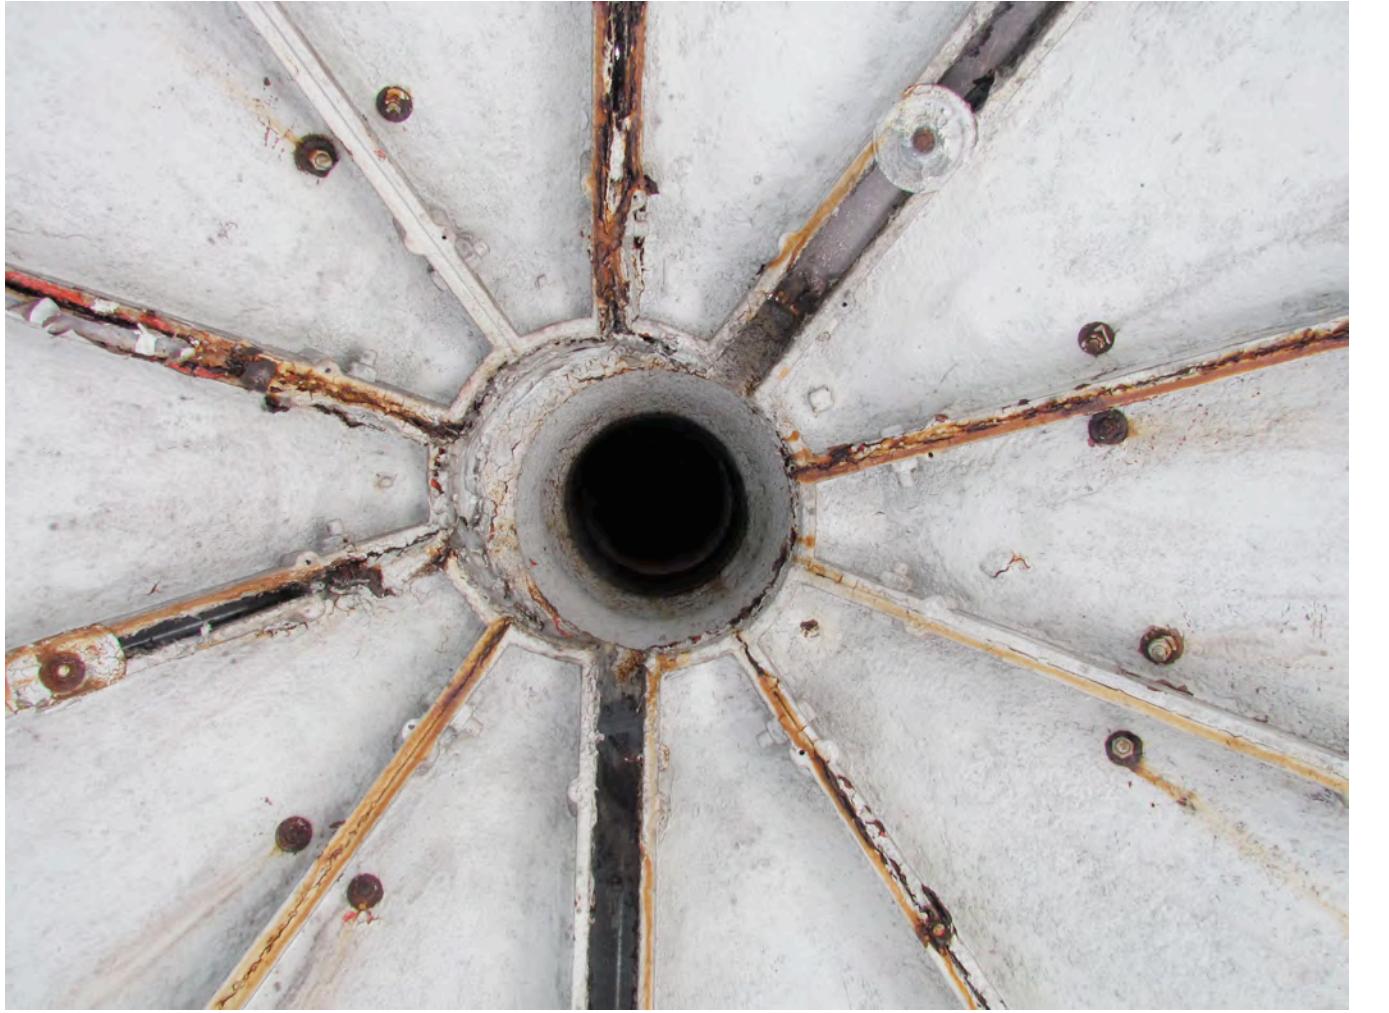
5 CAST IRON PANEL SEPARATION, PAINT FAILURE & GALVANIC CORROSION
LANTERN ROOF

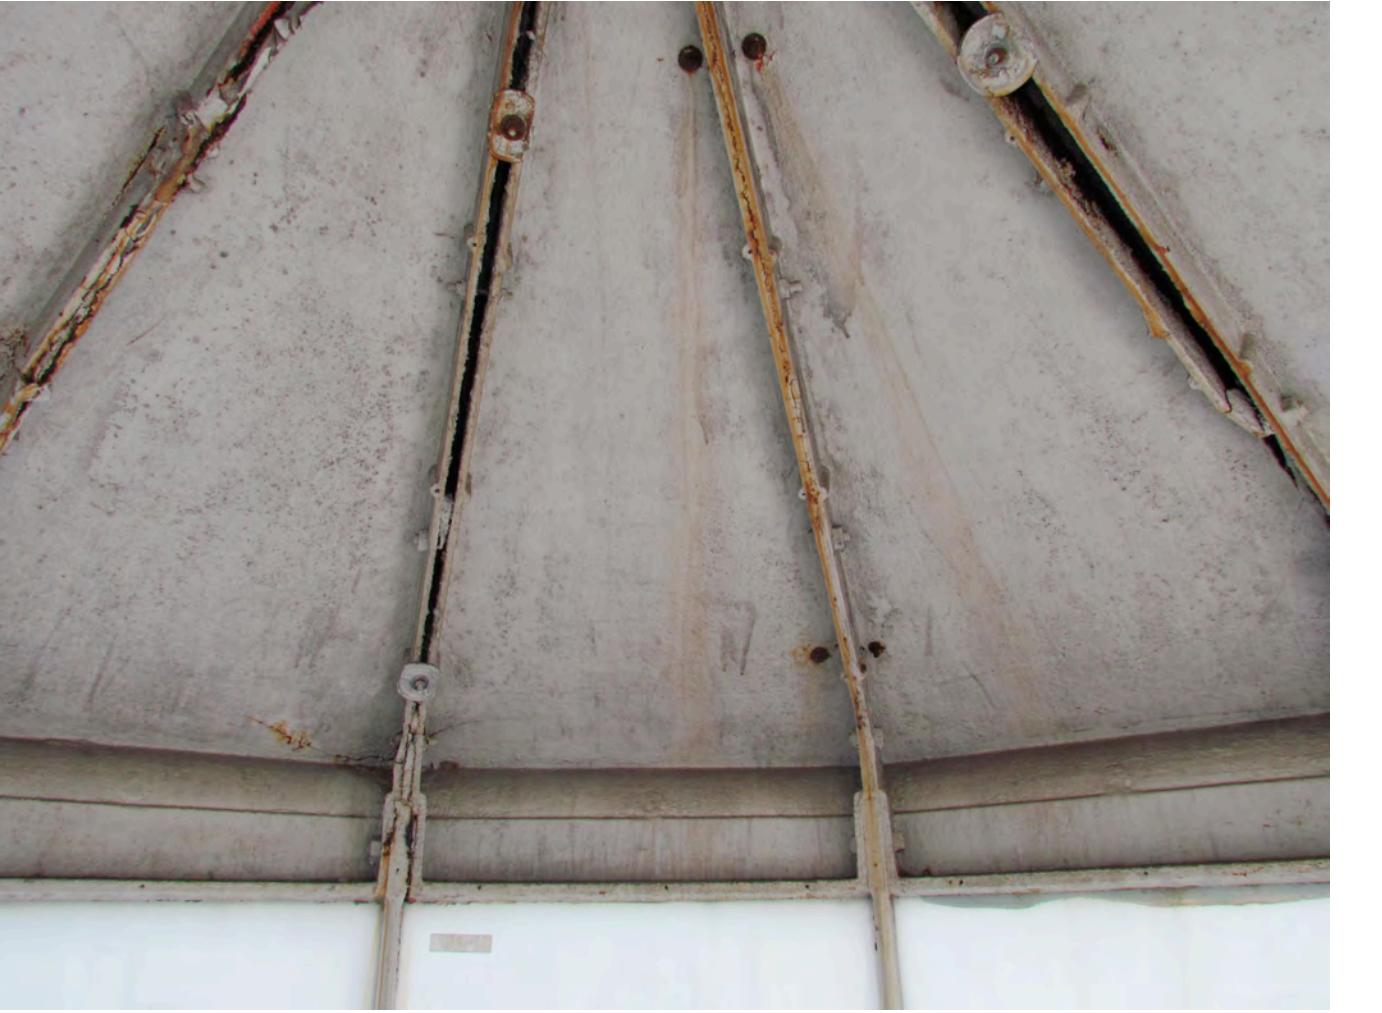
6 CAST IRON PANEL SEPARATION, PAINT FAILURE & GALVANIC CORROSION
LANTERN ROOF

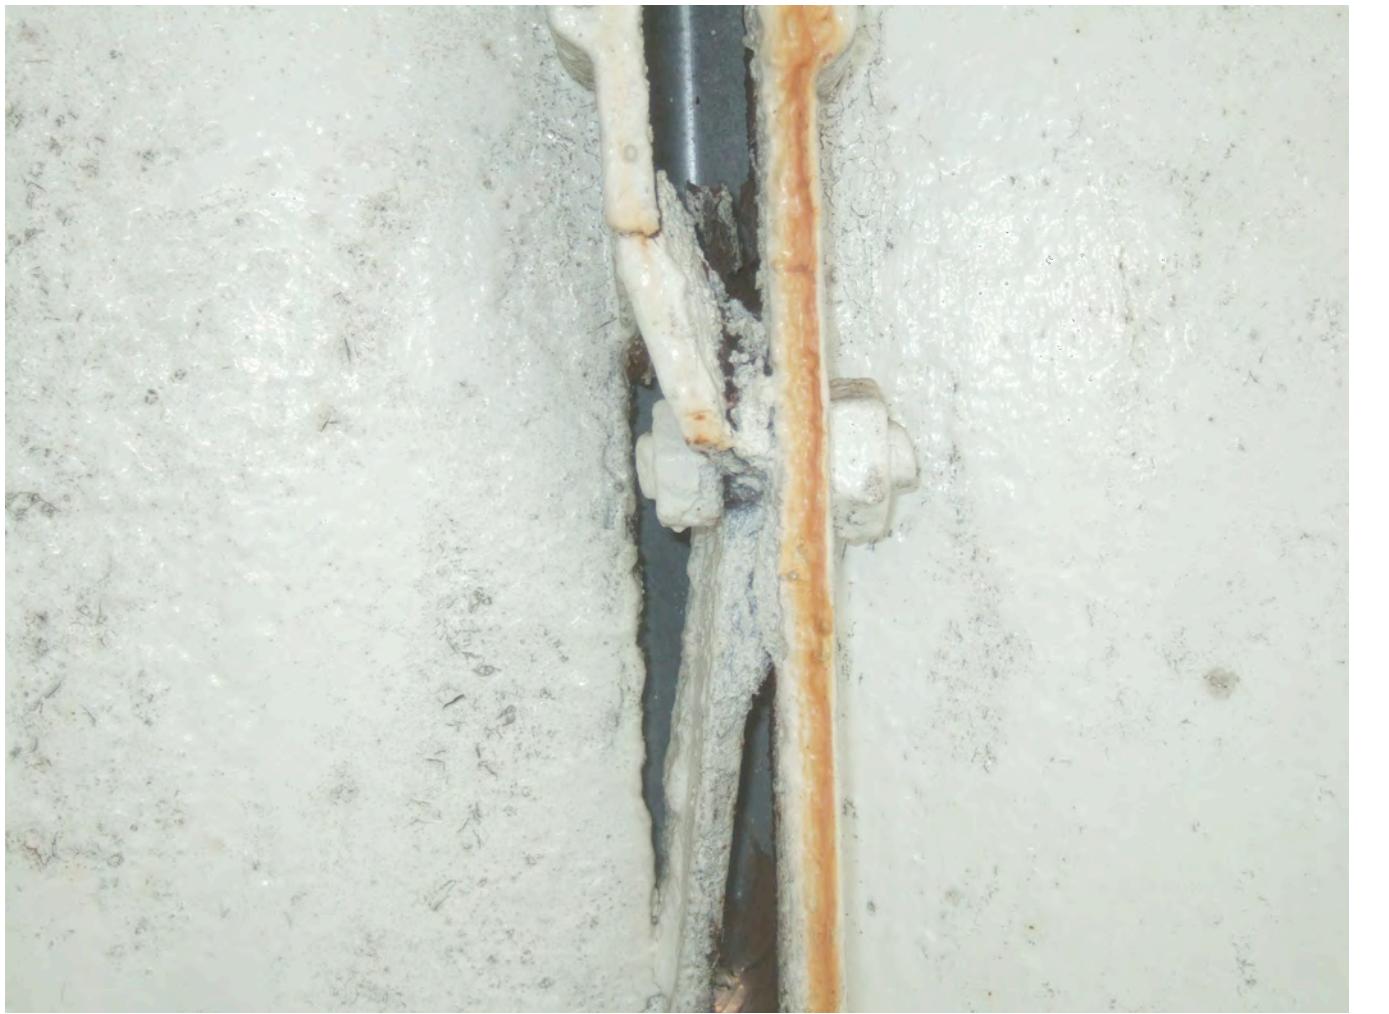
9 CAST IRON PANEL SEPARATION & DEFORMATION
LANTERN ROOF

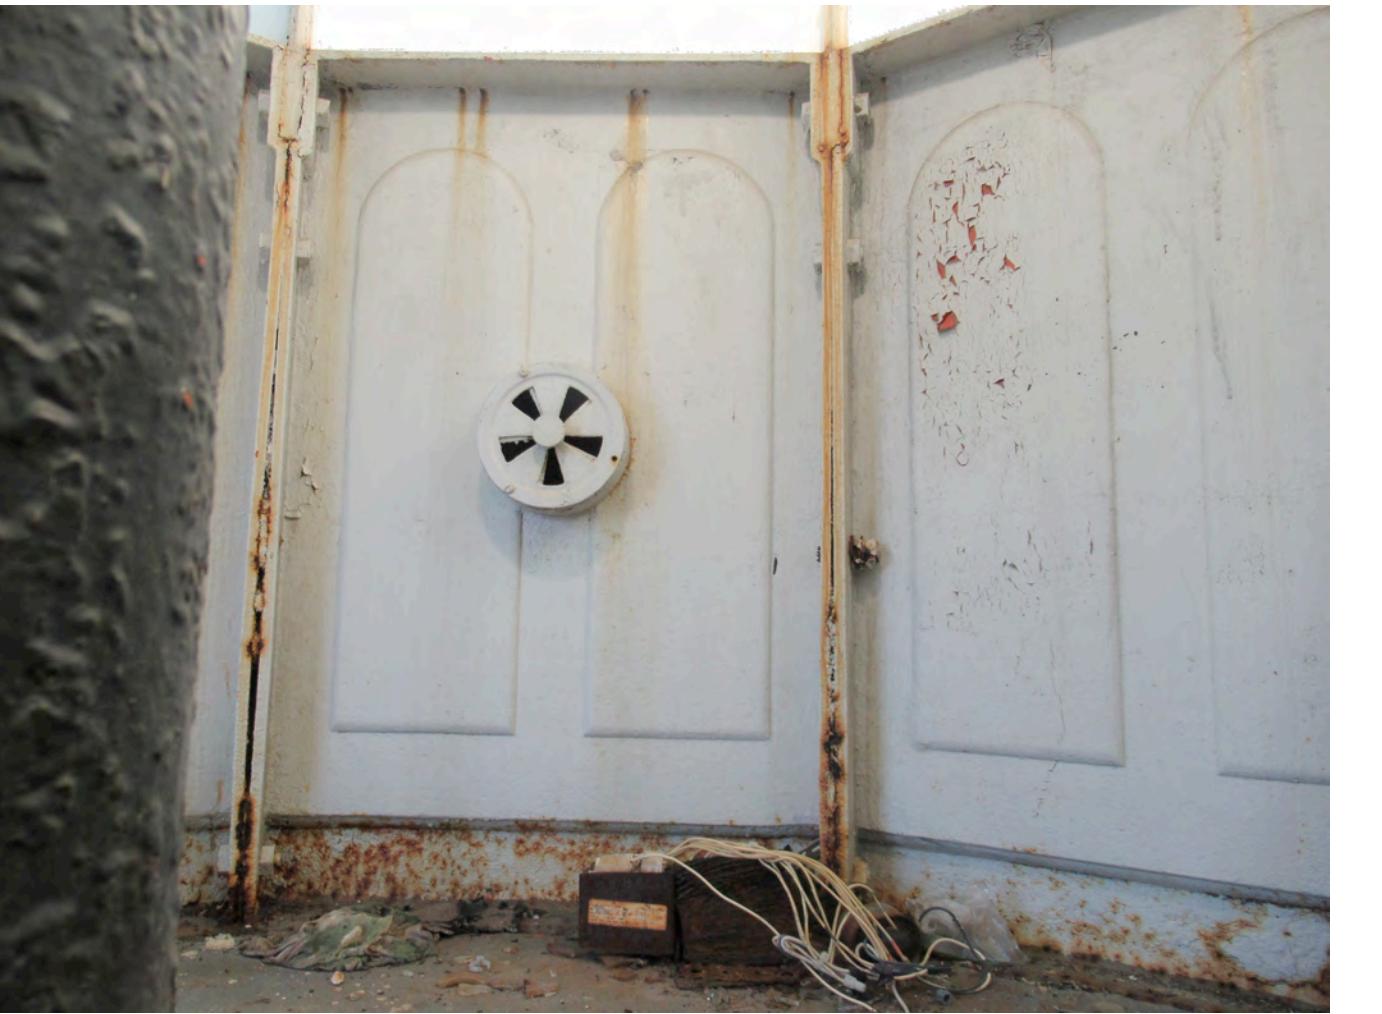
10 PAINT FAILURE & GALVANIC CORROSION
LANTERN PARAPET WALL

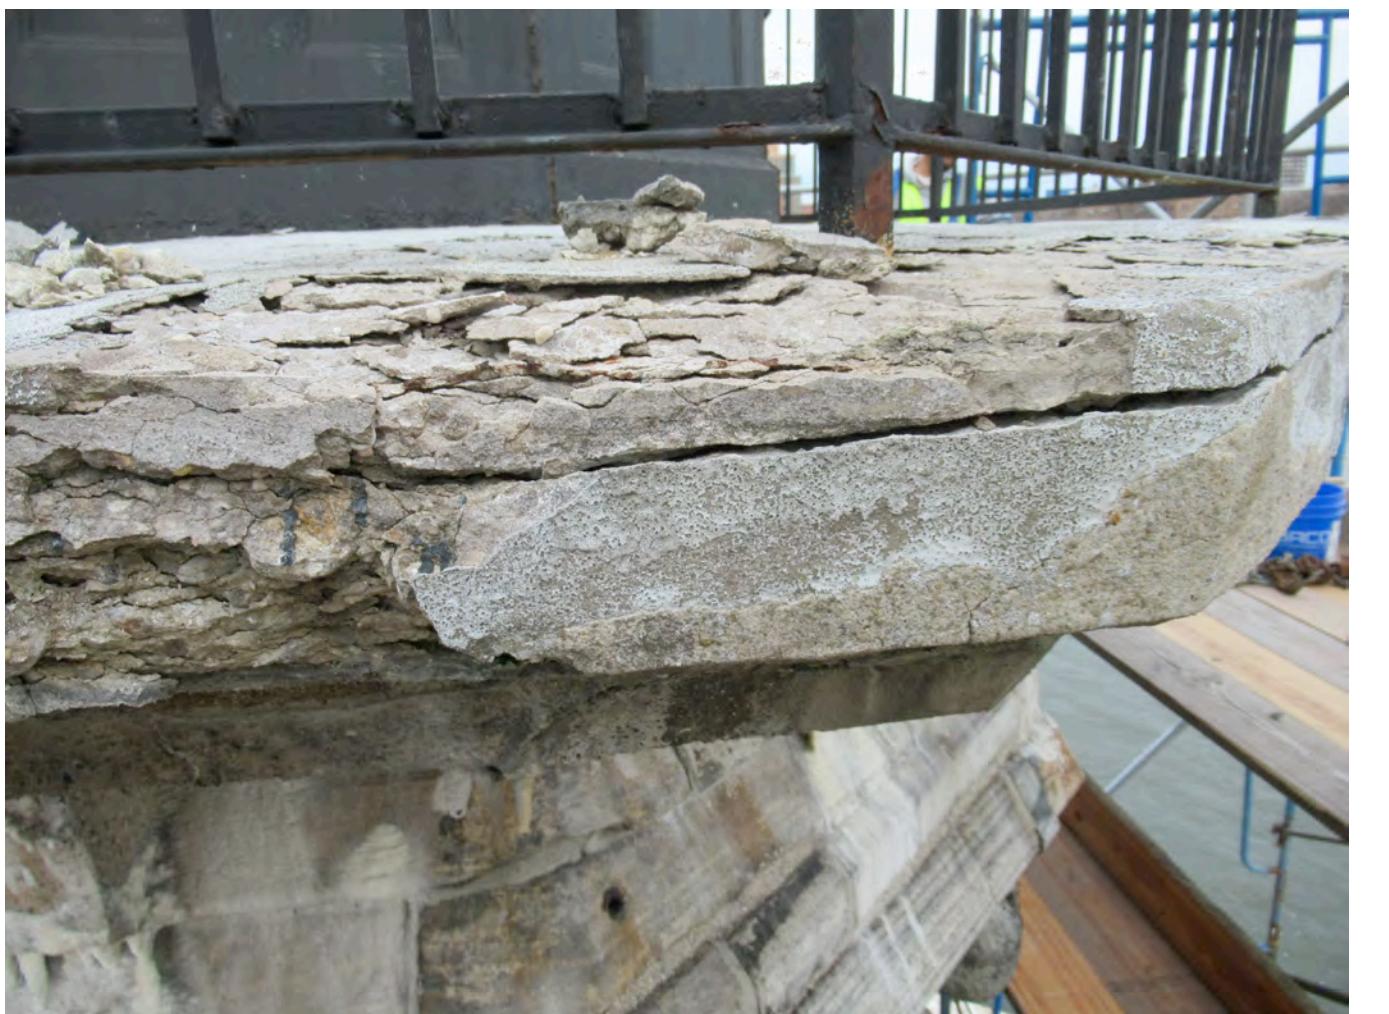
13 SEVERELY CRACKED, SPALLED CONCRETE & DELAMINATED TRAFFIC SURFACE
OBSERVATION DECK

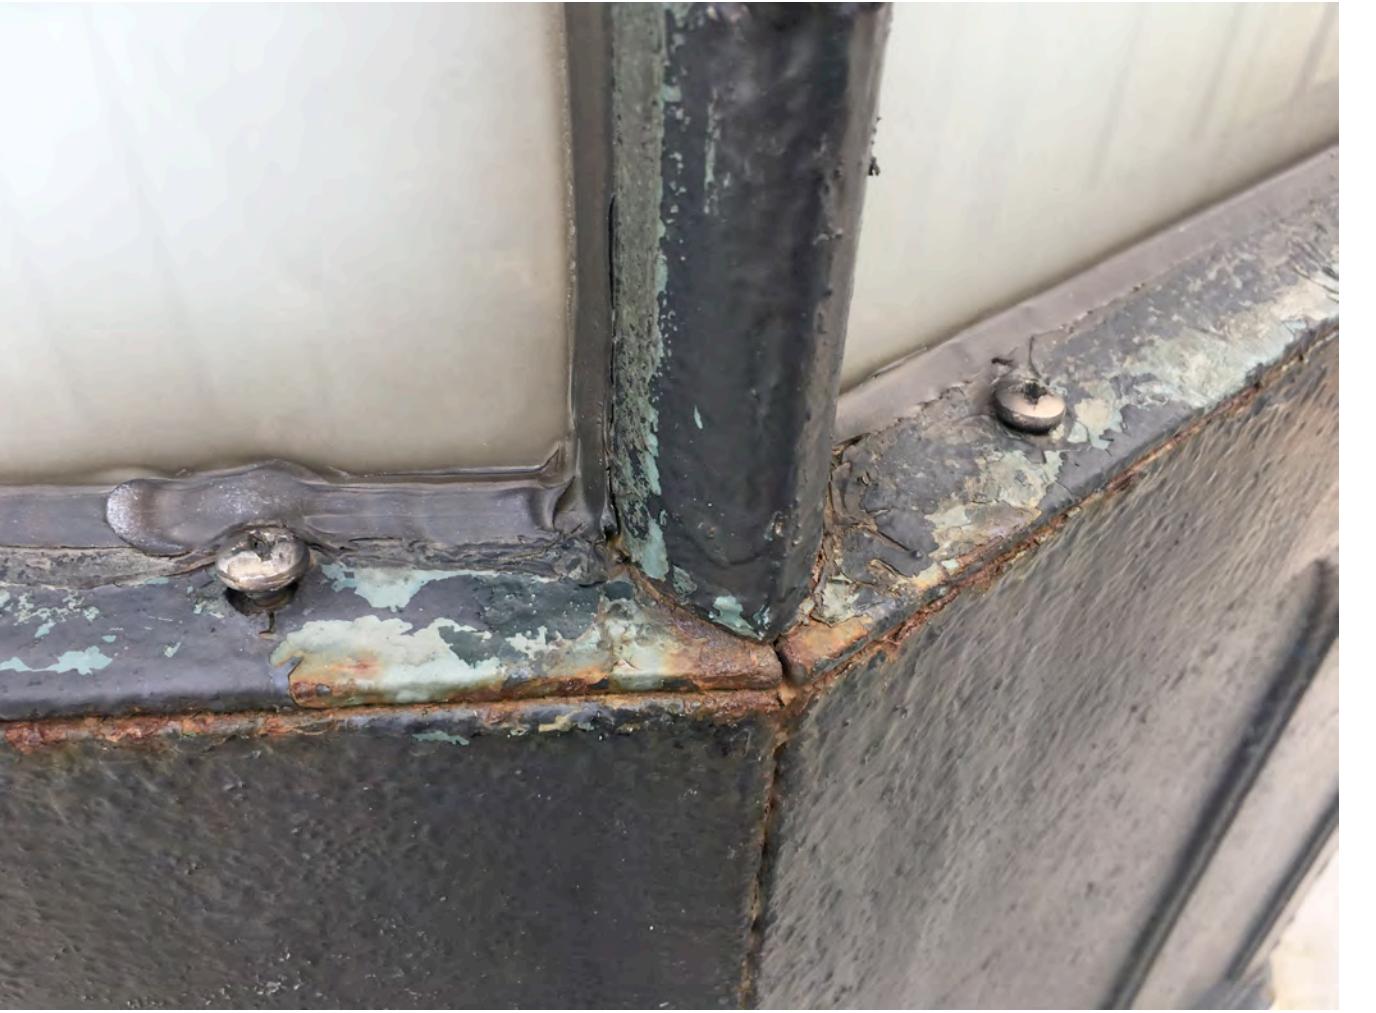
3 PAINT FAILURE, CORROSION OF UNDERLYING METAL & LOOSE FASTENERS
LANTERN PARAPET WALL TOP
