TITLE:
PHOTO SURVEY -
MASONRY & SITE
CONDITIONS

LIGHTHOUSE

LIGHTHOUSE PARK,
ROOSEVELT ISLAND, NY 10044

TITLE:
PHOTO SURVEY -
LANTERN & OBSERVATION
DECK CONDITIONS

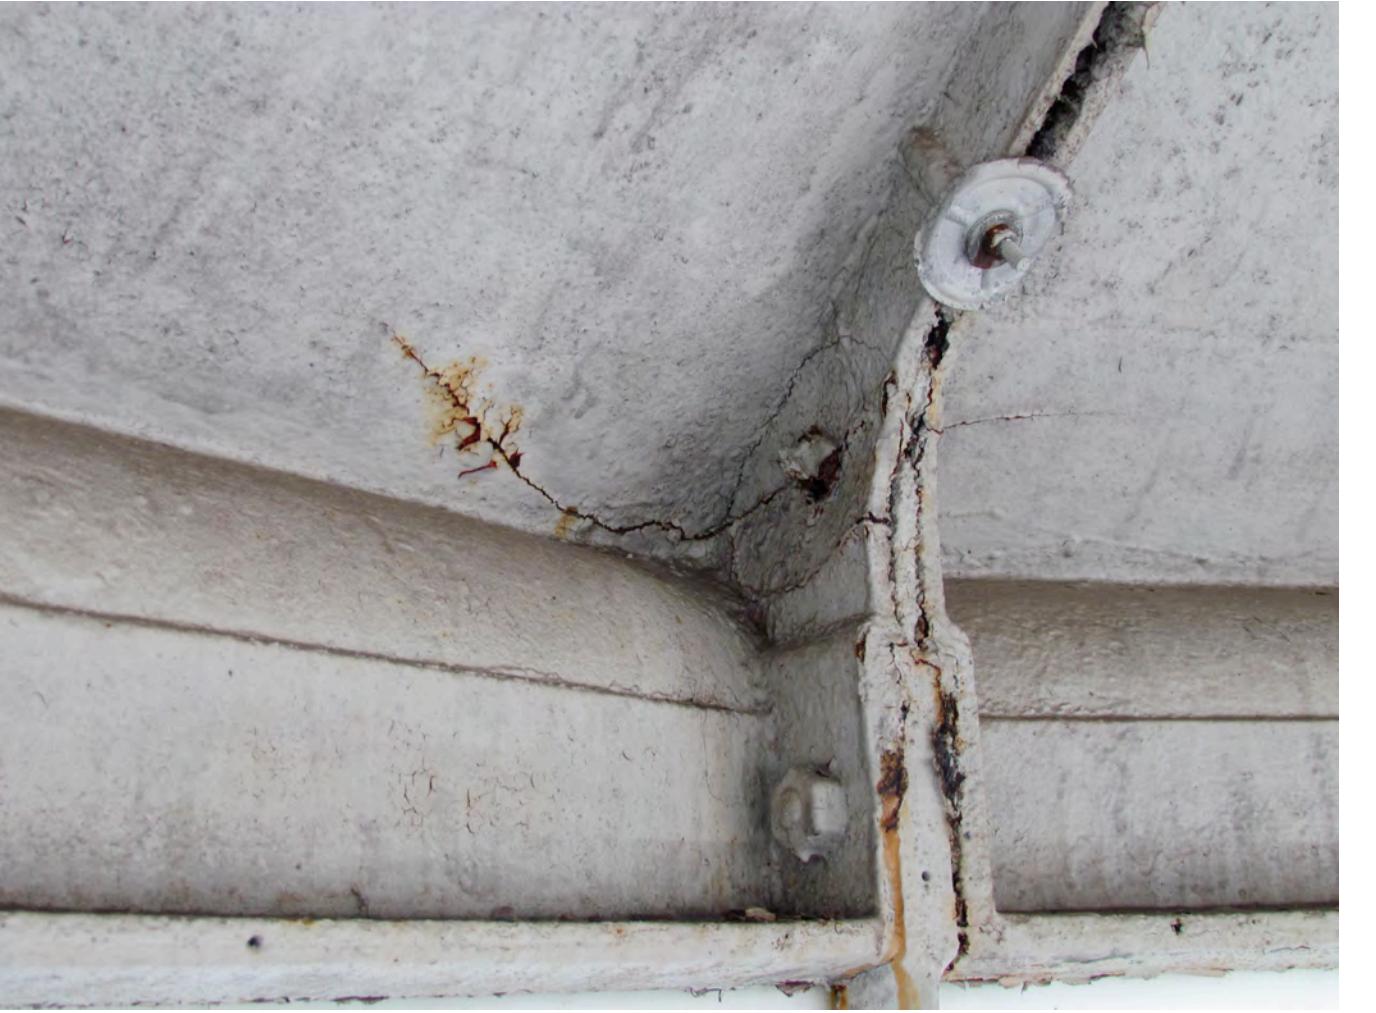
7 CRACKED CAST IRON PANEL, PAINT FAILURE & GALVANIC CORROSION
LANTERN ROOF

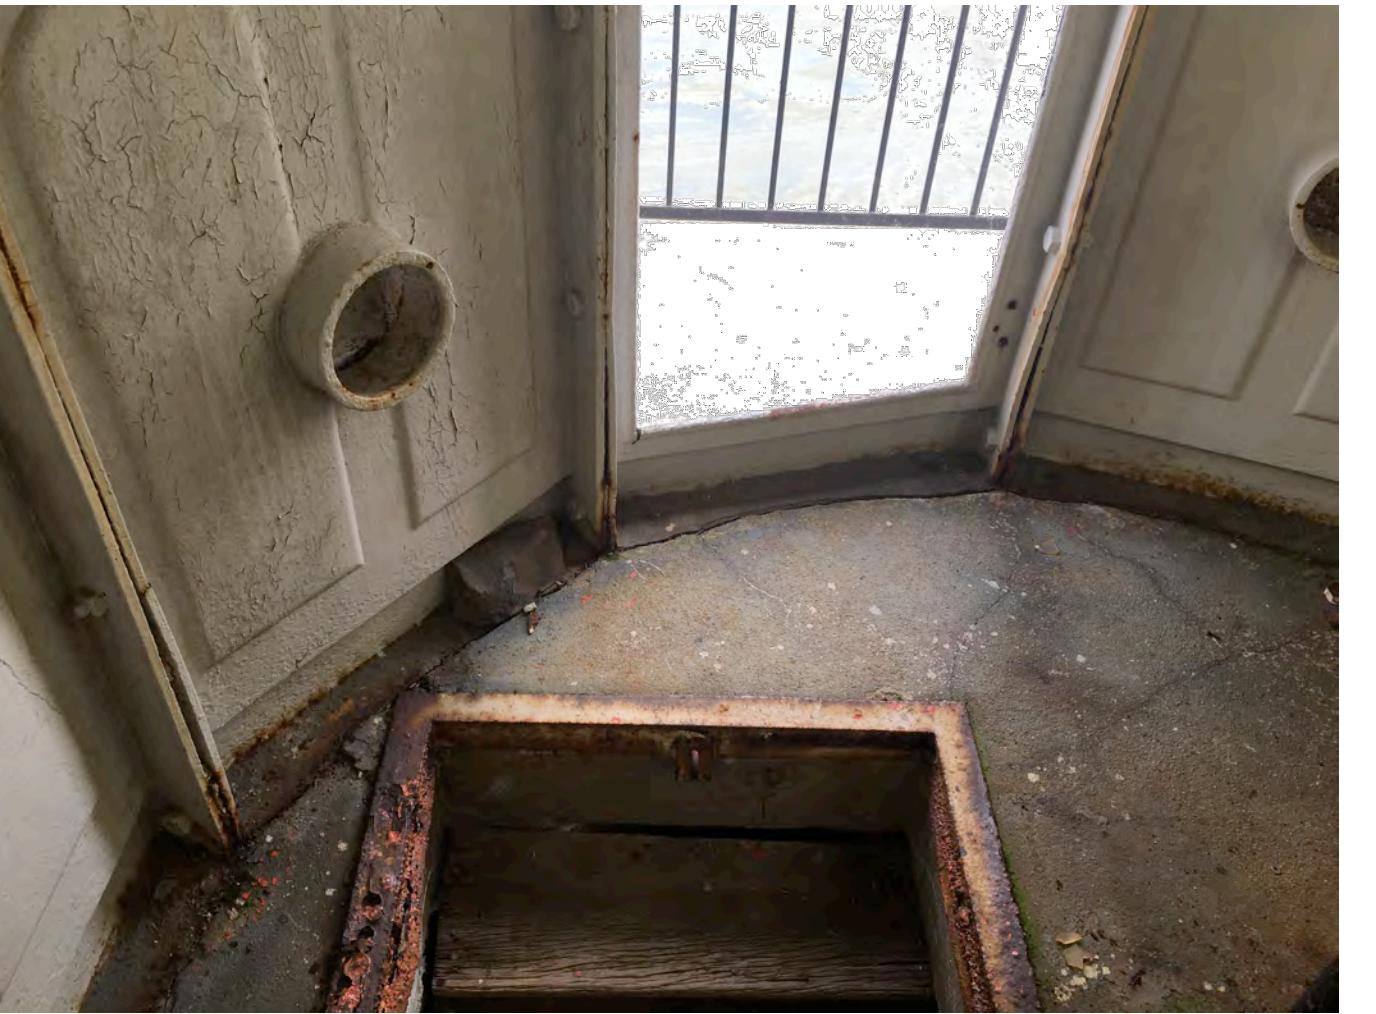
11 PAINT FAILURE, CORROSION OF UNDERLYING METAL & SEPARATION B/N LANTERN & DECK
LANTERN PARAPET WALL & OBSERVATION DECK HATCH

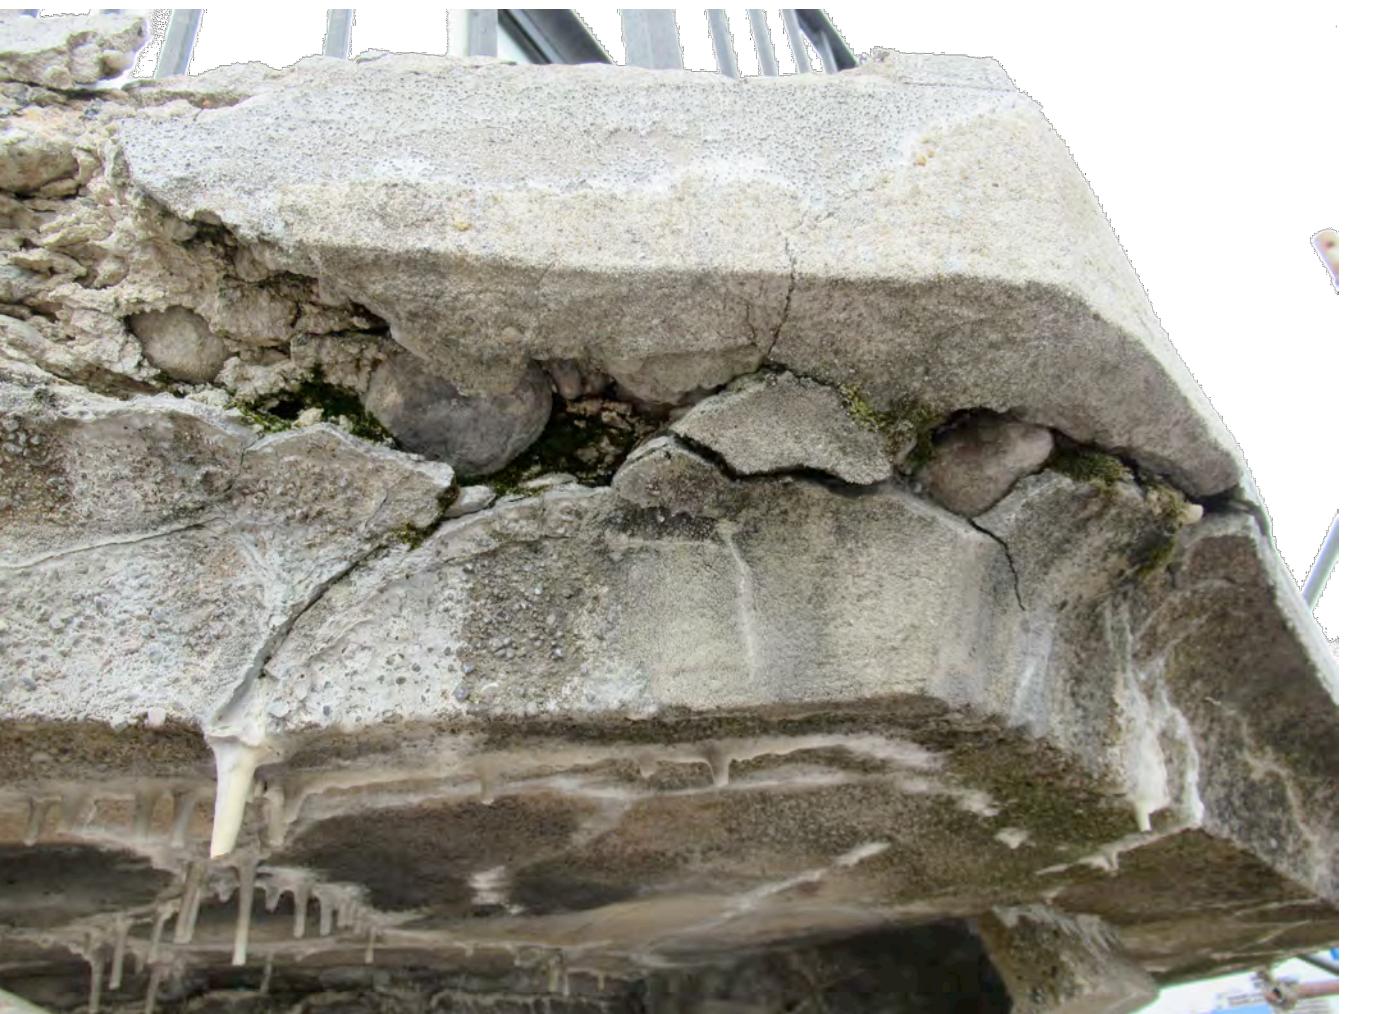
15 DETERIORATED MASONRY MORTAR JOINTS
OBSERVATION DECK

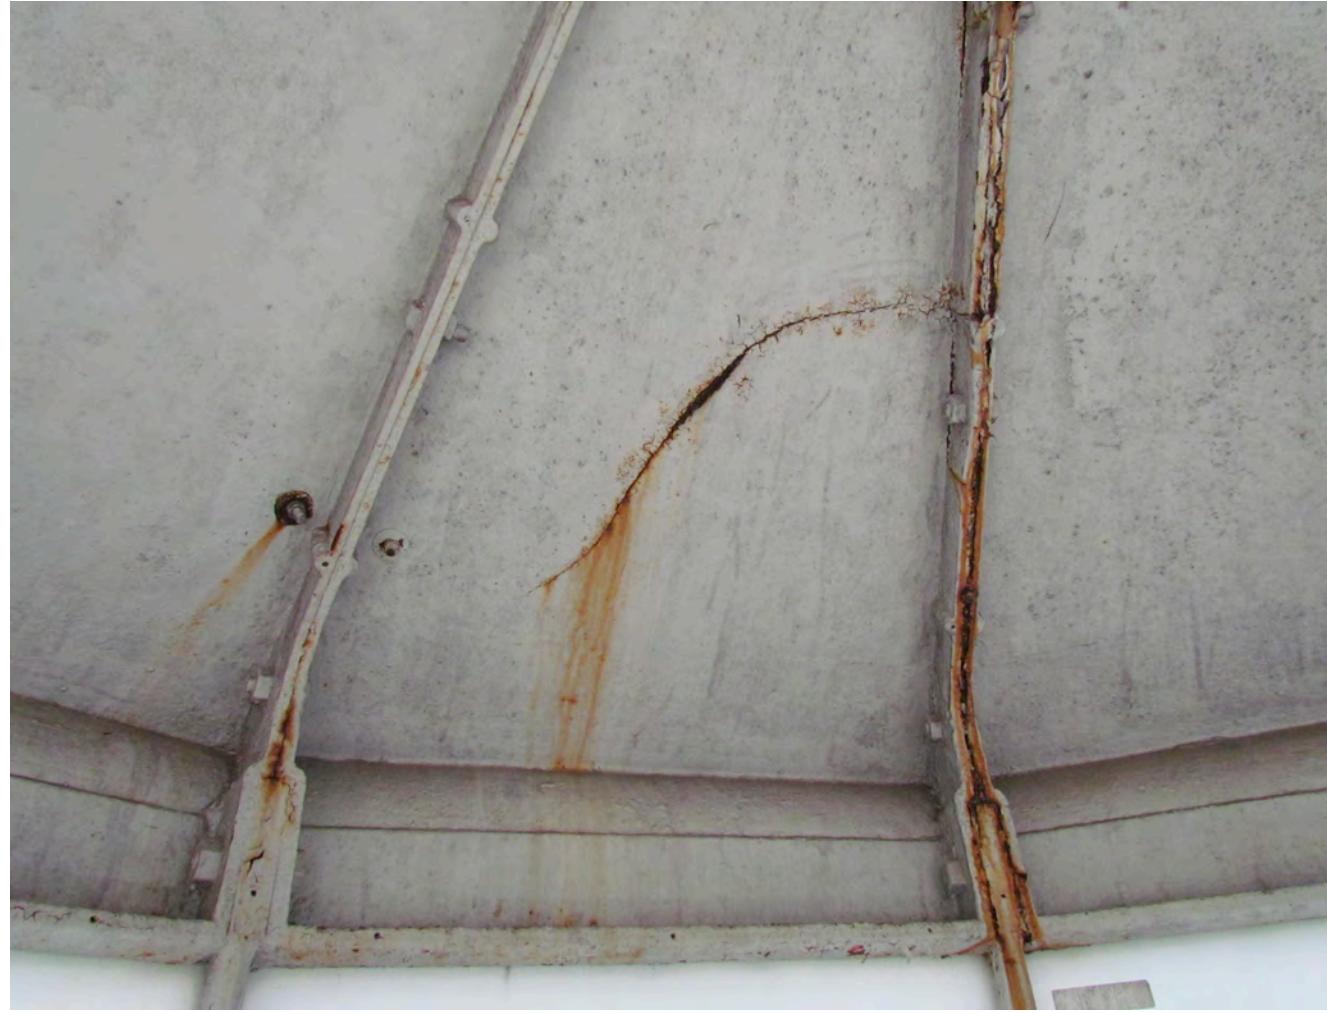
8 CRACKED CAST IRON PANEL, PAINT FAILURE & GALVANIC CORROSION
LANTERN ROOF

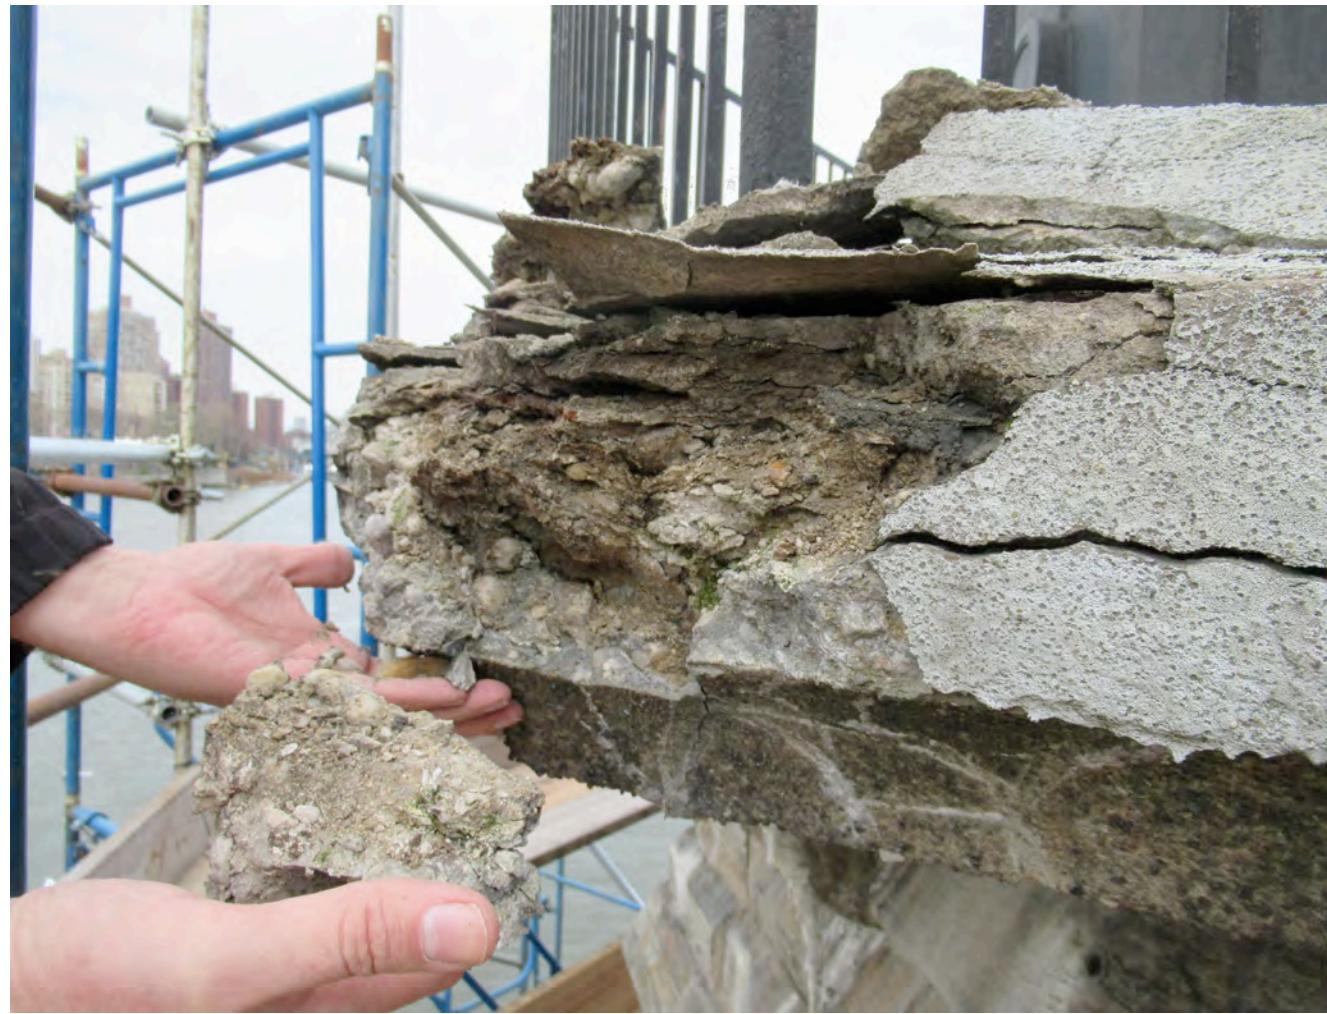
12 SEVERELY CRACKED, SPALLED CONCRETE & DELAMINATED TRAFFIC SURFACE
OBSERVATION DECK

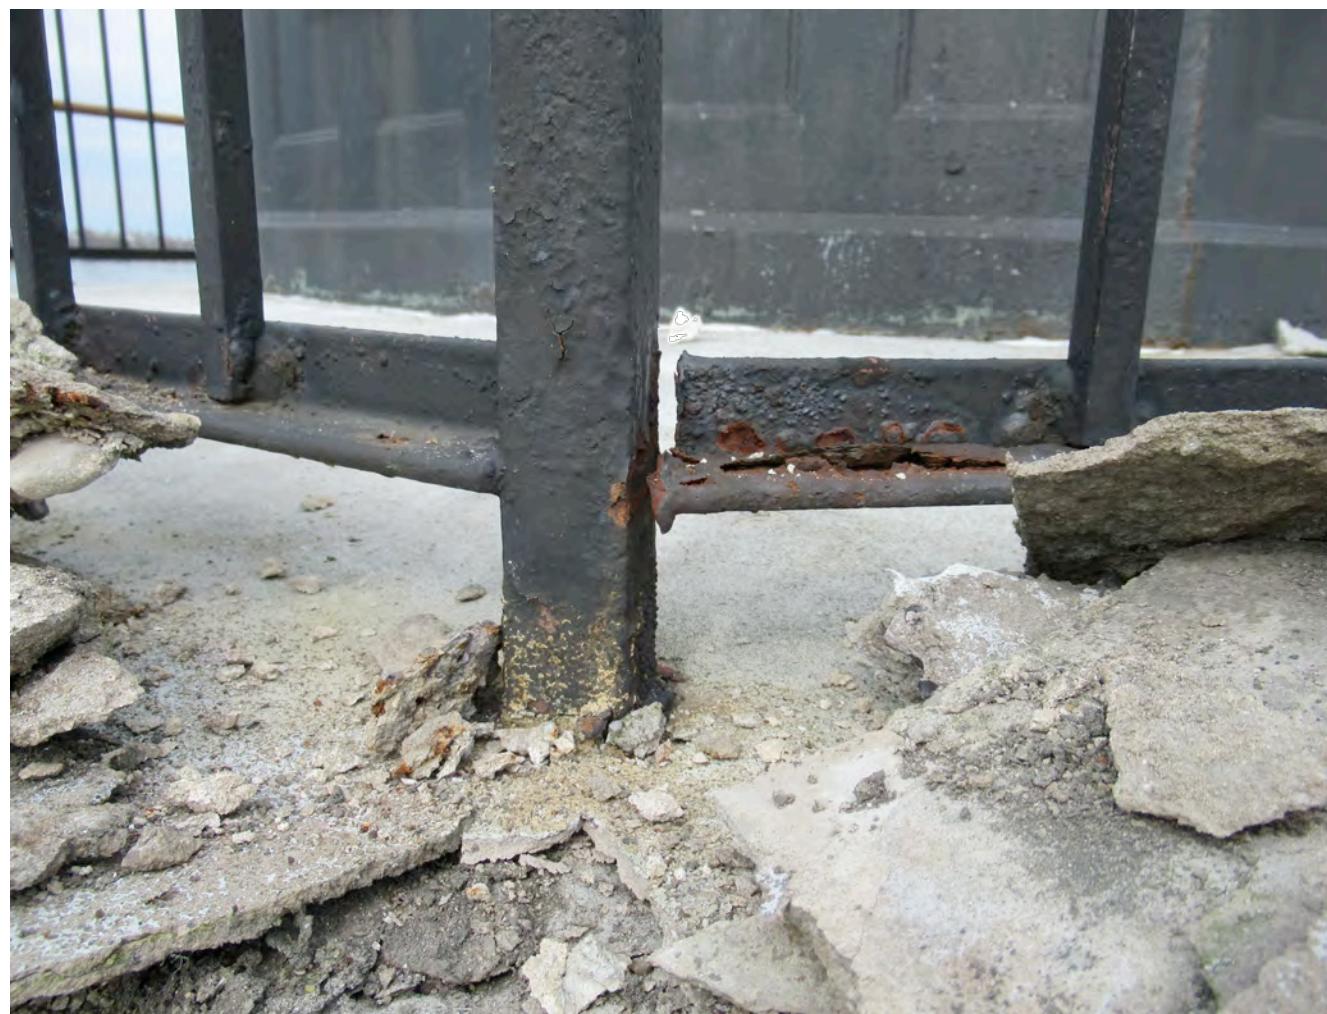
16 PAINT FAILURE, CORROSION OF UNDERLYING METAL & CONNECTION FAILURE
METAL RAILING
