# CONDITIONS REPORT & DESIGN MEMORANDUM

## STEAM TUNNEL ASSESSMENT ROOSEVELT ISLAND, NEW YORK

**ROOSEVELT ISLAND OPERATING CORPORATION**  
591 MAIN STREET  
ROOSEVELT ISLAND  
NEW YORK, NEW YORK 10044

*17 November 2014  
Project # 100444601*

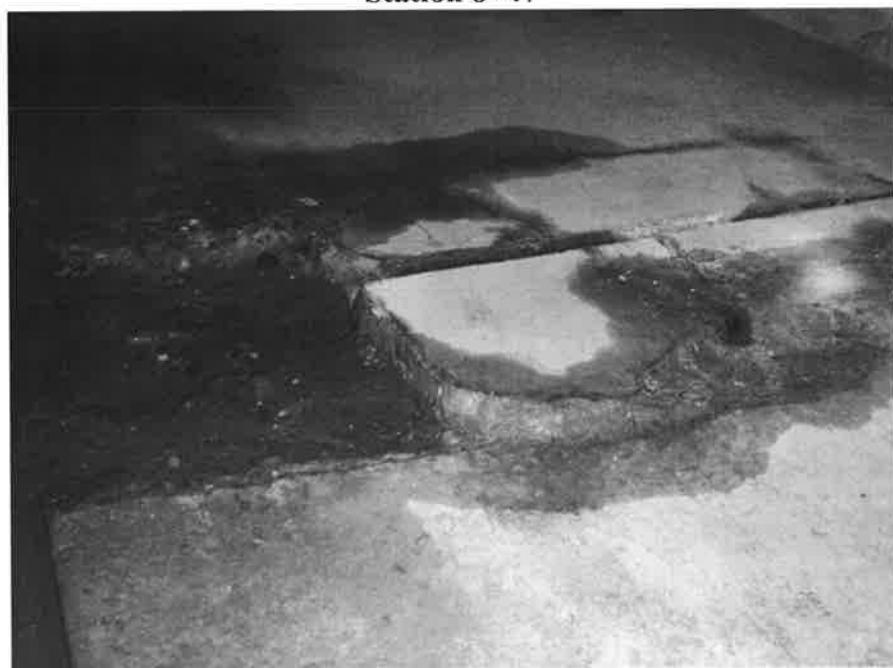
**Station 8+47**

**Direction:** Western Wall (In-Land)**Comments:** Concrete Spalling

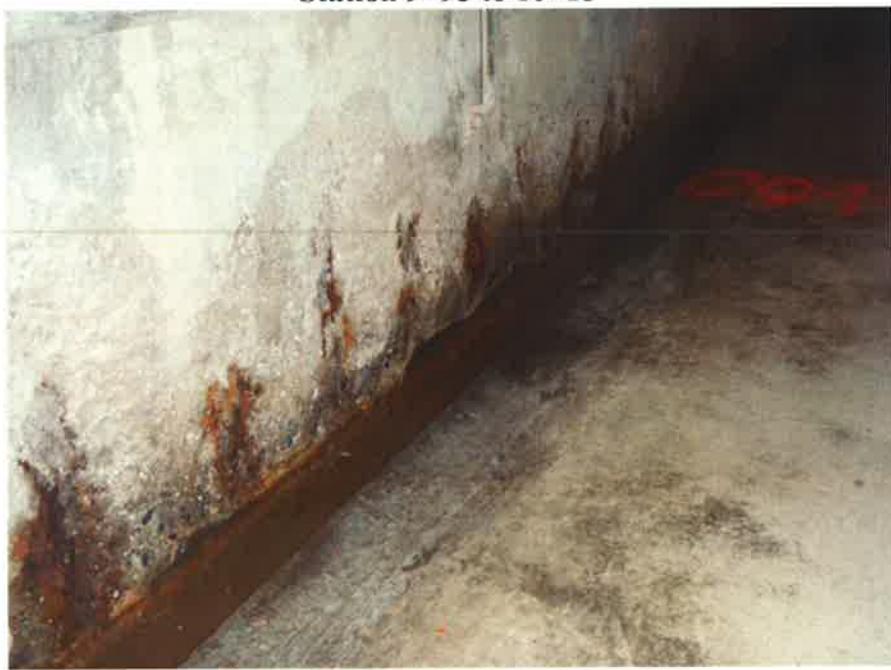
**Station 11+18**

**Direction:** Western Wall (In-Land)**Comments:** Spalling, Re-Bar Exposed and Corroded

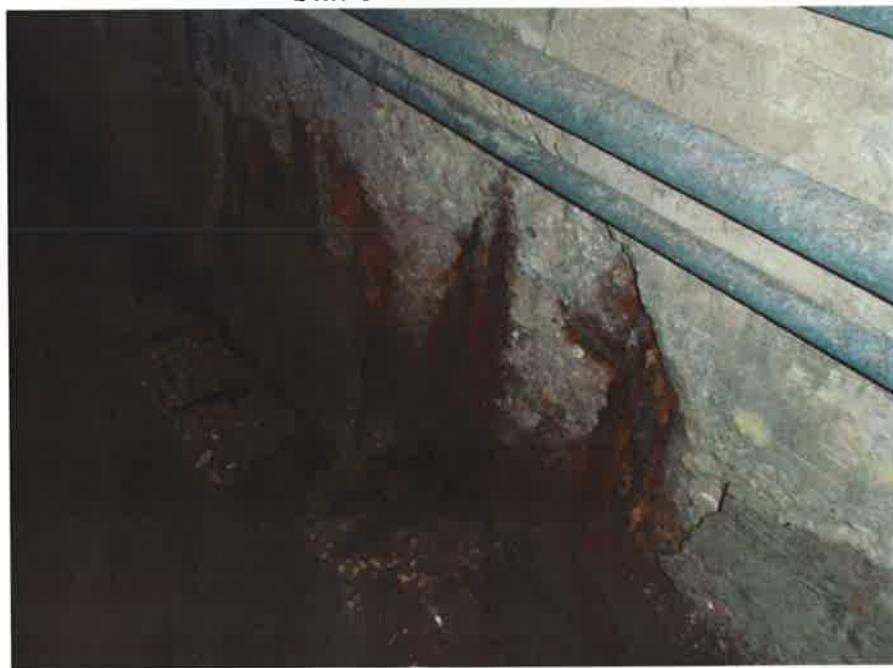
**Station 14+24 to 15+00**

**Direction:** Western Wall (In-Land)**Comments:** Concrete Spalling, Re-Bar Exposed and Corroded

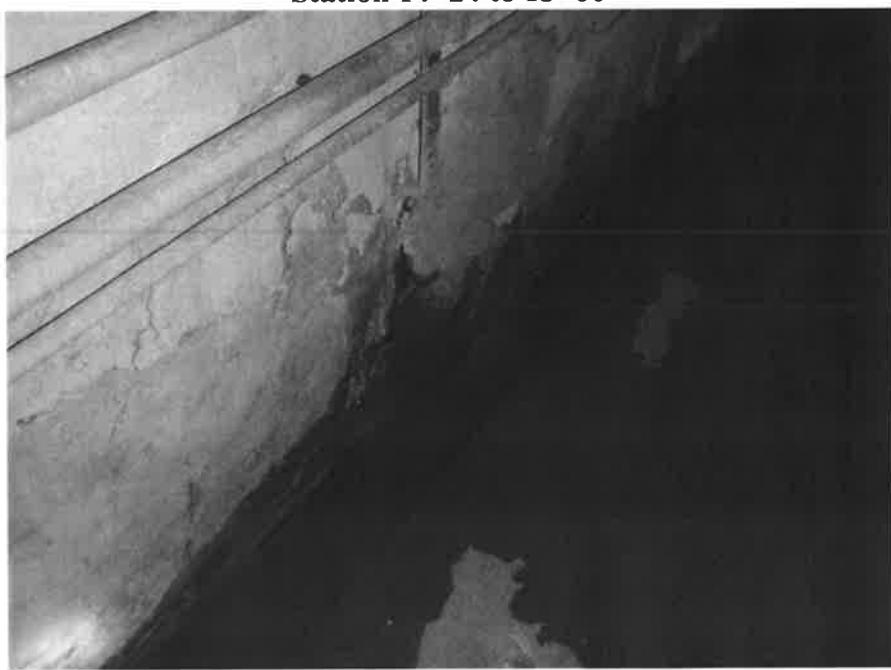
**Station 15+00**

**Direction:** Western Wall (In-Land)**Comments:** Spalling, Re-Bar Exposed and Corroded

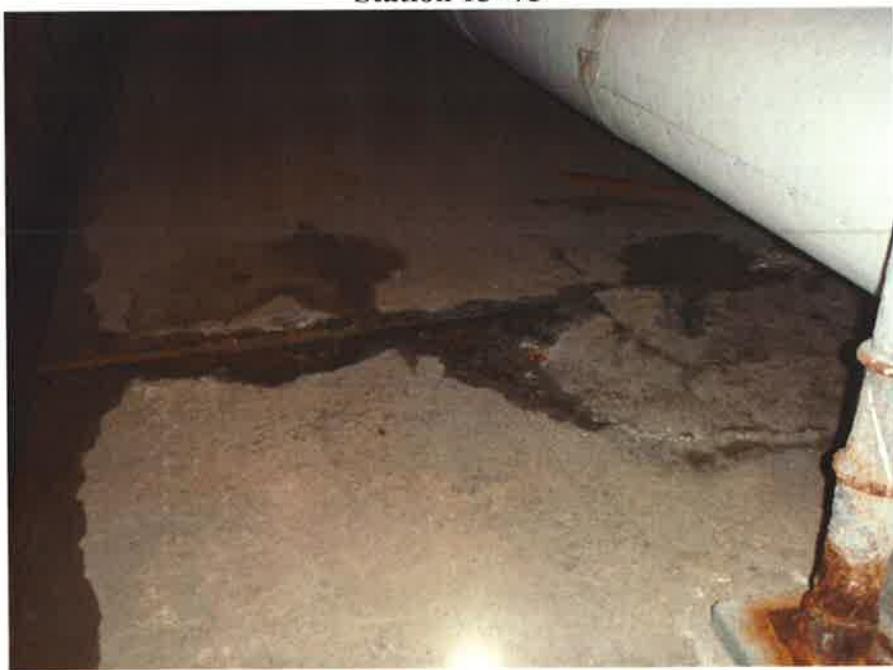
**Station 15+88 to 16+00**

**Direction:** Tunnel Floor**Comments:** Floor Slab Raised at Joint, Cracking, Loose Concrete

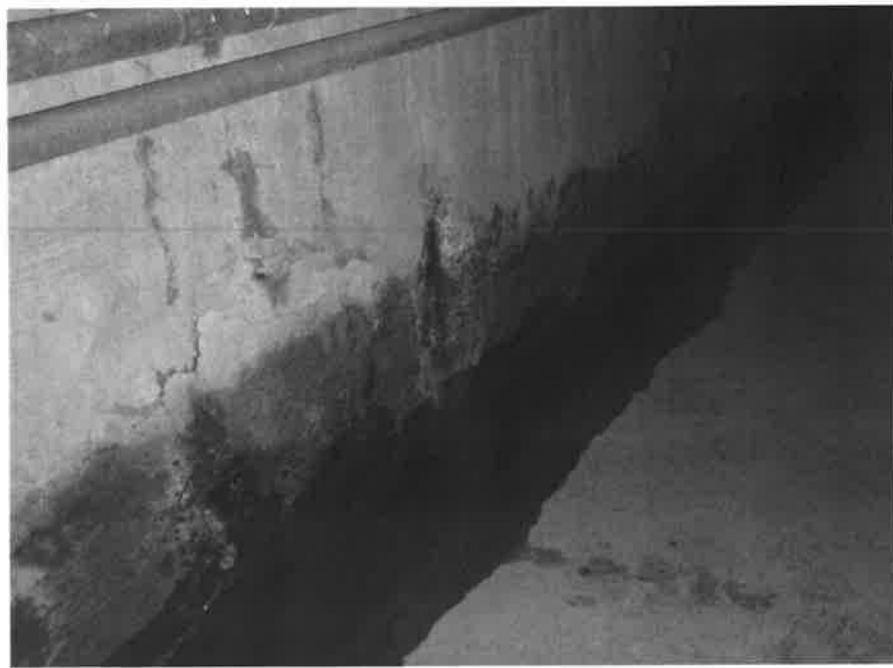
**Station 16+95**

**Direction:** Western Wall (In-Land)**Comments:** Spalling, Re-Bar Exposed and Corroded

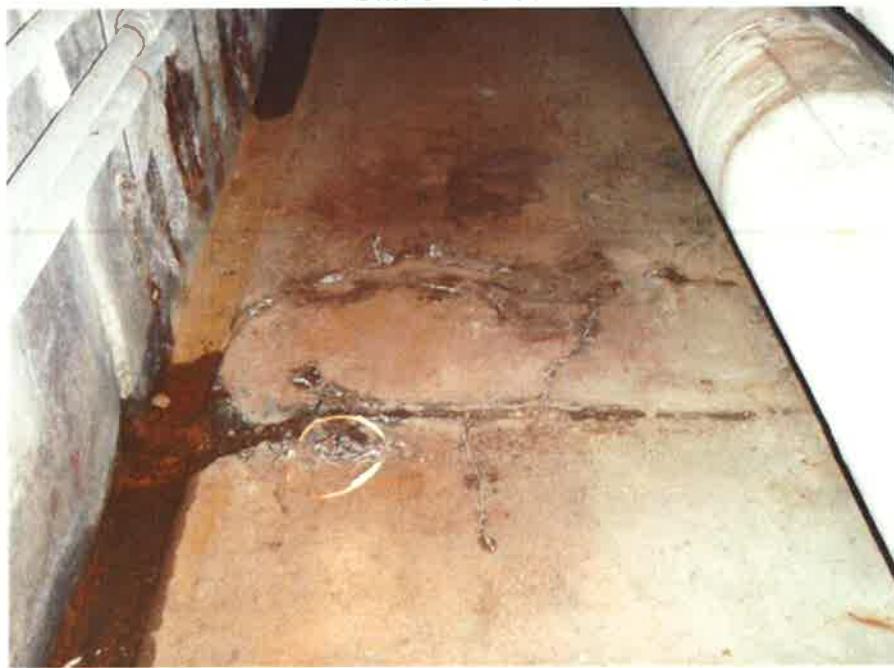
**Station 19+45**

**Direction:** Tunnel Floor**Comments:** Floor Slab Raised at Joint, Cracking, Loose Concrete

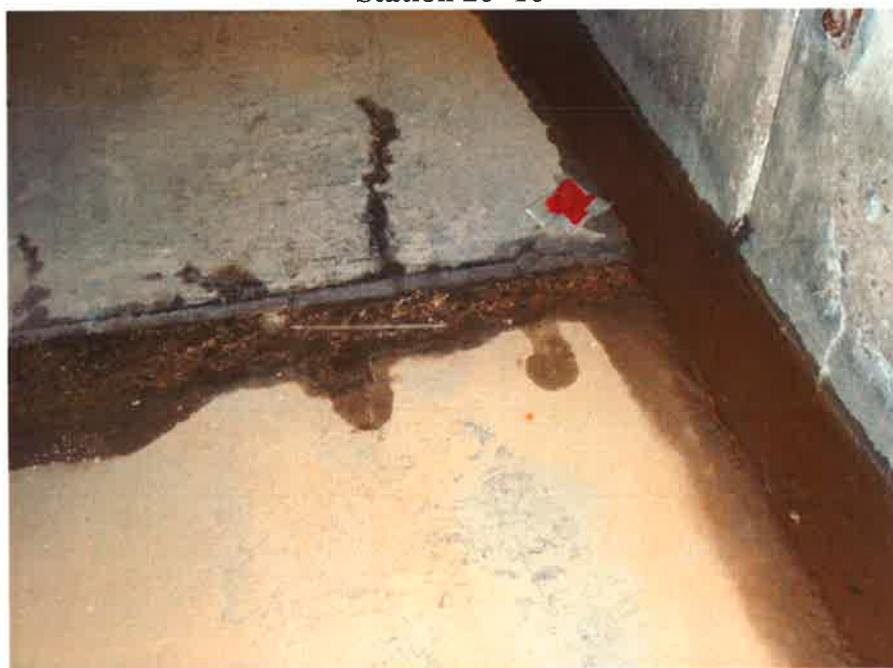
**Direction:** Tunnel Floor**Comments:** Floor Slab Raised at Joint, Cracking, Loose Concrete**Station 20+15 to 20+22**

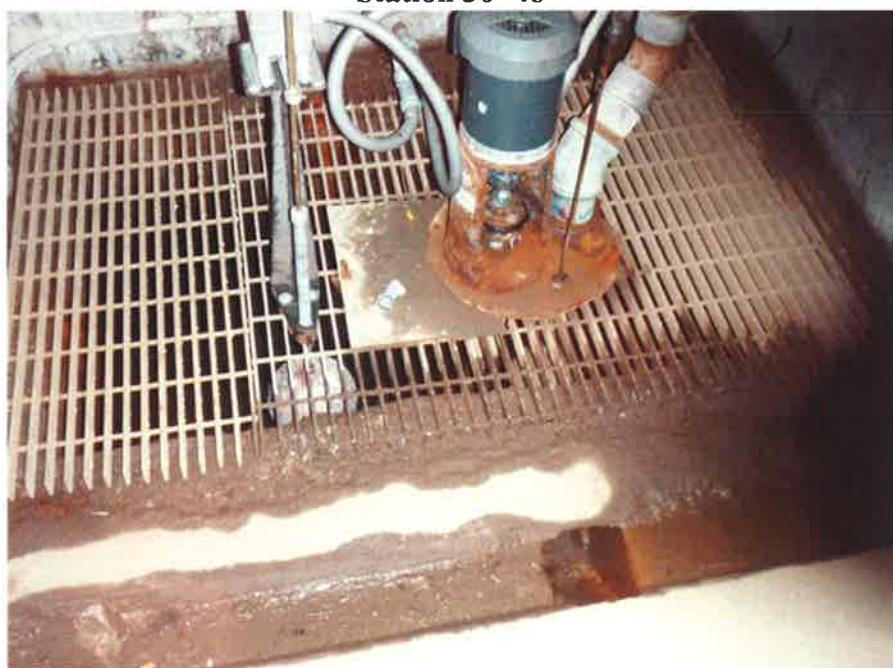
**Direction:** Air Vent 7**Comments:** Sump Pump in Working Order**Station 30+50 to 30+65**

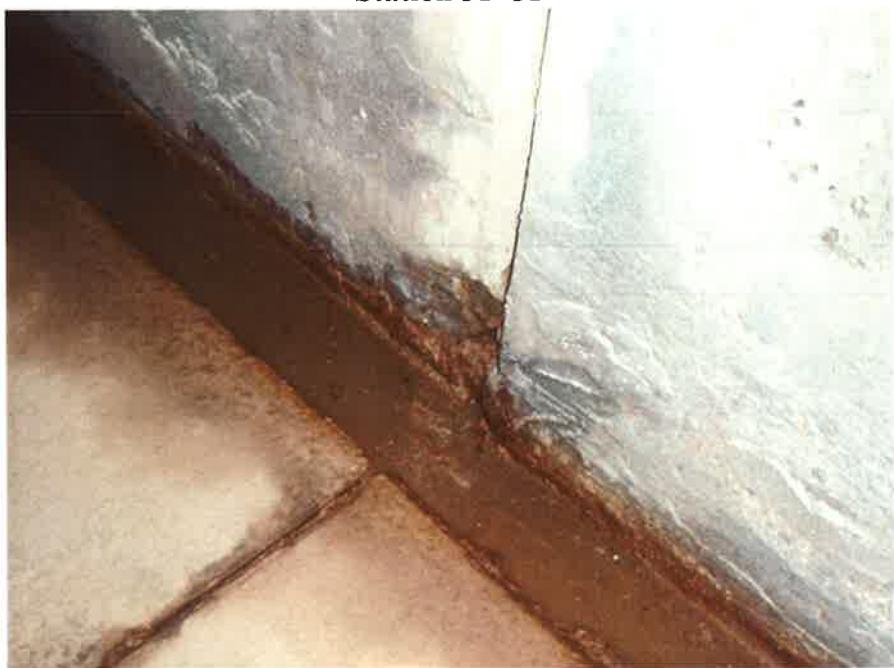
**Direction:** Tunnel Joint**Comments:** Concrete Spalling**Station 31+83 to 31+85**

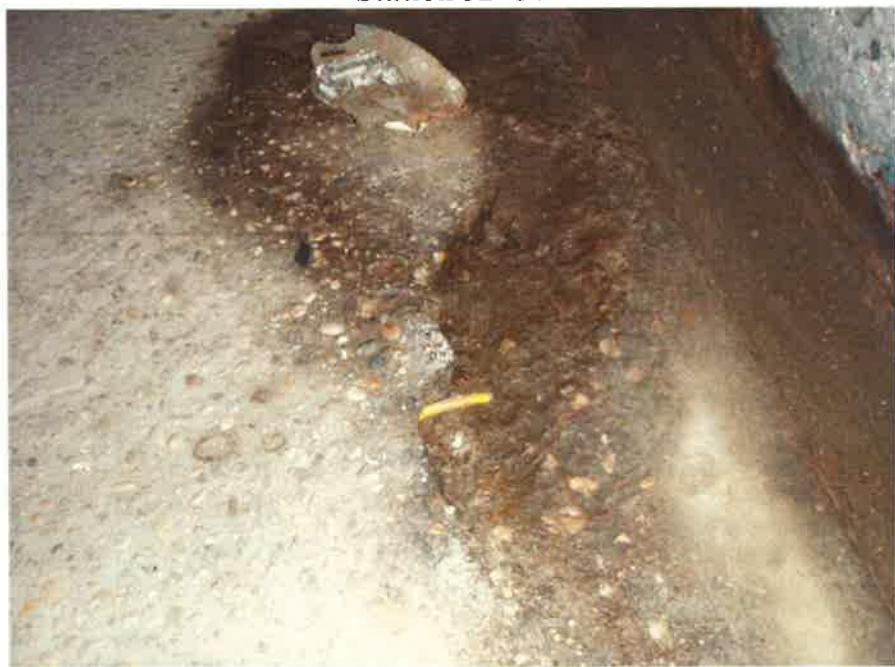
**Station 33+02**

**Direction:** Tunnel Floor**Comments:** Floor Slab Cracking

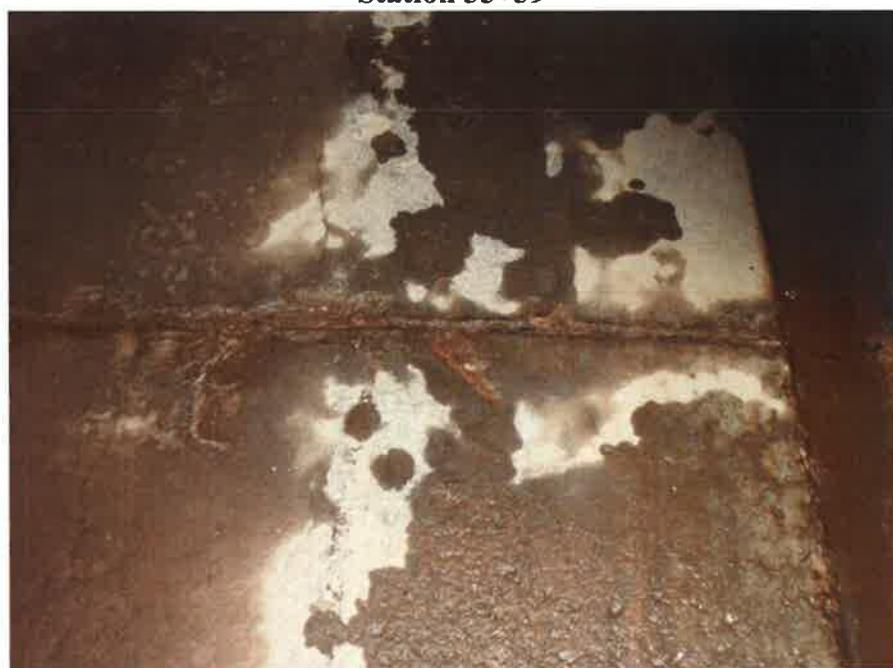
**Direction:** Tunnel Floor**Comments:** Floor Slab Cracked and Displaced**Station 35+52 to 35+63**

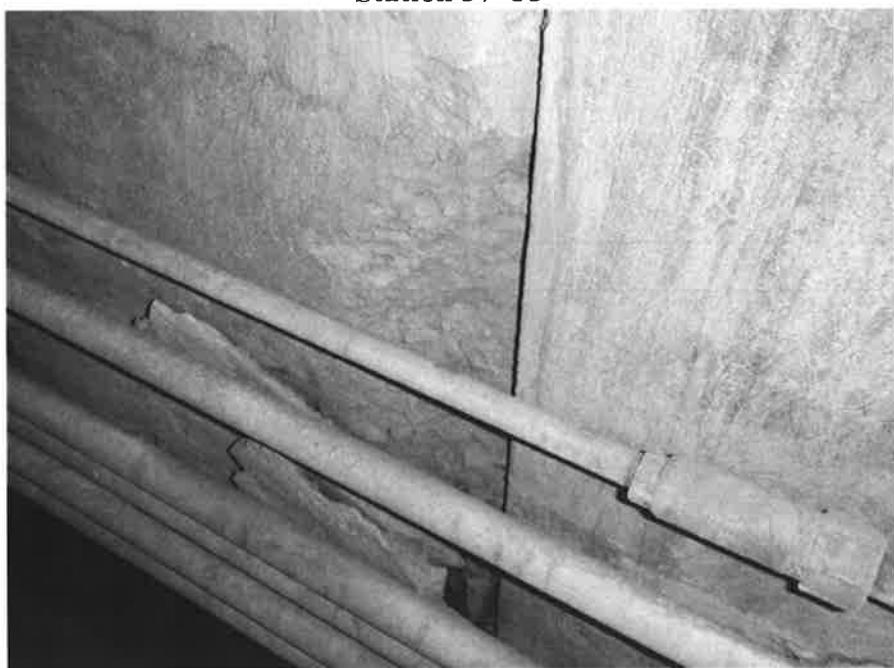
**Direction:** Tunnel Joint**Comments:** Joint Separation, Missing Concrete**Station 38+13**

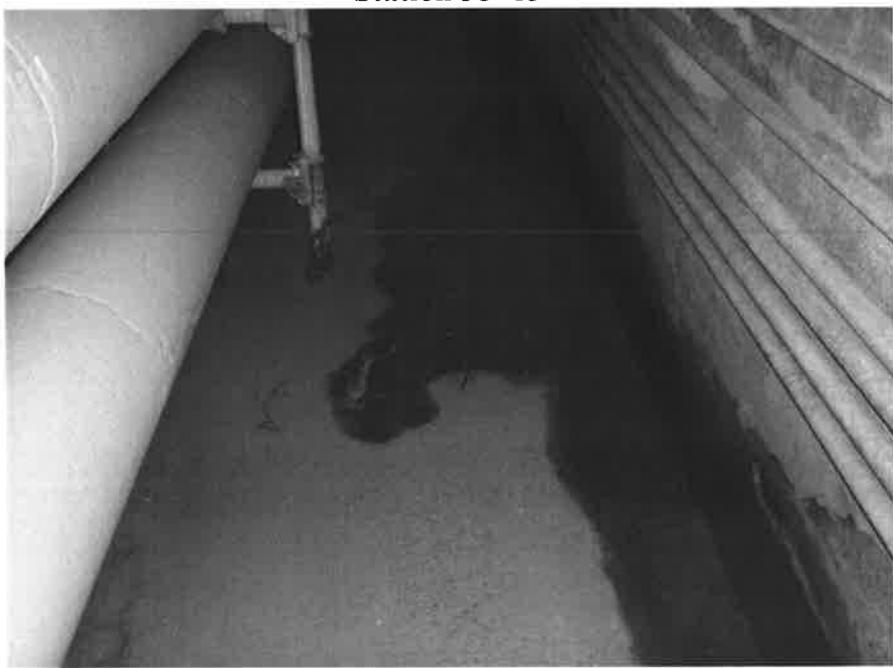
**Station 38+03 to 38+55**

**Direction:** Tunnel Floor**Comments:** Floor Slab Cracked

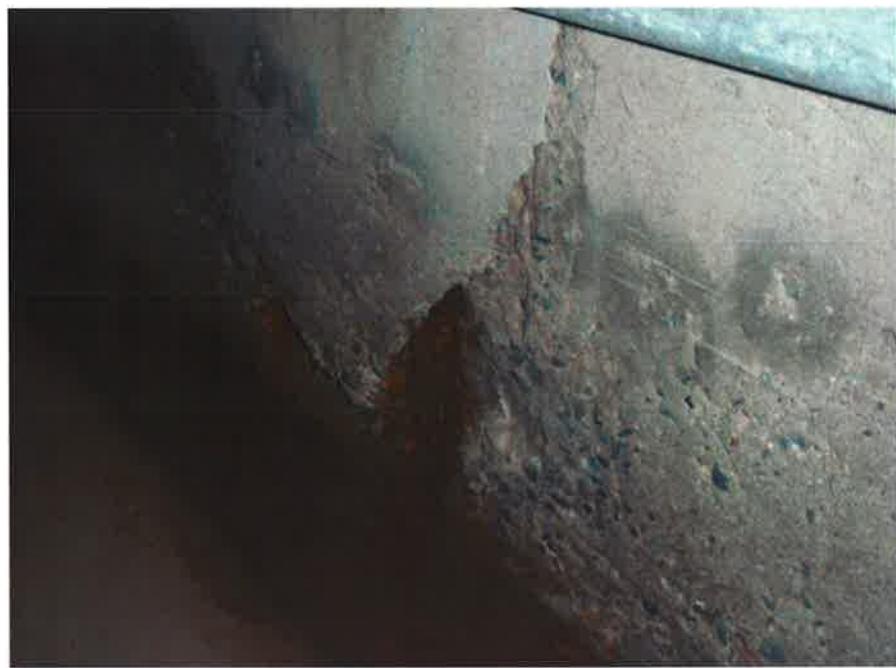
**Direction:** Western Wall (In-Land)**Comments:** Spalling, Loose Concrete**Station 39+23**

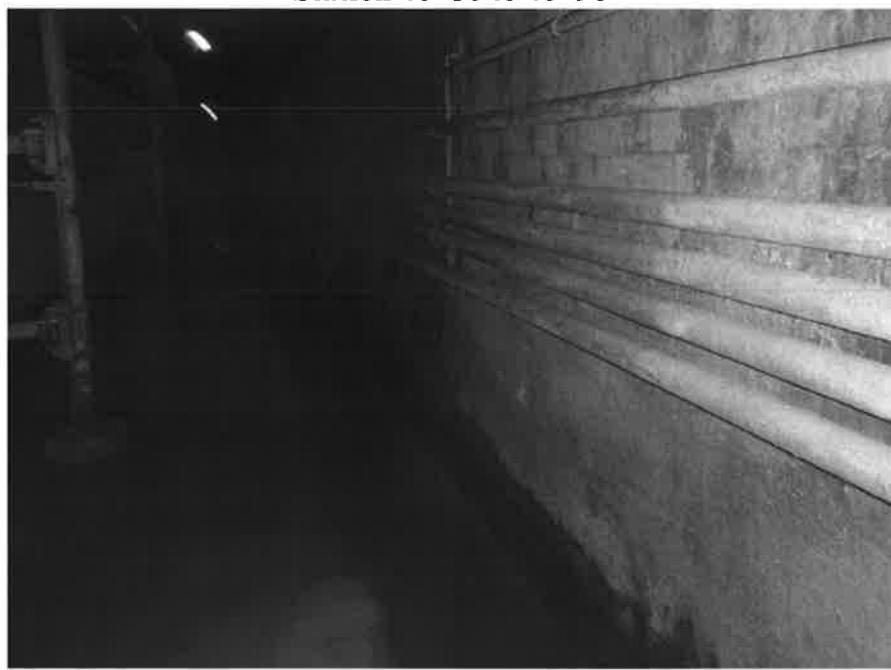
**Direction:** Western Wall (In-Land)**Comments:** Concrete Spalling**Station 40+98 to 41+40**

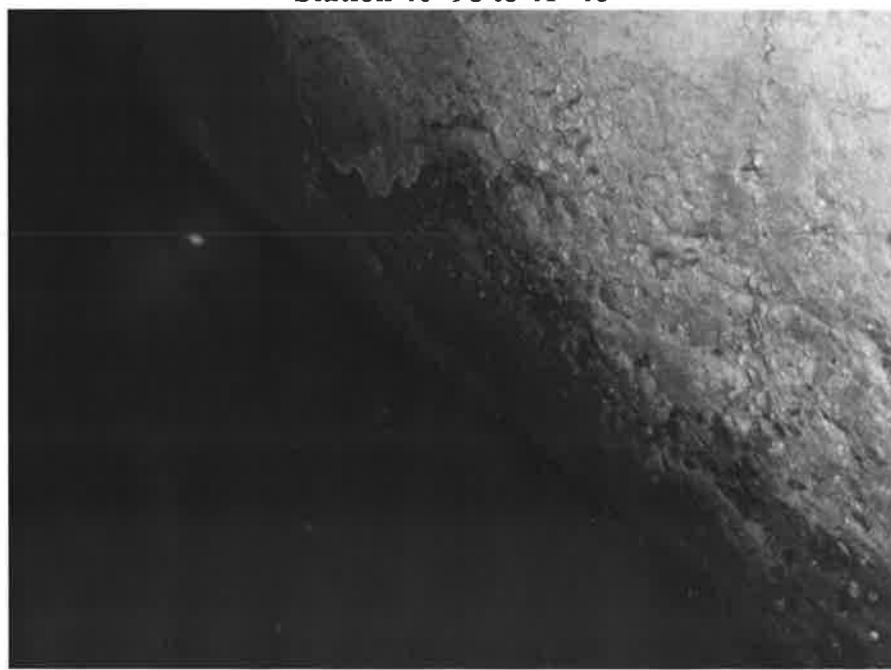
**Station 42+24**

**Direction:** Western Wall (In-Land)**Comments:** Concrete Spalling

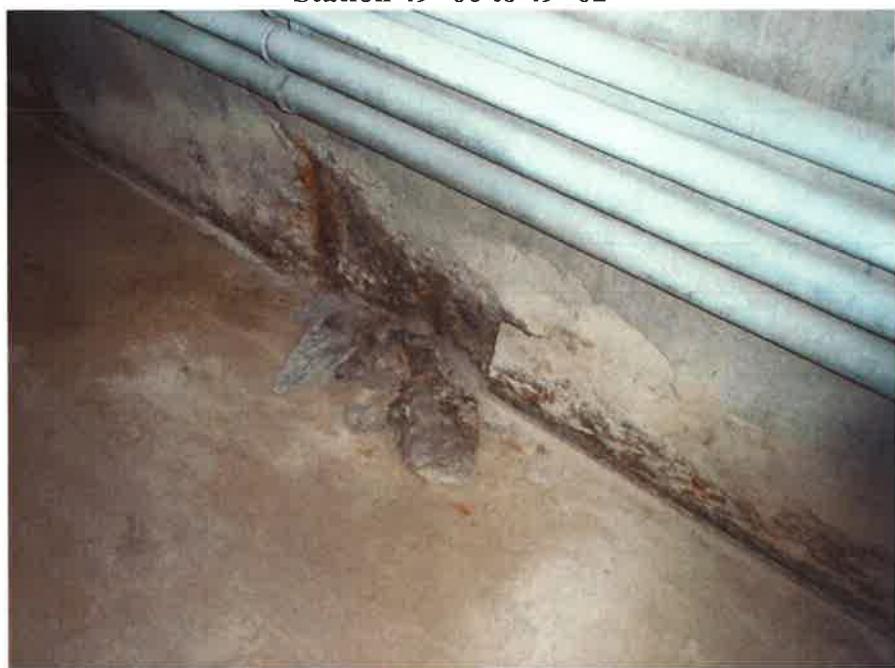
**Direction:** Western Wall (In-Land)**Comments:** Concrete Spalling**Station 49+17**

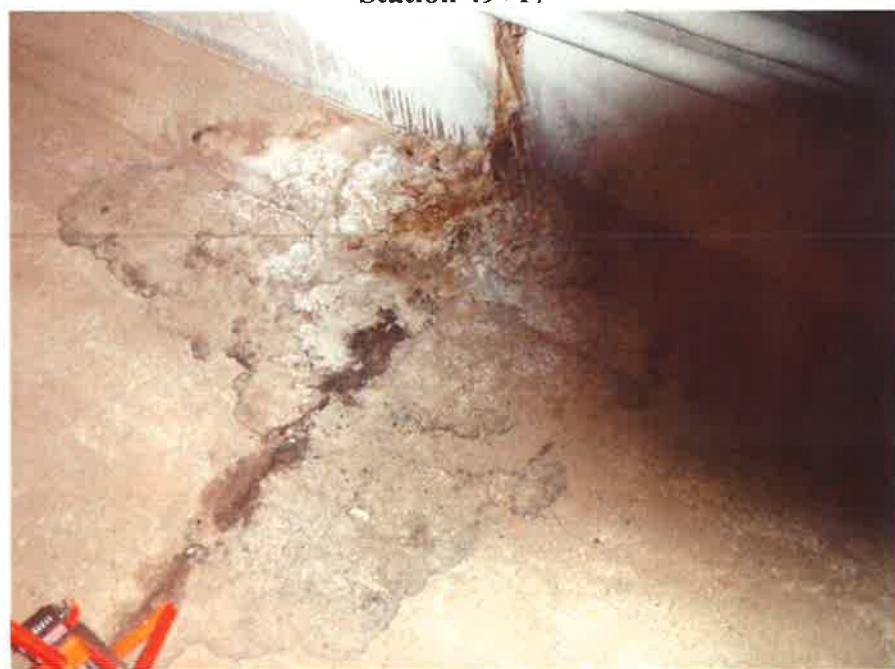
**Station 50+06**

**Direction:** Tunnel Floor**Comments:** Joint Filler

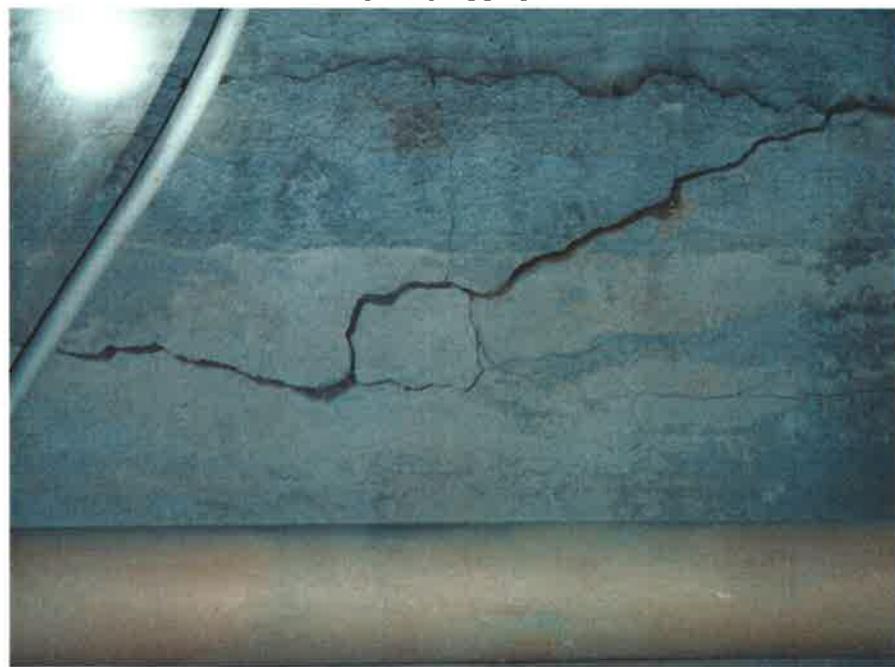
**Station 56+52 to 56+55**

**Direction:** Eastern Wall**Comments:** Concrete Cracking

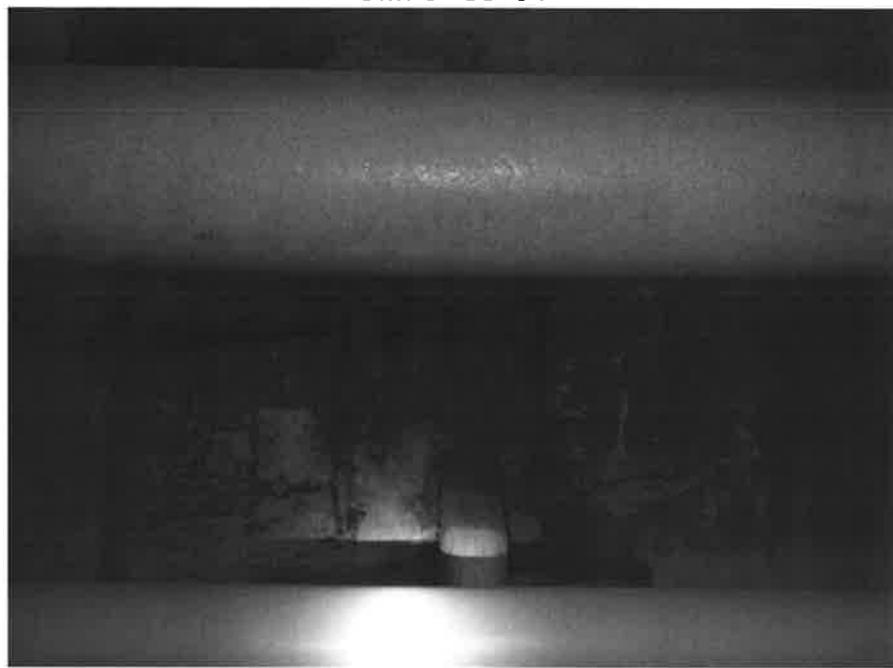
**Direction:** Eastern Wall**Comments:** Concrete Spalling around pipe opening**Station 58+96**

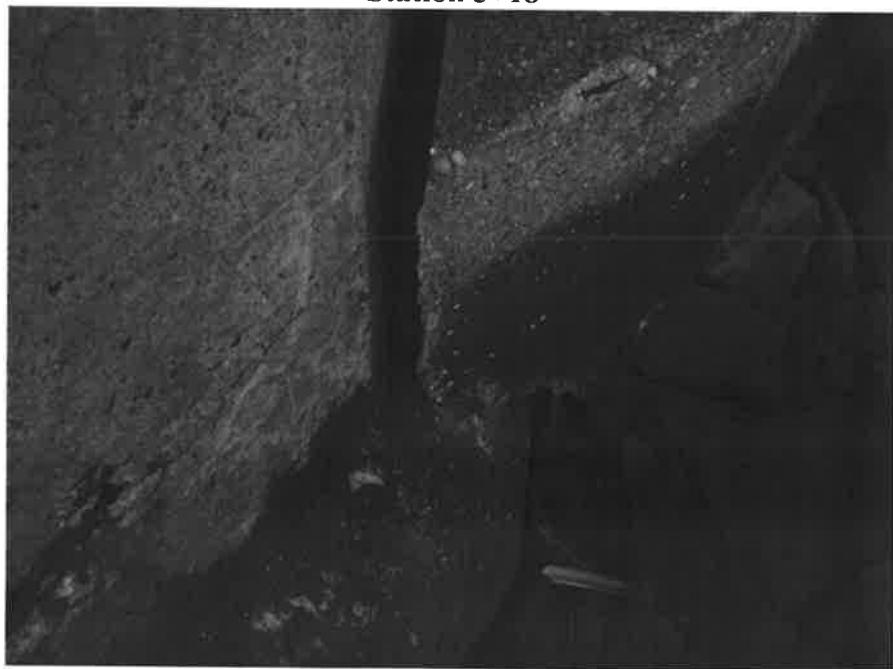
**Station 5+61**

**Direction:** Northern Seawall Terminus

**Comments:** Spalling at Haunch

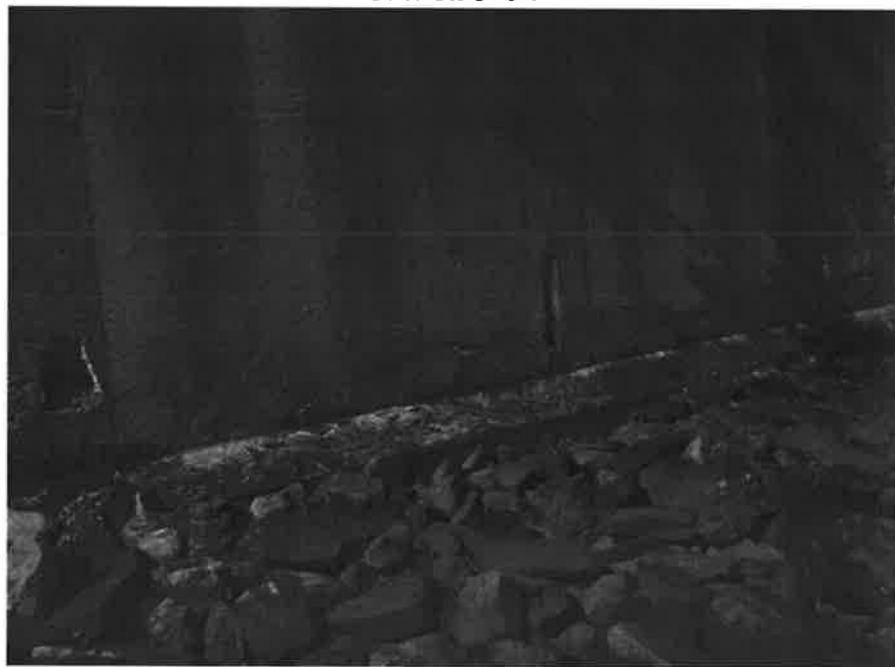
**Station 6+16**

**Direction:** Seawall**Comments:** Concrete Cracks, Imbedded Wood Missing

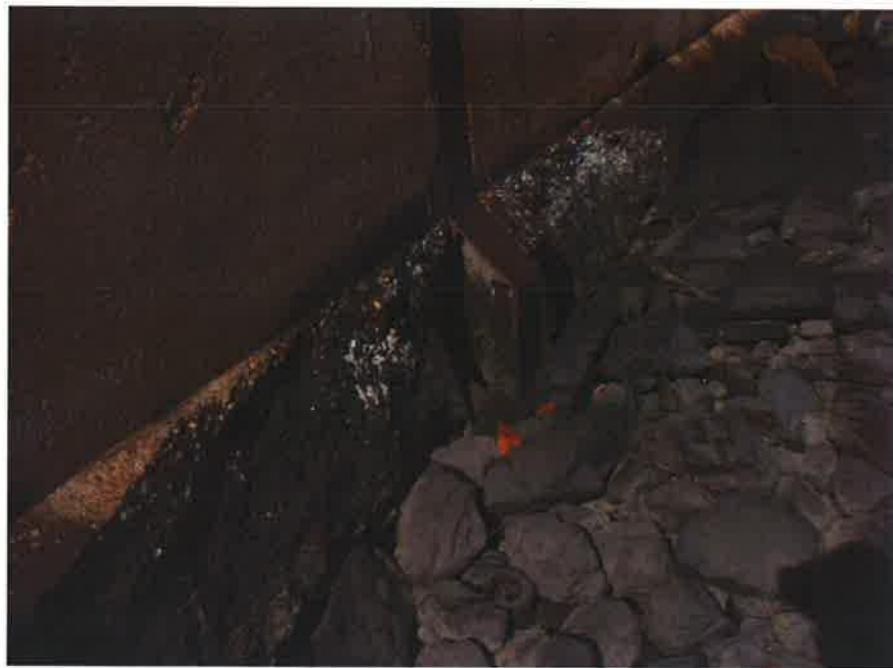
**Direction:** Seawall Joint**Comments:** Spalling at Haunch, Missing Large Sections of Concrete**Station 6+96**

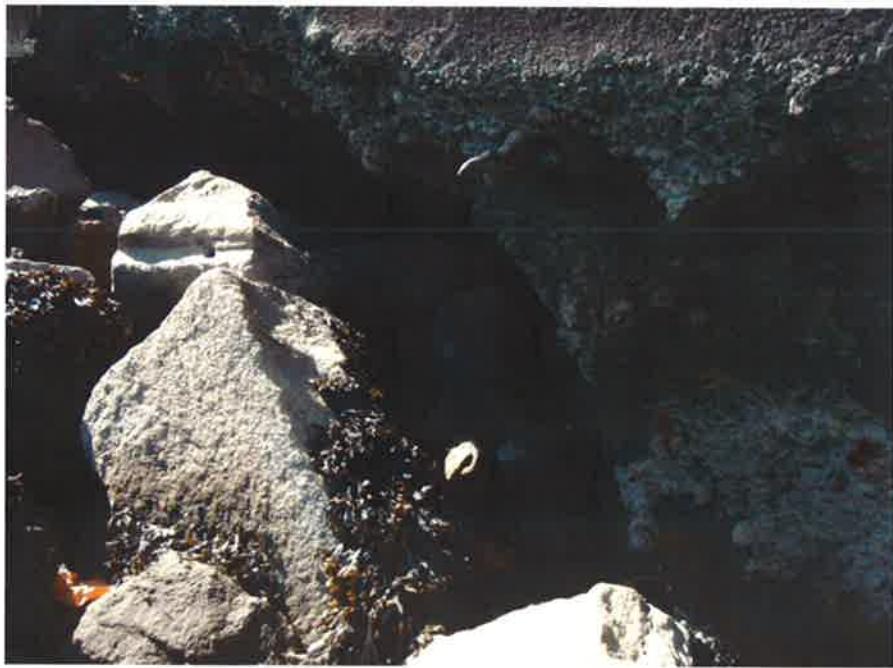
**Station 7+26**

**Direction:** Seawall**Comments:** Missing Rip-Rap, Tunnel Undermined

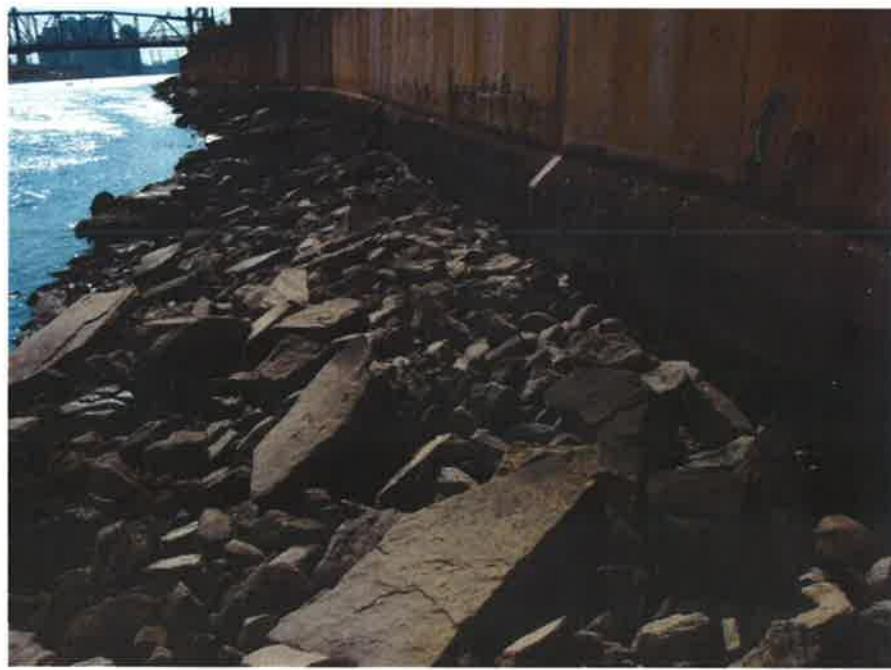
**Station 8+12**

**Direction:** Seawall (Looking South)**Comments:** Missing Rip-Rap, Tunnel Undermined

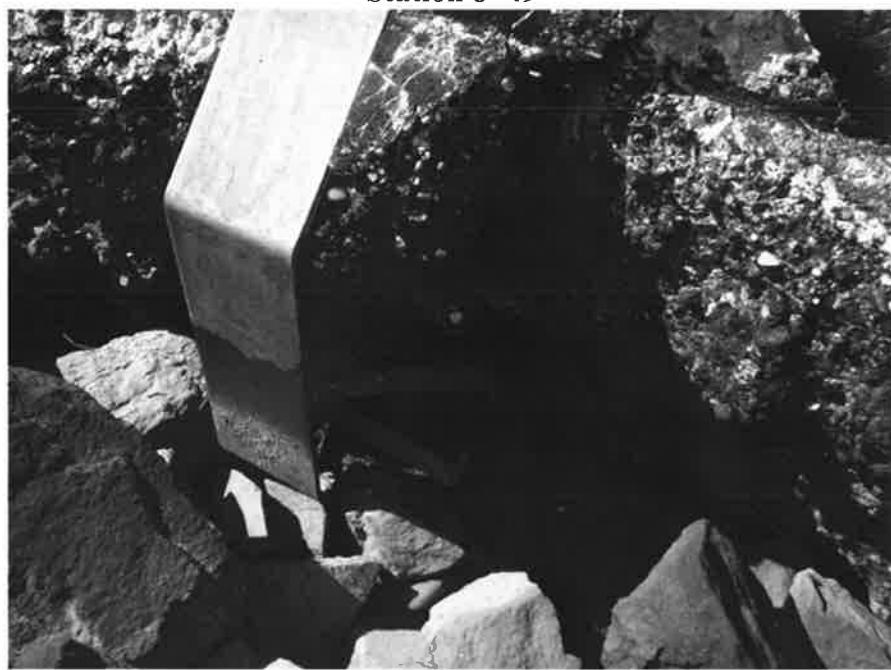
**Direction:** Seawall Joint**Comments:** Spalling at Haunch, Missing Large Sections of Concrete, Tunnel has been Undermined**Station 8+80**

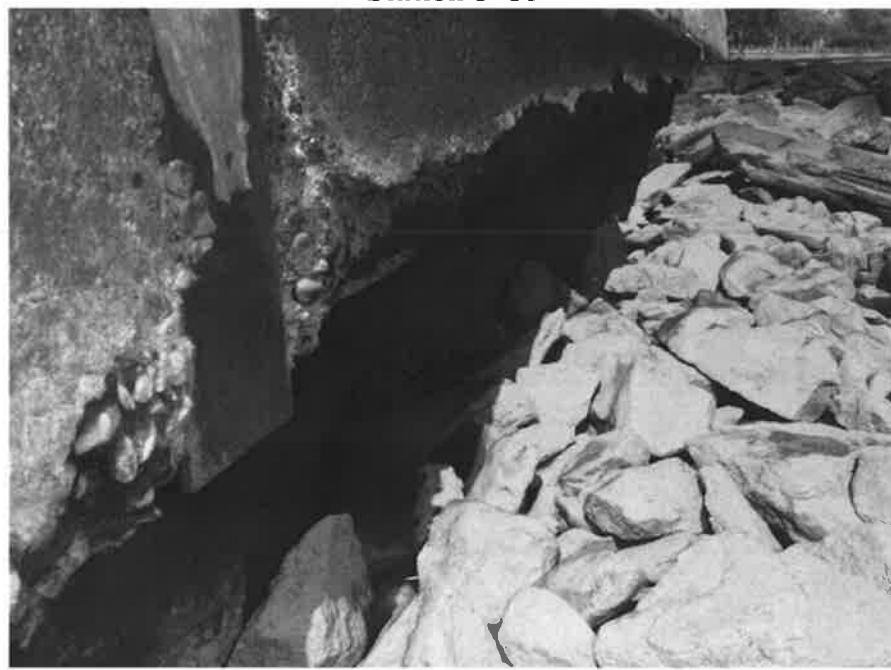
**Station 8+94**

**Direction:** Seawall Joint (Looking North)**Comments:** Spalling at Haunch, Missing Large Sections of Concrete, Tunnel has been Undermined

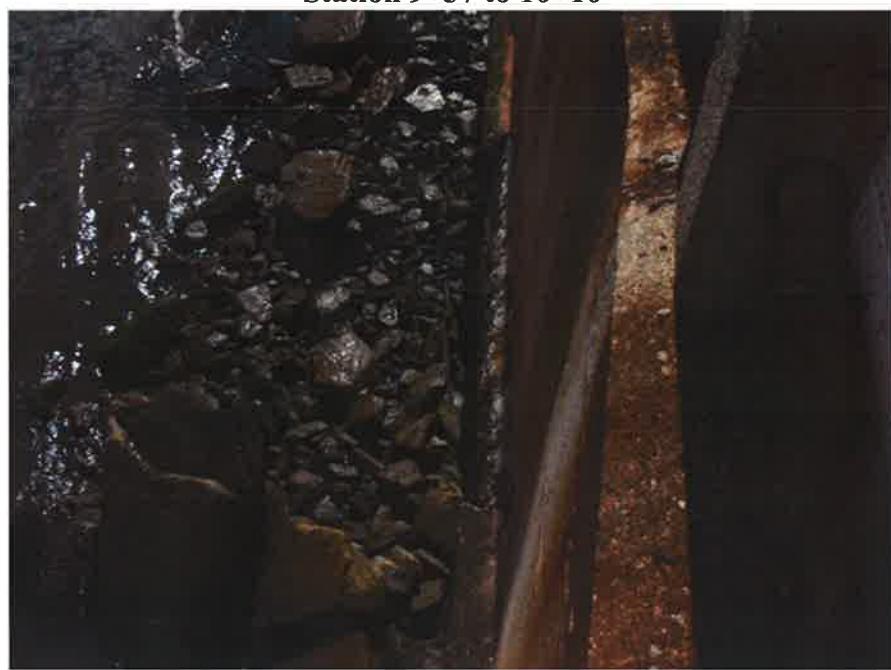
**Direction:** Seawall**Comments:** Spalling at Haunch, Missing Large Sections of Concrete, Tunnel has been Undermined**Station 9+96**

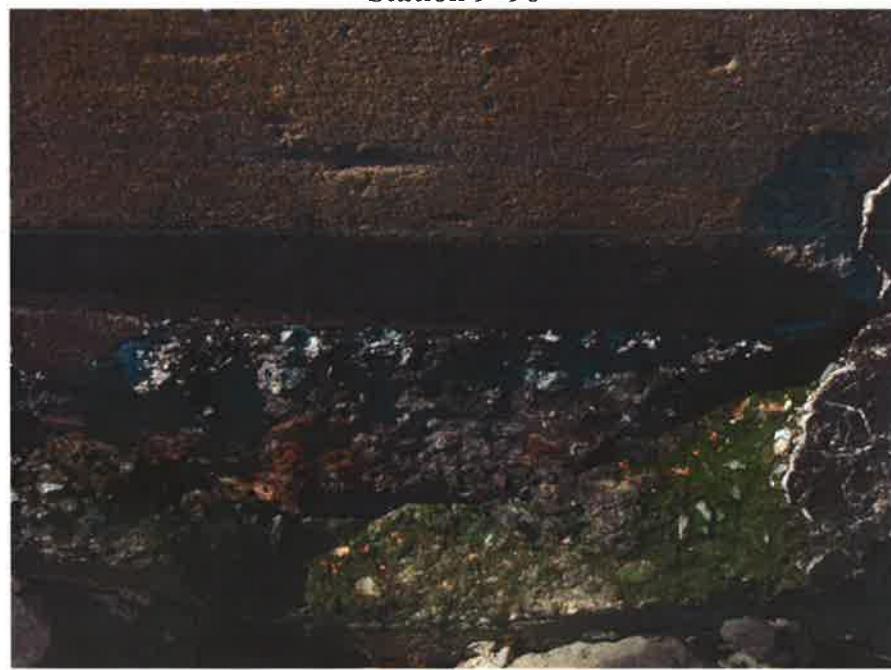
**Station 10+43**

**Direction:** Seawall**Comments:** Spalling at Haunch, Missing Large Sections of Concrete, Tunnel has been Undermined

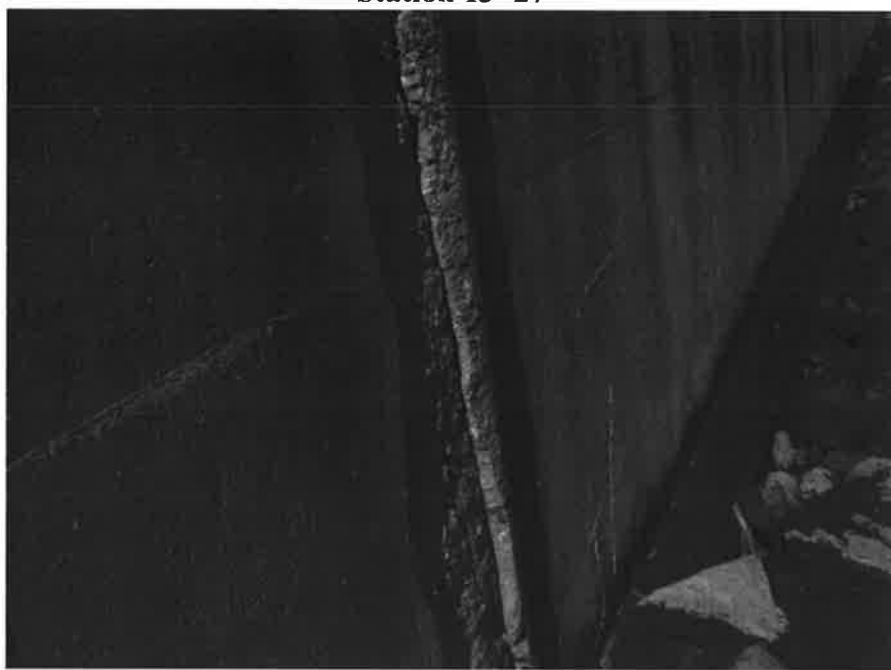
**Direction:** Seawall Joint**Comments:** Concrete Spalling**Station 13+74**

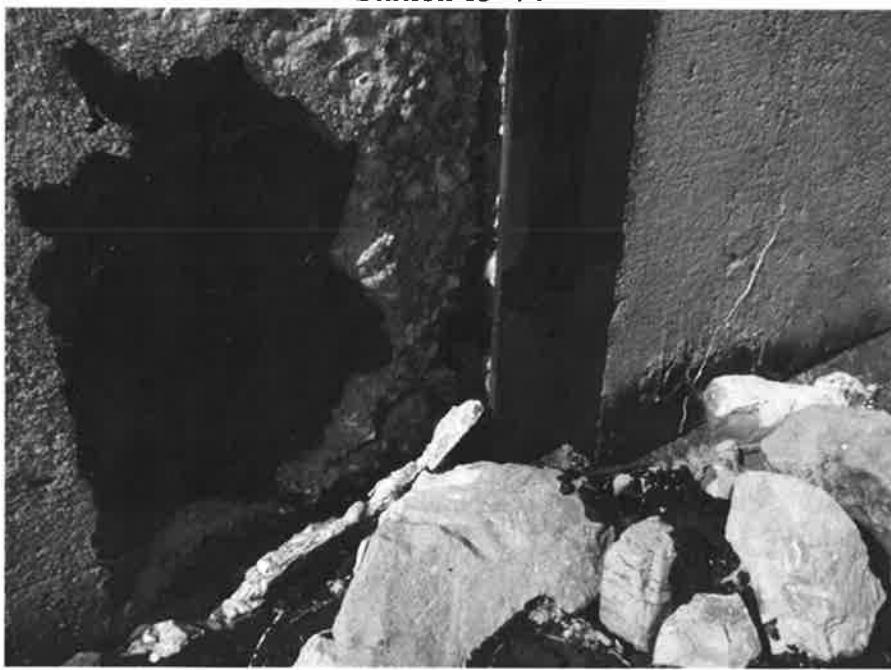
**Station 14+37**

**Direction:** Seawall Joint**Comments:** Concrete Spalling and Repair

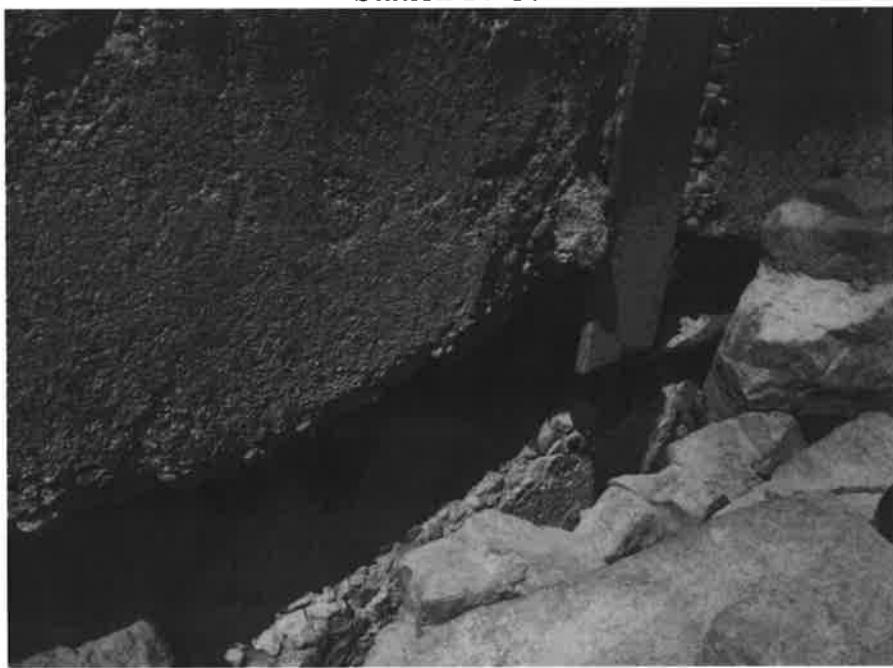
**Station 15+06**

**Direction:** Seawall Joint**Comments:** Concrete Spalling, Loose Sections of Concrete

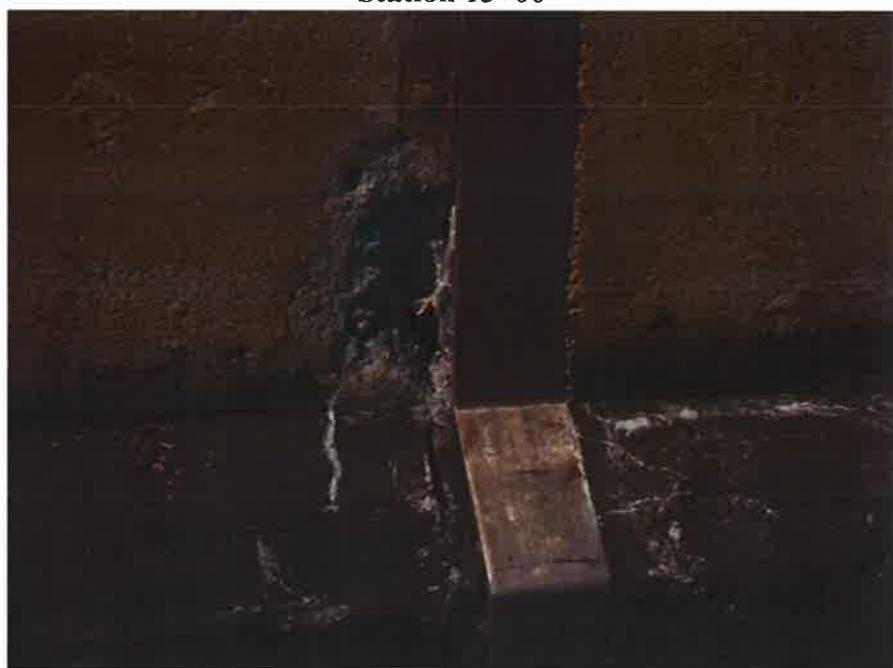
**Direction:** Seawall Joint**Comments:** Spalling along Joint and Haunch, Loose Concrete**Station 15+22**

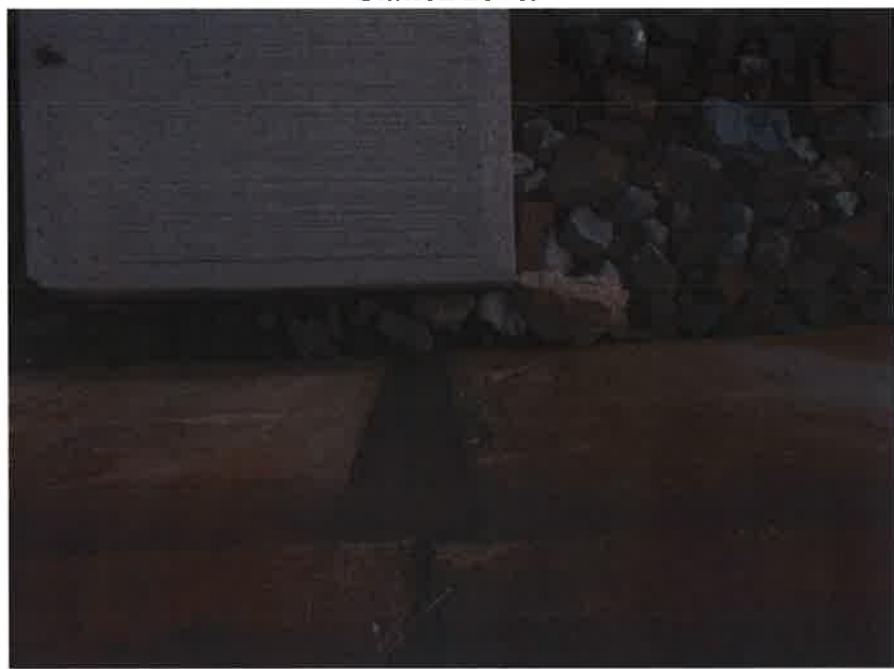
**Direction:** Seawall Joint**Comments:** Concrete Spalling**Station 20+30**

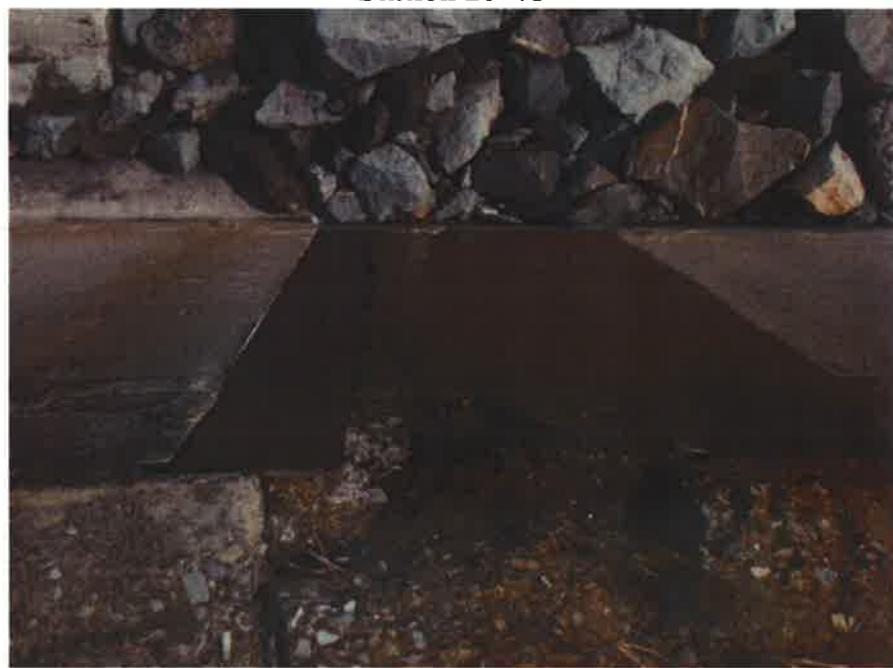
**Station 21+33**

**Direction:** Seawall Joint**Comments:** Concrete Spalling and repair

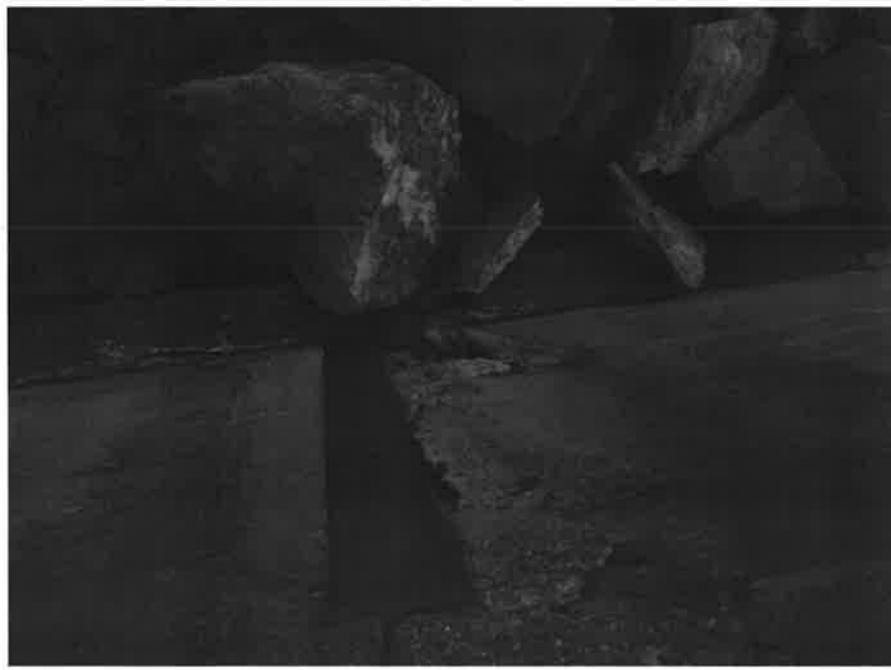
**Station 32+16**

**Direction:** Seawall Joint**Comments:** Concrete Spalling, Loose Section of Concrete, Re-Bar Exposed
