# CONDITIONS REPORT & DESIGN MEMORANDUM

## STEAM TUNNEL ASSESSMENT ROOSEVELT ISLAND, NEW YORK

**ROOSEVELT ISLAND OPERATING CORPORATION**  
591 MAIN STREET  
ROOSEVELT ISLAND  
NEW YORK, NEW YORK 10044

*17 November 2014  
Project # 100444601*

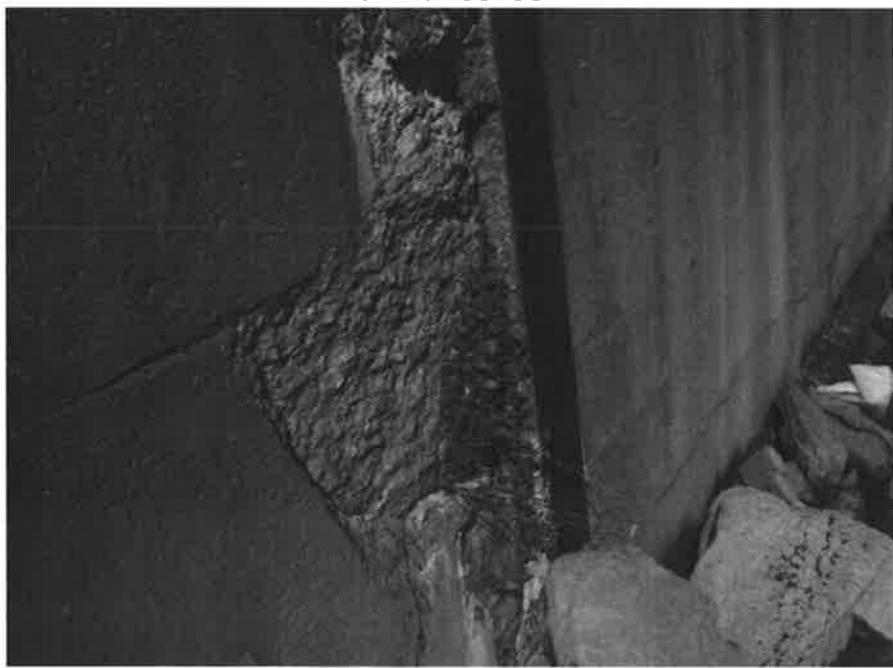
**Station 35+54**

**Direction:** Seawall Joint**Comments:** Concrete Spalling, Missing Large Section of Concrete, Re-Bar Exposed

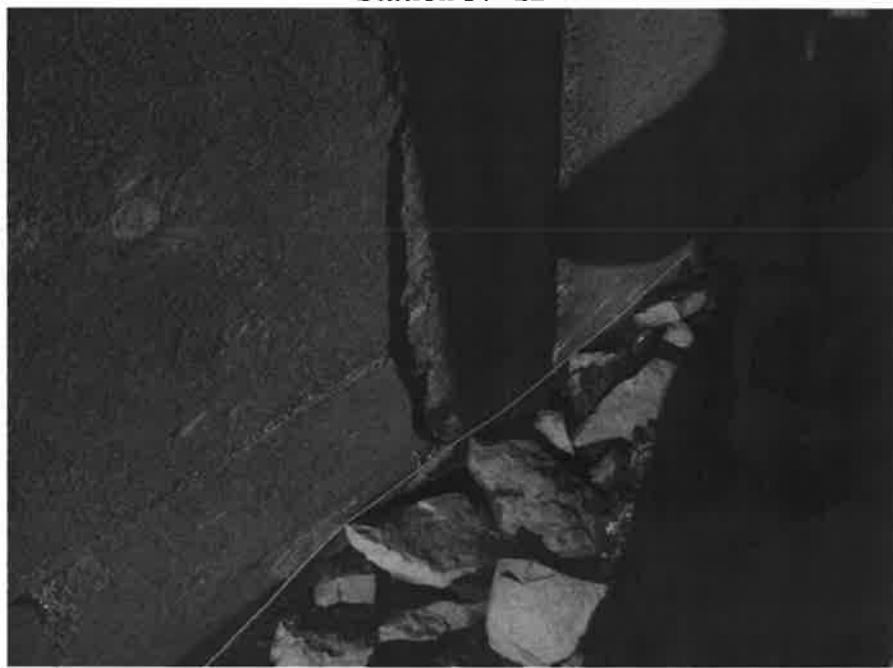
**Station 37+22**

**Direction:** Seawall Joint**Comments:** Concrete Spalling

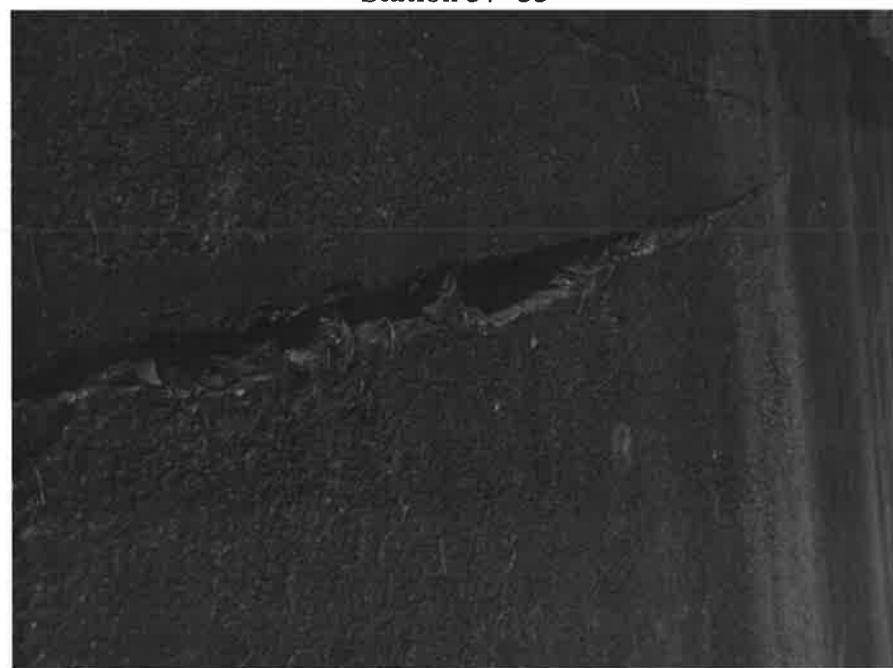
**Station 38+82**

**Direction:** Seawall**Comments:** Cut in wall (Inch Deep)

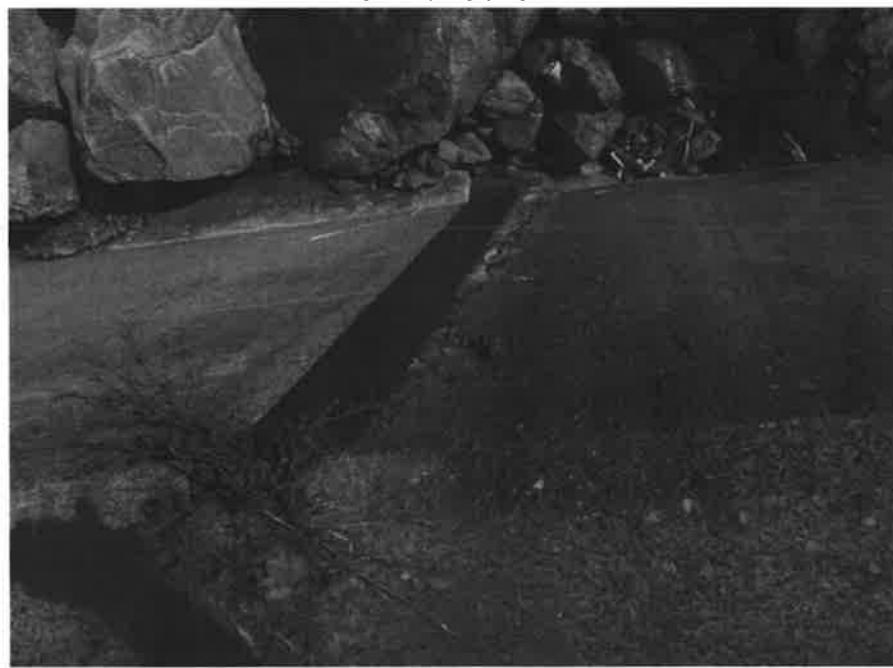
**Station 39+03**

**Direction:** Seawall Joint**Comments:** Concrete Spalling

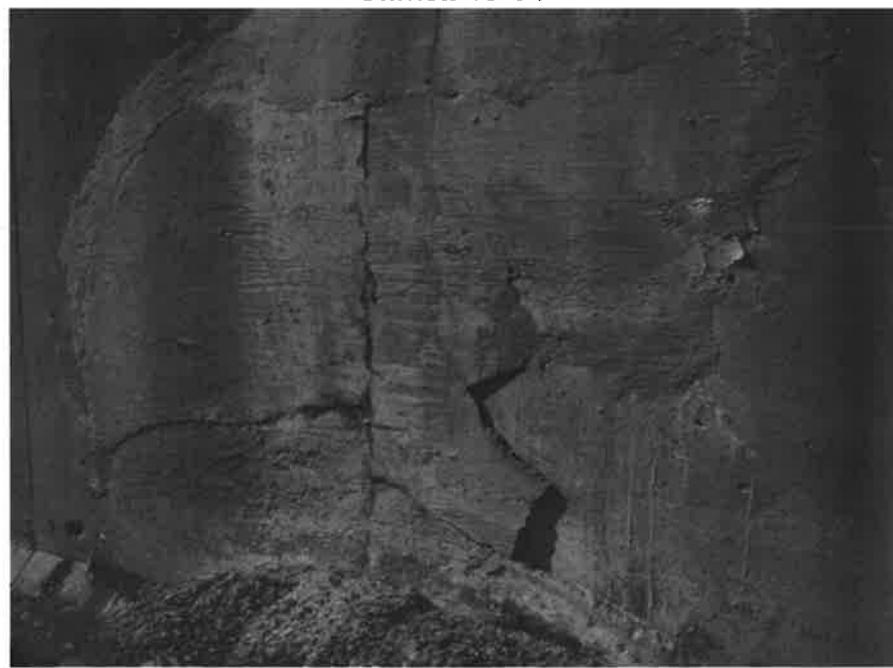
**Station 42+18**

**Direction:** Seawall**Comments:** Concrete Repair

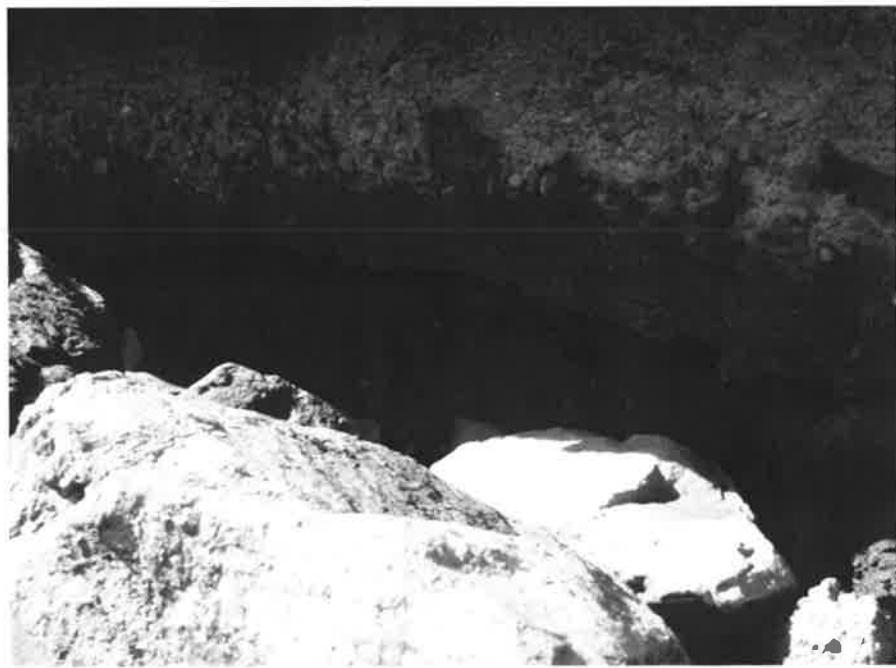
**Station 43+04**

**Direction:** Seawall**Comments:** Spalling at Haunch

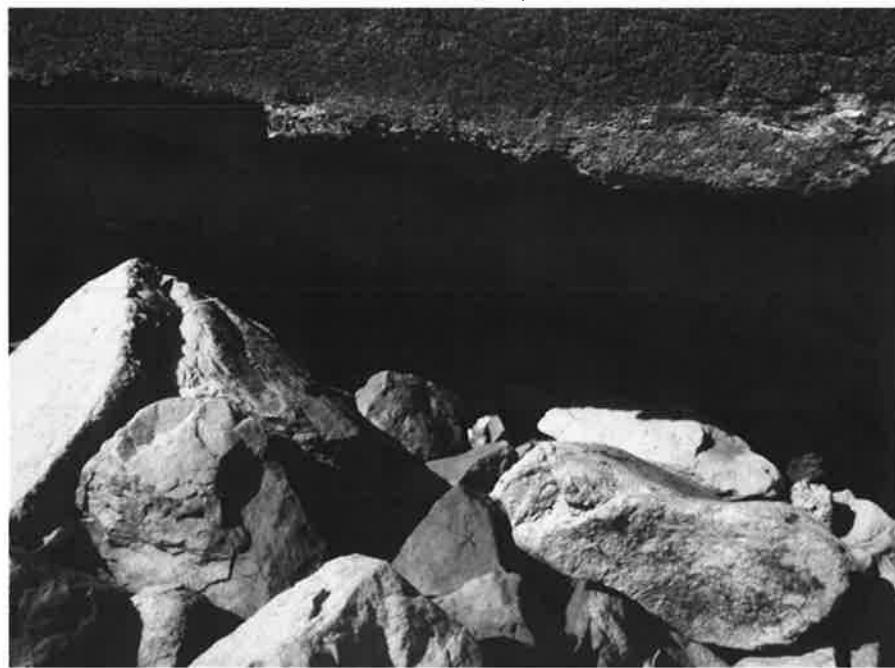
**Direction:** Seawall**Comments:** Spalling at Haunch**Station 43+44**

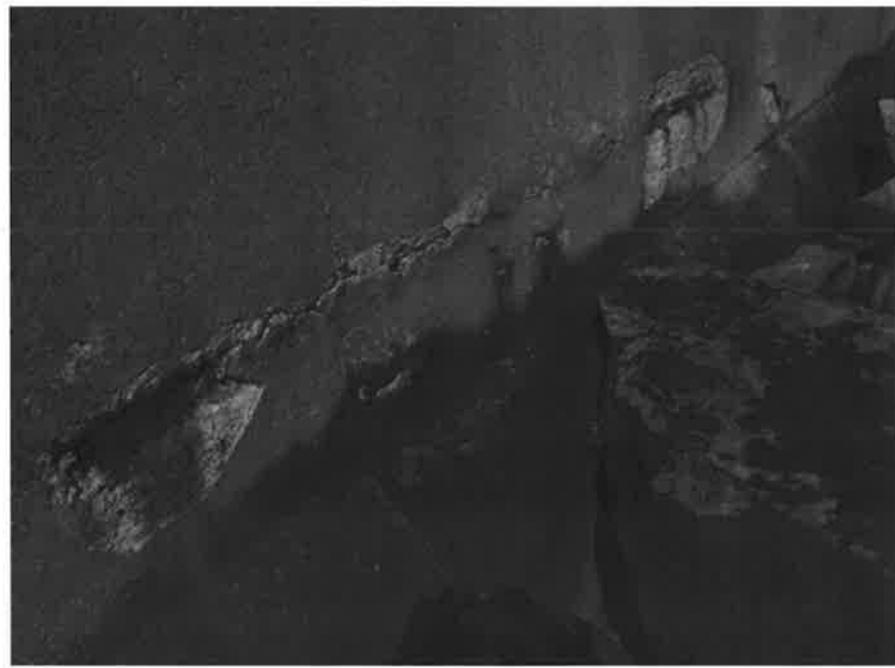
**Station 43+66**

**Direction:** Seawall**Comments:** Concrete Spalling, Exposed Re-bar

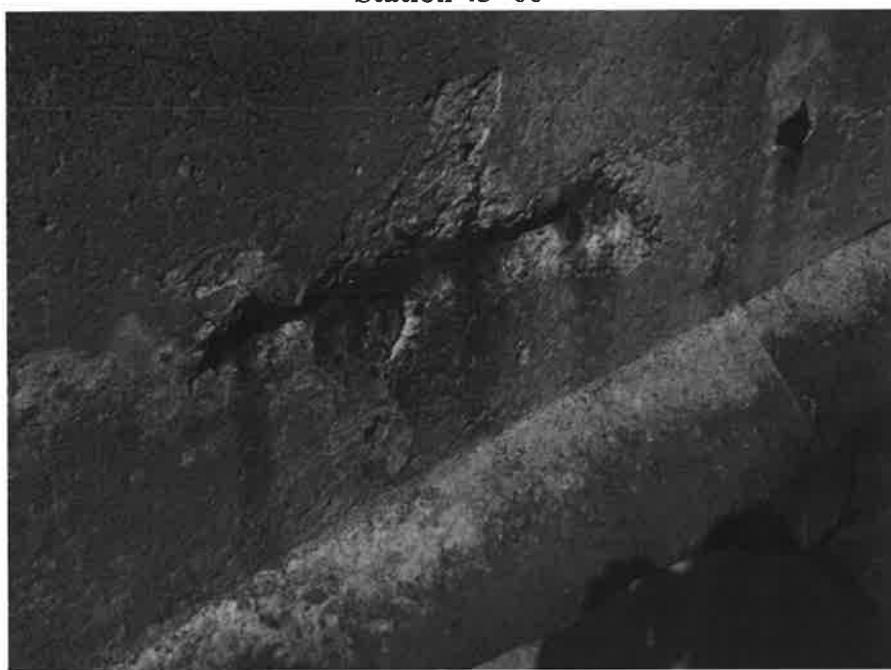
**Direction:** Seawall**Comments:** Exposed Re-Bar**Station 43+87**

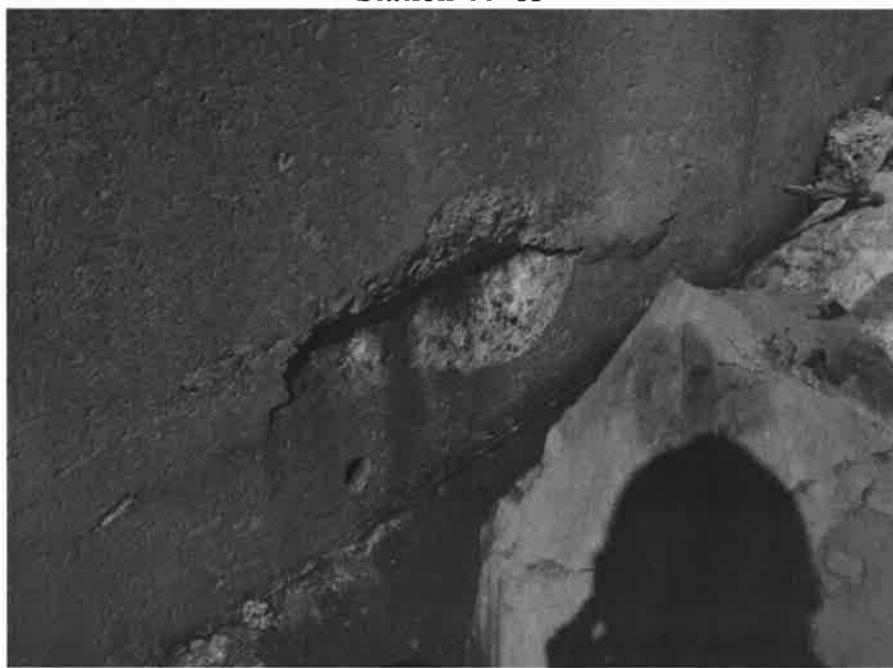
**Station 45+77**

**Direction:** Seawall**Comments:** Exposed Re-Bar
