# **CONDITIONS REPORT & CONCEPTUAL DESIGN MEMORANDUM**

## **STEAM TUNNEL ASSESSMENT**

**ROOSEVELT ISLAND, NEW YORK**

**28 December 2018  
Project # 100444601**

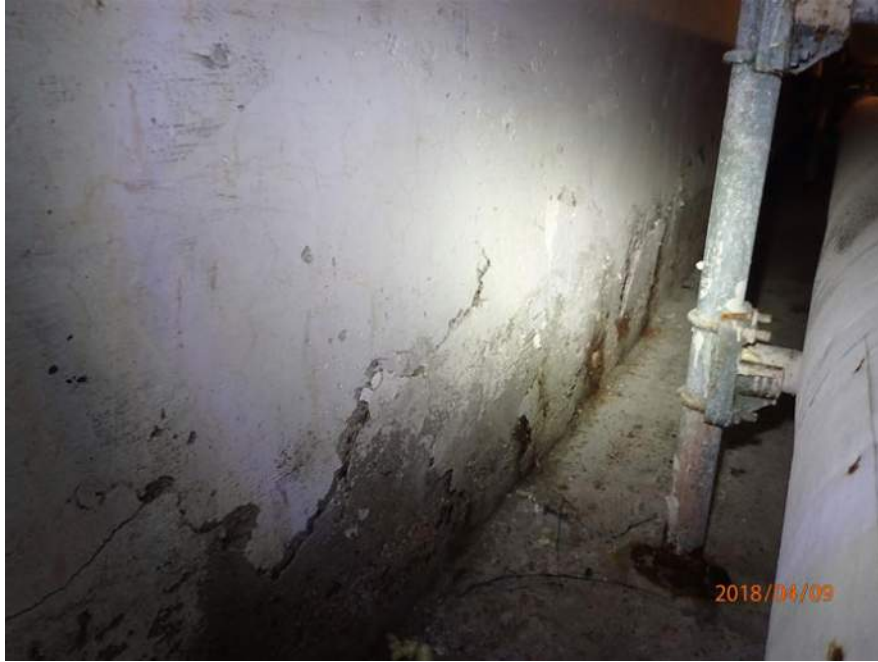
Station 4+80 to 5+15

**Direction:** Eastern Wall (Seawall)

**Comments:** Concrete Spalling

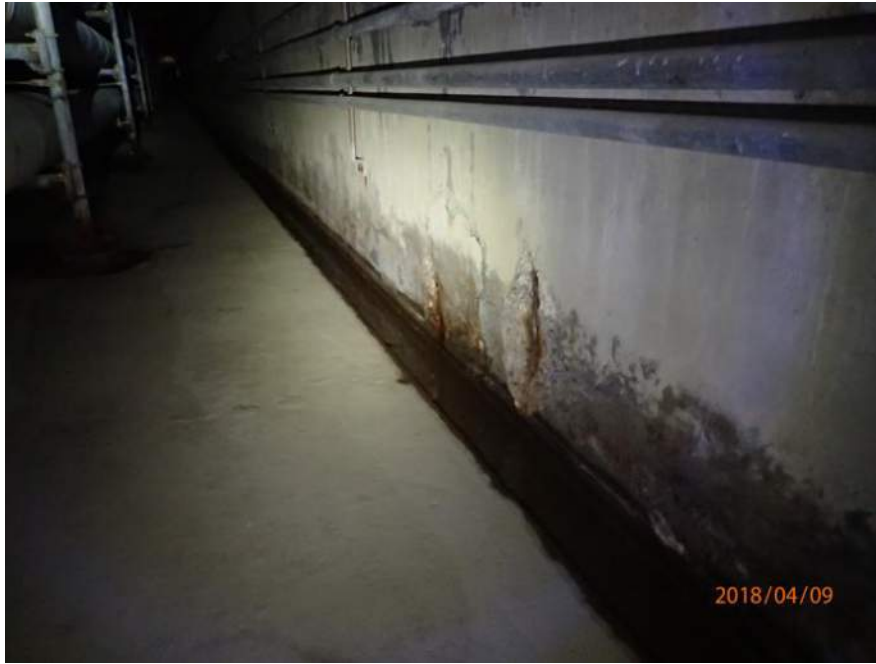
**Station 16+53 to 16+60**

**Direction:** Western Wall (In-Land)

**Comments:** Spalling, Re-Bar Exposed and Corroded

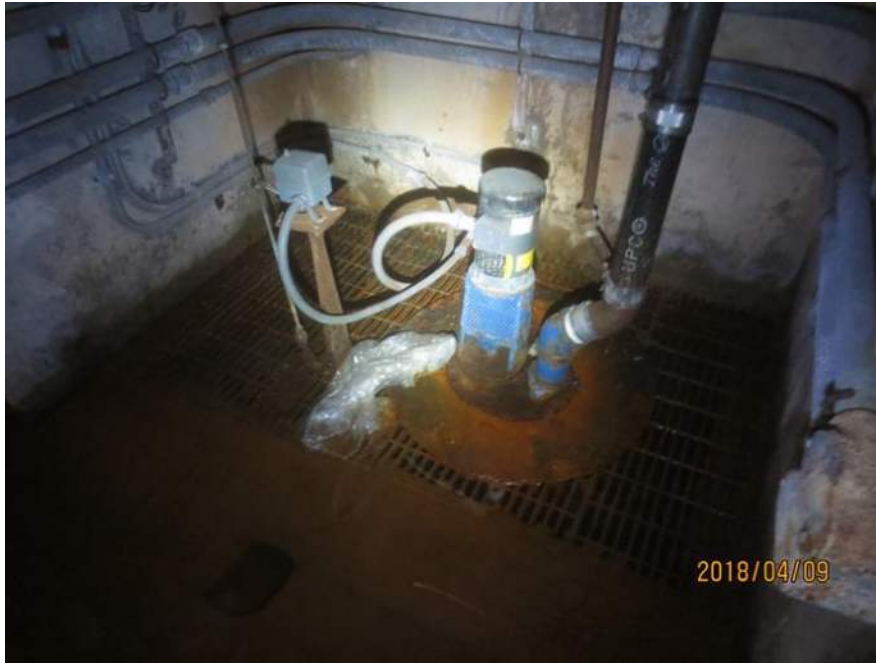
Station 20+30

**Direction:** Tunnel Floor

**Comments:** Sump Pump - Not Working

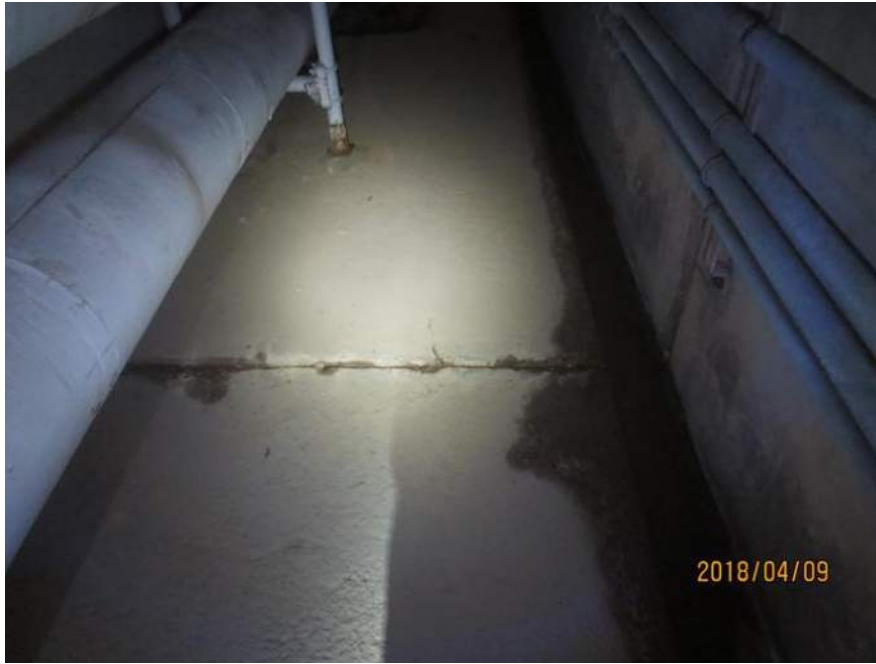
Station 25+10

**Direction:** Tunnel Floor

**Comments:** Floor Slab Raised at Joint

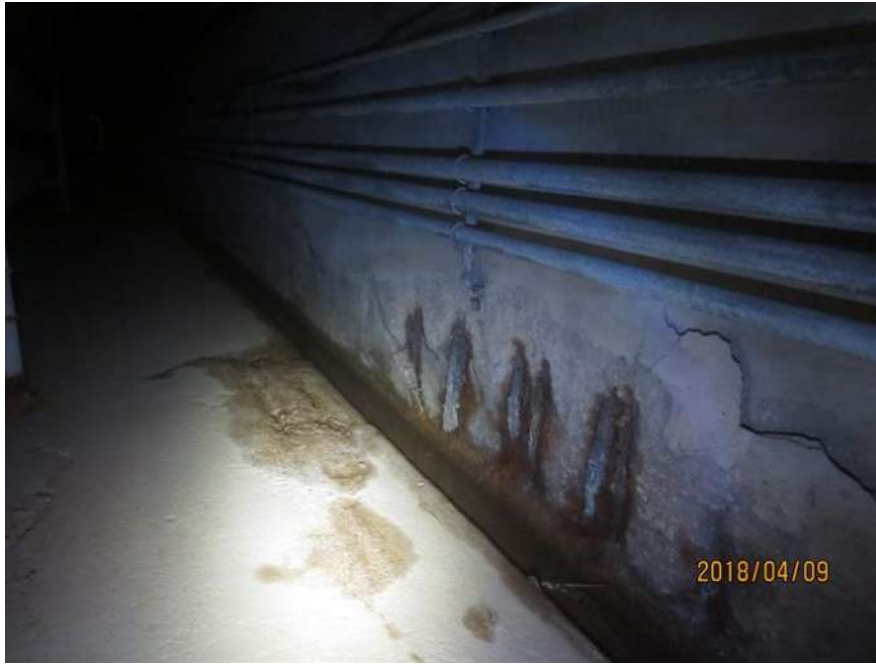
Station 26+03 to 26+20

**Direction:** Western Wall (In-Land)/ Tunnel Floor

**Comments:** Concrete Spalling, Re-Bar Exposed and Corroded

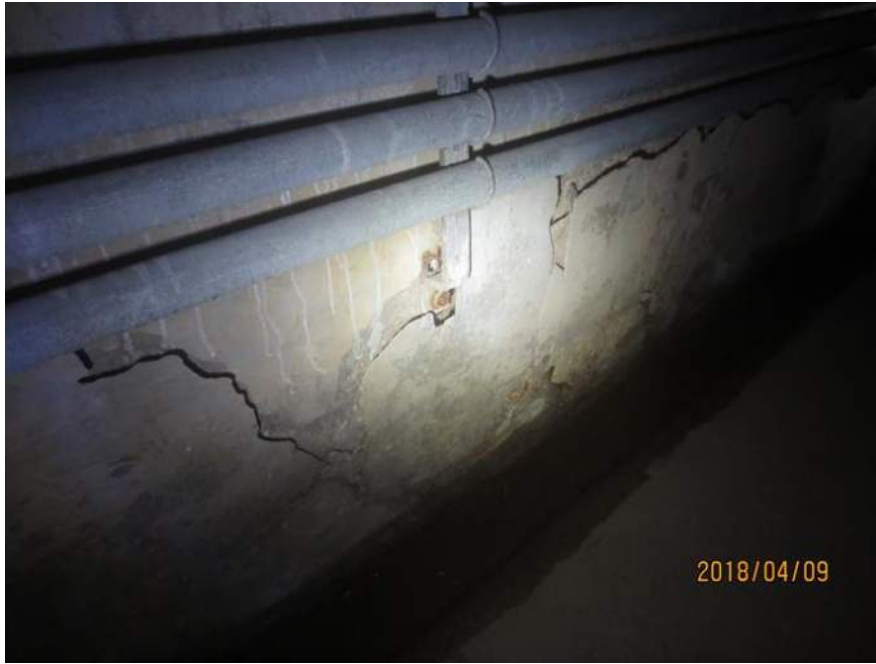
Station 28+62 to 28+86

**Direction:** Western Wall (In-Land)

**Comments:** Spalling, Re-Bar Exposed and Corroded, Loose Concrete

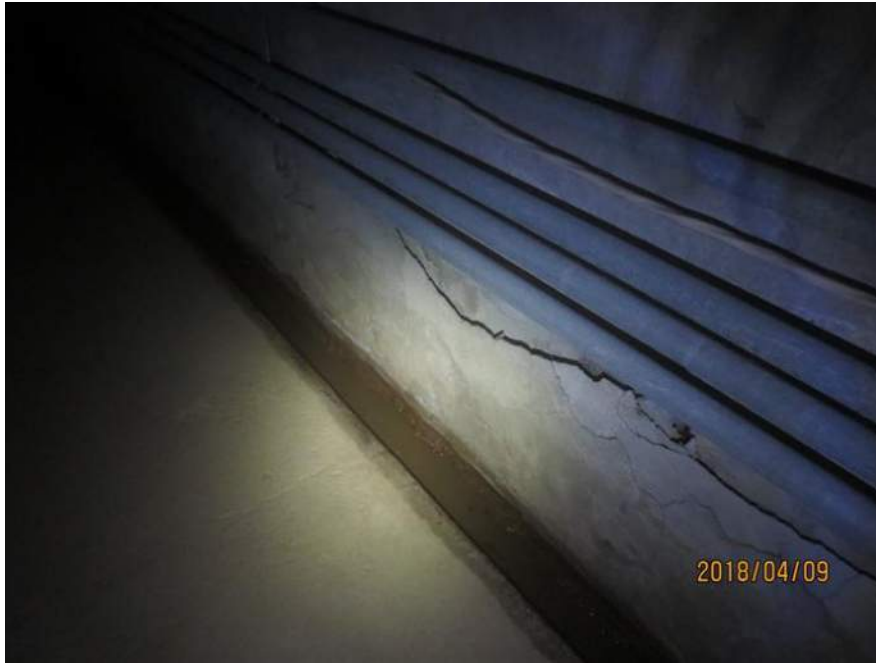
Station 30+93 to 31+50

**Direction:** Western Wall (In-Land)

**Comments:** Concrete Spalling

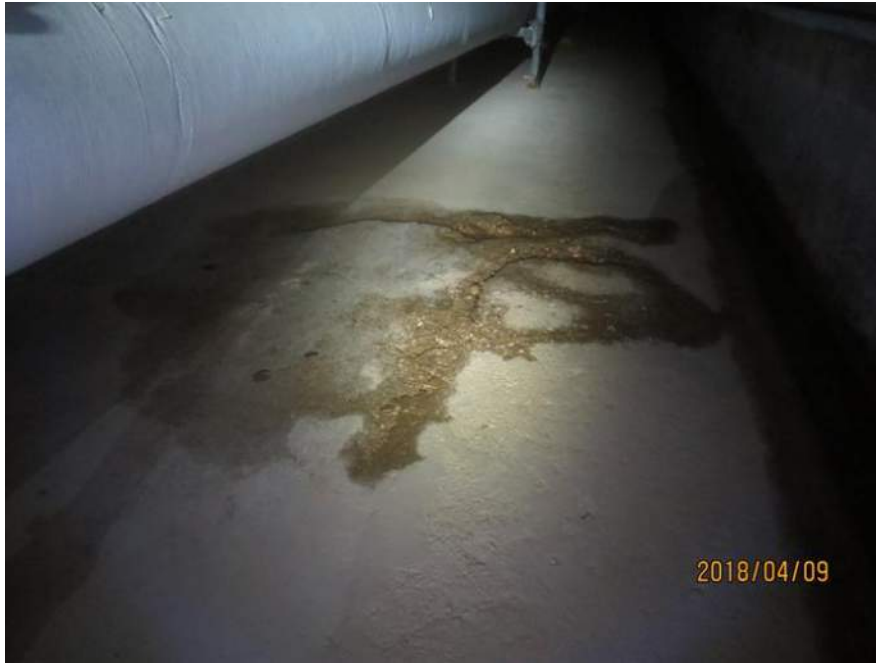
Station 31+94

**Direction:** Tunnel Floor

**Comments:** Floor Slab Cracking

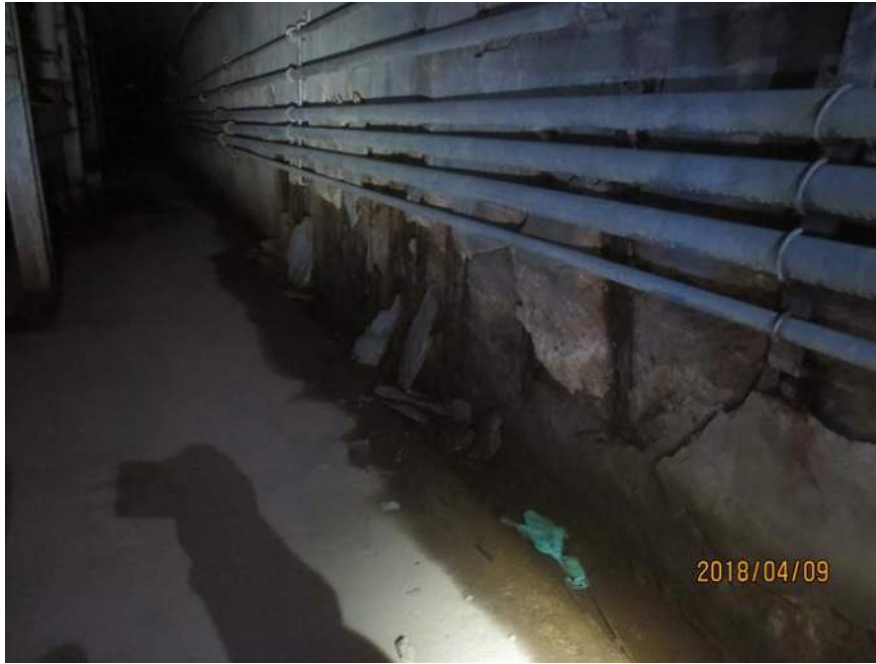
Station 34+23 to 34+75

**Direction:** Western Wall (In-Land)

**Comments:** Concrete Spalling, Re-Bar Exposed and Corroded

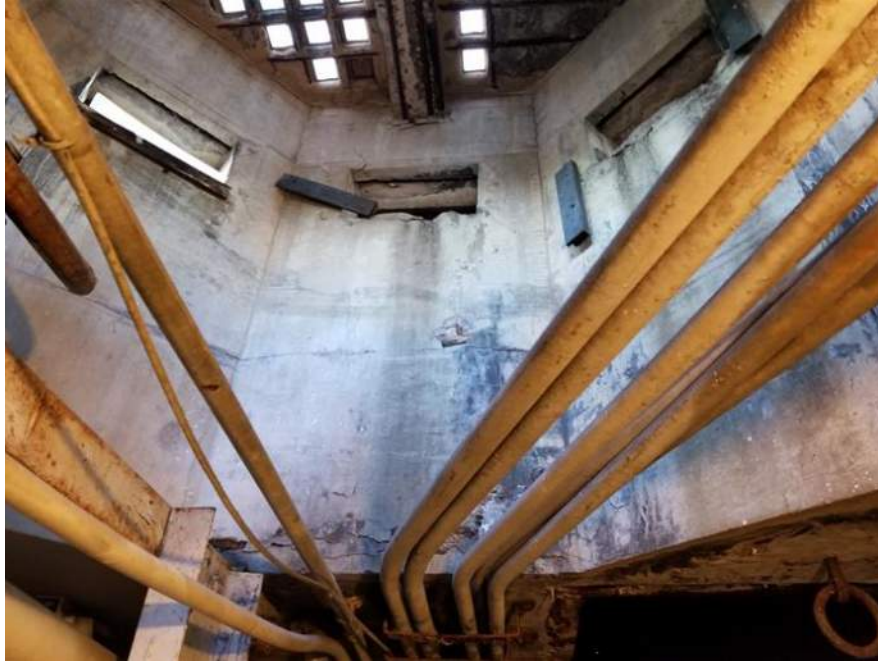
**Station 55+00**

**Direction:** Tunnel Joint

**Comments:** Concrete Spalling, Corroded Utilities

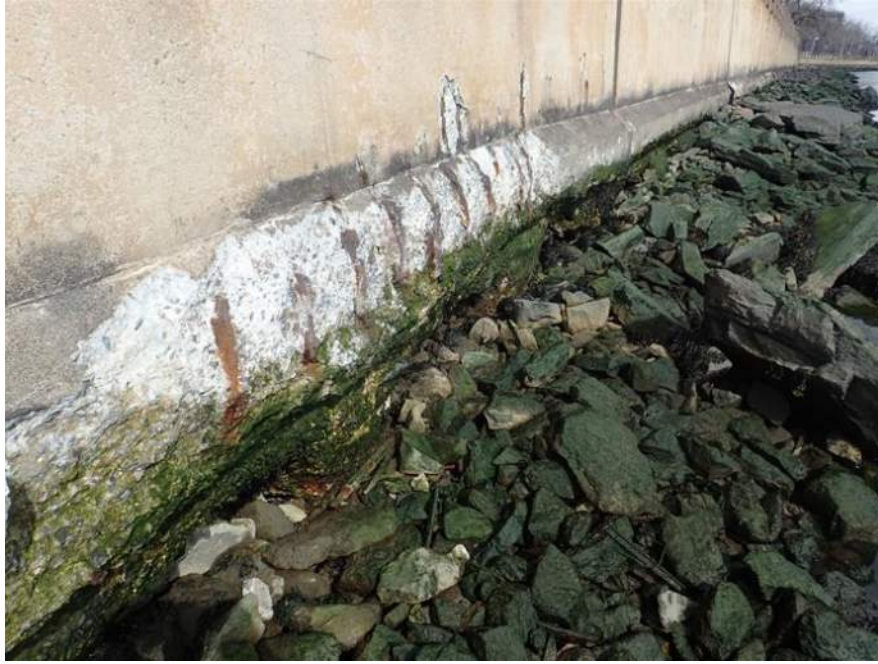
**Station 9+10**

**Direction:** Seawall Joint

**Comments:** Spalling at Haunch, Missing Large Sections of Concrete, Metal Joint Covering Loose

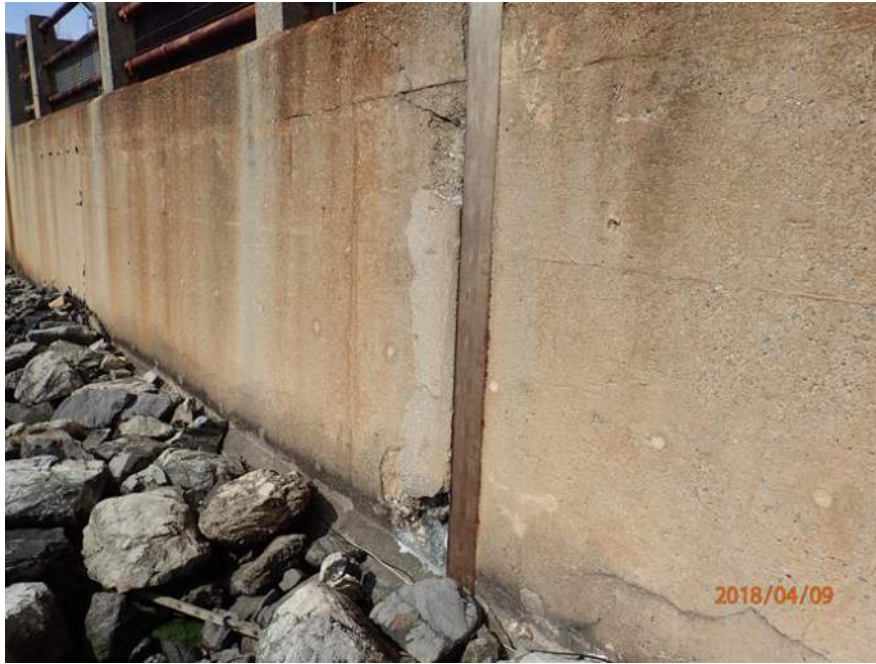
Station 12+68

**Direction:** Seawall Joint

**Comments:** Concrete Spalling, Missing Large Section of Concrete, Re-Bar Exposed. Tunnel has been Undermined. Missing Rip-Rap

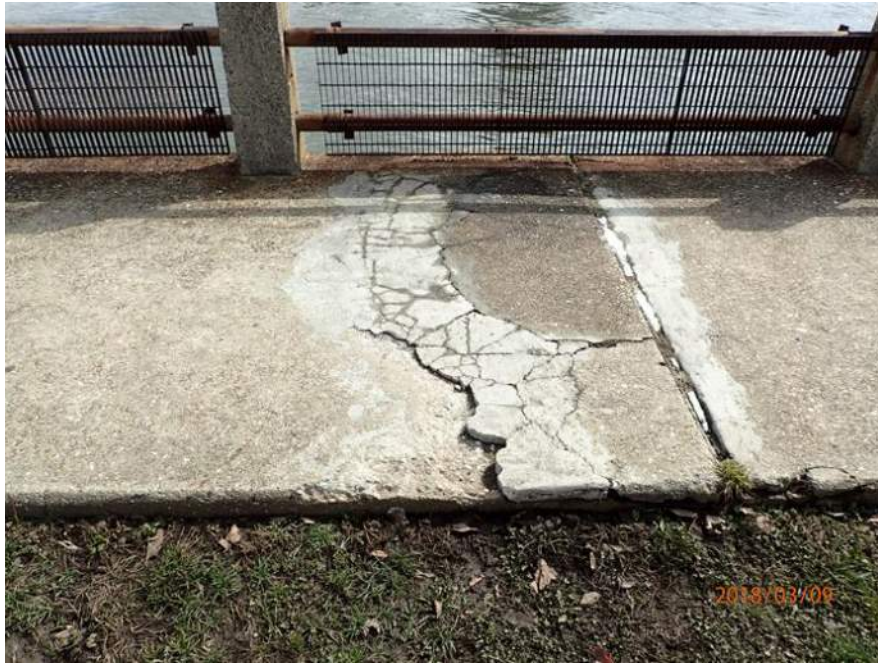
Station 13+03

**Direction:** Seawall Sidewalk Joint

**Comments:** Concrete Spalling

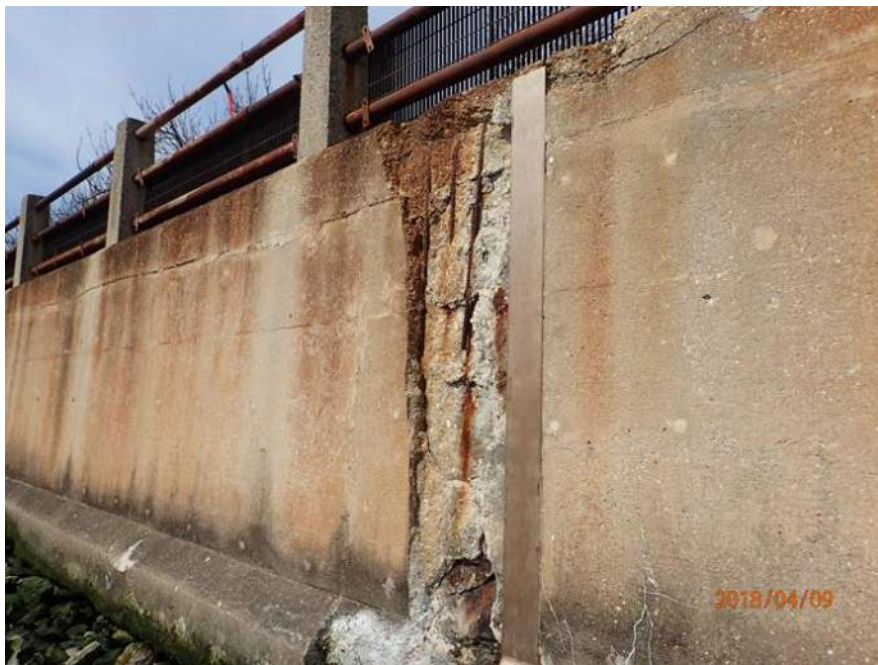
Station 13+10

**Direction:** Seawall Joint

**Comments:** Spalling at Haunch, Missing Large Sections of Concrete

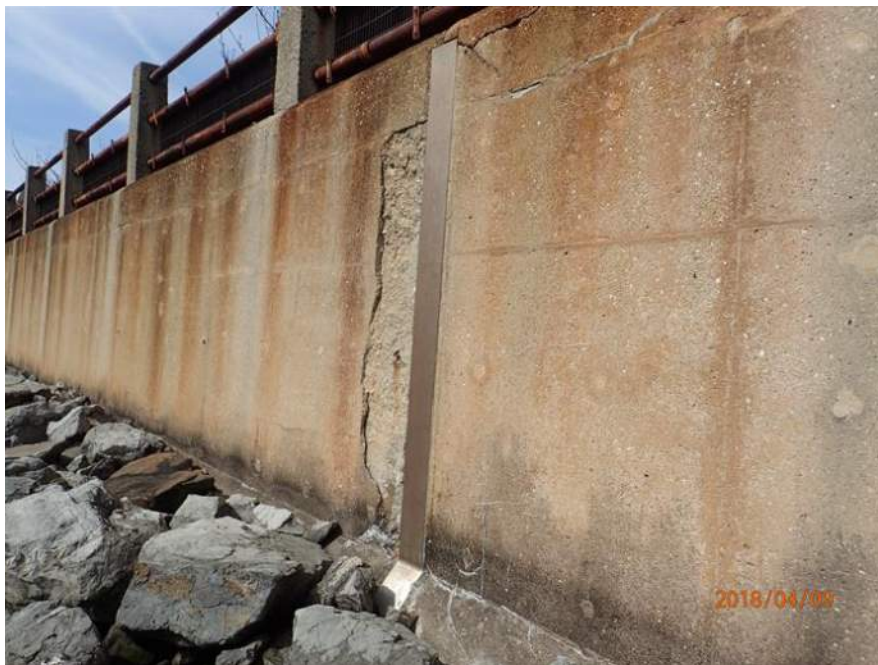
Station 13+27

**Direction:** Seawall Joint

**Comments:** Concrete Spalling

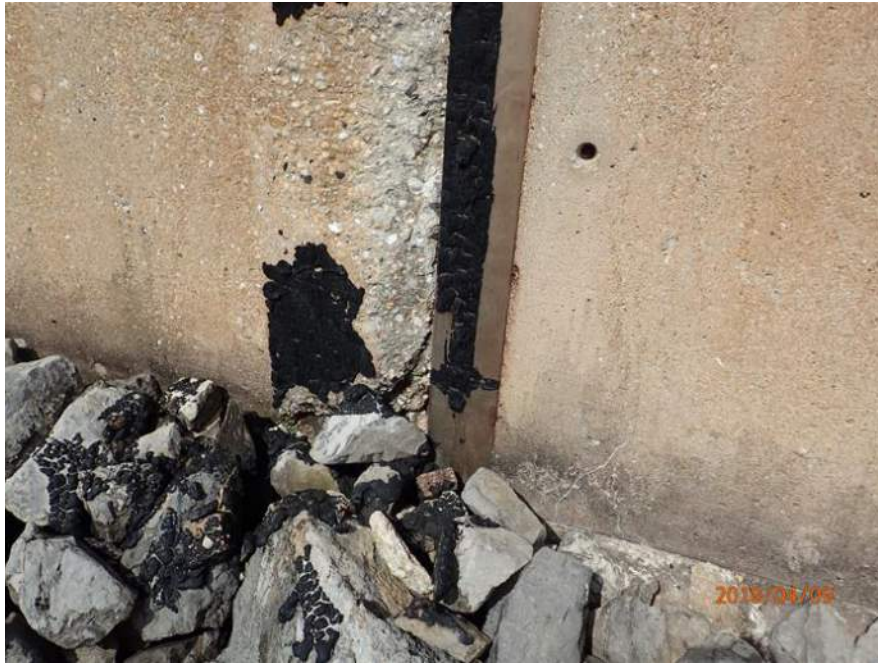
Station 13+74

**Direction:** Seawall Joint

**Comments:** Concrete Spalling and Repair

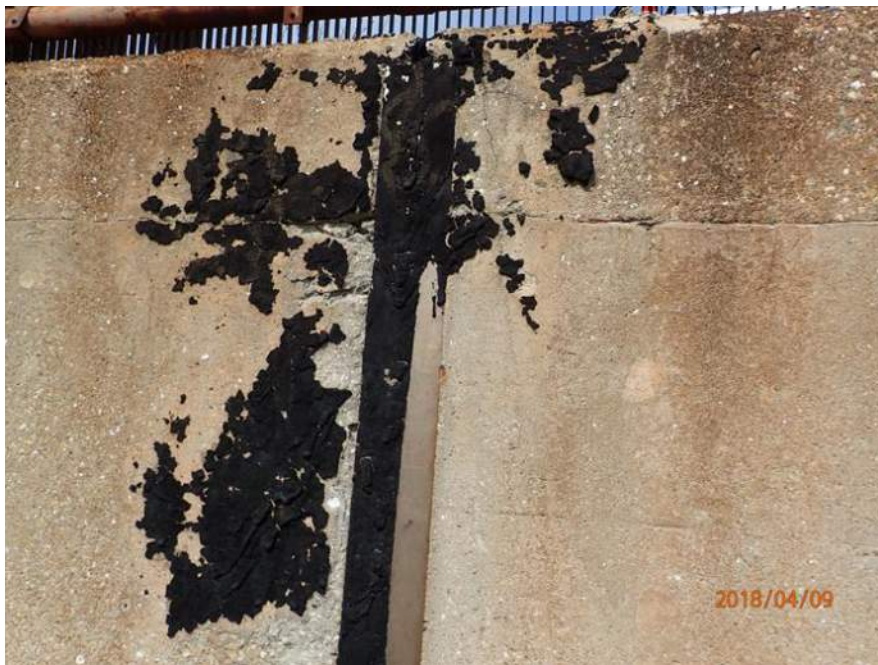
Station 14+37

**Direction:** Seawall Joint

**Comments:** Concrete Spalling, Loose Sections of Concrete

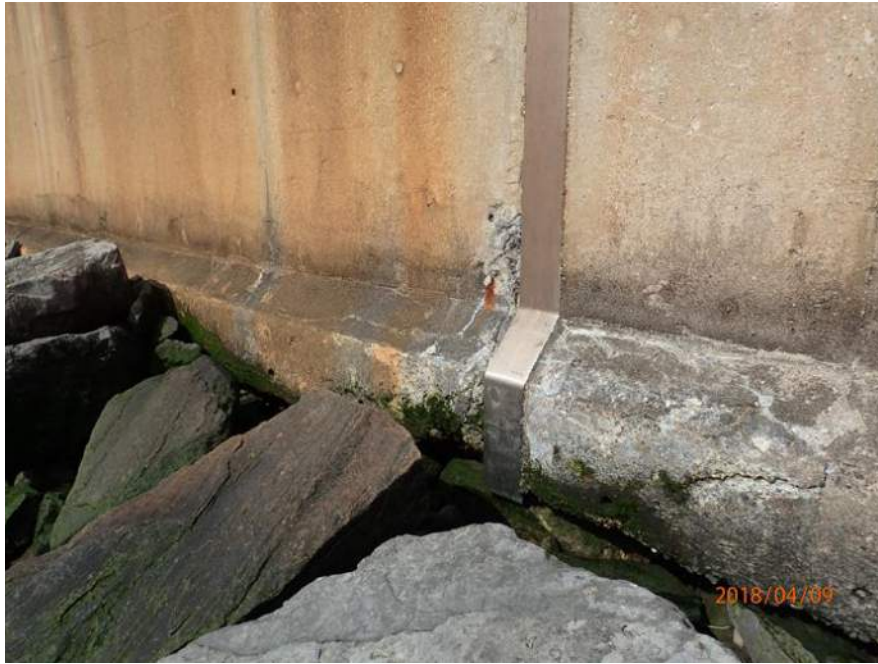
**Station 15+40**

**Direction:** Seawall Joint

**Comments:** Concrete Spalling, Exposed Re-bar

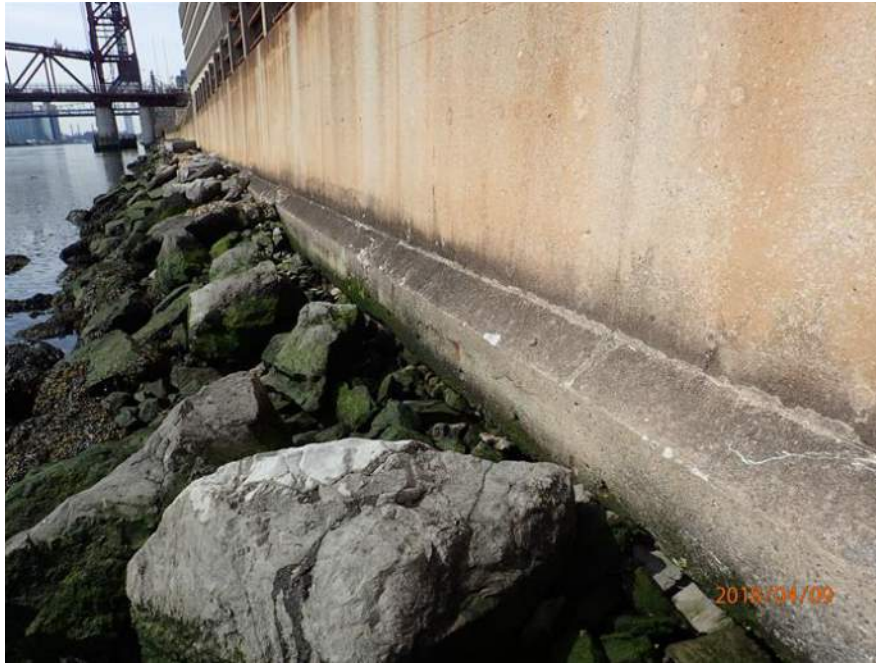
**Station 15+63**

**Direction:** Seawall

**Comments:** Tunnel has been Undermined

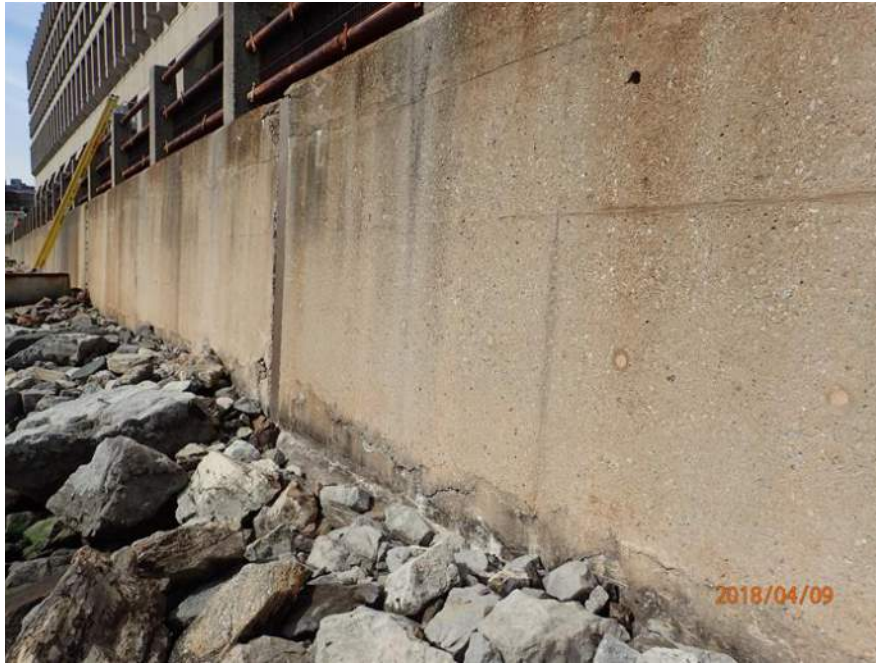
Station 17+75 to 17+85

**Direction:** Seawall

**Comments:** Concrete Spalling

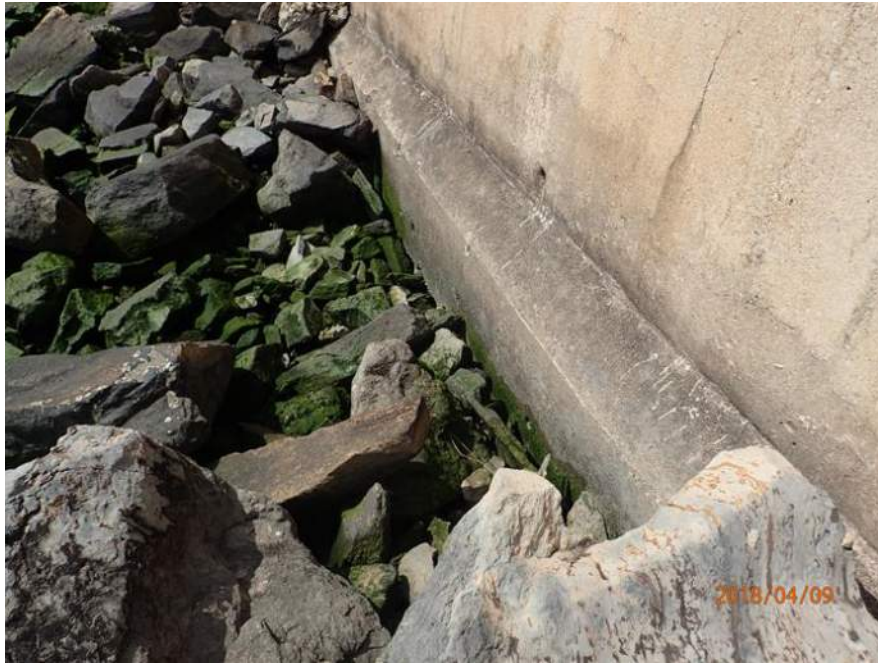
Station 21+43

**Direction:** Seawall

**Comments:** Tunnel has been Undermined

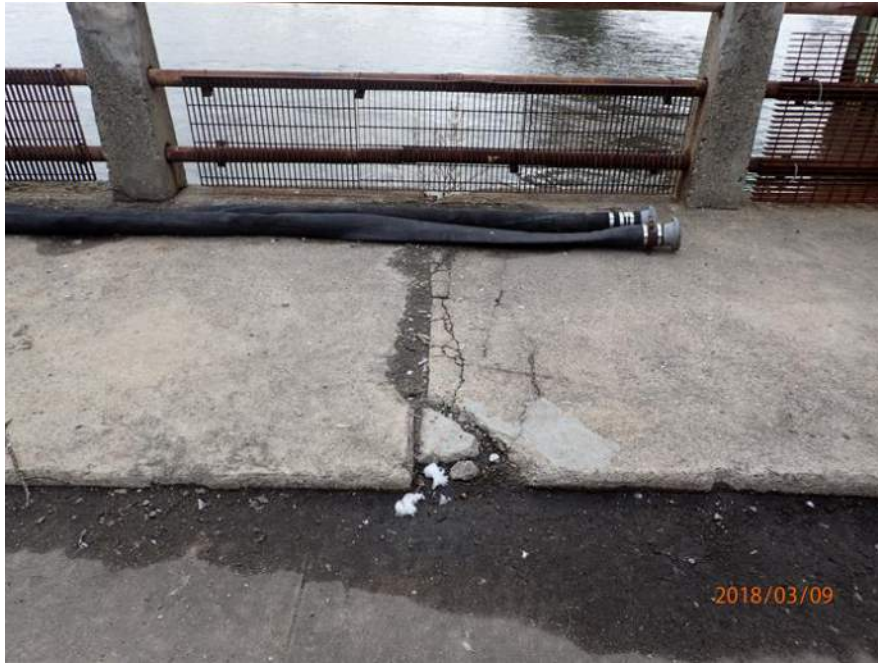
Station 22+57

**Direction:** Seawall Sidewalk Joint

**Comments:** Concrete Cracks

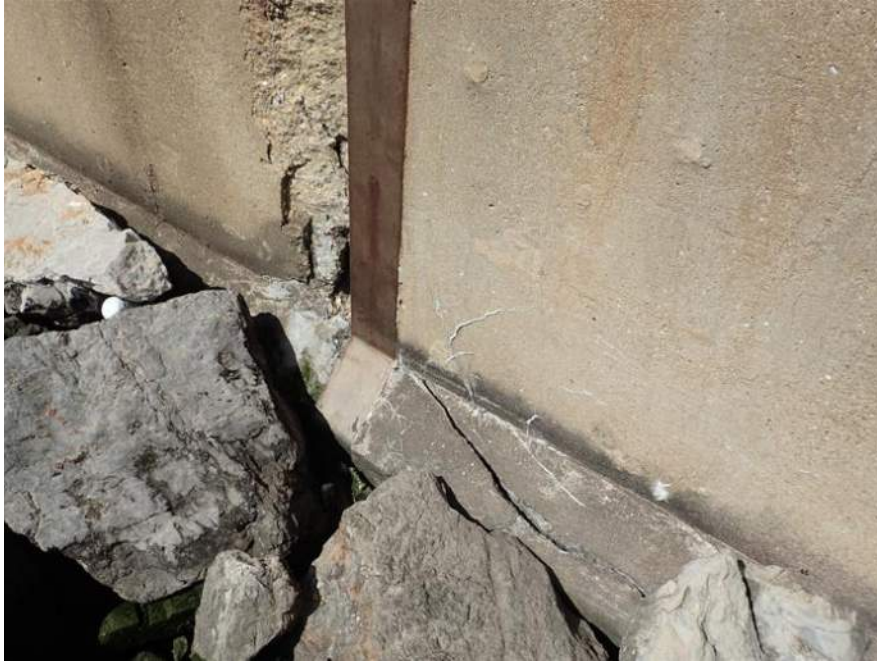
Station 28+34

**Direction:** Seawall Joint

**Comments:** Concrete Spalling, Missing Large Section of Concrete, Re-Bar Exposed

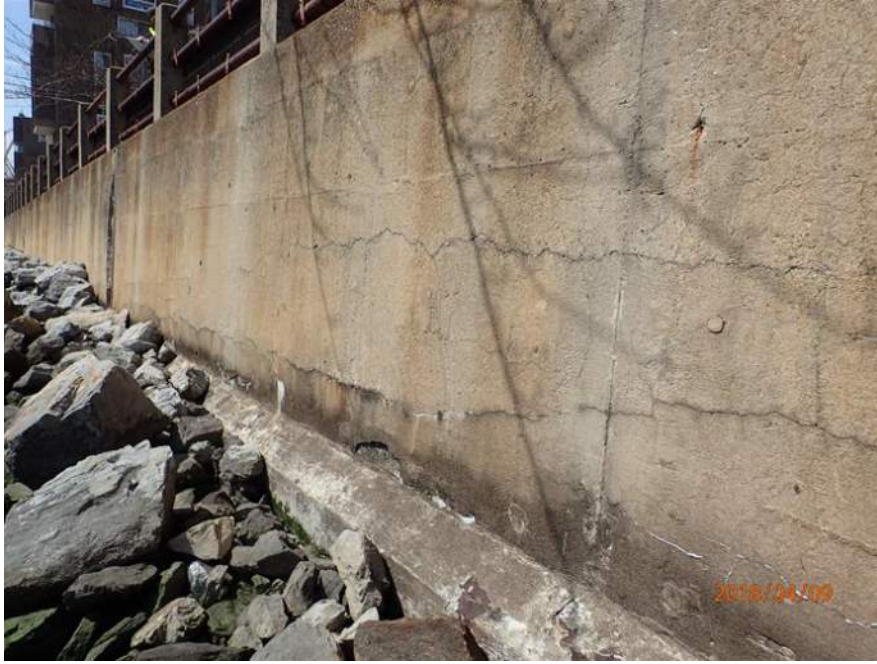
Station 33+84

**Direction:** Seawall

**Comments:** Concrete Spalling

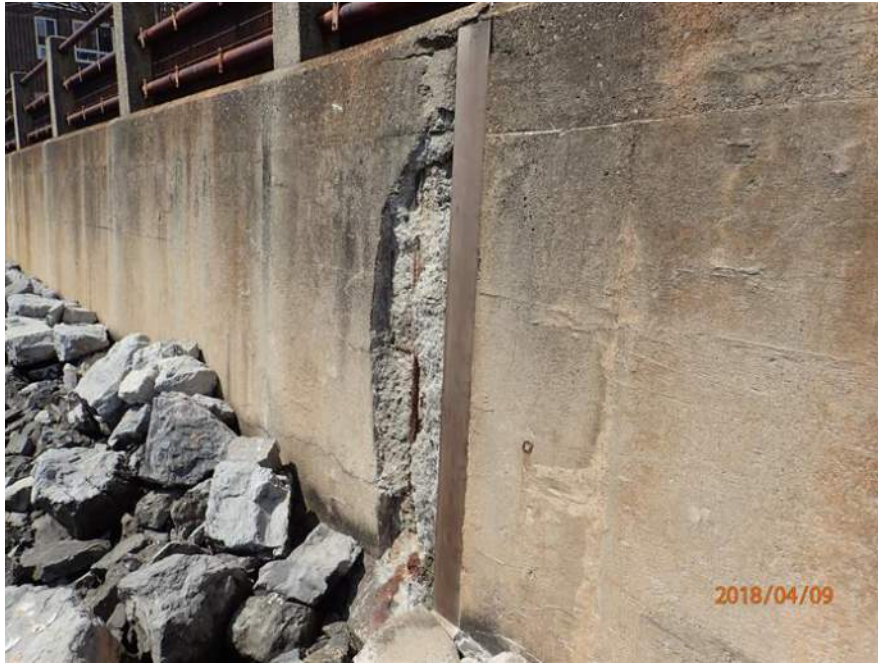
Station 34+06

**Direction:** Seawall Joint

**Comments:** Concrete Spalling, Missing Large Section of Concrete, Re-Bar Exposed

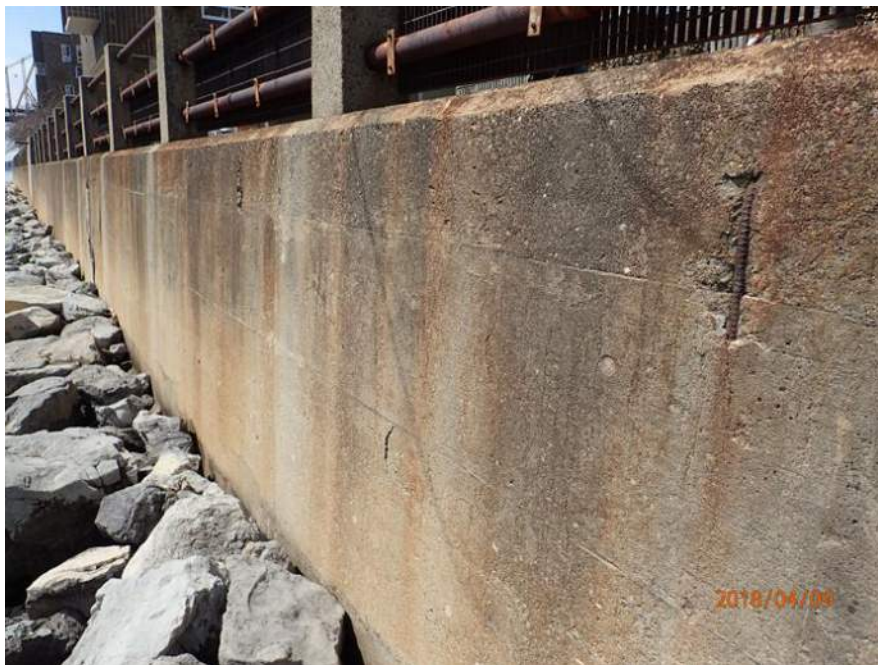
Station 34+30

**Direction:** Seawall

**Comments:** Re-Bar Exposed

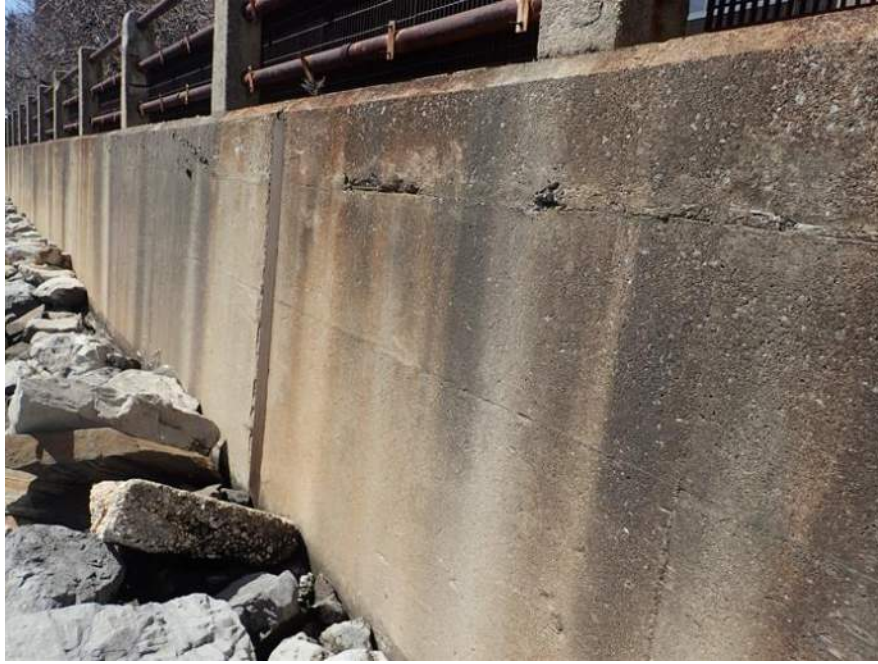
Station 35+93

**Direction:** Seawall

**Comments:** Exposed Re-Bar, Concrete Spalling

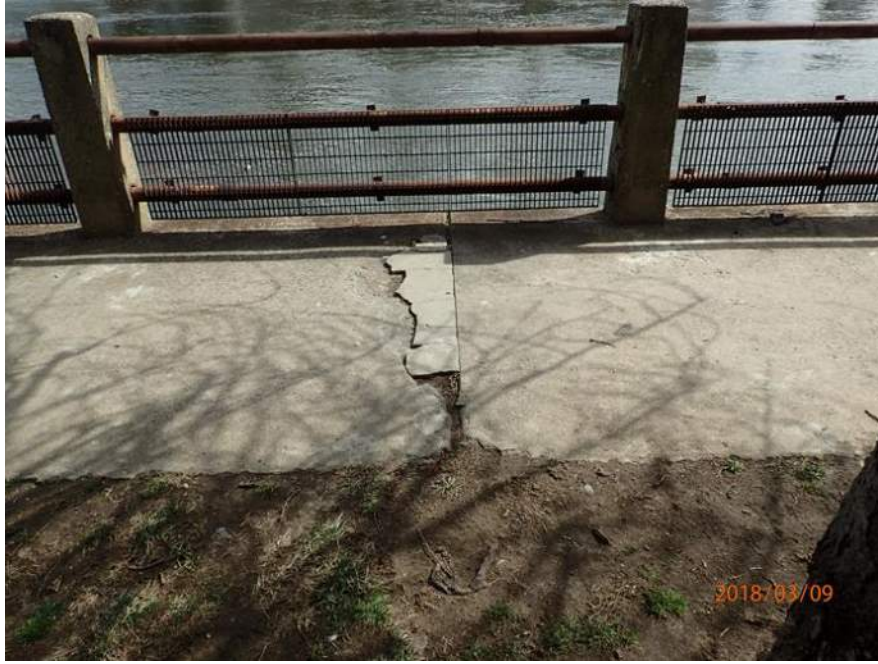
Station 36+56

**Direction:** Seawall Sidewalk Joint

**Comments:** Concrete Cracks

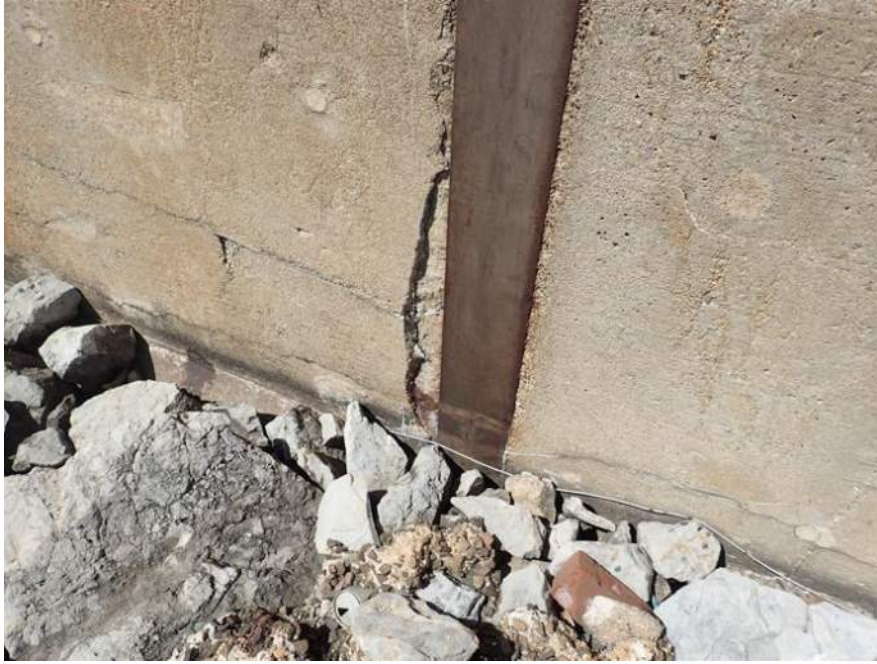
**Station 37+22**

**Direction:** Seawall Joint

**Comments:** Concrete Spalling

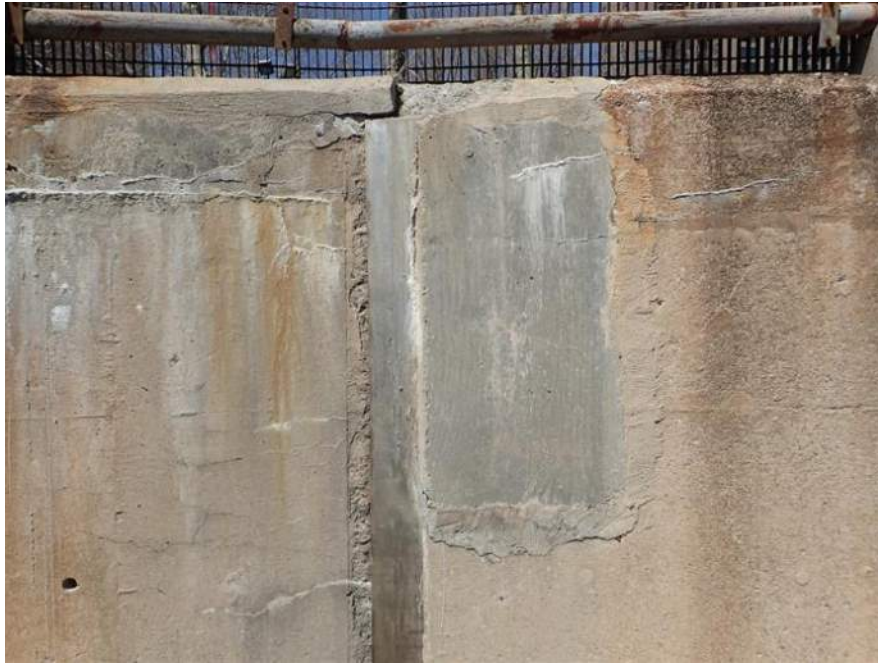
**Station 41+31**

**Direction:** Seawall Joint

**Comments:** Concrete Repair

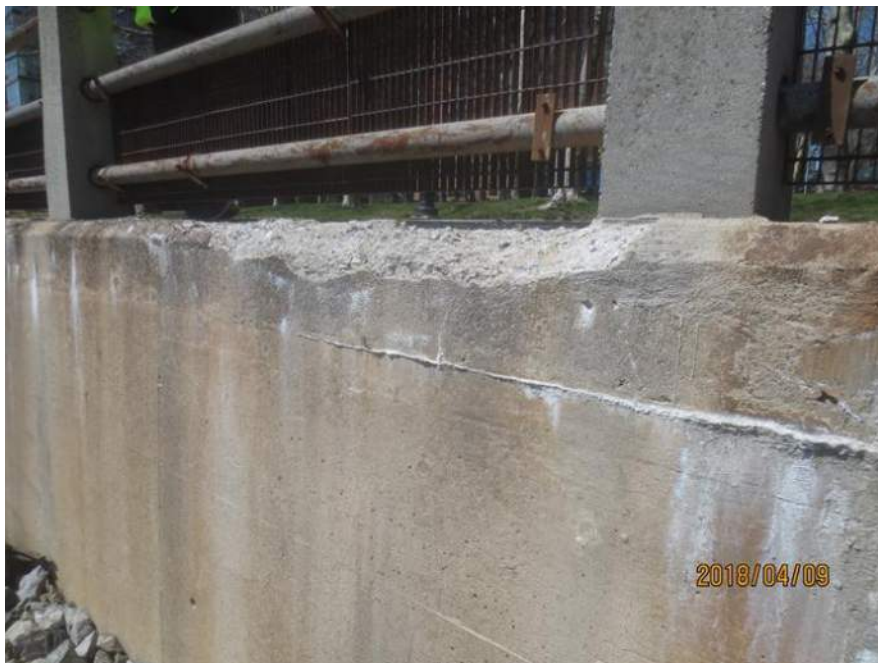
**Station 41+50**

**Direction:** Seawall

**Comments:** Missing Large Section of Concrete

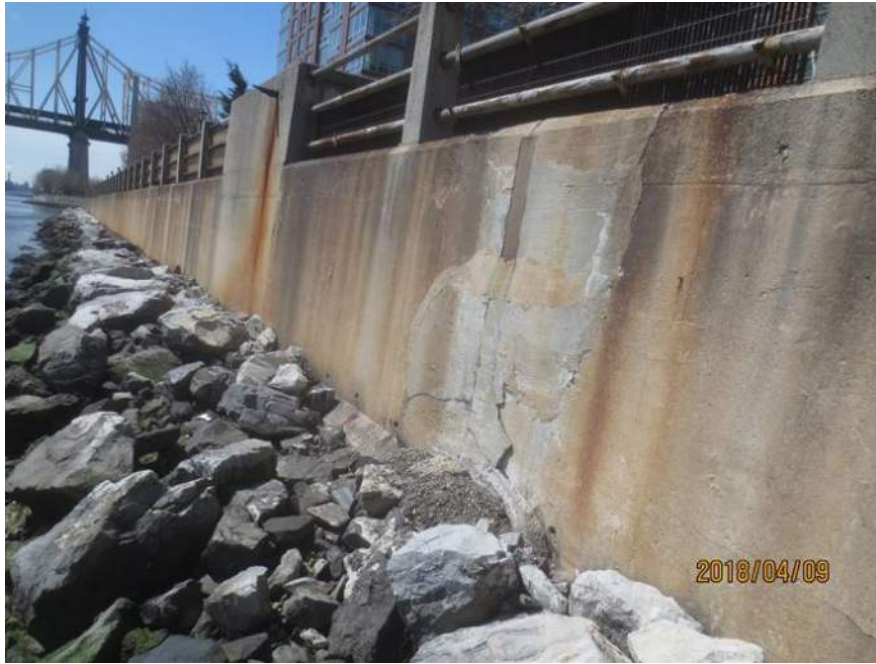
Station 41+97

**Direction:** Seawall

**Comments:** Concrete Repair

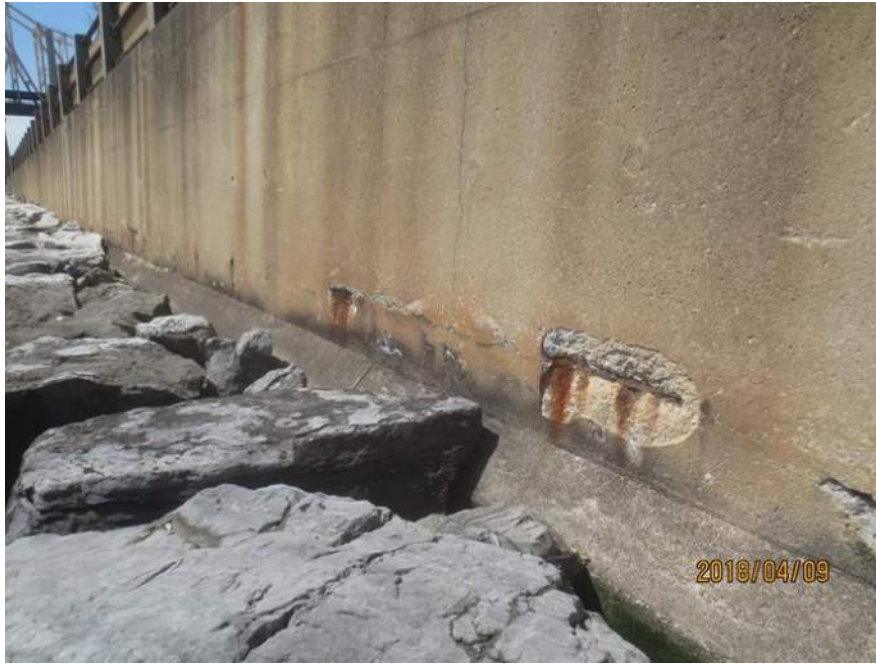
**Station 43+44**

**Direction:** Seawall

**Comments:** Concrete Spalling, Exposed Re-bar

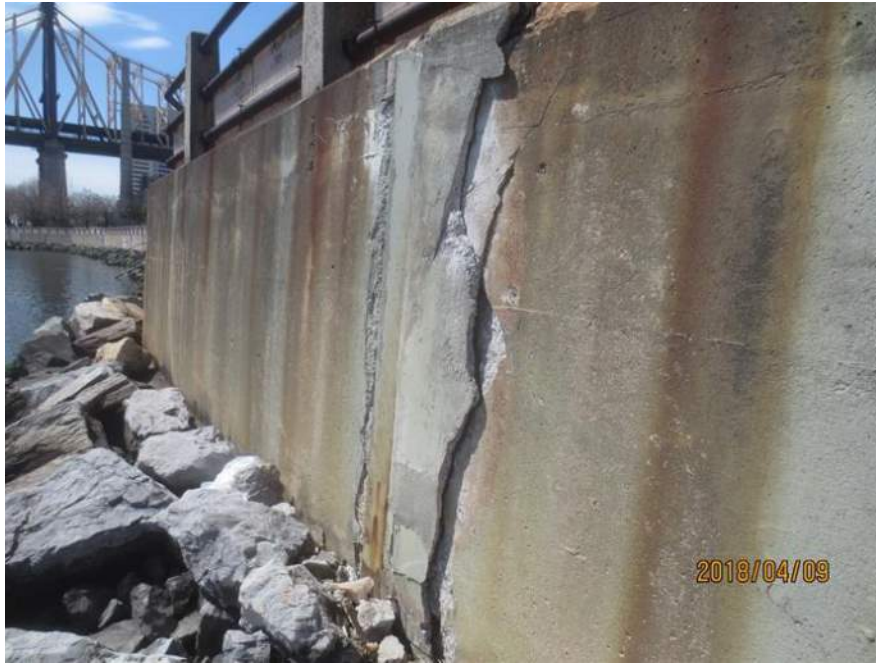
Station 45+77

**Direction:** Seawall Joint

**Comments:** Concrete Spalling, Missing Large Section of Concrete, Re-Bar Exposed

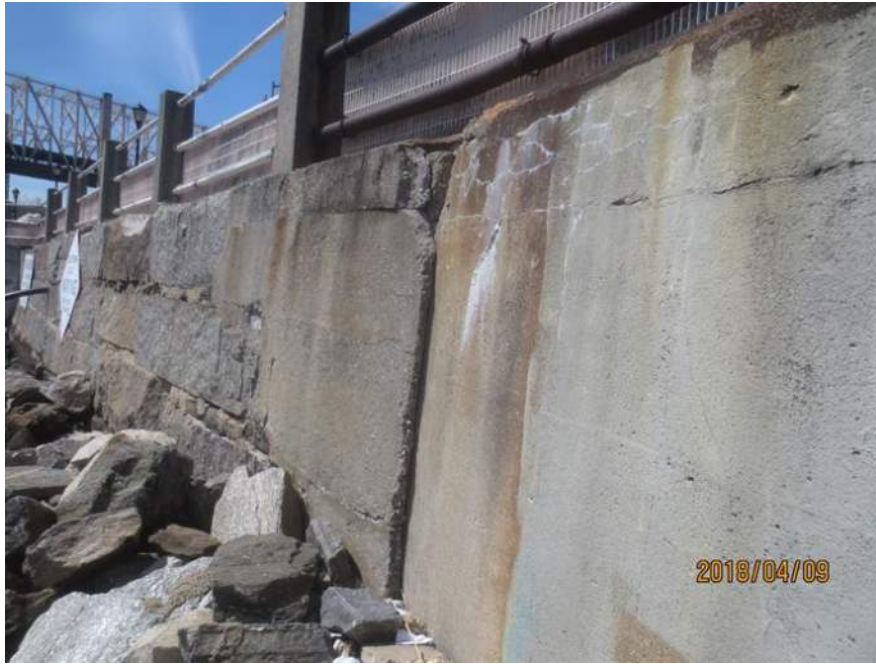
**Station 45+97**

**Direction:** Southern Seawall Terminus

**Comments:** Spalling at Haunch

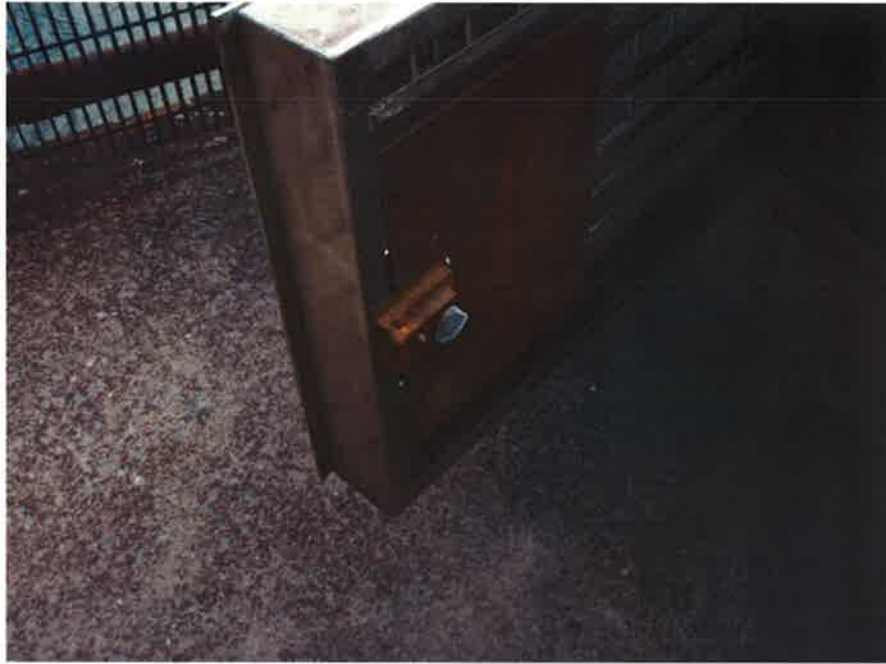
Station 12+84

**Direction:** Air Vent 13

**Comments:** Northern Face Door Unlocked, Broken Lock
