CONDITIONS REPORT & CONCEPTUAL DESIGN MEMORANDUM

STEAM TUNNEL ASSESSMENT

ROOSEVELT ISLAND, NEW YORK

17 November 2014
Revised 28 December 2018
Revised 18 September 2020
Project # 100444601

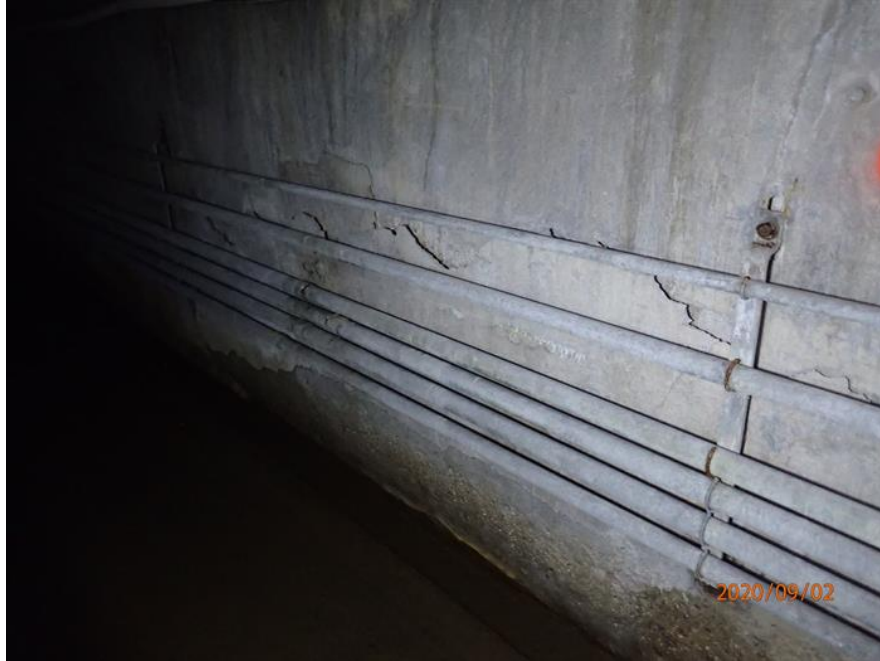
Station 37+00 to 37+50

Comments: Concrete Spalling up to 5 feet Height

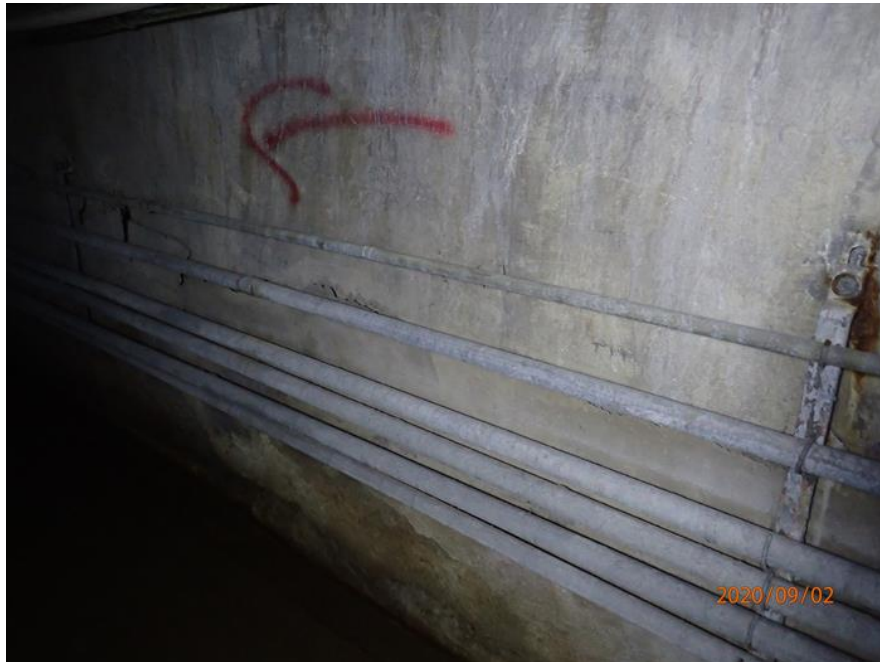
Station 37+00 to 37+50

Comments: Concrete Spalling up to 5 feet Height

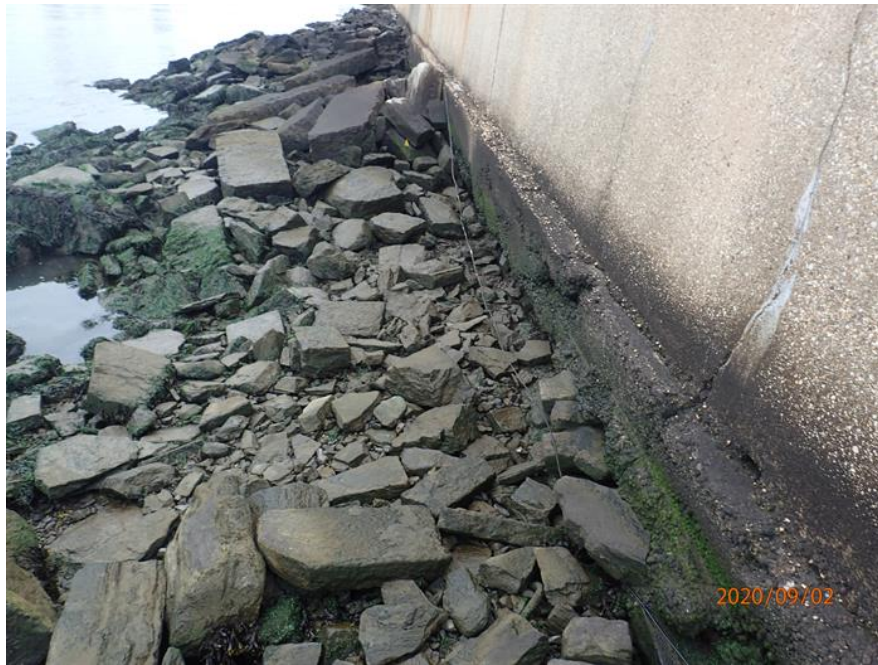
Station Before Tunnel

Comments: Missing Rip-Rap, Seawall Undermined

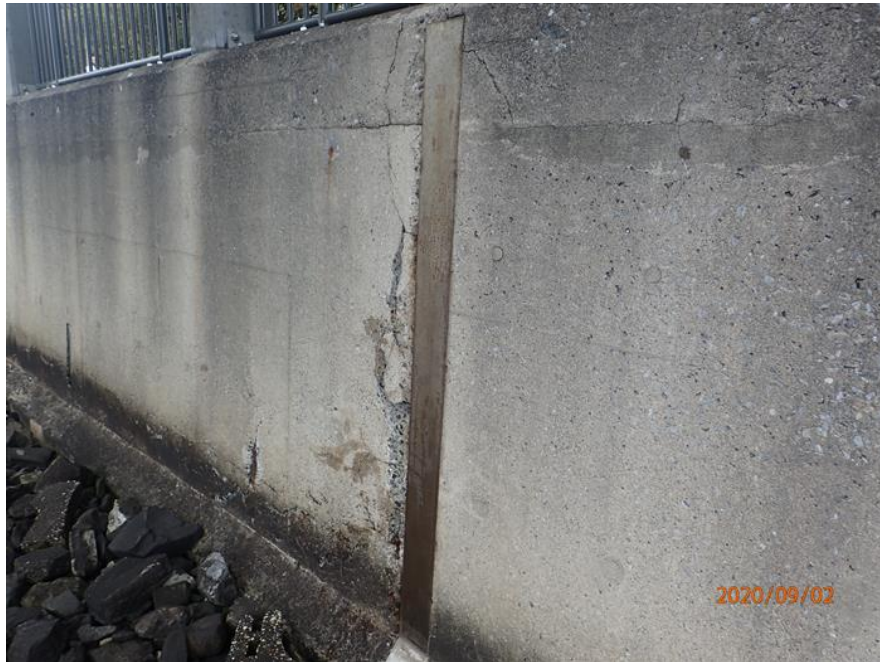
Station 5+40

Comments: Concrete Spalling

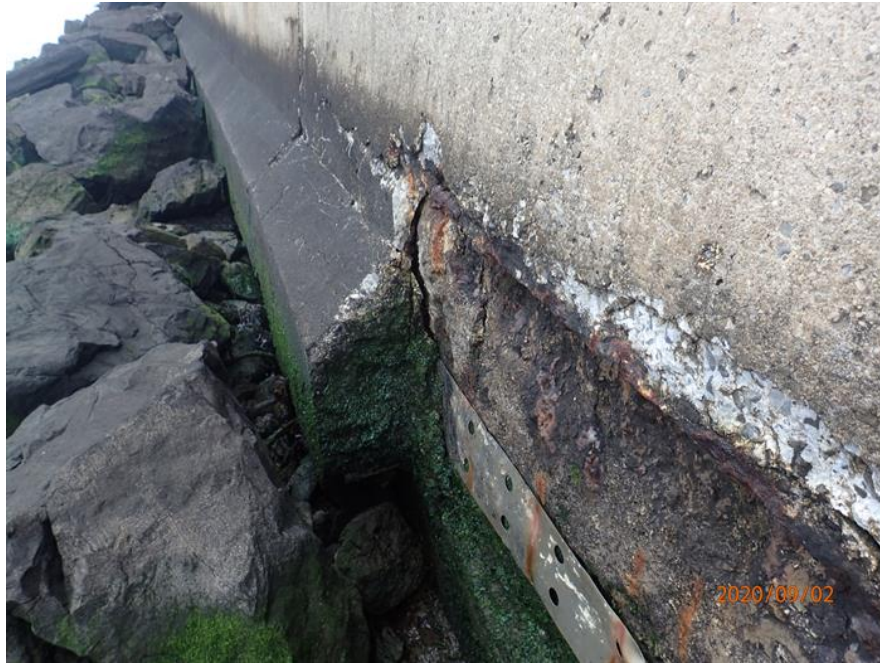
Station 9+25

Comments: Spalling at Haunch, Missing Large Sections of Concrete, Tunnel Undermined, Exposed Steel Plate

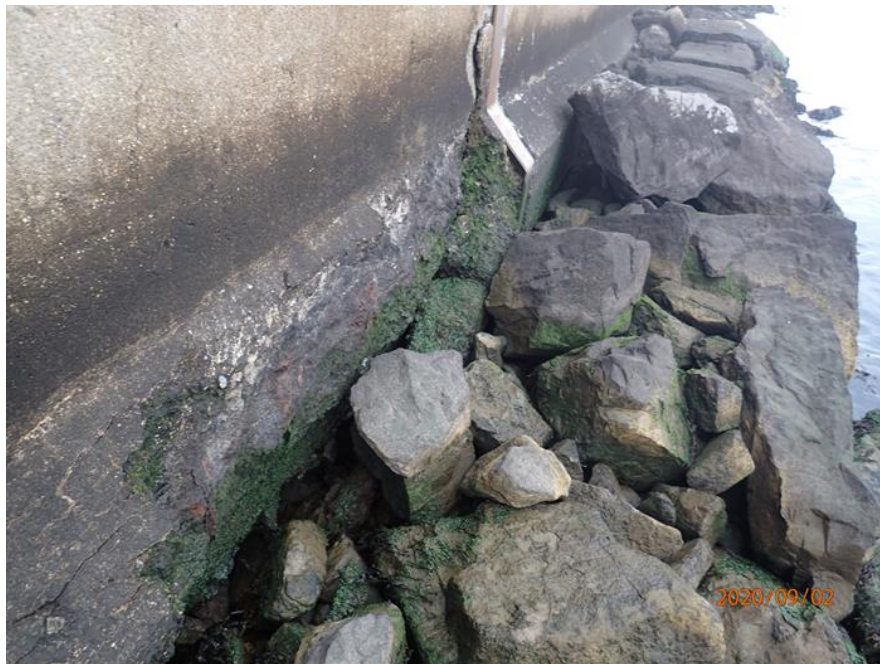
Station 9+82

Comments: Spalling at Haunch, Missing Large Sections of Concrete, Tunnel Undermined

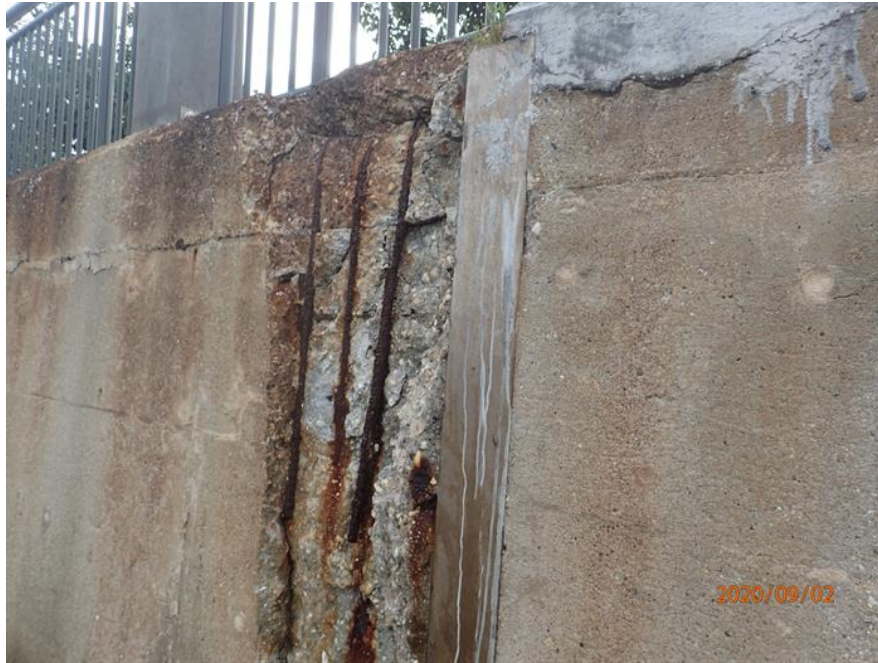
Station 13+10

Comments: Spalling at Haunch, Missing Large Sections of Concrete

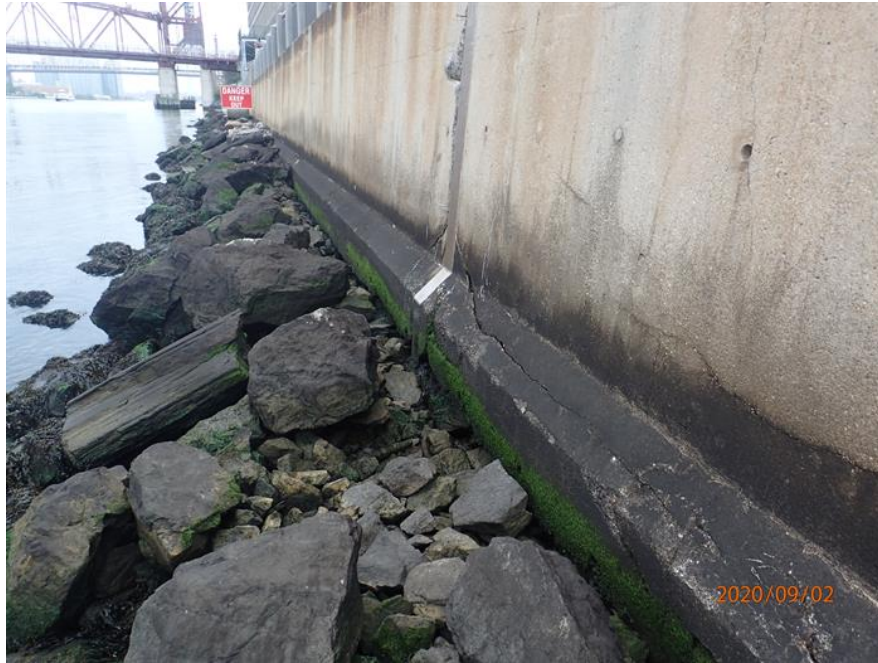
Station 15+63

Comments: Concrete Spalling, Loose Sections of Concrete, Tunnel Undermined, Rip-rap Deficiency

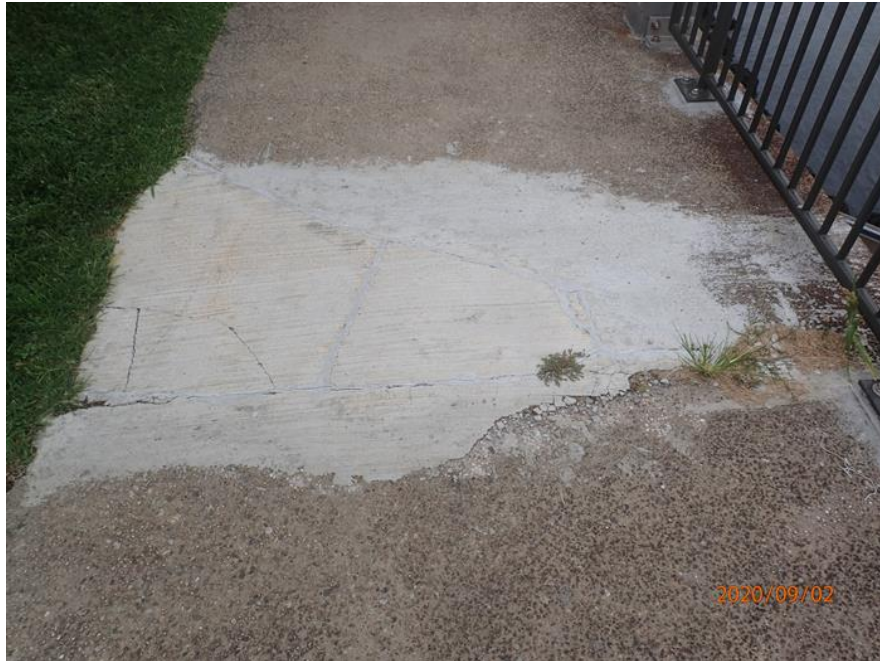
Station 17+66

Comments: Concrete Spalling and repair

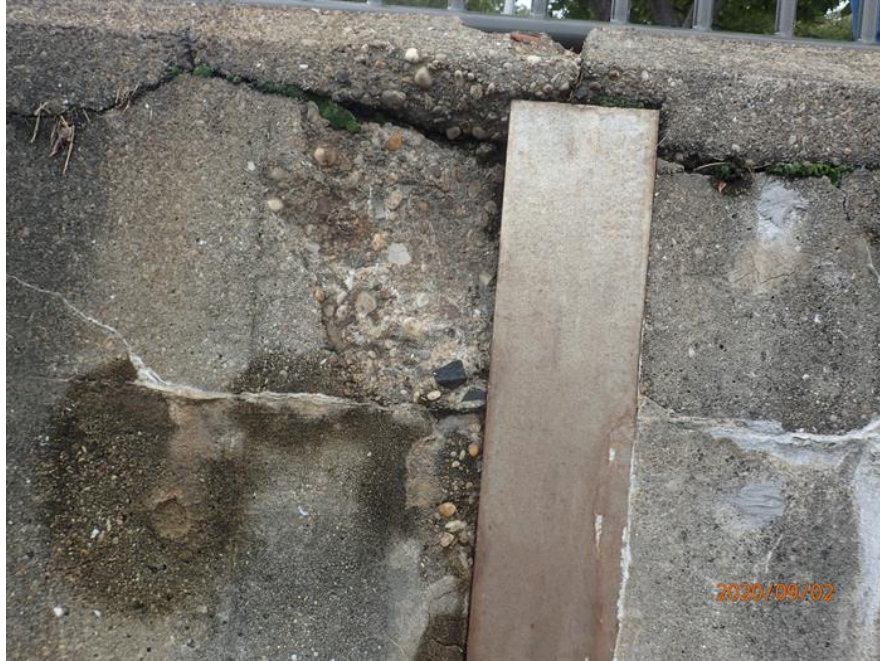
Station 27+07

Comments: Concrete Spalling, Missing Large Section of Concrete

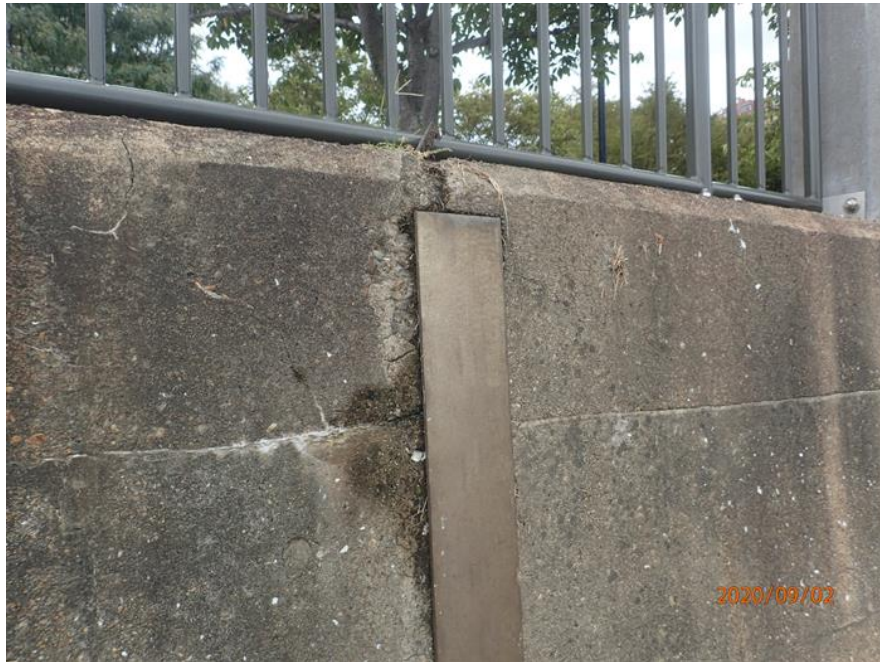
Station 27+57

Comments: Concrete Spalling, Missing Concrete

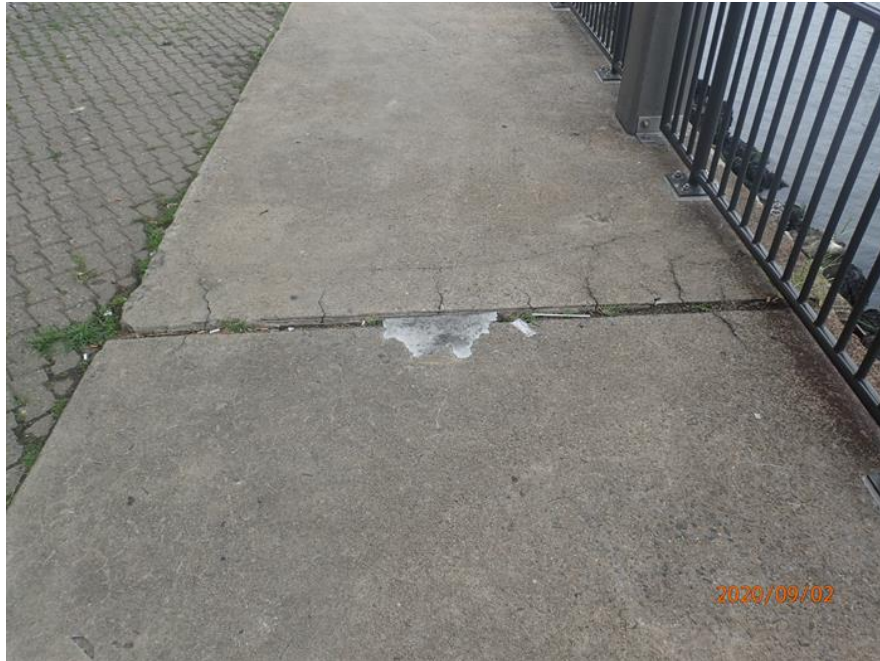
Station 30+24

Comments: Concrete Cracks

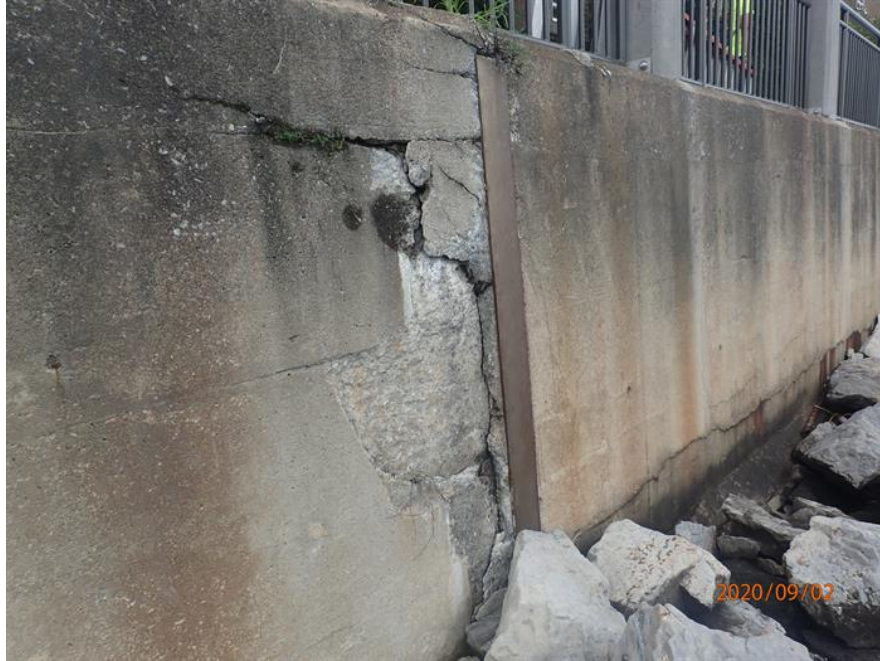
Station 35+38

Comments: Concrete Spalling, Missing Large Section of Concrete, Re-Bar Exposed

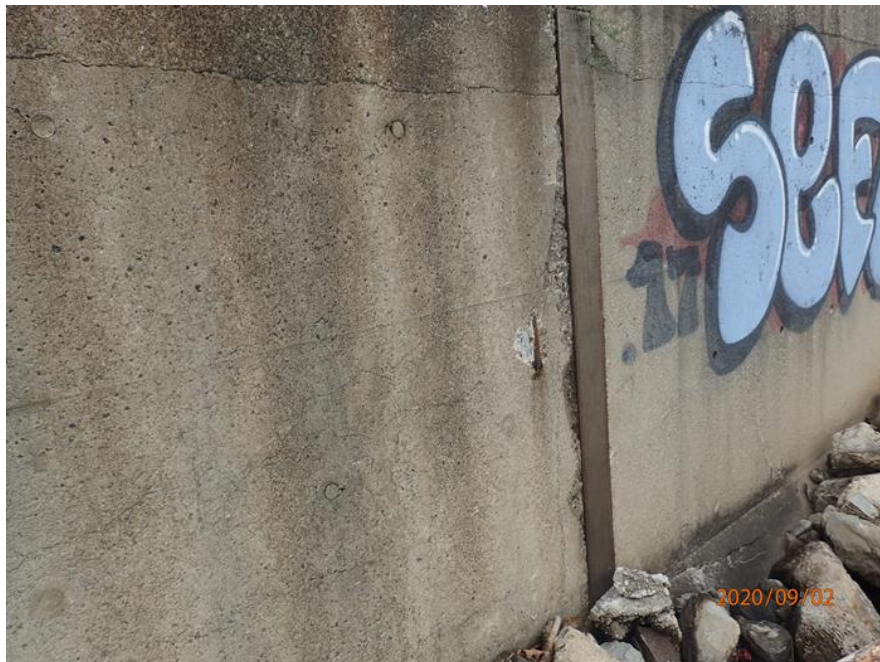
Station 39+03

Comments: Concrete Spalling, Missing Concrete, Concrete Cracks, Re-Bar Exposed

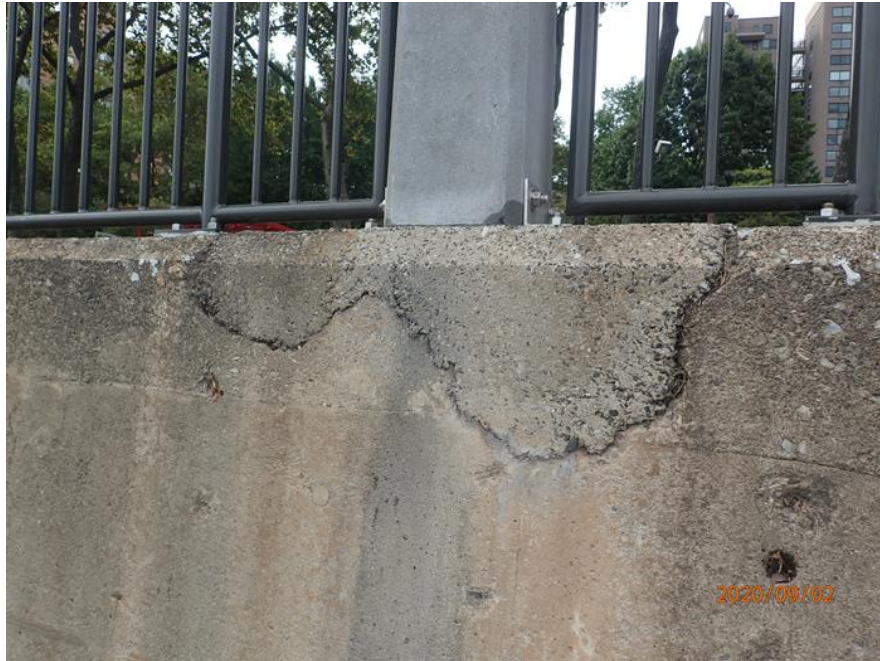
Station 40+00

Comments: Concrete Spalling

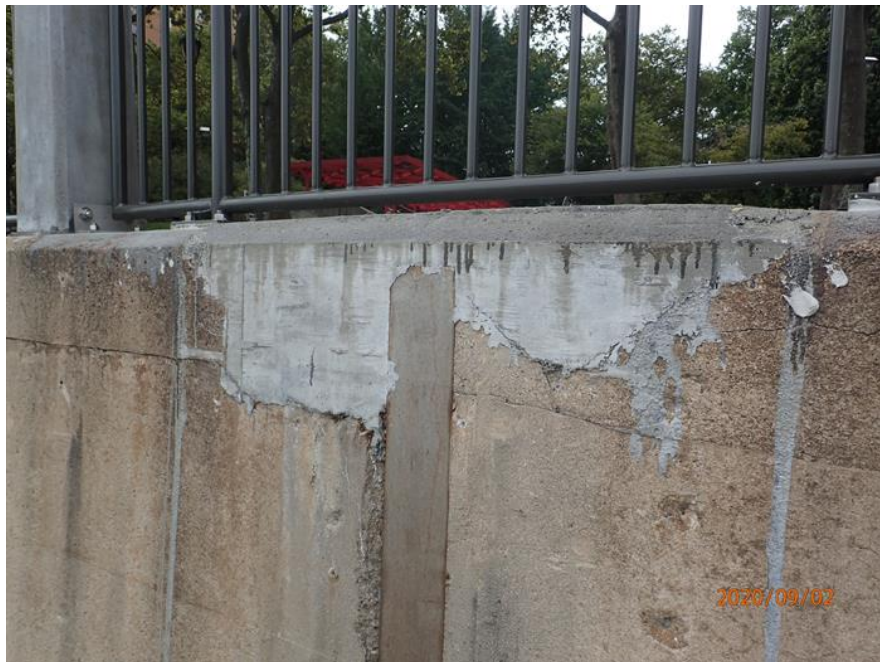
Station 40+15

Comments: Concrete Spalling, Attempt to Repair

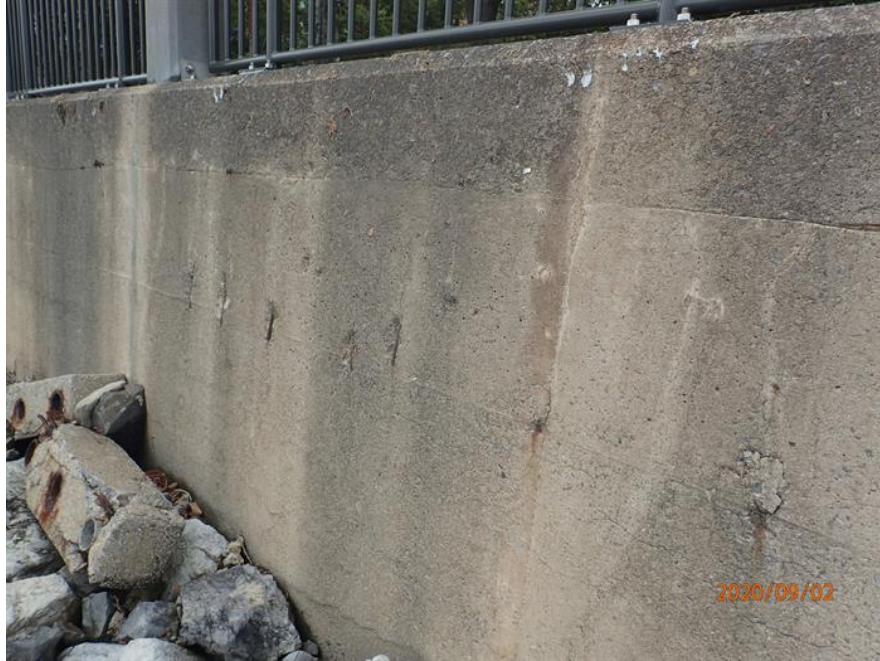
Station 40+50

Comments: Exposed Re-Bar

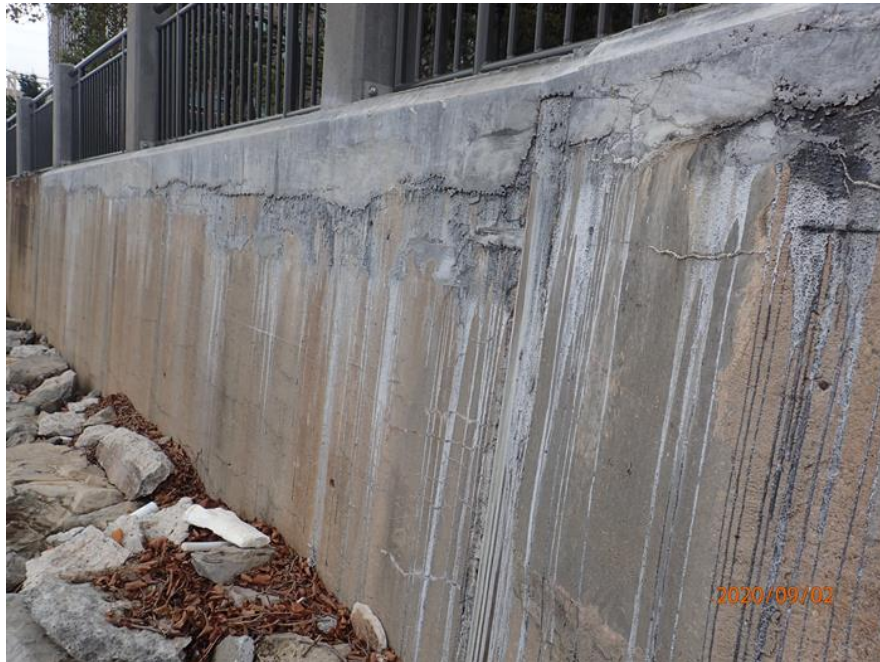
Station 41+00 to 41+25

Comments: Attempt to Repair

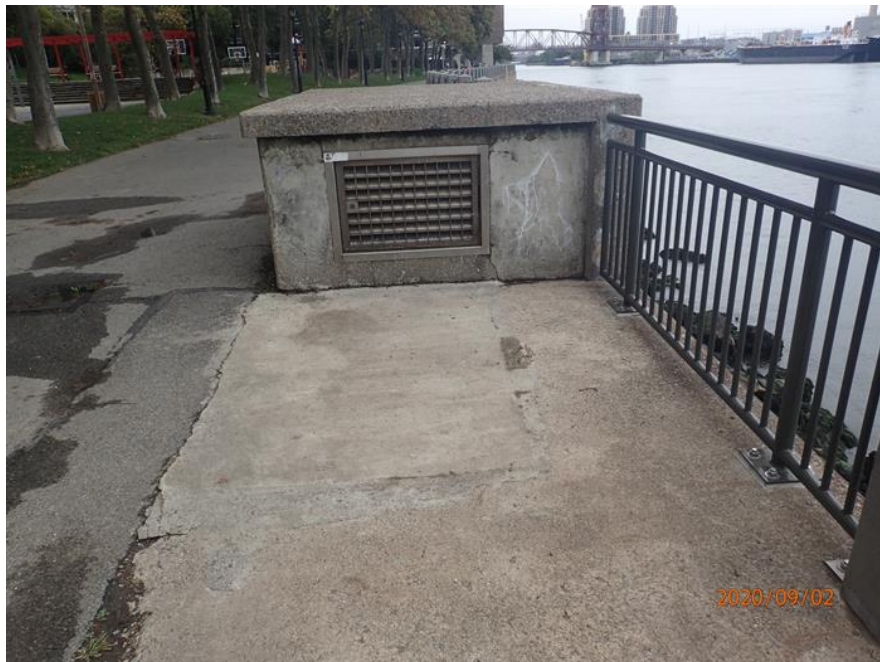
Station 42+18

Comments: Southern Face, Concrete Cracks, Attempt to Repair

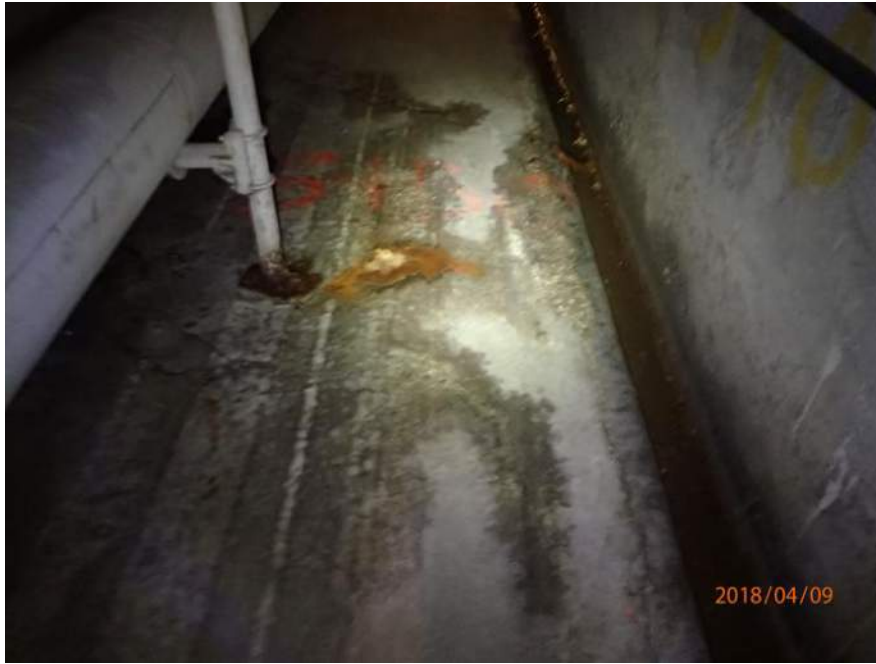
Station 5+45 to 5+55

Comments: Floor Slab Cracking

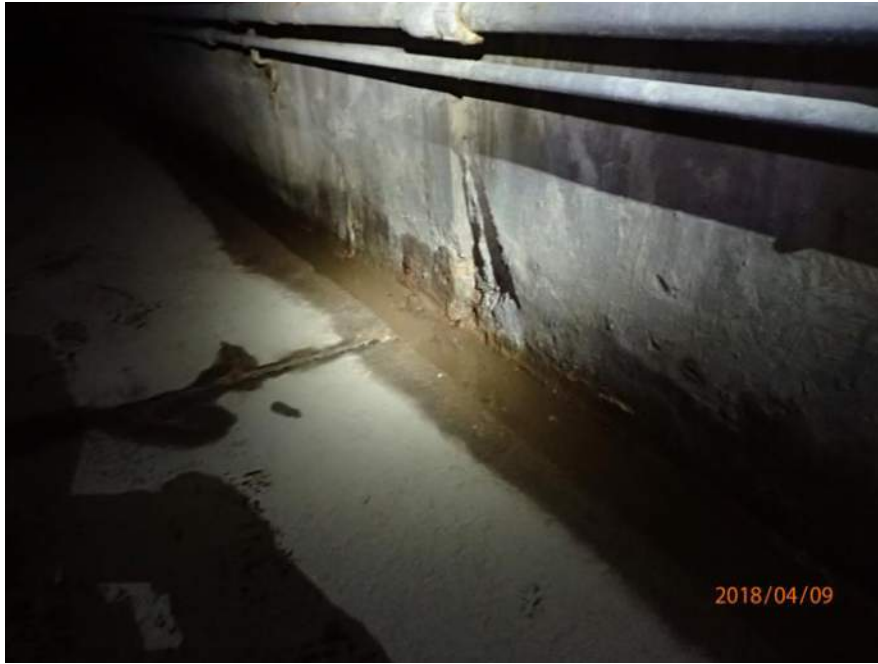
Station 35+39

Comments: Floor Slab Cracked and Displaced

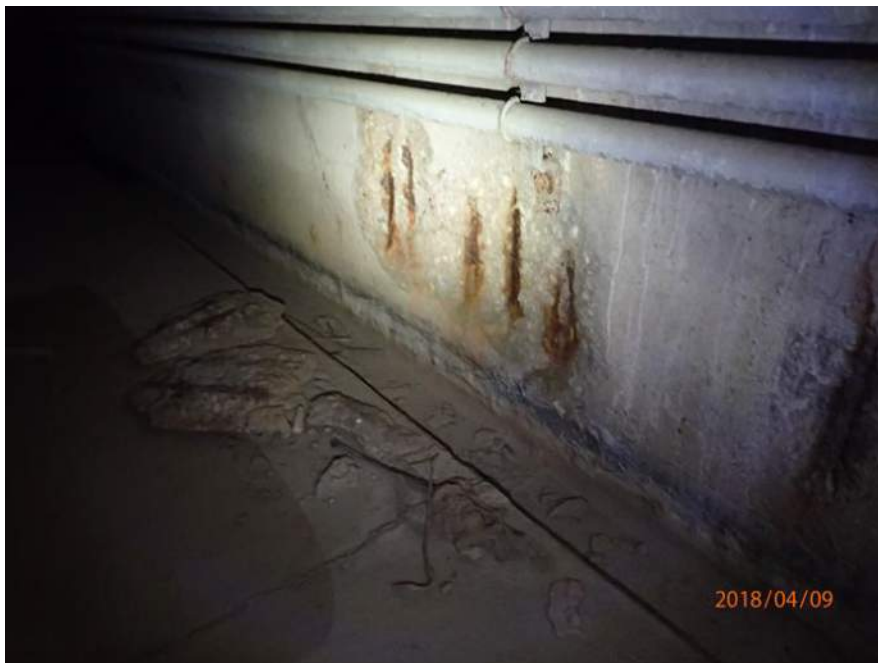
Station 45+61 to 45+66

Comments: Concrete Spalling

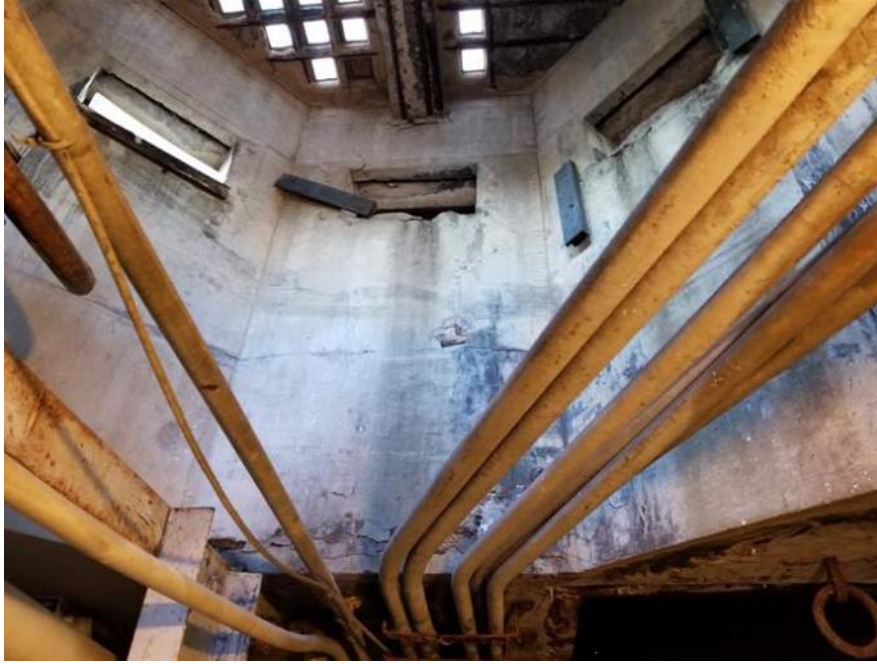
Station 55+00

Comments: Concrete Spalling, Corroded Utilities

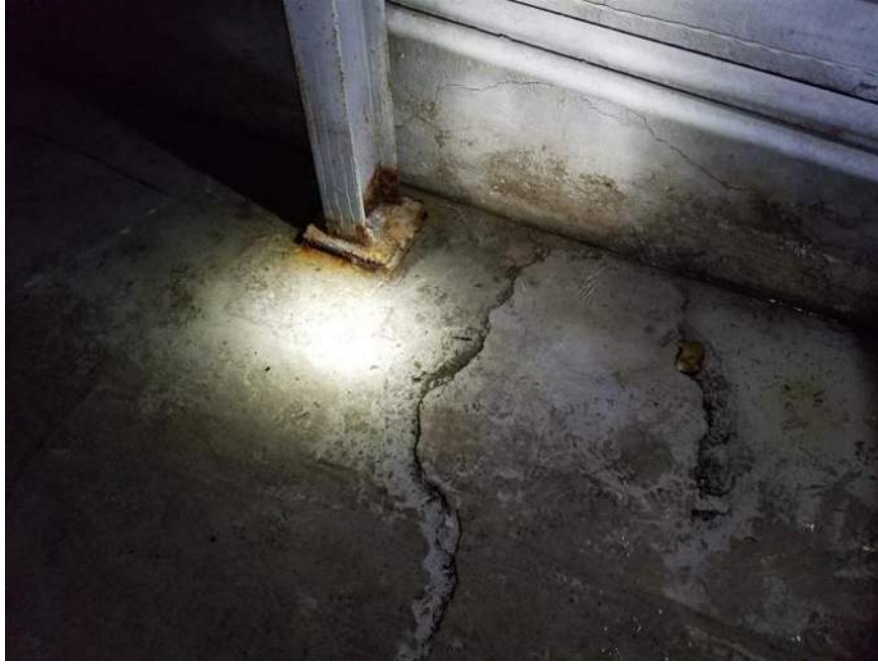
Station 55+65

Comments: Concrete Spalling

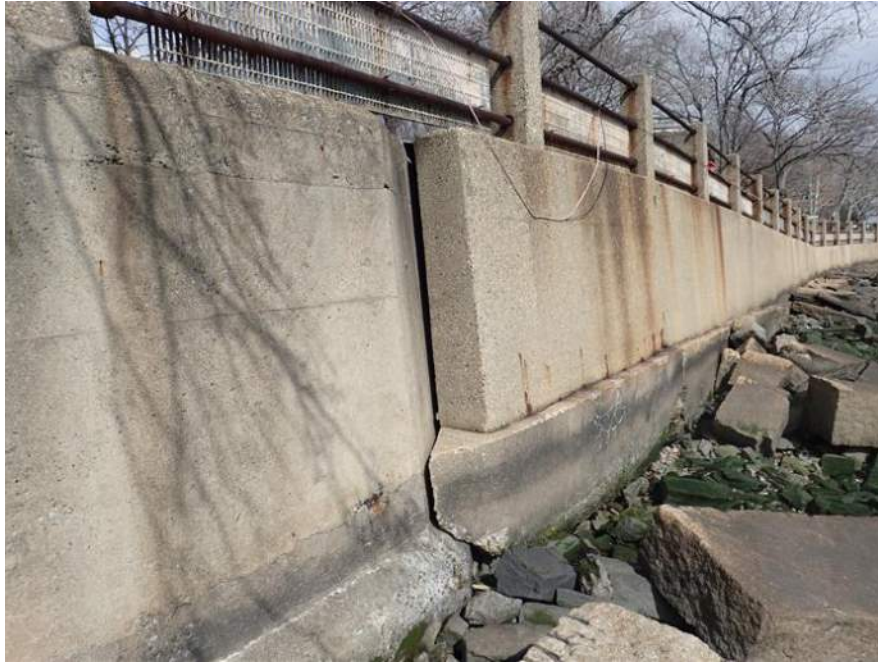
Station 5+18

Comments: Gap Between Steam Tunnel and Seawall

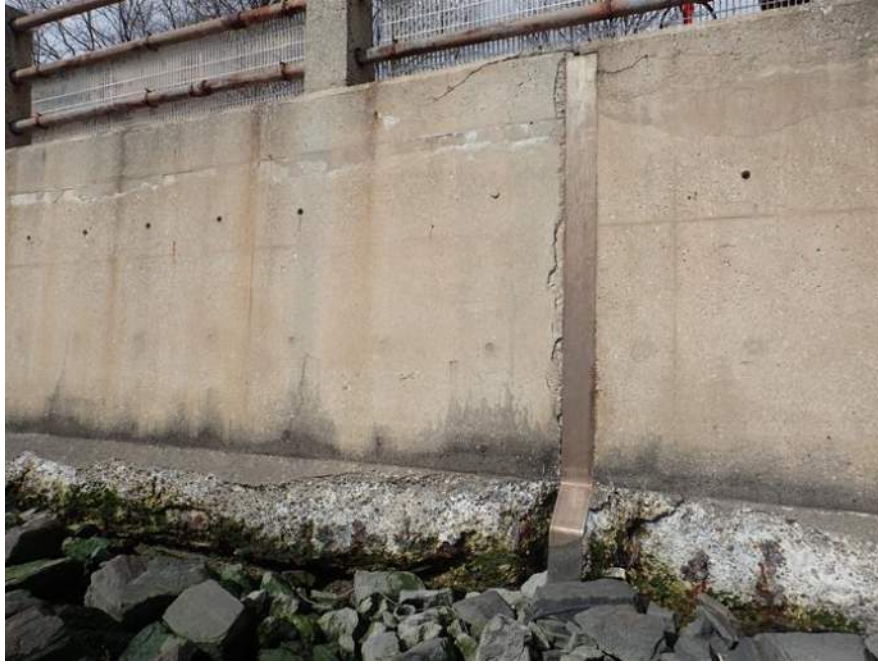
Station 6+60

Comments: Spalling at Haunch, Missing Large Sections of Concrete

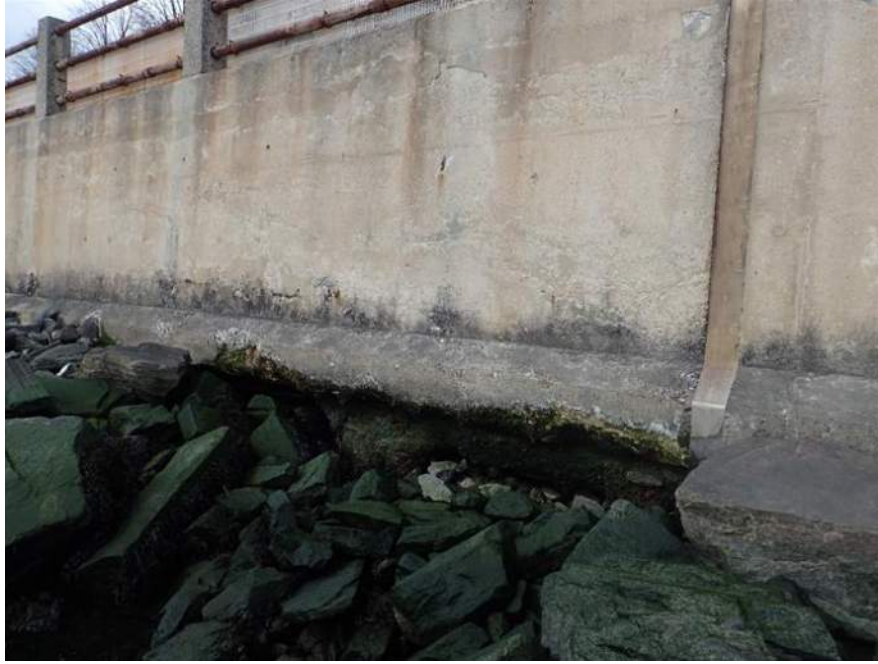
Station 6+96

Comments: Missing Rip-Rap, Tunnel Undermined

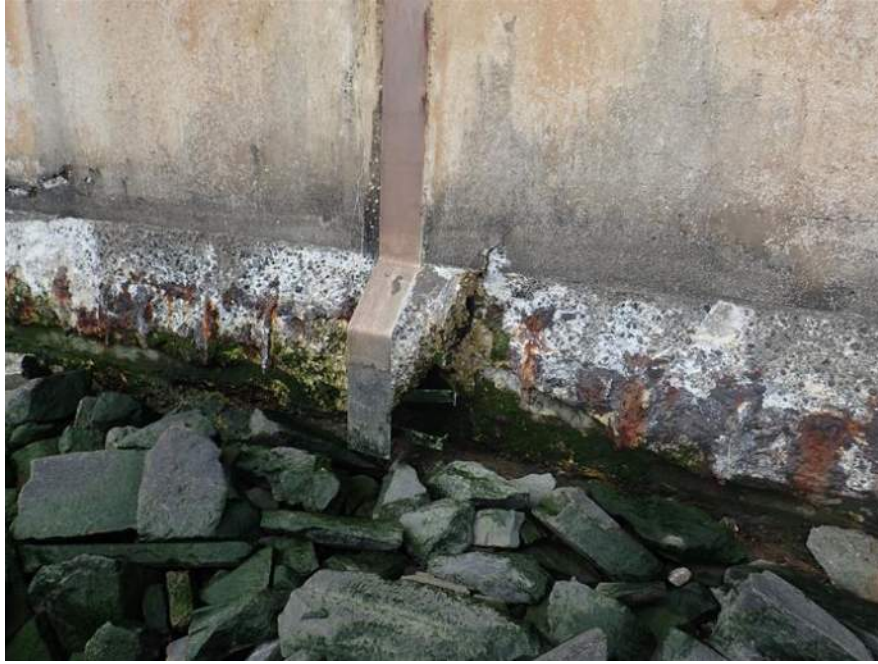
Station 7+86

Comments: Spalling at Haunch, Missing Large Sections of Concrete, Metal Joint Covering Loose

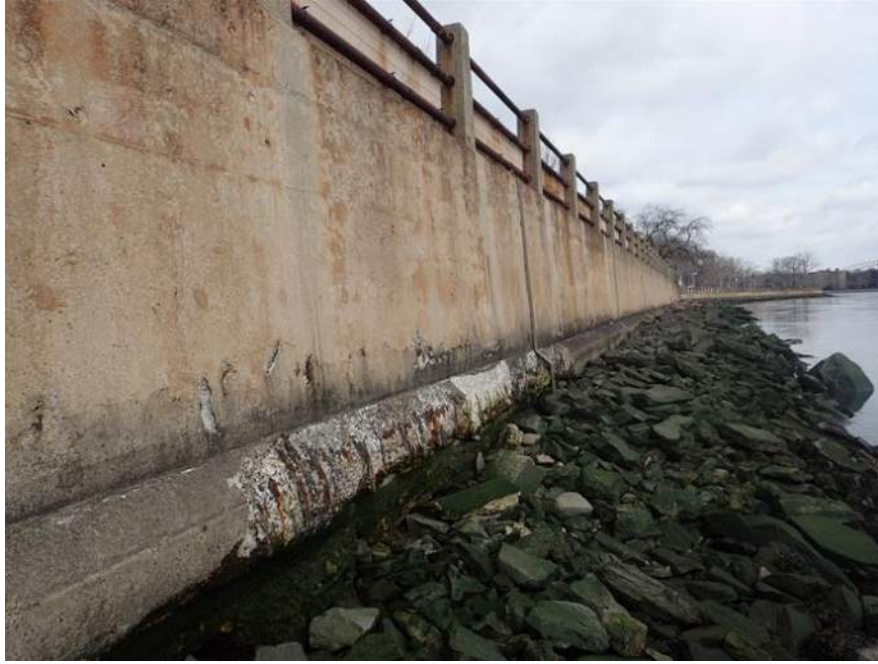
Station 8+12

Comments: Missing Rip-Rap, Tunnel Undermined, Exposed Re-Bar

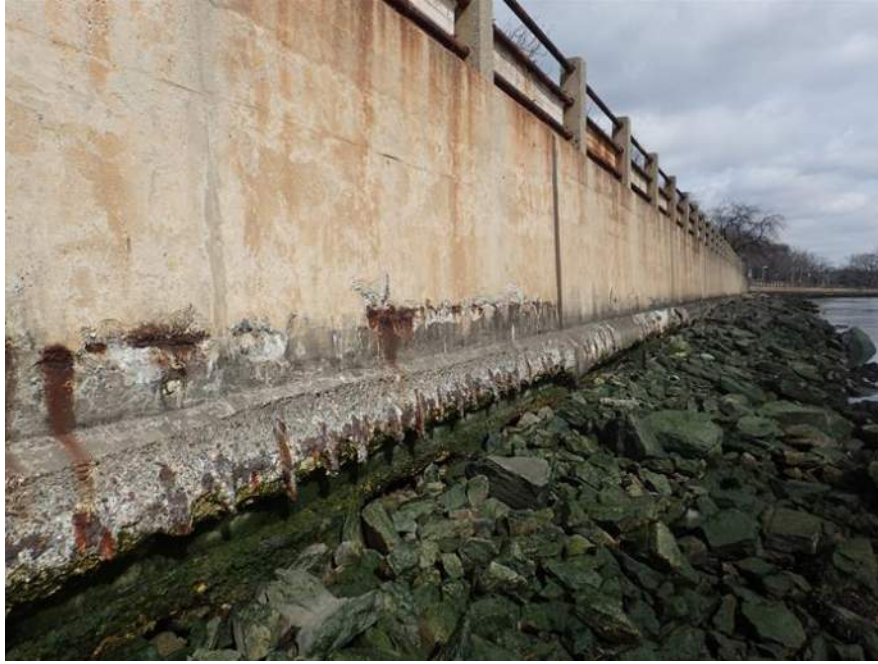
Station 8+37

Comments: Spalling at Haunch, Missing Large Sections of Concrete, Exposed Re-Bar

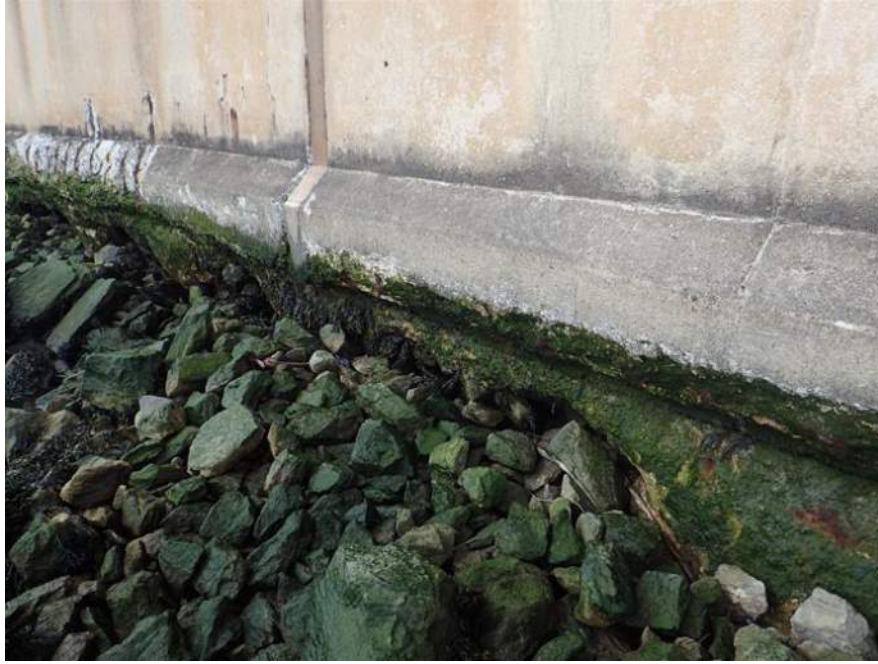
Station 8+94

Comments: Spalling at Haunch, Missing Large Sections of Concrete, Tunnel has been Undermined

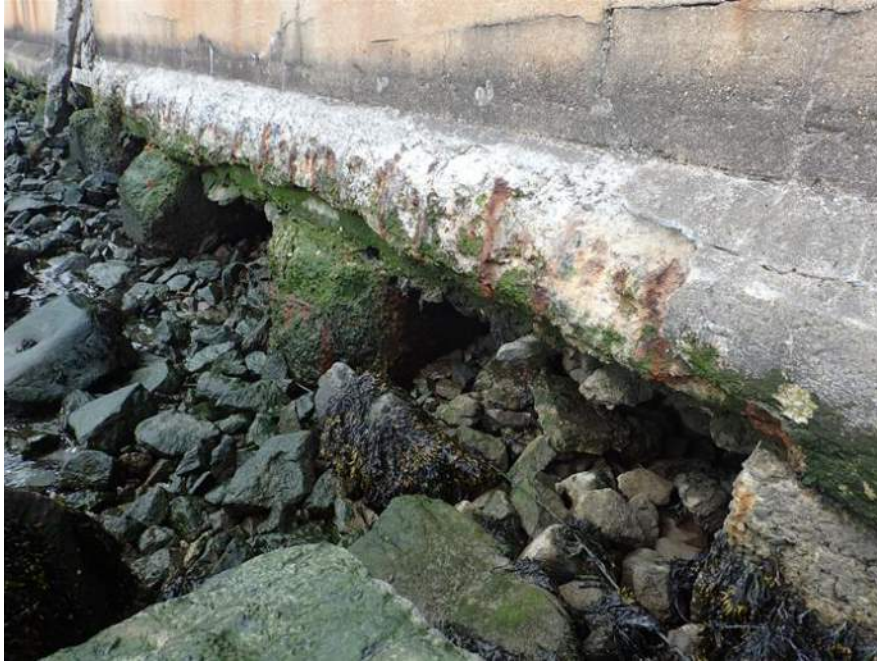
Station 10+43

Comments: Spalling at Haunch, Missing Large Sections of Concrete, Tunnel has been Undermined, Cap Beams Visible

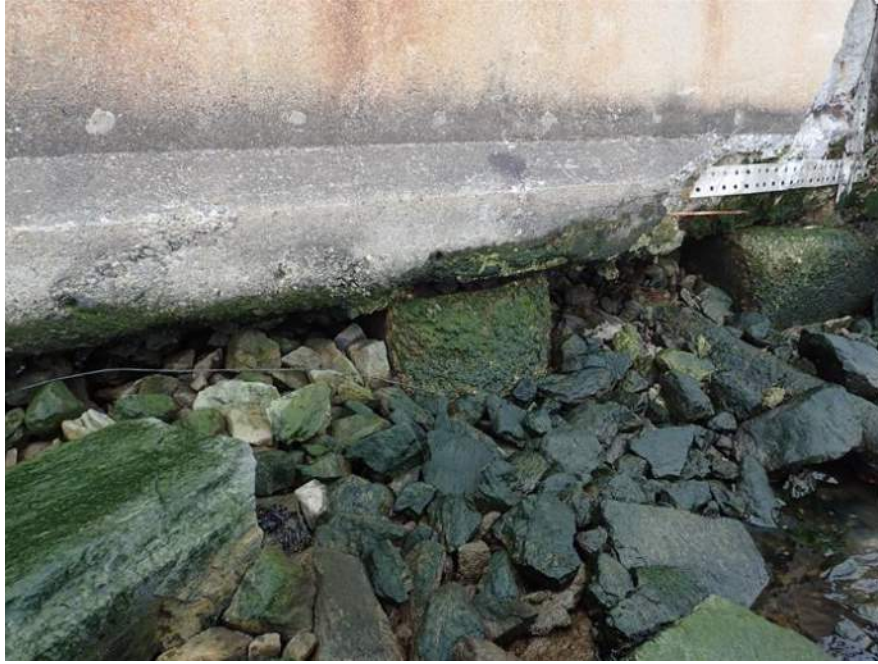
Station 10+57

Comments: Tunnel has been Undermined

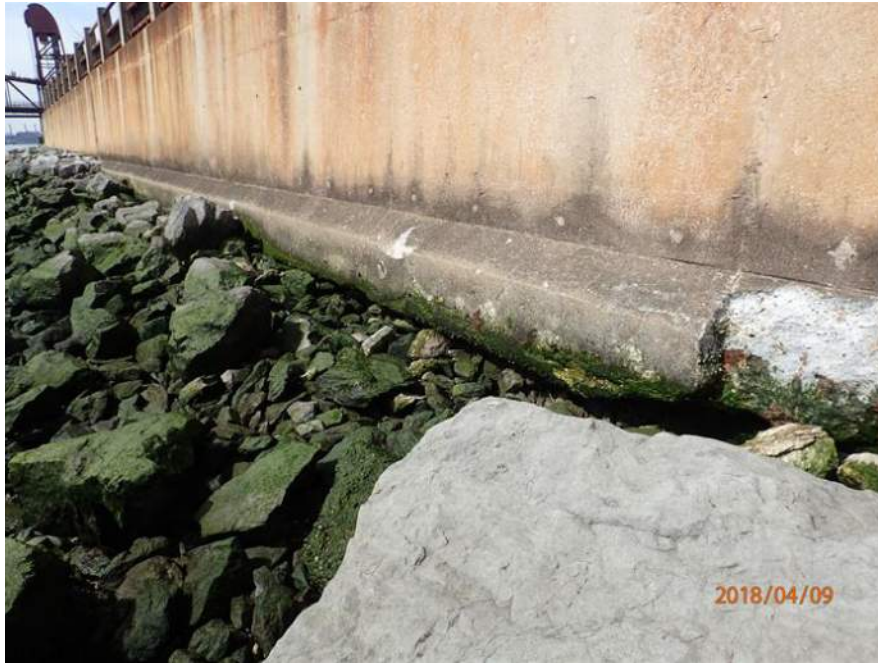
Station 13+15

Comments: Tunnel has been Undermined

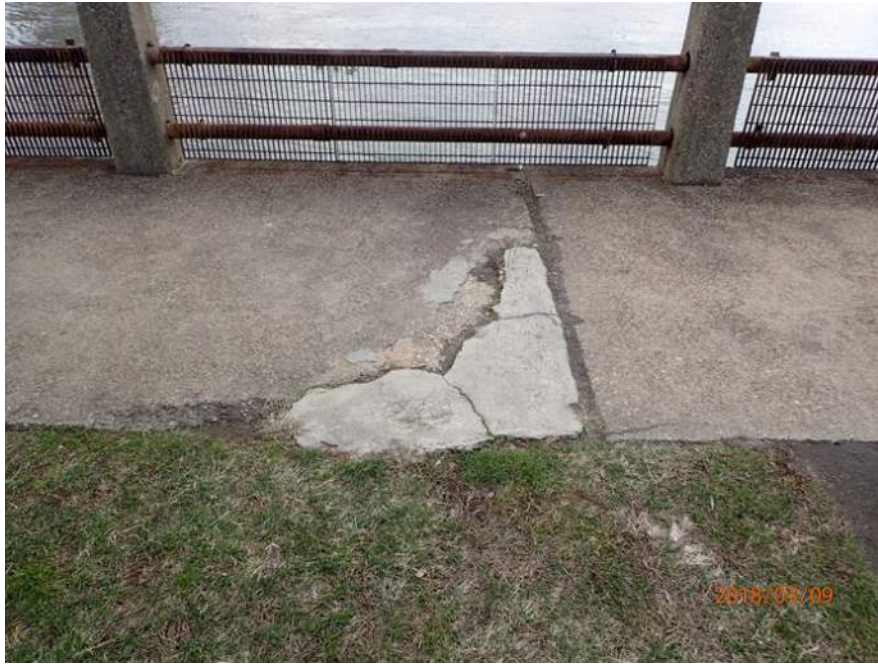
Station 17+66

Comments: Concrete Spalling

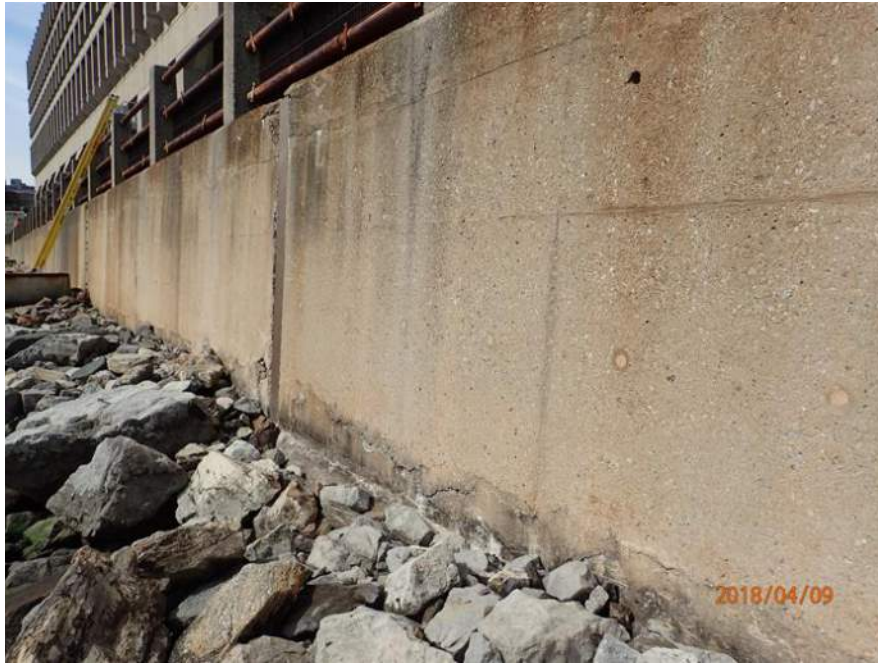
Station 17+75 to 17+85

Comments: Concrete Spalling

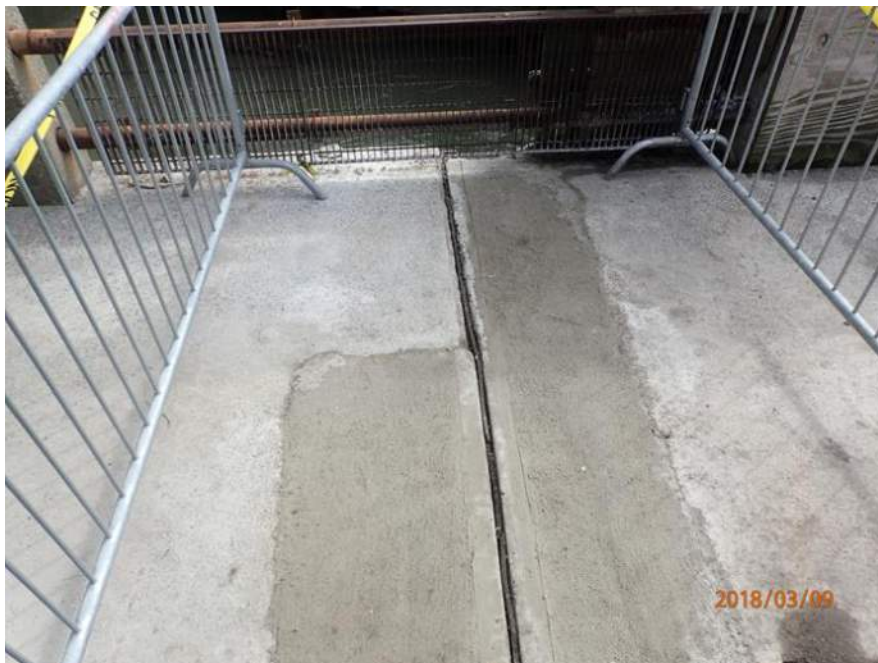
Station 23+88

Comments: Joint Repair

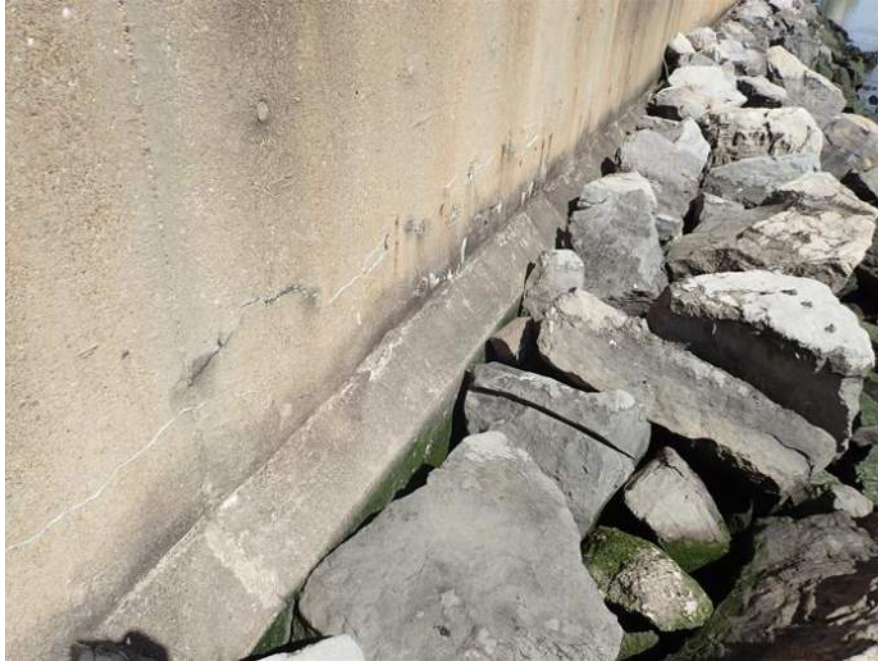
Station 28+40 to 28+50

Comments: Concrete Spalling
