CONDITIONS REPORT & CONCEPTUAL DESIGN MEMORANDUM

STEAM TUNNEL ASSESSMENT

ROOSEVELT ISLAND, NEW YORK

17 November 2014
Revised 28 December 2018
Revised 18 September 2020
Project # 100444601

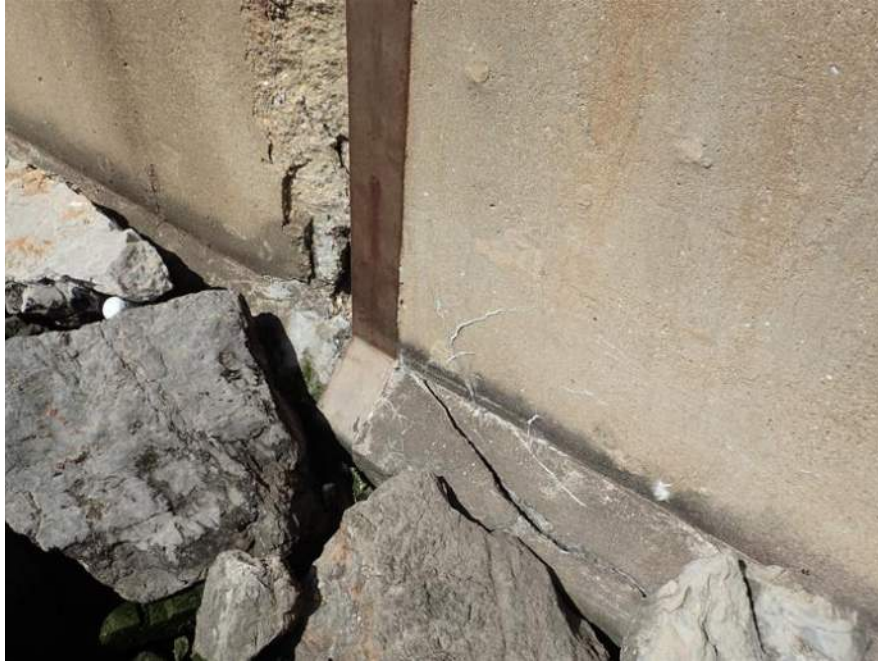
Station 28+34

Comments: Concrete Spalling, Missing Large Section of Concrete, Re-Bar Exposed

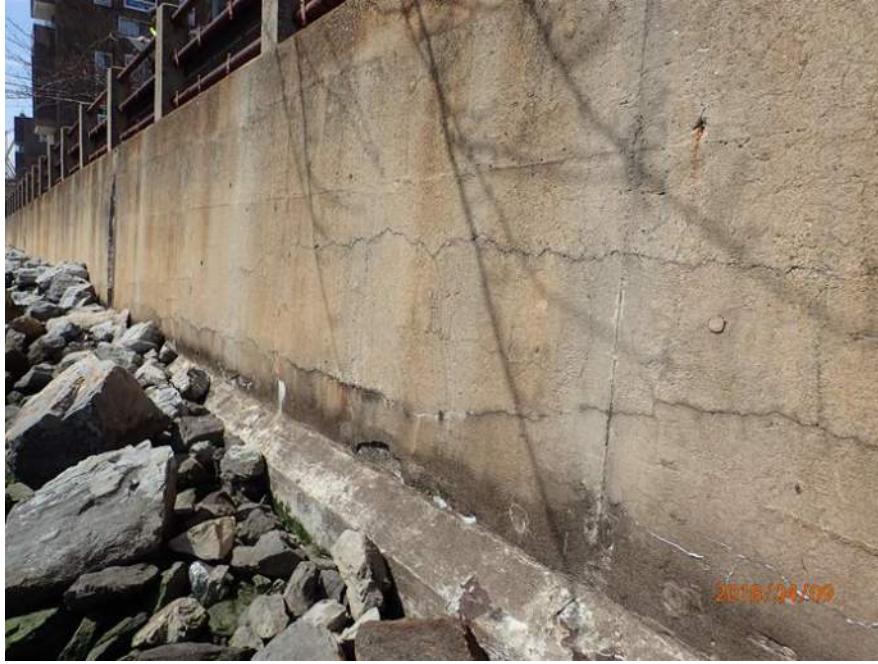
Station 33+84

Comments: Concrete Spalling

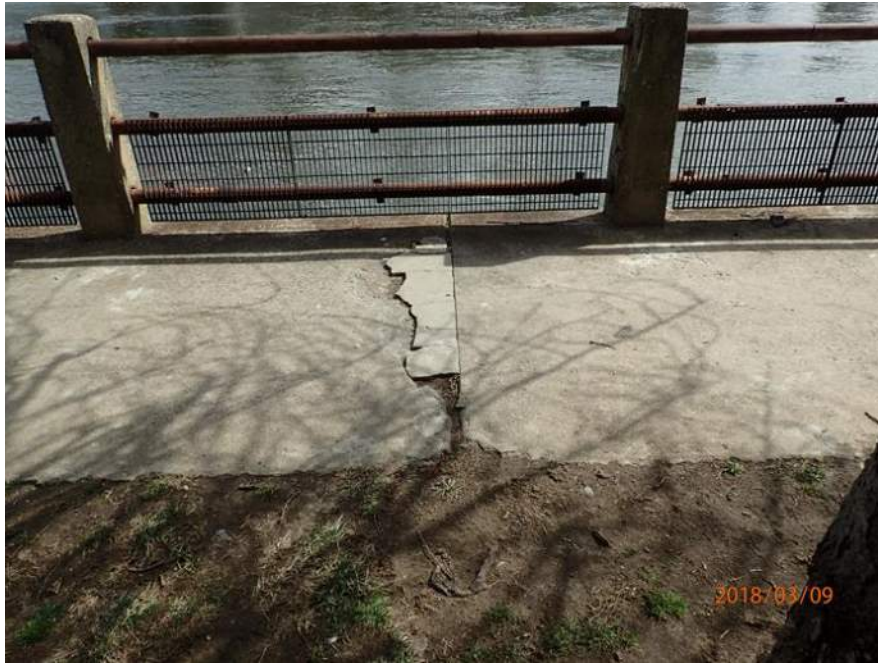
Station 36+56

Comments: Concrete Cracks

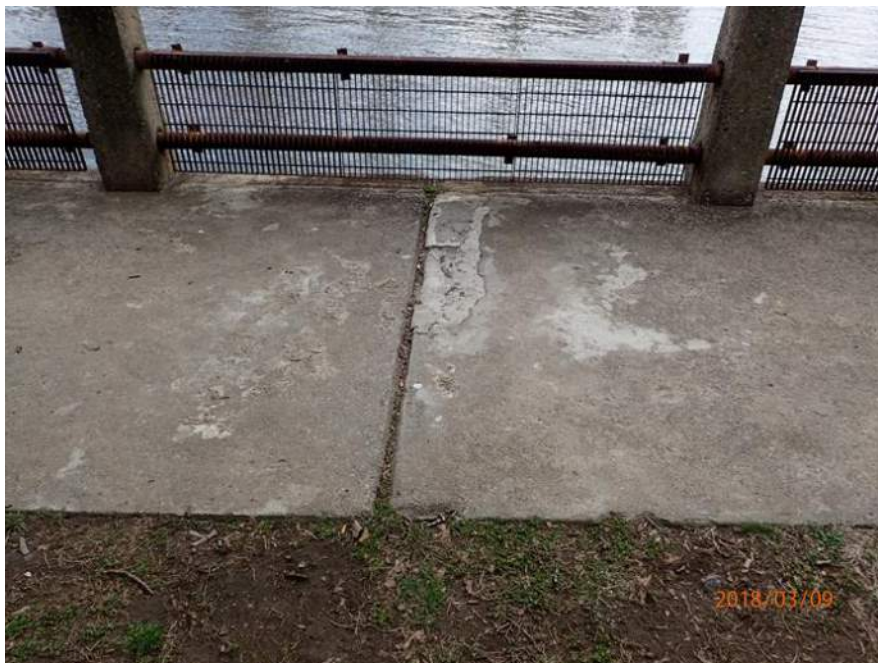
Station 37+22

Comments: Concrete Cracks

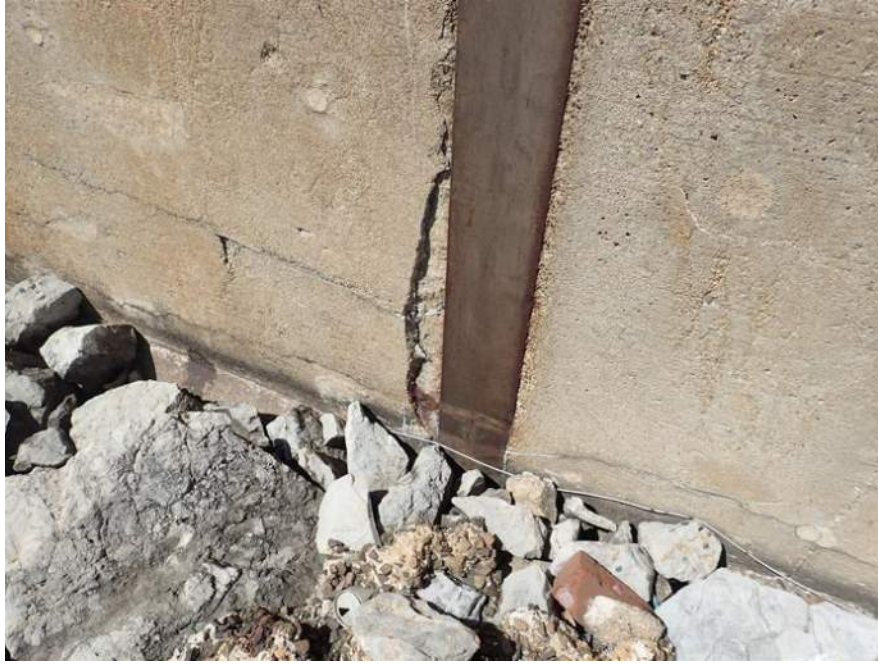
Station 37+22

Comments: Concrete Spalling

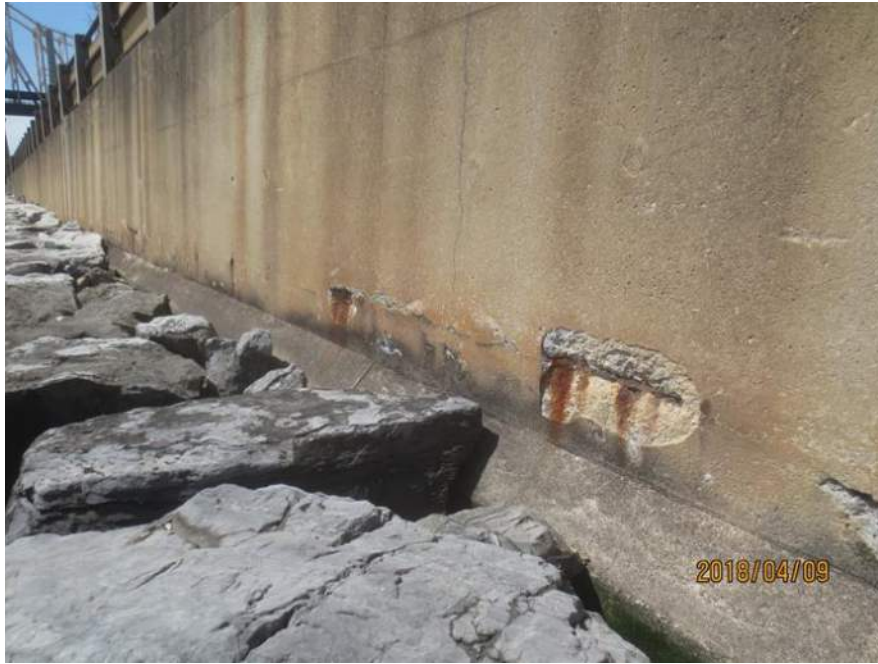
Station 43+44

Comments: Concrete Spalling, Exposed Re-bar

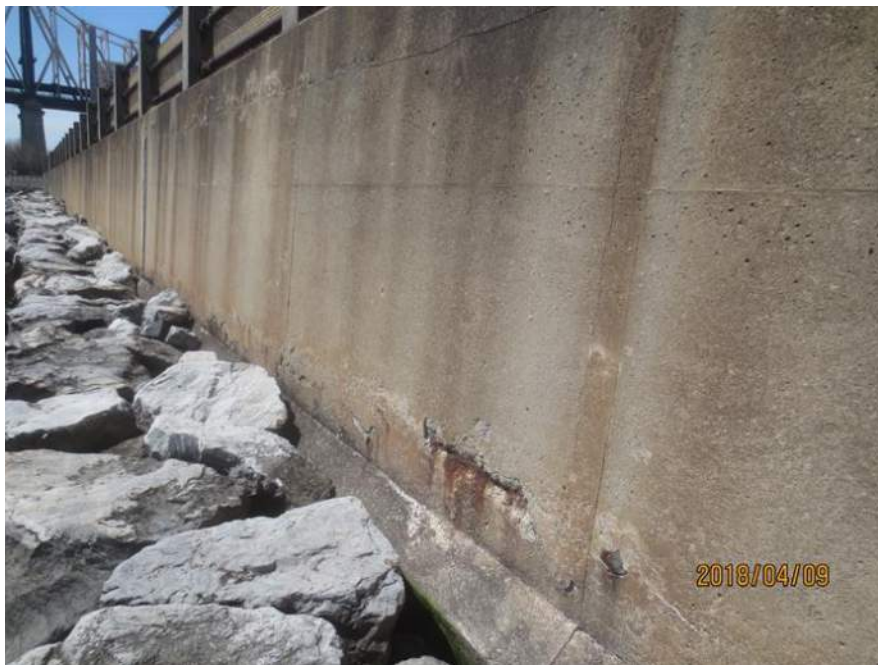
Station 43+66

Comments: Exposed Re-Bar

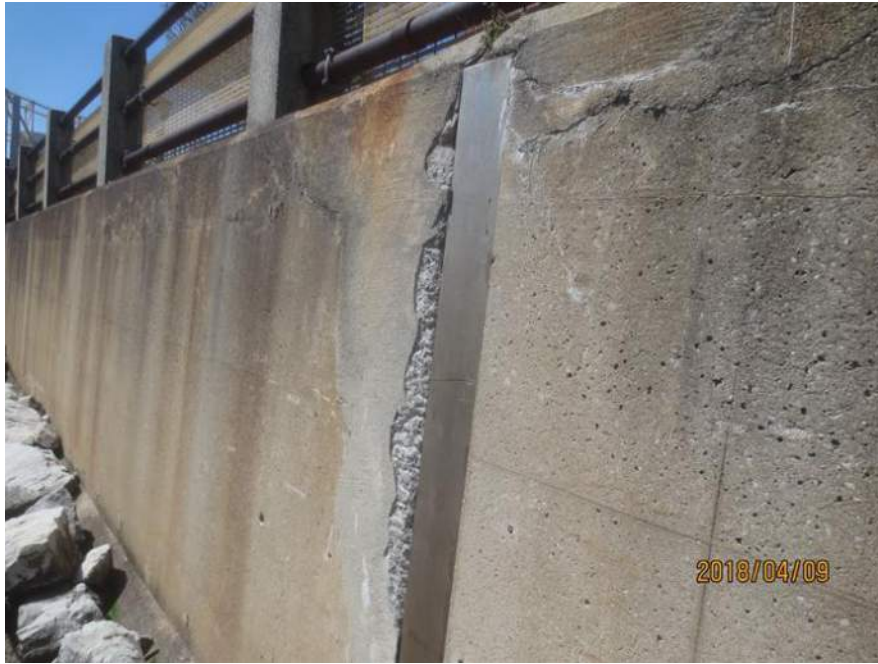
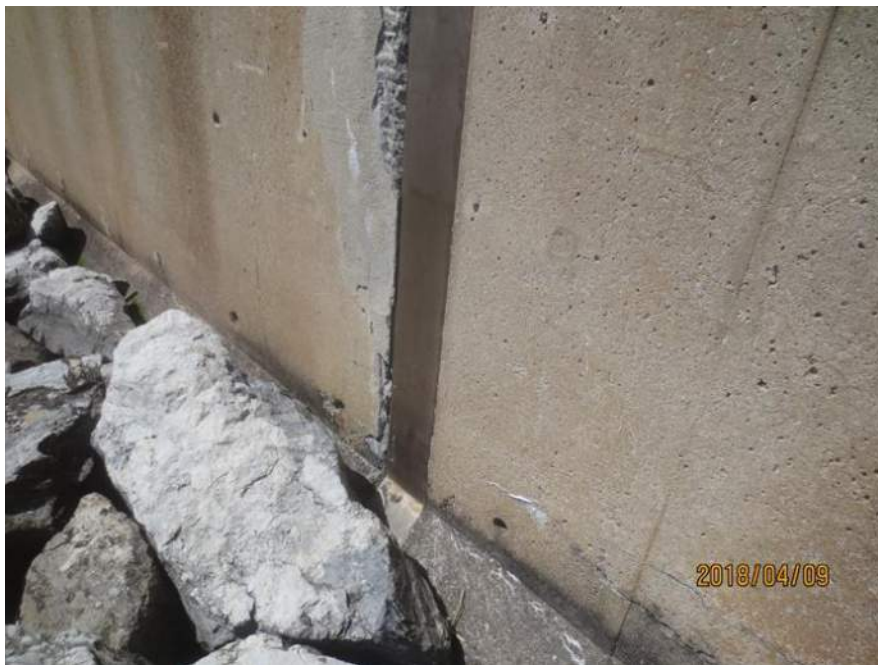
Station 43+87

Comments: Spalling and Concrete Repairs

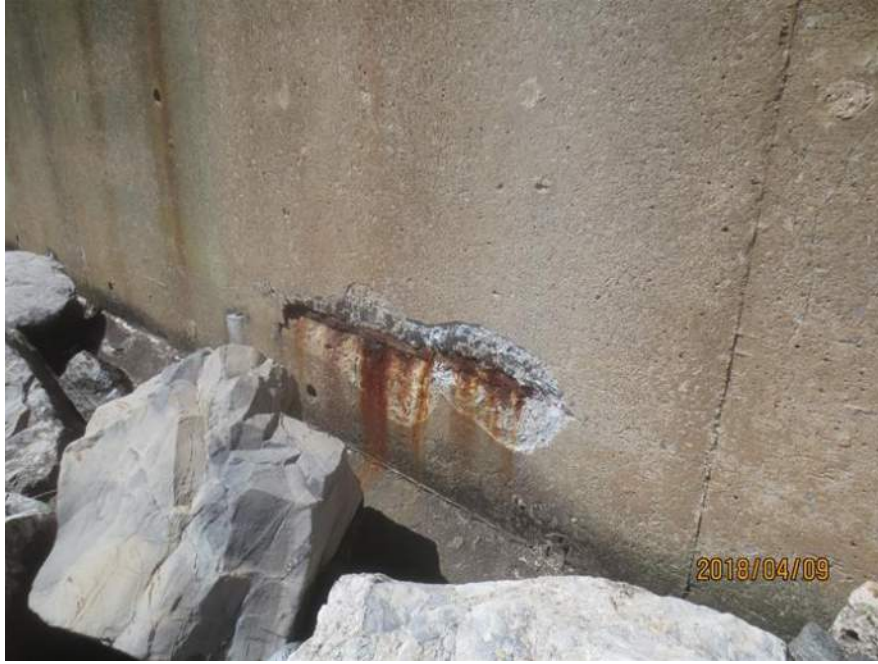
Station 44+65

Comments: Exposed Re-Bar
