THE ROOSEVELT ISLAND LIGHTHOUSE  
BUILDING CONDITION SURVEY

Roosevelt Island, New York

June 2011

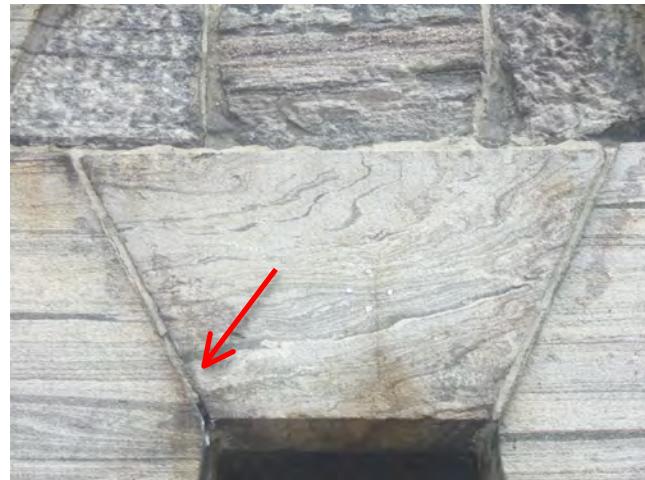
- iii. **Eroded Mortar Joints** - Most areas of the masonry mortar are in good condition, however, areas where eroded joints were noted are localized primarily to the north facing stones. Also, there is evidence of two mortar colors one dark (newer) and one lighter are found within the stonework.

9. Eroded mortar joints at lintel stone.

- iii. **The masonry mortar joints** will require partial repointing at severely exposed locations using appropriate methods and mortars. Full scale repointing will be required in 10-20 years.

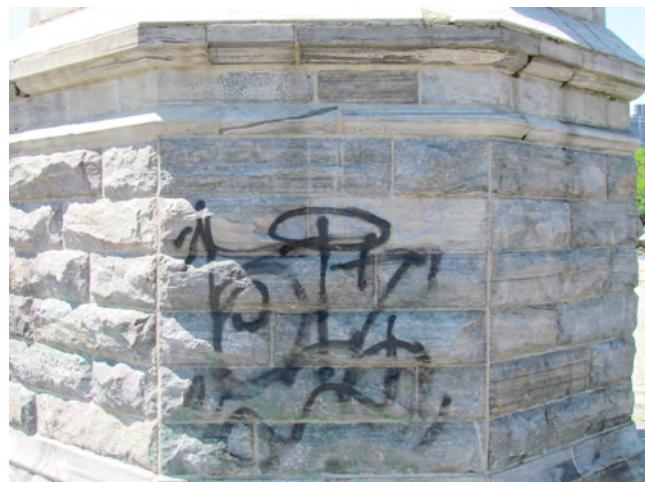
*At the rear (north elevation) evidence of graffiti is present.*

10. Base stone section tagged with graffiti.

- ii. **Perform a test cleaning** at an area of efflorescence and graffiti to see effectiveness prior to full scale cleaning.

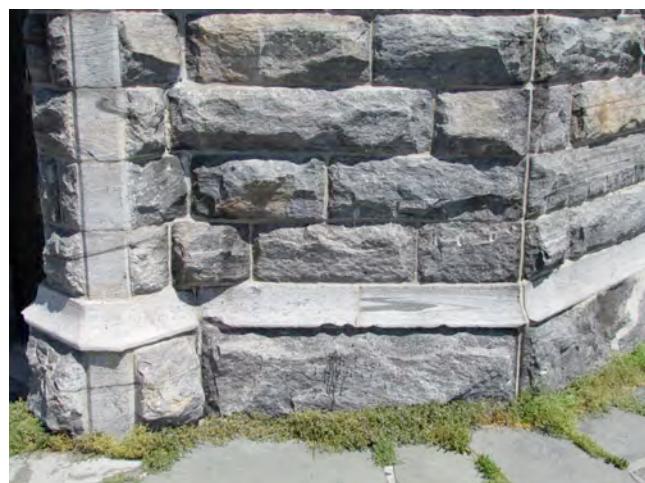
11. Base stone units with broken edges and open mortar joints.

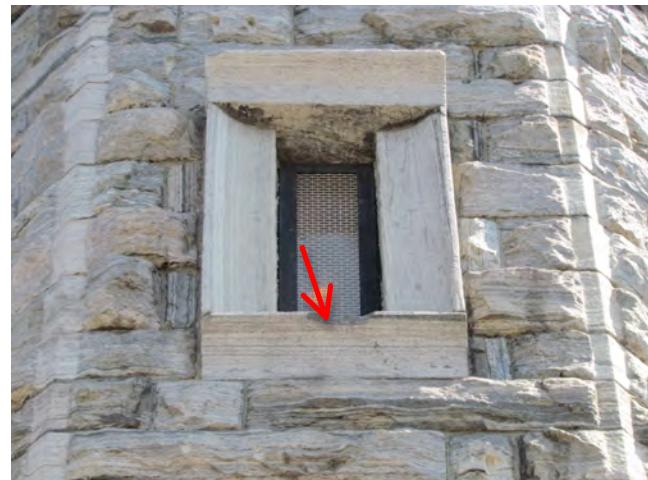
12. Upper level window with stone trim units. Note: broken edge of sill stone.

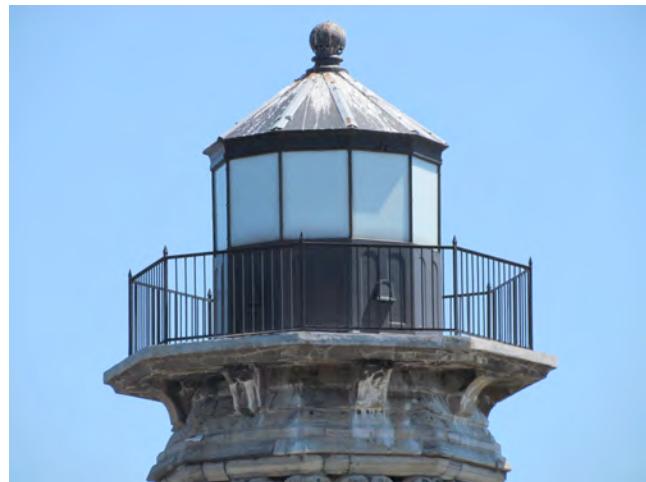
15. Lantern section set on deteriorated concrete platform.

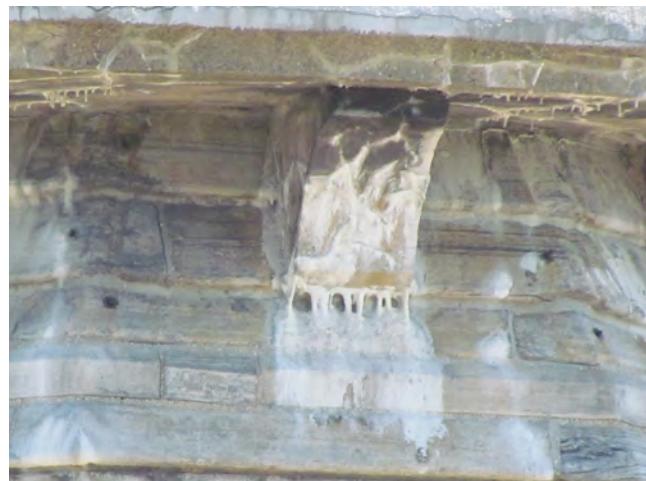
- i. **Staining** - The stone masonry is generally in good clean condition, however, at the upper stepped section there are deposits staining the stone from the deteriorating concrete platform.

17. Deteriorated concrete bracket causing damage to stone units below.

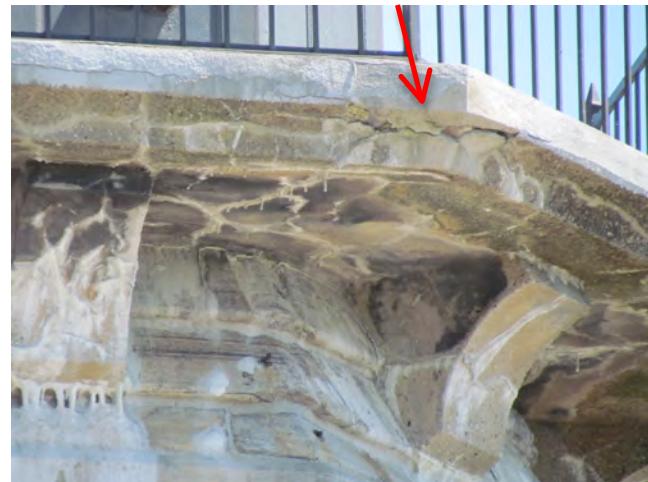
*Excessive amounts of moisture has migrated into the slab as evidenced by the cracks and noted staining at the underside. This condition has most likely compromised some of the reinforcing steel.*

18. Cracks and efflorescence at concrete platform.

- i. *A test to determine the design of the concrete use and reinforcing bars should be made to better evaluate the soundness of the platform. This can be accomplished by cutting cylindrical cores that are afterwards analyzed in a laboratory.*
- ii. *If the structure is deemed sound the concrete platform must be resurfaced with a new high performance breathable waterproof coating with migratory corrosion inhibitors.*
- iii. *All concrete sections must be sounded for loose material. All sections found to be defective must be cut back to sound material and patched with an appropriate concrete patching mortar.*

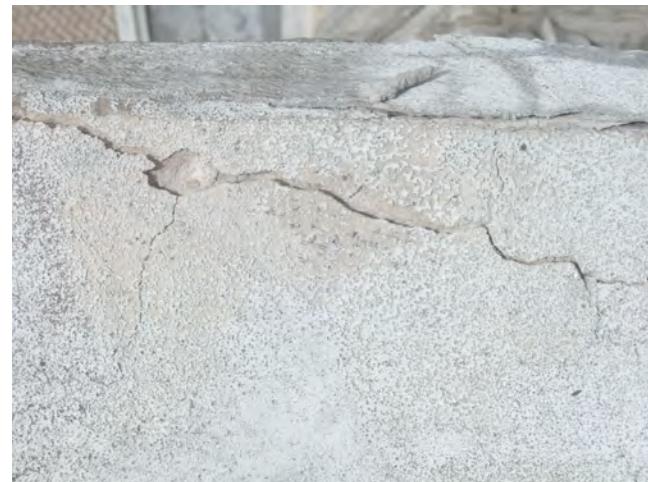
- i. **Concrete Coating** - *The exposed top face of the concrete has a topical coating applied to inhibit moisture penetration. This coating is in poor condition and does not terminate properly at the base of the lantern.*

19. Open cracks and deterioration at waterproof coating at concrete platform.

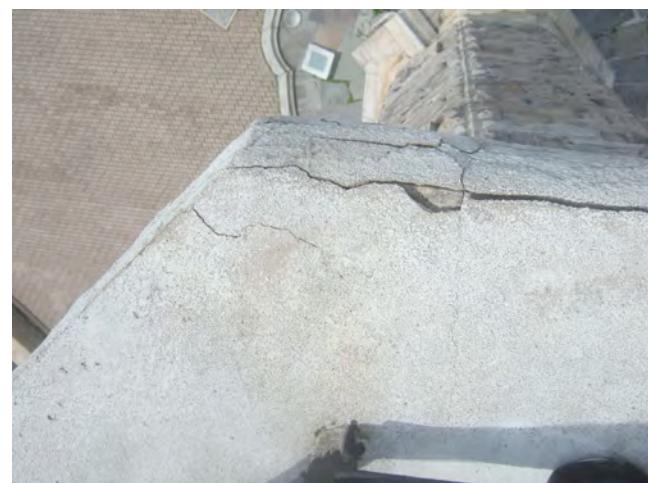
- ii. **Concrete Cracks** - *Cracks have developed at numerous locations throughout the underside of the slab. Cracked and loose sections of the concrete were noted at the south perimeter edge of the platform. These cracks pose dangerous conditions that should be addressed by removing loose sections.*

20. Loose section of concrete at south corner of platform.

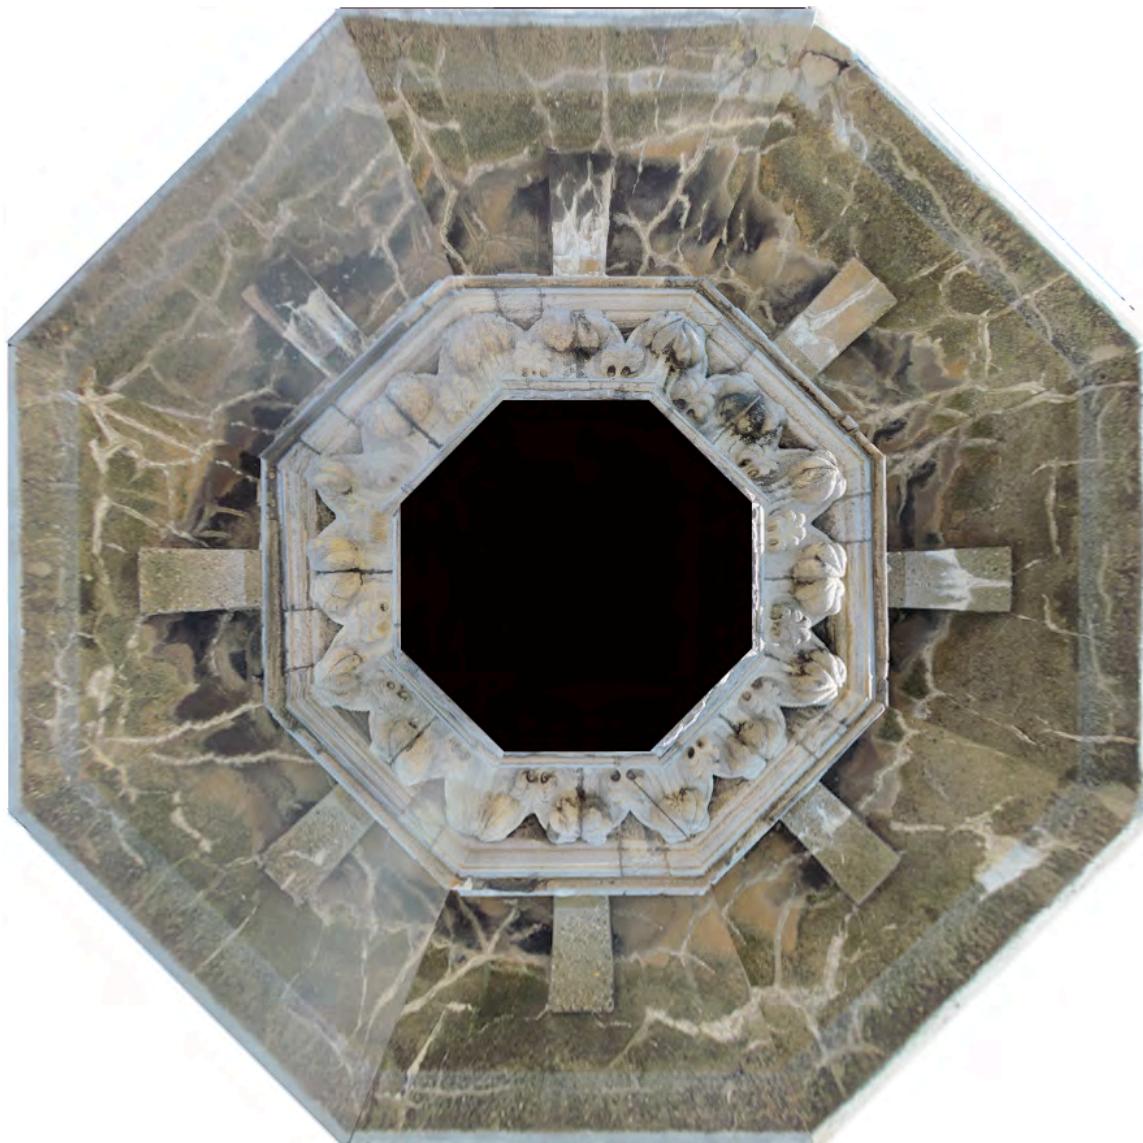
21. Composite view showing extent of cracks at underside of concrete platform.

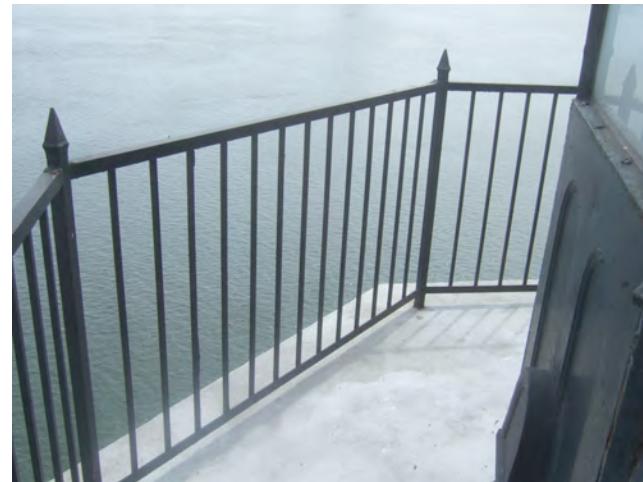
- iv. **Cast Iron Railings** – *As mentioned the existing railings are not the original more decorative units but a stripped down simple picket type railing with the square posts embedded into the concrete platform. The current condition is fair to good with some minor rust developed.*

*The rusting of the inner supports for the posts could be attributing to some of the deterioration of the concrete noted above.*

22. Iron railing mounted into concrete platform.

- ii. *The ventilator orb will require complete replacement.*
- iii. *The railings can be salvaged but the support posts will require further inspection in how they are embedded into the concrete.*

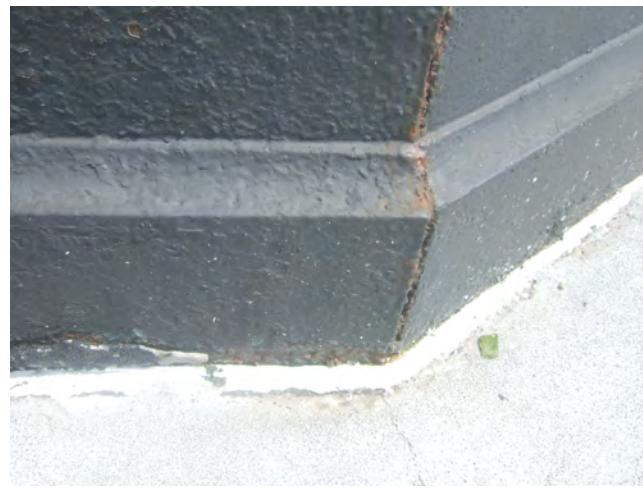
- i. **Cast Iron Lantern Base** – *The ten (10) sided lantern base has fixed panels with alternating panels having an integral ventilator. The panels are mounted directly into the cast concrete platform. Rust has developed at all bolted joints and connections. Excessive rust has caused structural failure of some of the connections.*

24. Typical open joint and rust at cast iron base sections.

- i. *All cast iron sections of the lantern need to be dismantled and repaired offsite and or replaced. The lower base sections can be salvageable but the upper roof sections have been greatly undermined by the excessive rust and spreading of the sections.*

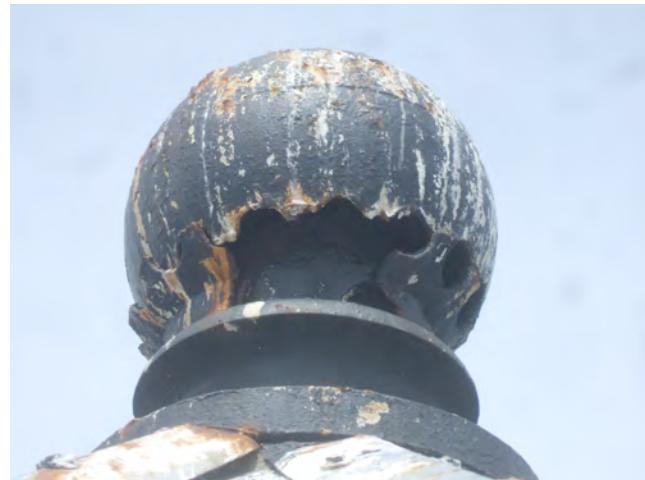
- iii. **Cast Iron Ventilator Orb** – *At the peak there is a cast iron ring mounted by an orb with ventilating holes at the perimeter. At this time this cast iron unit has cracked into pieces and is only held in place by gravity.*

25. Broken ventilator orb at top of lantern.

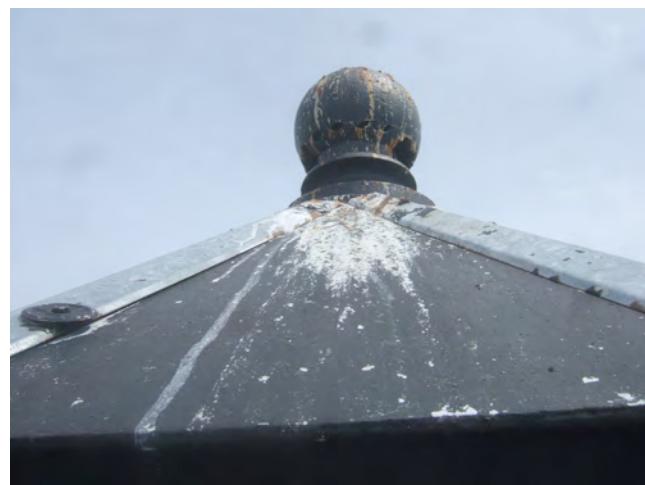
- ii. **Cast Iron Lantern Top** – *The ten (10) sided lantern top has pie shaped panels that have been repaired/strapped during a previous restoration campaign. Rust has developed at all bolted joints and connections. Excessive rust has caused structural failure at many the connections.*

26. Stained lantern roof with deteriorated hip sections.

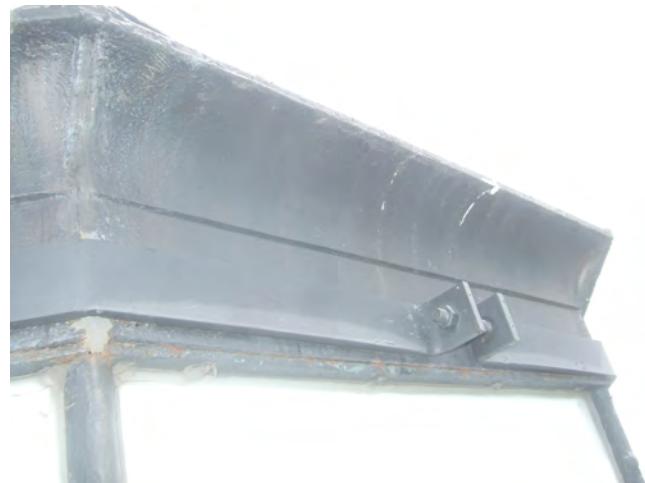
27. Strap at perimeter of lantern to prevent the spreading of the sections.

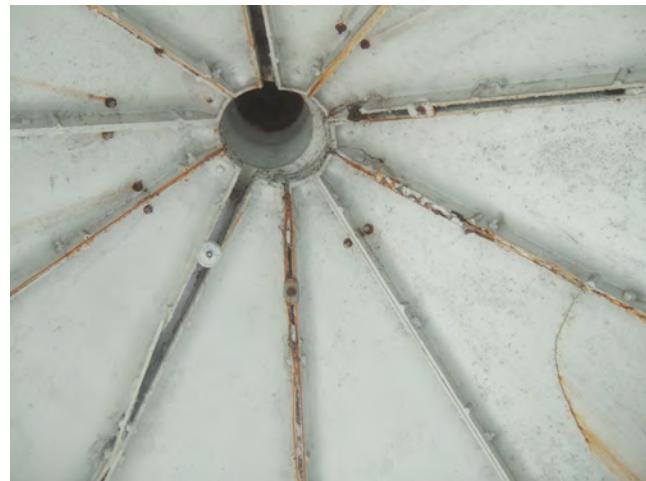
28. Deteriorated & cracked pie shaped roof sections separating from each other.

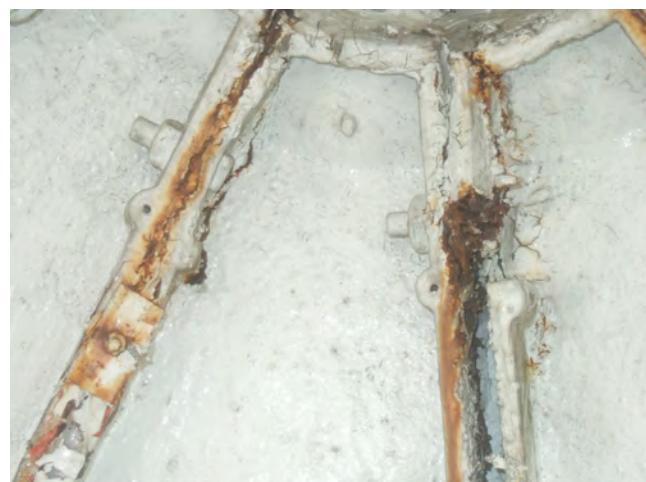
29. Detail of deterioration at center spoke of roof.

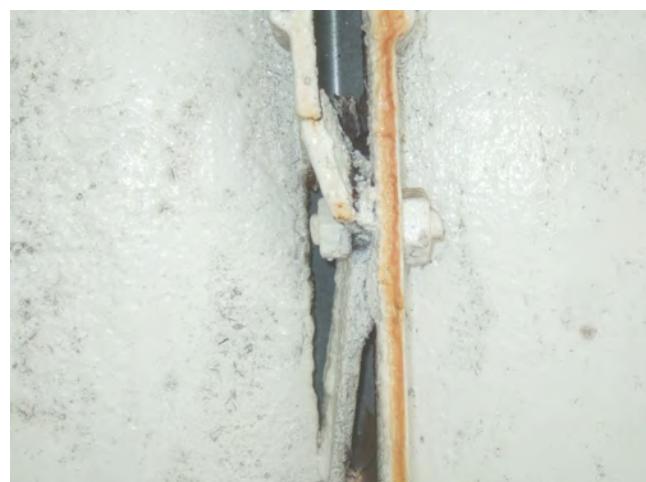
30. Cracked fastener and flange at roof section.

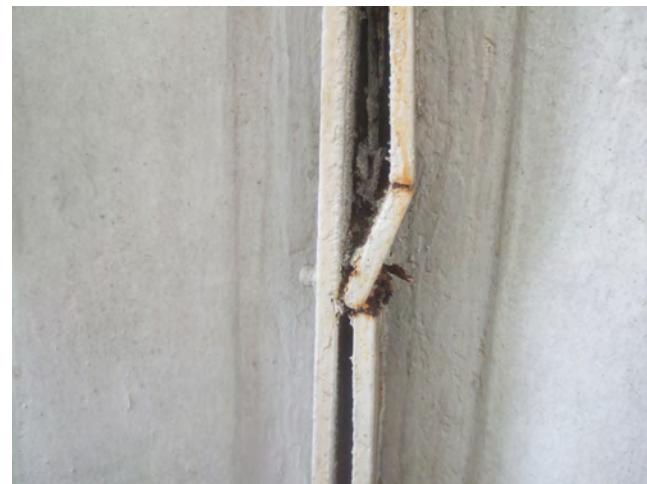
31. Cracked fastener and flange at typical cast iron base unit.

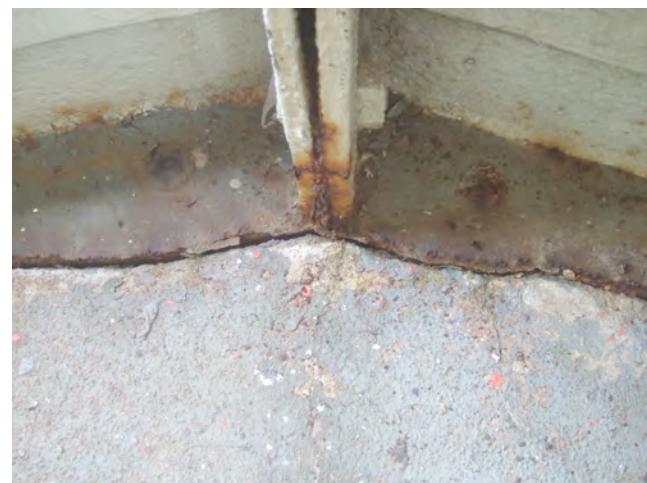
32. Rust and deteriorated cast iron at interior of base.

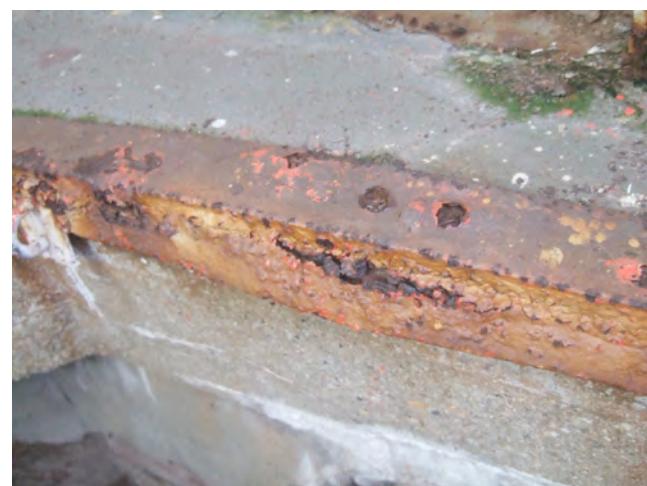
33. Deterioration metal flange at opening for access steps.

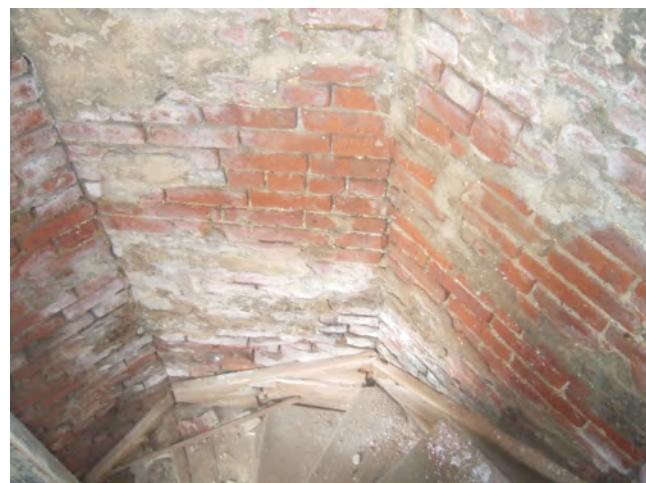
- The stucco is in a very deteriorated state with loose sections throughout the height of the tower.*
- The underlying brick masonry is in fair to good condition with evidence of eroded mortar joints throughout.*

- The wooden risers and treads are loose and deteriorated at much of the upper sections of the stair.*
- The large diameter central wooden post has evidence of splits and checks but is still structurally sound.*

35. Deteriorated stucco and wooden stairs at interior.

- Carefully remove all sections of stucco within the tower.*
- Test the interior mortar to determine the original color and composition.*
- Repoint all mortar joints at the brick masonry with an appropriate pointing mortar.*

- Depending on the long term goal for the Lighthouse either a restoration of the wood stair can be accomplished or the complete replacement with a new open grate galvanized metal spiral stair can be installed.*
- Install a perimeter railing mounted to the masonry.*
- Install new landing below the lantern platform level with a new galvanized metal access stair to the lantern.*

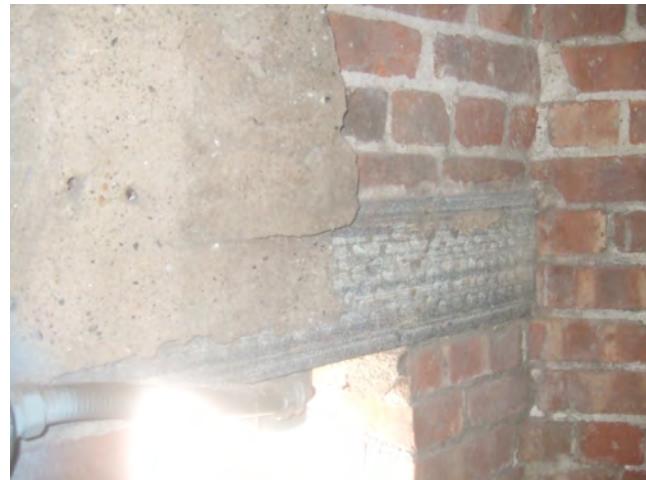
37. Eroded stucco covering original cut stone lintel.

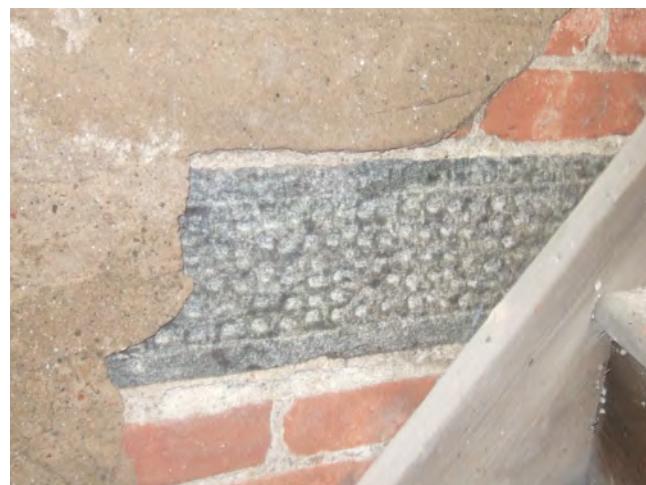
38. Detail view of loose stucco covering articulated trim stone.

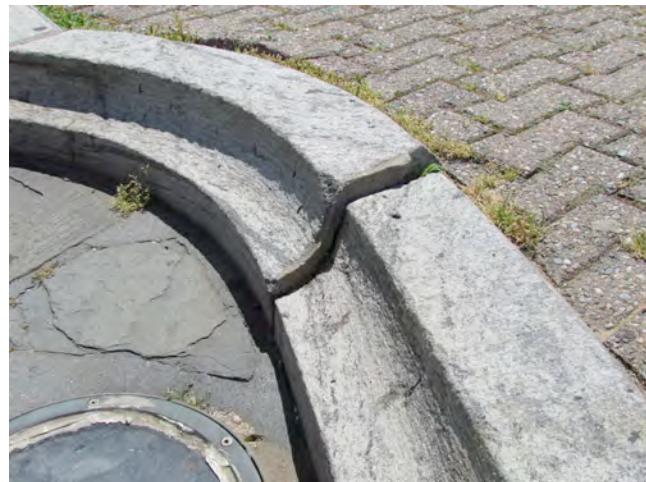
- i. *Due to the unstable soil conditions beneath the paving the stone pavers and edging have moved and settled.*
- ii. *Some of the edge stones exhibit chips and spalls but are mostly in good condition.*
- iii. *The bluestone pavers are installed in a variegated layout and have open joints and broken units at areas.*

40. Displaced stone units at perimeter of stone paving.

- i. *Reset perimeter stones on a new grade beam to inhibit settling.*
- ii. *Reset pavers and replace damaged units with new to match existing.*
2. BOLLARDS: There are two (2) decorative stone bollards mounted at either side of the entrance step to the Tower Base. These stones are carved in a similar style and are most likely original to the building. They were reset during the 1978 campaign.
  - a) ***Observations:*** *The stones are in good condition except for the damaged/broken tip of each bollard. Graffiti is evident at one unit as well.*
  - b) ***Recommendations:*** *Remove graffiti from stone and clean remaining units with appropriate material.*

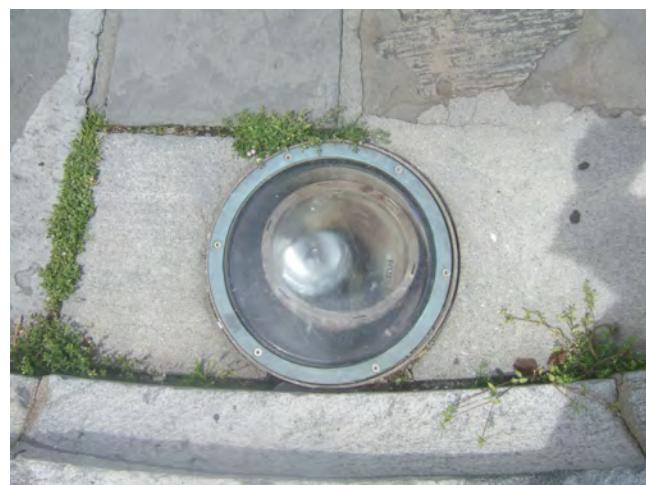
41. Deteriorated/nonfunctioning exterior light fixture.

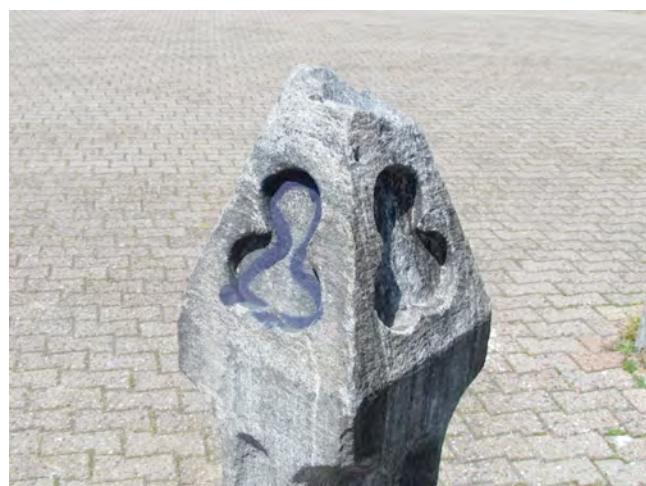
42. Stone bollard with broken tip and grafitti.
