THOMAS A. FENNIMAN
A R C H I T E C T

THE ROOSEVELT ISLAND LIGHTHOUSE
BUILDING CONDITION SURVEY

Roosevelt Island, New York

August 2018
DRAFT

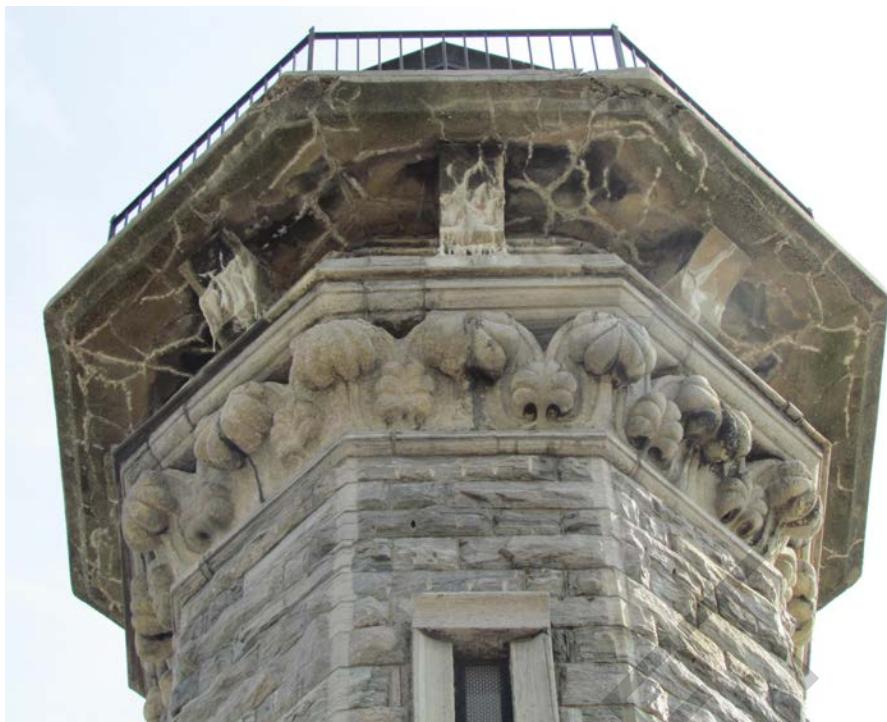
Excessive amounts of moisture has migrated into the slab as evidenced by the cracks and noted staining at the underside. This condition has most likely compromised some of the reinforcing steel.

- ii. ***Concrete Cracks*** - *Cracks have developed at numerous locations throughout the underside of the slab. Cracked and loose sections of the concrete were noted at the south perimeter edge of the platform. These cracks pose dangerous conditions that should be addressed by removing loose sections.*

10. View of underside at deteriorated concrete deck.

- i. *A test to determine the design of the concrete use and reinforcing bars should be made to better evaluate the soundness of the platform. This can be accomplished by cutting cylindrical cores that are afterwards analyzed in a laboratory.*

- ii. *If the structure is deemed sound the concrete platform must be resurfaced with a new high performance breathable waterproof coating with migratory corrosion inhibitors.*

- iii. *All concrete sections must be sounded for loose material. All sections found to be defective must be cut back to sound material and patched with an appropriate concrete patching mortar.*

- iv. ***2018 – The condition of the concrete deck has further deteriorated to the point that full scale replacement is likely required***
3. CAST IRON: As previously stated the cast iron lantern at the top is not original to the structure but was a later “stock” replacement lantern installed sometime between 1920-1940. The original lantern, as seen in photographs and the Thomas Edison movie, depict a much more ornate hand rail and platform structure together with a steep pitched eight (8) sided lantern with a smaller pyramidal peak at the very top with a pronounced weathervane.

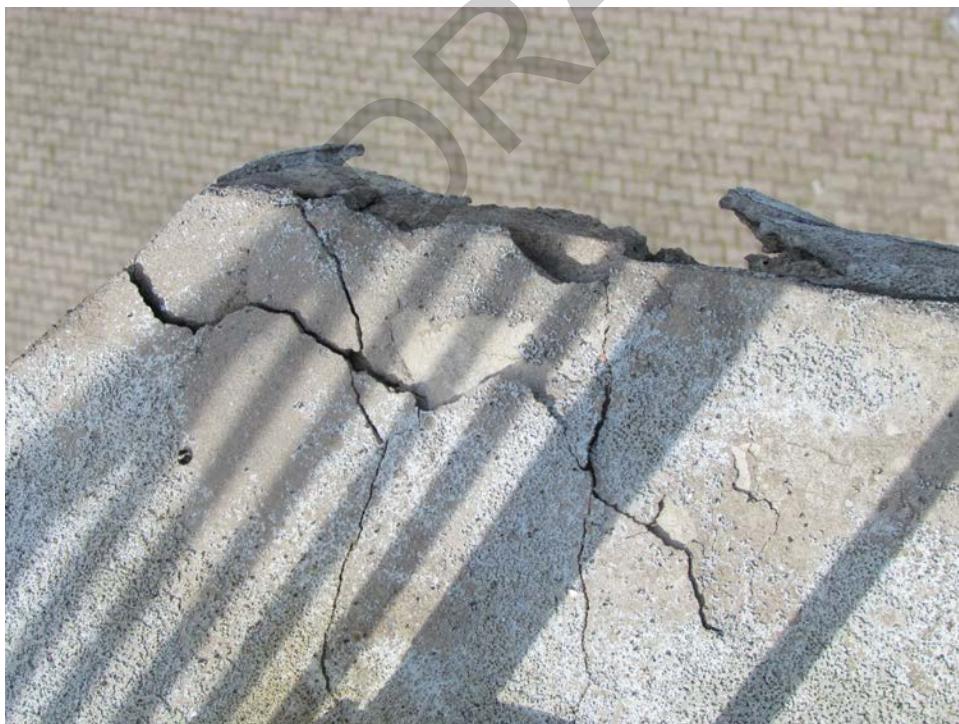
11. Severely deteriorated concrete deck.

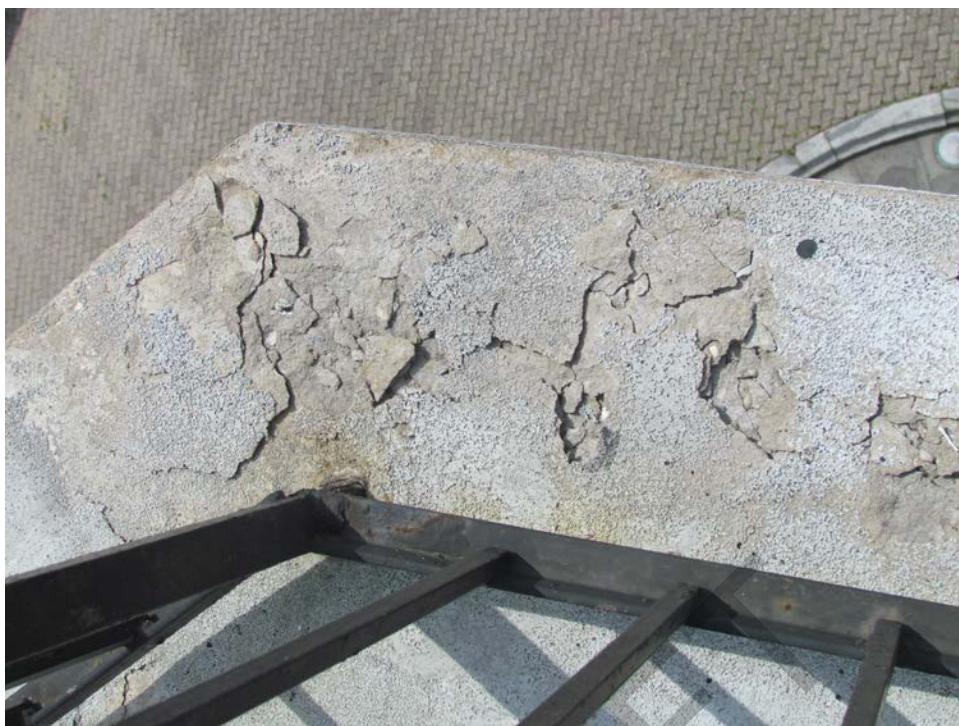
12. Severely deteriorated concrete deck.

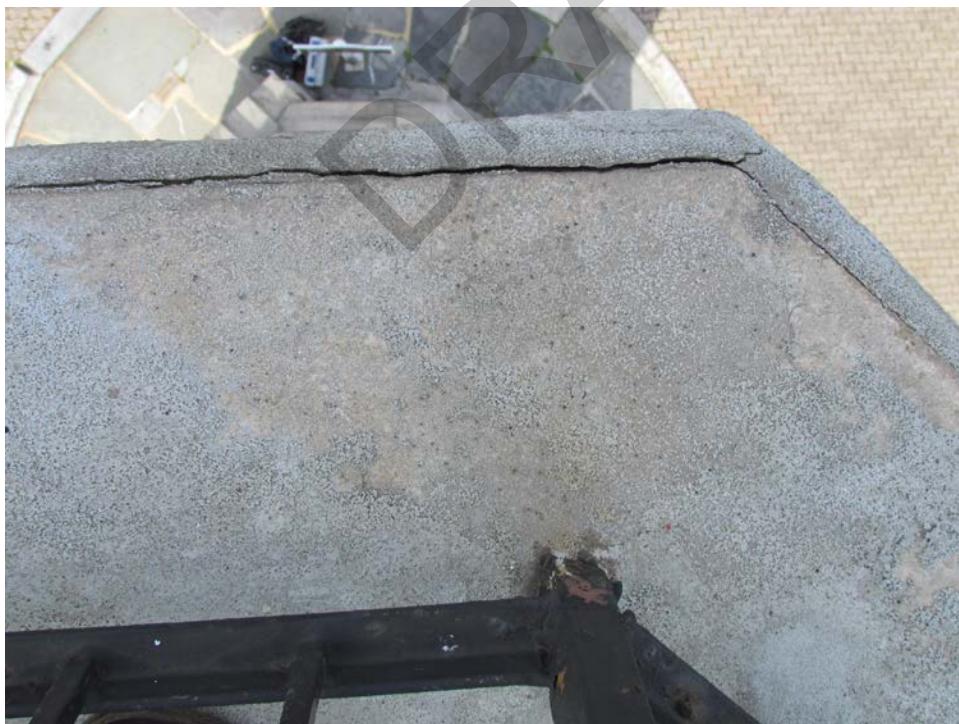
13. Cracks developing at perimeter of concrete deck.

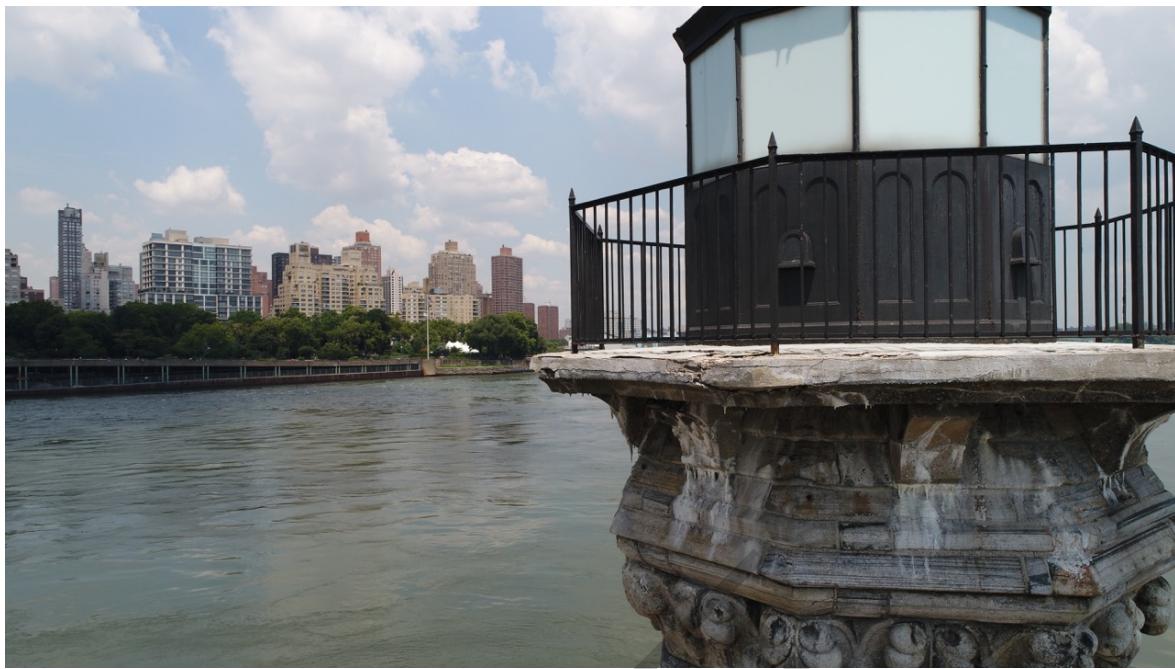
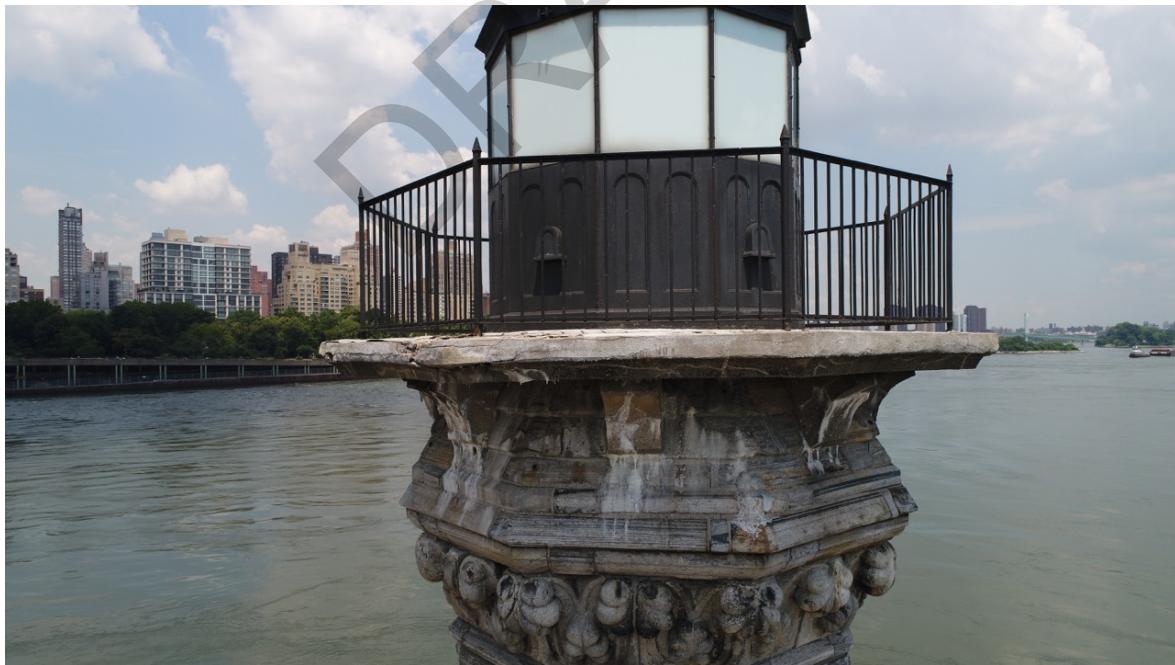
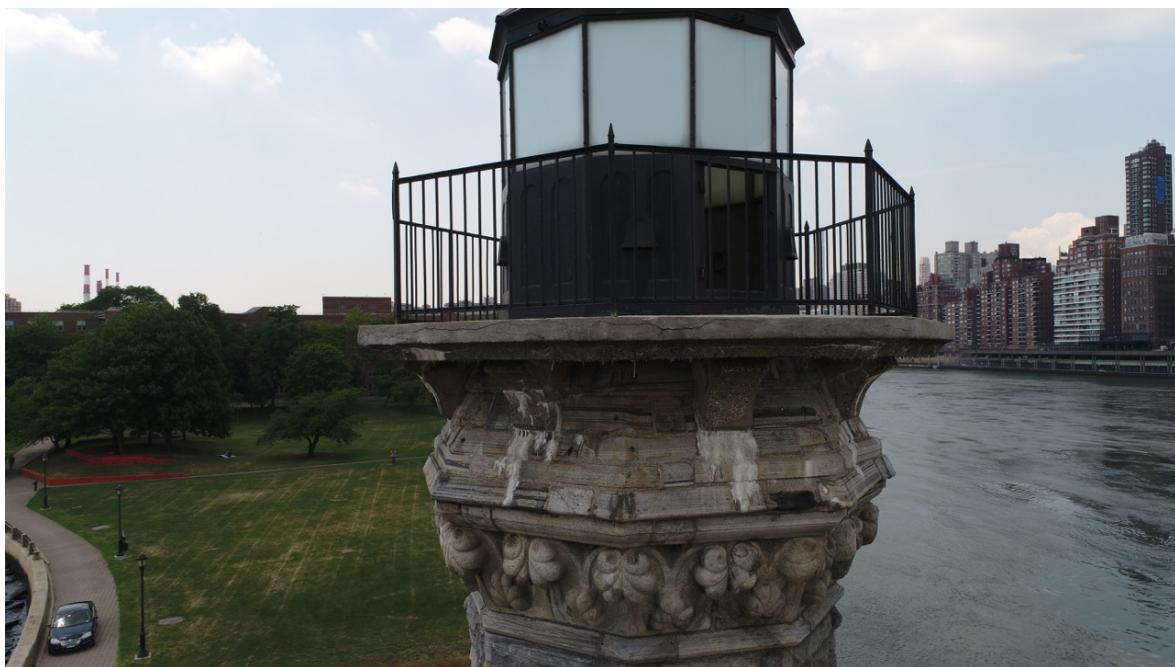
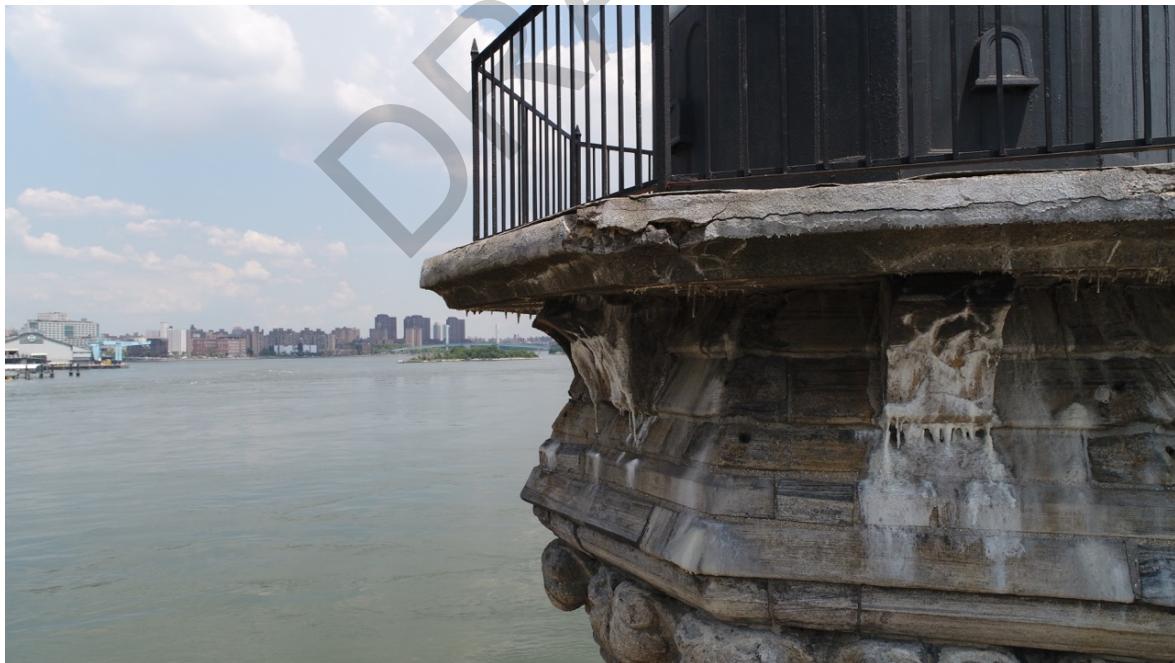
- i. ***Concrete Coating*** - *The exposed top face of the concrete has a topical coating applied to inhibit moisture penetration. This coating is in poor condition and does not terminate properly at the base of the lantern.*

14. Drone Photo showing severe deterioration at entire concrete deck.

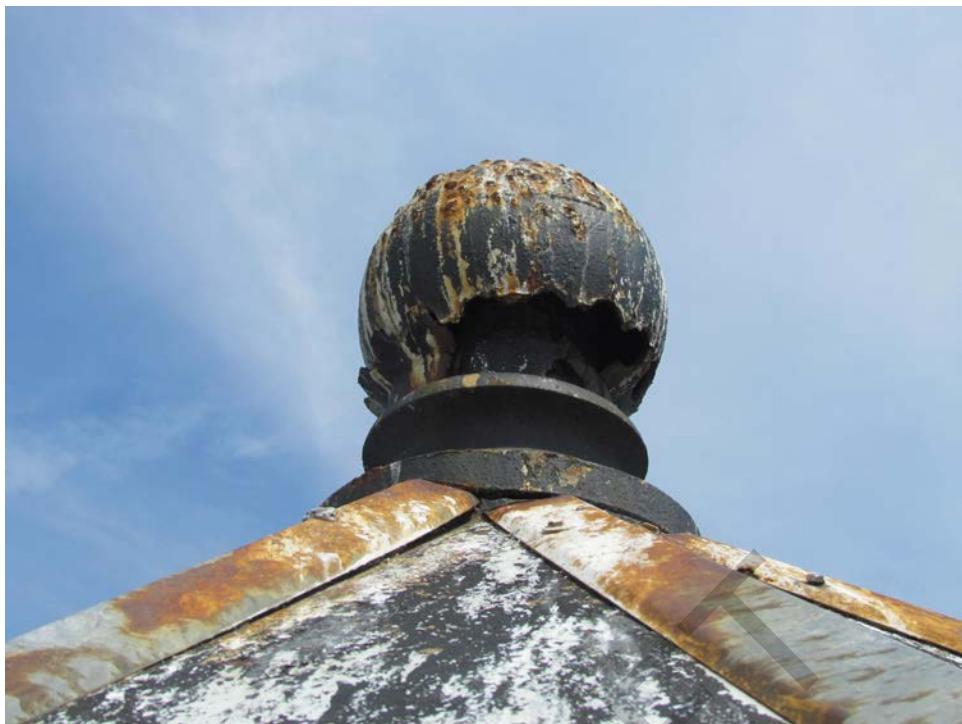
- iii. **Cast Iron Ventilator Orb** – *At the peak there is a cast iron ring mounted by an orb with ventilating holes at the perimeter. At this time this cast iron unit has cracked into pieces and is only held in place by gravity.*

18. Deteriorated cast iron ventilator at the top.

- ii. *The ventilator orb will require complete replacement.*
- iii. *The railings are not code compliant and will require either replacement or modification.*

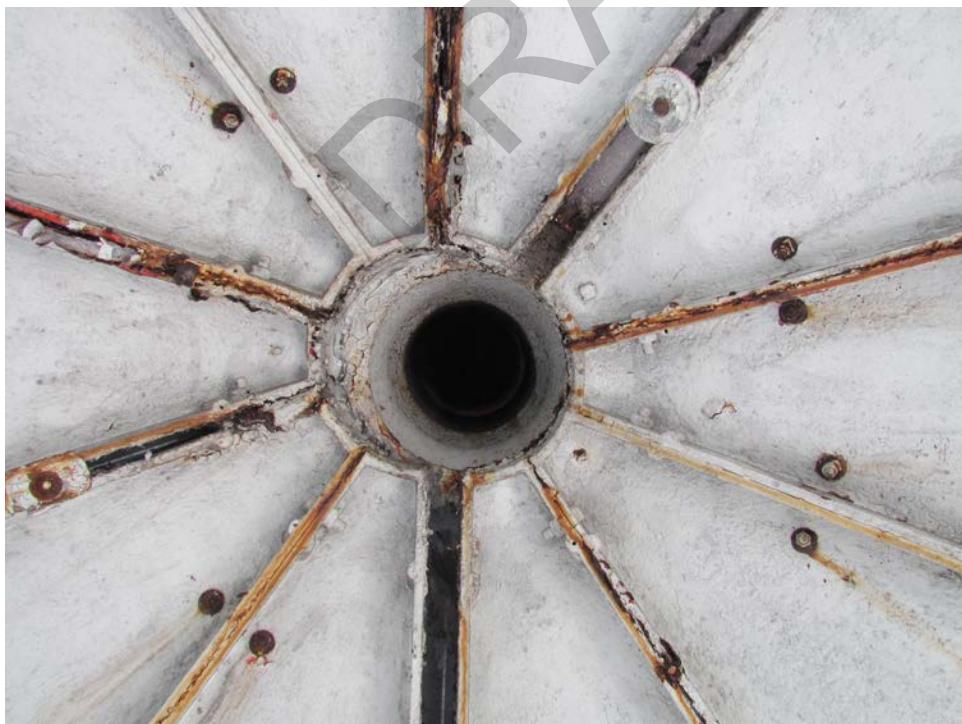
19. Underside view of ventilator and deteriorated cast iron sections.

- i. *All cast iron sections of the lantern need to be dismantled and repaired offsite and or replaced. The lower base sections and the upper roof sections have been greatly undermined by the excessive rust and spreading of the sections.*

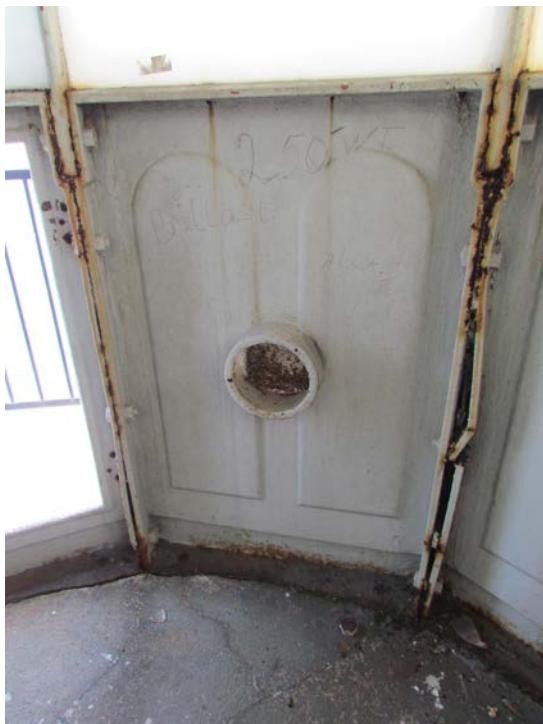
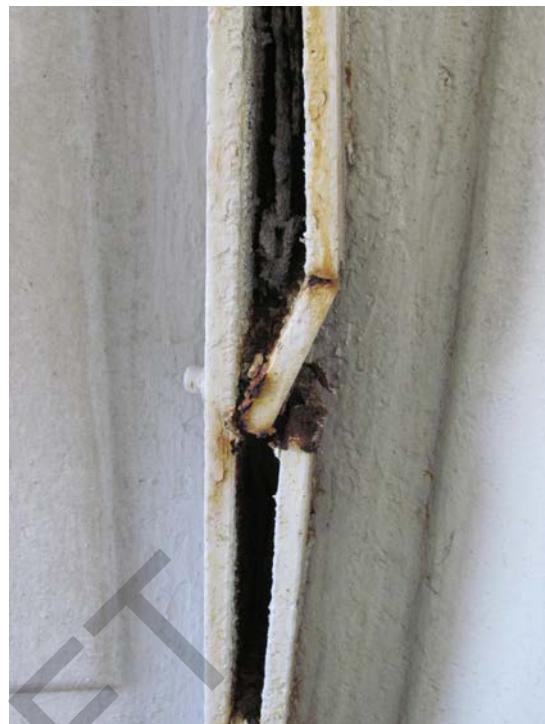
- i. **Cast Iron Lantern Base** – *The ten (10) sided lantern base has fixed panels with alternating panels having an integral ventilator. The panels are mounted directly into the cast concrete platform. Rust has developed at all bolted joints and connections. Excessive rust has caused structural failure of some of the connections.*

20. Severely deteriorated/rusted lower sections of cast iron with snapped bolt connections.

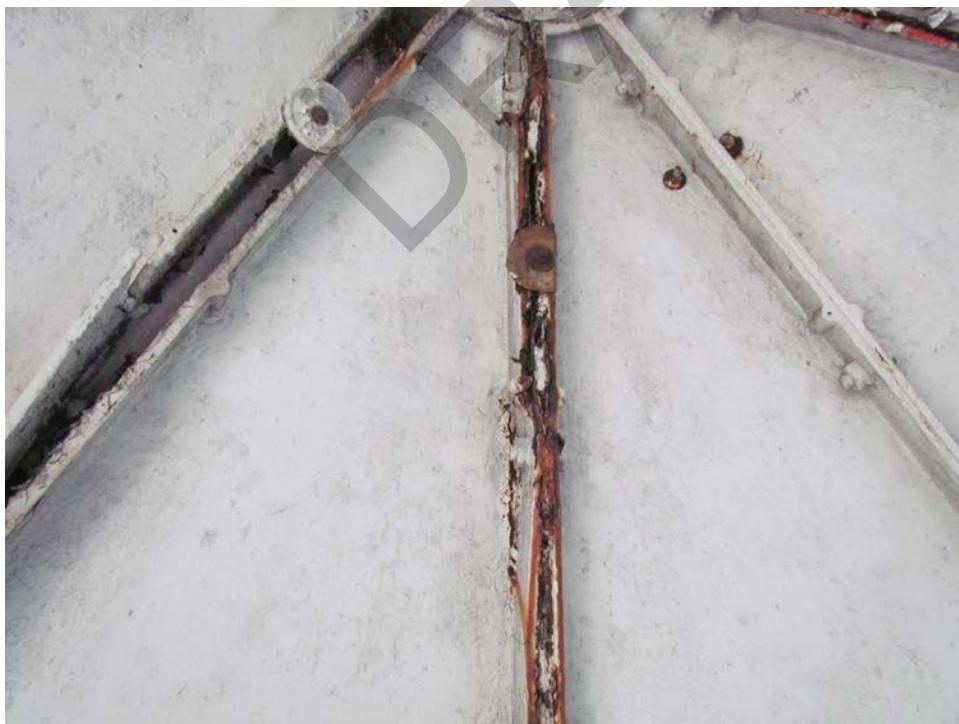
- ii. **Cast Iron Lantern Top** – *The ten (10) sided lantern top has pie shaped panels that have been repaired/strapped during a previous restoration campaign. Rust has developed at all bolted joints and connections. Excessive rust has caused structural failure at many the connections.*

21. Severely deteriorated/rusted upper sections of cast iron with snapped bolt connections.

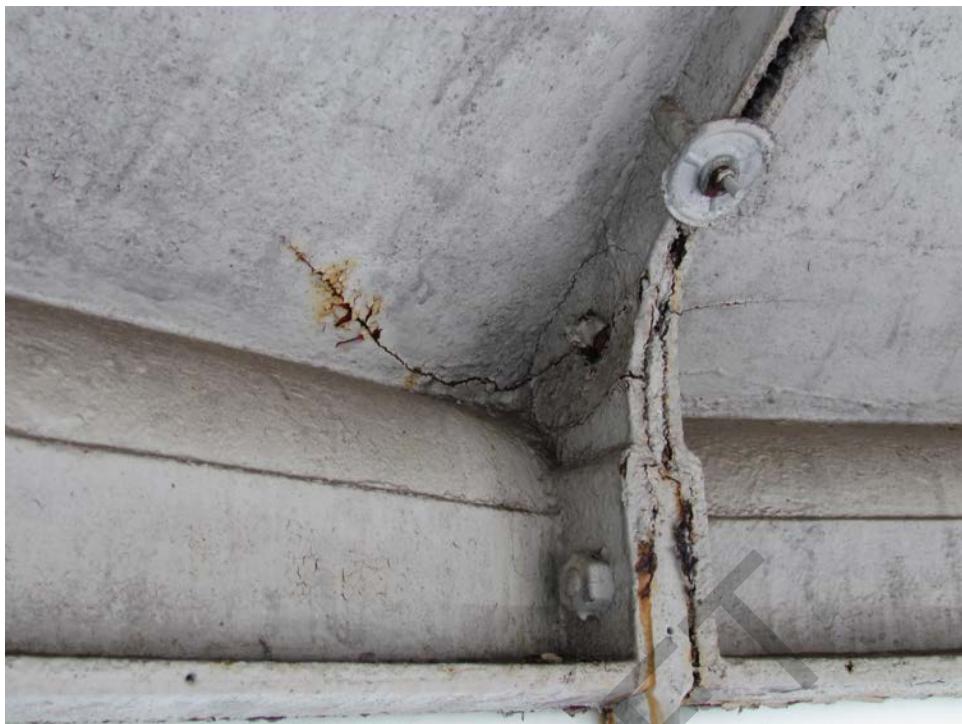
22. Typical stress cracks at cast iron sections.

2018 - The cast iron sections have continued to deteriorate and will require full scale replacement.

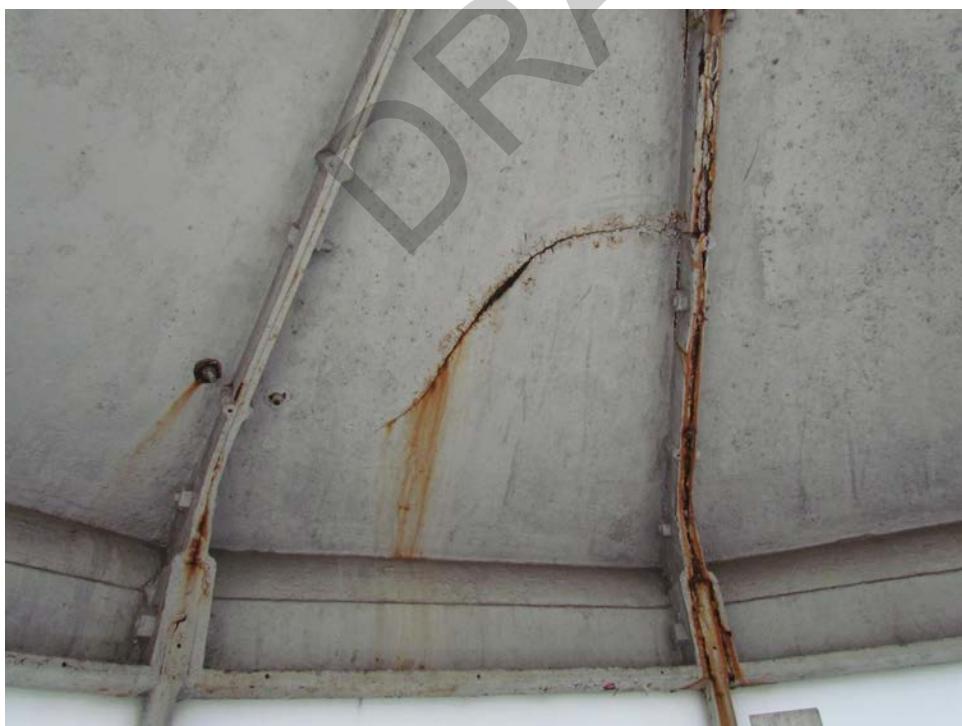
23. Typical stress cracks at cast iron sections.

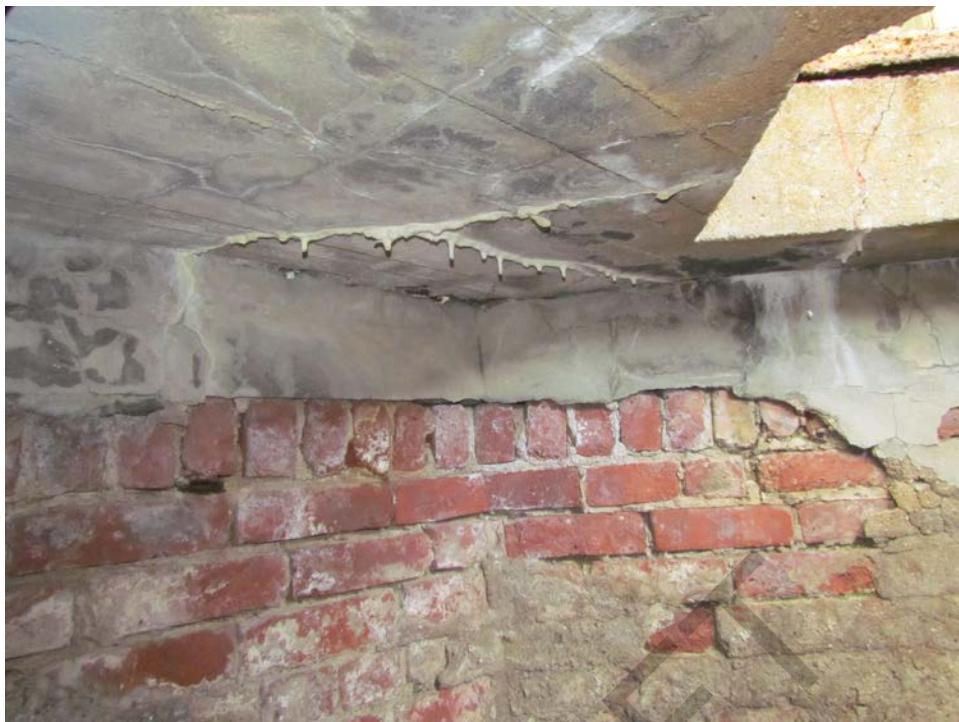
24. Moisture damage at upper sections of interior masonry and underside of concrete deck.

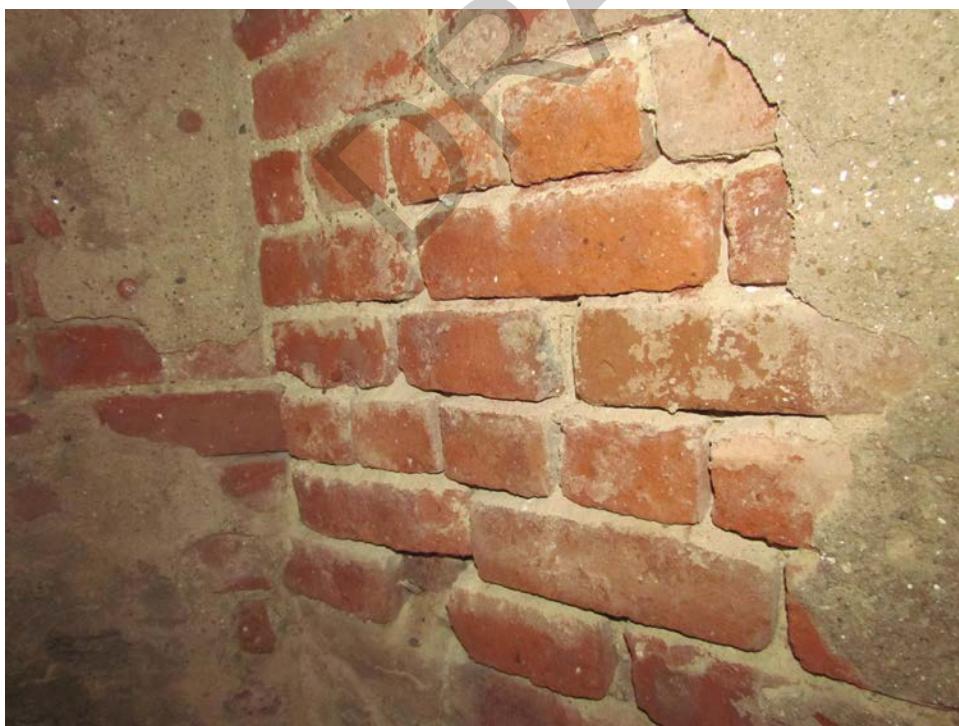
- i. *The stucco is in a very deteriorated state with loose sections throughout the height of the tower.*
- ii. *The underlying brick masonry is in fair to good condition with evidence of eroded mortar joints throughout.*

25. Deeply eroded mortar joints at brick masonry.

- i. *Carefully remove all sections of stucco within the tower.*
- ii. *Test the interior mortar to determine the original color and composition.*
- iii. *Repoint all mortar joints at the brick masonry with an appropriate pointing mortar.*
- iv. ***2018 - The brick mortar joints have continued to deteriorate and will require 100% repointing.***

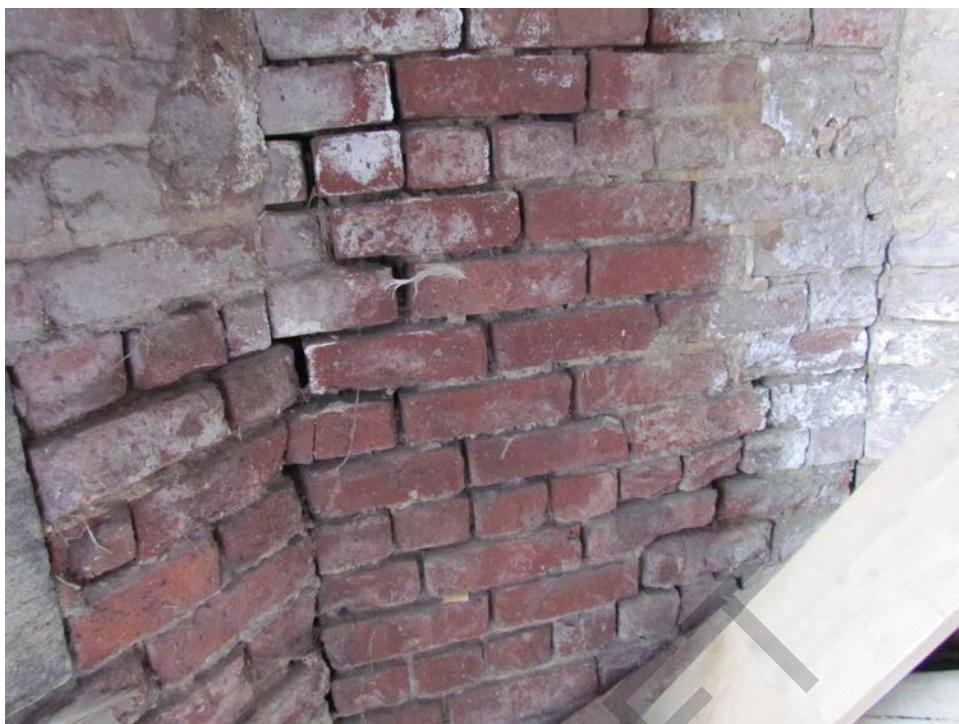
26. Deeply eroded mortar joints at lower section of brick masonry from rising damp.

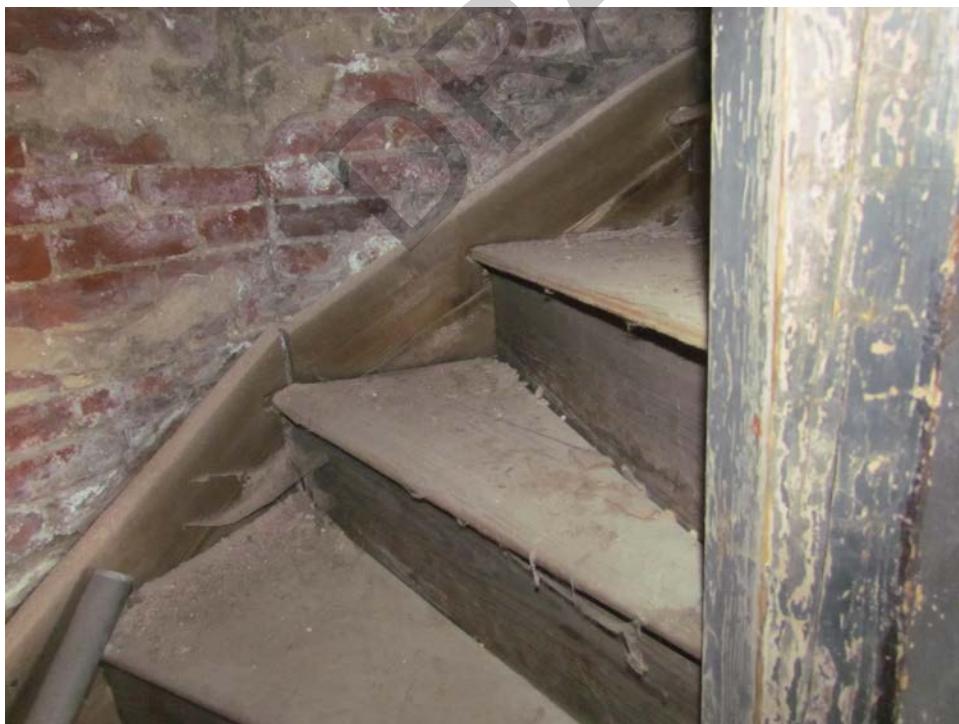
- i. *The wooden risers and treads are loose and deteriorated at much of the upper sections of the stair.*
- ii. *The large diameter central wooden post has evidence of splits and checks but is still structurally sound.*
- iii. ***2018 – The lower 8 treads have collapsed/missing and will require replacement.***

27. Loose and deteriorated sections of wood spiral stair.

- i. *Depending on the long term goal for the Lighthouse either a restoration of the wood stair can be accomplished or the complete replacement with a new open grate galvanized metal spiral stair can be installed.*
- ii. *Install a perimeter railing mounted to the masonry.*
- iii. *Install new landing below the lantern platform level with a new galvanized metal access stair to the lantern.*

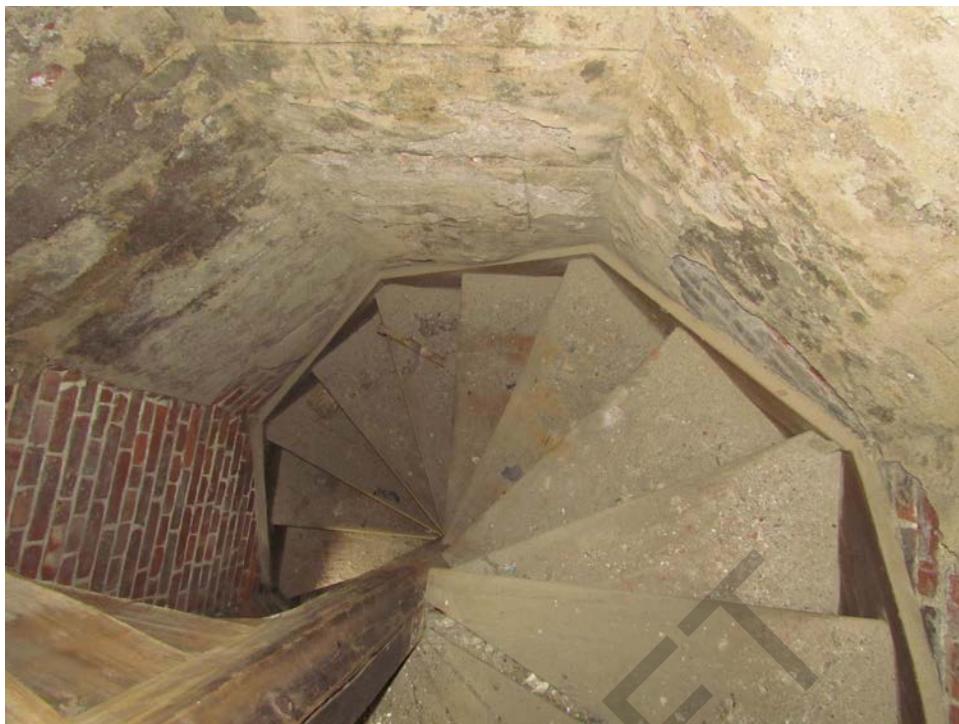
28. Interior walls have failing stucco.

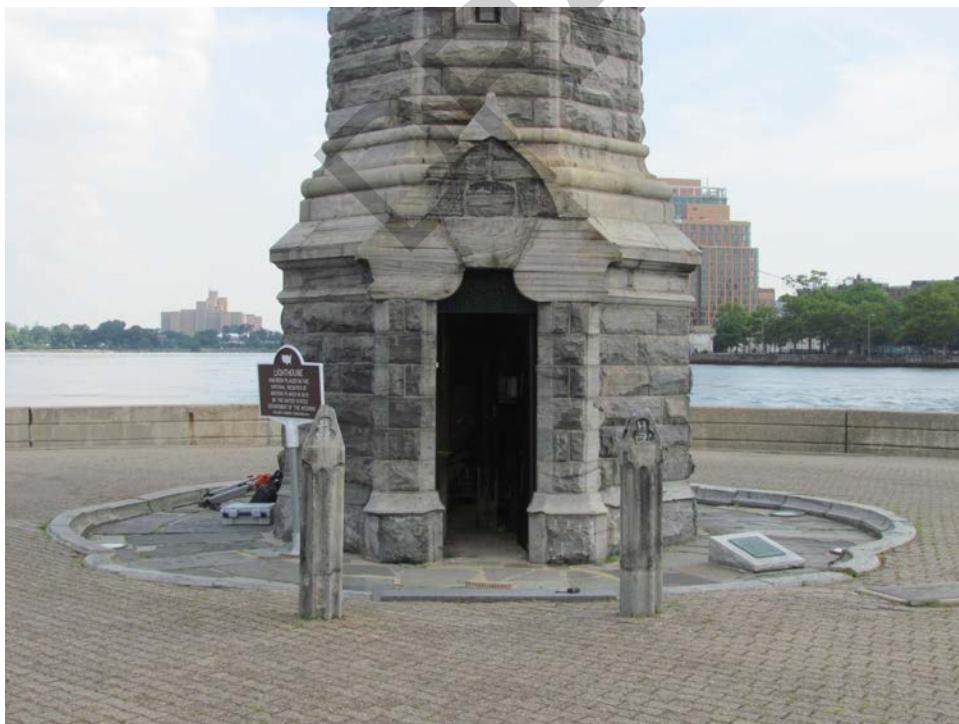
Observations: *The stones are in good condition except for the damaged/broken tip of each bollard. Graffiti is evident at one unit as well.*

29. View at base with historic granite bollards at either side of entrance.

Recommendations: *Remove graffiti from stone and clean remaining units with appropriate material.*

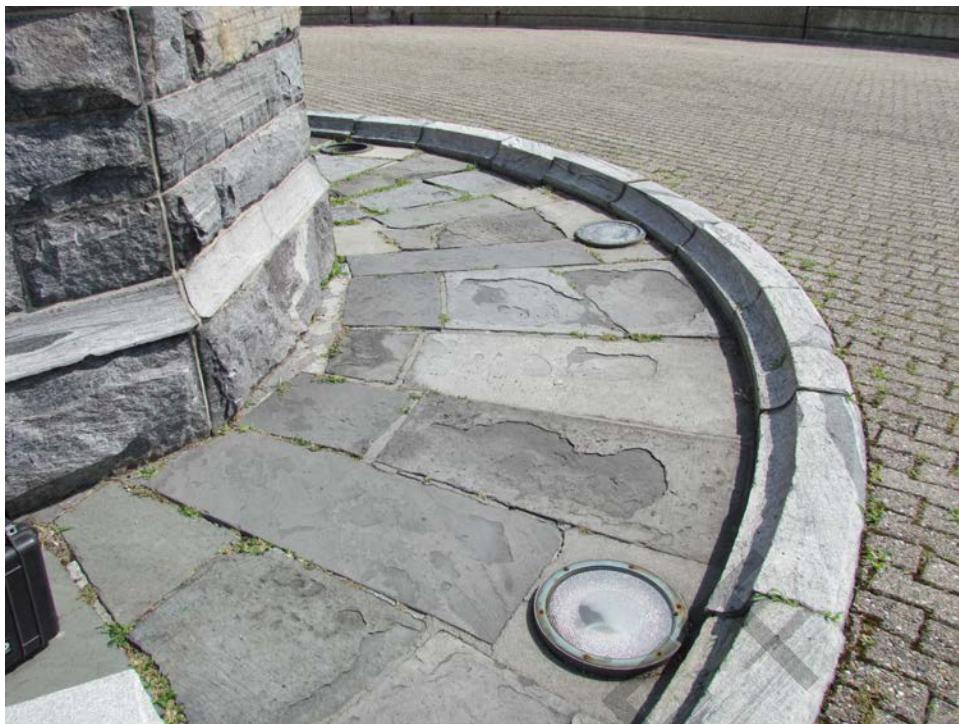
- i. *Due to the unstable soil conditions beneath the paving the stone pavers and edging have moved and settled.*
- ii. *Some of the edge stones exhibit chips and spalls but are mostly in good condition.*
- iii. *The bluestone pavers are installed in a variegated layout and have open joints and broken units at areas.*

30. Bluestone paving and granite curbing have settled with open joints.
Light fixtures have filled with water.

- i. Reset perimeter stones on a new grade beam to inhibit settling.*
- ii. Reset pavers and replace damaged units with new to match existing.*
- 2. BOLLARDS:** There are two (2) decorative stone bollards mounted at either side of the entrance step to the Tower Base. These stones are carved in a similar style and are most likely original to the building. They were reset during the 1978 campaign.

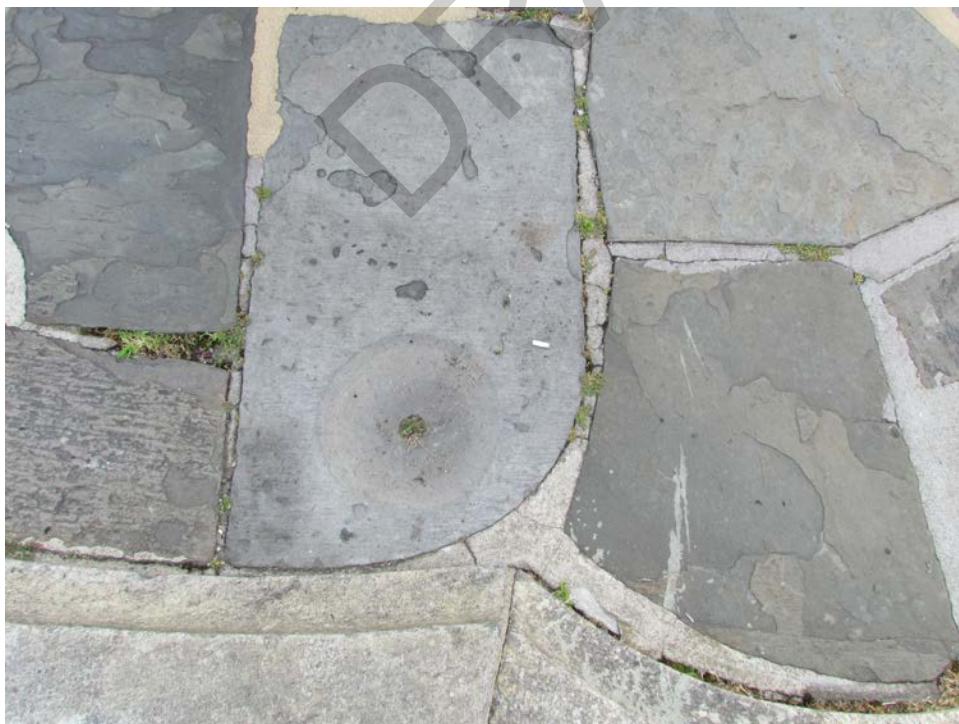
31. A mixture of old and new bluestone sections with open joints.

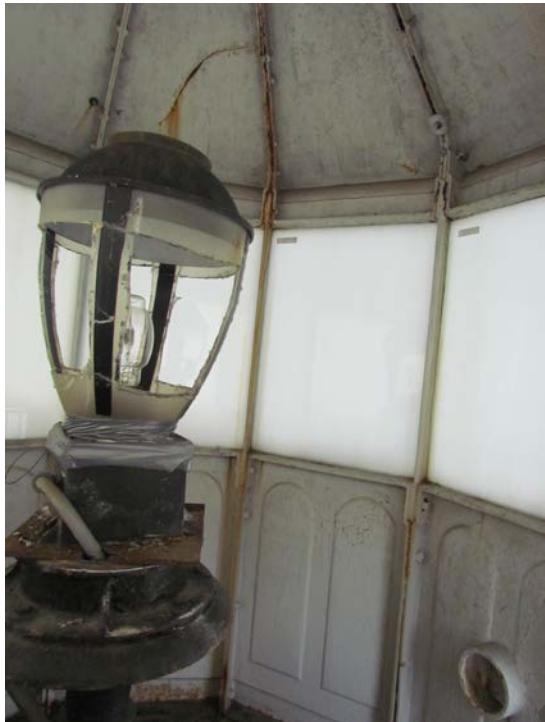
32. Current light fixture is a repurposed street lamp with 250 watt bulb.
