TITLE:
PHOTO SURVEY -
MASONRY & SITE
CONDITIONS

LIGHTHOUSE

LIGHTHOUSE PARK,
ROOSEVELT ISLAND, NY 10044

TITLE:
PHOTO SURVEY -
LANTERN & OBSERVATION
DECK CONDITIONS

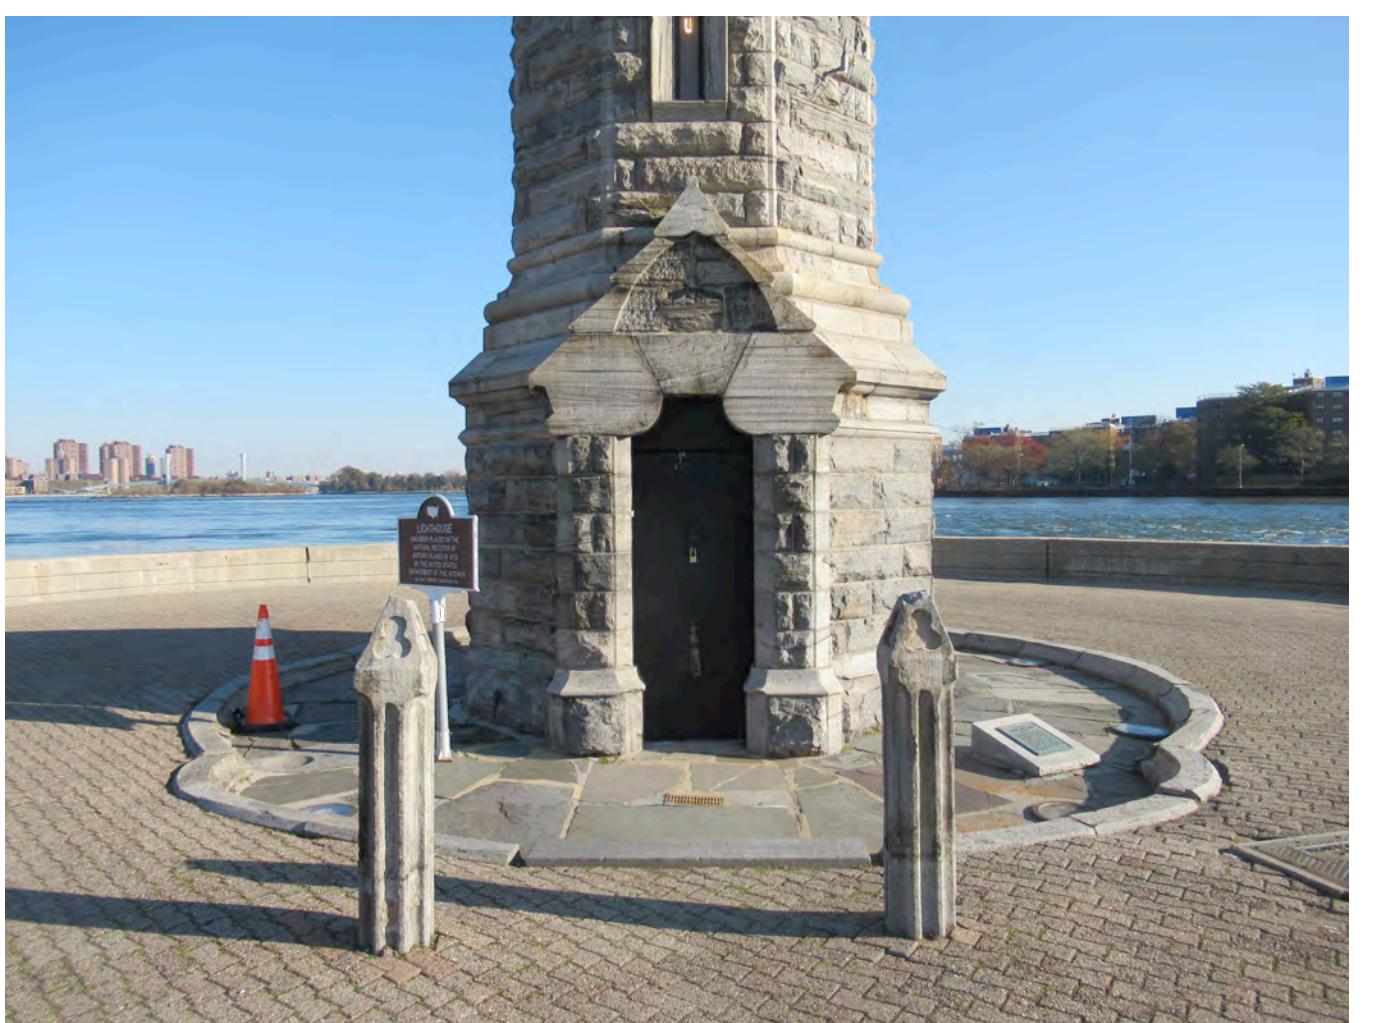
1 STONE BOLLARDS, DEPRESSED PAVED AREA & ENTRANCE DOOR at BASE
SOUTH ELEVATION

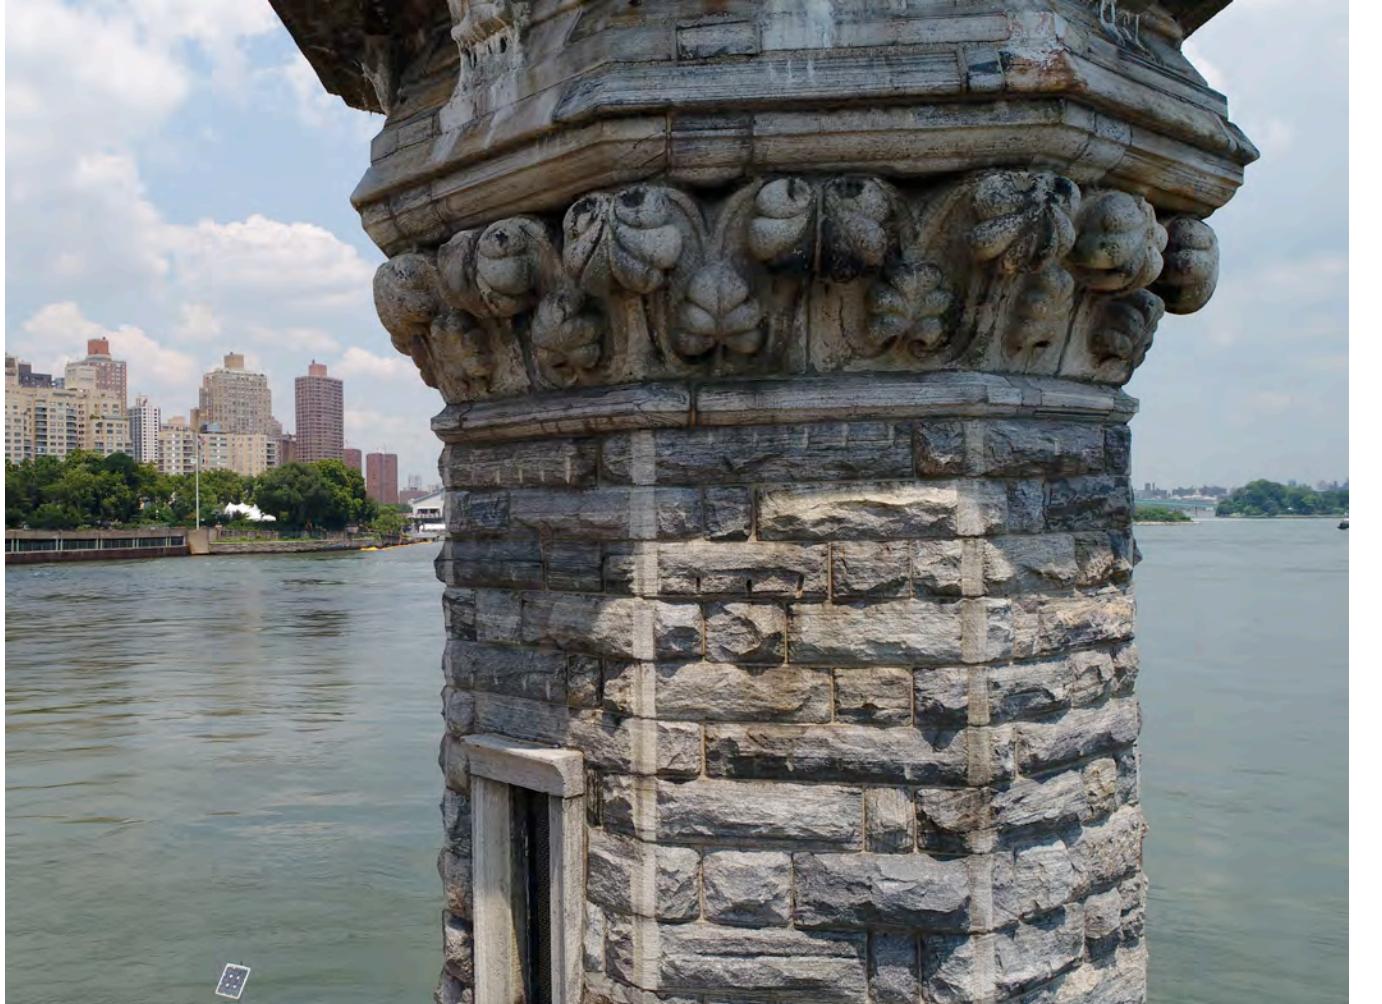
9 DETAIL VIEW OF STONE FOLIATE at TOP OF SHAFT
EAST ELEVATION

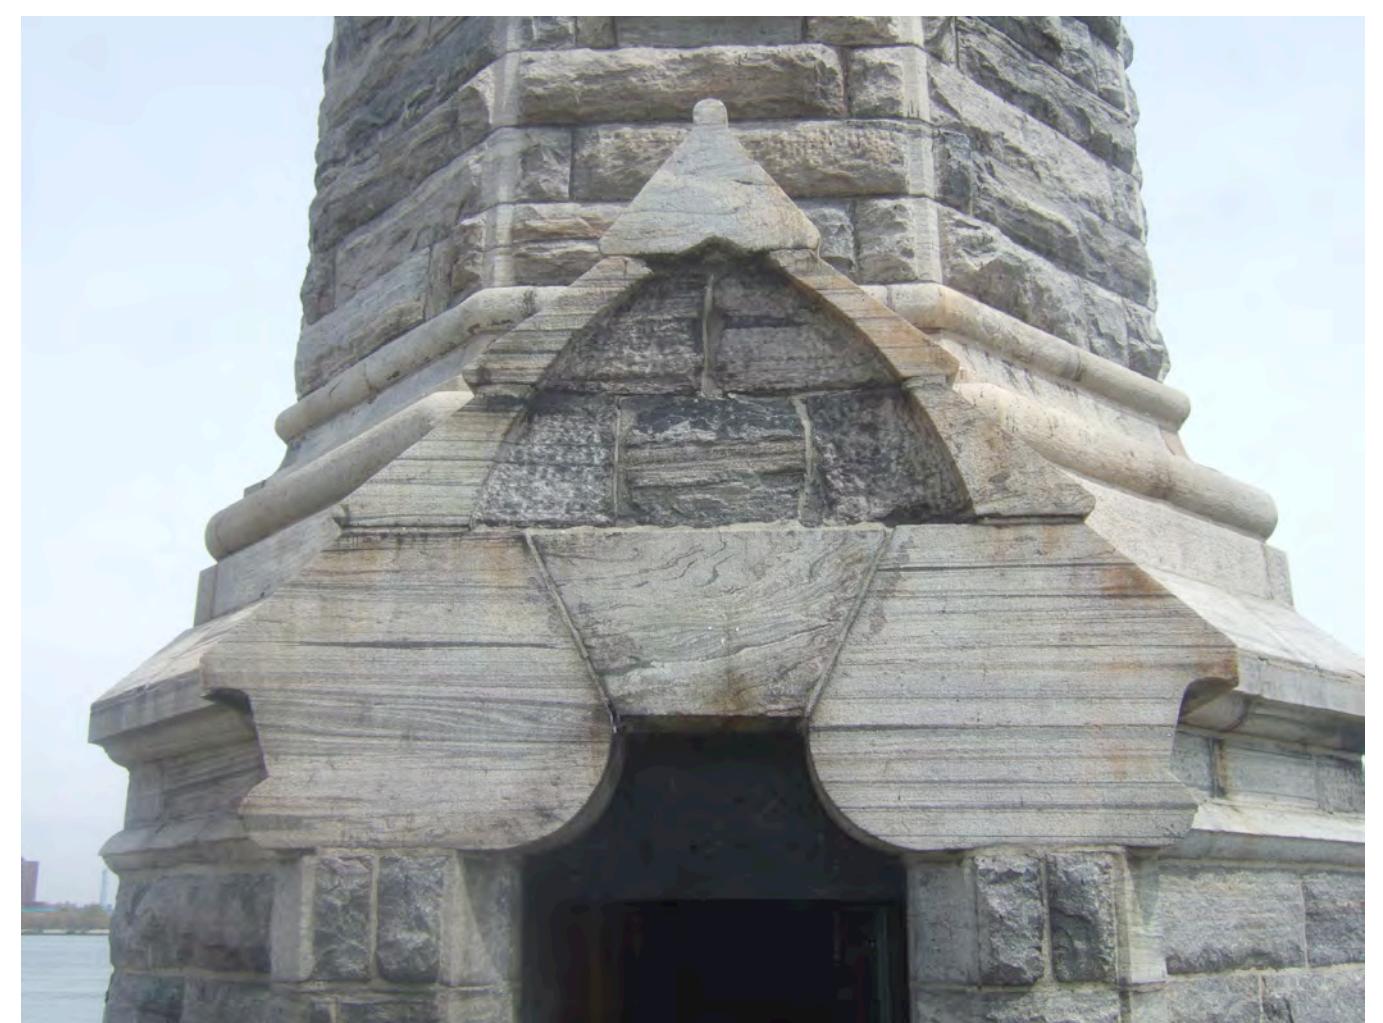
2 ENTRANCE DOOR & STONE GABLE PROFILE
SOUTH ELEVATION

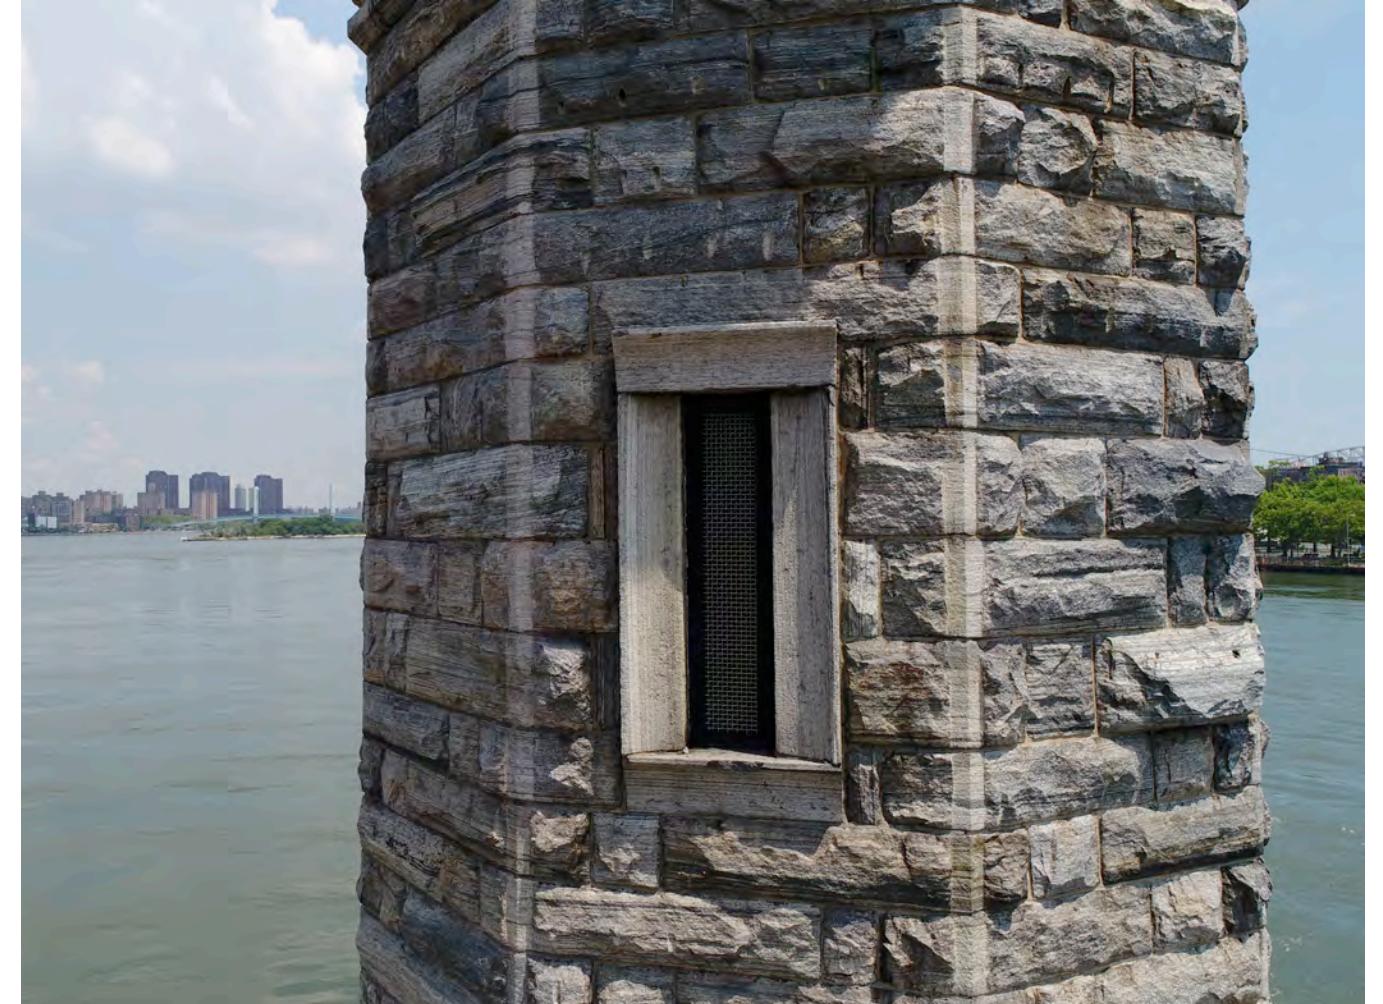
10 DETAIL VIEW OF WINDOW #2
SOUTH ELEVATION

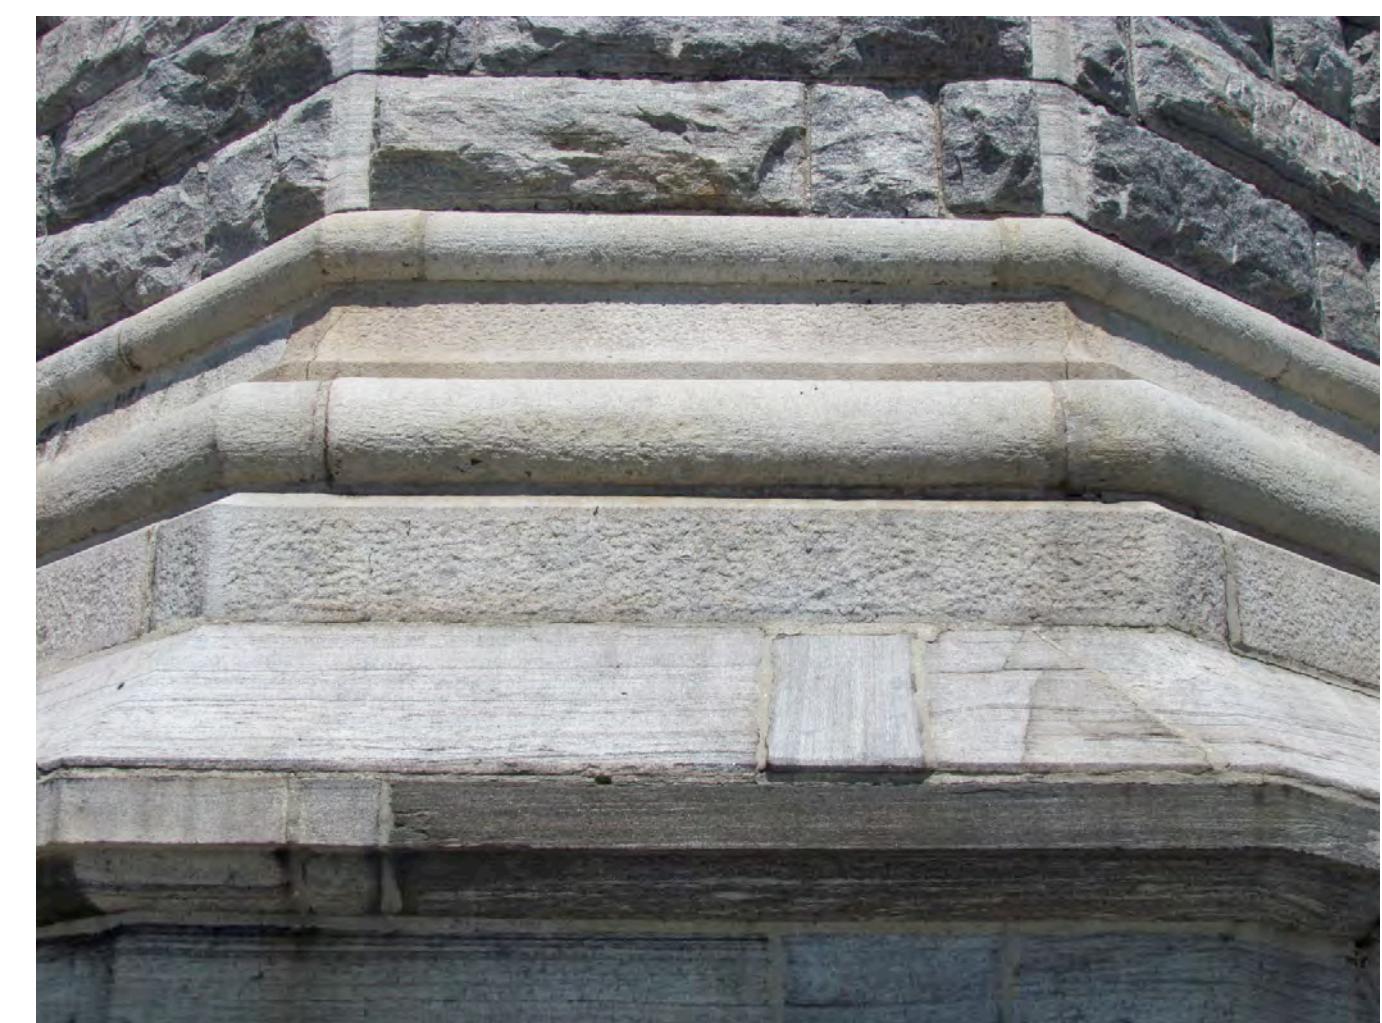
3 STONE CRACKING at MOLDING
BASE at DISPARATE LOCATIONS

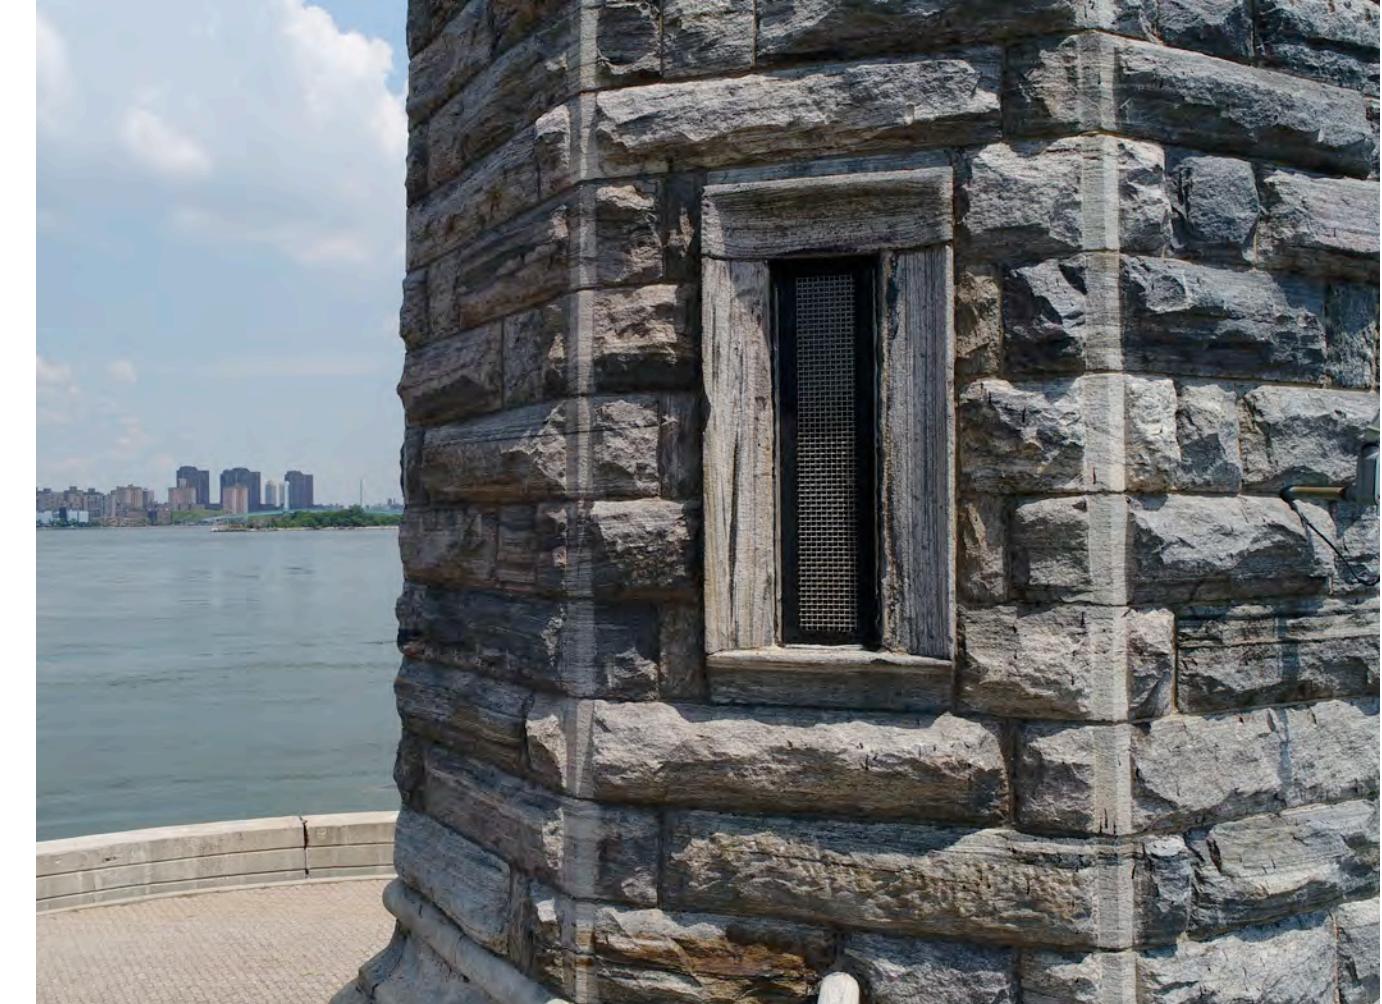
11 DETAIL VIEW OF WINDOW #1
SOUTH ELEVATION

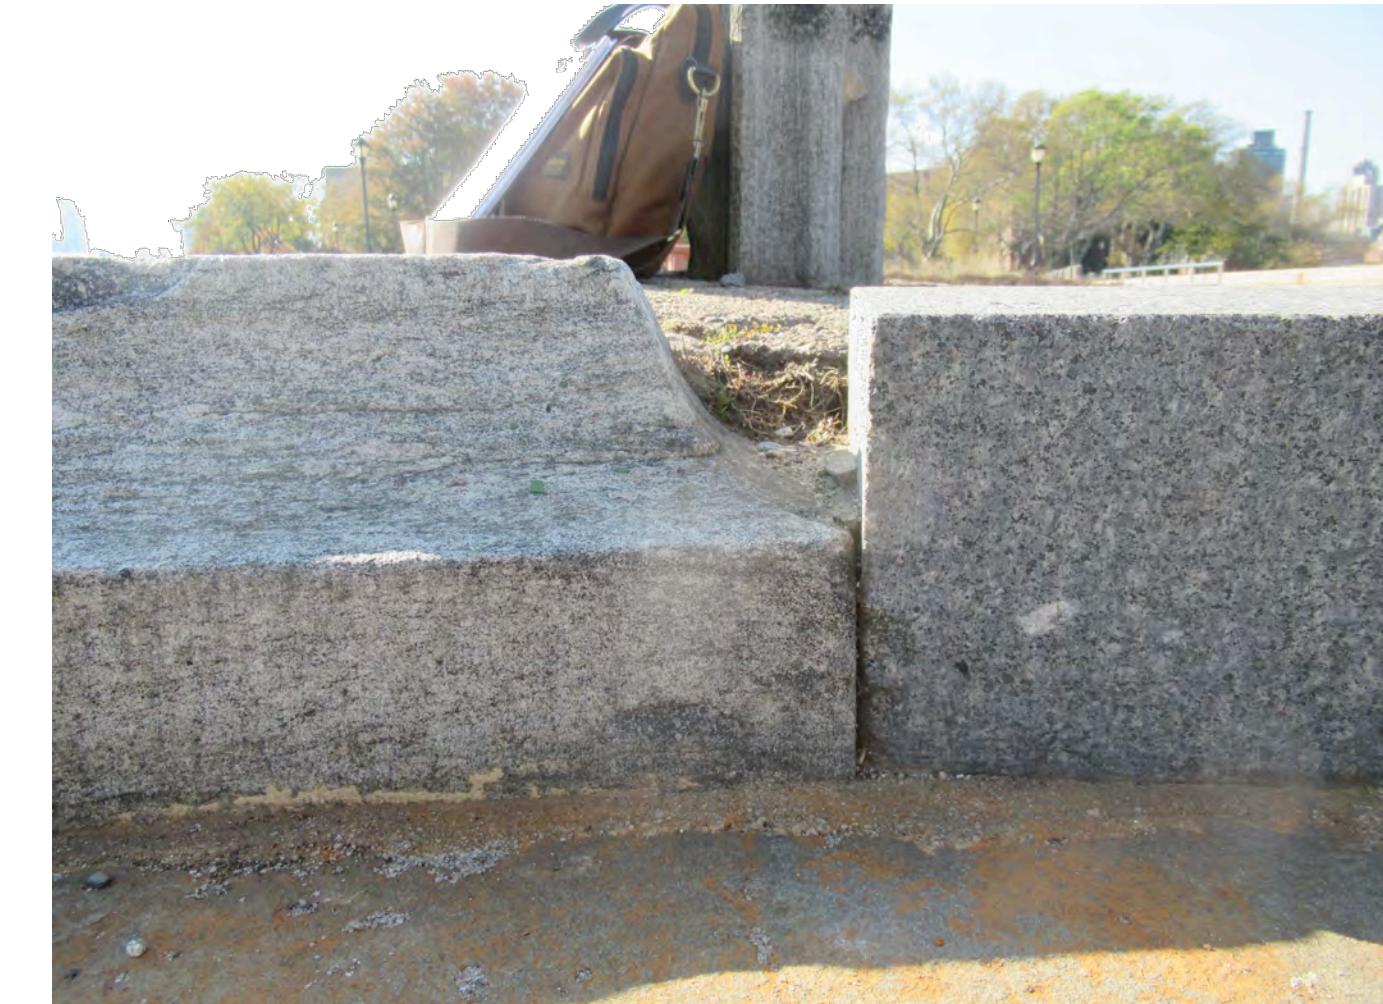
16 DETAIL VIEW OF STONE CURB END UNIT w/ NON-ORIGINAL STONE STEP at RIGHT
DEPRESSED PAVED AREA

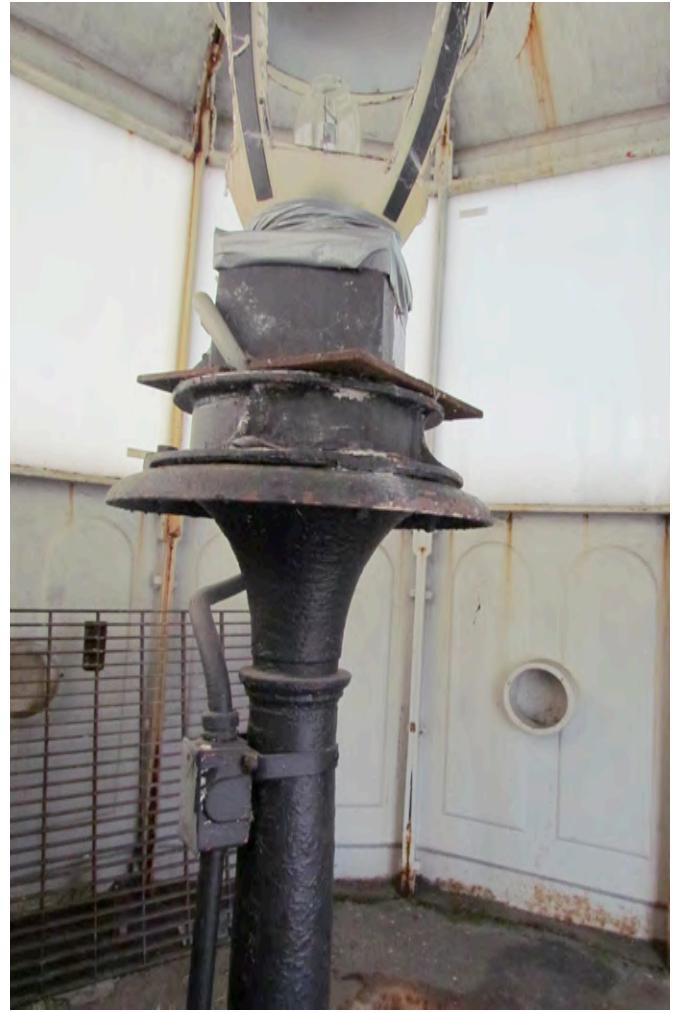
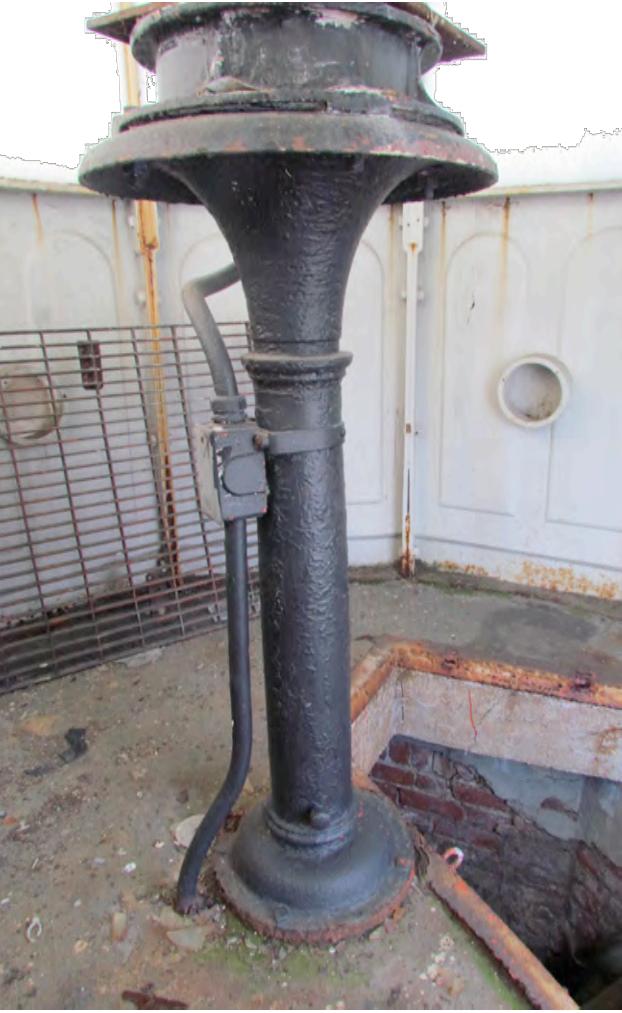
4 ORIGINAL HISTORIC METAL STANCHION
LANTERN HOUSE

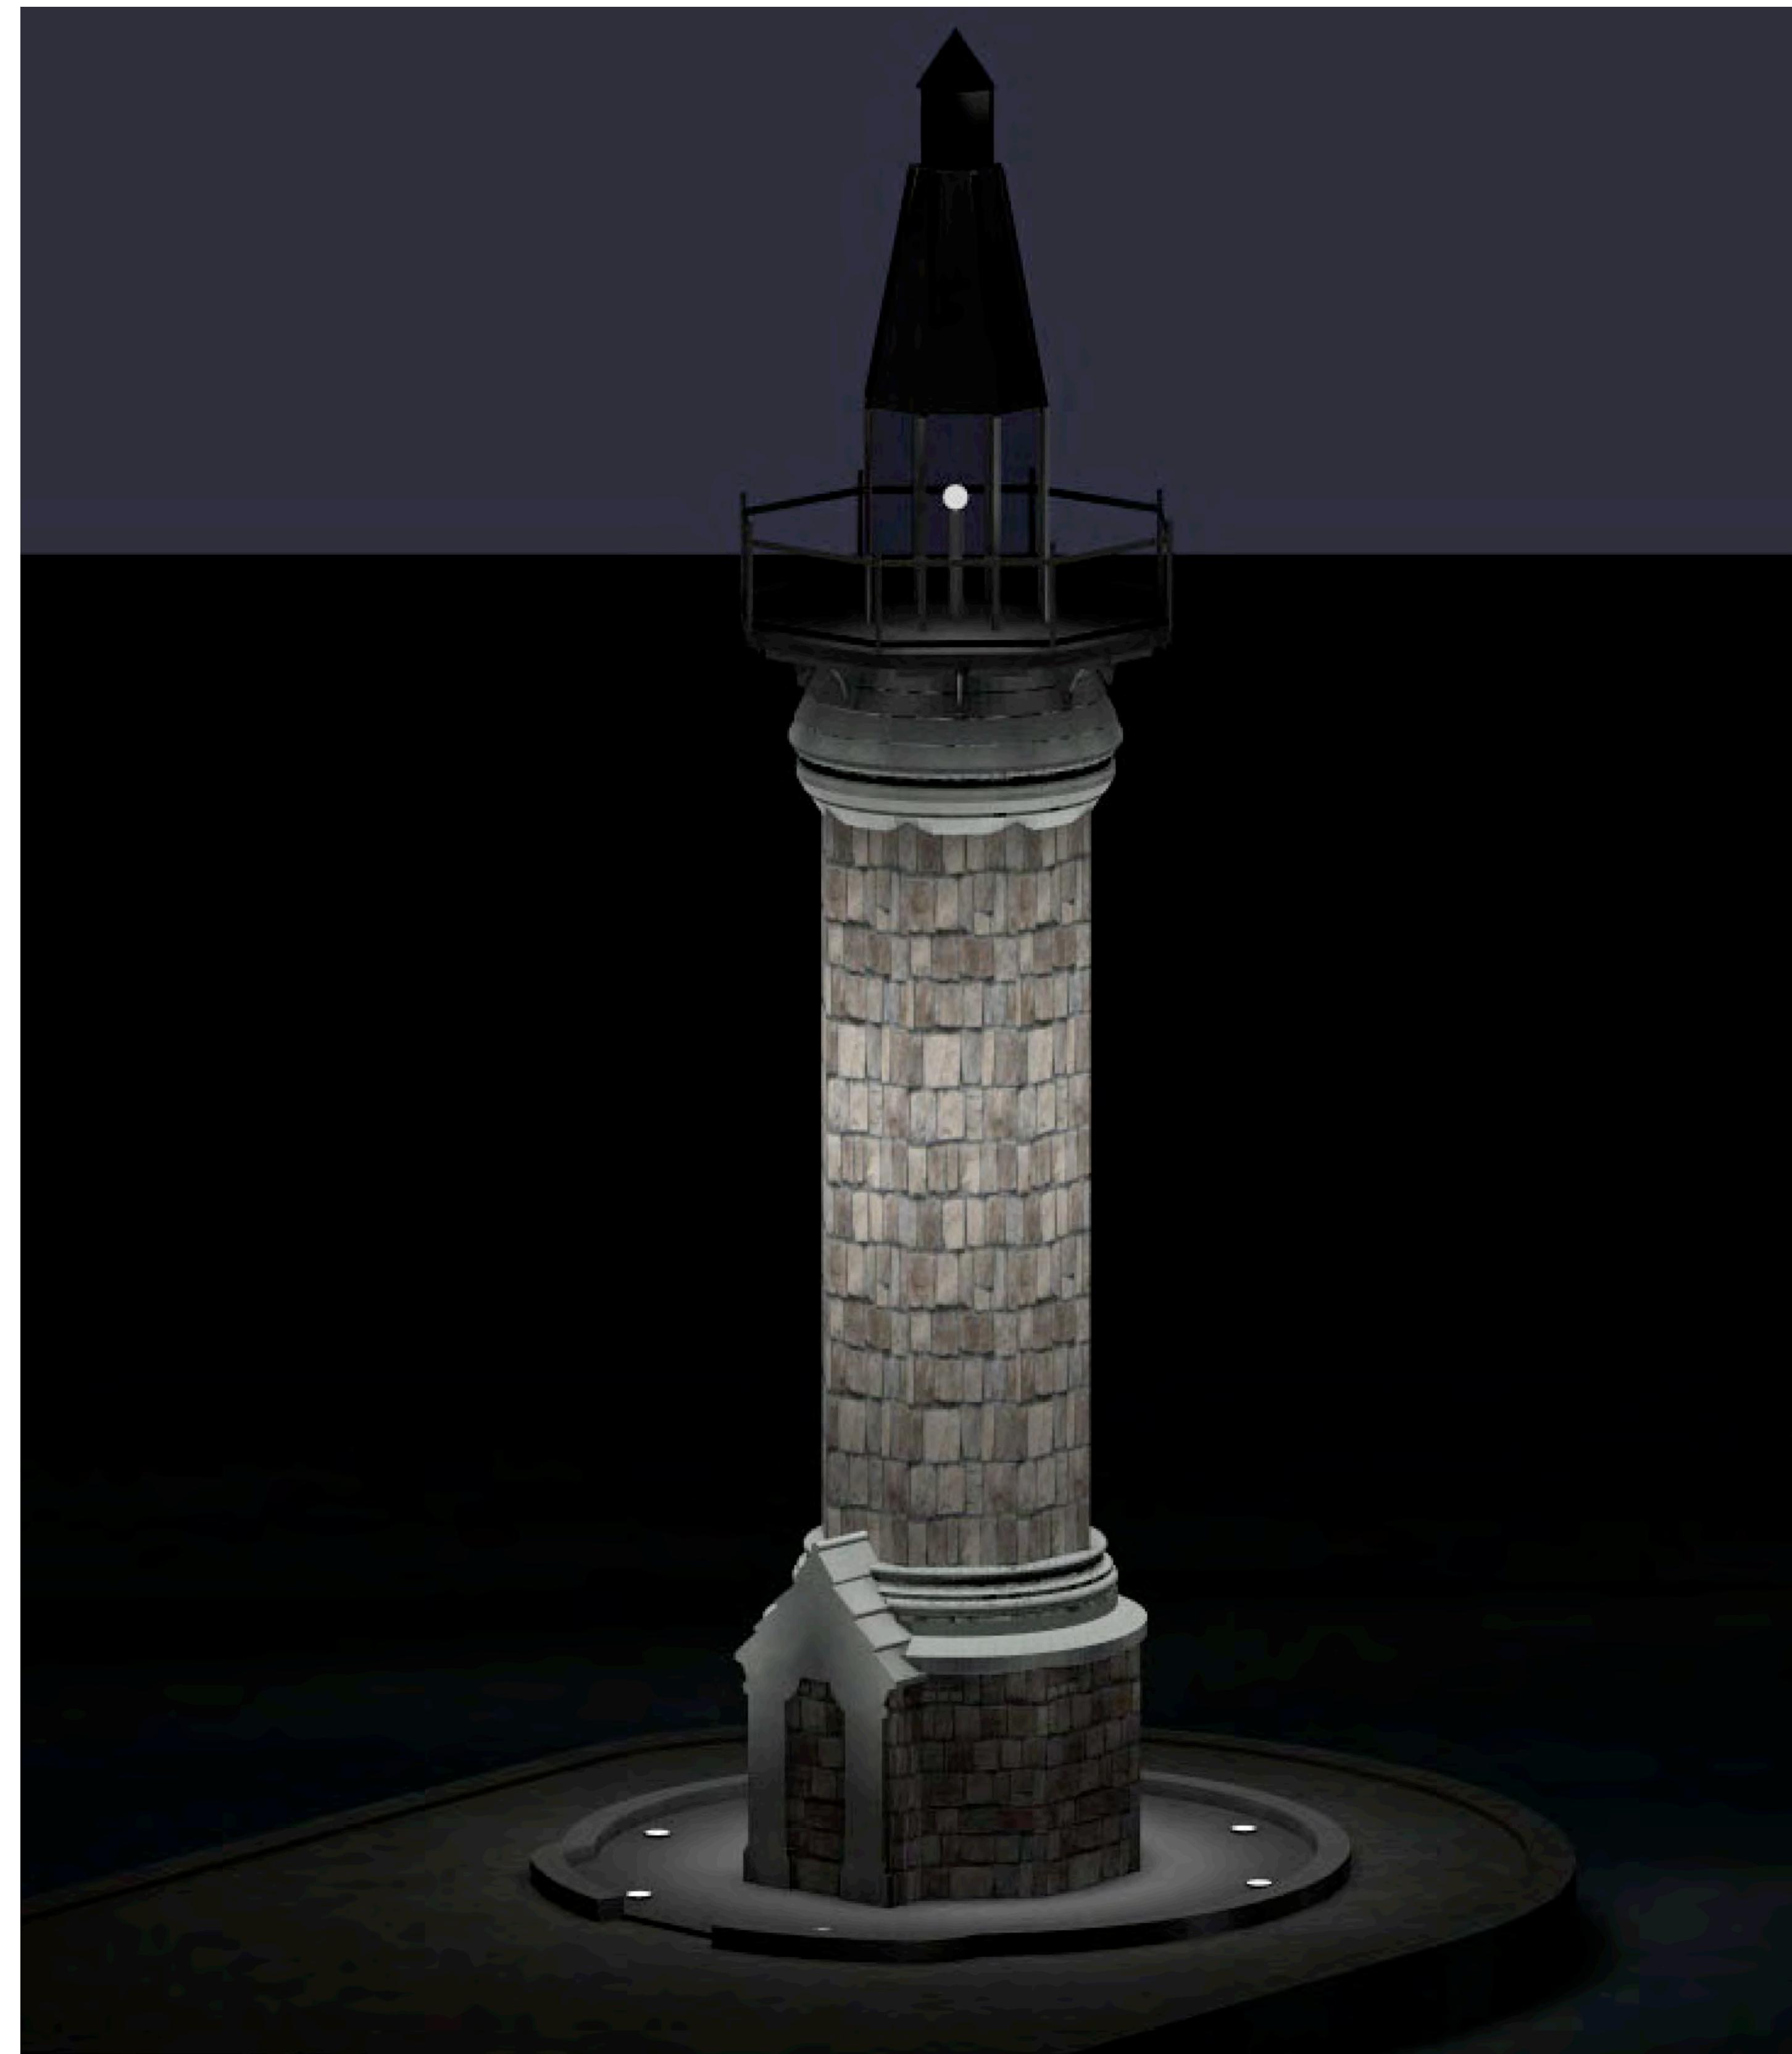
2 PROPOSED - EIGHT (8) NEW INGROUND L.E.D. FIXTURES w/ EIGHT (8)
NEW L.E.D. FIXTURES at OBSERVATION DECK
