# CONDITIONS REPORT & DESIGN MEMORANDUM

## STEAM TUNNEL ASSESSMENT ROOSEVELT ISLAND, NEW YORK

**ROOSEVELT ISLAND OPERATING CORPORATION**  
591 MAIN STREET  
ROOSEVELT ISLAND  
NEW YORK, NEW YORK 10044

*17 November 2014  
Project # 100444601*

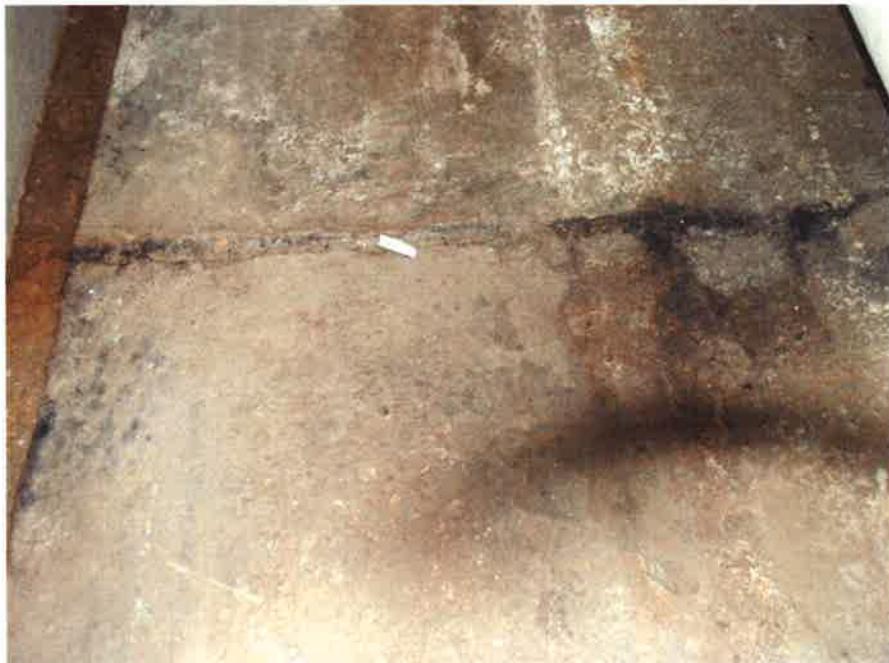
**Station 0+36**

| Station | Direction | Comments |
|---|---|---|
| 0+36 | Tunnel Floor | Floor Slab Cracking at Joint |

**Direction:** Tunnel Floor**Comments:** Floor Slab Cracking at Joint**Station 1+56**

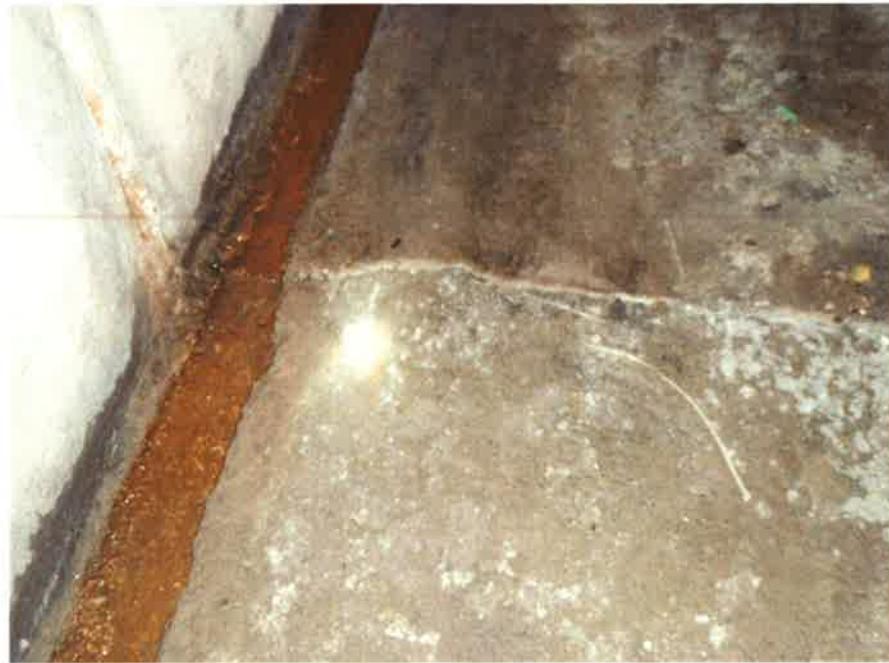
| Station | Direction | Comments |
|---|---|---|
| 1+56 | Tunnel Floor | Floor Slab Cracking |

**Direction:** Tunnel Floor**Comments:** Floor Slab Cracking

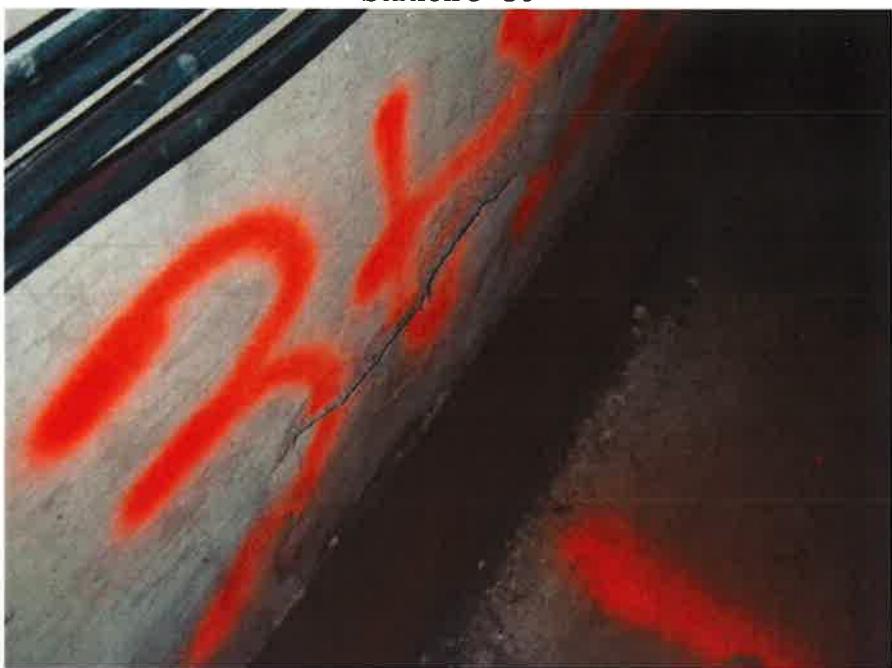
**Station 3+50**

| Station | Direction | Comments |
|---|---|---|
| 3+50 | Western Wall (In-Land) | Spalling, Loose Concrete |

**Direction:** Western Wall (In-Land)**Comments:** Spalling, Loose Concrete**Station 3+65**

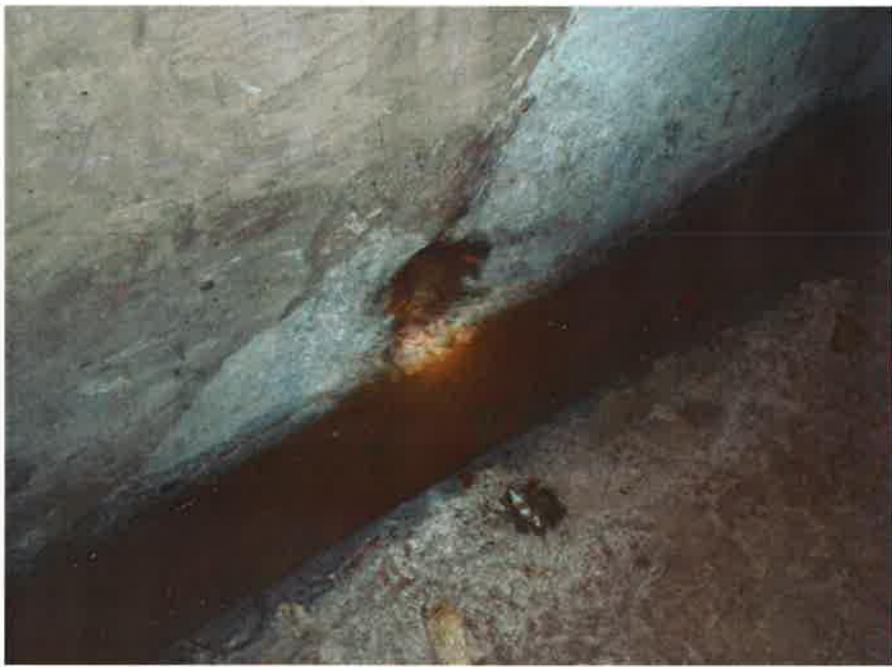
| Station | Direction | Comments |
|---|---|---|
| 3+65 | Western Wall (In-Land) | Concrete Spalling |

**Direction:** Western Wall (In-Land)**Comments:** Concrete Spalling

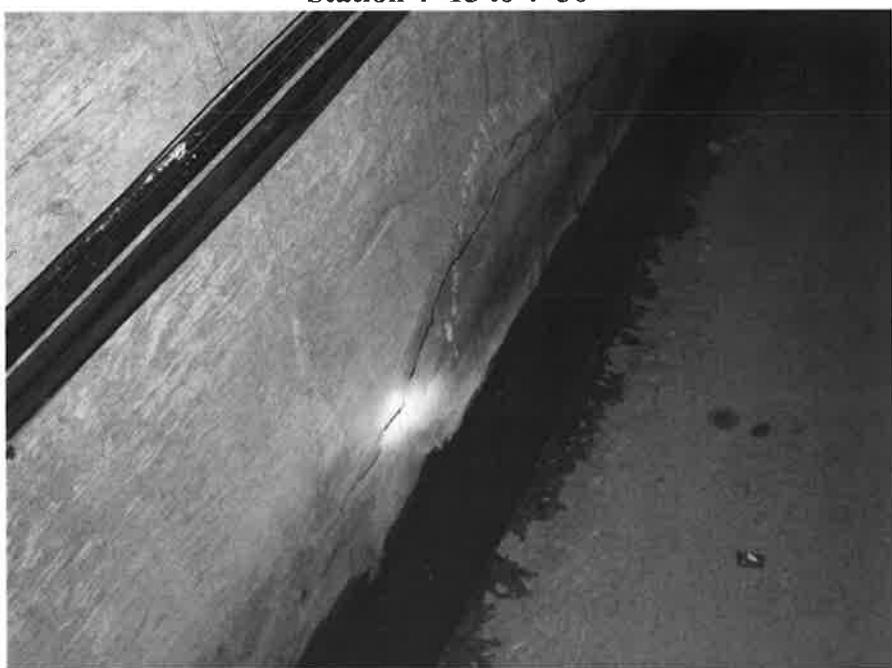
**Station 4+15 to 4+30**

| Station | Direction | Comments |
|---|---|---|
| 4+15 to 4+30 | Western Wall (In-Land) | Spalling, Loose Concrete |

**Direction:** Western Wall (In-Land)

**Comments:** Spalling, Loose Concrete

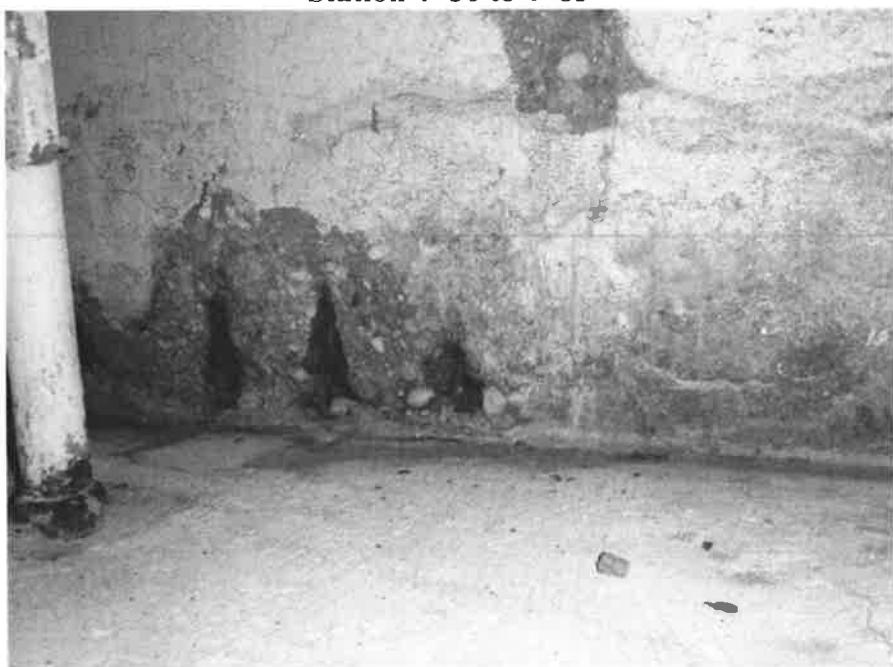
**Station 4+50 to 4+85**

| Station | Direction | Comments |
|---|---|---|
| 4+50 to 4+85 | Western Wall (In-Land) | Spalling, Re-Bar Exposed and Corroded |

**Direction:** Western Wall (In-Land)

**Comments:** Spalling, Re-Bar Exposed and Corroded

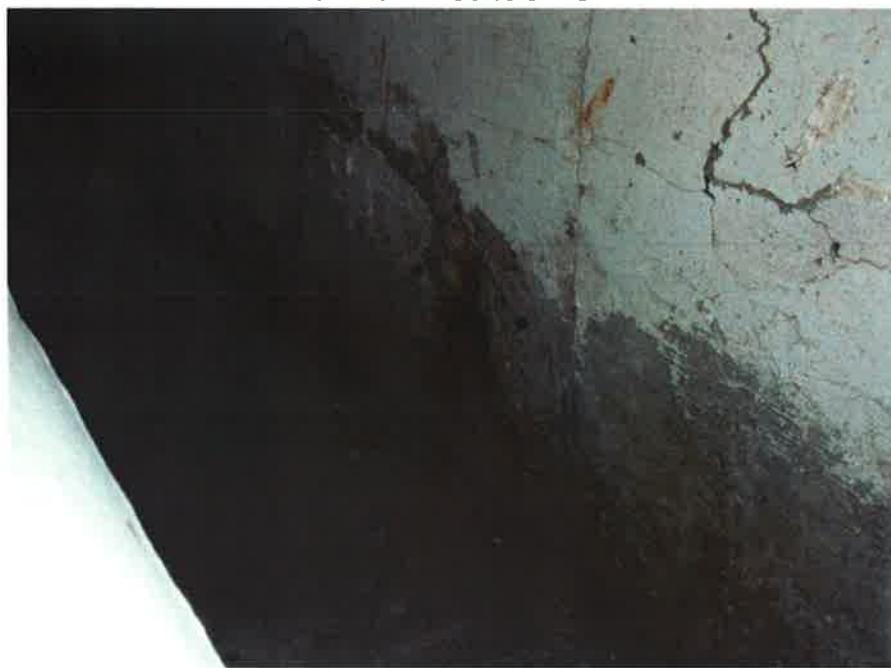
**Station 4+80 to 5+15**

| Station | Direction | Comments |
|---|---|---|
| 4+80 to 5+15 | Eastern Wall (Seawall) | Concrete Spalling |

**Direction:** Eastern Wall (Seawall)**Comments:** Concrete Spalling**Station 4+50 to 4+85**

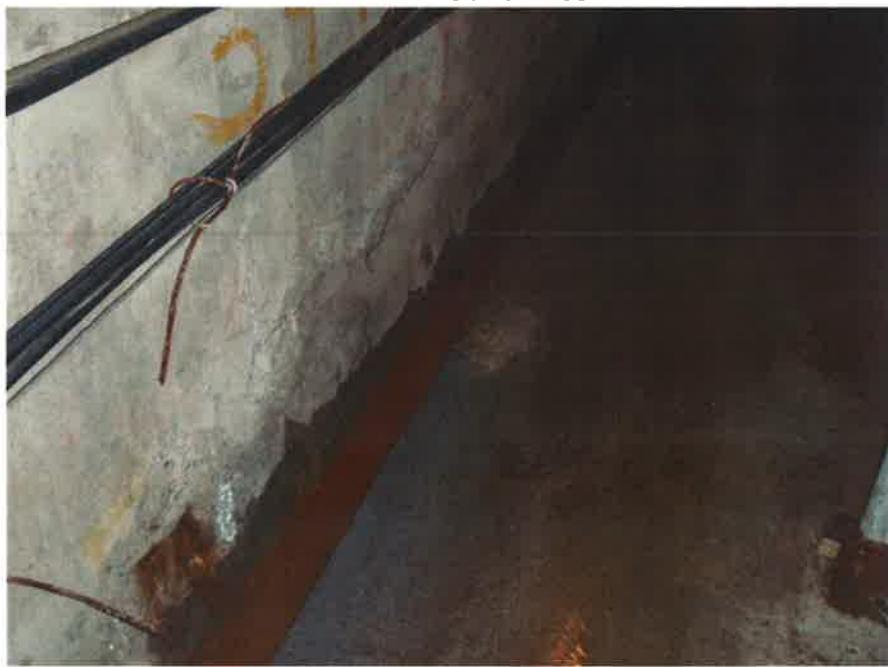
| Station | Direction | Comments |
|---|---|---|
| 4+50 to 4+85 | Western Wall (In-Land) | Spalling, Loose Concrete |

**Direction:** Western Wall (In-Land)**Comments:** Spalling, Loose Concrete

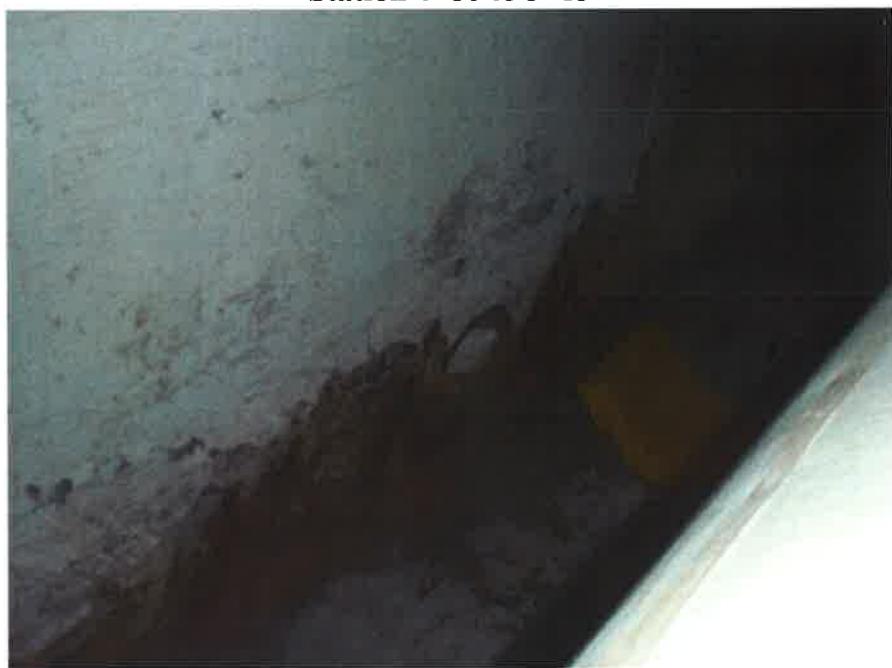
**Station 4+80 to 5+15**

| Station | Direction | Comments |
|---|---|---|
| 4+80 to 5+15 | Eastern Wall (Seawall) | Concrete Spalling |

**Direction:** Eastern Wall (Seawall)**Comments:** Concrete Spalling**Station 5+08**

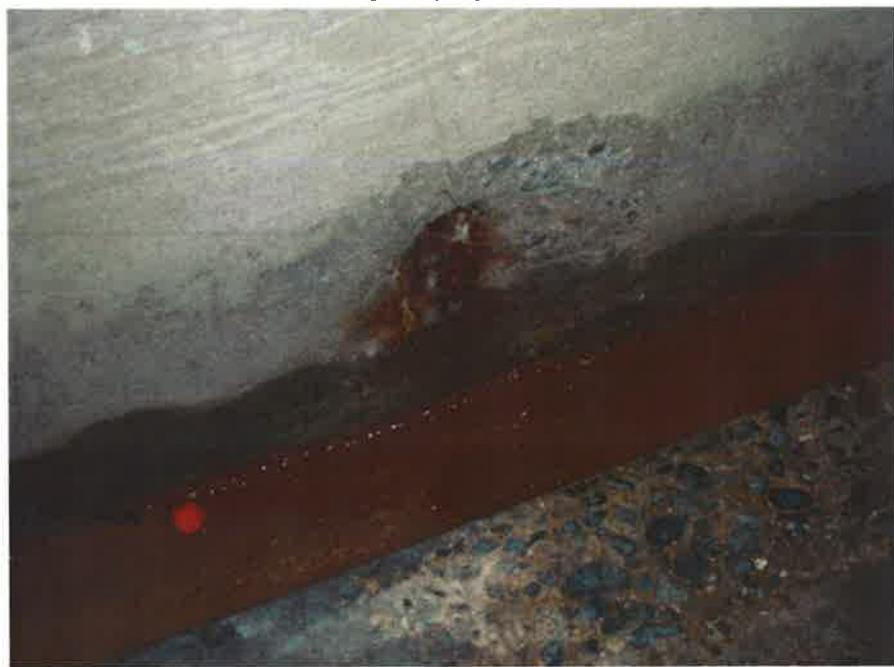
| Station | Direction | Comments |
|---|---|---|
| 5+08 | Western Wall (In-Land) | Concrete Spalling |

**Direction:** Western Wall (In-Land)**Comments:** Concrete Spalling

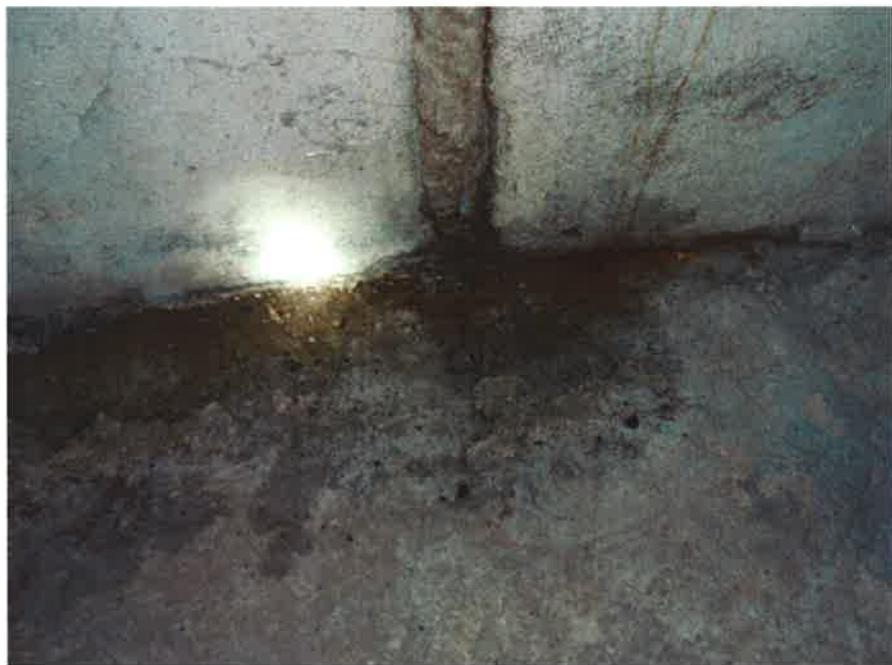
**Station 5+40**

| Station | Direction | Comments |
|---|---|---|
| 5+40 | Eastern Wall (Seawall) | Leaking Joint |

**Direction:** Eastern Wall (Seawall)**Comments:** Leaking Joint**Station 5+45 to 5+55**

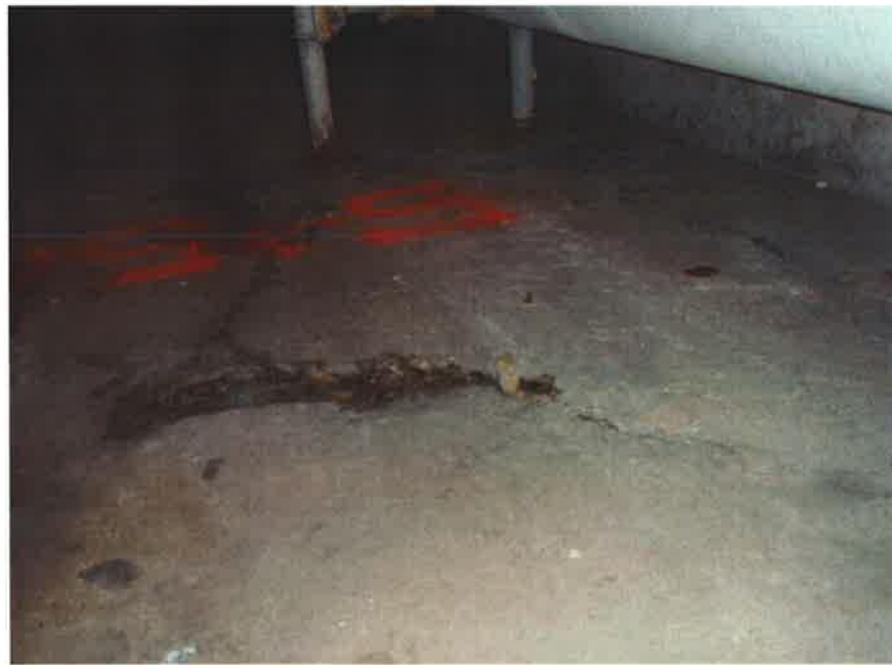
| Station | Direction | Comments |
|---|---|---|
| 5+45 to 5+55 | Tunnel Floor | Floor Slab Cracking |

**Direction:** Tunnel Floor**Comments:** Floor Slab Cracking

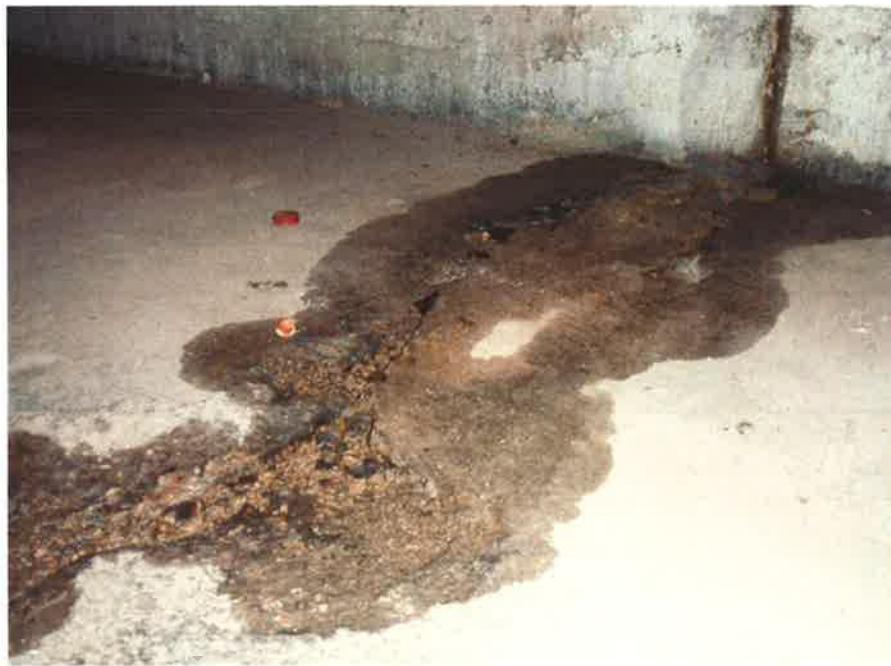
**Station 5+90**

| Station | Direction | Comments |
|---|---|---|
| 5+90 | Tunnel Floor | Raised Joint, Loose Concrete and Leaking at Seawall |

**Direction:** Tunnel Floor**Comments:** Raised Joint, Loose Concrete and Leaking at Seawall**Station 6+20 to 6+26**

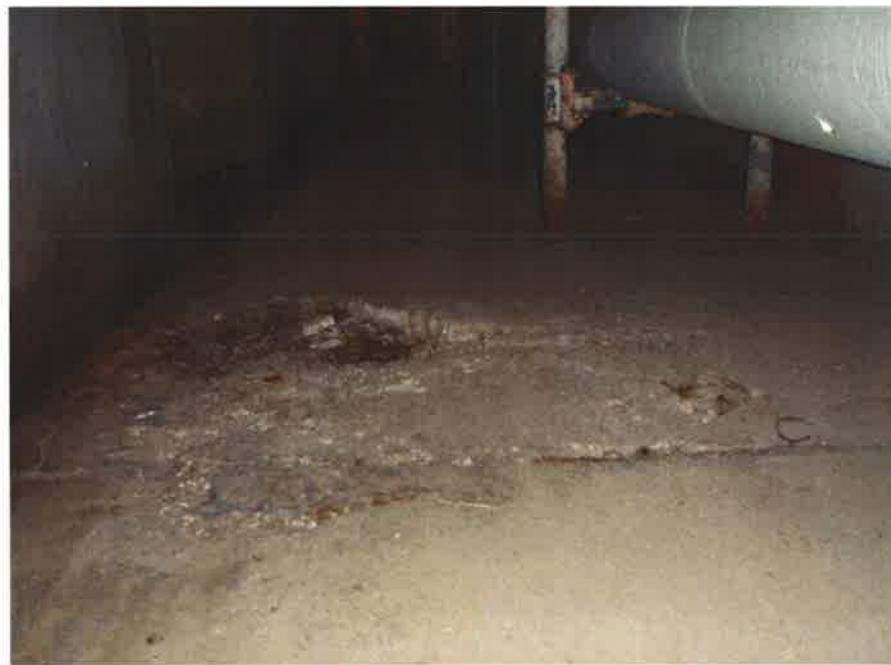
**Direction:** Tunnel Floor**Comments:** Floor Slab Cracking and Spalling

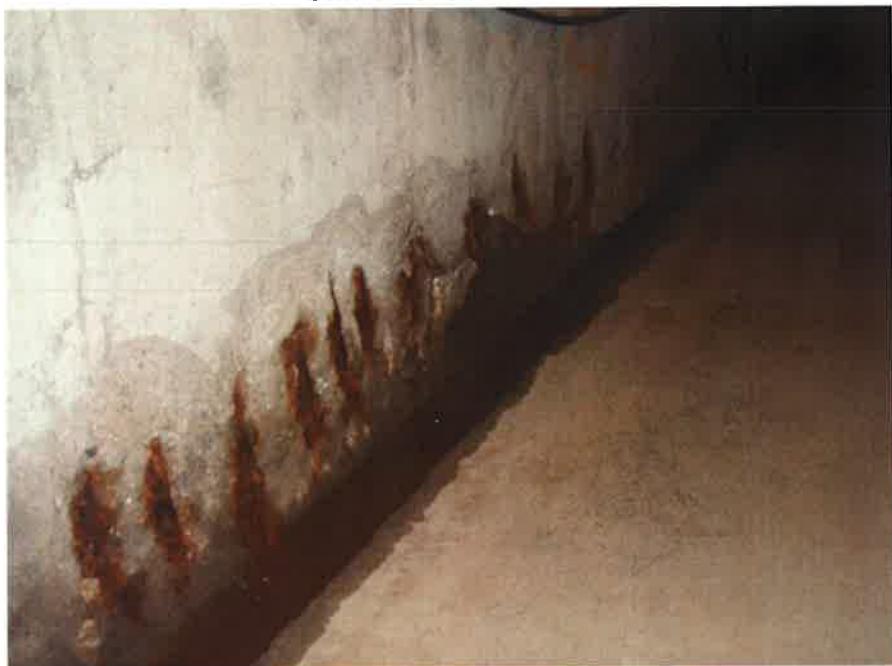
**Station 6+30 to 6+47**

**Direction:** Western Wall (In-Land)**Comments:** Concrete Spalling, Re-Bar Exposed and Corroded**Station 6+56**

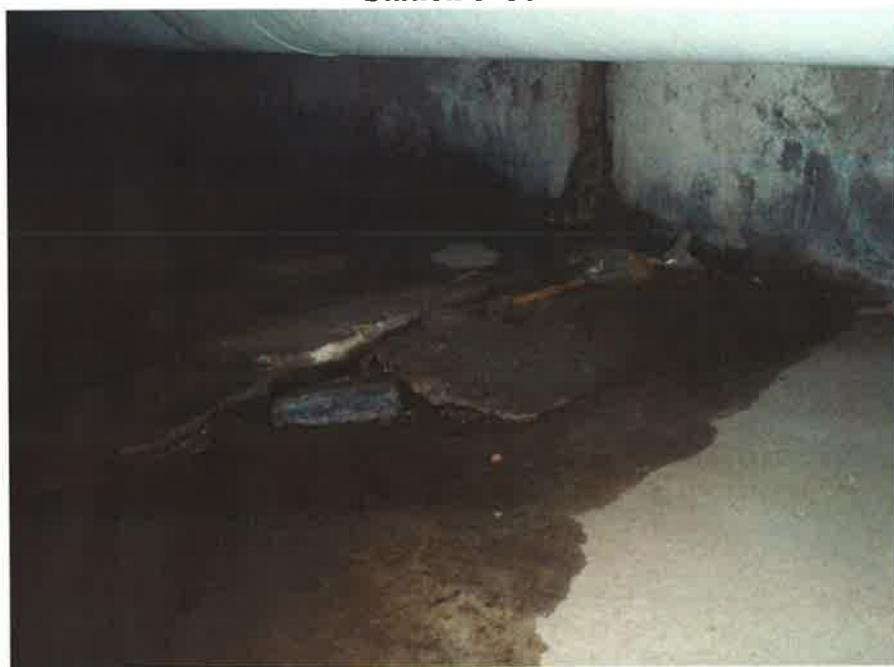
**Direction:** Tunnel Floor**Comments:** Raised Joint, Loose Concrete and Leaking at Seawall

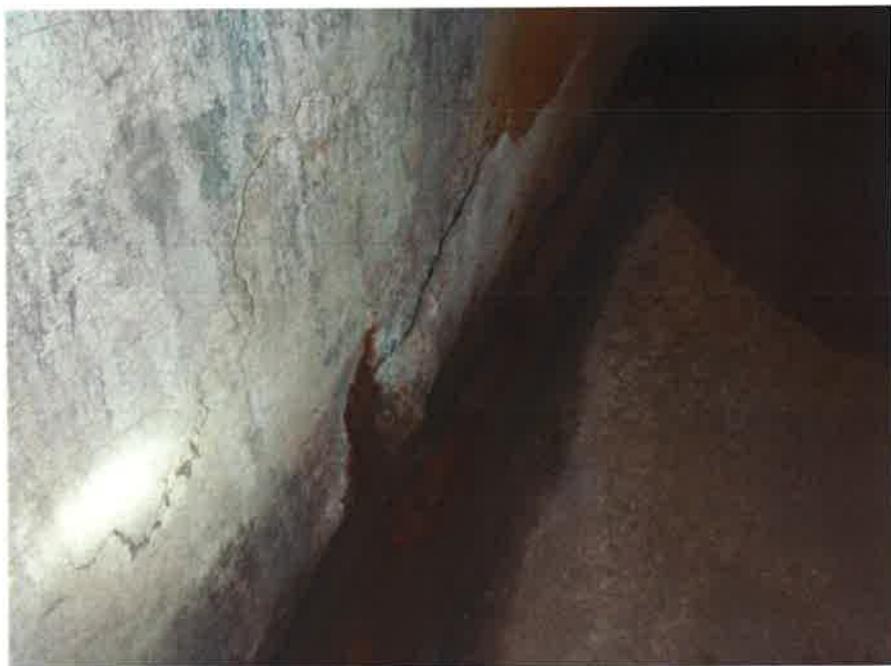
**Station 6+90**

**Direction:** Western Wall (In-Land)**Comments:** Spalling, Loose Concrete**Station 7+21**

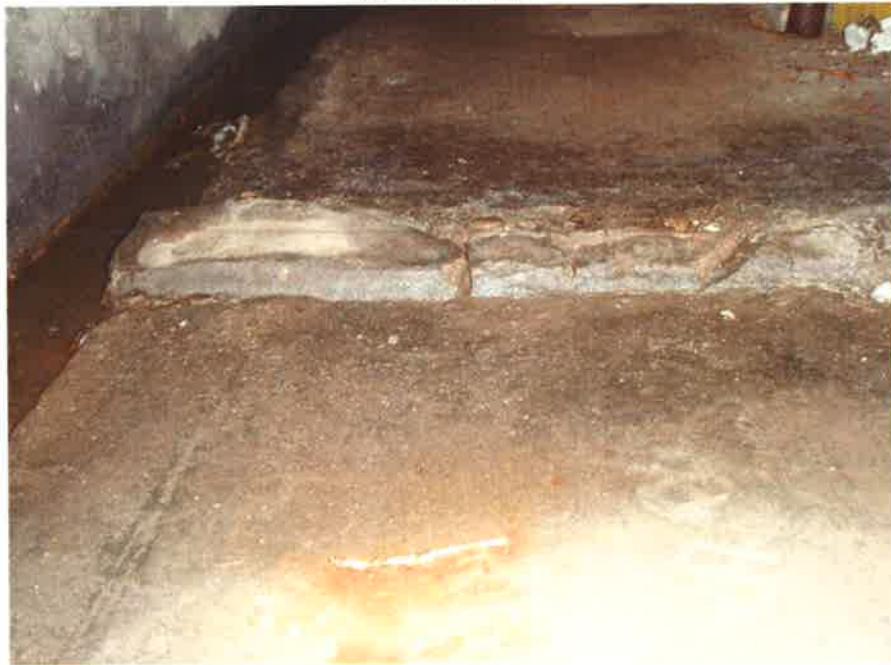
**Direction:** Tunnel Floor**Comments:** Floor Slab Raised at Joint, Cracking, Loose Concrete

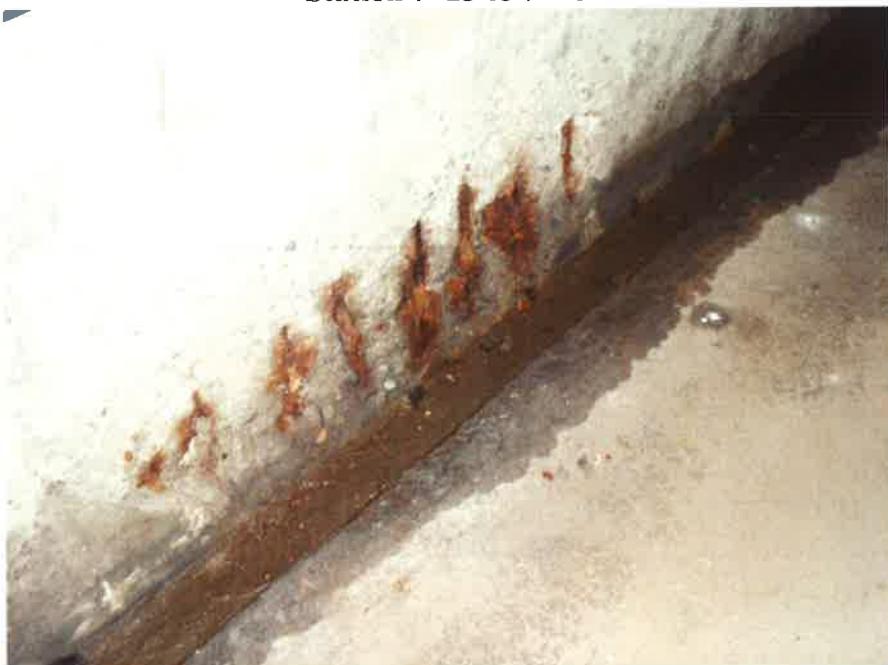
**Station 7+23 to 7+40**

**Direction:** Western Wall (In-Land)**Comments:** Spalling, Re-Bar Exposed and Corroded**Station 7+53**

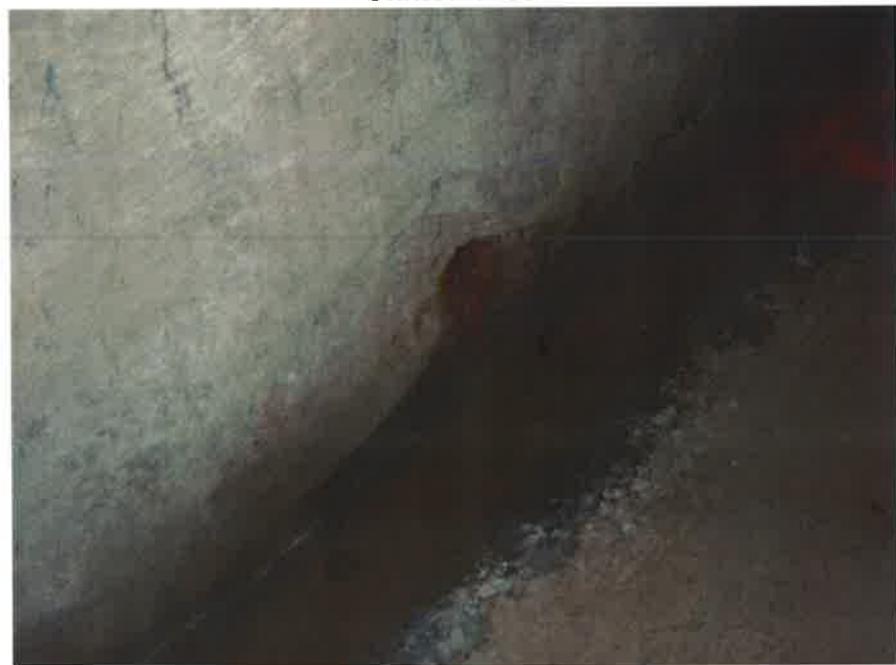
**Direction:** Western Wall (In-Land)**Comments:** Concrete Spalling

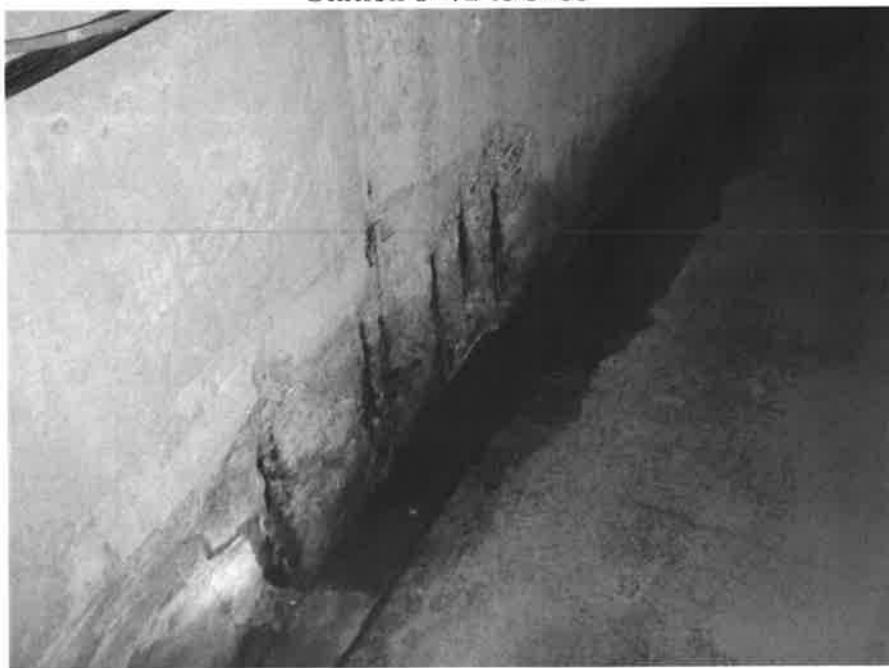
**Direction:** Western Wall (In-Land)**Comments:** Spalling, Re-Bar Exposed and Corroded

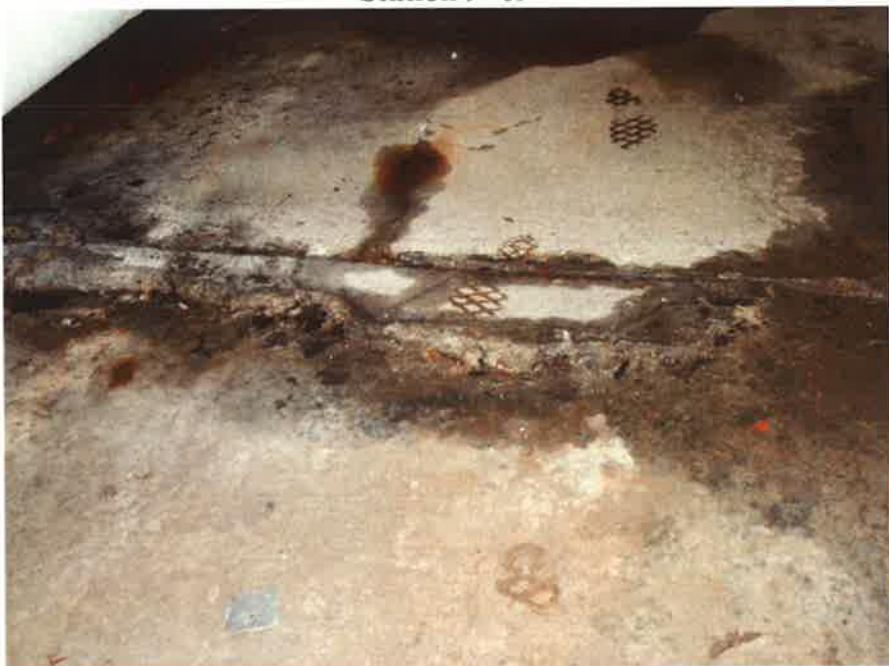
**Station 9+09**

**Direction:** Tunnel Floor**Comments:** Floor Slab Raised at Joint, Cracking, Loose Concrete**Station 9+95 to 10+15**

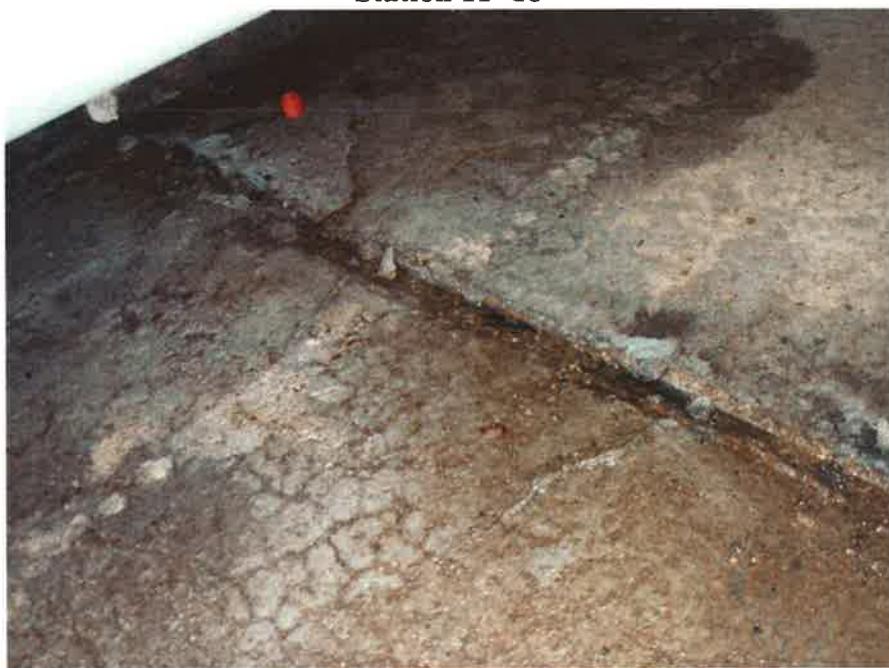
**Station 11+18**

**Direction:** Tunnel Floor**Comments:** Floor Slab Raised at Joint, Cracking, Loose Concrete**Station 11+29**

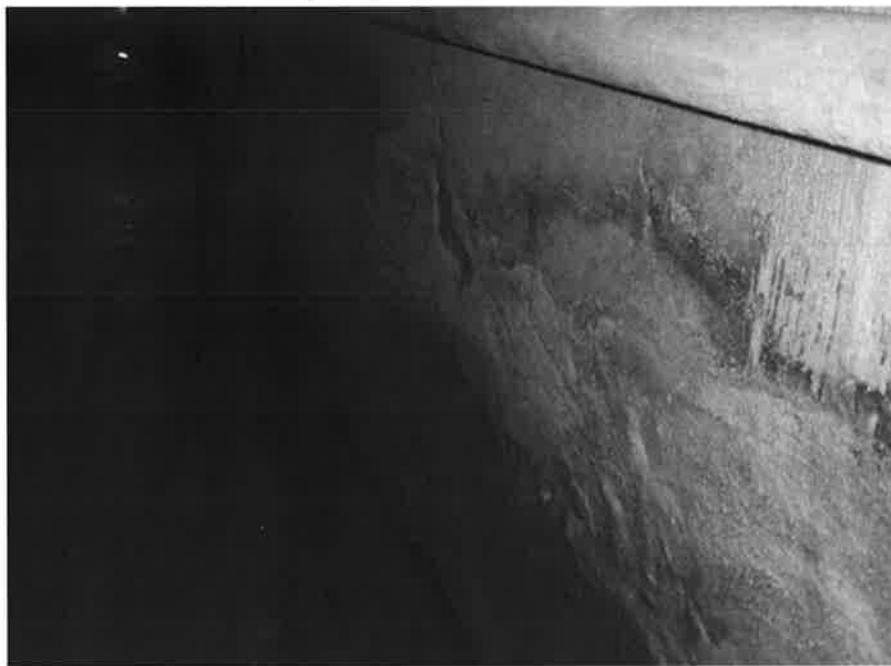
**Station 11+85 +12+50**

**Direction:** Western Wall (In-Land)**Comments:** Concrete Spalling and Bowing of Wall**Station 11+85 +12+50**

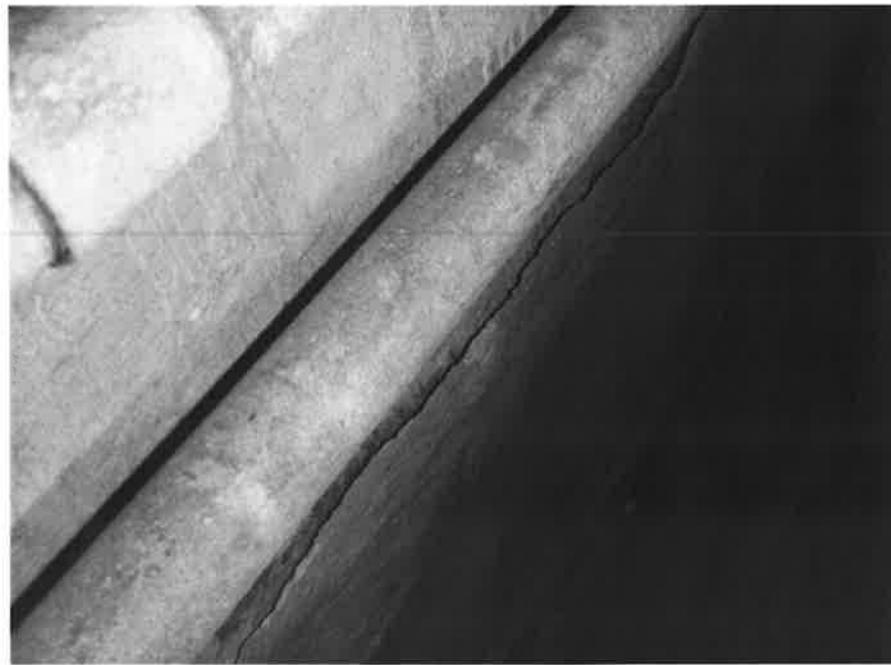
**Direction:** Western Wall (In-Land)**Comments:** Concrete Spalling and Bowing of Wall, Loose Concrete

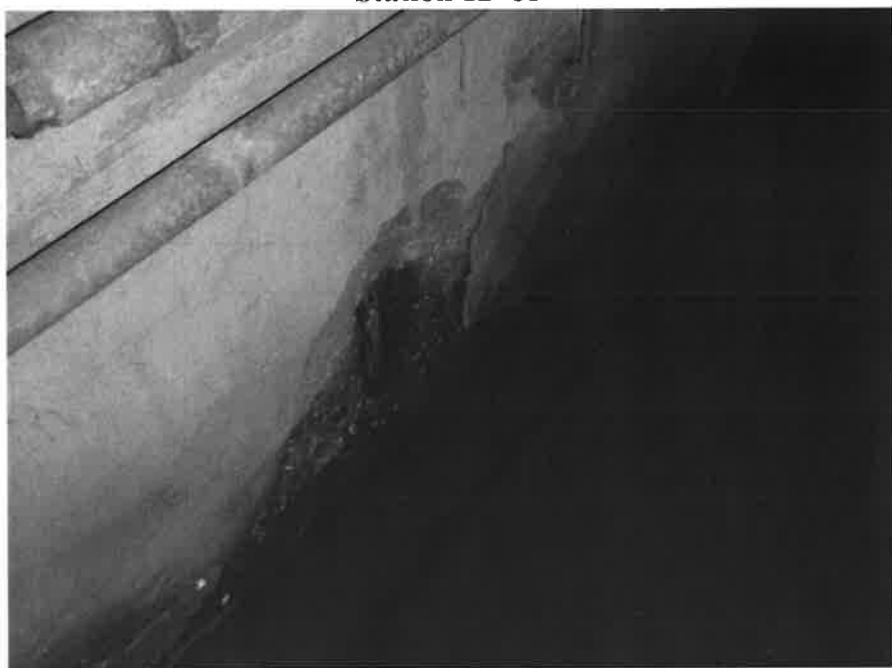
**Station 12+53**

**Direction:** Western Wall (In-Land)

**Comments:** Concrete Spalling, Re-Bar Exposed and Corroded

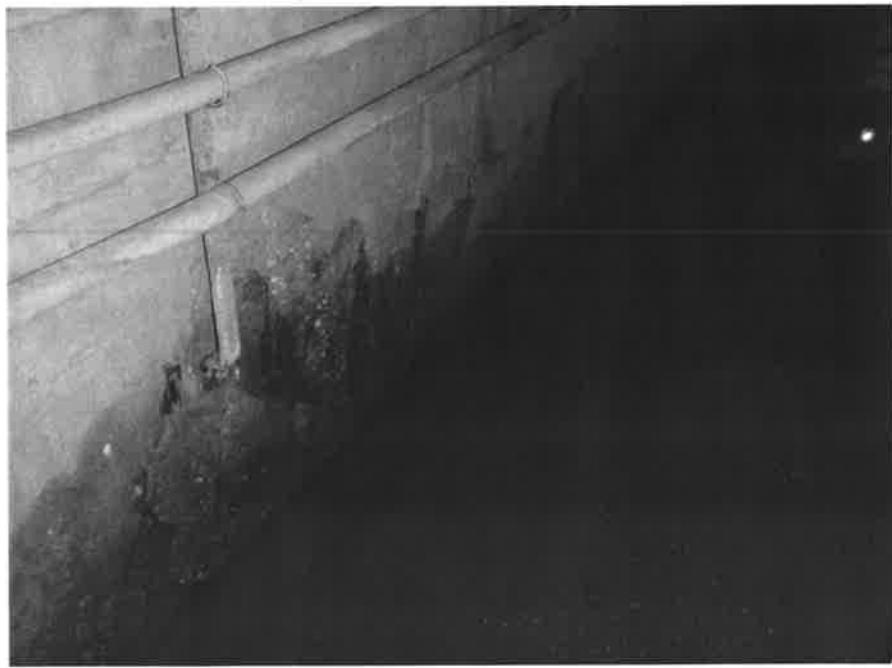
**Station 12+65 to 12+85**

**Direction:** Western Wall (In-Land)

**Comments:** Concrete Spalling, Re-Bar Exposed and Corroded

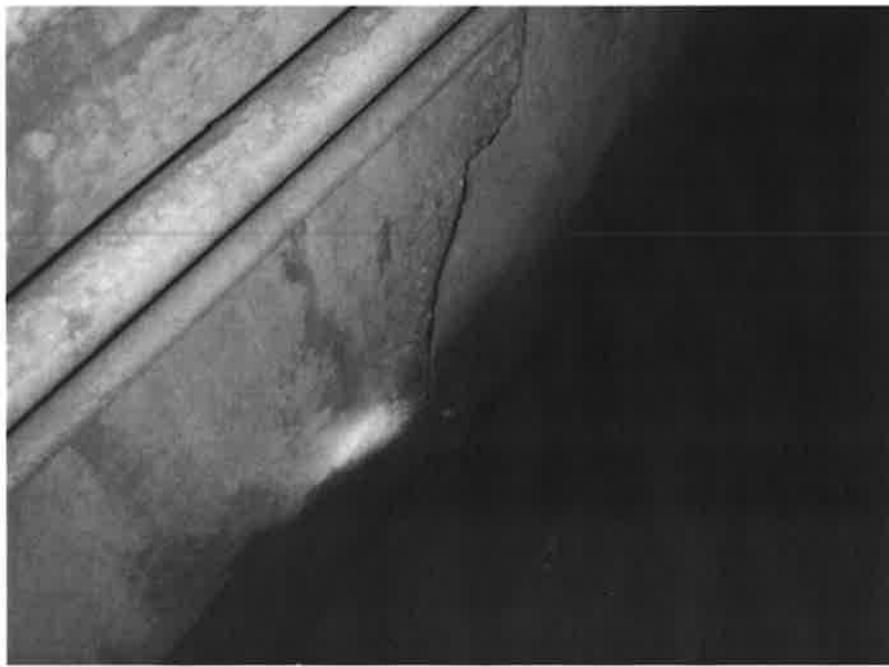
**Direction:** Western Wall (In-Land)**Comments:** Spalling, Loose Concrete

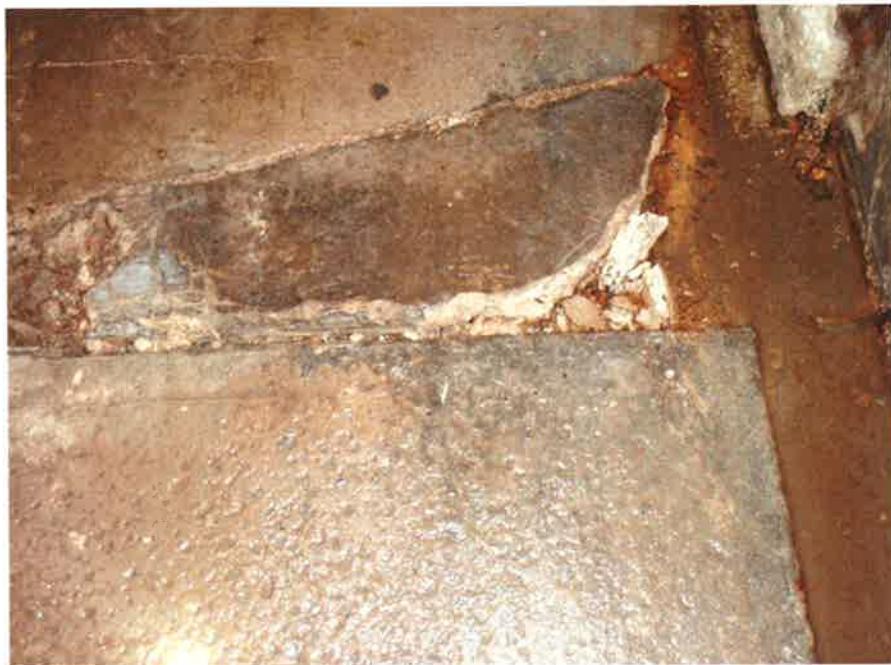
**Station 14+30**

**Direction:** Tunnel Floor**Comments:** Floor Slab Raised at Joint, Cracking, Loose Concrete**Station 14+24 to 15+00**

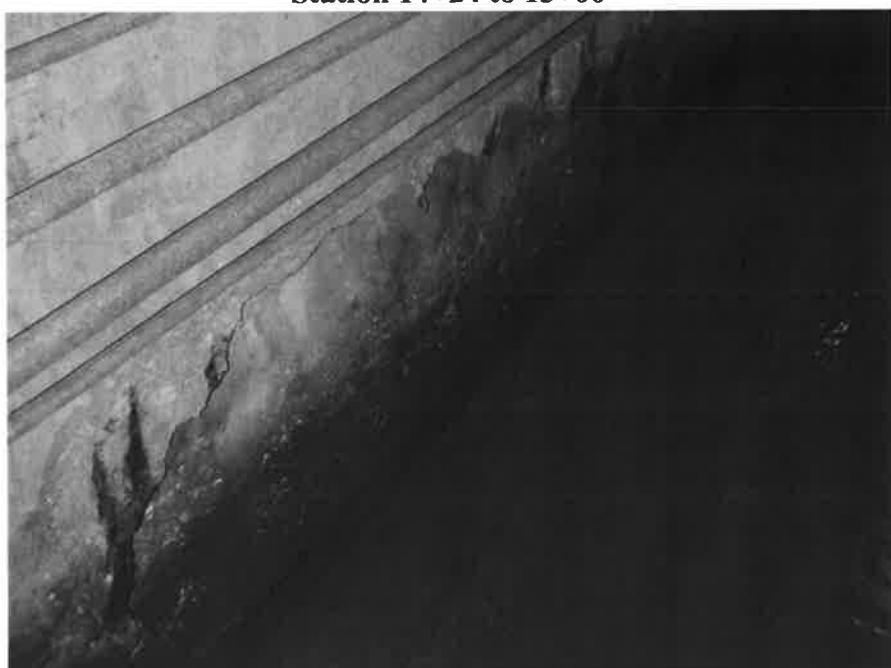
**Station 14+24 to 15+00**

**Direction:** Western Wall (In-Land)**Comments:** Spalling, Re-Bar Exposed and Corroded, Loose Concrete**Station 14+24 to 15+00**

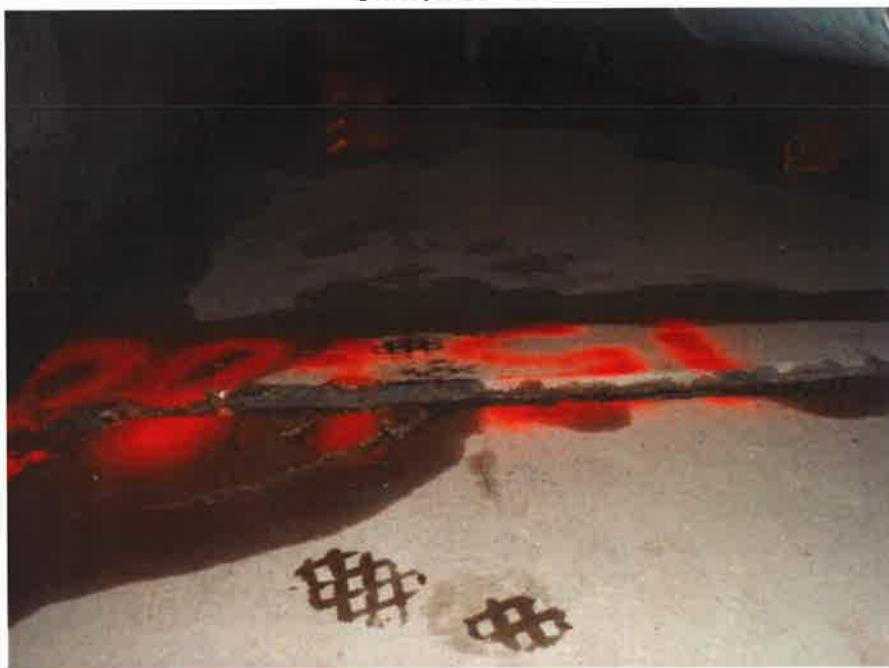
**Station 15+00**

**Direction:** Tunnel Floor**Comments:** Floor Slab Raised at Joint, Cracking, Loose Concrete**Station 15+09 to 15+20**

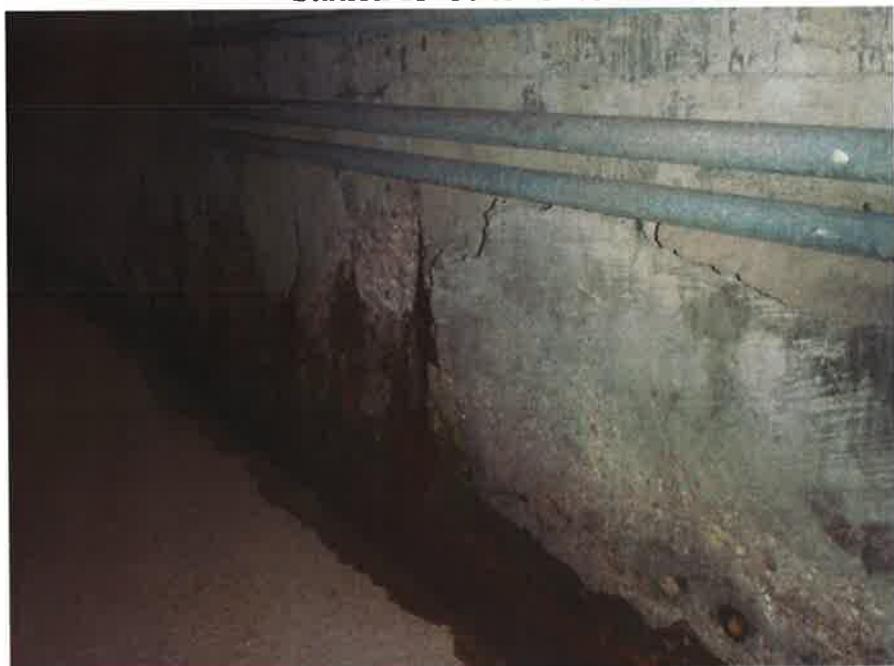
**Station 15+50 to 15+75**

**Direction:** Western Wall (In-Land)**Comments:** Spalling, Re-Bar Exposed and Corroded**Station 15+75**

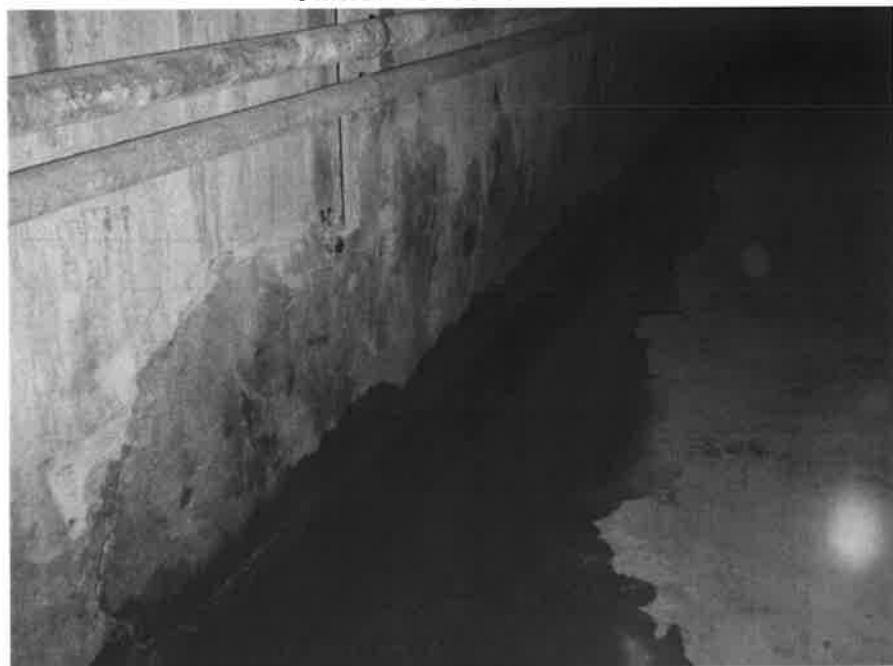
**Station 15+88 to 16+00**

**Direction:** Western Wall (In-Land)**Comments:** Concrete Spalling**Station 16+53 to 16+60**

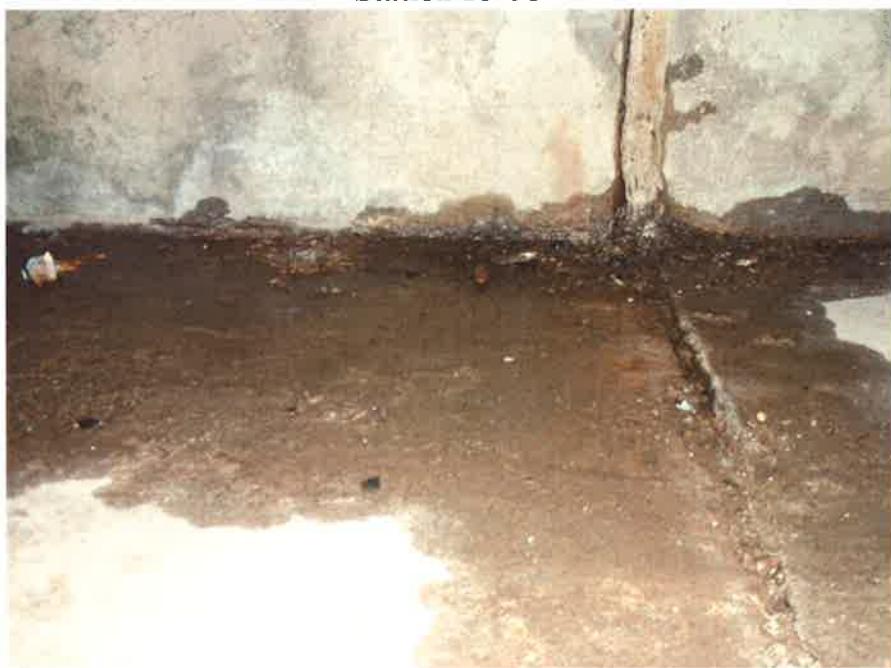
**Station 16+95**

**Direction:** Tunnel Joint**Comments:** Leaking at Seawall**Station 17+35**

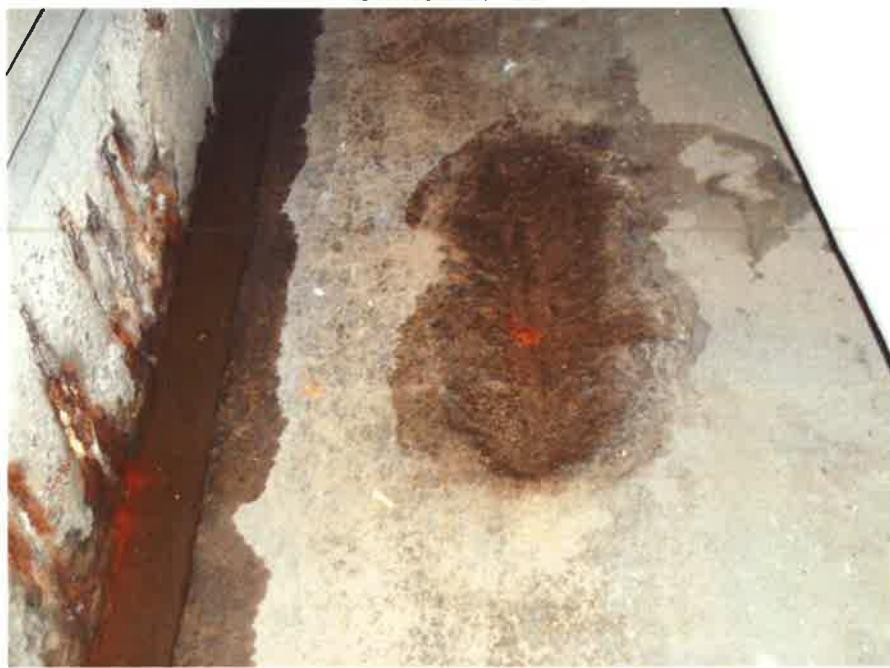
**Direction:** Tunnel Floor**Comments:** Concrete Spalling

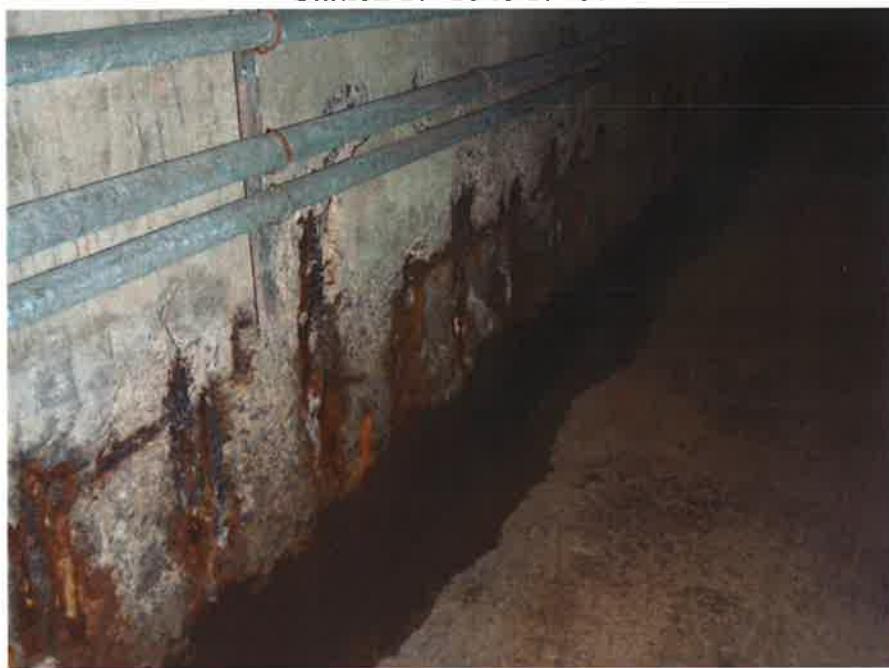
**Station 17+10 to 17+61**

**Direction:** Western Wall (In-Land)**Comments:** Spalling, Re-Bar Exposed and Corroded**Station 17+70**
