# CONDITIONS REPORT & DESIGN MEMORANDUM

## STEAM TUNNEL ASSESSMENT ROOSEVELT ISLAND, NEW YORK

**ROOSEVELT ISLAND OPERATING CORPORATION**  
591 MAIN STREET  
ROOSEVELT ISLAND  
NEW YORK, NEW YORK 10044

*17 November 2014  
Project # 100444601*

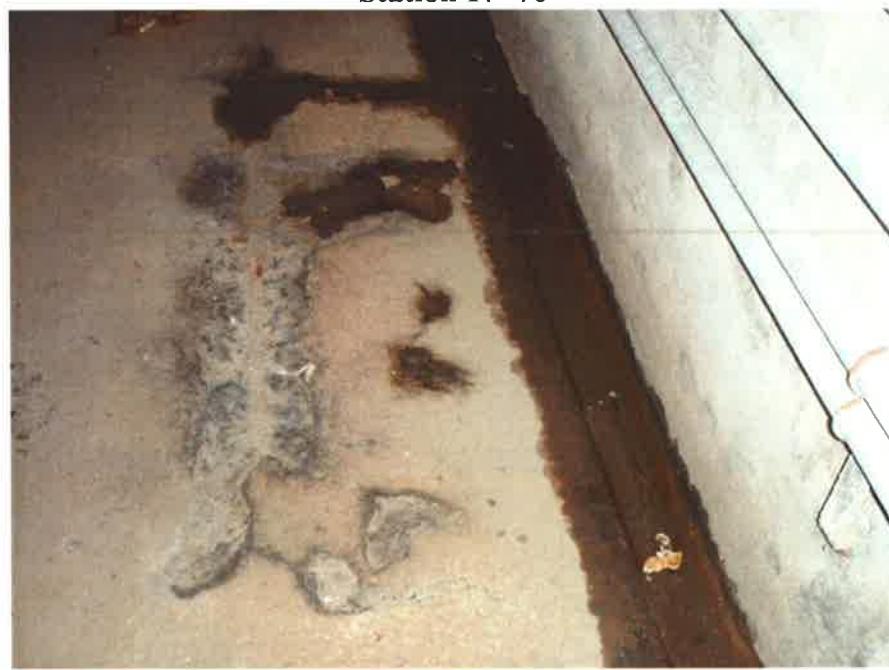
**Direction:** Tunnel Floor**Comments:** Concrete Spalling

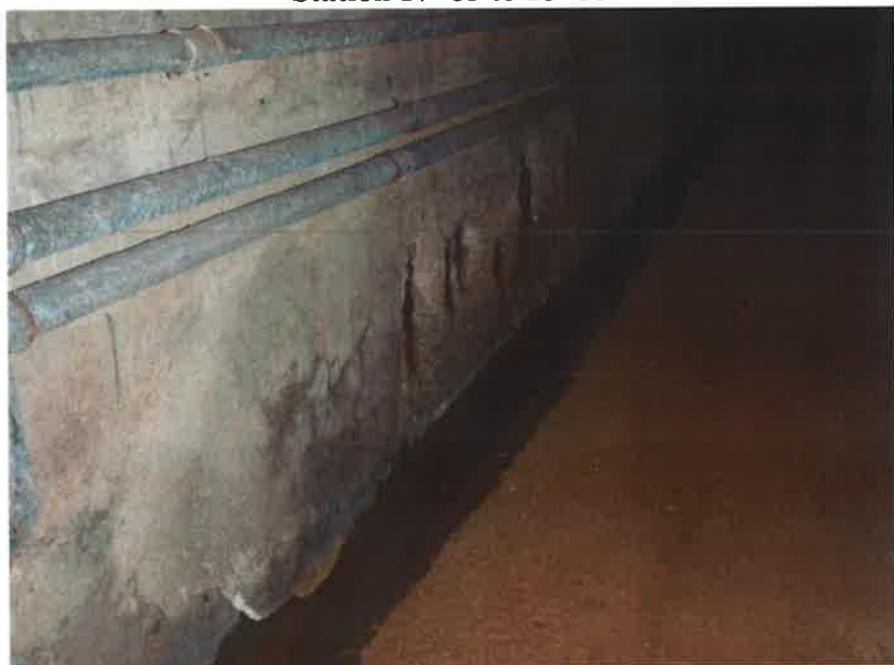
**Direction:** Western Wall (In-Land)**Comments:** Concrete Spalling, Re-Bar Exposed and Corroded

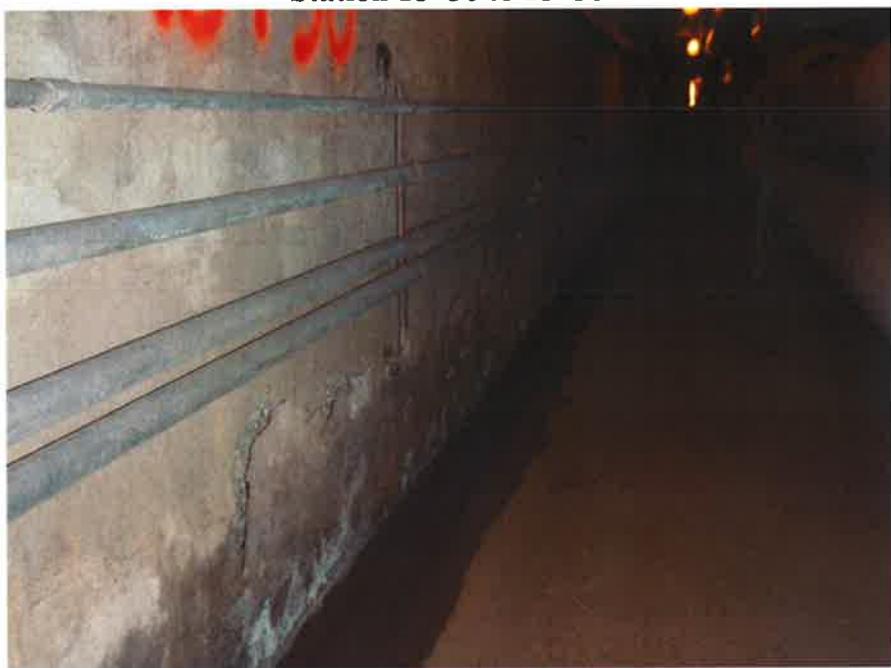
**Station 18+30 to 18+50**

**Direction:** Western Wall (In-Land)**Comments:** Spalling, Loose Concrete**Station 18+80**

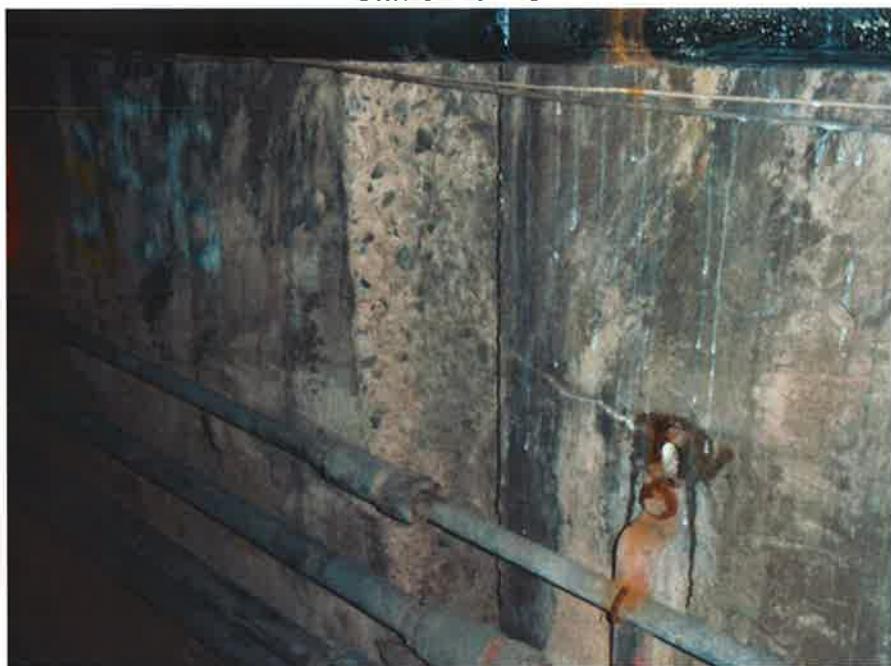
**Station 19+45**

**Direction:** Western Wall (In-Land)**Comments:** Cracking at Joint, Concrete Missing**Station 19+90 to 19+72**

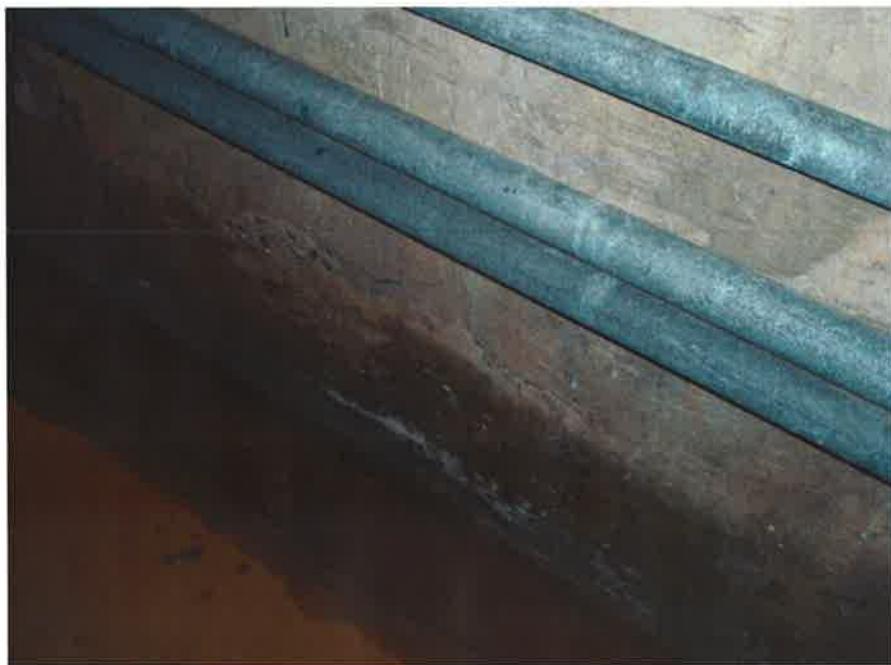
**Direction:** Western Wall (In-Land)**Comments:** Concrete Spalling

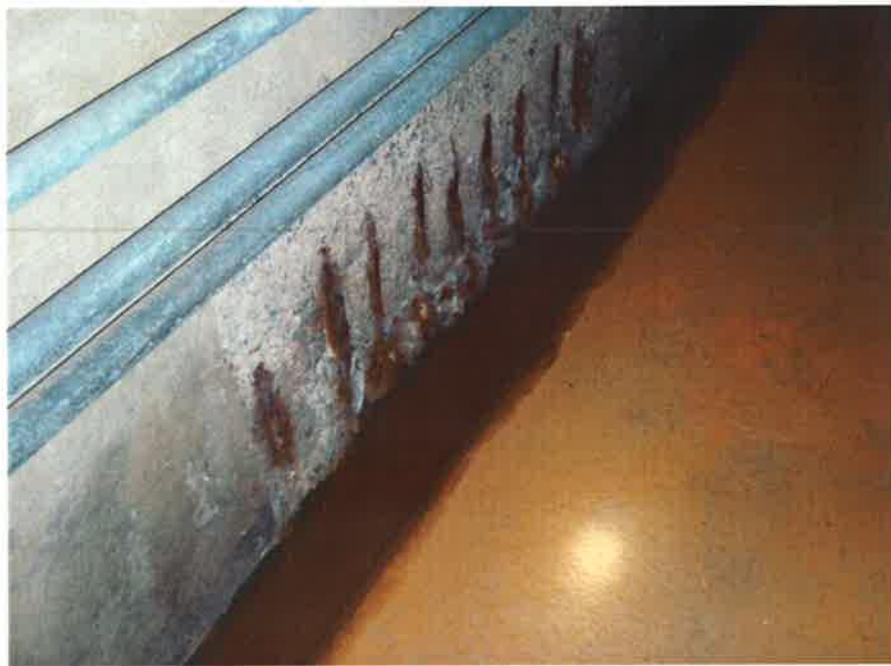
**Direction:** Western Wall (In-Land)**Comments:** Concrete Spalling, Re-Bar Exposed

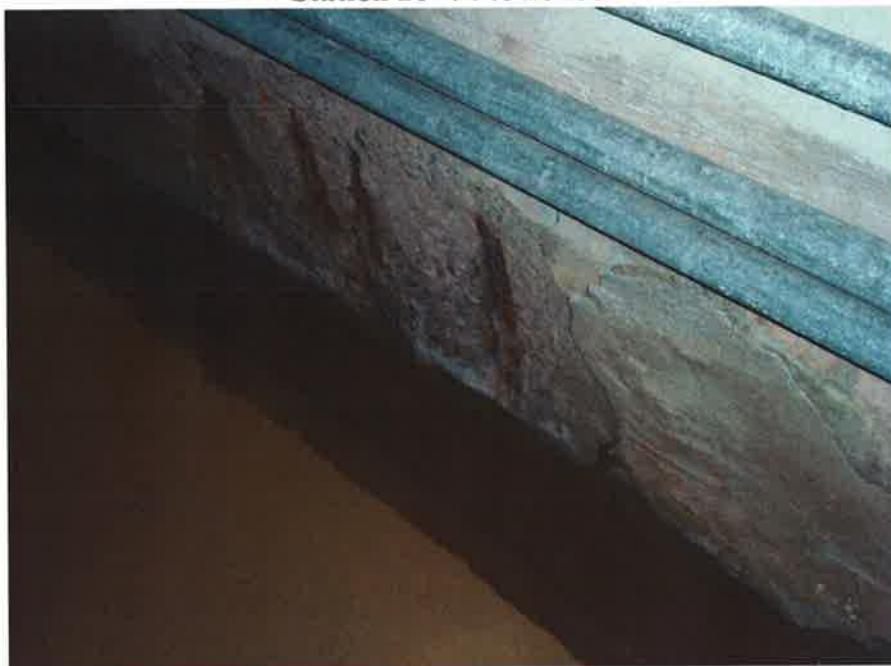
**Station 20+74 to 20+80**

**Direction:** Western Wall (In-Land)**Comments:** Concrete Spalling, Re-Bar Exposed**Station 20+90 to 21+30**

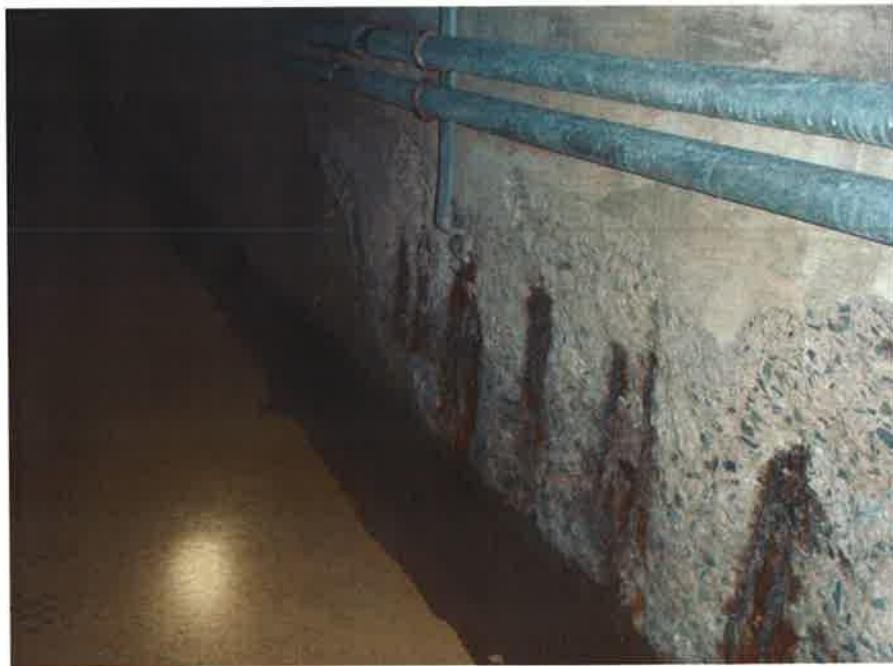
**Direction:** Western Wall (In-Land)**Comments:** Concrete Spalling, Re-Bar Exposed and Corroded

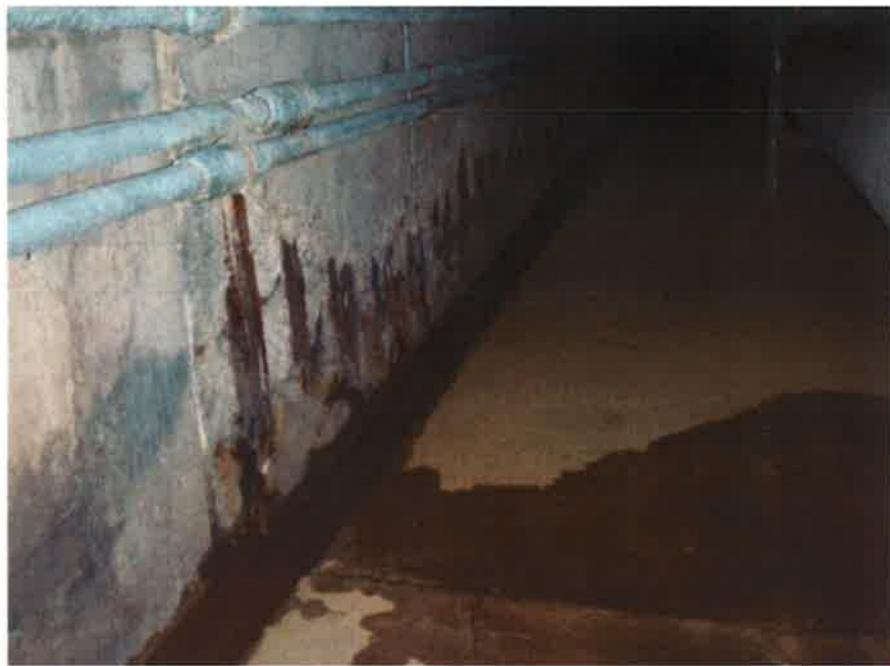
**Station 20+90 to 21+30**

**Direction:** Western Wall (In-Land)**Comments:** Concrete Spalling, Re-Bar Exposed and Corroded**Station 21+68 to 21+75**

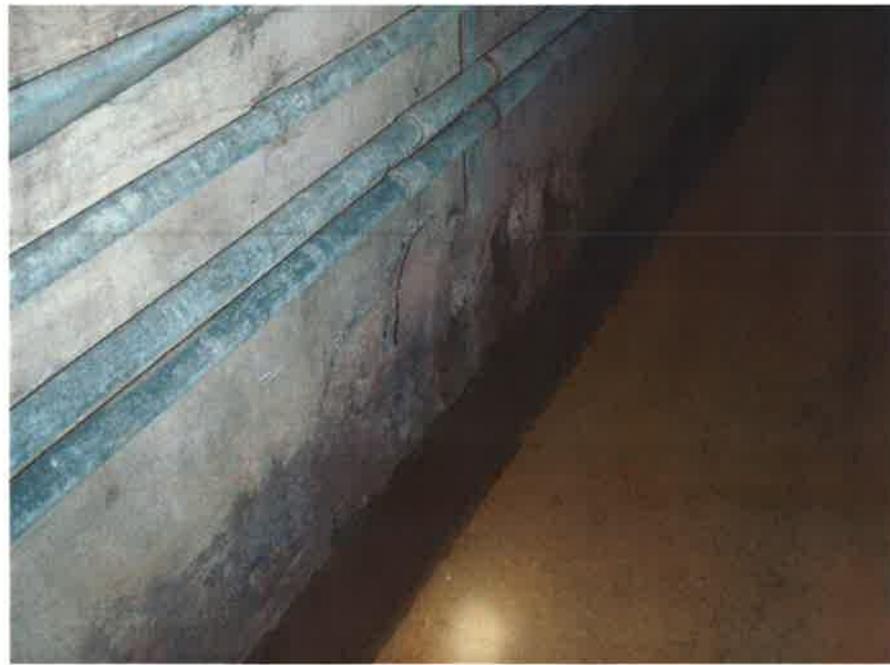
**Direction:** Western Wall (In-Land)**Comments:** Concrete Spalling, Re-Bar Exposed

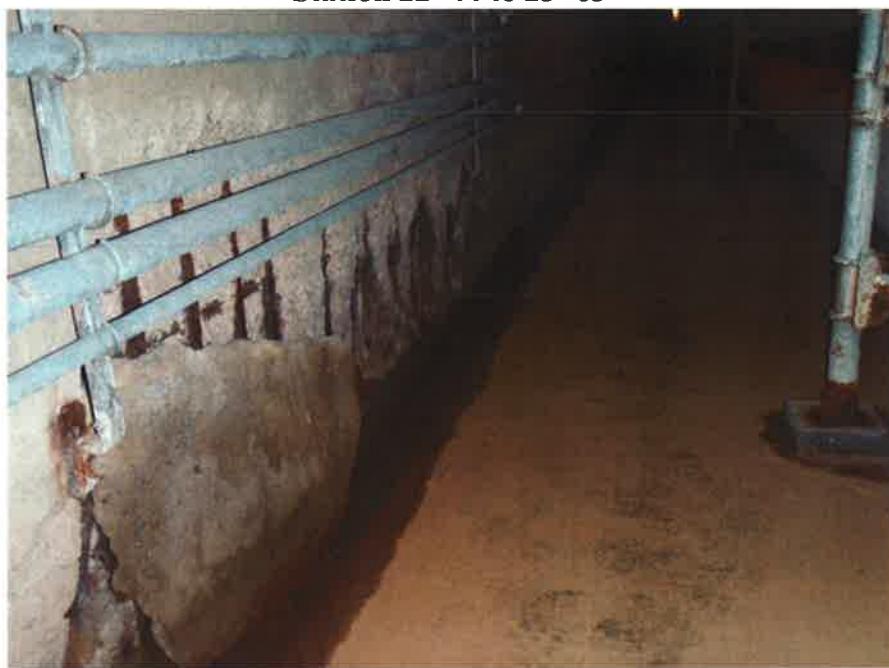
**Station 22+44 to 23+63**

**Direction:** Western Wall (In-Land)**Comments:** Spalling, Re-Bar Exposed and Corroded, Loose Concrete**Station 23+90 to 24+03**

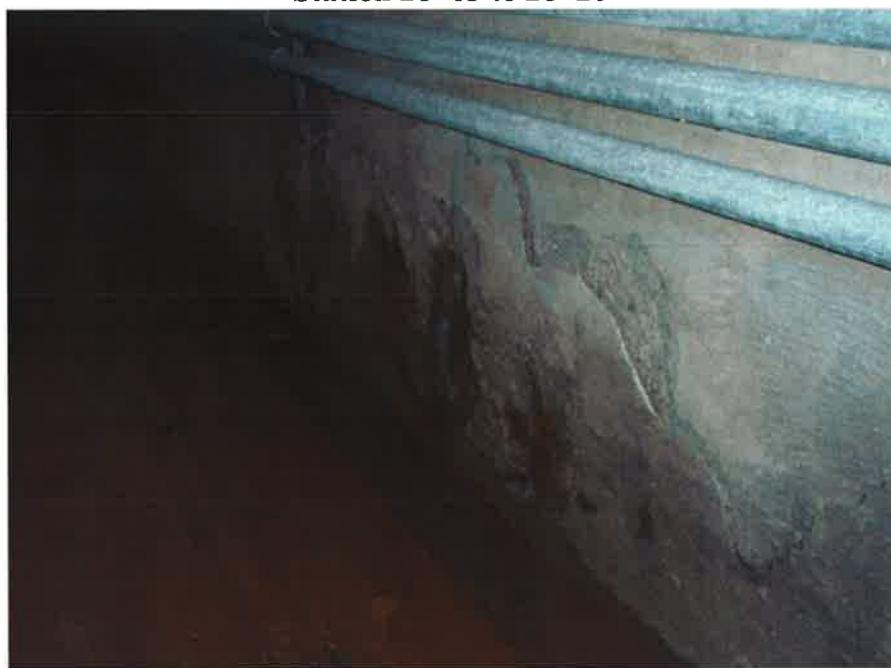
**Station 26+03 to 26+20**

**Direction:** Western Wall (In-Land)**Comments:** Concrete Spalling, Re-Bar Exposed and Corroded**Station 26+50 to 26+62**

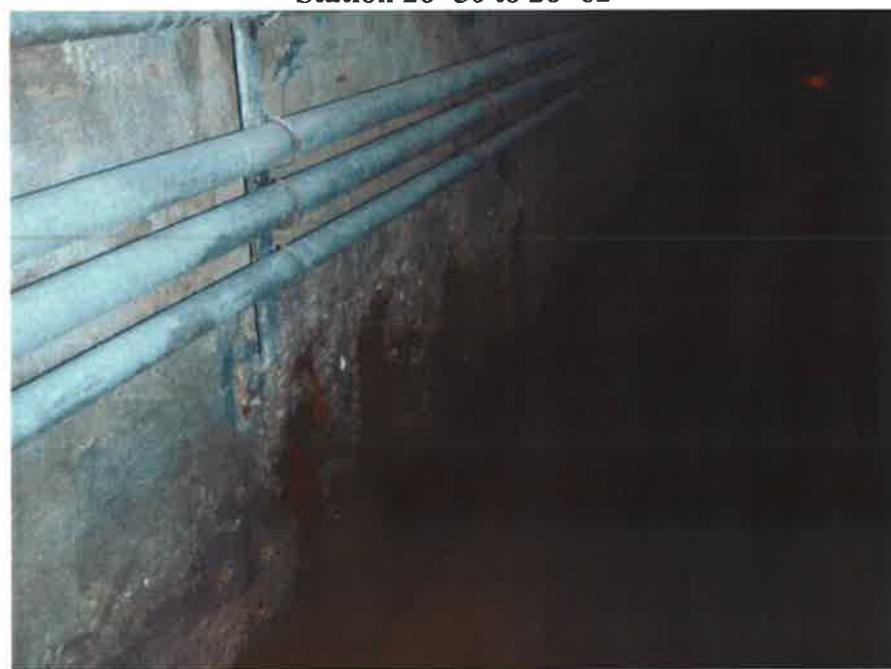
**Direction:** Western Wall (In-Land)**Comments:** Concrete Spalling, Re-Bar Exposed and Corroded

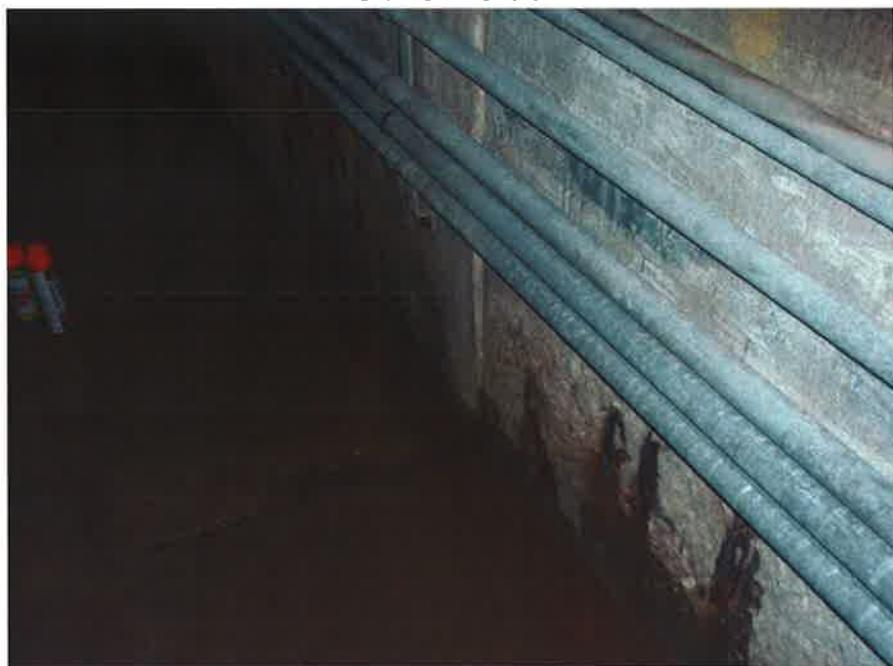
**Station 26+90**

**Direction:** Western Wall (In-Land)**Comments:** Concrete Spalling, Re-Bar Exposed and Corroded**Station 27+23**

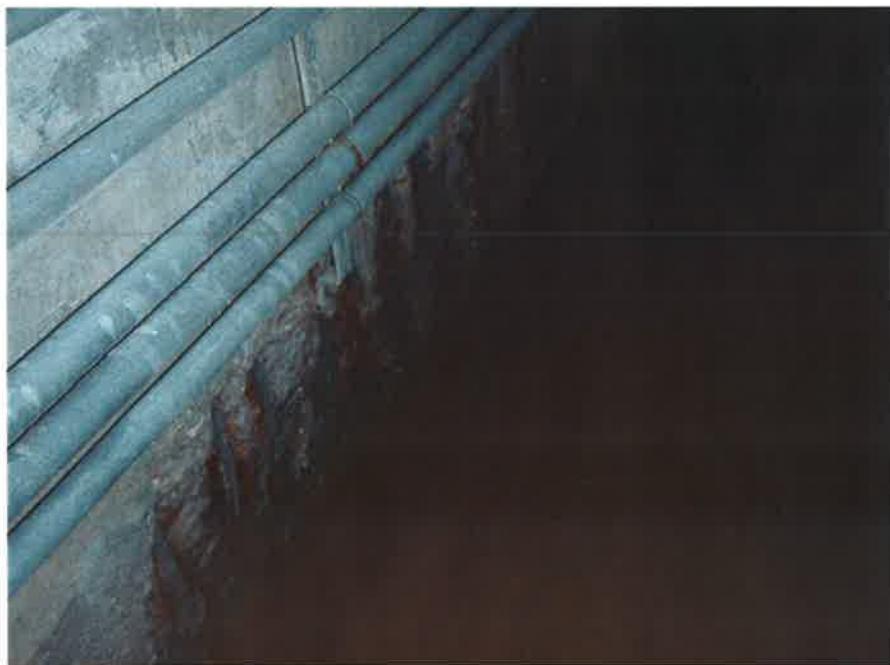
**Direction:** Western Wall (In-Land)**Comments:** Concrete Spalling, Re-Bar Exposed and Corroded

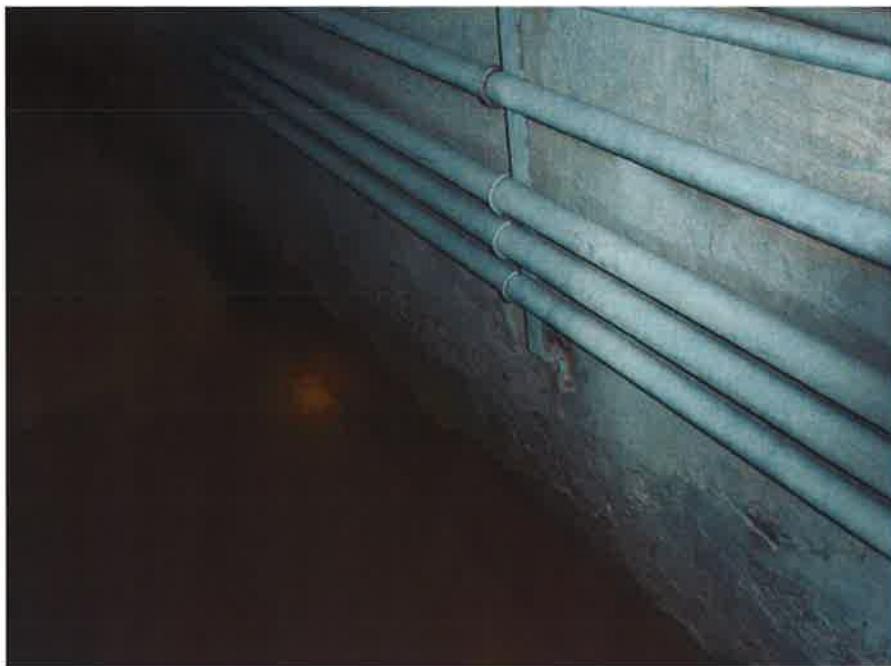
**Station 27+51 to 27+69**

**Direction:** Western Wall (In-Land)**Comments:** Concrete Spalling**Station 27+94**

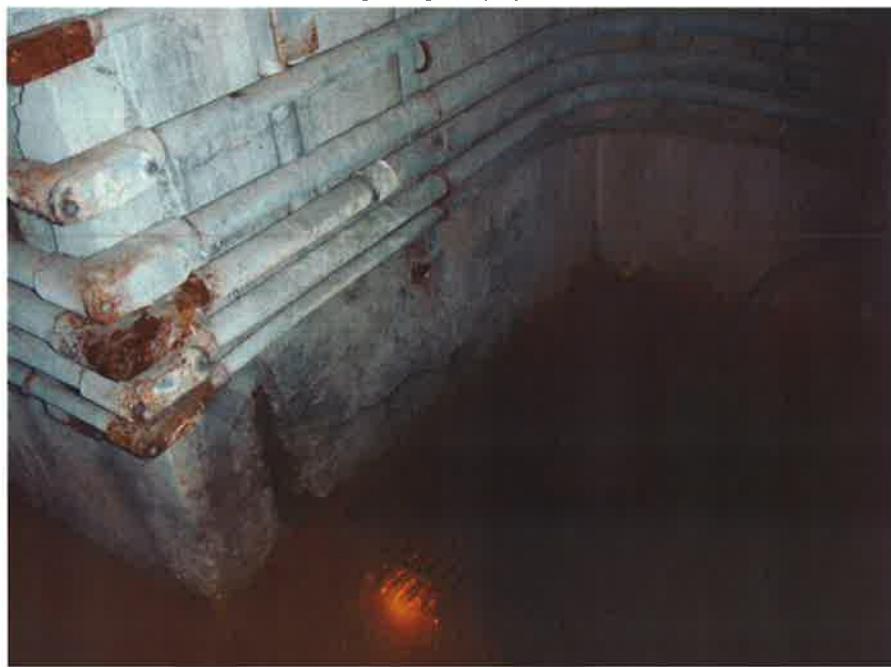
**Direction:** Western Wall (In-Land) - Air Vent 8**Comments:** Concrete Spalling

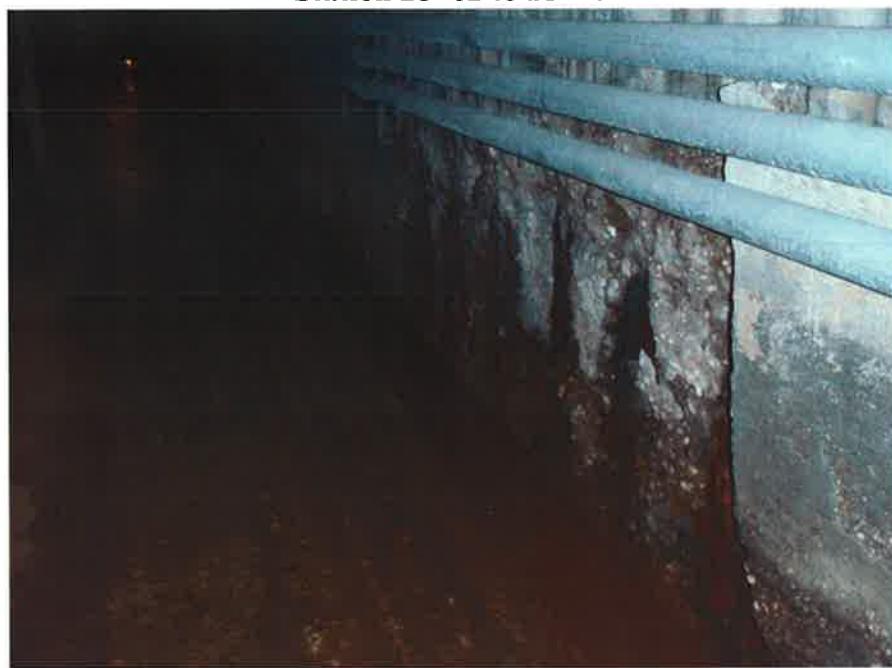
**Station 28+02 to 28+27**

**Direction:** Western Wall (In-Land)**Comments:** Concrete Spalling, Re-Bar Exposed and Corroded**Station 28+62 to 28+86**

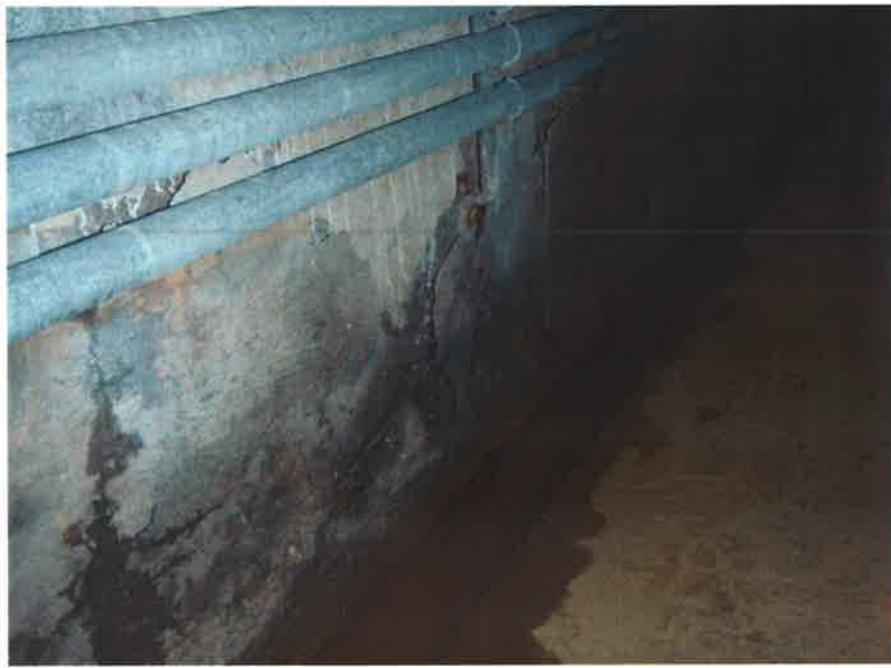
**Direction:** Western Wall (In-Land)**Comments:** Spalling, Re-Bar Exposed and Corroded, Loose Concrete

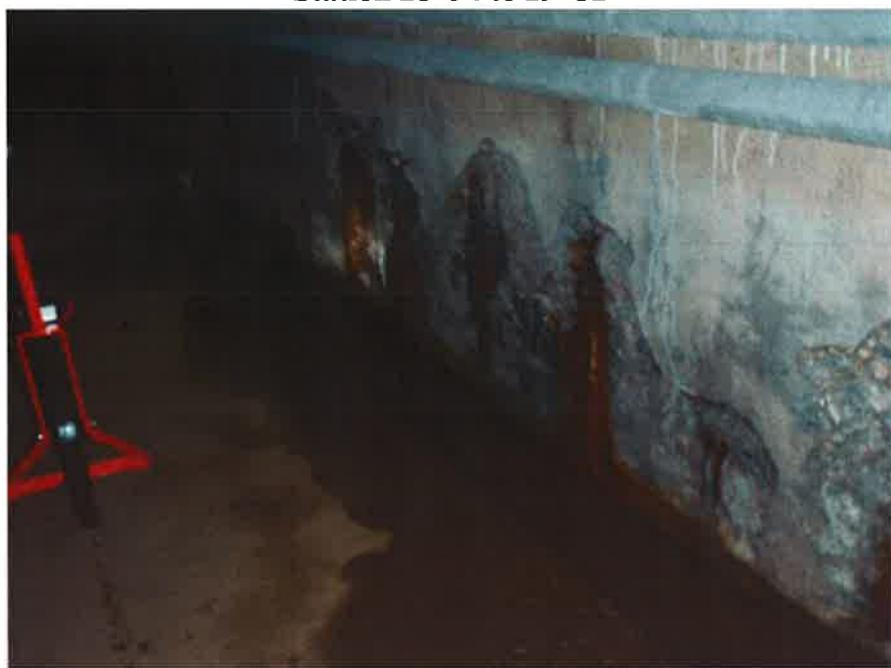
**Station 28+94 to 29+32**

**Direction:** Western Wall (In-Land)**Comments:** Concrete Spalling, Re-Bar Exposed and Corroded**Station 29+45 to 29+70**

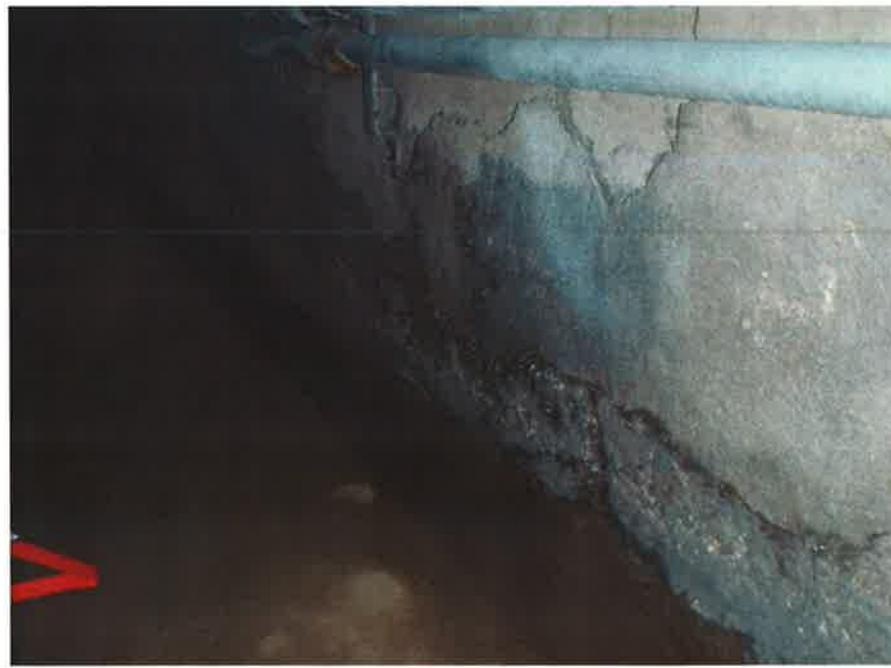
**Direction:** Western Wall (In-Land)**Comments:** Spalling, Re-Bar Exposed and Corroded, Loose Concrete

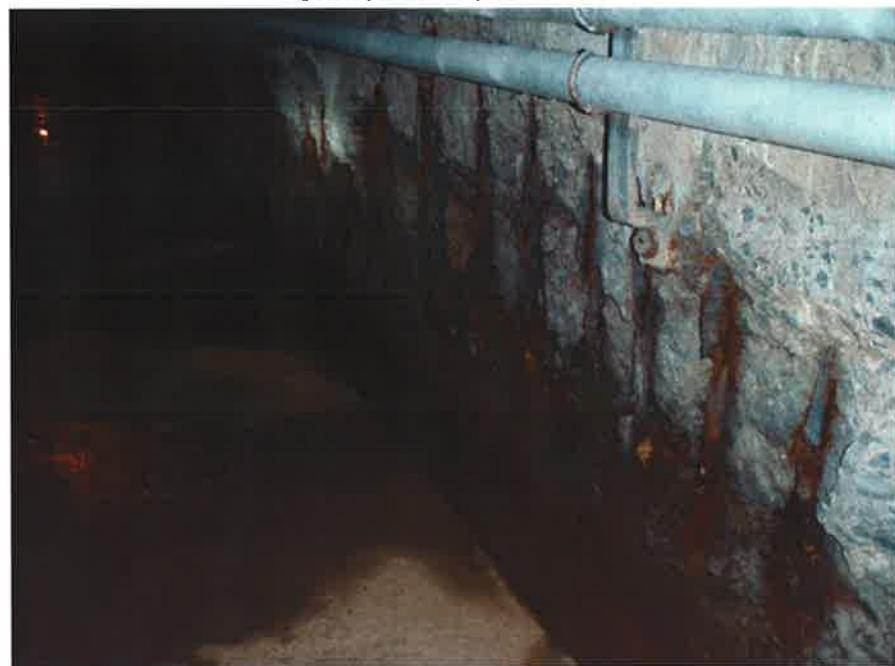
**Station 29+76 to 29+96**

**Direction:** Western Wall (In-Land)**Comments:** Concrete Spalling, Re-Bar Exposed and Corroded**Station 30+31 to 30+41**

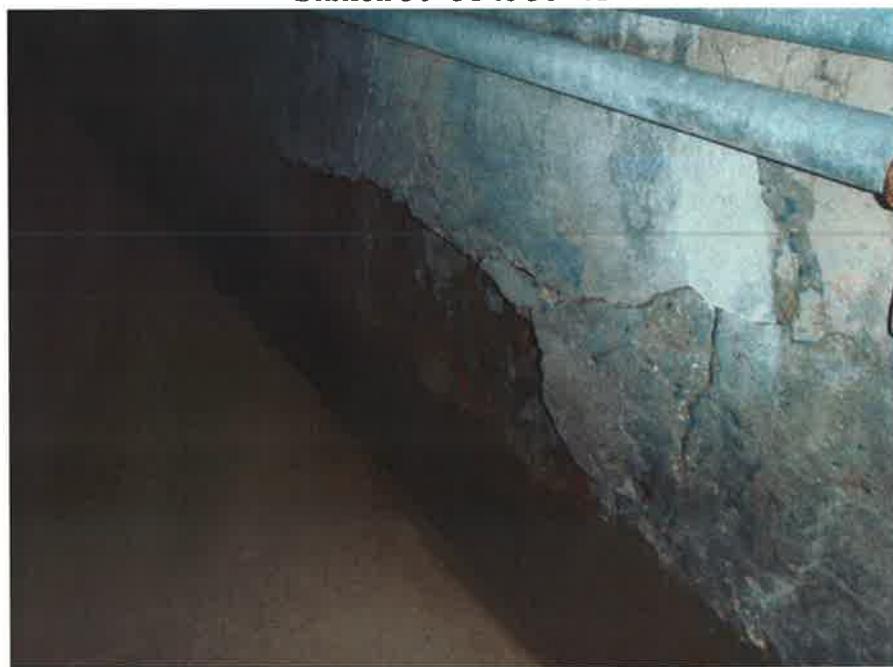
**Direction:** Western Wall (In-Land)**Comments:** Concrete Spalling, Re-Bar Exposed and Corroded

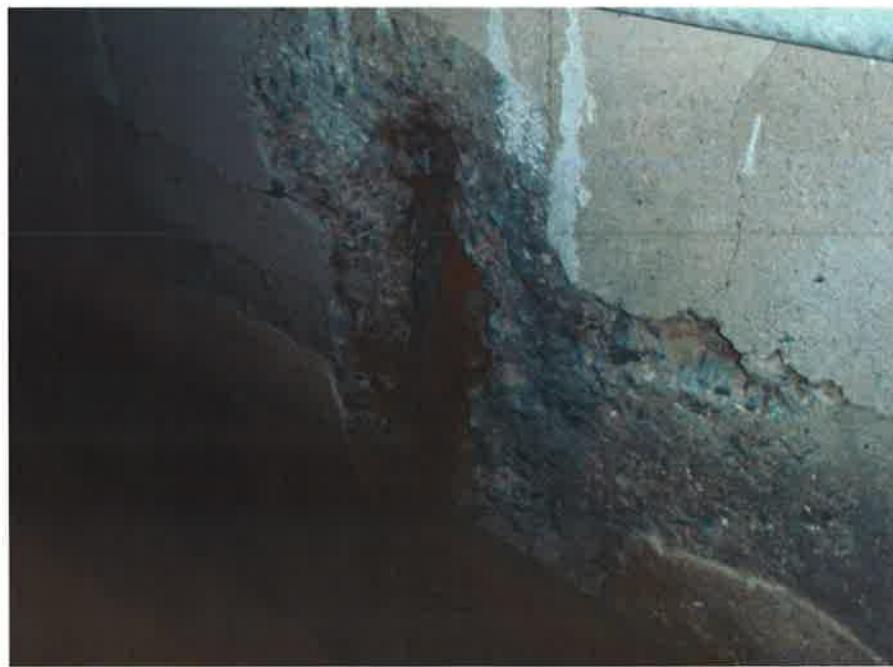
**Direction:** Western Wall (In-Land)**Comments:** Concrete Spalling, Re-Bar Exposed and Corroded

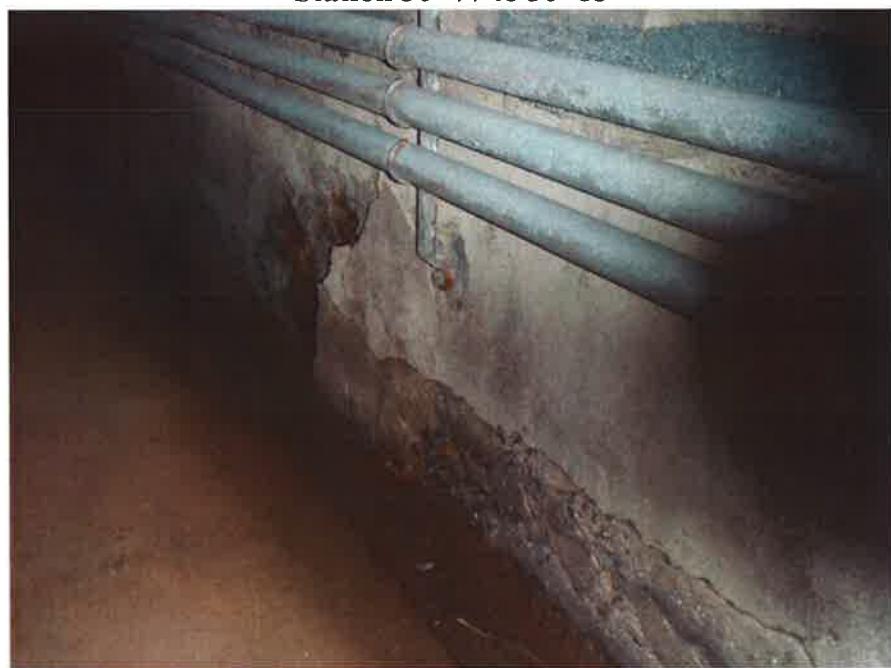
**Station 30+77 to 30+85**

**Direction:** Western Wall (In-Land)**Comments:** Spalling, Re-Bar Exposed and Corroded, Loose Concrete**Station 30+93 to 31+31**

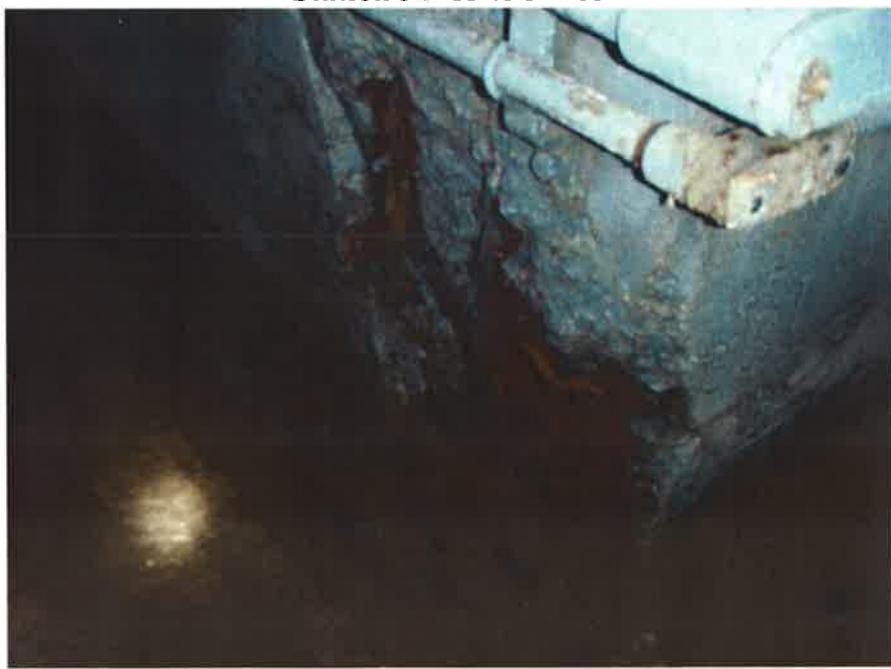
**Direction:** Western Wall (In-Land)**Comments:** Concrete Spalling, Re-Bar Exposed and Corroded

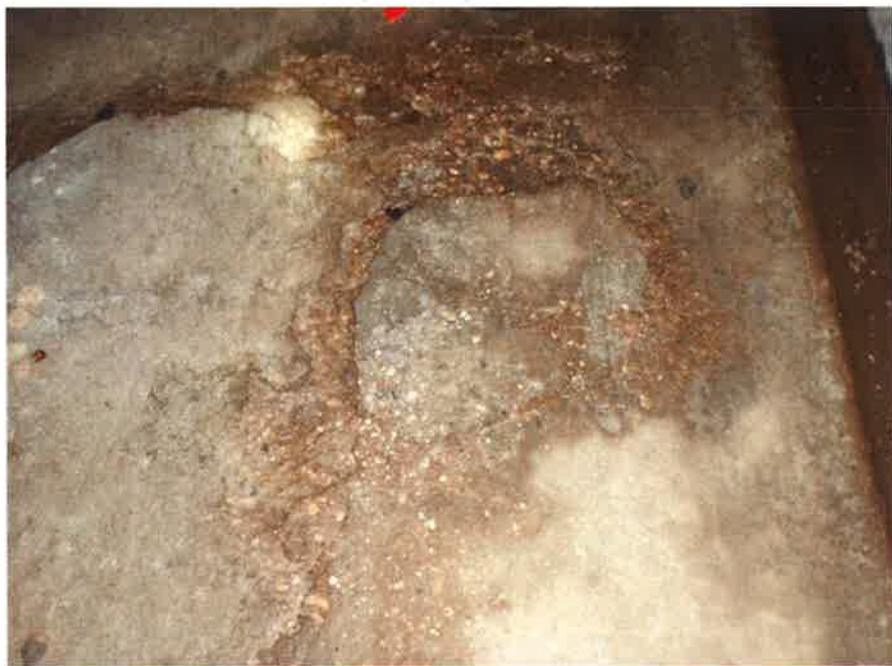
**Station 31+94**

**Direction:** Tunnel Floor**Comments:** Floor Slab Cracking**Station 32+00 to 32+02**

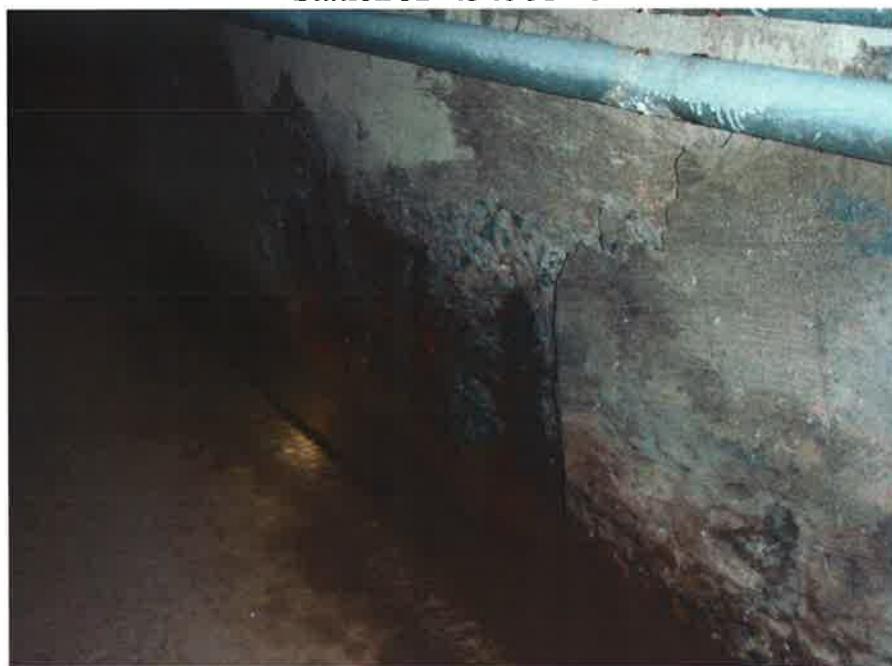
**Station 32+43 to 32+49**

**Direction:** Western Wall (In-Land)**Comments:** Concrete Spalling, Re-Bar Exposed and Corroded**Station 32+77 to 32+80**

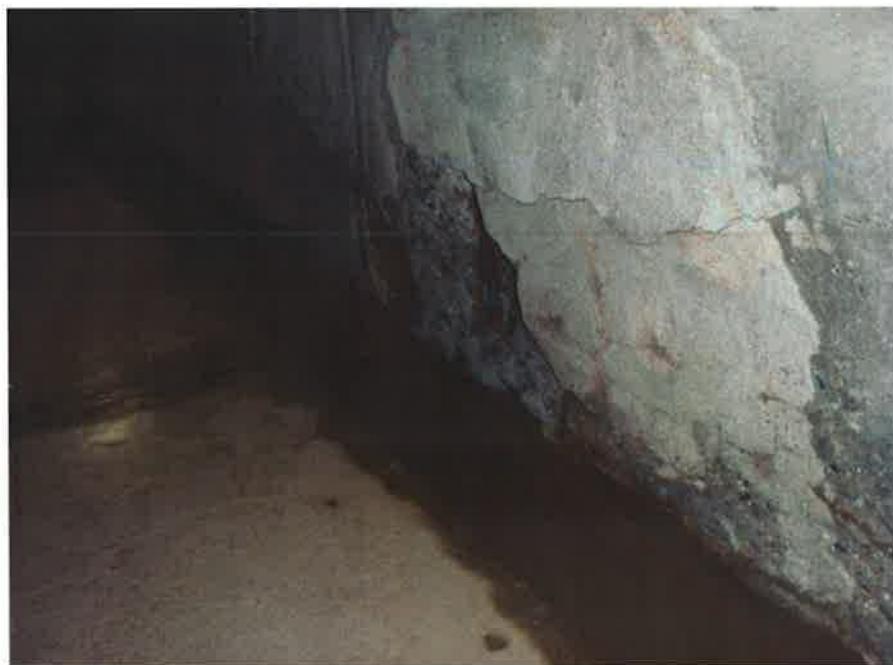
**Direction:** Western Wall (In-Land)**Comments:** Concrete Spalling, Re-Bar Exposed and Corroded

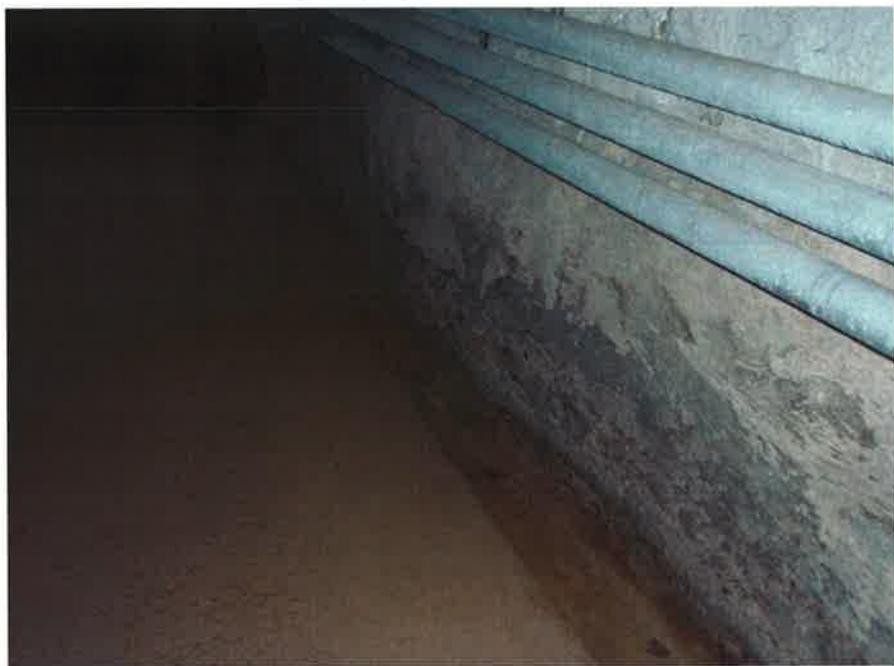
**Station 32+89 to 33+00**

**Direction:** Western Wall (In-Land)**Comments:** Concrete Spalling**Station 32+84**

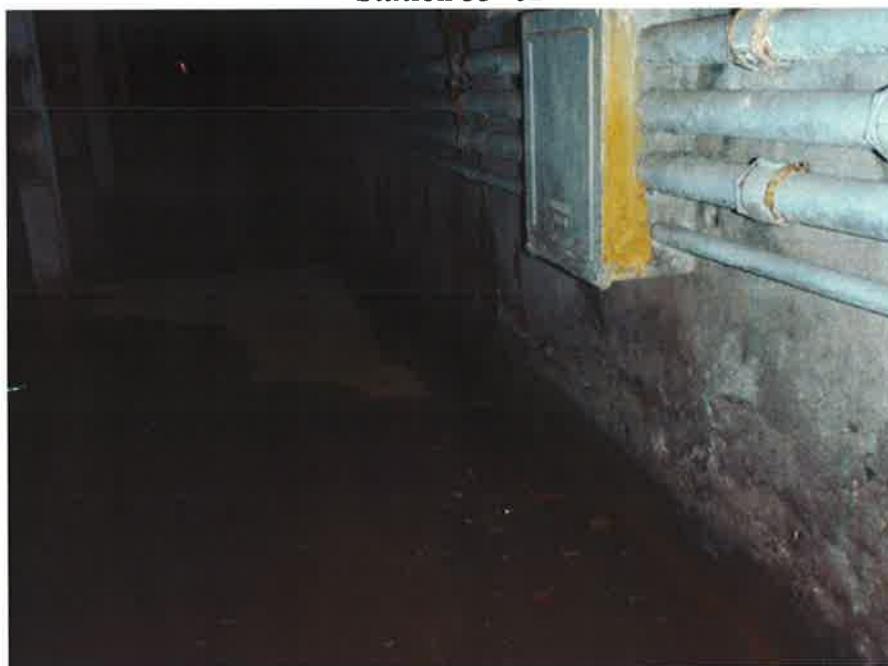
**Station 33+02**

**Direction:** Western Wall (In-Land)**Comments:** Concrete Spalling**Station 33+04 to 33+71**

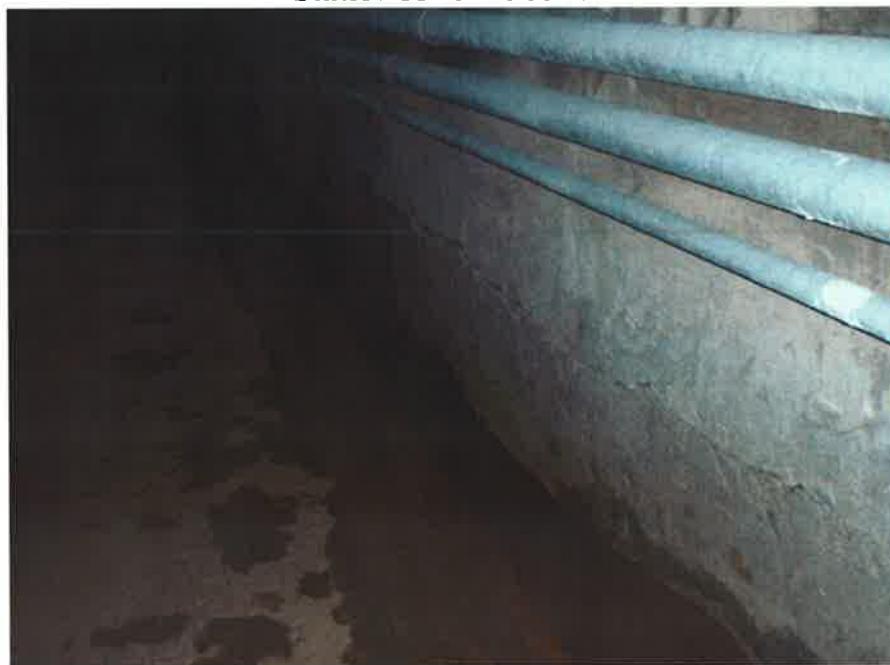
**Direction:** Western Wall (In-Land)**Comments:** Spalling, Loose Concrete

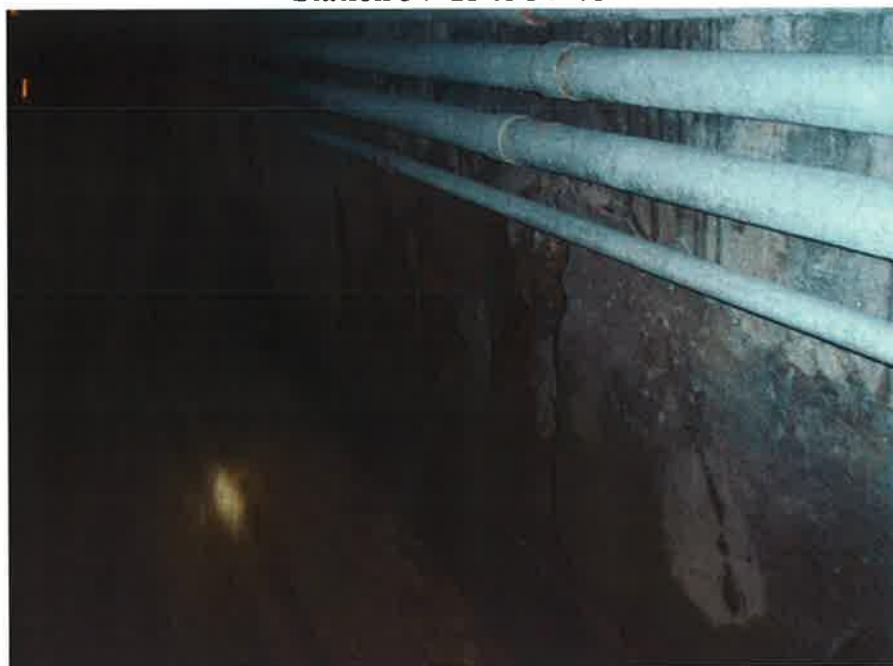
**Station 34+23 to 34+75**

**Direction:** Western Wall (In-Land)**Comments:** Concrete Spalling, Re-Bar Exposed and Corroded**Station 35+00 to 35+08**

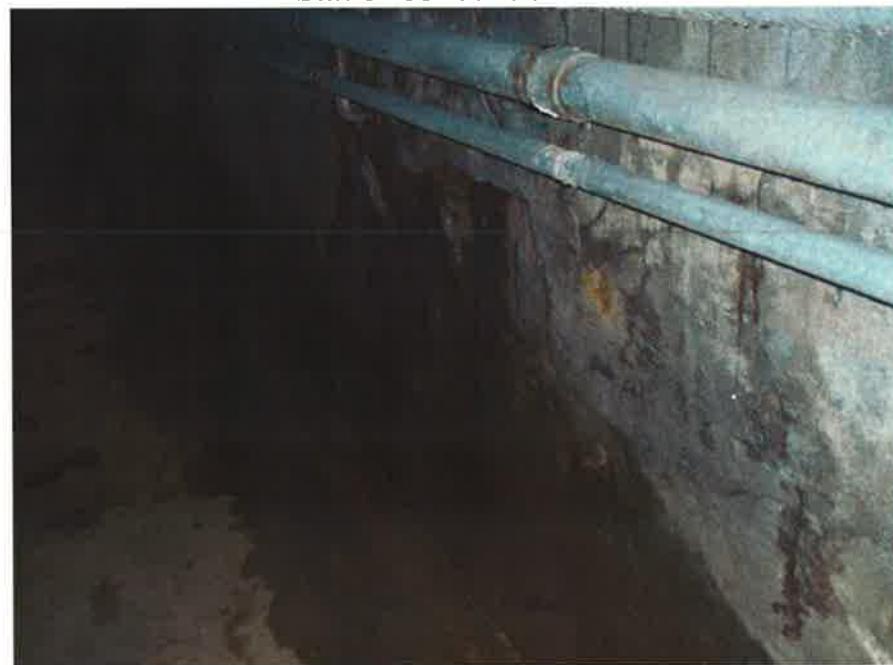
**Direction:** Western Wall (In-Land)**Comments:** Concrete Spalling, Re-Bar Exposed and Corroded

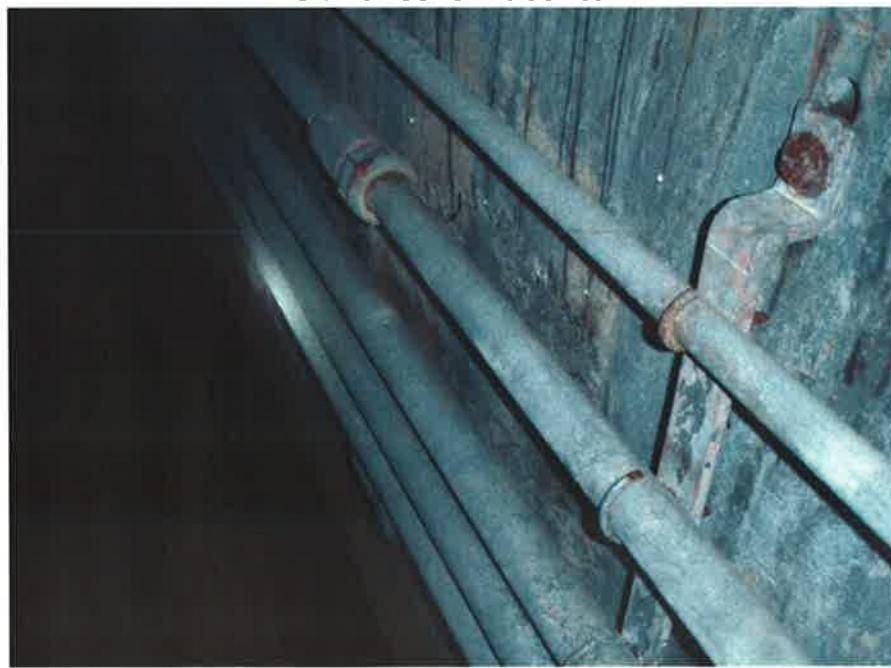
**Direction:** Western Wall (In-Land)**Comments:** Concrete Spalling

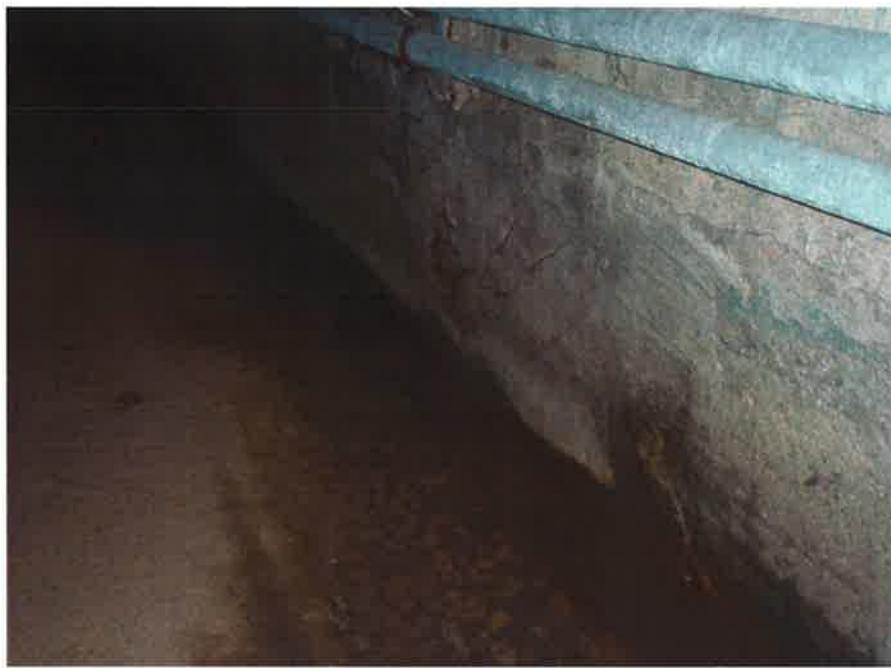
**Station 35+75 to 36+29**

**Direction:** Western Wall (In-Land)**Comments:** Concrete Spalling up to 5 feet Height**Station 36+57 to 36+62**

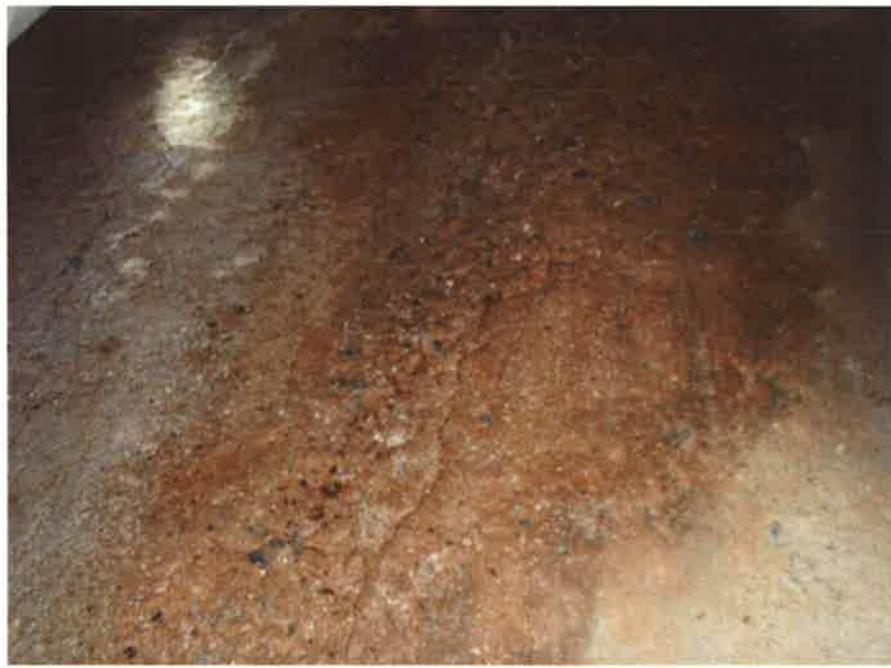
**Direction:** Tunnel Floor**Comments:** Floor Slab Cracked
