# CONDITIONS REPORT & DESIGN MEMORANDUM

## STEAM TUNNEL ASSESSMENT ROOSEVELT ISLAND, NEW YORK

**ROOSEVELT ISLAND OPERATING CORPORATION**  
591 MAIN STREET  
ROOSEVELT ISLAND  
NEW YORK, NEW YORK 10044

*17 November 2014  
Project # 100444601*

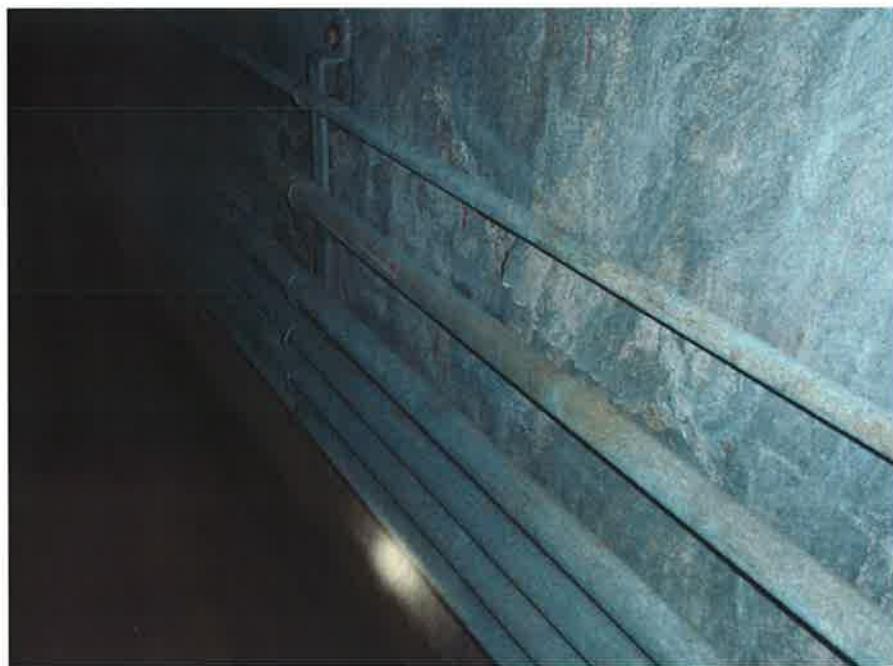
**Station 36+57 to 36+90**

**Direction:** Western Wall (In-land)**Comments:** Concrete Spalling**Station 36+99 to 36+00**

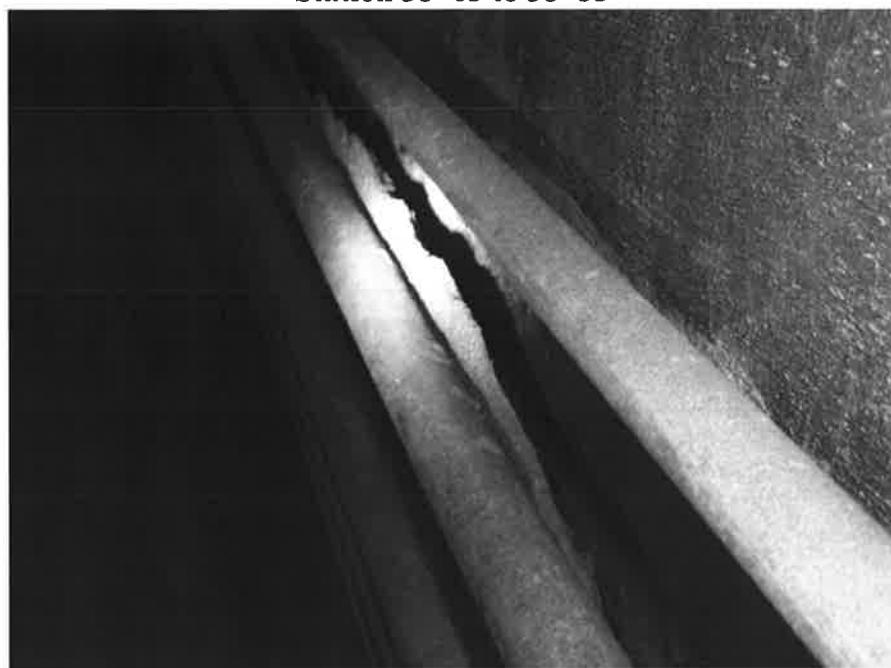
**Station 38+03 to 38+55**

**Direction:** Western Wall (In-Land)**Comments:** Concrete Spalling**Station 38+64**

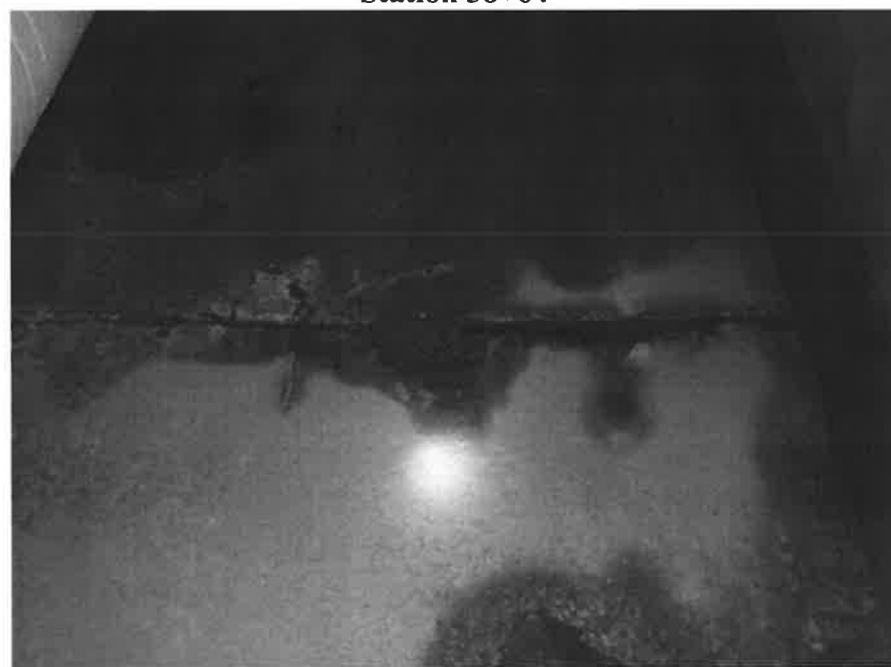
**Direction:** Tunnel Floor**Comments:** Floor Slab Cracking at Joint

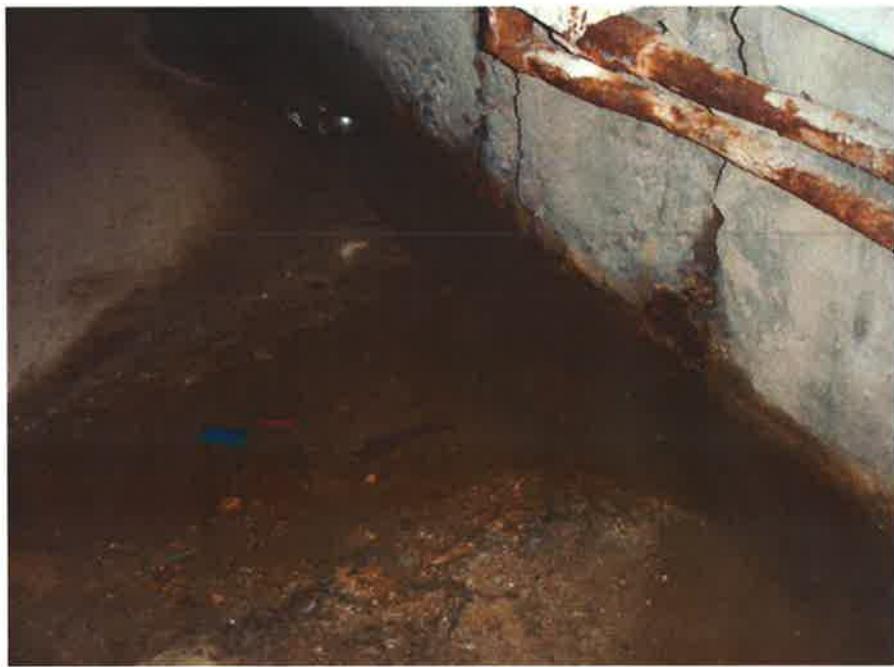
**Direction:** Tunnel Floor**Comments:** Floor Slab Cracking

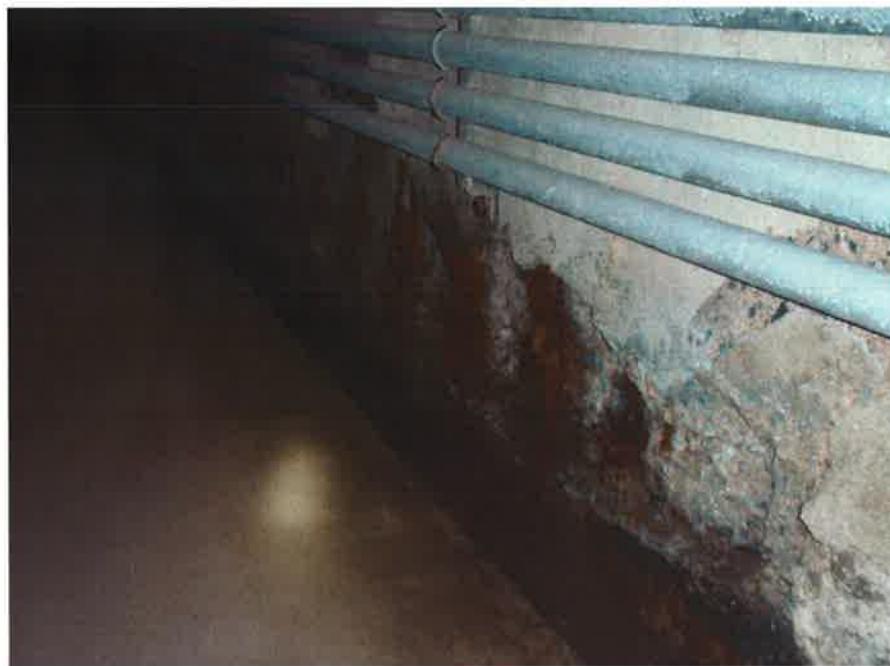
**Station 39+58 to 39+74**

**Direction:** Western Wall (In-Land)**Comments:** Concrete Spalling, Re-Bar Exposed and Corroded**Station 40+02 to 40+03**

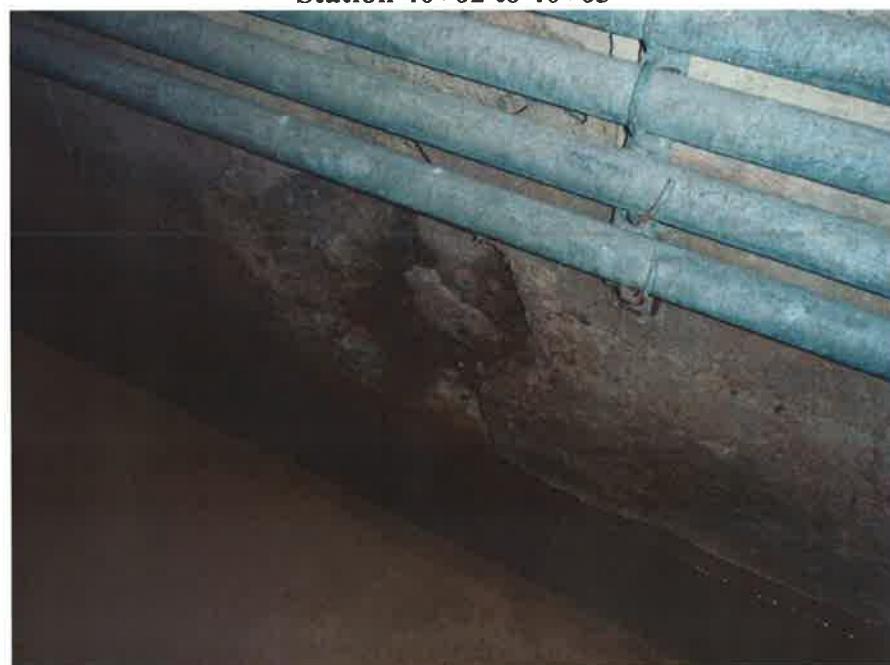
**Direction:** Western Wall (In-Land)**Comments:** Concrete Spalling, Re-Bar Exposed and Corroded

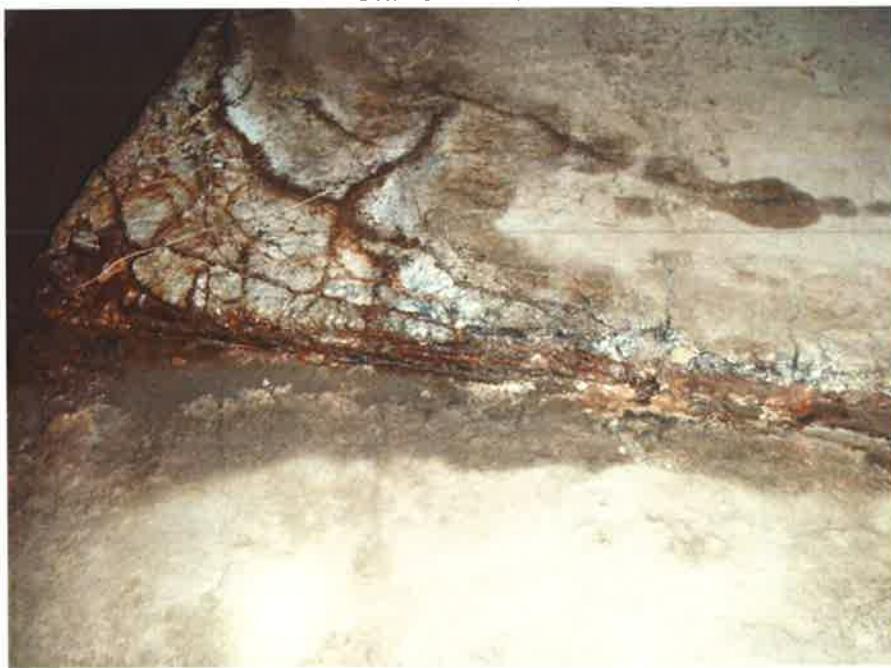
**Direction:** Tunnel Floor**Comments:** Floor Slab Raised at Joint

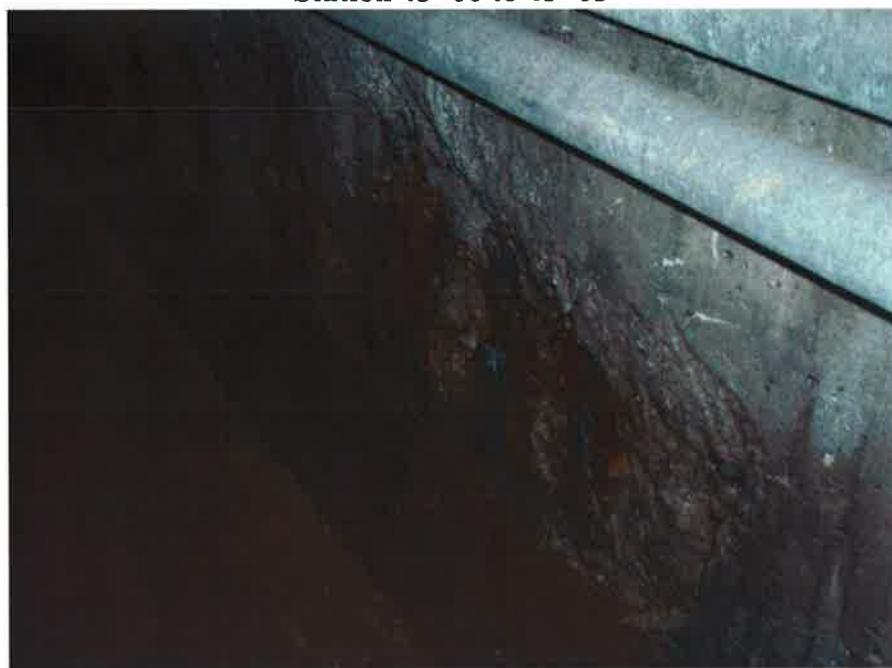
**Station 45+00 to 45+05**

**Direction:** Western Wall (In-Land)**Comments:** Concrete Spalling, Re-Bar Exposed and Corroded**Station 45+34 to 45+47**

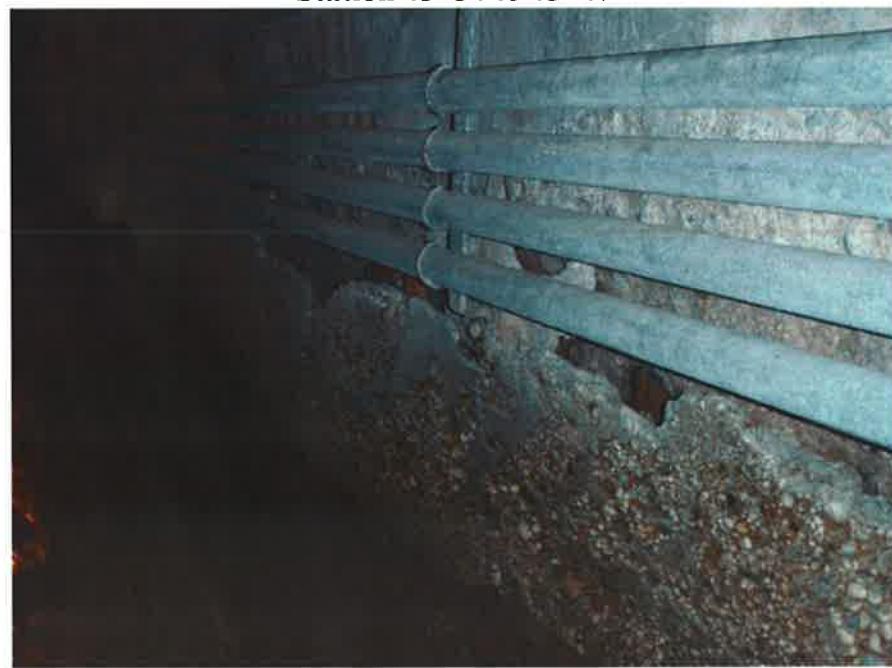
**Direction:** Western Wall (In-Land)**Comments:** Spalling, Loose Concrete

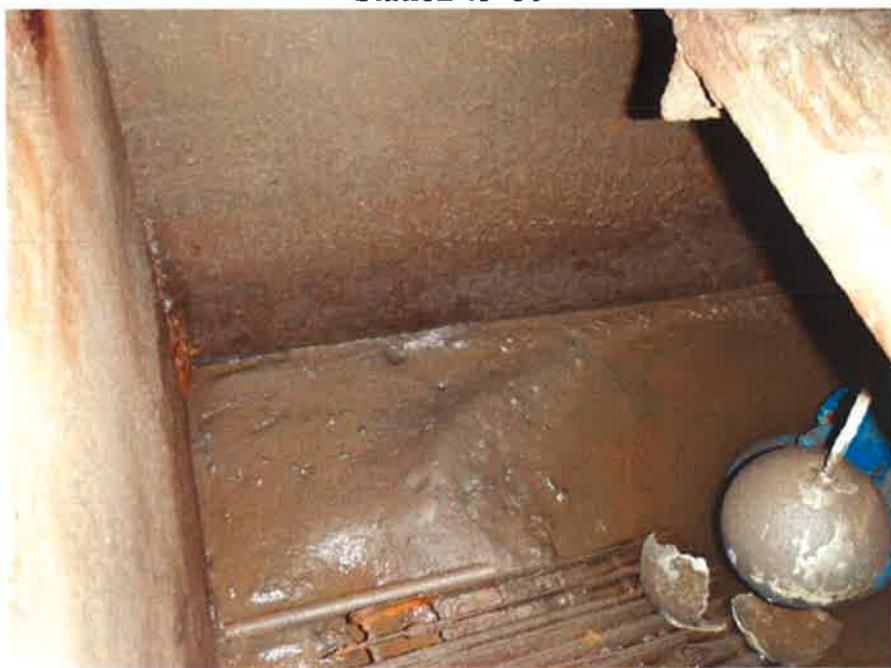
**Station 45+50**

**Direction:** Air Vent 2**Comments:** Sump Pump in Working Order**Station 45+61 to 45+66**

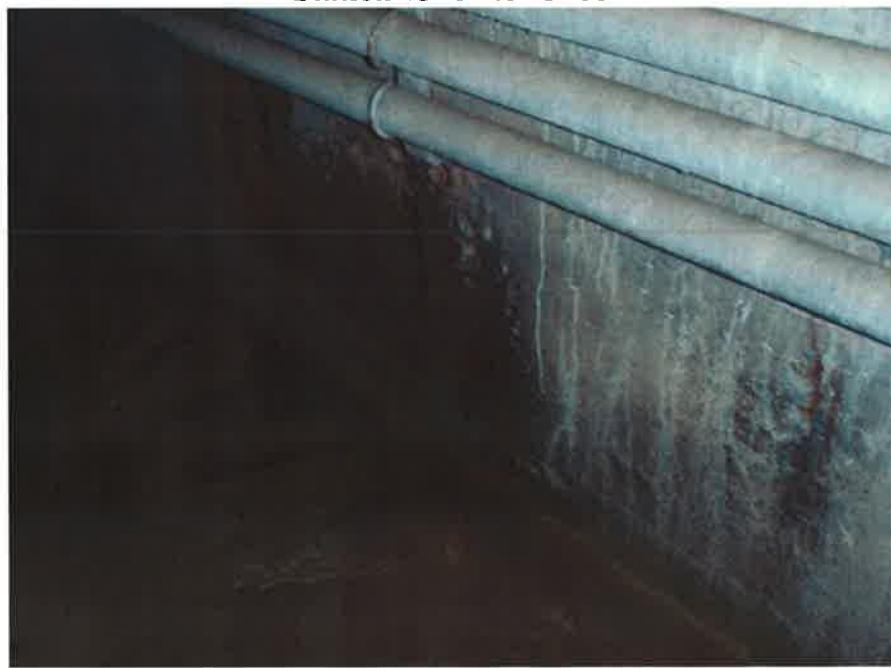
**Direction:** Western Wall (In-Land)**Comments:** Concrete Spalling

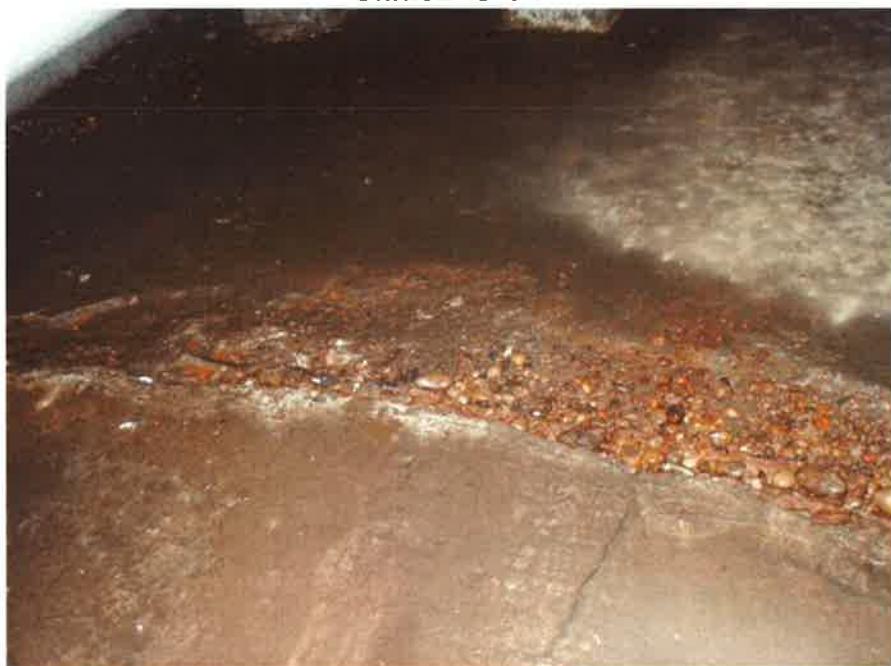
**Station 45+94**

**Direction:** Tunnel Joint**Comments:** Cracks**Station 46+60**

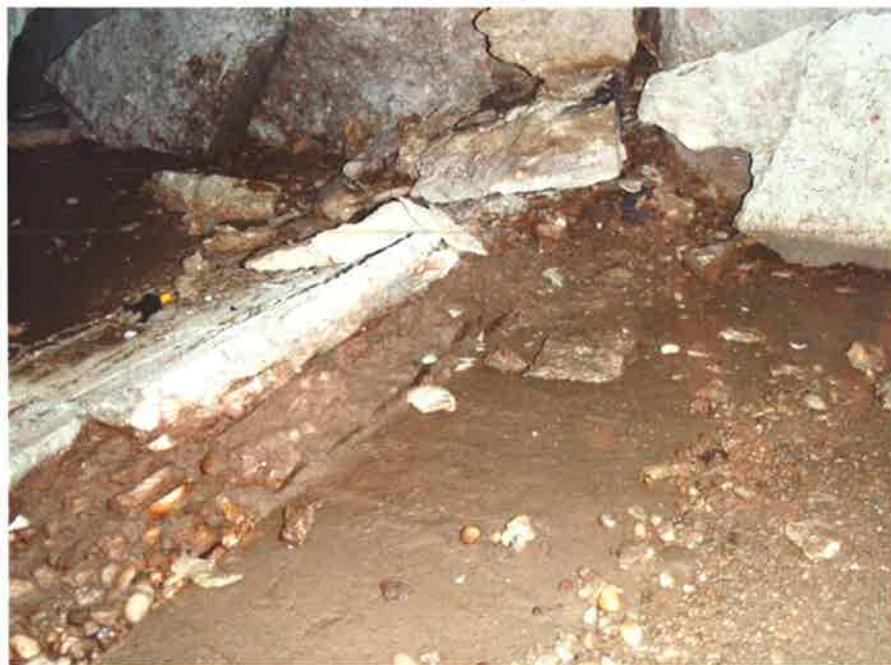
**Direction:** Tunnel Joint**Comments:** Floor Slab Raised at Joint, Cracking, Loose Concrete

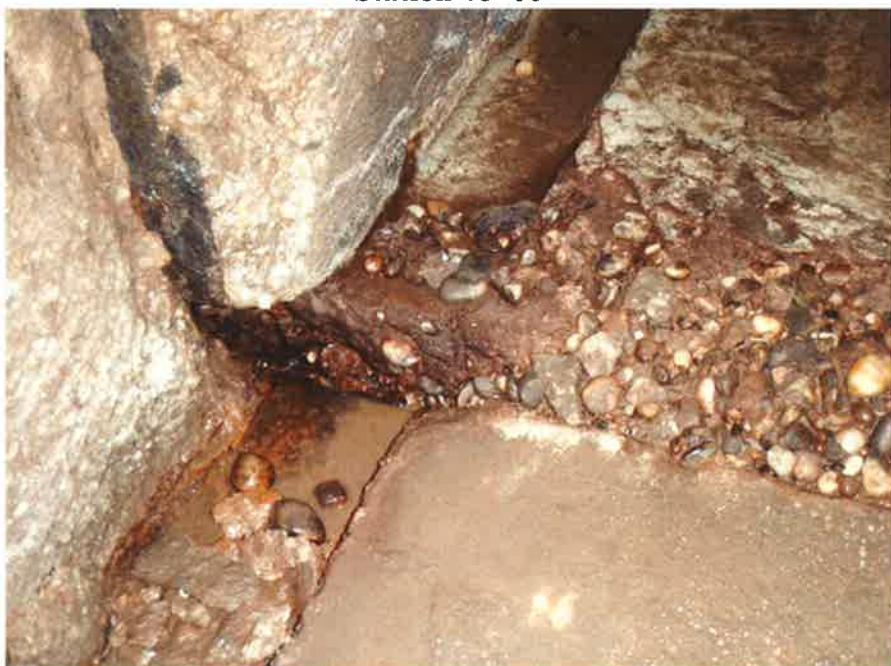
**Station 46+60**

**Direction:** Tunnel Joint**Comments:** Floor Slab Raised at Joint, Cracking, Loose Concrete**Station 46+60**

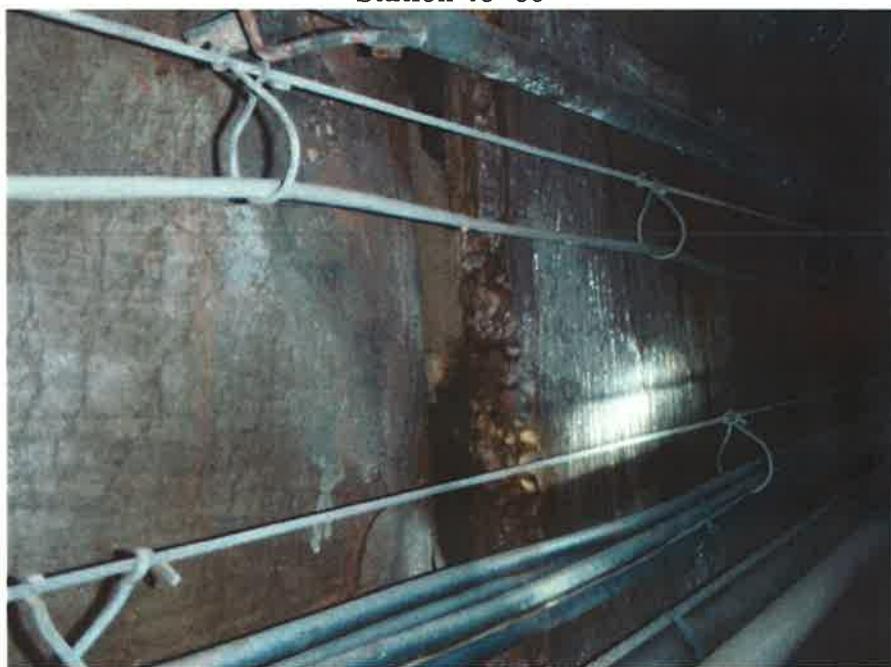
**Direction:** Tunnel Joint**Comments:** Tunnel Displaced

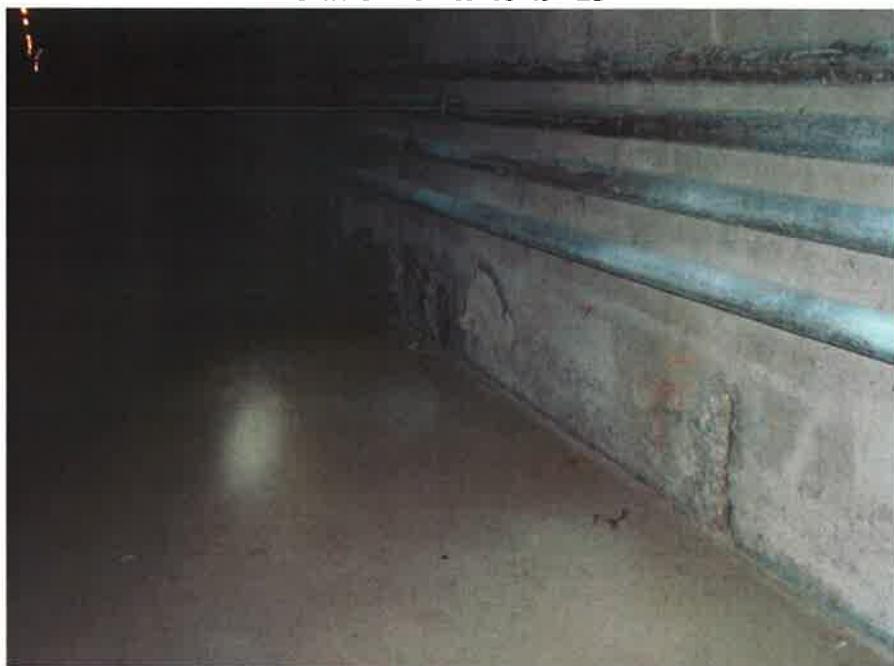
**Station 49+09 to 49+23**

**Direction:** Western Wall (In-Land)**Comments:** Concrete Spalling**Station 49+50 to 51+50**

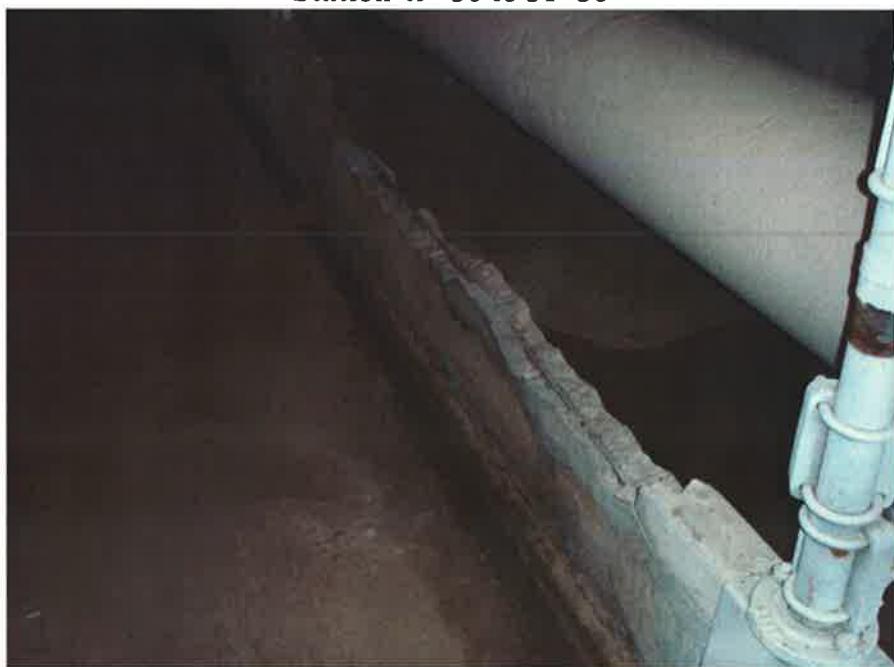
**Direction:** Tunnel Mid-Wall**Comments:** Cracked, Missing Concrete on its Entirety

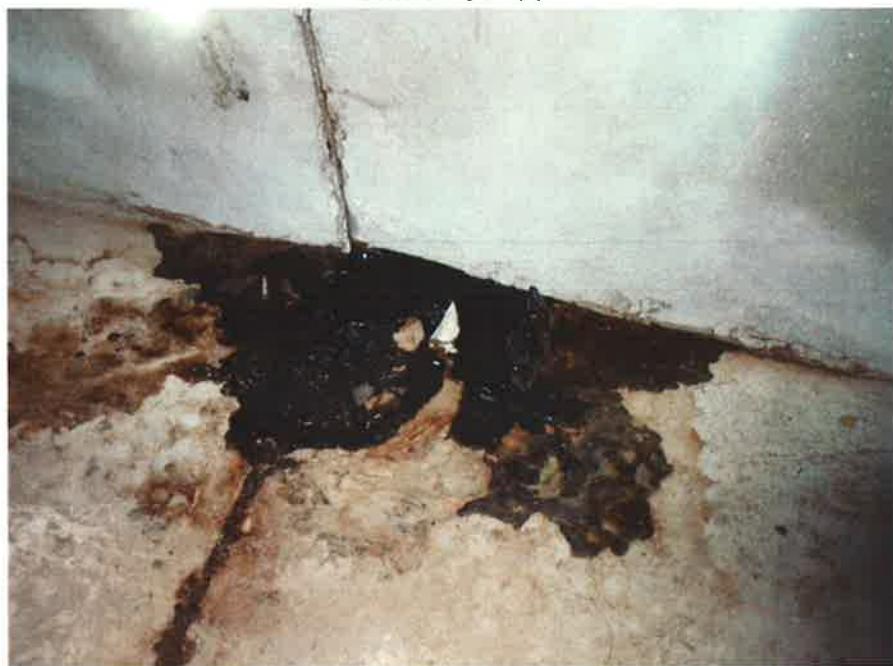
**Station 50+06**

**Direction:** Tunnel Floor**Comments:** Joint Filler**Station 55+52**

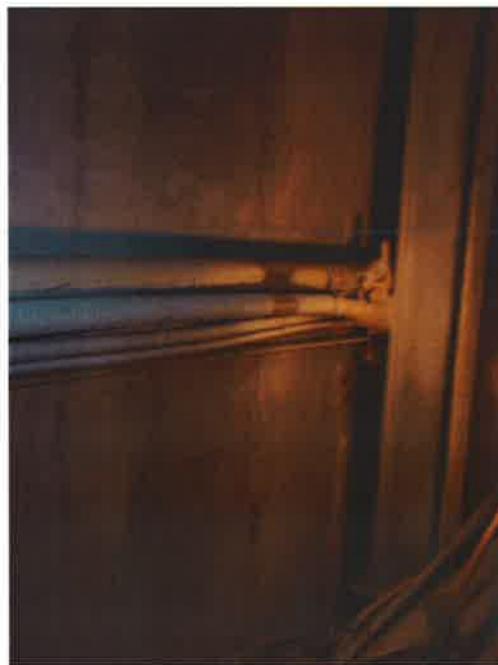
**Direction:** Eastern Wall**Comments:** "1/8"" Thick Crack running from the Floor to the roof of the Tunnel!"

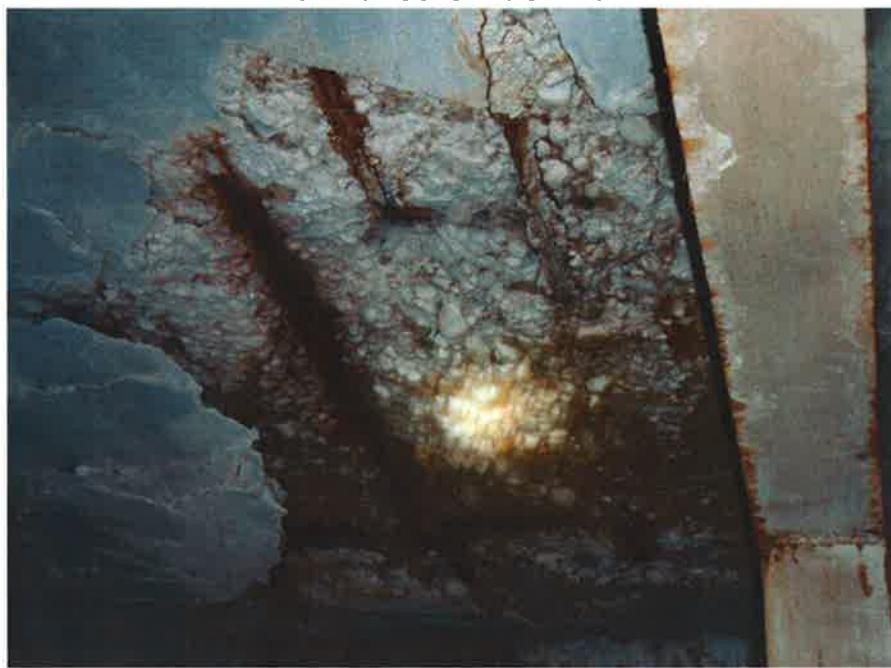
**Station 56+52 to 56+55**

**Direction:** Tunnel Roof**Comments:** Concrete Spalling, Exposed rebar**Station 58+00**

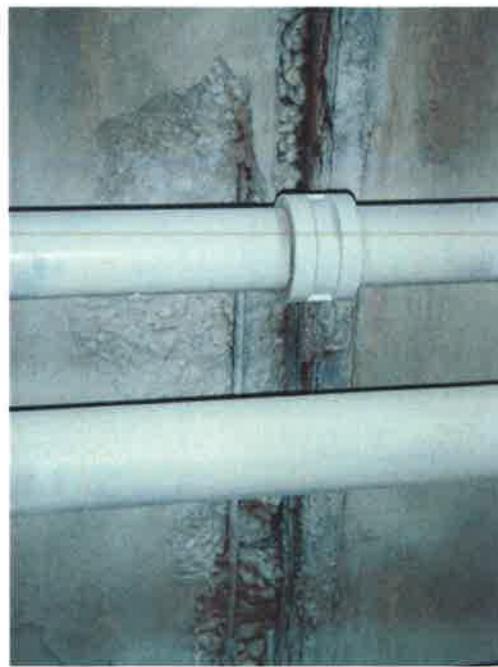
**Direction:** Eastern Wall**Comments:** Offset joint

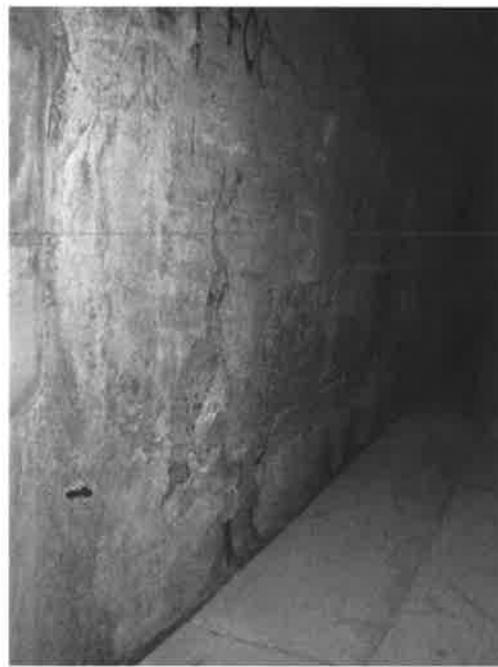
**Direction:** Western Wall**Comments:** Concrete Spalling

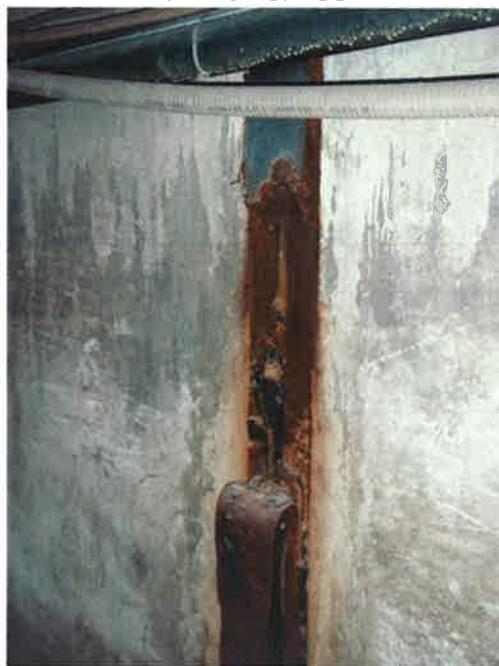
**Station 59+33**

**Direction:** Tunnel joint**Comments:** Failing Joint Sealer**Station 59+53**

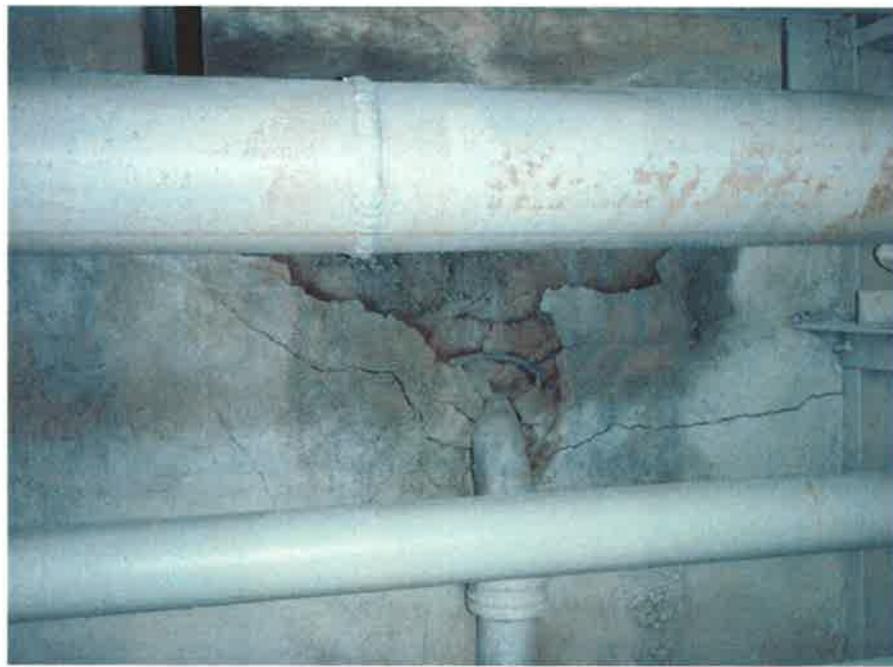
**Direction:** Eastern Wall**Comments:** Concrete Spalling around pipe opening

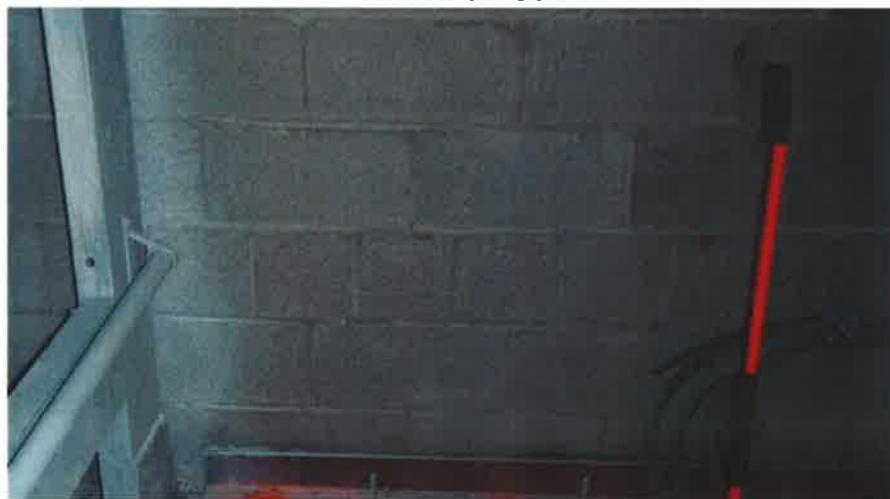
**Direction:** Southern end of Tunnel**Comments:** Brick Wall

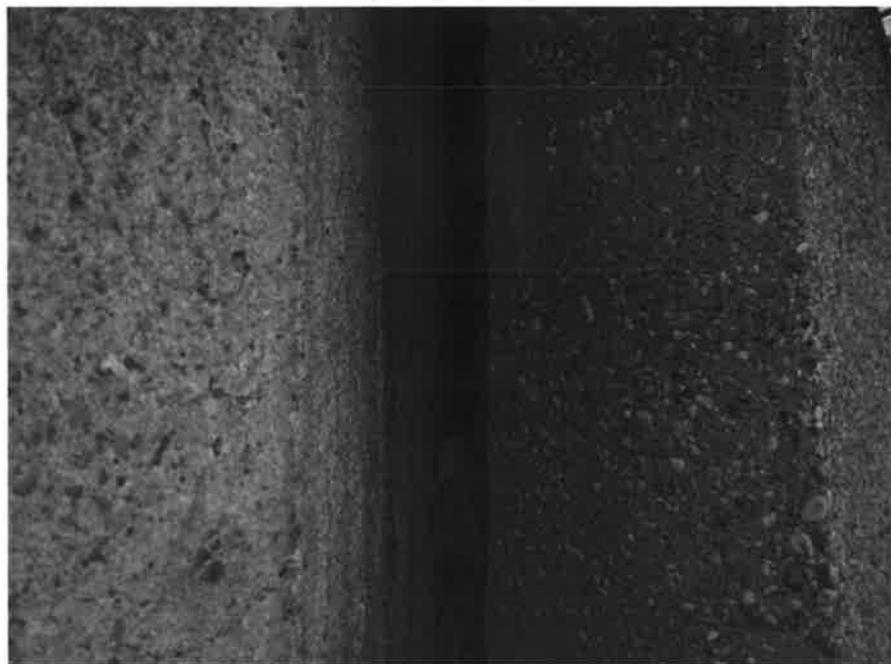
**Station 5+18**

**Direction:** Northern Seawall Terminus

**Comments:** Gap Between Steam Tunnel and Seawall

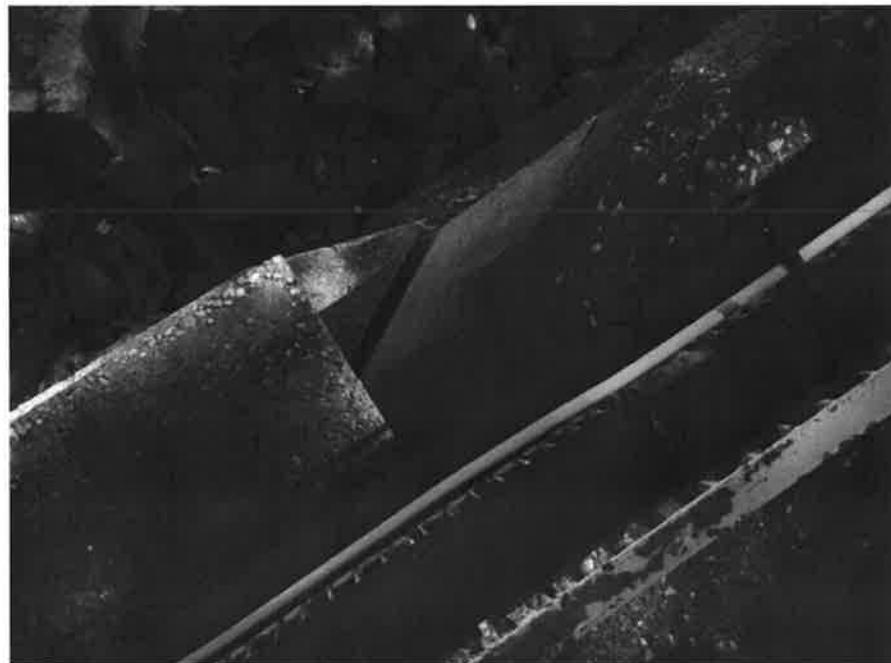
**Station 5+18**

**Direction:** Northern Seawall Terminus

**Comments:** Gap Between Steam Tunnel and Seawall

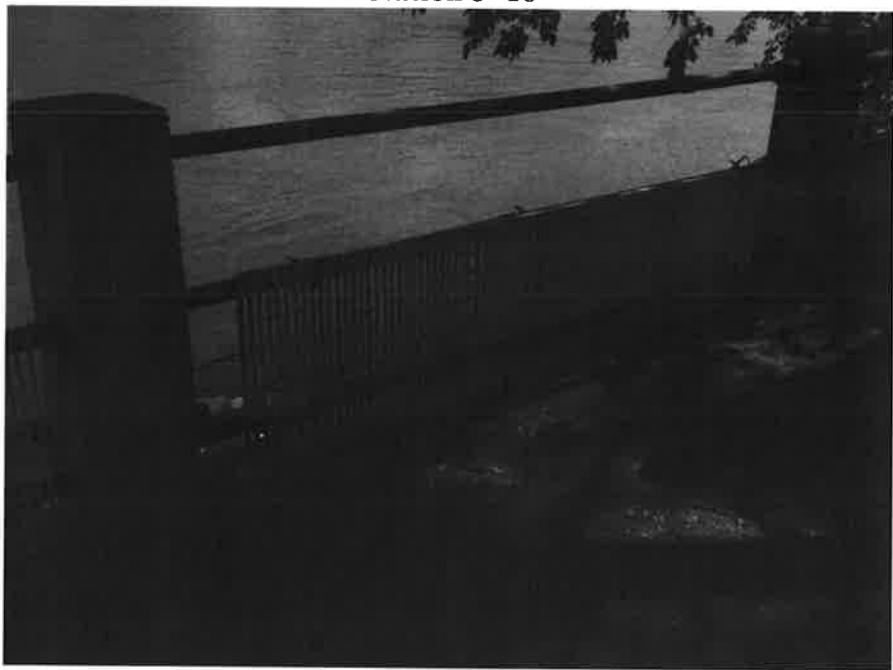
**Station 5+18**

**Direction:** Northern Seawall Terminus

**Comments:** Tunnel Terminus from Inland

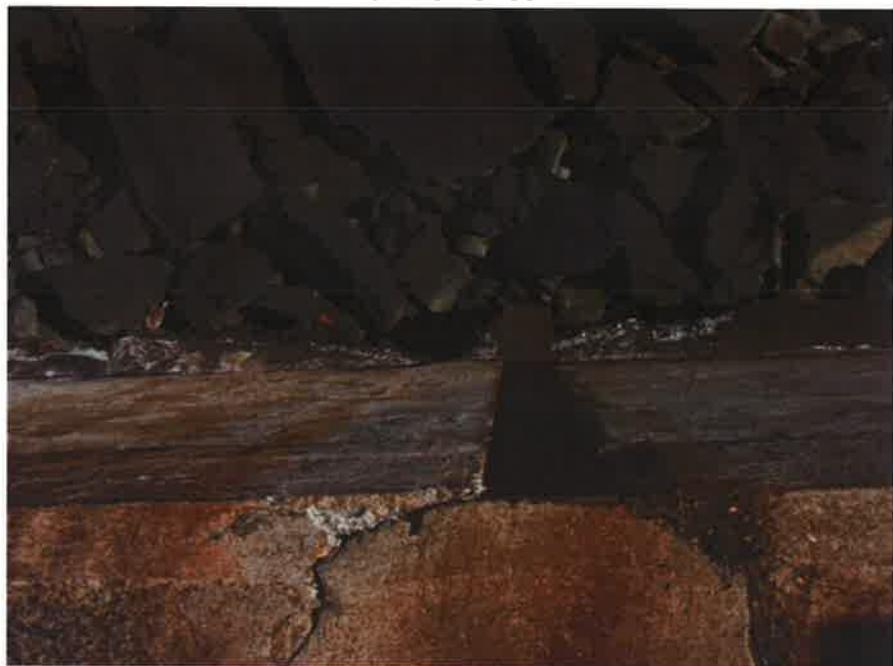
**Station 6+60**

**Direction:** Seawall Joint**Comments:** Spalling at Haunch, Missing Large Sections of Concrete, Tunnel has been Undermined**Station 6+60**

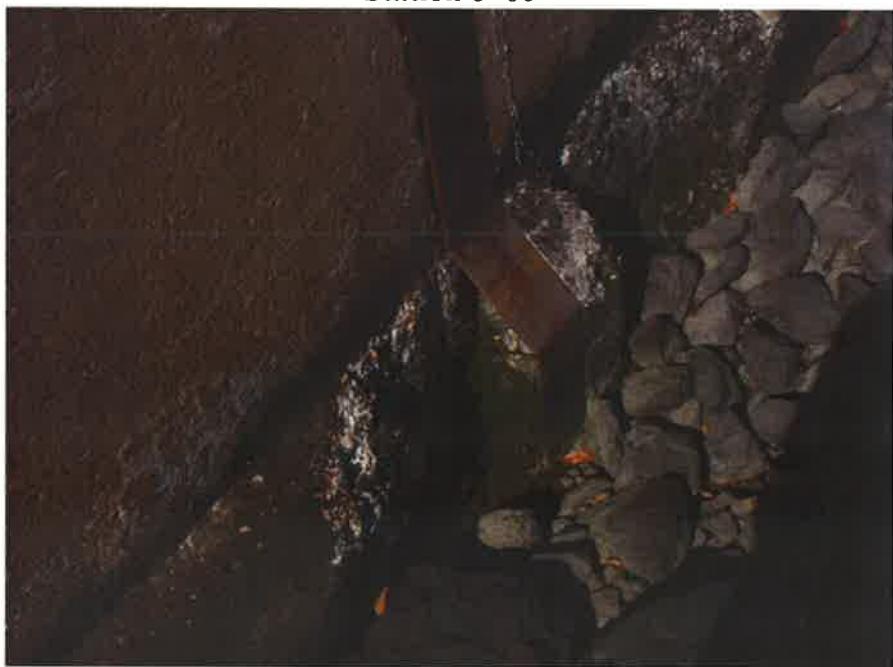
**Direction:** Seawall Joint**Comments:** Spalling at Haunch, Missing Large Sections of Concrete

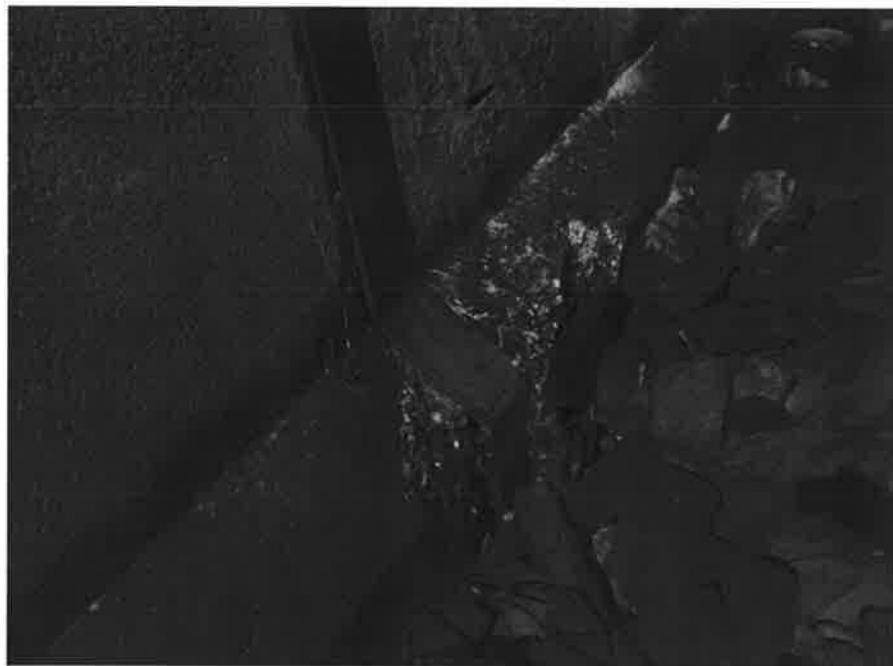
**Station 7+26**

**Direction:** Seawall Joint**Comments:** Spalling at Haunch, Missing Large Sections of Concrete**Station 7+68**

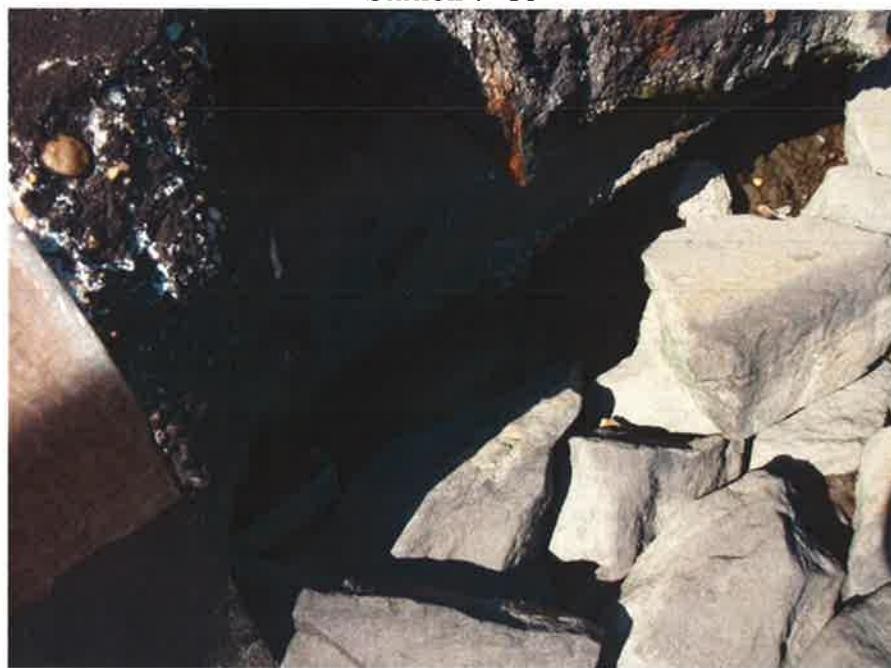
**Station 7+86**

**Direction:** Seawall Joint**Comments:** Spalling at Haunch, Missing Large Sections of Concrete, Metal Joint Covering Loose**Station 7+99**

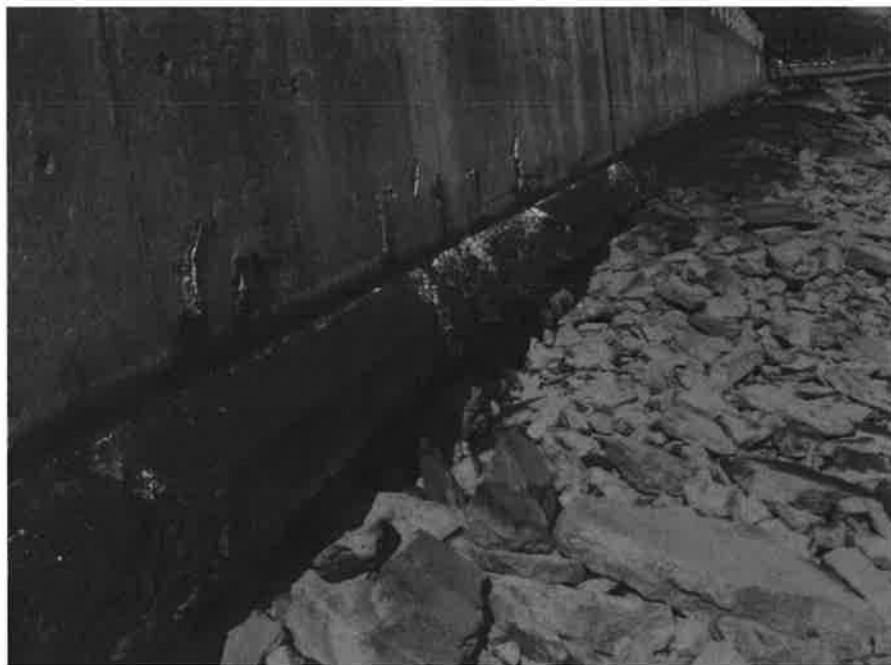
**Station 8+12**

**Direction:** Seawall (Looking North)

**Comments:** Missing Rip-Rap, Tunnel Undermined, Exposed Re-Bar

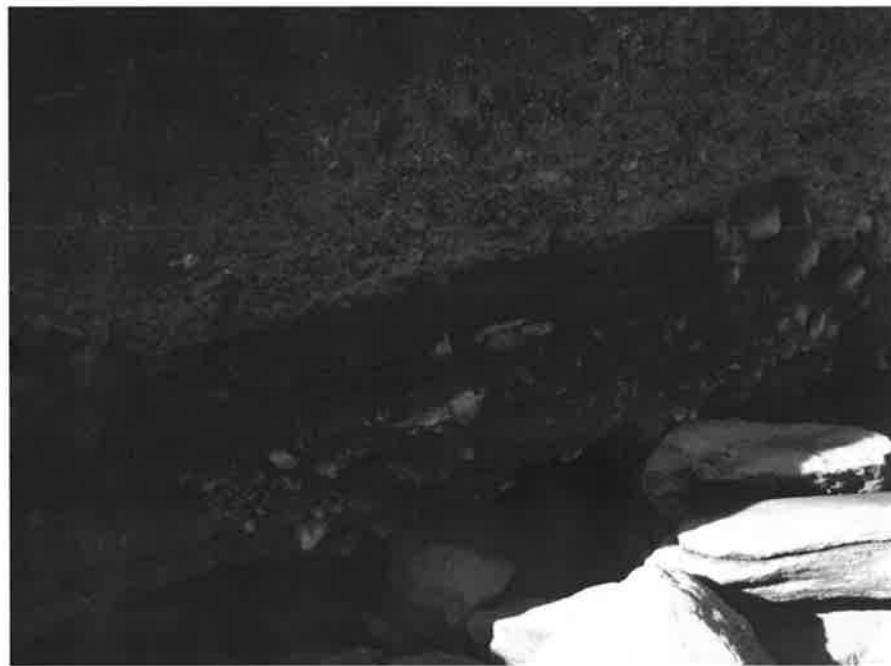
**Station 8+28**

**Direction:** Seawall

**Comments:** Missing Rip-Rap, Tunnel Undermined

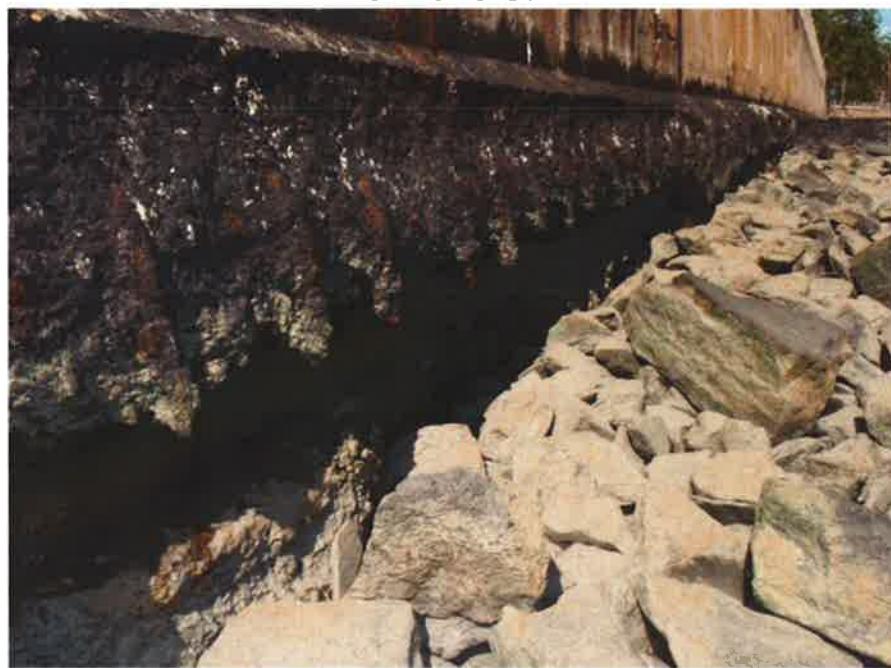
**Station 8+37**

**Direction:** Seawall (Looking North)

**Comments:** Spalling at Haunch, Missing Large Sections of Concrete, Exposed Re-Bar

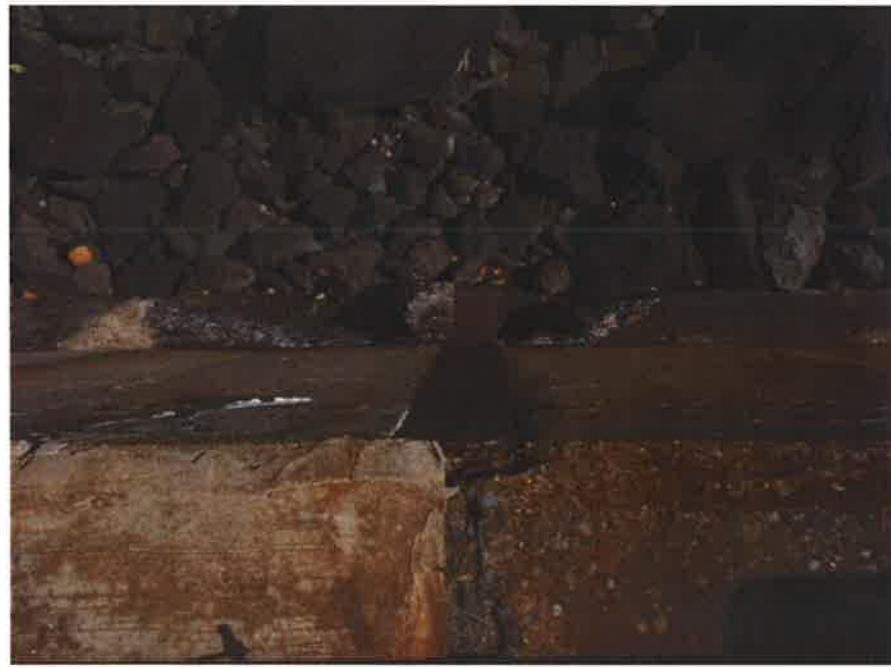
**Station 8+49**

**Direction:** Seawall Joint

**Comments:** Spalling at Haunch, Missing Large Sections of Concrete, Tunnel has been Undermined

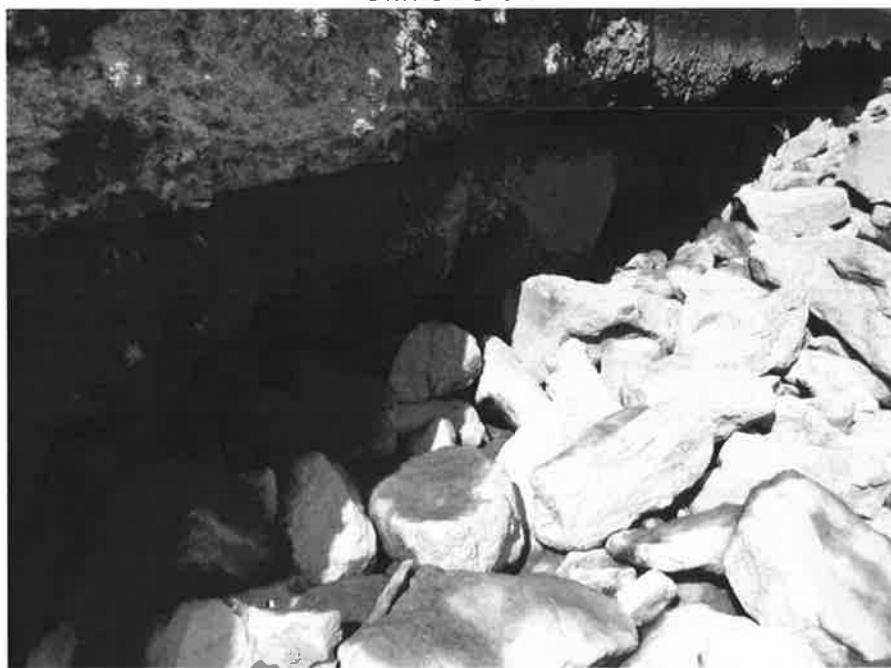
**Station 8+94**

**Direction:** Seawall**Comments:** Spalling at Haunch, Missing Large Sections of Concrete, Tunnel has been Undermined**Station 8+97**

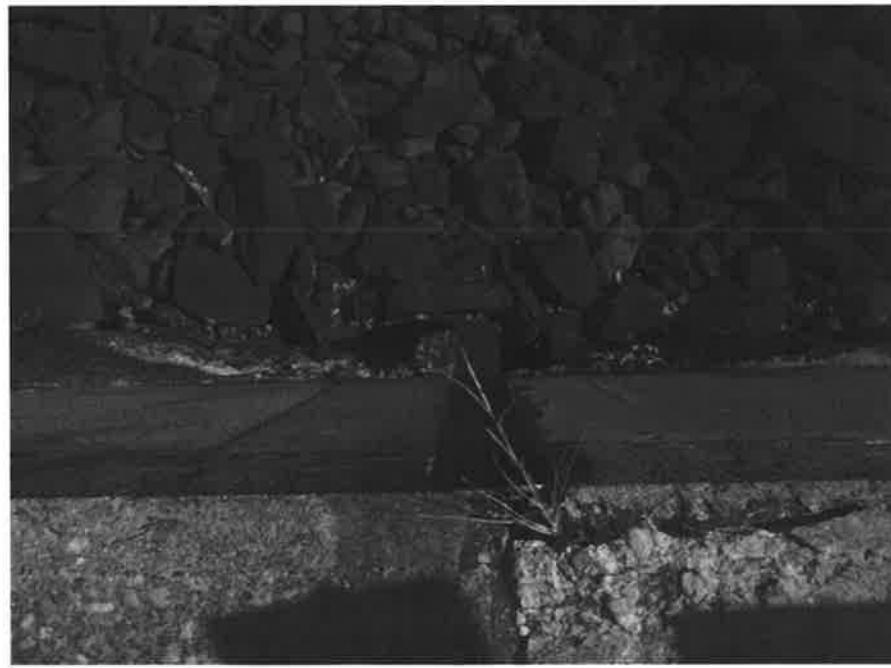
**Direction:** Seawall Joint**Comments:** Missing Large Concrete Section, Tunnel has been Undermined

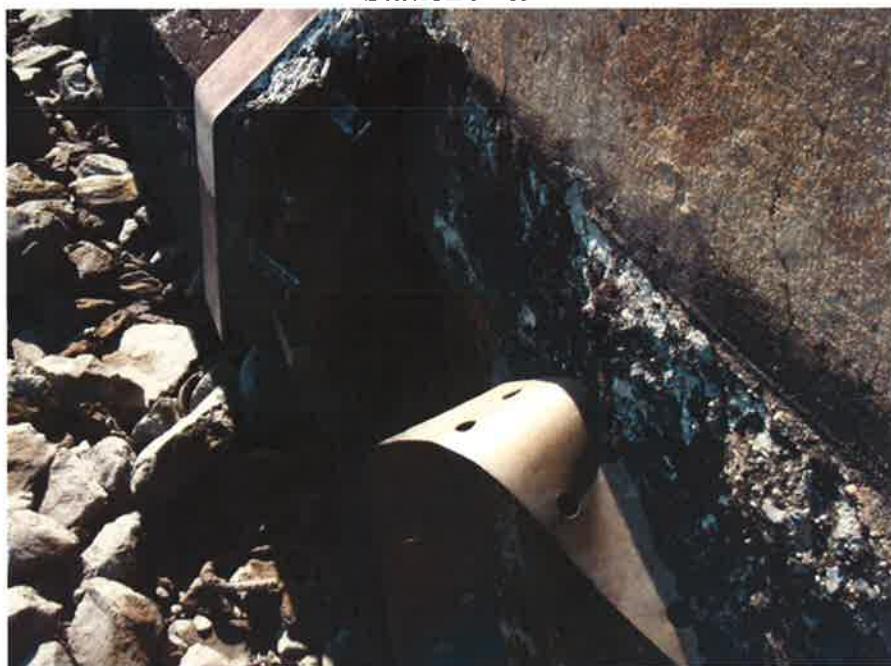
**Station 9+09**

**Direction:** Seawall Joint**Comments:** Spalling at Haunch, Missing Large Sections of Concrete, Metal Joint Covering Loose**Station 9+21**
