# CONDITIONS REPORT & DESIGN MEMORANDUM

## STEAM TUNNEL ASSESSMENT ROOSEVELT ISLAND, NEW YORK

**ROOSEVELT ISLAND OPERATING CORPORATION**  
591 MAIN STREET  
ROOSEVELT ISLAND  
NEW YORK, NEW YORK 10044

*17 November 2014  
Project # 100444601*

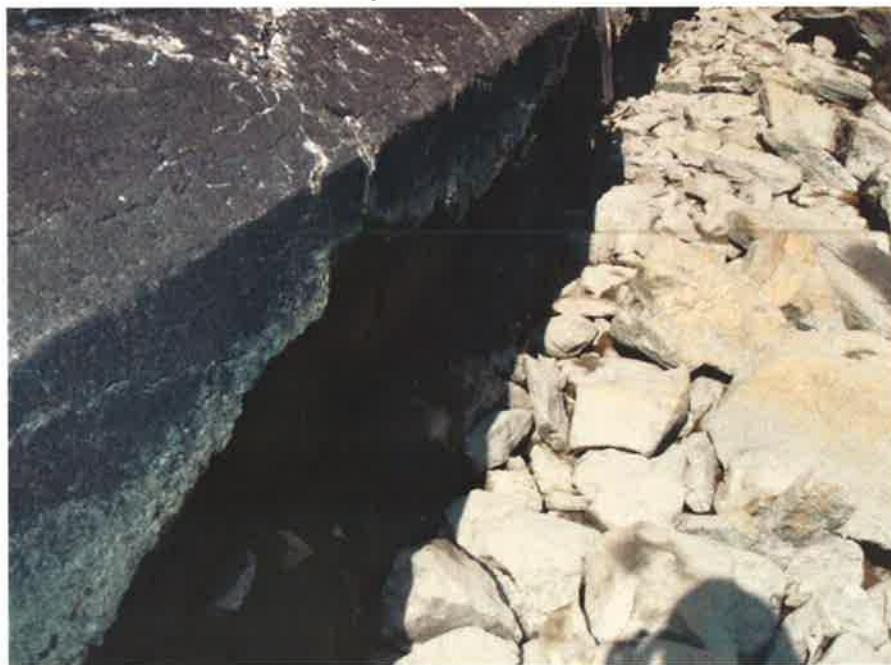
**Direction:** Seawall**Comments:** Spalling at Haunch, Missing Large Sections of Concrete, Tunnel has been Undermined

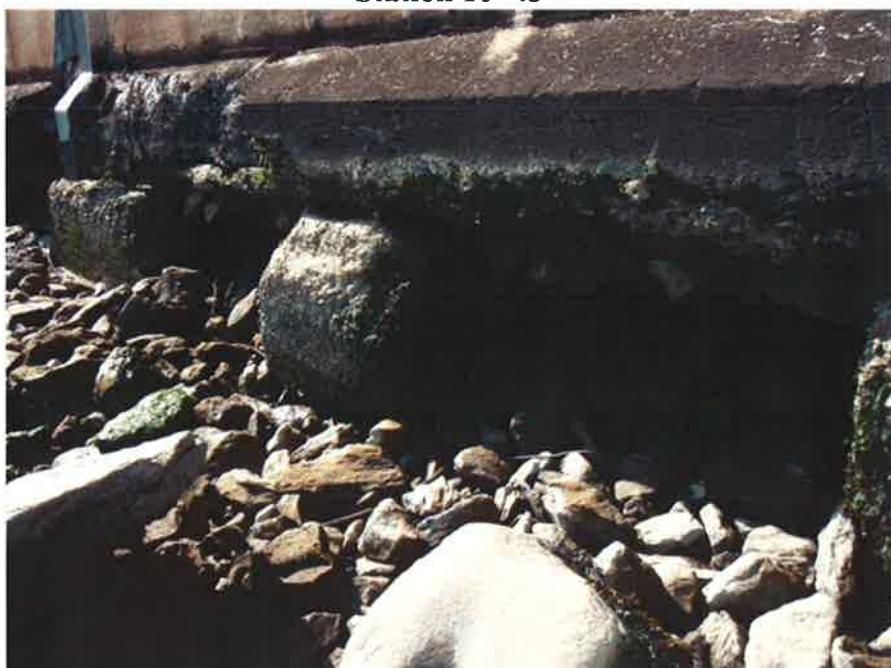
**Station 10+43**

**Direction:** Seawall**Comments:** Spalling at Haunch, Missing Large Sections of Concrete, Tunnel has been Undermined, Cap Beams Visible**Station 10+43**

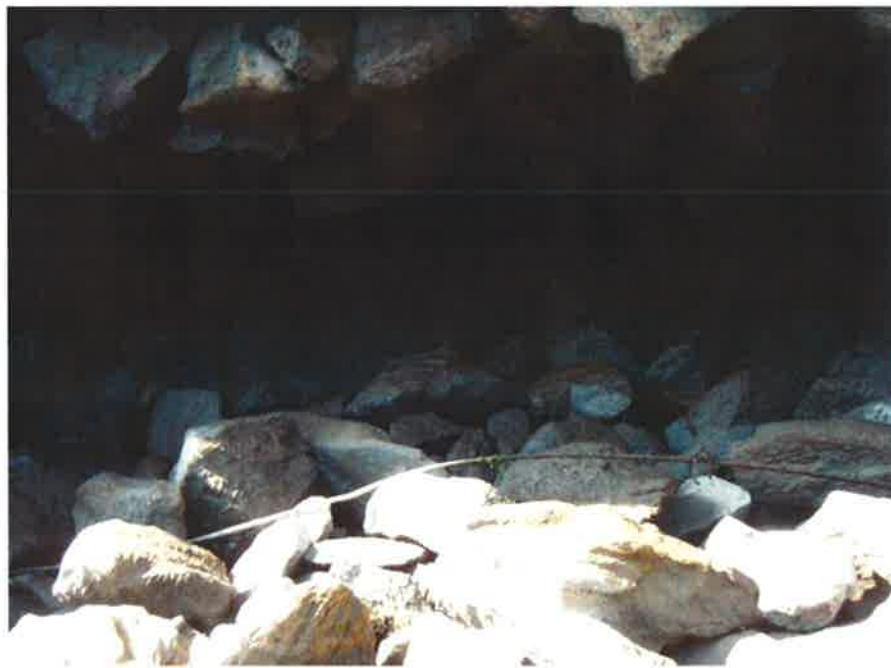
**Direction:** Seawall**Comments:** Tunnel has been Undermined

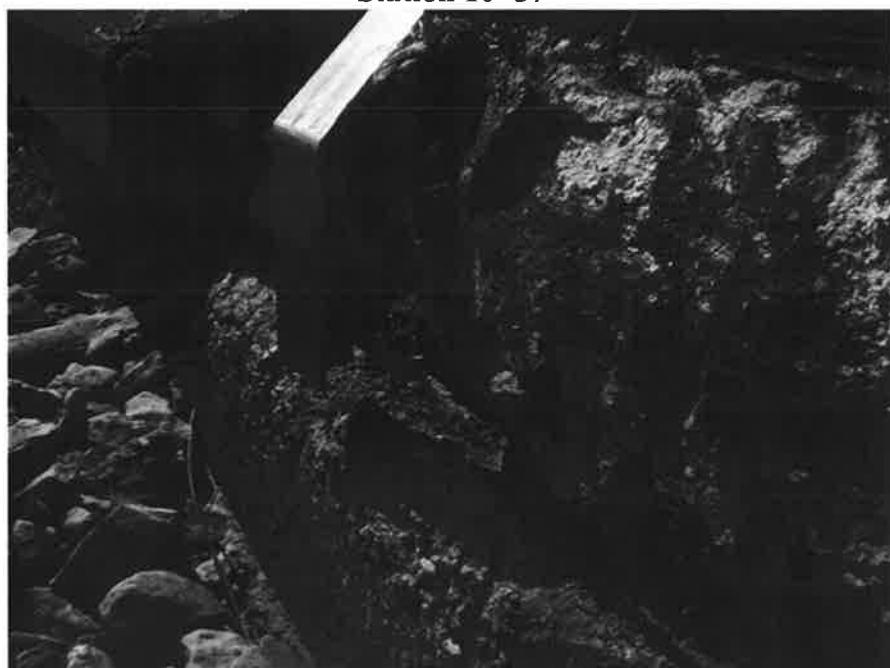
**Station 10+57**

**Direction:** Seawall Joint**Comments:** Spalling at Haunch, Missing Large Sections of Concrete, Metal Joint Covering Loose**Station 10+57**

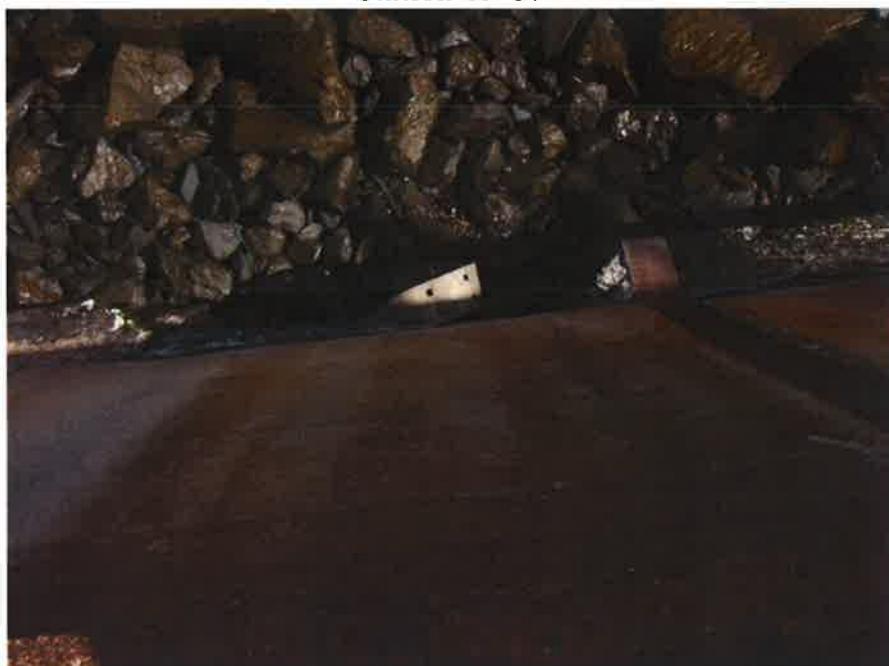
**Station 10+57**

**Direction:** Seawall Joint

**Comments:** Spalling at Haunch, Missing Large Sections of Concrete, Metal Joint Covering Loose

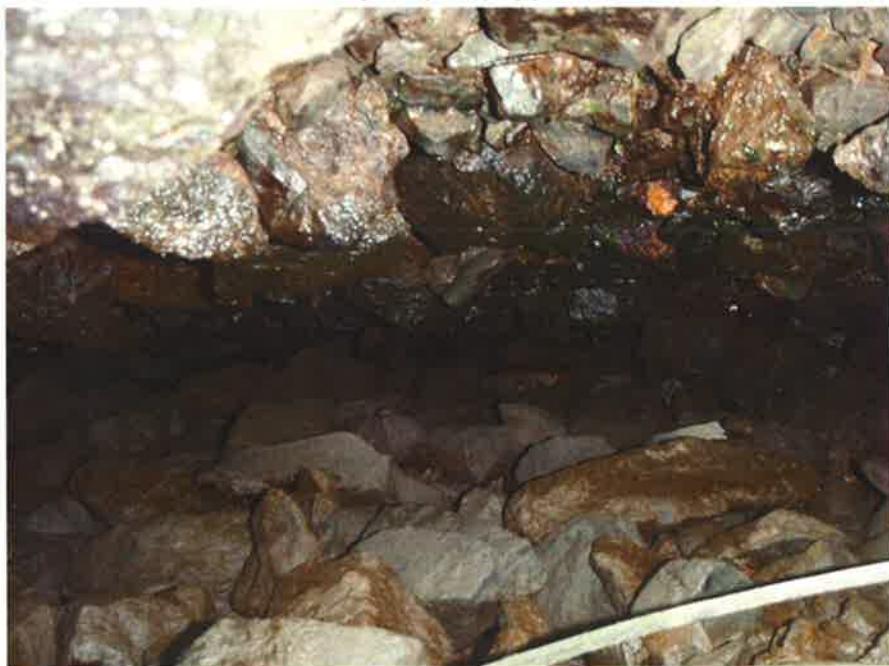
**Station 10+57**

**Direction:** Seawall

**Comments:** Tunnel has been Undermined

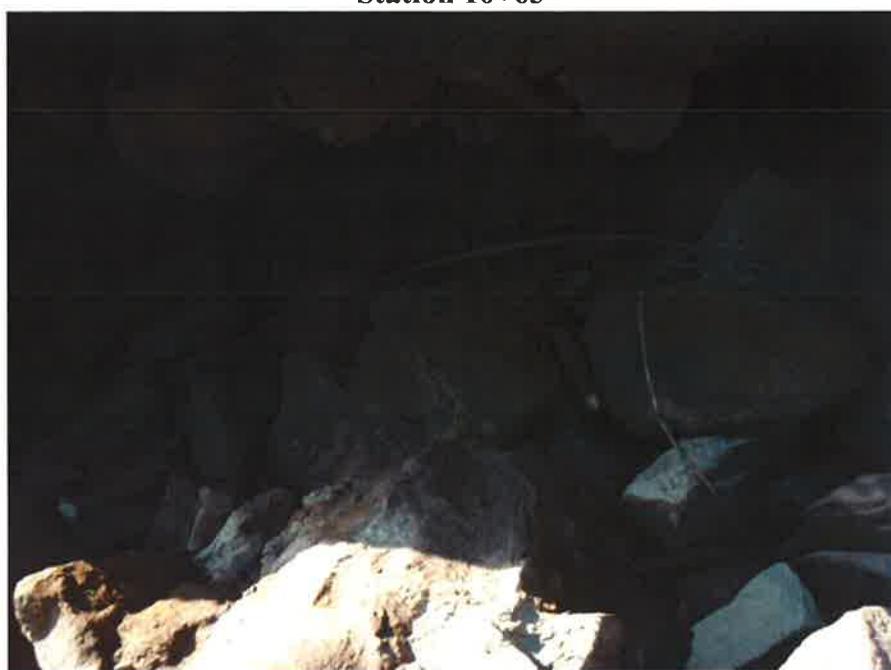
**Station 10+63**

**Direction:** Seawall**Comments:** Tunnel has been Undermined**Station 10+72**

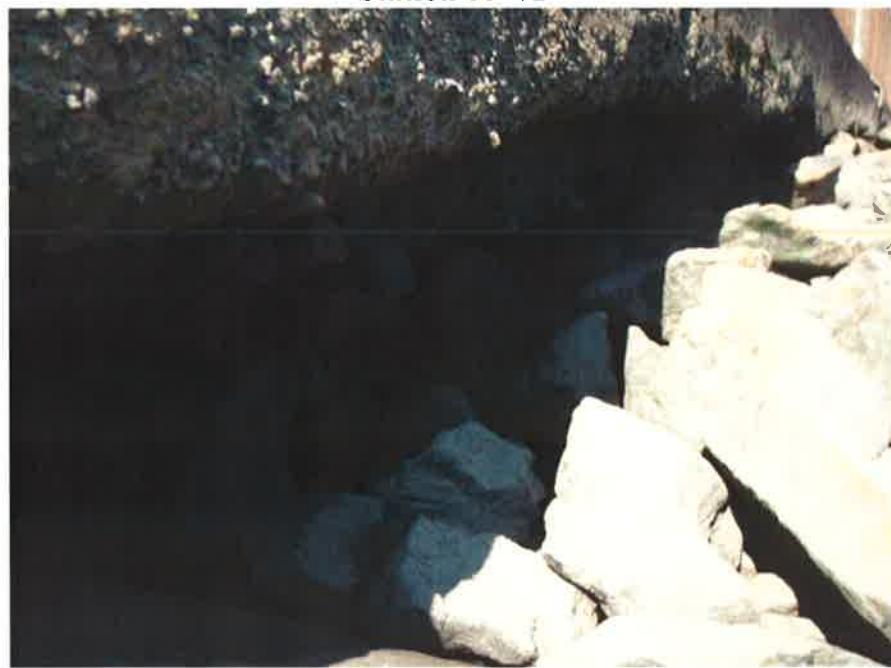
**Direction:** Seawall**Comments:** Tunnel has been Undermined

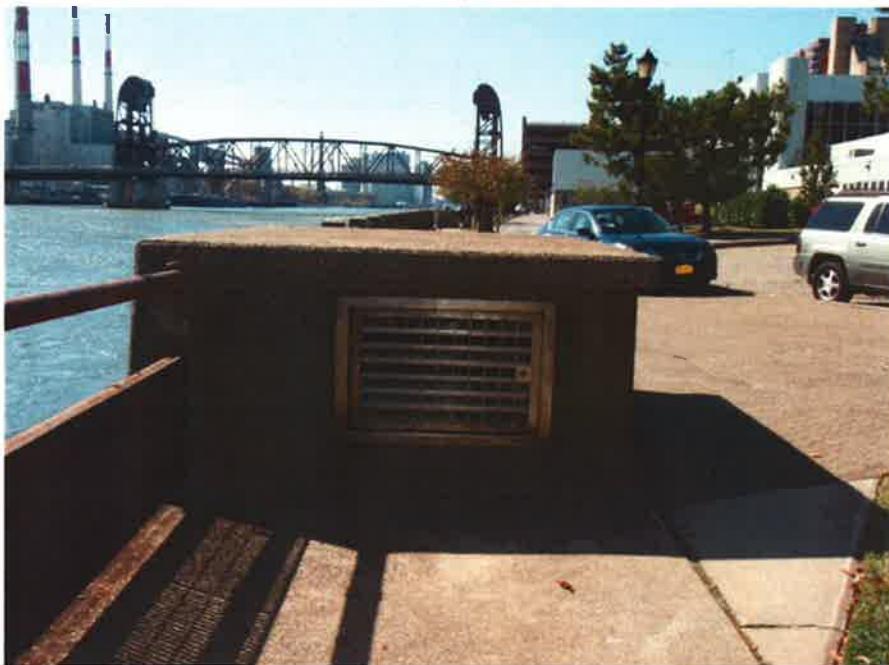
**Station 10+77**

**Direction:** Air Vent 14**Comments:** Northern Face**Station 10+77**

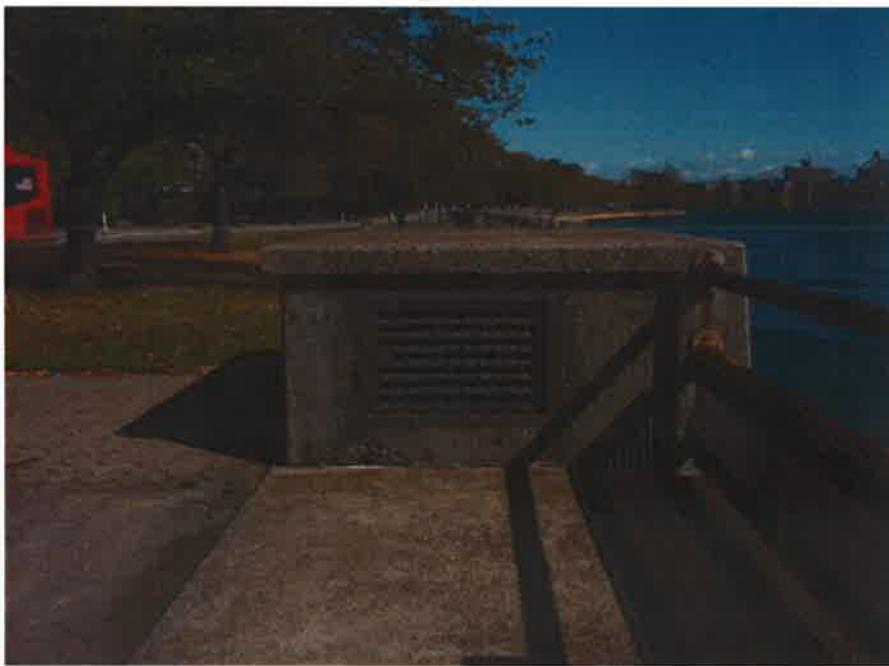
**Direction:** Air Vent 14**Comments:** Sothern Face

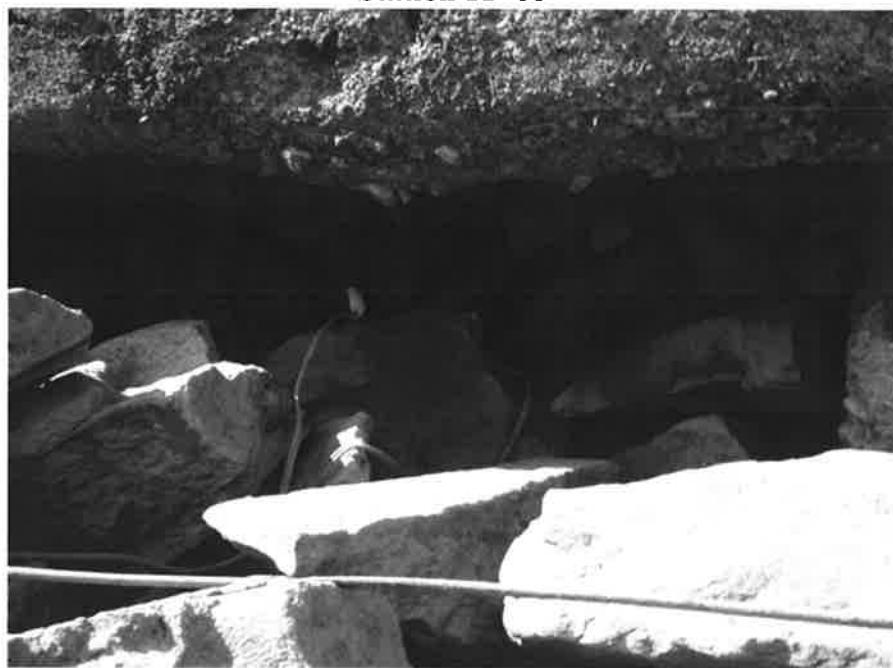
**Station 11+06**

**Direction:** Seawall**Comments:** Tunnel has been Undermined**Station 11+19**

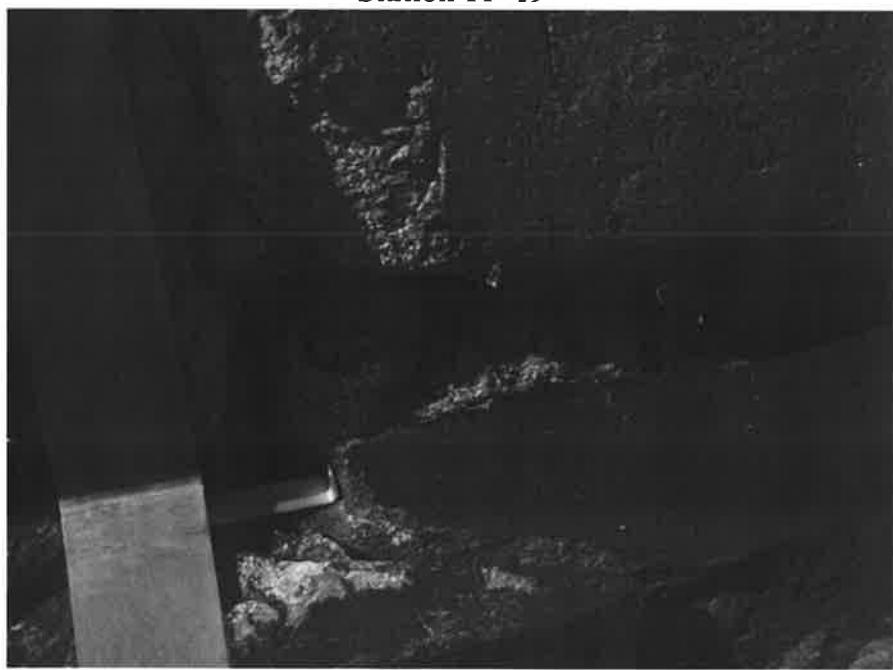
**Direction:** Seawall Joint**Comments:** Remnant of Timber Formwork

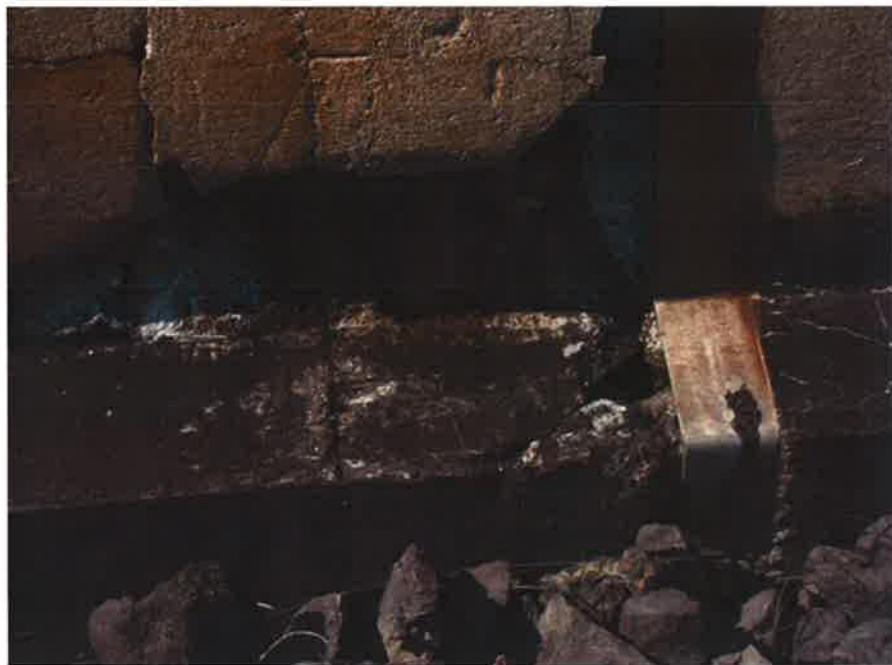
**Station 11+83**

**Direction:** Seawall Joint**Comments:** Spalling at Haunch, Missing Large Sections of Concrete**Station 11+83**

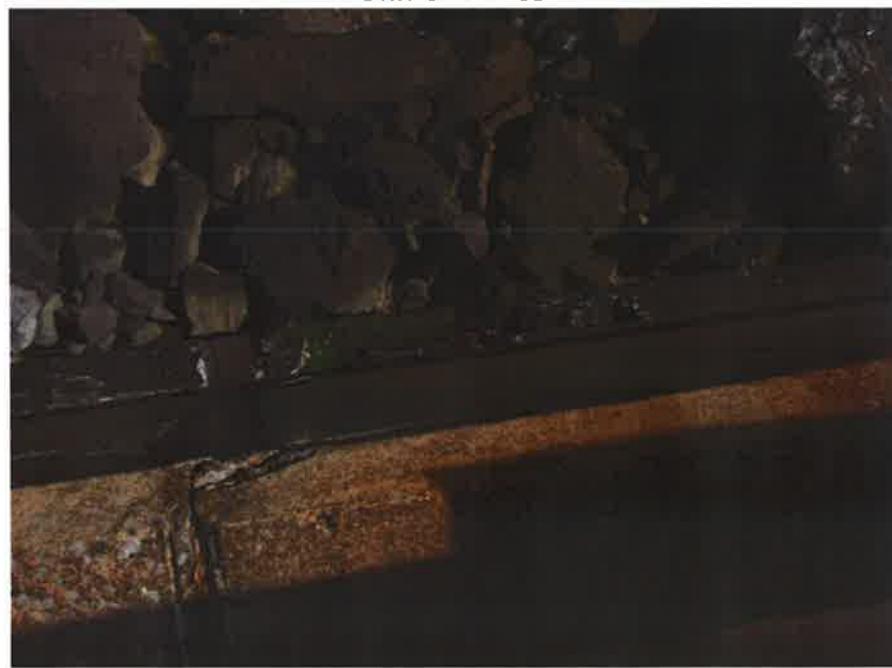
**Direction:** Seawall Joint**Comments:** Spalling at Haunch, Missing Large Sections of Concrete

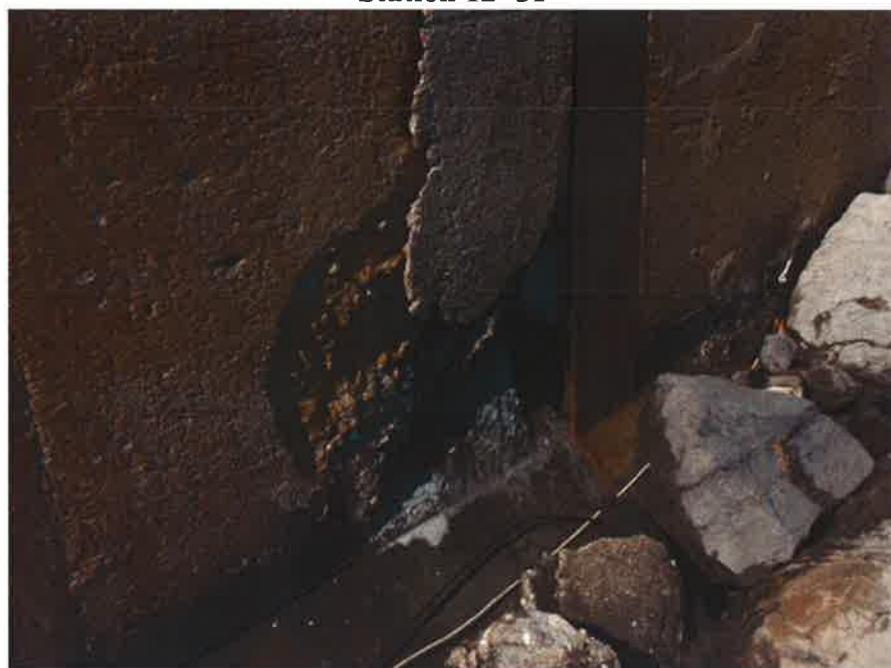
**Station 12+51**

**Direction:** Seawall Joint**Comments:** Spalling at Haunch, Missing Large Sections of Concrete**Station 12+68**

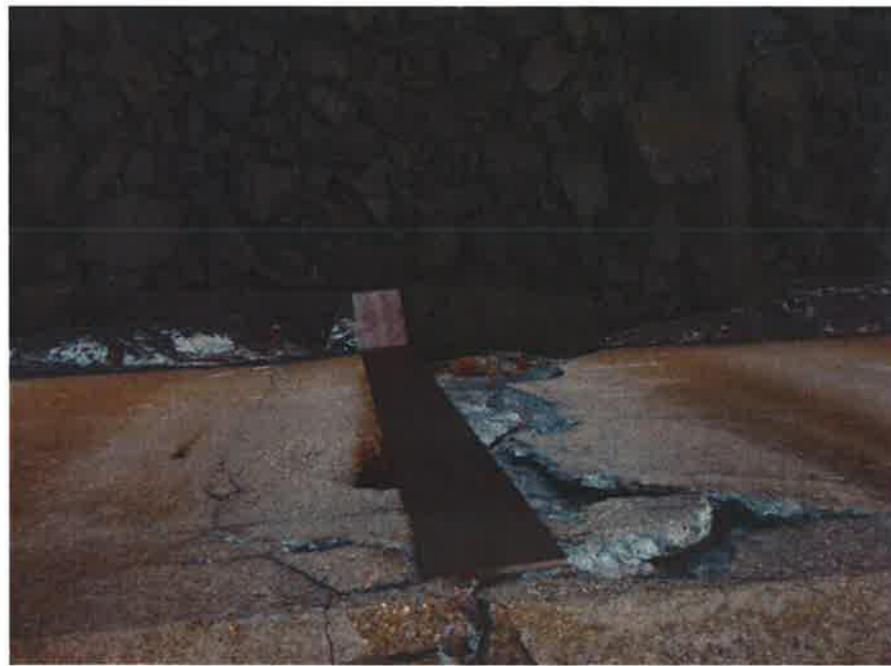
**Direction:** Seawall Joint**Comments:** Concrete Spalling, Missing Large Section of Concrete, Re-Bar Exposed. Tunnel has been Undermined. Missing Rip-Rap

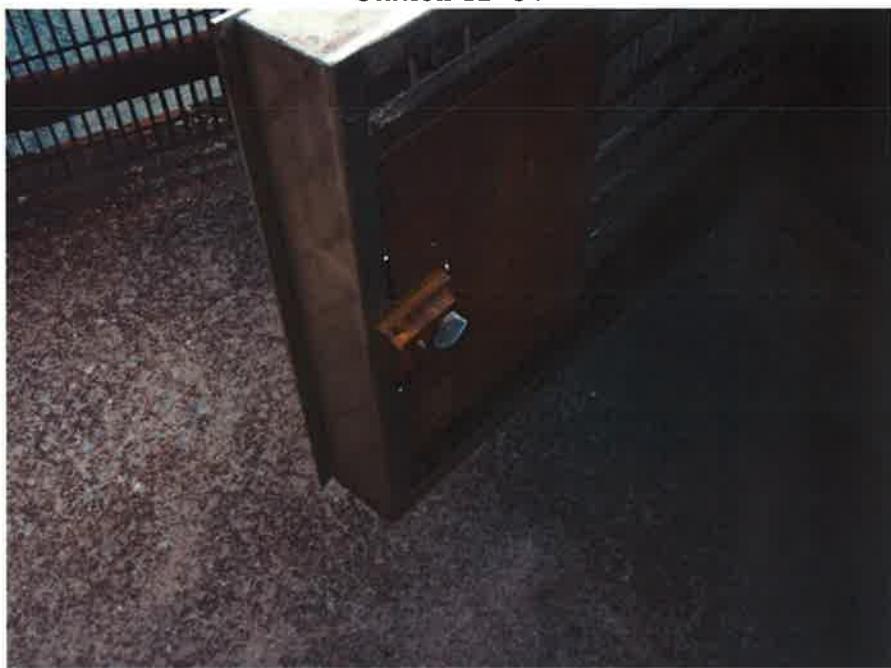
**Station 12+84**

**Direction:** Air Vent 13

**Comments:** Northern Face Door Unlocked, Broken Lock

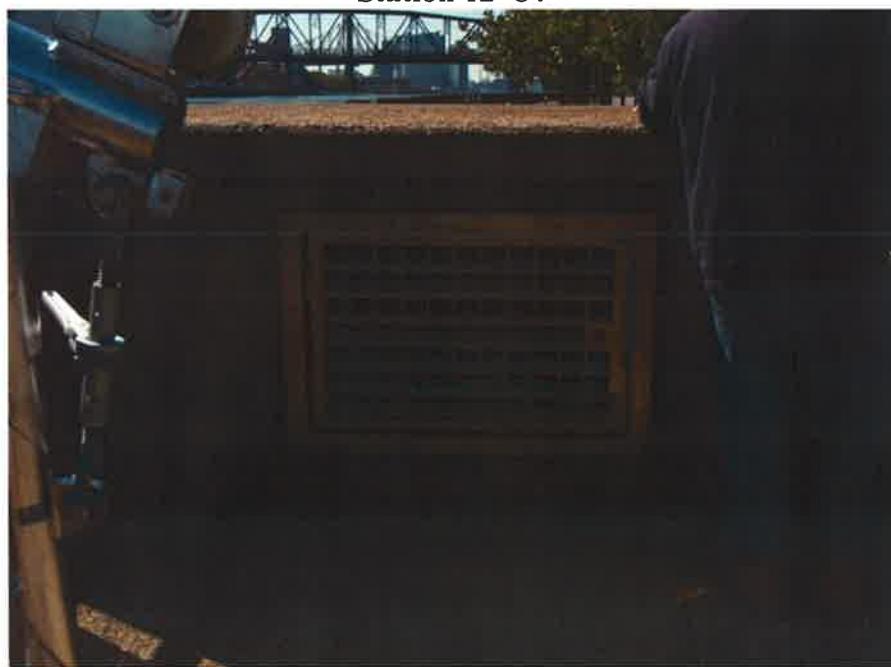
**Station 12+84**

**Direction:** Air Vent 13

**Comments:** Northern Face

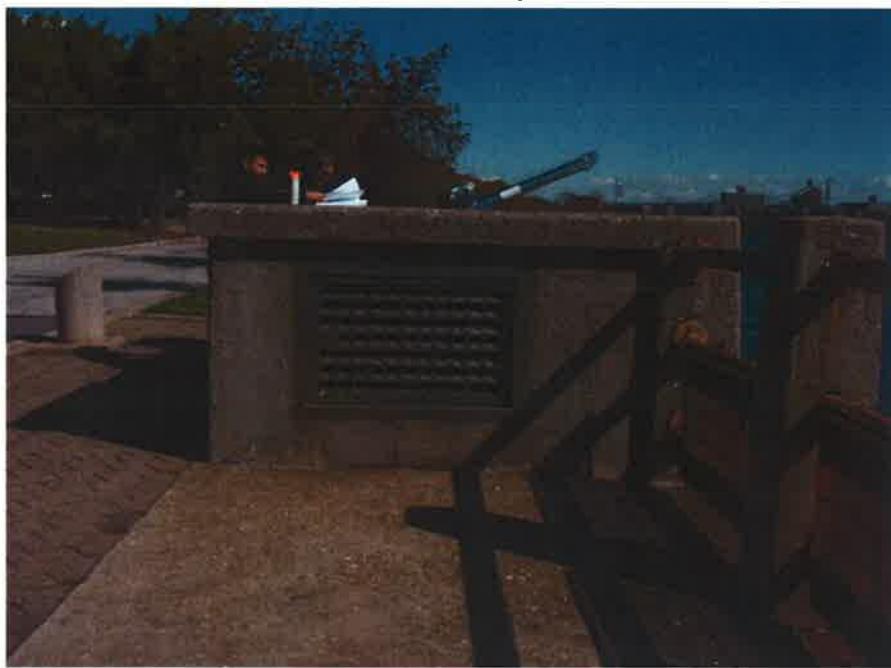
**Station 12+84**

**Direction:** Air Vent 13**Comments:** Sothern Face**Station 13+10**

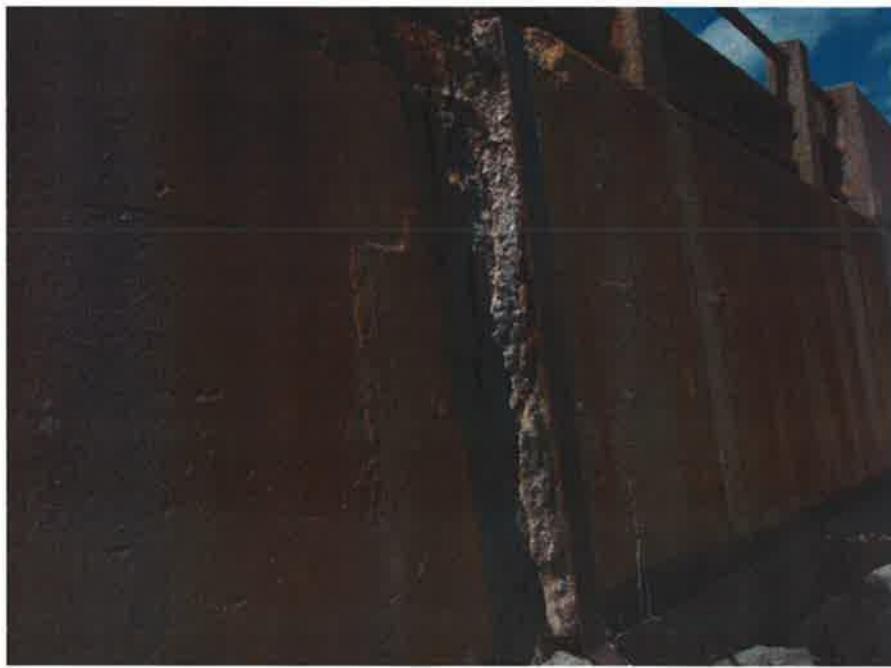
**Direction:** Seawall Joint**Comments:** Spalling at Haunch, Missing Large Sections of Concrete

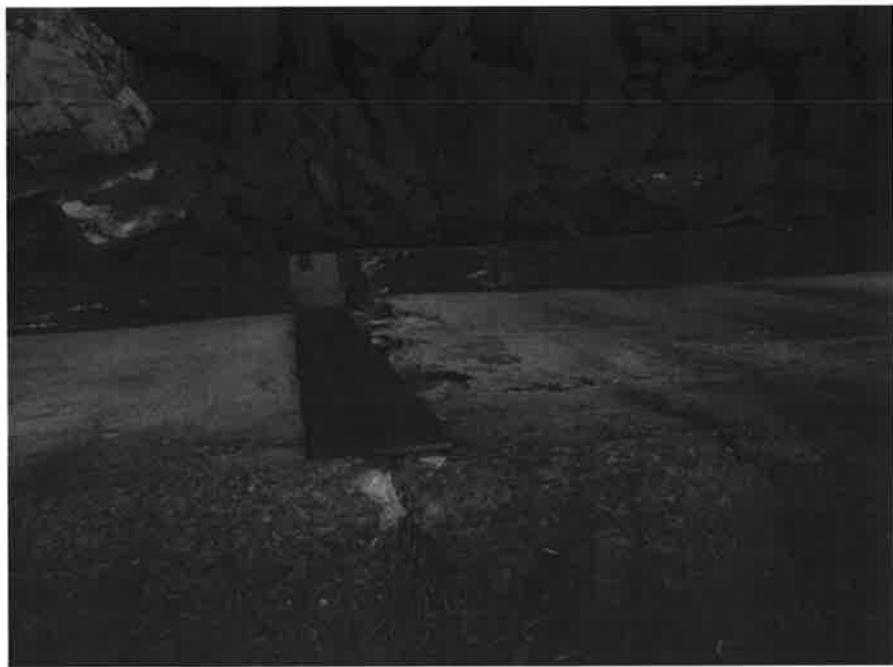
**Station 14+37**

**Direction:** Seawall Joint**Comments:** Concrete Spalling, Loose Sections of Concrete**Station 14+37**

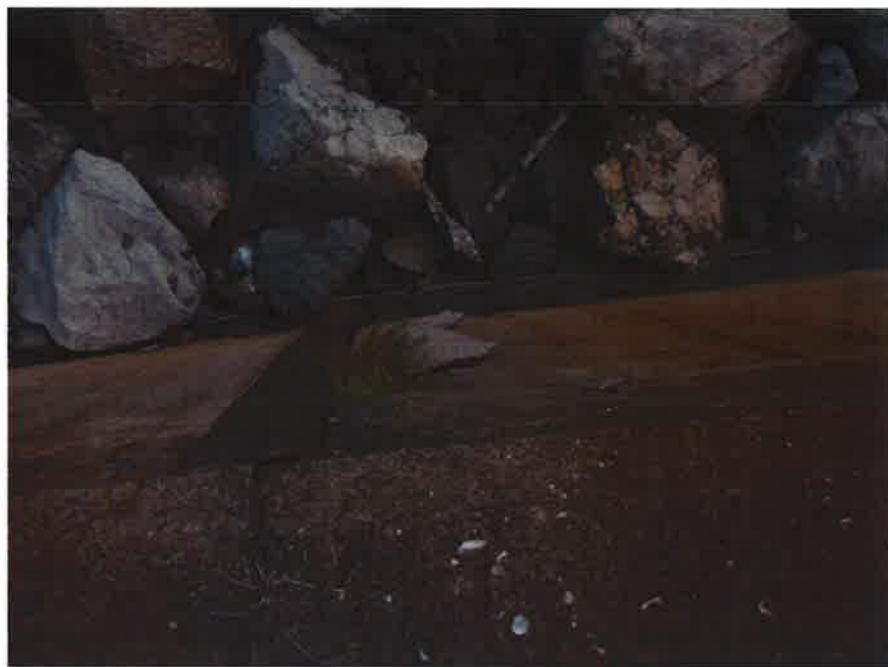
**Station 15+06**

**Direction:** Seawall Joint**Comments:** Concrete Spalling, Loose Sections of Concrete**Station 15+06**

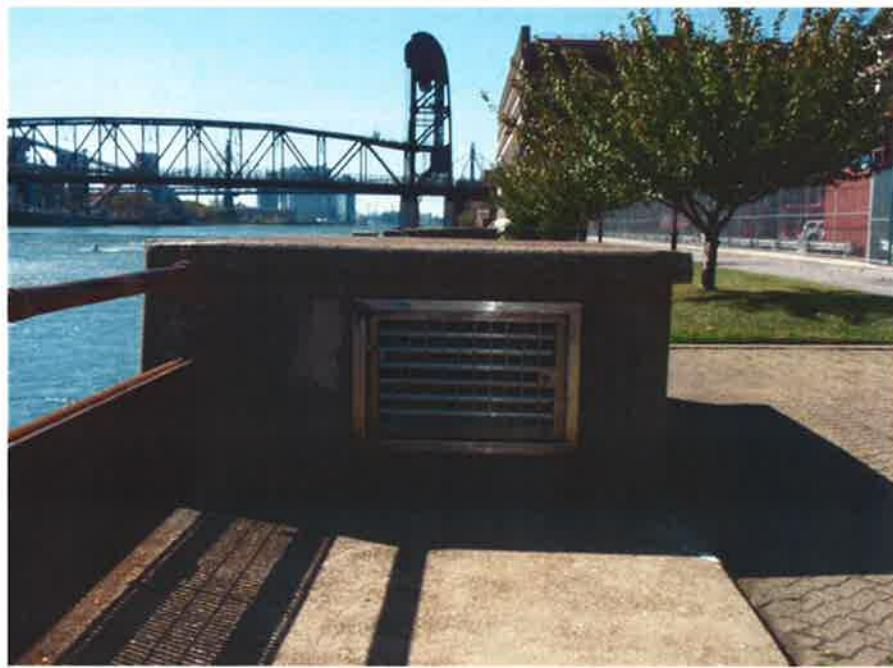
**Direction:** Air Vent 12**Comments:** Northern Face

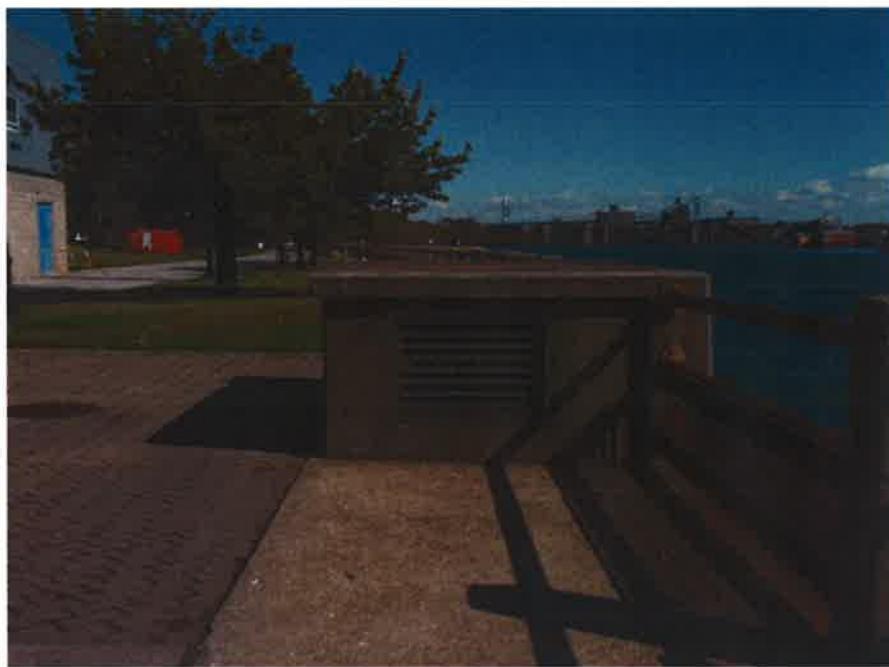
**Station 15+22**

**Direction:** Air Vent 12**Comments:** Sothern Face**Station 15+63**

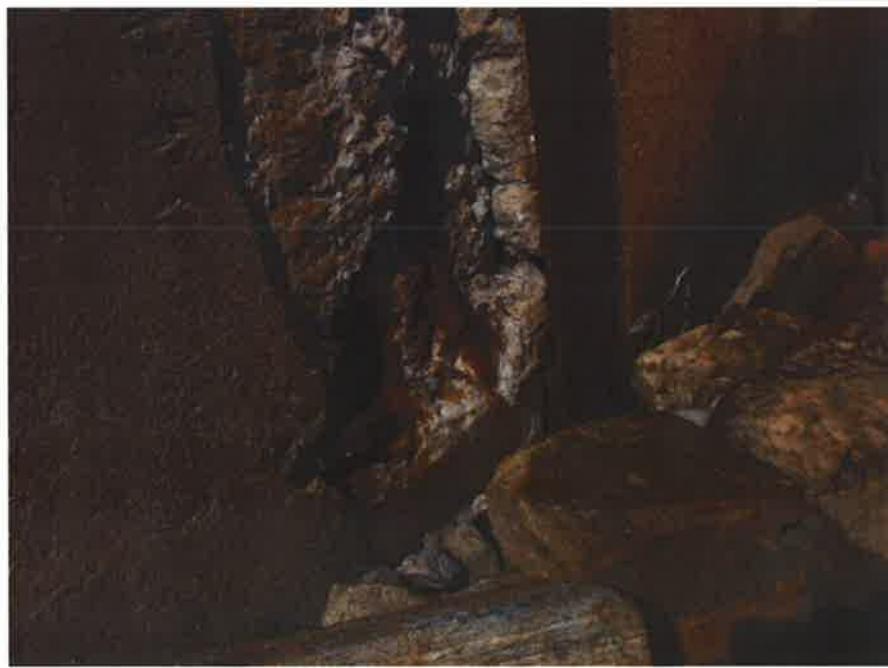
**Direction:** Seawall Joint**Comments:** Concrete Spalling, Exposed Re-bar

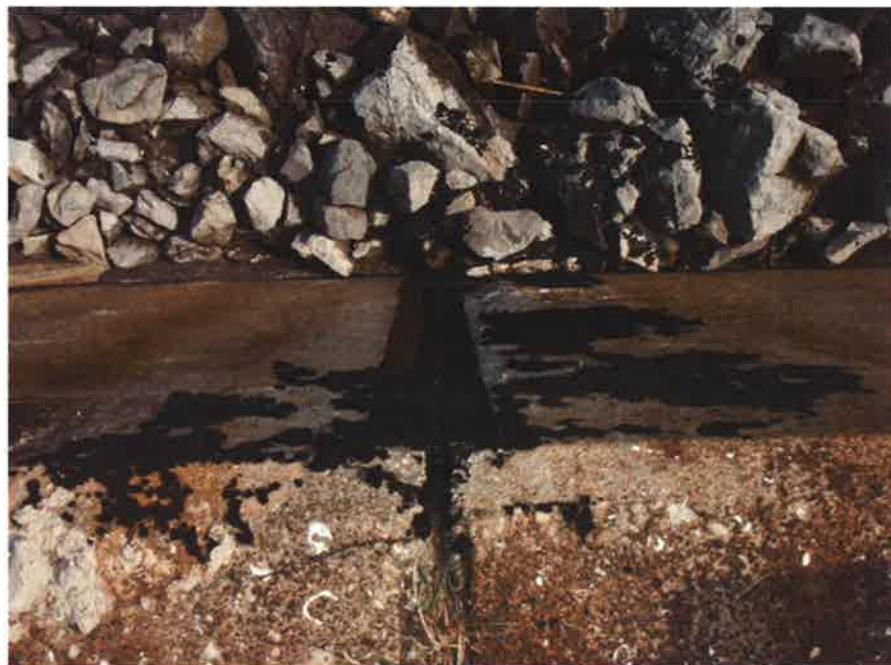
**Station 16+88**

**Direction:** Seawall Joint**Comments:** Joint Repair**Station 17+55**

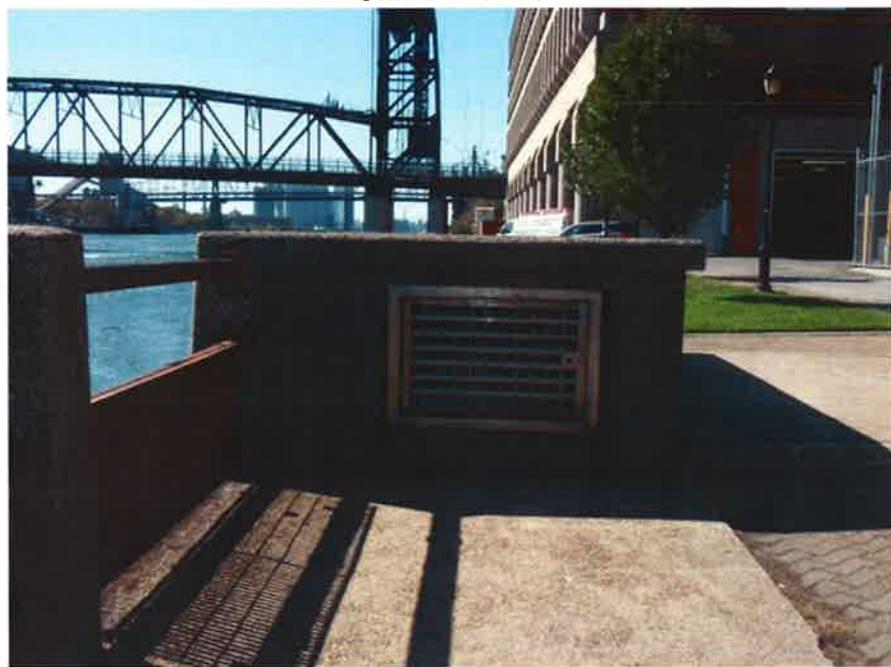
**Station 17+76**

**Direction:** Air Vent 11**Comments:** Northern Face**Station 17+76**

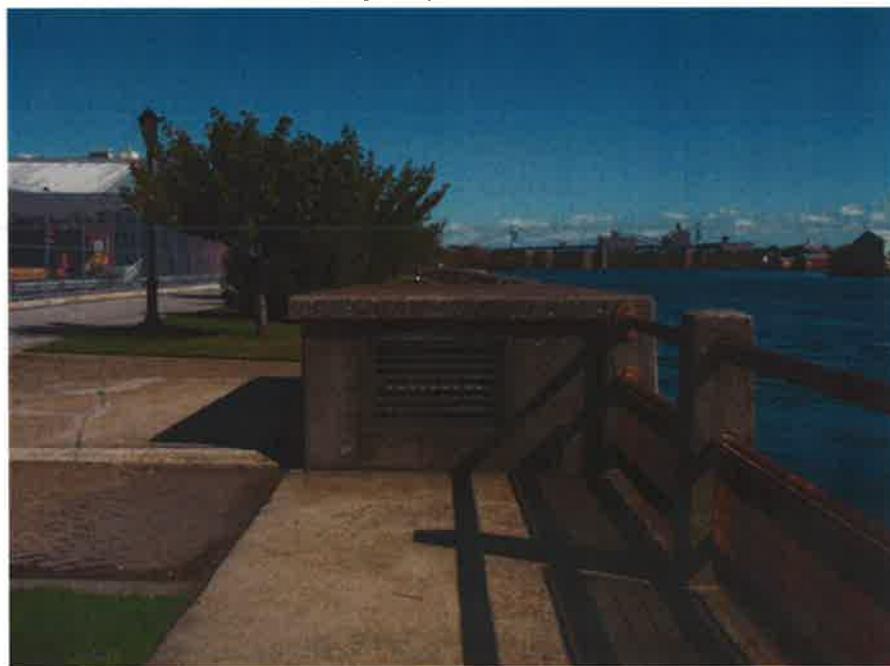
**Direction:** Air Vent 11**Comments:** Sothern Face

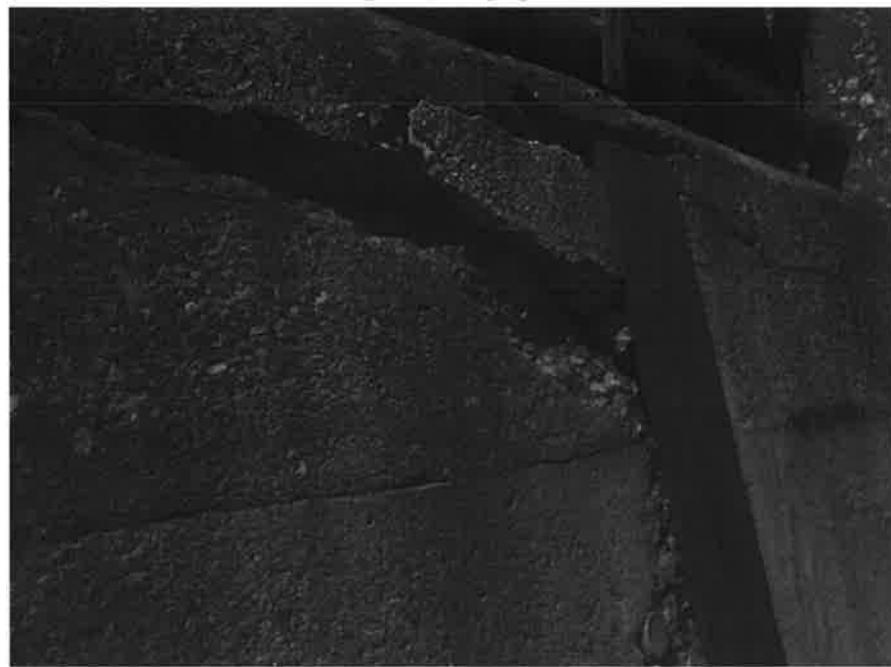
**Station 18+82**

**Direction:** Seawall Joint**Comments:** Concrete Spalling, Exposed Re-bar, Cracks about 3-inches Deep**Station 18+82**

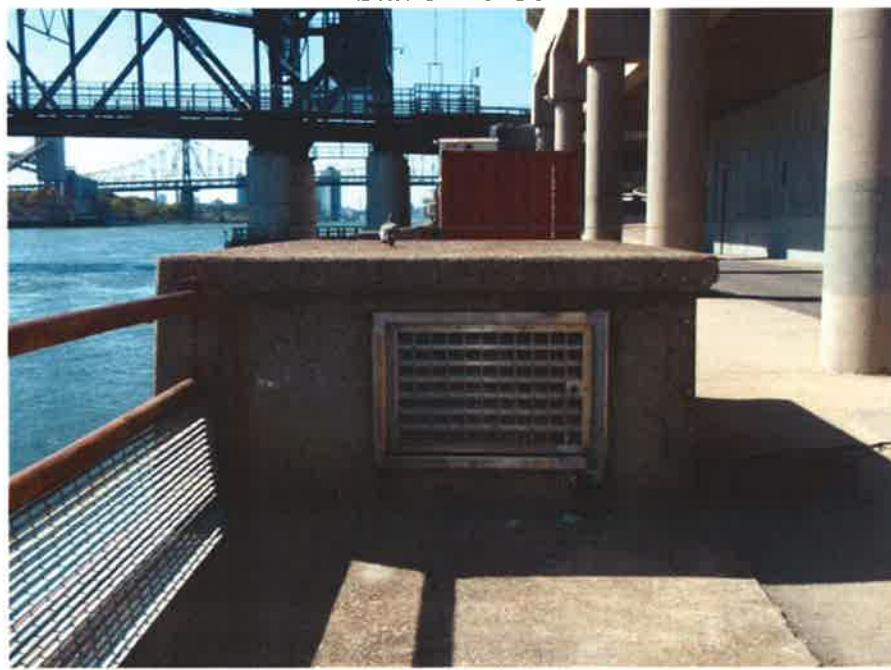
**Direction:** Air Vent 10**Comments:** Northern Face

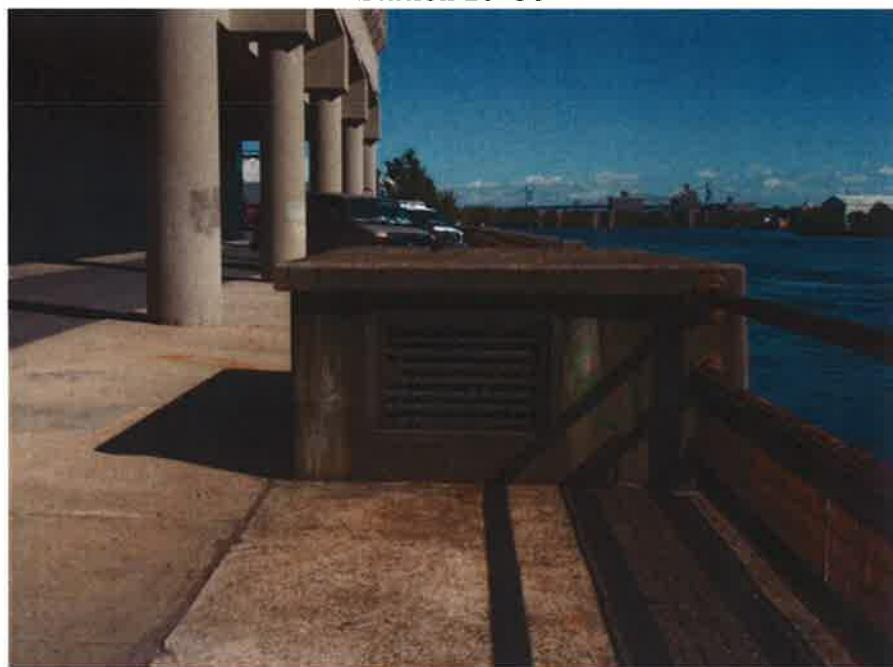
**Station 20+30**

**Direction:** Air Vent 10**Comments:** Sothern Face**Station 20+73**

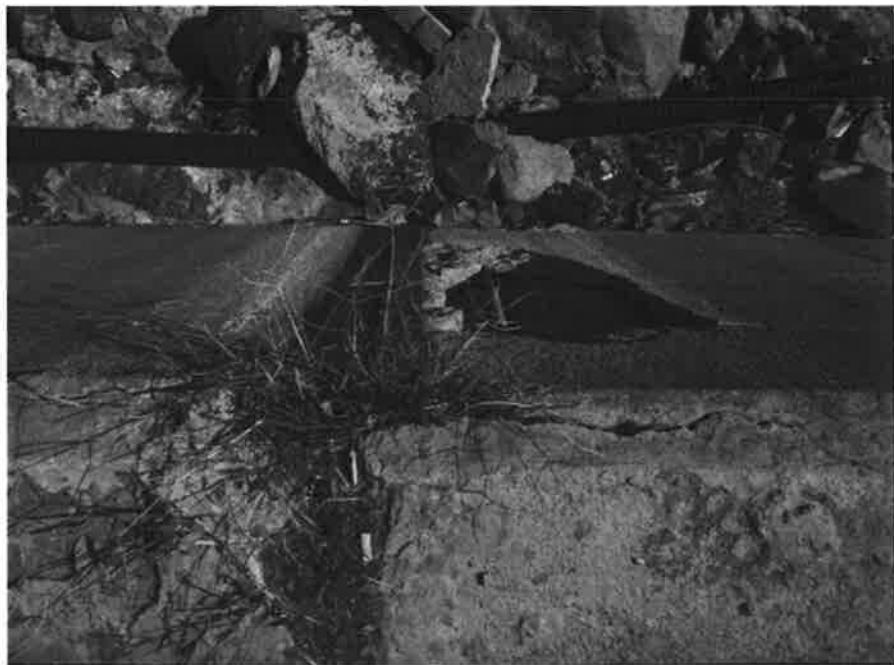
**Station 21+33**

**Direction:** Seawall Joint**Comments:** Concrete Spalling, Missing Large Section of Concrete, Re-Bar Exposed**Station 22+64**

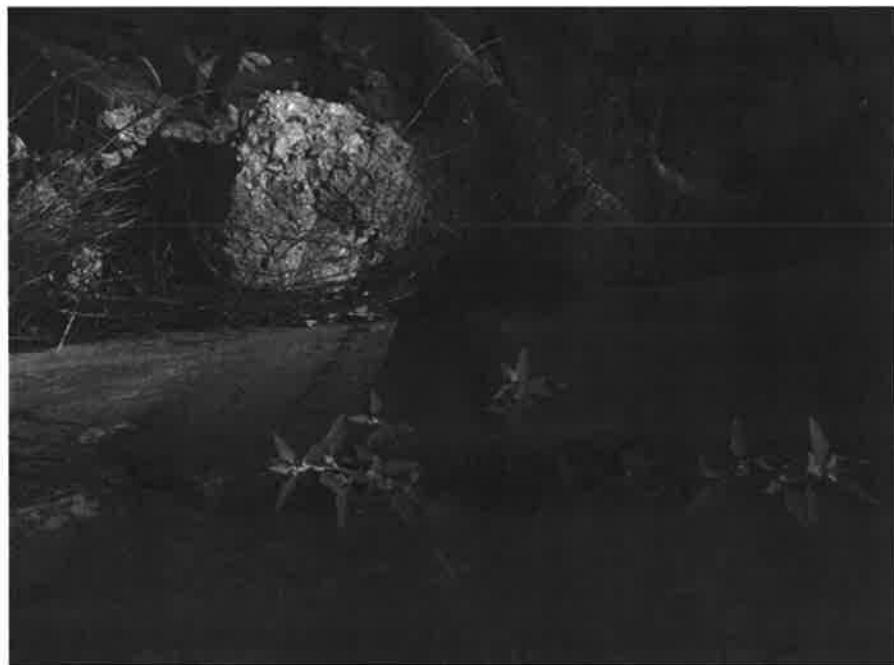
**Direction:** Seawall Joint**Comments:** Concrete Spalling

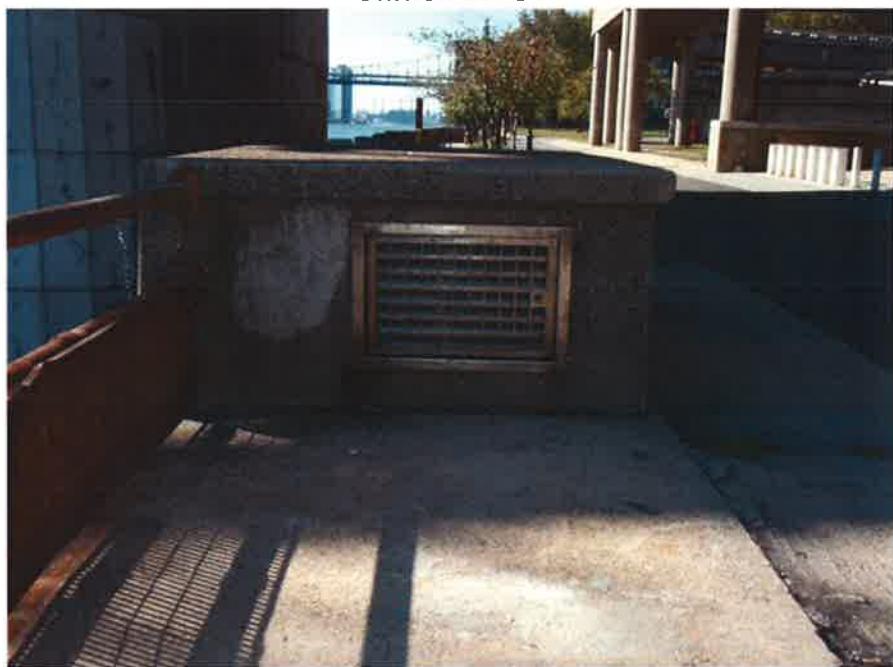
**Station 22+84**

**Direction:** Air Vent 9**Comments:** Northern Face**Station 22+84**

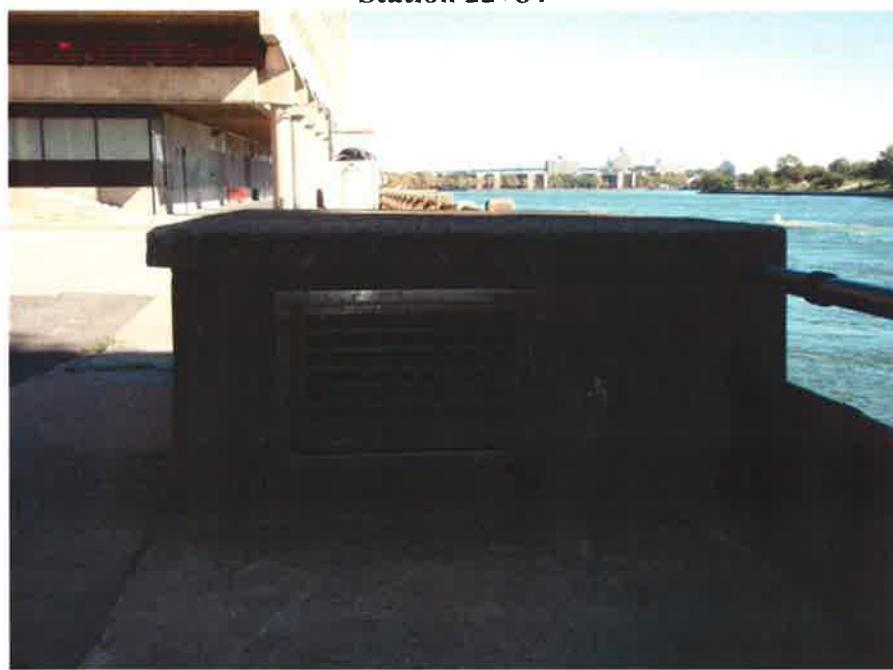
**Direction:** Air Vent 9**Comments:** Sothern Face

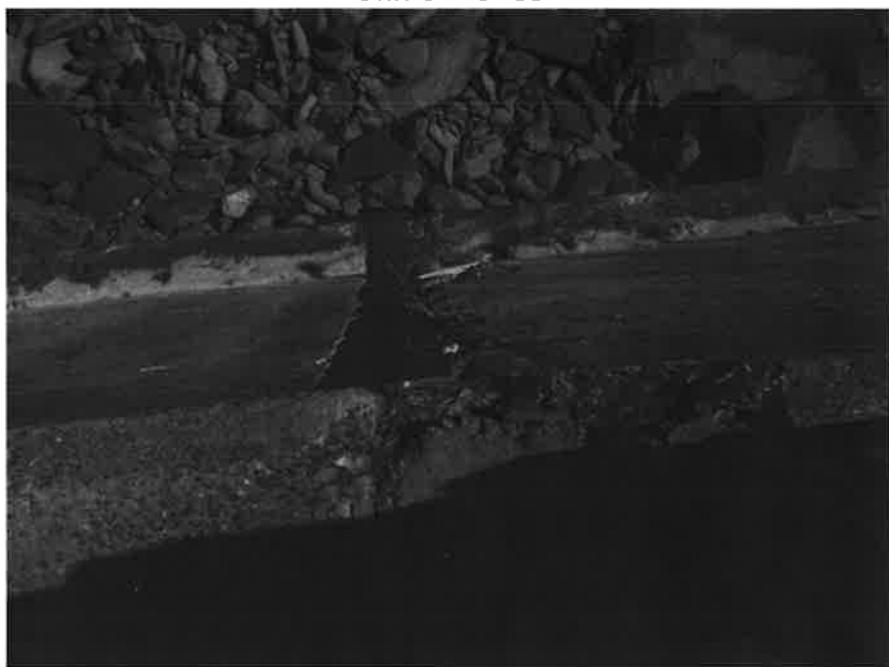
**Station 23+88**

**Direction:** Seawall Joint**Comments:** Concrete Spalling**Station 24+53**

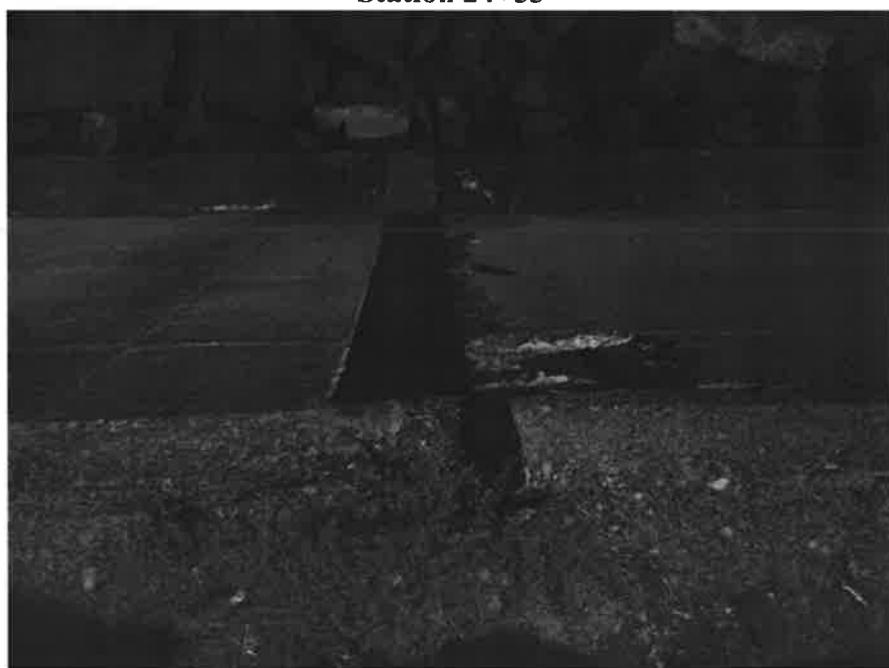
**Direction:** Seawall Joint**Comments:** Concrete Spalling, Missing Large Section of Concrete, Re-Bar Exposed
