# CONDITIONS REPORT & DESIGN MEMORANDUM

## STEAM TUNNEL ASSESSMENT ROOSEVELT ISLAND, NEW YORK

**ROOSEVELT ISLAND OPERATING CORPORATION**  
591 MAIN STREET  
ROOSEVELT ISLAND  
NEW YORK, NEW YORK 10044

*17 November 2014  
Project # 100444601*

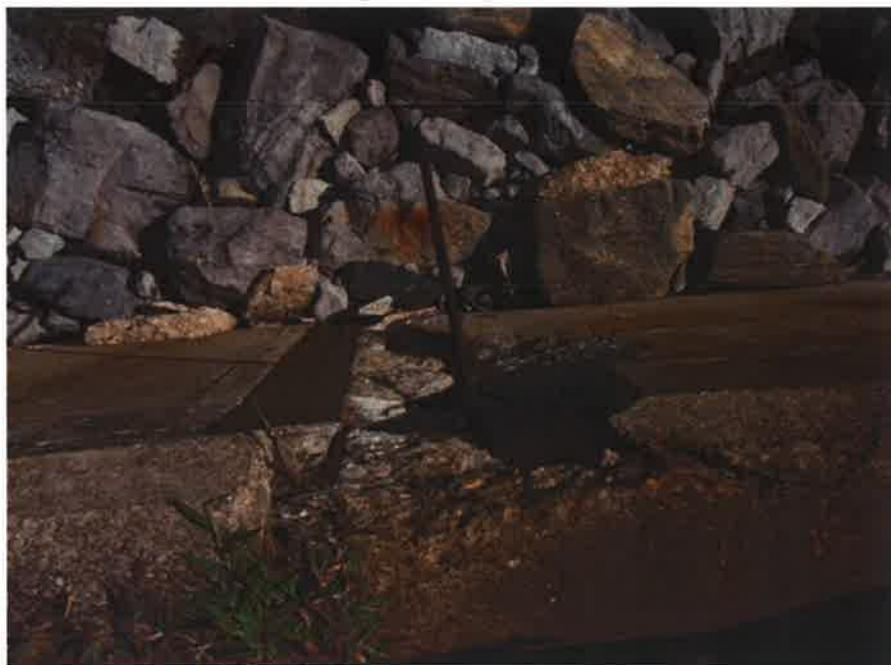
**Station 25+17**

**Direction:** Seawall Joint**Comments:** Concrete Spalling, Missing Large Section of Concrete, Re-Bar Exposed and Loose**Station 25+38**

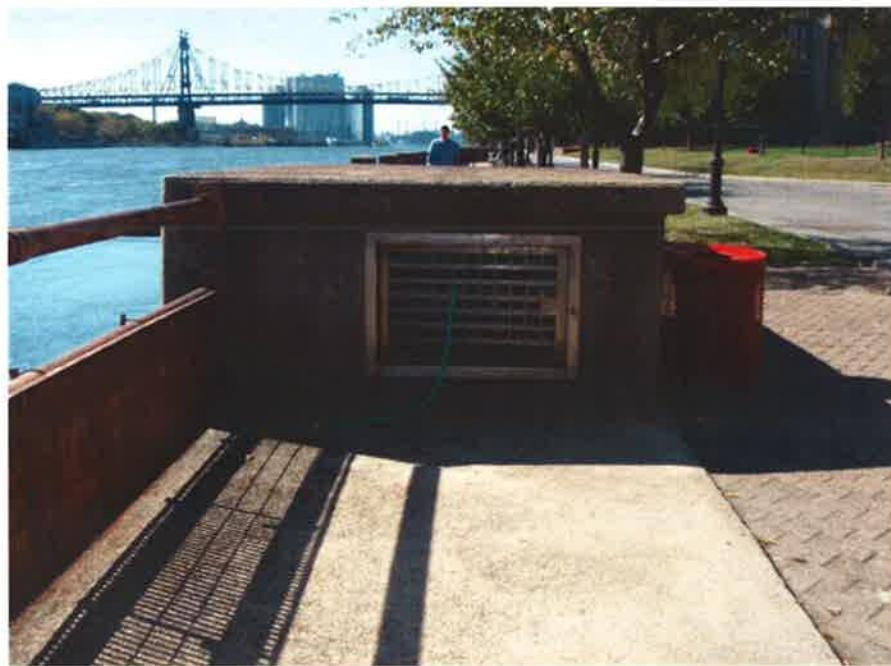
**Direction:** Air Vent 8**Comments:** Northern Face

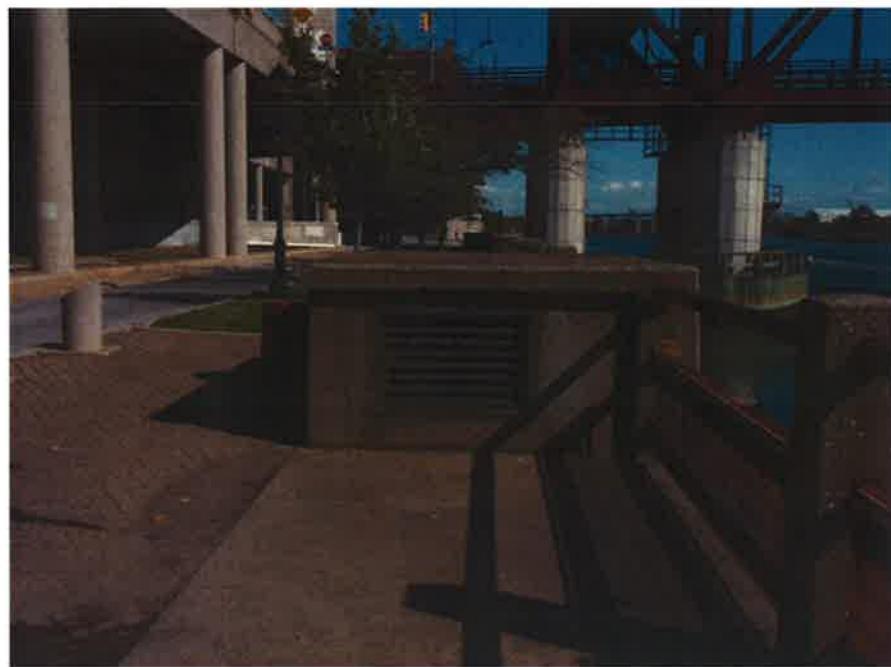
**Station 25+38**

**Direction:** Air Vent 8**Comments:** Southern Face**Station 25+82**

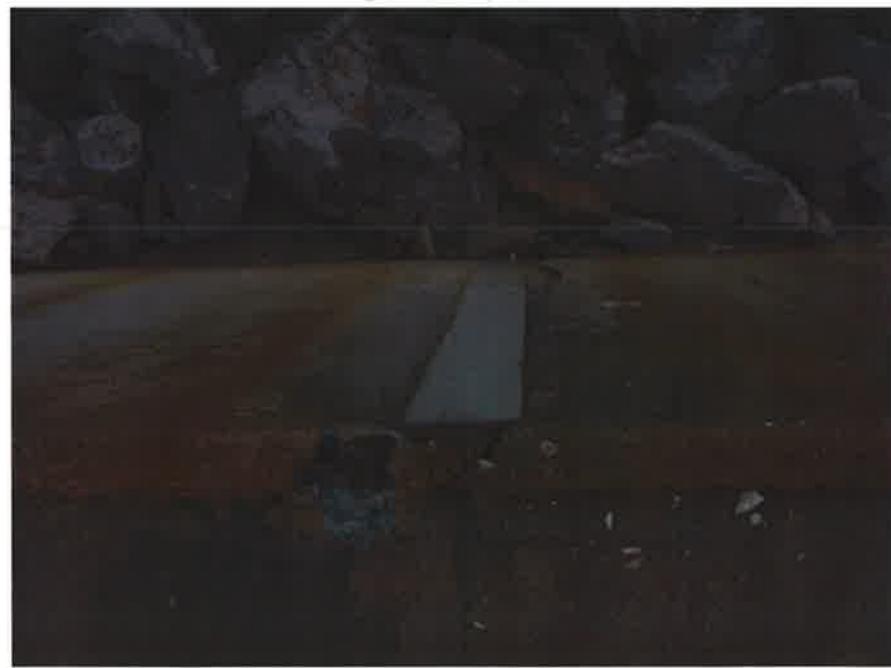
**Direction:** Seawall Joint**Comments:** Concrete Spalling

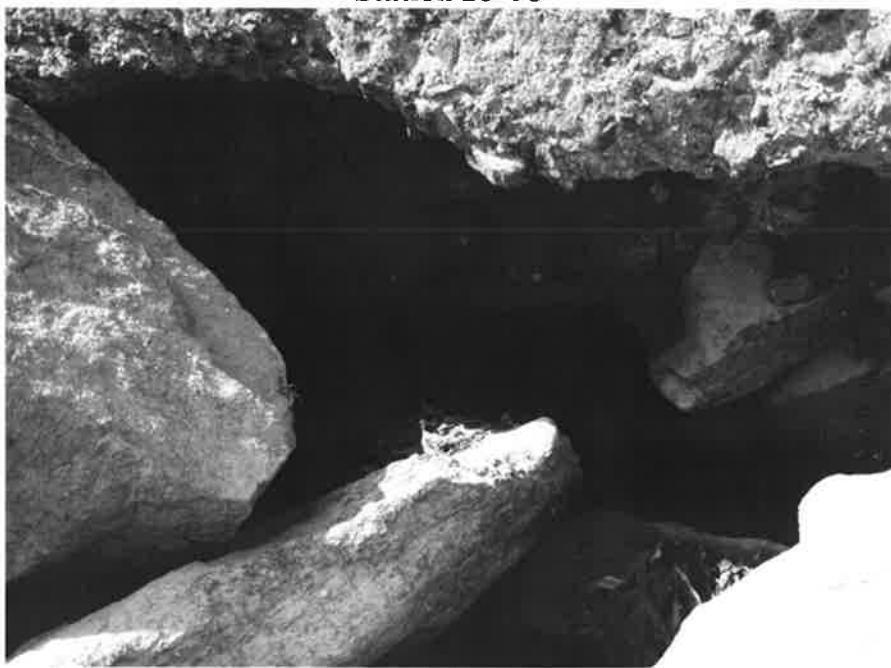
**Direction:** Seawall**Comments:** Undermined Seawall

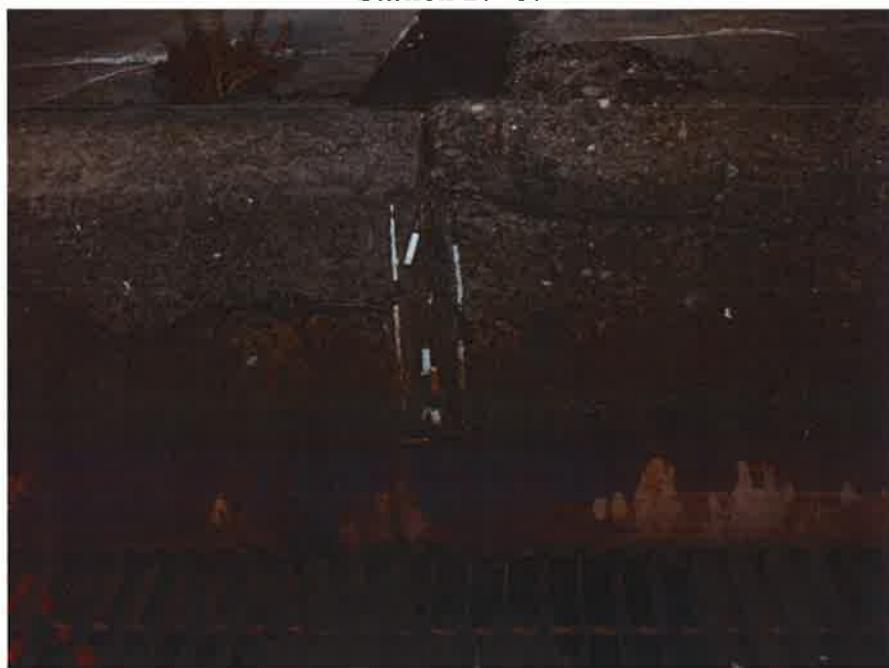
**Station 27+07**

**Direction:** Seawall Joint**Comments:** Concrete Spalling, Missing Large Section of Concrete, Re-Bar Exposed**Station 27+07**

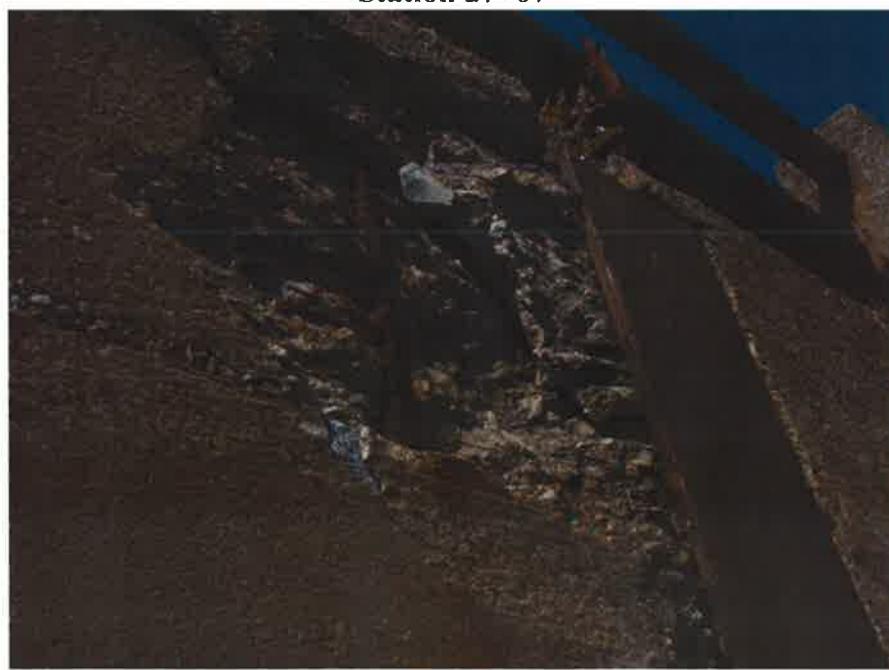
**Direction:** Seawall Joint**Comments:** Concrete Spalling, Missing Large Section of Concrete, Re-Bar Exposed

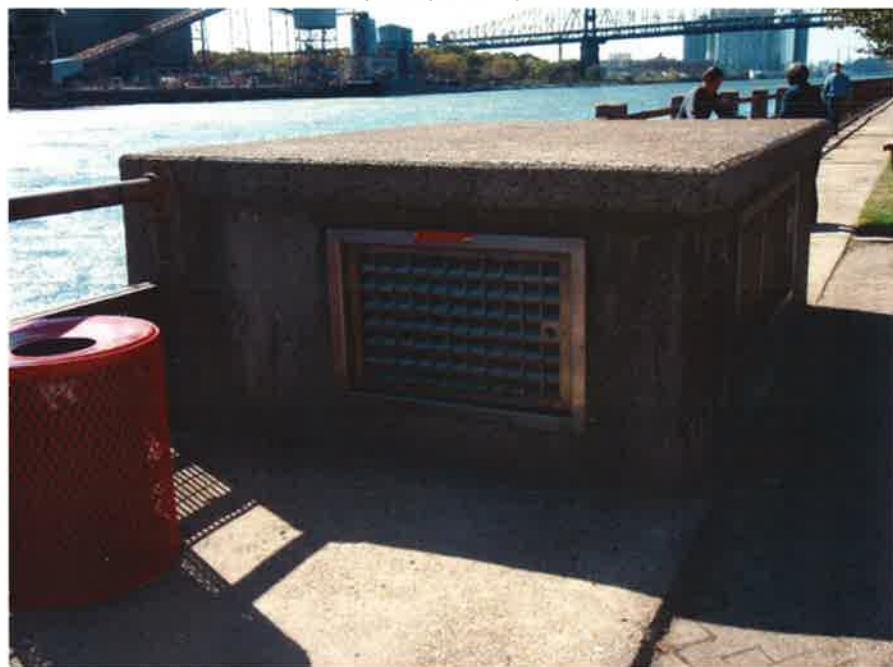
**Station 27+92**

**Direction:** Air Vent 7**Comments:** Northern Face**Station 27+92**

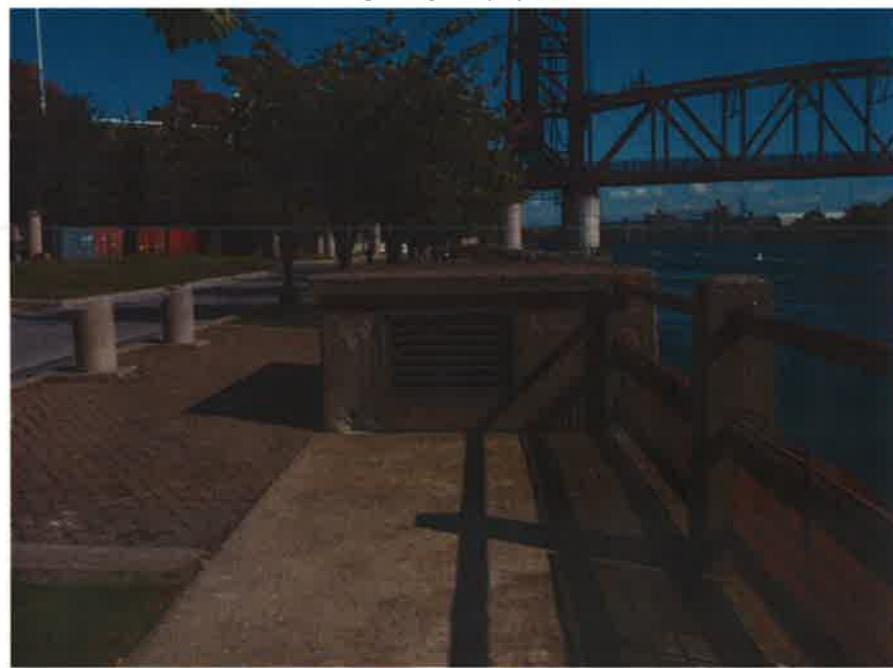
**Direction:** Air Vent 7**Comments:** Sothern Face

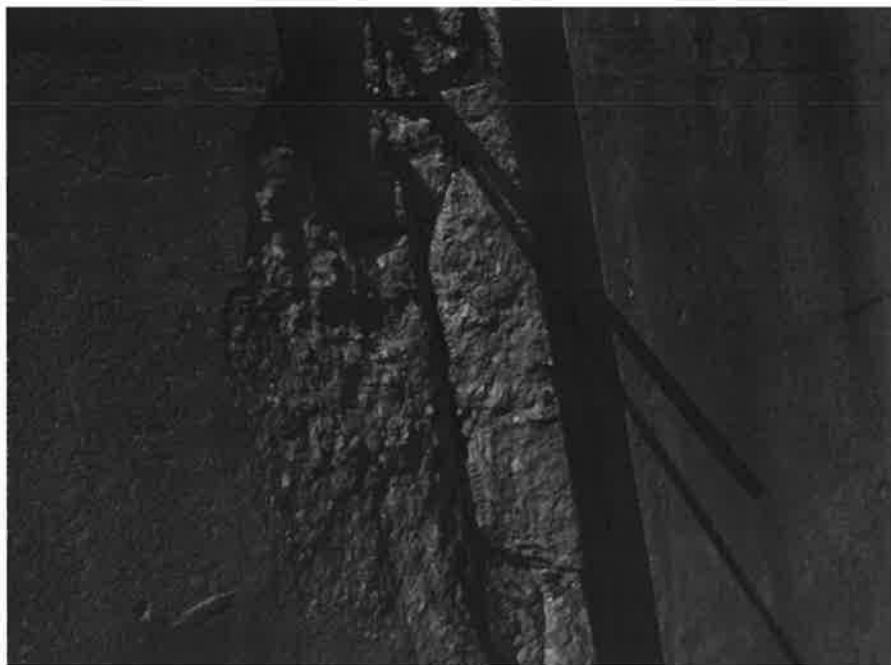
**Station 28+02**

**Direction:** Seawall Joint**Comments:** Concrete Spalling, Missing Large Section of Concrete, Re-Bar Exposed**Station 28+24**

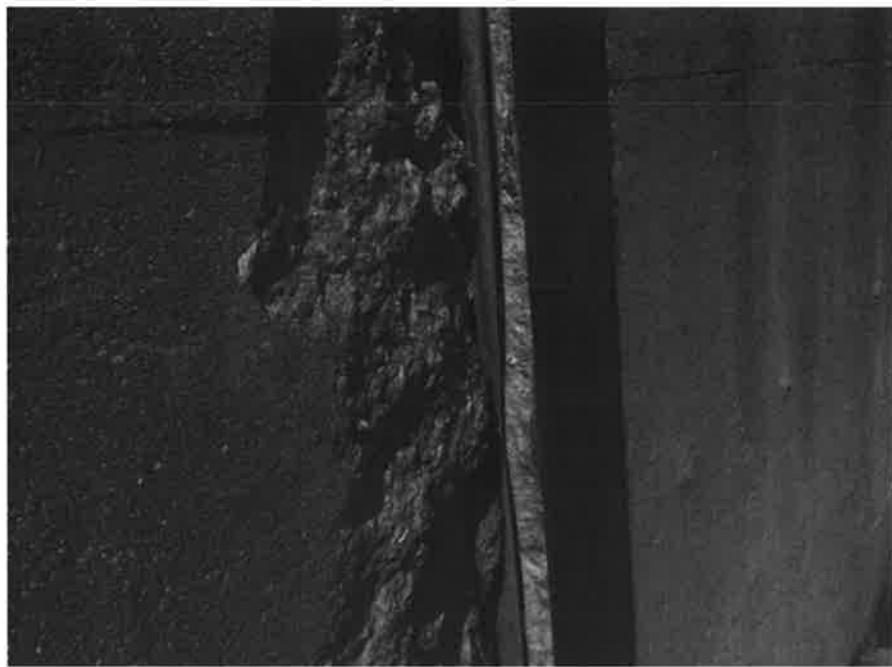
**Station 28+96**

**Direction:** Seawall Joint**Comments:** Concrete Spalling, Missing Large Section of Concrete, Re-Bar Exposed**Station 28+96**

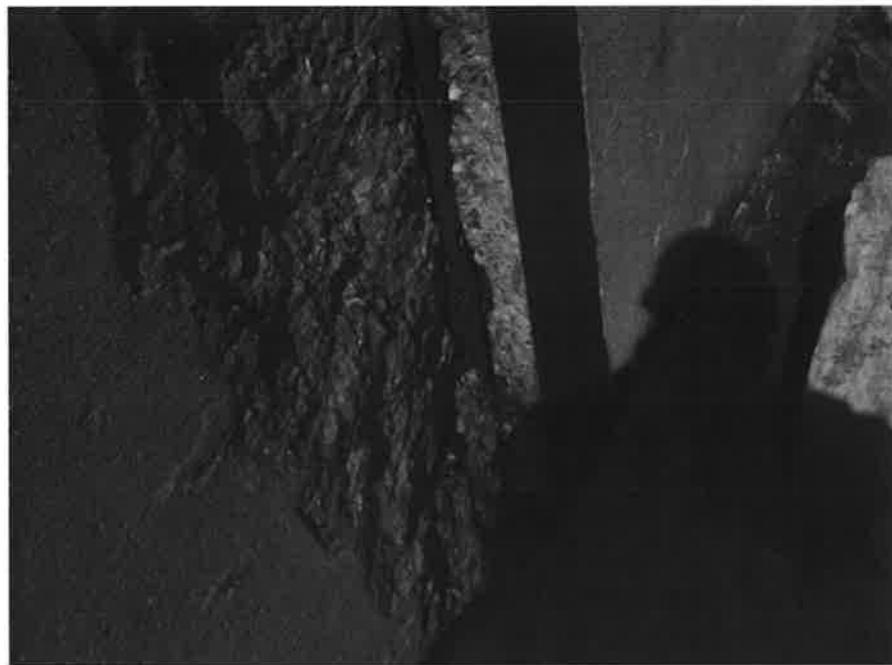
**Station 29+62**

**Direction:** Seawall Joint**Comments:** Concrete Spalling, Missing Large Section of Concrete, Re-Bar Exposed**Station 30+24**

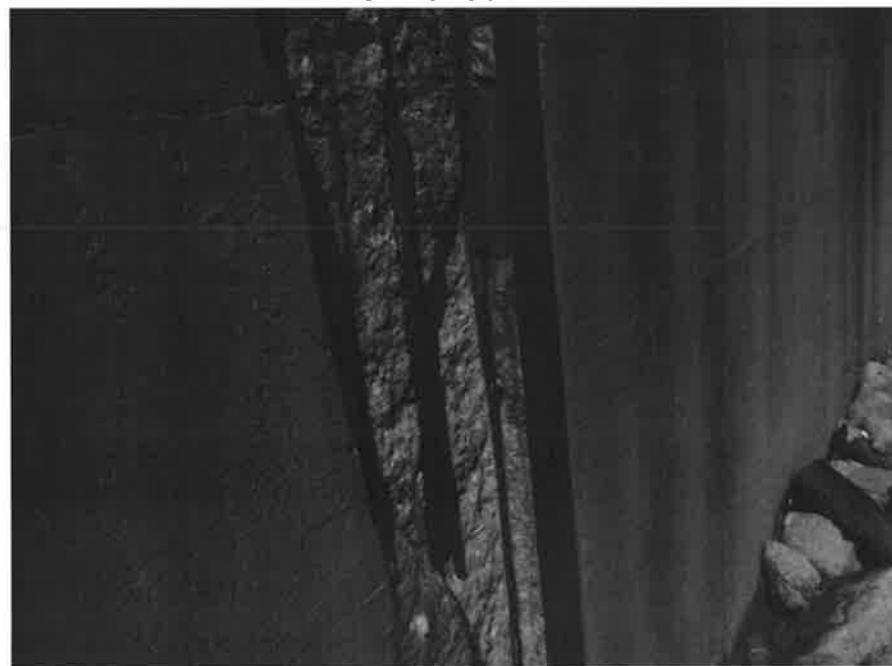
**Direction:** Seawall Joint**Comments:** Concrete Spalling, Missing Large Section of Concrete, Re-Bar Exposed

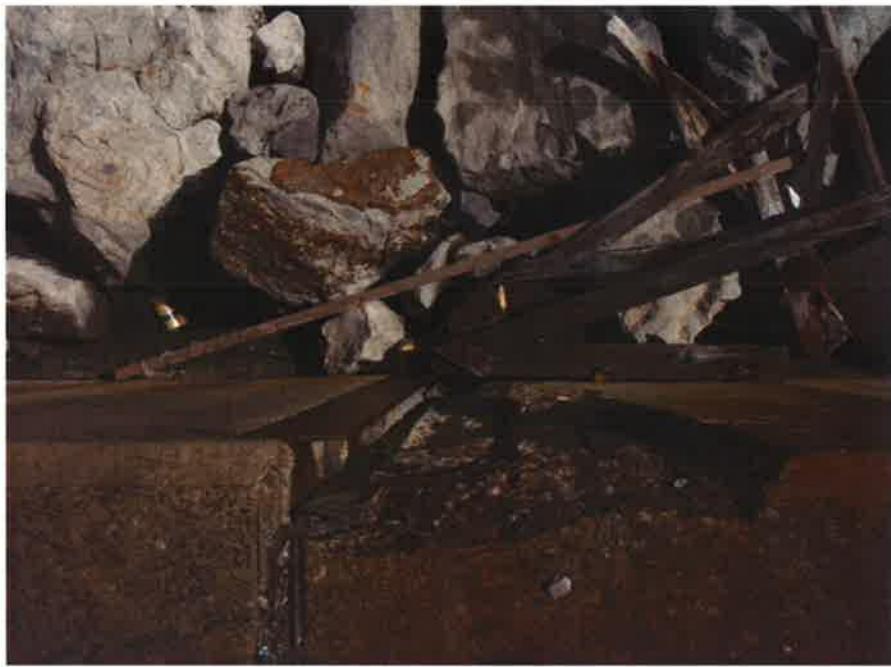
**Station 30+24**

**Direction:** Seawall Joint**Comments:** Concrete Spalling, Missing Large Section of Concrete, Re-Bar Exposed**Station 30+46**

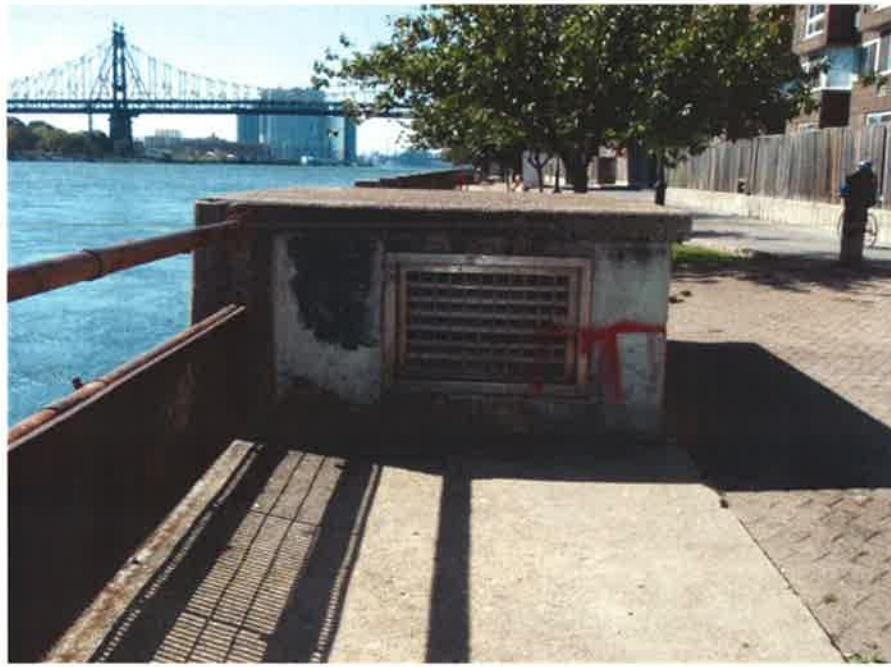
**Direction:** Air Vent 6**Comments:** Northern Face

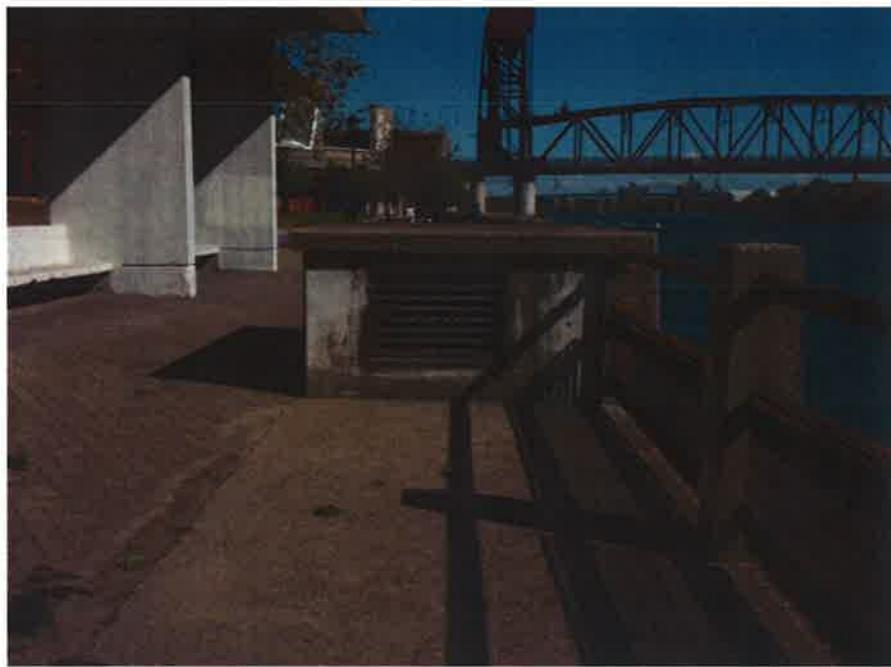
**Station 30+46**

**Direction:** Air Vent 6**Comments:** Sothern Face**Station 30+88**

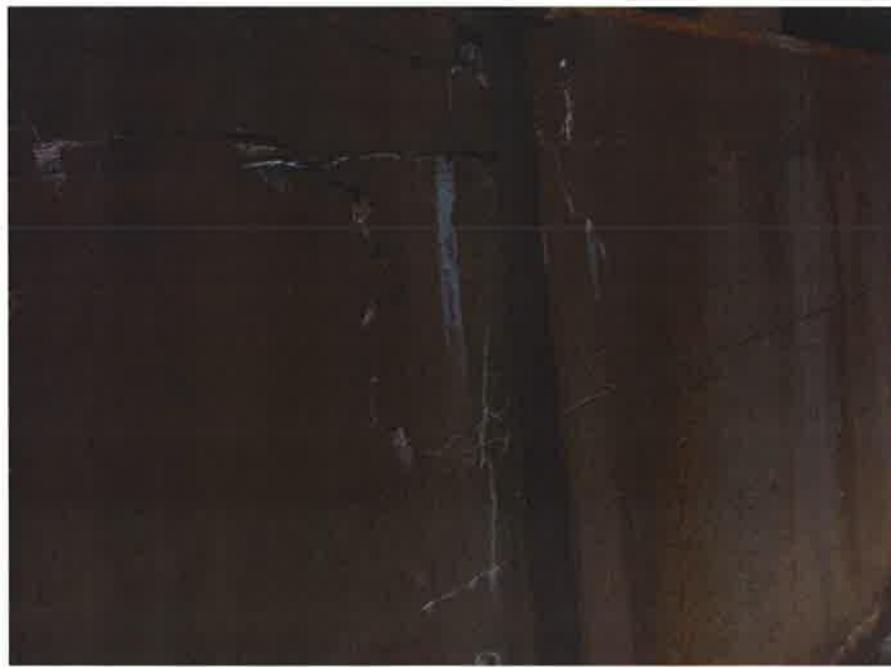
**Direction:** Seawall Joint**Comments:** Concrete Spalling, Missing Large Section of Concrete, Re-Bar Exposed

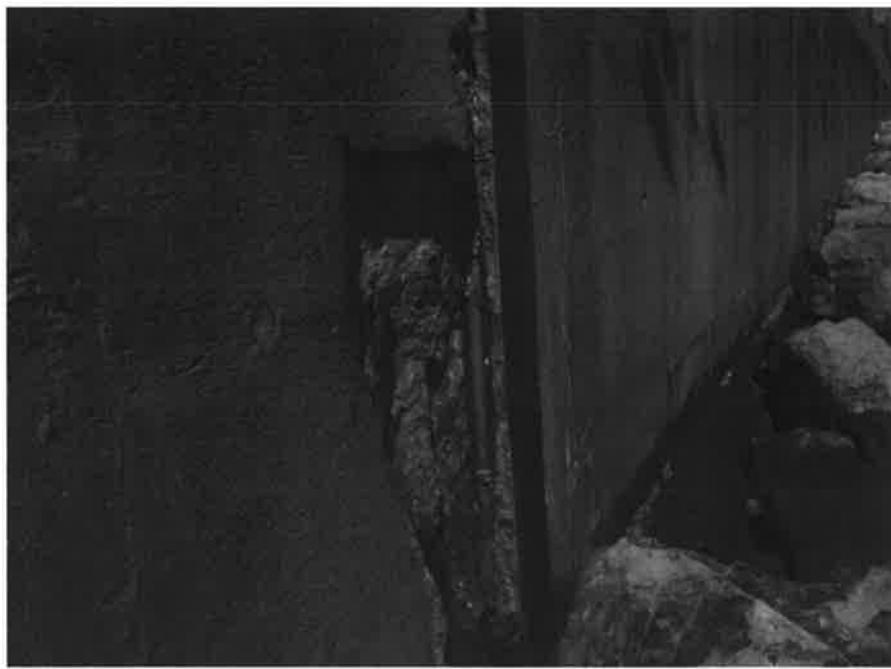
**Station 31+52**

**Direction:** Seawall Joint**Comments:** Concrete Spalling, Missing Large Section of Concrete, Re-Bar Exposed**Station 31+52**

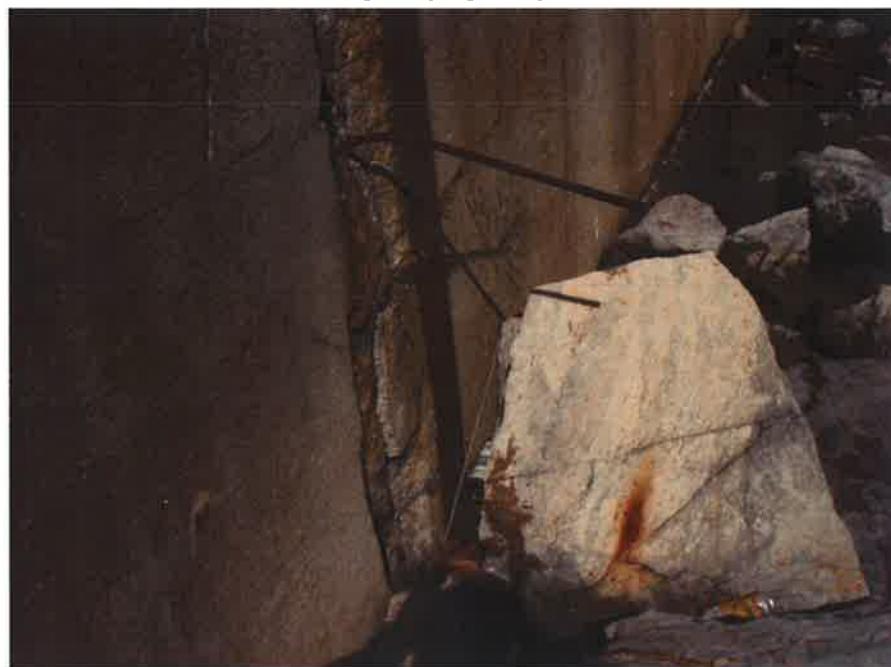
**Station 32+16**

**Direction:** Seawall Joint**Comments:** Concrete Spalling, Loose Section of Concrete, Re-Bar Exposed**Station 32+16**

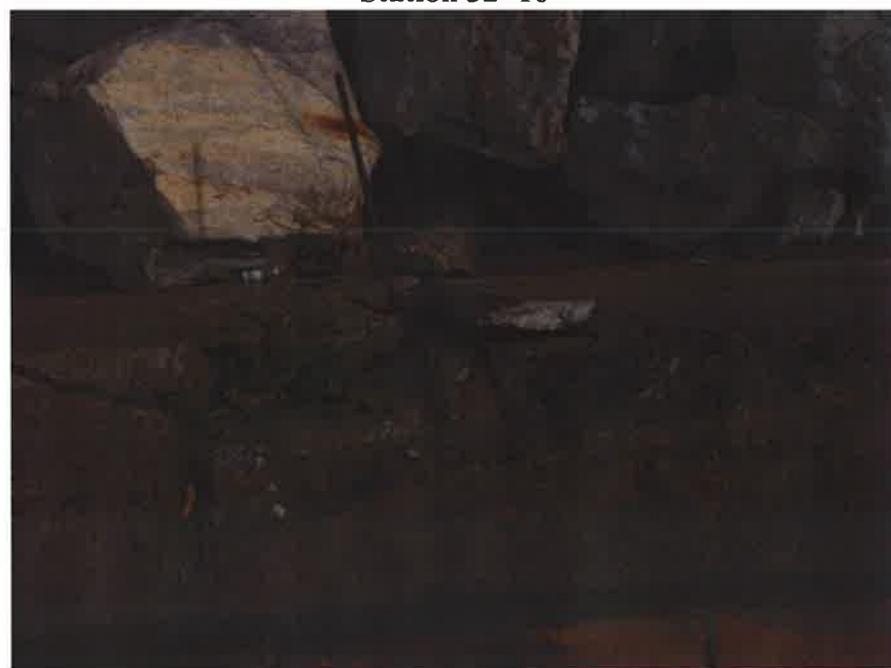
**Direction:** Seawall Joint**Comments:** Concrete Spalling, Missing Large Section of Concrete, Re-Bar Exposed and Loose

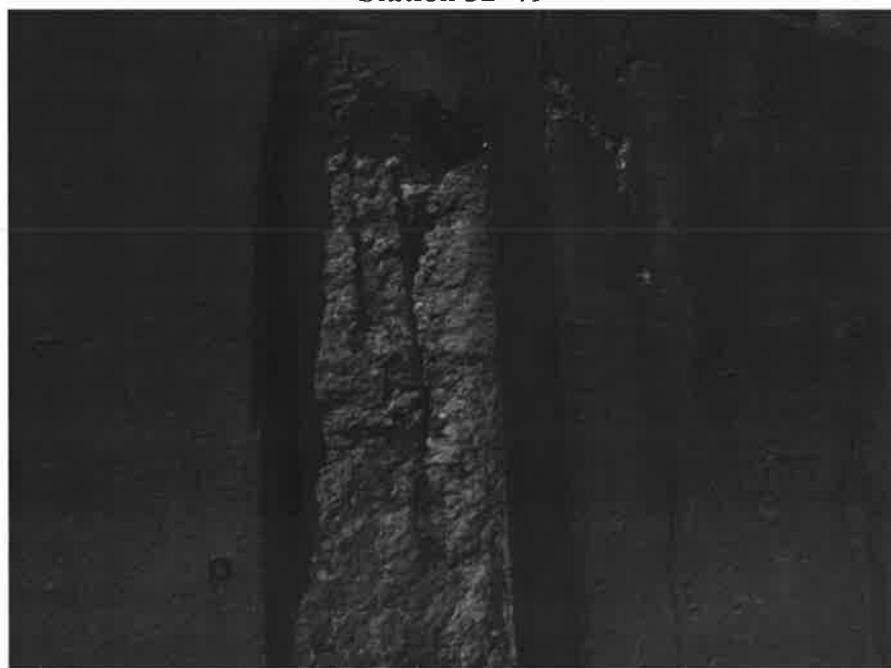
**Direction:** Seawall Joint**Comments:** Concrete Spalling, Missing Large Section of Concrete, Re-Bar Exposed

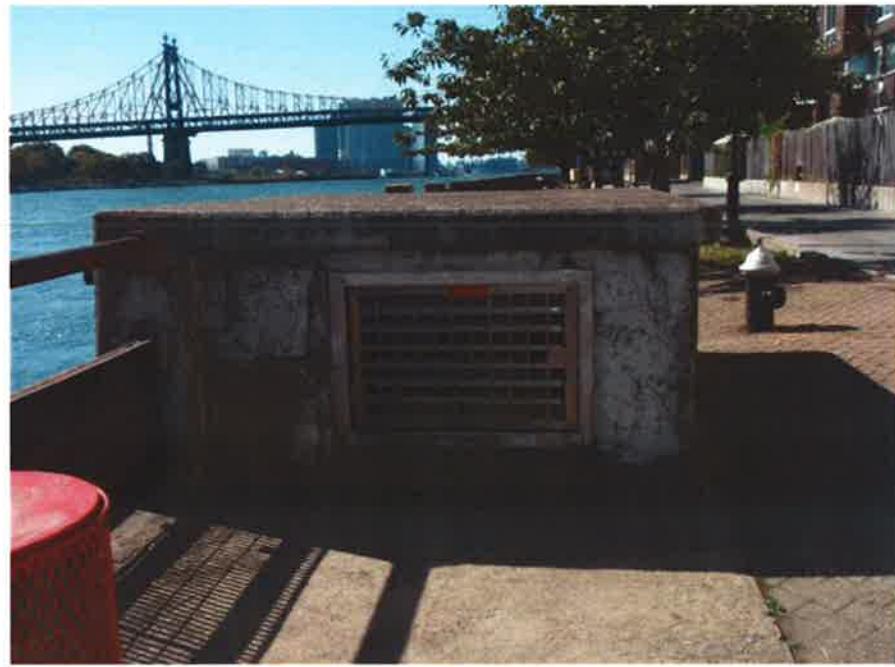
**Direction:** Air Vent 5**Comments:** Northern Face

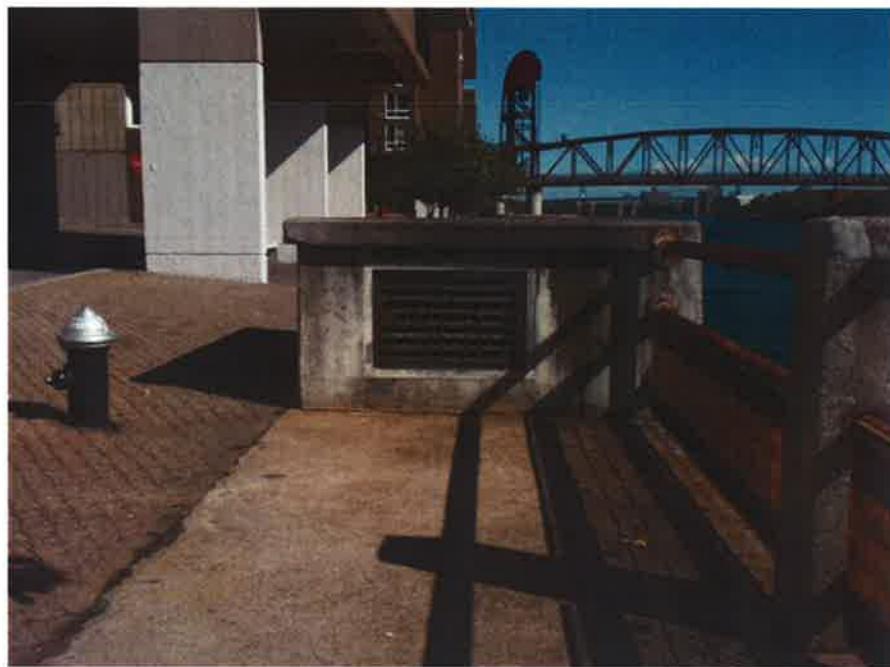
**Station 33+00**

**Direction:** Air Vent 5**Comments:** Sothern Face**Station 33+84**

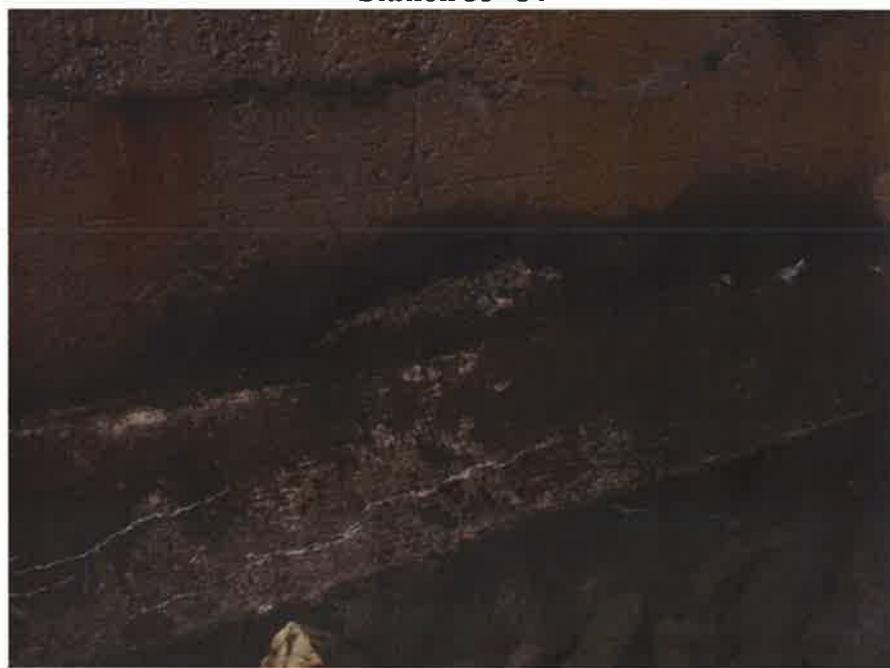
**Direction:** Seawall**Comments:** Concrete Spalling

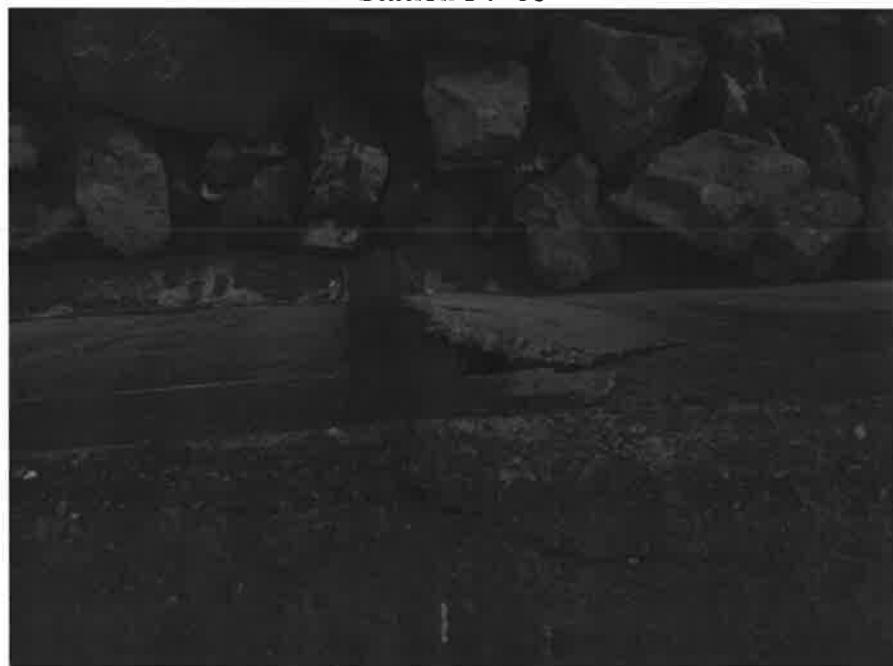
**Direction:** Seawall Joint**Comments:** Concrete Repair Spalling

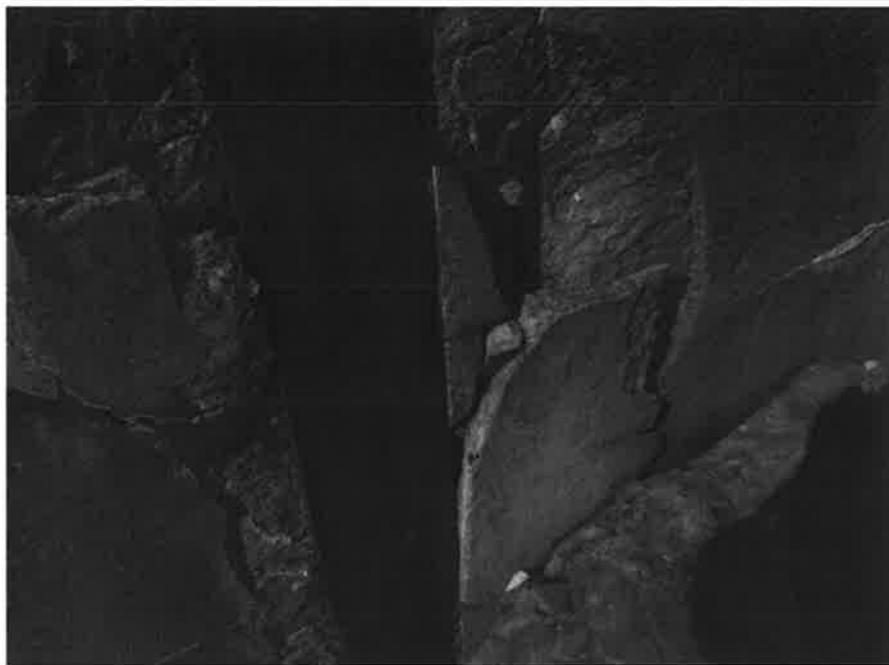
**Station 34+70**

**Direction:** Seawall Joint**Comments:** Concrete Spalling, Missing Large Section of Concrete, Re-Bar Exposed**Station 34+70**

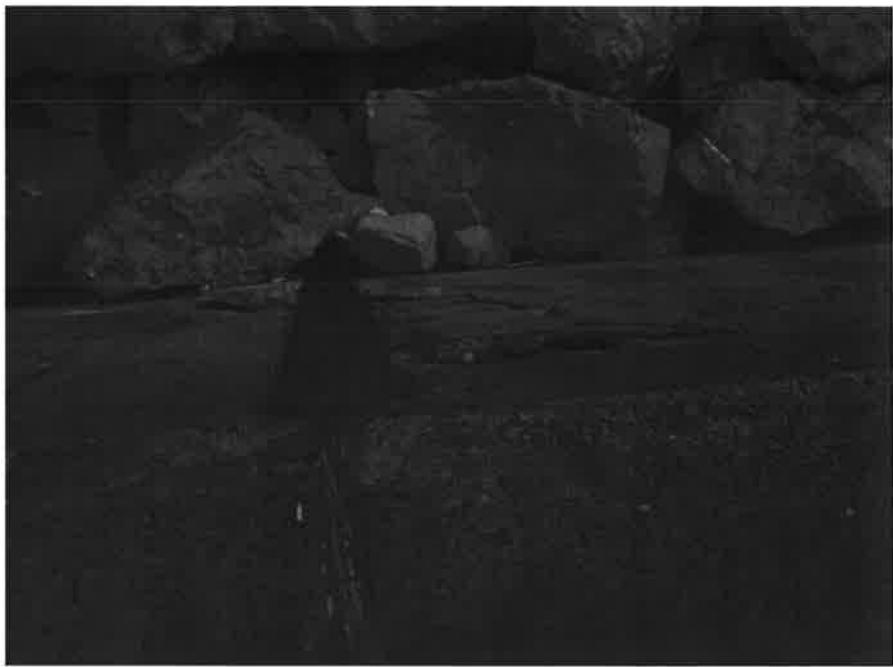
**Station 34+70**

**Direction:** Seawall Joint**Comments:** Concrete Spalling, Loose Concrete**Station 35+38**

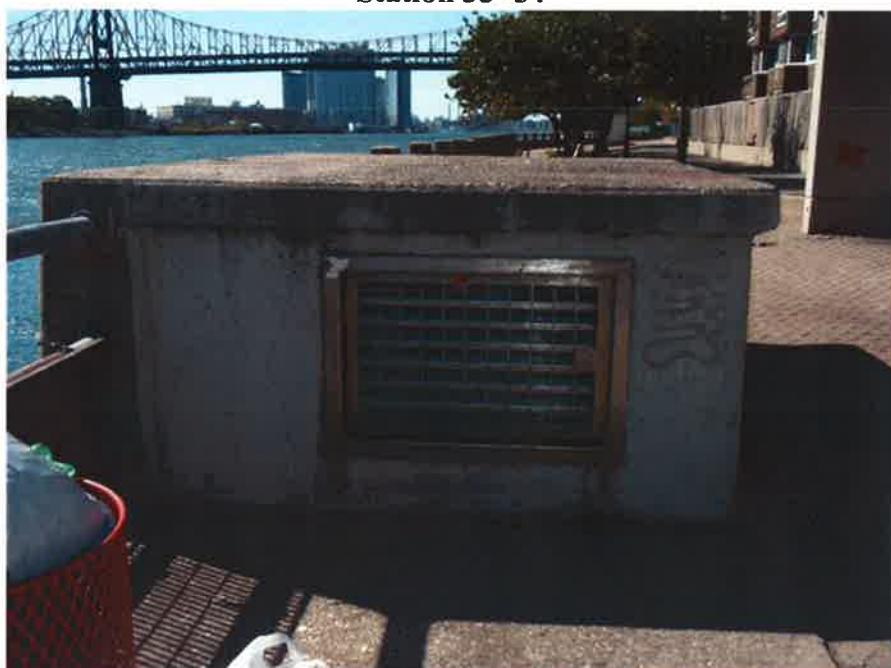
**Station 35+54**

**Direction:** Air Vent 4**Comments:** Northern Face**Station 35+54**

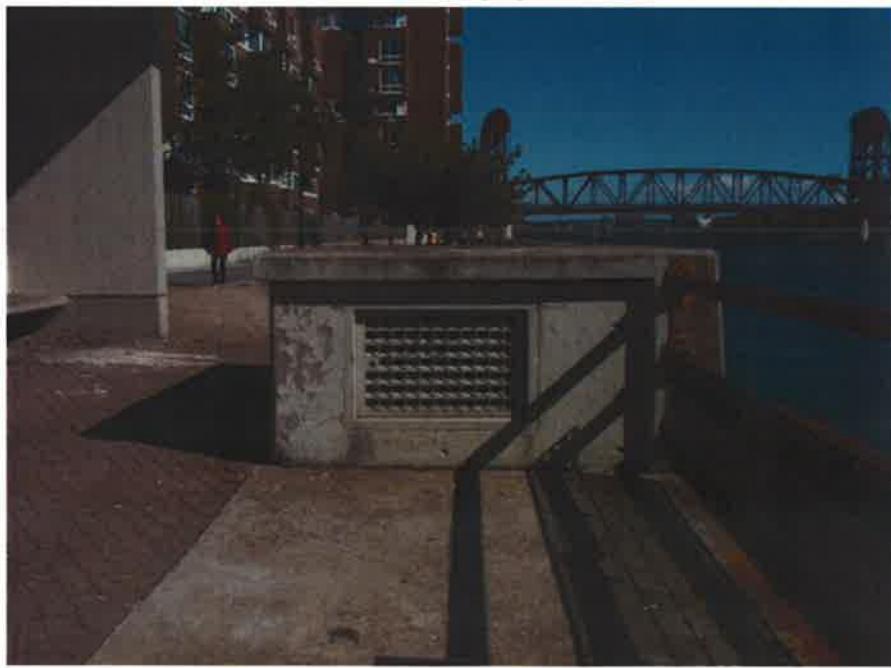
**Direction:** Air Vent 4**Comments:** Sothern Face

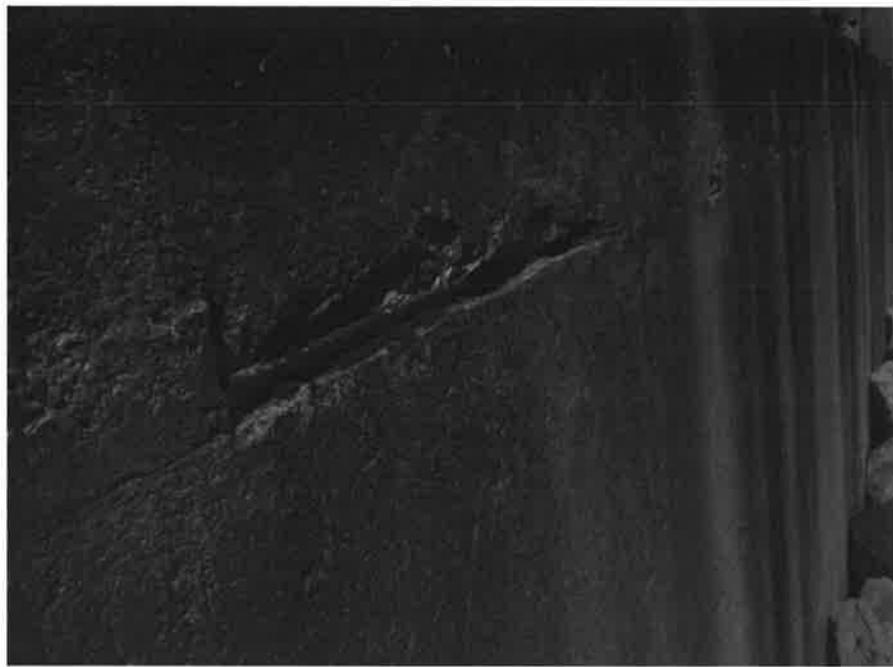
**Station 35+93**

**Direction:** Seawall**Comments:** Exposed Re-Bar, Concrete Spalling**Station 37+22**

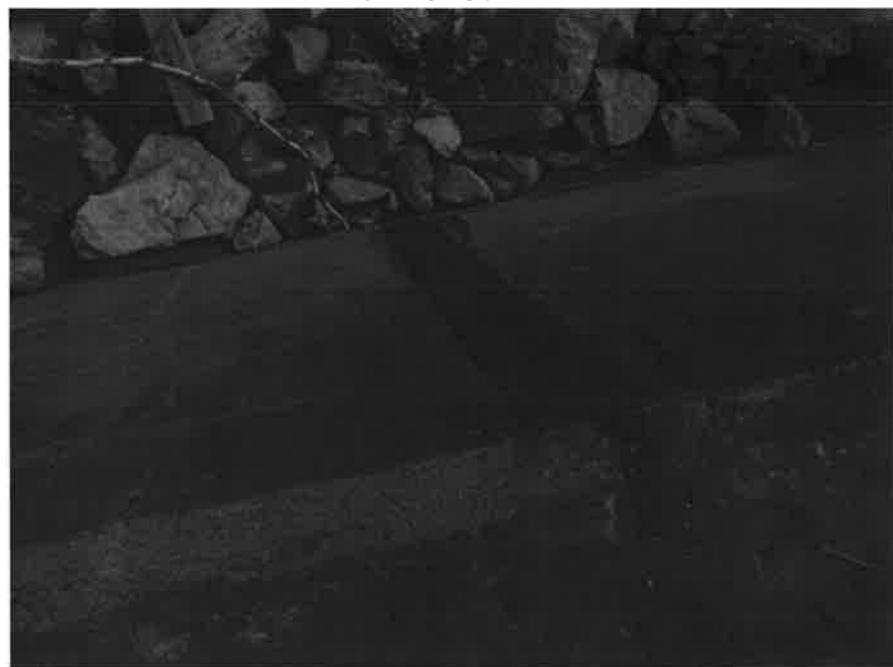
**Station 37+22**

**Direction:** Seawall Joint**Comments:** Concrete Spalling

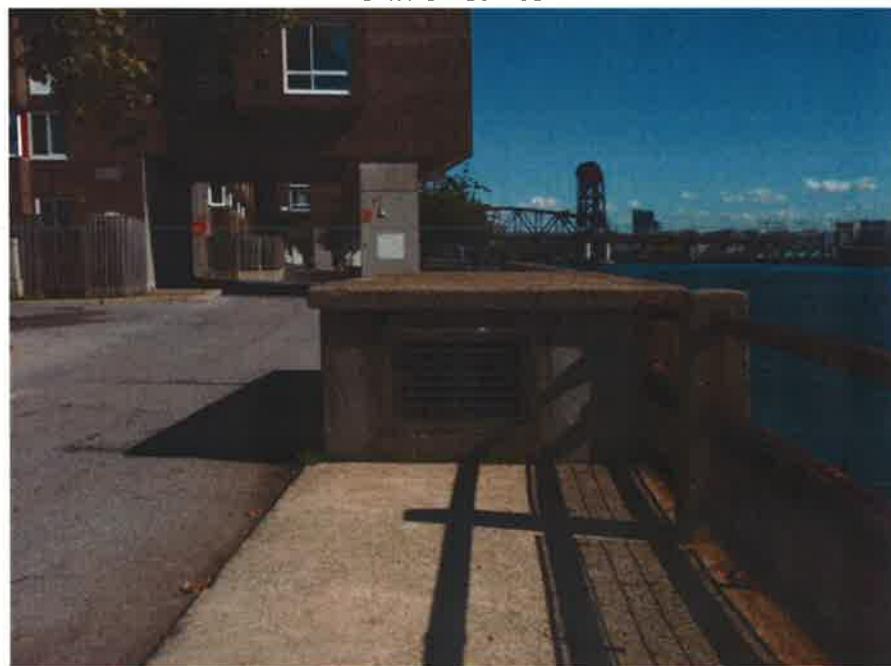
**Direction:** Air Vent 3**Comments:** Northern Face**Station 39+03**

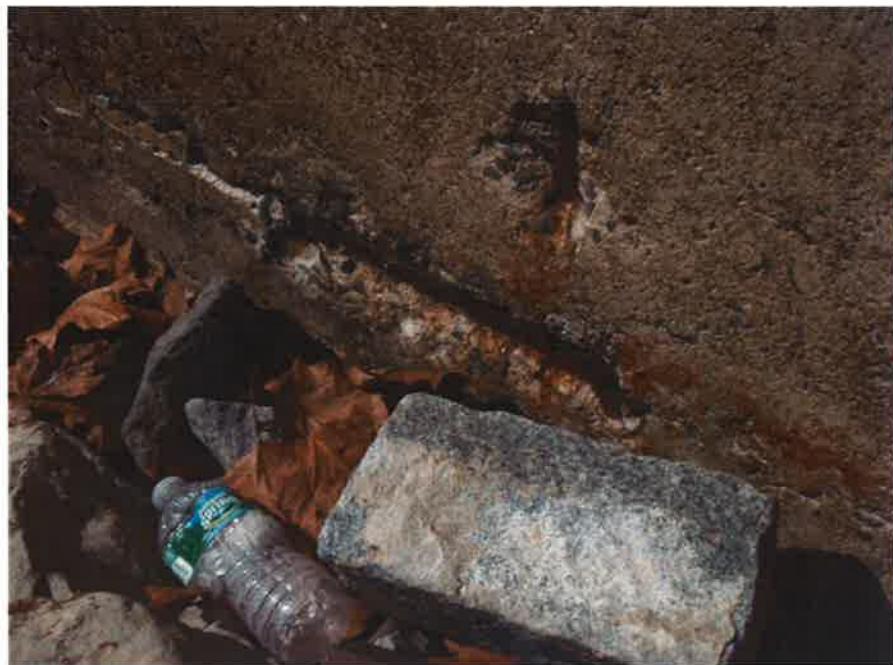
**Station 39+22**

**Direction:** Air Vent 3**Comments:** Sothern Face

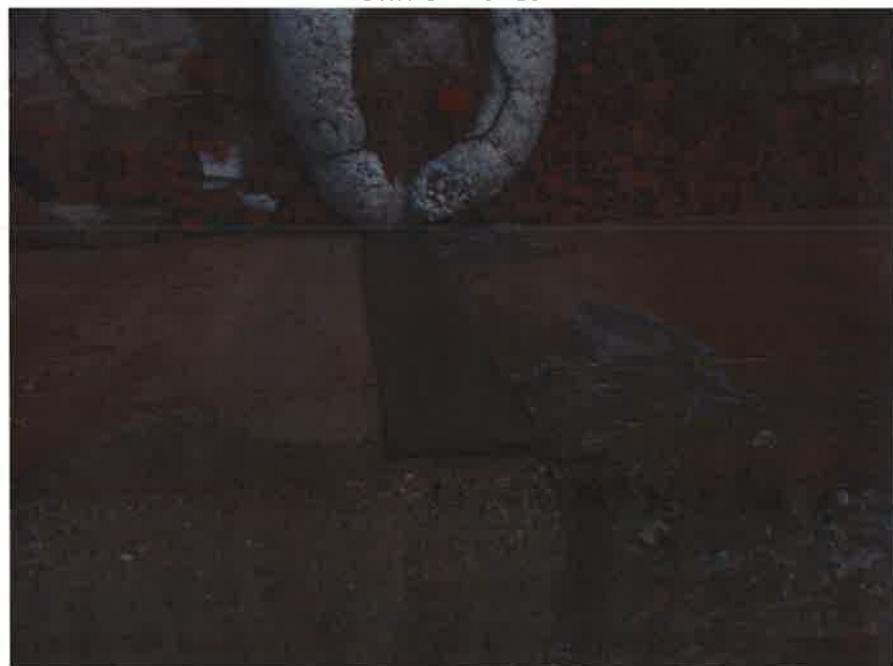
**Direction:** Seawall**Comments:** Exposed Re-Bar**Station 40+39**

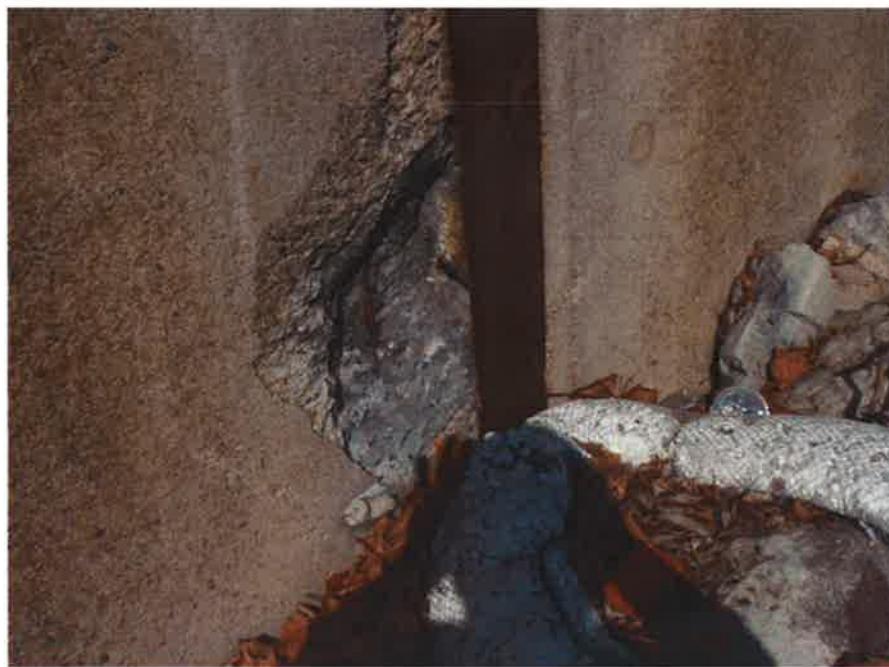
**Station 40+39**

**Direction:** Seawall Joint**Comments:** Concrete Spalling

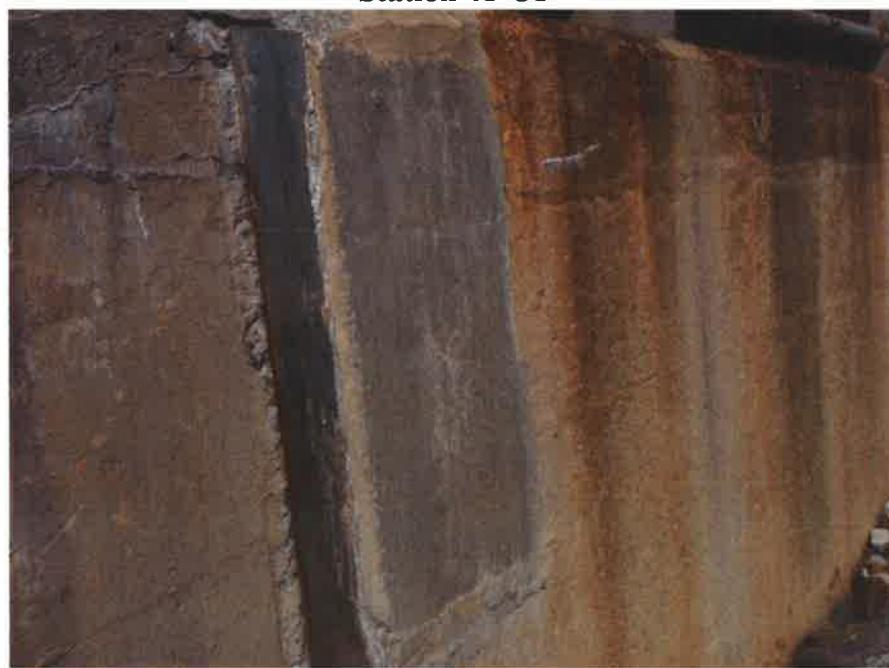
**Direction:** Seawall Joint**Comments:** Concrete Spalling**Station 41+31**

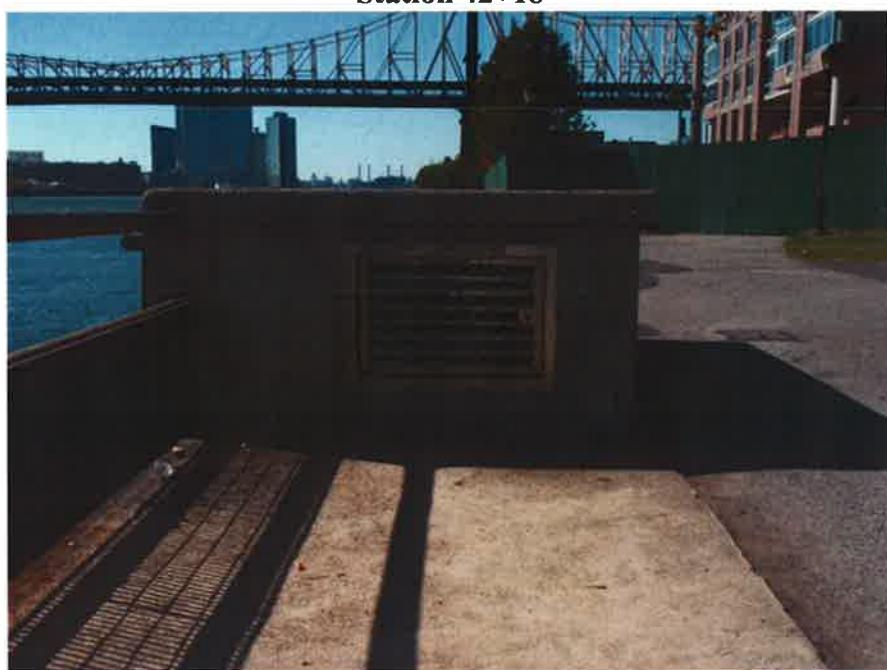
**Station 42+18**

**Direction:** Seawall**Comments:** Concrete Repair
