# CONDITIONS REPORT & DESIGN MEMORANDUM

## STEAM TUNNEL ASSESSMENT ROOSEVELT ISLAND, NEW YORK

**ROOSEVELT ISLAND OPERATING CORPORATION**  
591 MAIN STREET  
ROOSEVELT ISLAND  
NEW YORK, NEW YORK 10044

*17 November 2014  
Project # 100444601*

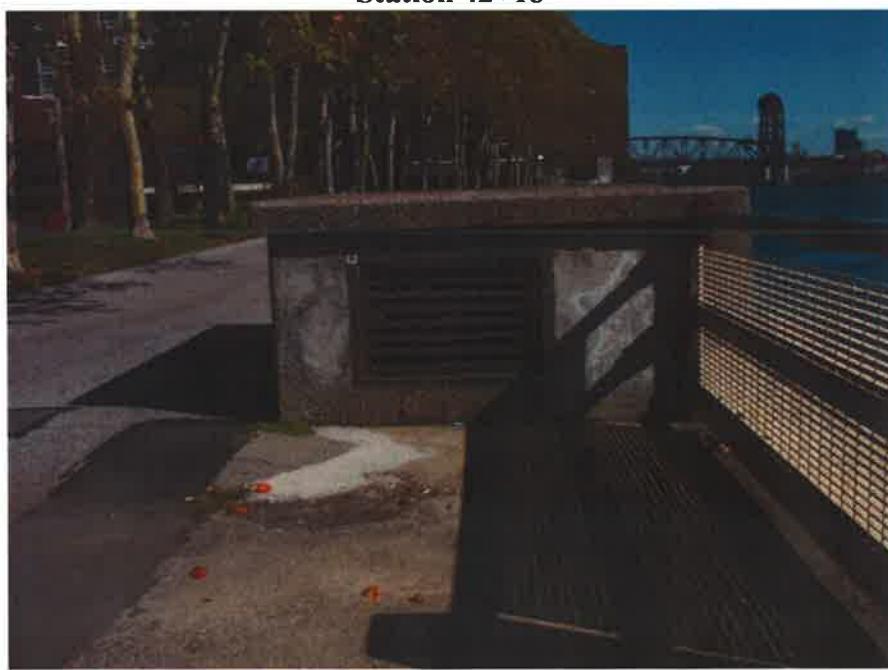
**Direction:** Air Vent 2**Comments:** Northern Face**Station 42+18**

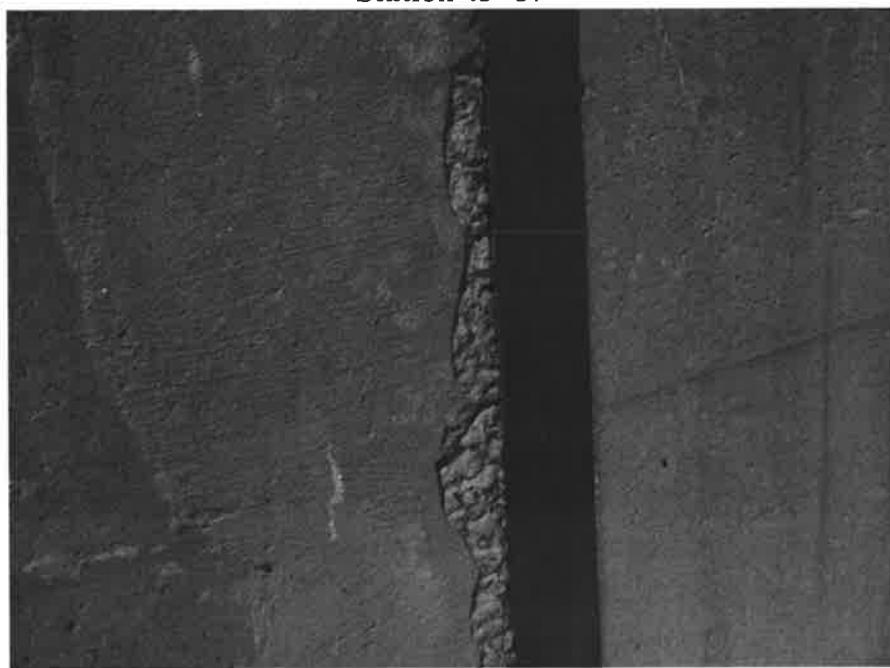
**Direction:** Seawall**Comments:** Exposed Re-Bar**Station 43+87**

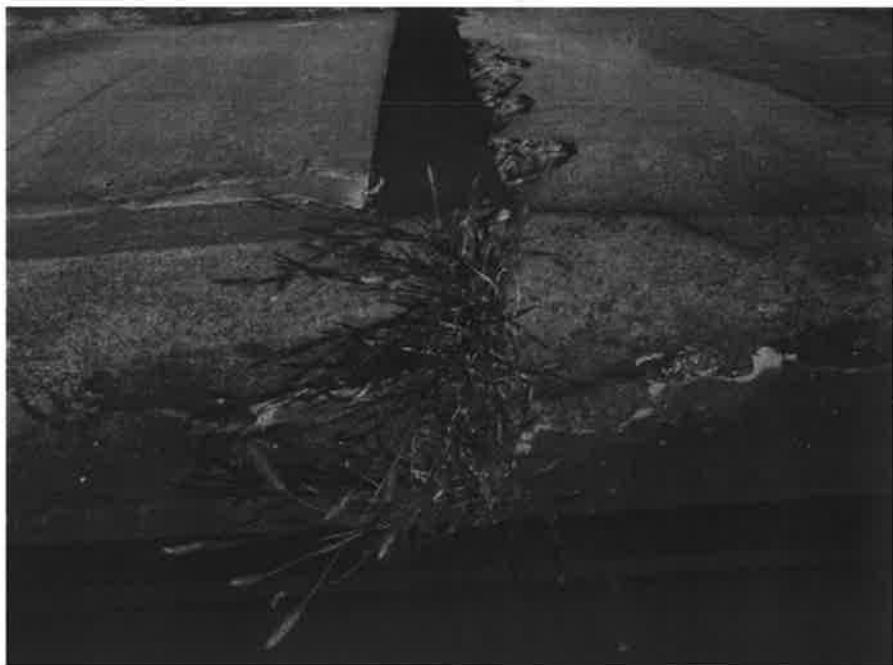
**Station 43+87**

**Direction:** Seawall Joint**Comments:** Spalling and Concrete Repairs

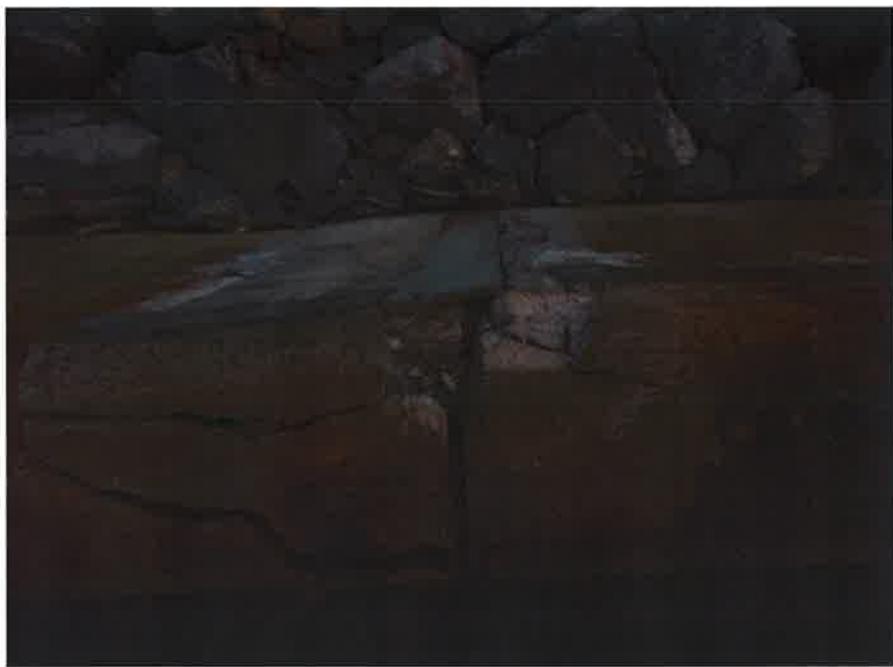
**Station 45+77**

**Direction:** Seawall**Comments:** Exposed Re-Bar

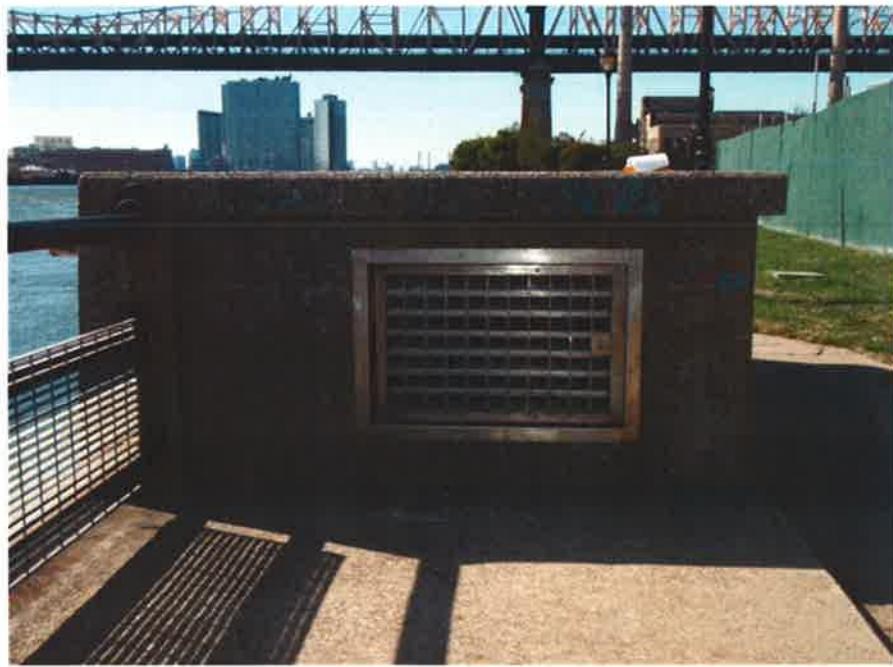
**Direction:** Seawall Joint**Comments:** Concrete Spalling, Large Concrete Cracks**Station 45+34**

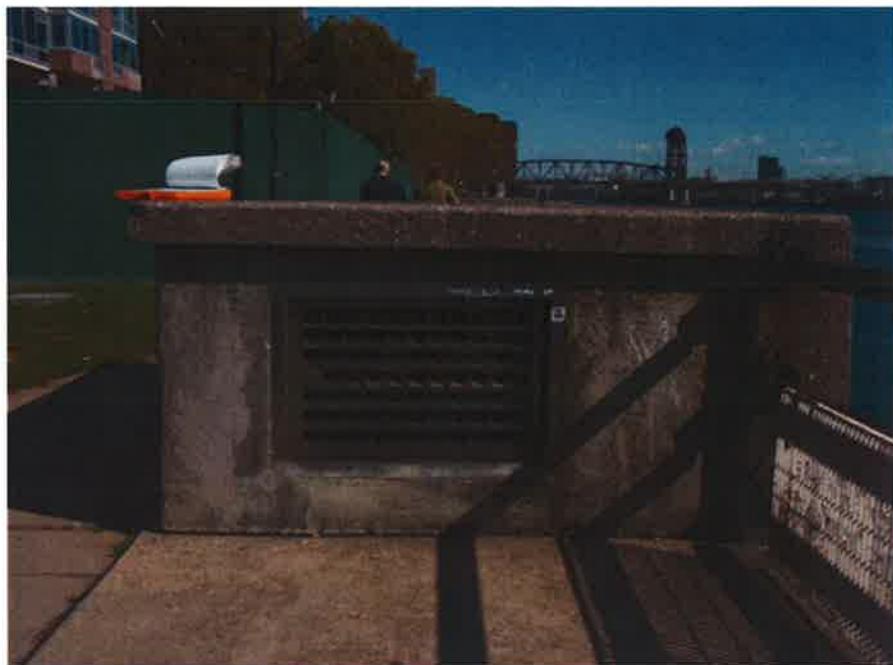
**Station 45+34**

**Direction:** Air Vent 1**Comments:** Northern Face

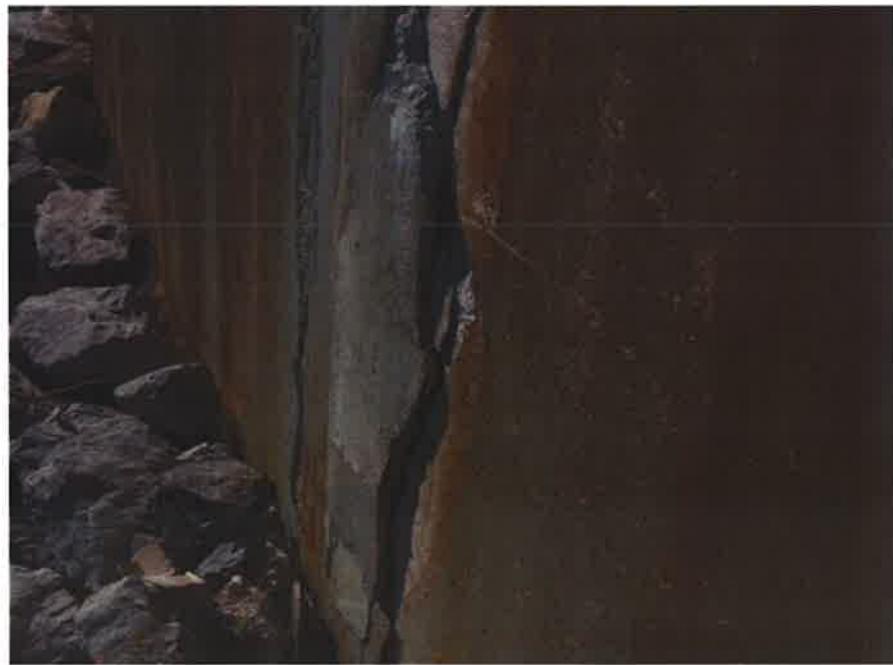
**Direction:** Air Vent 1**Comments:** Sothern Face**Station 45+77**

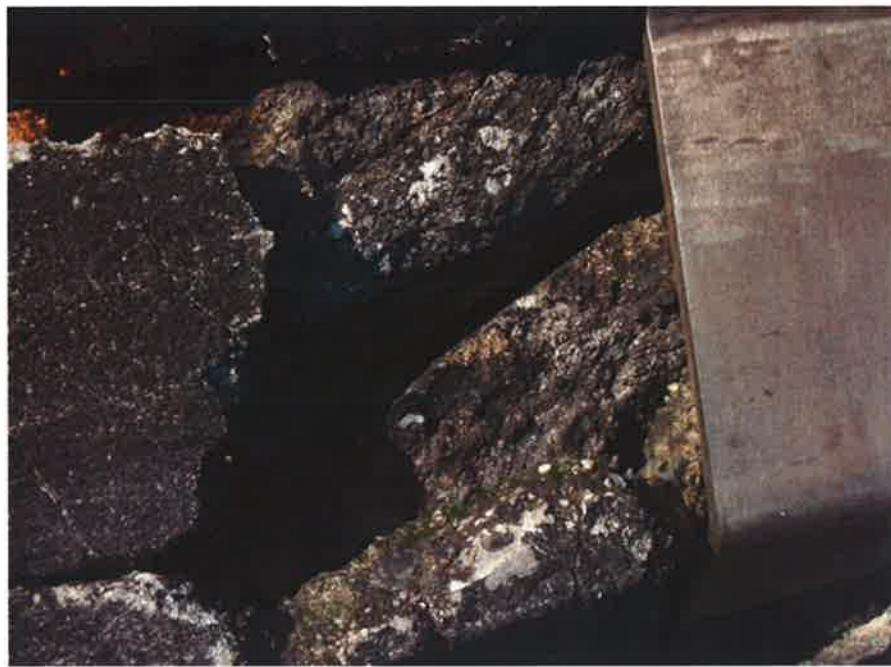
**Station 45+97**

**Direction:** Seawall Joint**Comments:** Concrete Spalling, Missing Large Section of Concrete, Re-Bar Exposed

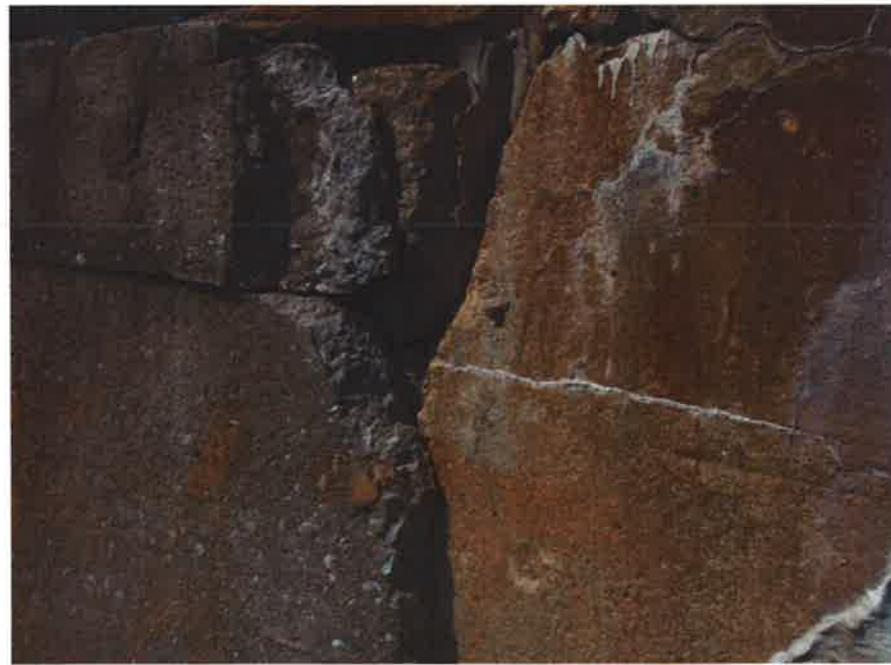
**Station 45+97**

**Comments:** Spalling at Haunch

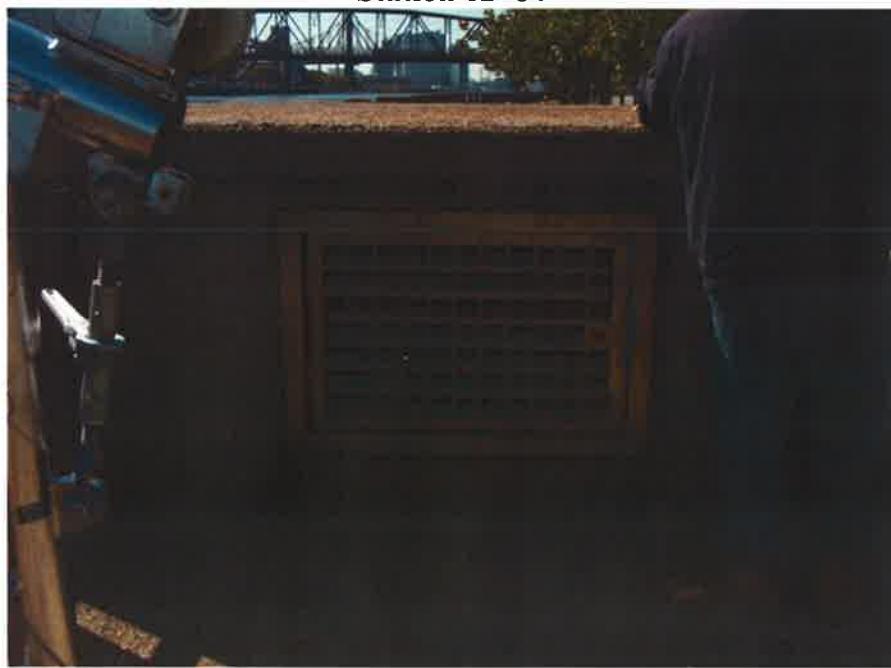
**Direction:** Air Vent 13**Comments:** Northern Face Door Unlocked, Broken Lock**Station 12+84**

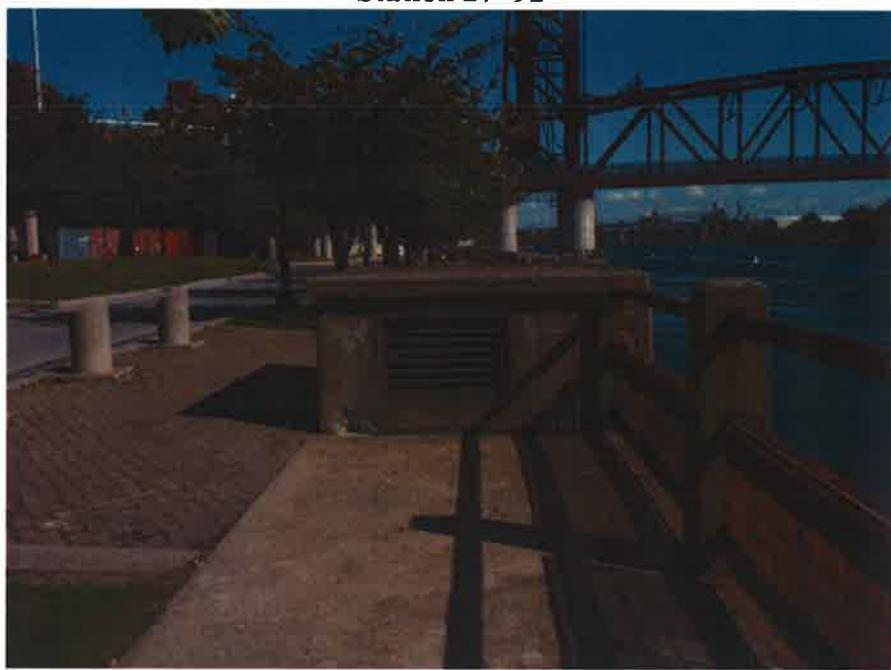
**Station 27+92**

**Direction:** Air Vent 7**Comments:** Northern Face

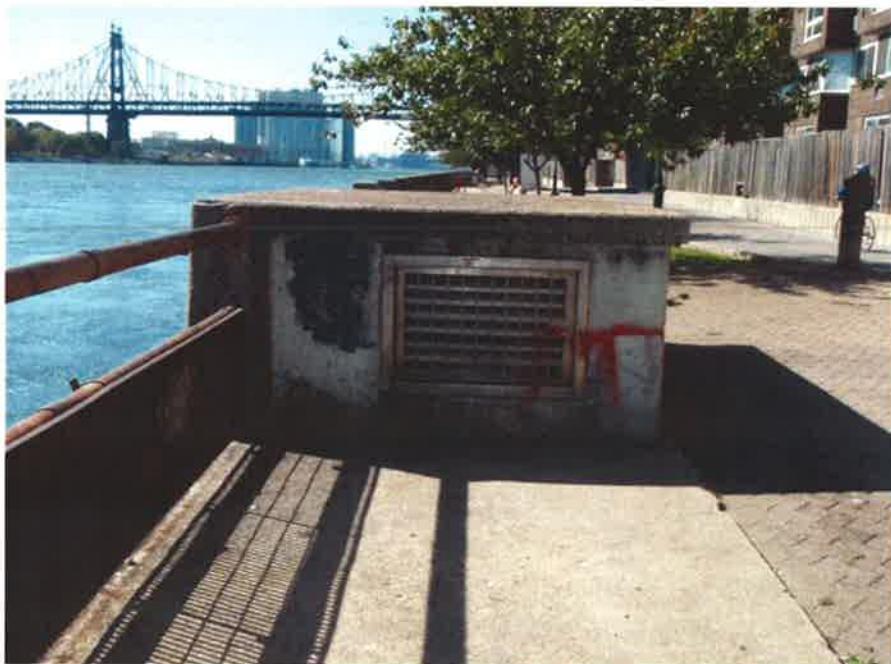
**Direction:** Air Vent 7**Comments:** Southern Face**Station 30+46**

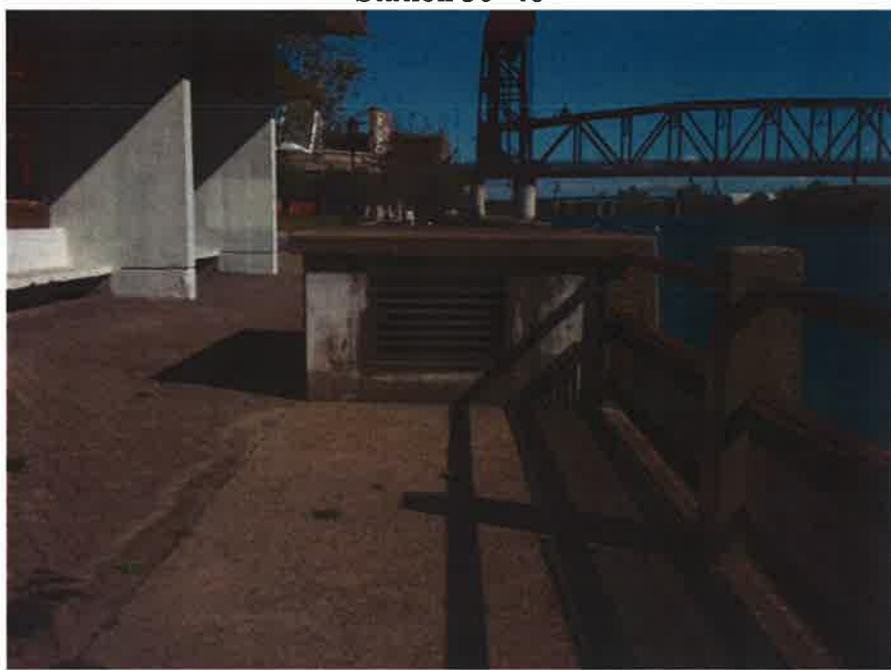
**Station 30+46**

**Direction:** Air Vent 6**Comments:** Northern Face

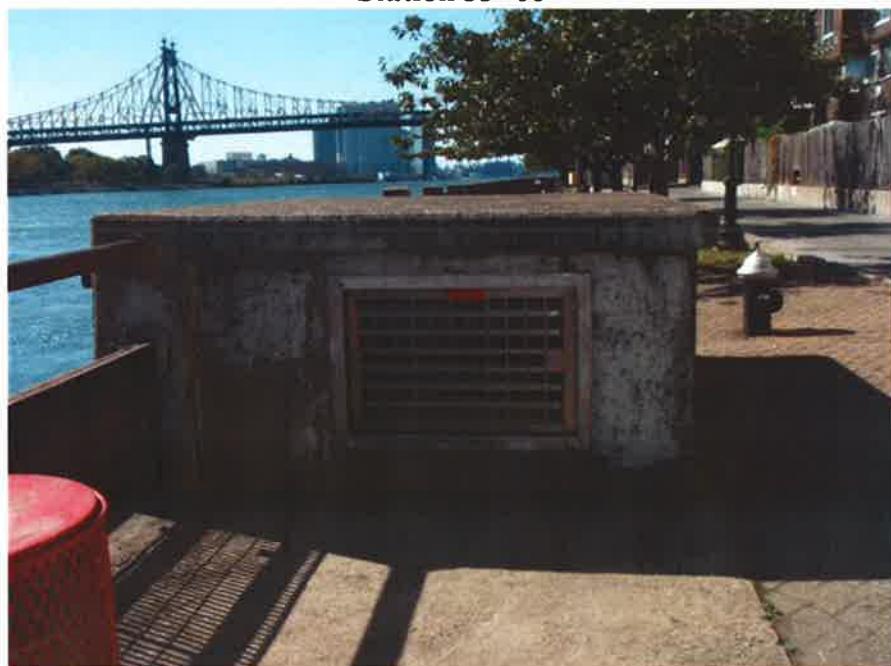
**Direction:** Air Vent 6**Comments:** Sothern Face**Station 33+00**

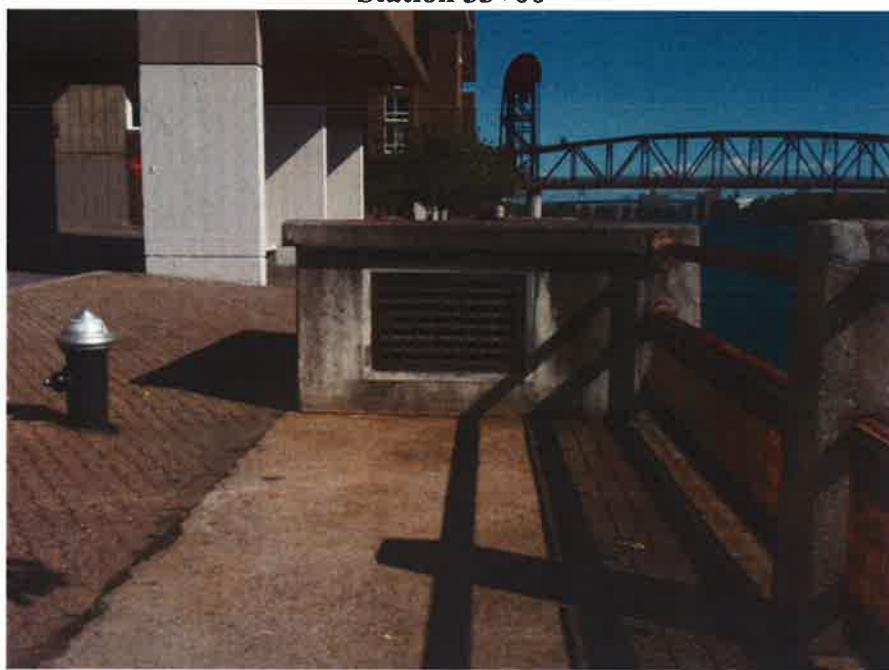
**Station 33+00**

**Direction:** Air Vent 5**Comments:** Northern Face

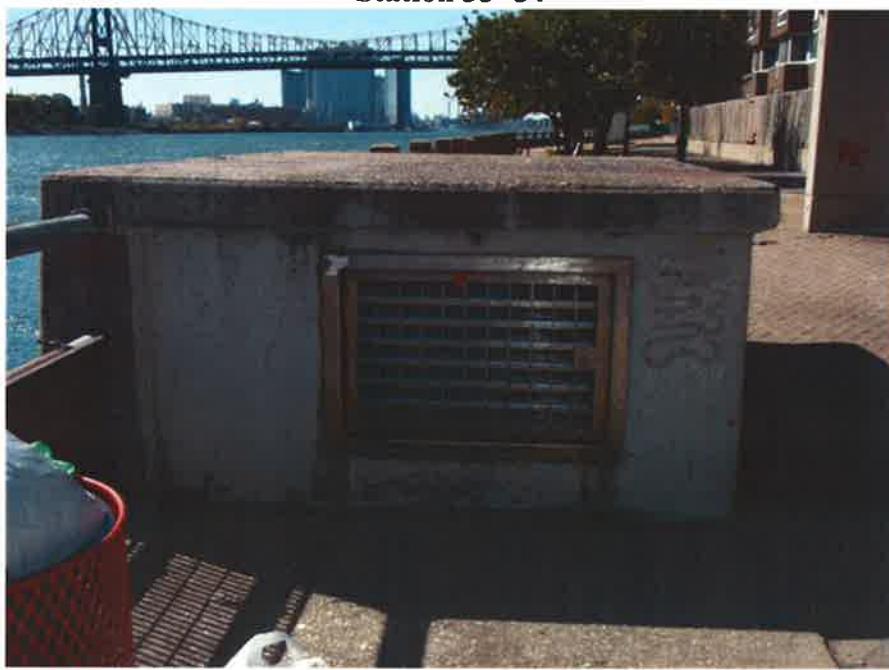
**Direction:** Air Vent 5**Comments:** Southern Face**Station 35+54**

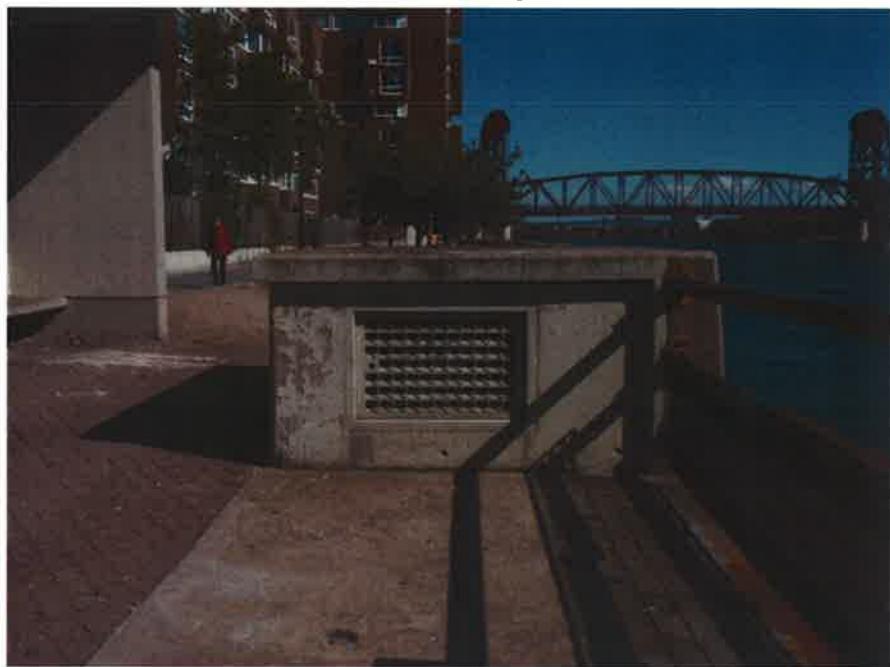
**Station 35+54**

**Direction:** Air Vent 4**Comments:** Northern Face

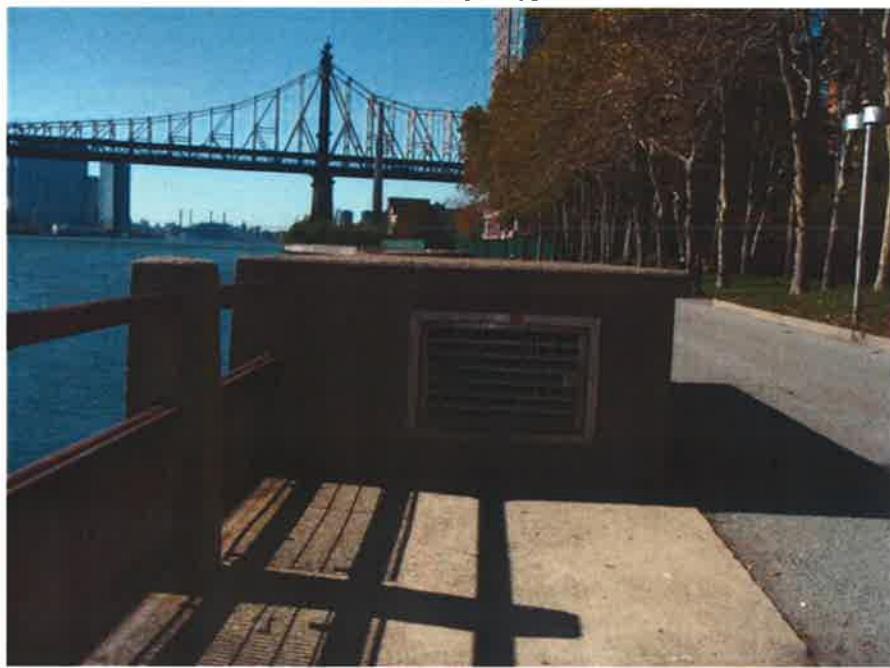
**Direction:** Air Vent 4**Comments:** Southern Face**Station 39+03**

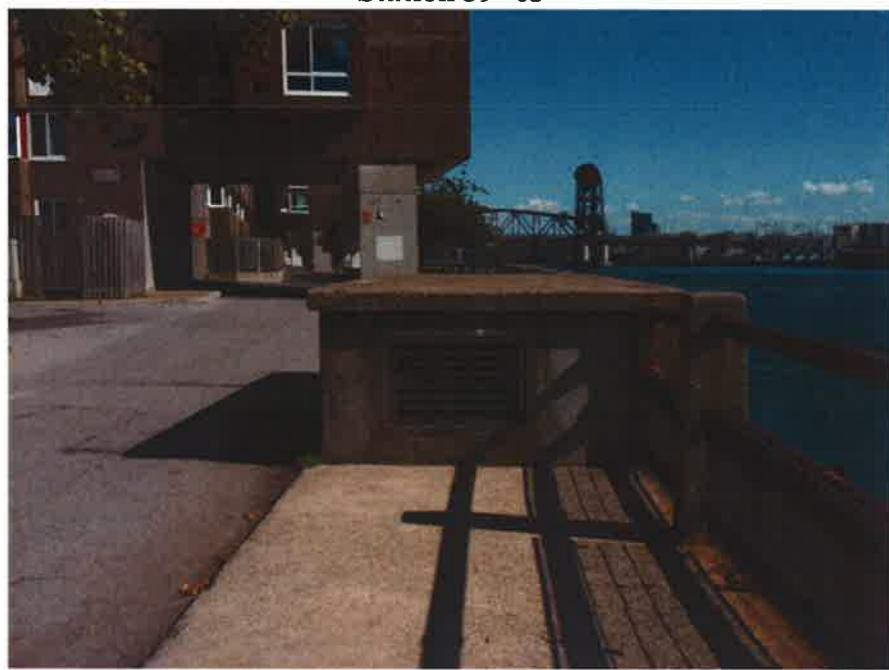
**Station 39+03**

**Direction:** Air Vent 3**Comments:** Northern Face

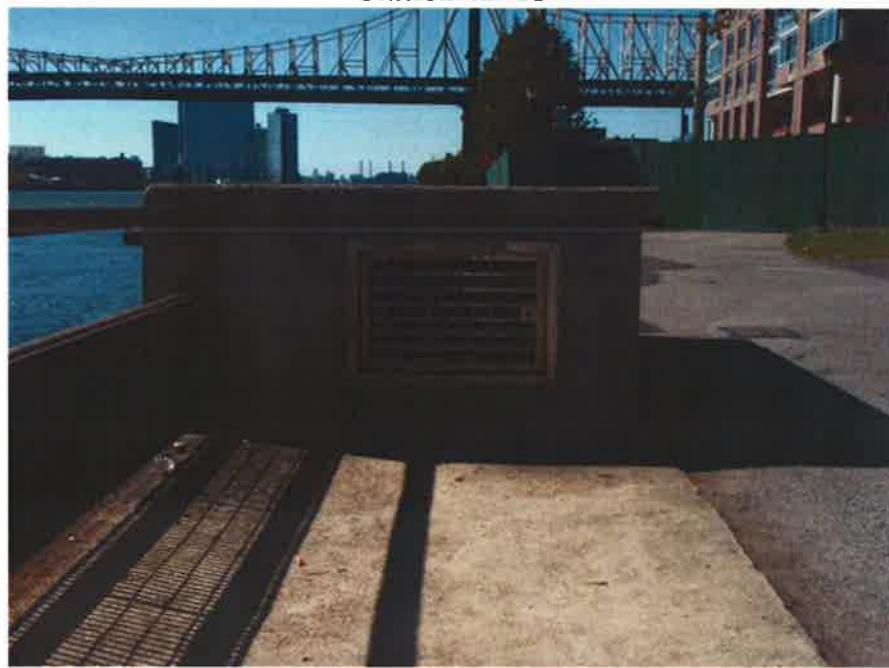
**Direction:** Air Vent 3**Comments:** Southern Face**Station 42+18**

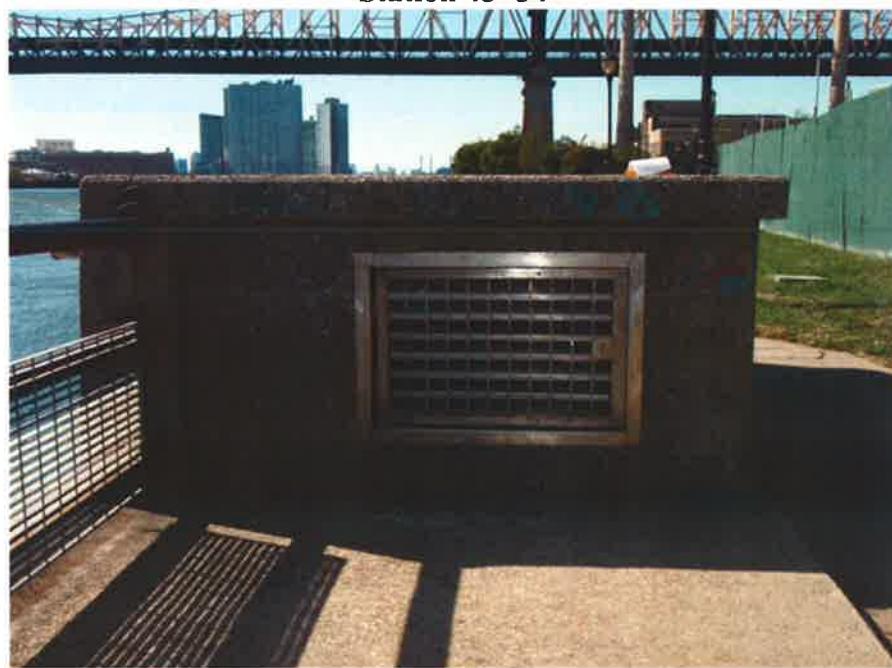
**Direction:** Air Vent 2**Comments:** Southern Face**Station 45+34**

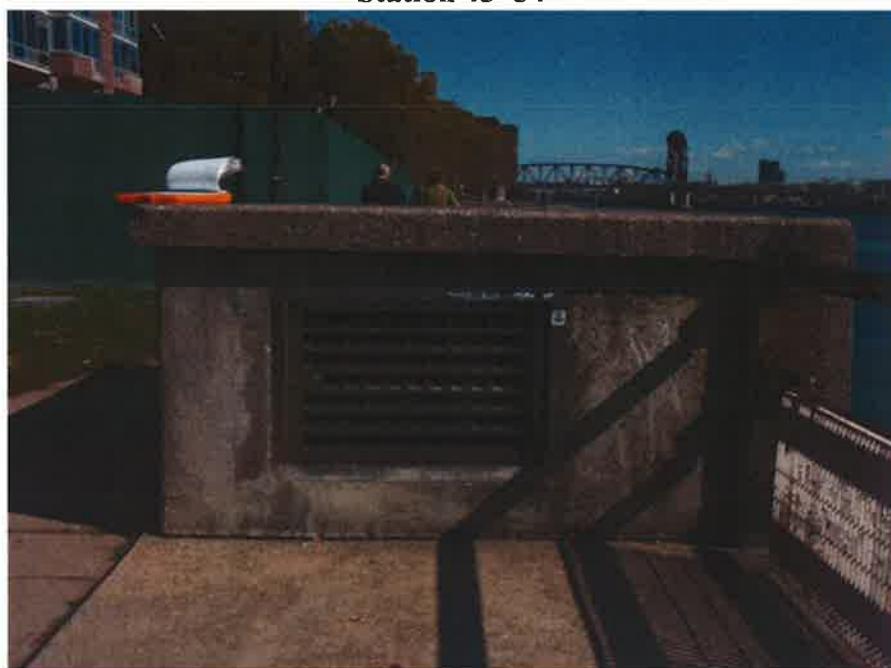
**Station 45+34**

**Direction:** Air Vent 1**Comments:** Northern Face

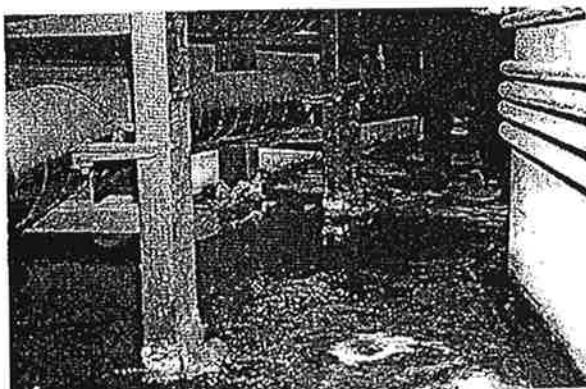
Leaks occur approximately 60 feet before Vent 1 at a bend. See Appendix B, photo 1, pg. 1..

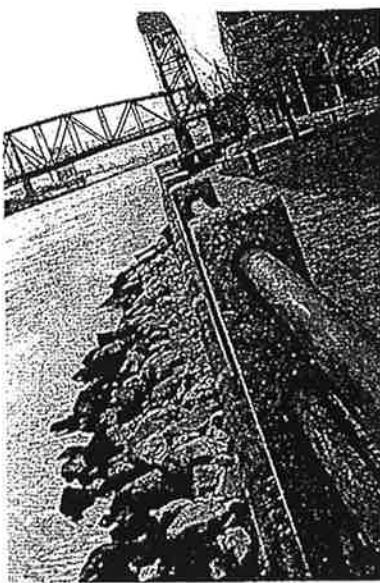
This section is experiencing water infiltration from both the land and water side due to cracks in the roof grassed areas, deteriorated wall joints and missing rip rap all as shown in photos 3, 5, 6, 7 and 8. Photo 5 shows moisture path on grassed area toward interior tunnel wall. Photo 1 shows a section of adequate rip rap.

Check tunnel interior wall for adequacy of waterproofing. See detail for 1949 waterproofing system design in Appendix C. Waterproof as required. Replace rip rap as required. Repair tunnel roof cracks and expansion joints. Check tunnel piers, piles & caps for deterioration. Repair as required.

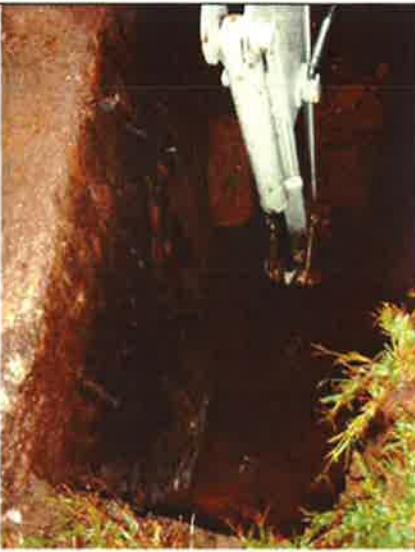
Test Pit 6 – Steam Tunnel exterior wall in good condition
