# **CONDITIONS REPORT & CONCEPTUAL DESIGN MEMORANDUM**

## **STEAM TUNNEL ASSESSMENT**

**ROOSEVELT ISLAND, NEW YORK**

**28 December 2018  
Project # 100444601**

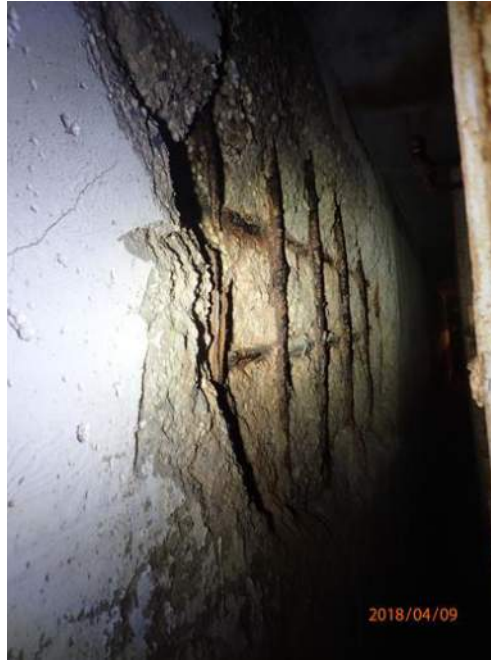
Station 1+95

**Direction:** Eastern Wall (Seawall)

**Comments:** Spalling, Loose Concrete, Exposed Rebar

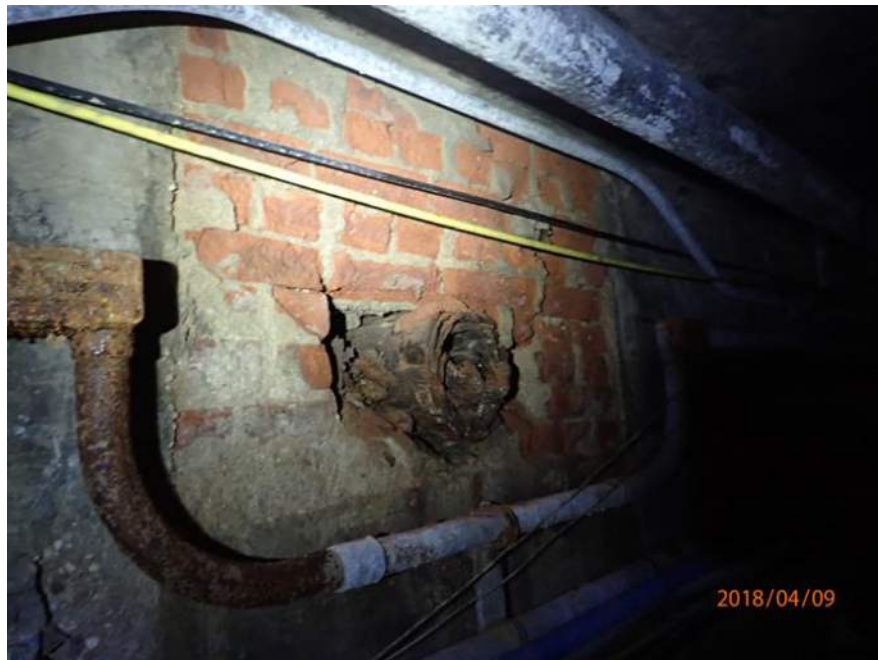
Station 1+95

**Direction:** Western Wall (In-Land)

**Comments:** Spalling, Loose Concrete, Exposed Rebar

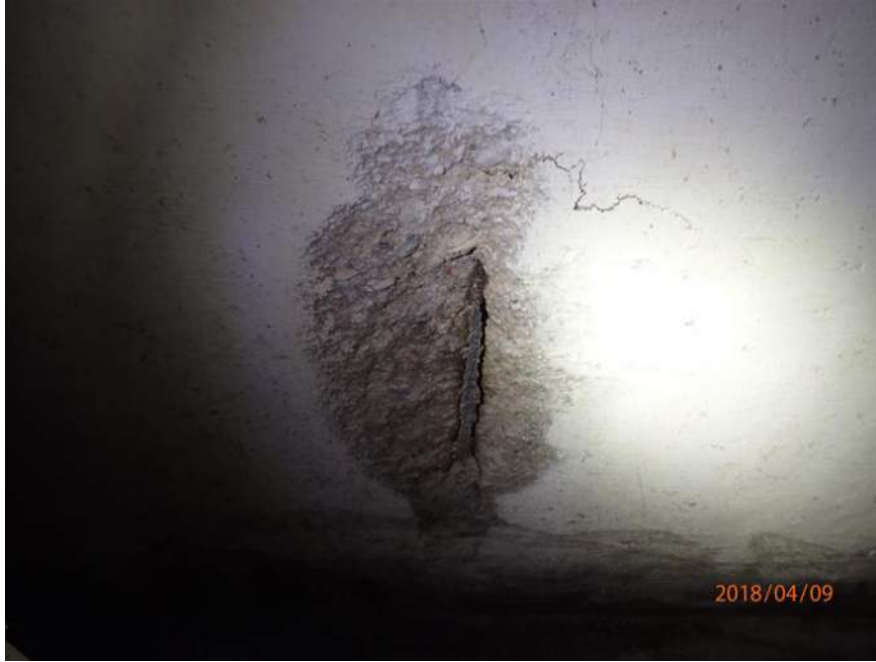
**Station 4+50**

**Direction:** Eastern Wall (Seawall)

**Comments:** Spalling, Re-Bar Exposed and Corroded

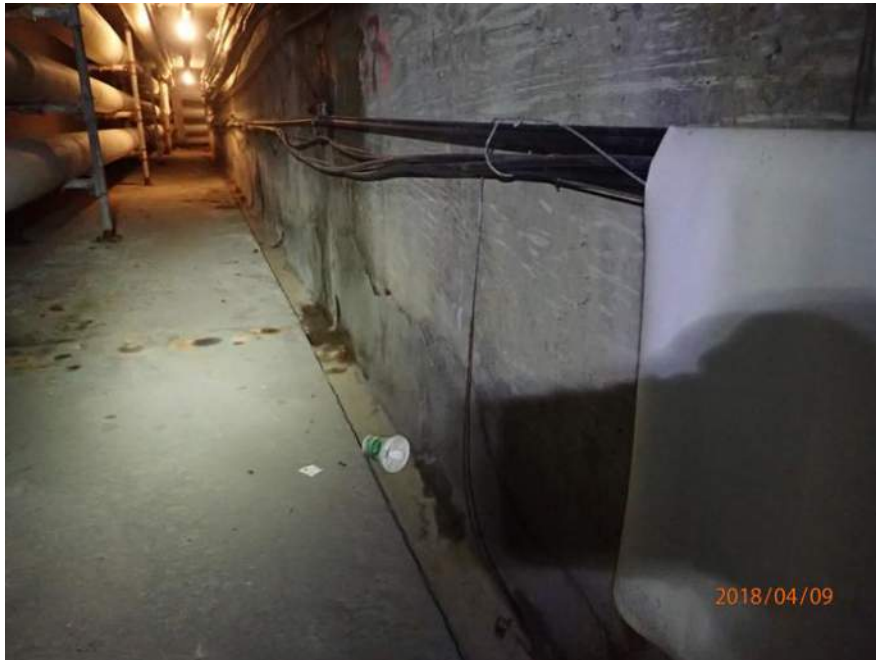
**Station 4+50 to 4+55**

**Direction:** Western Wall (In-Land)

**Comments:** Spalling, Loose Concrete

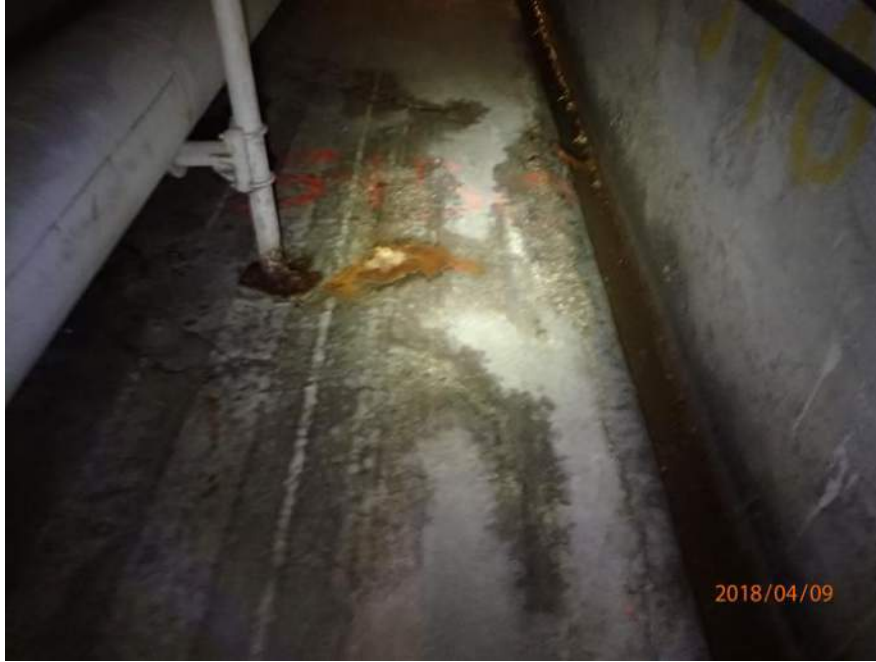
Station 5+45 to 5+55

**Direction:** Tunnel Floor

**Comments:** Floor Slab Cracking

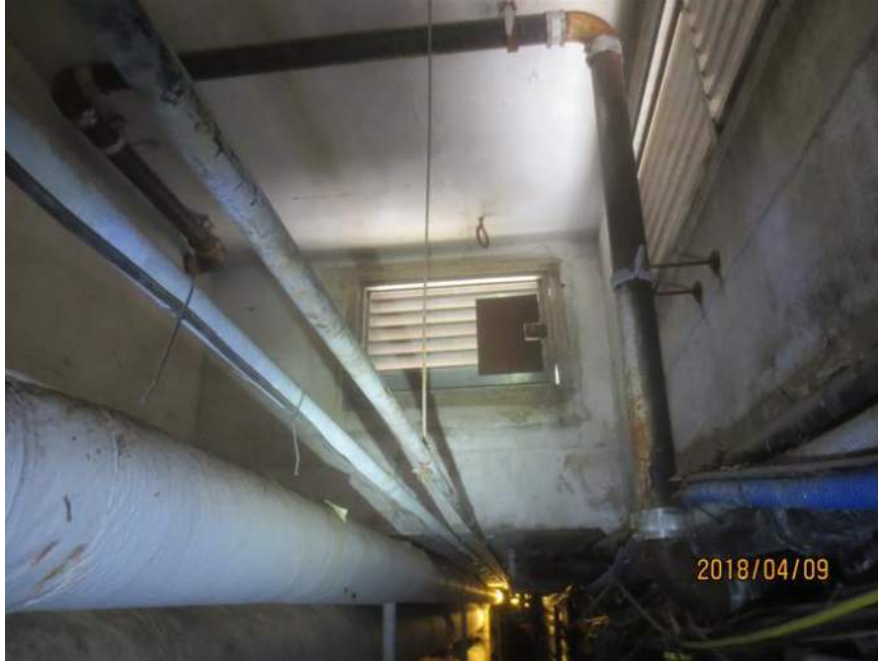
Station 6+16

**Direction:** Tunnel Floor

**Comments:** Sump Pump - Not Working

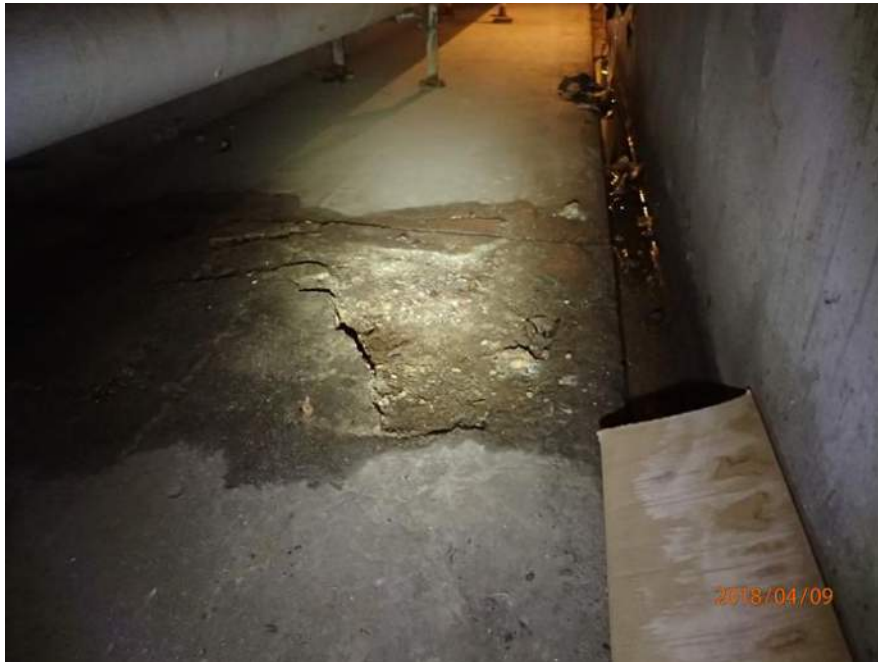
Station 6+20 to 6+26

**Direction:** Tunnel Floor

**Comments:** Floor Slab Cracking and Spalling

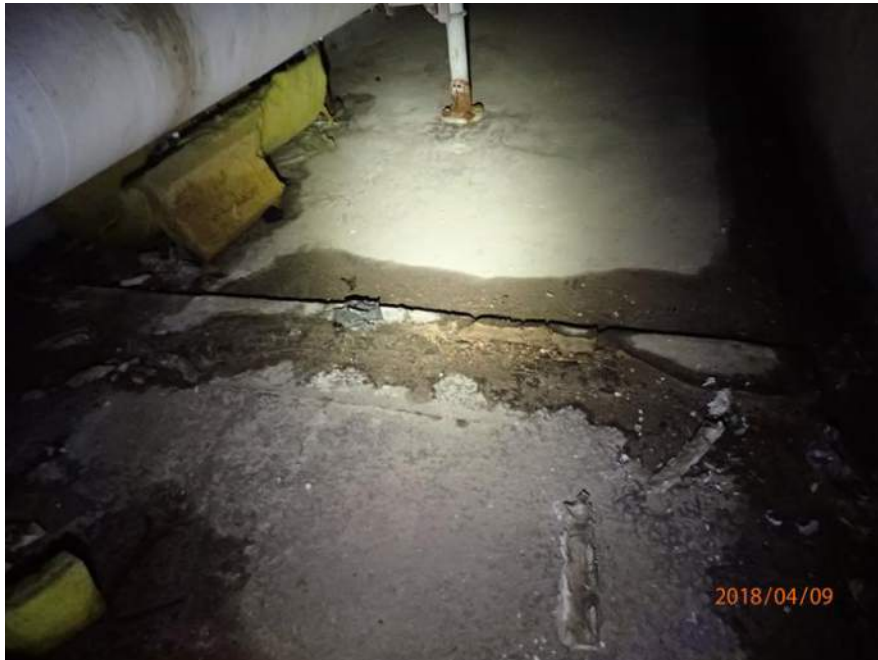
Station 7+21

**Direction:** Tunnel Floor

**Comments:** Floor Slab Raised at Joint, Cracking, Loose Concrete

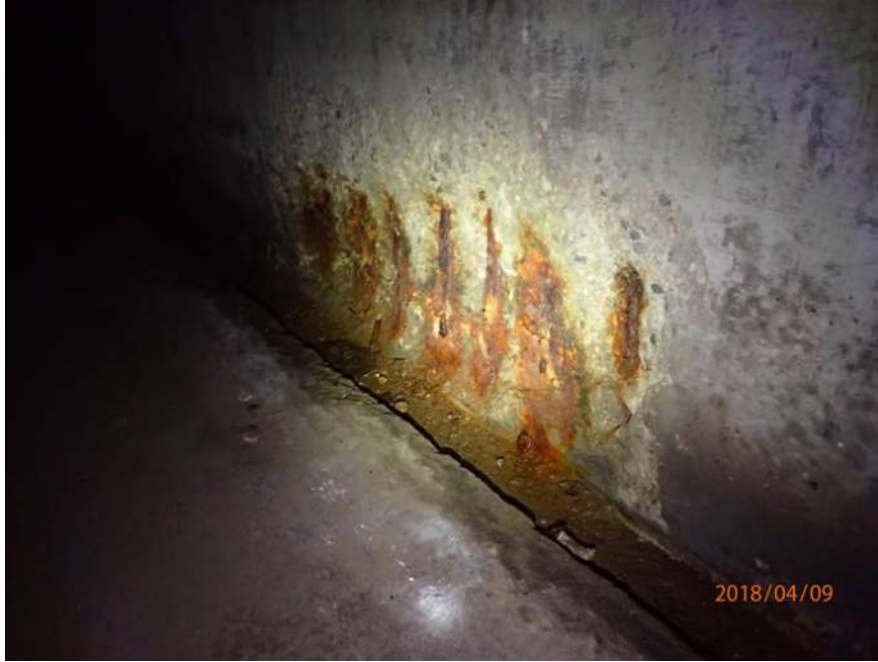
Station 7+23 to 7+40

**Direction:** Western Wall (In-Land)

**Comments:** Spalling, Re-Bar Exposed and Corroded

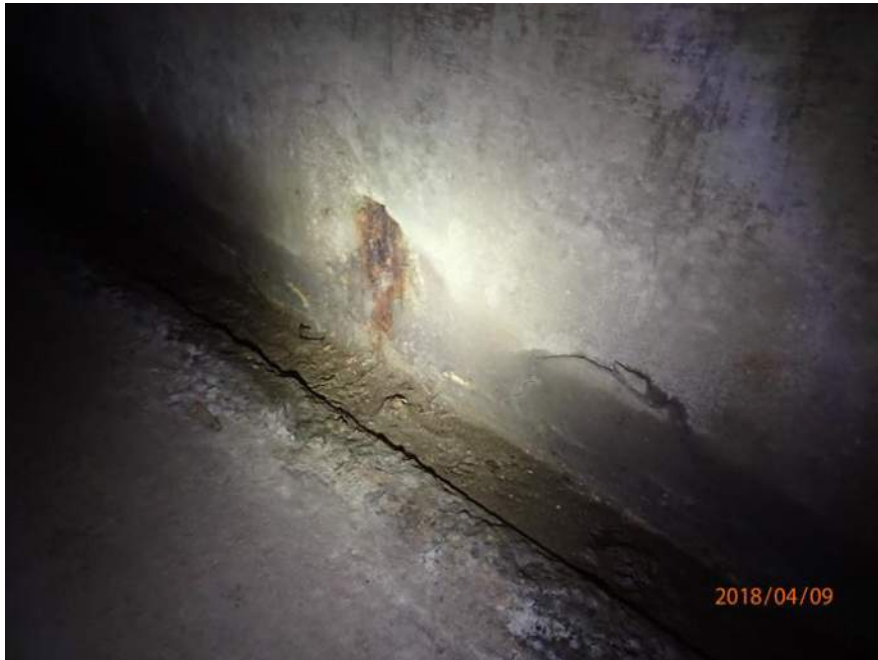
Station 7+53

**Direction:** Western Wall (In-Land)

**Comments:** Concrete Spalling

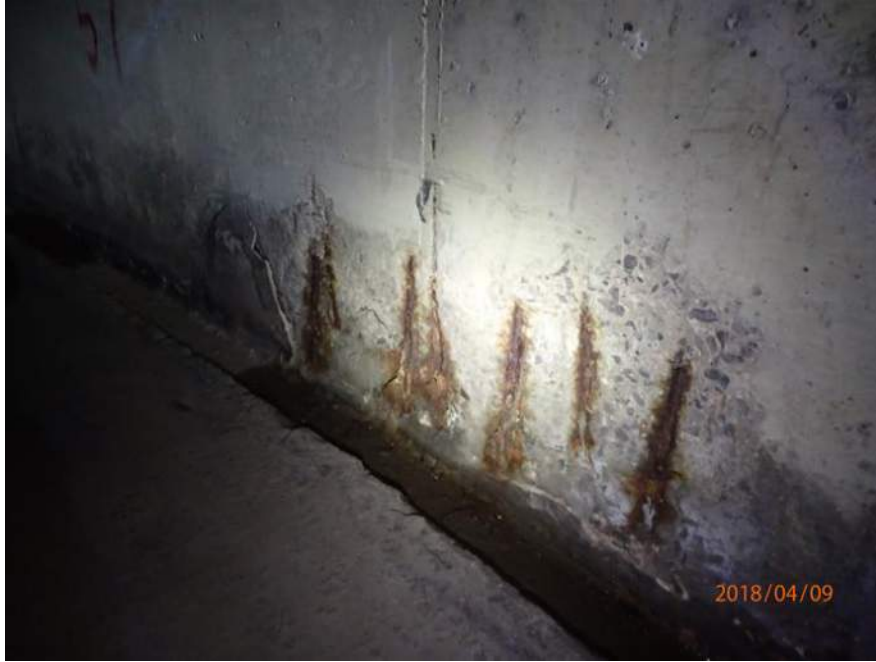
Station 8+72 to 8+88

**Direction:** Western Wall (In-Land)

**Comments:** Spalling, Re-Bar Exposed and Corroded

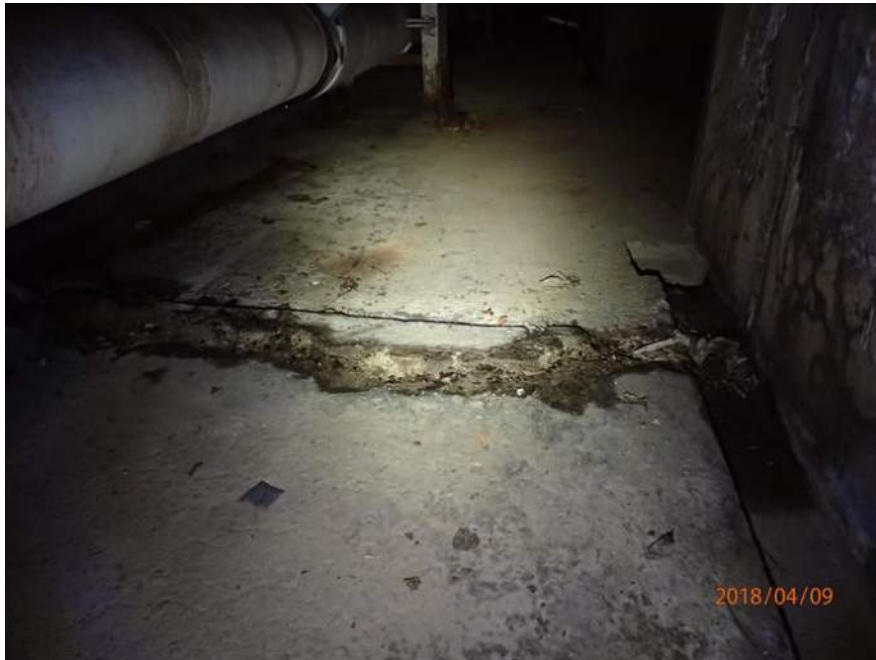
Station 9+09

**Direction:** Tunnel Floor

**Comments:** Floor Slab Raised at Joint, Cracking, Loose Concrete

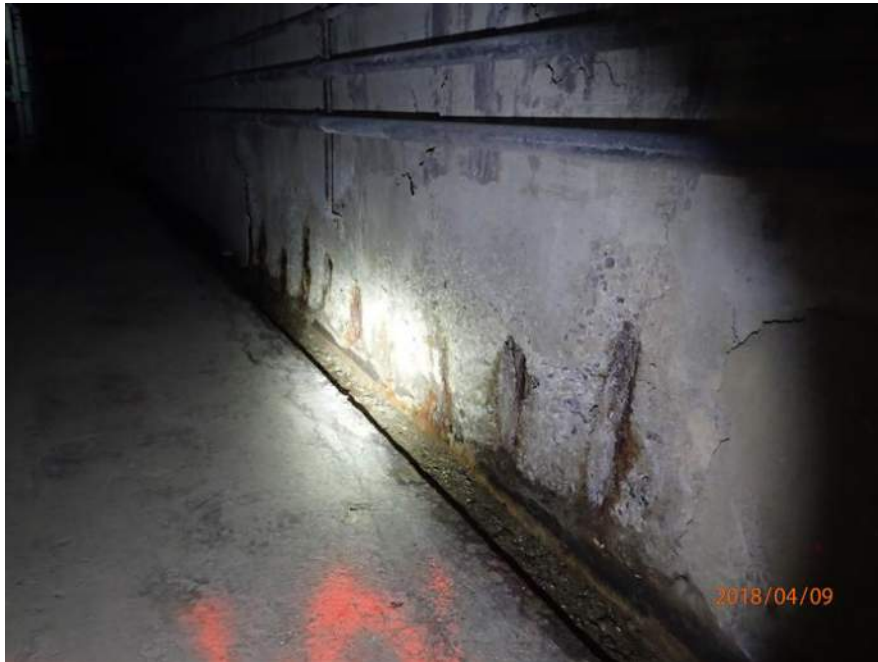
**Station 9+95 to 10+15**

**Direction:** Western Wall (In-Land)

**Comments:** Spalling, Re-Bar Exposed and Corroded

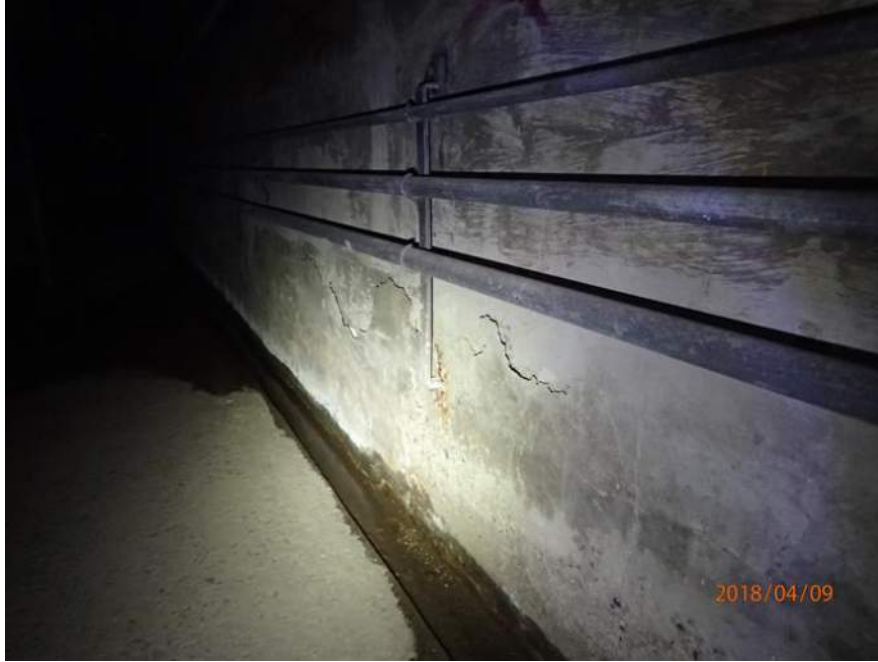
Station 11+85 +12+50

**Direction:** Western Wall (In-Land)

**Comments:** Concrete Spalling and Bowing of Wall

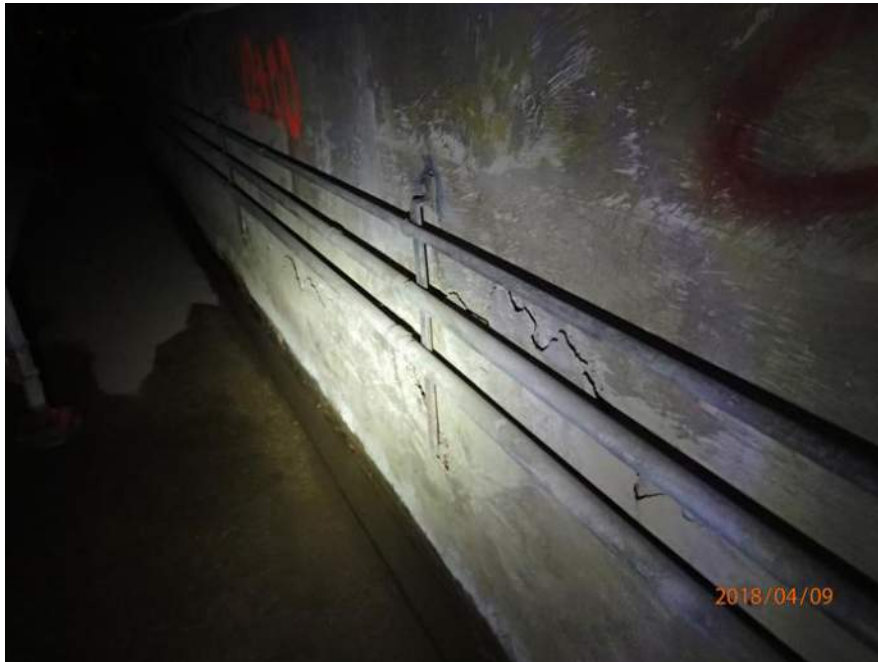
Station 11+85 +12+50

**Direction:** Western Wall (In-Land)

**Comments:** Concrete Spalling and Bowing of Wall, Loose Concrete

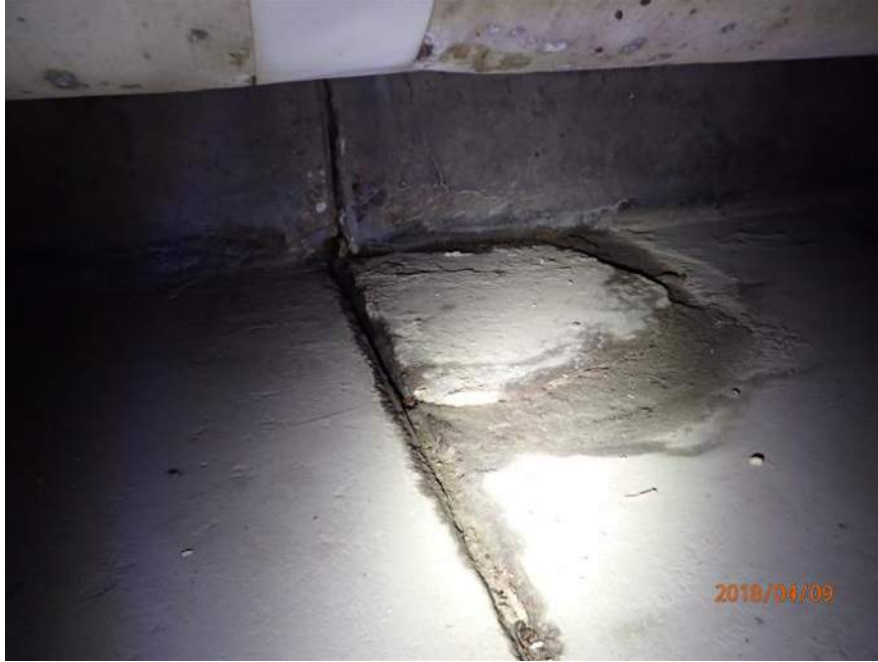
**Station 13+25**

**Direction:** Tunnel Floor

**Comments:** Floor Slab Raised at Joint, Cracking, Loose Concrete

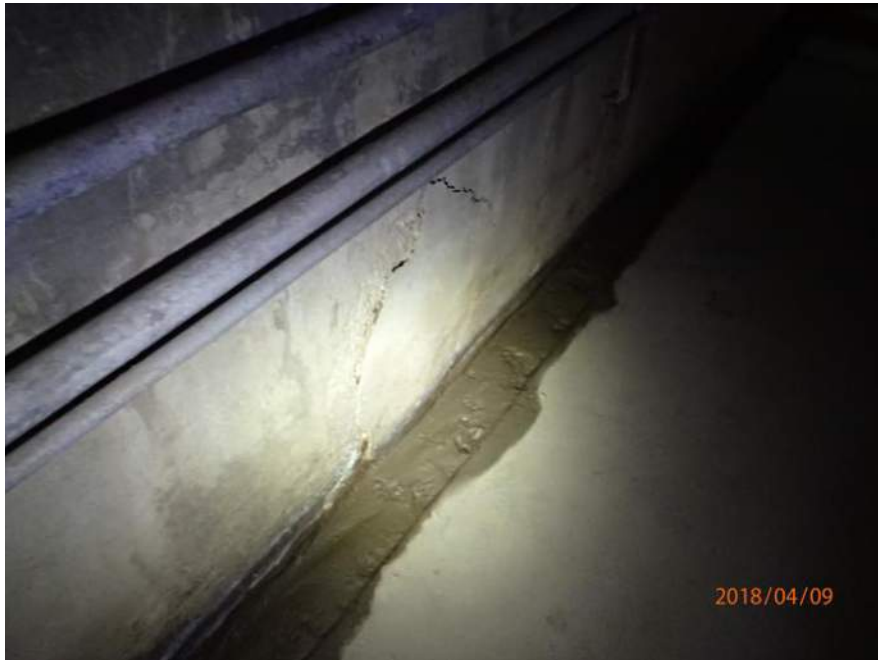
**Station 13+31**

**Direction:** Western Wall (In-Land)

**Comments:** Spalling, Loose Concrete

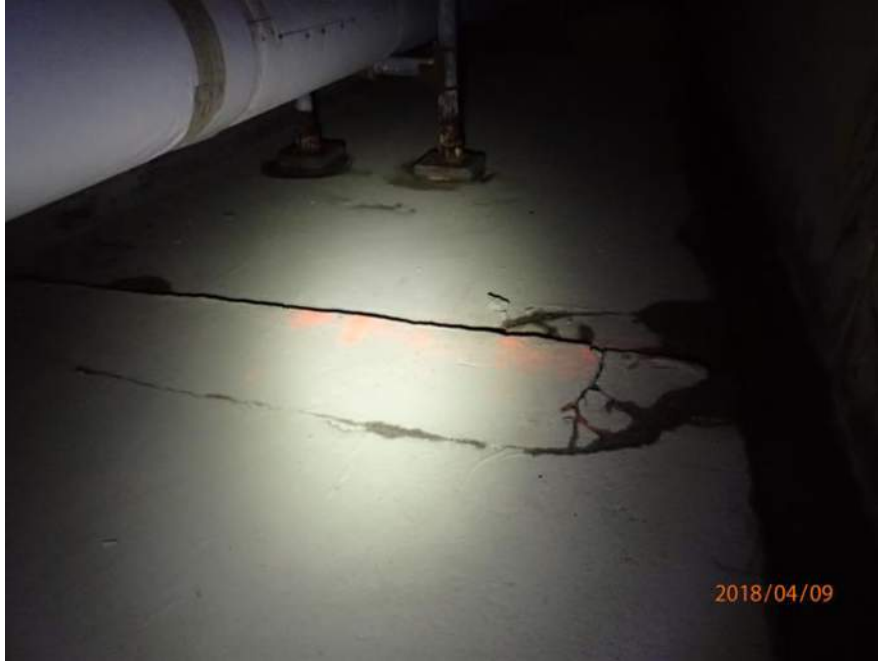
**Station 15+00**

**Direction:** Tunnel Floor

**Comments:** Floor Slab Raised at Joint, Cracking, Loose Concrete

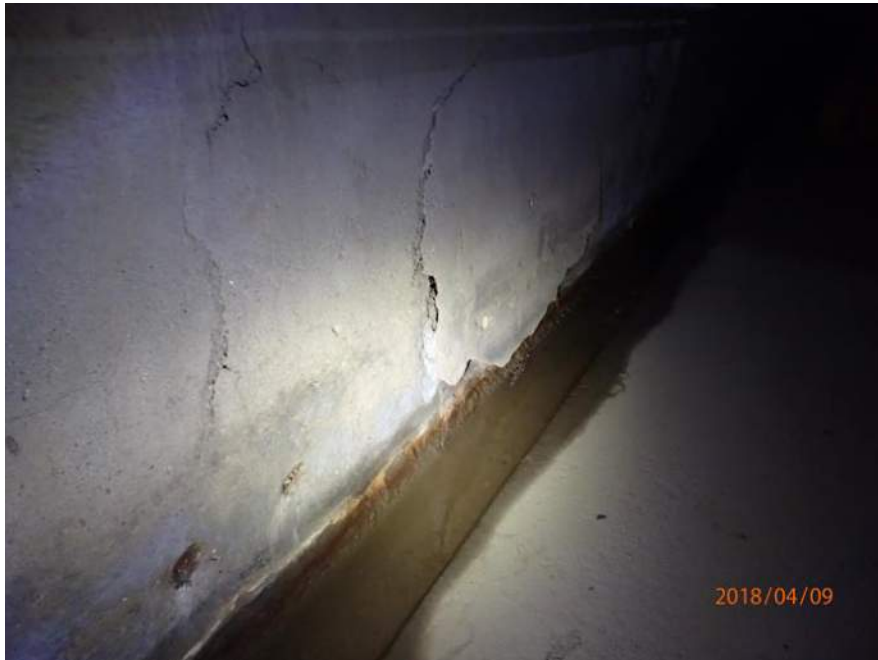
**Station 15+09 to 15+20**

**Direction:** Western Wall (In-Land)

**Comments:** Concrete Spalling

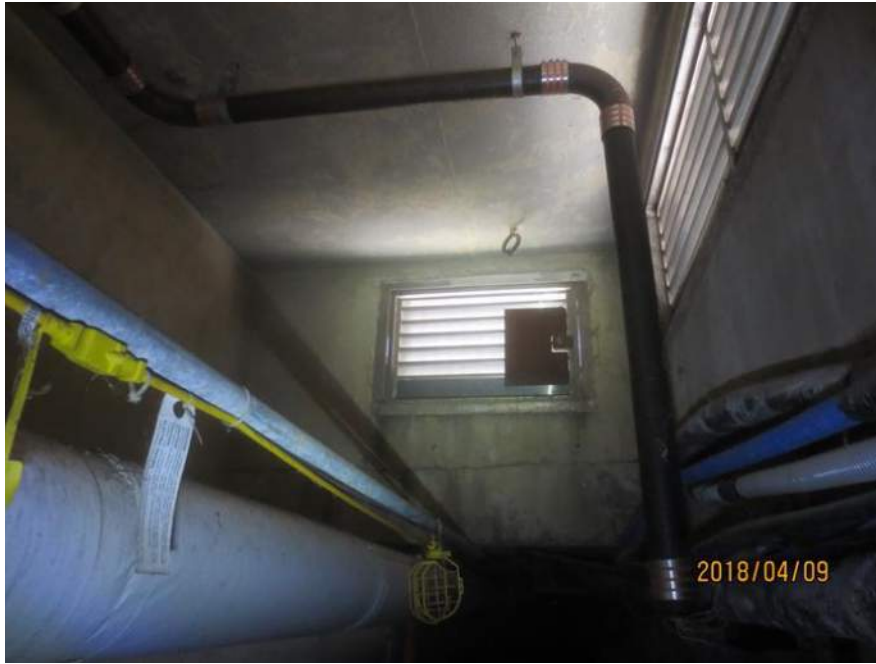
Station 15+22

**Comments:** Air Vent 12

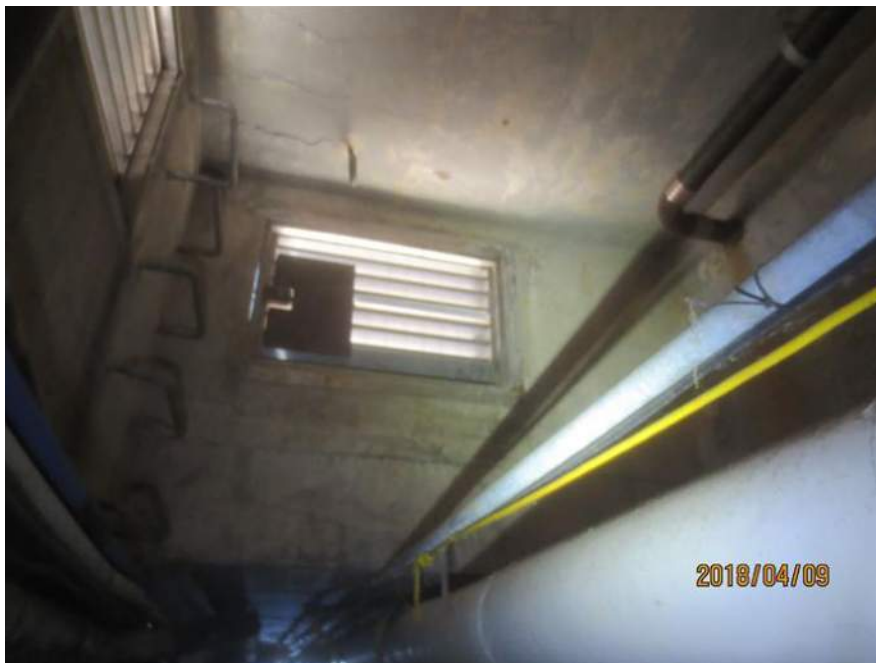
Station 15+22

**Comments:** Air Vent 12

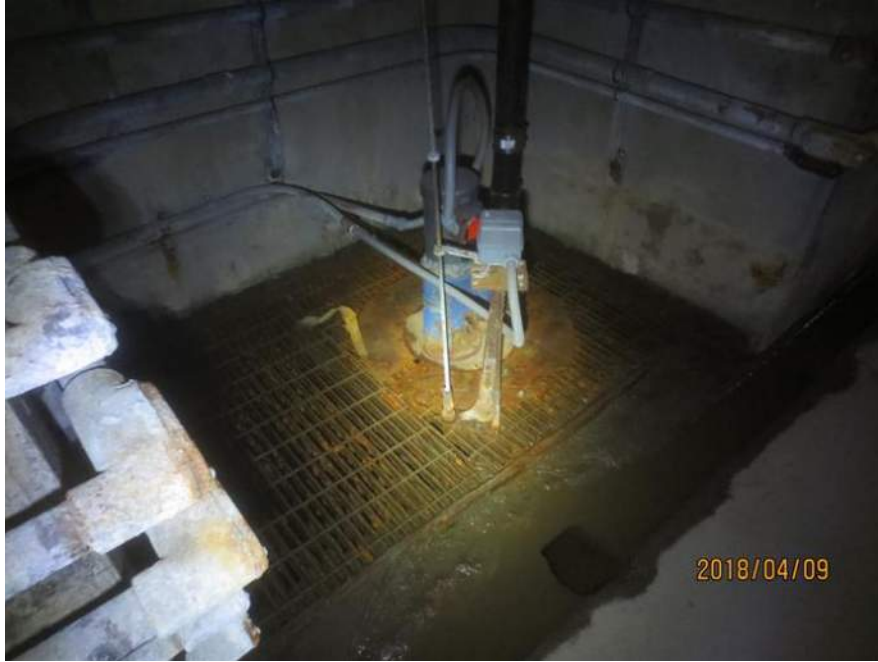
Station 15+22

**Comments:** Sump Pump - Not Working

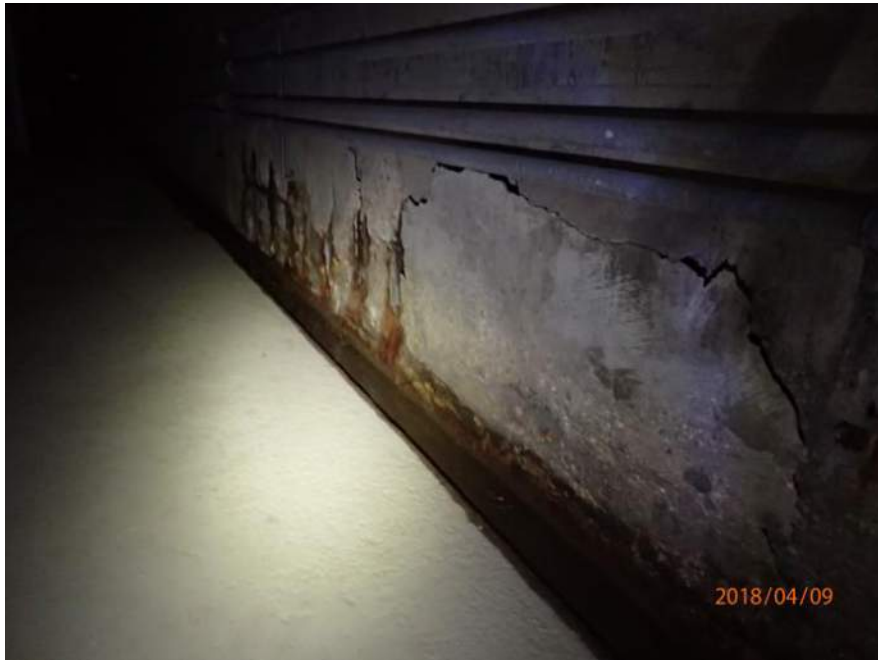
Station 15+50 to 15+75

**Comments:** Spalling, Re-Bar Exposed and Corroded

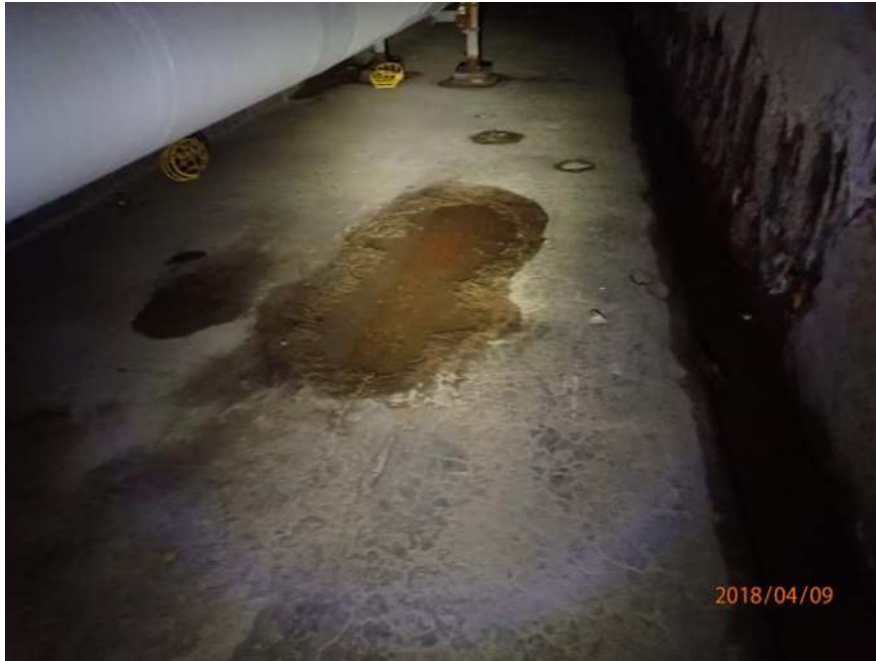
**Station 17+35**

**Comments:** Concrete Spalling

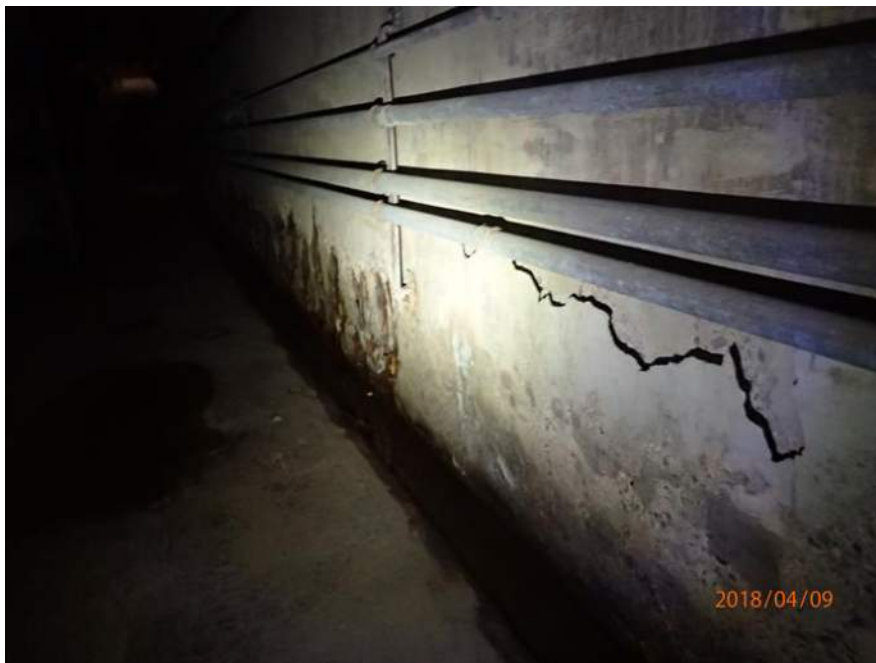
**Station 17+10 to 17+61**

**Comments:** Spalling, Re-Bar Exposed and Corroded

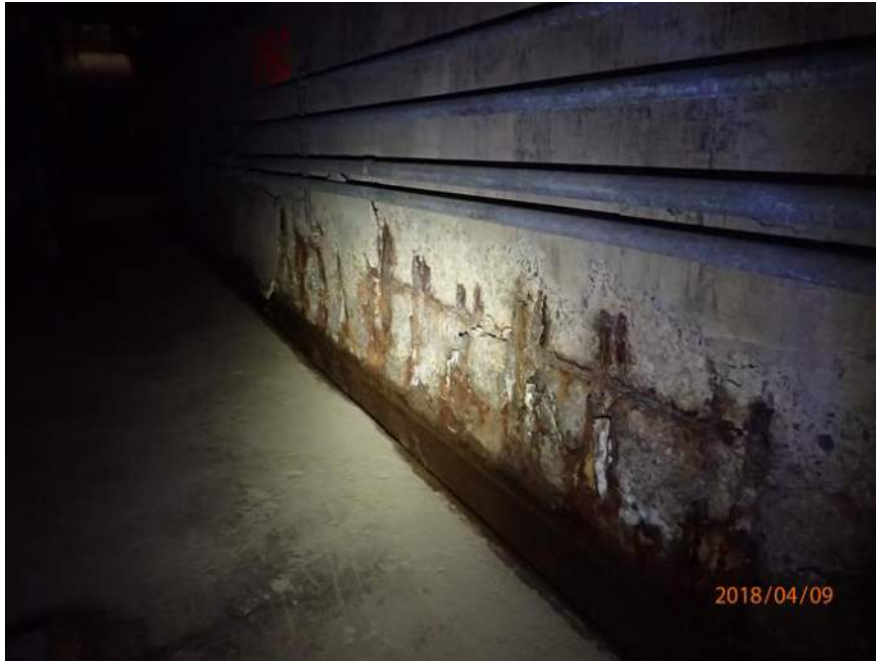
Station 17+10 to 17+61

**Comments:** Spalling, Re-Bar Exposed and Corroded

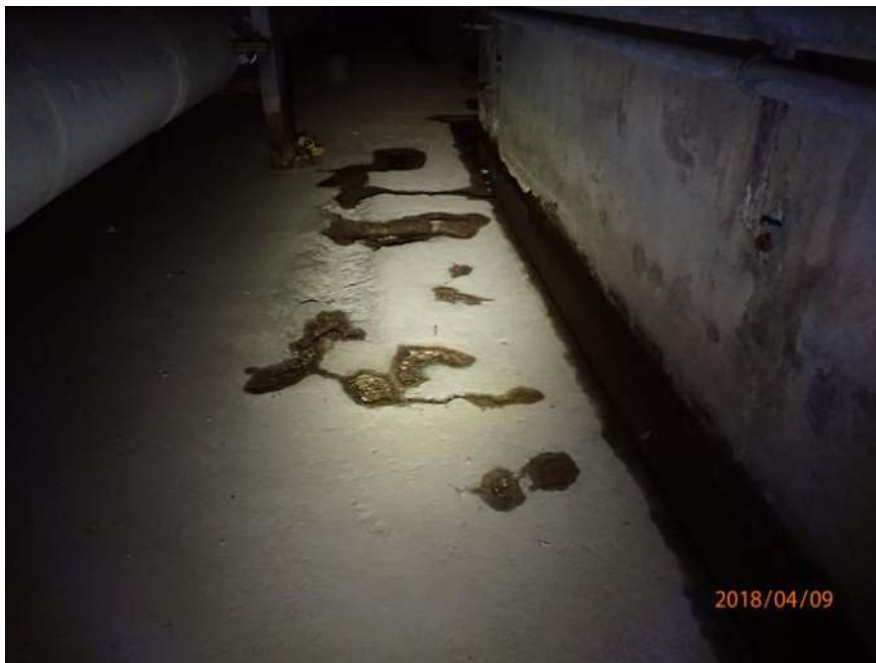
Station 17+70

**Comments:** Concrete Spalling

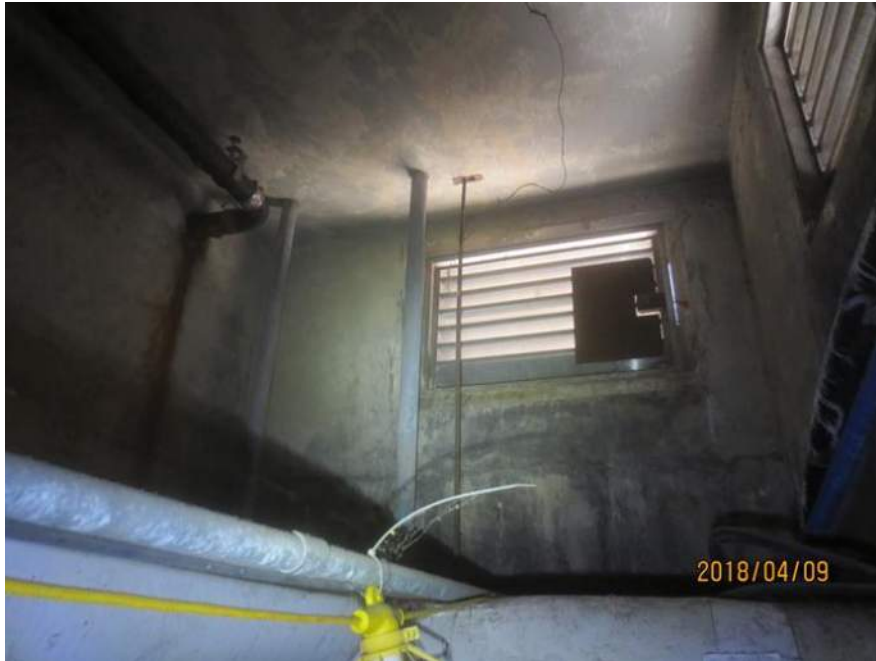
Station 17+76

**Comments:** Air Vent 11

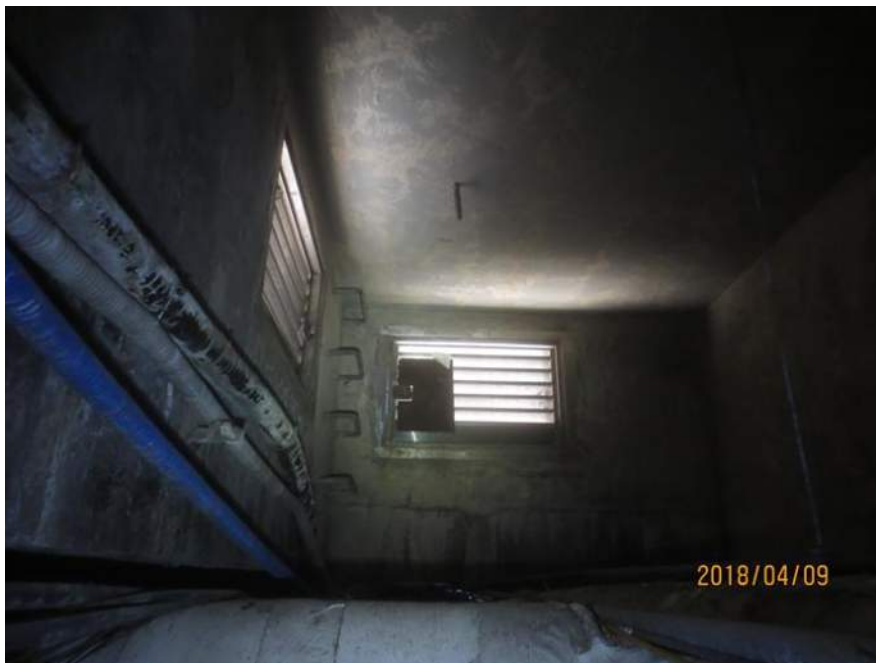
Station 17+76

**Comments:** Air Vent 11

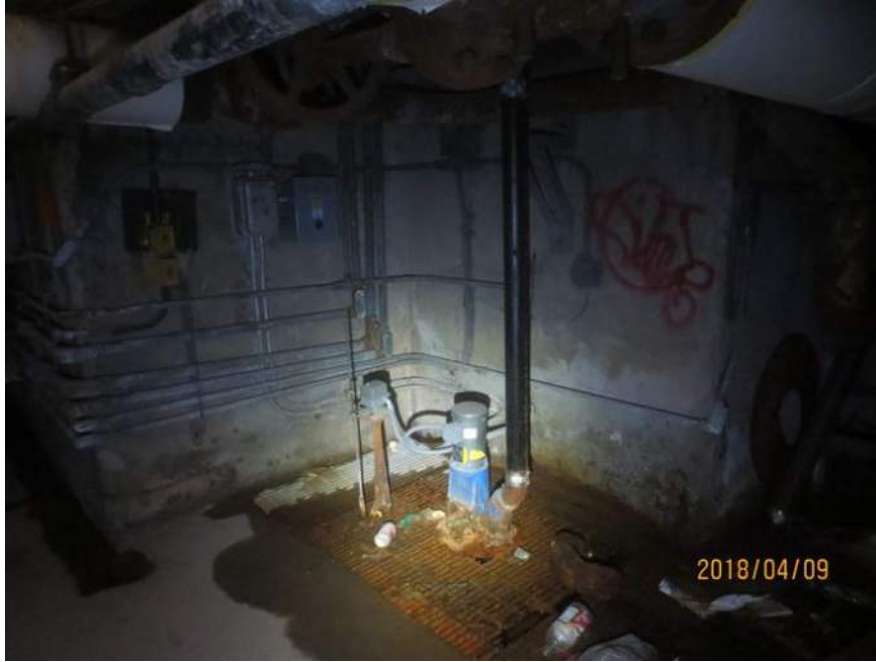
**Station 17+76**

**Comments:** Sump Pump - Not Working

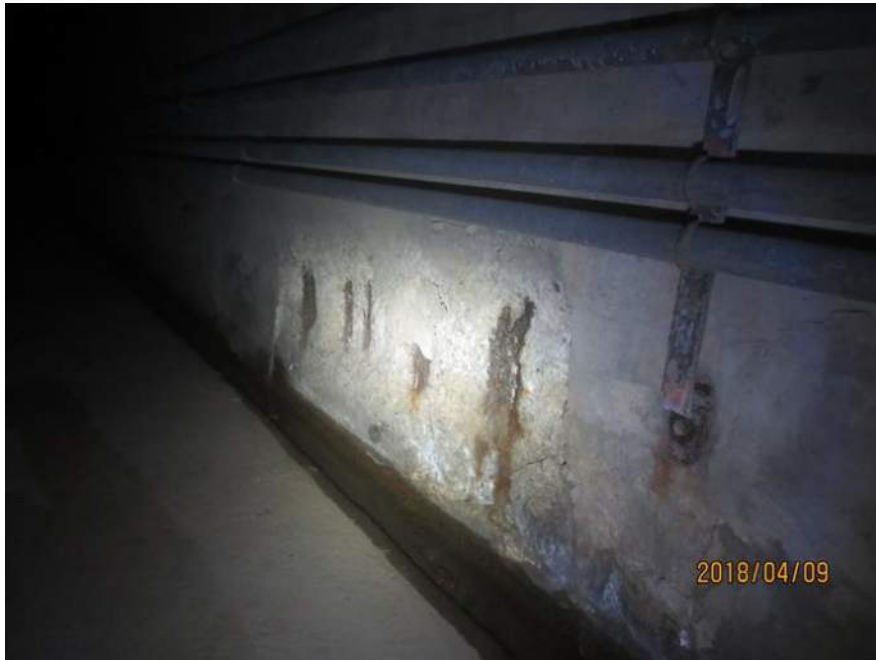
**Station 17+85 to 18+10**

**Comments:** Concrete Spalling, Re-Bar Exposed and Corroded

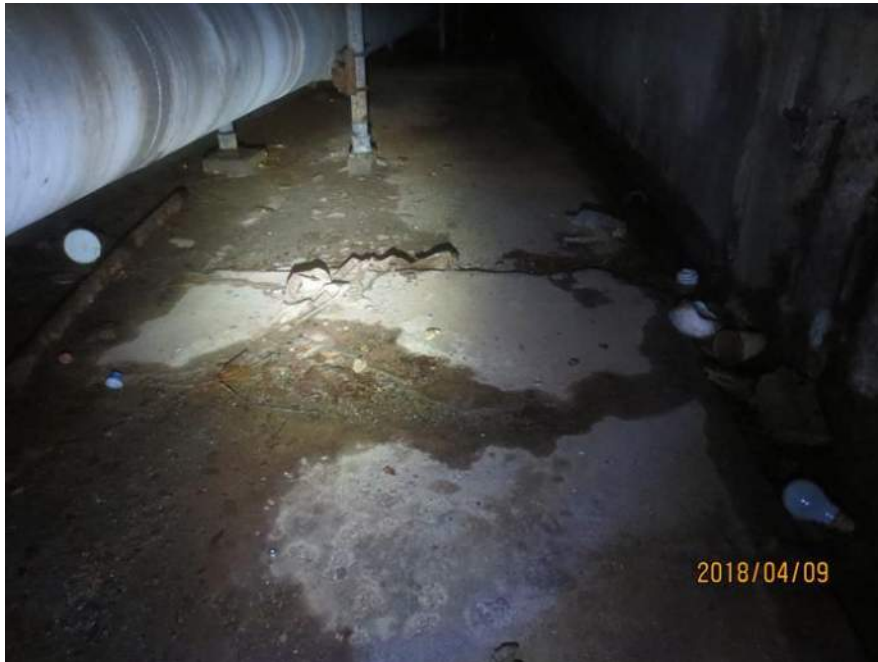
Station 18+75

**Comments:** Floor Slab Raised at Joint, Cracking, Loose Concrete

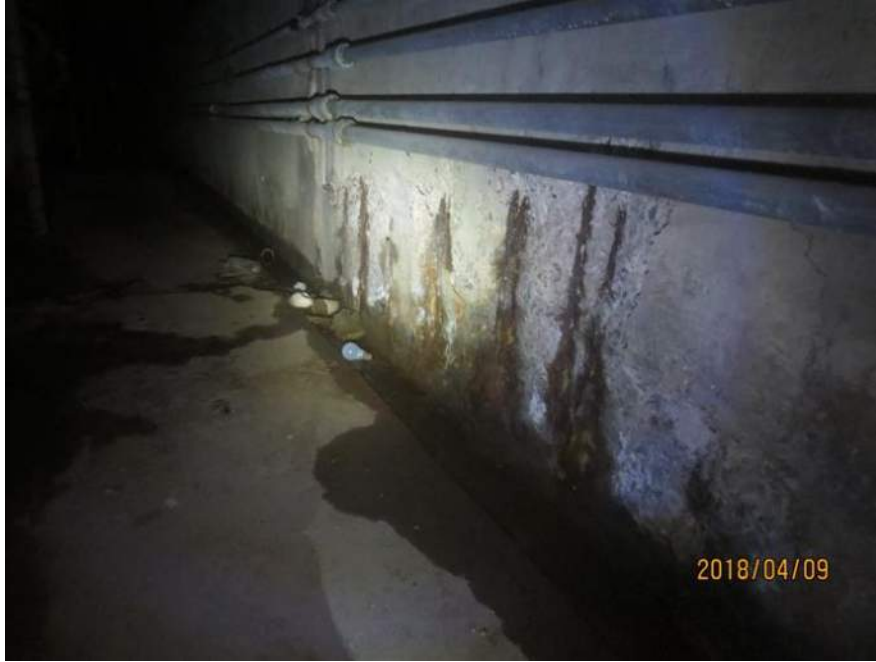
Station 18+75 to 18+80

**Comments:** Concrete Spalling and Bowing of Wall, Loose Concrete, Re-Bar Exposed

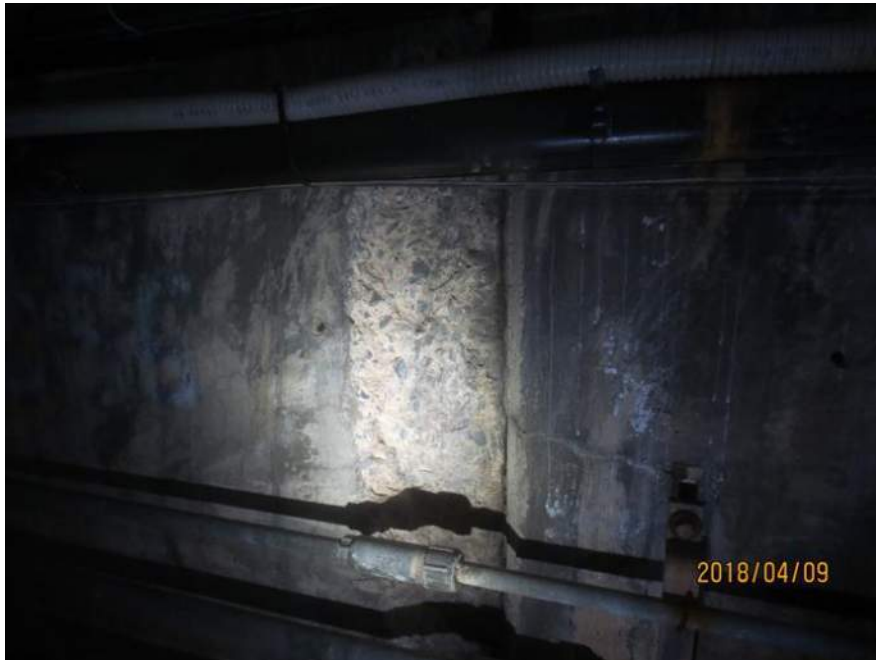
Station 19+45

**Comments:** Cracking at Joint, Concrete Missing

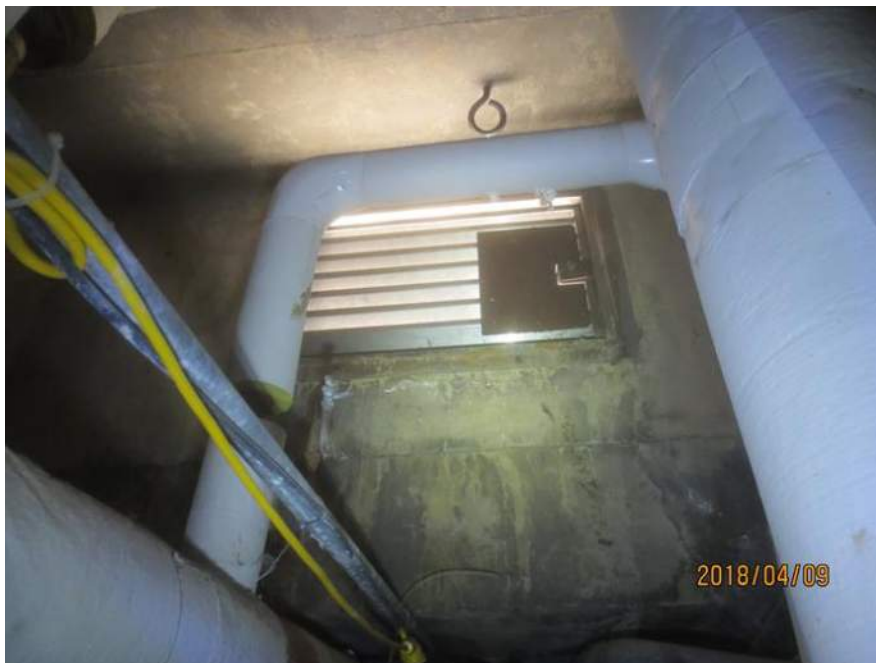
Station 20+30

**Comments:** Air Vent 10

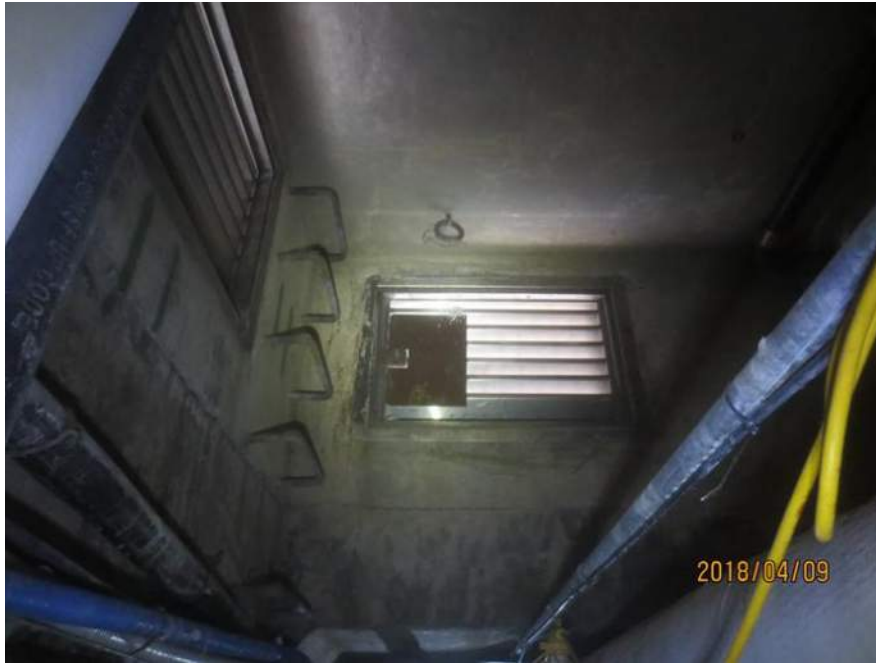
**Station 20+30**

**Comments:** Air Vent 10

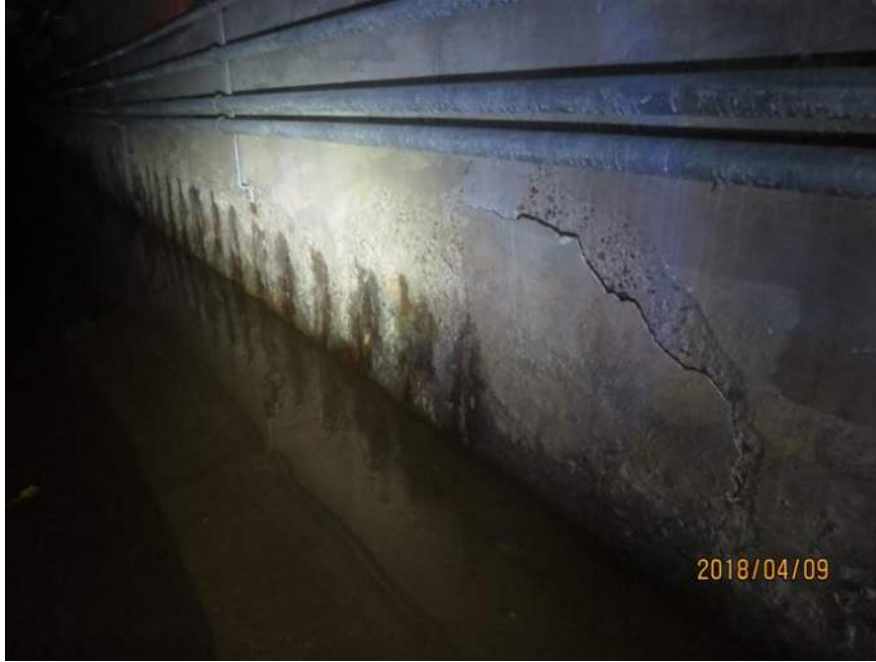
Station 20+90 to 21+30

**Comments:** Concrete Spalling, Re-Bar Exposed and Corroded

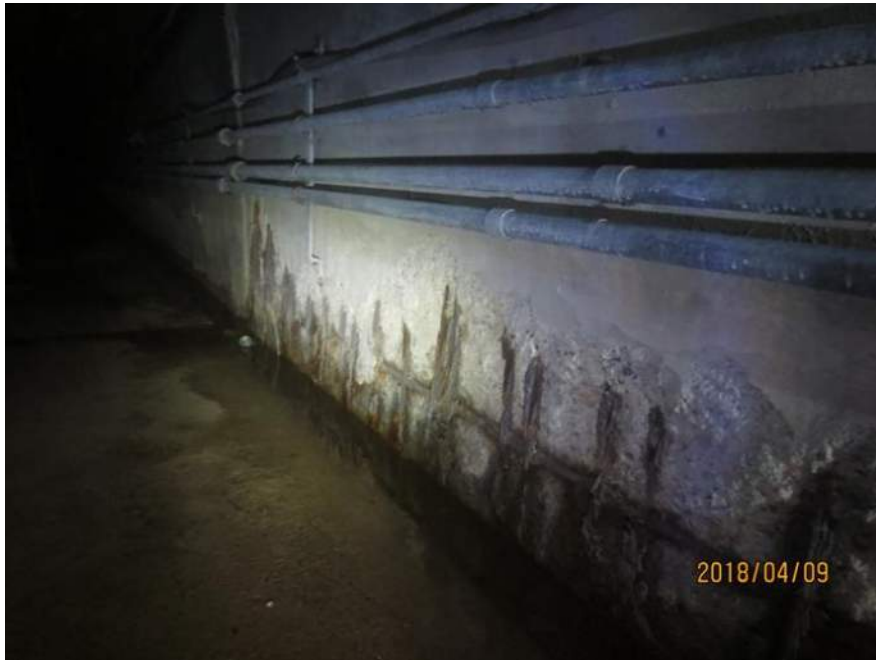
Station 20+90 to 21+30

**Comments:** Concrete Spalling, Re-Bar Exposed and Corroded

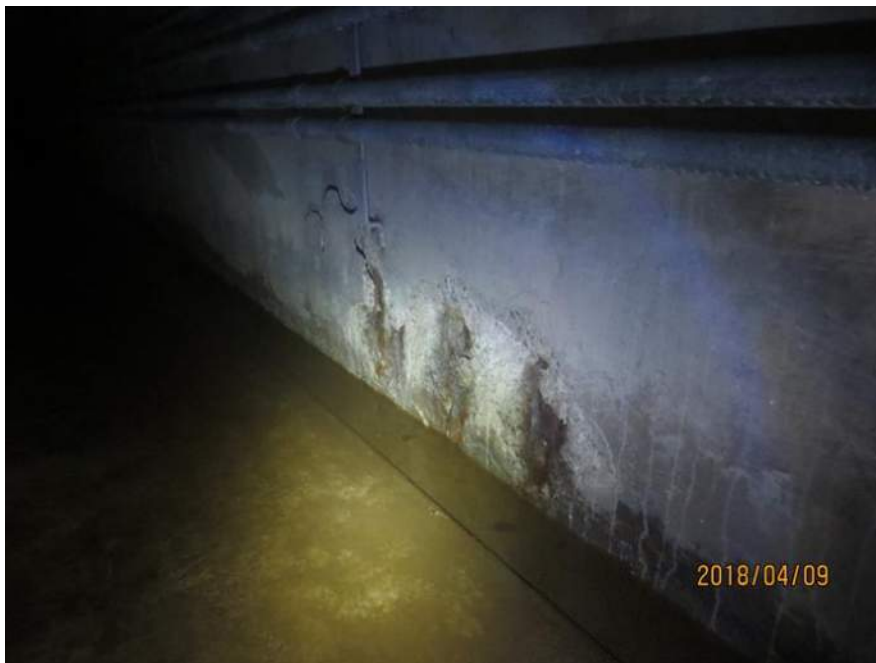
**Station 21+68 to 21+75**

**Comments:** Concrete Spalling, Re-Bar Exposed
