# **CONDITIONS REPORT & CONCEPTUAL DESIGN MEMORANDUM**

## **STEAM TUNNEL ASSESSMENT**

**ROOSEVELT ISLAND, NEW YORK**

**28 December 2018  
Project # 100444601**

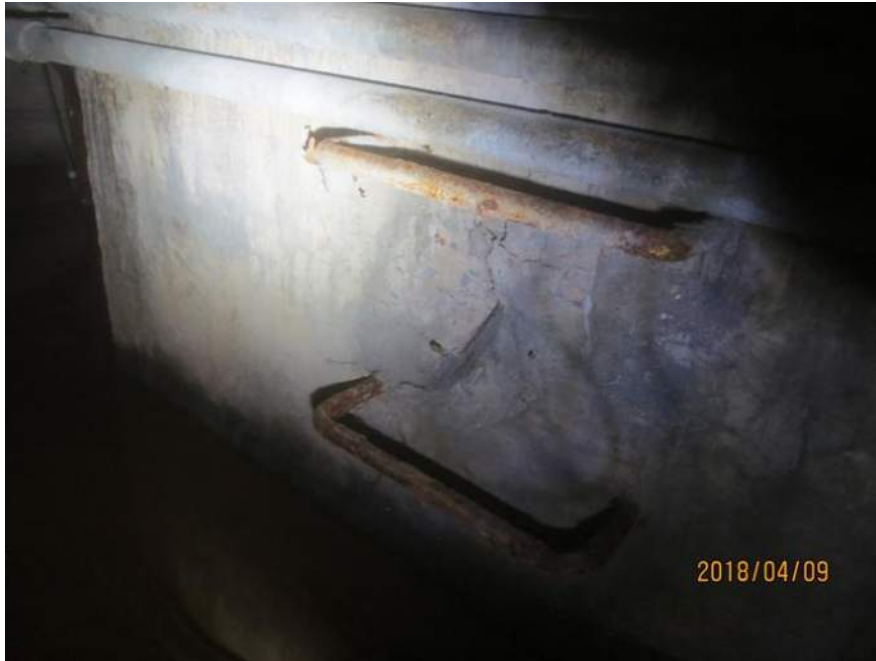
Station 22+70

**Comments:** Concrete Spalling, Re-Bar Exposed

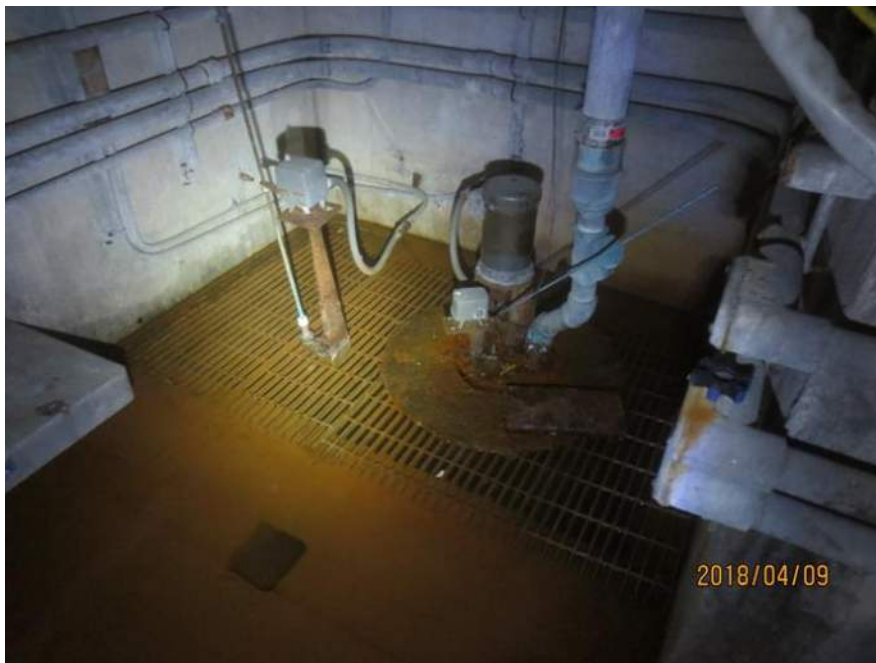
Station 22+84

**Comments:** Sump Pump - Not Working

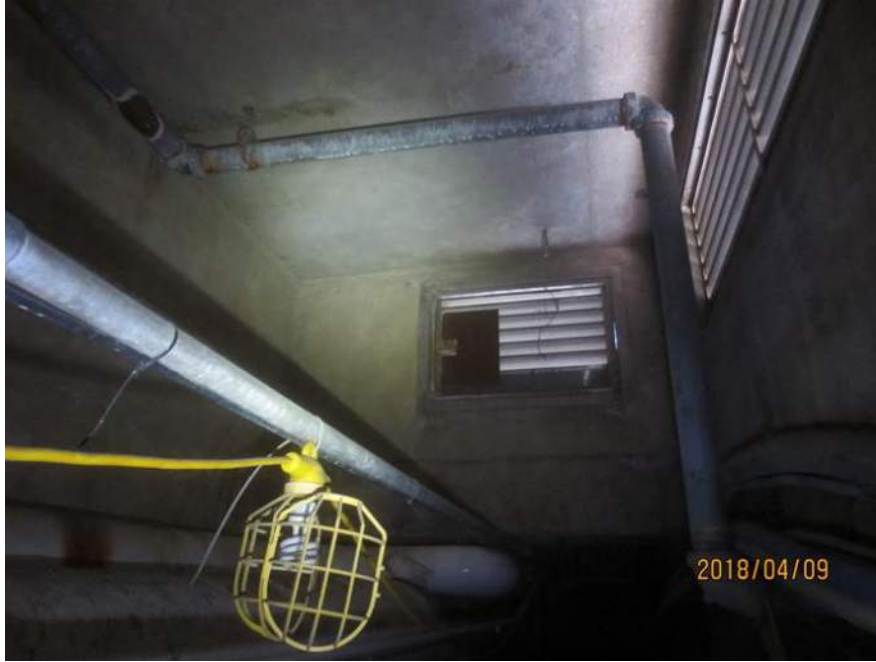
Station 22+84

**Comments:** Air Vent 9

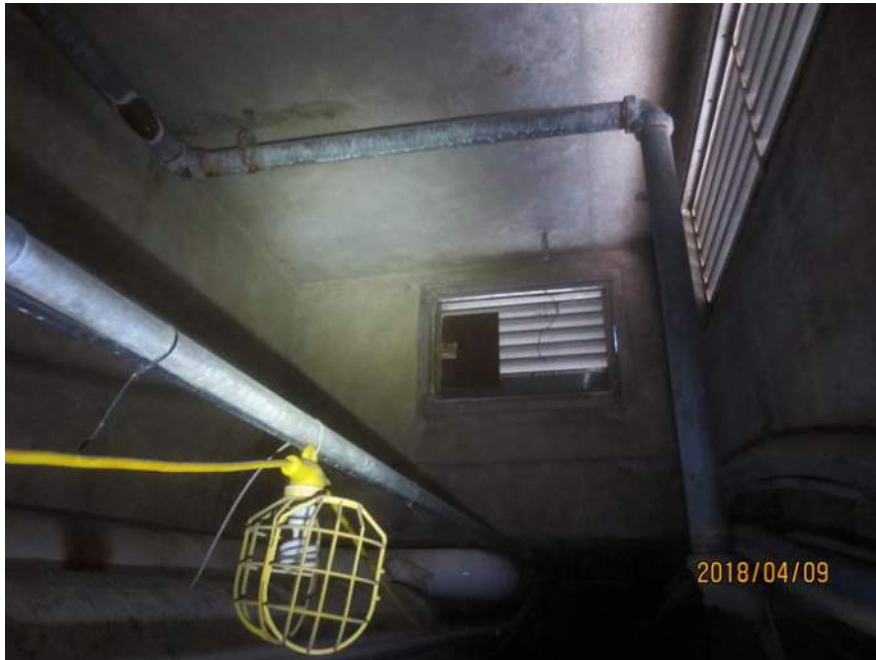
Station 22+84

**Comments:** Air Vent 9

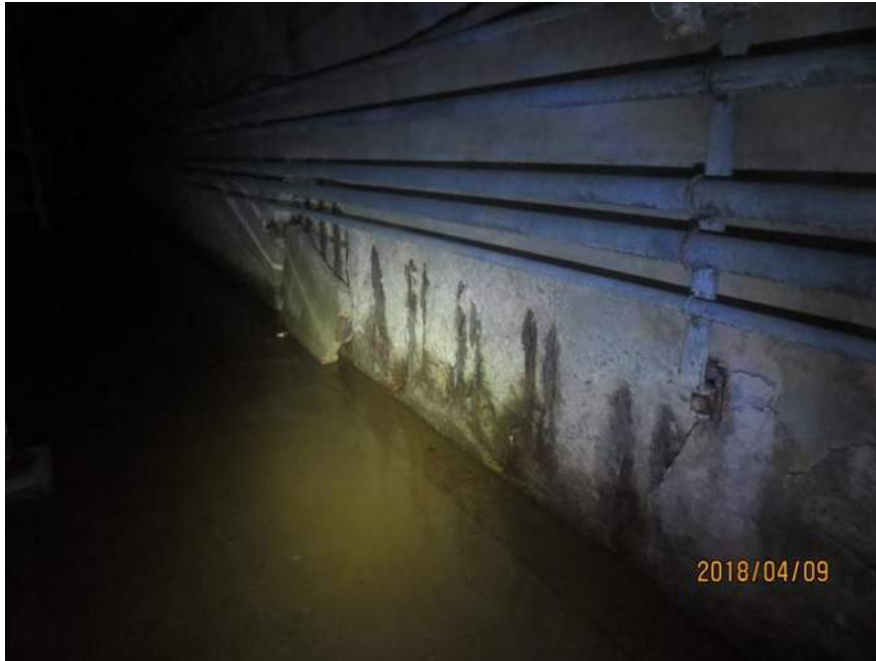
Station 23+44 to 23+63

**Comments:** Spalling, Re-Bar Exposed and Corroded, Loose Concrete

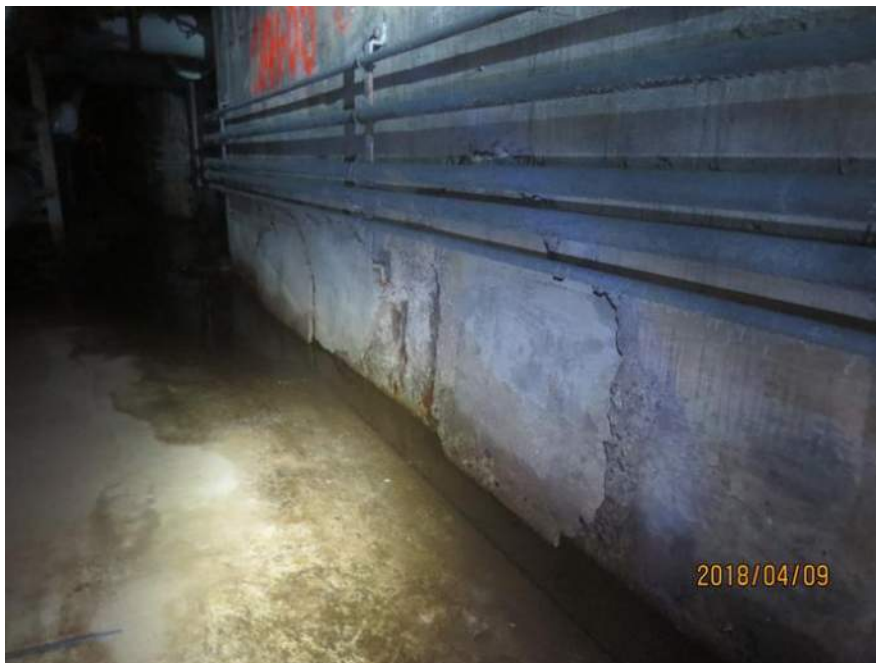
Station 23+90 to 24+03

**Comments:** Spalling, Loose Concrete

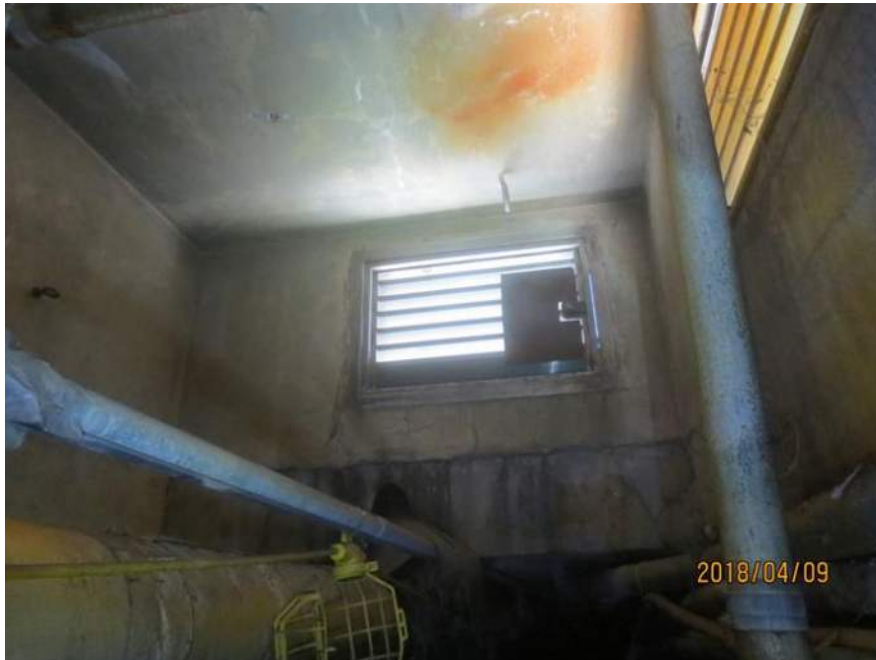
Station 25+38

**Comments:** Air Vent 8

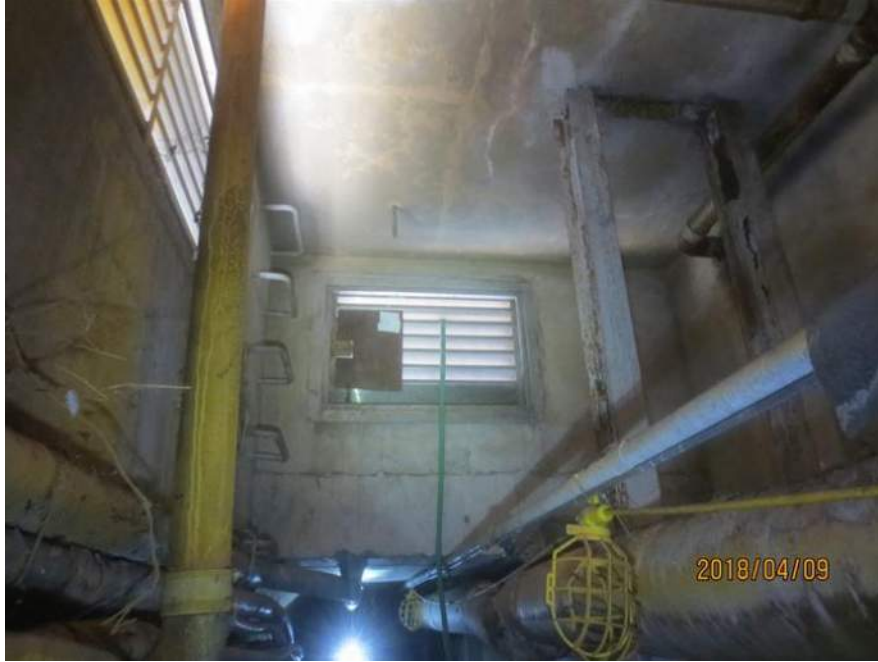
Station 25+38

**Comments:** Air Vent 8

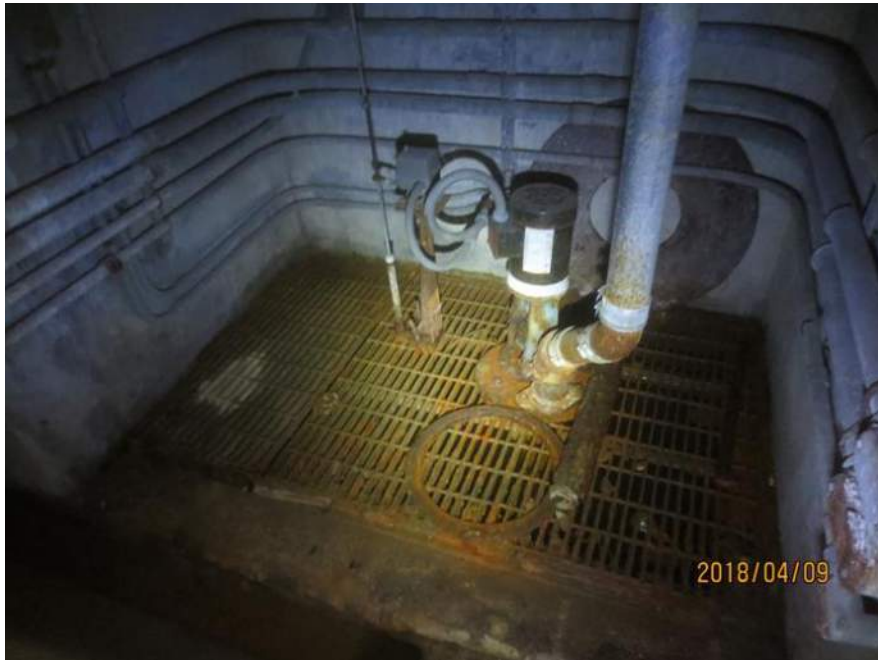
Station 25+38

**Comments:** Sump Pump

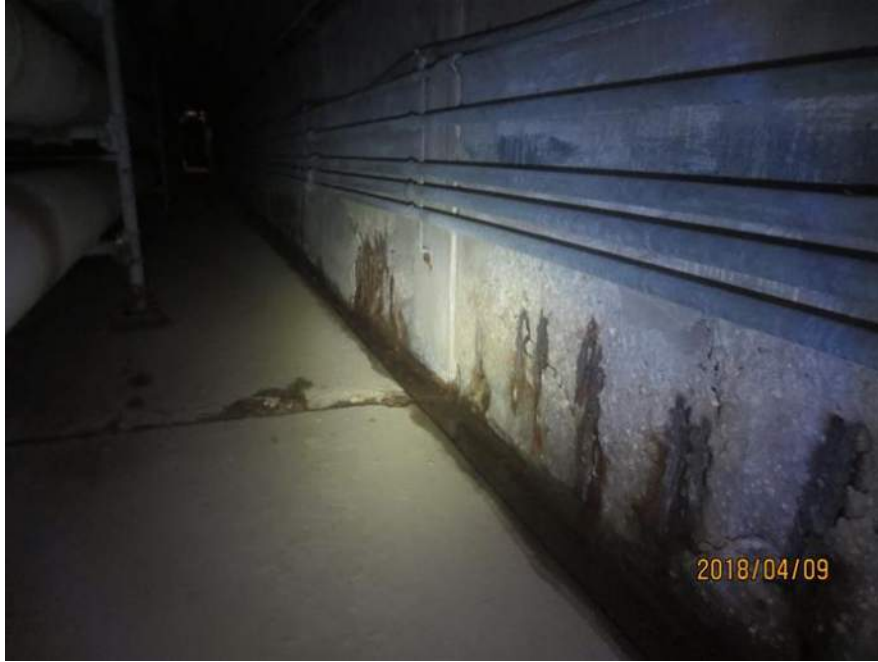
Station 26+90 to 27+25

**Comments:** Concrete Spalling, Re-Bar Exposed and Corroded

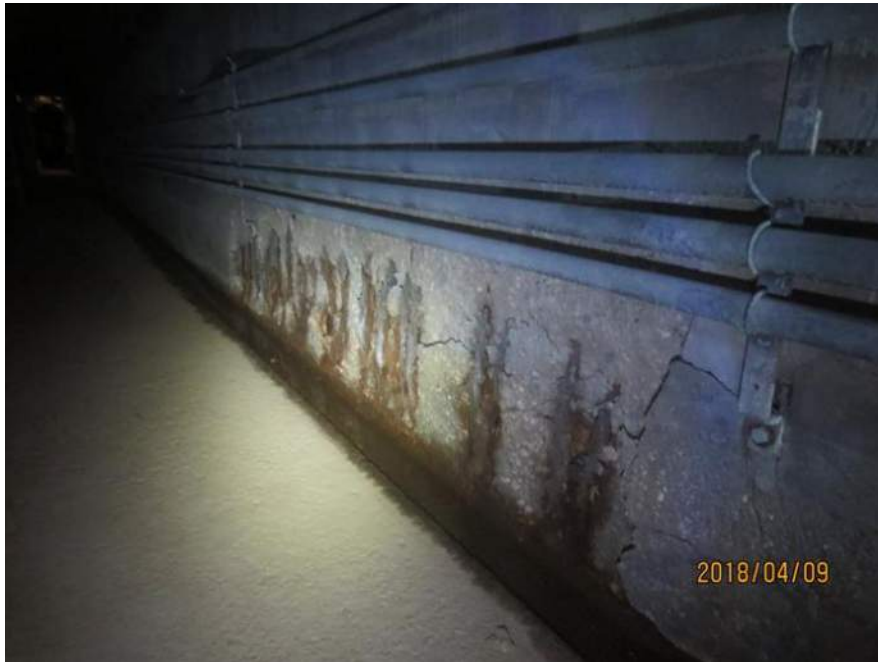
Station 27+25

**Comments:** Concrete Spalling, Re-Bar Exposed and Corroded

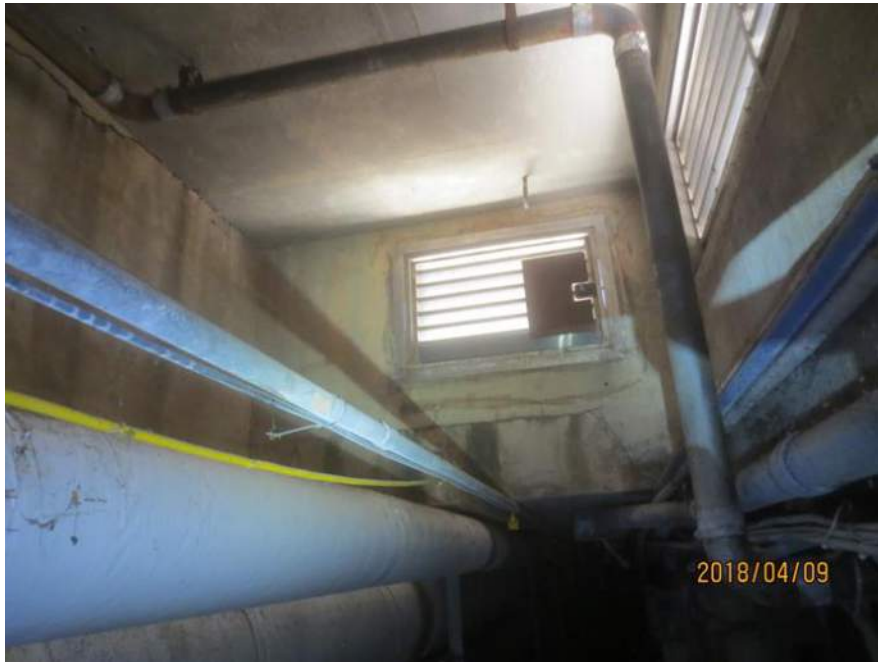
Station 27+92

**Comments:** Air Vent 7

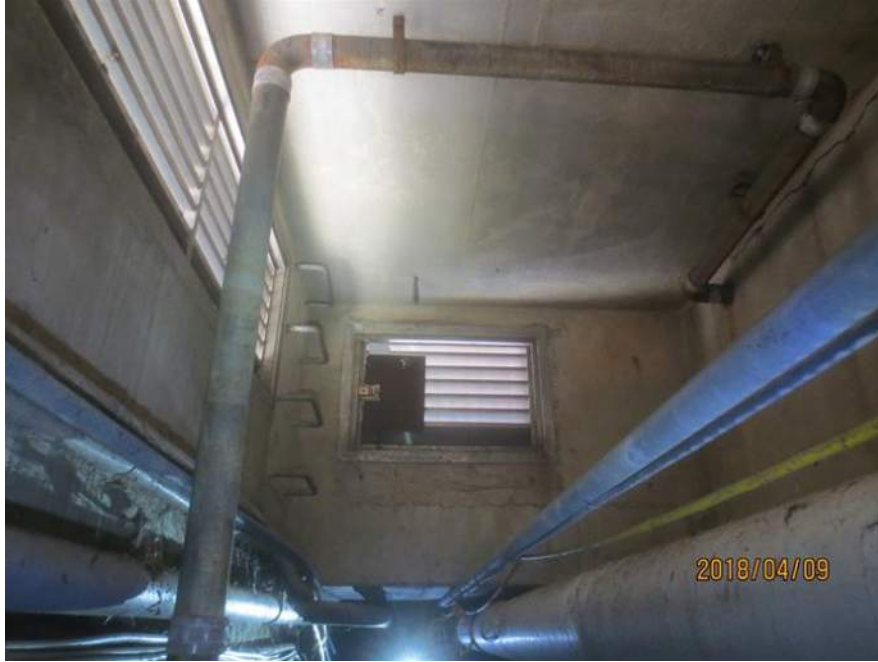
Station 27+92

**Comments:** Air Vent 7

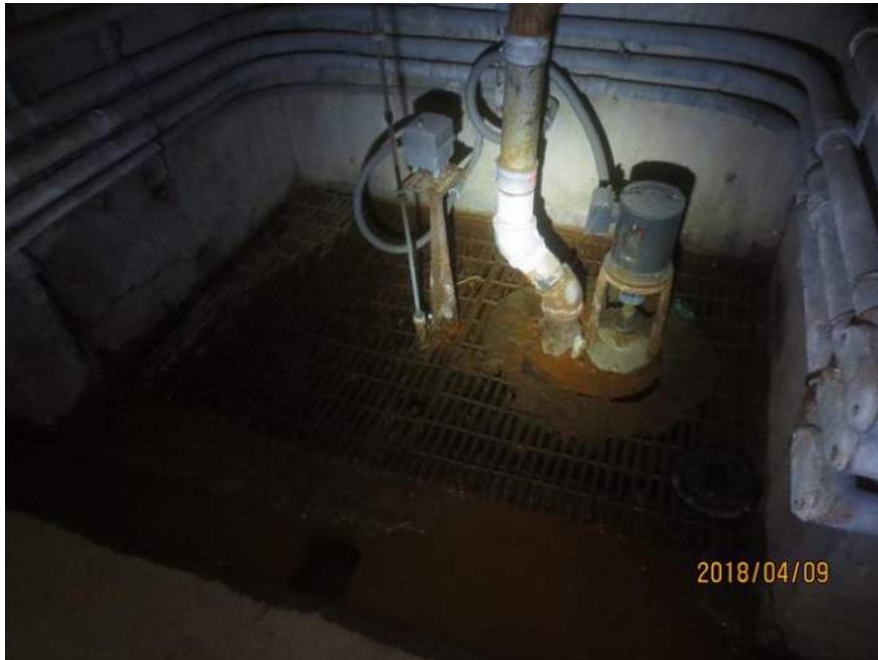
Station 27+92

**Comments:** Sump Pump

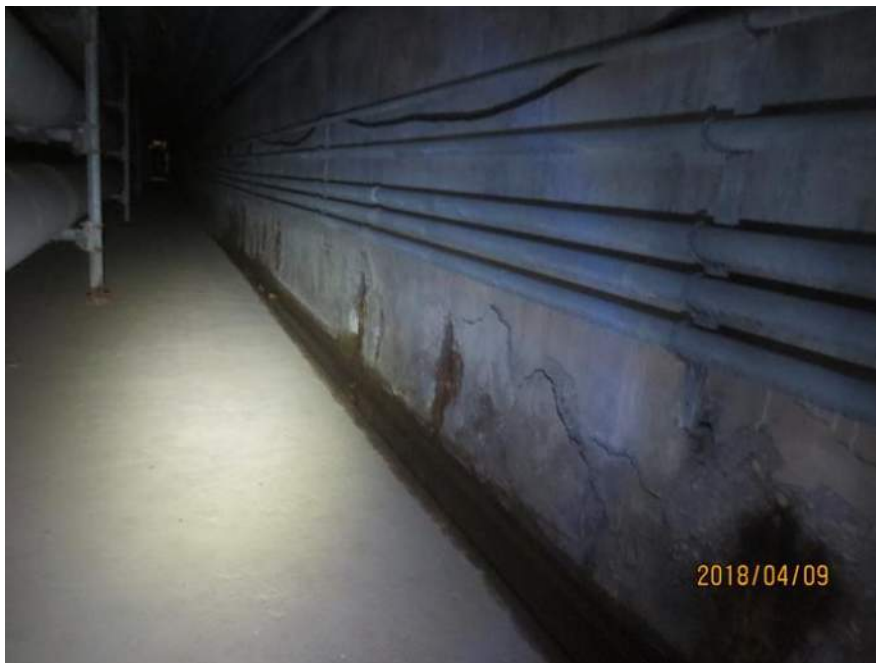
Station 28+94 to 29+32

**Comments:** Concrete Spalling, Re-Bar Exposed and Corroded

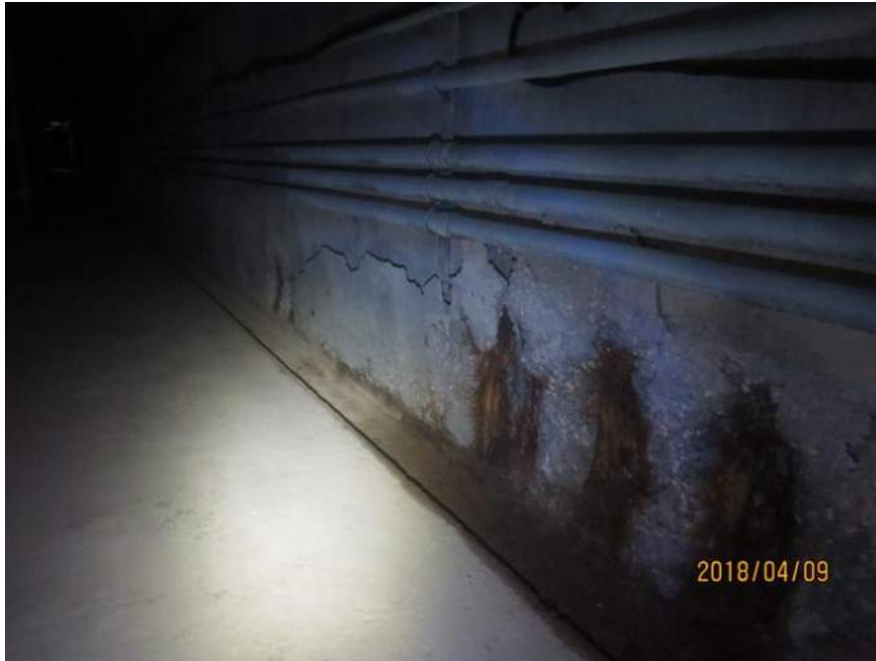
Station 29+45 to 29+70

**Comments:** Spalling, Re-Bar Exposed and Corroded, Loose Concrete

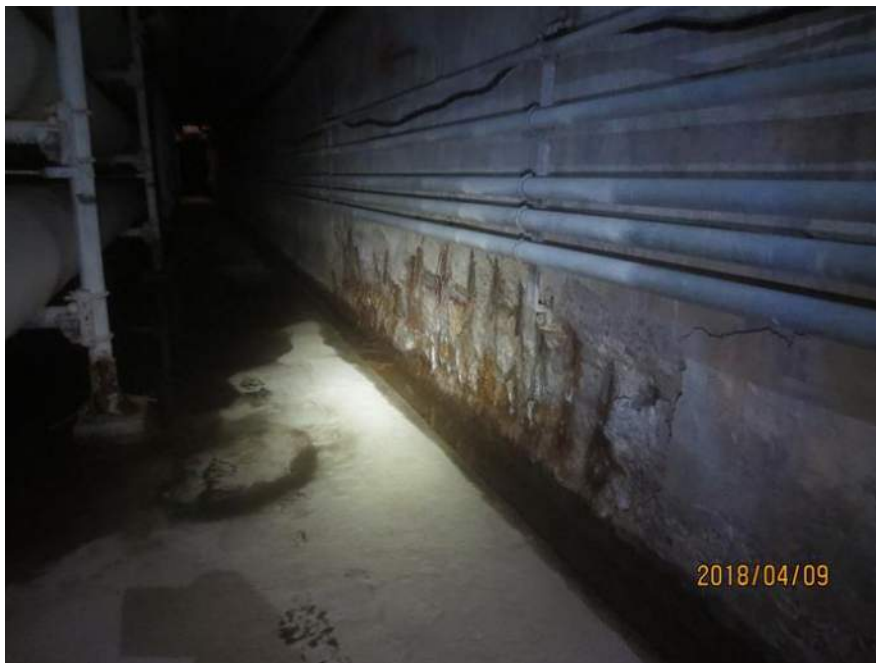
Station 29+76 to 29+96

**Comments:** Concrete Spalling, Re-Bar Exposed and Corroded

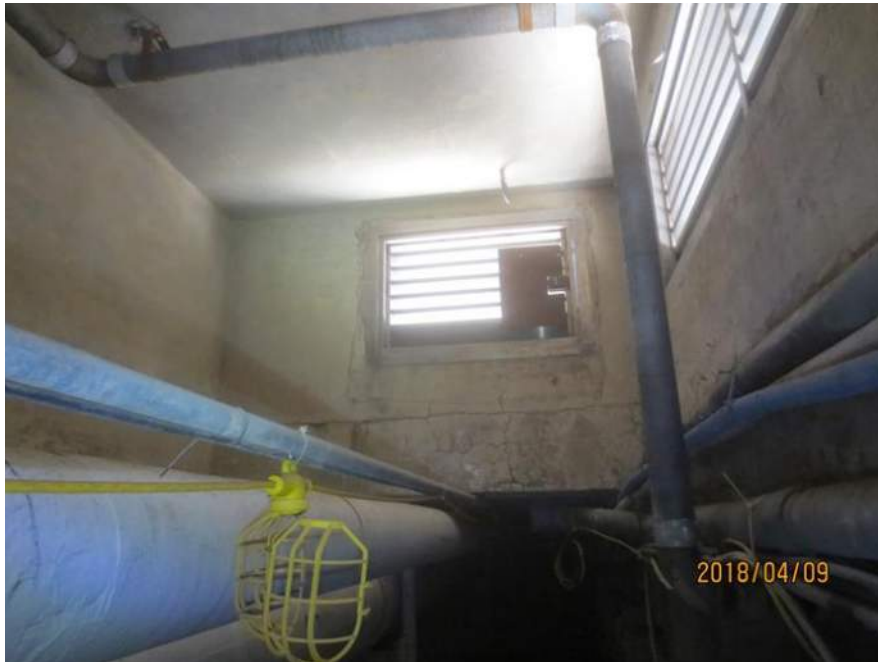
Station 30+46

**Comments:** Air Vent 6

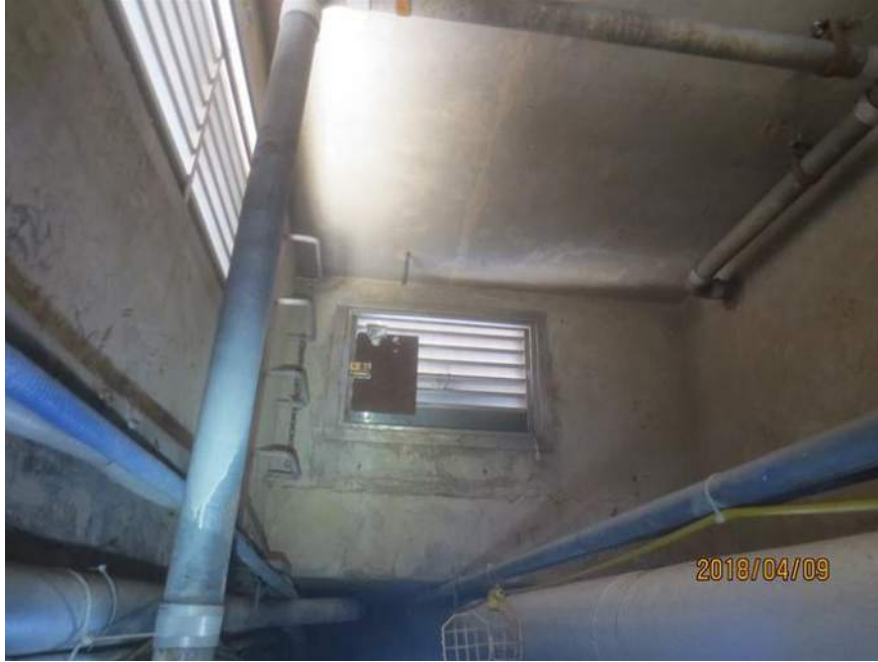
Station 30+46

**Comments:** Air Vent 6

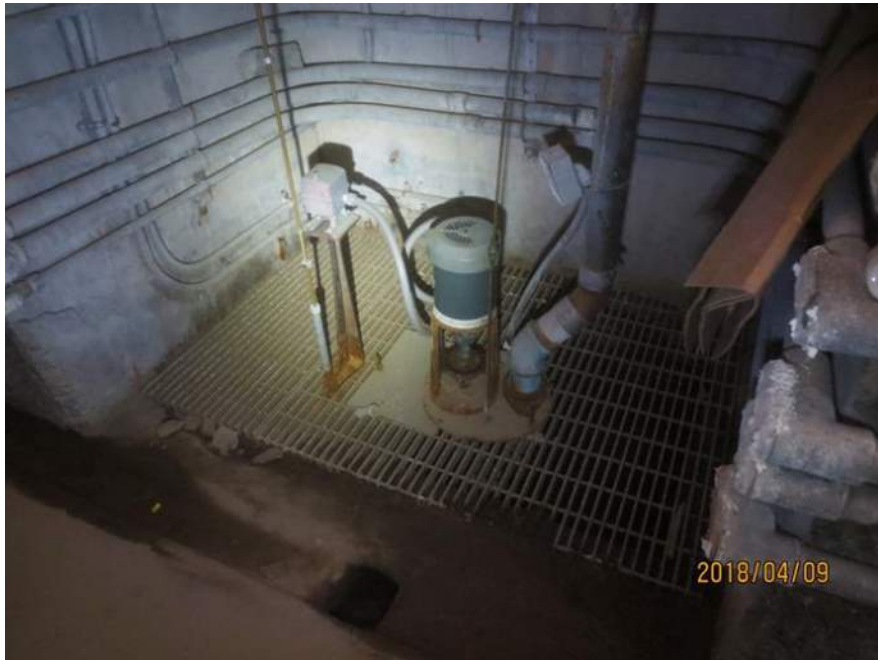
Station 30+46

**Comments:** Sump Pump

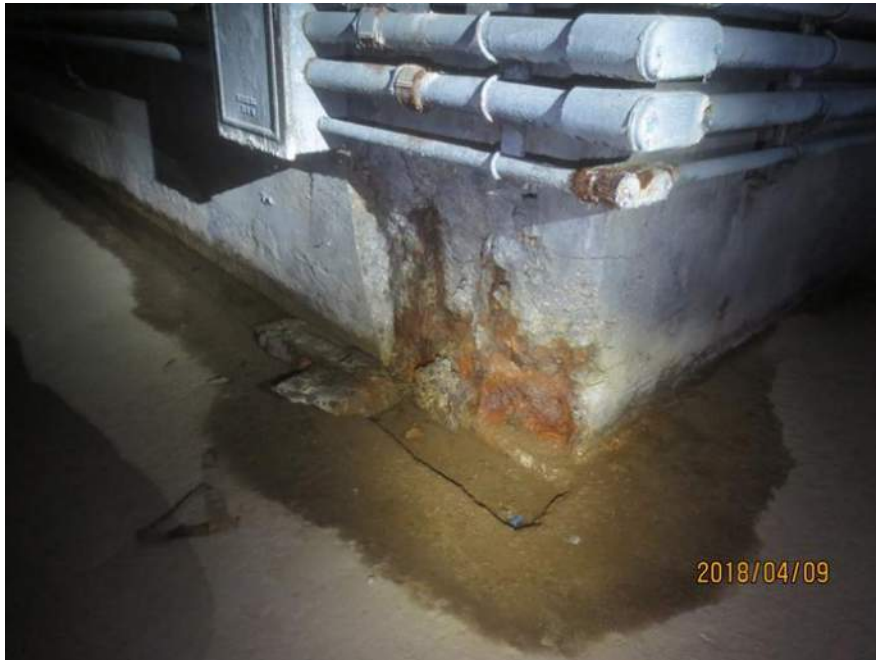
Station 31+83 to 31+85

**Comments:** Concrete Spalling, Re-Bar Exposed and Corroded

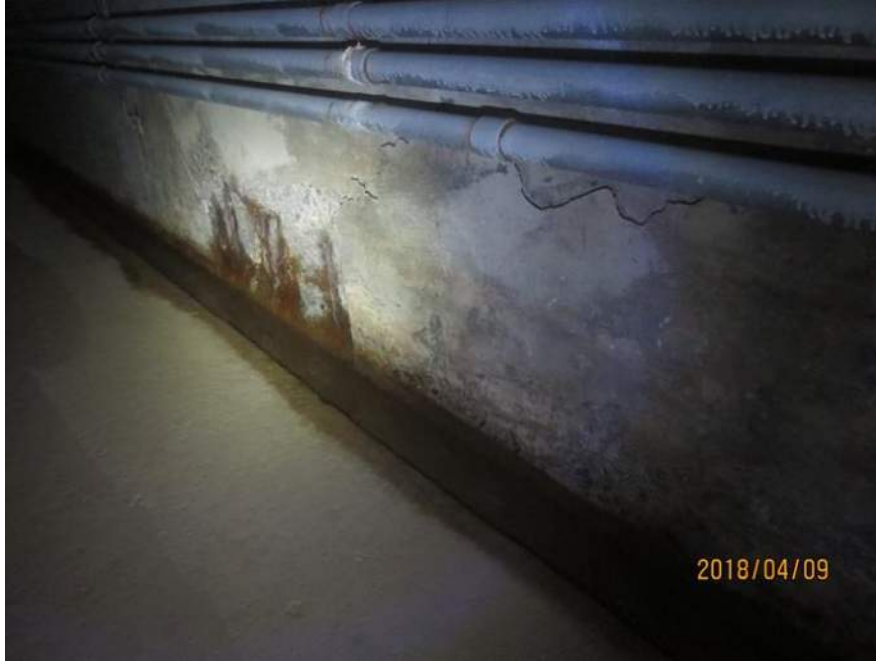
Station 32+43 to 32+49

**Comments:** Concrete Spalling, Re-Bar Exposed and Corroded

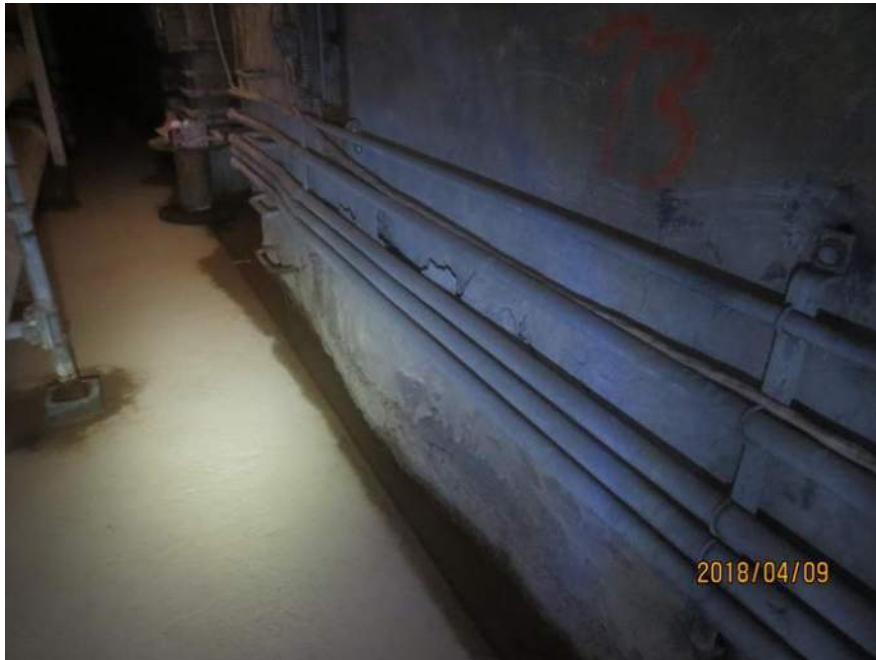
Station 32+77 to 33+00

**Comments:** Concrete Spalling, Re-Bar Exposed and Corroded

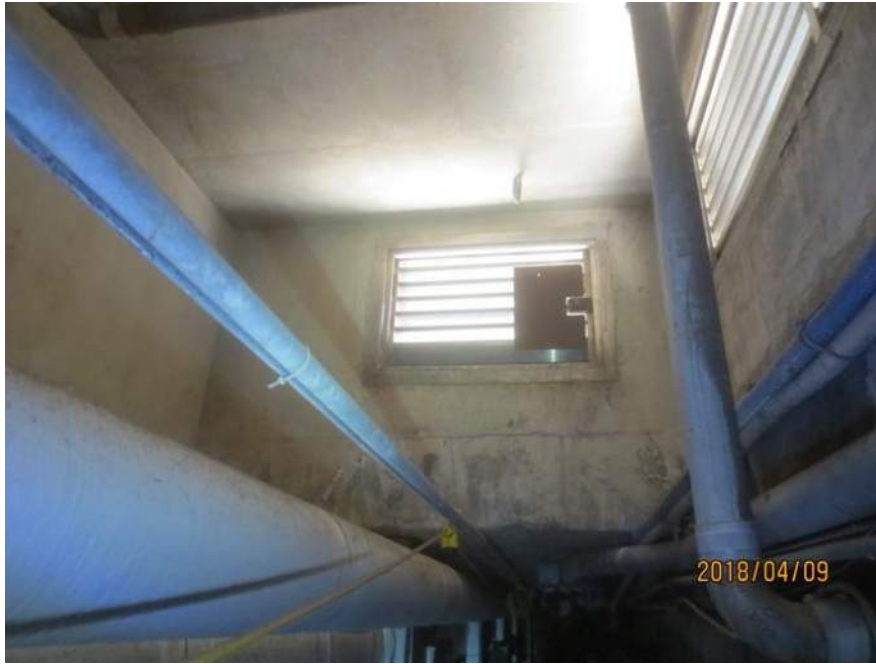
Station 33+00

**Comments:** Air Vent 5

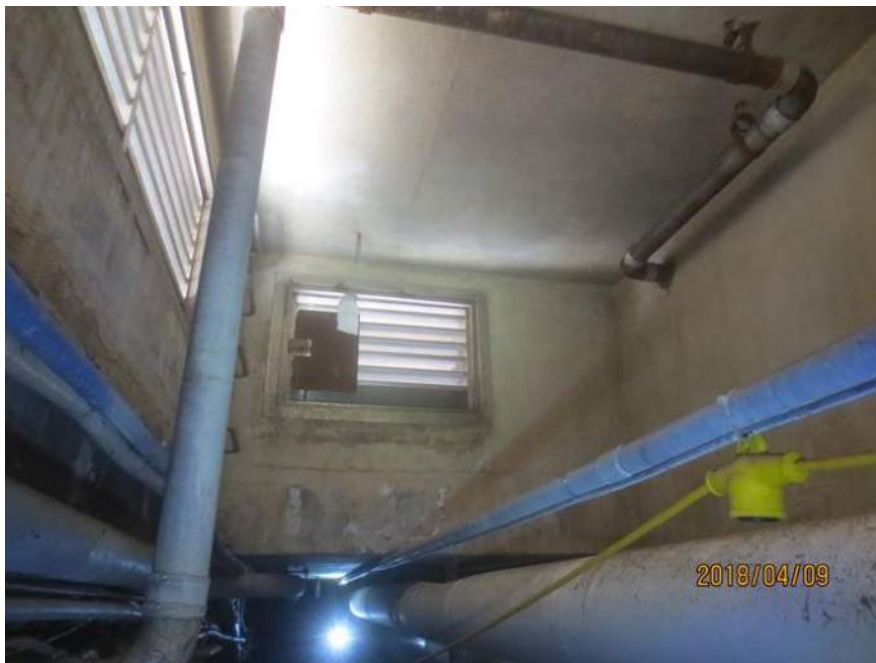
Station 33+00

**Comments:** Air Vent 5

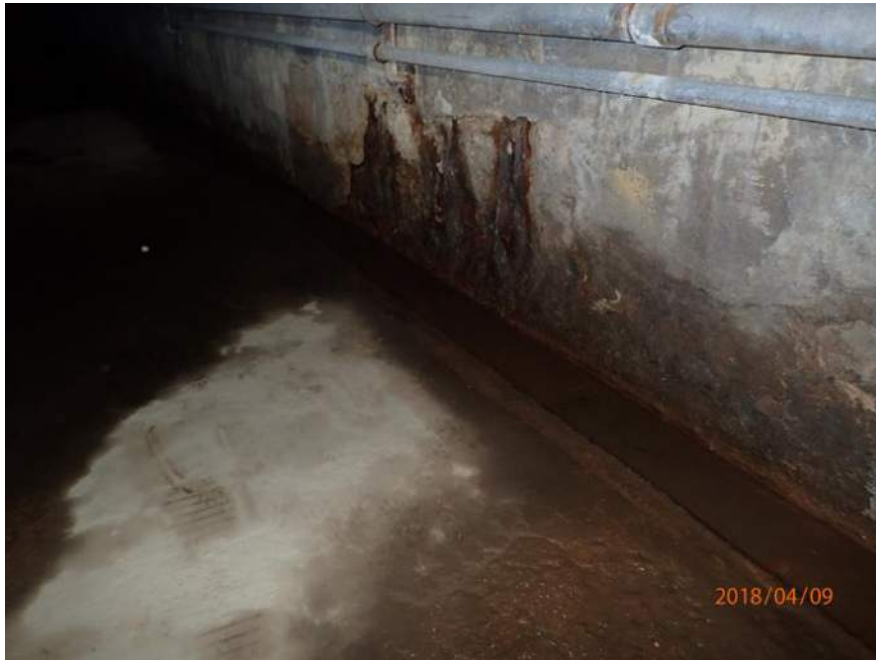
Station 35+00 to 35+08

**Comments:** Concrete Spalling, Re-Bar Exposed and Corroded

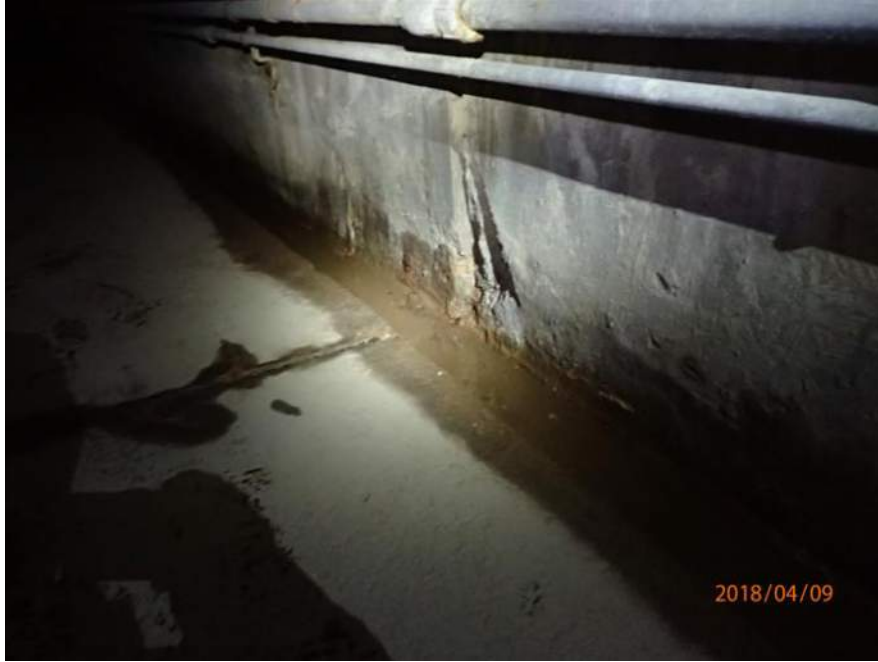
Station 35+39

**Comments:** Floor Slab Cracked and Displaced

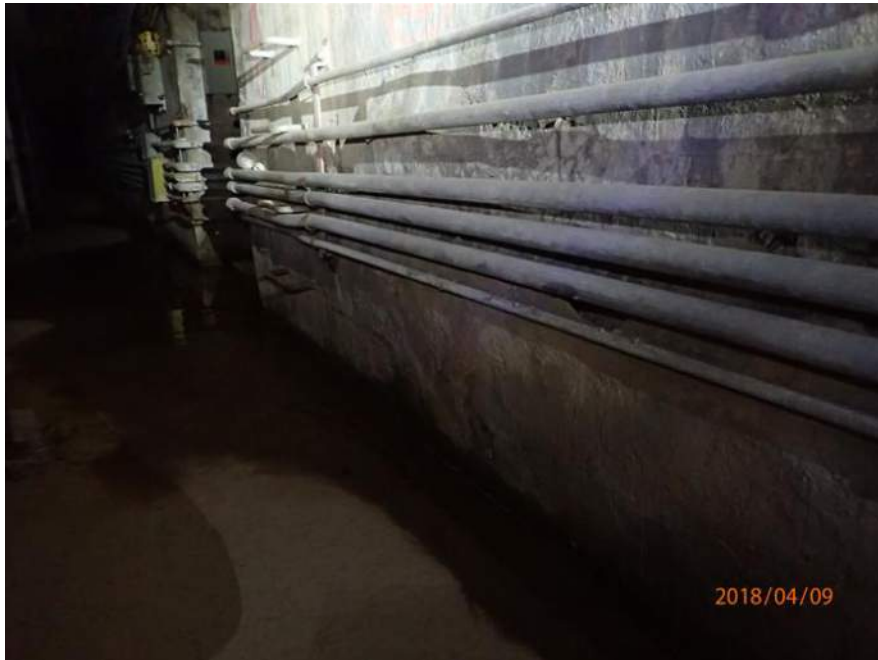
Station 35+52 to 35+63

**Comments:** Concrete Spalling

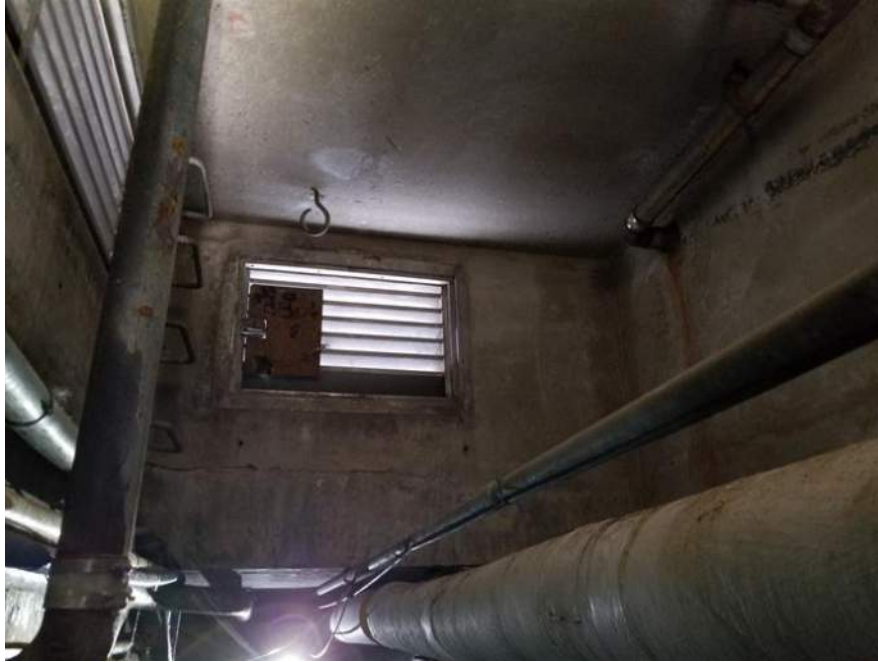
Station 35+54

**Comments:** Air Vent 4

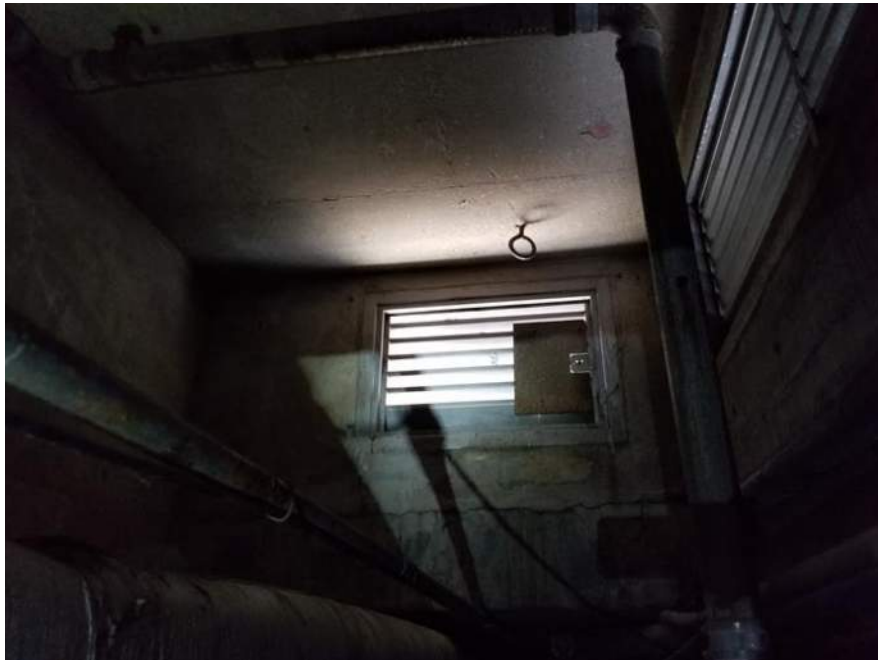
Station 35+54

**Comments:** Air Vent 4

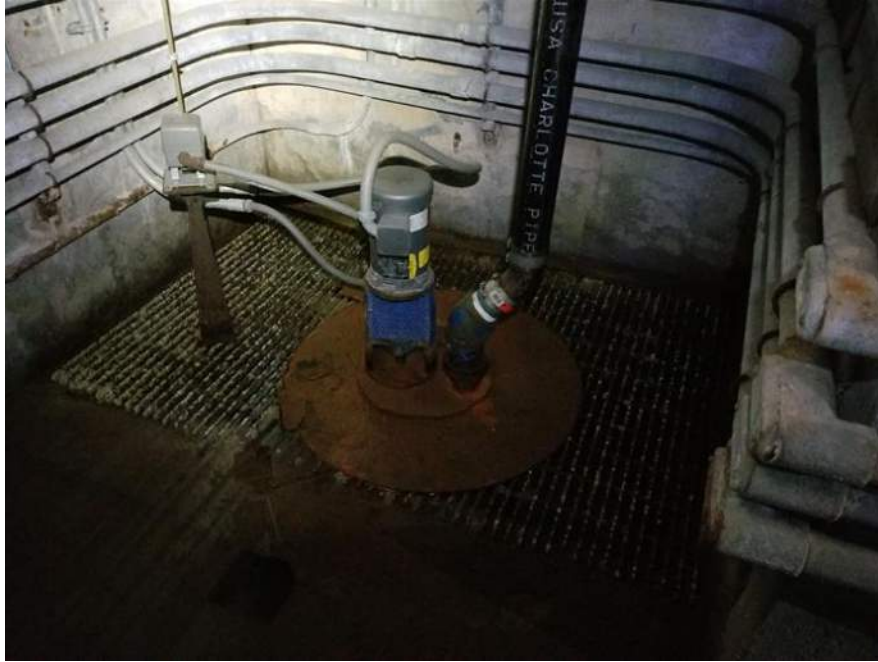
Station 35+54

**Comments:** Sump Pump

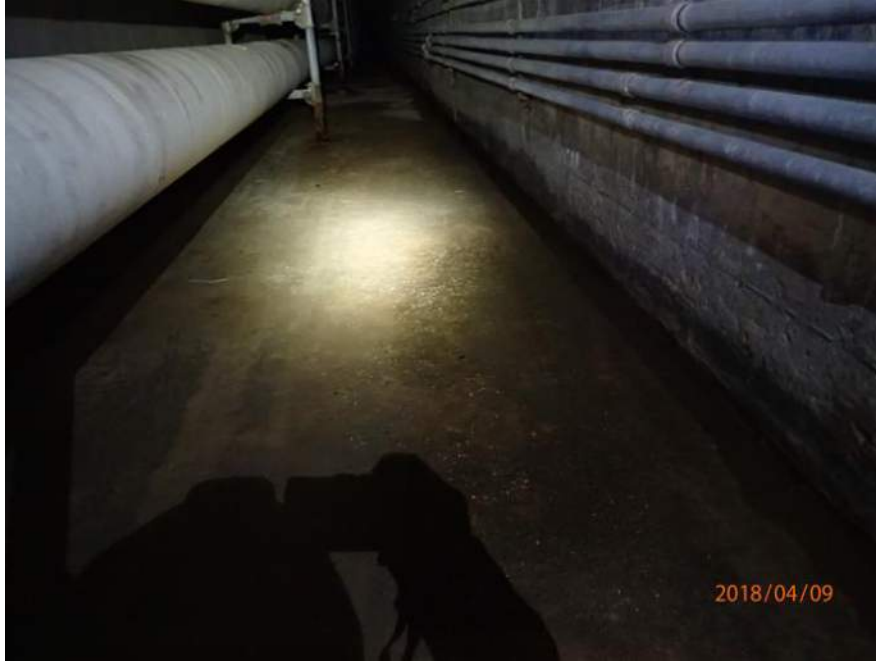
Station 36+57 to 36+62

**Comments:** Floor Slab Cracked

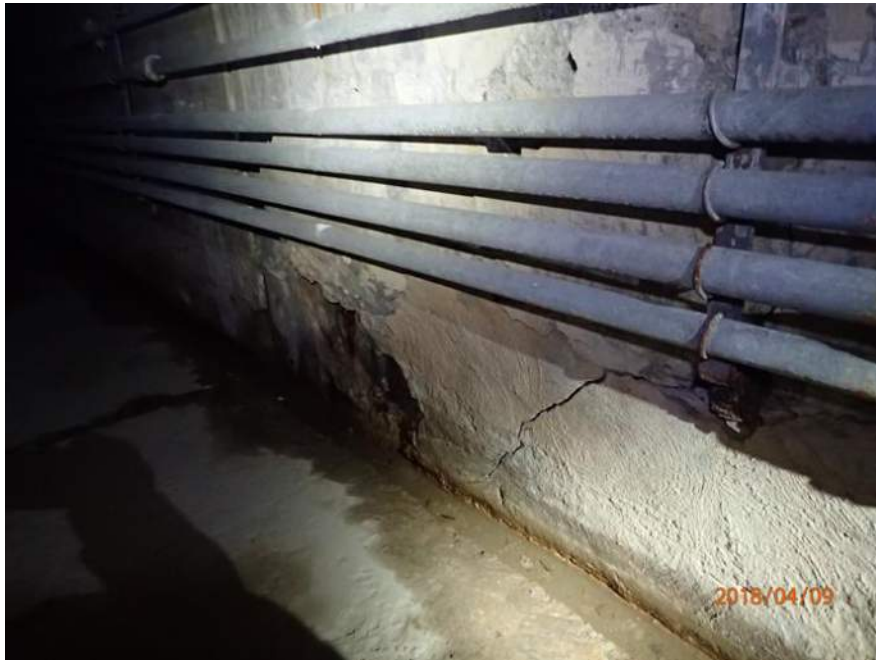
Station 36+57 to 36+90

**Comments:** Concrete Spalling

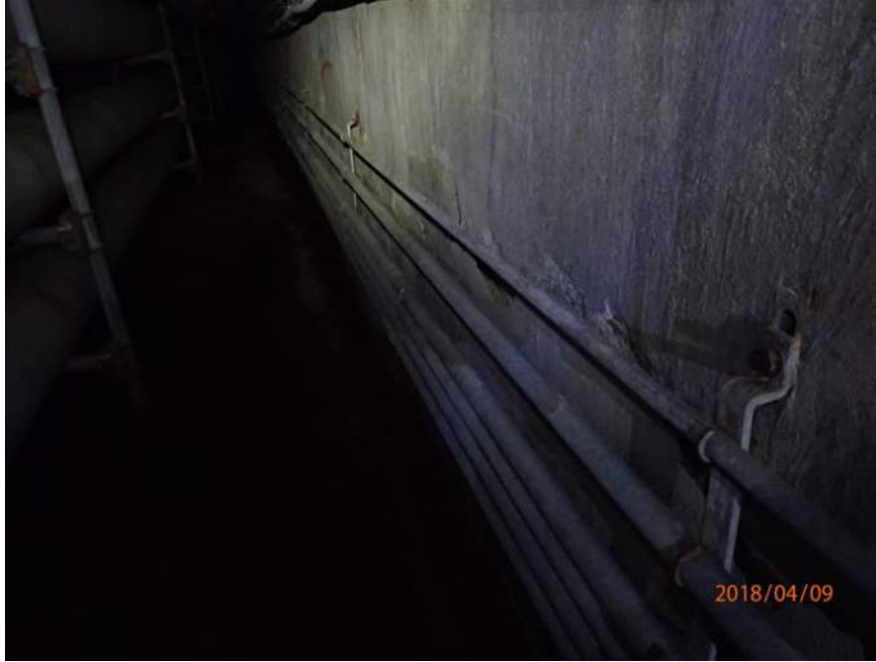
**Station 37+00**

**Direction:** Western Wall (In-Land)

**Comments:** Concrete Spalling up to 5 feet Height

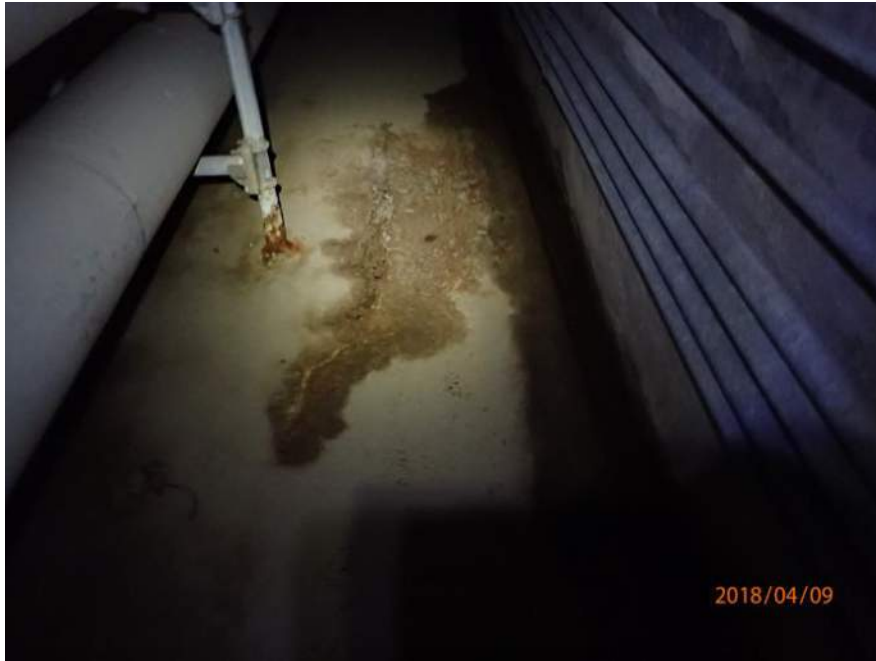
Station 38+13

**Direction:** Tunnel Floor

**Comments:** Floor Slab Cracked

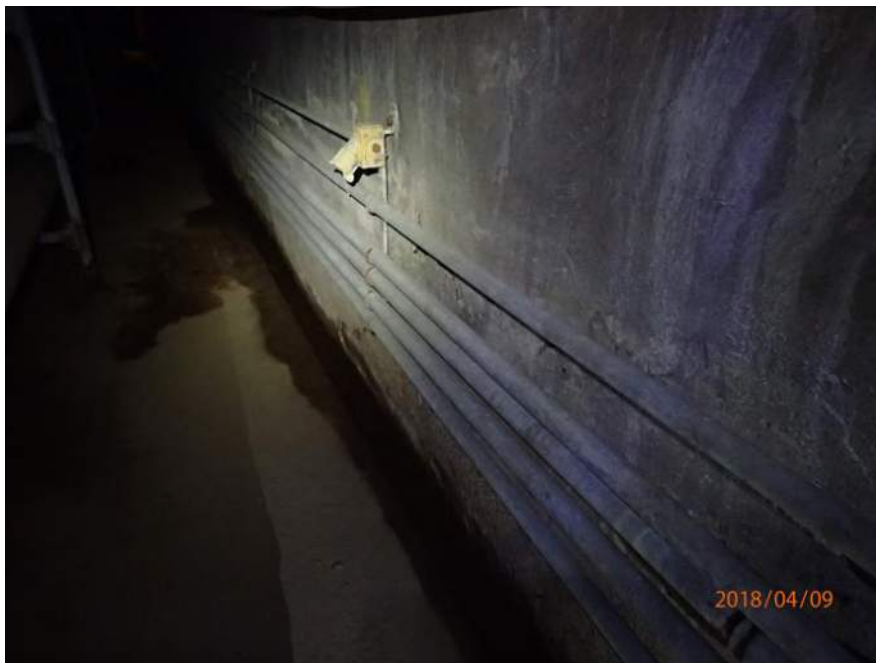
Station 38+03 to 38+55

**Direction:** Western Wall (In-Land)

**Comments:** Concrete Spalling

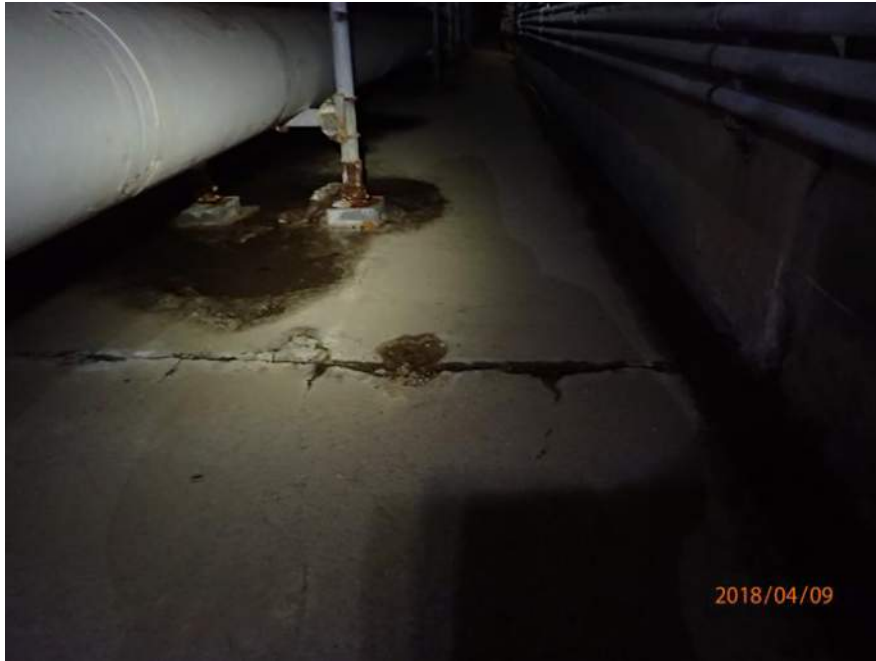
**Station 38+64**

**Direction:** Tunnel Floor

**Comments:** Floor Slab Cracking at Joint

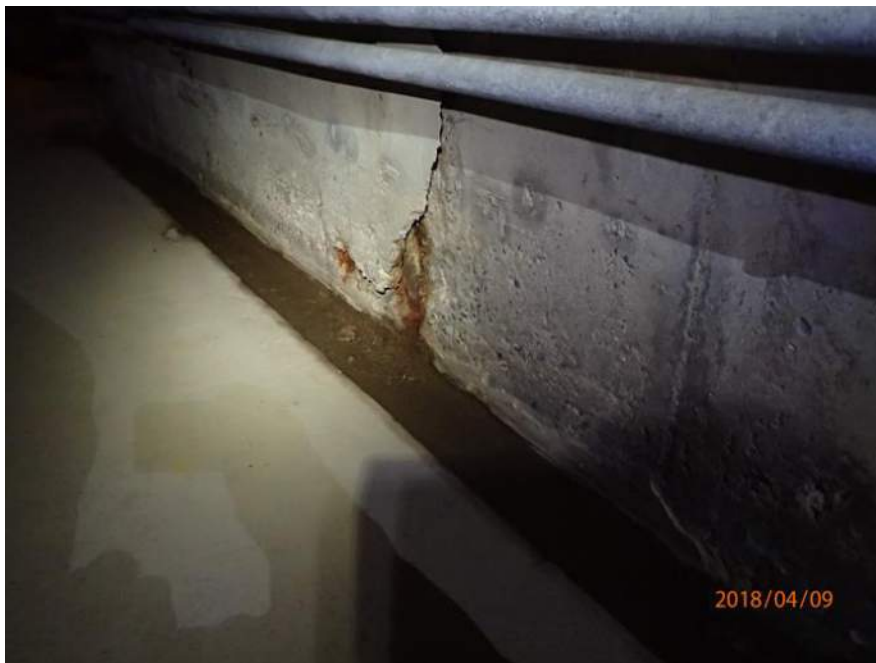
**Station 39+00**

**Direction:** Western Wall (In-Land)

**Comments:** Spalling, Loose Concrete

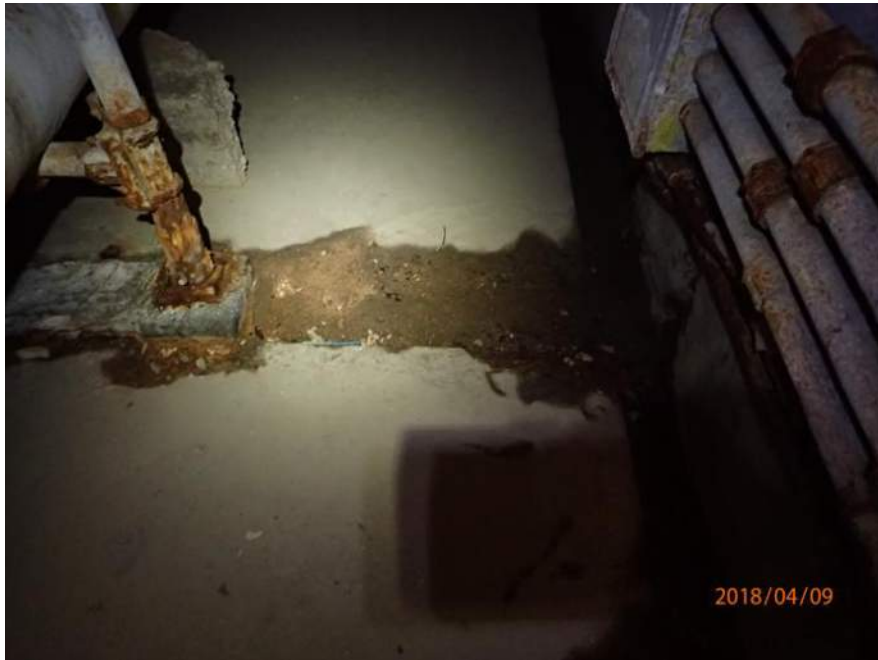
**Station 39+23**

**Direction:** Tunnel Floor

**Comments:** Floor Slab Cracking
