# **CONDITIONS REPORT & CONCEPTUAL DESIGN MEMORANDUM**

## **STEAM TUNNEL ASSESSMENT**

**ROOSEVELT ISLAND, NEW YORK**

**28 December 2018  
Project # 100444601**

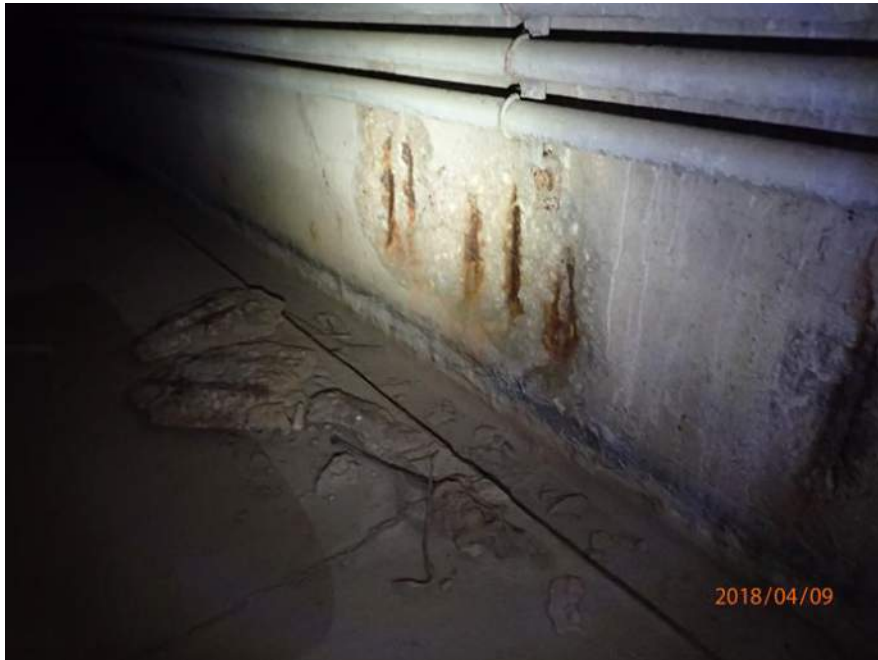
Station 45+61 to 45+66

**Direction:** Western Wall (In-Land)

**Comments:** Concrete Spalling

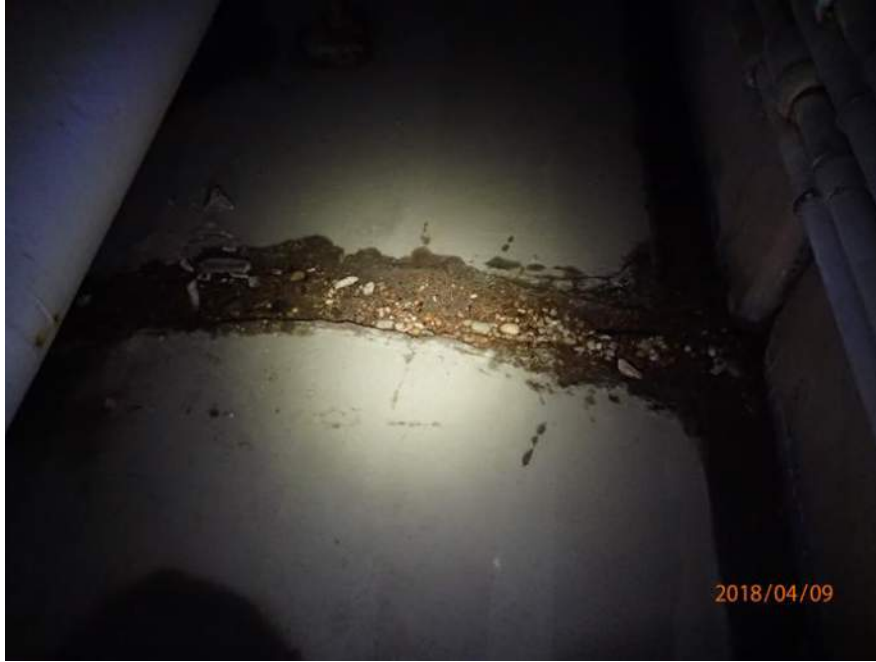
Station 45+94

**Direction:** Tunnel Joint

**Comments:** Cracks

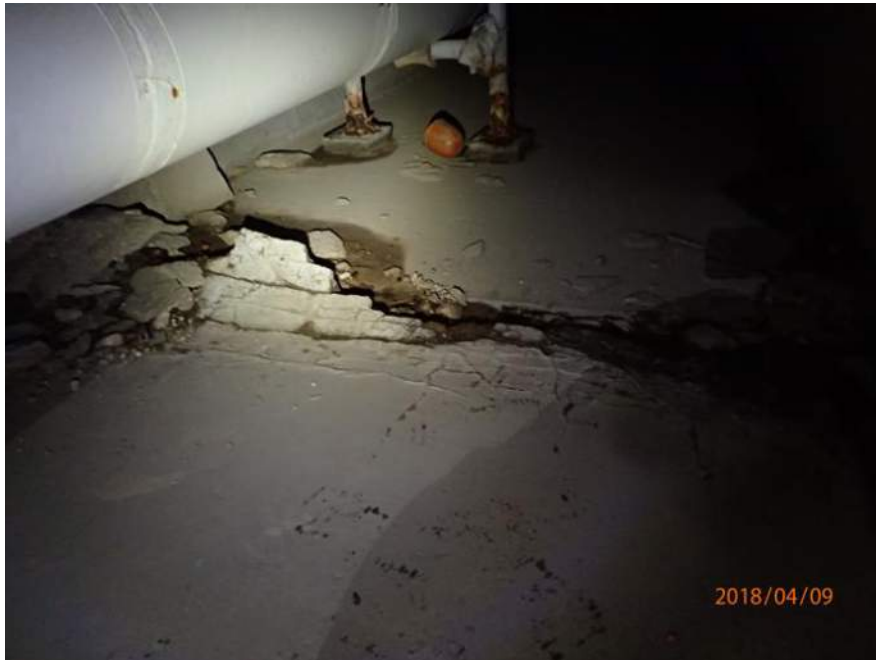
Station 46+60

**Direction:** Tunnel Joint

**Comments:** Floor Slab Raised at Joint, Cracking, Loose Concrete

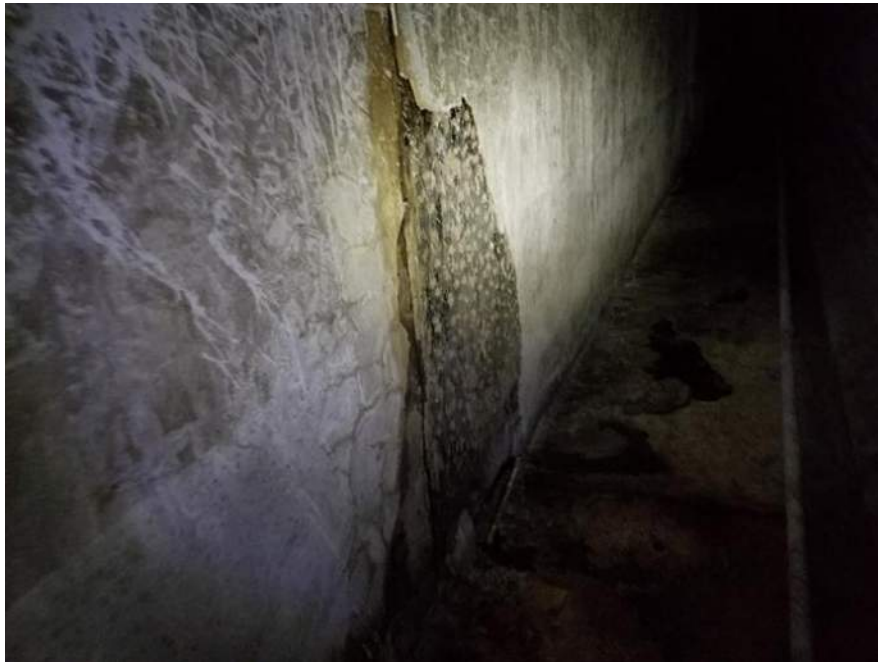
**Station 53+50**

**Direction:** Tunnel Mid-Wall (East Face)/ Tunnel Floor

**Comments:** Concrete Spalling

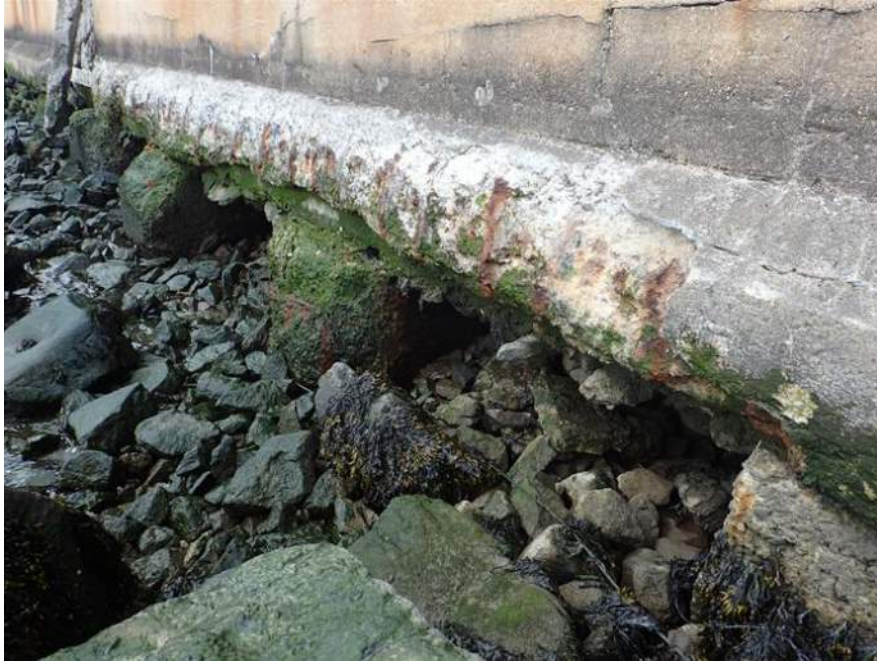
Station 10+43

**Comments:** Spalling at Haunch, Missing Large Sections of Concrete, Tunnel has been Undermined, Cap Beams Visible

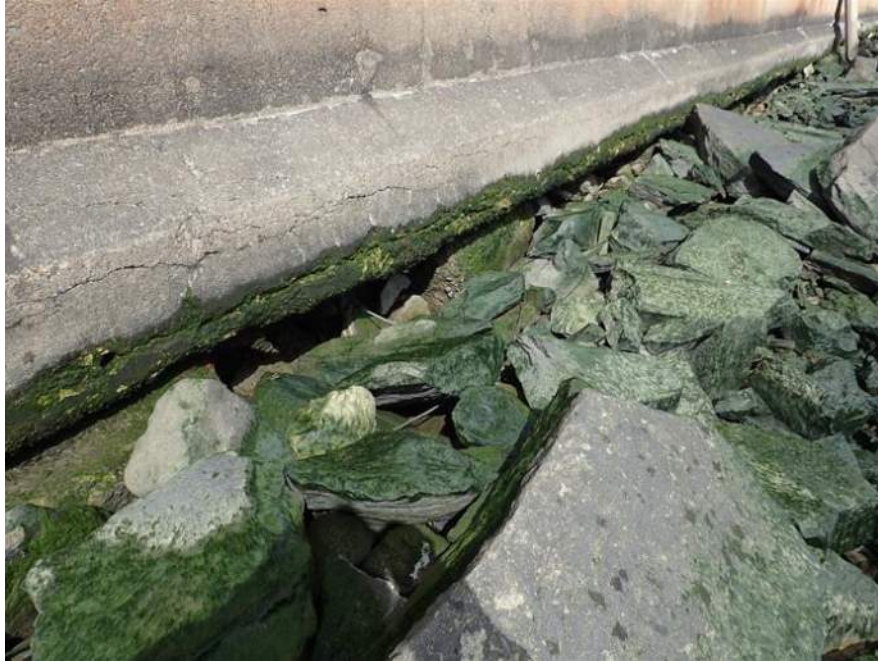
**Station 11+06**

**Comments:** Tunnel has been Undermined

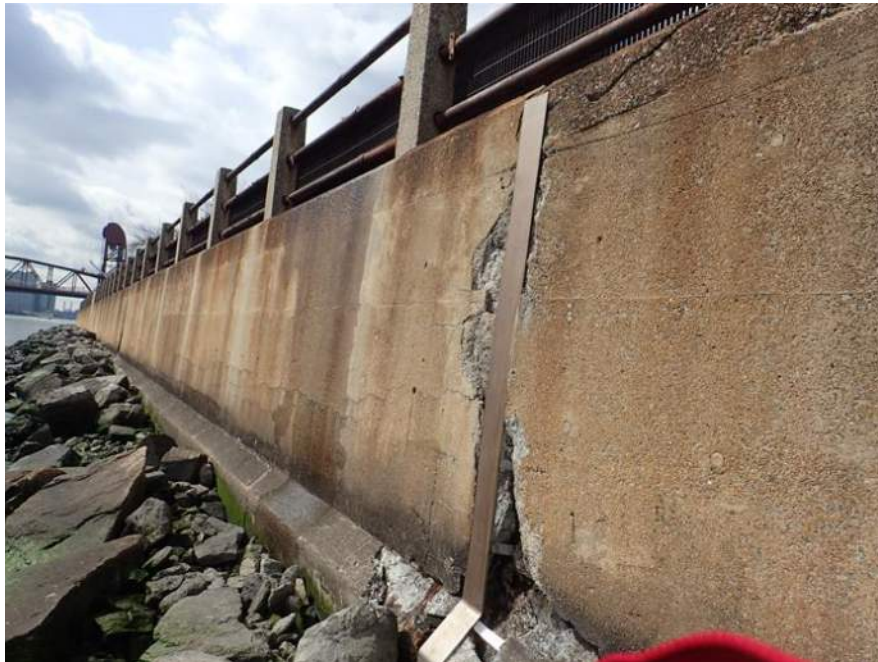
**Station 11+19**

**Comments:** Remnant of Timber Formwork

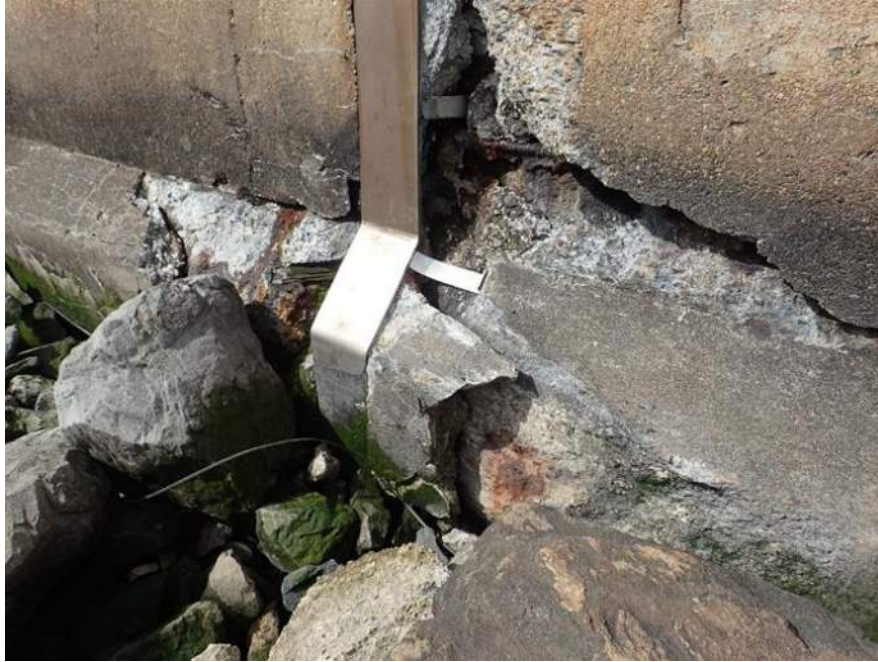
**Station 11+19**

**Comments:** Remnant of Timber Formwork

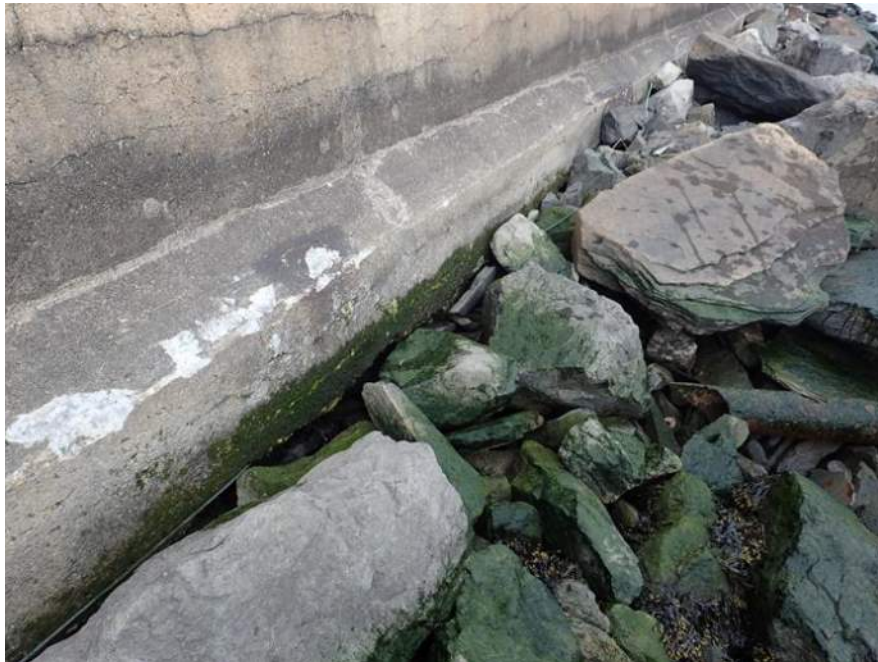
**Station 11+66**

**Comments:** Tunnel has been Undermined

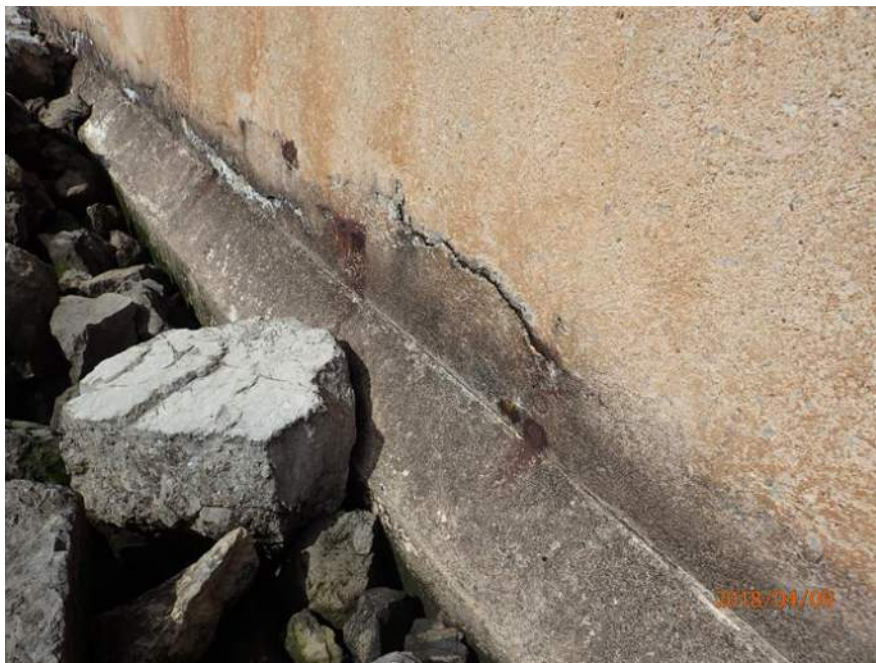
**Station 16+00**

**Comments:** Concrete Spalling

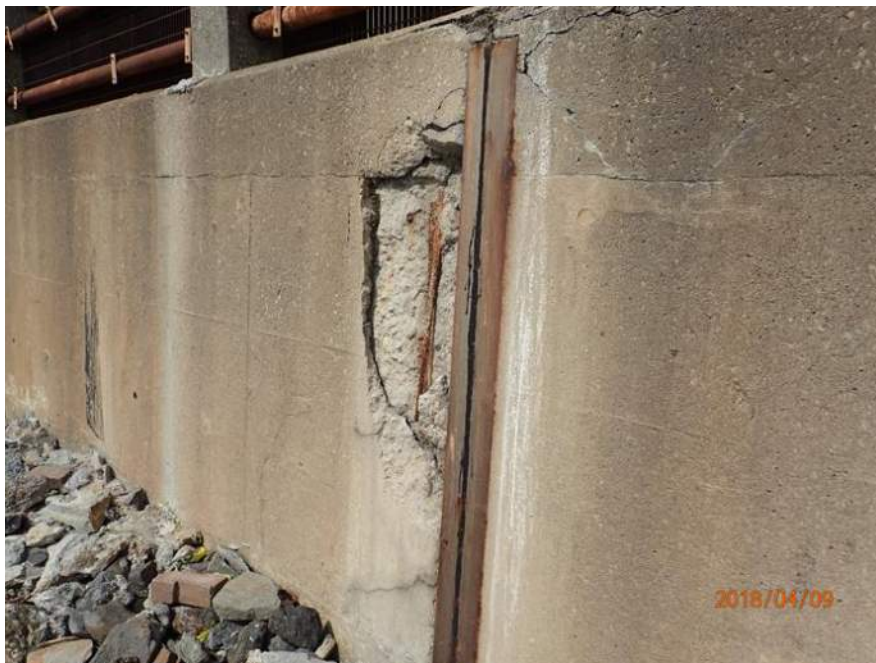
Station 17+85

**Comments:** Concrete Spalling, Missing Large Section of Concrete, Re-Bar Exposed

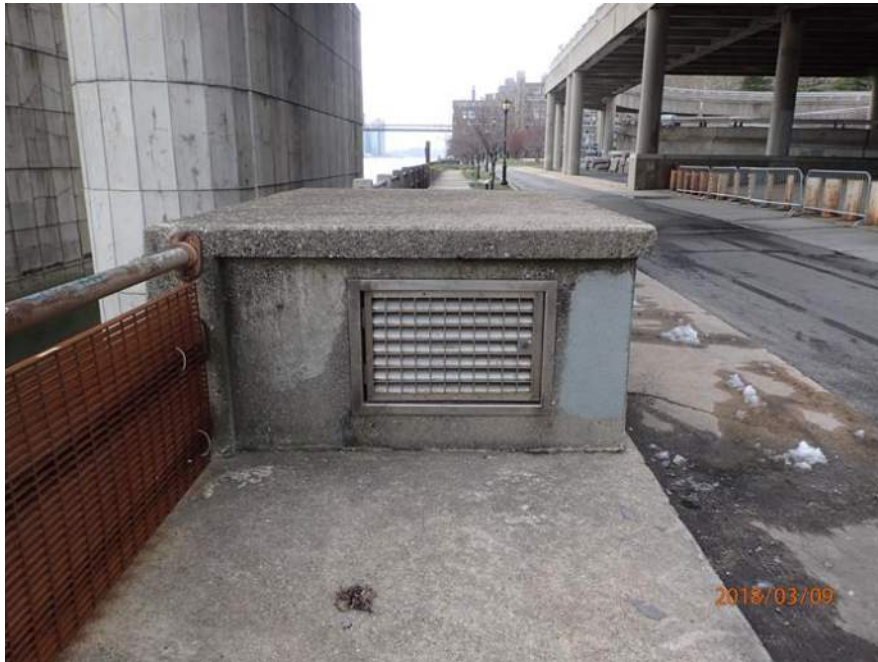
Station 22+84

**Direction:** Air Vent 9

**Comments:** Northern Face

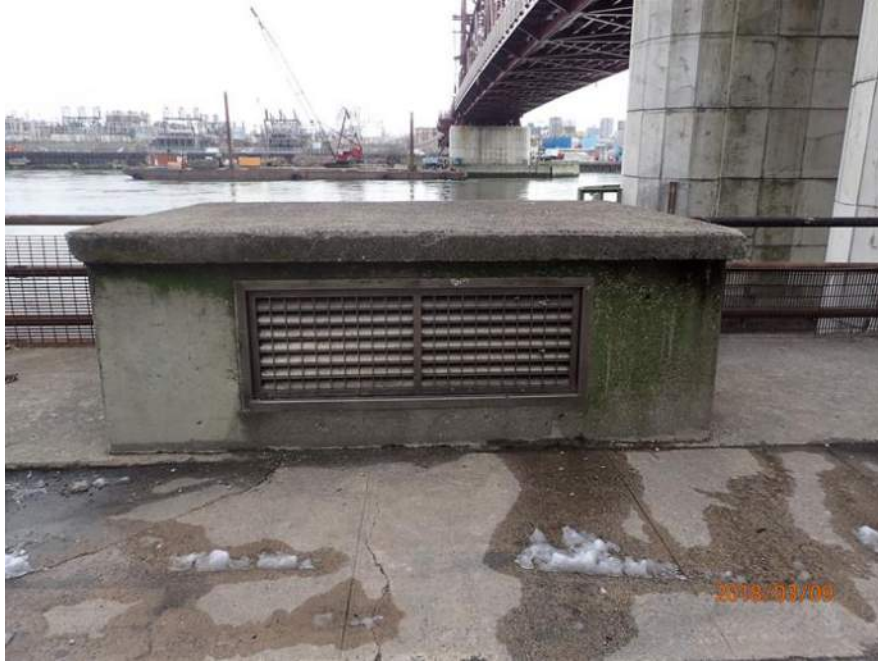
Station 22+84

**Direction:** Air Vent 9

**Comments:** Western Face

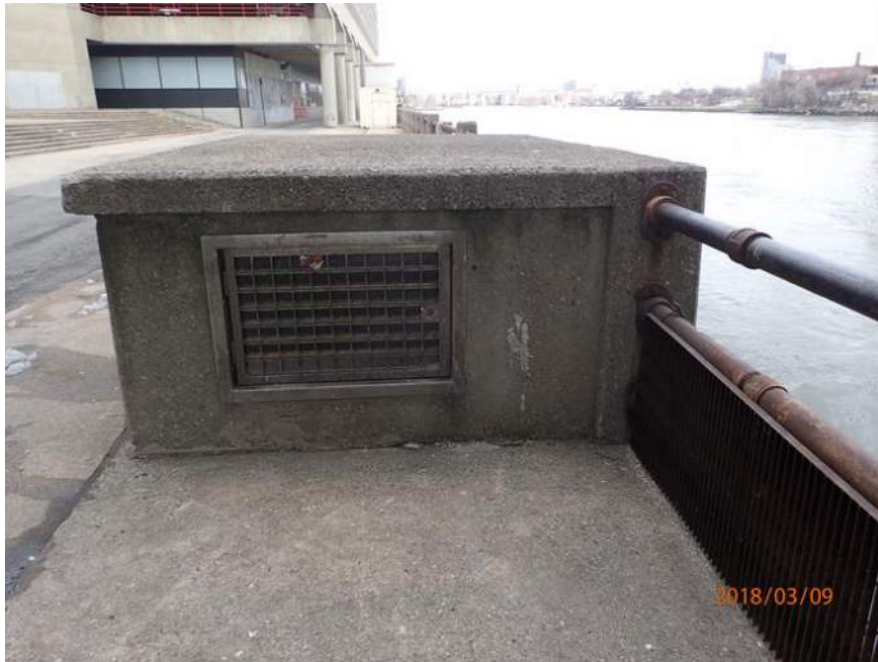
Station 22+84

**Direction:** Air Vent 9

**Comments:** Southern Face

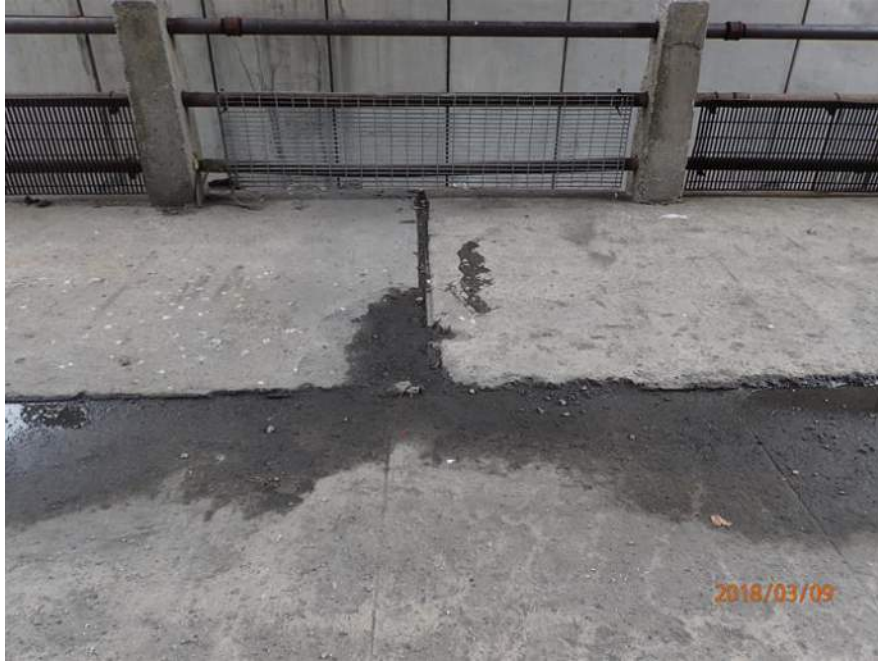
Station 23+20

**Direction:** Seawall Sidewalk Joint

**Comments:** Concrete Cracks

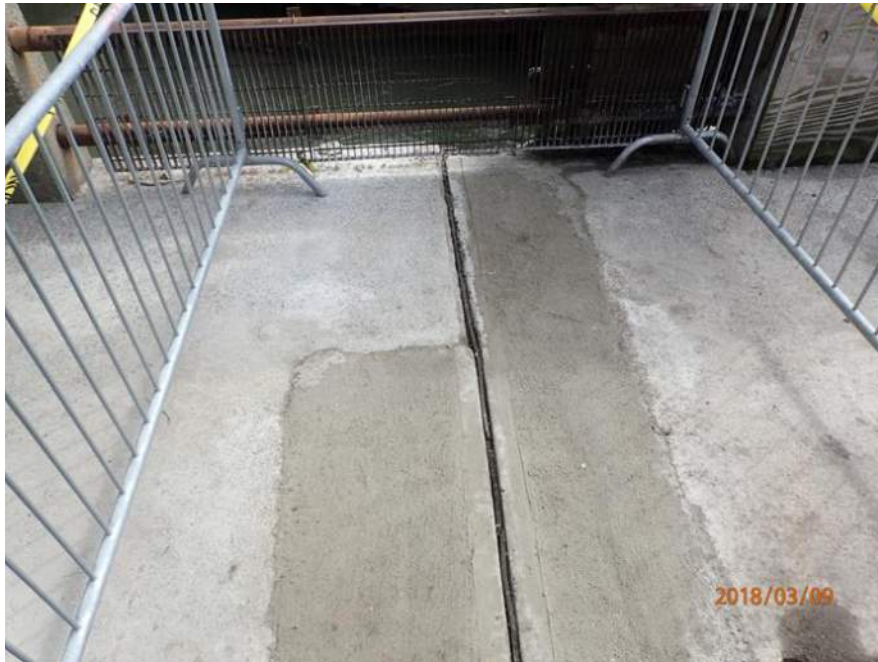
Station 23+88

**Direction:** Seawall Sidewalk Joint

**Comments:** Joint Repair

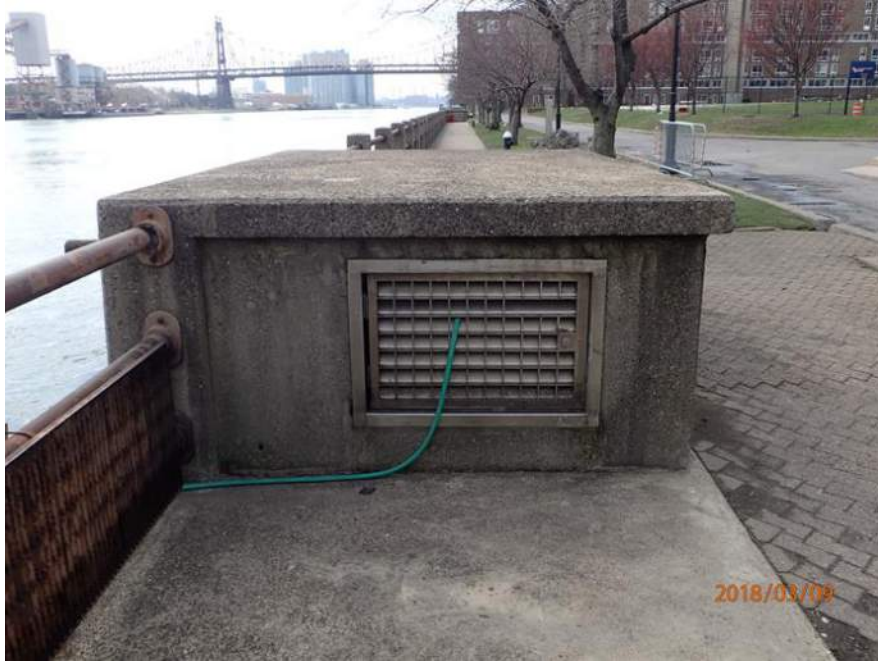
Station 25+38

**Direction:** Air Vent 8

**Comments:** Northern Face

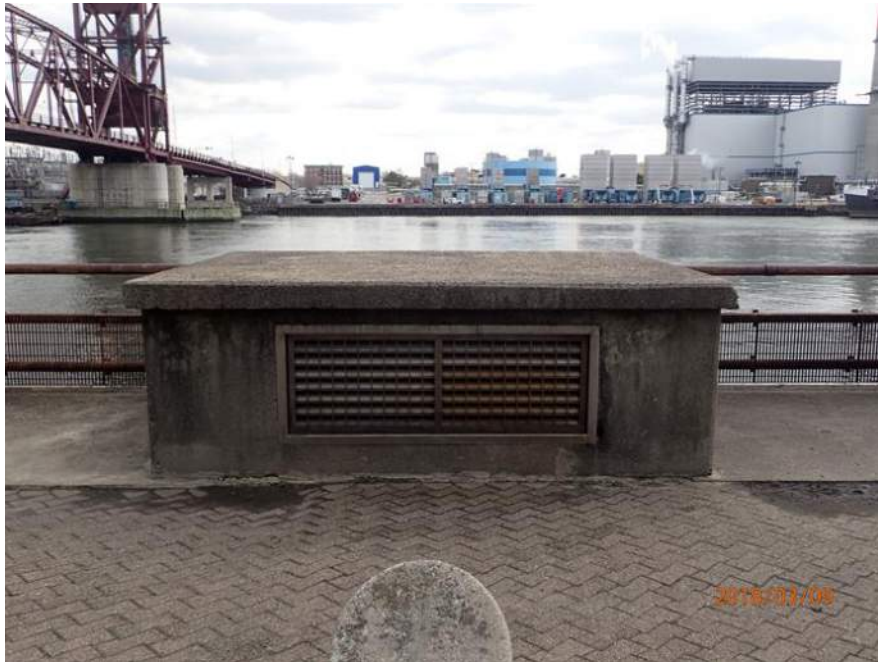
Station 25+38

**Direction:** Air Vent 8

**Comments:** Western Face

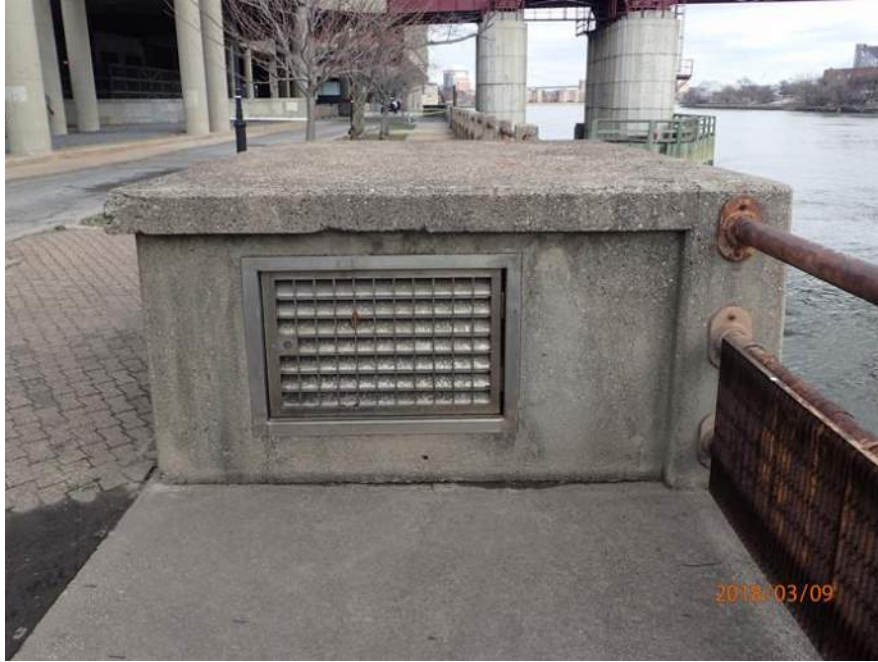
Station 25+38

**Direction:** Air Vent 8

**Comments:** Southern Face

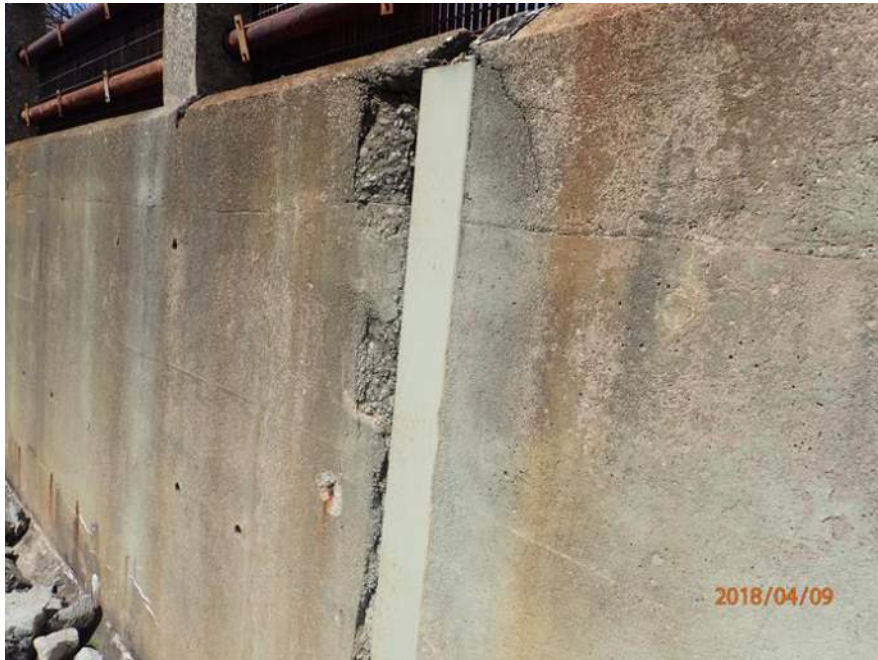
Station 25+82

**Direction:** Seawall Joint

**Comments:** Concrete Spalling

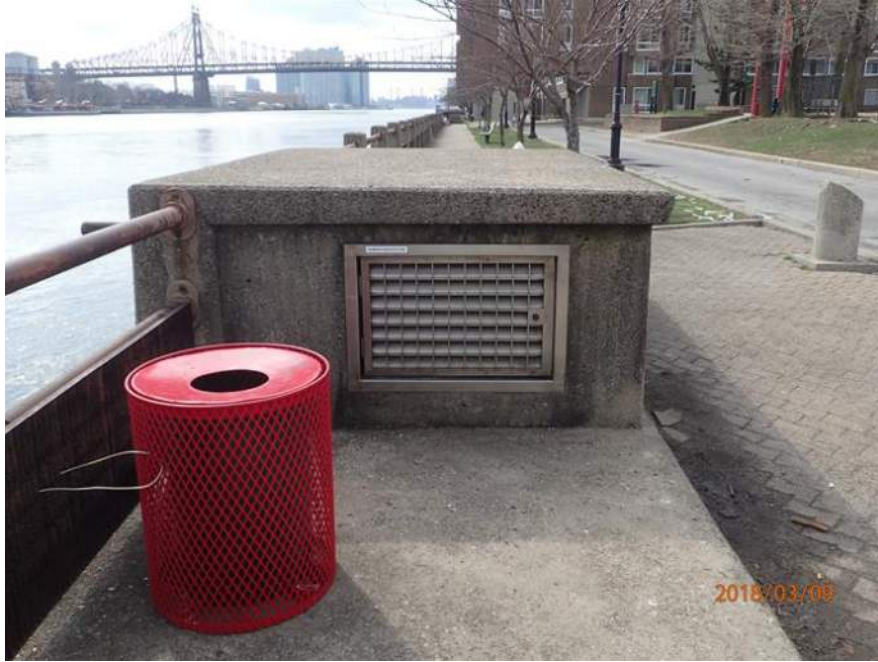
Station 27+92

**Direction:** Air Vent 7

**Comments:** Northern Face

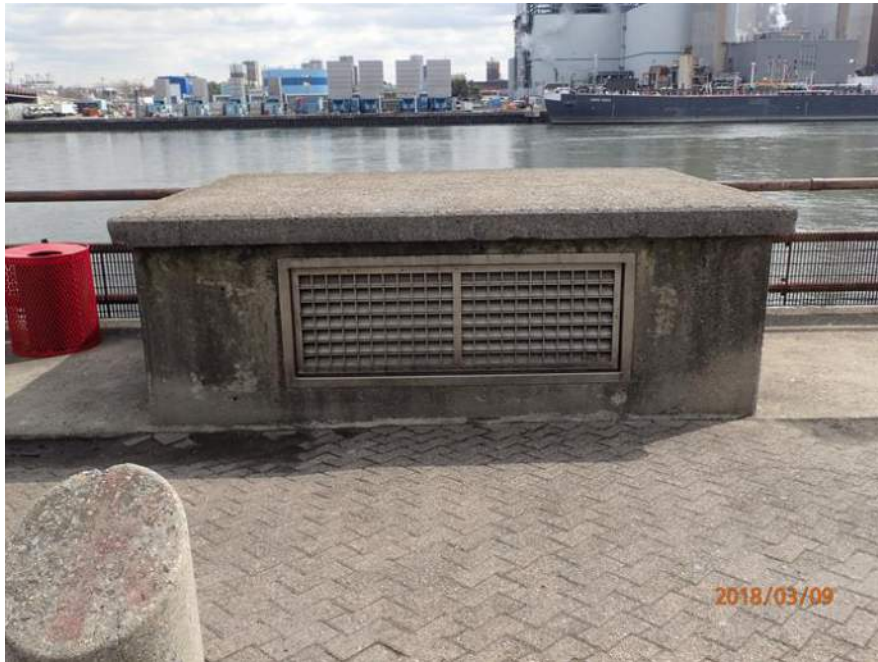
Station 27+92

**Direction:** Air Vent 7

**Comments:** Western Face

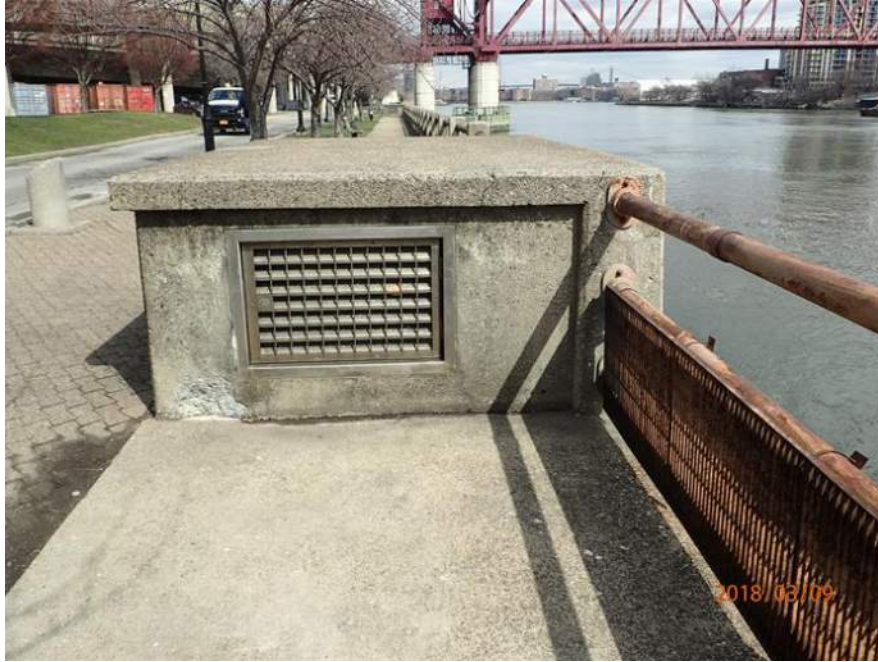
**Station 27+92**

**Direction:** Air Vent 7

**Comments:** Southern Face

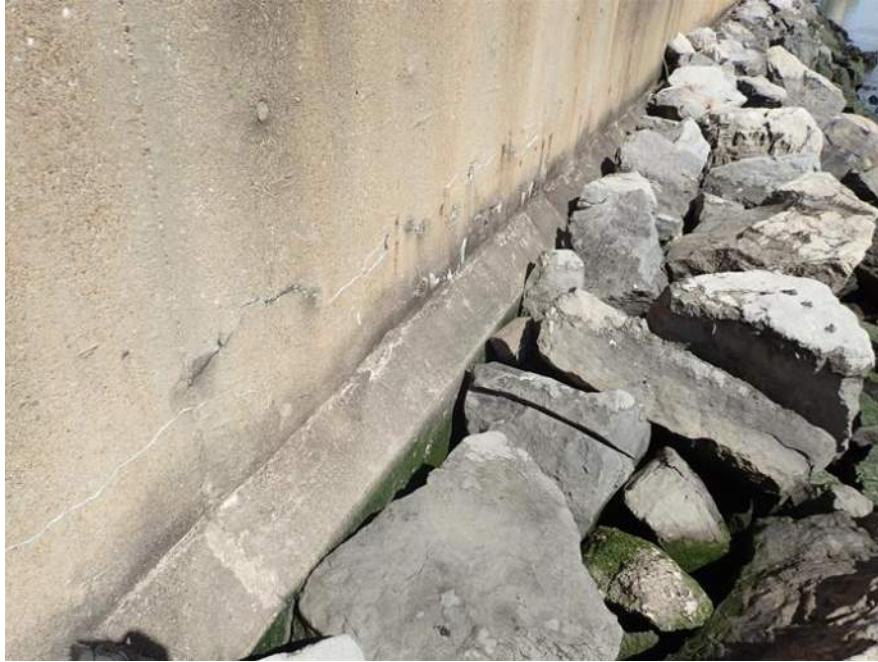
Station 28+40 to 28+50

**Direction:** Seawall

**Comments:** Concrete Spalling

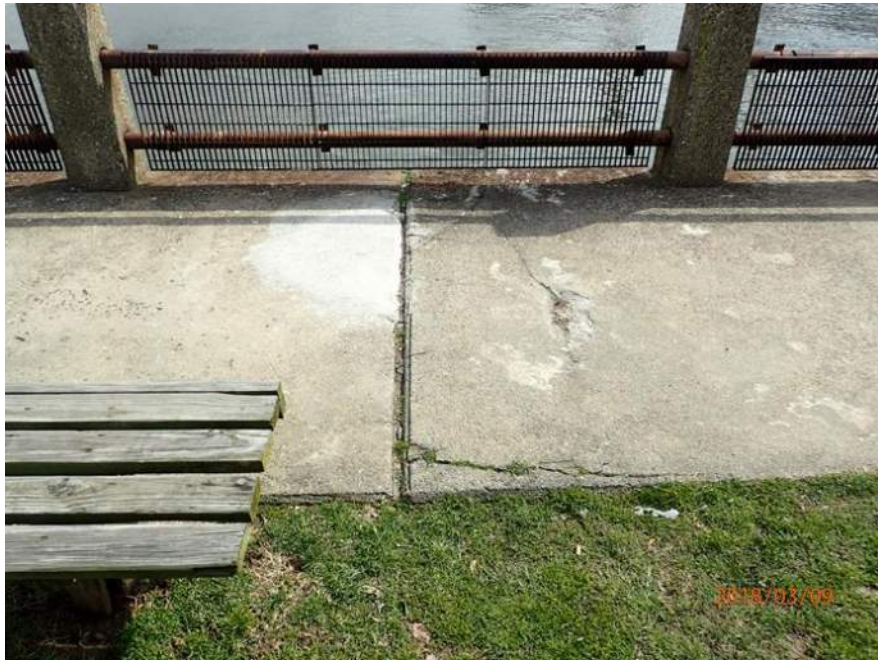
Station 28+34

**Direction:** Seawall Sidewalk Joint

**Comments:** Concrete Cracks

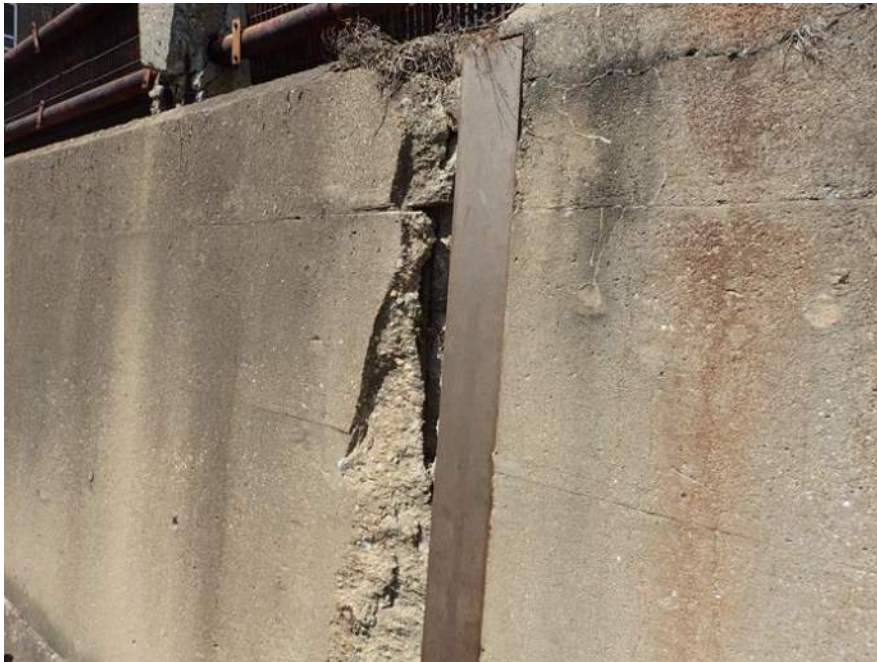
Station 28+34

**Direction:** Seawall Joint

**Comments:** Concrete Spalling, Missing Large Section of Concrete, Re-Bar Exposed

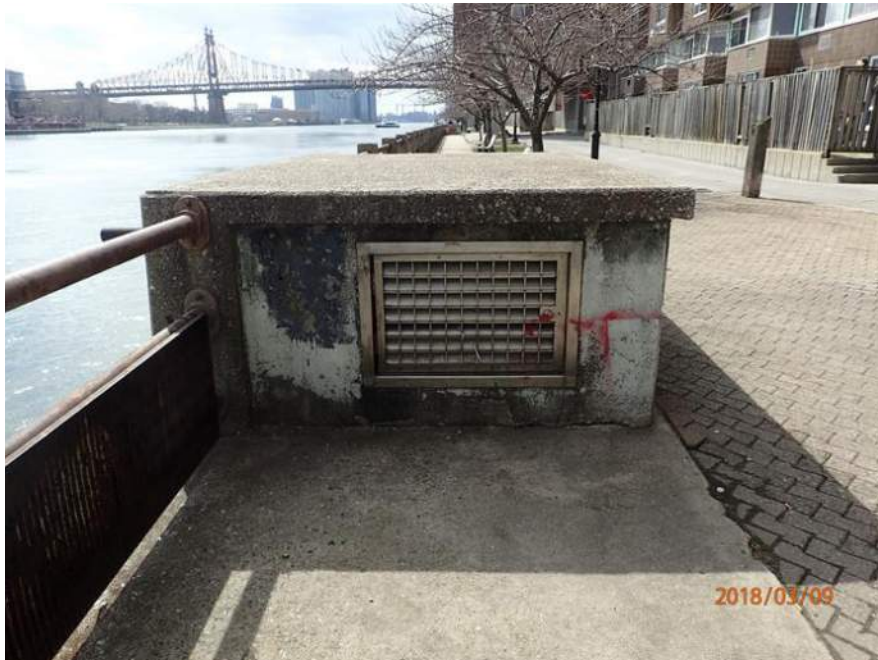
Station 30+46

**Direction:** Air Vent 6

**Comments:** Northern Face

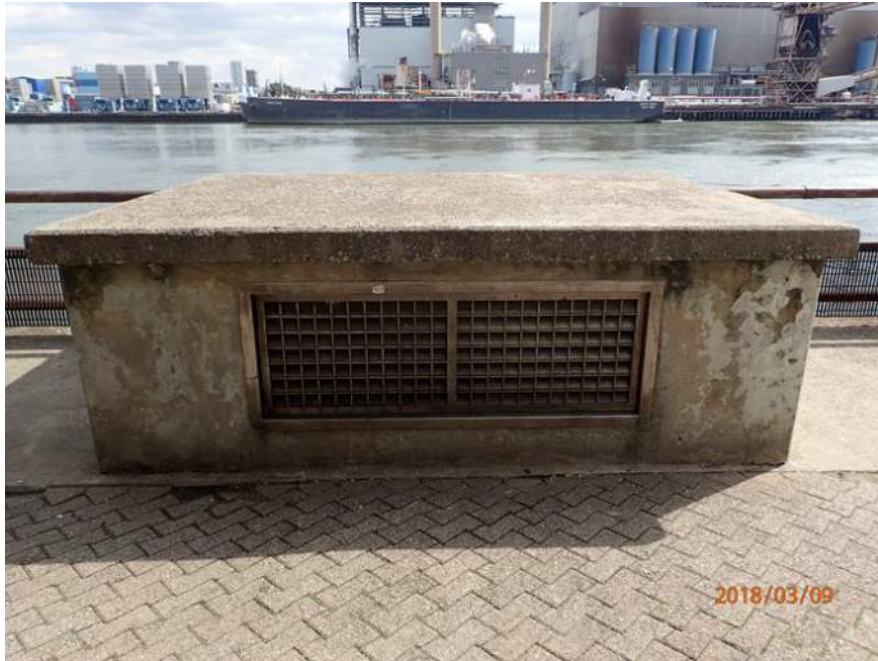
Station 30+46

**Direction:** Air Vent 6

**Comments:** Western Face

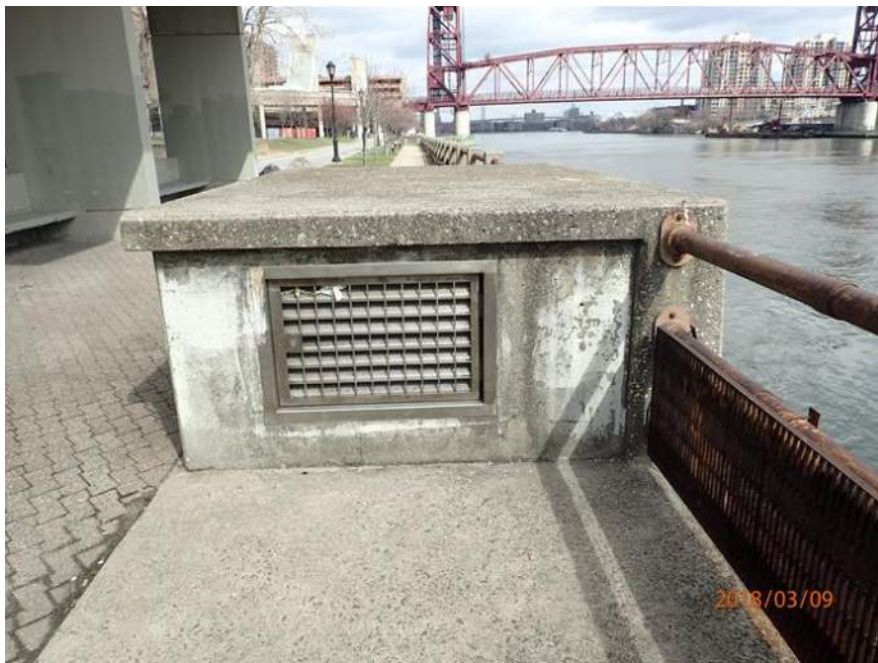
Station 30+46

**Direction:** Air Vent 6

**Comments:** Southern Face

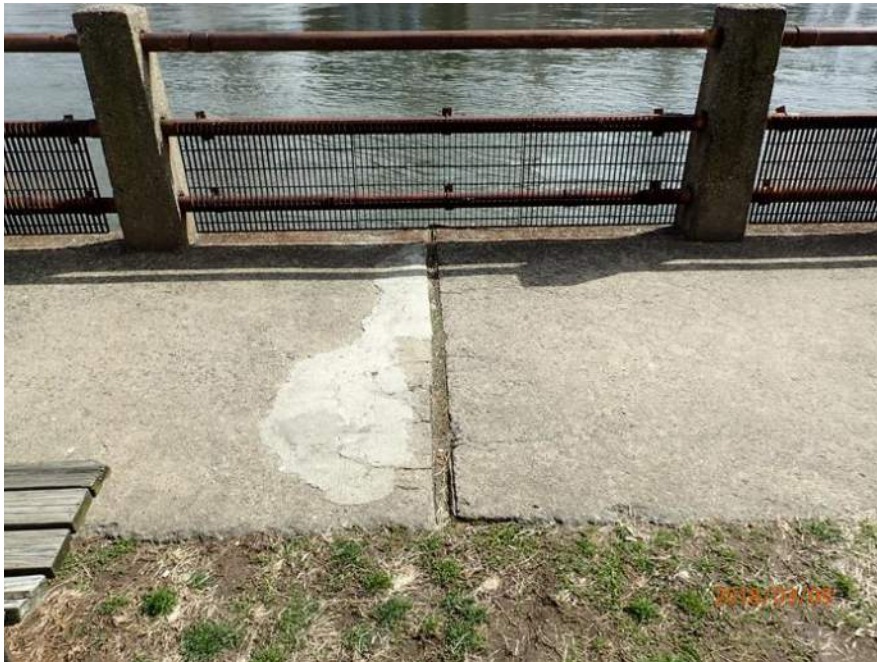
Station 34+06

**Comments:** Concrete Cracks

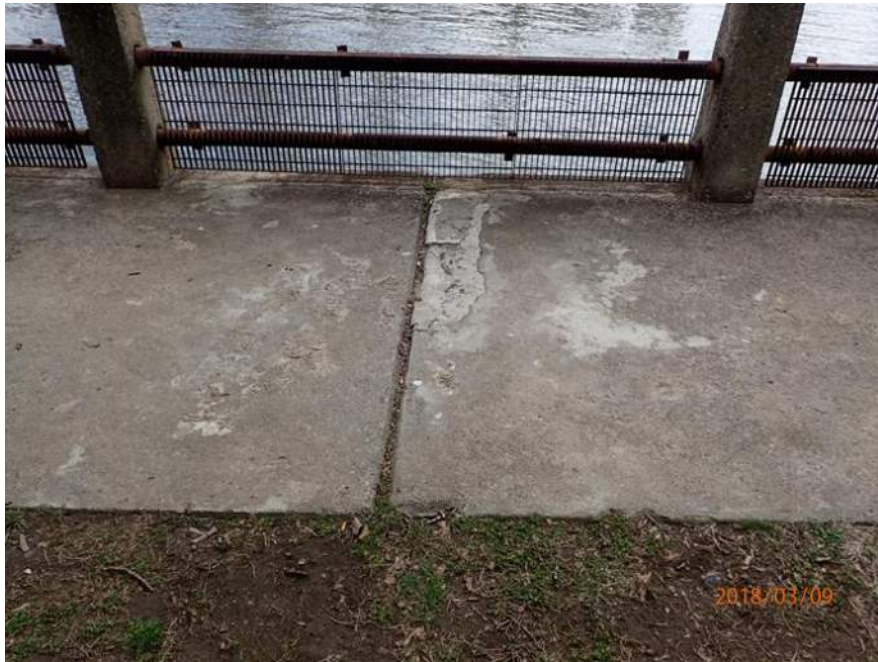
Station 37+22

**Comments:** Concrete Cracks

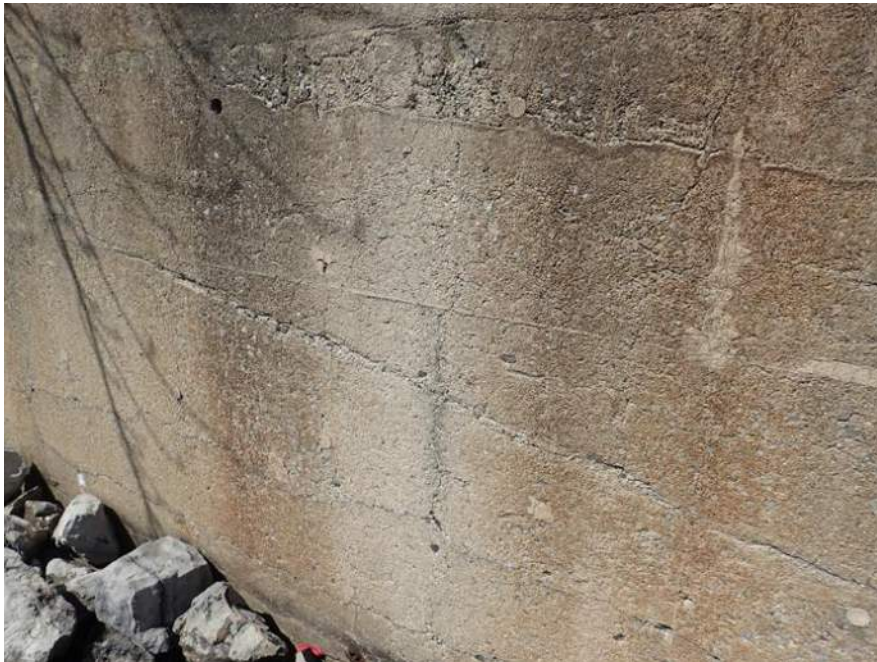
**Station 37+40**

**Comments:** Concrete Cracks

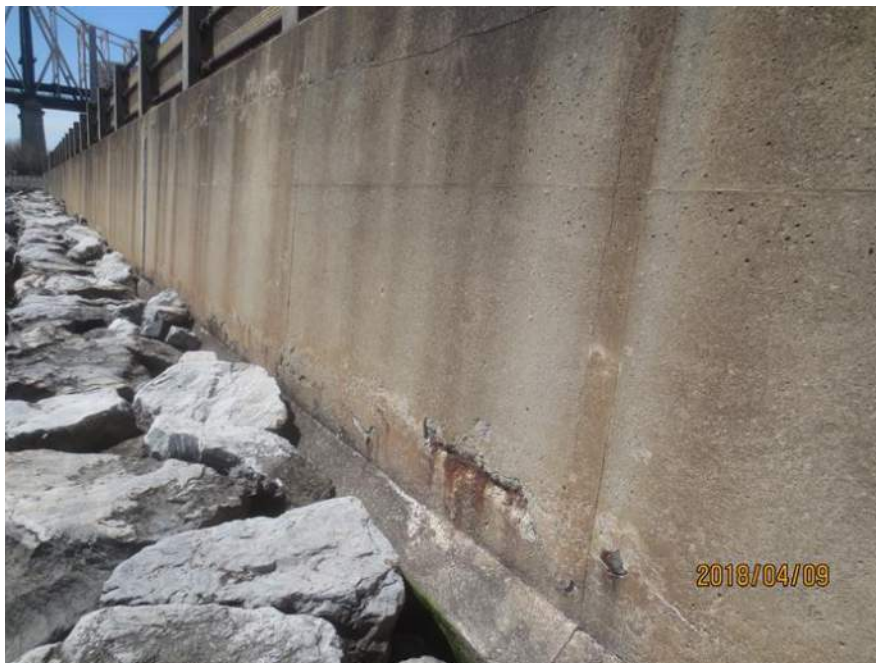
**Station 43+66**

**Direction:** Seawall

**Comments:** Exposed Re-Bar

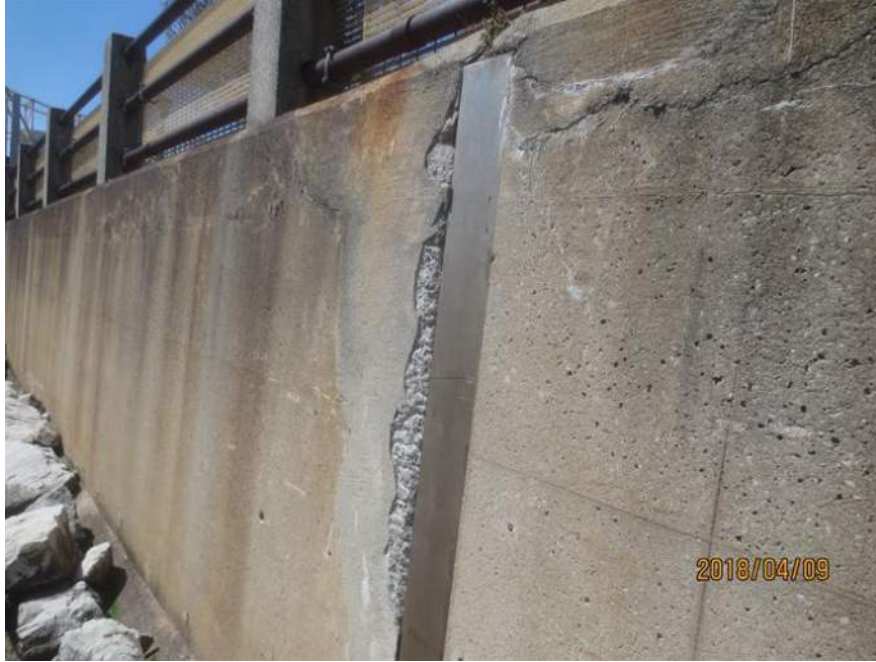
Station 43+87

**Direction:** Seawall Joint

**Comments:** Spalling and Concrete Repairs

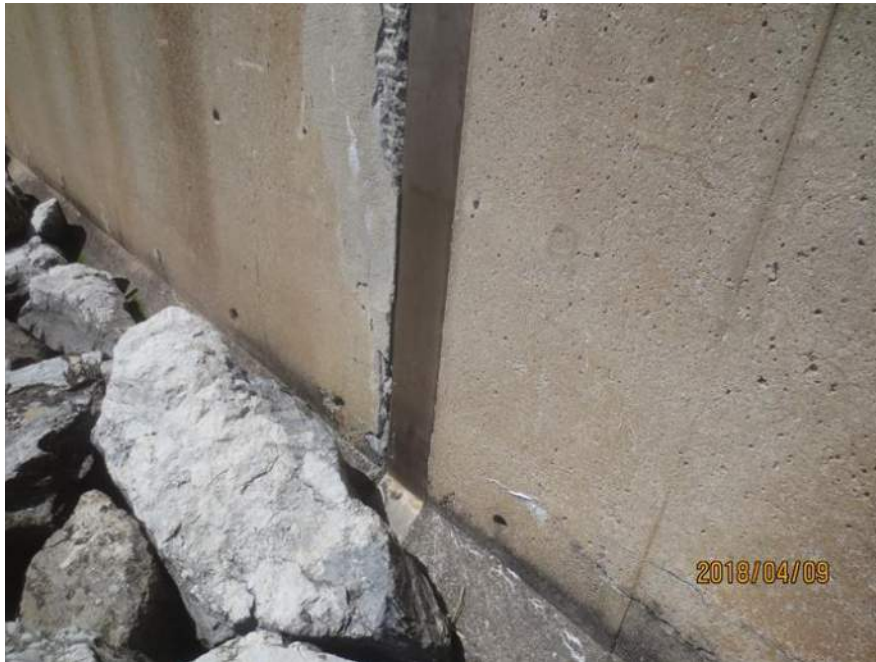
Station 43+87

**Direction:** Seawall Joint

**Comments:** Spalling and Concrete Repairs

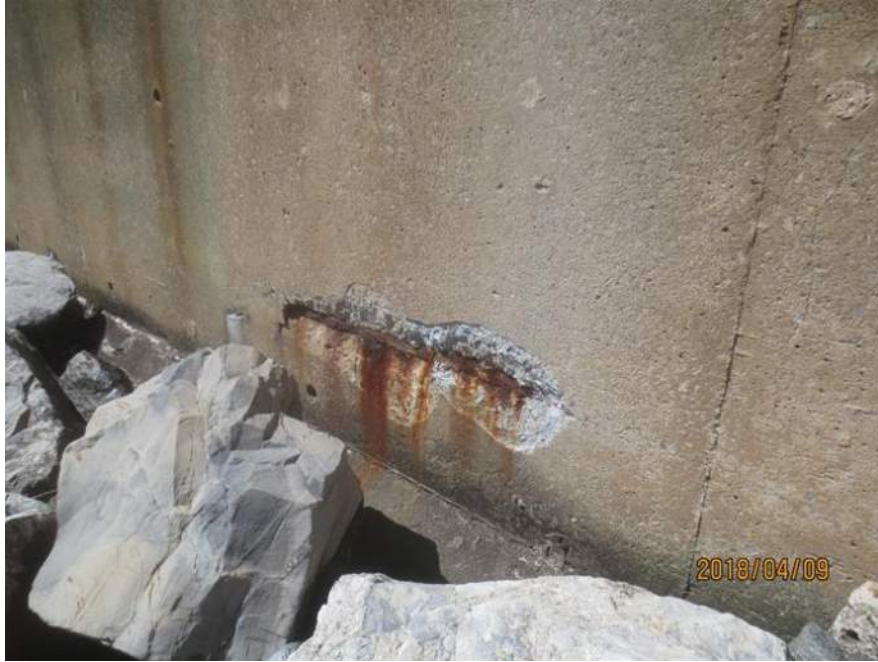
**Station 44+65**

**Direction:** Seawall

**Comments:** Exposed Re-Bar

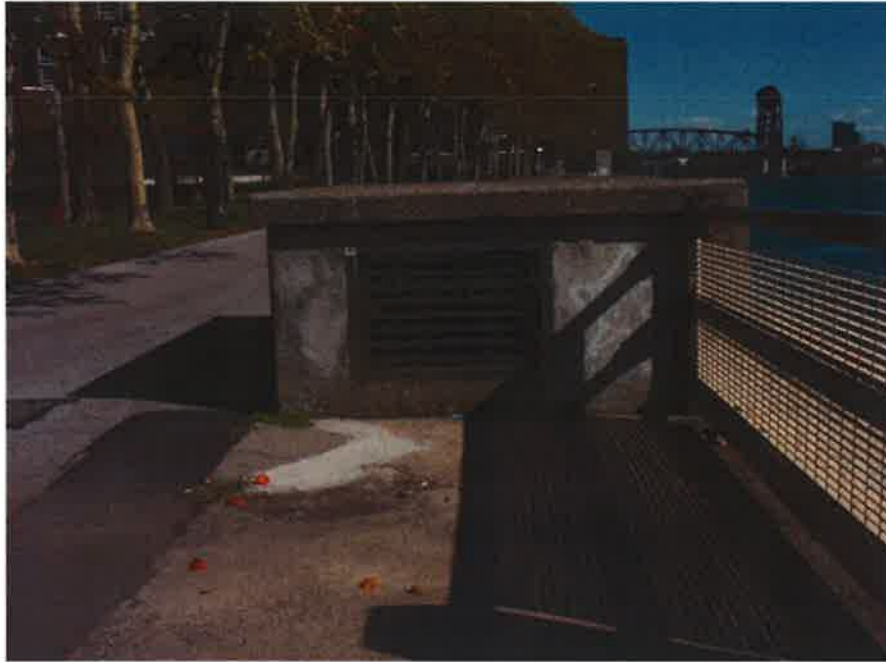
**Station 42+18**

**Direction:** Air Vent 2

**Comments:** Sothern Face

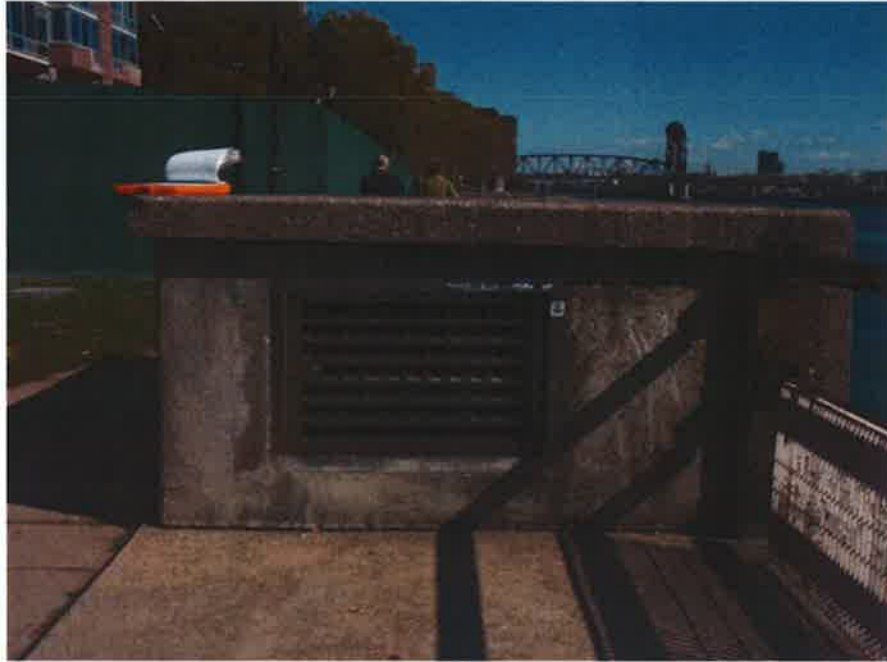
Station 45+34

**Direction:** Air Vent 1

**Comments:** Sothern Face

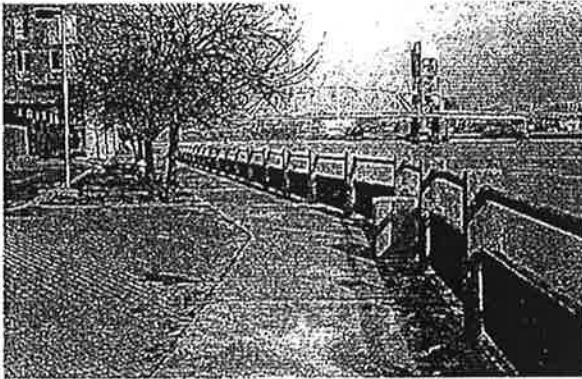
The bulge in the landside wall may be caused by a row of trees and grassed area at landside. See photos 2 and 3. Photo 6 shows adequate rip rap. Expansion joints appear to be a problem for the sea wall side.

Check tree roots for possible wall damage. Check tunnel interior wall waterproofing system. See detail for 1949 waterproofing design in Appendix C. Waterproof as required. Repair expansion joints as required.
