# **CONDITIONS REPORT & CONCEPTUAL DESIGN MEMORANDUM**

## **STEAM TUNNEL ASSESSMENT**

**ROOSEVELT ISLAND, NEW YORK**

**28 December 2018  
Project # 100444601**

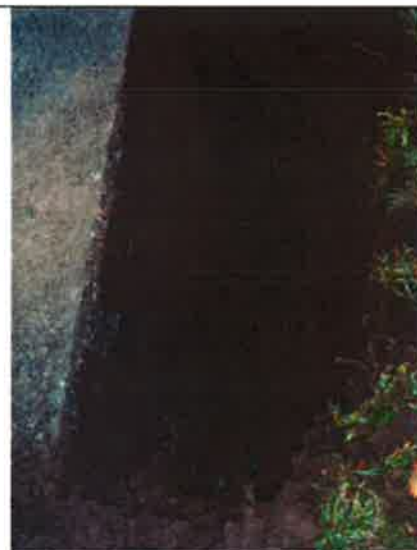
Test Pit 5 – Steam Tunnel exterior wall in good condition
