CONDITIONS REPORT & CONCEPTUAL DESIGN MEMORANDUM

STEAM TUNNEL ASSESSMENT

ROOSEVELT ISLAND, NEW YORK

17 November 2014
Revised 28 December 2018
Revised 18 September 2020
Project # 100444601

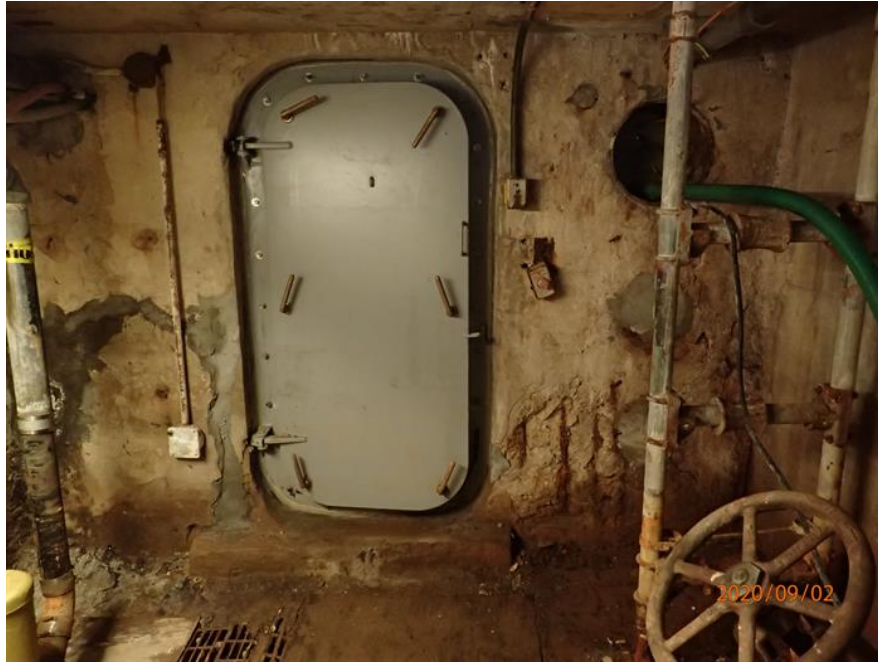
Station 0+00

Direction: Tunnel Entrance Wall

Comments: Concrete Spalling, Re-Bar Exposed and Corroded

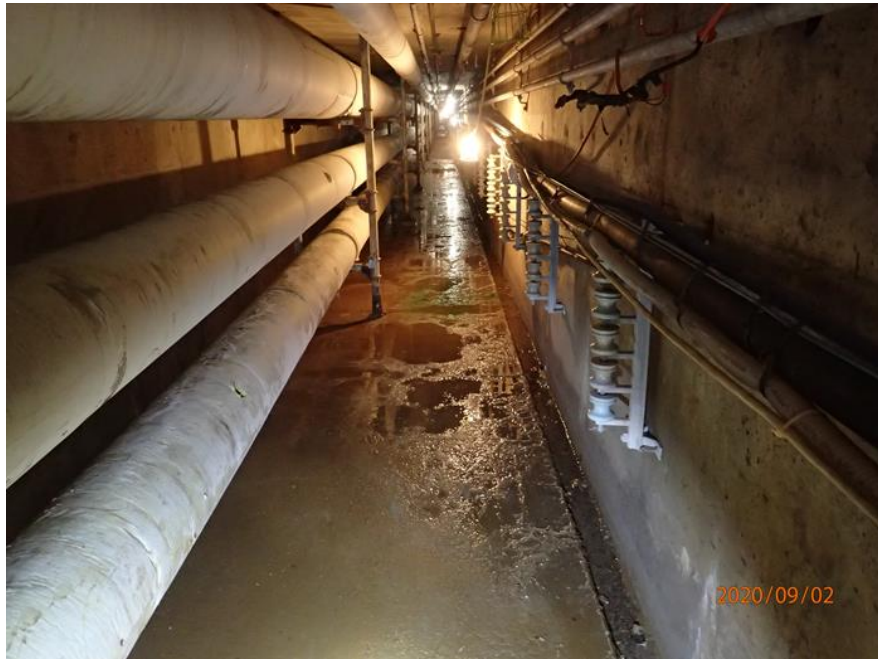
Station 0+90 to 1+60

Direction: Tunnel Floor

Comments: Floor Slab Cracking

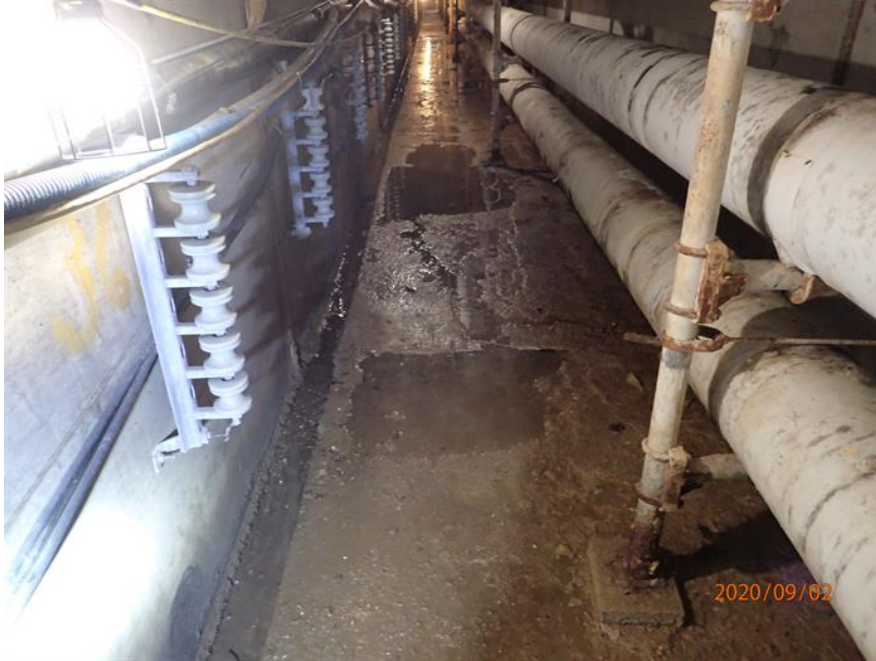
Station 0+90 to 1+60

Direction: Tunnel Floor

Comments: Floor Slab Cracking

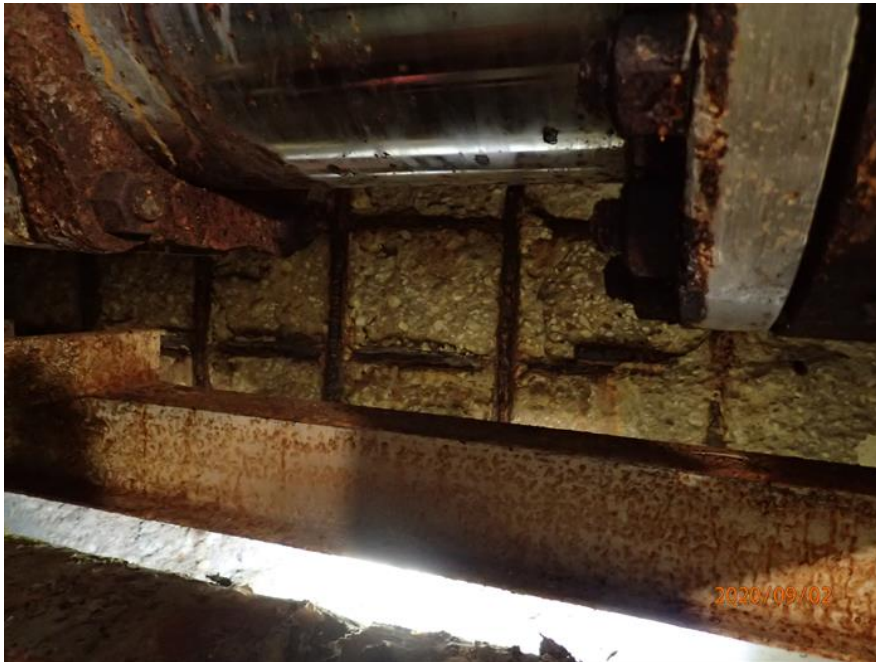
Station 1+95

Direction: Eastern Wall (Seawall)

Comments: Concrete Spalling, Loose Concrete, Exposed Rebar

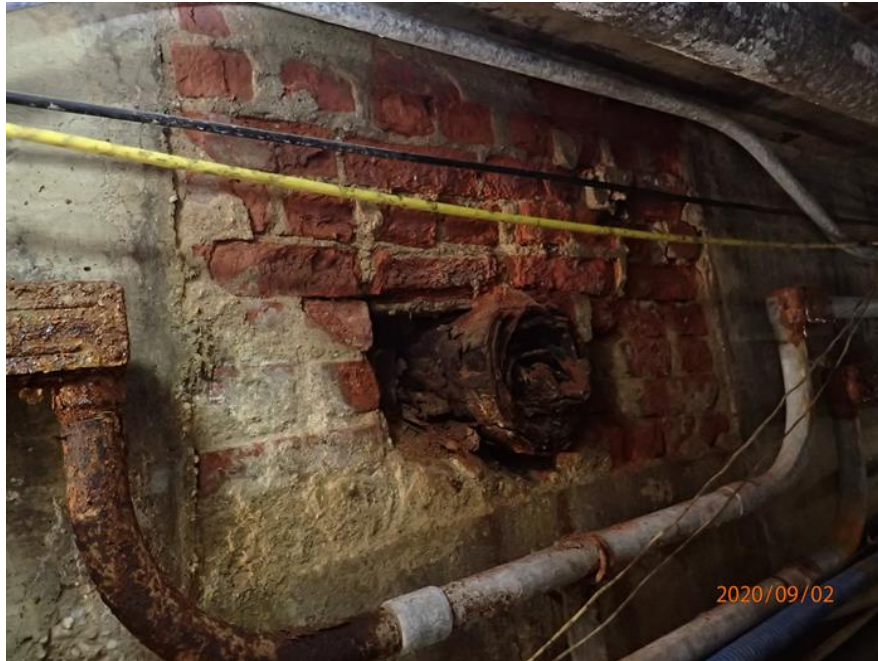
Station 1+95

Direction: Western Wall (In-Land)

Comments: Concrete Spalling, Loose Concrete, Exposed Rebar

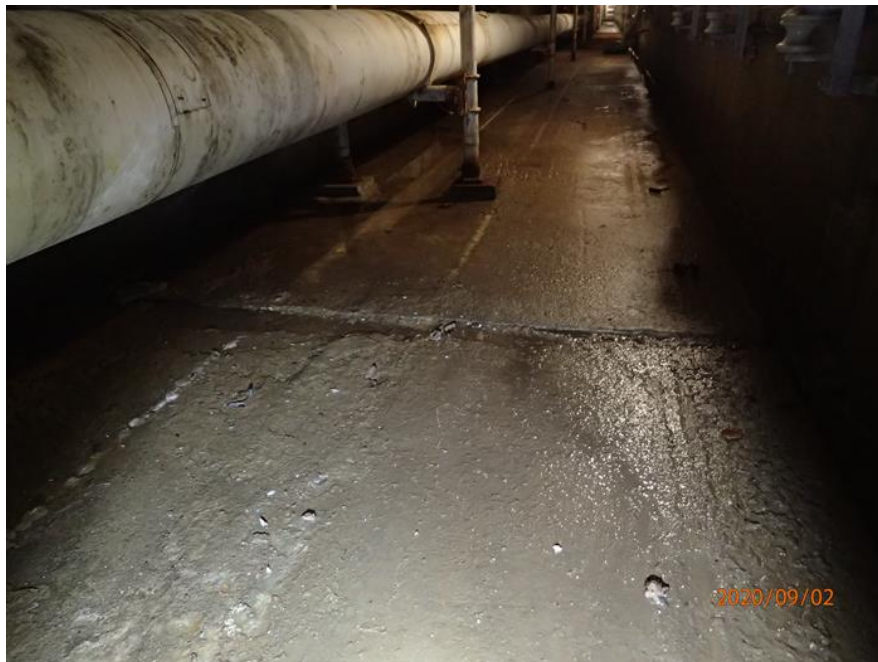
Station 2+80

Direction: Tunnel Floor

Comments: Raised Joint and Separation at Joint

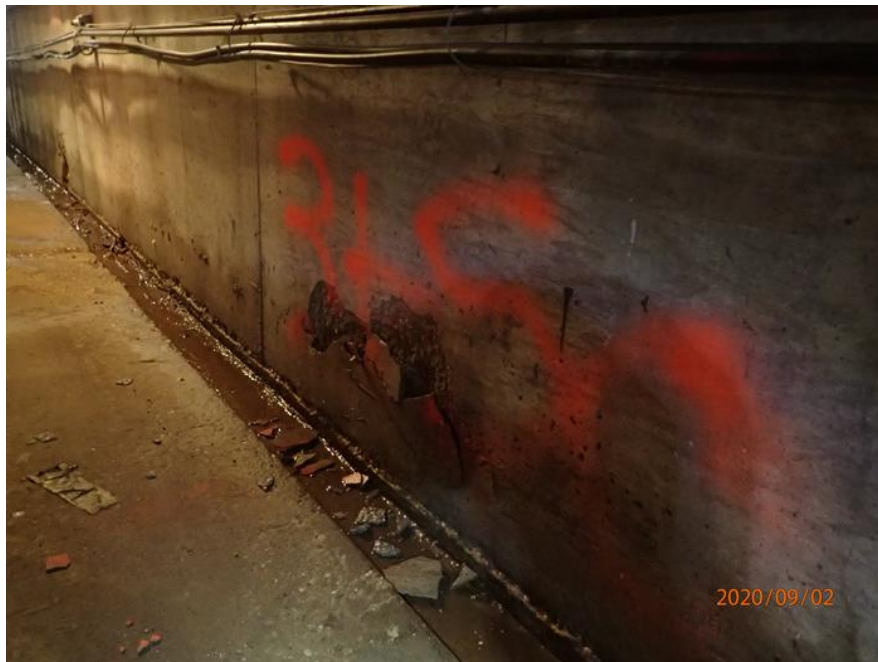
Station 3+50

Direction: Western Wall (In-Land)

Comments: Loose Concrete, Deteriorating Pipe and Brick

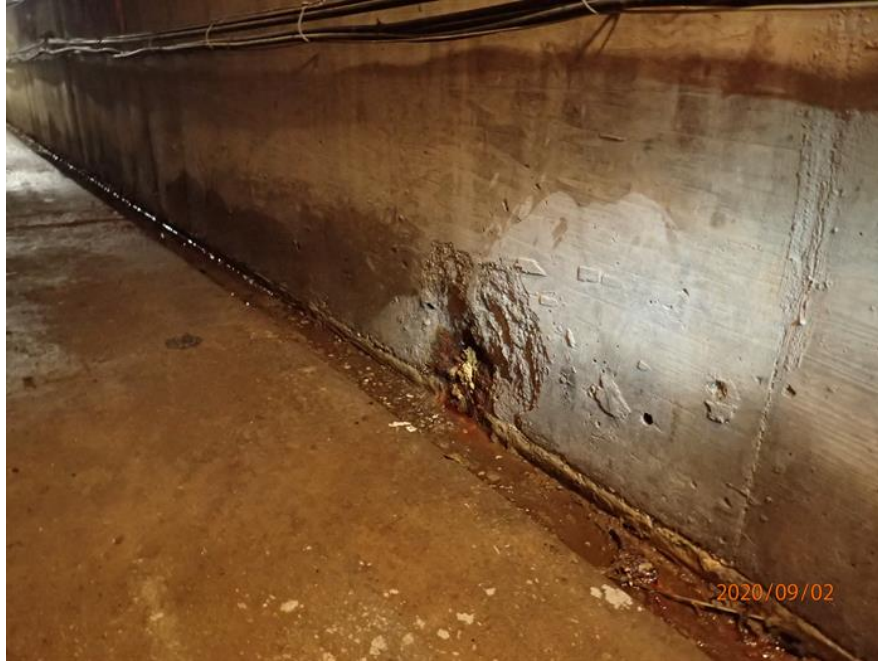
Station 3+60

Direction: Western Wall (In-Land)

Comments: Concrete Spalling

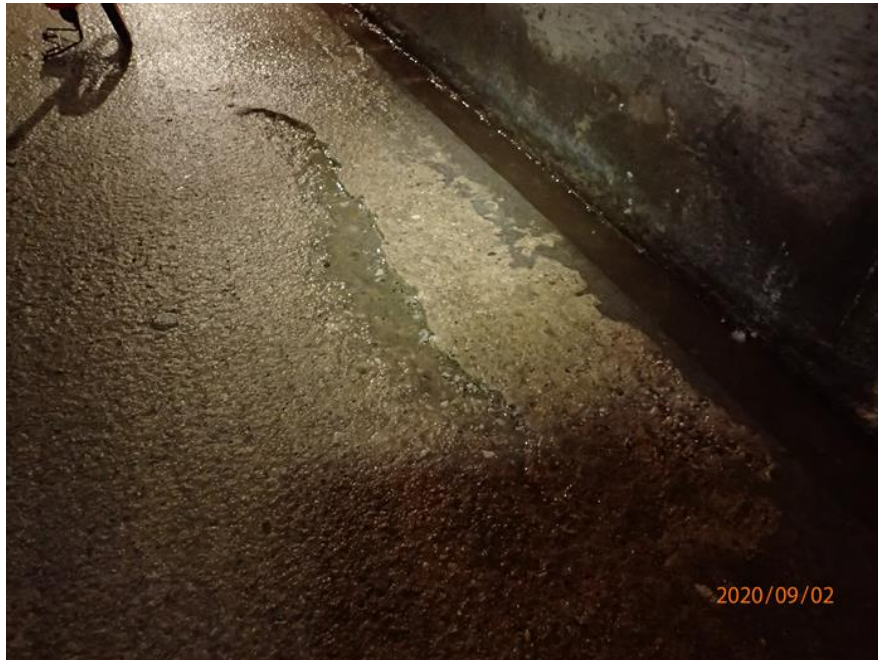
Station 3+80

Direction: Tunnel Floor

Comments: Floor Slab Cracking

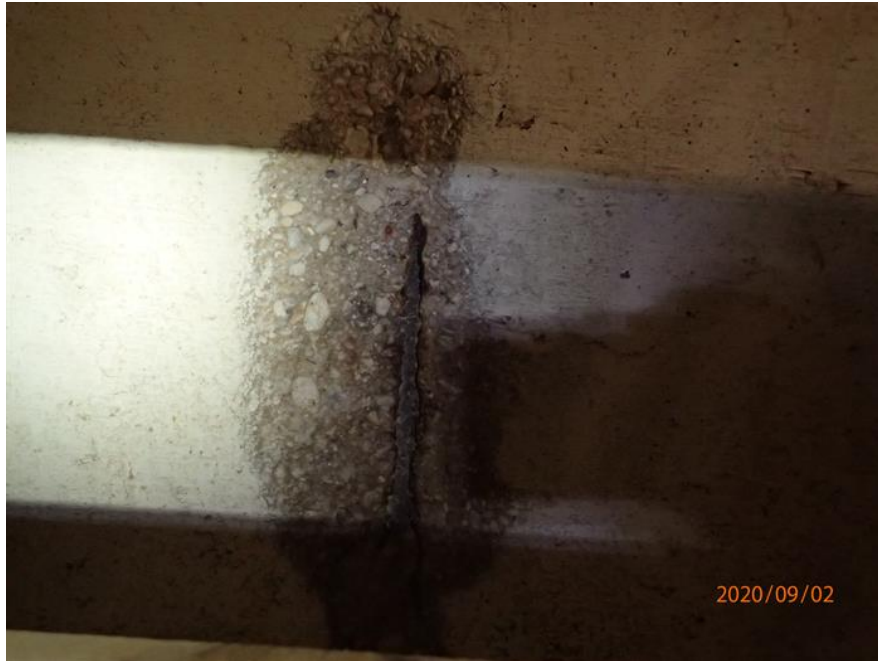
Station 4+50

Direction: Eastern Wall (Seawall)

Comments: Concrete Spalling, Re-Bar Exposed and Corroded

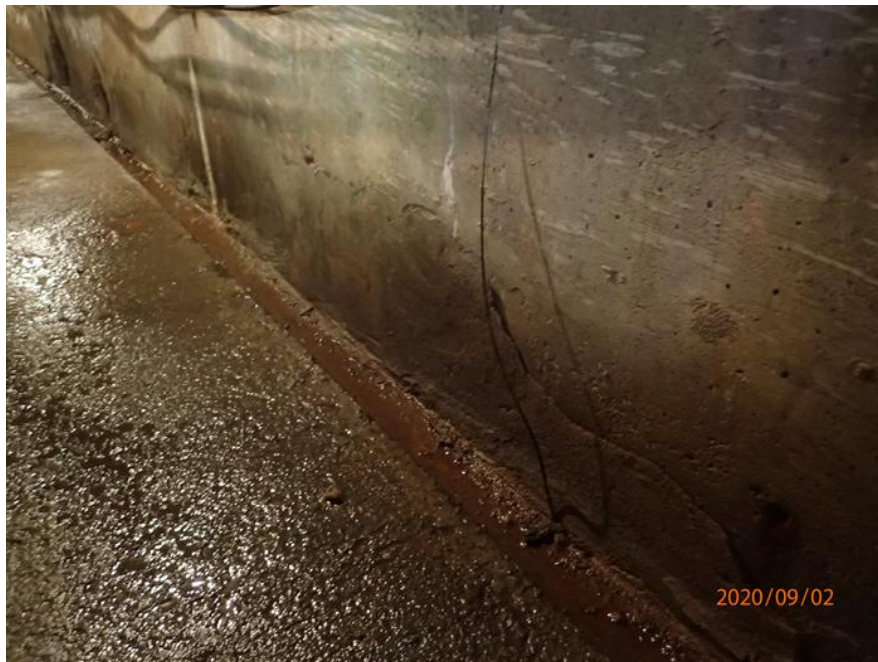
Station 4+50 to 4+55

Direction: Western Wall (In-Land)

Comments: Concrete Spalling, Loose Concrete

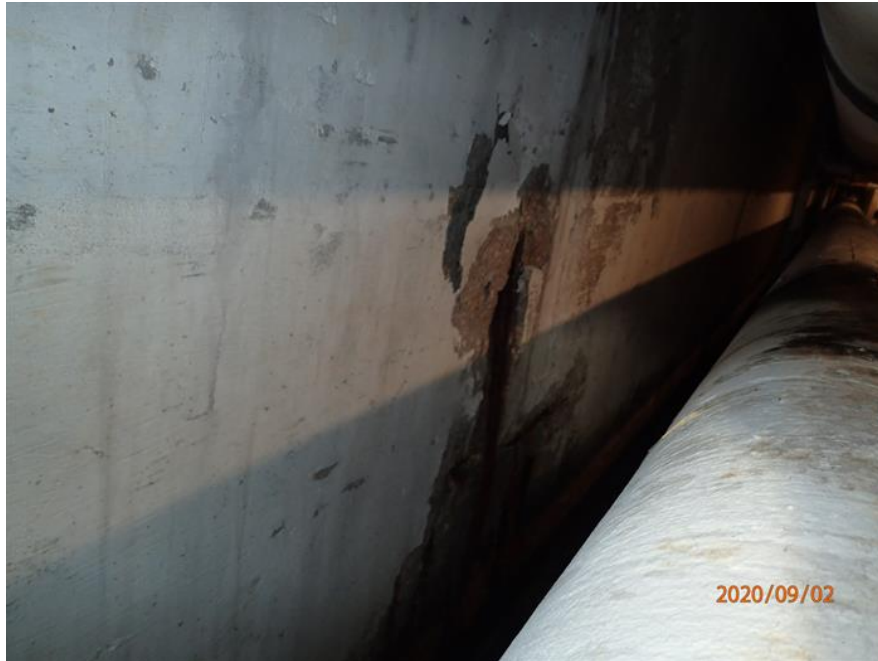
Station 4+50

Direction: Eastern Wall (Seawall)

Comments: Concrete Spalling, Re-Bar Exposed and Corroded

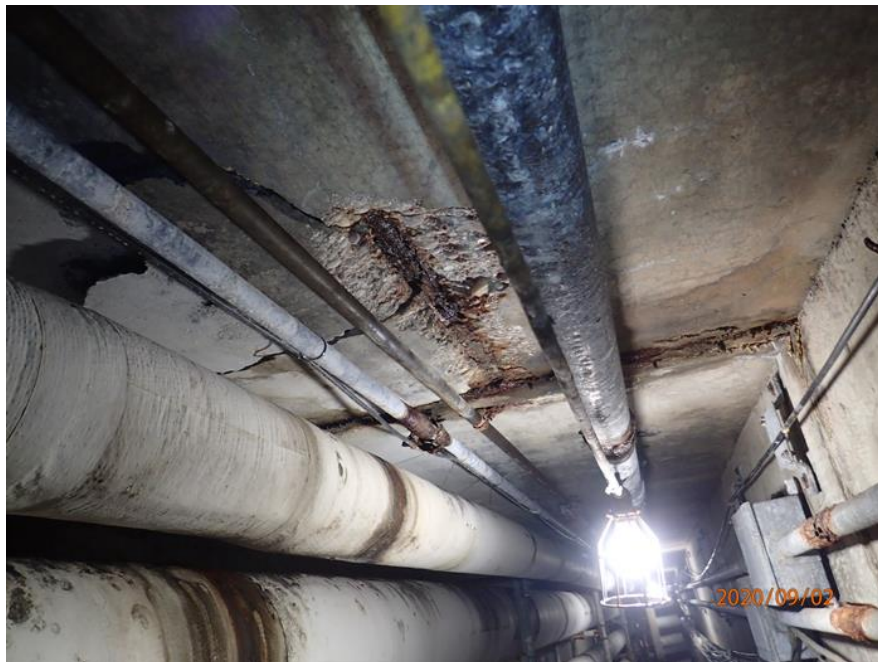
Station 4+55

Direction: Tunnel Ceiling

Comments: Joint Leaking, Concrete Spalling, Re-Bar Exposed and Corroded

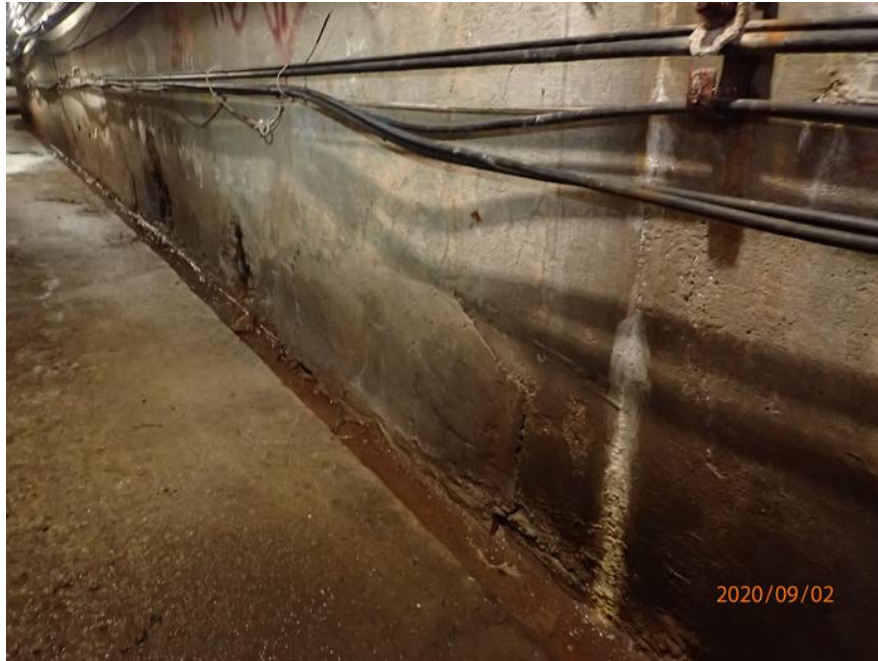
Station 4+50 to 4+85

Direction: Western Wall (In-Land)

Comments: Concrete Spalling, Re-Bar Exposed and Corroded

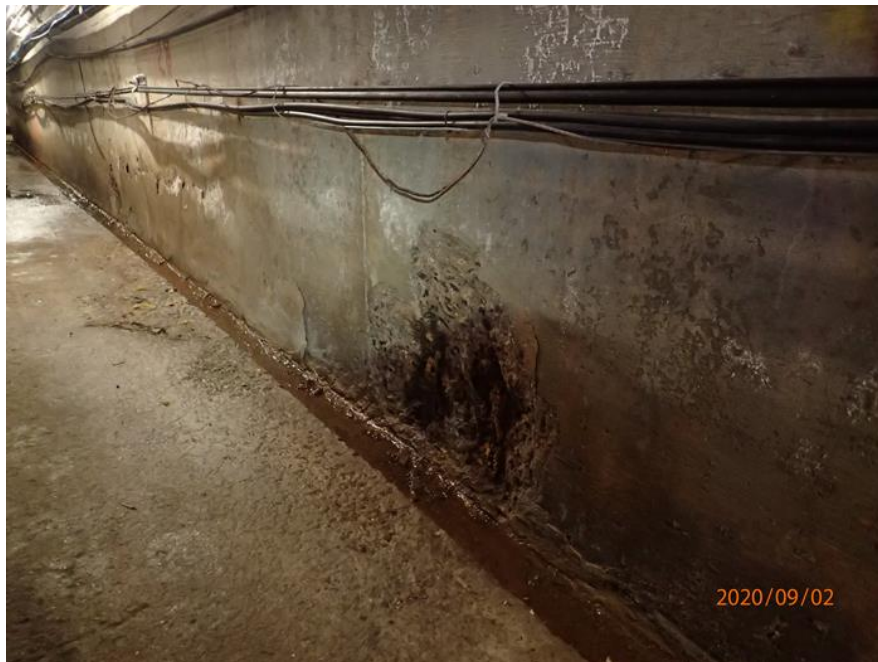
Station 4+50 to 4+85

Direction: Western Wall (In-Land)

Comments: Concrete Spalling, Re-Bar Exposed and Corroded

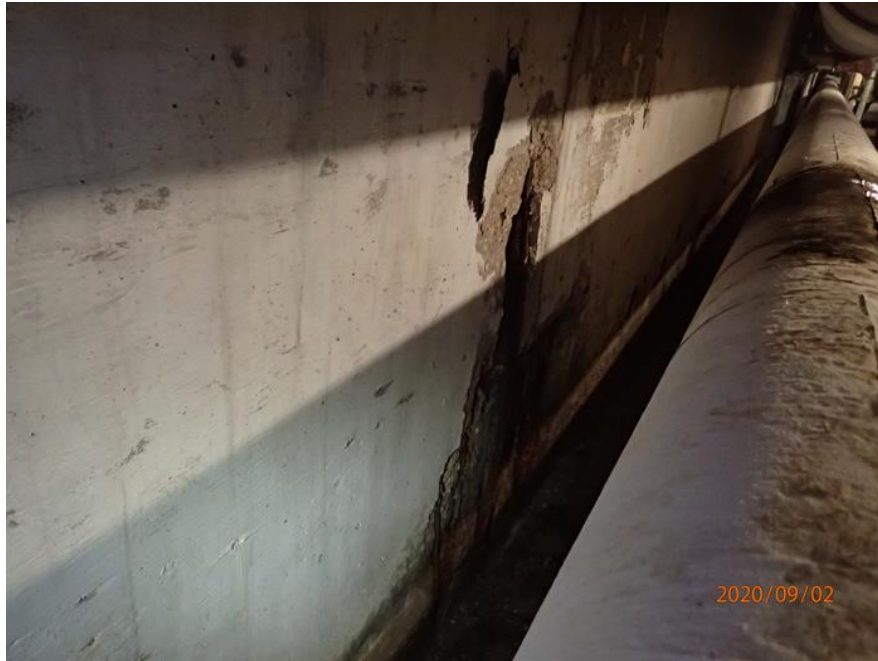
Station 4+80 to 5+15

Direction: Eastern Wall (Seawall)

Comments: Concrete Spalling, Re-Bar Exposed and Corroded

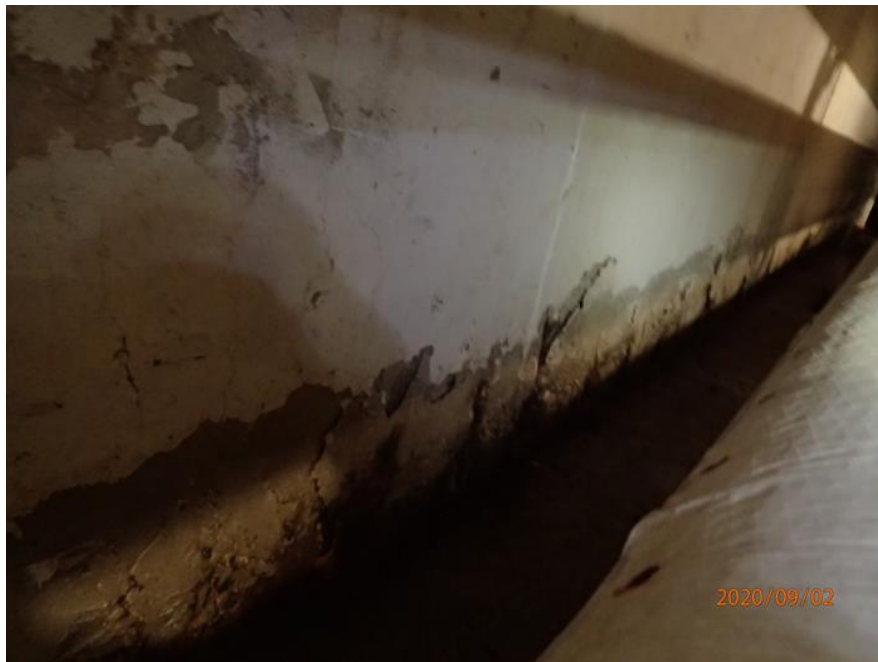
Station 4+80 to 5+15

Direction: Eastern Wall (Seawall)

Comments: Concrete Spalling, Re-Bar Exposed and Corroded

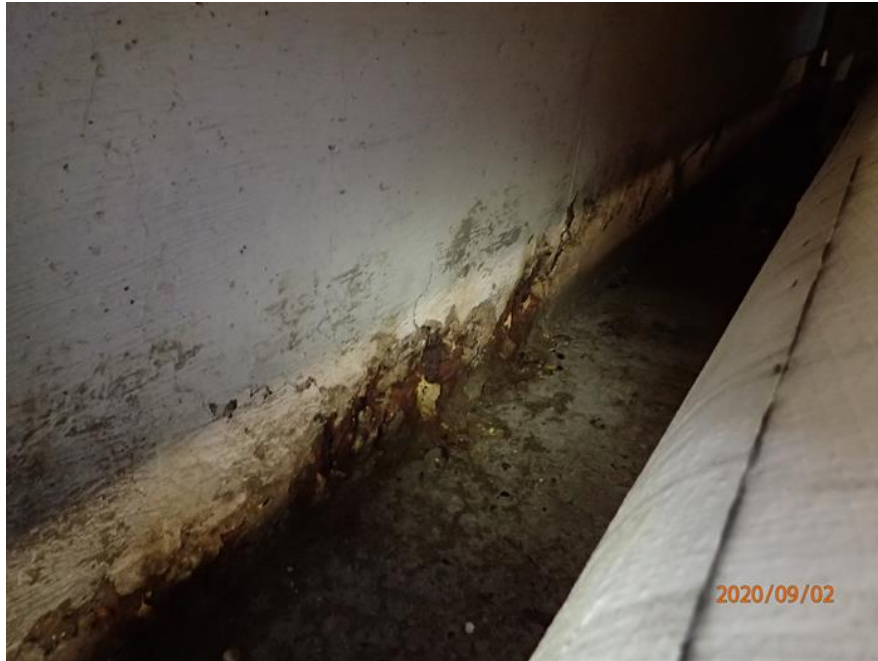
Station 4+80 to 5+15

Direction: Eastern Wall (Seawall)

Comments: Concrete Spalling, Re-Bar Exposed and Corroded

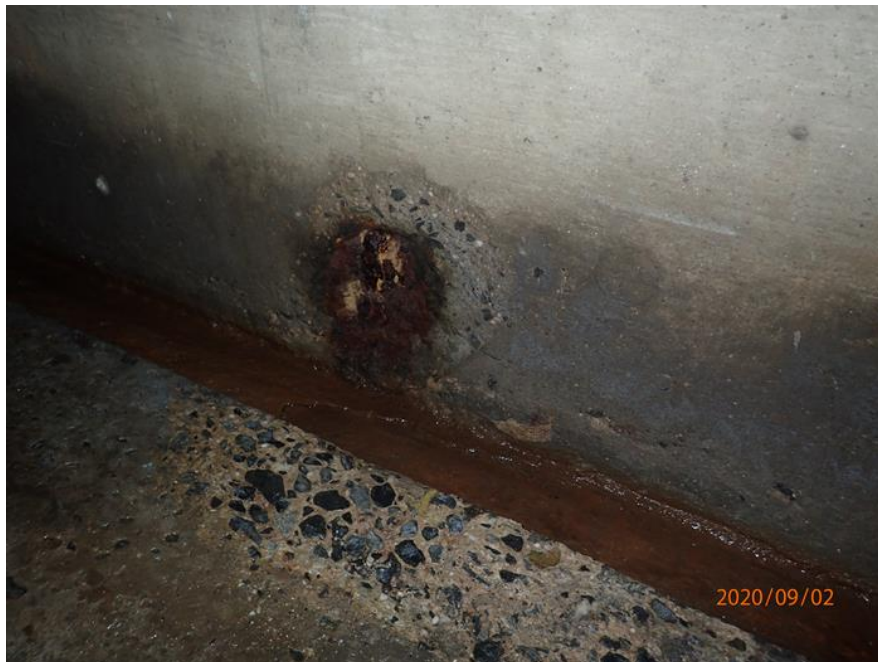
Station 5+08

Direction: Western Wall (In-Land)

Comments: Concrete Spalling

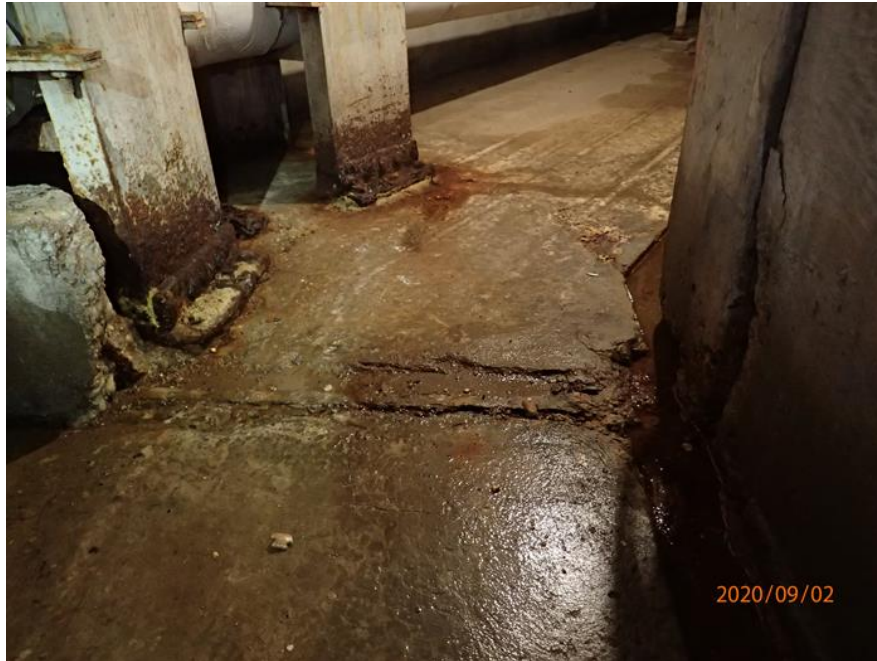
Station 5+30 to 5+35

Direction: Tunnel Floor, Joint

Comments: Floor Slab Raised at Joint, Cracking, Loose Concrete

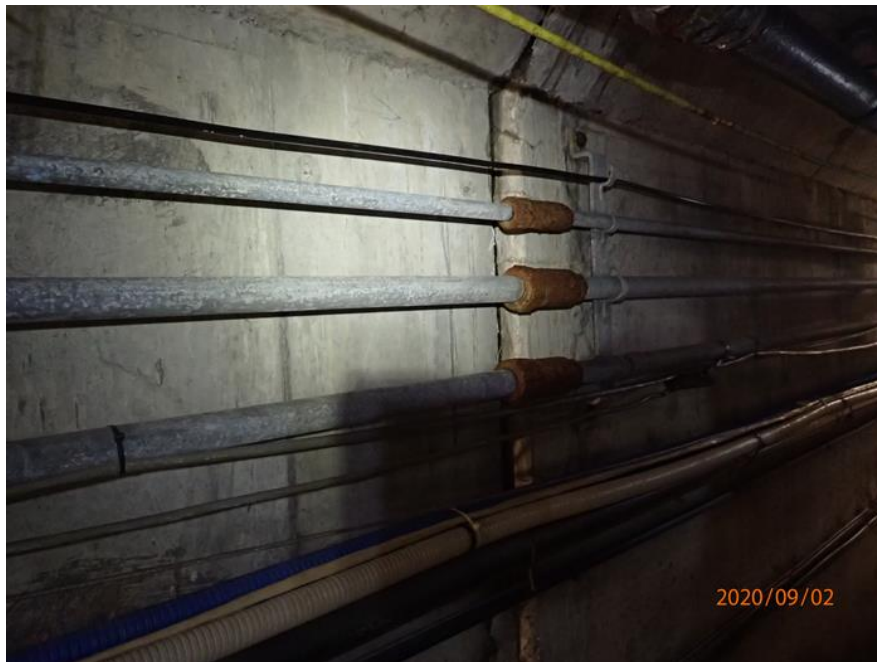
Station 5+40

Direction: Eastern Wall (Seawall)/ Western Wall (In-Land)

Comments: Joint Leaking, Separated

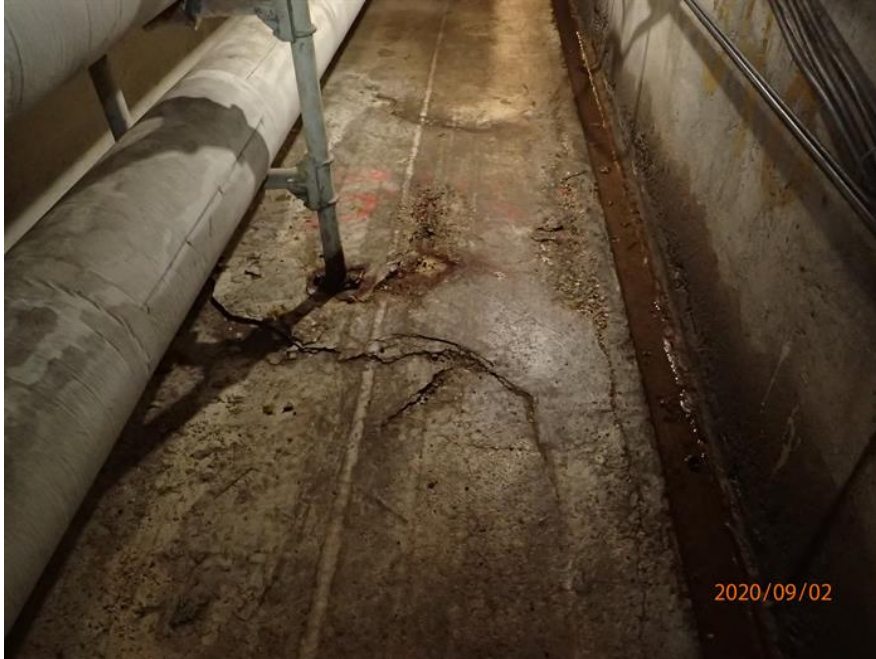
Station 5+45 to 5+55

Direction: Tunnel Floor

Comments: Floor Slab Cracking

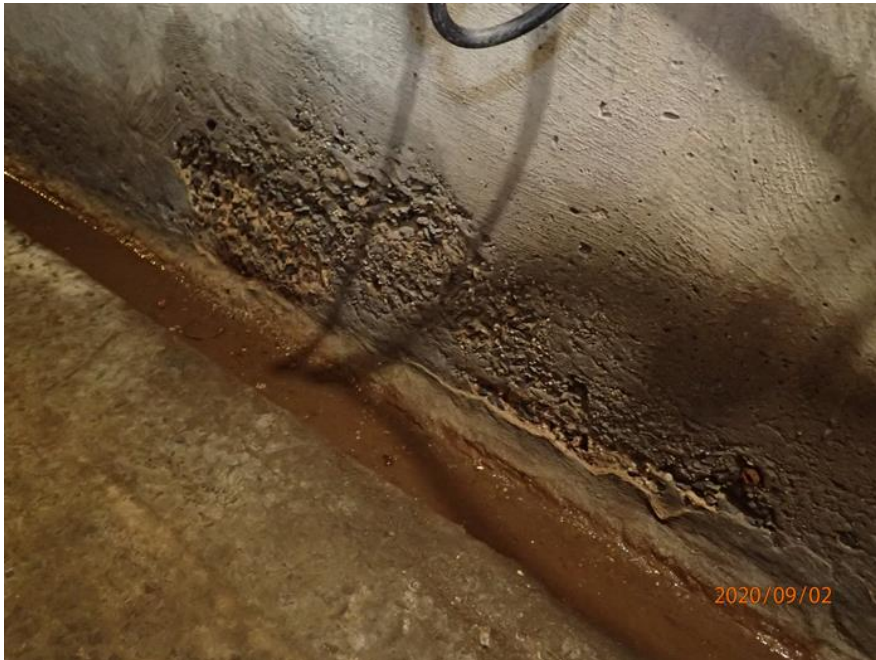
Station 5+55

Direction: Western Wall (In-Land)

Comments: Concrete Spalling

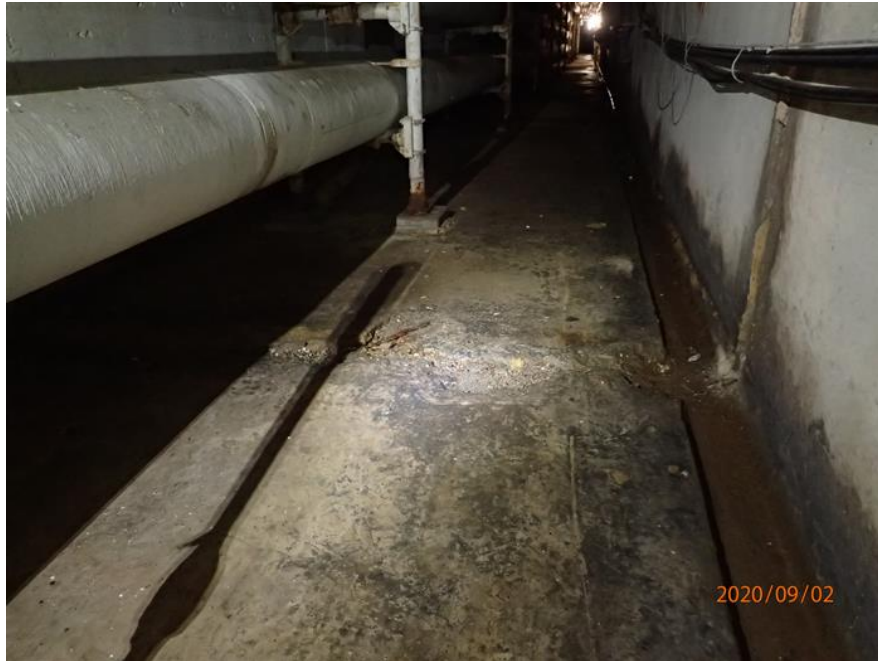
Station 5+90

Direction: Tunnel Floor

Comments: Raised Joint, Loose Concrete and Leaking at Seawall

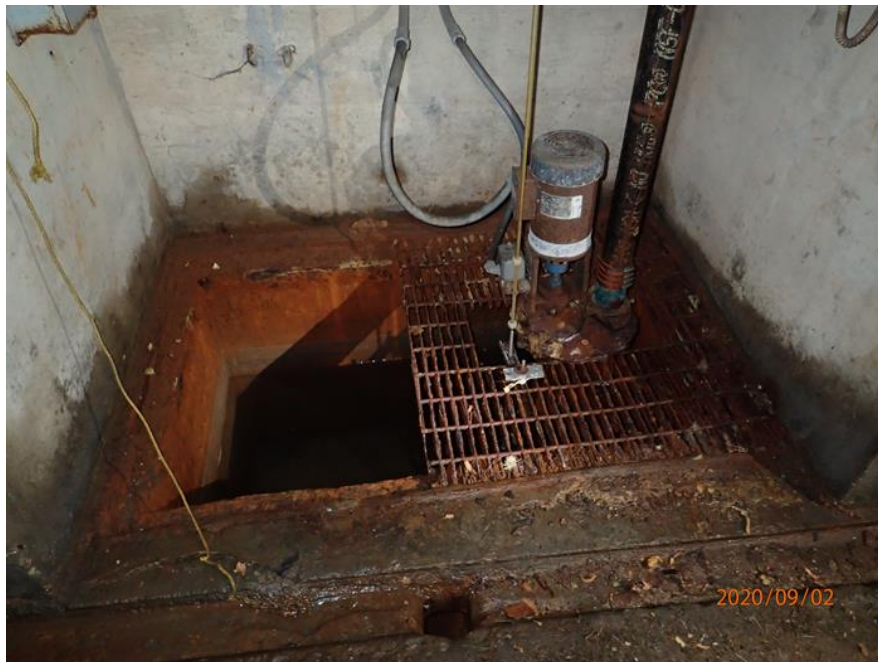
Station 6+16

Direction: Tunnel Floor

Comments: Sump Pump - Not Working

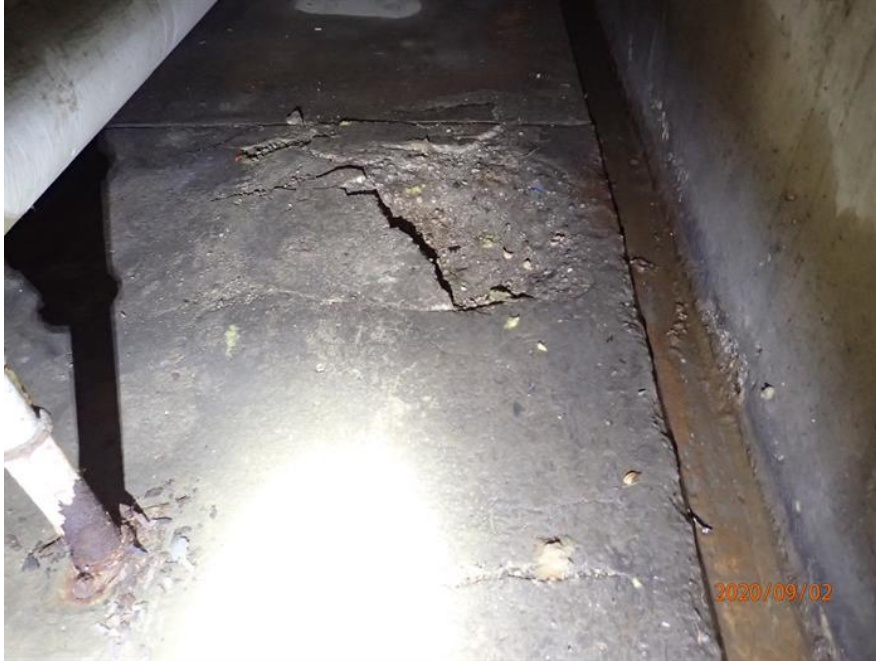
Station 6+20 to 6+25

Direction: Tunnel Floor

Comments: Floor Slab Cracking and Spalling

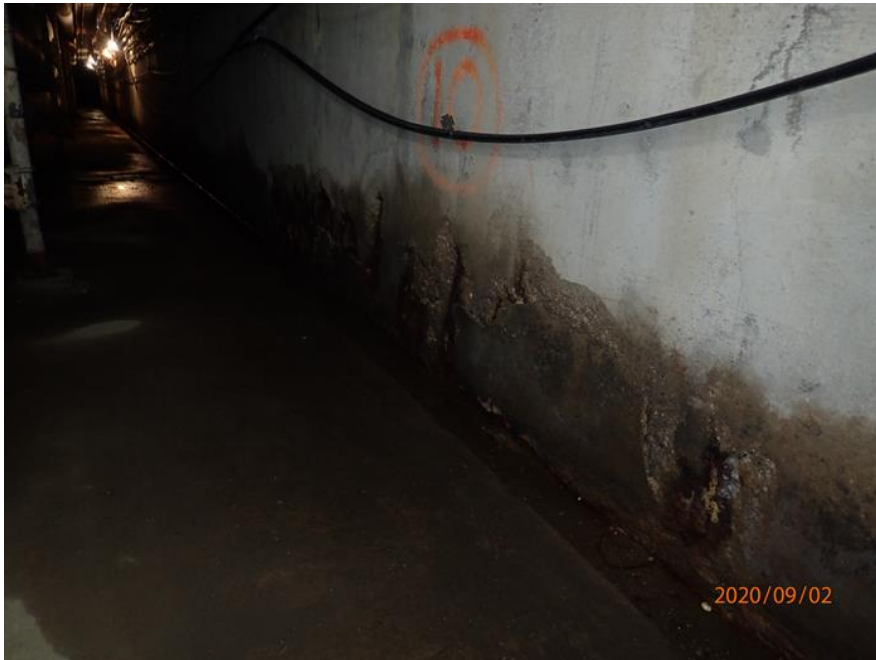
Station 6+30 to 6+50

Direction: Western Wall (In-Land)

Comments: Concrete Spalling, Re-Bar Exposed and Corroded

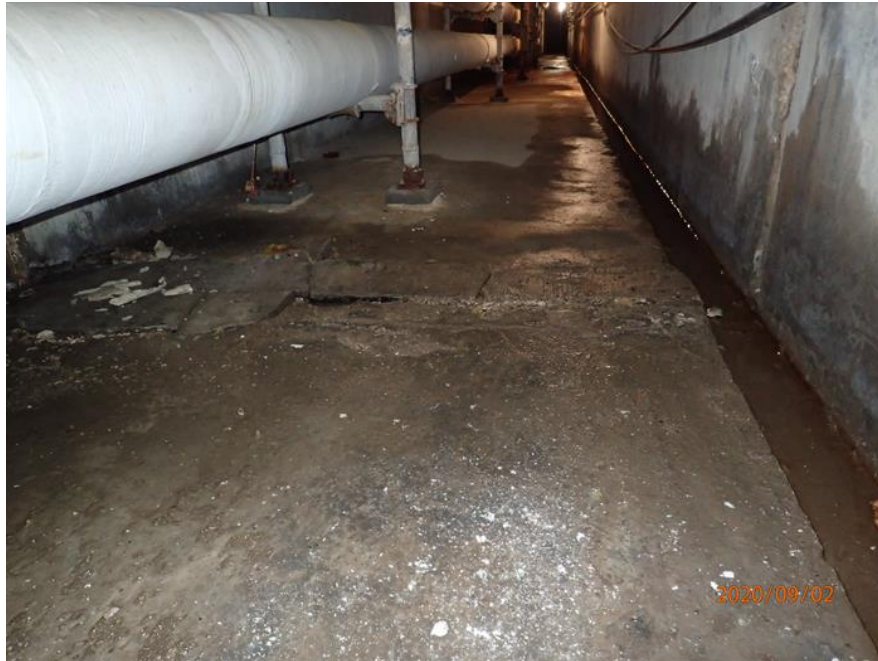
Station 6+56

Direction: Tunnel Floor

Comments: Raised Joint, Loose Concrete and Leaking at Seawall

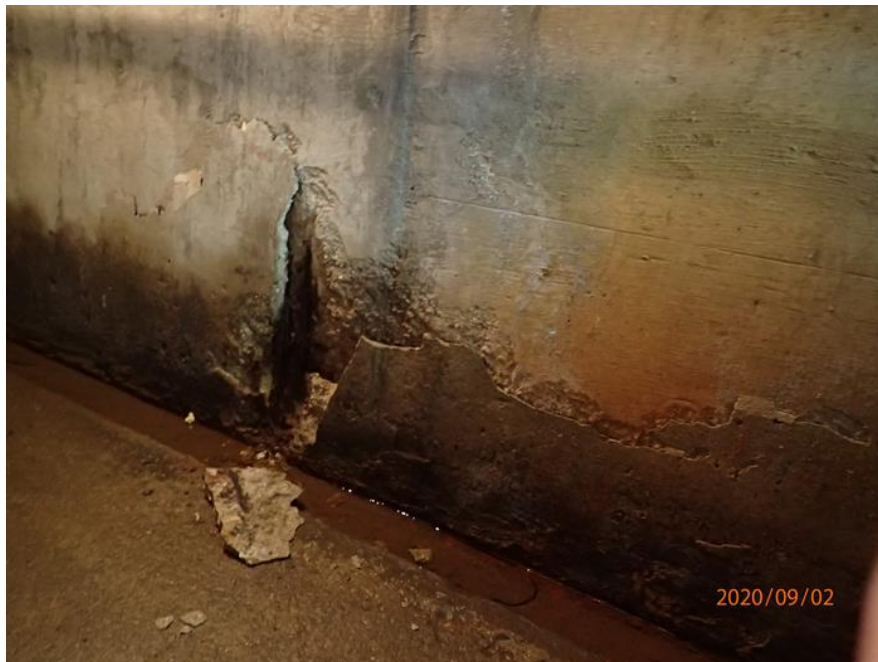
Station 6+90

Direction: Western Wall (In-Land)

Comments: Spalling, Loose Concrete

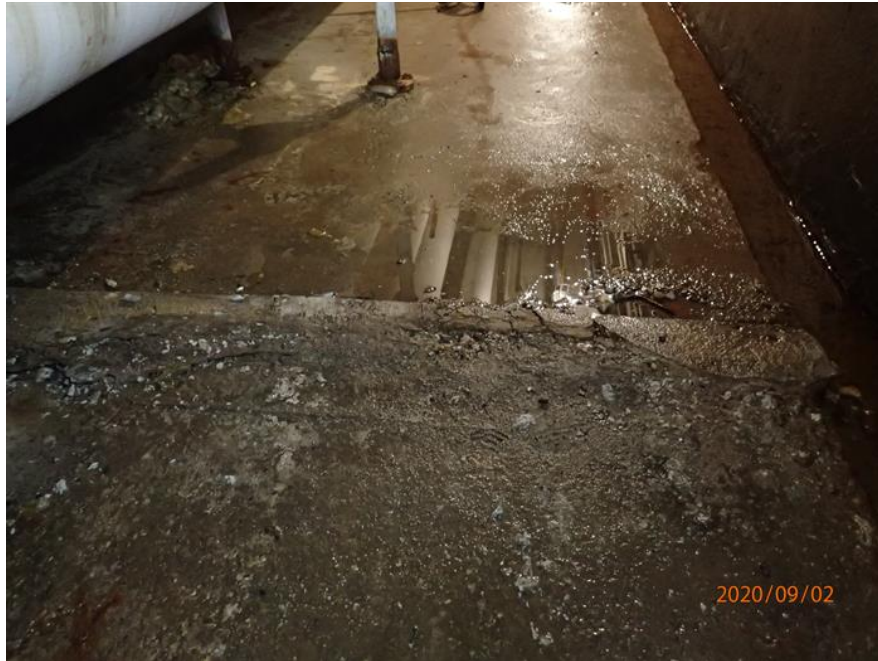
Station 7+20

Direction: Tunnel Floor

Comments: Floor Slab Raised at Joint, Cracking, Loose Concrete

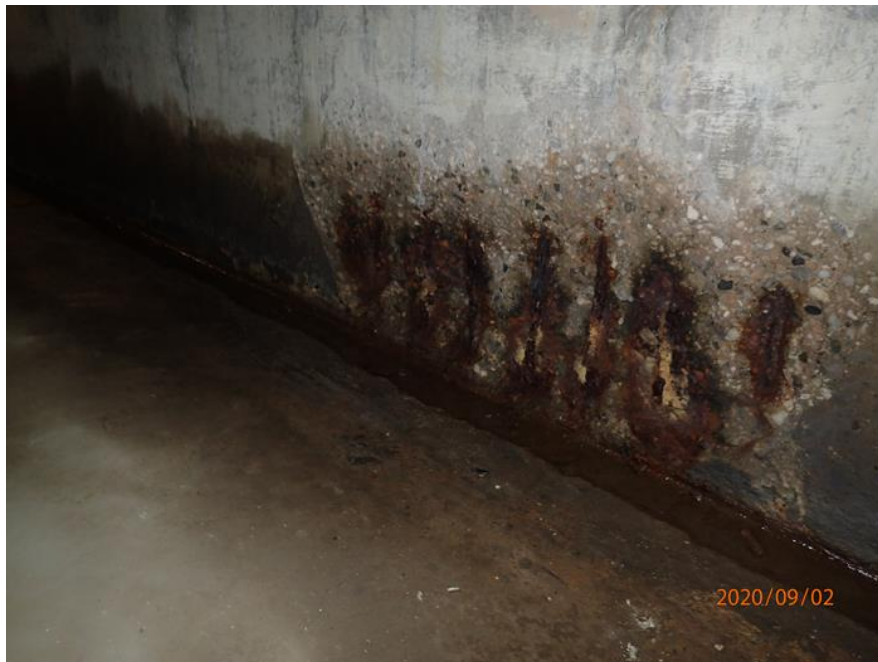
Station 7+25 to 7+40

Direction: Western Wall (In-Land)

Comments: Spalling, Re-Bar Exposed and Corroded

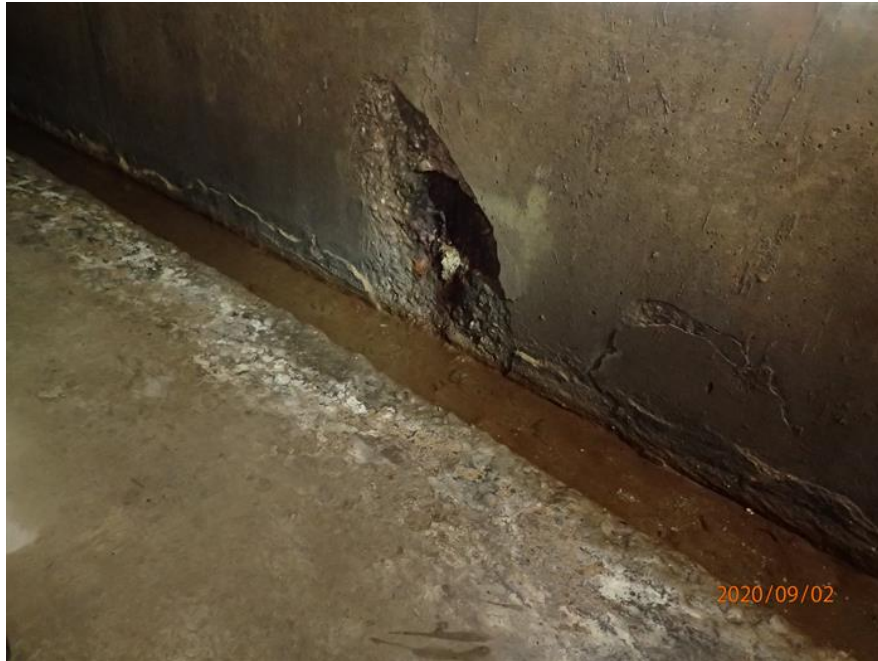
Station 7+53

Direction: Western Wall (In-Land)

Comments: Concrete Spalling

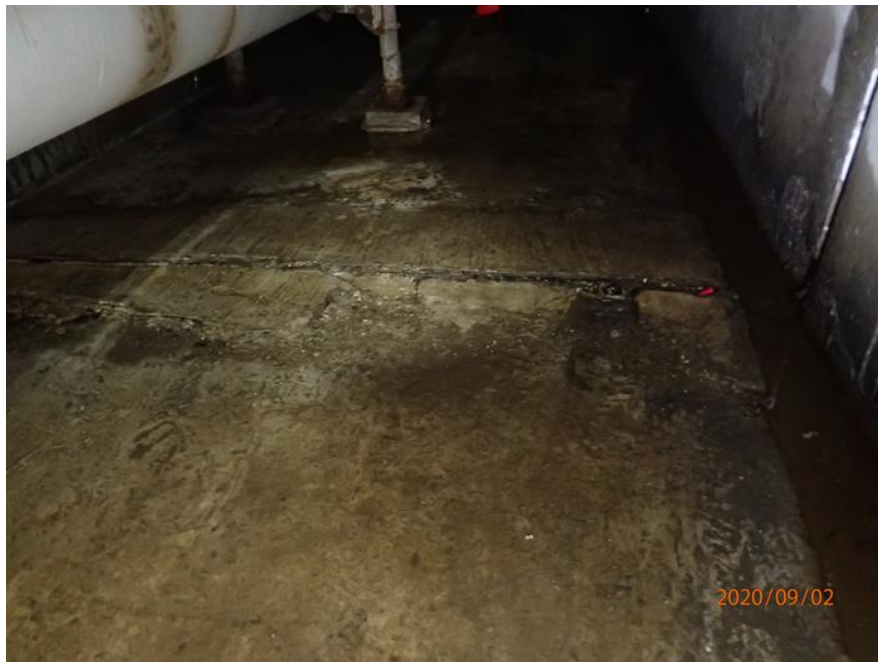
Station 7+80

Direction: Tunnel Floor

Comments: Floor Slab Raised at Joint, Cracking, Loose Concrete

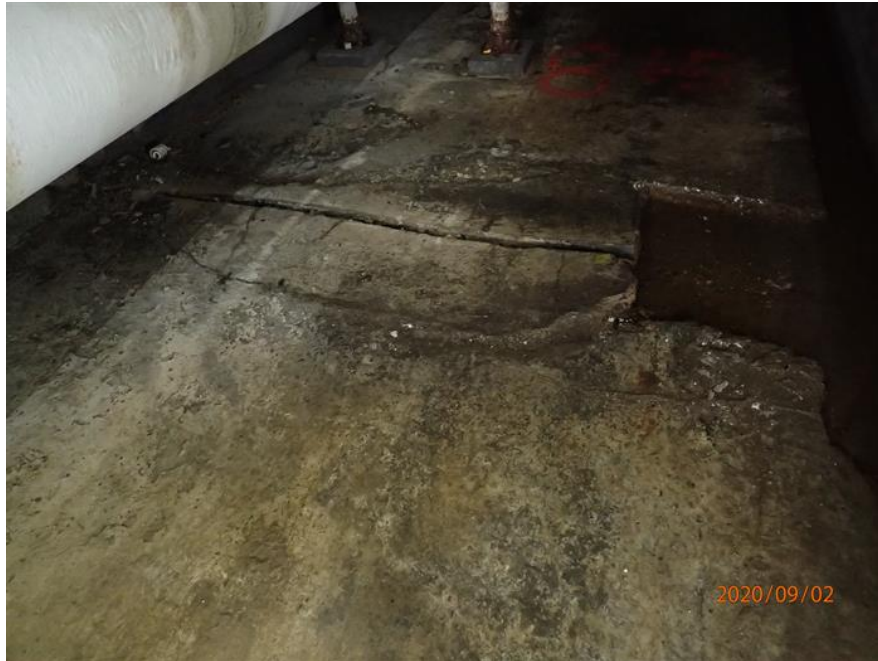
Station 8+50

Direction: Tunnel Floor

Comments: Floor Slab Raised at Joint, Cracking, Loose Concrete

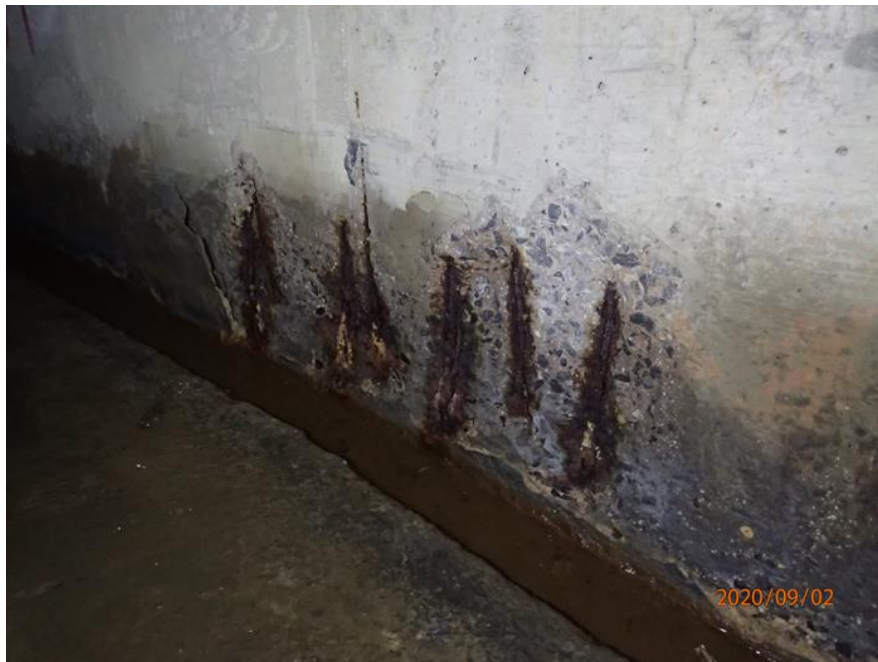
Station 8+80 to 8+90

Direction: Western Wall (In-Land)

Comments: Spalling, Re-Bar Exposed and Corroded

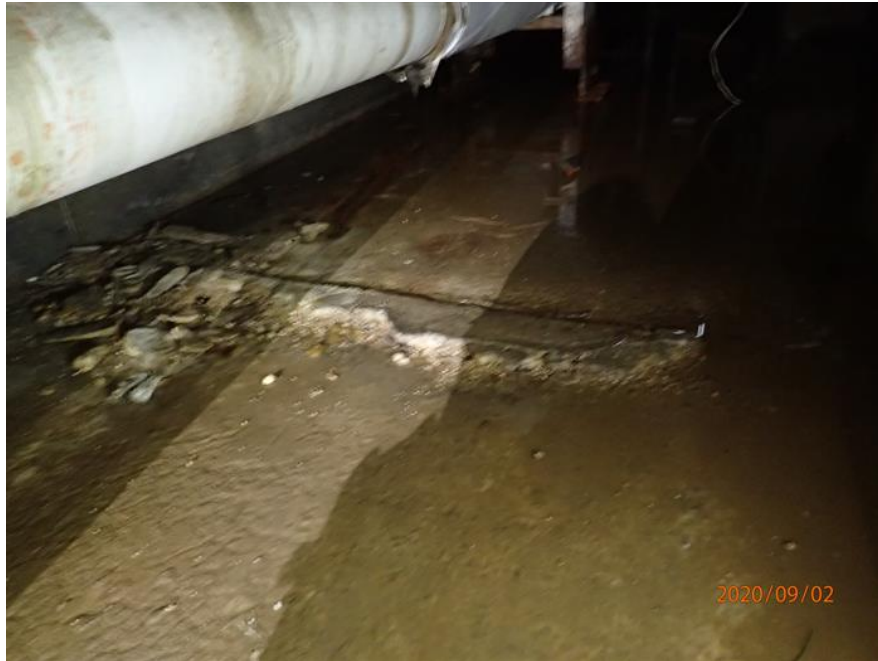
Station 9+10

Direction: Tunnel Floor

Comments: Floor Slab Raised at Joint, Cracking, Loose Concrete

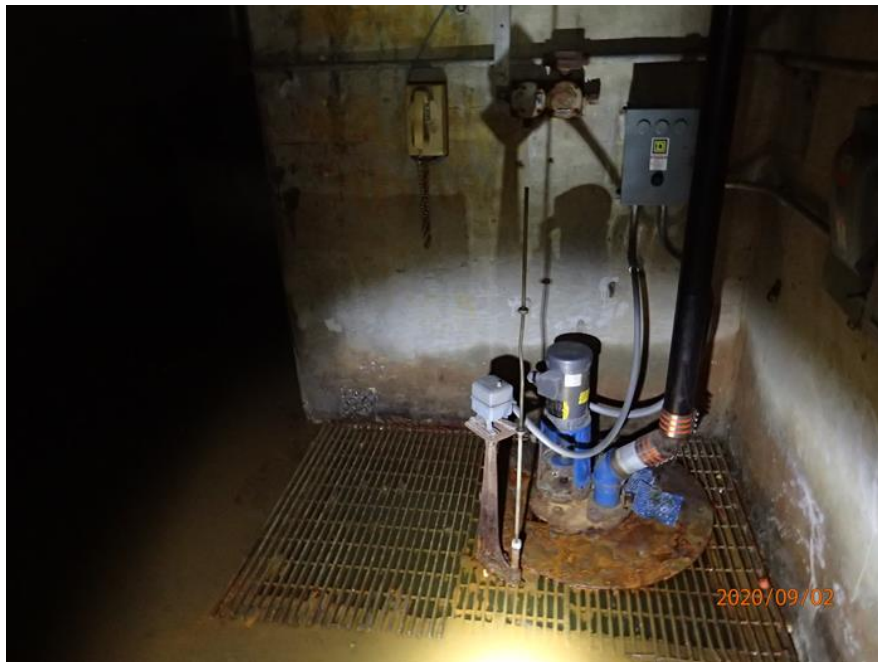
Station 9+21

Direction: Tunnel Floor

Comments: Sump Pump - Not Working

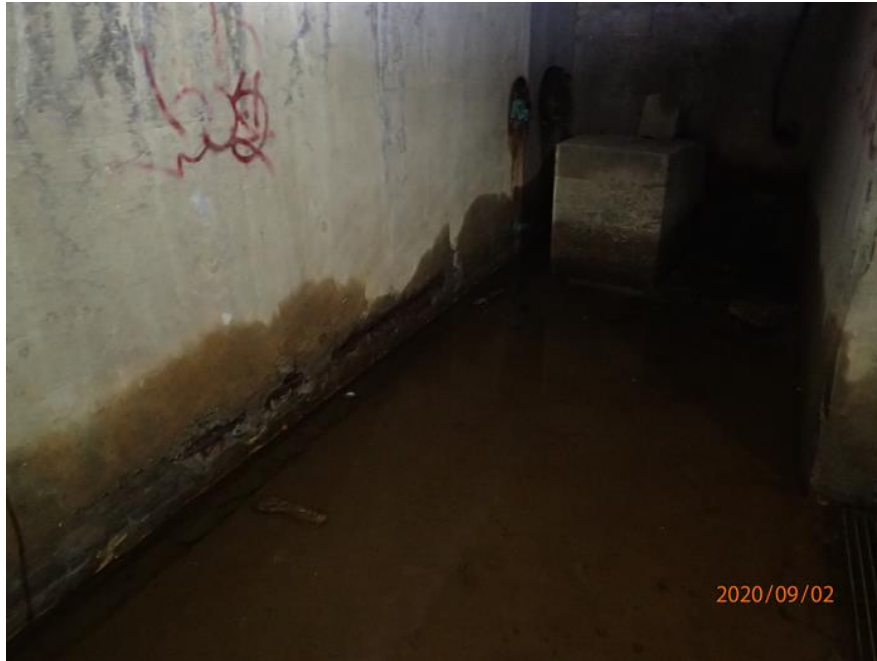
Station 9+21

Direction: Western Wall (In-Land) at Air Vent 15

Comments: Concrete Spalling, Re-Bar Exposed and Corroded
