CONDITIONS REPORT & CONCEPTUAL DESIGN MEMORANDUM

STEAM TUNNEL ASSESSMENT

ROOSEVELT ISLAND, NEW YORK

17 November 2014
Revised 28 December 2018
Revised 18 September 2020
Project # 100444601

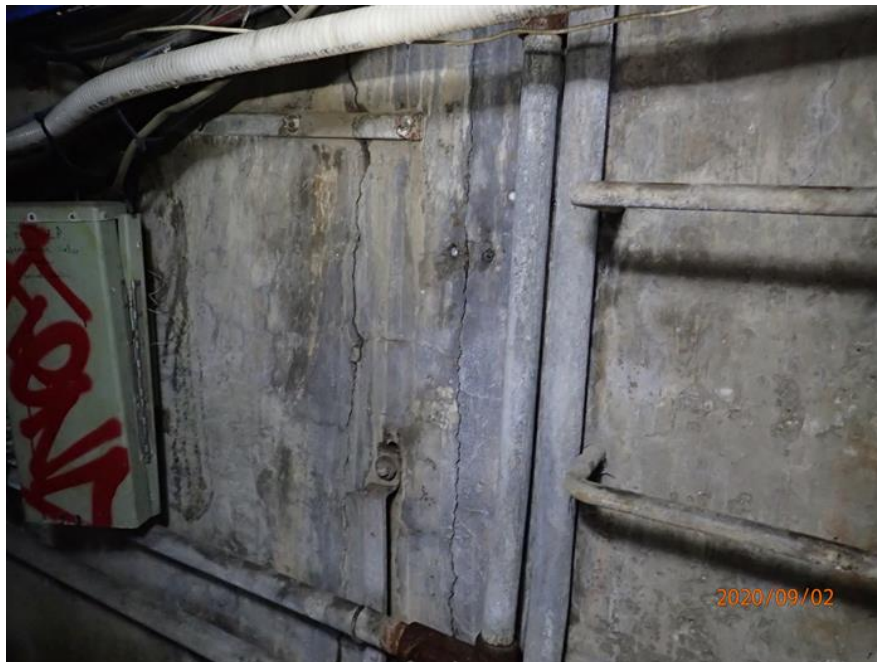
Station 9+21

Direction: Western Wall (In-Land) at Air Vent 15

Comments: Concrete Spalling, Cracking

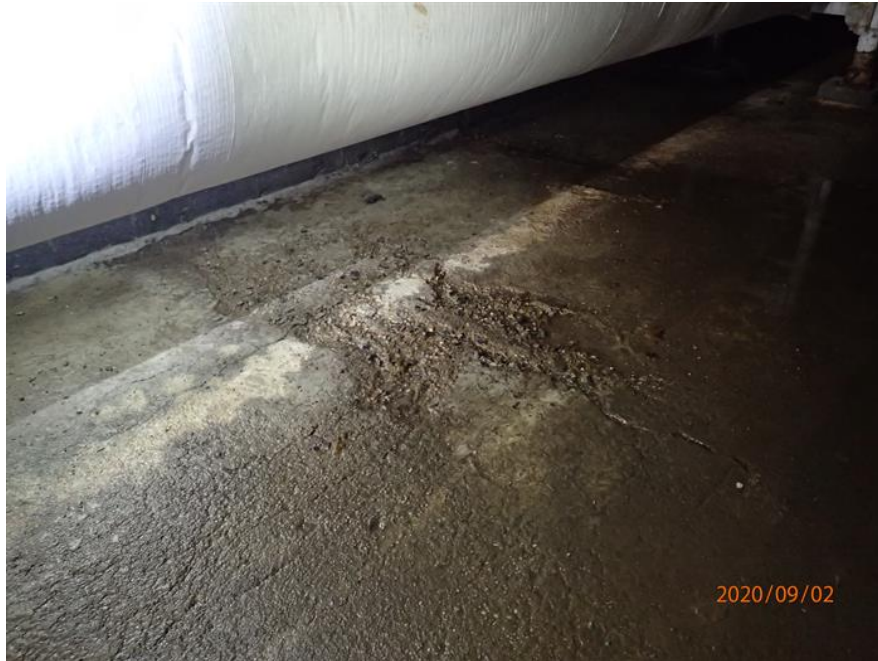
Station 9+30

Direction: Tunnel Floor

Comments: Concrete Spalling, Floor Slab Cracking, Loose Concrete

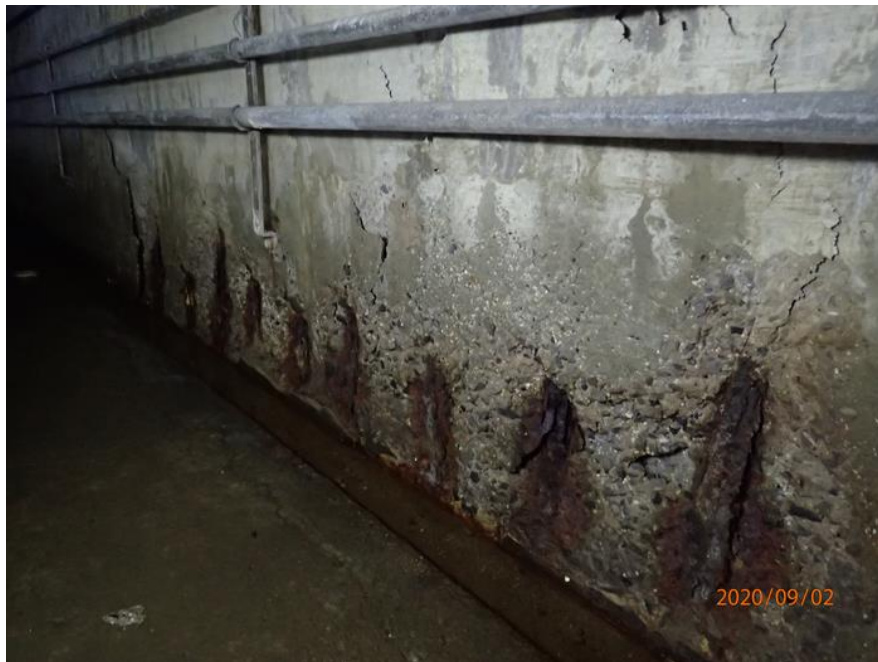
Station 9+95 to 10+15

Direction: Western Wall (In-Land)

Comments: Spalling, Re-Bar Exposed and Corroded

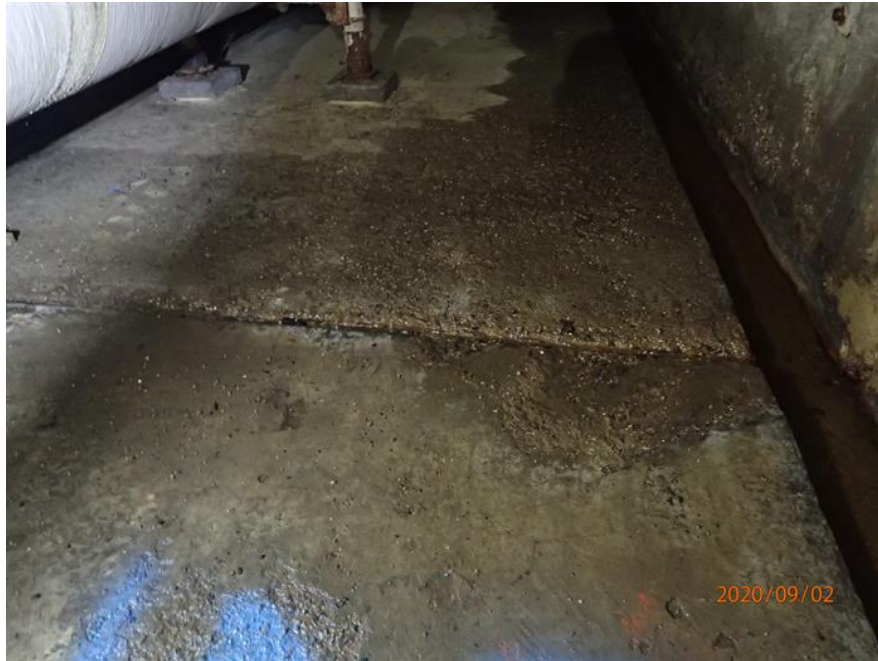
Station 10+52

Direction: Tunnel Floor

Comments: Floor Slab Raised at Joint, Cracking, Loose Concrete

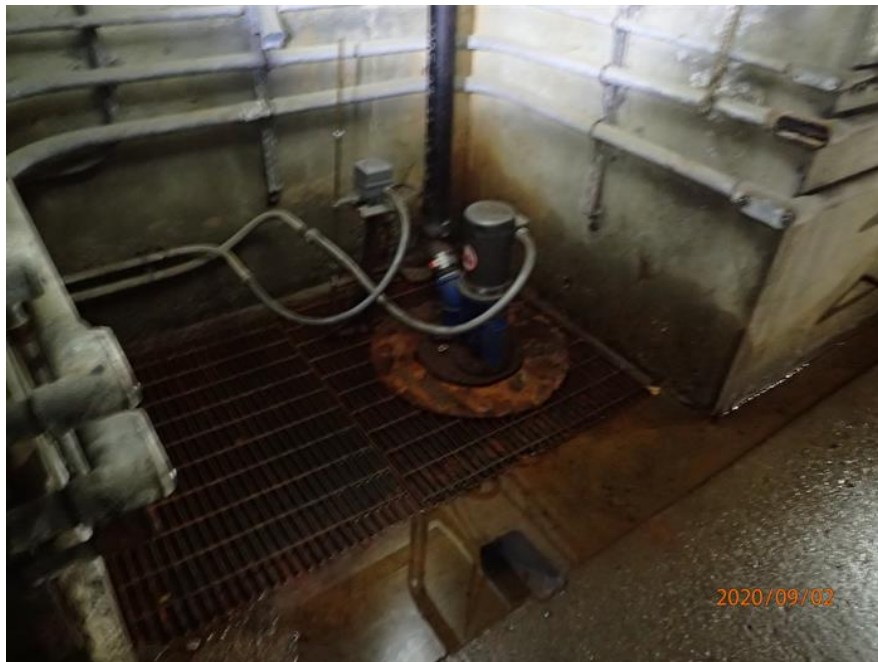
Station 10+77

Direction: Tunnel Floor

Comments: Sump Pump - Not Working

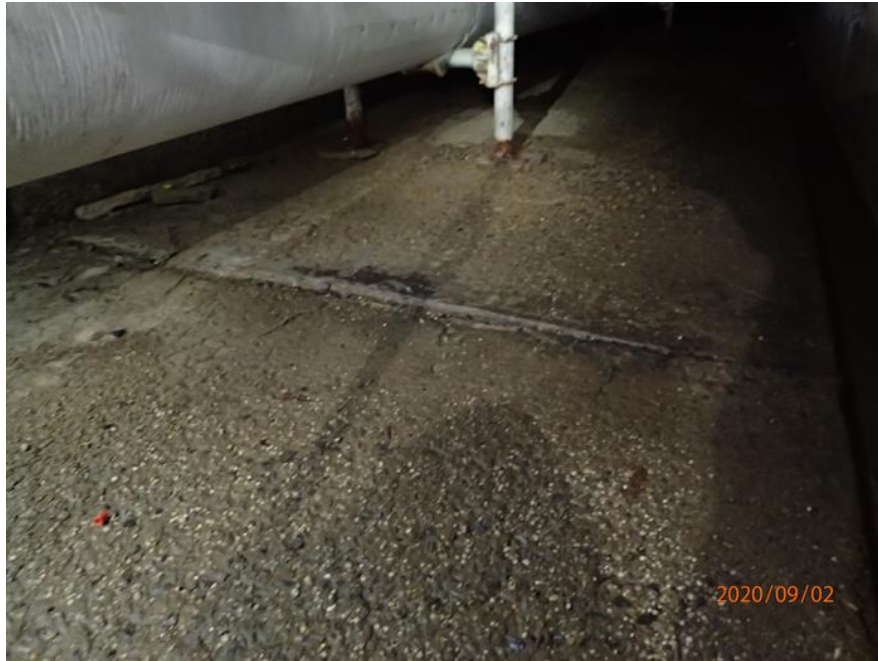
Station 11+18

Direction: Tunnel Floor

Comments: Floor Slab Raised at Joint, Cracking, Loose Concrete

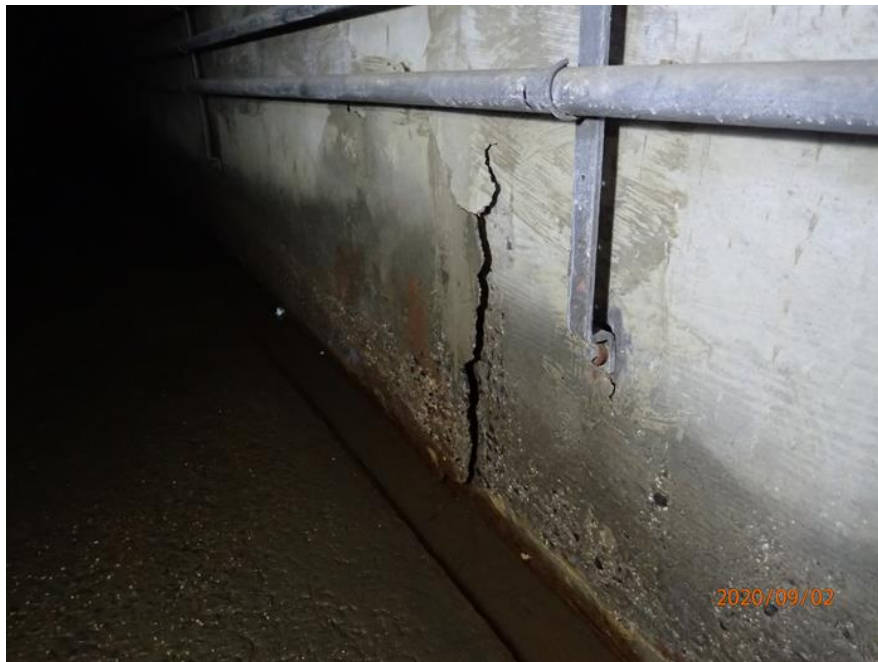
Station 11+29

Direction: Western Wall (In-Land)

Comments: Concrete Spalling

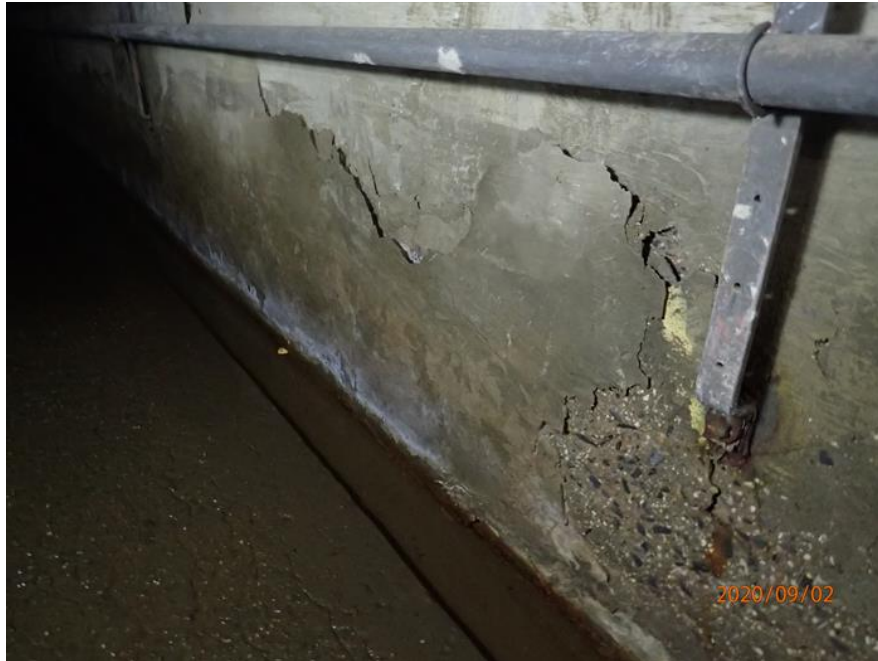
Station 11+85 +12+50

Direction: Western Wall (In-Land)

Comments: Concrete Spalling and Bowing of Wall

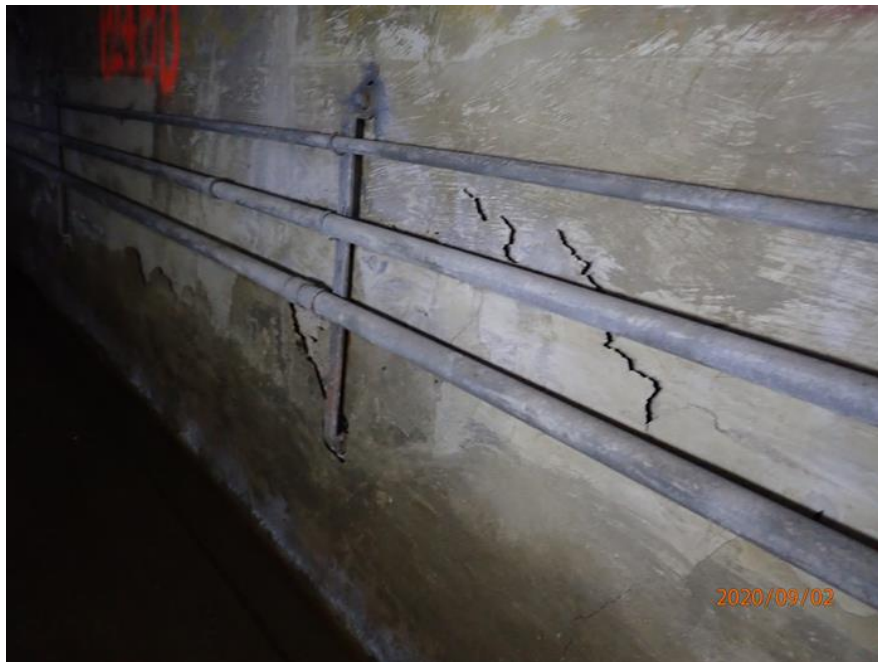
Station 11+85 +12+50

Direction: Western Wall (In-Land)

Comments: Concrete Spalling and Bowing of Wall, Loose Concrete

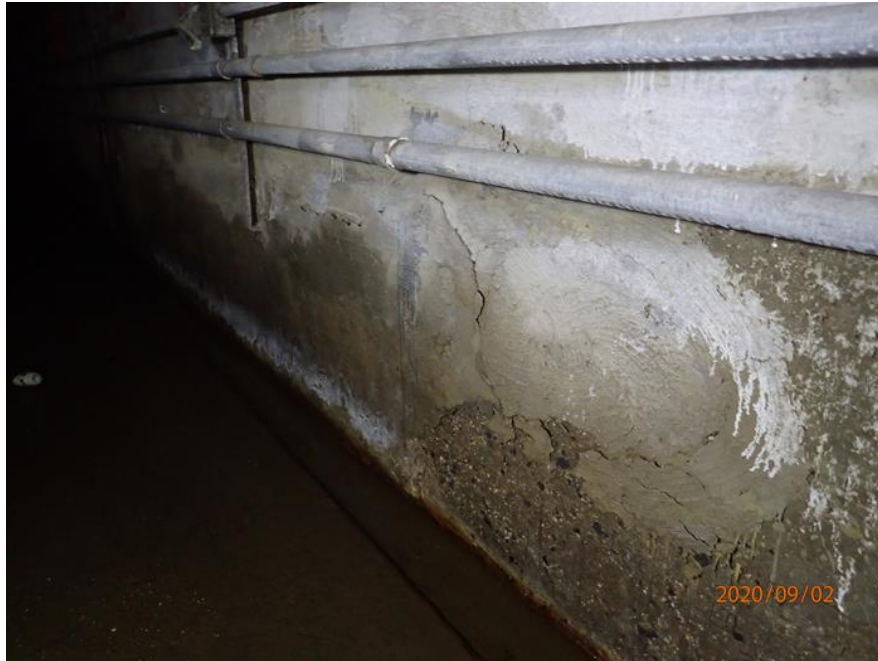
Station 12+35

Direction: Western Wall (In-Land)

Comments: Concrete Spalling

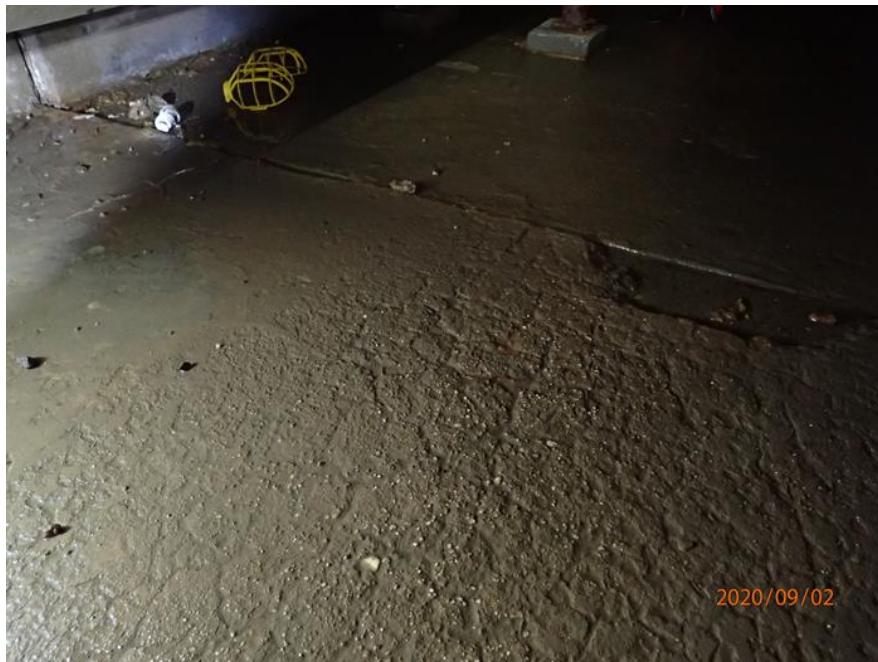
Station 12+45

Direction: Tunnel Floor

Comments: Floor Slab Raised at Joint, Cracking, Loose Concrete

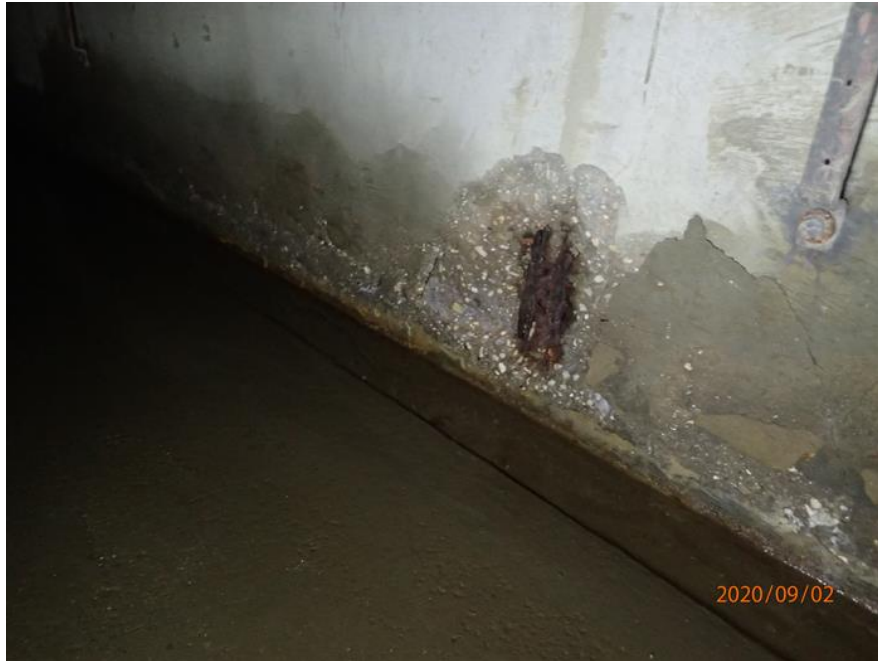
Station 12+53

Direction: Western Wall (In-Land)

Comments: Concrete Spalling, Re-Bar Exposed and Corroded

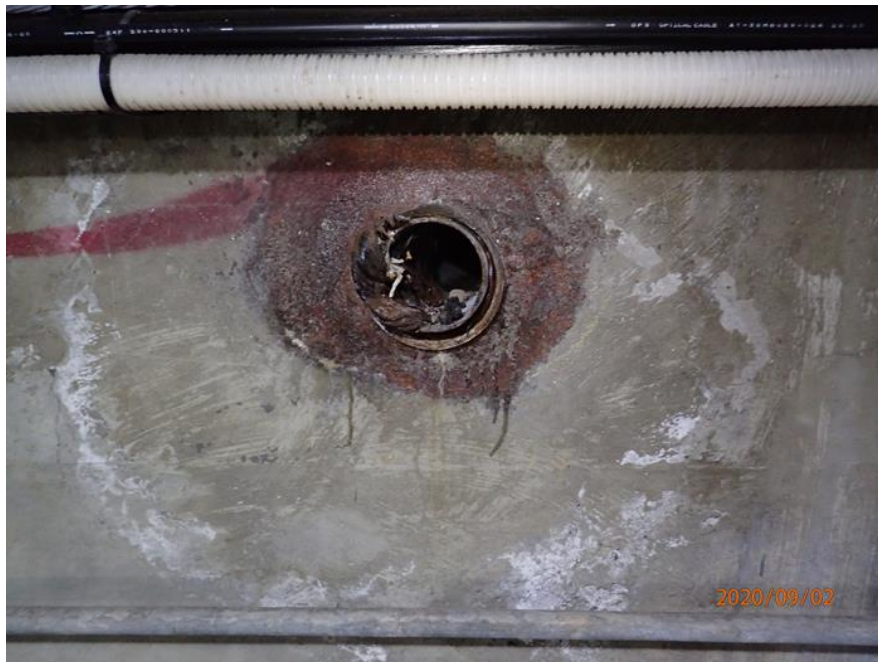
Station 12+53

Direction: Western Wall (In-Land)

Comments: Pipe Penetration

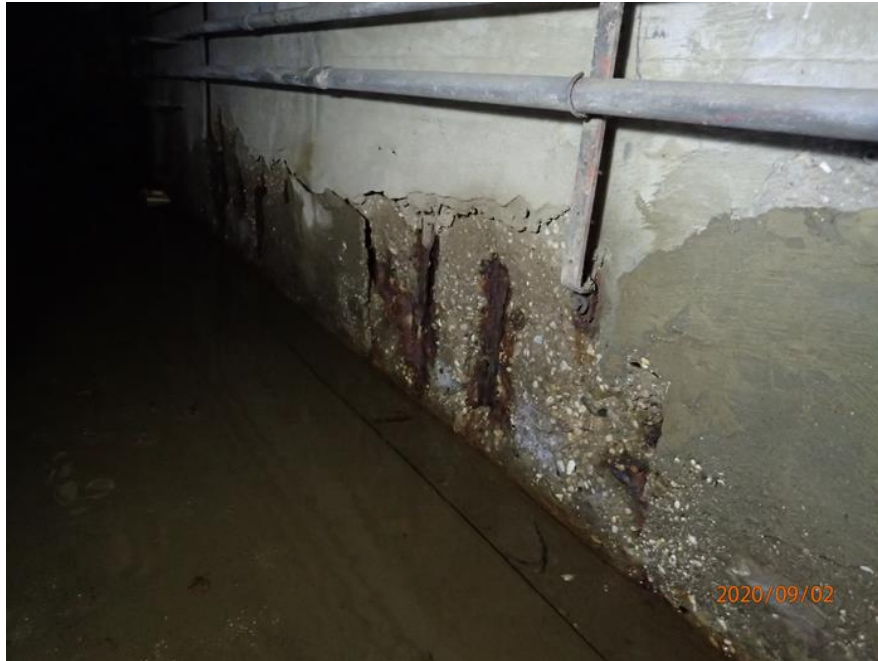
Station 12+65 to 12+85

Direction: Western Wall (In-Land)

Comments: Concrete Spalling, Re-Bar Exposed and Corroded

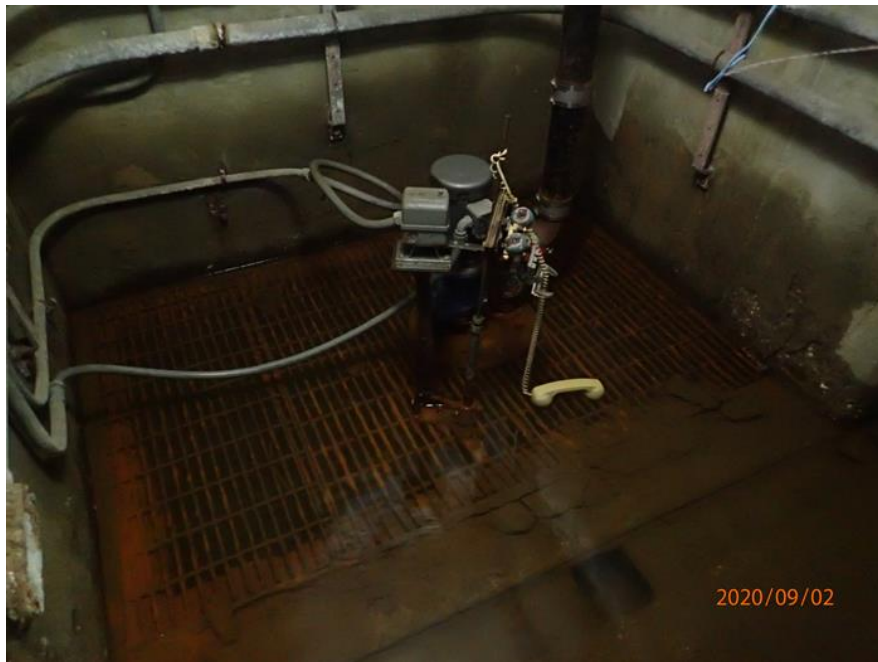
Station 12+84

Direction: Tunnel Floor

Comments: Sump Pump - Not Working

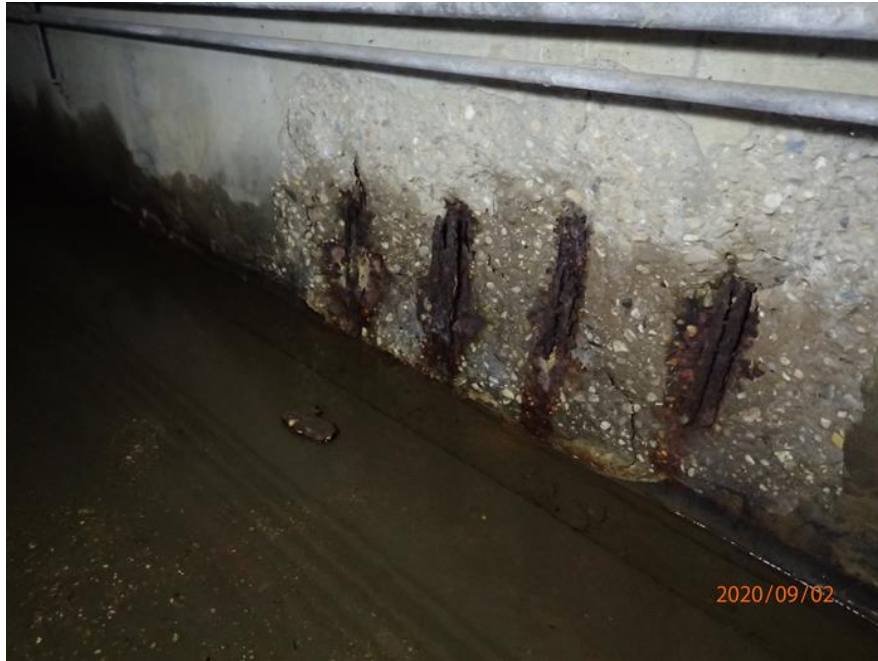
Station 12+90 to 12+96

Direction: Western Wall (In-Land)

Comments: Concrete Spalling, Re-Bar Exposed and Corroded

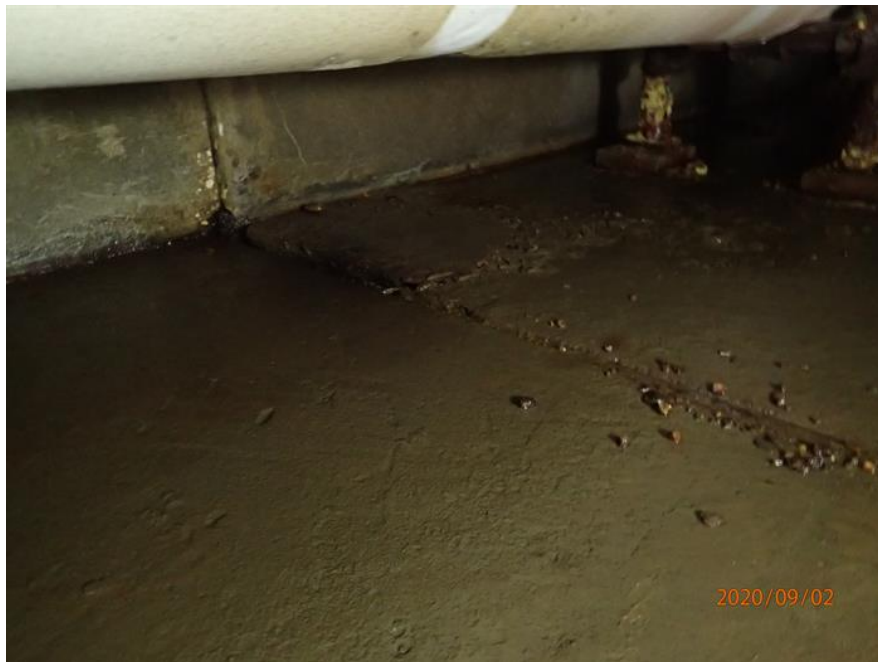
Station 13+25

Direction: Tunnel Floor

Comments: Floor Slab Raised at Joint, Cracking, Loose Concrete

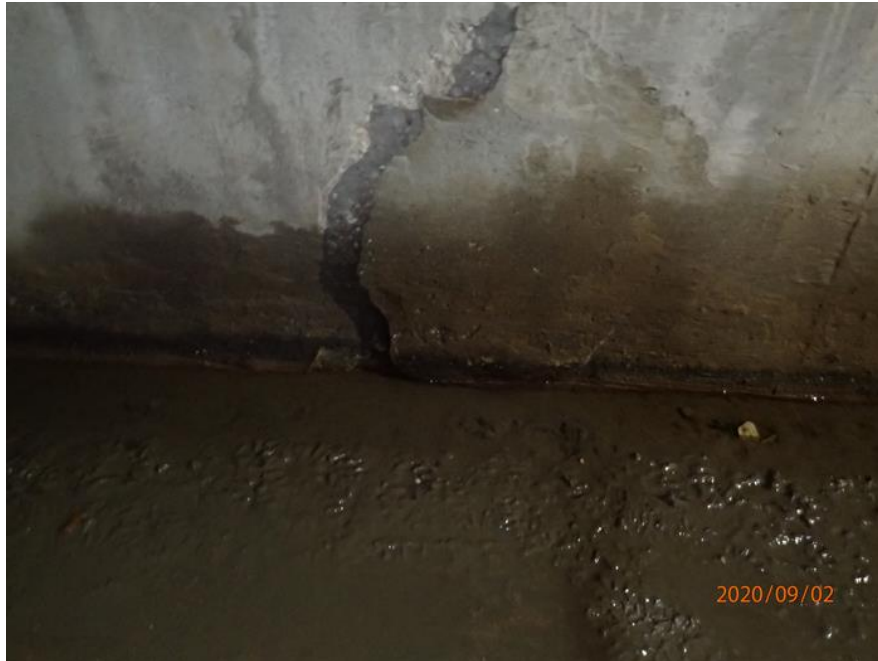
Station 13+31

Direction: Western Wall (In-Land)

Comments: Spalling, Loose Concrete

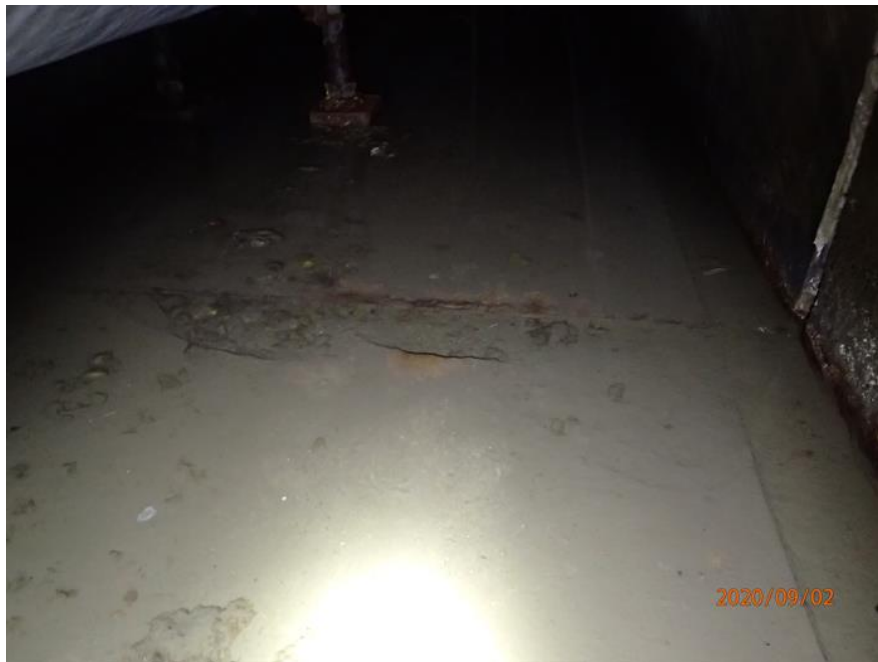
Station 13+70

Direction: Tunnel Floor

Comments: Floor Slab Raised at Joint, Cracking, Loose Concrete

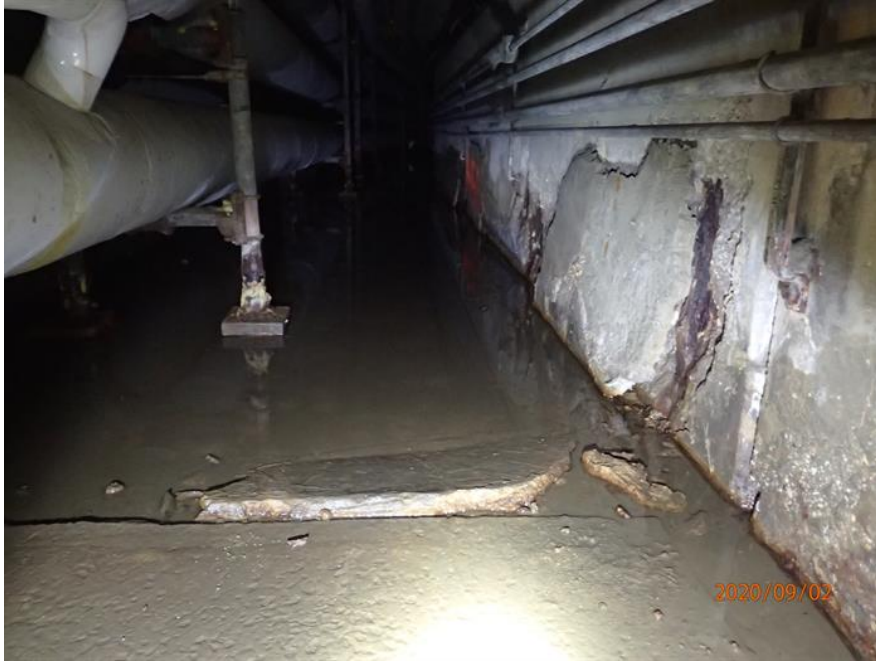
Station 14+30

Direction: Tunnel Floor

Comments: Floor Slab Raised at Joint, Cracking, Loose Concrete

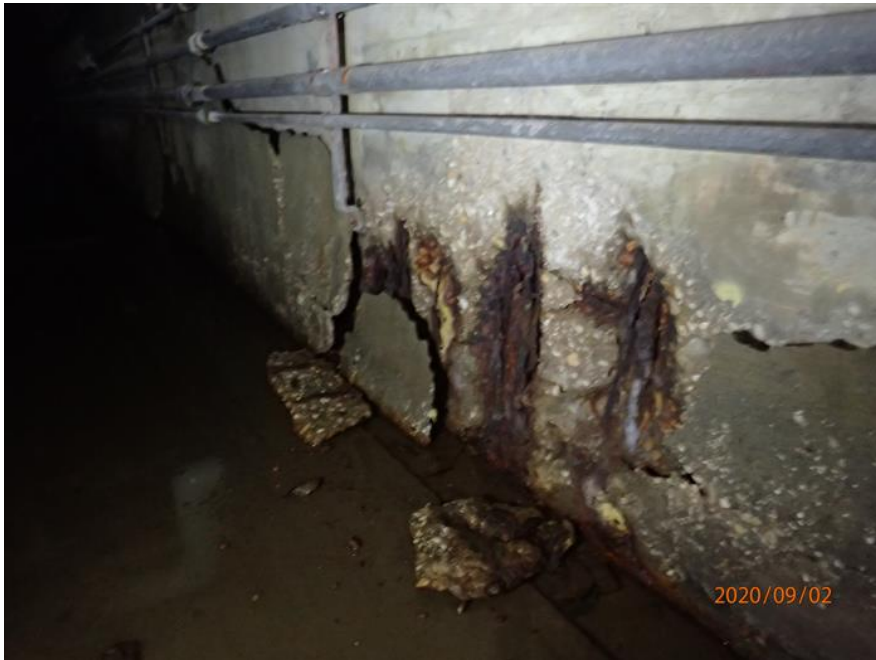
Station 14+24 to 15+00

Direction: Western Wall (In-Land)

Comments: Concrete Spalling, Re-Bar Exposed and Corroded

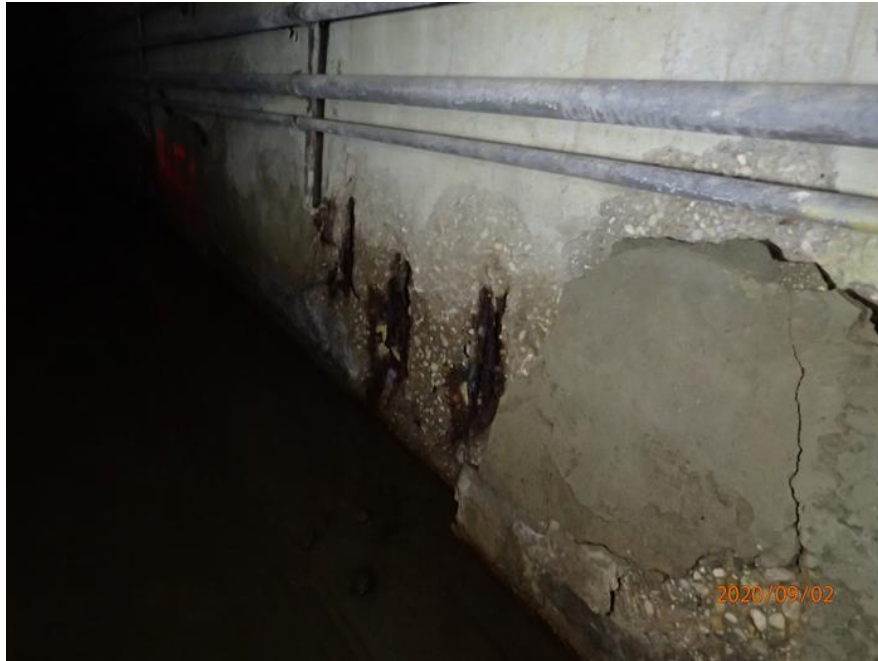
Station 14+24 to 15+00

Direction: Western Wall (In-Land)

Comments: Spalling, Re-Bar Exposed and Corroded, Loose Concrete

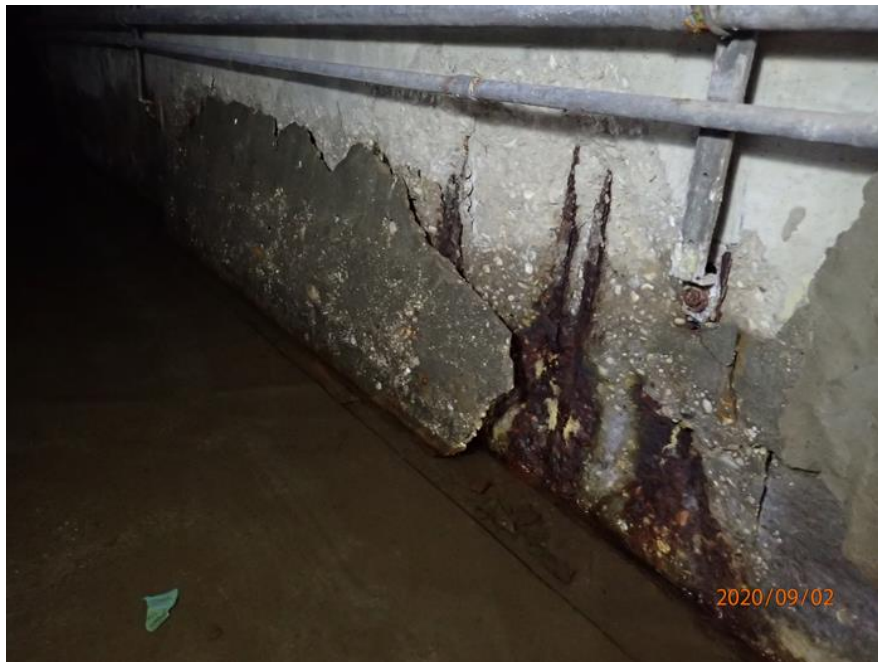
Station 14+24 to 15+00

Direction: Western Wall (In-Land)

Comments: Spalling, Re-Bar Exposed and Corroded

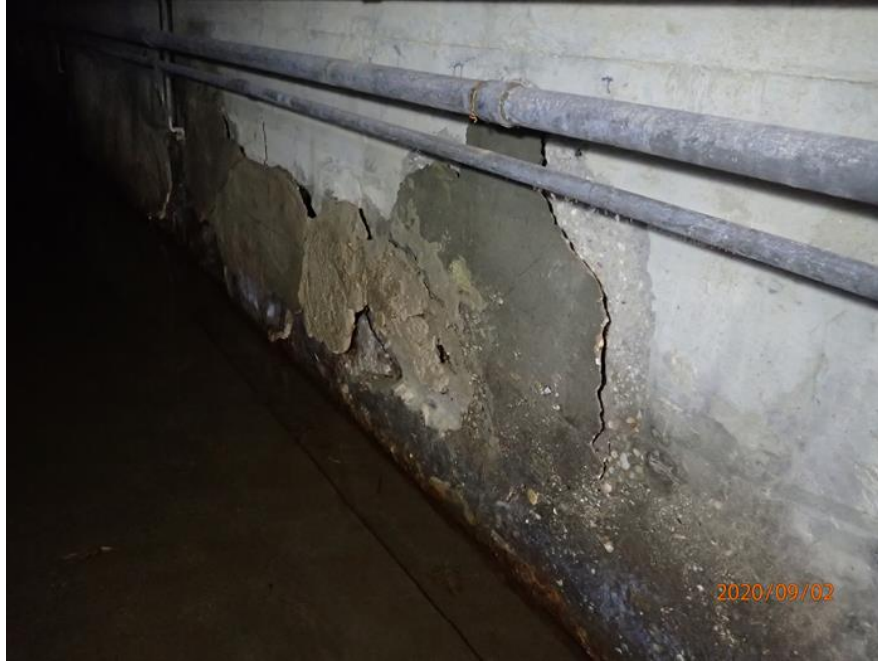
Station 14+24 to 15+00

Direction: Western Wall (In-Land)

Comments: Spalling, Re-Bar Exposed and Corroded

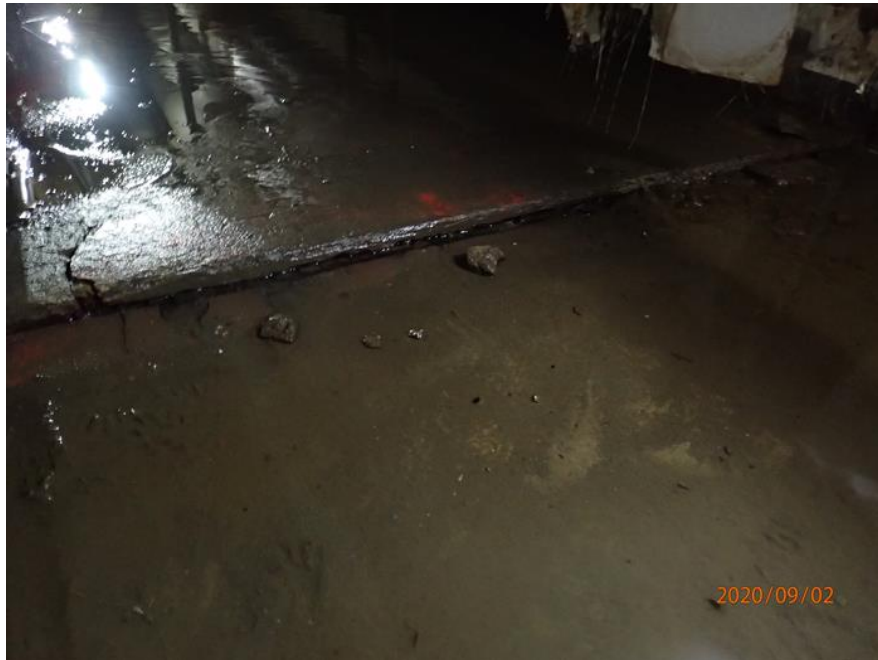
Station 15+00

Direction: Tunnel Floor

Comments: Floor Slab Raised at Joint, Cracking, Loose Concrete

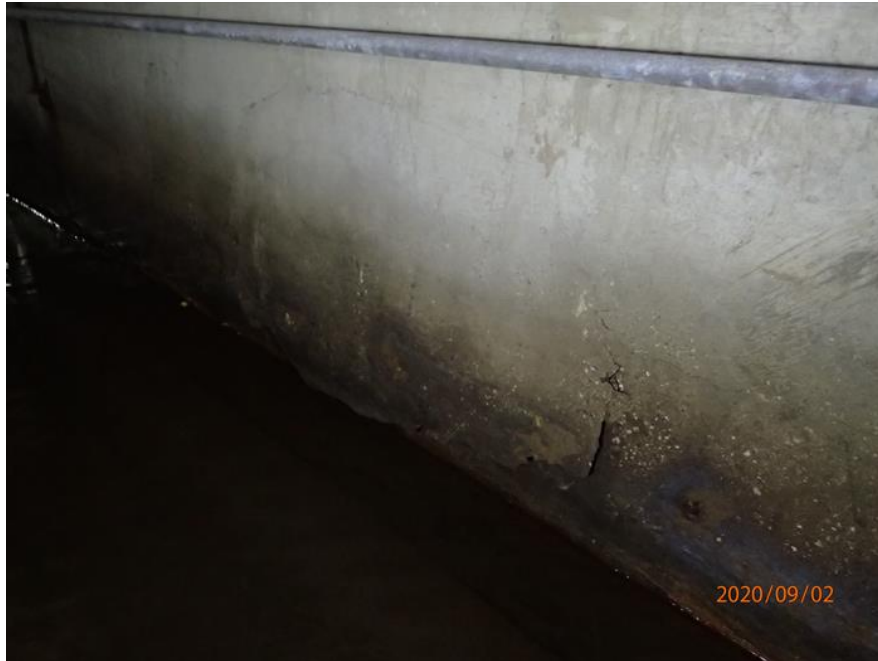
Station 15+09 to 15+20

Direction: Western Wall (In-Land)

Comments: Concrete Spalling

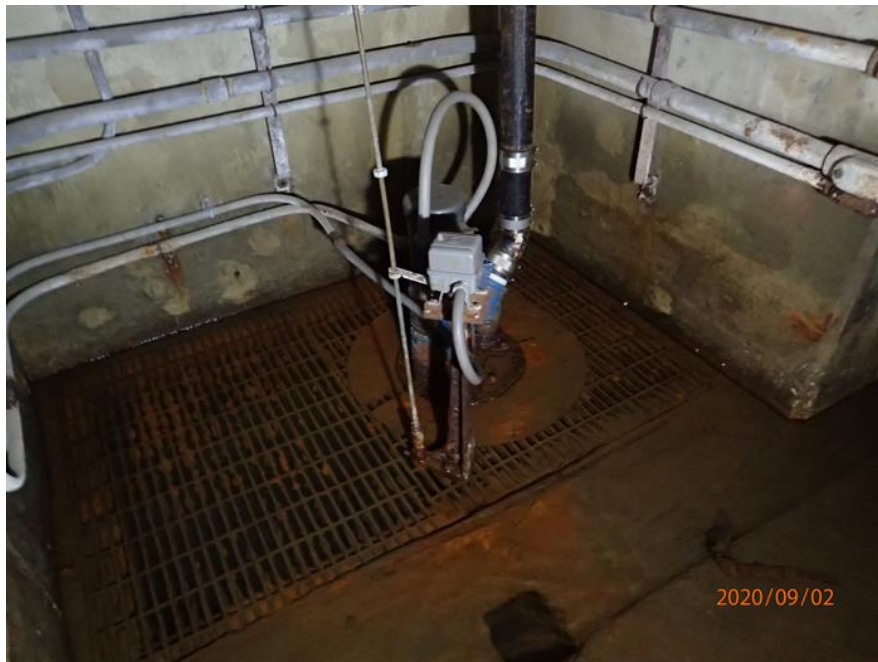
Station 15+22

Direction: Tunnel Floor

Comments: Sump Pump - Not Working

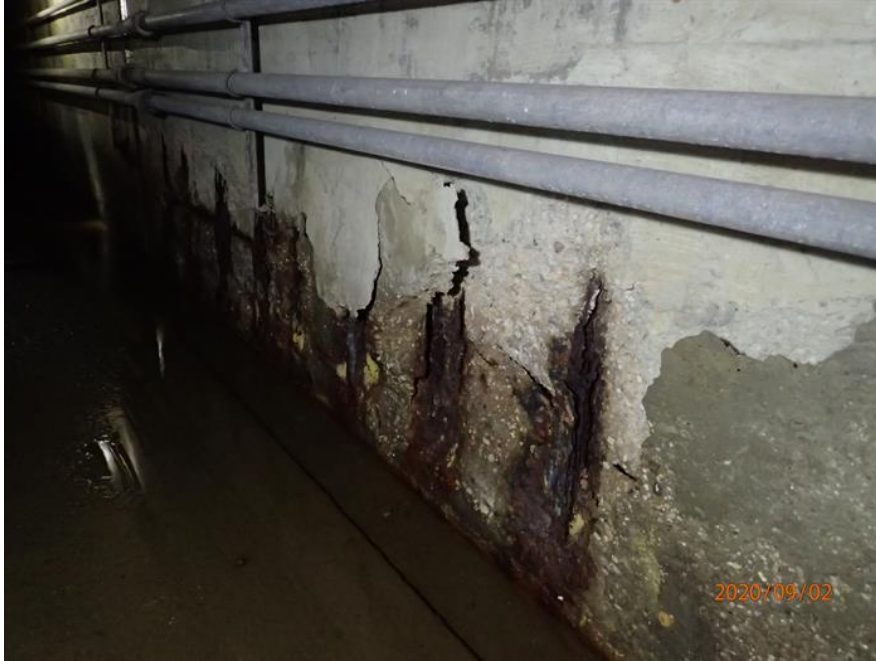
Station 15+50 to 15+75

Direction: Western Wall (In-Land)

Comments: Spalling, Re-Bar Exposed and Corroded

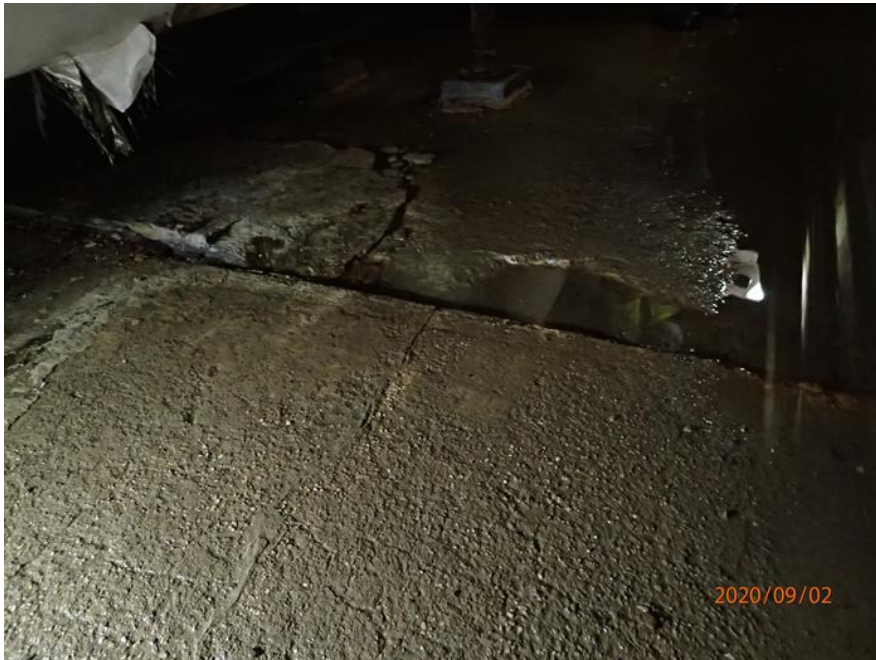
Station 15+75

Direction: Tunnel Floor

Comments: Floor Slab Raised at Joint, Cracking, Loose Concrete

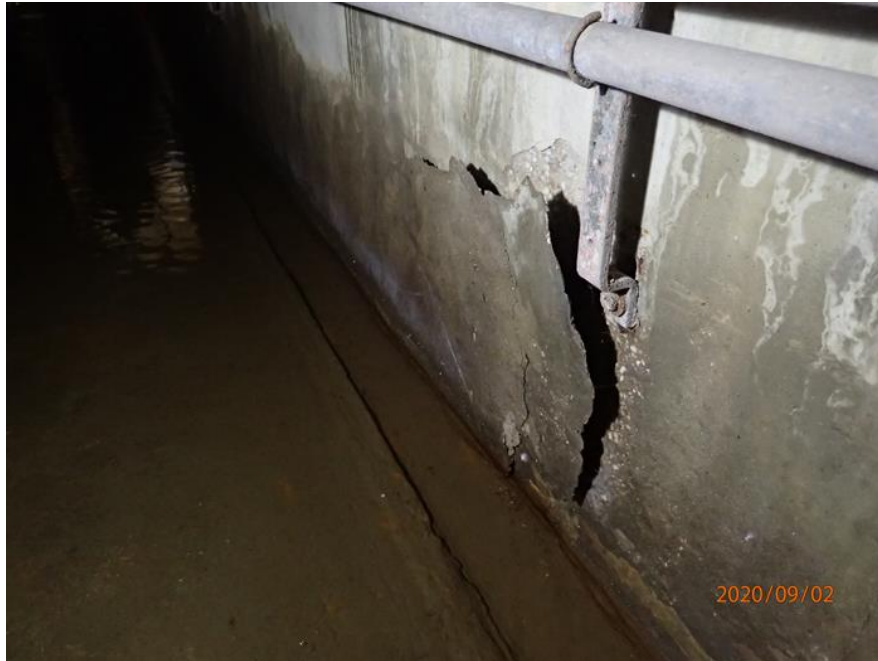
Station 15+88 to 16+00

Direction: Western Wall (In-Land)

Comments: Concrete Spalling

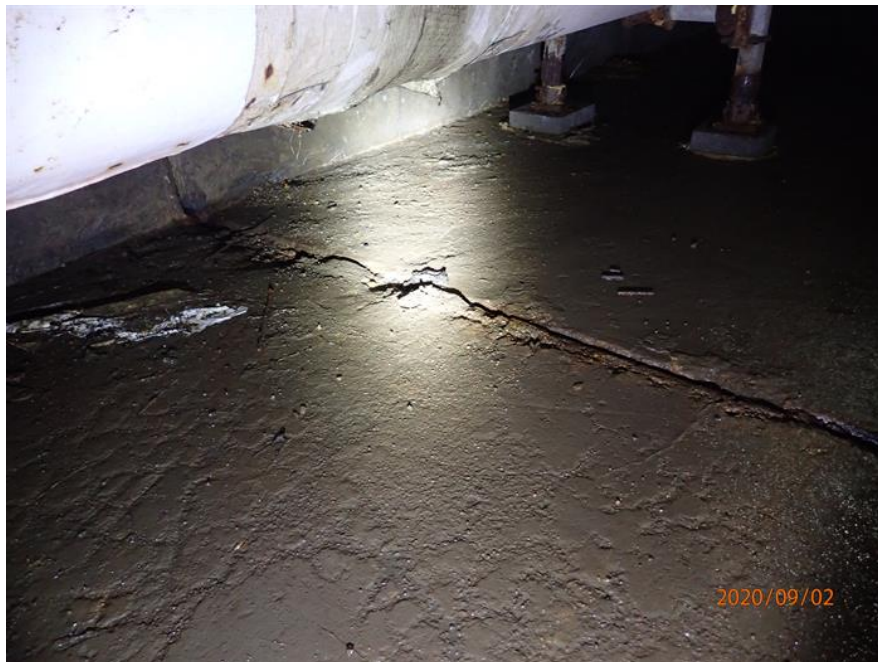
Station 16+30

Direction: Tunnel Floor

Comments: Floor Slab Raised at Joint, Cracking, Loose Concrete

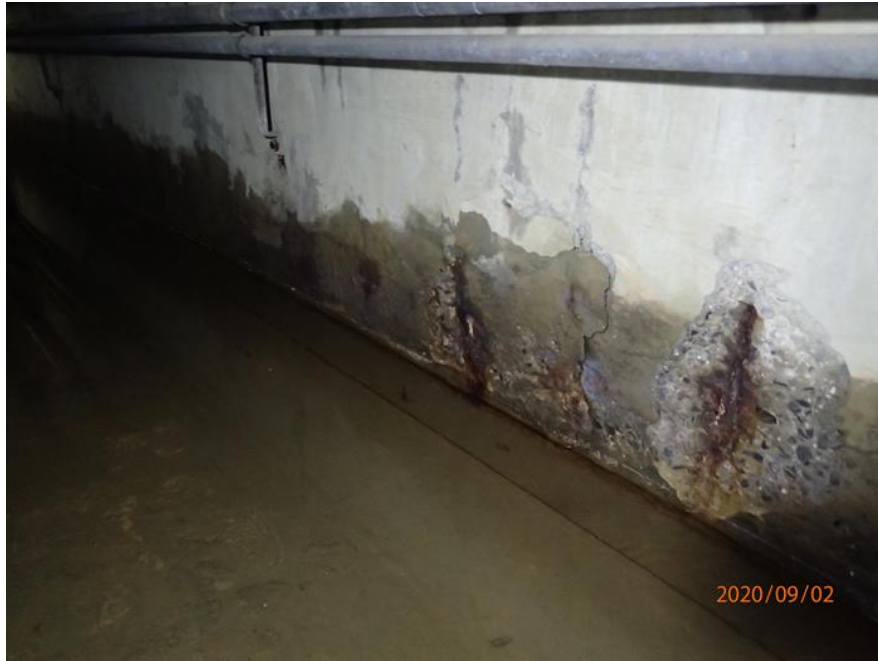
Station 16+53 to 16+60

Direction: Western Wall (In-Land)

Comments: Spalling, Re-Bar Exposed and Corroded

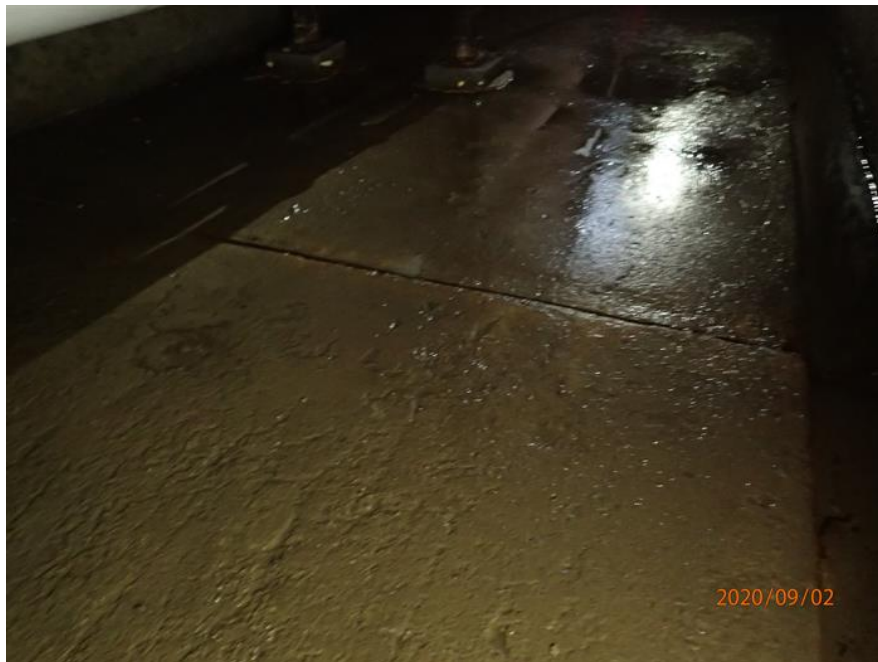
Station 16+90

Direction: Tunnel Joint

Comments: Leaking at Seawall

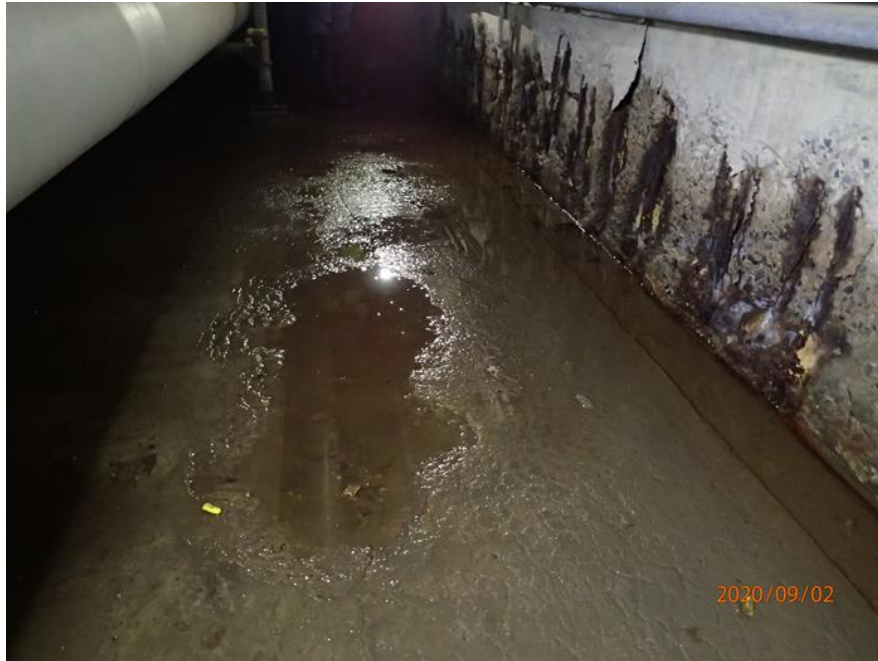
Station 17+35

Direction: Tunnel Floor

Comments: Concrete Spalling

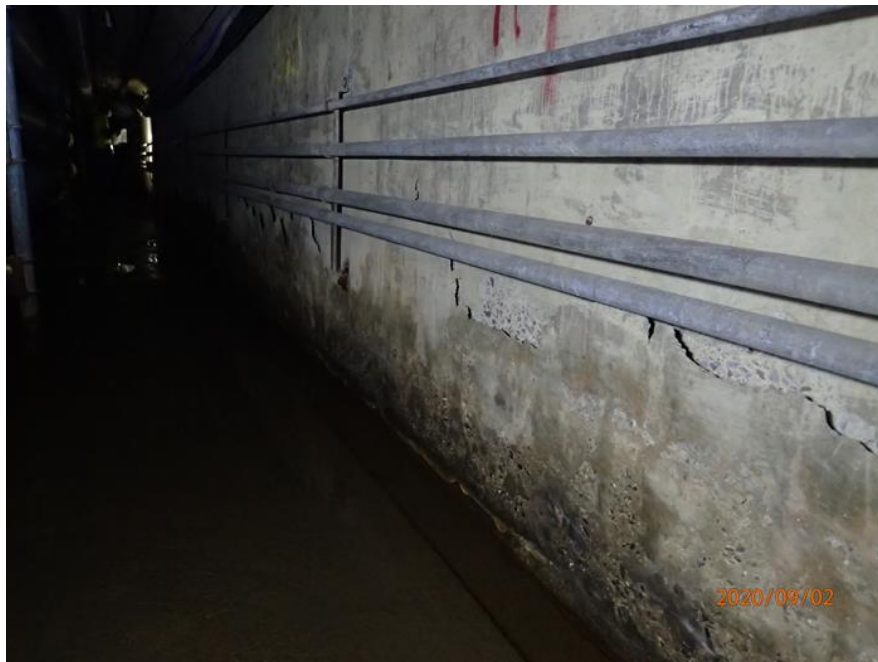
Station 17+10 to 17+60

Direction: Western Wall (In-Land)

Comments: Spalling, Re-Bar Exposed and Corroded

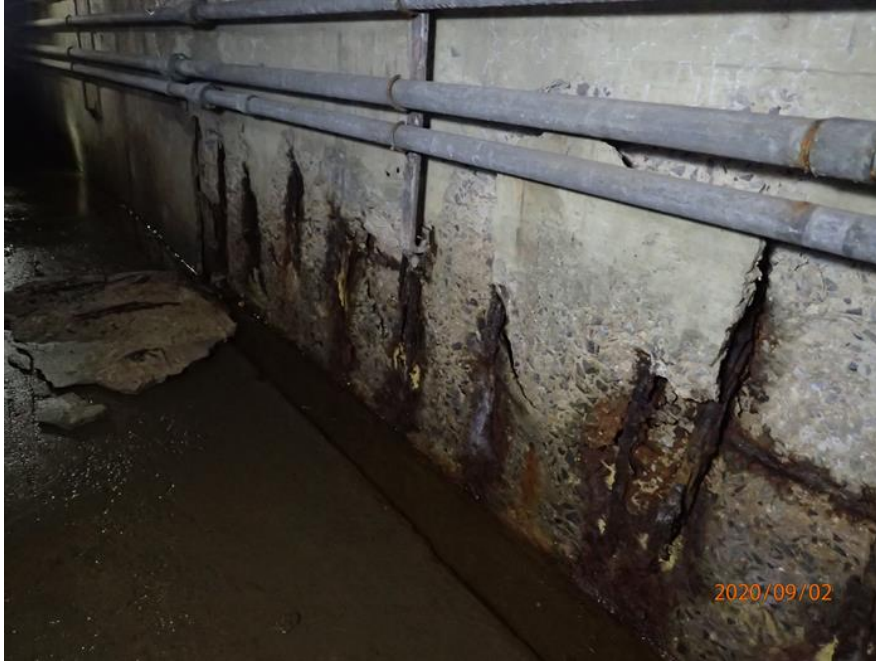
Station 17+10 to 17+60

Direction: Western Wall (In-Land)

Comments: Spalling, Re-Bar Exposed and Corroded

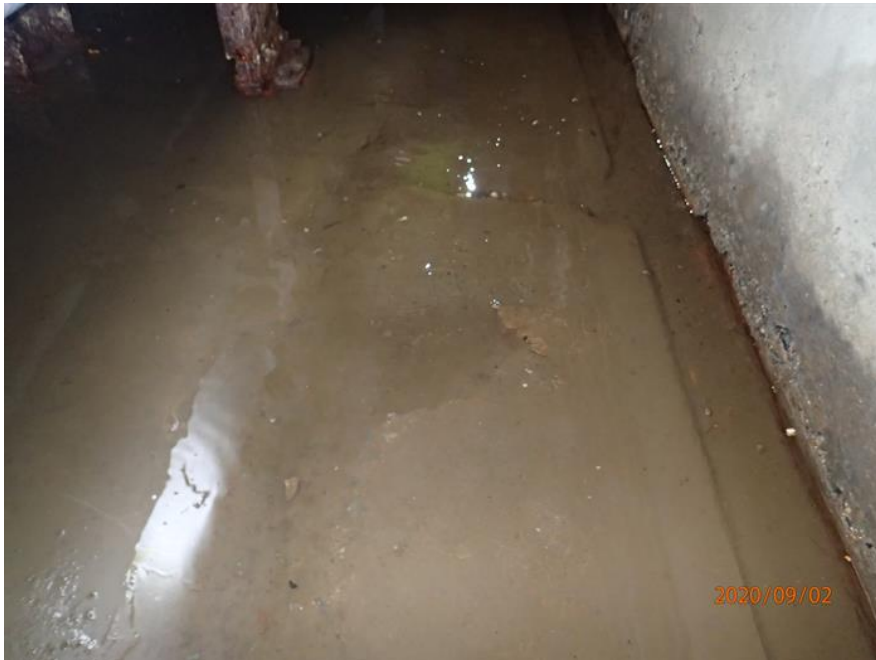
Station 17+70

Direction: Tunnel Floor

Comments: Concrete Spalling

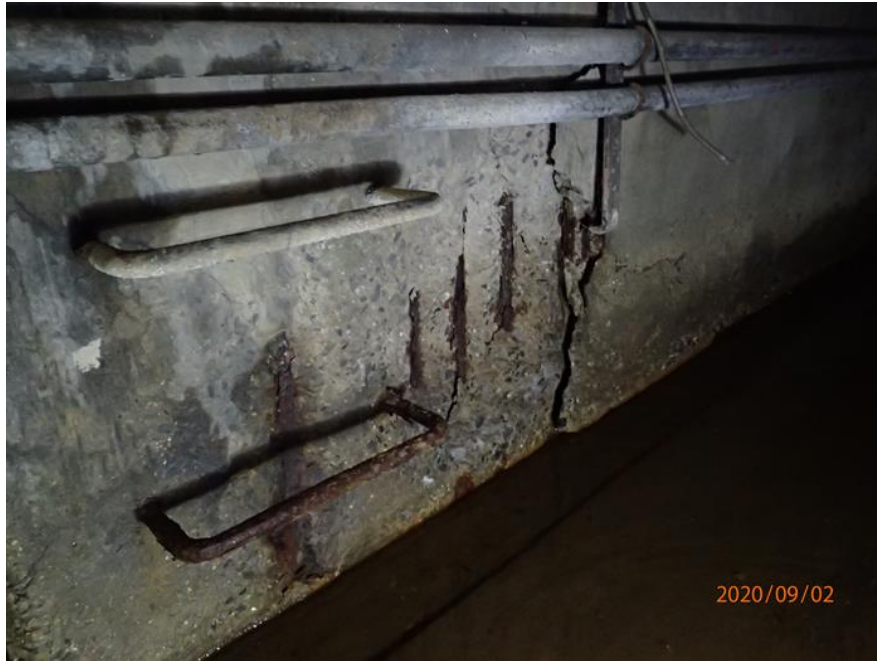
Station 17+76

Direction: Western Wall (In-Land) at Air Vent 11

Comments: Concrete Spalling
