CONDITIONS REPORT & CONCEPTUAL DESIGN MEMORANDUM

STEAM TUNNEL ASSESSMENT

ROOSEVELT ISLAND, NEW YORK

17 November 2014
Revised 28 December 2018
Revised 18 September 2020
Project # 100444601

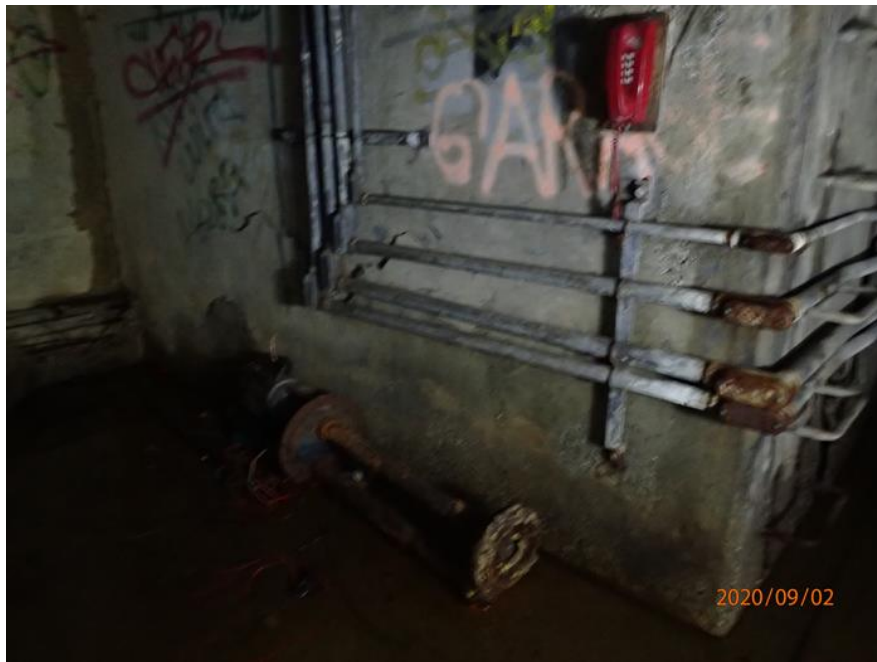
Station 17+76

Direction: Western Wall (In-Land) at Air Vent 11

Comments: Concrete Spalling

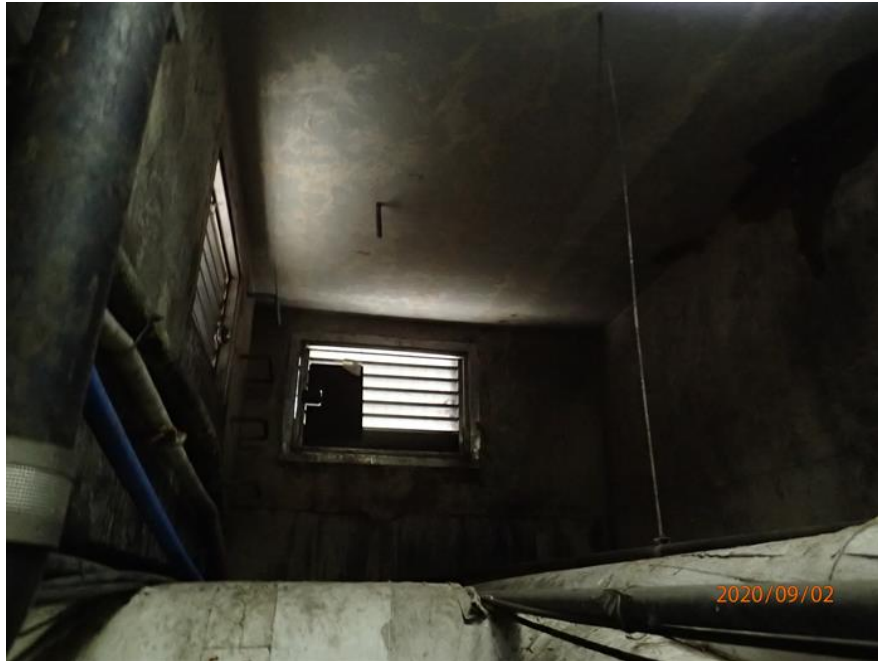
Station 17+76

Comments: Air Vent 11

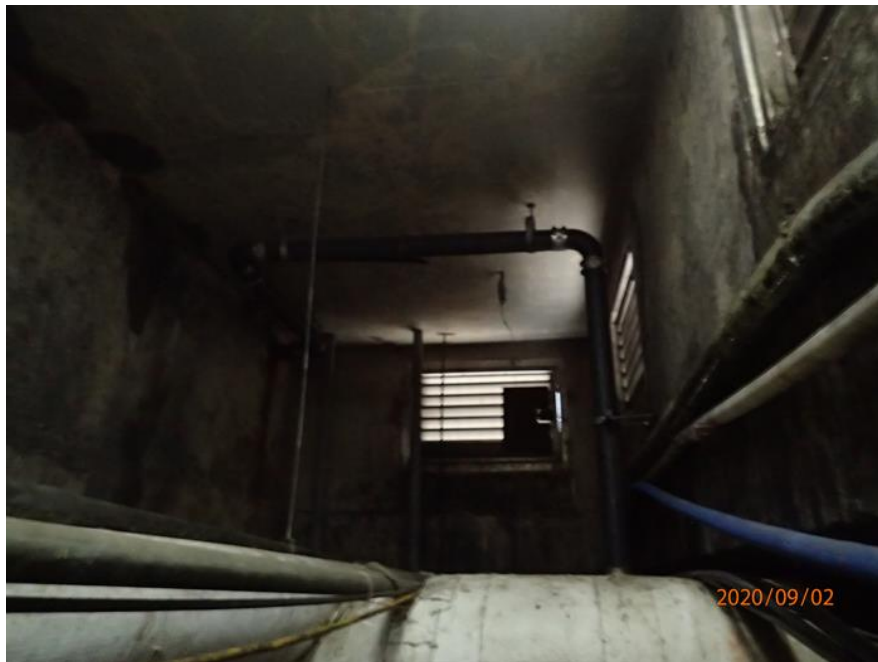
Station 17+76

Comments: Air Vent 11

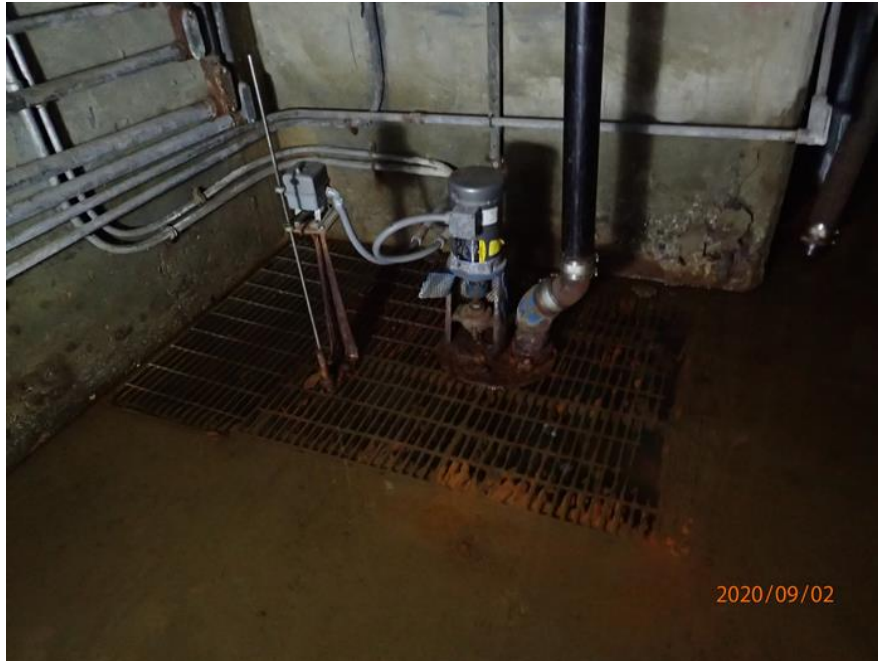
Station 17+76

Comments: Sump Pump - Not Working

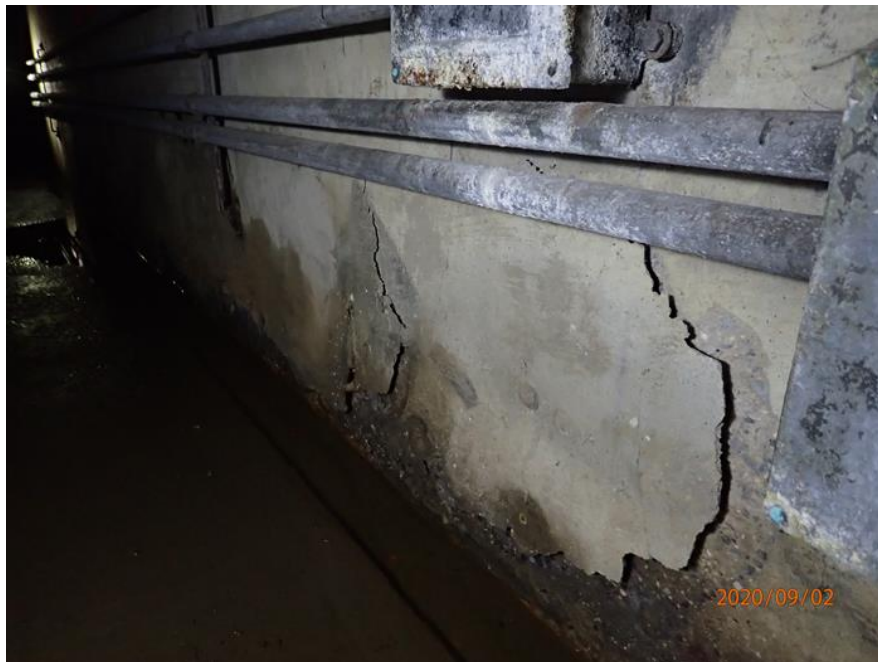
Station 17+85 to 18+10

Comments: Concrete Spalling, Re-Bar Exposed and Corroded

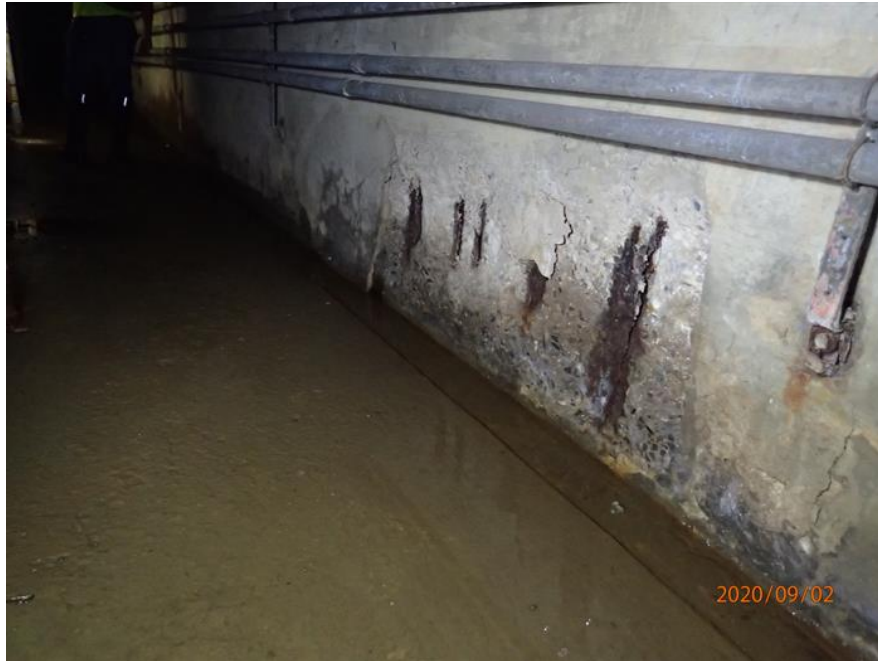
Station 17+85 to 18+10

Comments: Concrete Spalling, Re-Bar Exposed and Corroded

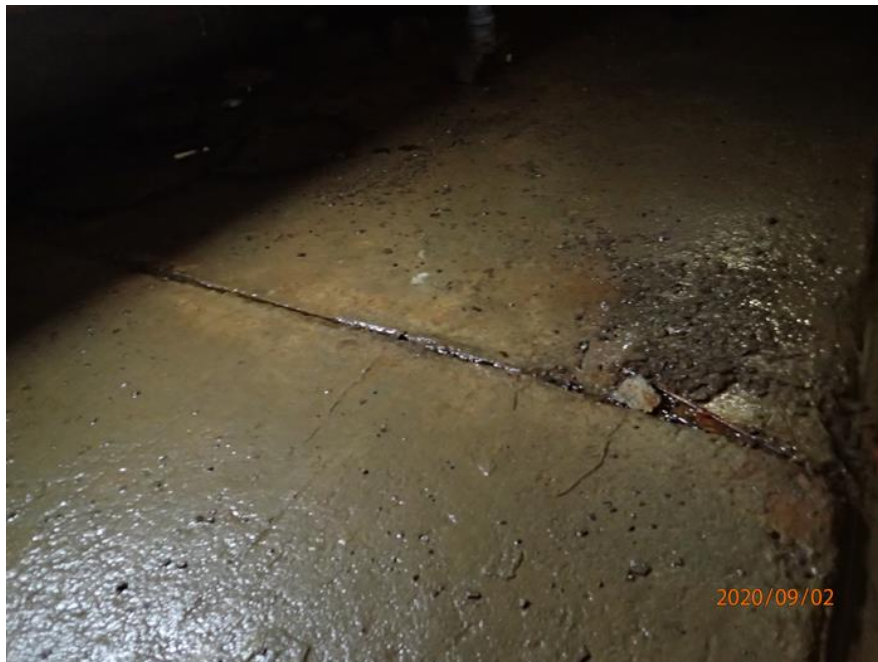
Station 18+20

Comments: Floor Slab Cracking at Joint

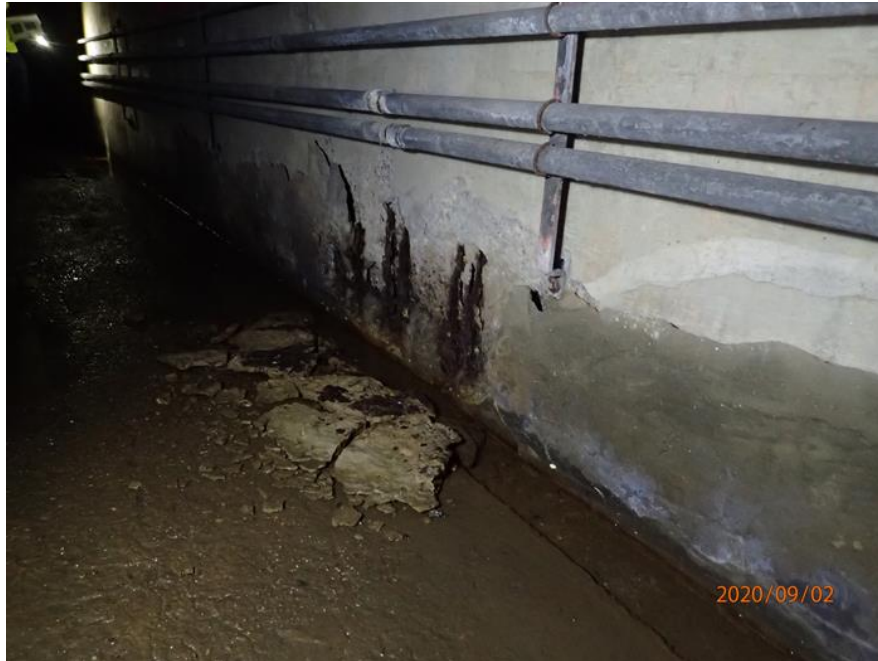
Station 18+30 to 18+50

Comments: Concrete Spalling, Loose Concrete, Re-Bar Exposed and Corroded

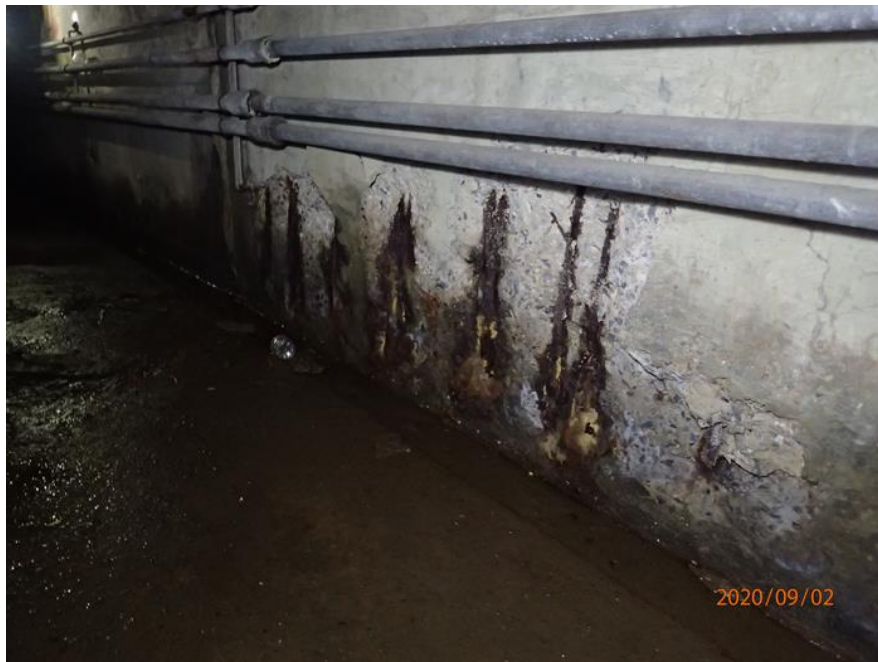
Station 18+70 to 18+75

Comments: Concrete Spalling, Loose Concrete, Re-Bar Exposed and Corroded

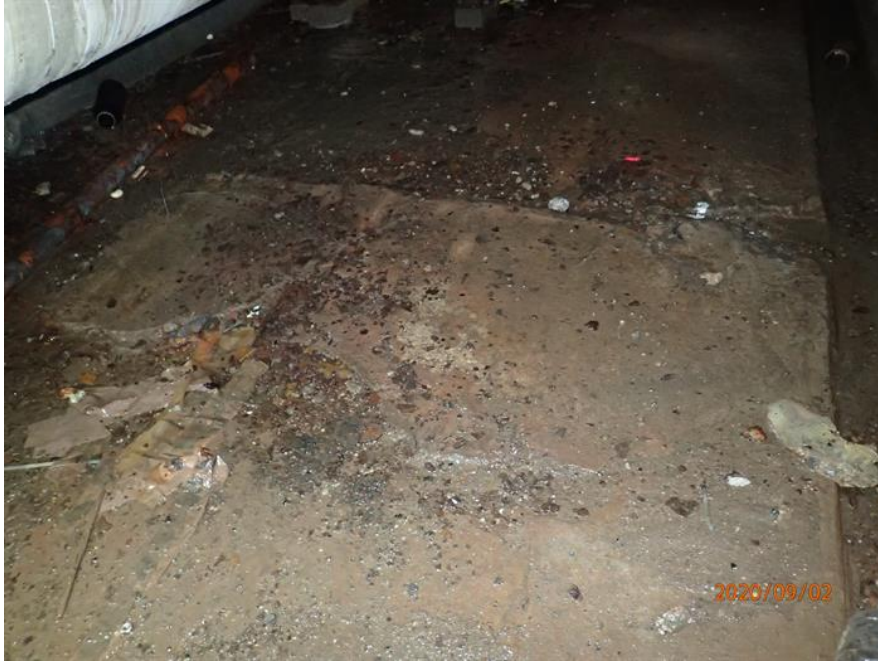
Station 18+75

Comments: Floor Slab Raised at Joint, Cracking, Loose Concrete

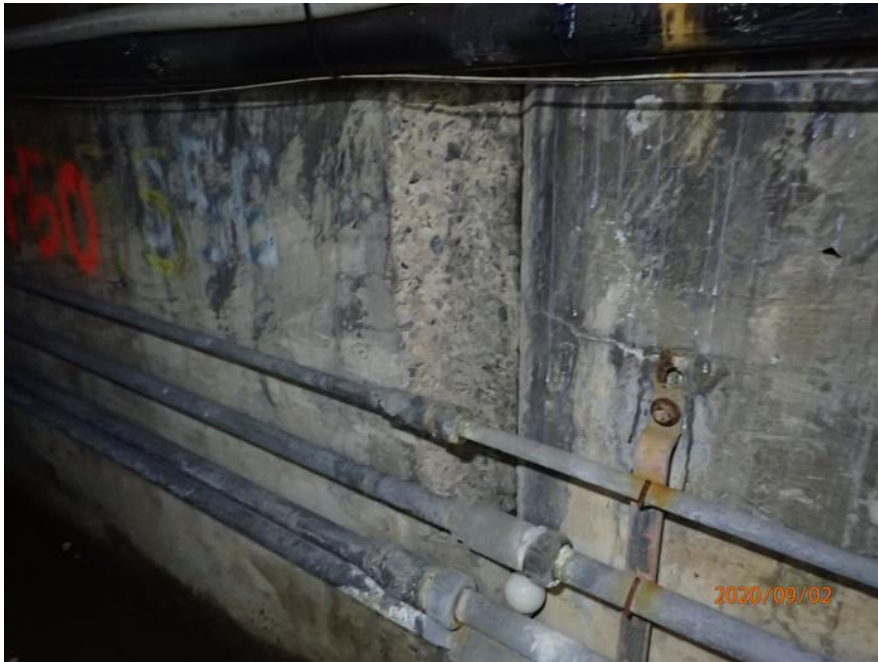
Station 19+45

Comments: Cracking at Joint, Concrete Missing

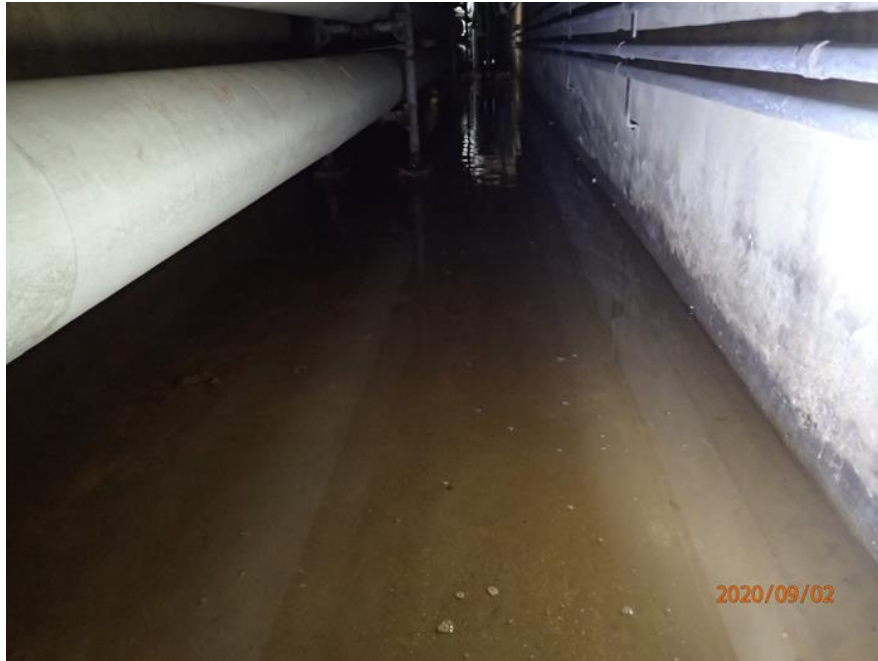
Station 19+50 to 20+00

Comments: Water Observed in the Tunnel

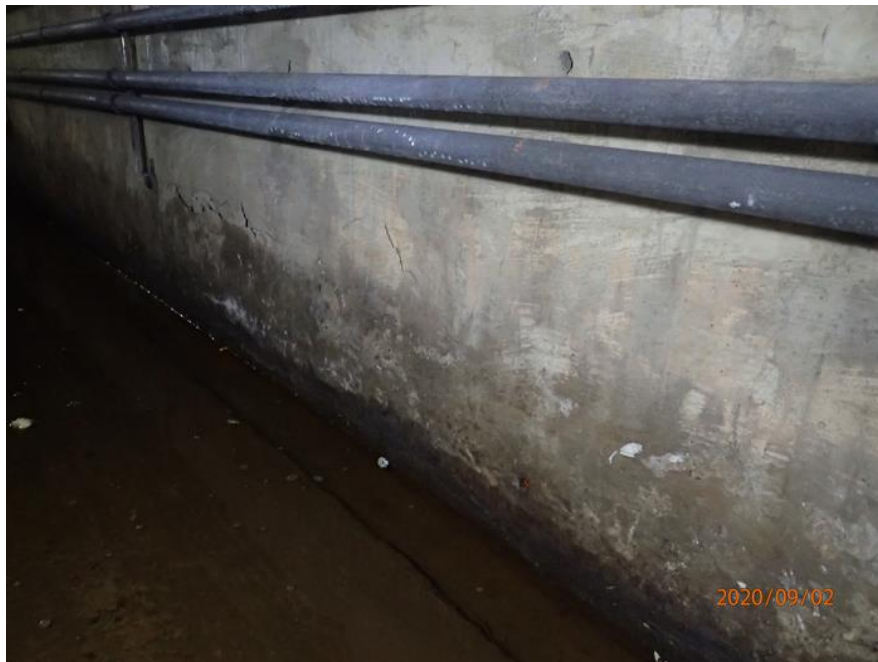
Station 19+60 to 19+70

Comments: Concrete Spalling

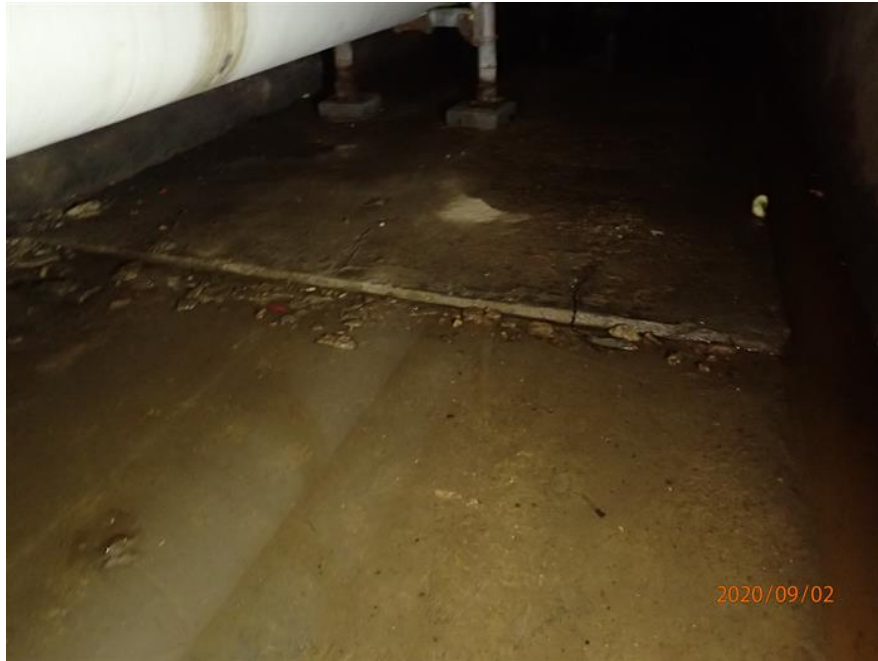
Station 20+10

Comments: Floor Slab Raised at Joint, Cracking, Loose Concrete

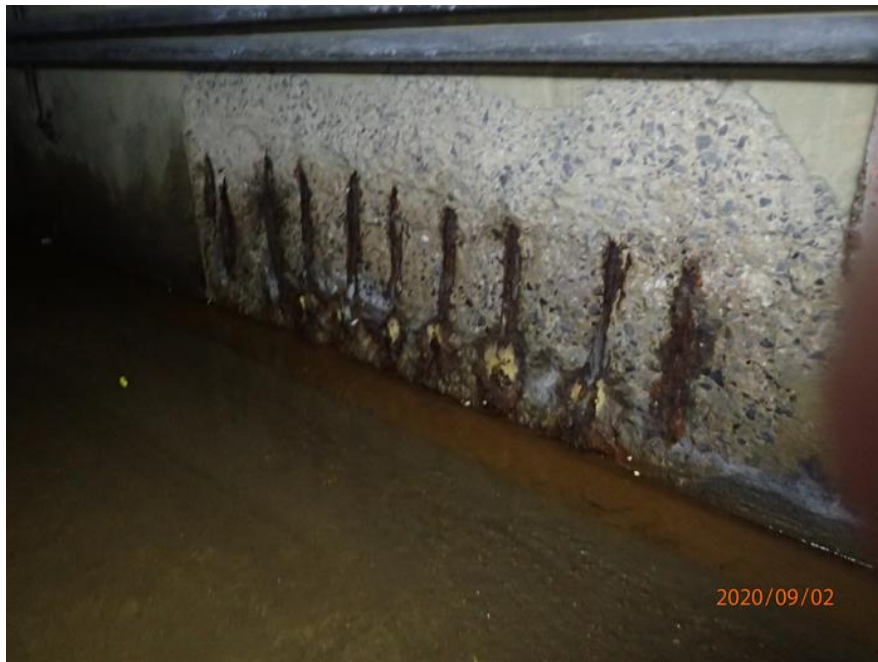
Station 20+15 to 20+22

Comments: Concrete Spalling, Re-Bar Exposed

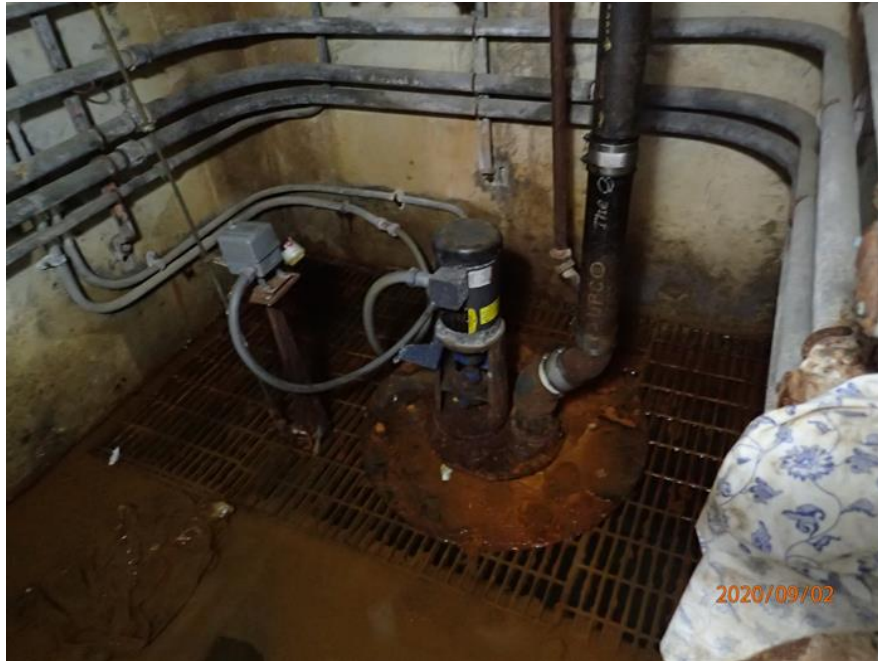
Station 20+30

Comments: Sump Pump - Not Working

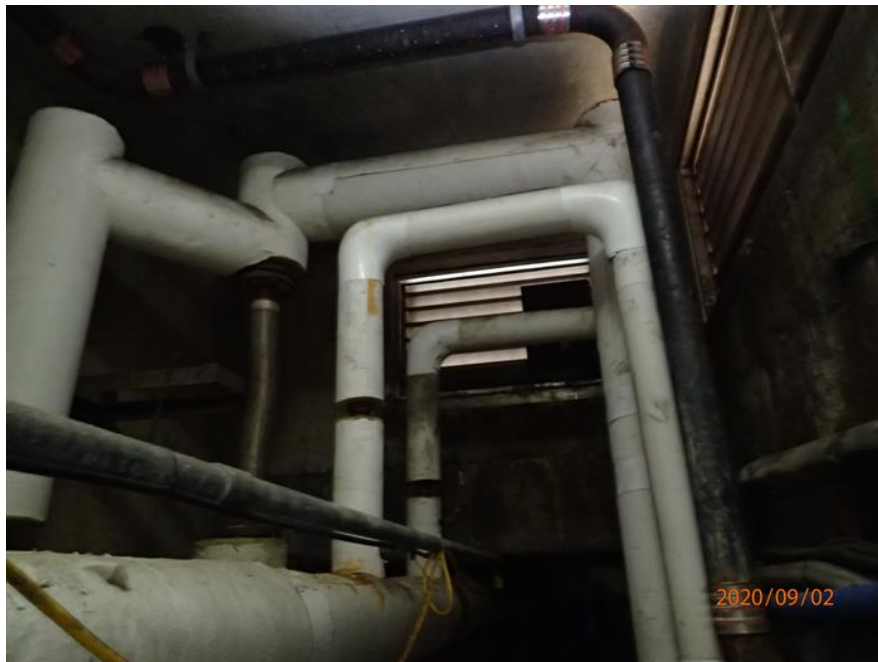
Station 20+30

Comments: Air Vent 10

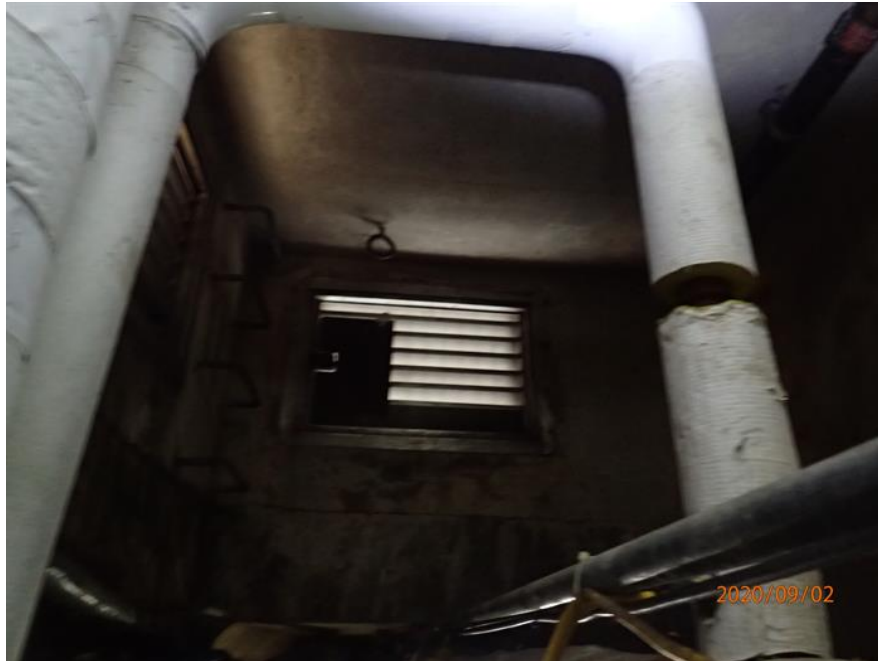
Station 20+30

Comments: Air Vent 10

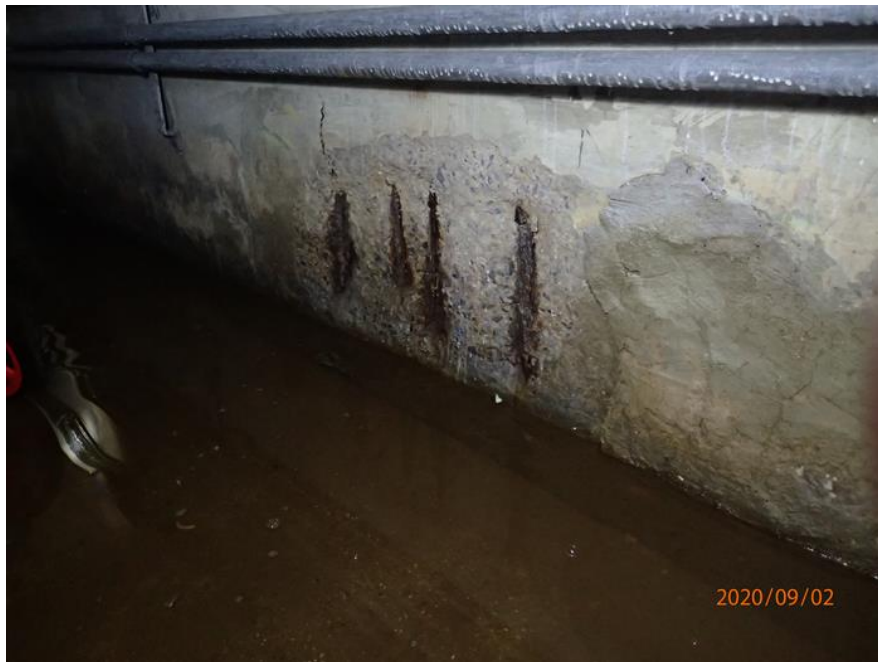
Station 20+74 to 20+80

Comments: Concrete Spalling, Re-Bar Exposed

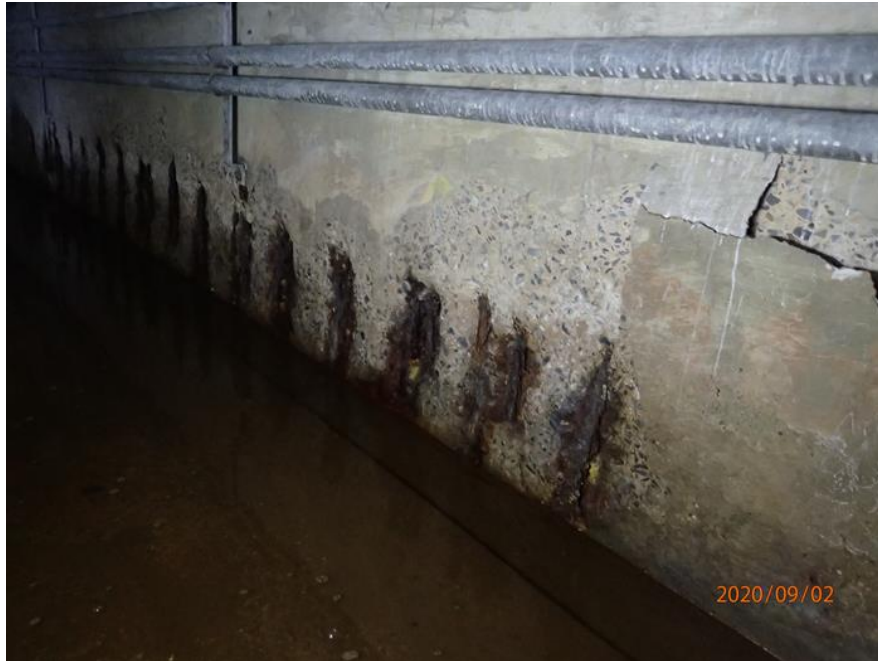
Station 20+90 to 21+30

Comments: Concrete Spalling, Re-Bar Exposed and Corroded

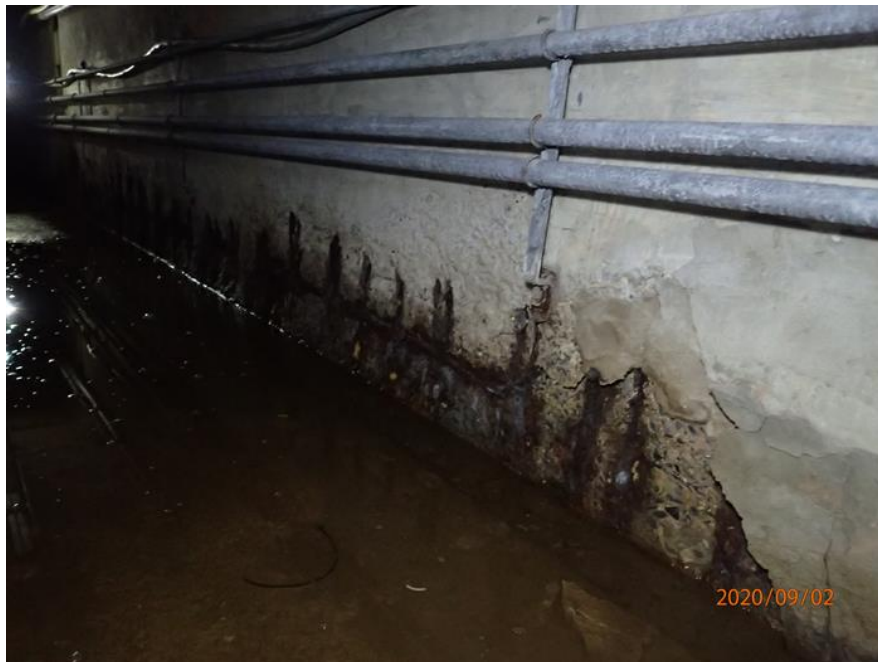
Station 20+90 to 21+30

Comments: Concrete Spalling, Re-Bar Exposed and Corroded

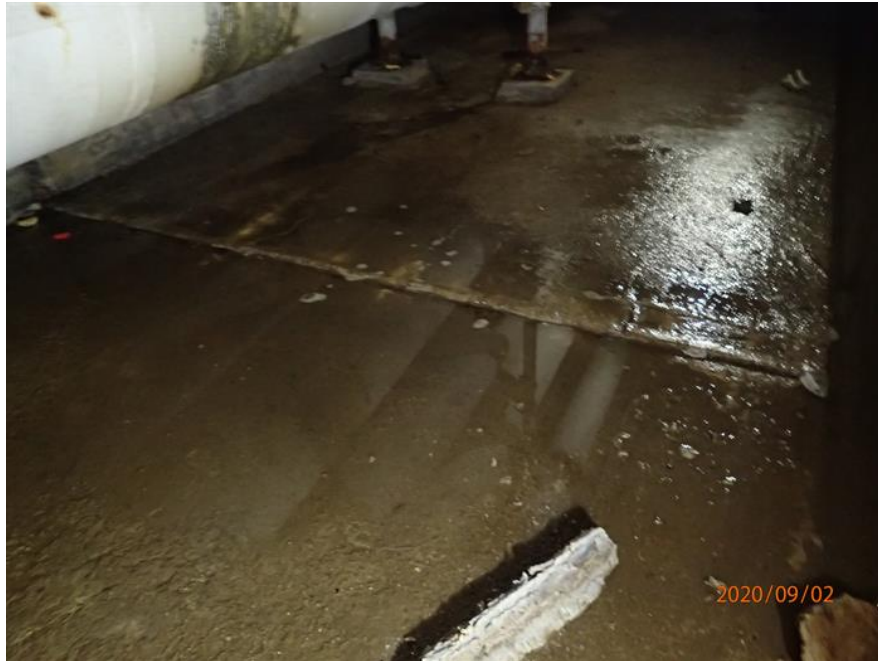
Station 21+20

Comments: Floor Slab Raised at Joint, Cracking

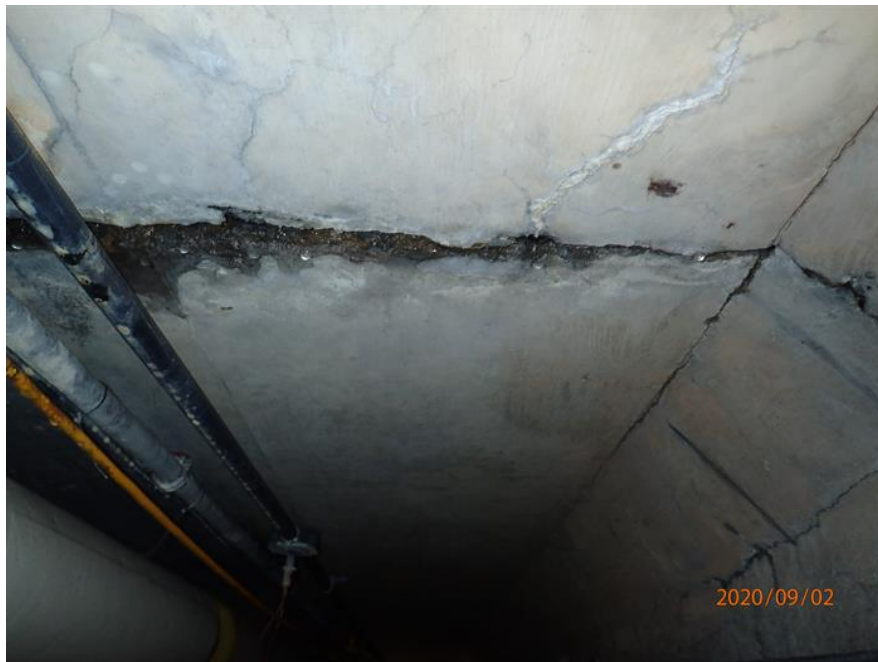
Station 21+20

Comments: Cracking at Joint, Concrete Spalling

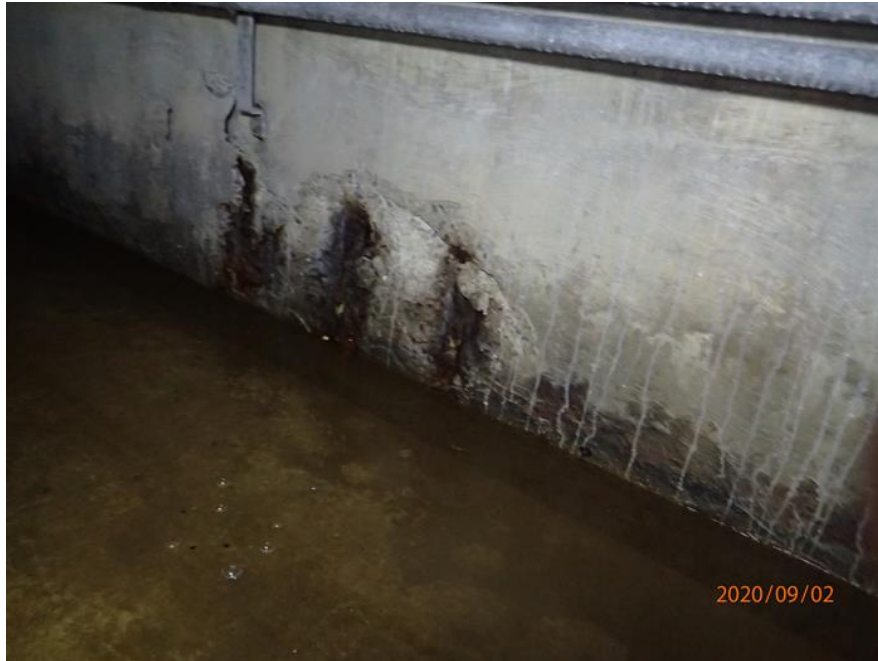
Station 21+68 to 21+75

Comments: Concrete Spalling, Re-Bar Exposed

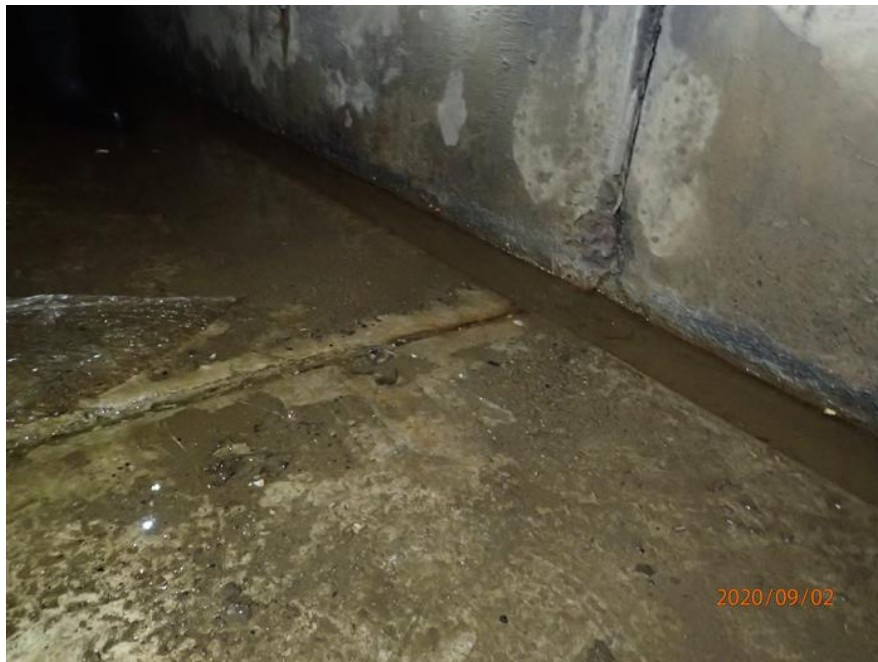
Station 22+60

Comments: Floor Slab Raised at Joint, Cracking, Loose Concrete

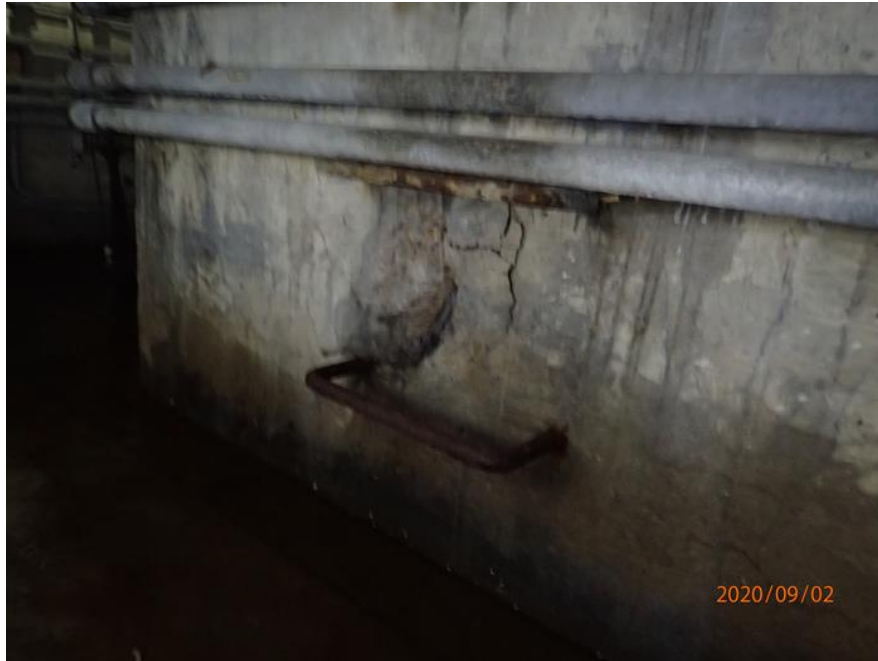
Station 22+70

Comments: Concrete Spalling, Re-Bar Exposed

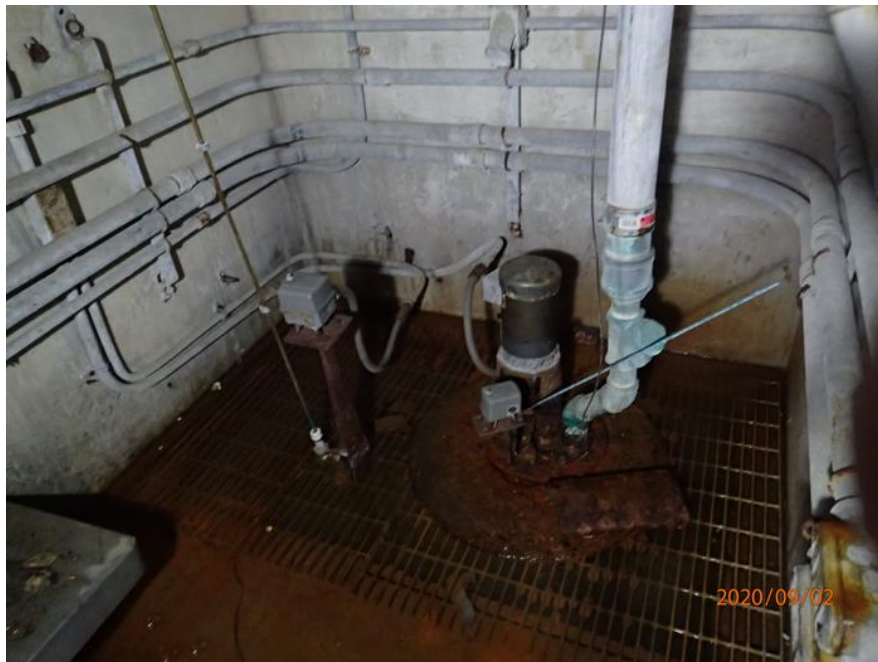
Station 22+84

Comments: Sump Pump - Not Working

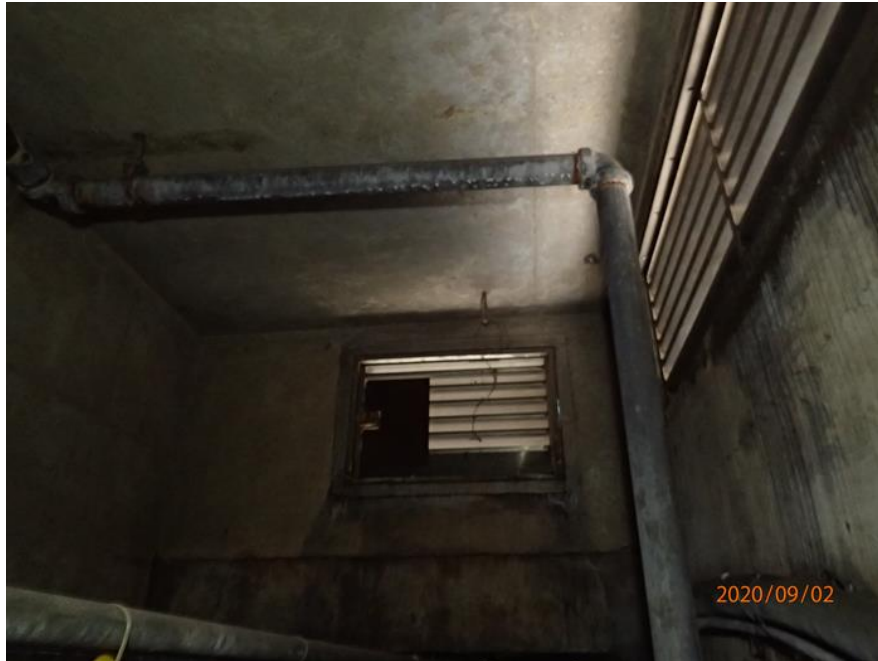
Station 22+84

Comments: Air Vent 9

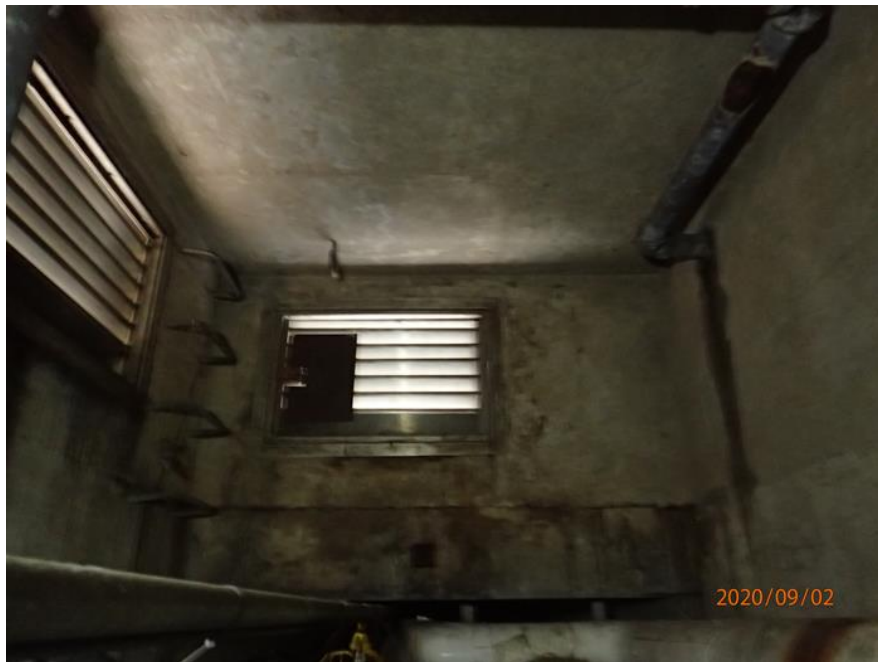
Station 22+84

Comments: Air Vent 9

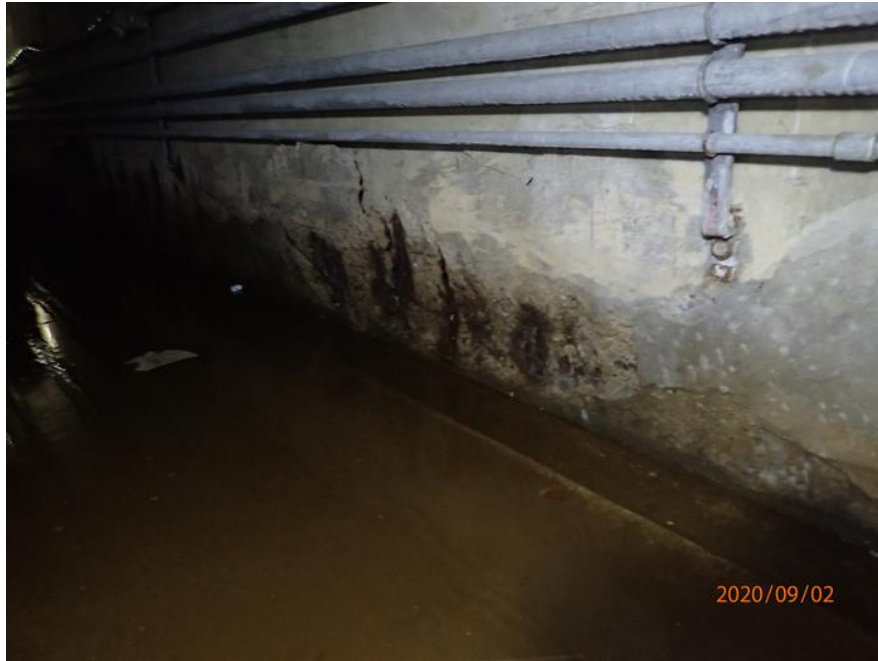
Station 23+45 to 23+65

Comments: Concrete Spalling, Re-Bar Exposed and Corroded, Loose Concrete

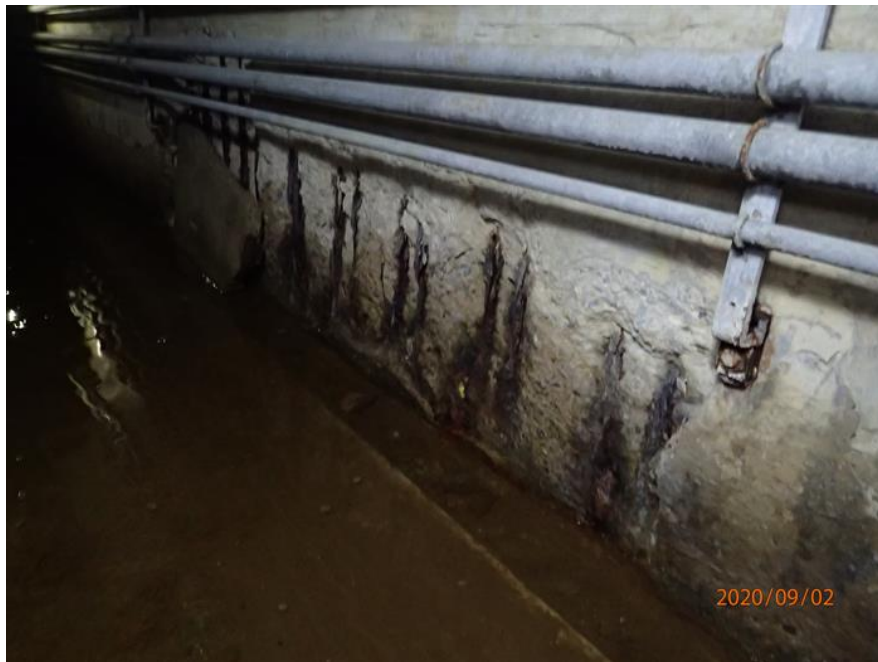
Station 23+45 to 23+65

Comments: Concrete Spalling, Re-Bar Exposed and Corroded, Loose Concrete

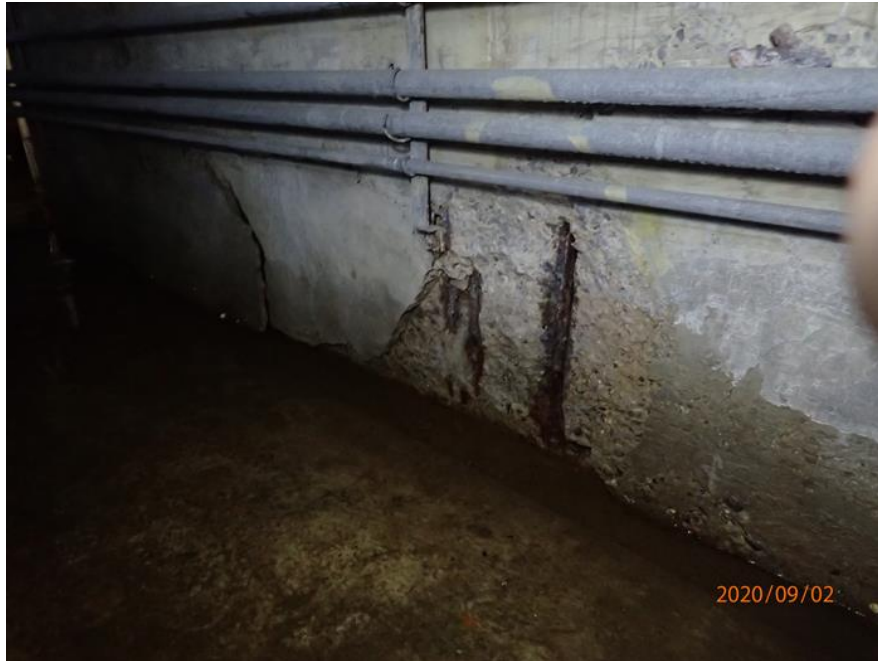
Station 23+90 to 24+00

Comments: Concrete Spalling, Re-Bar Exposed and Corroded, Loose Concrete

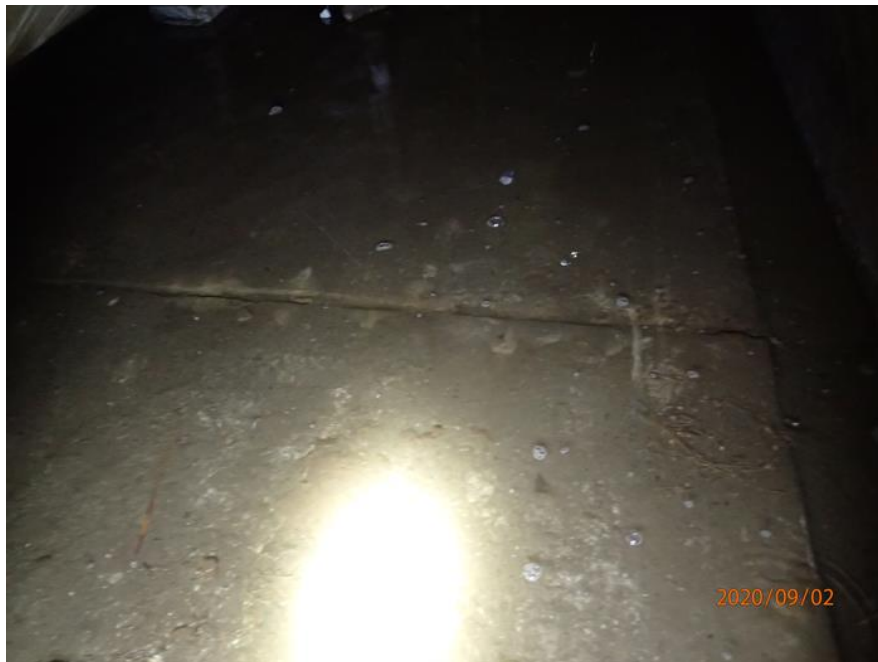
Station 25+10

Comments: Floor Slab Raised at Joint. Joint Leaking.

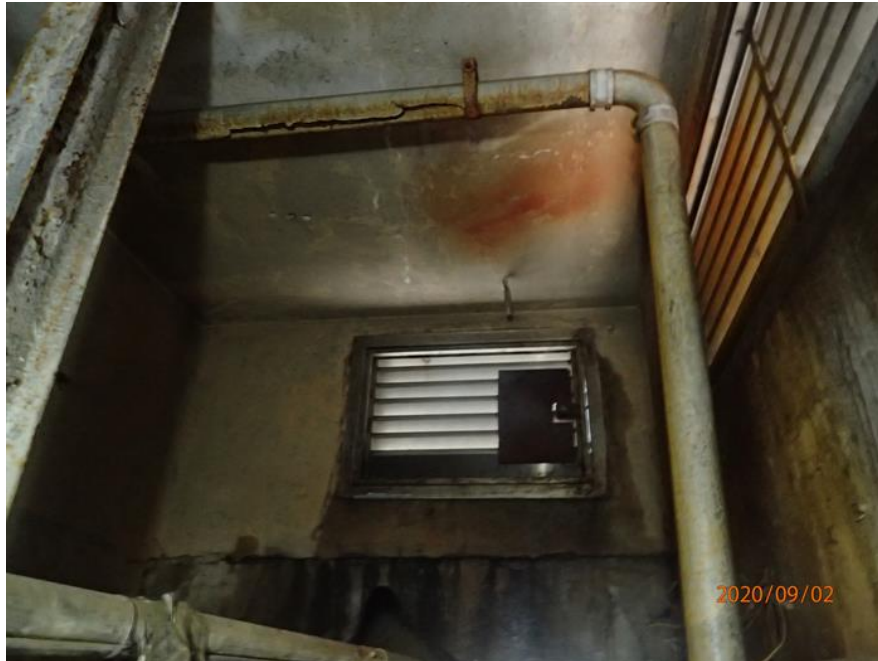
Station 25+38

Comments: Air Vent 8

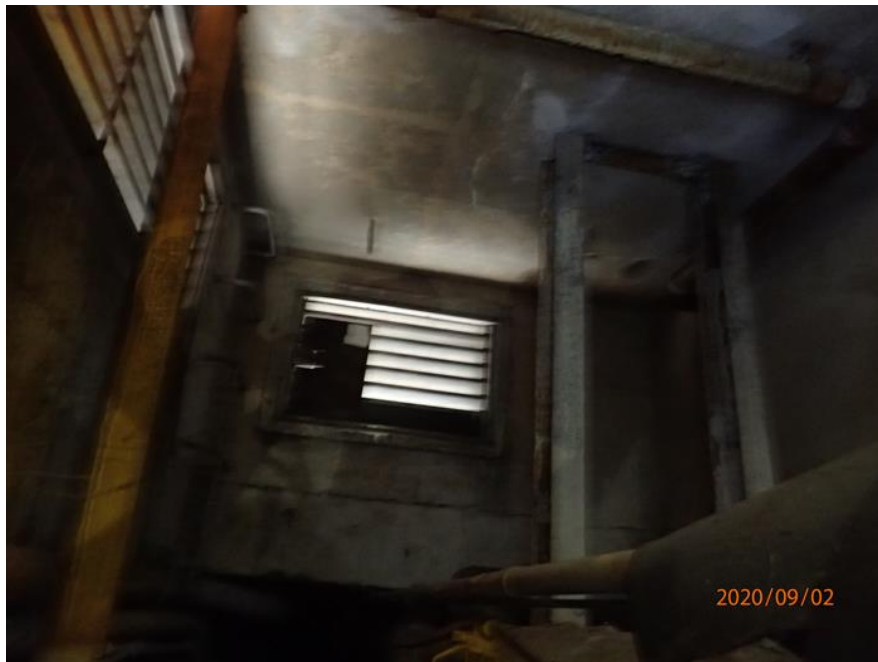
Station 25+38

Comments: Air Vent 8

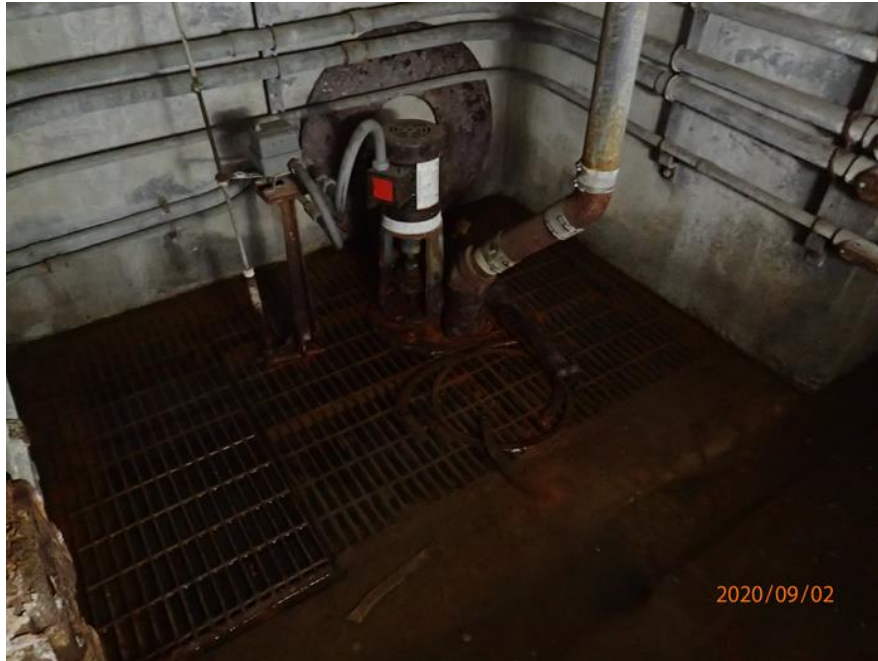
Station 25+38

Comments: Sump Pump

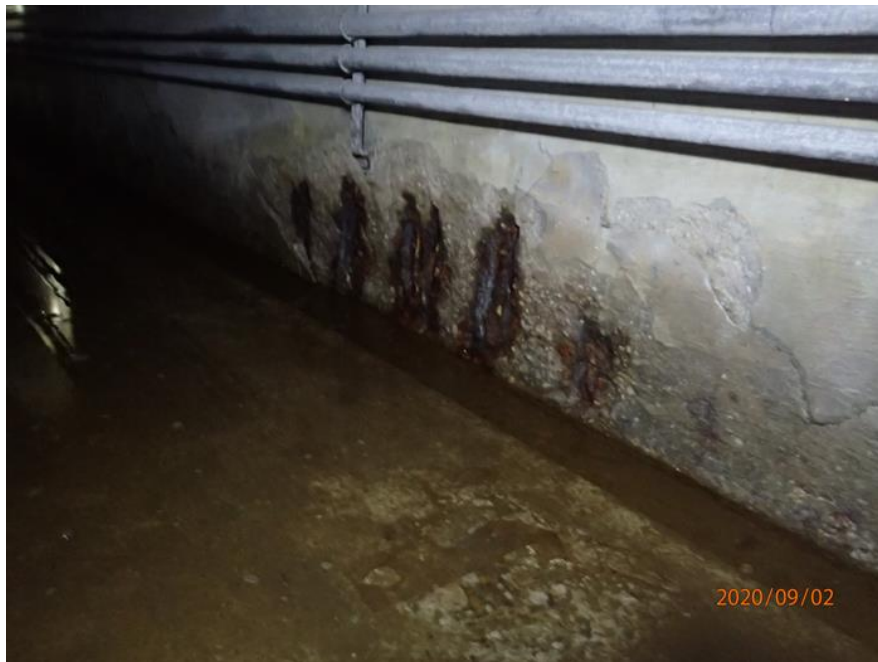
Station 26+00 to 26+20

Comments: Concrete Spalling, Re-Bar Exposed and Corroded

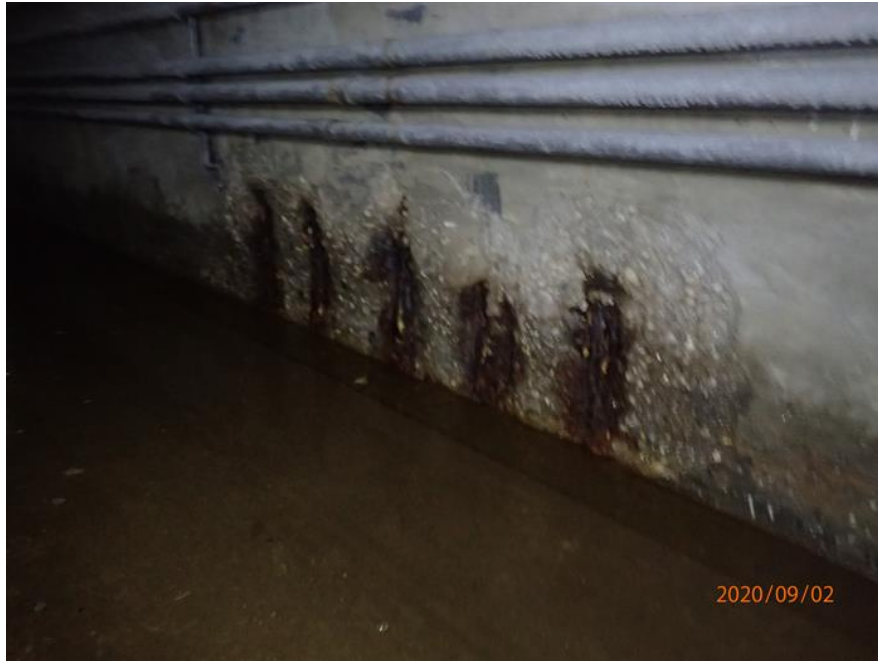
Station 26+50 to 26+60

Comments: Concrete Spalling, Re-Bar Exposed and Corroded

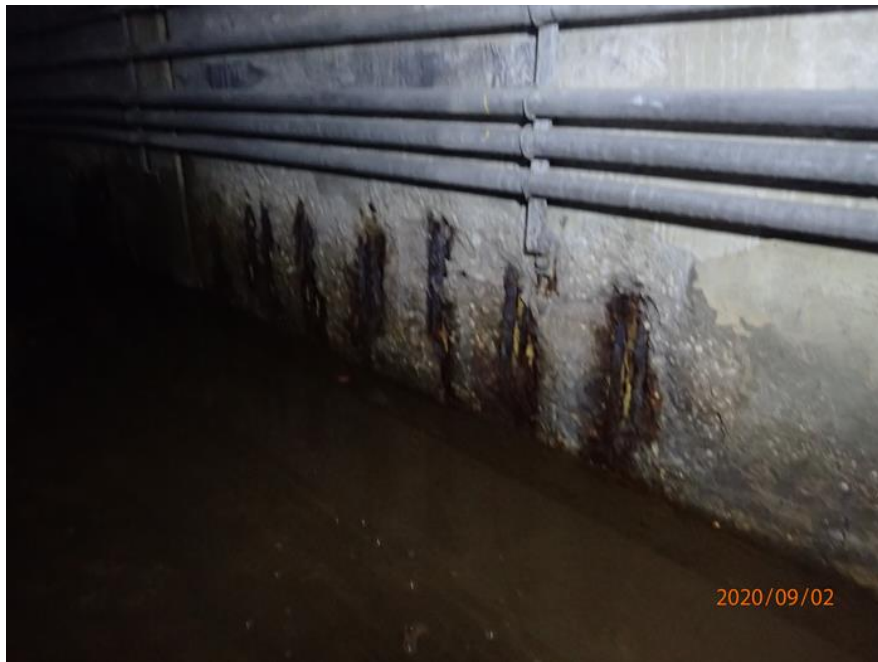
Station 26+90 to 27+25

Comments: Concrete Spalling, Re-Bar Exposed and Corroded
