CONDITIONS REPORT & CONCEPTUAL DESIGN MEMORANDUM

STEAM TUNNEL ASSESSMENT

ROOSEVELT ISLAND, NEW YORK

17 November 2014
Revised 28 December 2018
Revised 18 September 2020
Project # 100444601

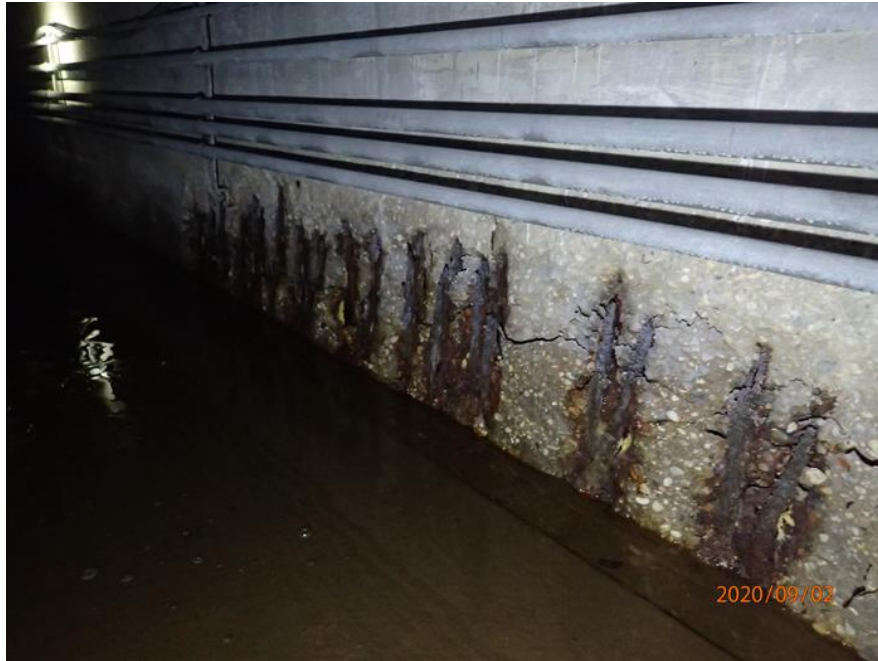
Station 26+90 to 27+25

Comments: Concrete Spalling, Re-Bar Exposed and Corroded

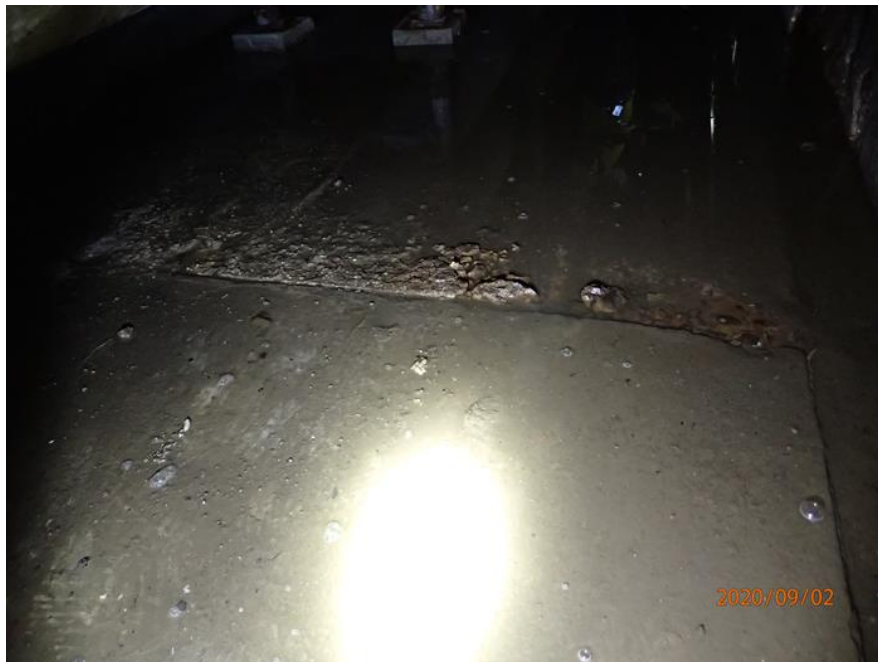
Station 27+05

Comments: Floor Slab Raised at Joint, Cracking

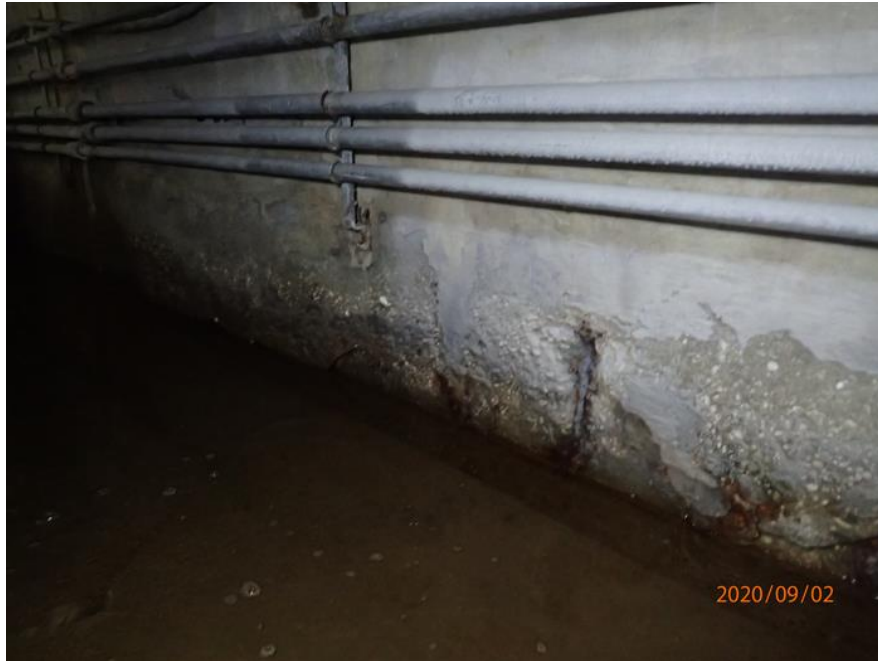
Station 27+50 to 27+70

Direction: Western Wall (In-Land)

Comments: Concrete Spalling, Re-Bar Exposed and Corroded

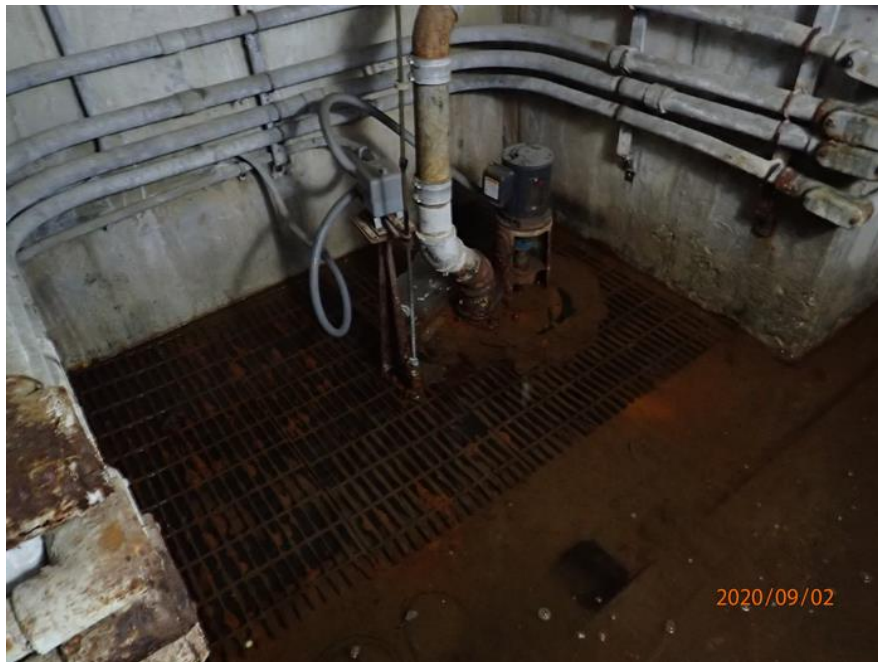
Station 27+92

Direction: Tunnel Floor at Air Vent 7

Comments: Sump Pump - Not Working

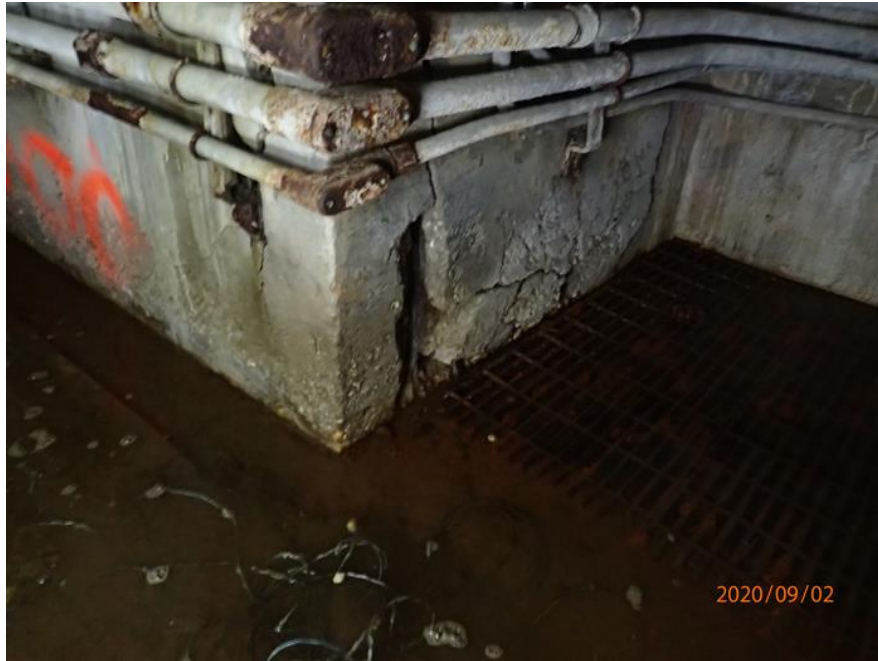
Station 27+92

Direction: Western Wall (In-Land) at Air Vent 7

Comments: Concrete Spalling, Re-Bar Exposed and Corroded

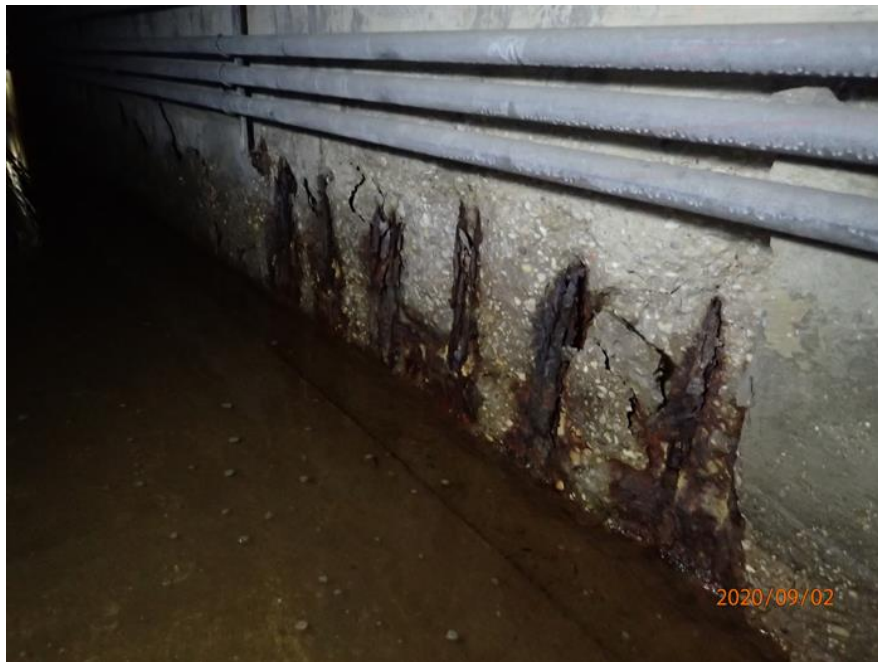
Station 28+00 to 30+00

Direction: Western Wall (In-Land)

Comments: Concrete Spalling, Re-Bar Exposed and Corroded

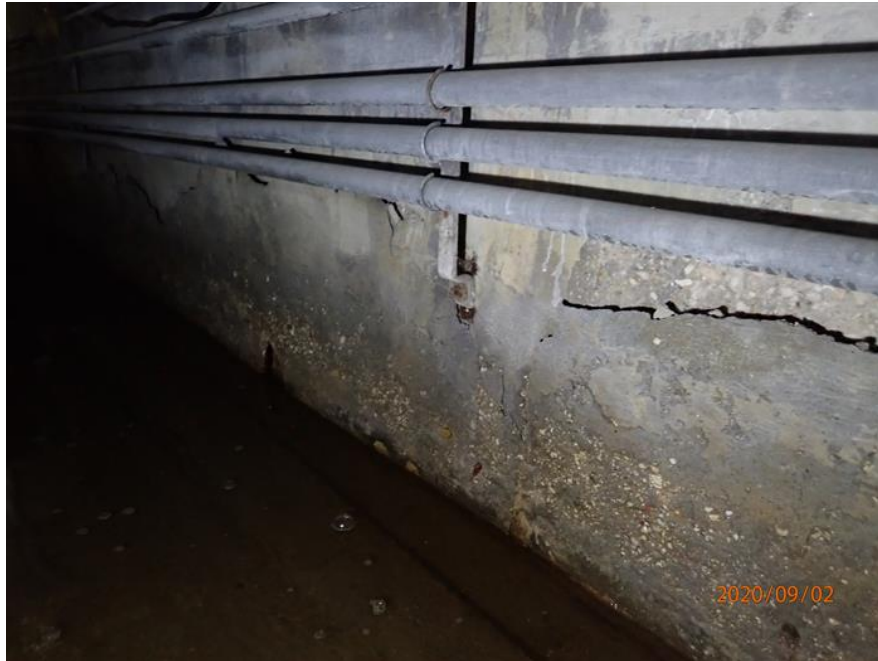
Station 28+00 to 30+00

Direction: Western Wall (In-Land)

Comments: Concrete Spalling and Bowing of Wall, Re-Bar Exposed and Corroded

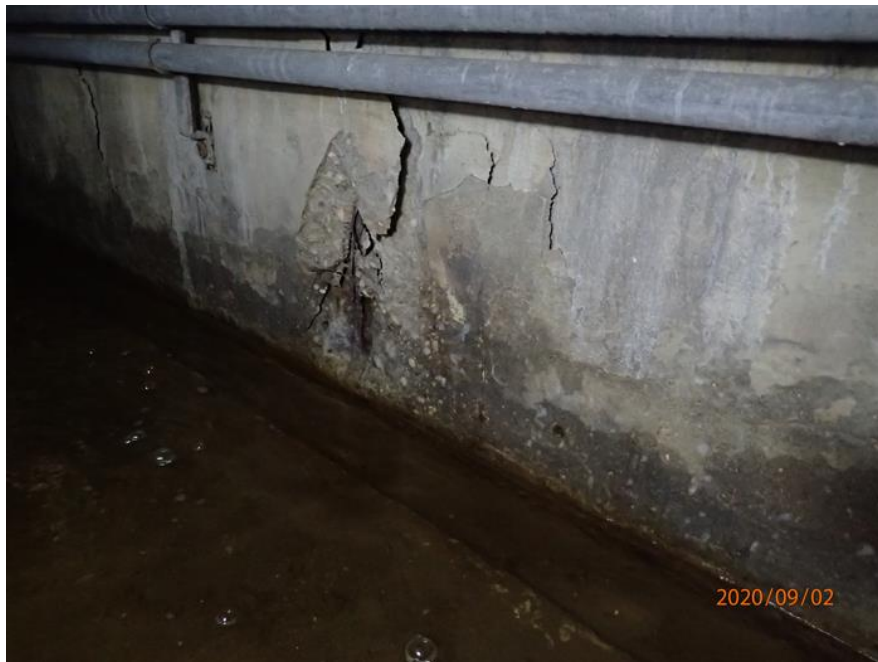
Station 28+00 to 30+00

Direction: Western Wall (In-Land)

Comments: Concrete Spalling, Re-Bar Exposed and Corroded

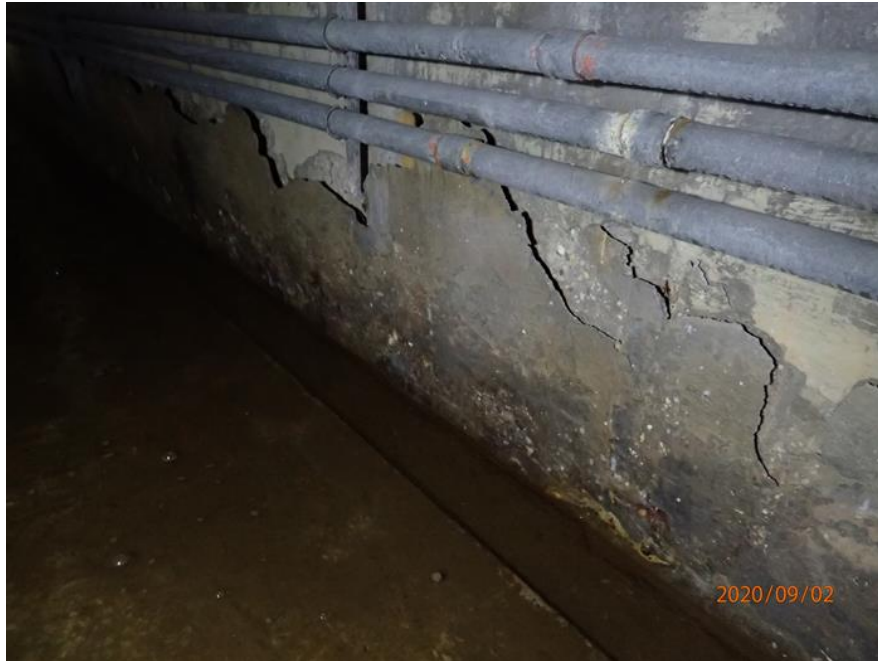
Station 28+00 to 30+00

Direction: Western Wall (In-Land)

Comments: Concrete Spalling, Re-Bar Exposed and Corroded

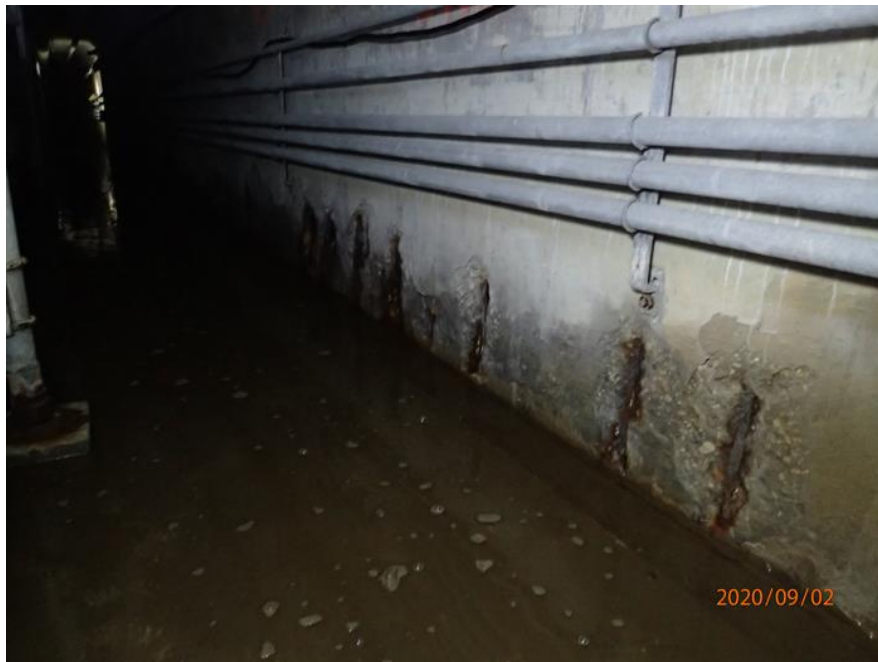
Station 28+00 to 30+00

Direction: Western Wall (In-Land)

Comments: Spalling, Re-Bar Exposed and Corroded, Loose Concrete

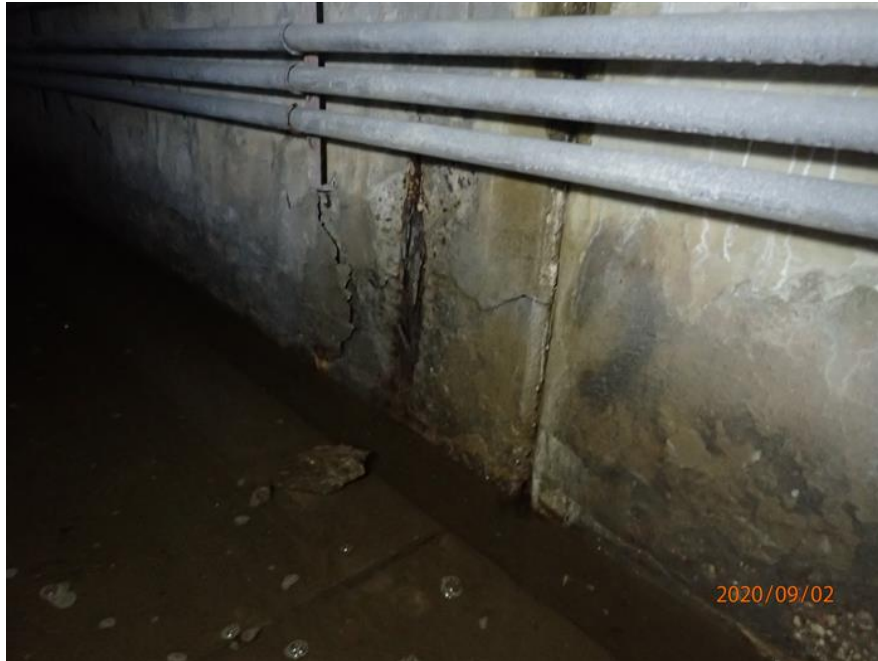
Station 28+00 to 30+00

Direction: Western Wall (In-Land)

Comments: Concrete Spalling, Re-Bar Exposed and Corroded

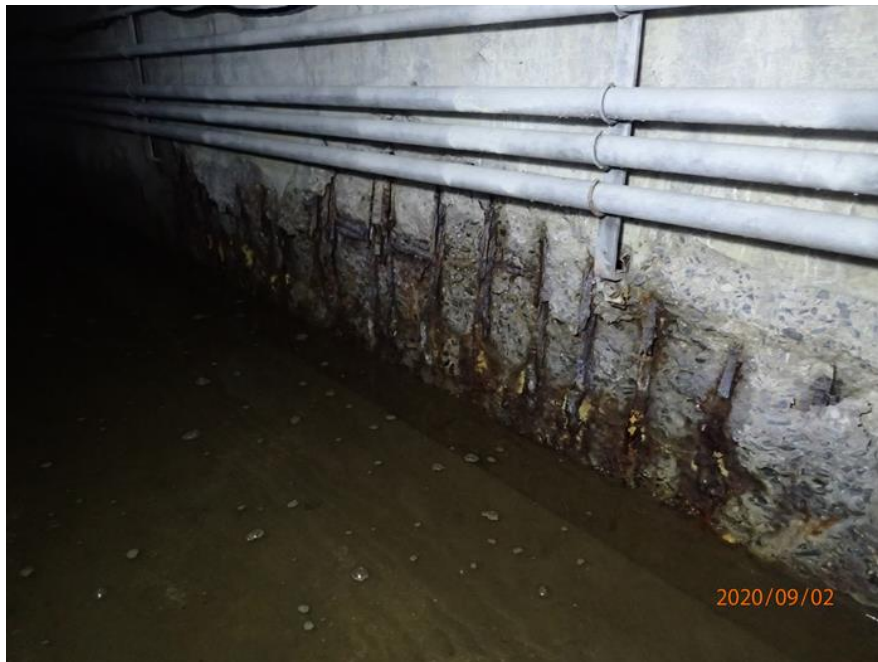
Station 28+00 to 30+00

Direction: Western Wall (In-Land)

Comments: Spalling, Re-Bar Exposed and Corroded, Loose Concrete

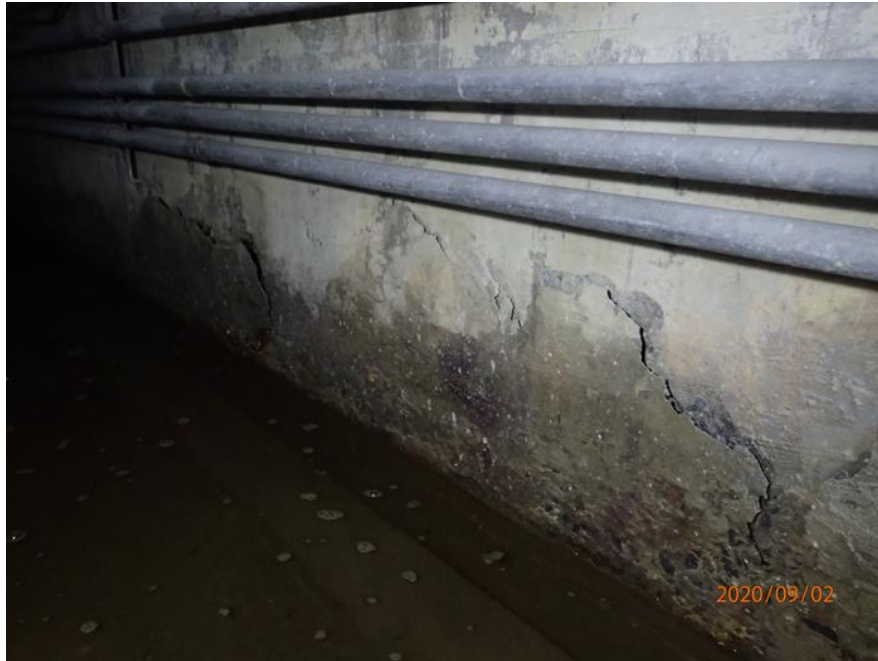
Station 28+00 to 30+00

Direction: Western Wall (In-Land)

Comments: Concrete Spalling, Re-Bar Exposed and Corroded

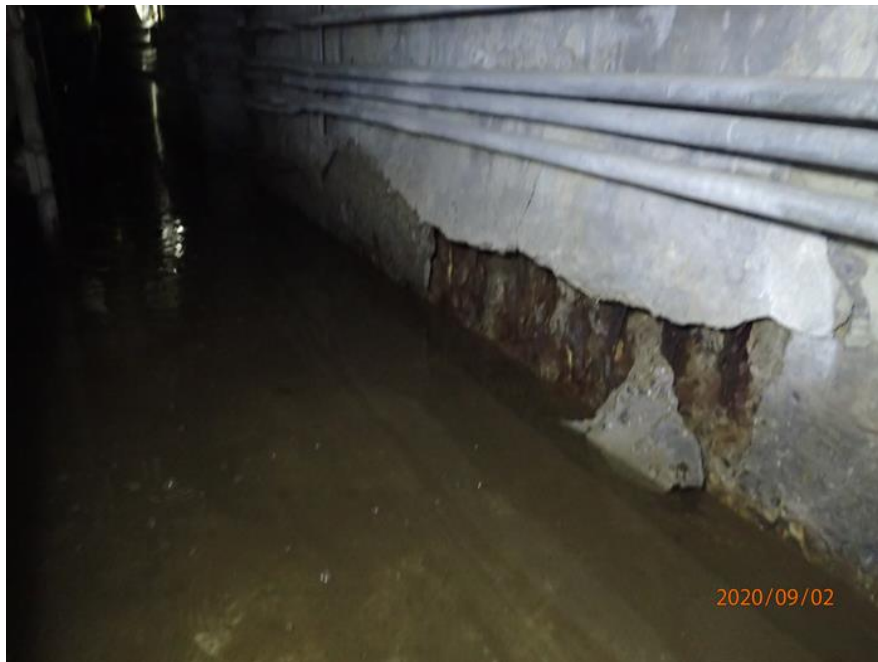
Station 30+30 to 30+40

Direction: Western Wall (In-Land)

Comments: Concrete Spalling and Bowing of Wall, Re-Bar Exposed and Corroded

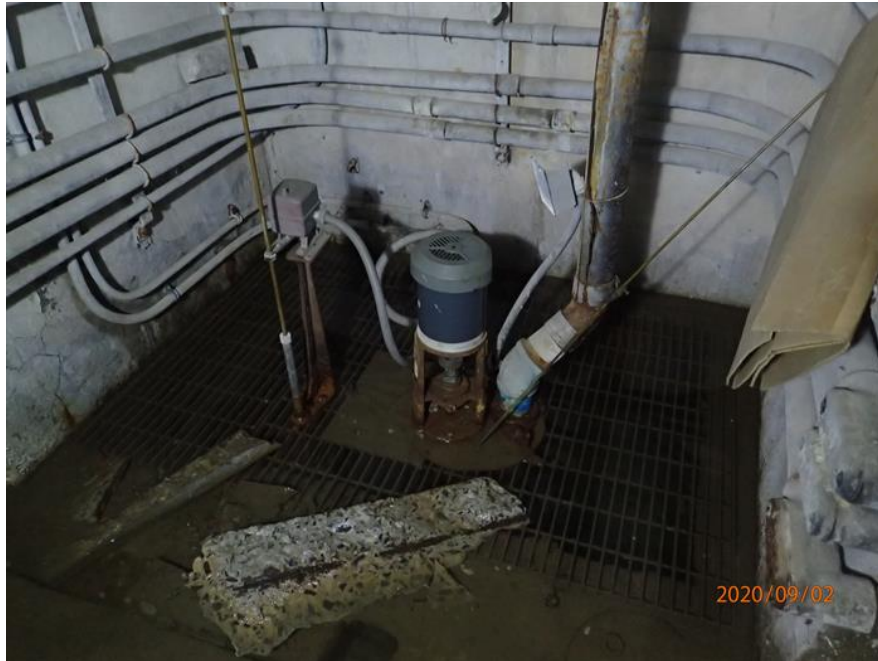
Station 30+46

Direction: Tunnel Floor at Air Vent 6

Comments: Sump Pump - Not Working

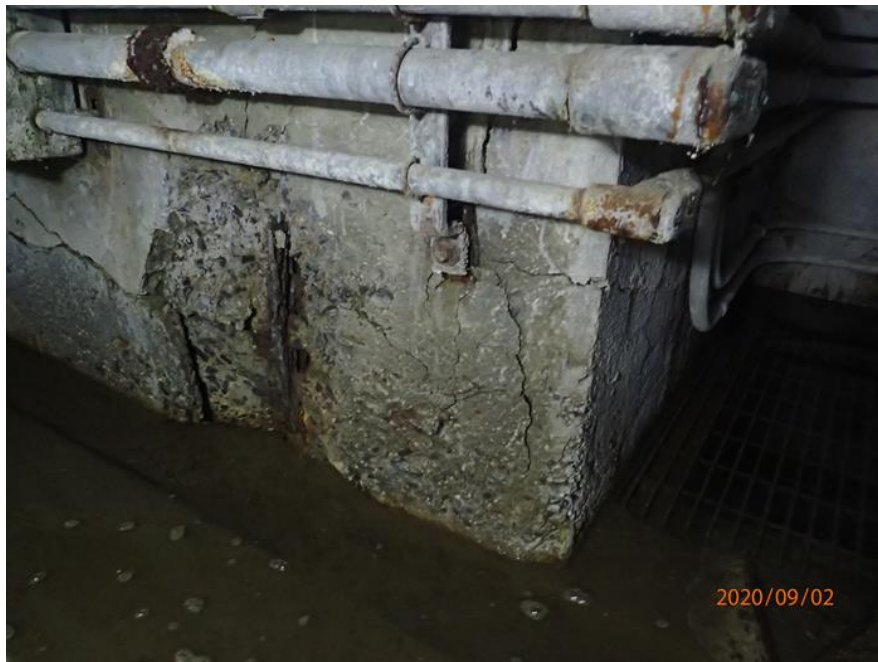
Station 30+46 to 30+65

Direction: Western Wall (In-Land)

Comments: Concrete Spalling, Re-Bar Exposed and Corroded

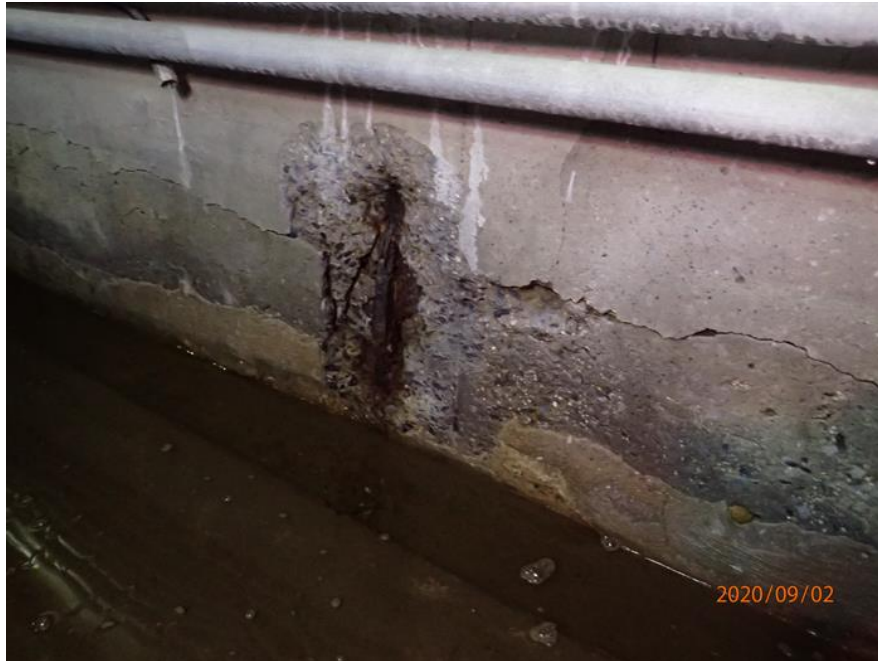
Station 30+46 to 30+65

Direction: Western Wall (In-Land)

Comments: Concrete Spalling, Re-Bar Exposed and Corroded

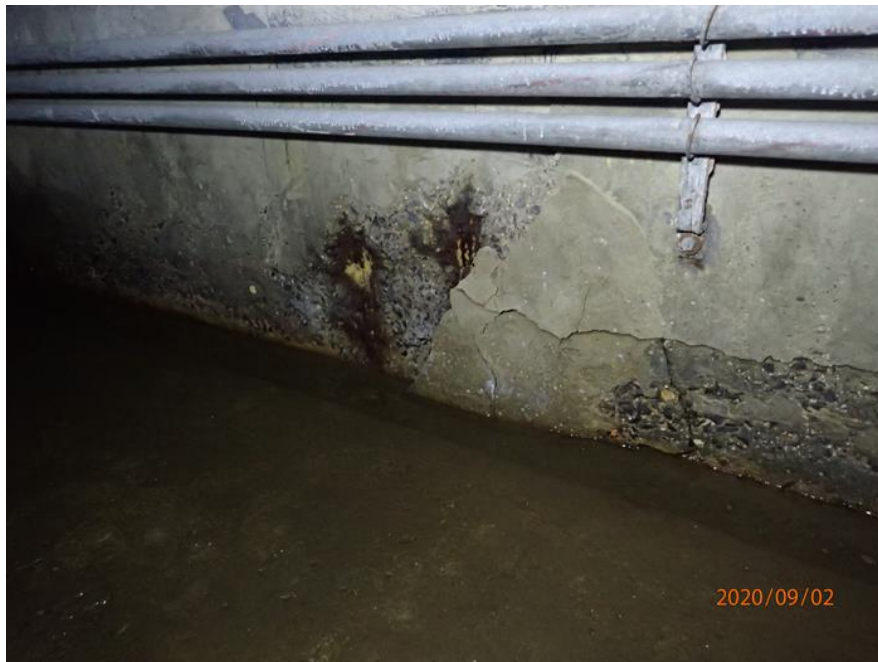
Station 30+80 to 30+85

Direction: Western Wall (In-Land)

Comments: Concrete Spalling, Re-Bar Exposed and Corroded, Loose Concrete

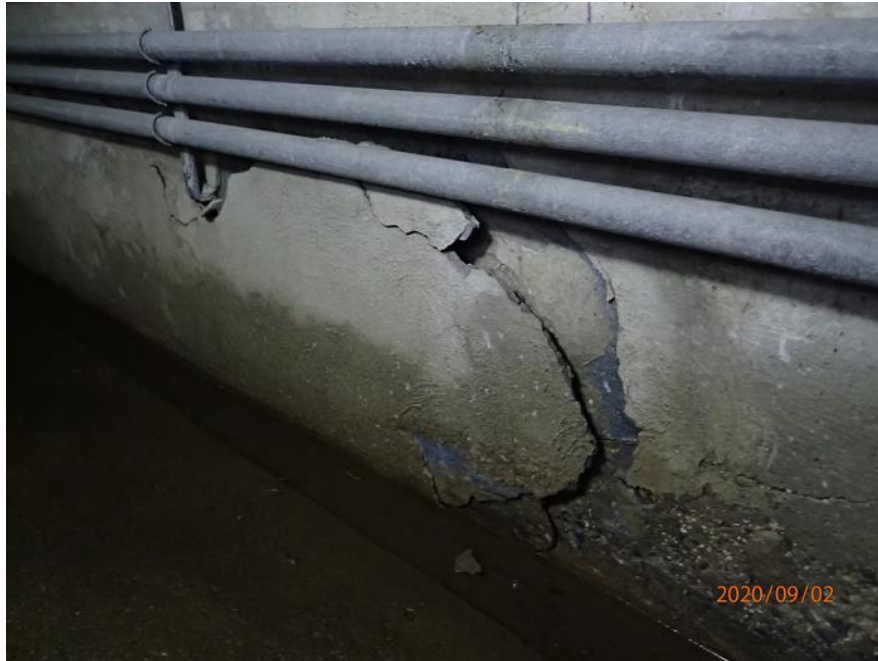
Station 30+95

Direction: Western Wall (In-Land)

Comments: Concrete Spalling, Loose Concrete

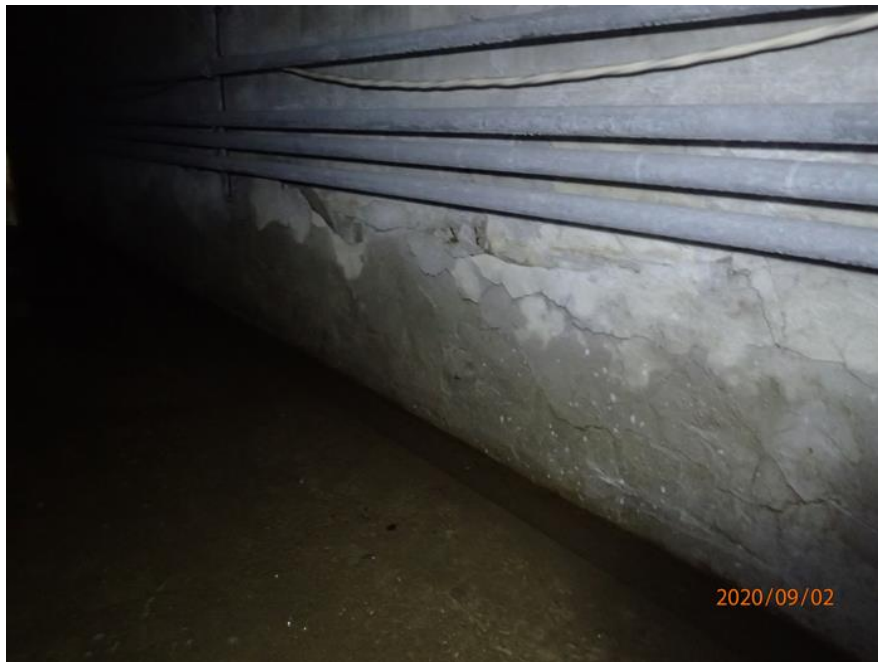
Station 31+10 to 31+50

Direction: Western Wall (In-Land)

Comments: Concrete Spalling

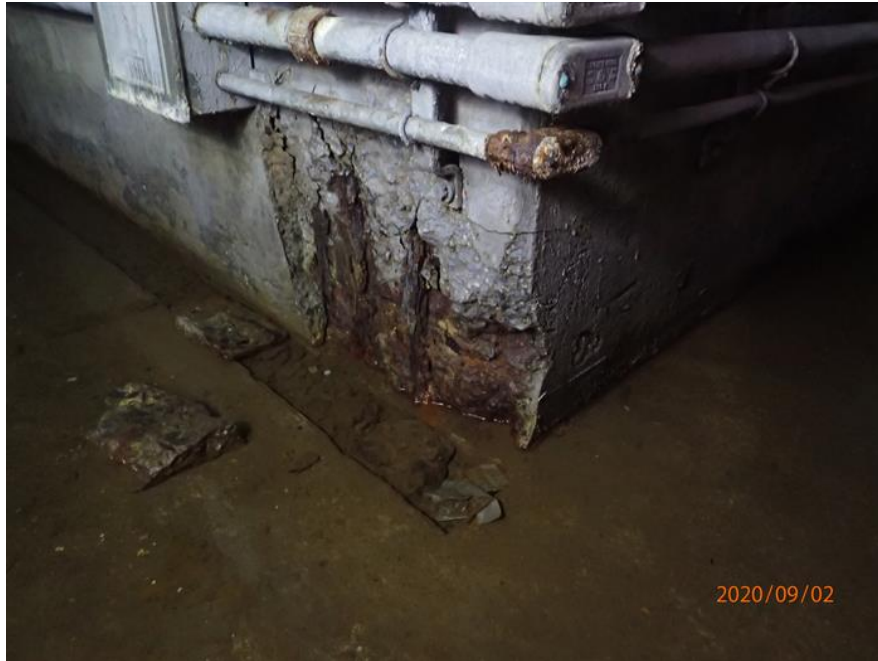
Station 31+85

Direction: Western Wall (In-Land)

Comments: Concrete Spalling, Re-Bar Exposed and Corroded

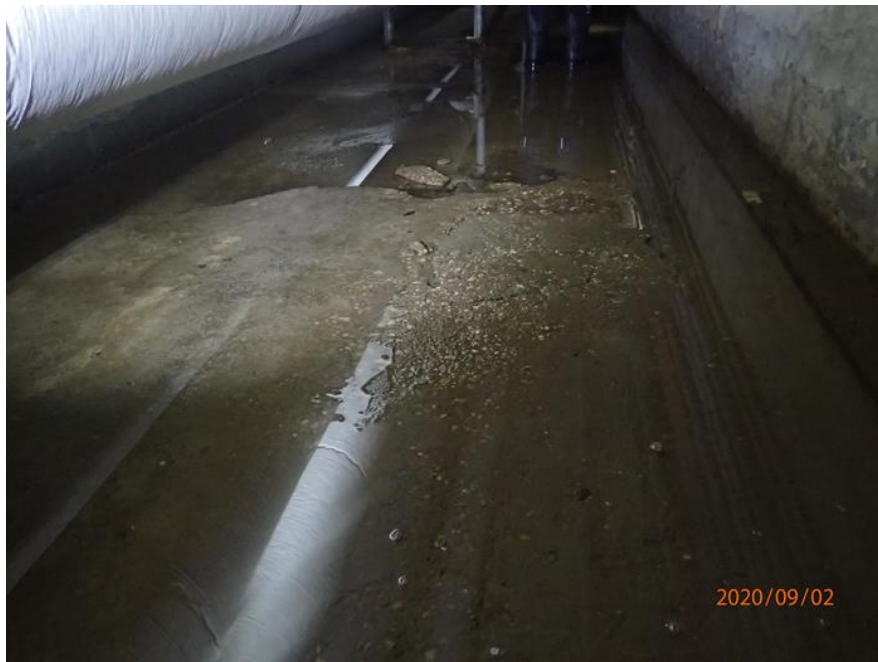
Station 31+95

Direction: Tunnel Floor

Comments: Floor Slab Cracking, Concrete Spalling

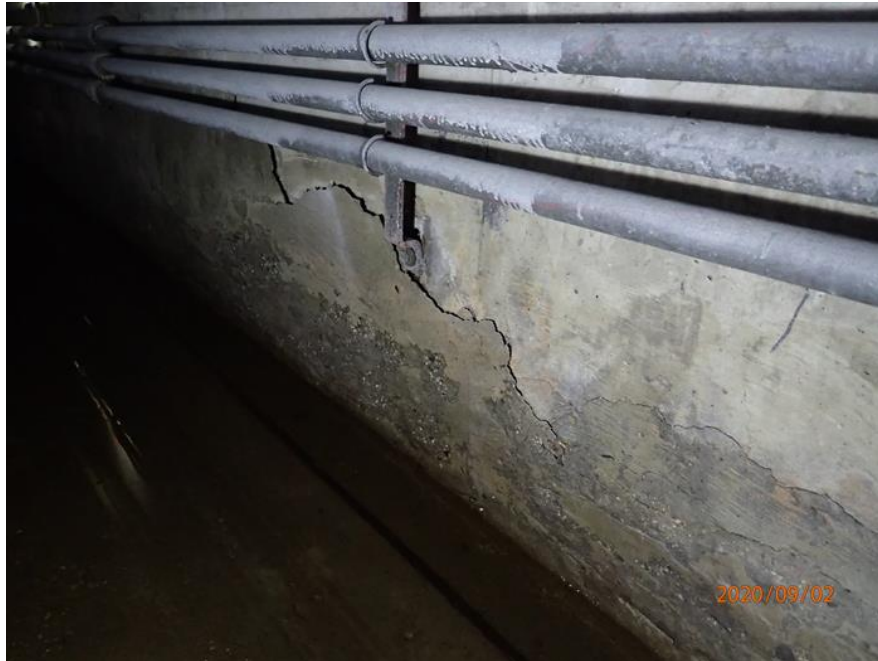
Station 32+00

Direction: Western Wall (In-Land)

Comments: Concrete Spalling

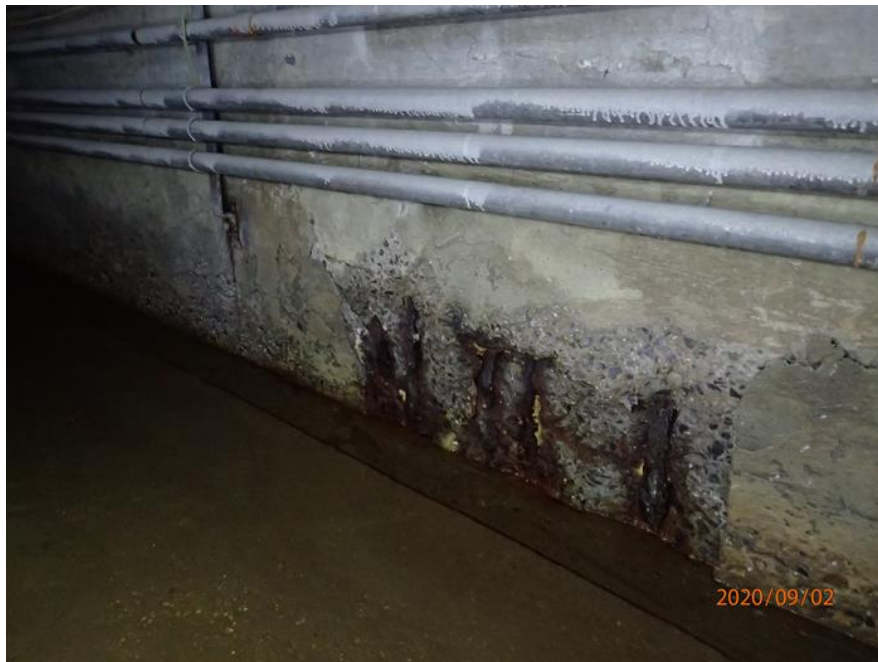
Station 32+45 to 32+50

Direction: Western Wall (In-Land)

Comments: Concrete Spalling, Re-Bar Exposed and Corroded

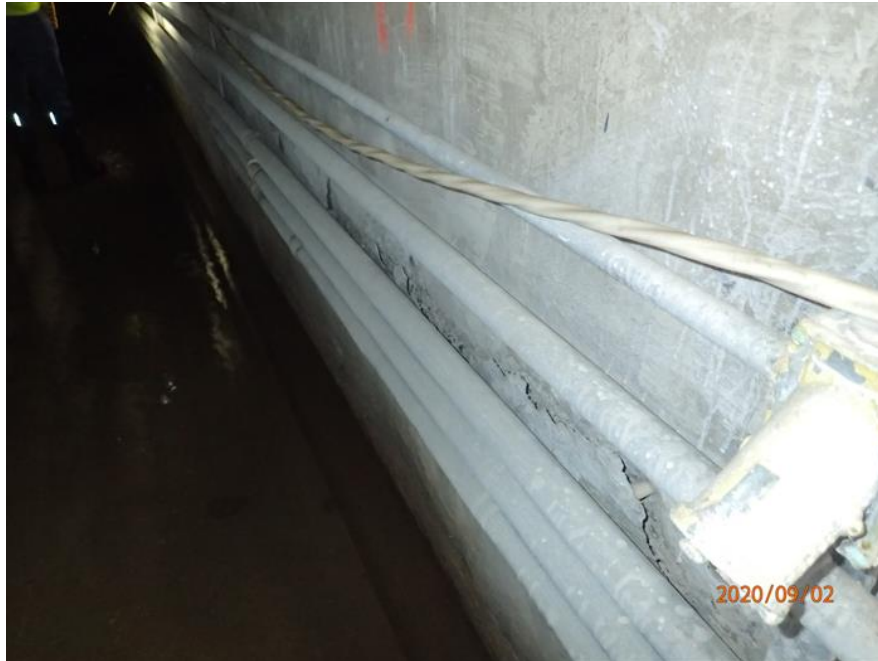
Station 32+60 to 32+65

Direction: Western Wall (In-Land)

Comments: Concrete Spalling, Loose Concrete

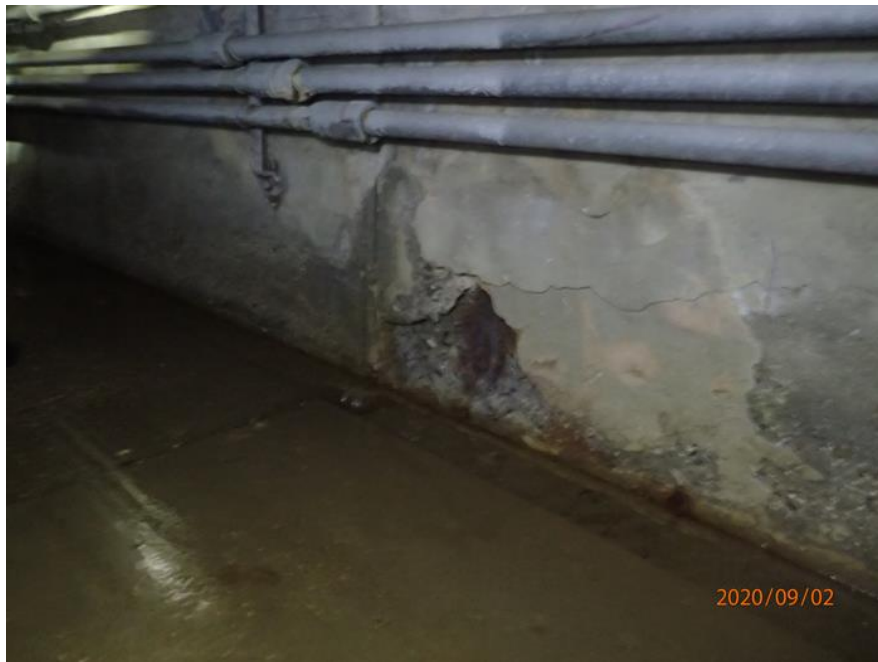
Station 32+90

Direction: Tunnel Joint (Floor and In-Land Wall)

Comments: Concrete Spalling, Re-Bar Exposed and Corroded

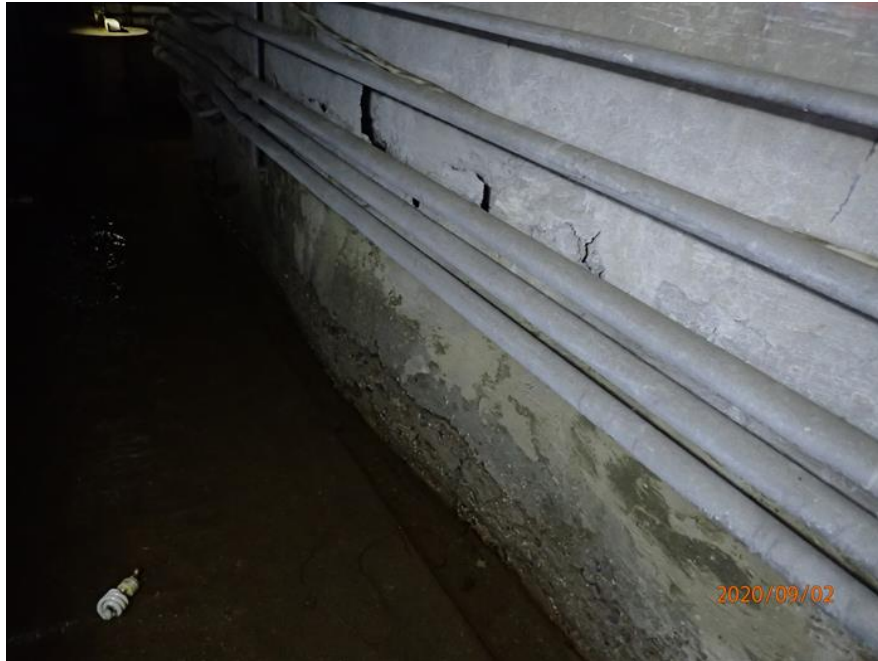
Station 32+90 to 33+00

Direction: Western Wall (In-Land)

Comments: Concrete Spalling

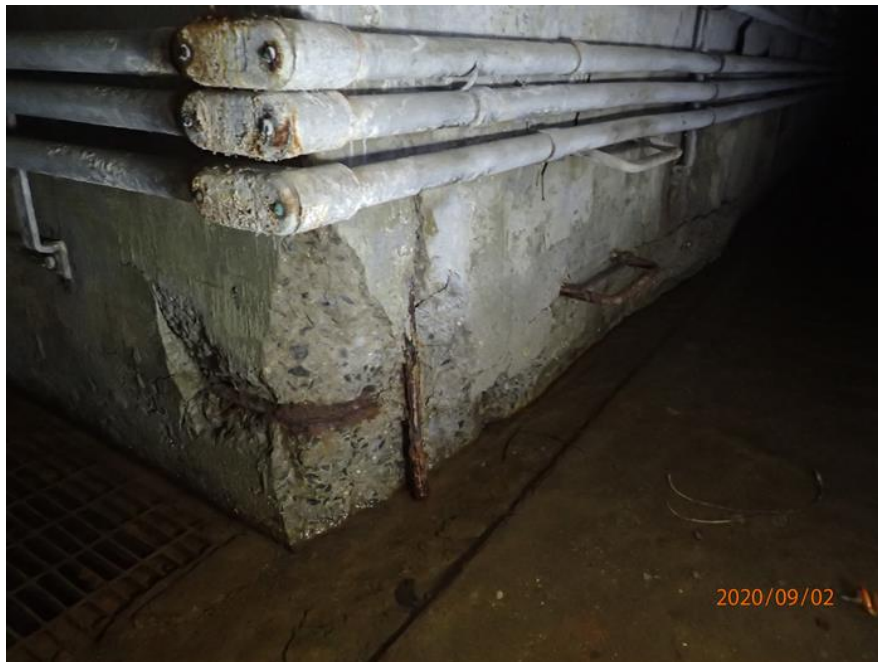
Station 32+90 to 33+00

Direction: Western Wall (In-Land)

Comments: Concrete Spalling, Re-Bar Exposed and Corroded

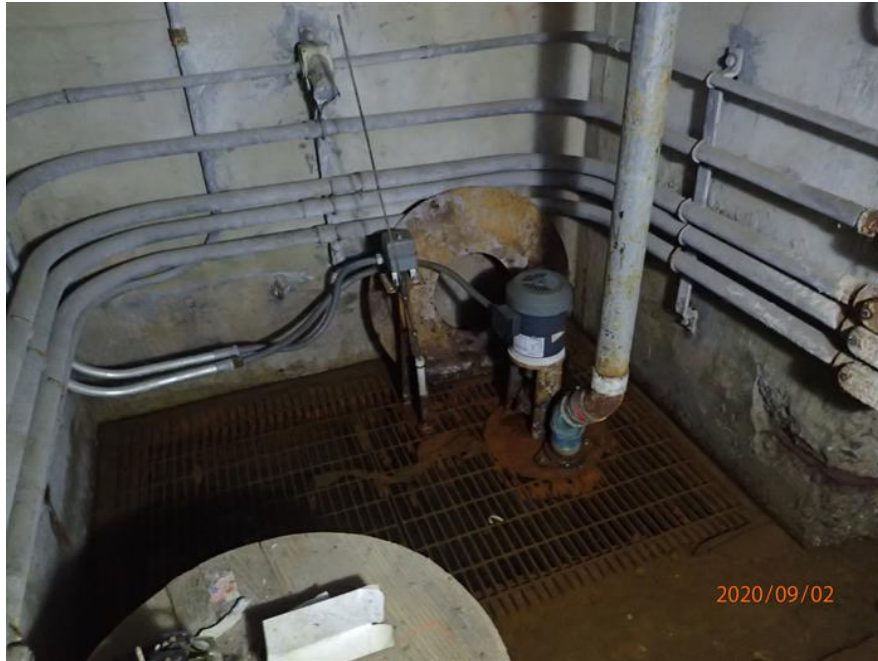
Station 33+00

Direction: Tunnel Floor at Air Vent 5

Comments: Sump Pump - Not Working

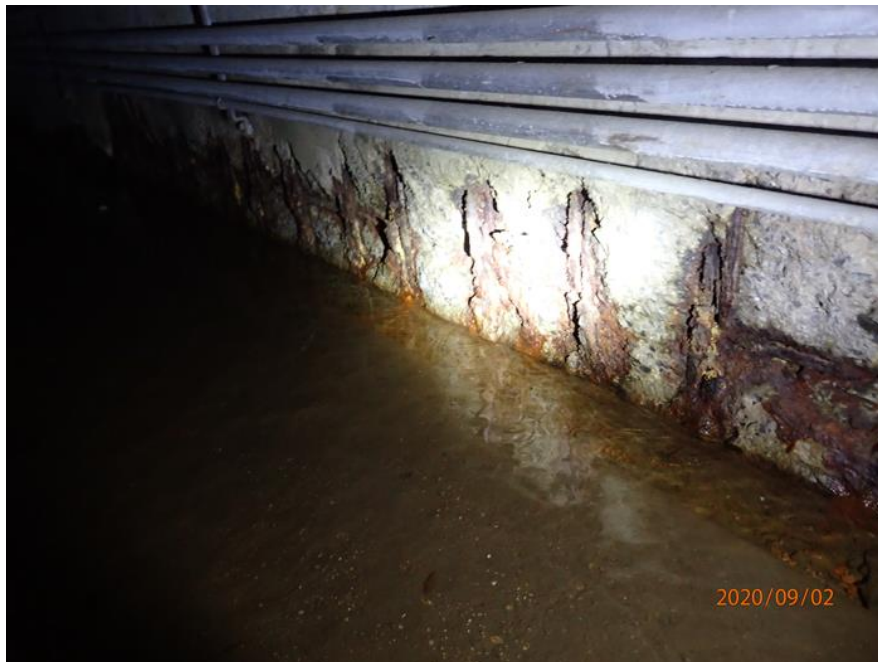
Station 33+10 to 33+70

Direction: Western Wall (In-Land)

Comments: Concrete Spalling, Loose Concrete, Re-Bar Exposed and Corroded

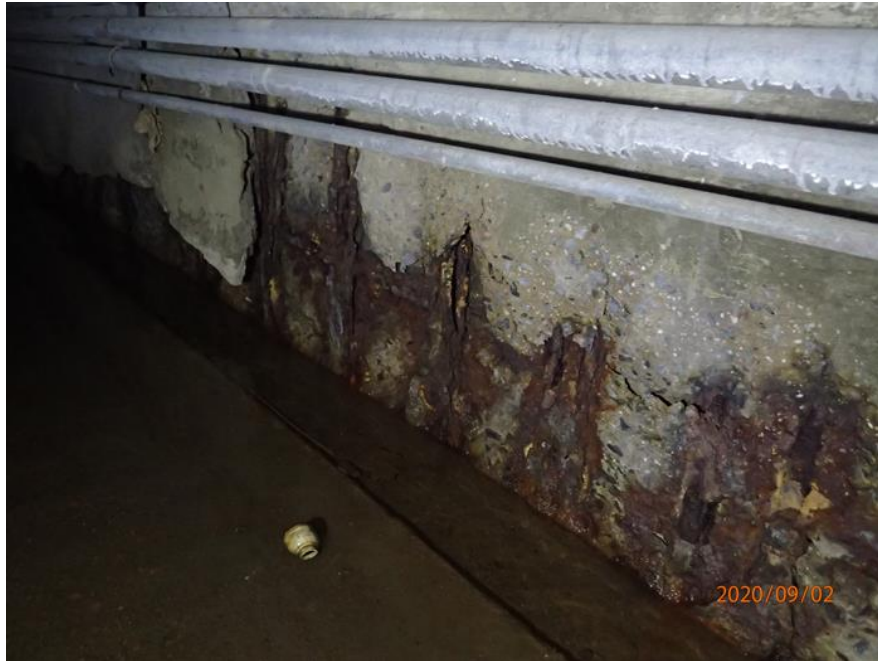
Station 33+10 to 33+70

Direction: Western Wall (In-Land)

Comments: Concrete Spalling, Loose Concrete, Re-Bar Exposed and Corroded

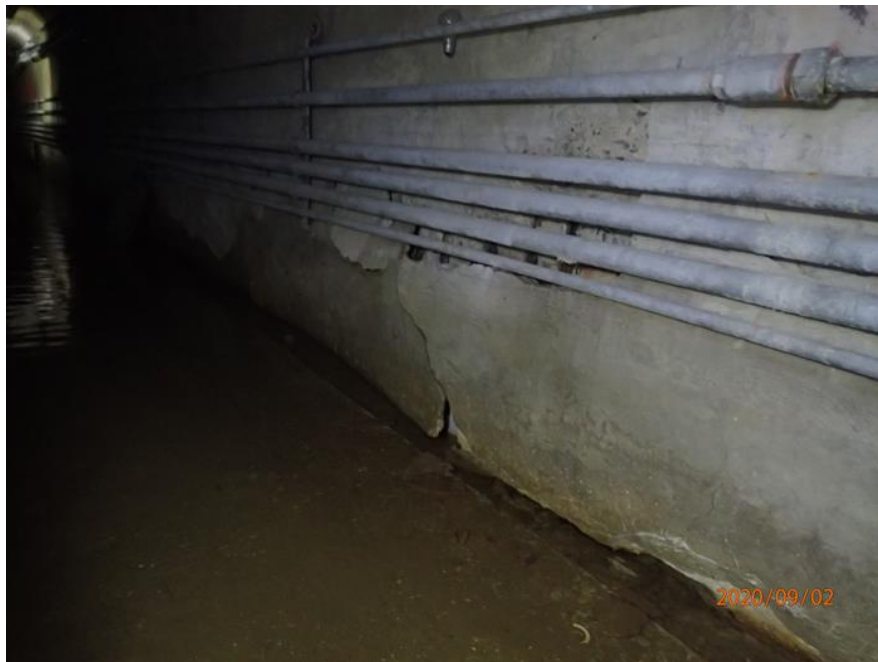
Station 33+10 to 33+70

Direction: Western Wall (In-Land)

Comments: Concrete Spalling, Loose Concrete, Re-Bar Exposed and Corroded

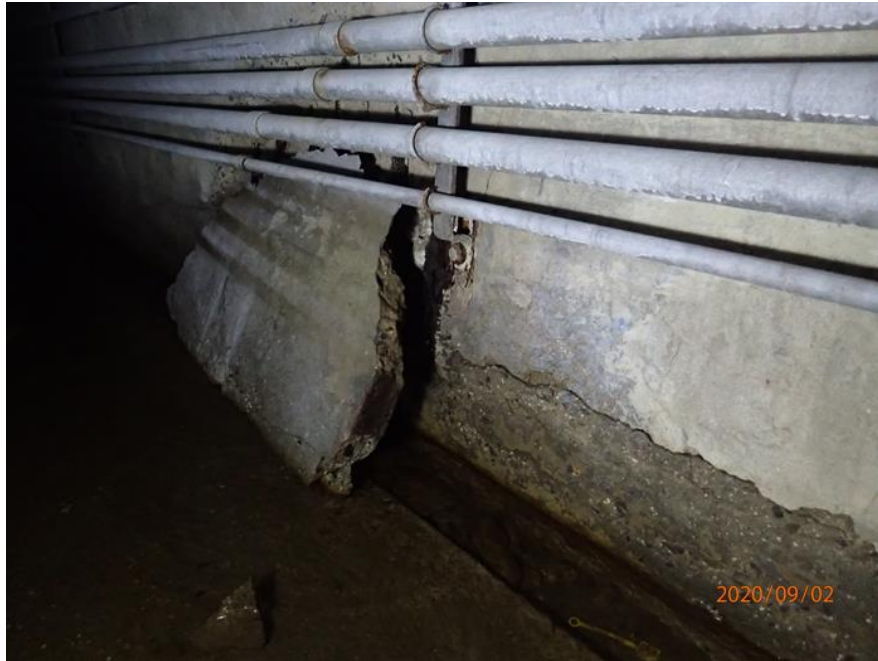
Station 33+10 to 33+70

Direction: Western Wall (In-Land)

Comments: Concrete Spalling, Loose Concrete, Re-Bar Exposed and Corroded

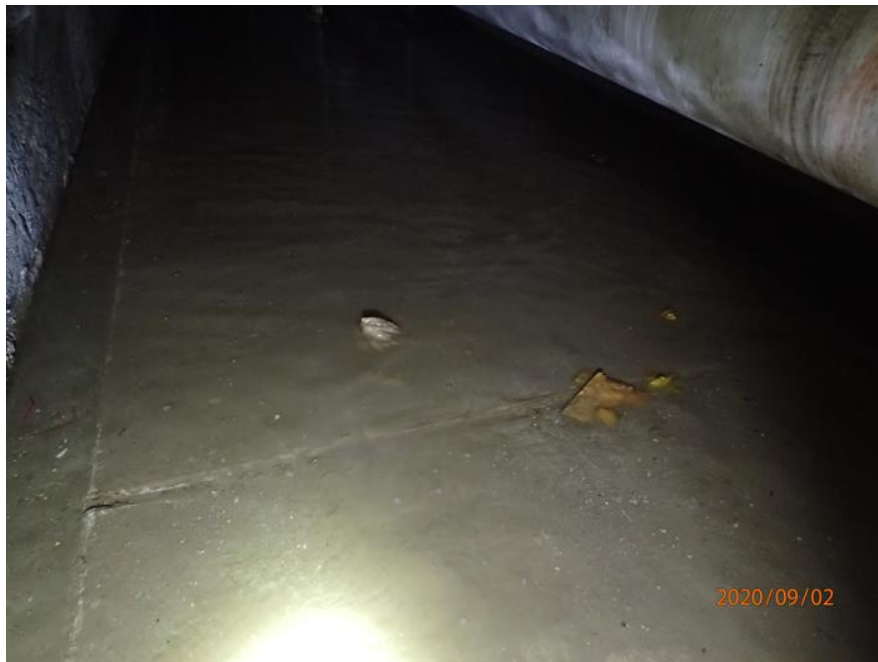
Station 34+10

Direction: Tunnel Joint (Floor)

Comments: Joint Separation

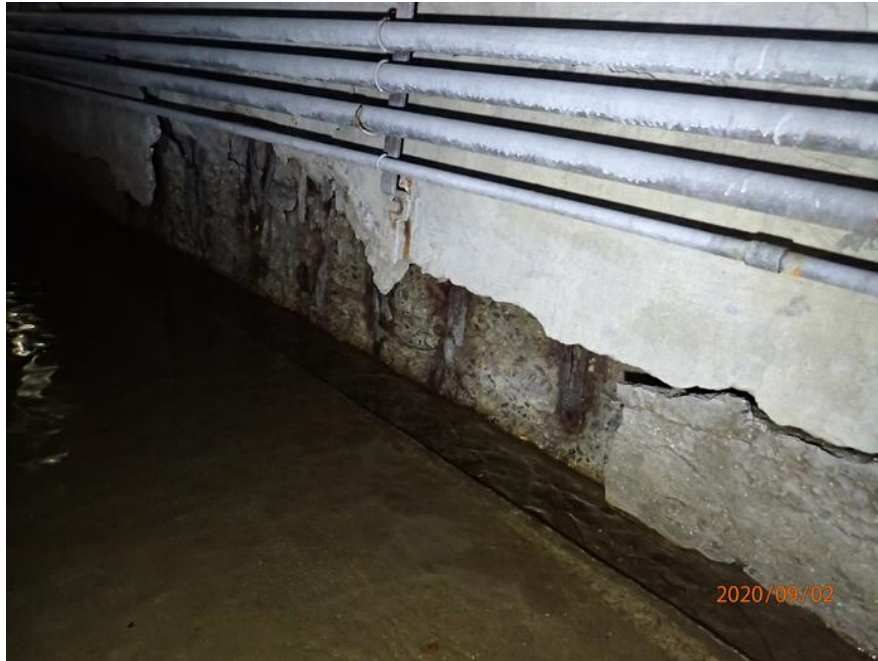
Station 34+25 to 34+70

Direction: Western Wall (In-Land)

Comments: Concrete Spalling, Loose Concrete, Re-Bar Exposed and Corroded

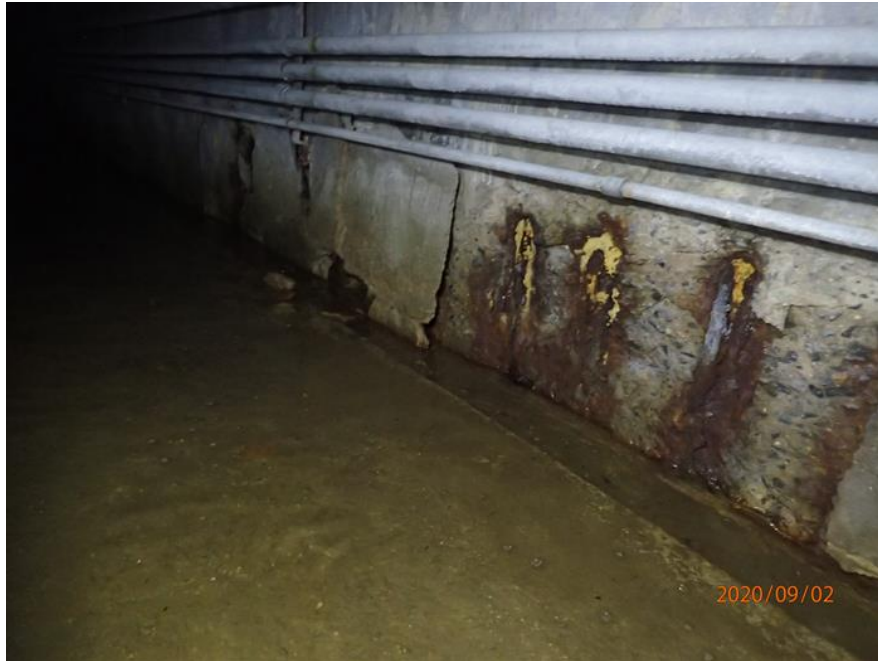
Station 34+25 to 34+70

Direction: Western Wall (In-Land)

Comments: Concrete Spalling, Loose Concrete, Re-Bar Exposed and Corroded

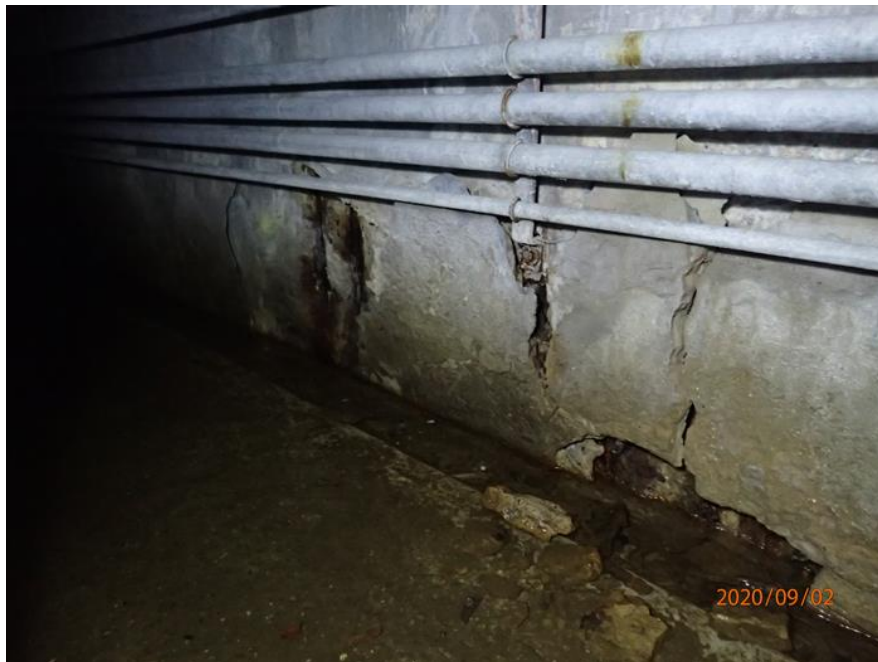
Station 34+25 to 34+70

Direction: Western Wall (In-Land)

Comments: Concrete Spalling, Loose Concrete, Re-Bar Exposed and Corroded

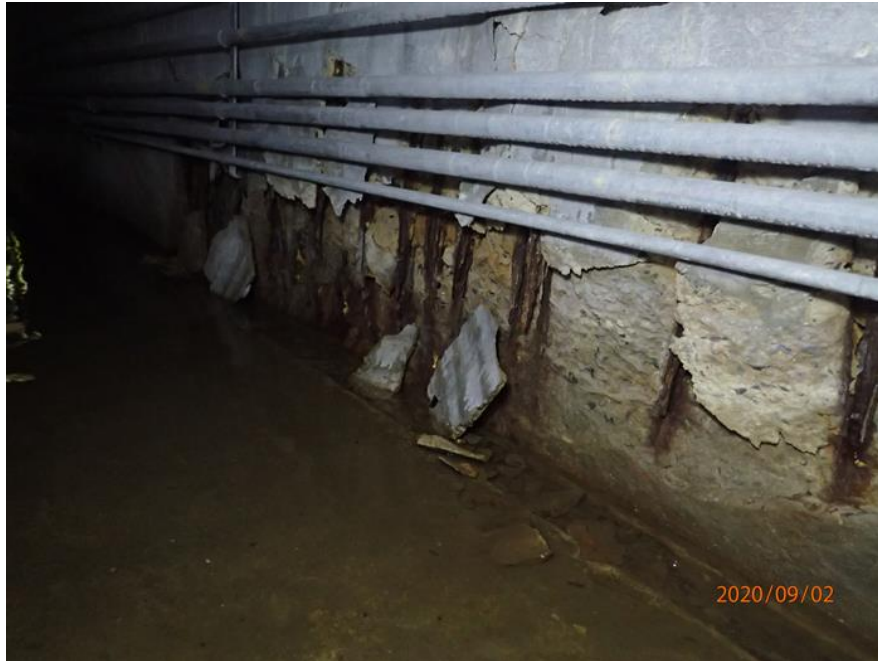
Station 34+25 to 34+70

Direction: Western Wall (In-Land)

Comments: Concrete Spalling, Loose Concrete, Re-Bar Exposed and Corroded
