CONDITIONS REPORT & CONCEPTUAL DESIGN MEMORANDUM

STEAM TUNNEL ASSESSMENT

ROOSEVELT ISLAND, NEW YORK

17 November 2014
Revised 28 December 2018
Revised 18 September 2020
Project # 100444601

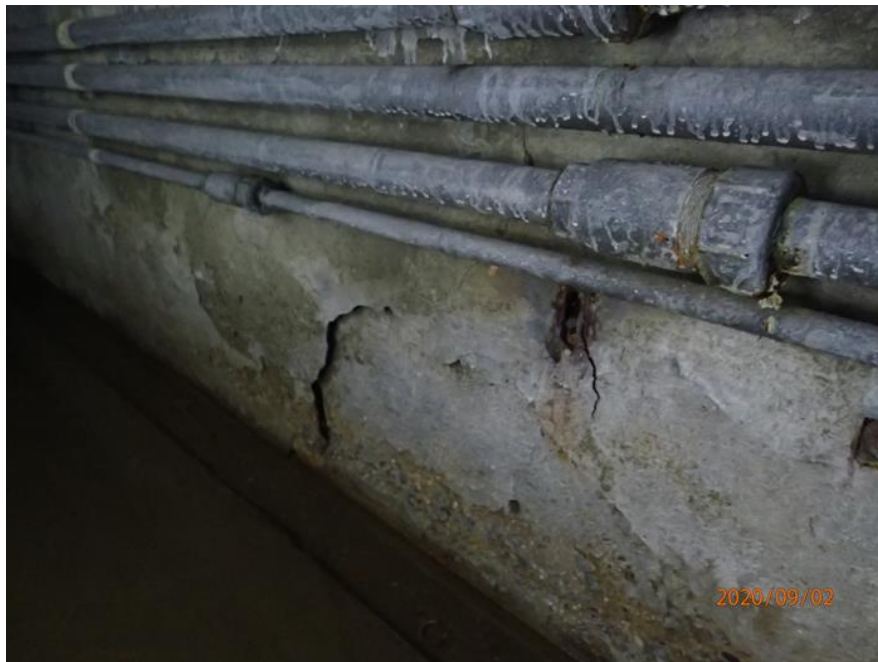
Station 34+25 to 34+70

Direction: Western Wall (In-Land)

Comments: Concrete Spalling, Loose Concrete, Re-Bar Exposed and Corroded

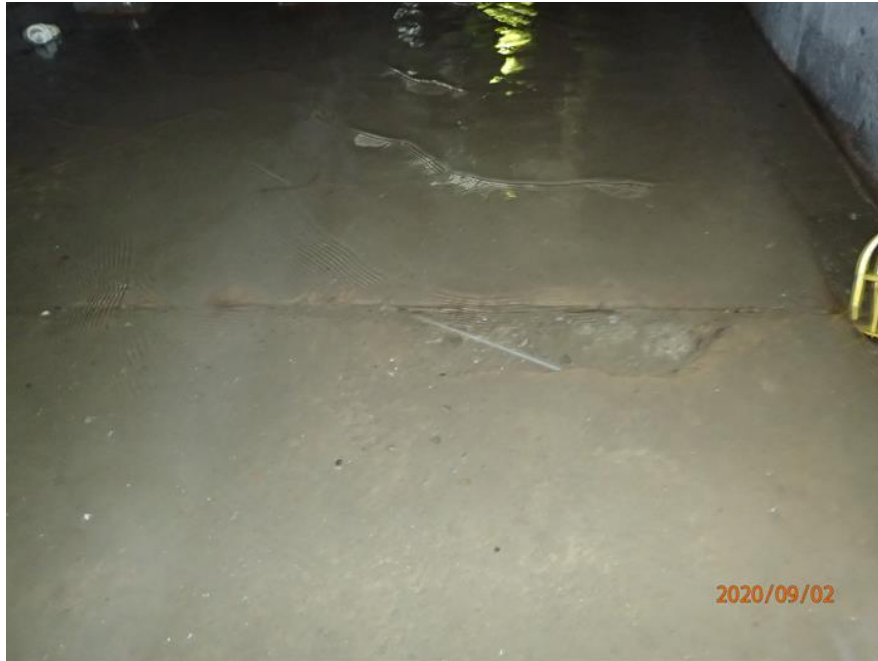
Station 34+75

Direction: Tunnel Joint (Floor)

Comments: Joint Separation, Missing Concrete

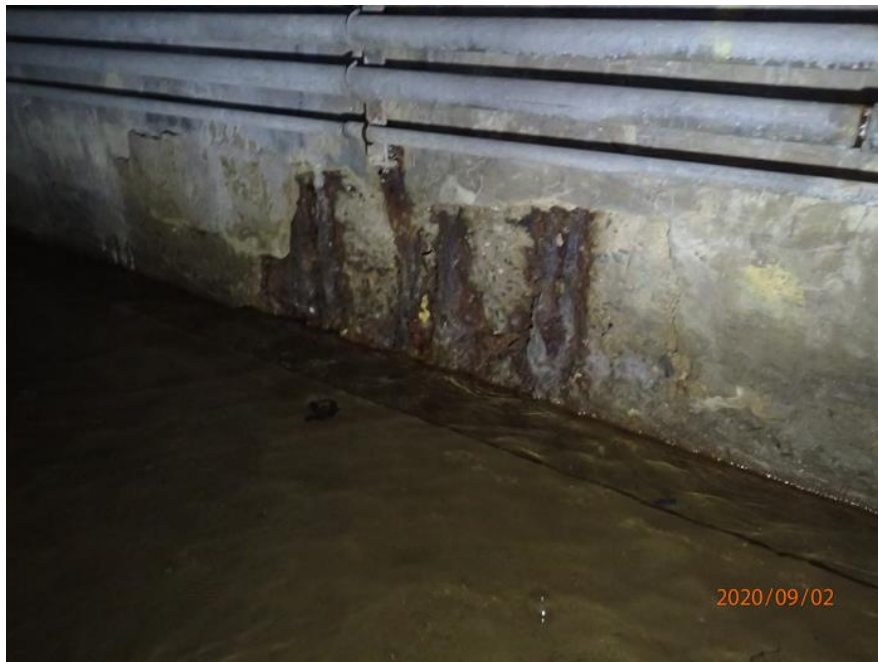
Station 35+00 to 35+10

Direction: Western Wall (In-Land)

Comments: Concrete Spalling, Re-Bar Exposed and Corroded

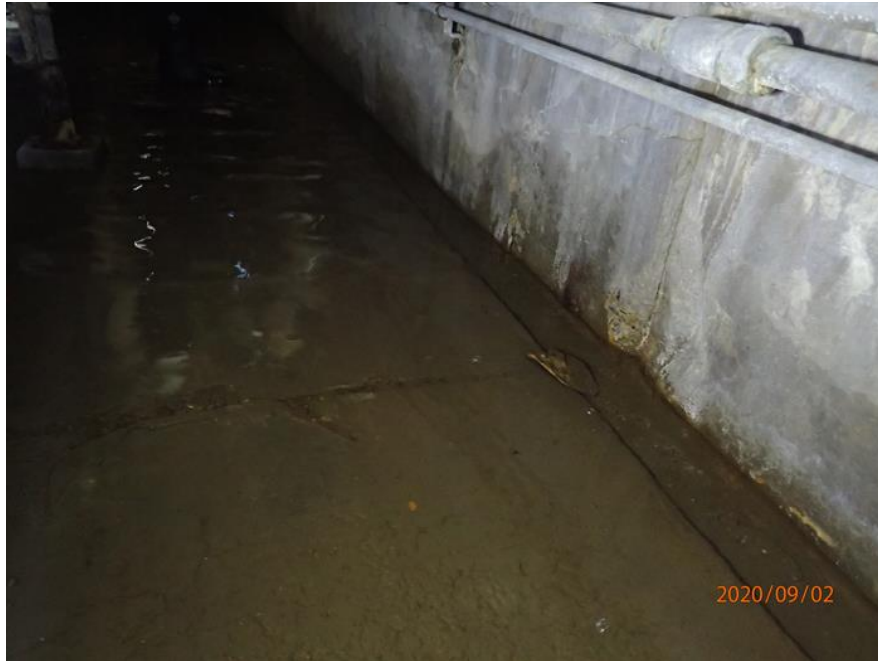
Station 35+40

Direction: Western Wall (In-Land)/ Tunnel Floor

Comments: Floor Slab Cracked and Displaced

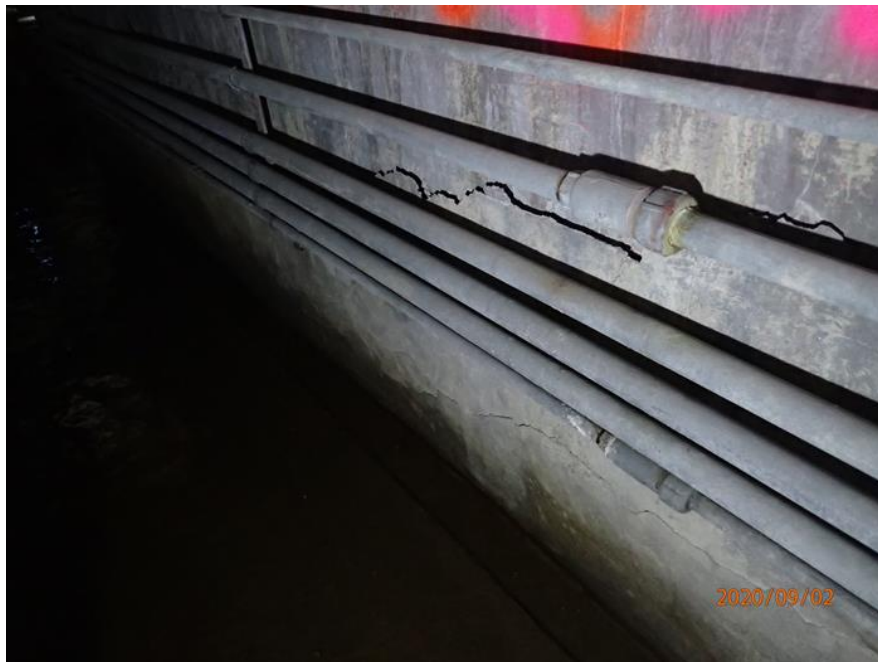
Station 35+50 to 35+60

Direction: Western Wall (In-Land)

Comments: Concrete Spalling and Bowing of Wall

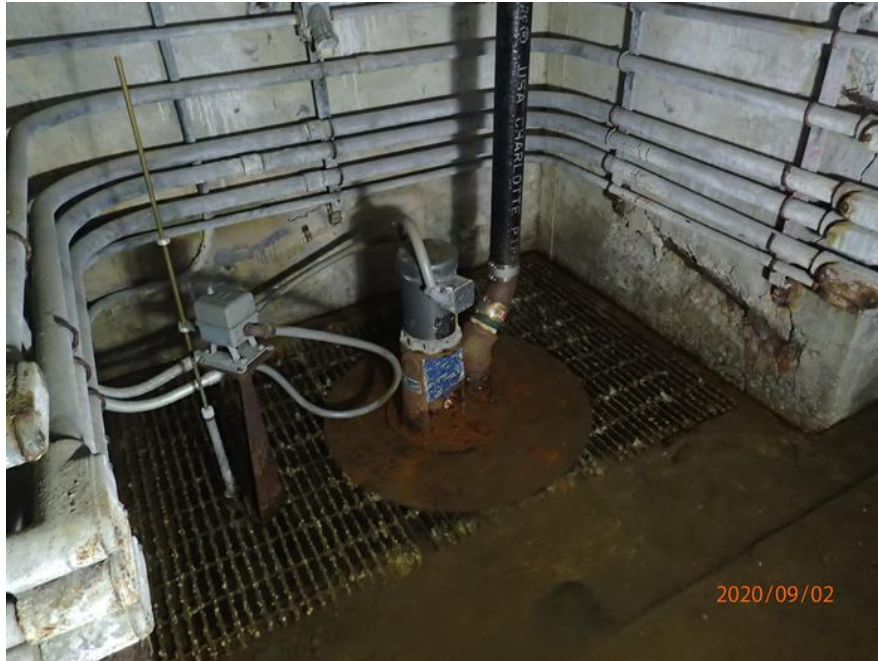
Station 35+54

Direction: Tunnel Floor and Wall at Air Vent 4

Comments: Sump Pump - Not Working; Concrete Spalling, Re-Bar Exposed and Corroded

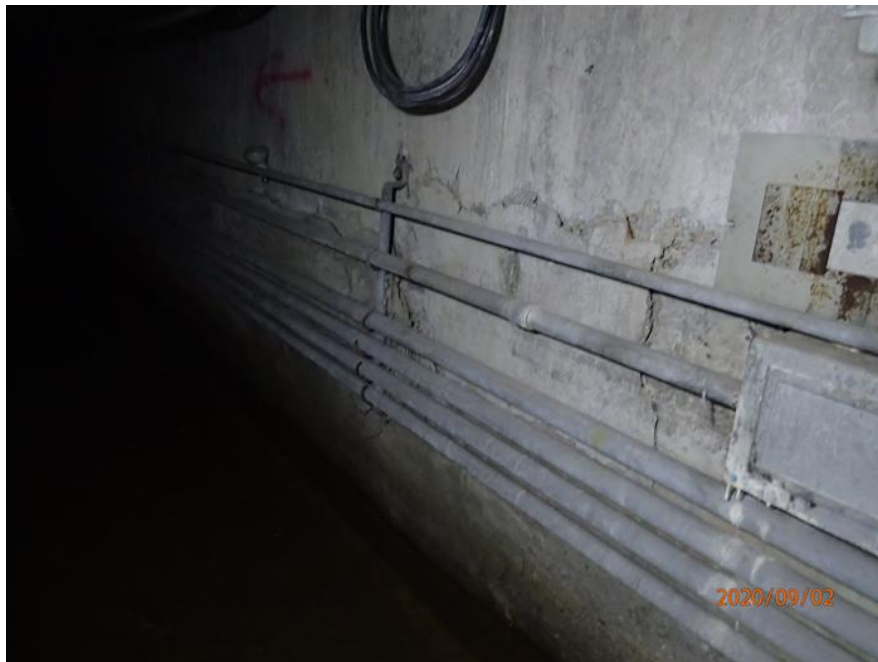
Station 35+75 to 36+30

Direction: Western Wall (In-Land)

Comments: Concrete Spalling up to 5 feet Height, Loose Concrete

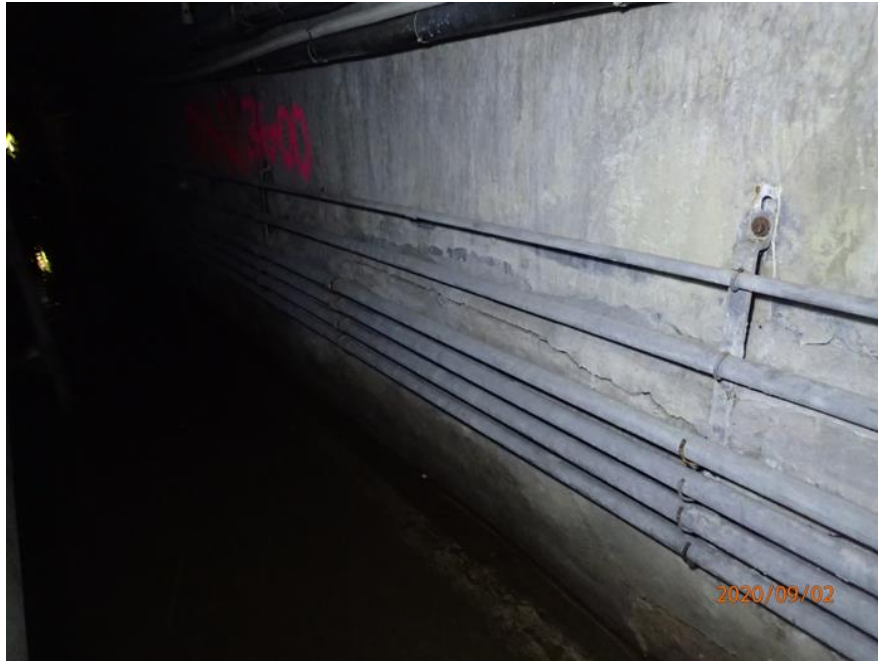
Station 35+75 to 36+30

Direction: Western Wall (In-Land)

Comments: Concrete Spalling up to 5 feet Height, Loose Concrete

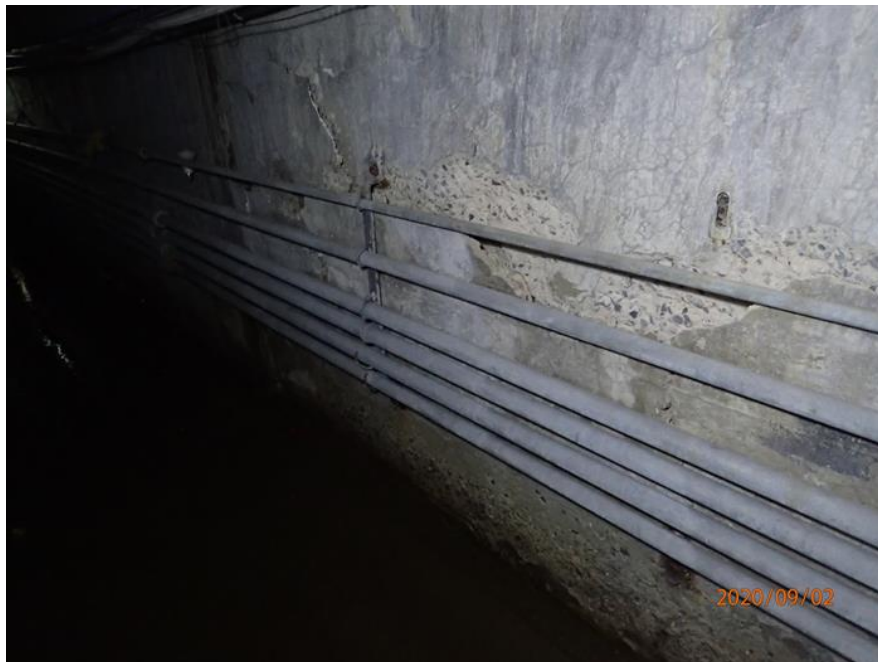
Station 35+75 to 36+30

Direction: Western Wall (In-Land)

Comments: Concrete Spalling up to 5 feet Height, Loose Concrete

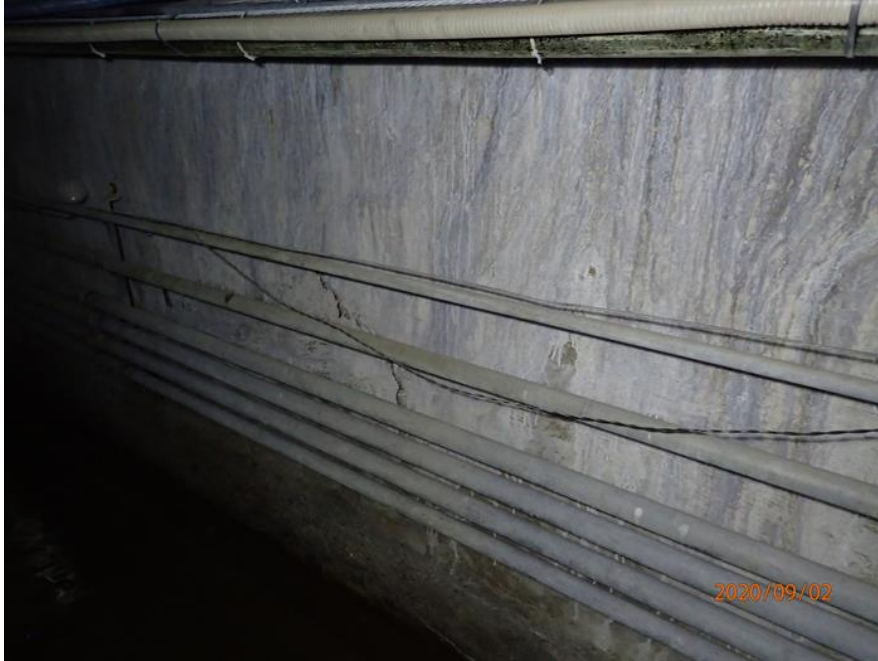
Station 35+75 to 36+30

Direction: Western Wall (In-Land)

Comments: Concrete Spalling up to 5 feet Height, Loose Concrete

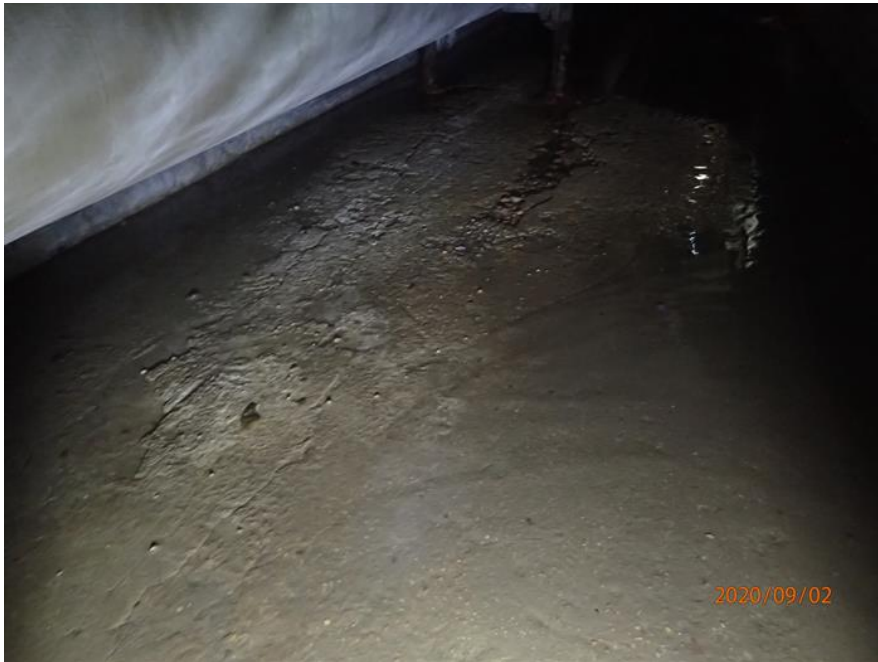
Station 36+57 to 36+62

Direction: Tunnel Floor

Comments: Floor Slab Cracked, Concrete Spalling

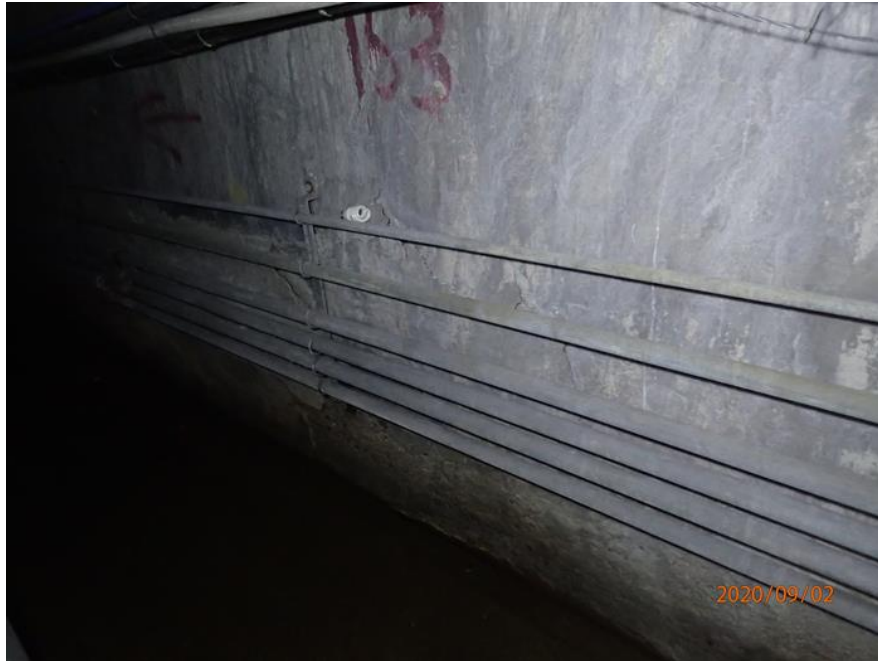
Station 36+60 to 36+90

Direction: Western Wall (In-land)

Comments: Concrete Spalling, Loose Concrete

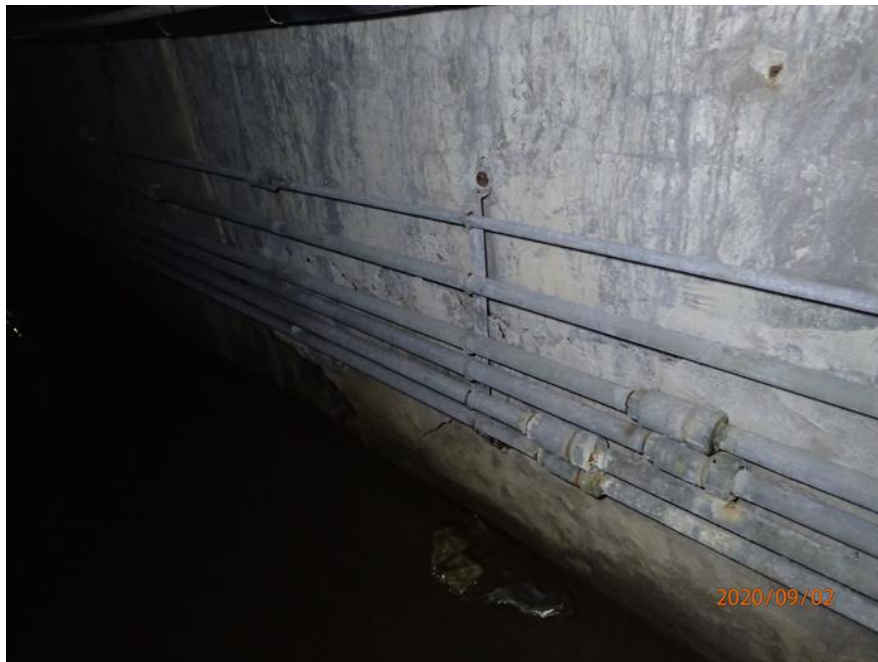
Station 36+60 to 36+90

Direction: Western Wall (In-land)

Comments: Concrete Spalling, Loose Concrete

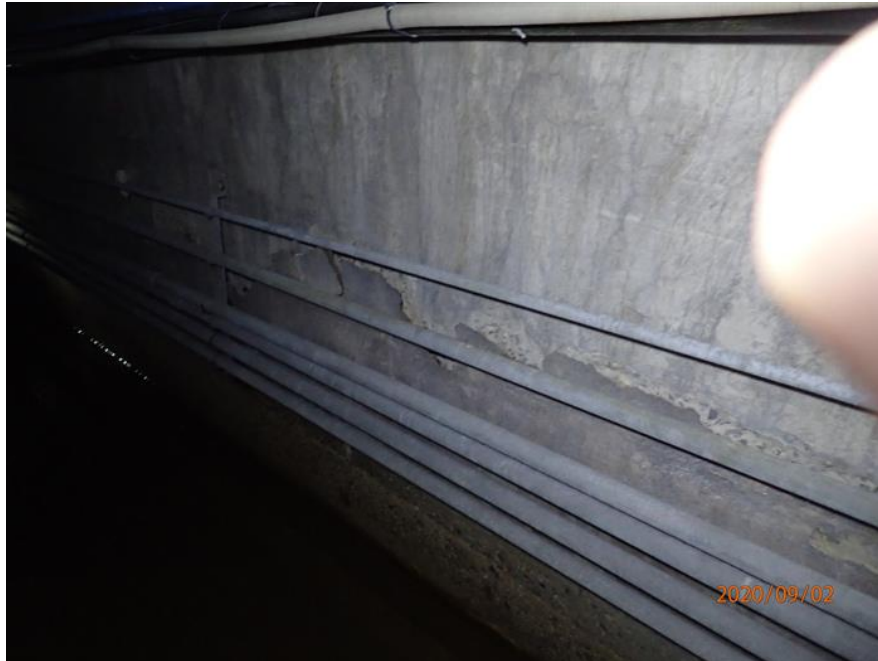
Station 36+60 to 36+90

Direction: Western Wall (In-land)

Comments: Concrete Spalling, Loose Concrete

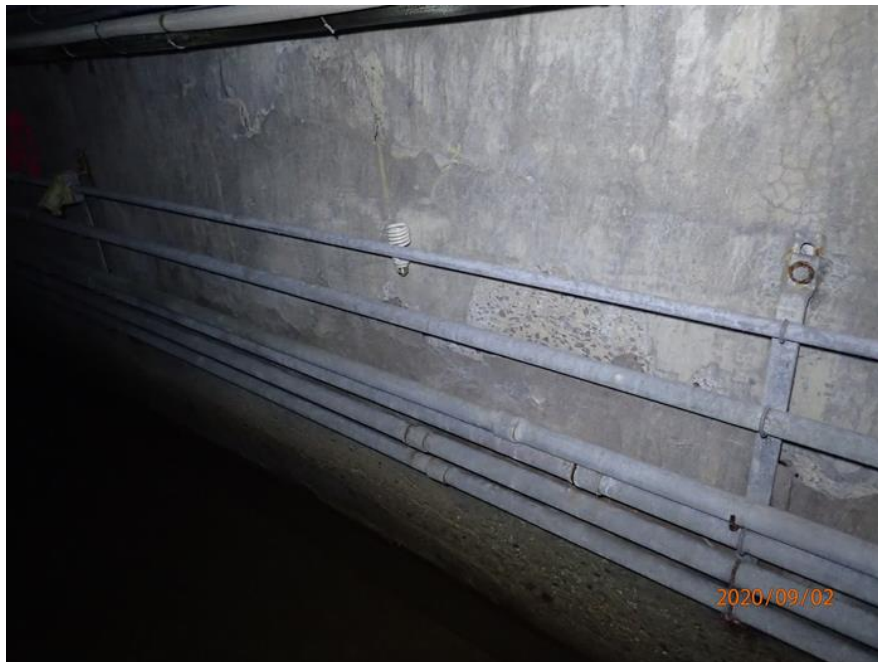
Station 36+60 to 36+90

Direction: Western Wall (In-land)

Comments: Concrete Spalling, Loose Concrete

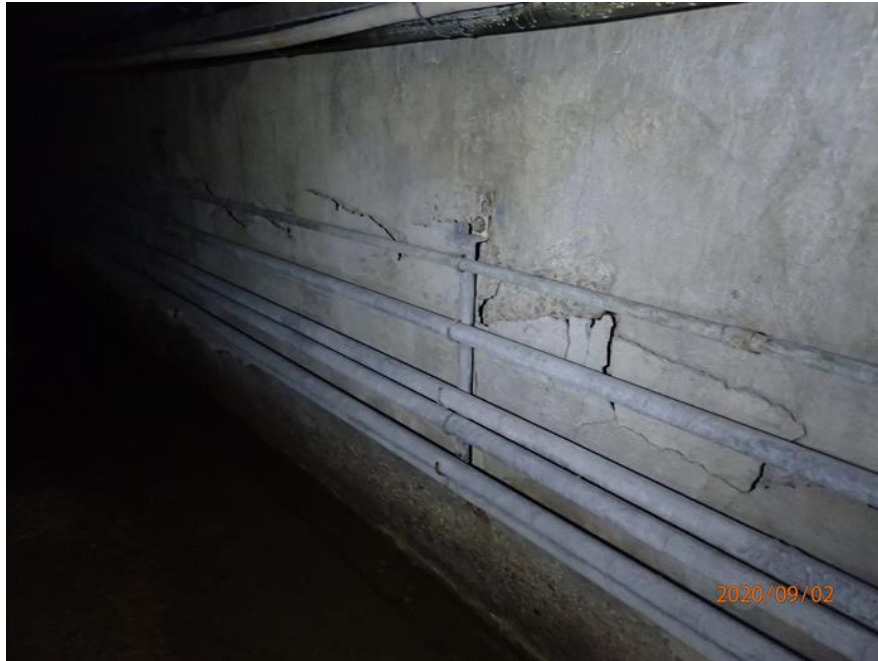
Station 37+00 to 37+50

Direction: Western Wall (In-Land)

Comments: Concrete Spalling up to 5 feet Height

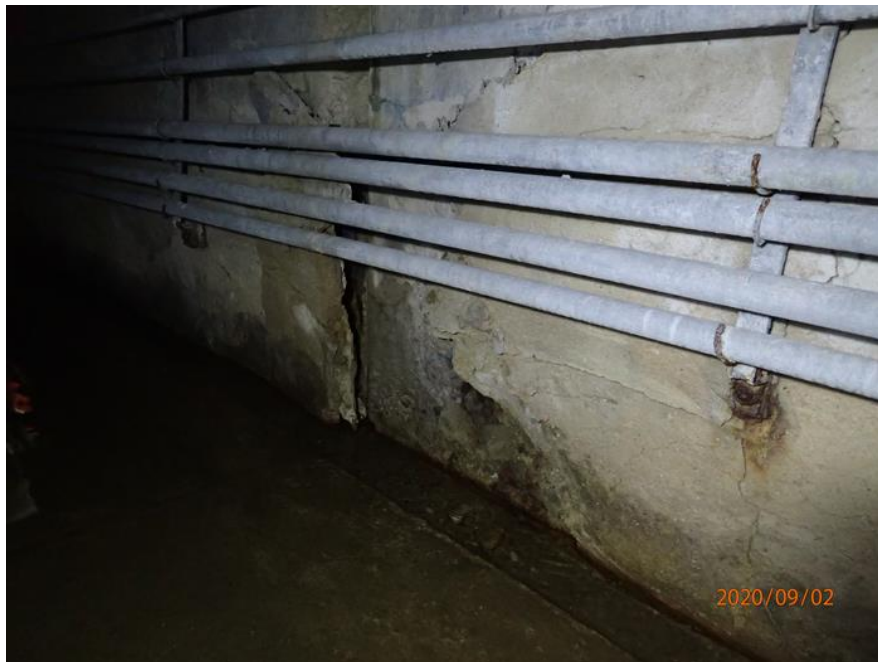
Station 37+00 to 37+50

Direction: Western Wall (In-Land)

Comments: Concrete Spalling up to 5 feet Height; Re-Bar Exposed and Corroded

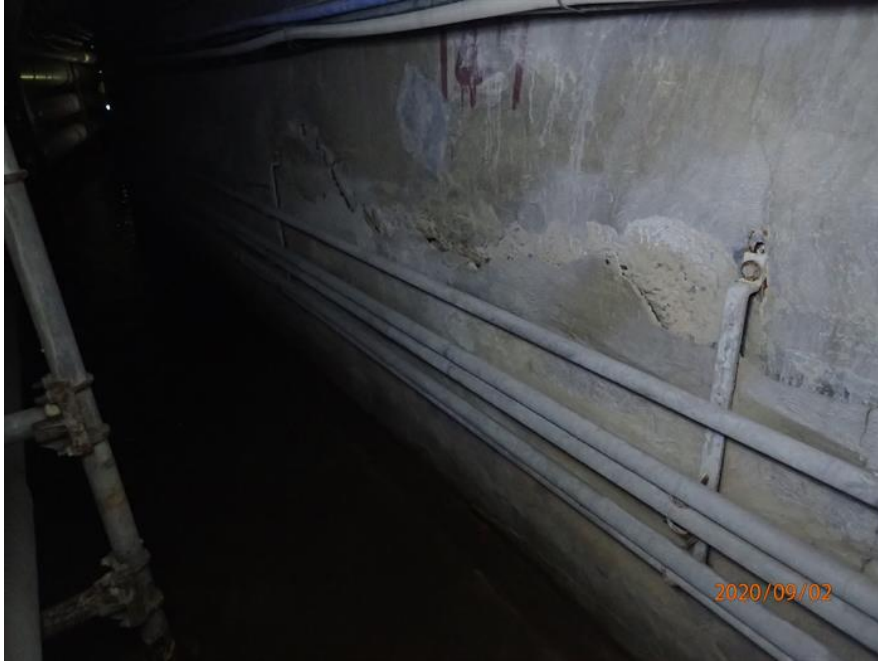
Station 37+50 to 38+00

Direction: Western Wall (In-land)

Comments: Concrete Spalling, Loose Concrete

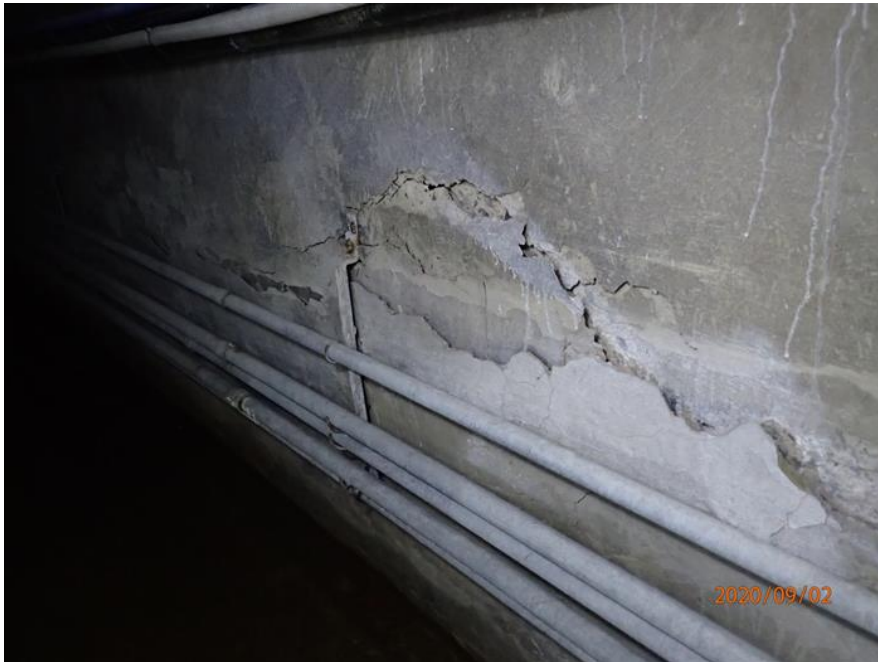
Station 37+50 to 38+00

Direction: Western Wall (In-land)

Comments: Concrete Spalling, Loose Concrete

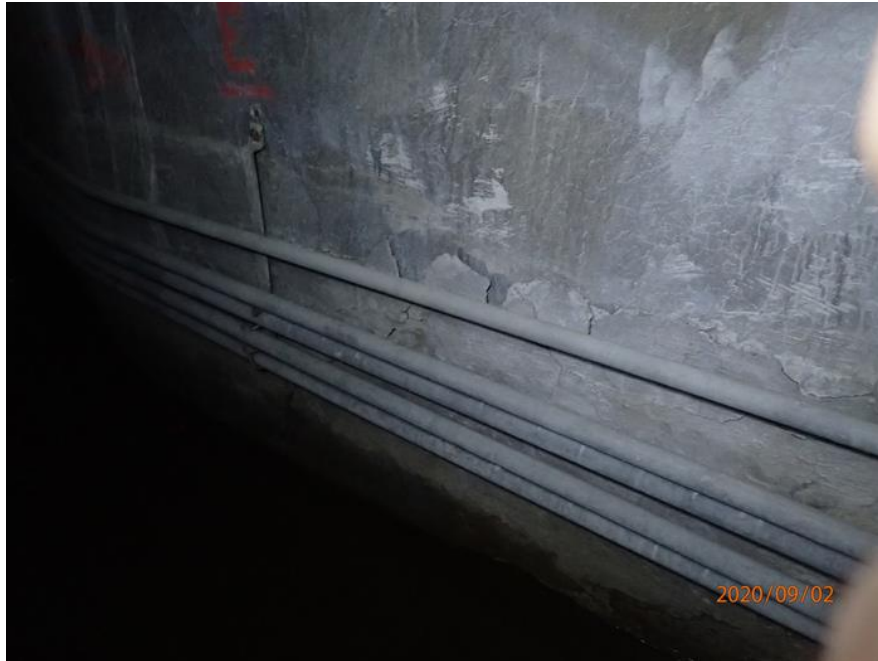
Station 37+50 to 38+00

Direction: Western Wall (In-land)

Comments: Concrete Spalling, Loose Concrete

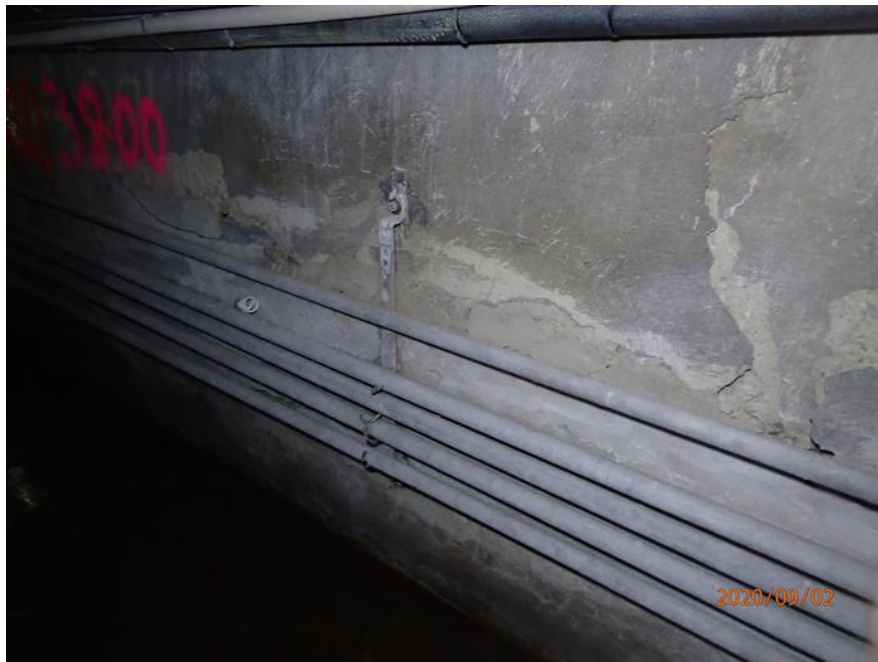
Station 37+50 to 38+00

Direction: Western Wall (In-land)

Comments: Concrete Spalling, Loose Concrete

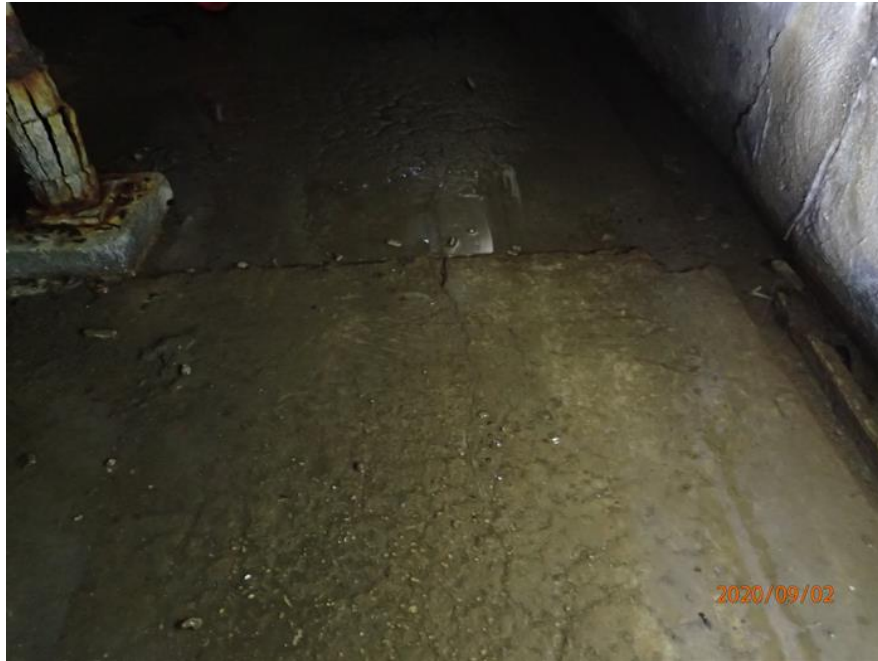
Station 38+00

Direction: Tunnel Joint (Floor)

Comments: Floor Slab Raised at Joint, Concrete Spalling

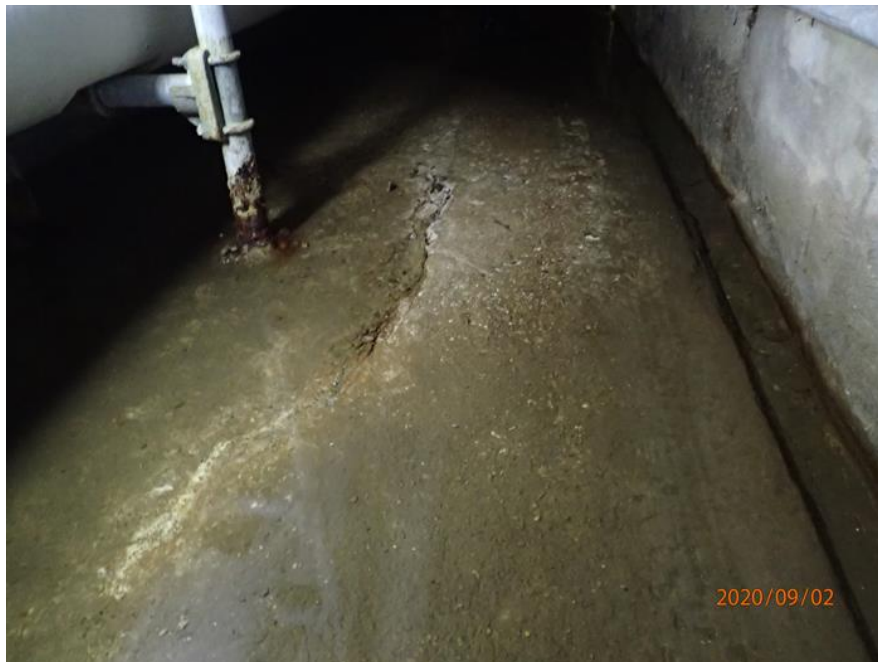
Station 38+13

Direction: Tunnel Joint (Floor)

Comments: Floor Slab Cracked

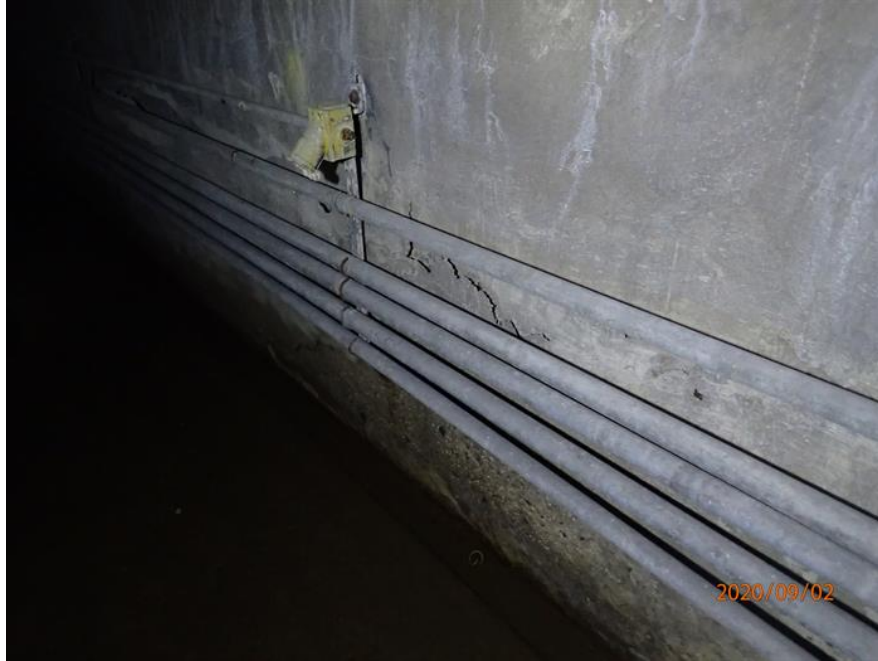
Station 38+00 to 38+55

Direction: Western Wall (In-Land)

Comments: Concrete Spalling, Loose Concrete

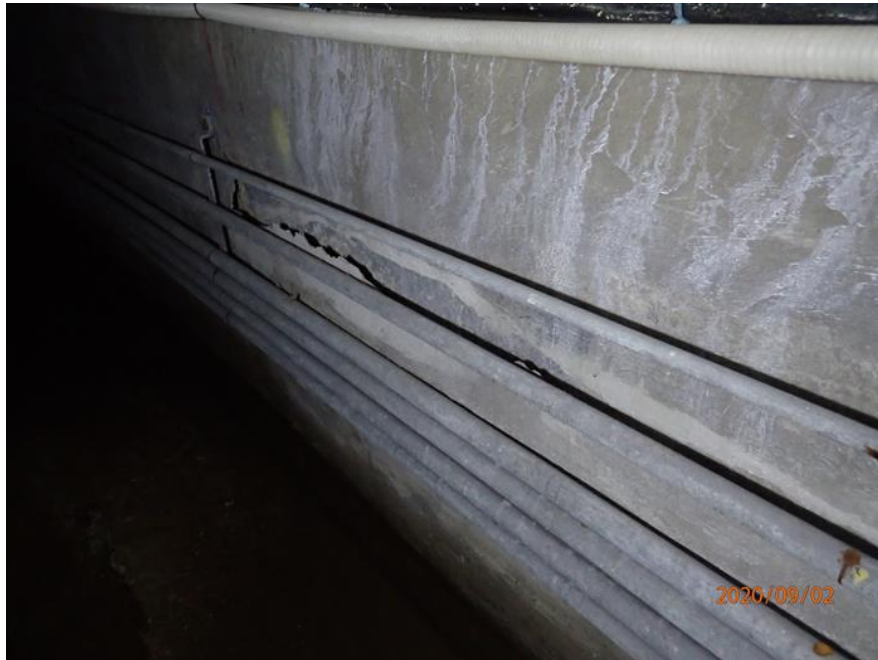
Station 38+00 to 38+55

Direction: Western Wall (In-Land)

Comments: Concrete Spalling, Loose Concrete

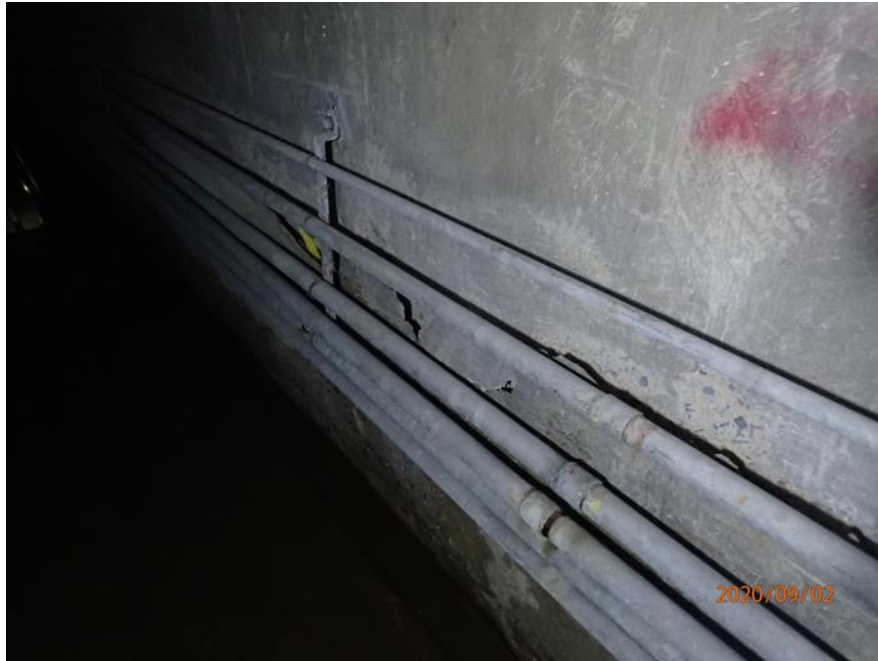
Station 38+00 to 38+55

Direction: Western Wall (In-Land)

Comments: Concrete Spalling, Loose Concrete

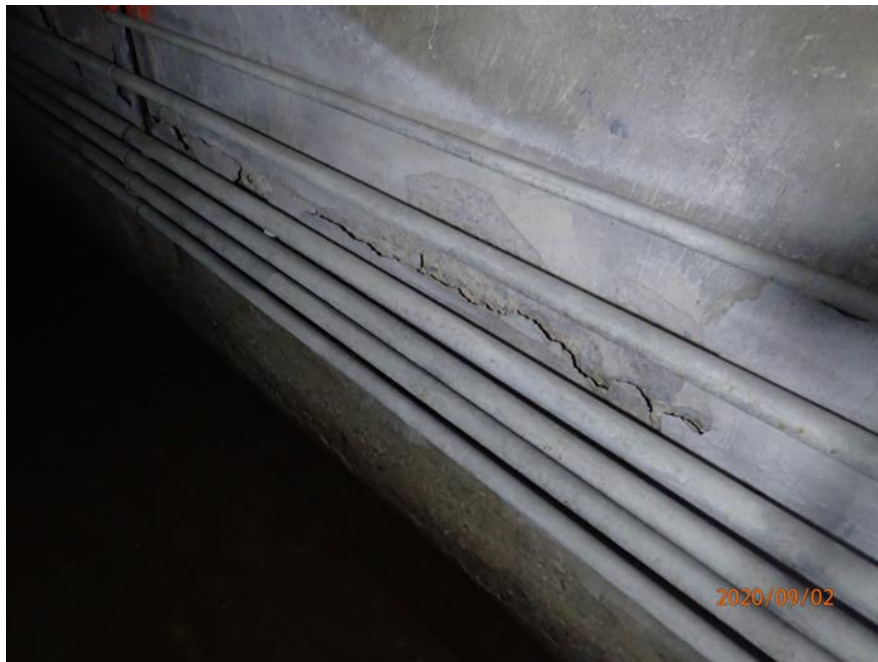
Station 38+00 to 38+55

Direction: Western Wall (In-Land)

Comments: Concrete Spalling, Loose Concrete

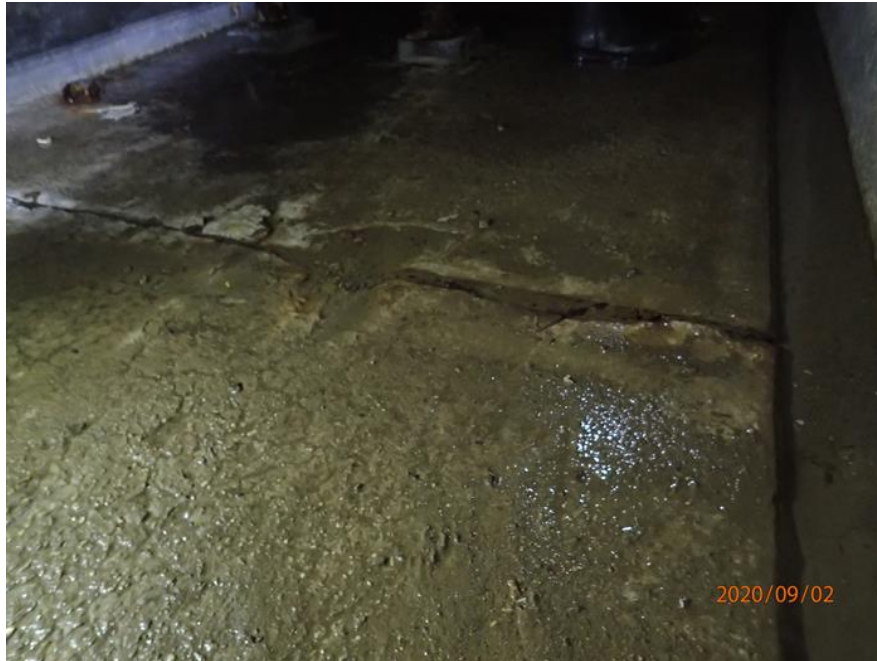
Station 38+65

Direction: Tunnel Joint (Floor)

Comments: Floor Slab Cracked

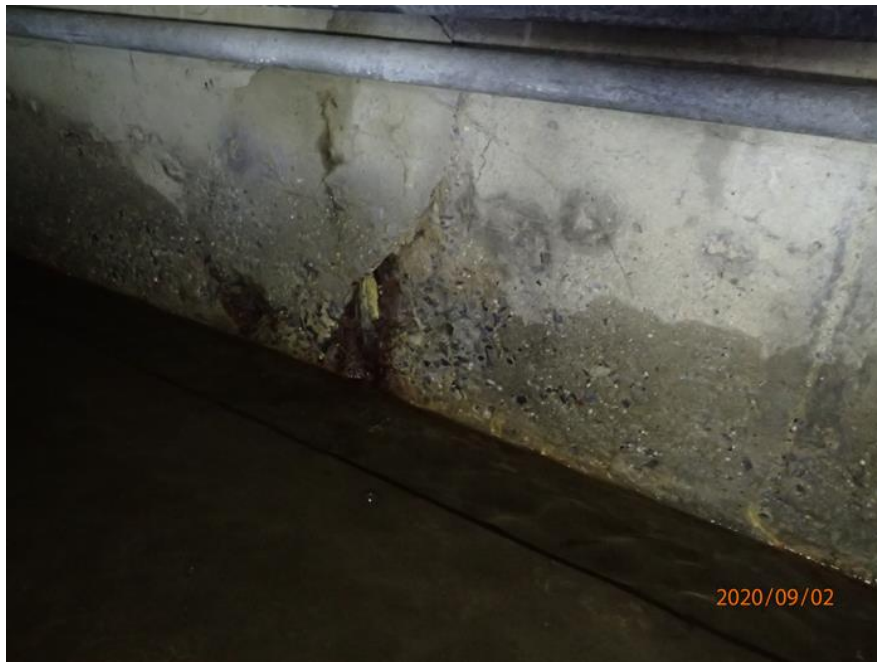
Station 39+00

Direction: Western Wall (In-Land)

Comments: Concrete Spalling, Loose Concrete

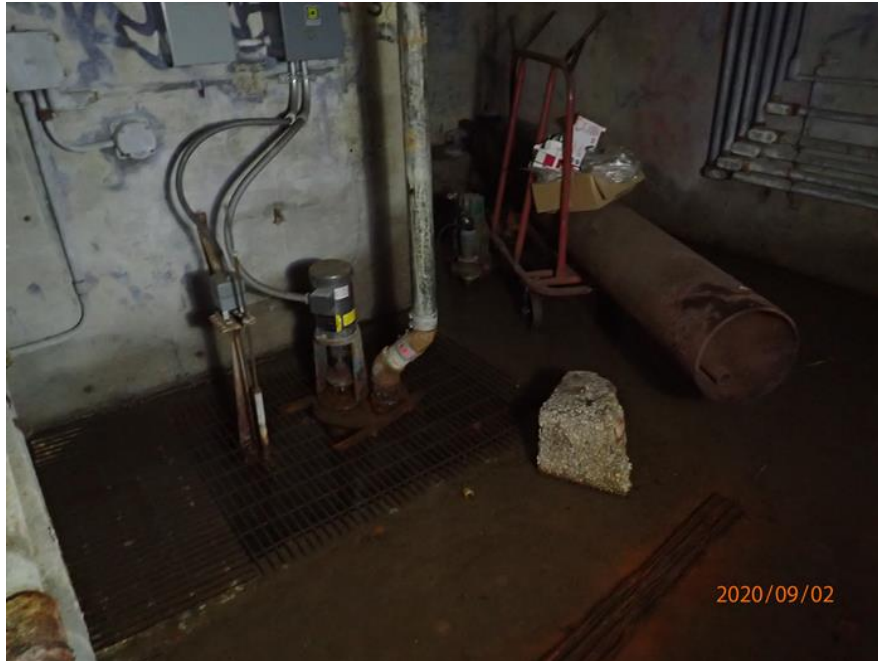
Station 39+03

Direction: Tunnel Floor at Air Vent 3

Comments: Sump Pump - Not Working

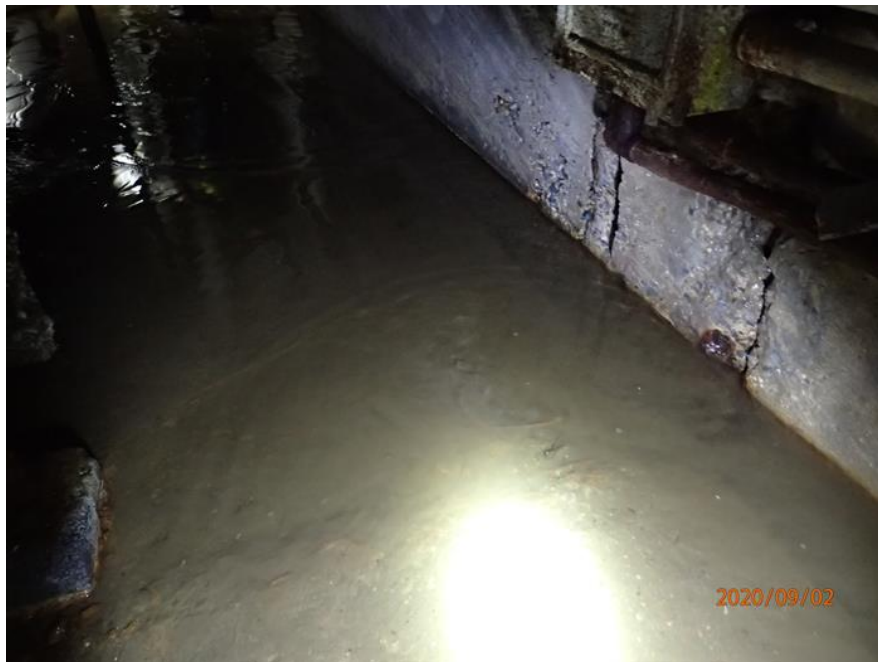
Station 39+23

Direction: Tunnel Floor and Western Wall (In-Land)

Comments: Concrete Spalling, Re-Bar Exposed and Corroded

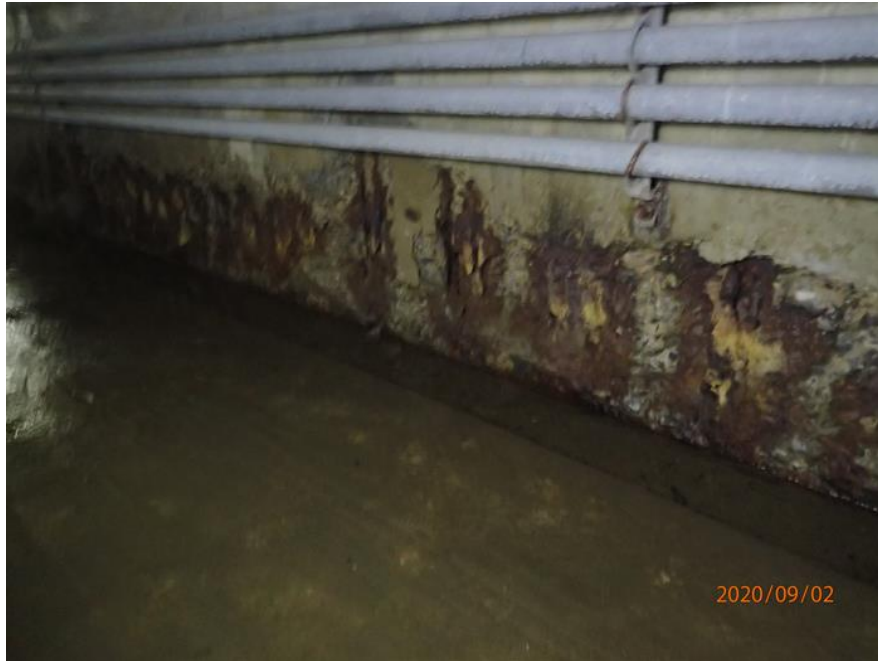
Station 39+60 to 39+75

Direction: Western Wall (In-Land)

Comments: Concrete Spalling, Re-Bar Exposed and Corroded

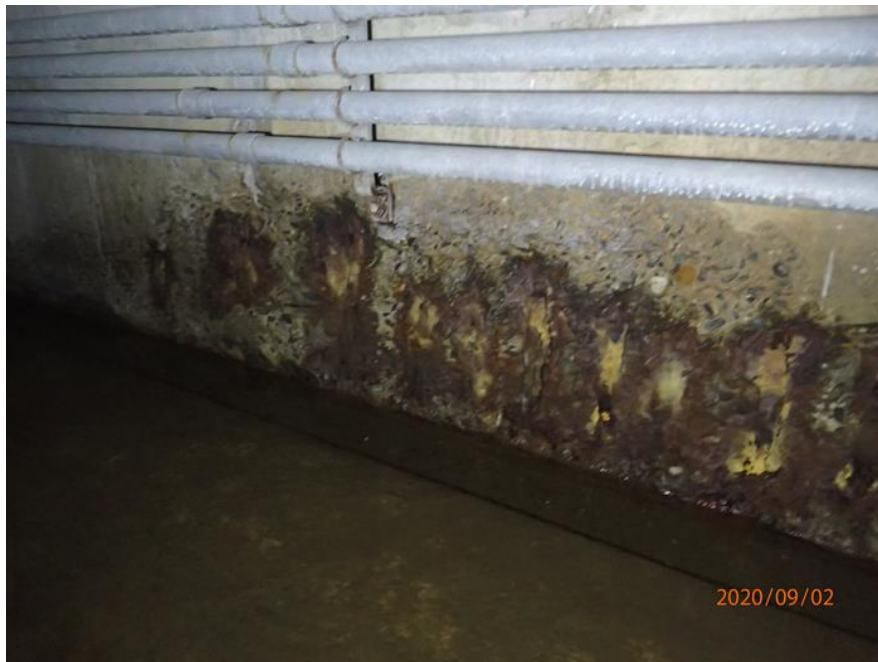
Station 39+60 to 39+75

Direction: Western Wall (In-Land)

Comments: Concrete Spalling, Re-Bar Exposed and Corroded

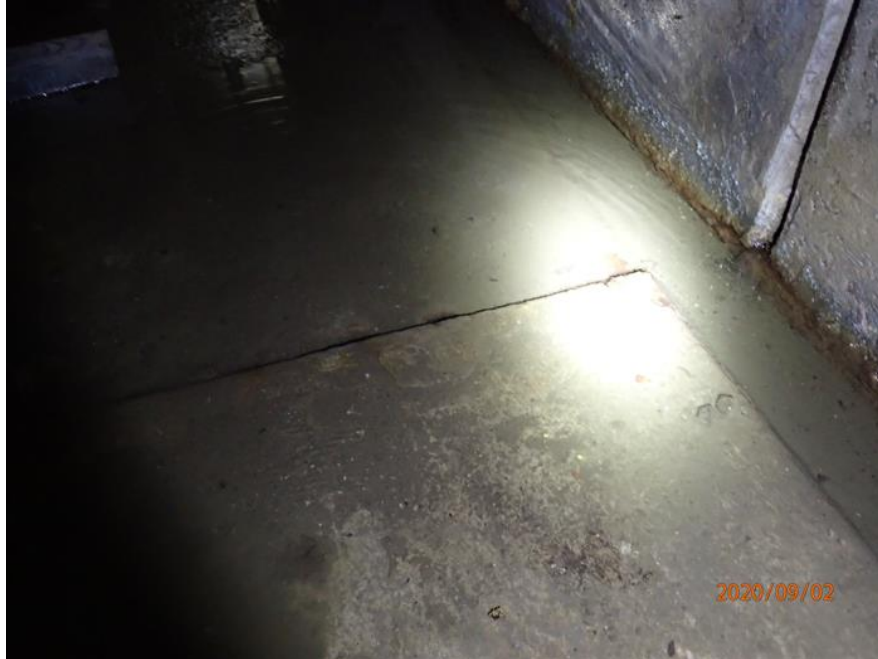
Station 39+90

Direction: Tunnel Joint (Floor and Wall)

Comments: Joint Separation, Floor Slab Raised at Joint

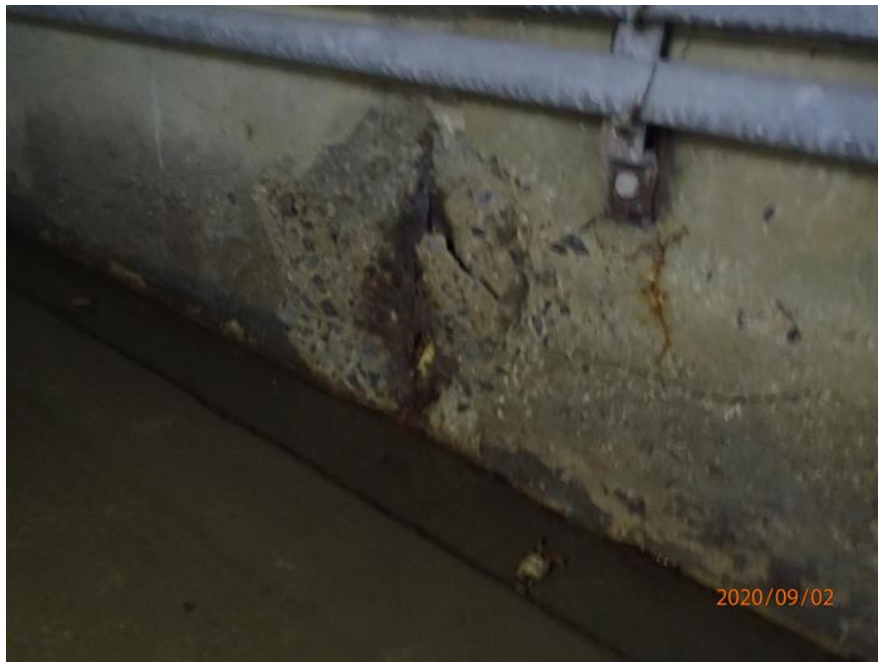
Station 40+02

Comments: Concrete Spalling, Re-Bar Exposed and Corroded

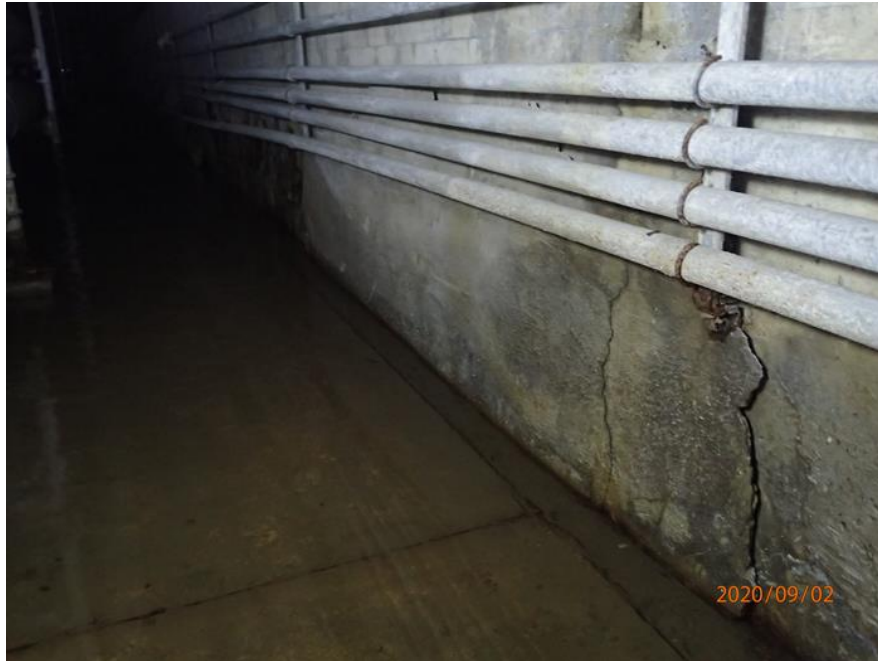
Station 40+50 to 41+90

Comments: Concrete Spalling, Loose Concrete, Re-Bar Exposed and Corroded

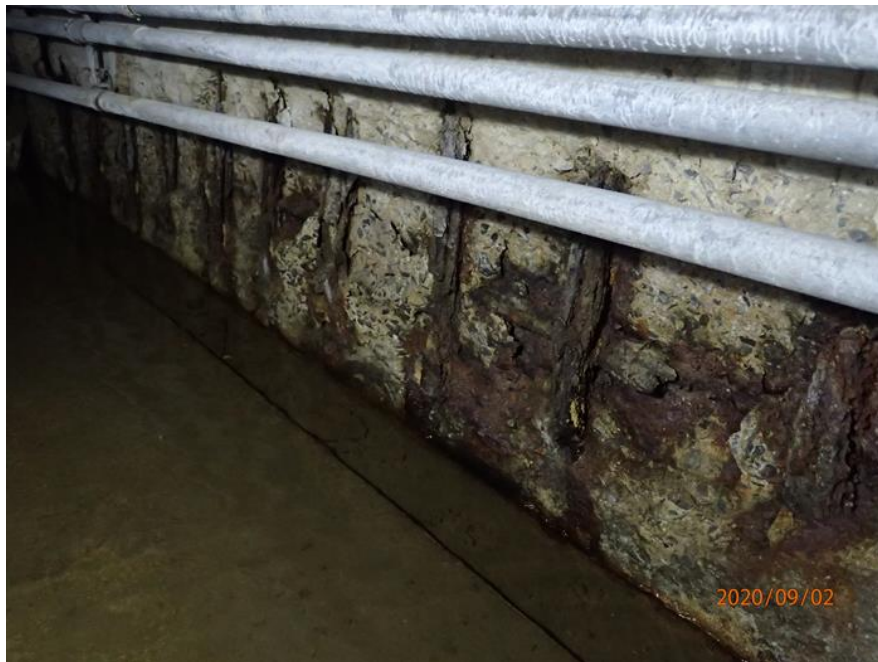
Station 40+50 to 41+90

Comments: Concrete Spalling, Loose Concrete, Re-Bar Exposed and Corroded

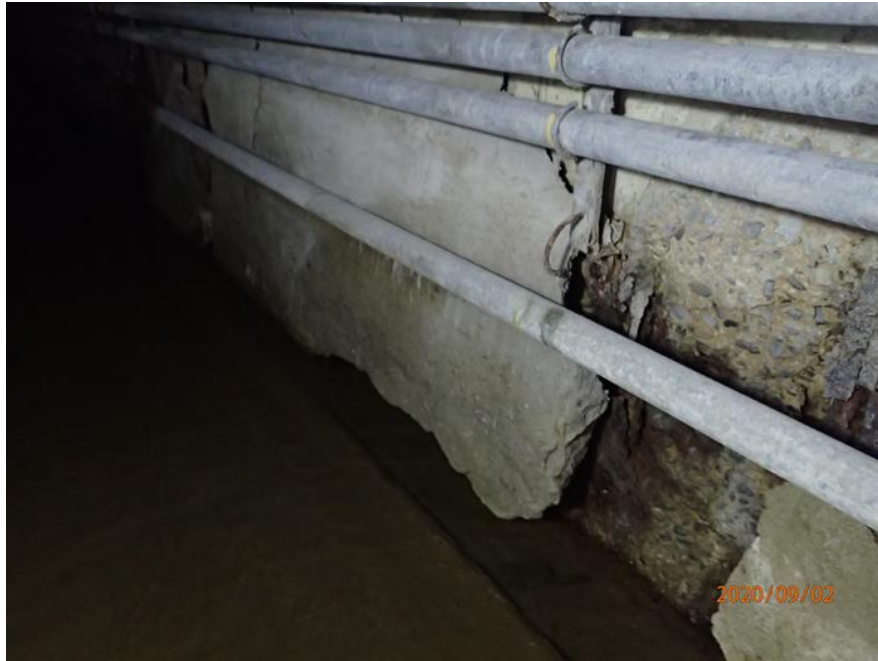
Station 40+50 to 41+90

Comments: Concrete Spalling, Loose Concrete, Re-Bar Exposed and Corroded
