CONDITIONS REPORT & CONCEPTUAL DESIGN MEMORANDUM

STEAM TUNNEL ASSESSMENT

ROOSEVELT ISLAND, NEW YORK

17 November 2014
Revised 28 December 2018
Revised 18 September 2020
Project # 100444601

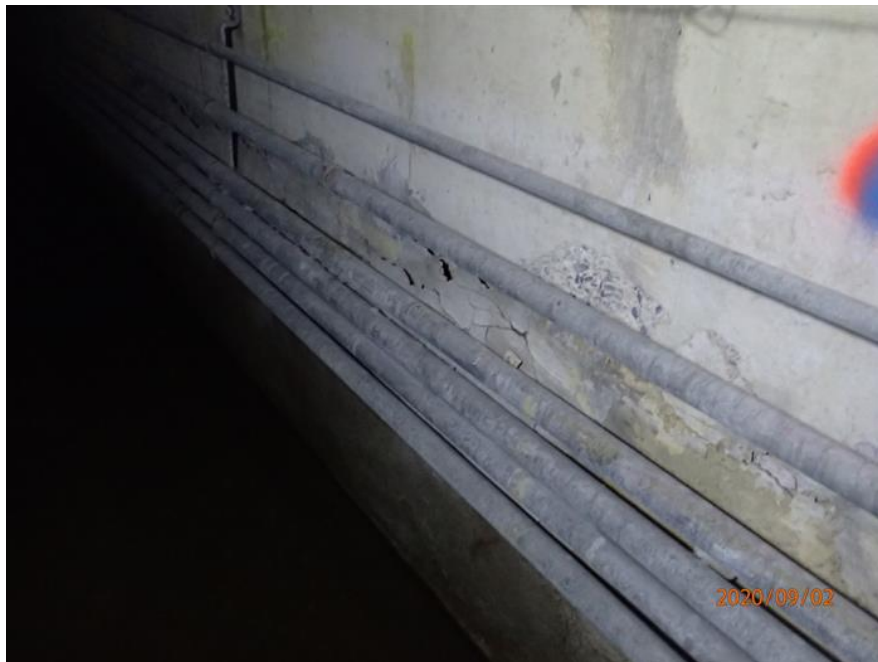
Station 40+50 to 41+90

Comments: Concrete Spalling, Loose Concrete, Re-Bar Exposed and Corroded

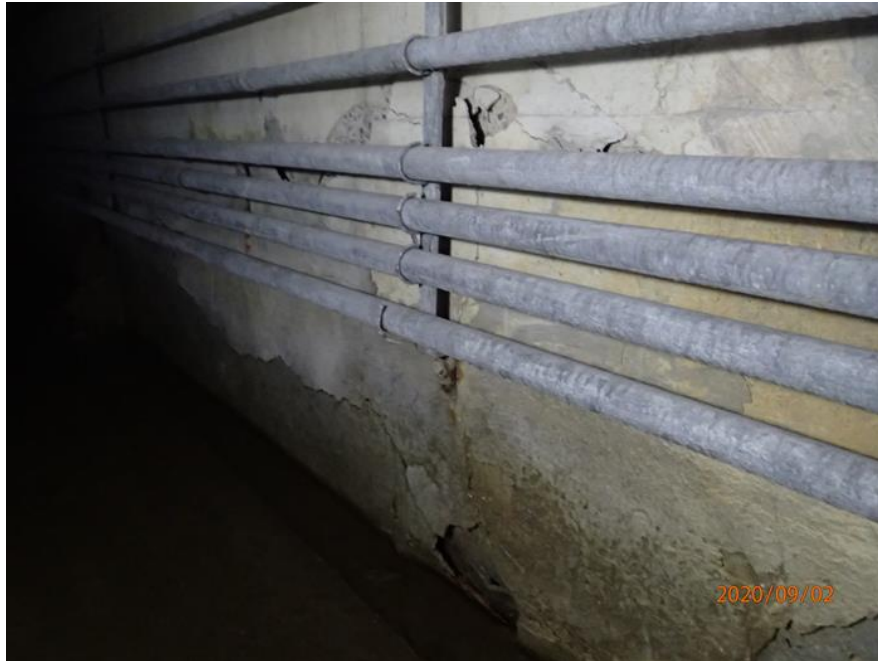
Station 40+50 to 41+90

Comments: Concrete Spalling, Loose Concrete, Re-Bar Exposed and Corroded

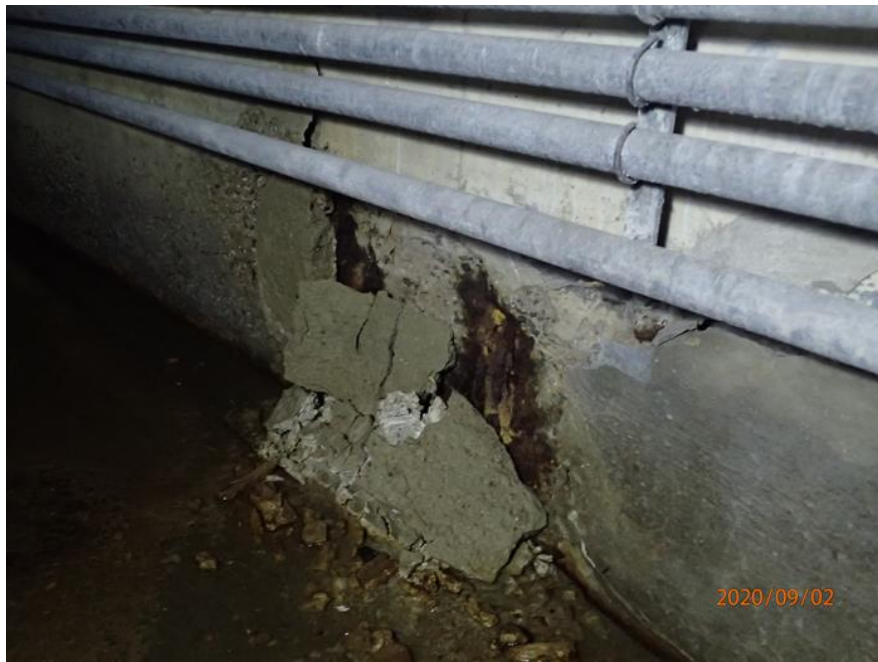
Station 40+50 to 41+90

Comments: Concrete Spalling, Loose Concrete, Re-Bar Exposed and Corroded

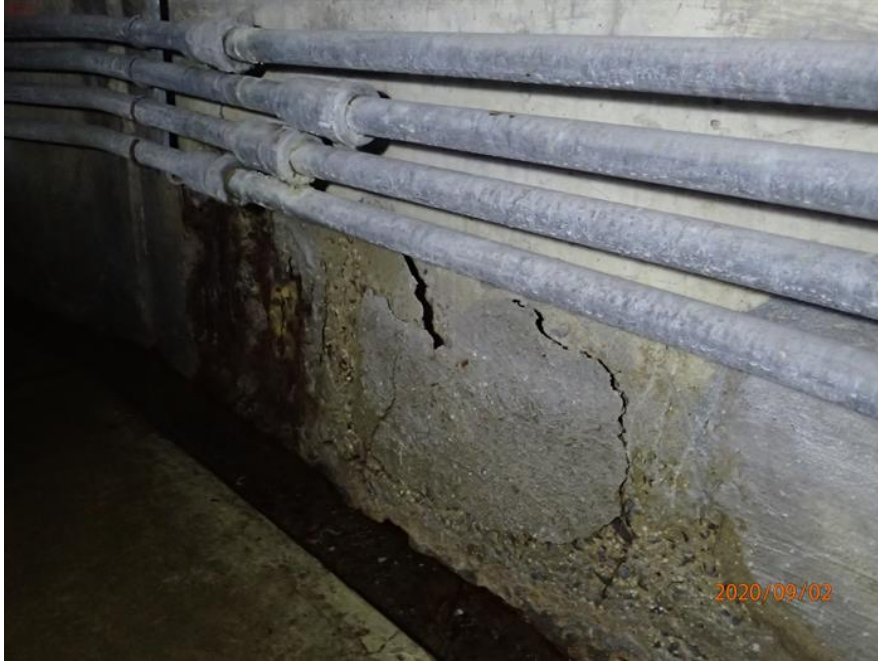
Station 40+50 to 41+90

Comments: Concrete Spalling, Loose Concrete, Re-Bar Exposed and Corroded

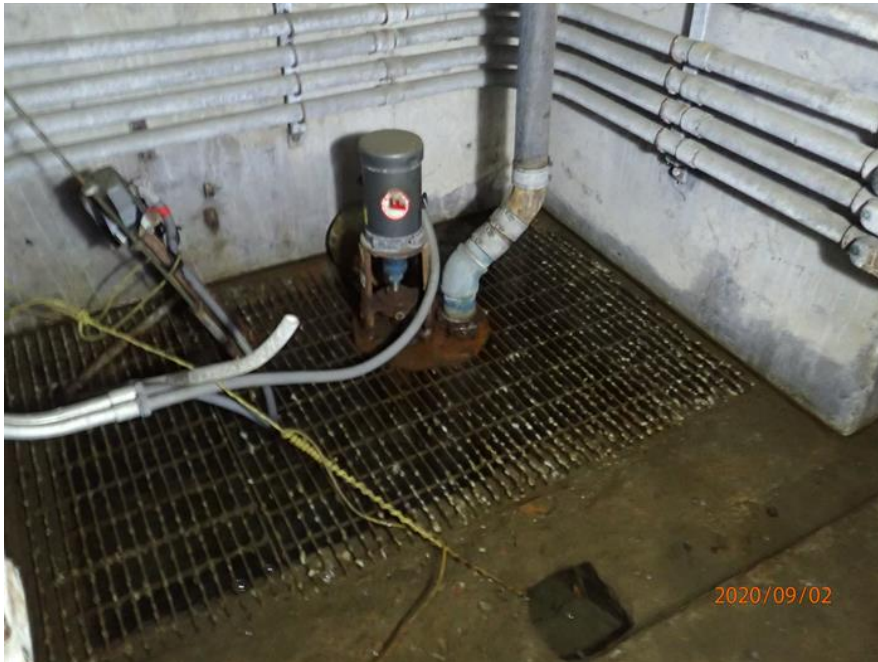
Station 42+18

Comments: Sump Pump - Not Working

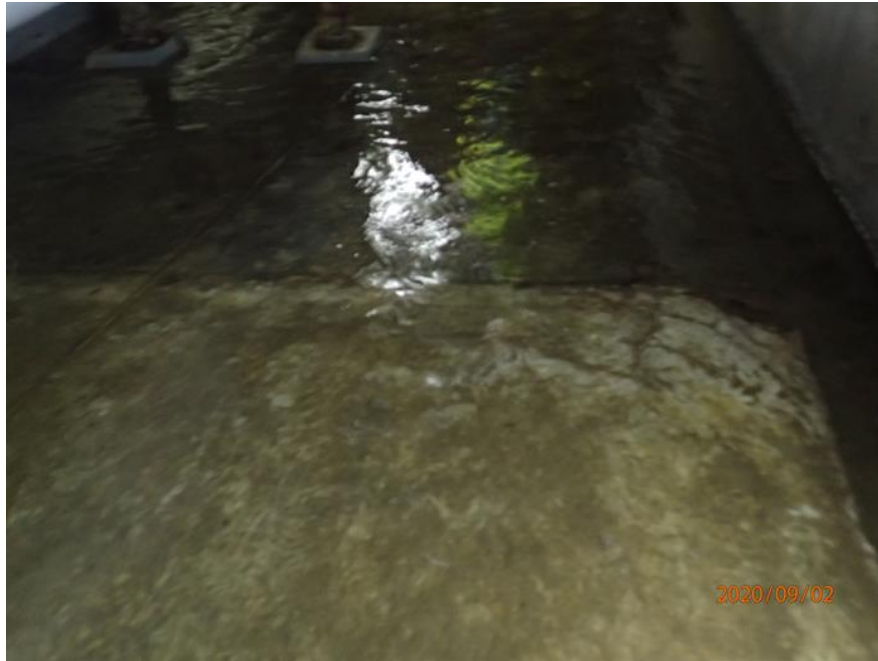
Station 42+75

Comments: Floor Slab Raised at Joint

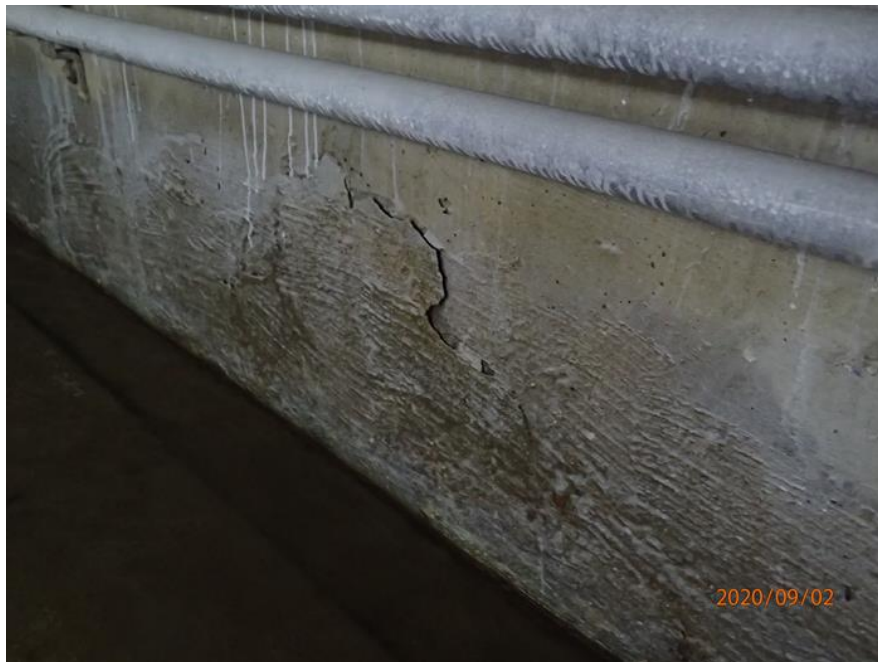
Station 43+00

Comments: Concrete Spalling

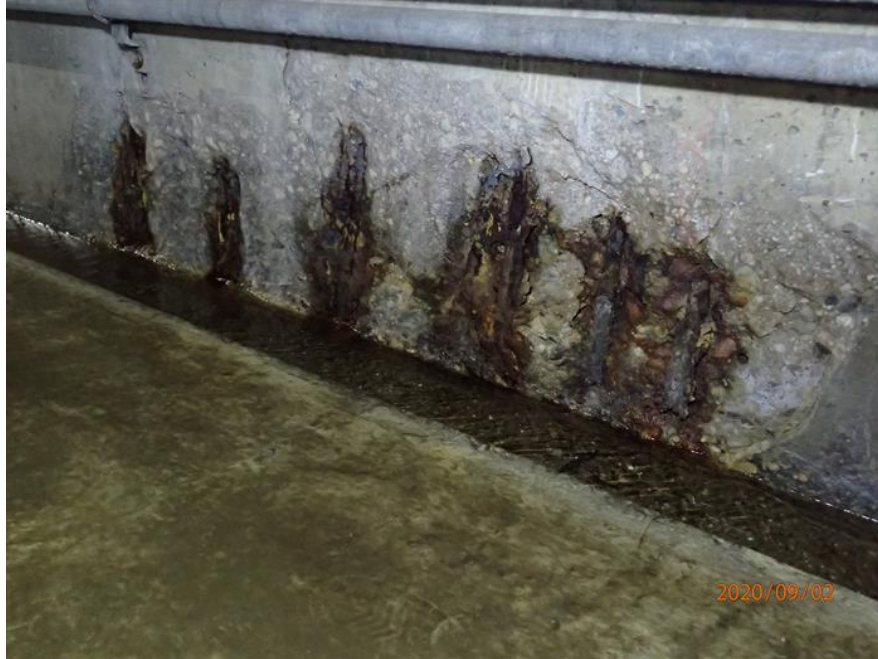
Station 45+00 to 45+05

Comments: Concrete Spalling, Loose Concrete

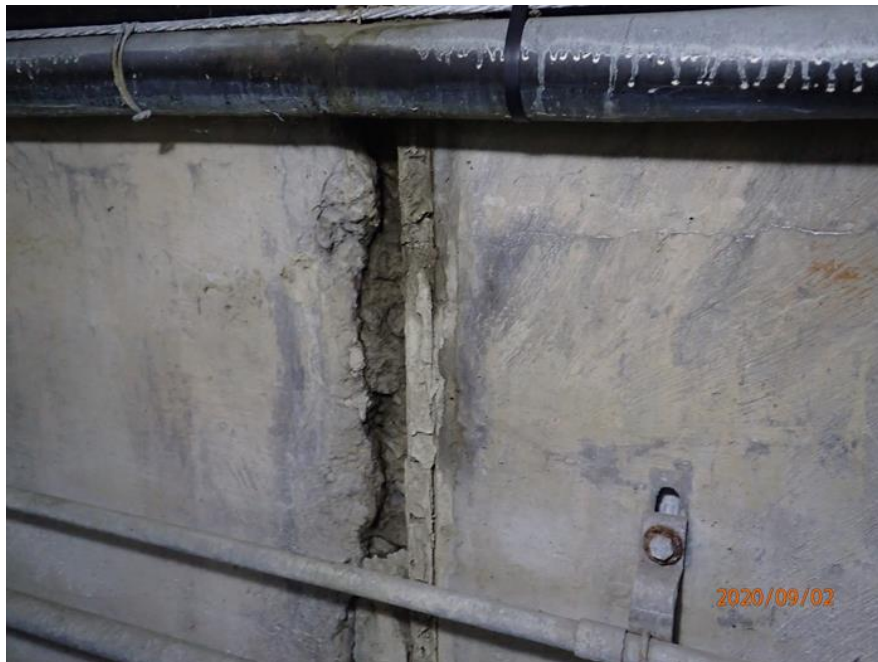
Station 45+35

Comments: Separation at Joint, Missing Concrete

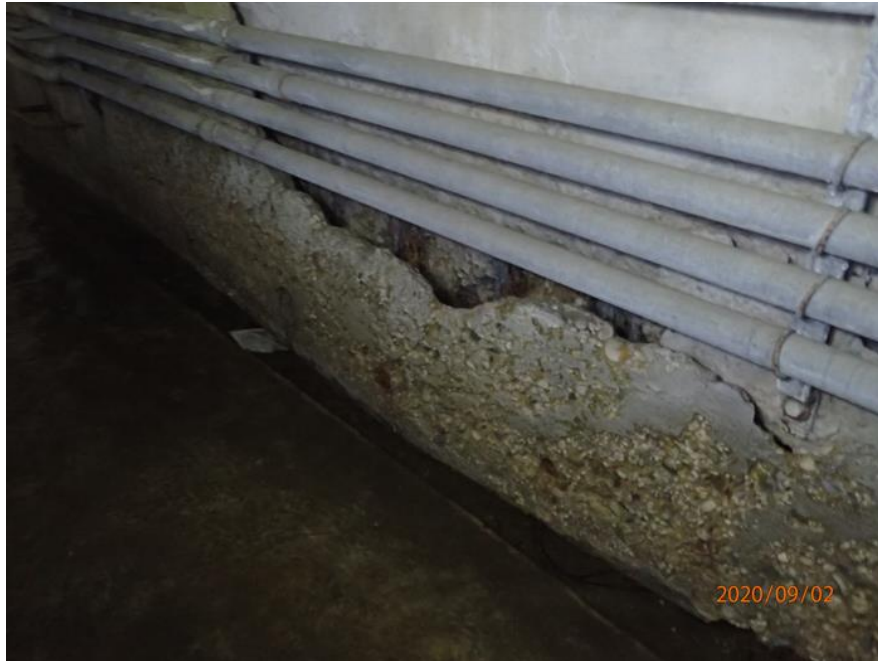
Station 45+35 to 45+50

Comments: Concrete Spalling, Loose Concrete

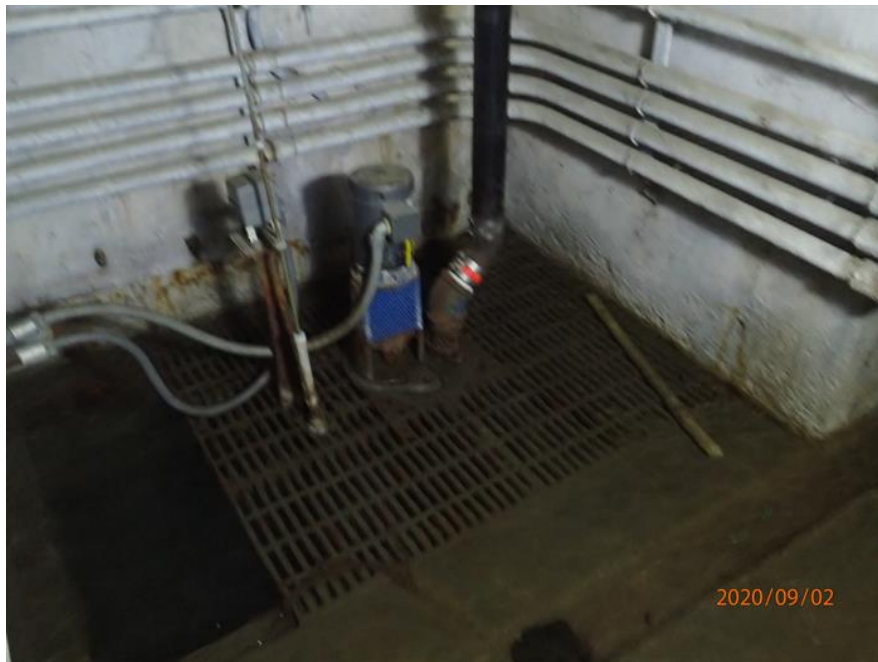
Station 45+34

Comments: Sump Pump - Not Working

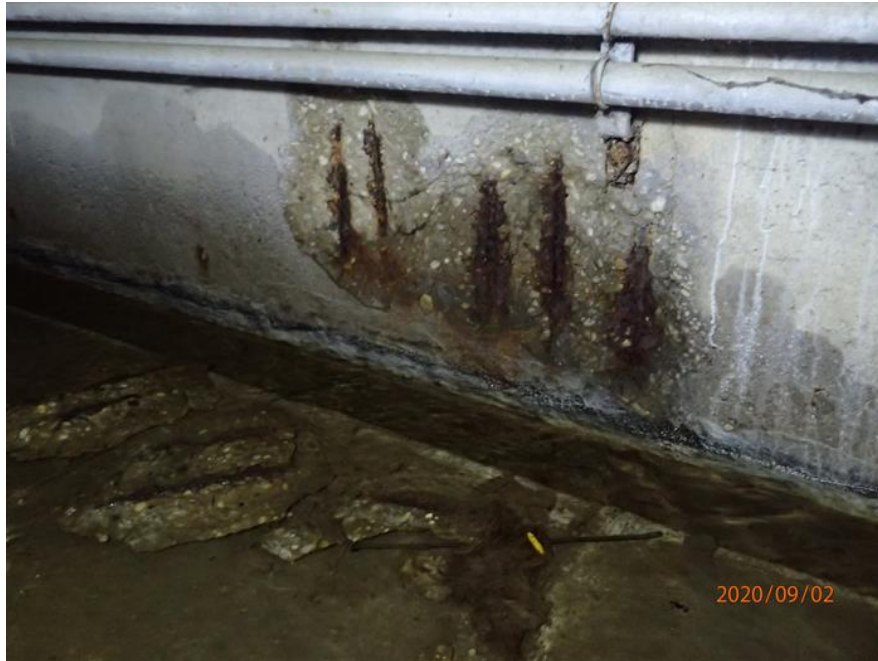
Station 45+60 to 45+65

Comments: Concrete Spalling, Re-Bar Exposed and Corroded

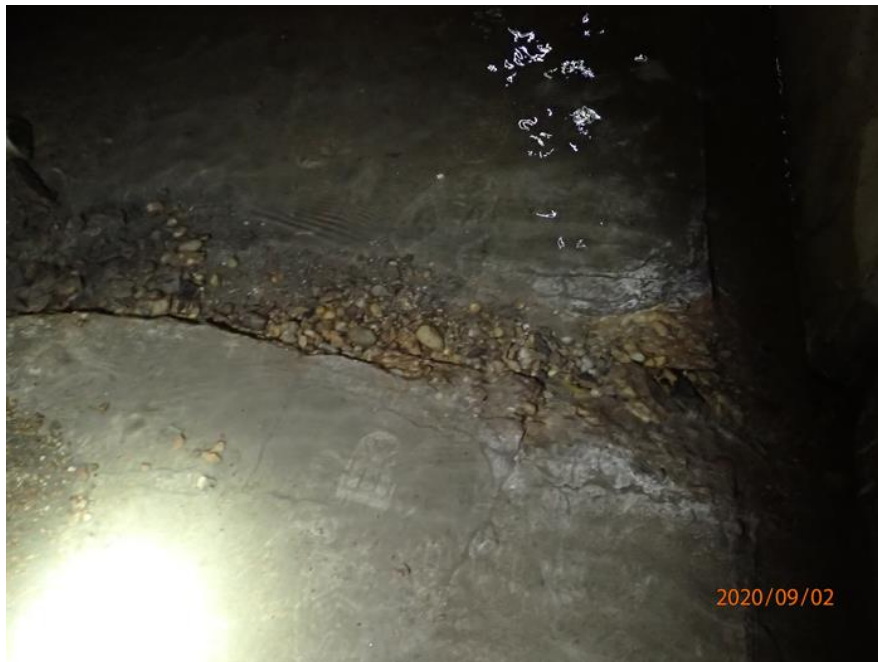
Station 45+95

Comments: Floor Slab Cracked, Concrete Spalling, Missing Concrete

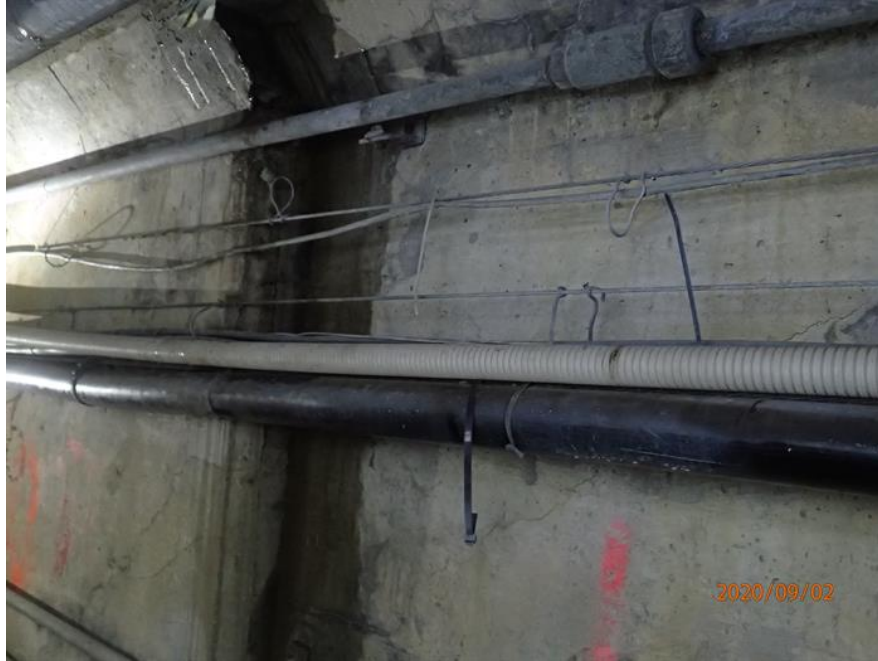
Station 45+95

Comments: Tunnel Displaced

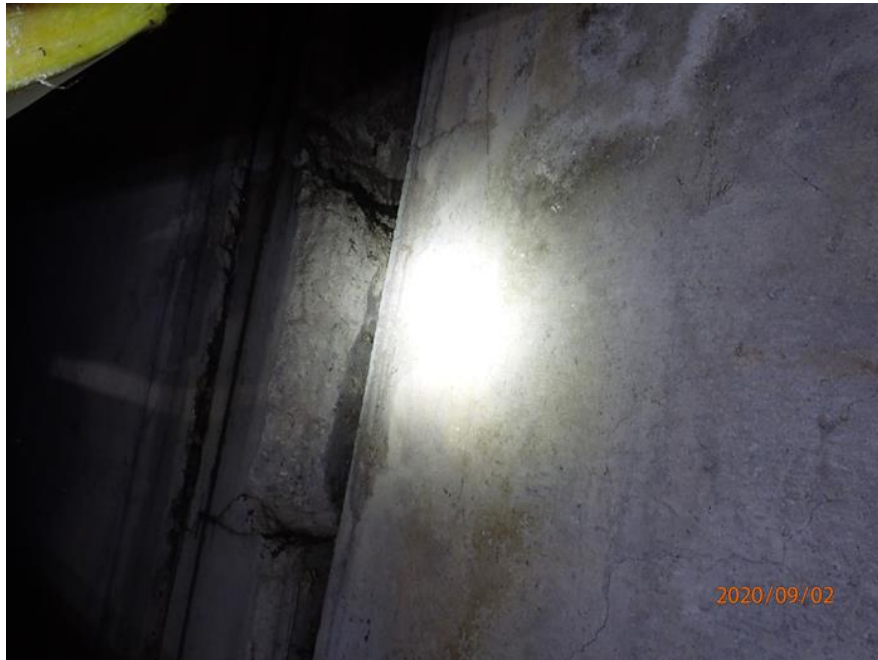
Station 45+95

Comments: Tunnel Displaced, Concrete Spalling

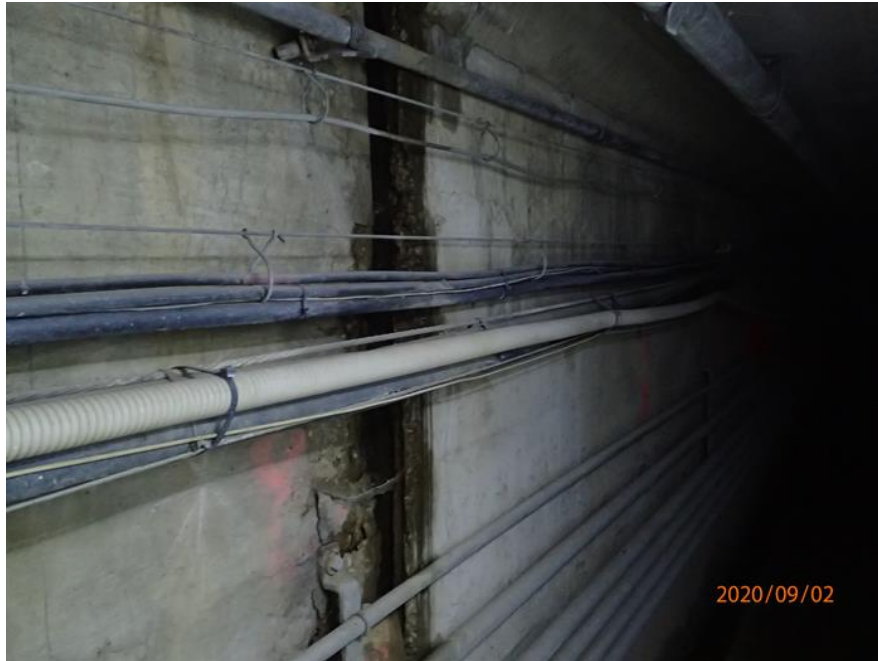
Station 46+60

Comments: Tunnel Displaced, Concrete Spalling

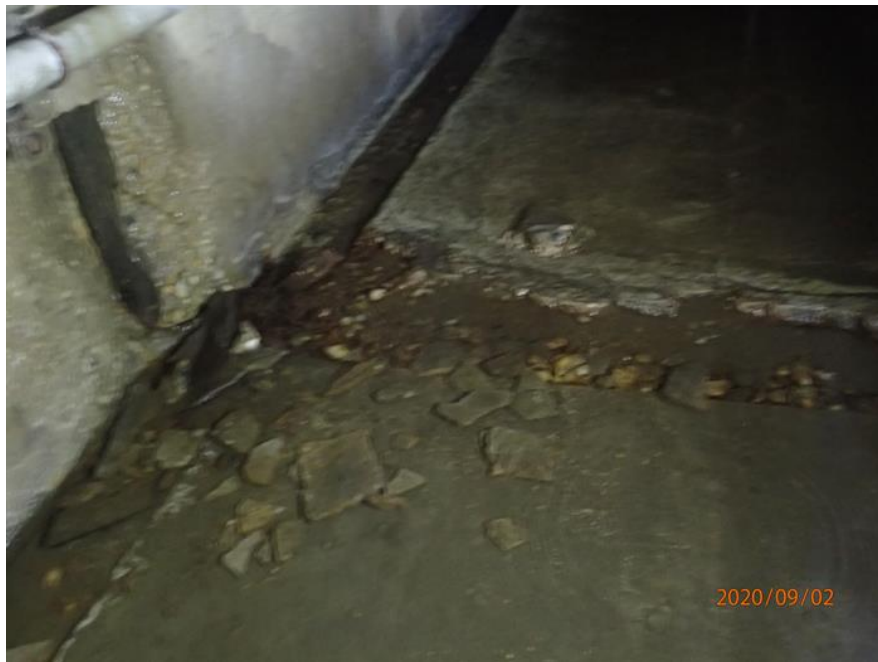
Station 46+60

Comments: Floor Slab Raised at Joint, Cracking, Loose Concrete

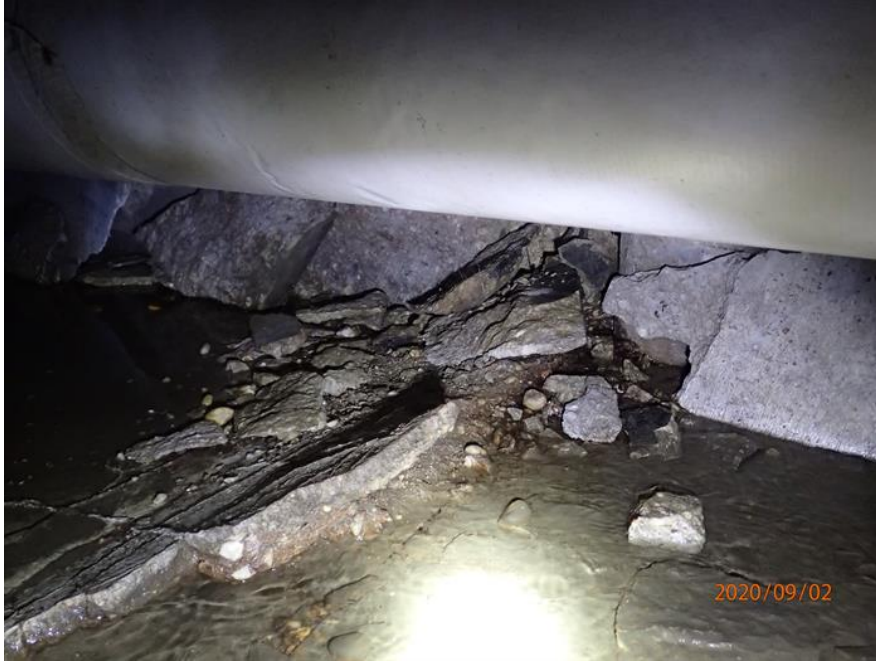
Station 46+60

Comments: Floor Slab Raised at Joint, Cracking, Loose Concrete

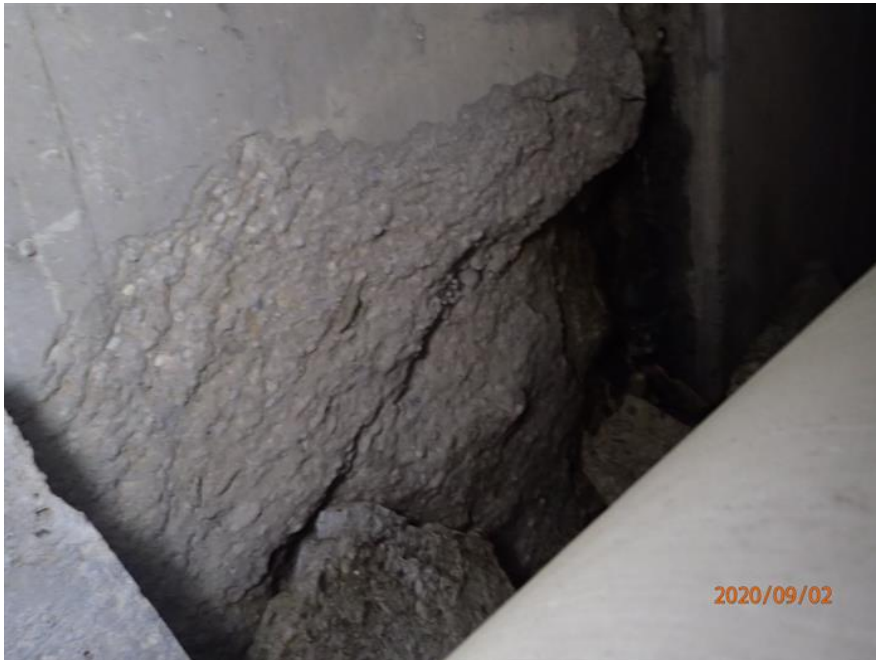
Station 46+60

Comments: Tunnel Displaced, Concrete Spalling, Loose Concrete

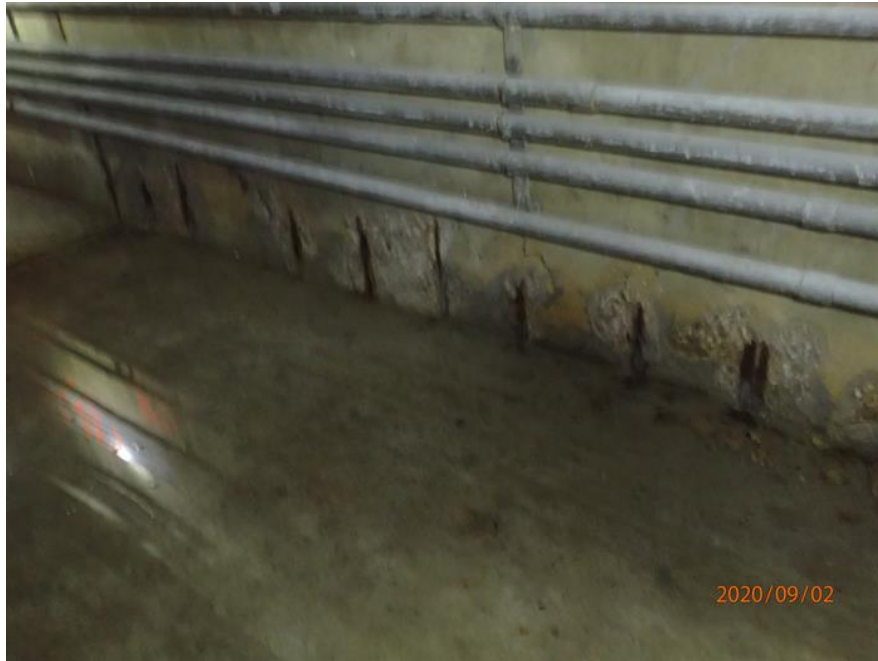
Station 49+10 to 49+20

Comments: Concrete Spalling

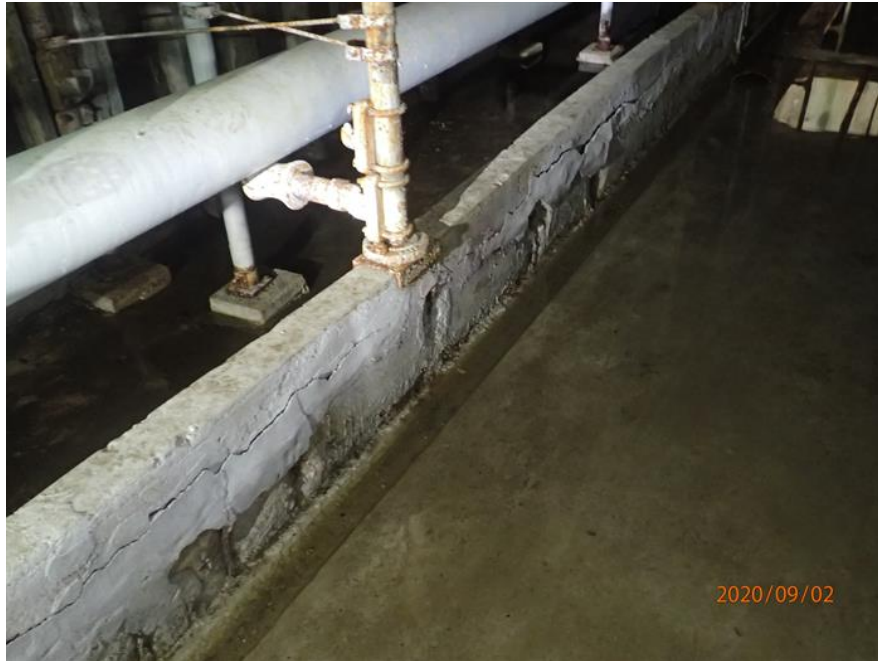
Station 49+10 to 51+75

Comments: Cracked, Missing Concrete on its Entirety

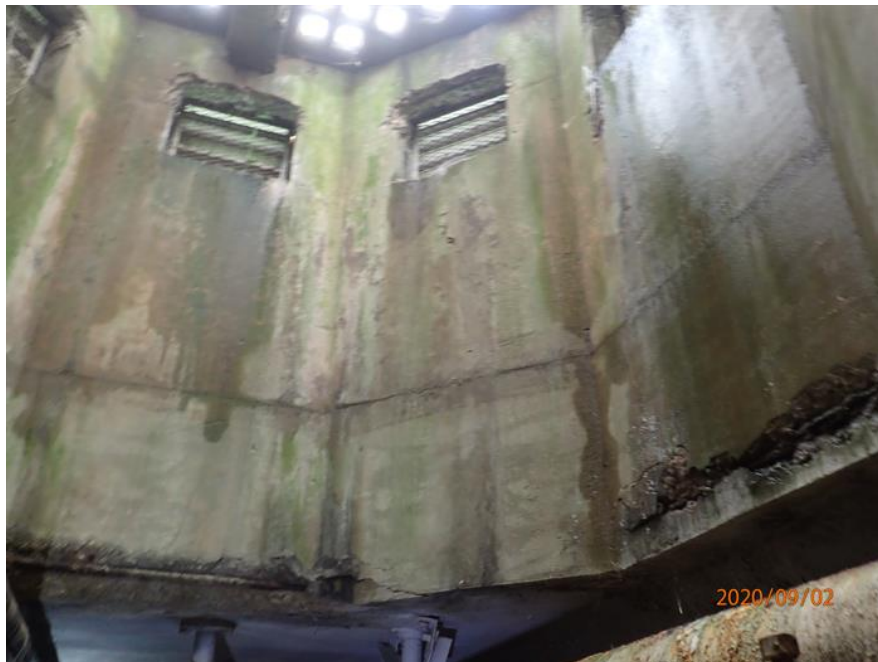
Station 49+20

Comments: Air Vent 2A; Concrete Spalling, Re-Bar Exposed and Corroded

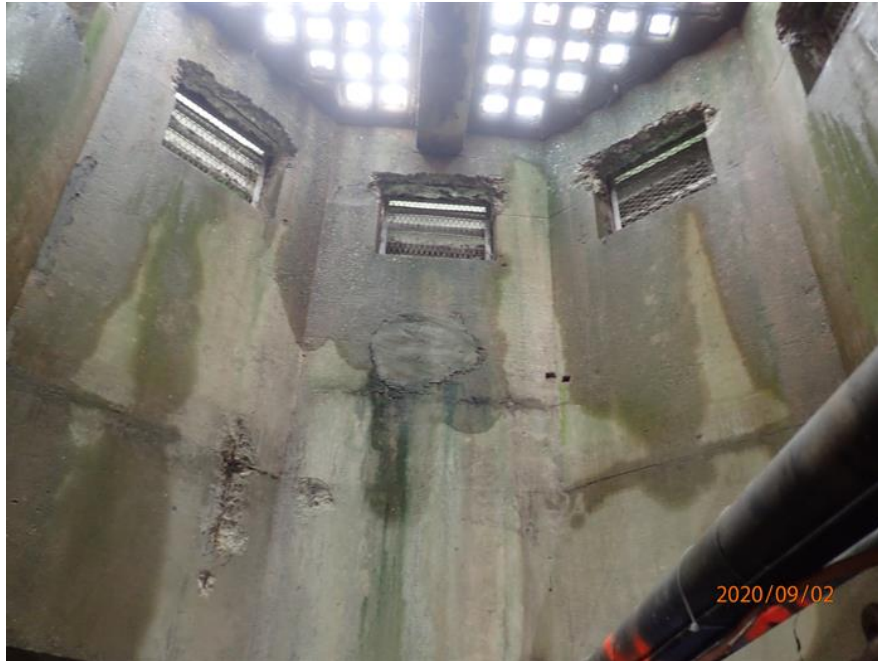
Station 49+20

Comments: Air Vent 2A; Concrete Spalling, Re-Bar Exposed and Corroded

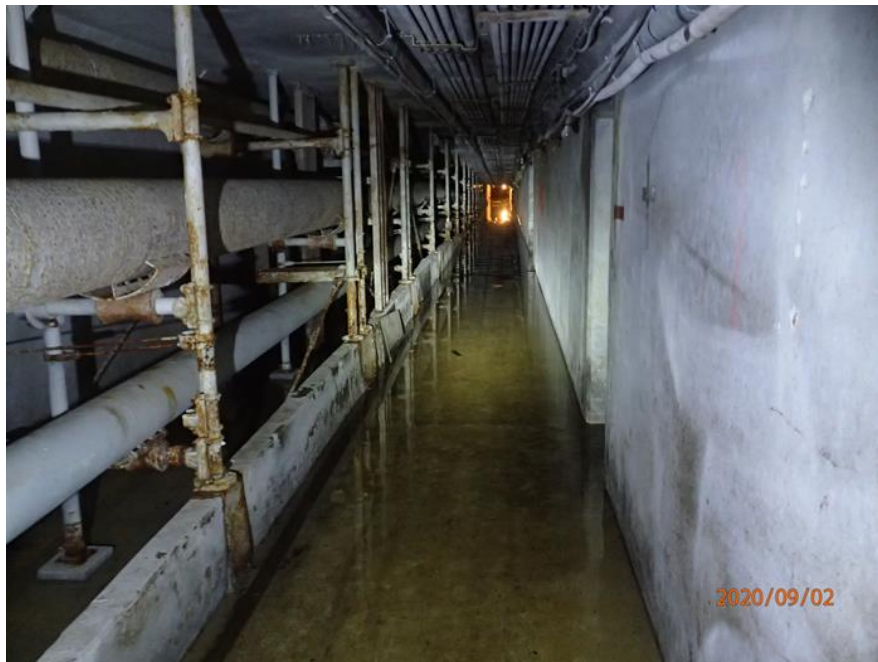
Station 50+00 to 61+50

Comments: Water Observed in the Tunnel, Tunnel Inaccessible

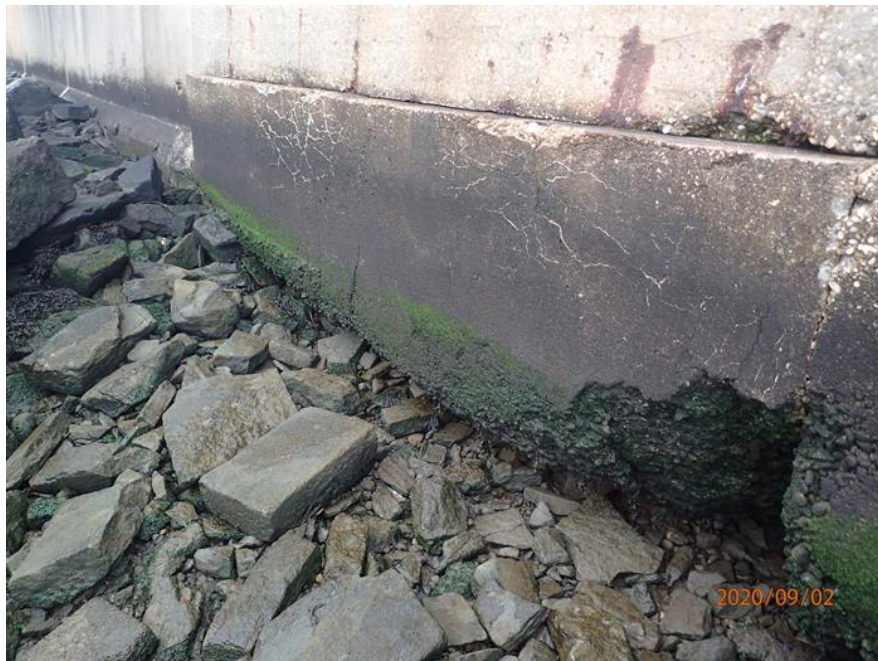
Station Before Tunnel

Comments: Spalling at Haunch, Missing Large Sections of Concrete, Rip-rap Deficiency, Seawall Undermined

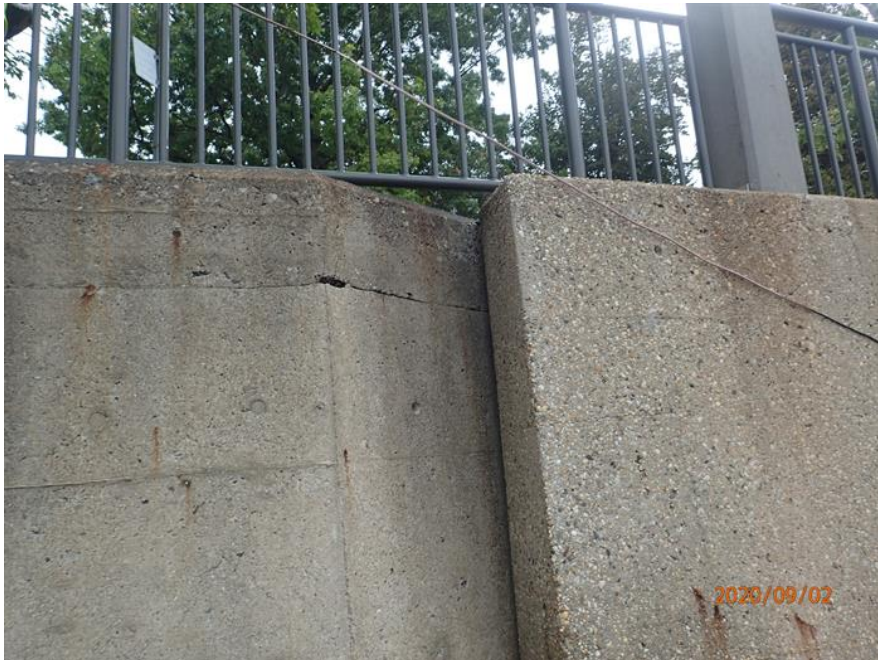
Station 5+18

Comments: Gap Between Steam Tunnel and Seawall

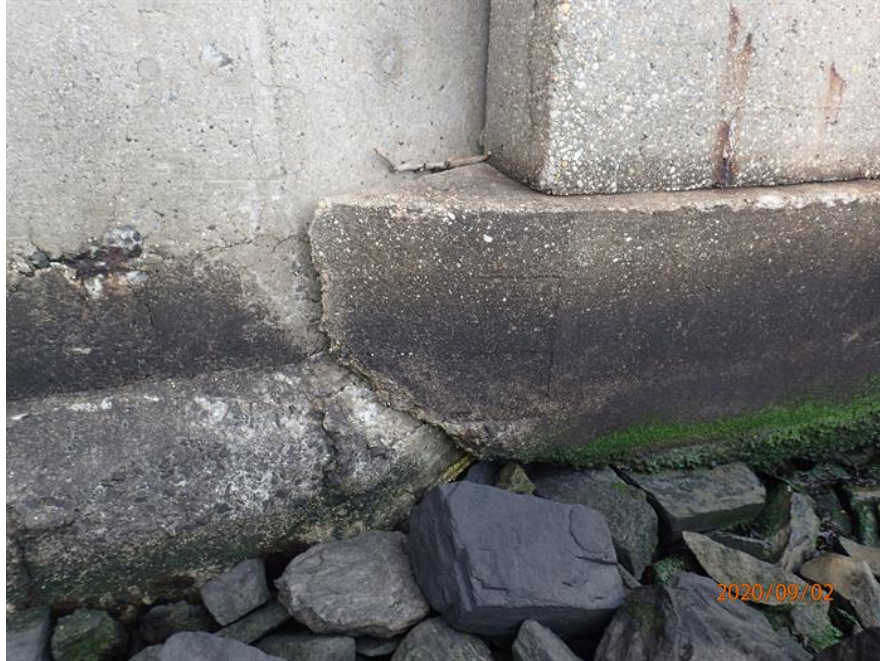
Station 5+18

Comments: Gap Between Steam Tunnel and Seawall

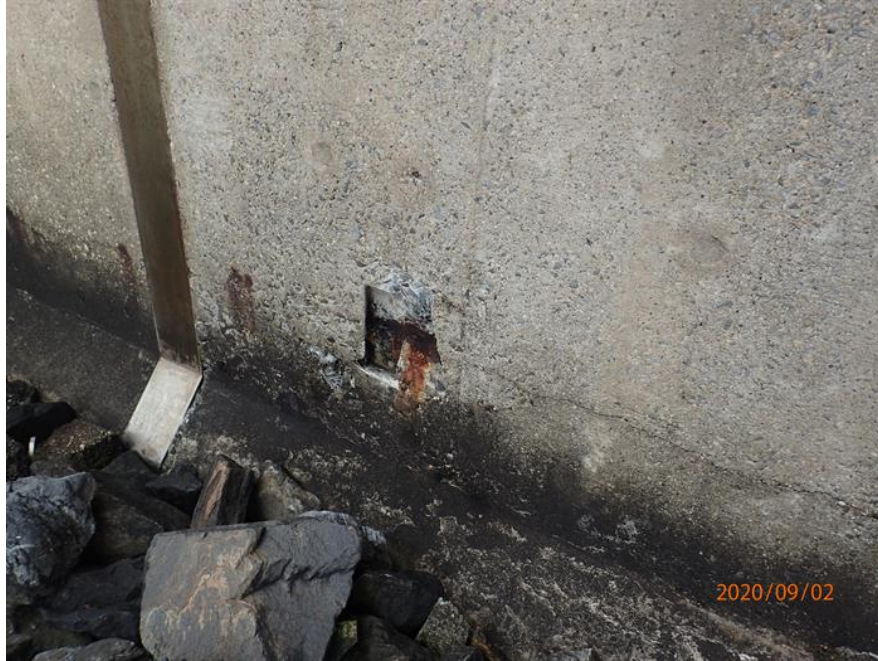
Station 5+60

Comments: Concrete Spalling

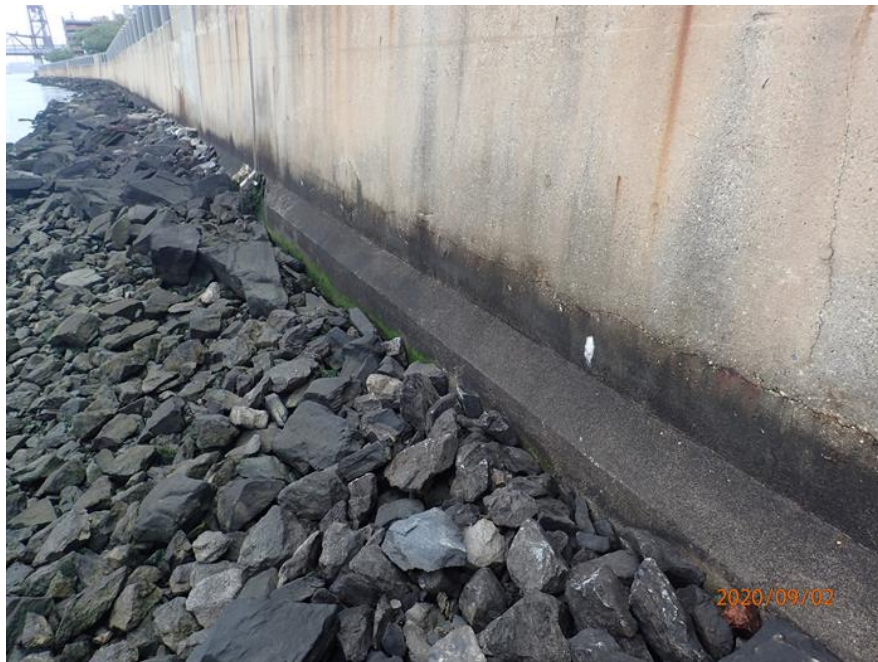
Station 5+60 to 5+94

Comments: Concrete Spalling, Concrete Cracks, Rip-rap Deficiency

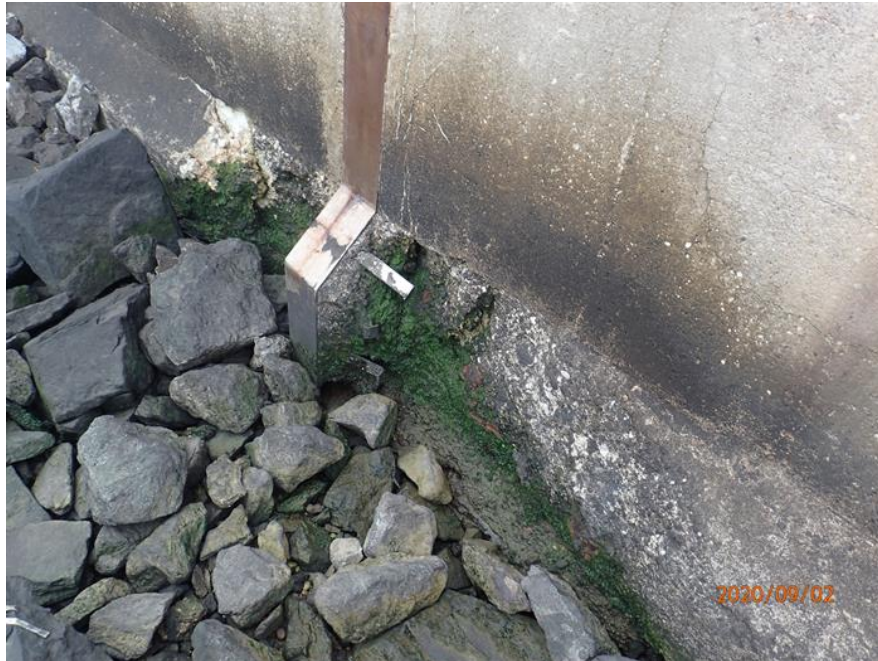
Station 5+94

Comments: Concrete Cracks, Imbedded Wood Missing

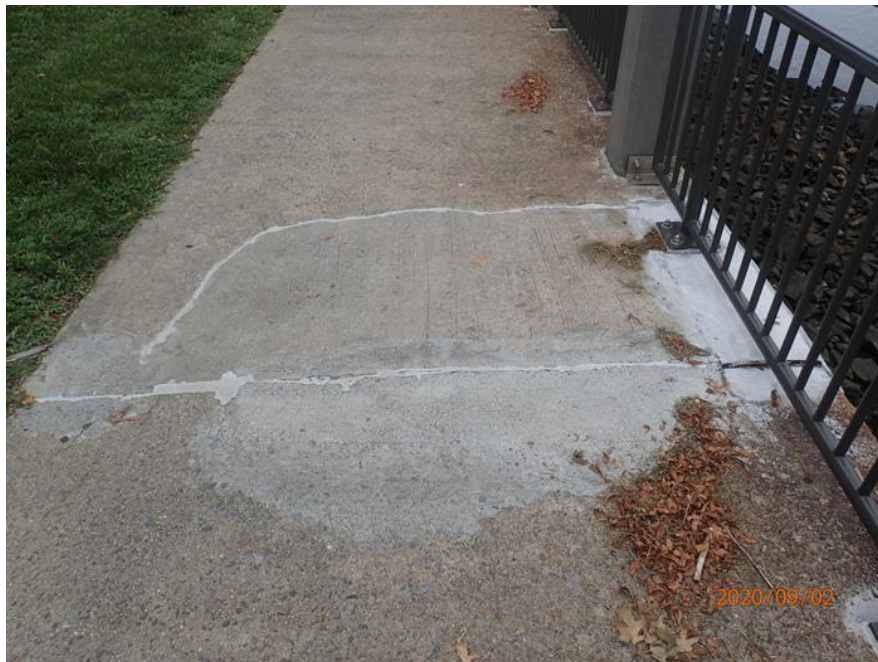
Station 6+06

Comments: Concrete Spalling and Repair

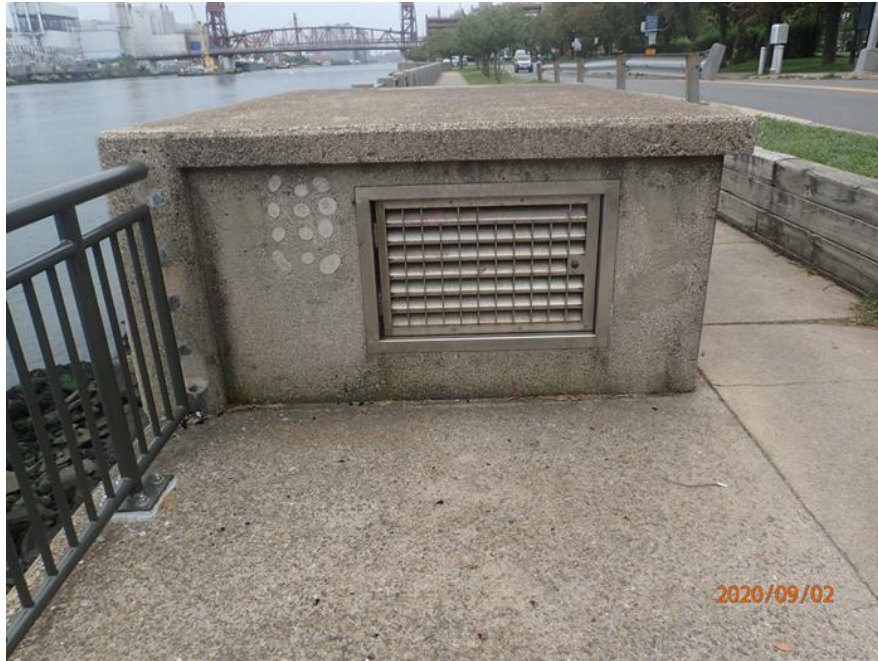
Station 6+16

Comments: Northern Face

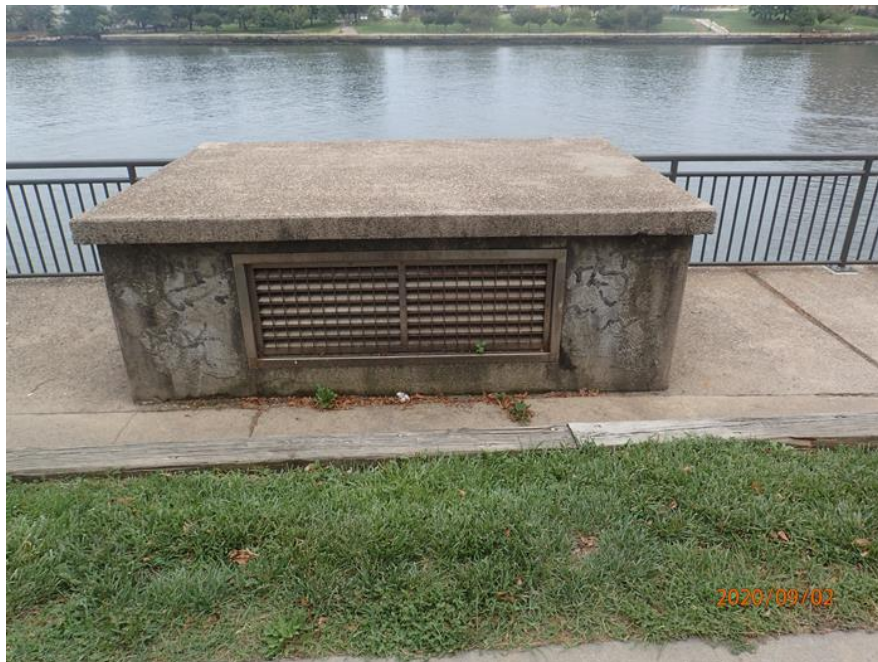
Station 6+16

Comments: Western Face

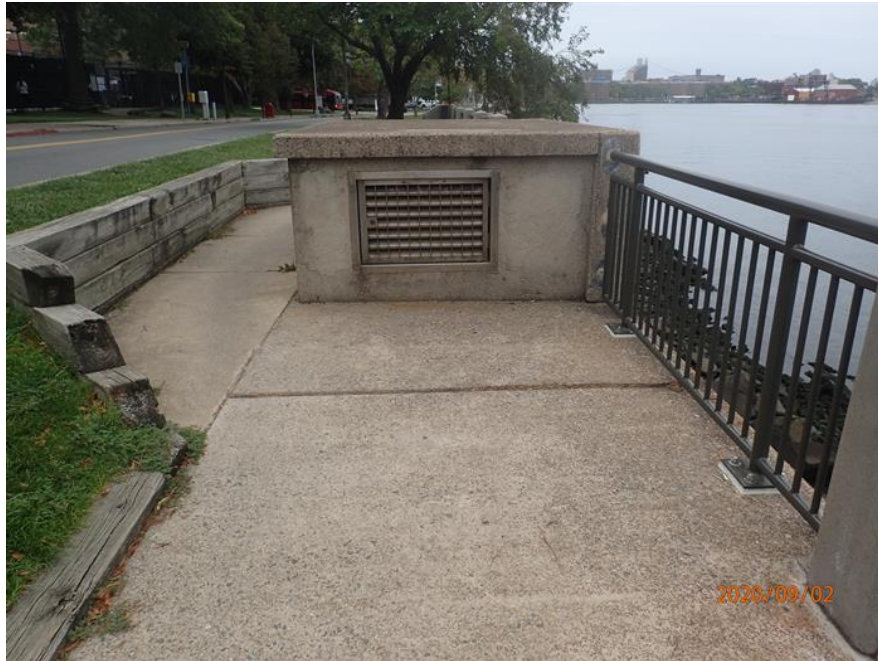
Station 6+16

Comments: Sothern Face

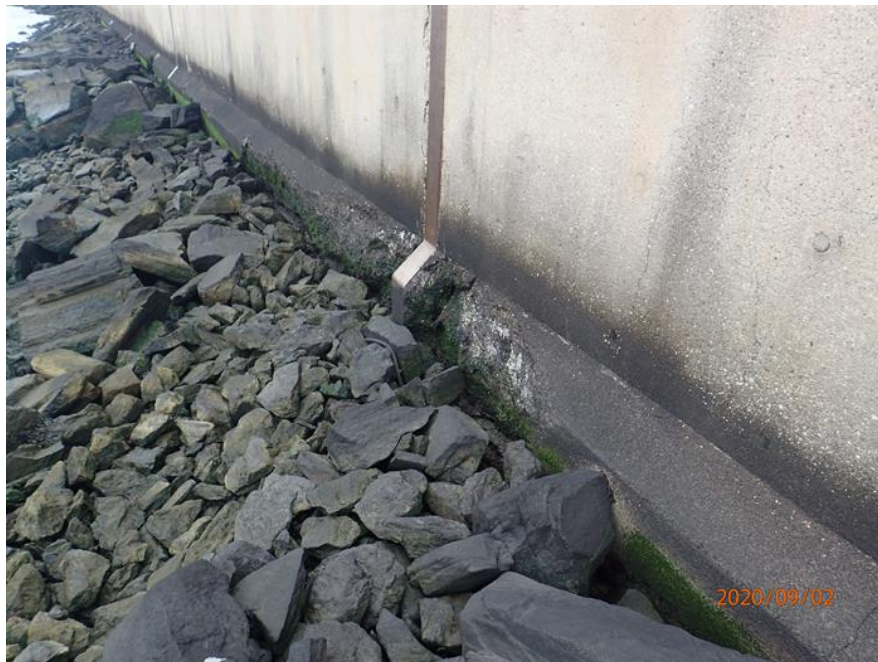
Station 6+60

Comments: Spalling at Haunch, Missing Large Sections of Concrete, Tunnel Undermined

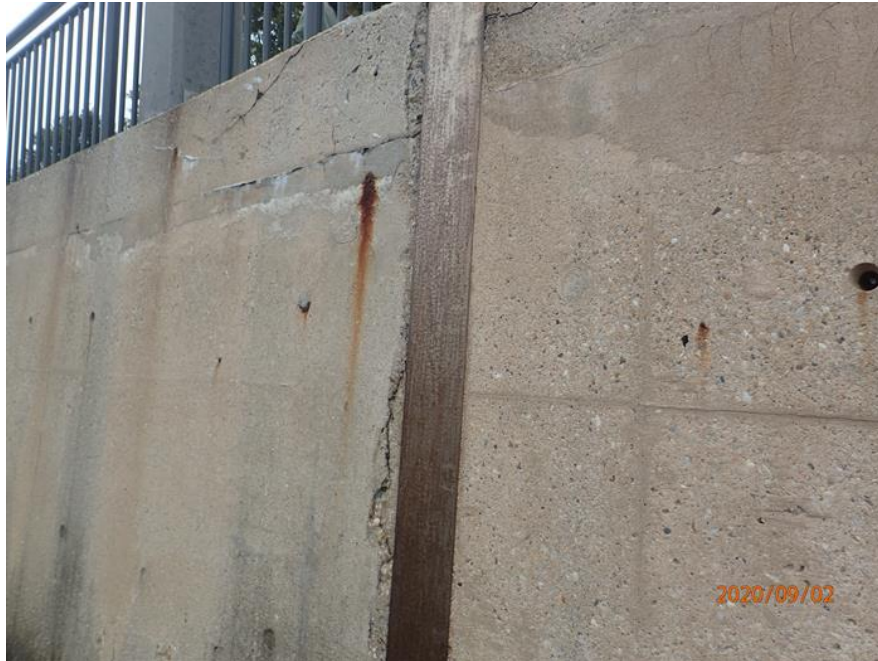
Station 6+60

Comments: Spalling at Haunch, Missing Large Sections of Concrete

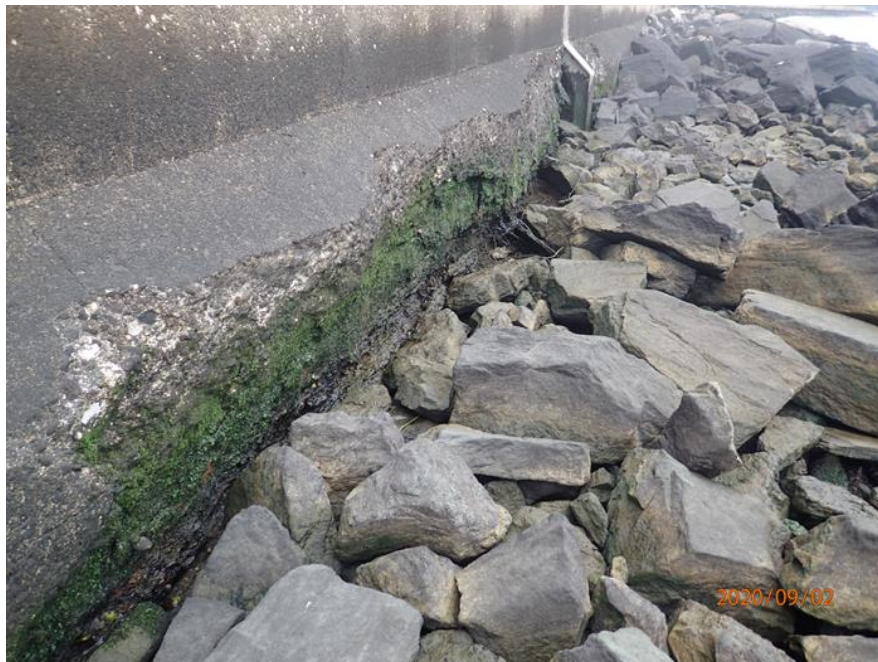
Station 6+60

Comments: Spalling at Haunch, Missing Large Sections of Concrete, Tunnel Undermined, Rip-rap Deficiency

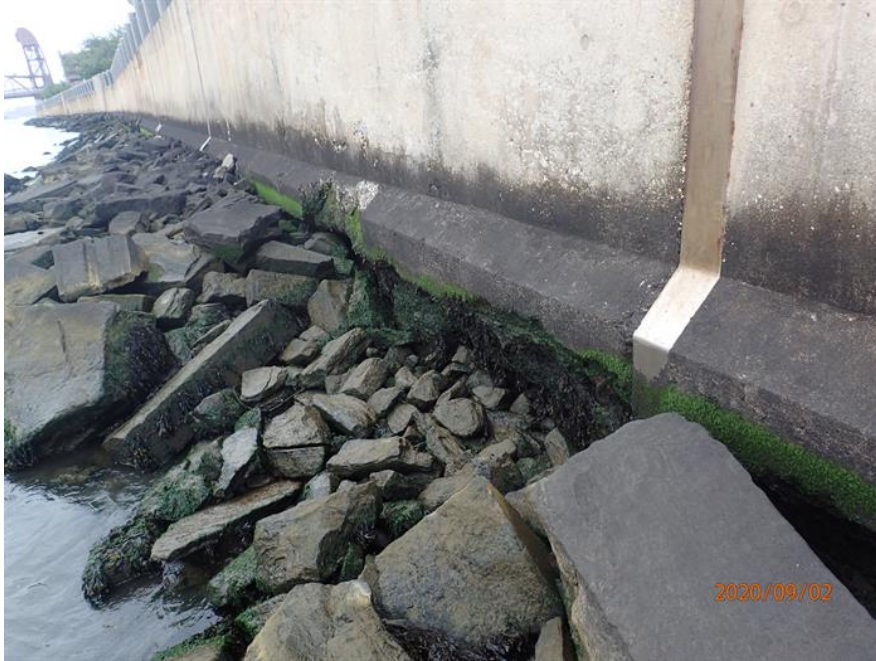
Station 6+96

Comments: Missing Rip-Rap, Tunnel Undermined, Rip-rap Deficiency
