CONDITIONS REPORT & CONCEPTUAL DESIGN MEMORANDUM

STEAM TUNNEL ASSESSMENT

ROOSEVELT ISLAND, NEW YORK

17 November 2014
Revised 28 December 2018
Revised 18 September 2020
Project # 100444601

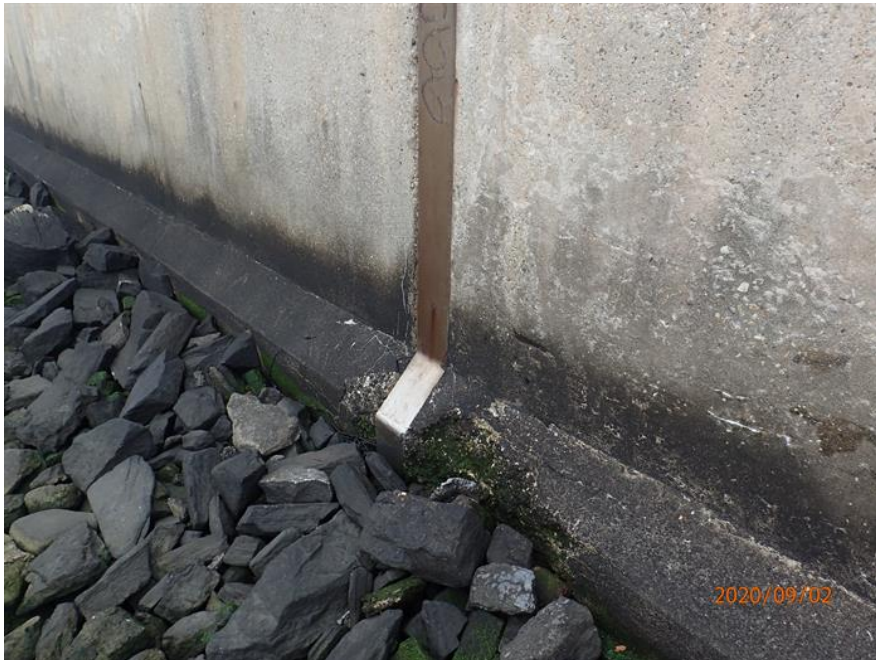
Station 7+26

Comments: Spalling at Haunch, Missing Large Sections of Concrete

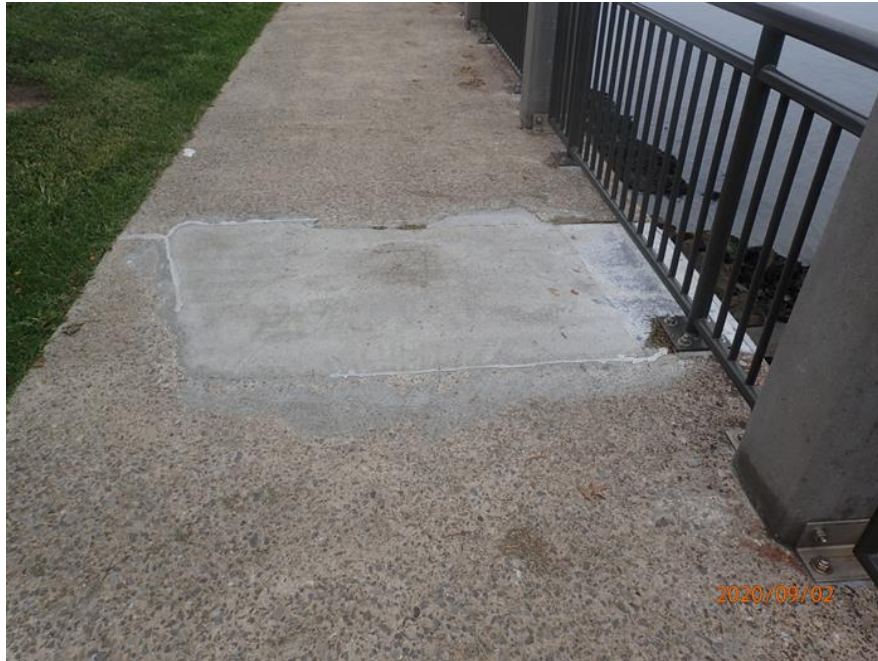
Station 7+26

Comments: Concrete Spalling and Repair

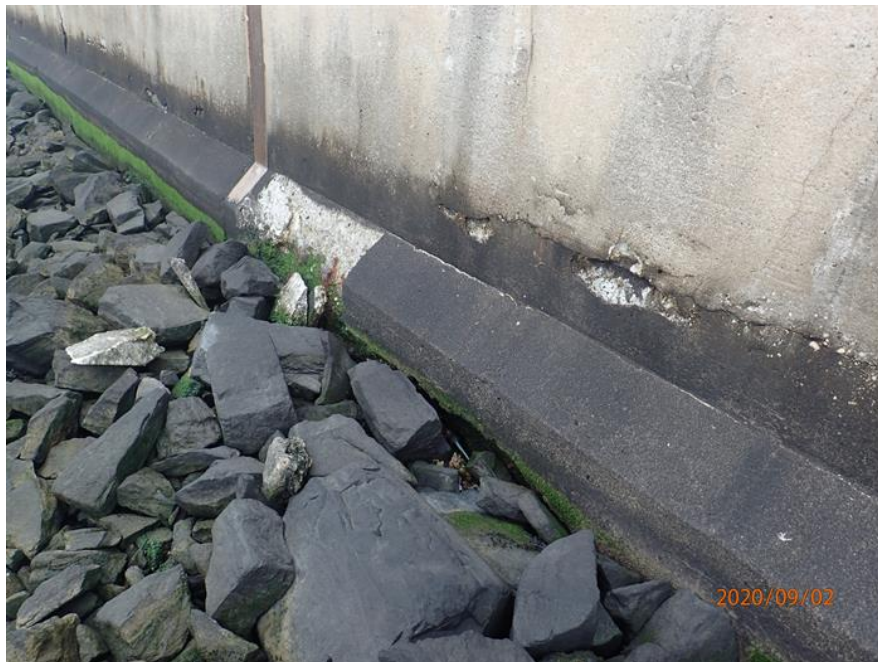
Station 7+86

Comments: Spalling at Haunch, Missing Large Sections of Concrete, Tunnel Undermined, Rip-rap Deficiency

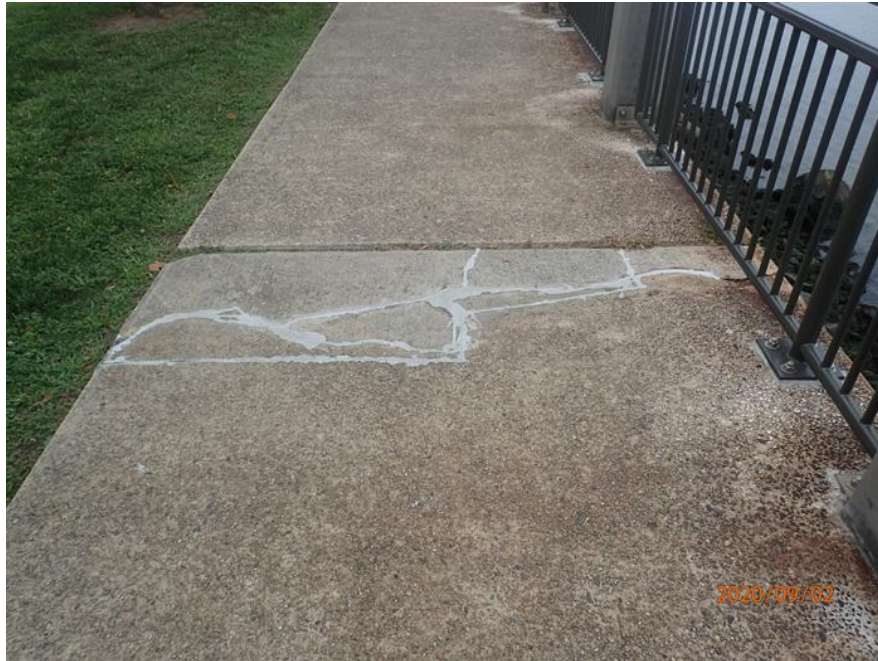
Station 7+96

Comments: Concrete Cracks, Attempt to Repair

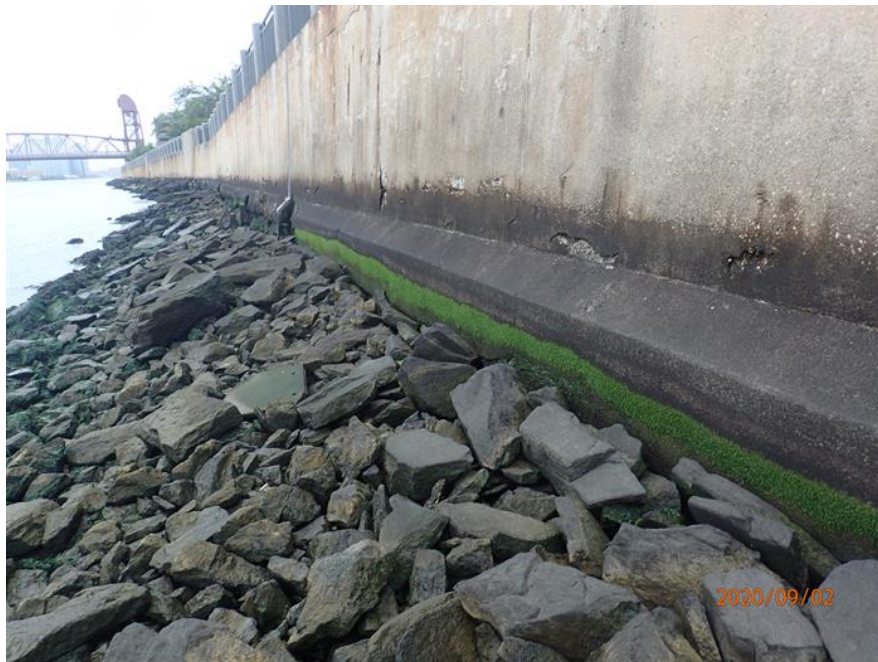
Station 7+99

Comments: Missing Rip-Rap, Tunnel Undermined

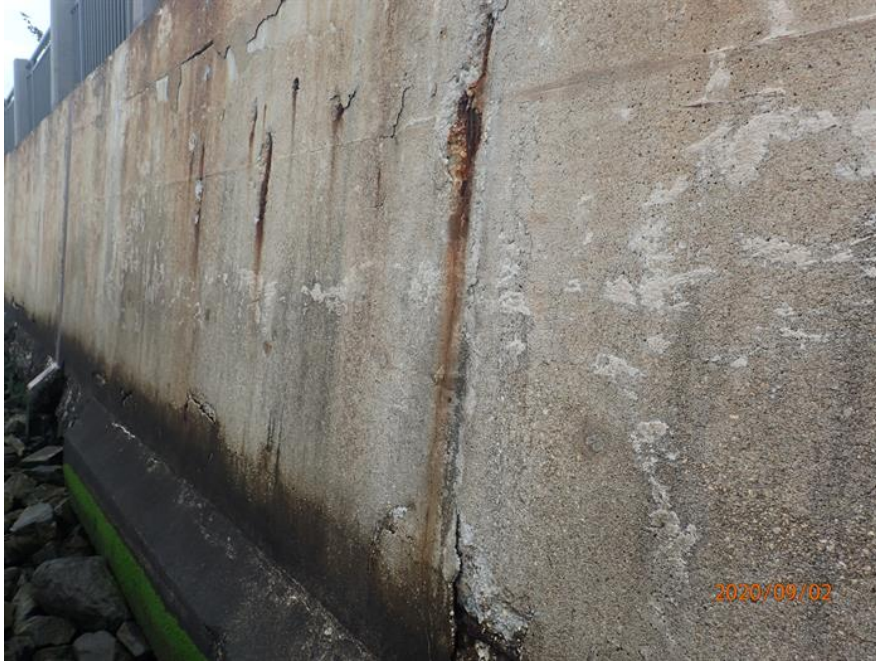
Station 8+05

Comments: Concrete Spalling, Missing Large Section of Concrete, Re-Bar Exposed

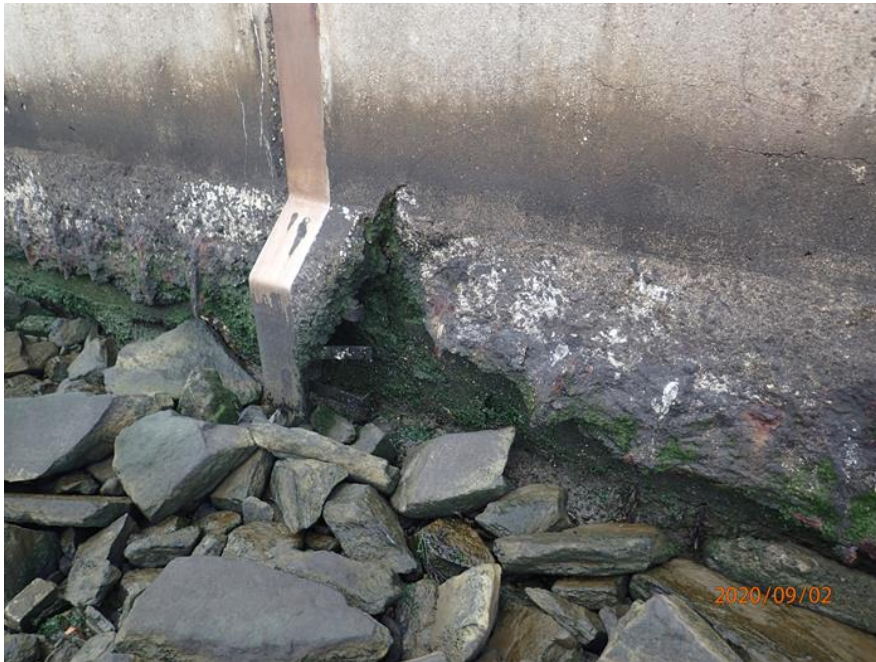
Station 8+49

Comments: Spalling at Haunch, Missing Large Sections of Concrete, Tunnel Undermined

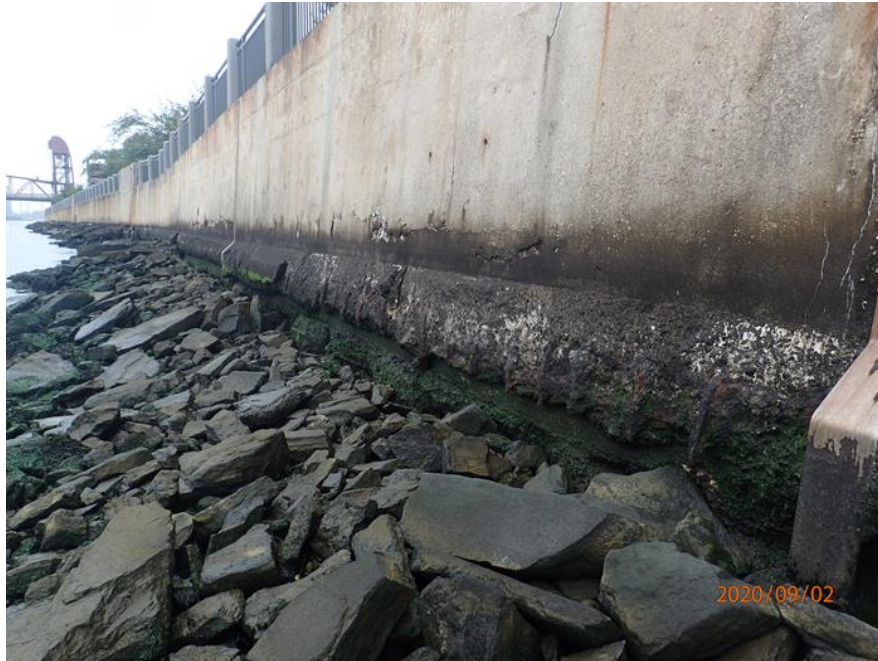
Station 8+40 to 9+21

Comments: Spalling at Haunch, Missing Large Sections of Concrete, Tunnel Undermined, Rip-rap Deficiency, Exposed Rebar

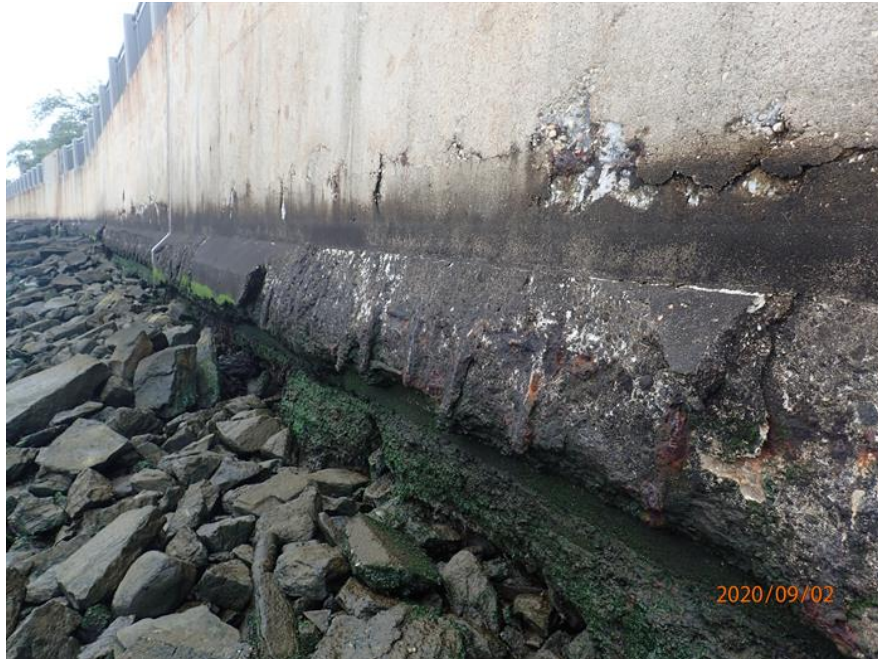
Station 8+40 to 9+21

Comments: Spalling at Haunch, Missing Large Sections of Concrete, Tunnel Undermined, Rip-rap Deficiency, Exposed Rebar

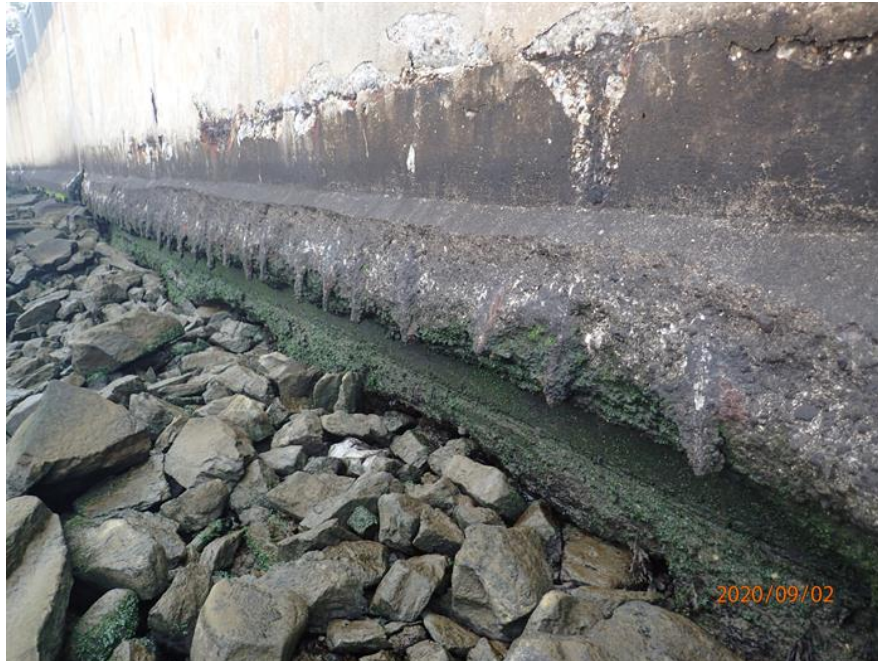
Station 8+40 to 9+21

Comments: Spalling at Haunch, Missing Large Sections of Concrete, Tunnel Undermined, Rip-rap Deficiency, Exposed Rebar

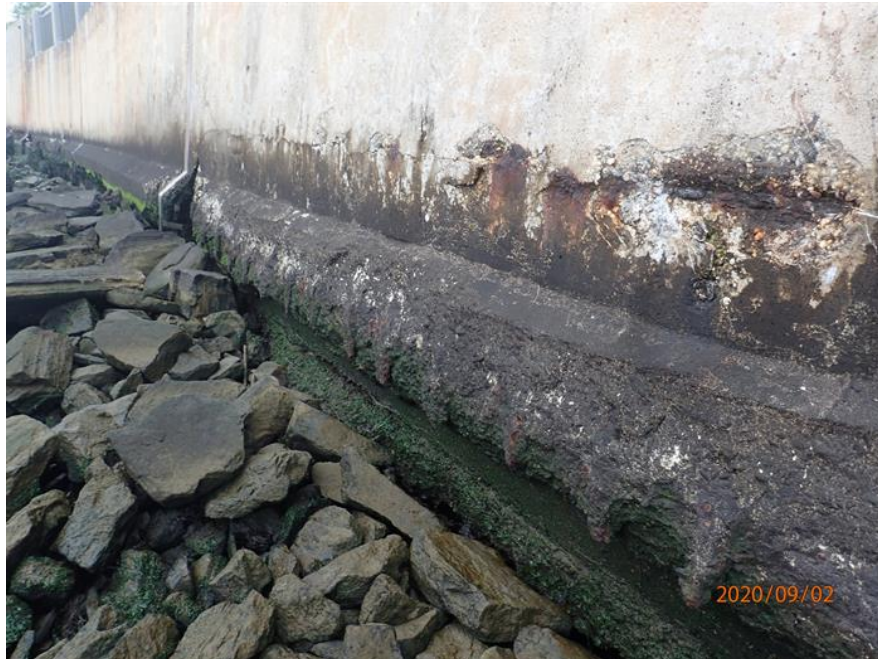
Station 8+40 to 9+21

Comments: Spalling at Haunch, Missing Large Sections of Concrete, Tunnel Undermined, Rip-rap Deficiency, Exposed Rebar

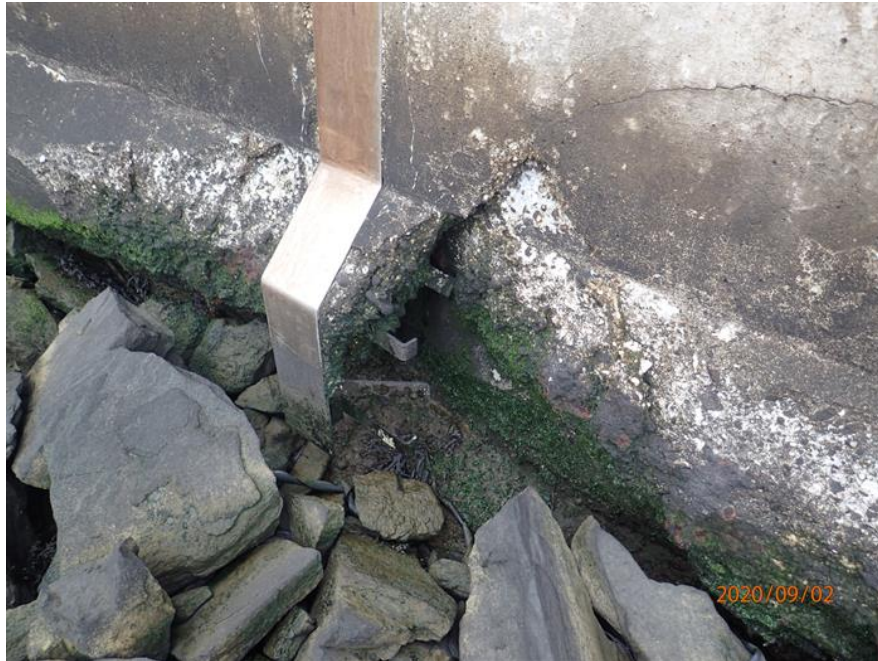
Station 8+40 to 9+21

Comments: Spalling at Haunch, Missing Large Sections of Concrete, Tunnel Undermined, Rip-rap Deficiency, Exposed Rebar

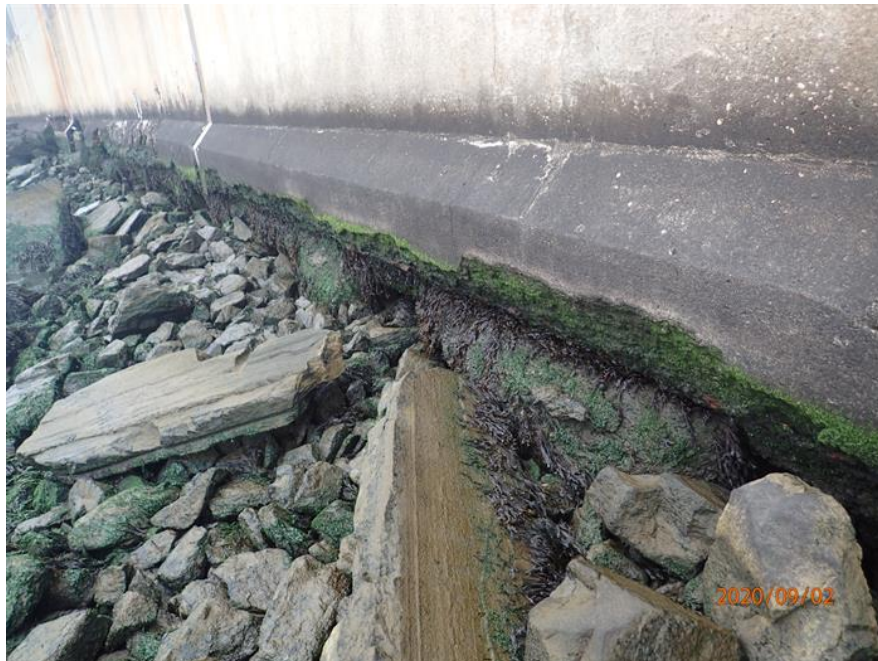
Station 8+40 to 9+21

Comments: Spalling at Haunch, Missing Large Sections of Concrete, Tunnel Undermined, Rip-rap Deficiency, Exposed Rebar

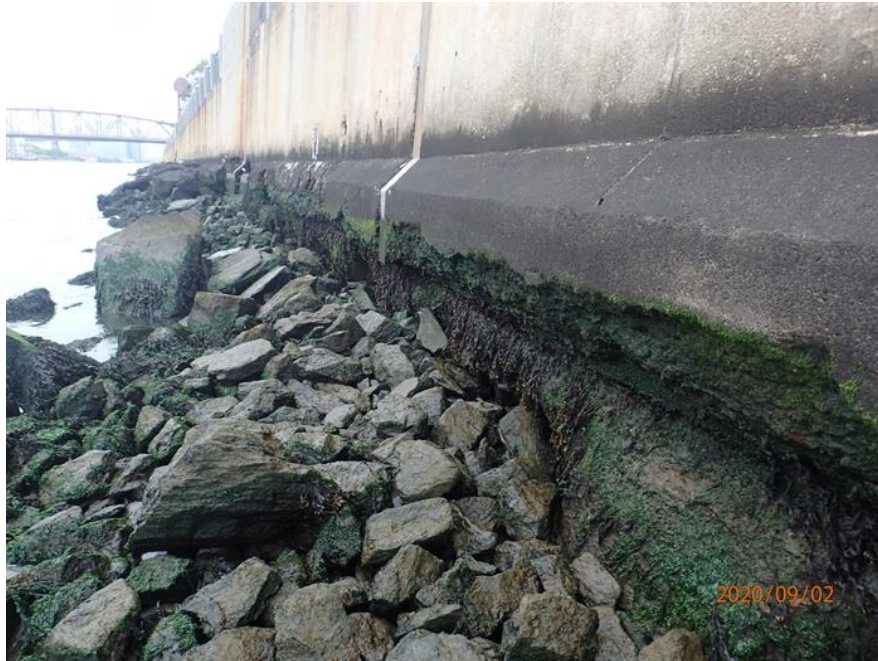
Station 8+40 to 9+21

Comments: Spalling at Haunch, Missing Large Sections of Concrete, Tunnel Undermined, Rip-rap Deficiency, Exposed Rebar

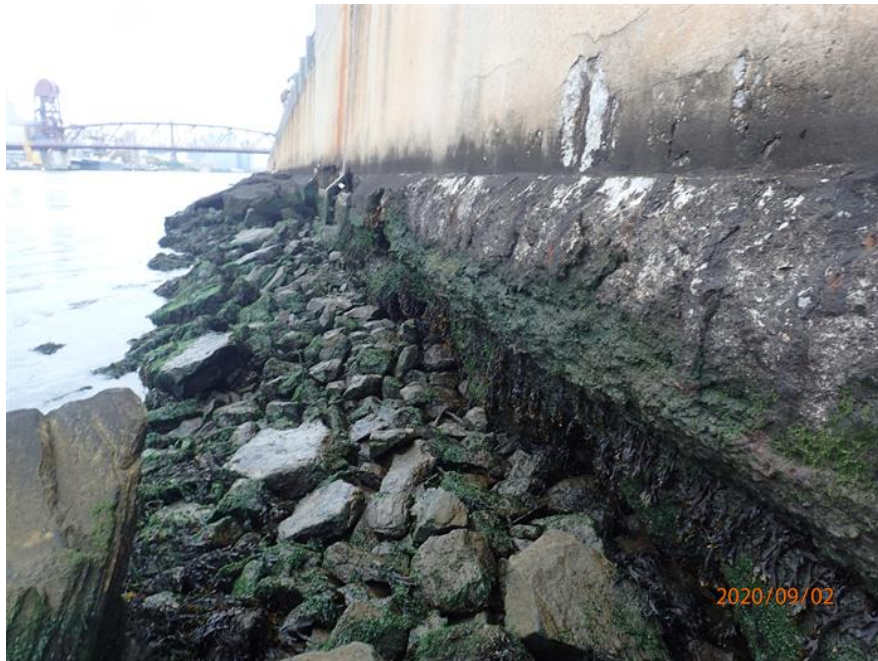
Station 8+40 to 9+21

Comments: Spalling at Haunch, Missing Large Sections of Concrete, Tunnel Undermined, Rip-rap Deficiency, Exposed Rebar

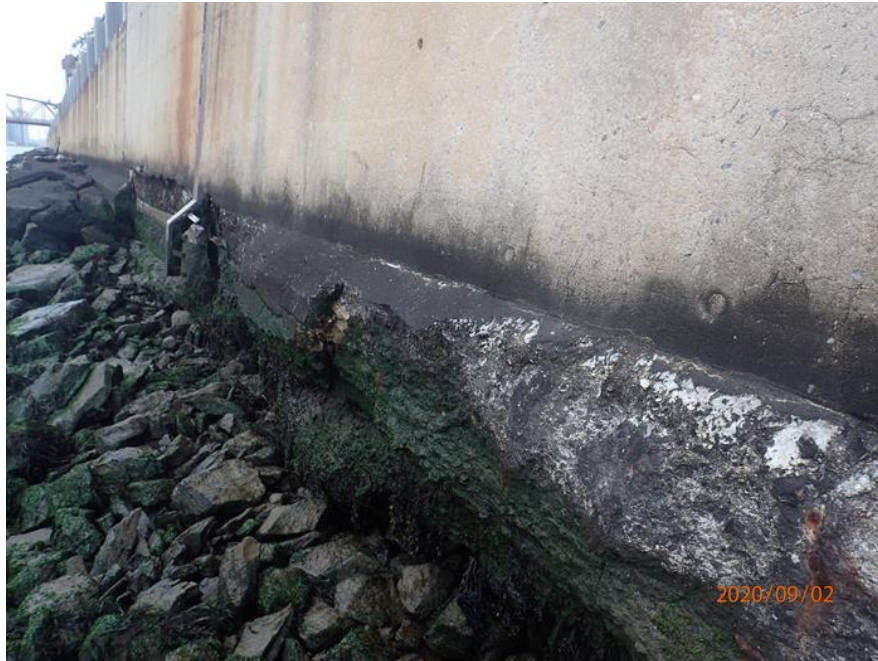
Station 8+40 to 9+21

Comments: Spalling at Haunch, Missing Large Sections of Concrete, Tunnel Undermined, Rip-rap Deficiency, Exposed Rebar

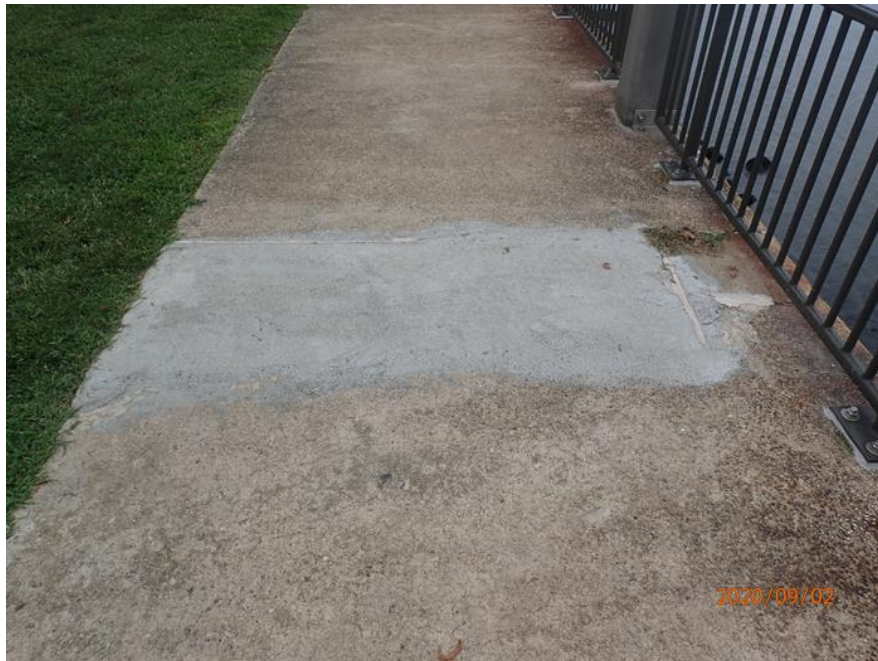
Station 8+60

Comments: Concrete Cracks, Attempt to Repair

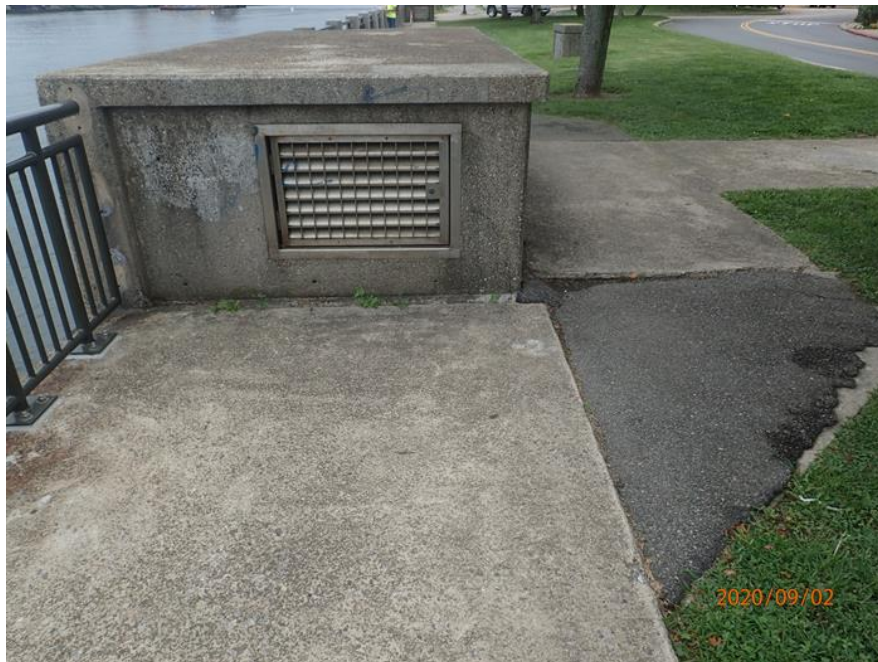
Station 9+21

Comments: Northern Face

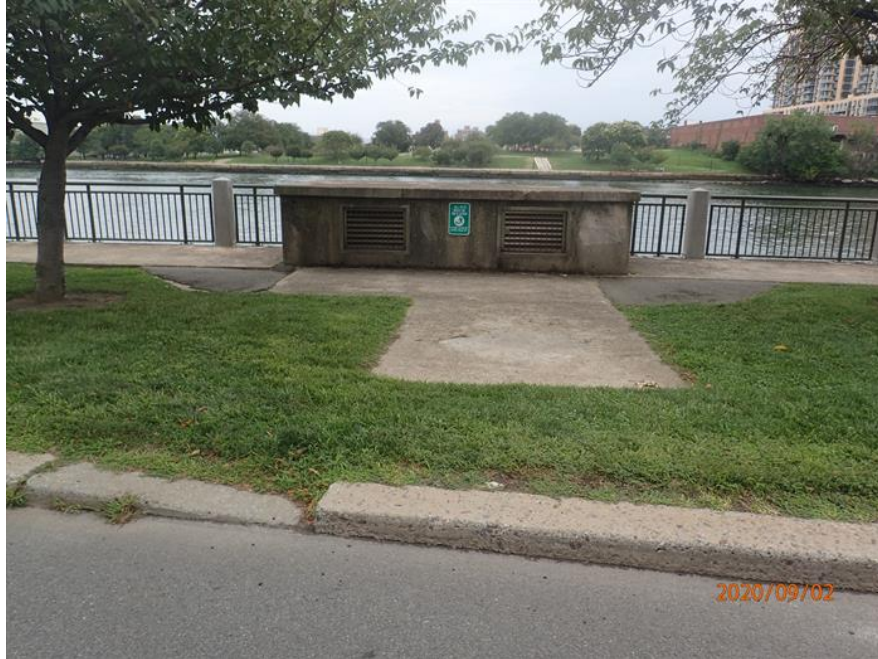
Station 9+21

Comments: Western Face

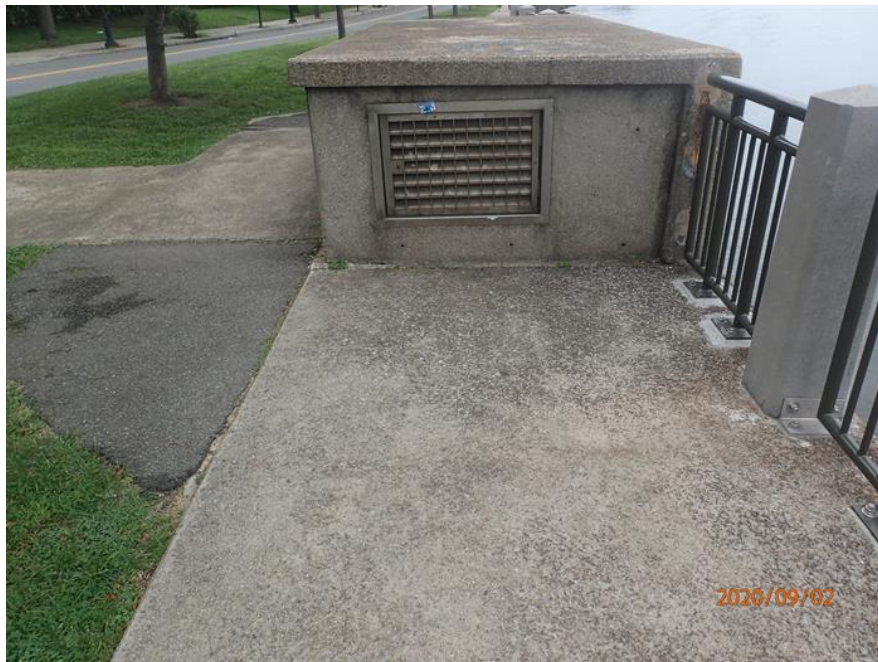
Station 9+21

Comments: Southern Face

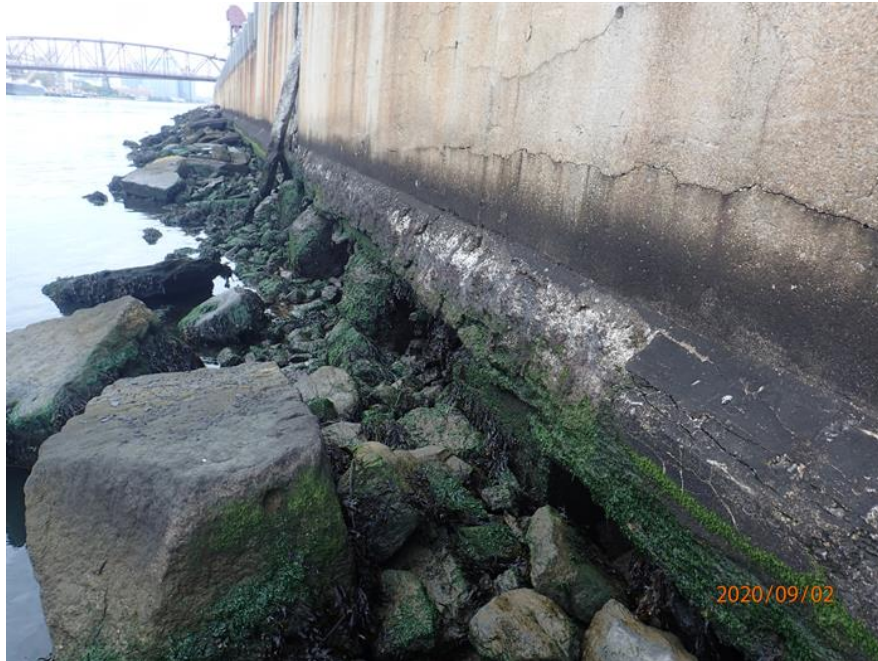
Station 10+43

Comments: Spalling at Haunch, Missing Large Sections of Concrete, Tunnel Undermined, Cap Beams Visible, Rip-rap Deficiency

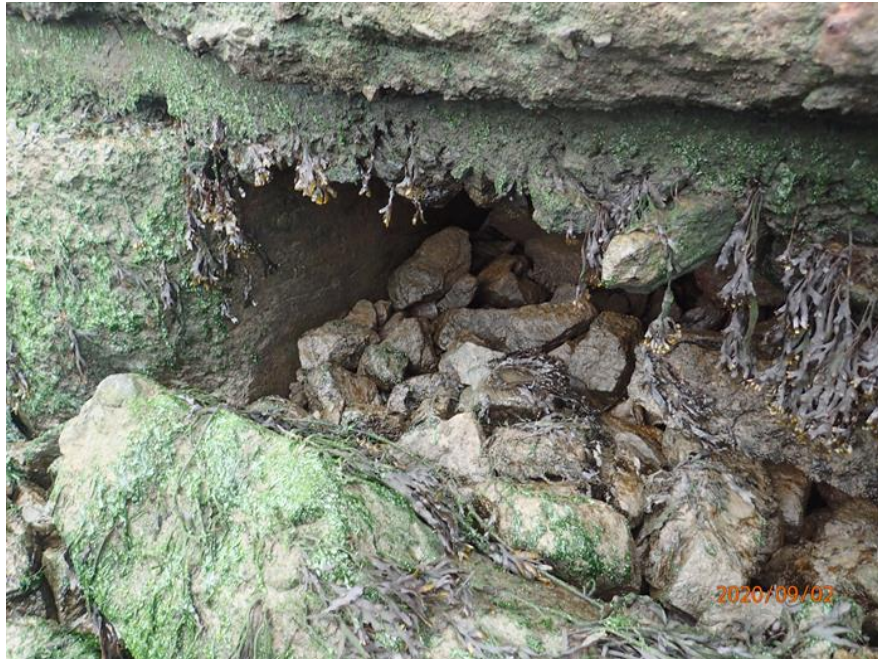
Station 10+43

Comments: Spalling at Haunch, Missing Large Sections of Concrete, Tunnel Undermined, Cap Beams Visible, Rip-rap Deficiency

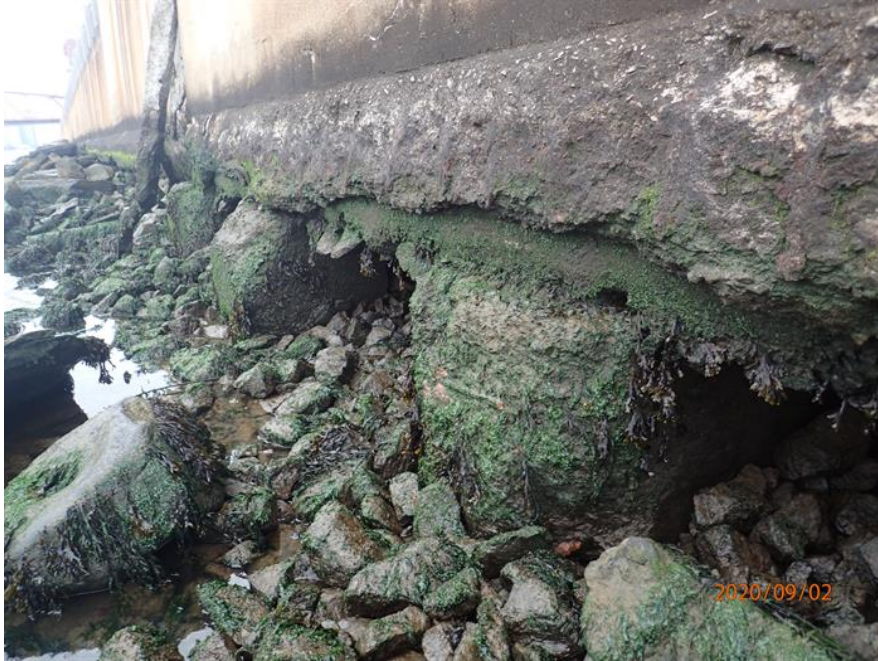
Station 10+43

Comments: Spalling at Haunch, Missing Large Sections of Concrete, Tunnel Undermined, Cap Beams Visible, Rip-rap Deficiency

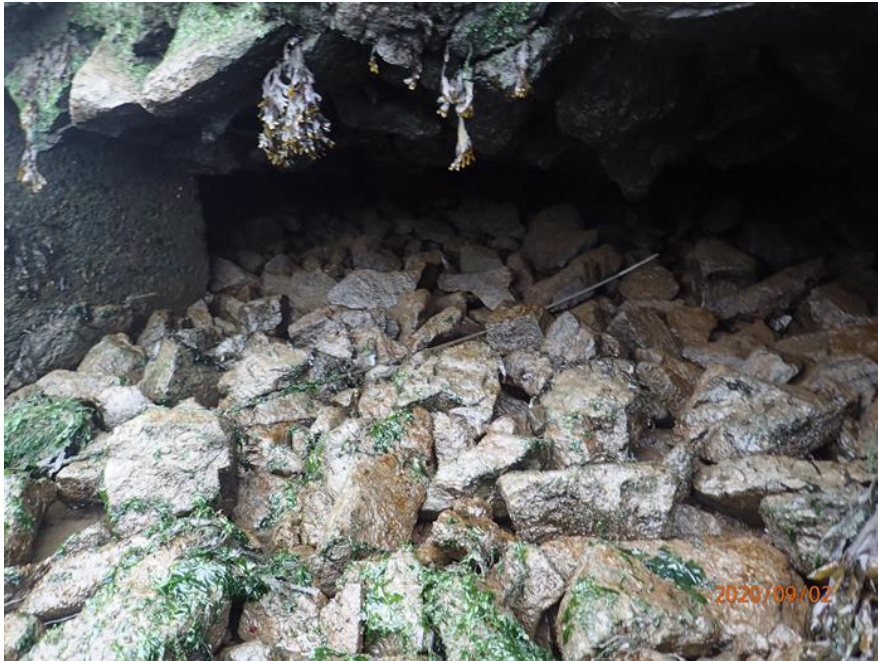
Station 10+43

Comments: Spalling at Haunch, Missing Large Sections of Concrete, Tunnel Undermined, Cap Beams Visible, Rip-rap Deficiency

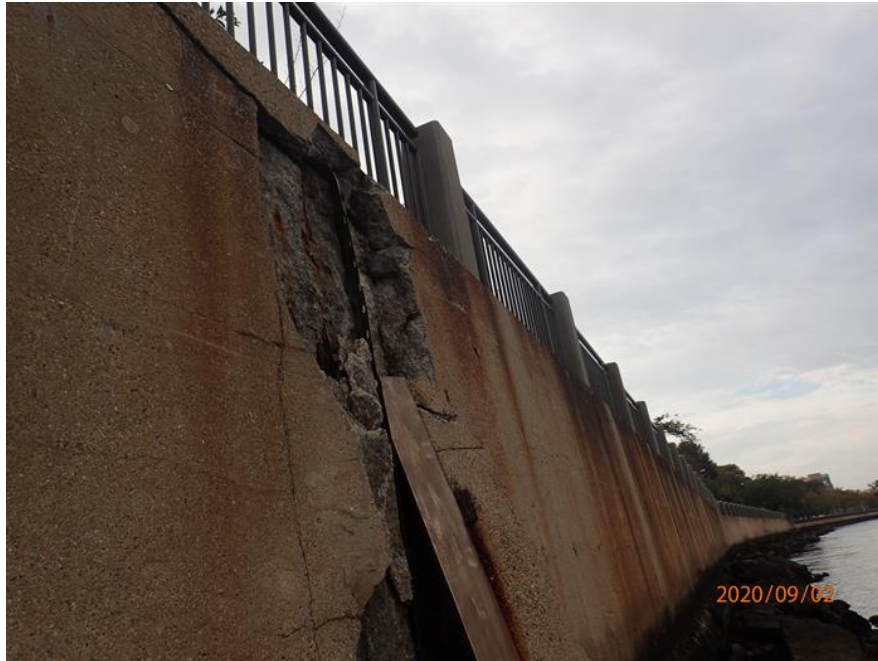
Station 10+57

Comments: Spalling at Haunch, Missing Large Sections of Concrete, Metal Joint Covering Loose

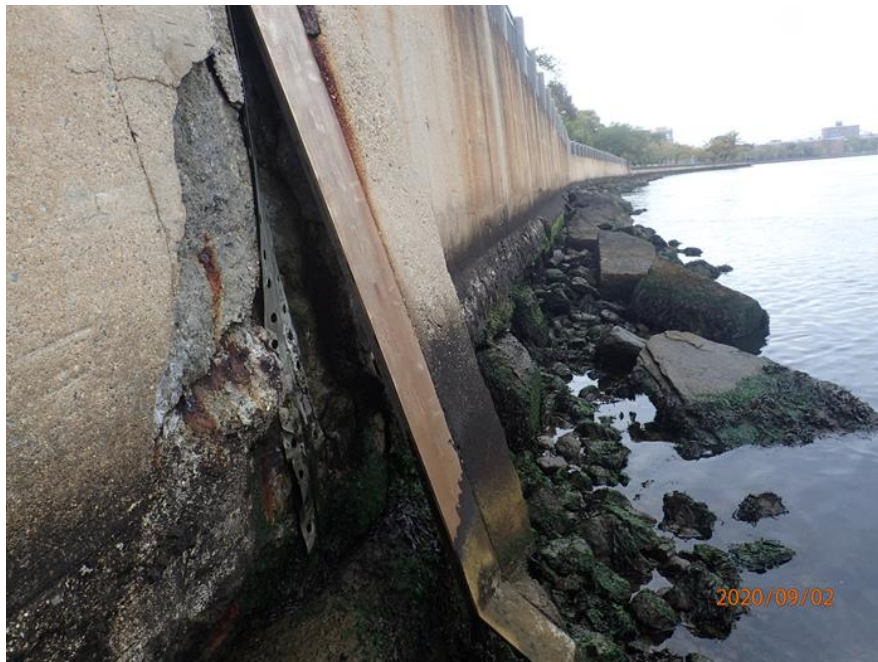
Station 10+57

Comments: Spalling at Haunch, Missing Large Sections of Concrete, Metal Joint Covering Loose

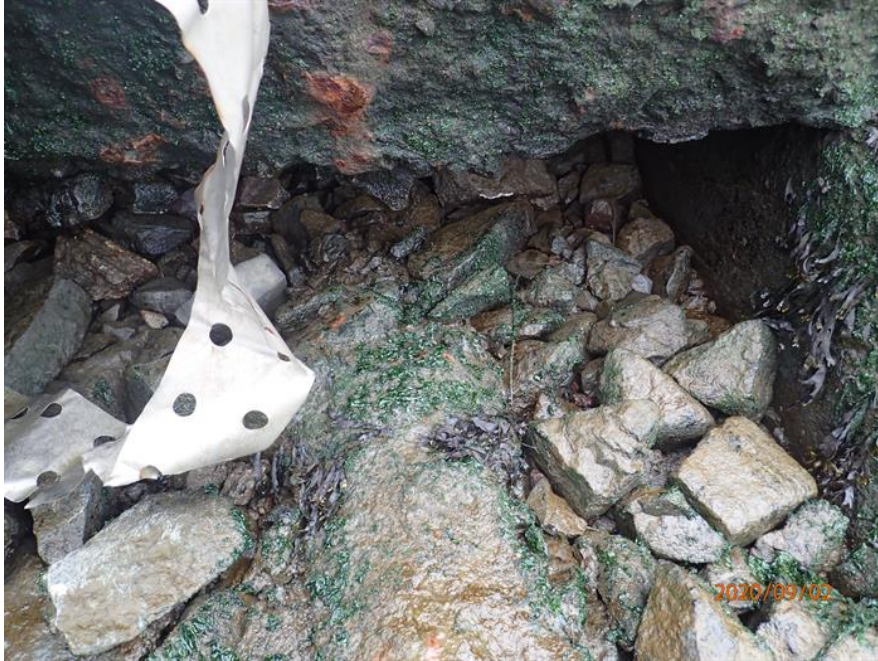
Station 10+57

Comments: Tunnel Undermined, Rip-rap Deficiency

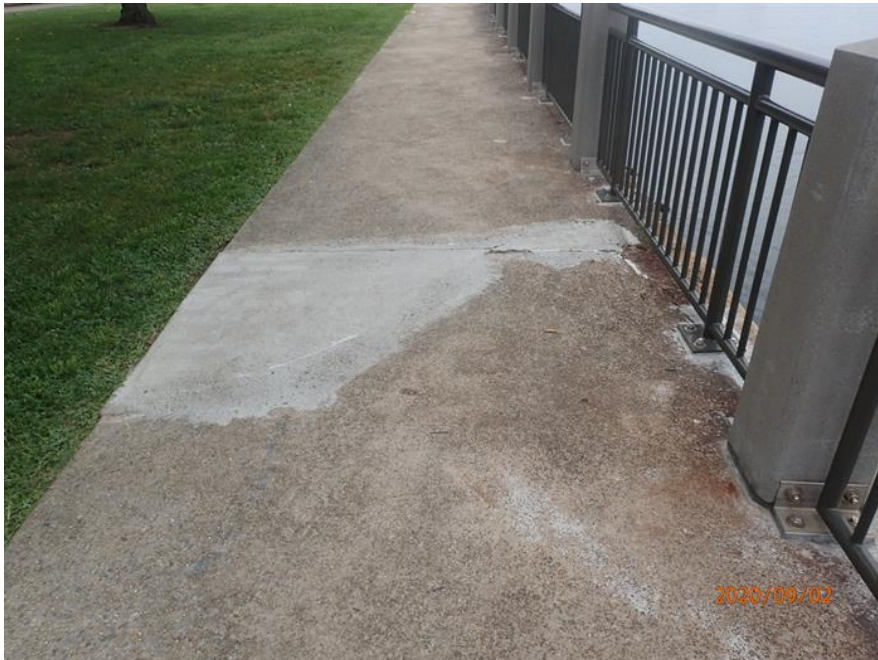
Station 10+57

Comments: Concrete Spalling

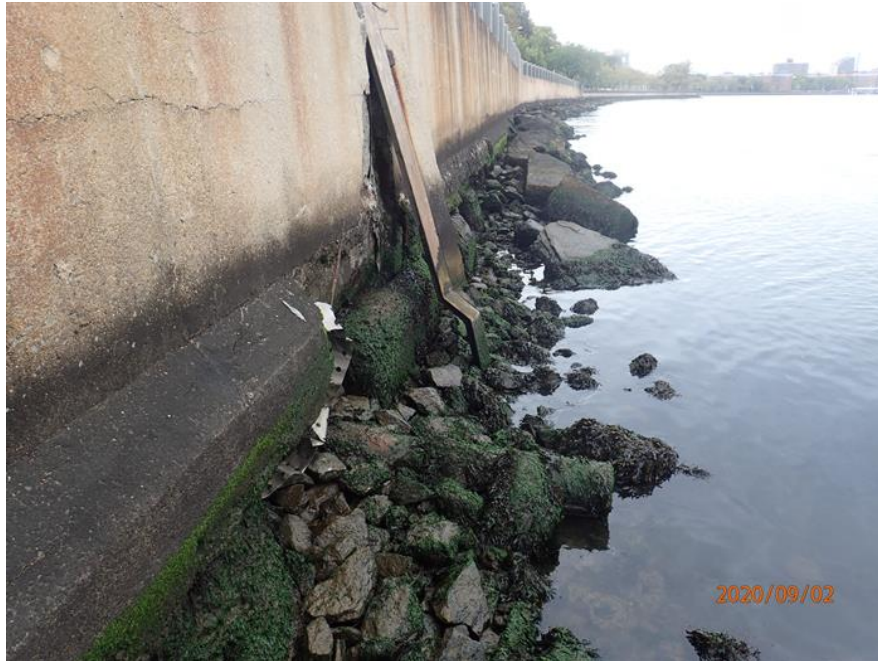
Station 10+57

Comments: Spalling at Haunch, Missing Large Sections of Concrete, Metal Joint Covering Loose

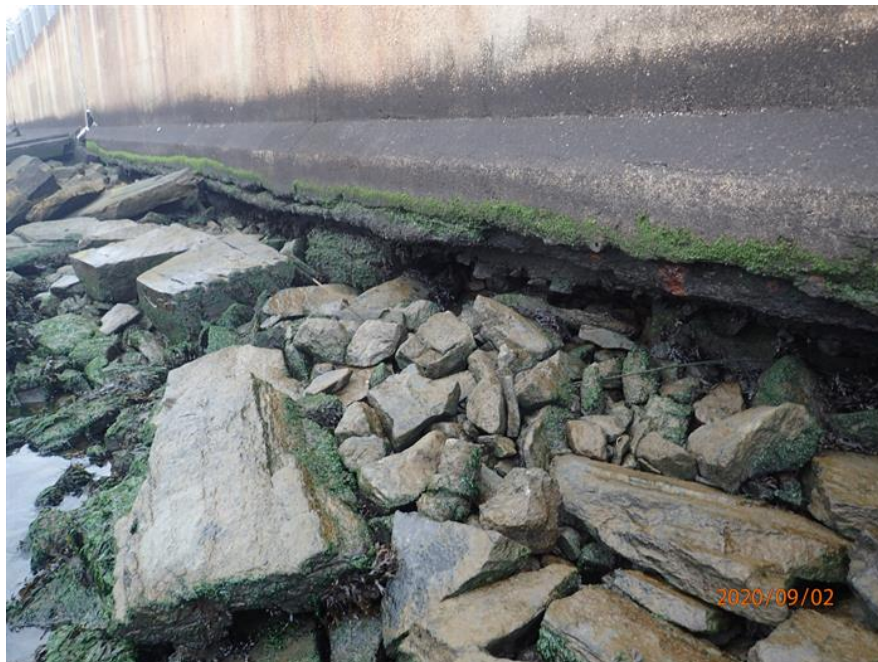
Station 10+63

Comments: Tunnel Undermined, Rip-rap Deficiency

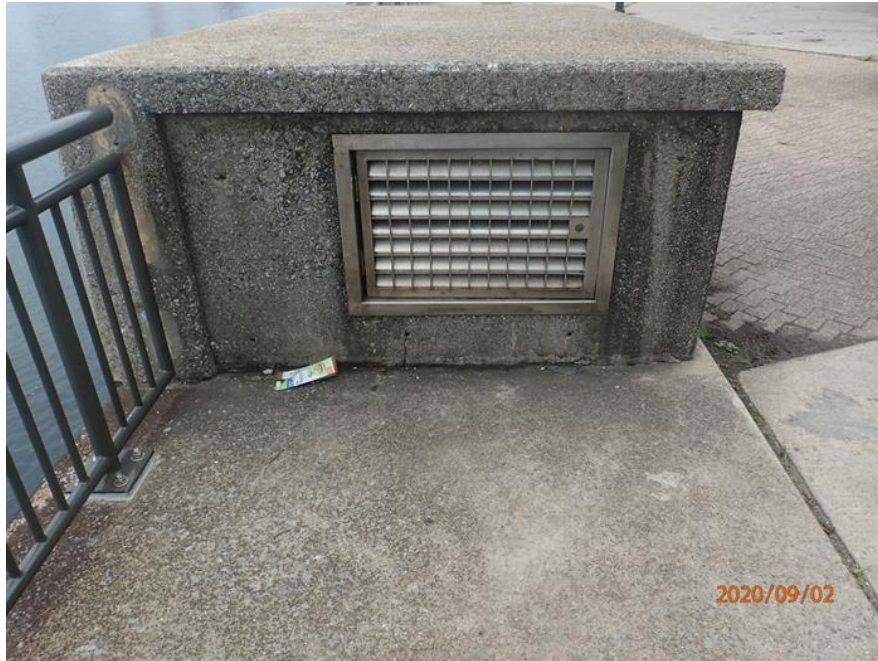
Station 10+77

Comments: Northern Face

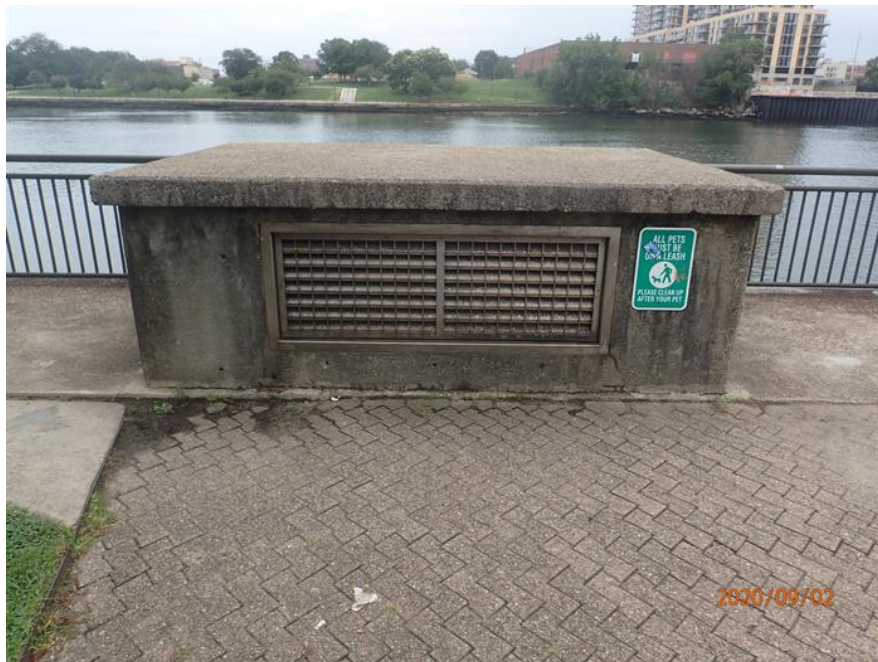
Station 10+77

Comments: Western Face

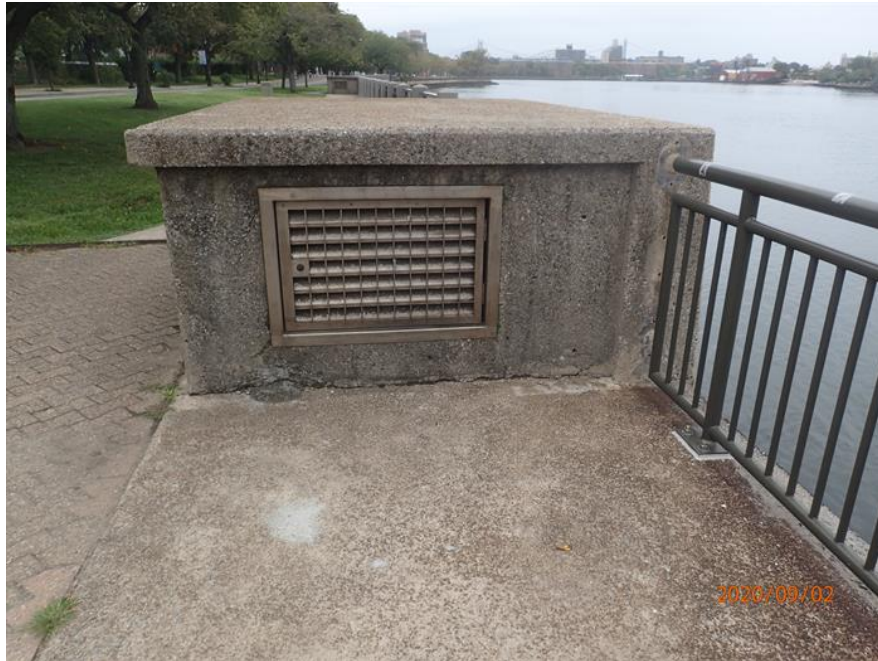
Station 10+77

Comments: Sothern Face

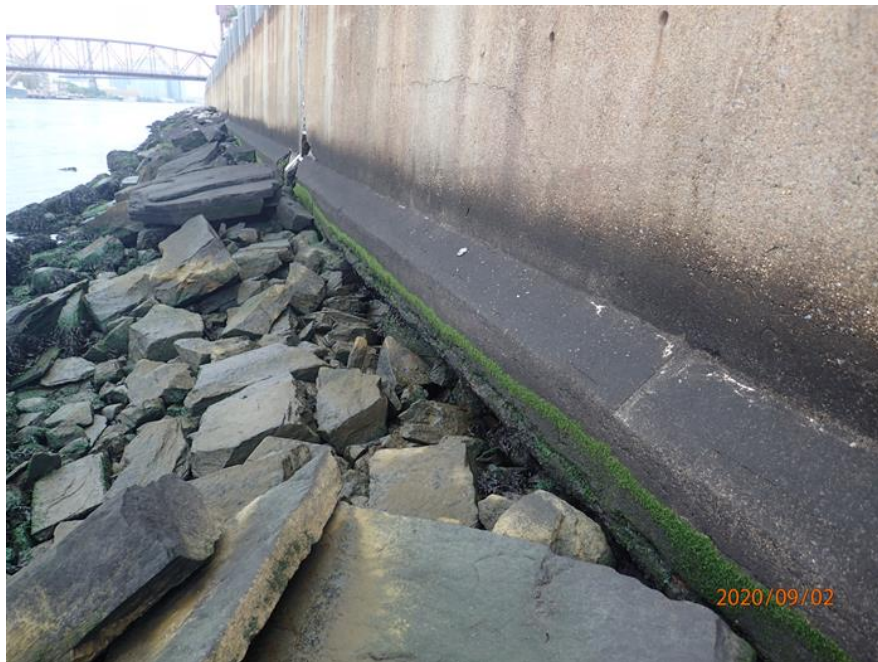
Station 11+06

Comments: Tunnel Undermined, Rip-rap Deficiency

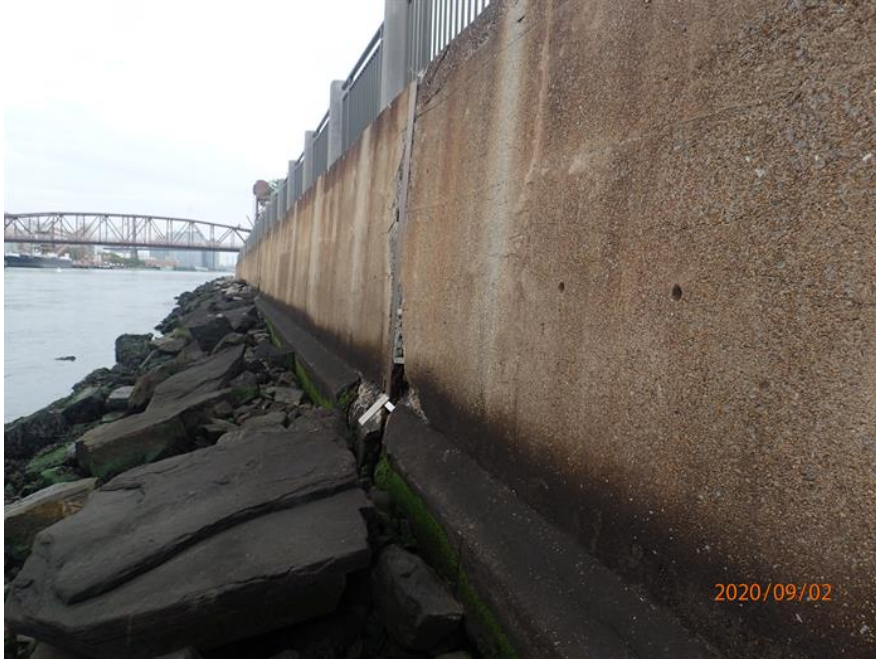
Station 11+19

Comments: Spalling at Haunch, Missing Large Sections of Concrete, Metal Joint Covering Loose

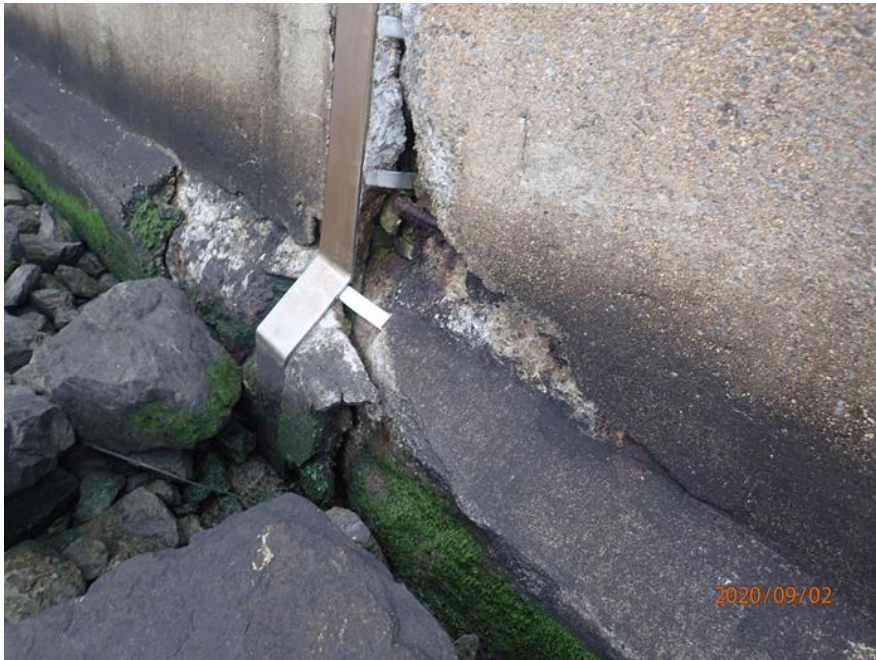
Station 11+19

Comments: Spalling at Haunch, Missing Large Sections of Concrete, Metal Joint Covering Loose

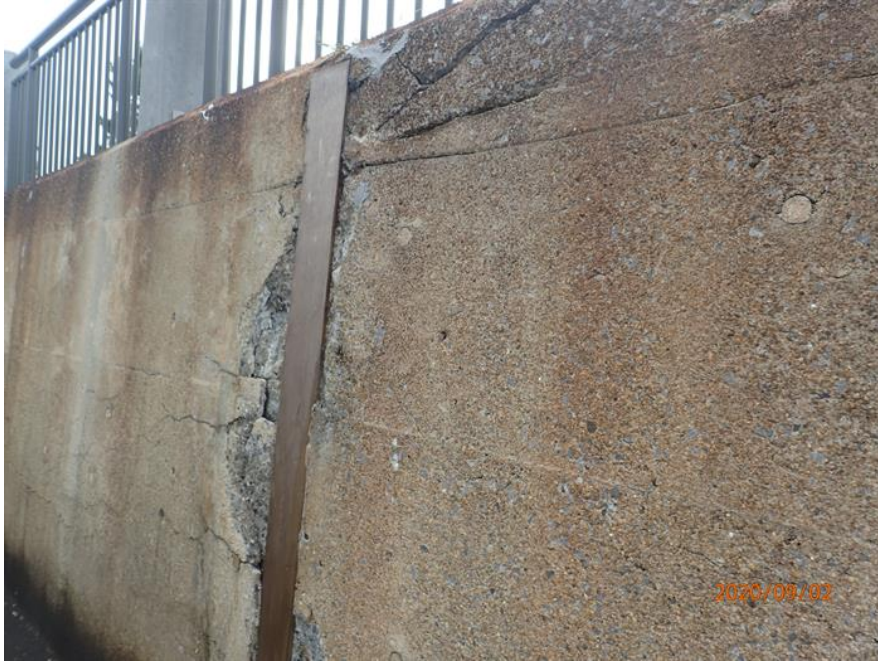
Station 11+19

Comments: Concrete Spalling, Missing Concrete, Concrete Cracks

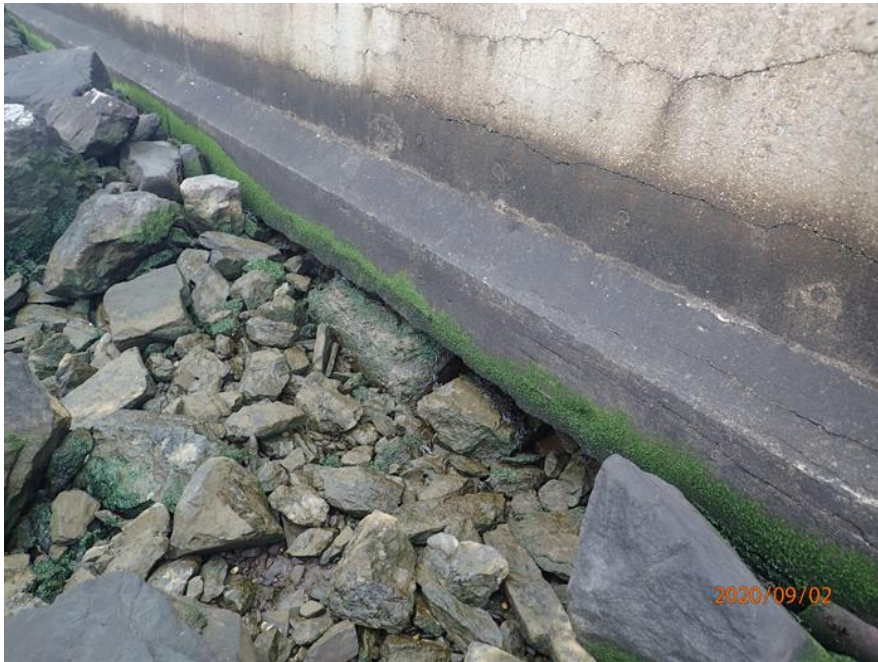
Station 11+66

Comments: Tunnel Undermined, Rip-rap Deficiency
