CONDITIONS REPORT & CONCEPTUAL DESIGN MEMORANDUM

STEAM TUNNEL ASSESSMENT

ROOSEVELT ISLAND, NEW YORK

17 November 2014
Revised 28 December 2018
Revised 18 September 2020
Project # 100444601

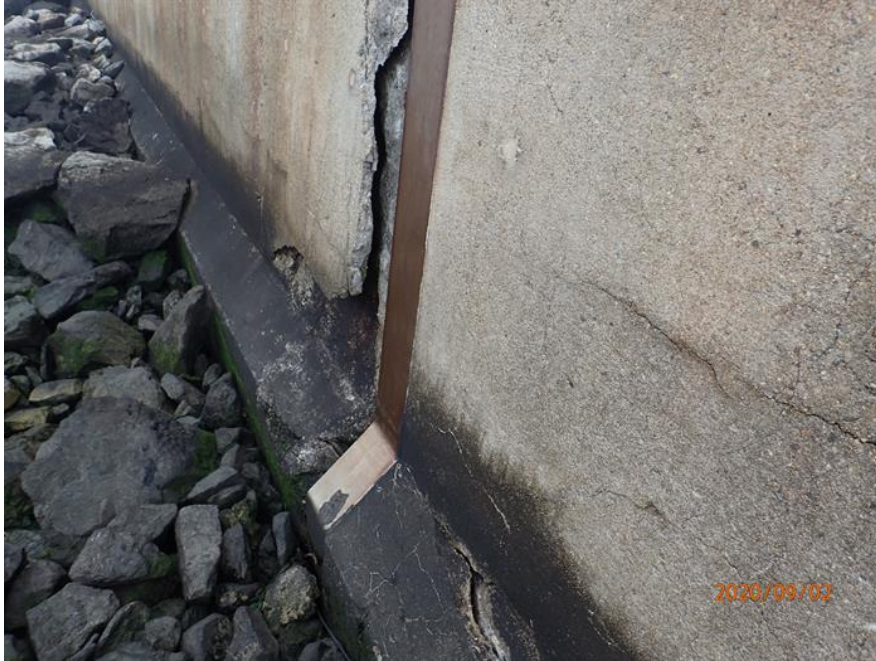
Station 11+83

Comments: Spalling at Haunch, Missing Large Sections of Concrete

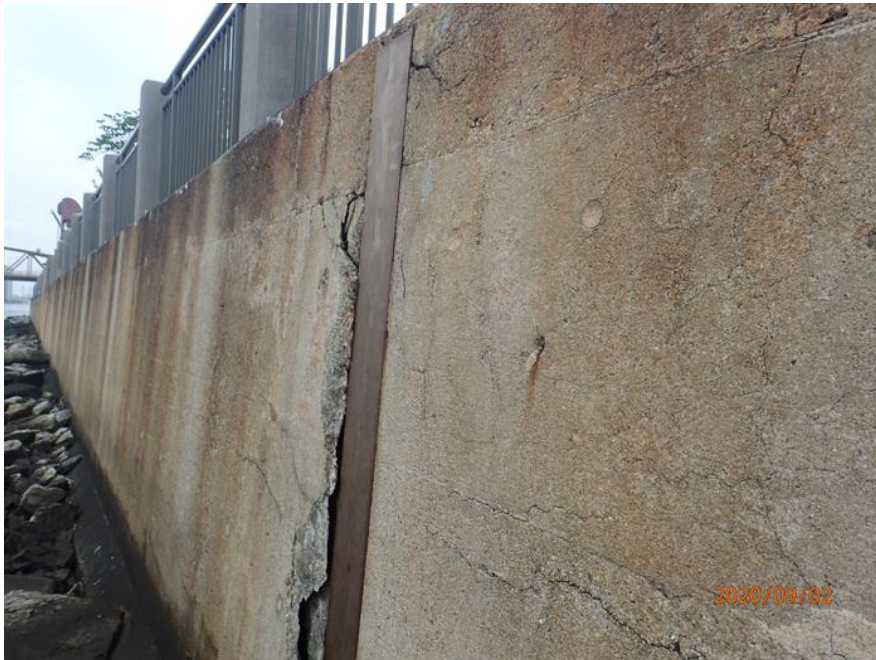
Station 11+83

Comments: Spalling at Haunch, Missing Large Sections of Concrete

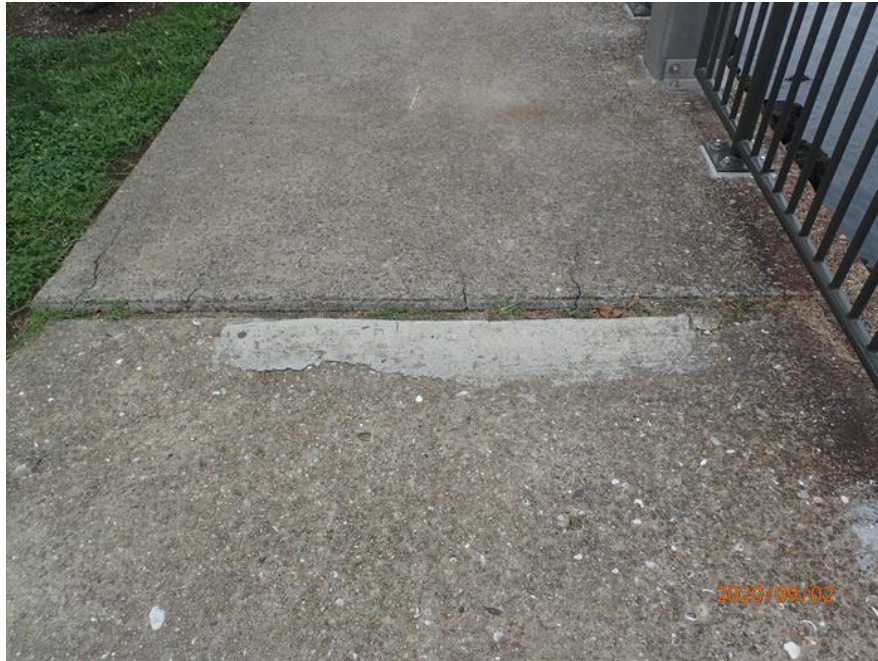
Station 12+54

Comments: Concrete Cracks

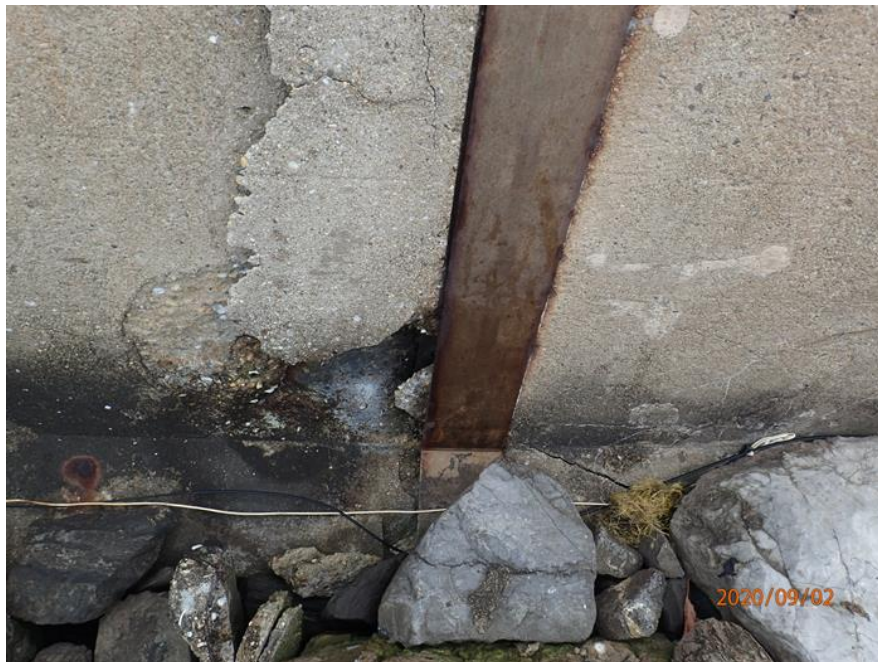
Station 12+68

Comments: Concrete Spalling, Missing Large Section of Concrete, Re-Bar Exposed. Tunnel Undermined, Rip-rap Deficiency

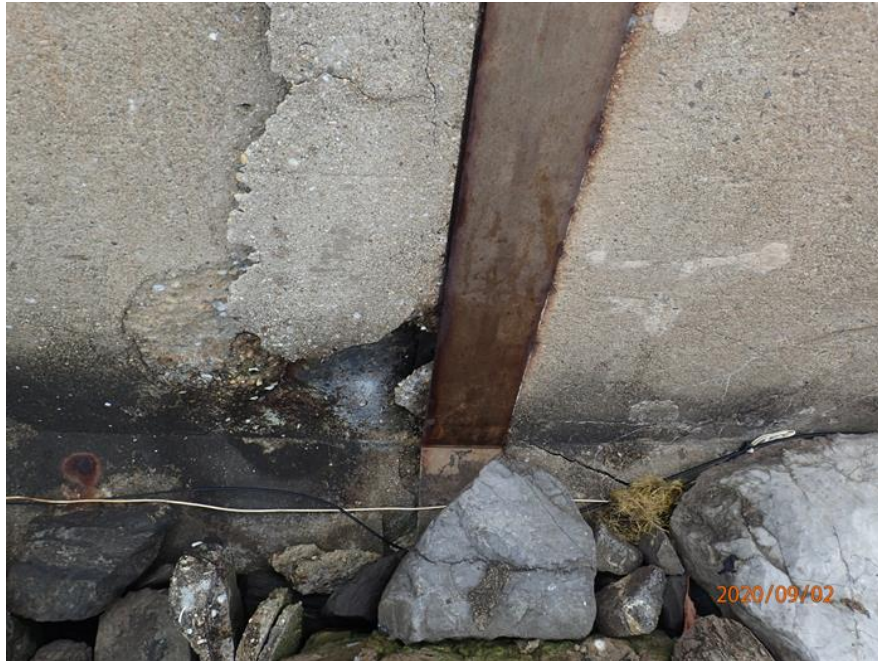
Station 12+68

Comments: Concrete Spalling, Missing Large Section of Concrete, Re-Bar Exposed. Tunnel Undermined, Rip-rap Deficiency

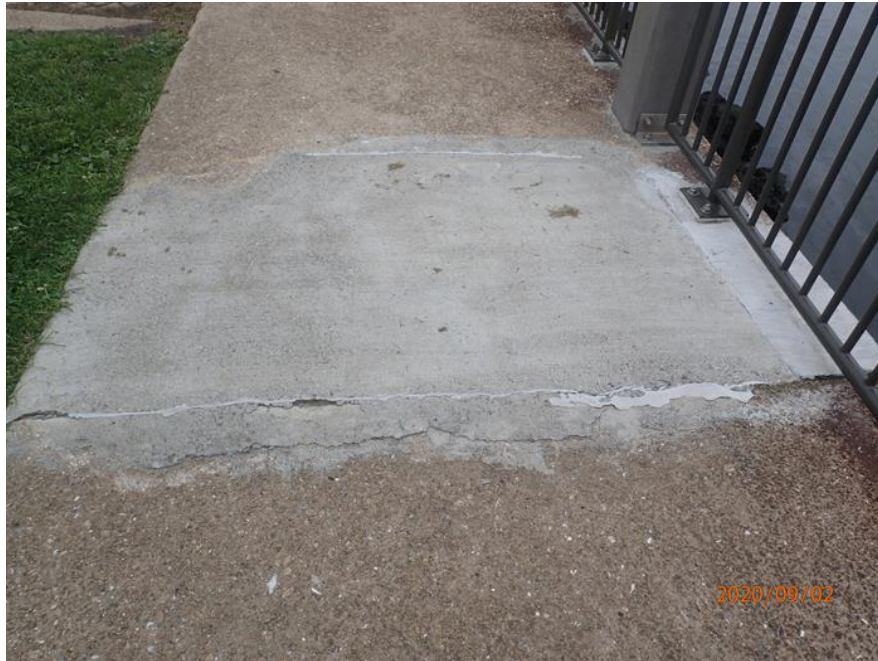
Station 13+03

Comments: Concrete Cracks, Attempt to Repair

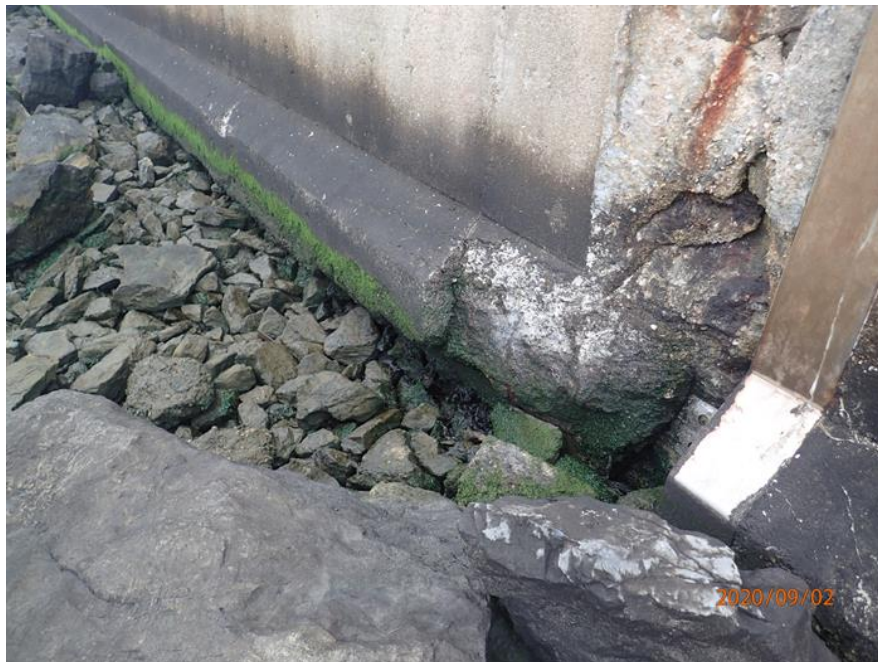
Station 13+10

Comments: Spalling at Haunch, Missing Large Sections of Concrete

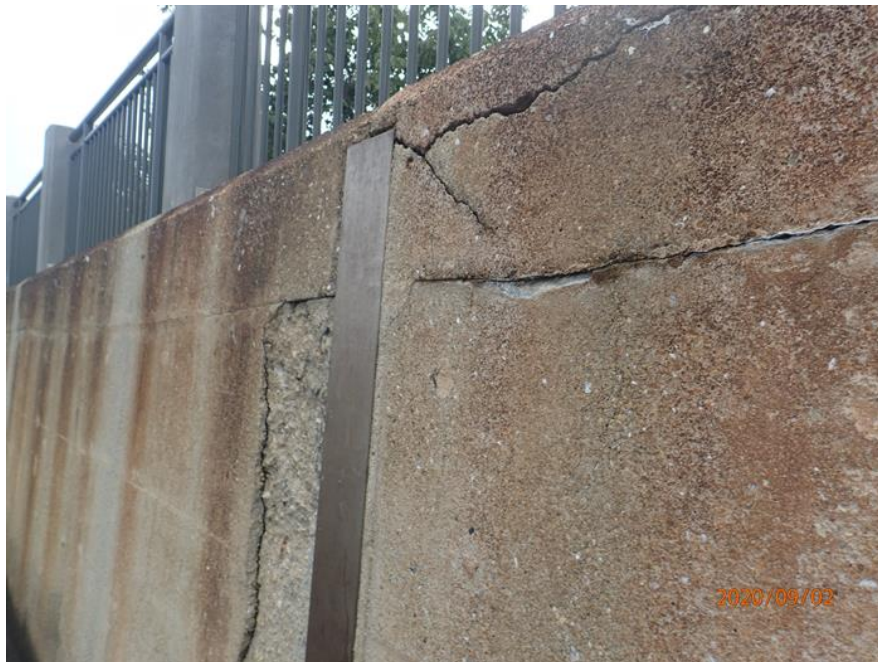
Station 13+27

Comments: Spalling at Haunch, Concrete Cracks, Missing Concrete

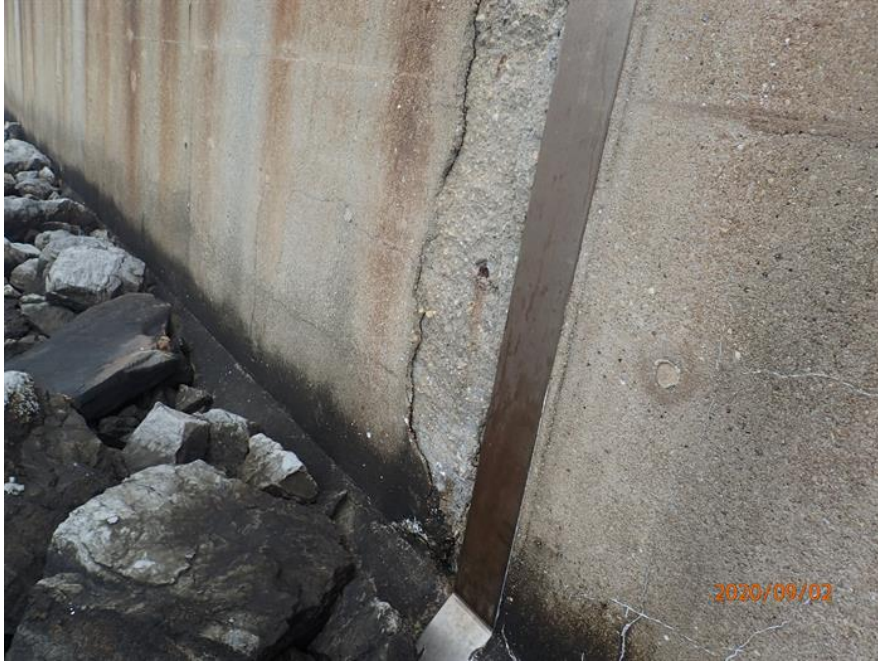
Station 13+27

Comments: Spalling at Haunch, Concrete Cracks, Missing Concrete

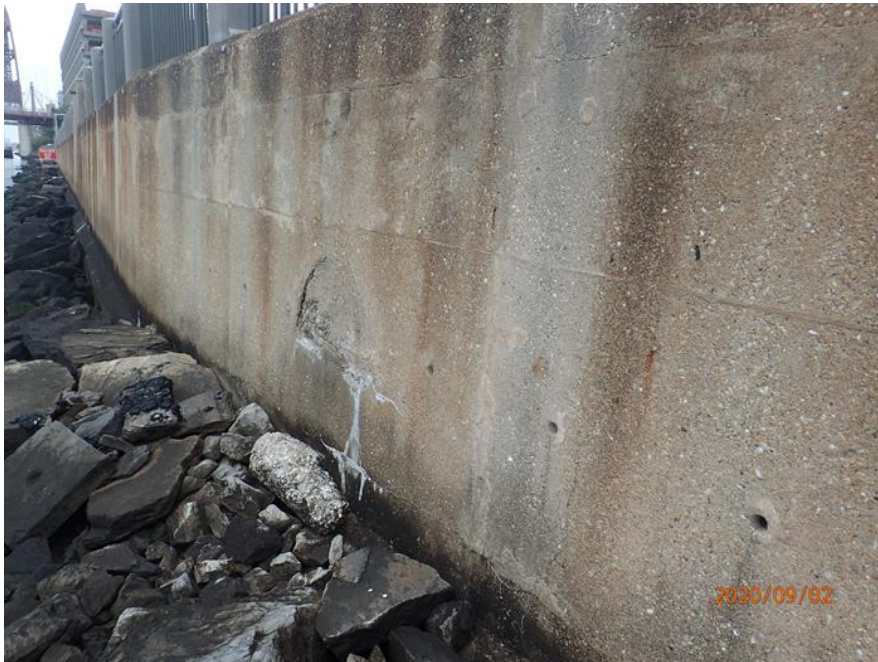
Station 14+50

Comments: Concrete Spalling

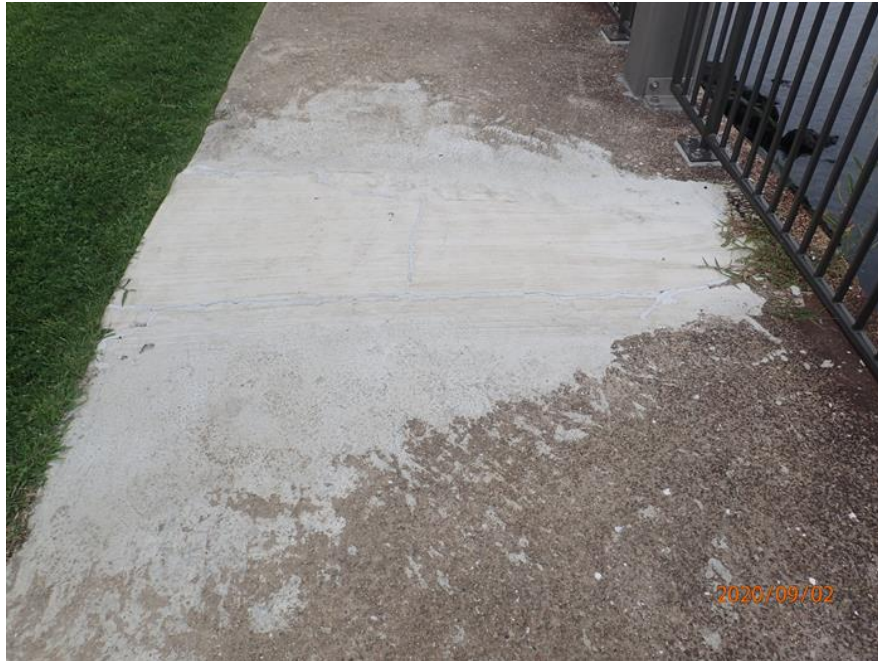
Station 14+57

Comments: Concrete Cracks, Loose Sections of Concrete

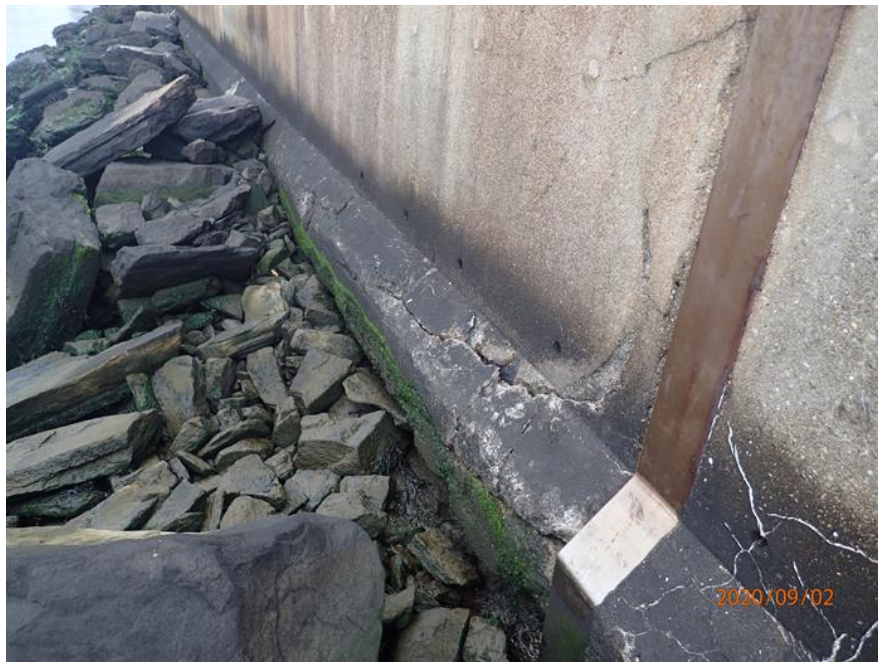
Station 15+06

Comments: Concrete Spalling, Loose Sections of Concrete, Tunnel Undermined, Rip-rap Deficiency

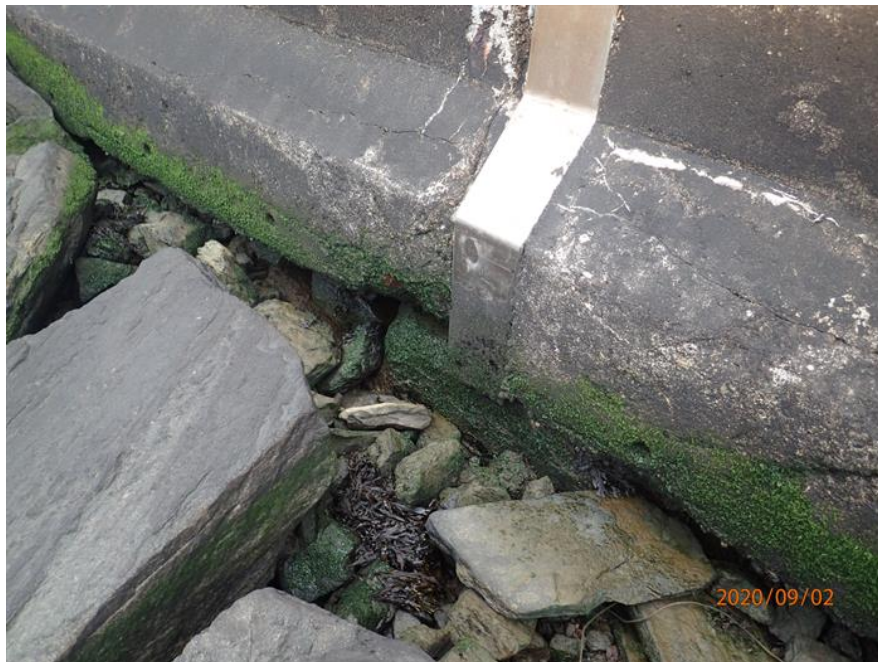
Station 15+40

Comments: Concrete Spalling, Loose Sections of Concrete, Tunnel Undermined, Rip-rap Deficiency

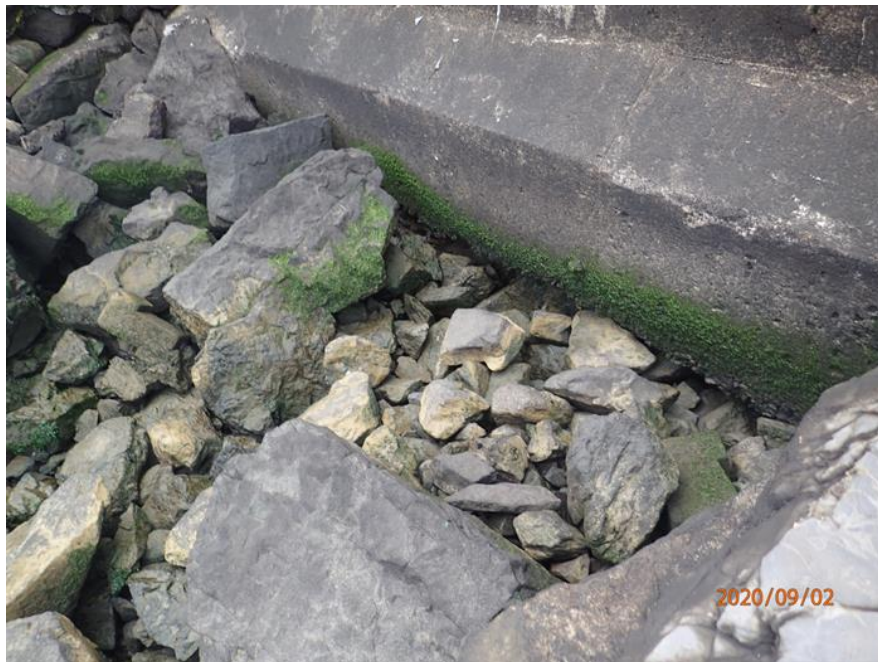
Station 15+63

Comments: Tunnel Undermined, Rip-rap Deficiency

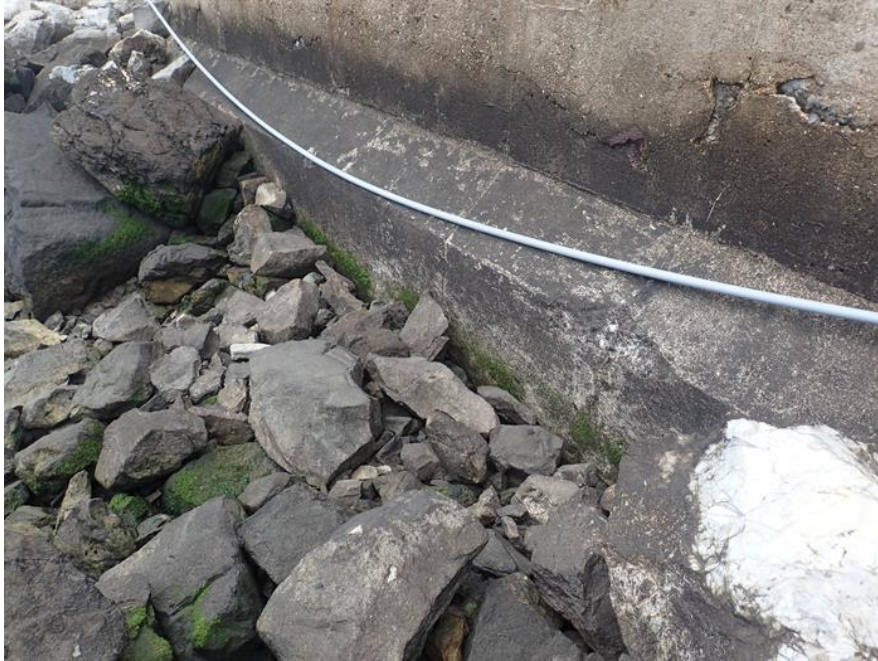
Station 16+00

Comments: Concrete Spalling, Rip-rap Deficiency

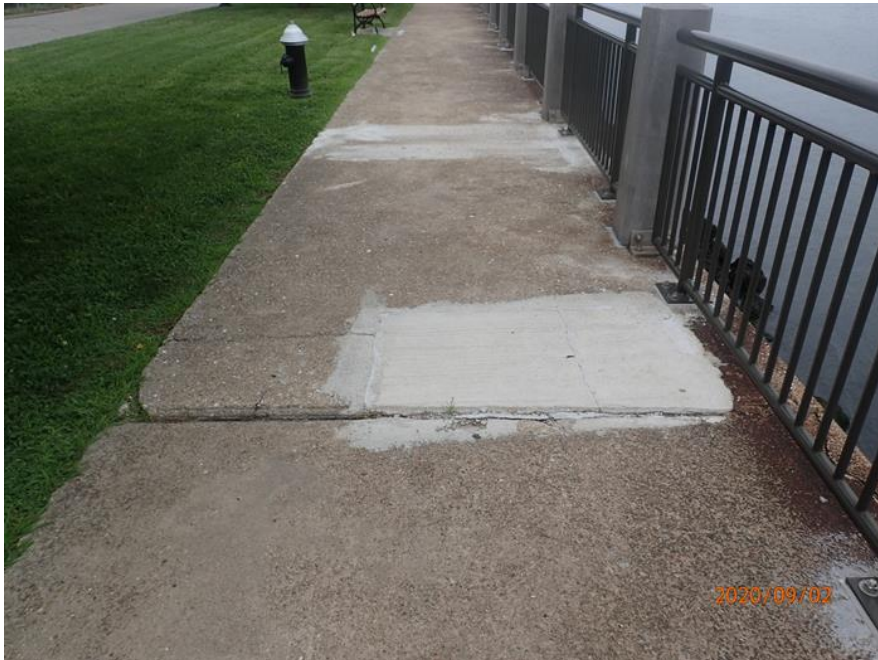
Station 16+37

Comments: Concrete Cracks, Attempt to Repair

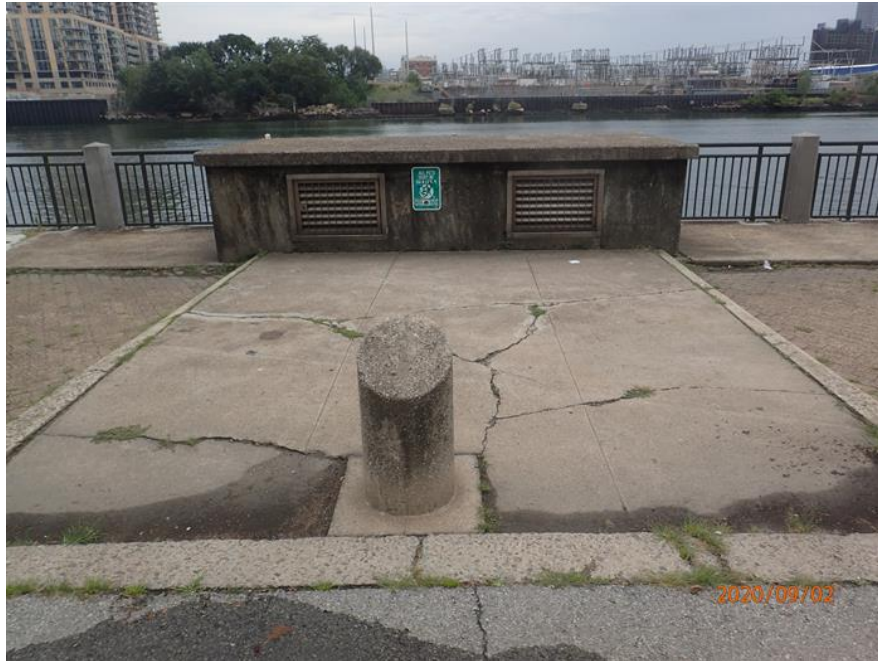
Station 17+76

Comments: Western Face, Concrete Cracks at the Sidewalk

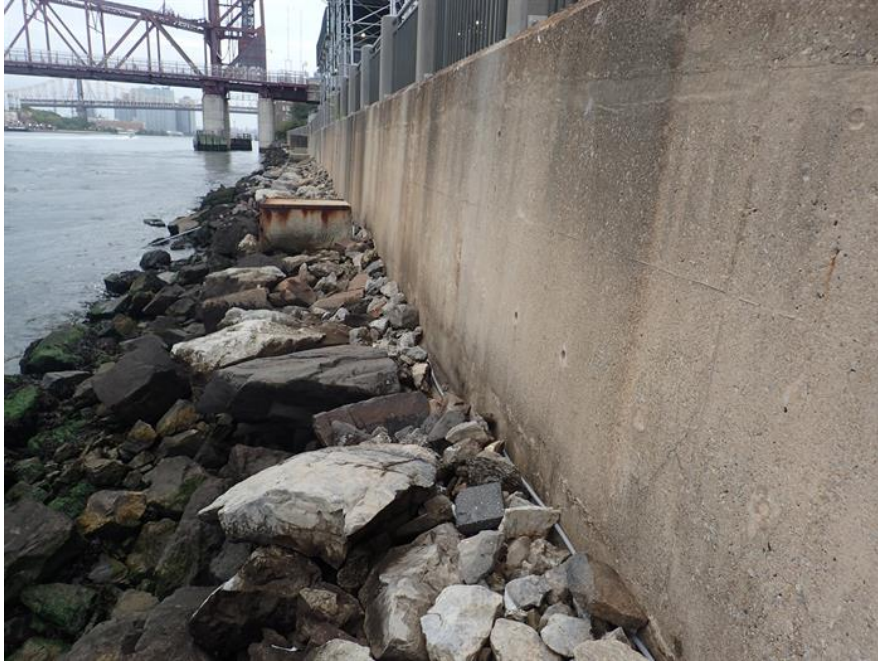
Station 17+75 to 17+85

Comments: Concrete Spalling

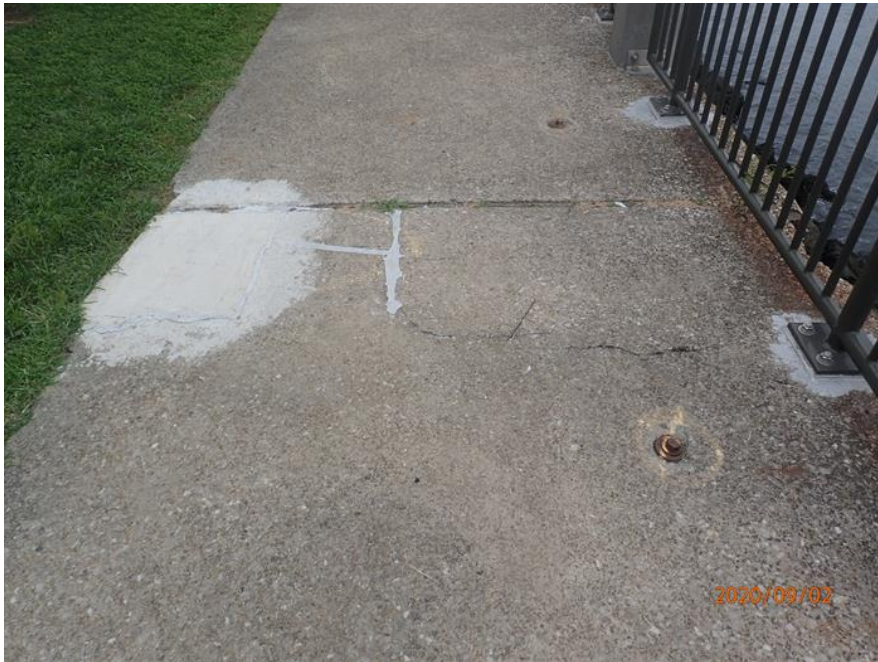
Station 17+85

Comments: Concrete Cracks, Attempt to Repair

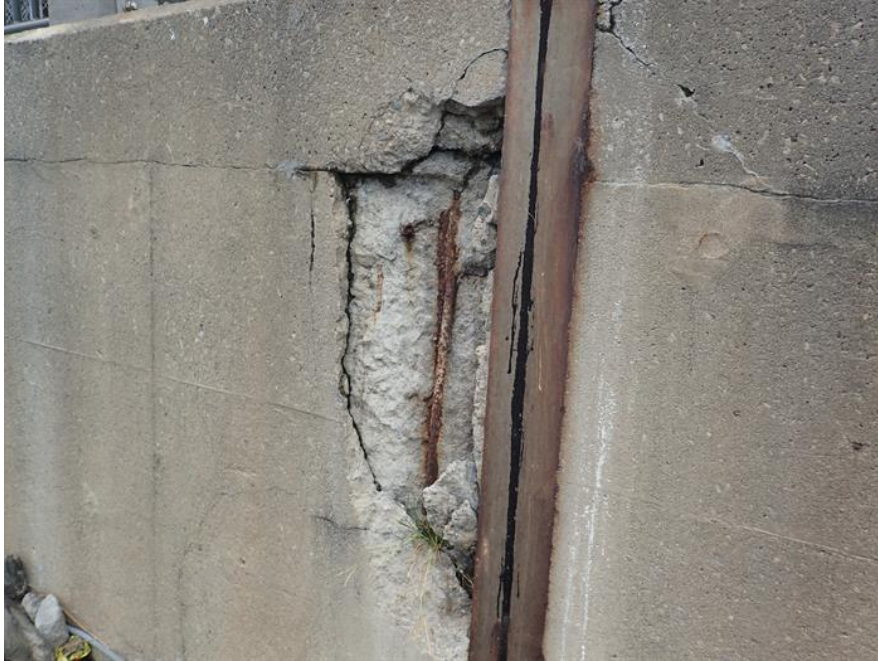
Station 17+85

Comments: Concrete Spalling, Missing Large Section of Concrete, Re-Bar Exposed

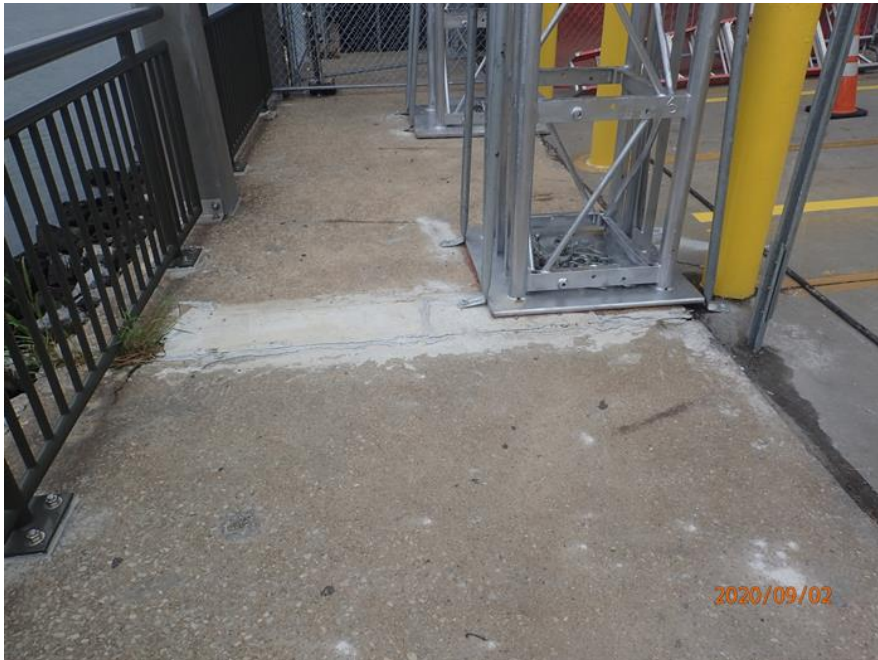
Station 18+10

Comments: Concrete Cracks, Attempt to Repair

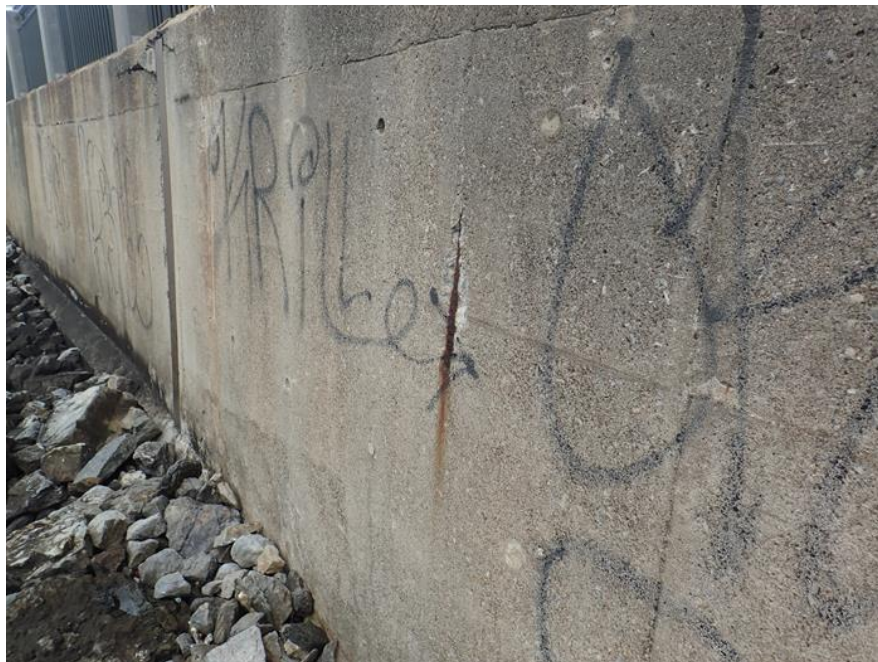
Station 20+73

Comments: Concrete Spalling, Re-Bar Exposed

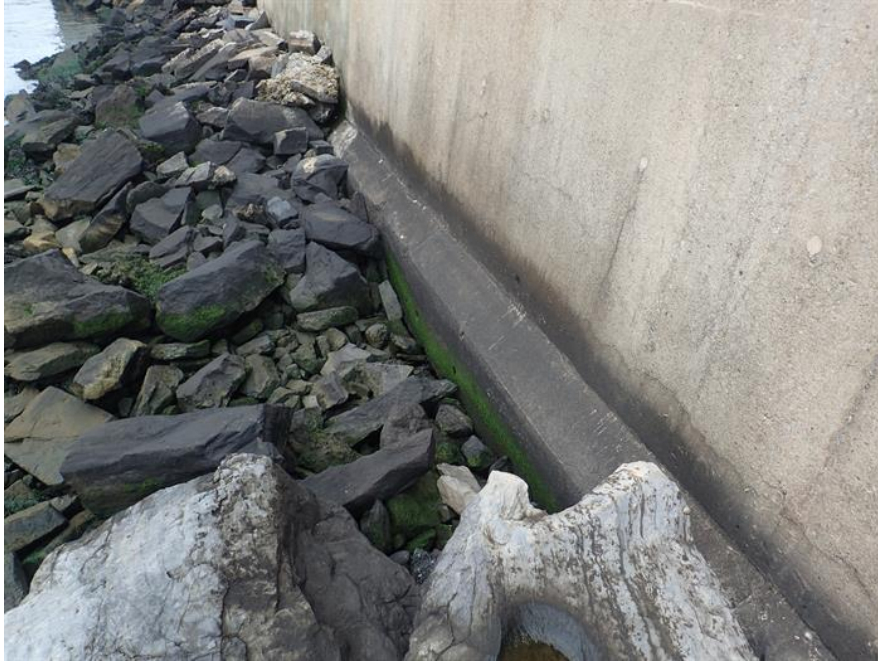
Station 21+43

Direction: Seawall

Comments: Tunnel Undermined, Rip-rap Deficiency

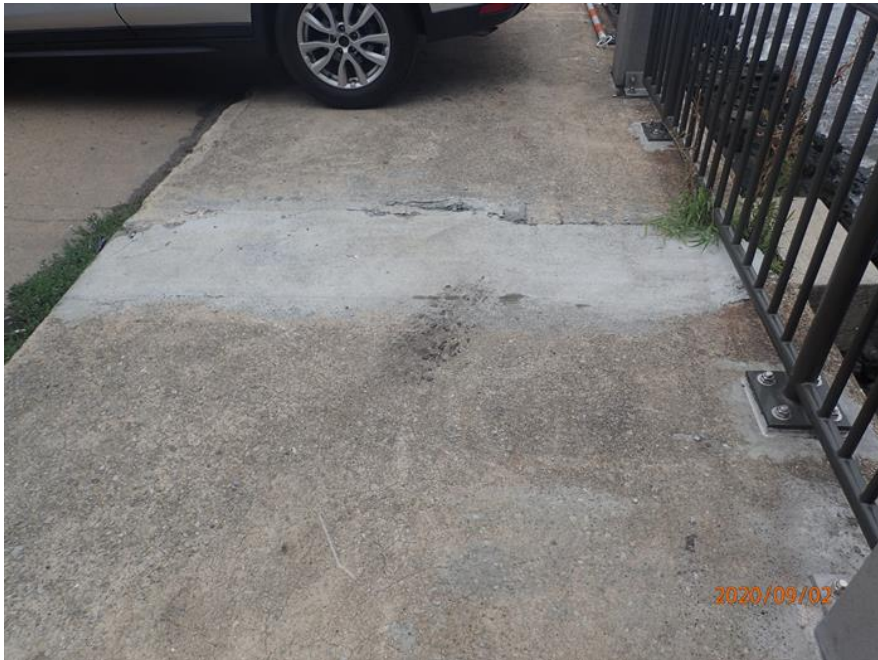
Station 22+57

Direction: Seawall Sidewalk Joint

Comments: Concrete Cracks

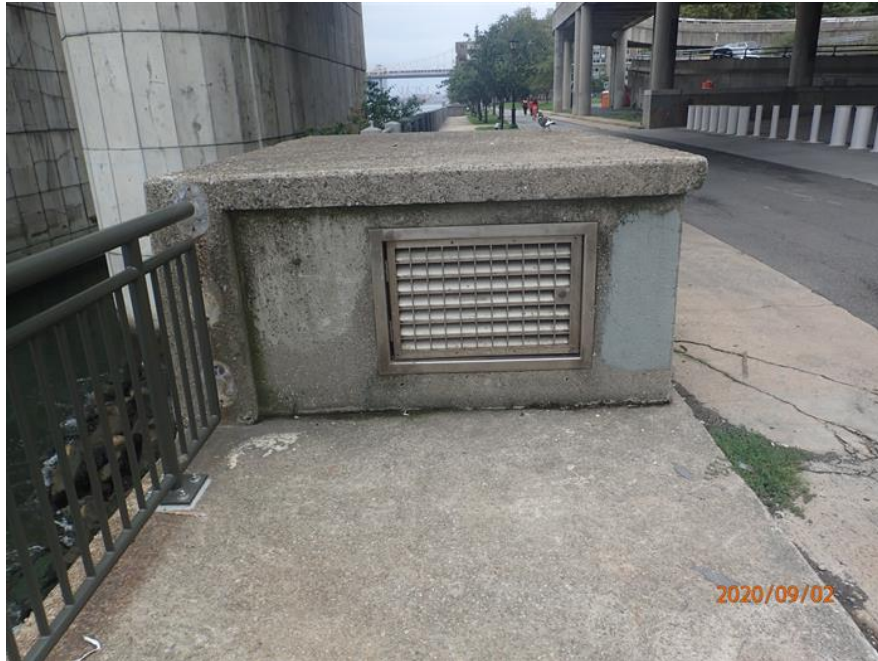
Station 22+84

Direction: Air Vent 9

Comments: Northern Face

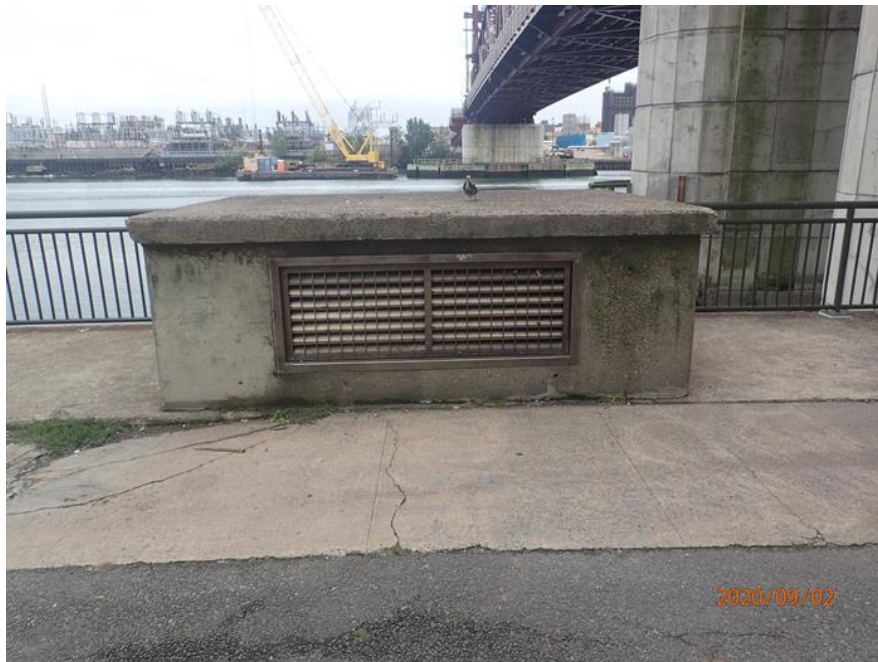
Station 22+84

Direction: Air Vent 9

Comments: Western Face

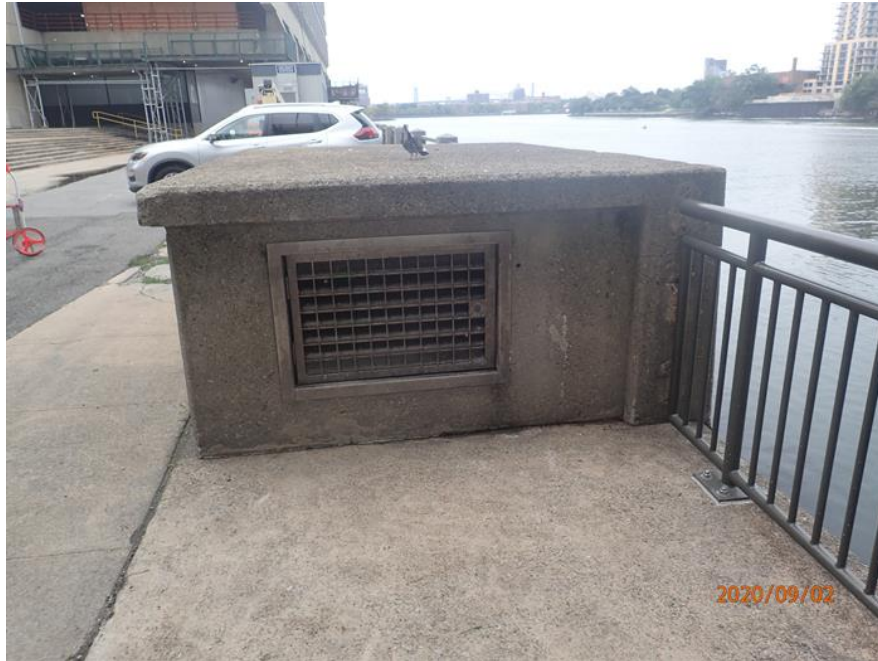
Station 22+84

Direction: Air Vent 9

Comments: Southern Face

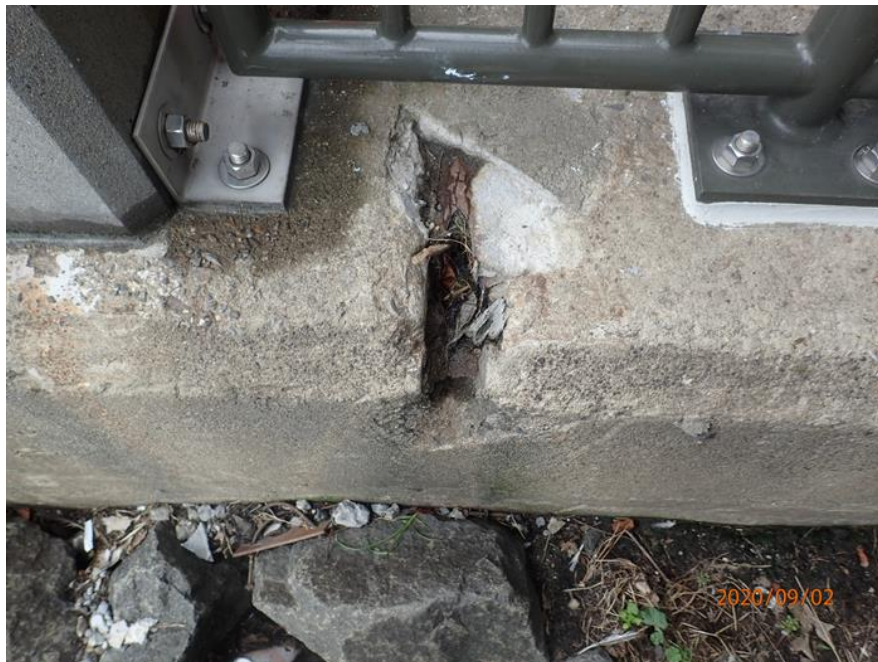
Station 23+05

Direction: Seawall

Comments: Corroded Drainage Pipe; Concrete Spalling

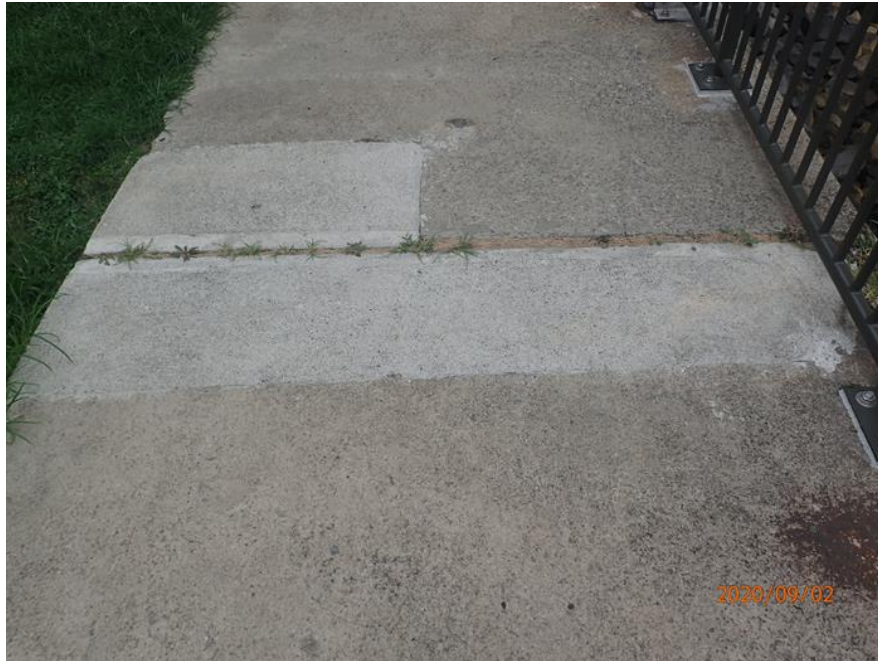
Station 23+88

Direction: Seawall Sidewalk Joint

Comments: Joint Repair

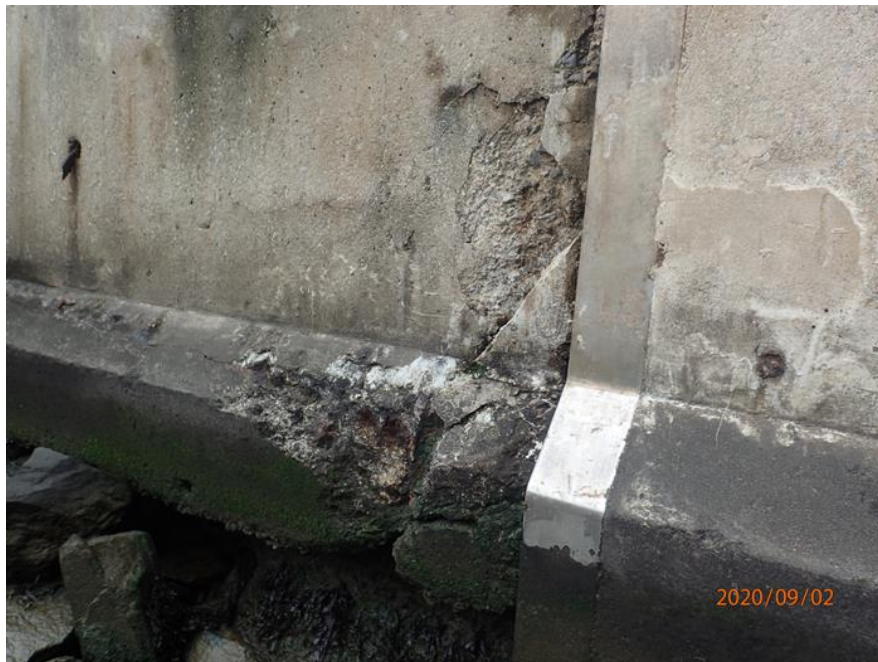
Station 23+88

Direction: Seawall Joint

Comments: Concrete Spalling, Missing Large Section of Concrete

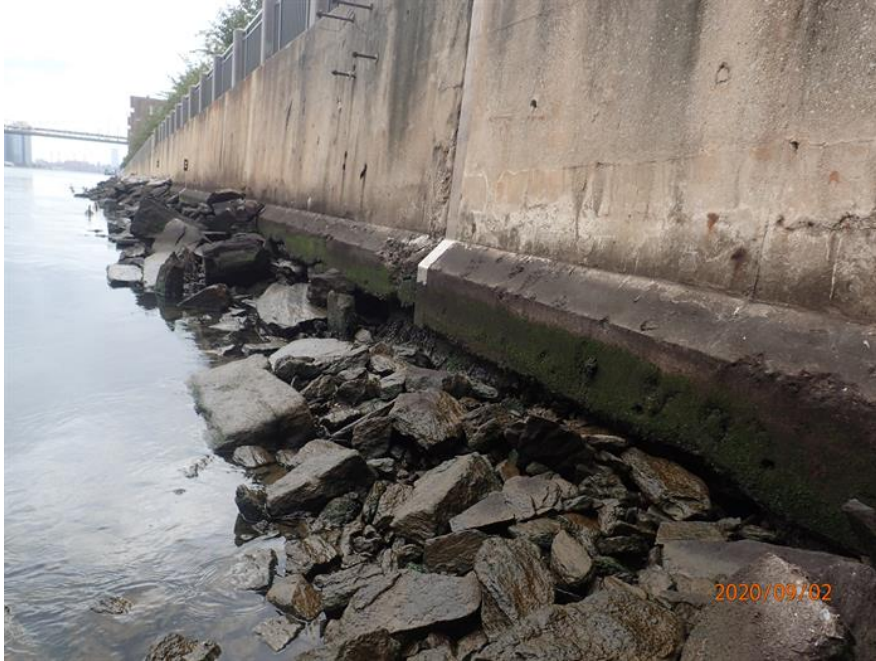
Station 23+78 to 24+00

Direction: Seawall

Comments: Tunnel Undermined

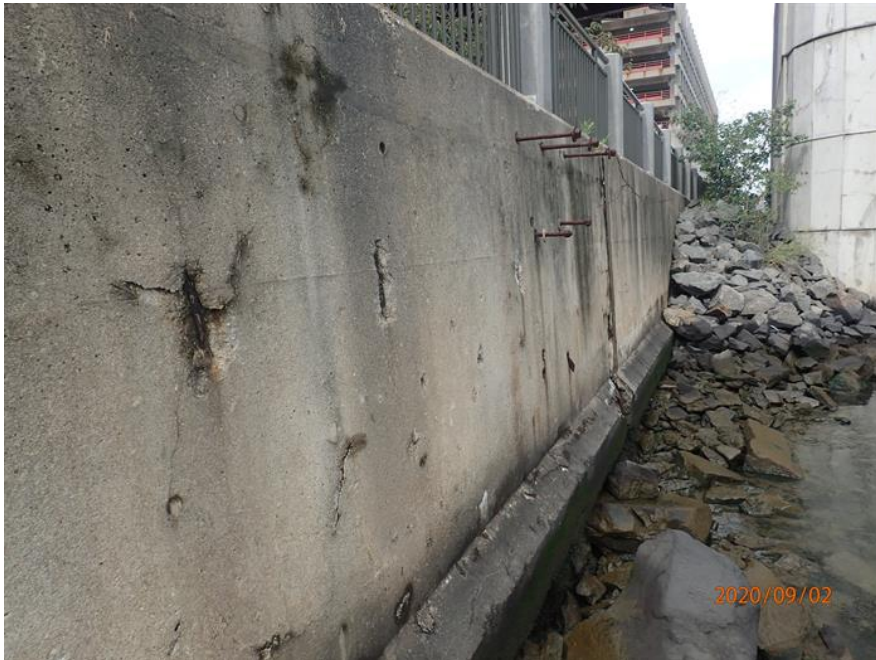
Station 24+10 to 24+50

Direction: Seawall

Comments: Re-Bar Exposed and Corroded

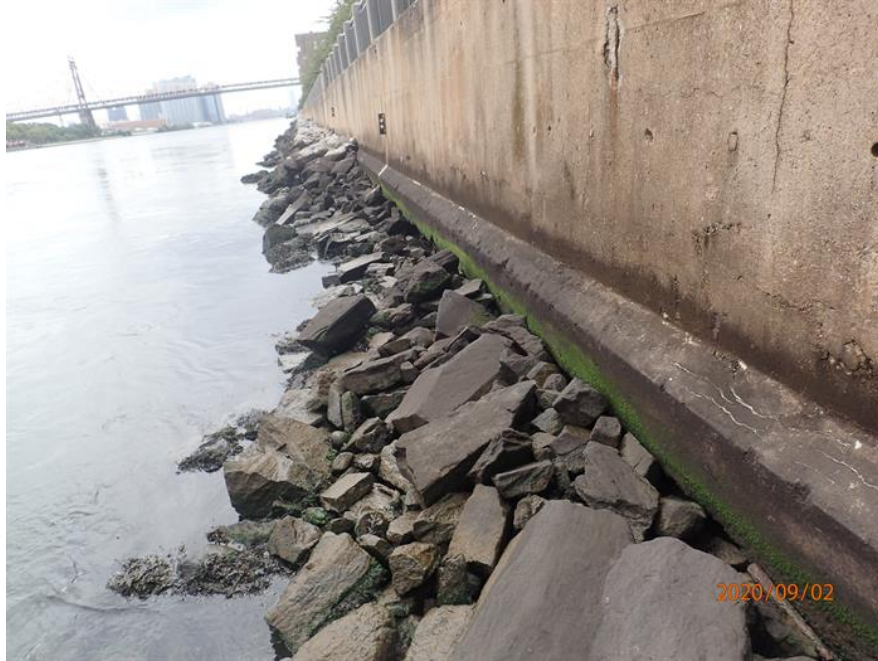
Station 24+00 to 24+20

Direction: Seawall

Comments: Tunnel Undermined

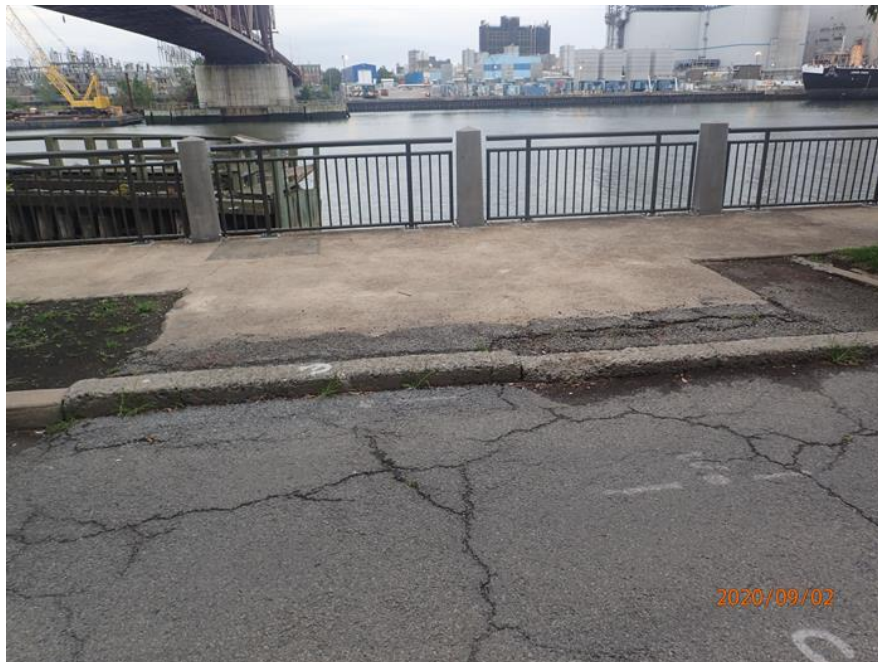
Station 24+20

Direction: Seawall Sidewalk Joint

Comments: Concrete Cracks on Cross Over Chamber

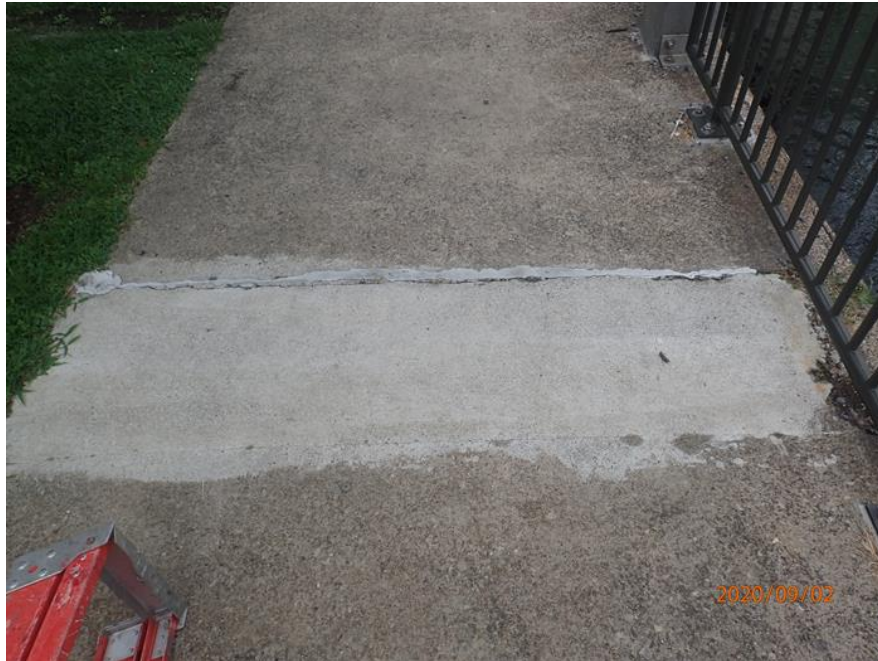
Station 24+50

Direction: Seawall Sidewalk Joint

Comments: Concrete Cracks, Attempt to Repair

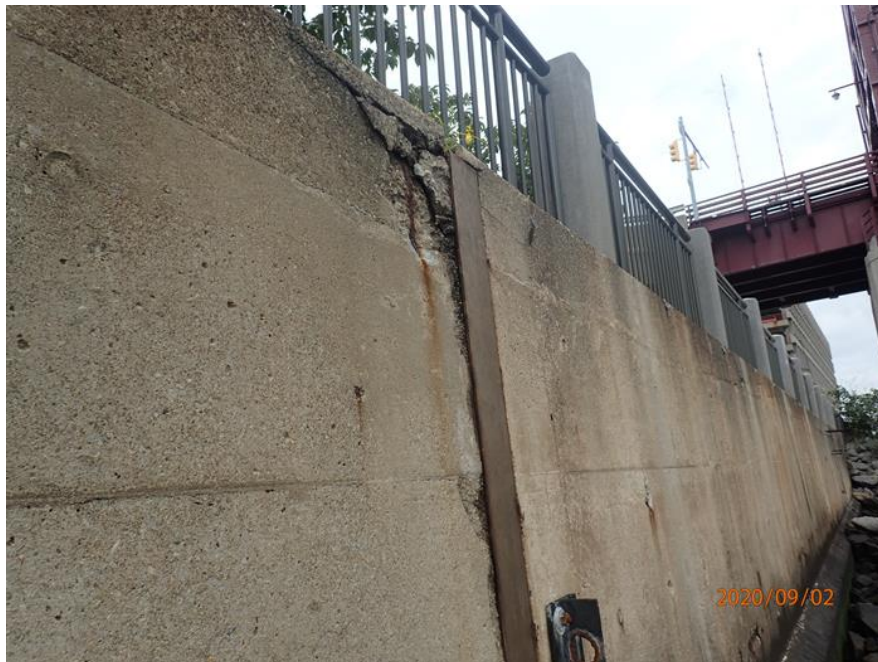
Station 24+50

Direction: Seawall Joint

Comments: Concrete Spalling, Missing Large Section of Concrete, Re-Bar Exposed

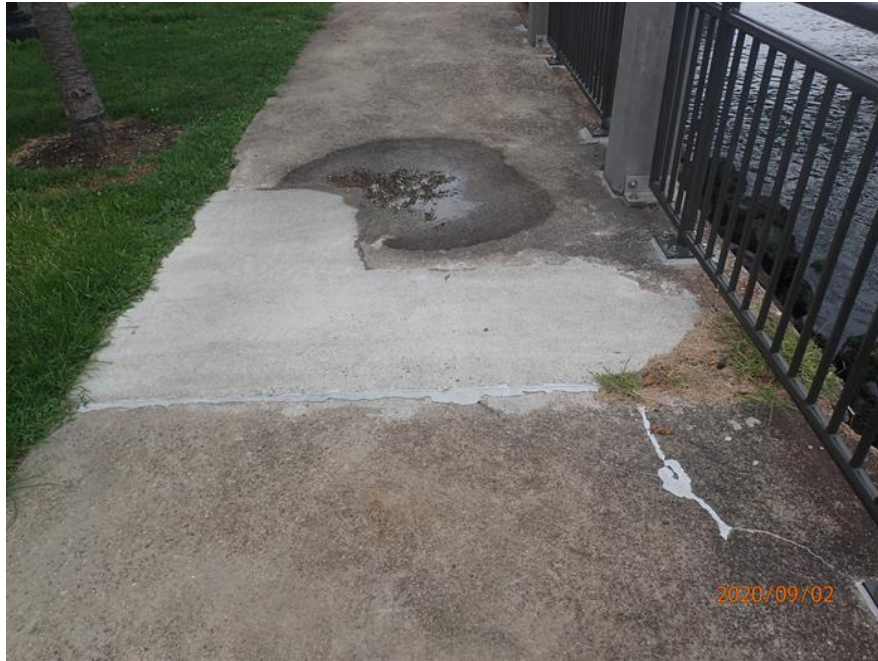
Station 25+17

Direction: Seawall Sidewalk Joint

Comments: Concrete Cracks, Attempt to Repair

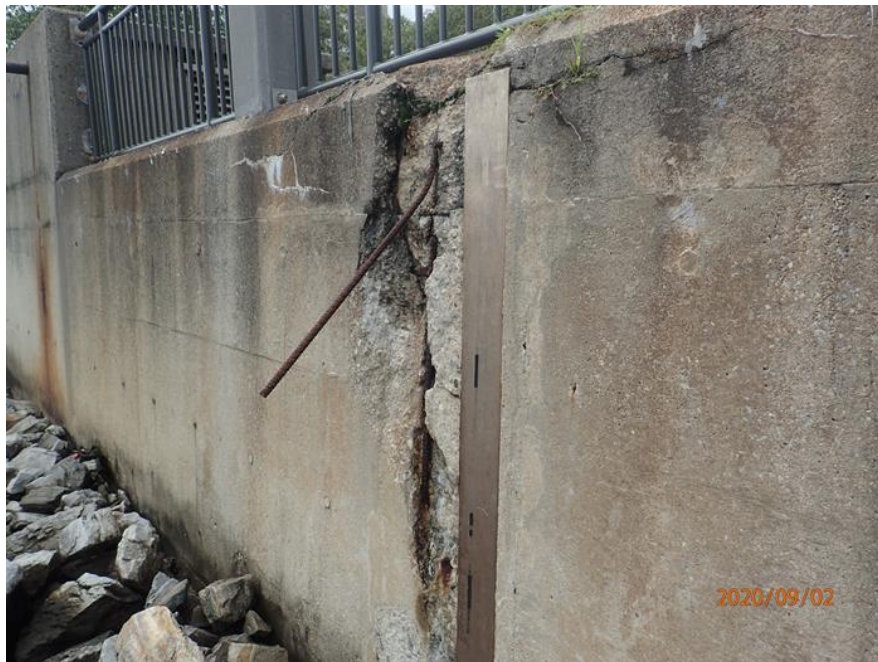
Station 25+17

Direction: Seawall Joint

Comments: Concrete Spalling, Missing Large Section of Concrete, Re-Bar Exposed and Loose
