CONDITIONS REPORT & CONCEPTUAL DESIGN MEMORANDUM

STEAM TUNNEL ASSESSMENT

ROOSEVELT ISLAND, NEW YORK

17 November 2014
Revised 28 December 2018
Revised 18 September 2020
Project # 100444601

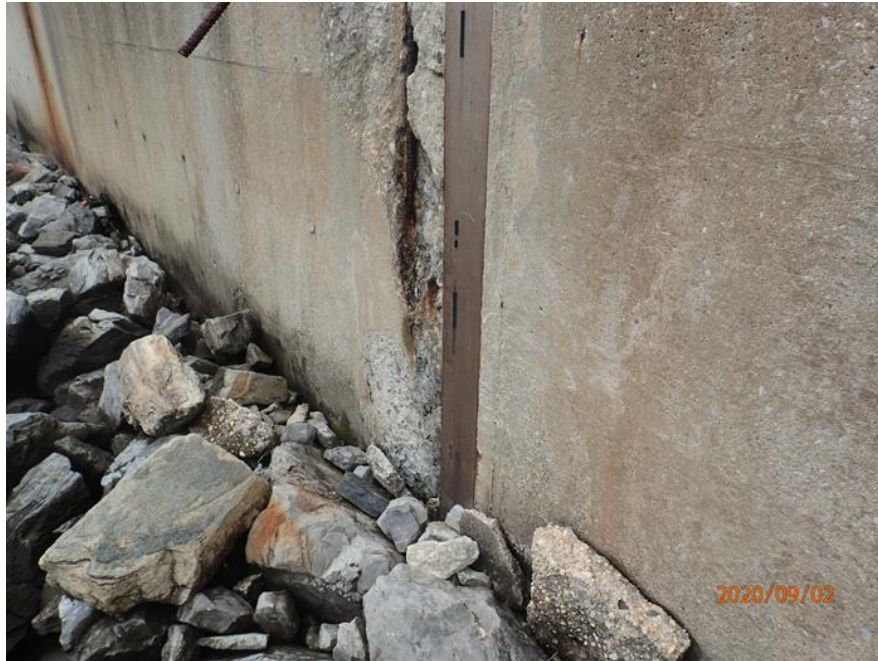
Station 25+17

Direction: Seawall Joint

Comments: Concrete Spalling, Missing Large Section of Concrete, Re-Bar Exposed and Loose

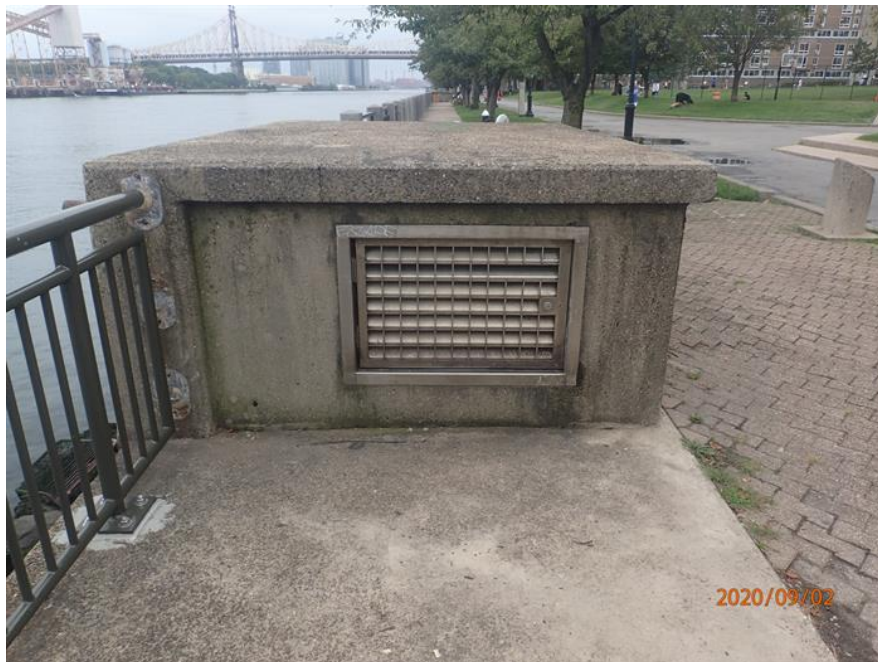
Station 25+38

Direction: Air Vent 8

Comments: Northern Face

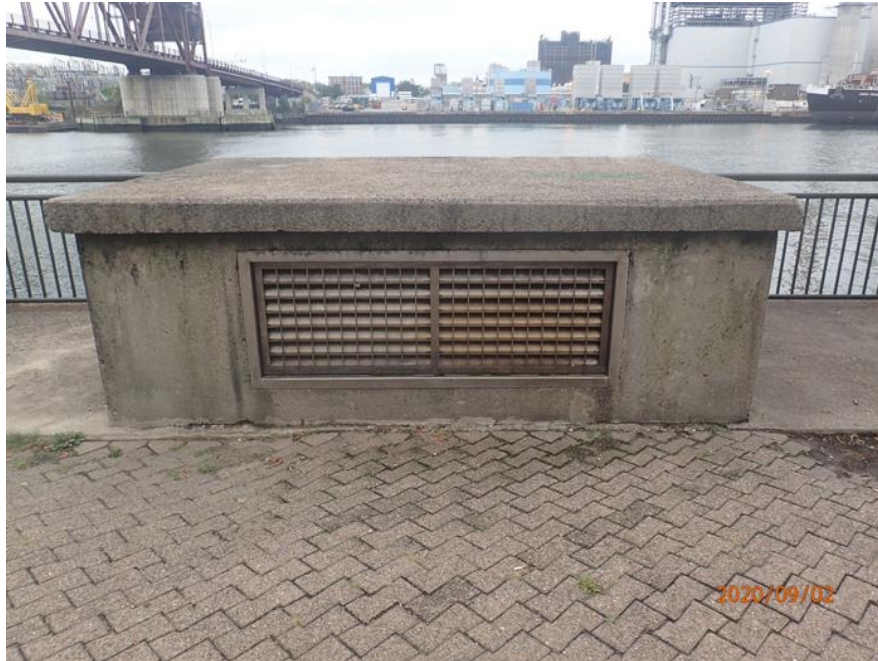
Station 25+38

Direction: Air Vent 8

Comments: Western Face

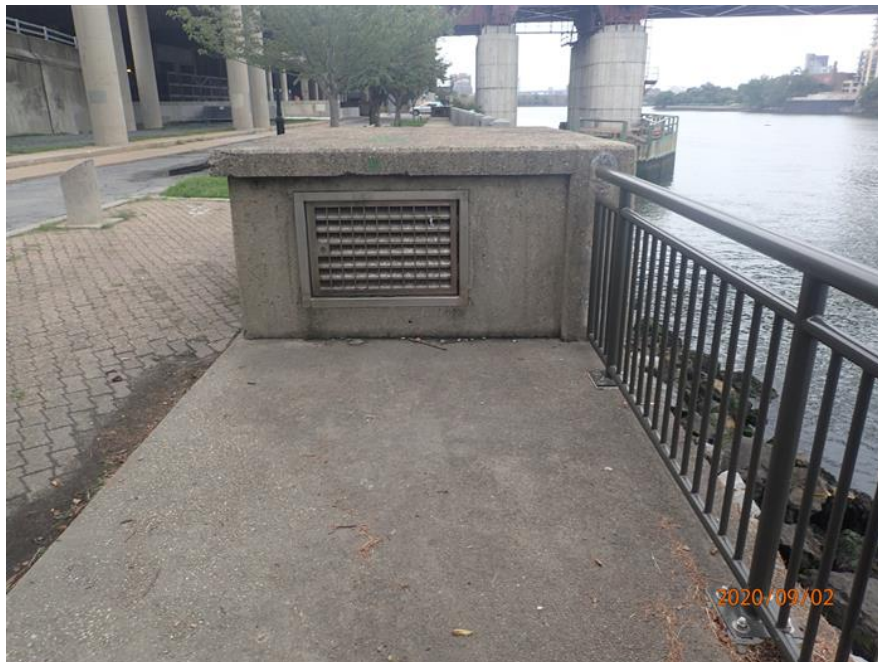
Station 25+38

Direction: Air Vent 8

Comments: Southern Face

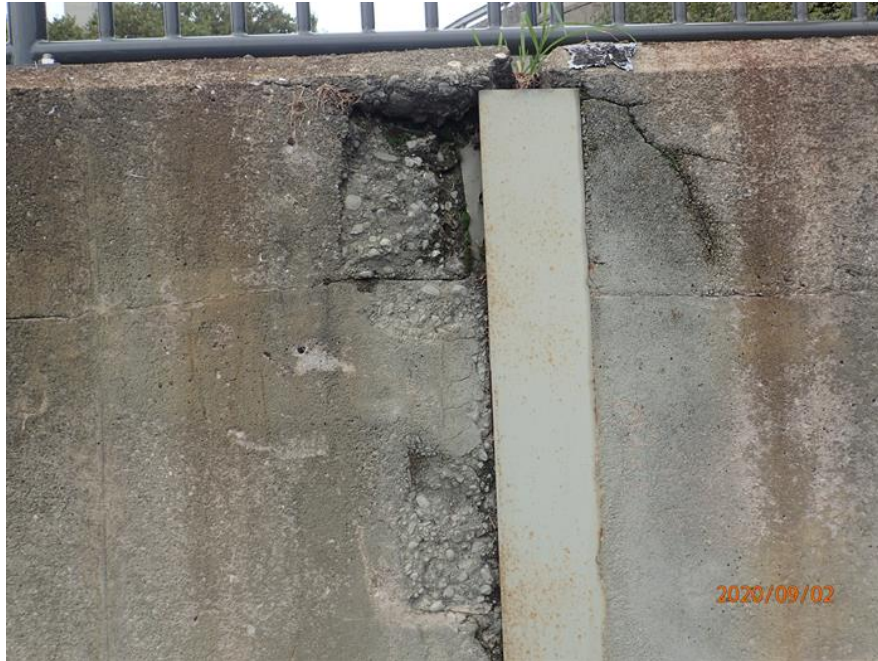
Station 25+80

Direction: Seawall Joint

Comments: Concrete Spalling, Missing Large Section of Concrete

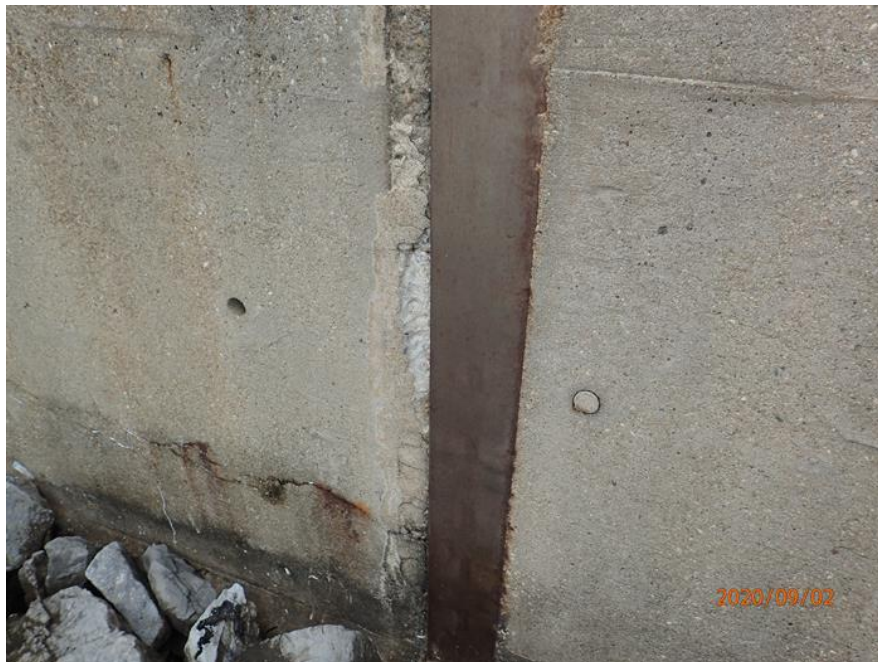
Station 26+40

Direction: Seawall Joint

Comments: Concrete Spalling, Missing Concrete

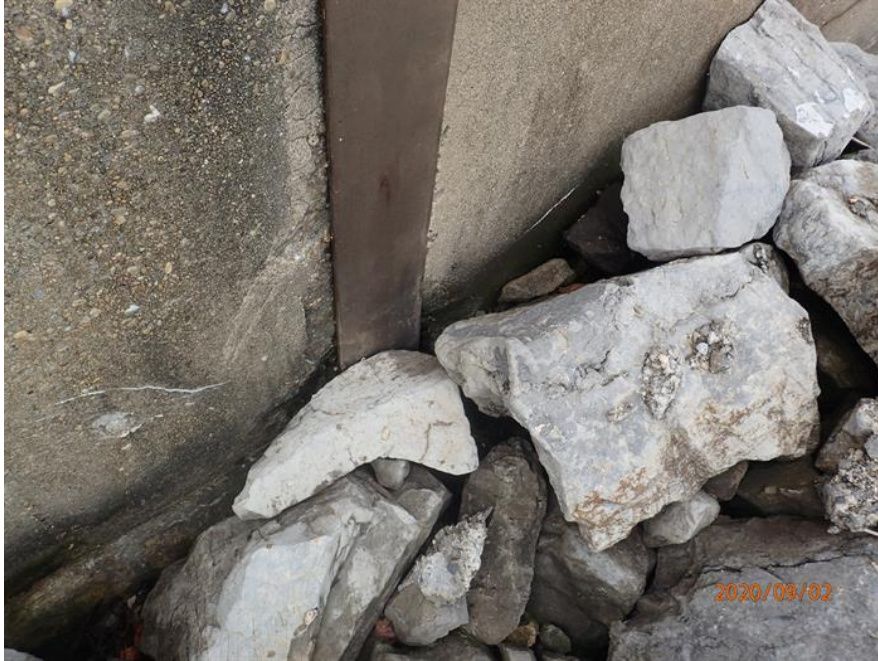
Station 27+57

Direction: Seawall Joint

Comments: Concrete Spalling, Missing Concrete

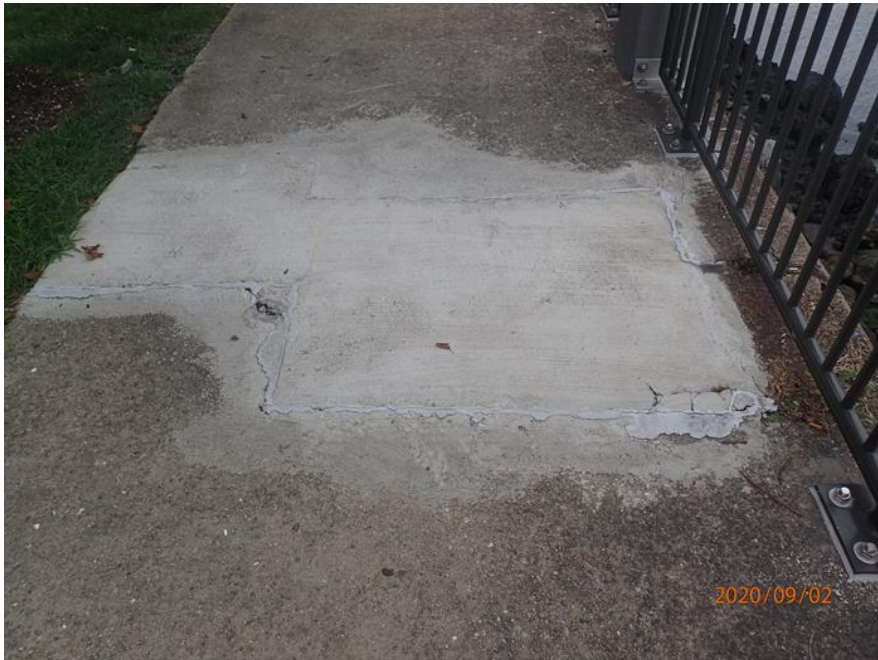
Station 27+57

Direction: Seawall Sidewalk Joint

Comments: Concrete Cracks, Attempt to Repair

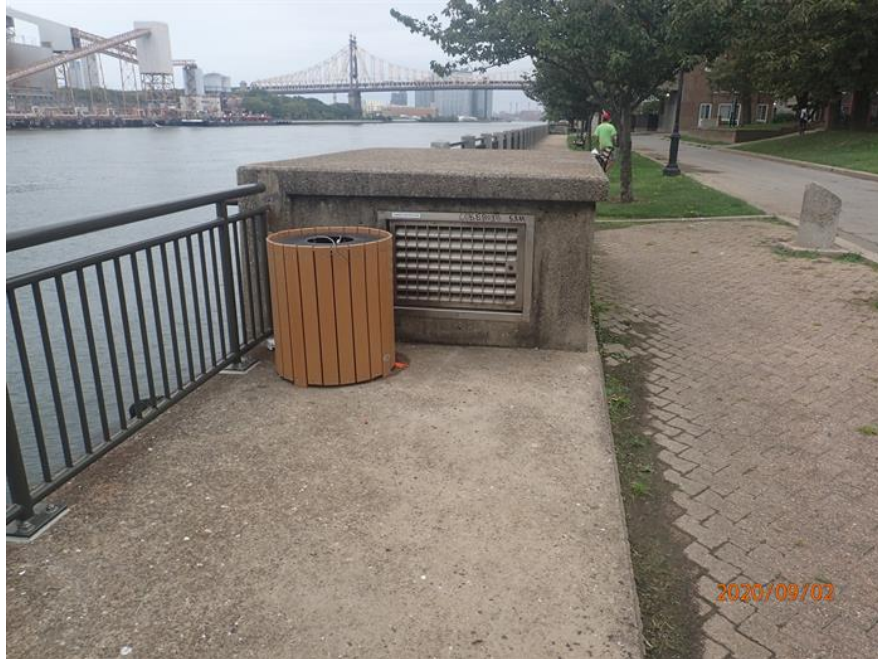
Station 27+92

Direction: Air Vent 7

Comments: Northern Face

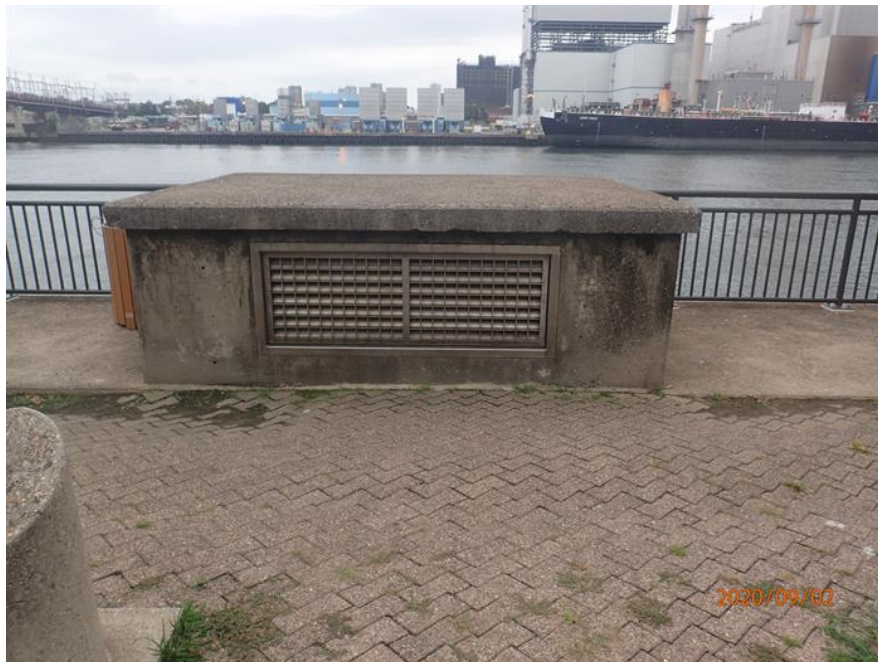
Station 27+92

Direction: Air Vent 7

Comments: Western Face

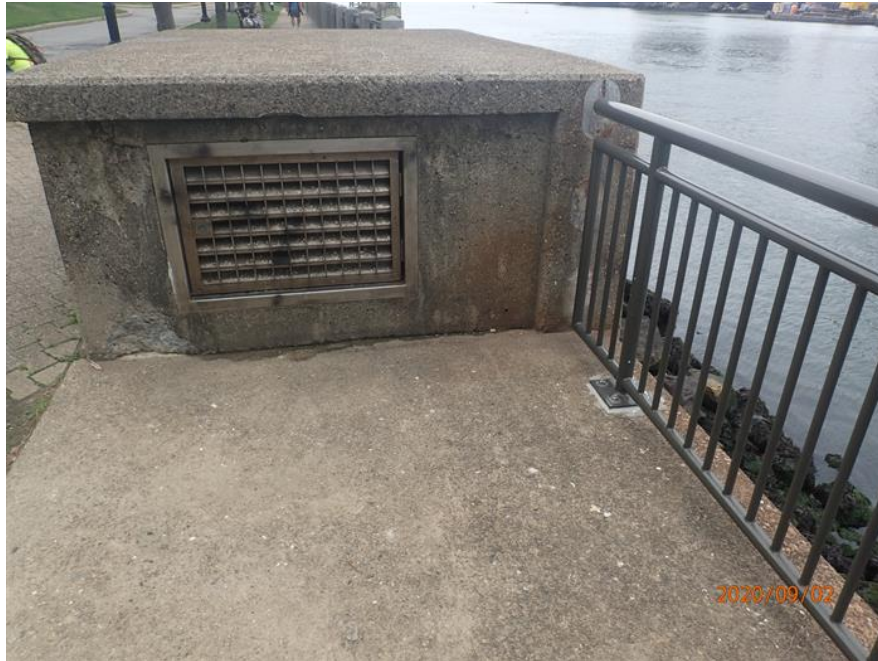
Station 27+92

Direction: Air Vent 7

Comments: Southern Face

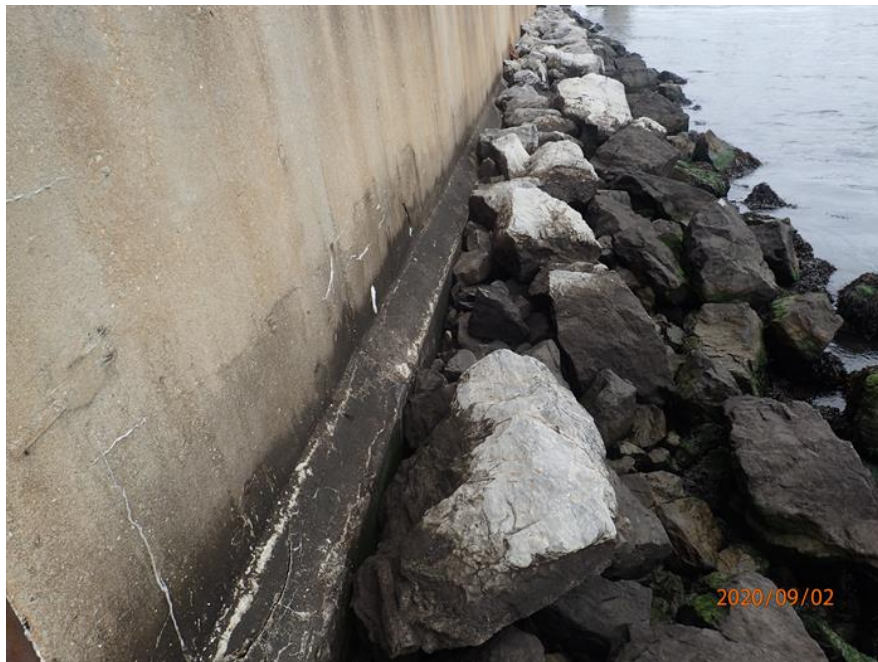
Station 27+92 to 28+02

Direction: Seawall

Comments: Rip-rap Deficiency

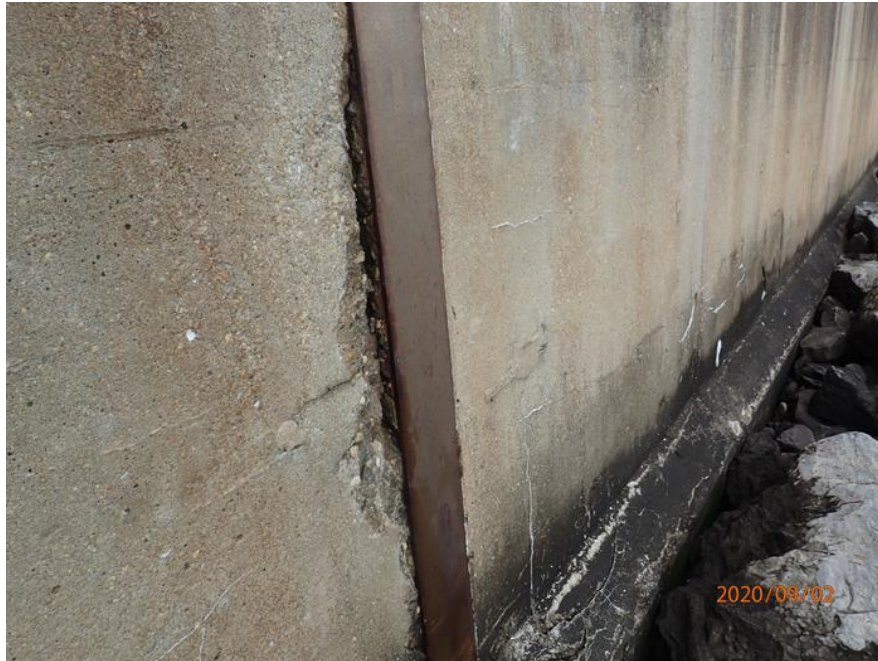
Station 28+02

Direction: Seawall Joint

Comments: Concrete Spalling, Missing Large Section of Concrete

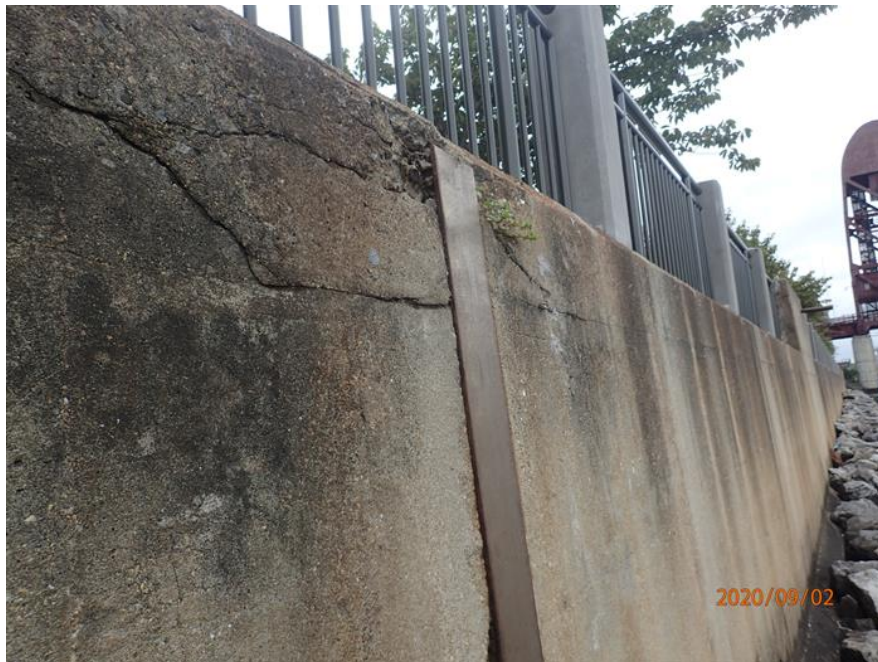
Station 28+02

Direction: Seawall Joint

Comments: Concrete Spalling, Missing Large Section of Concrete

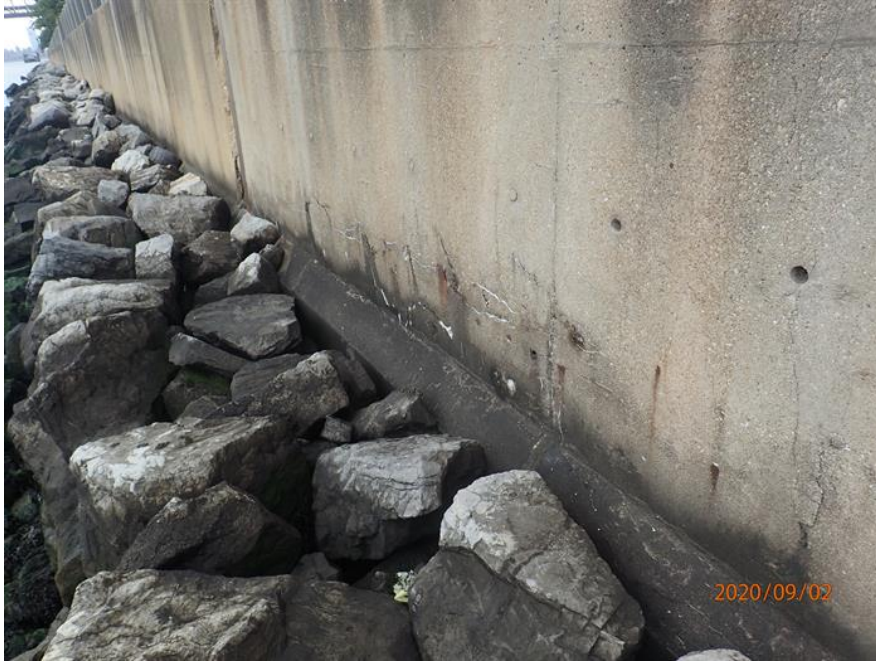
Station 28+40 to 28+50

Direction: Seawall

Comments: Concrete Spalling, Rip-rap Deficiency

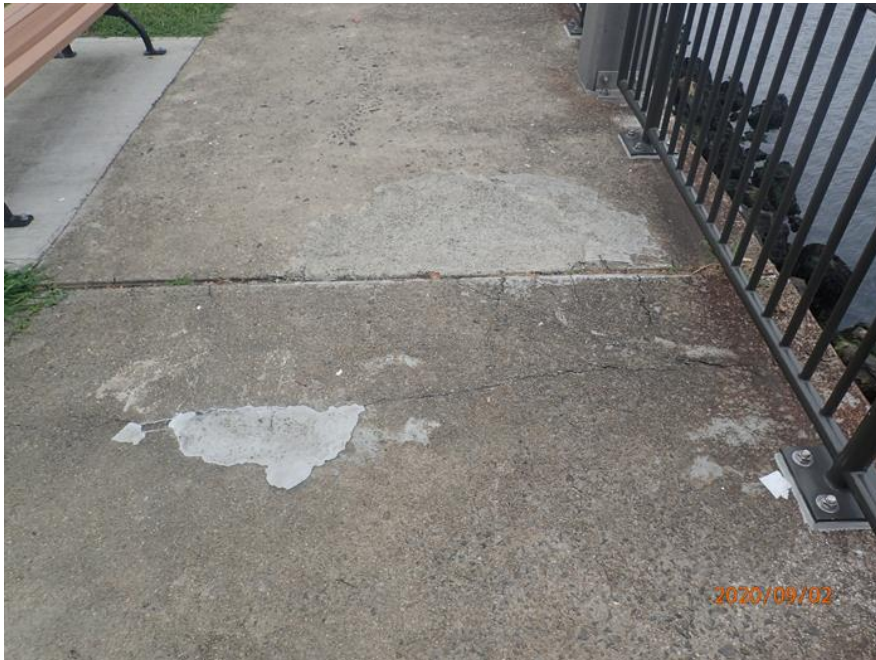
Station 28+34

Direction: Seawall Sidewalk Joint

Comments: Concrete Cracks

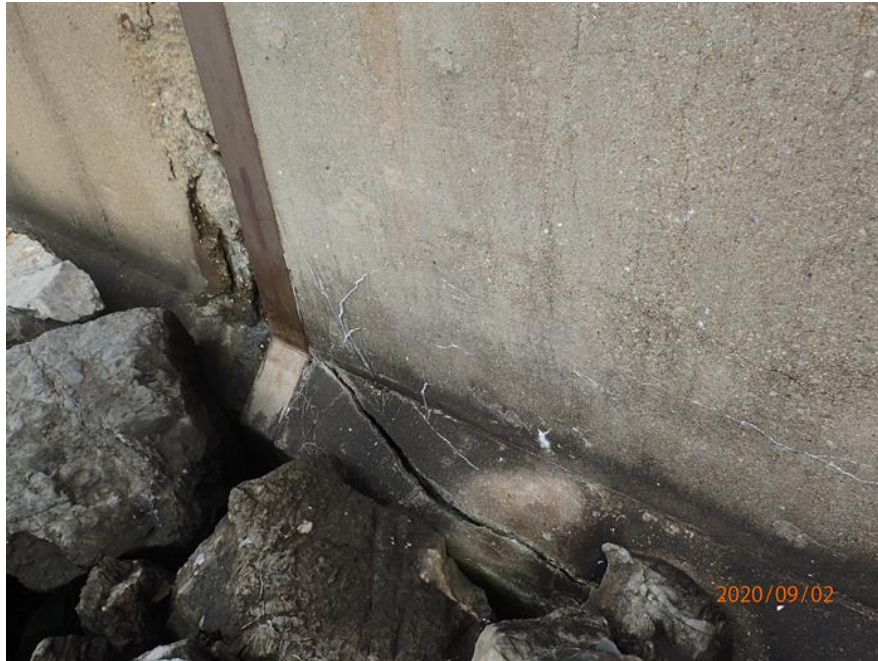
Station 28+34

Direction: Seawall Joint

Comments: Concrete Spalling, Missing Large Section of Concrete, Large Concrete Cracks, Re-Bar Exposed

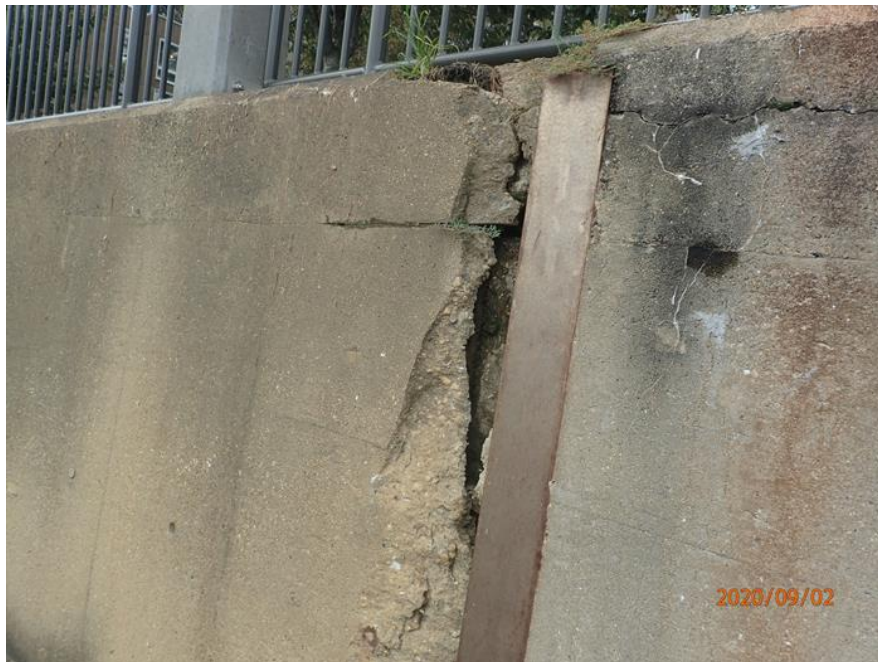
Station 28+34

Direction: Seawall Joint

Comments: Concrete Spalling, Missing Large Section of Concrete, Large Concrete Cracks, Re-Bar Exposed

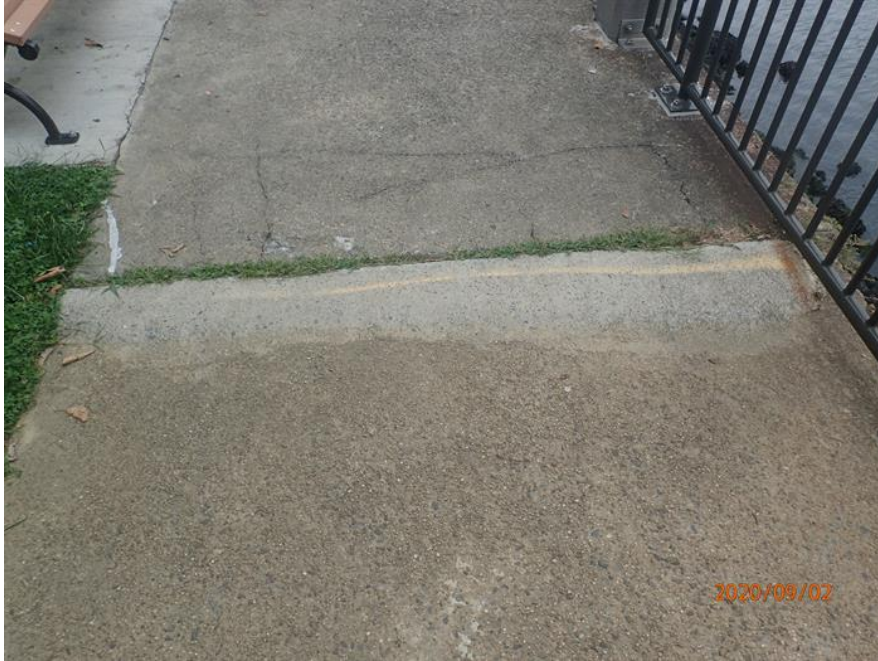
Station 28+91

Direction: Seawall Sidewalk Joint

Comments: Concrete Cracks, Attempt to Repair

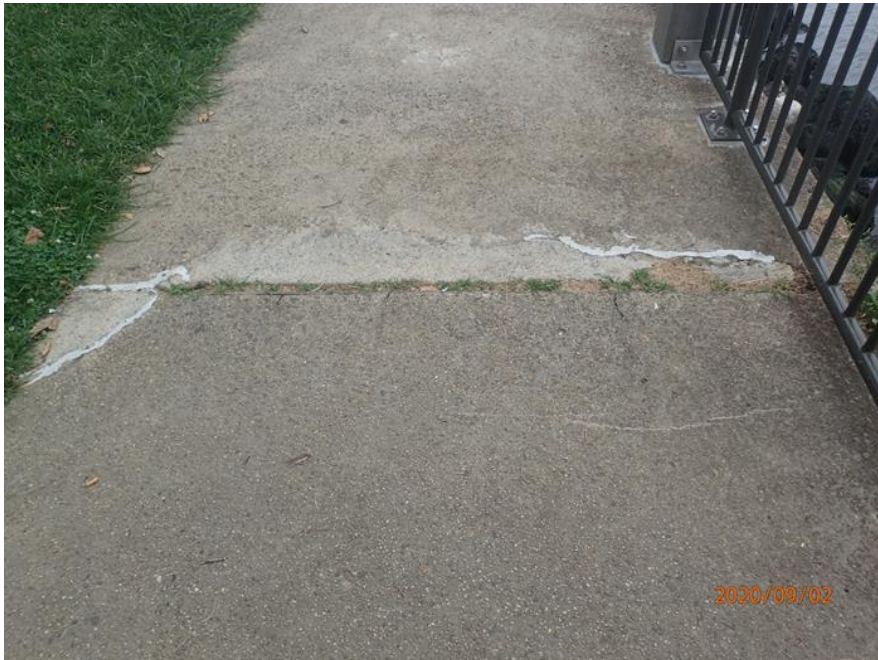
Station 29+62

Direction: Seawall Sidewalk Joint

Comments: Concrete Cracks

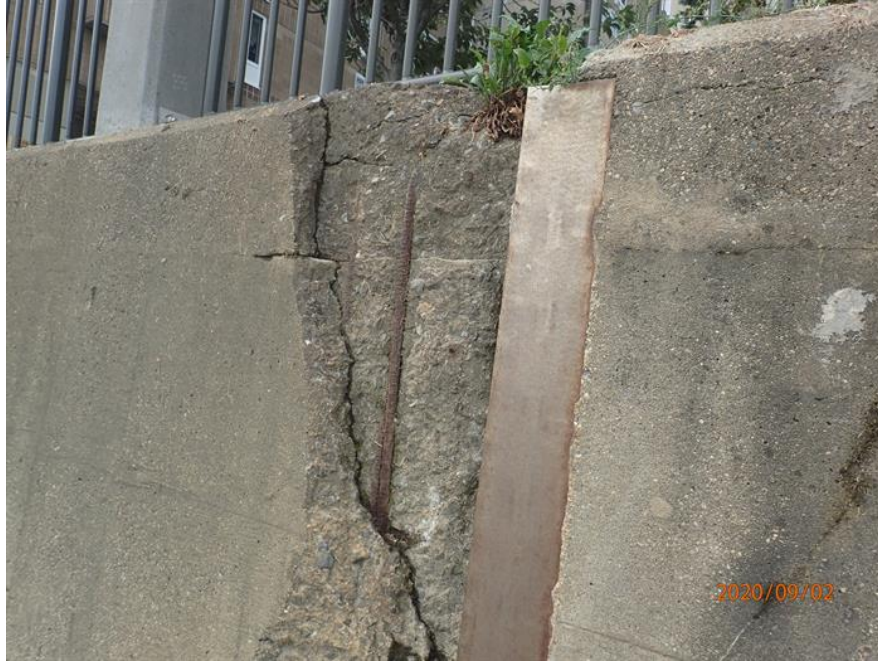
Station 29+62

Direction: Seawall Joint

Comments: Concrete Spalling, Missing Large Section of Concrete, Re-Bar Exposed

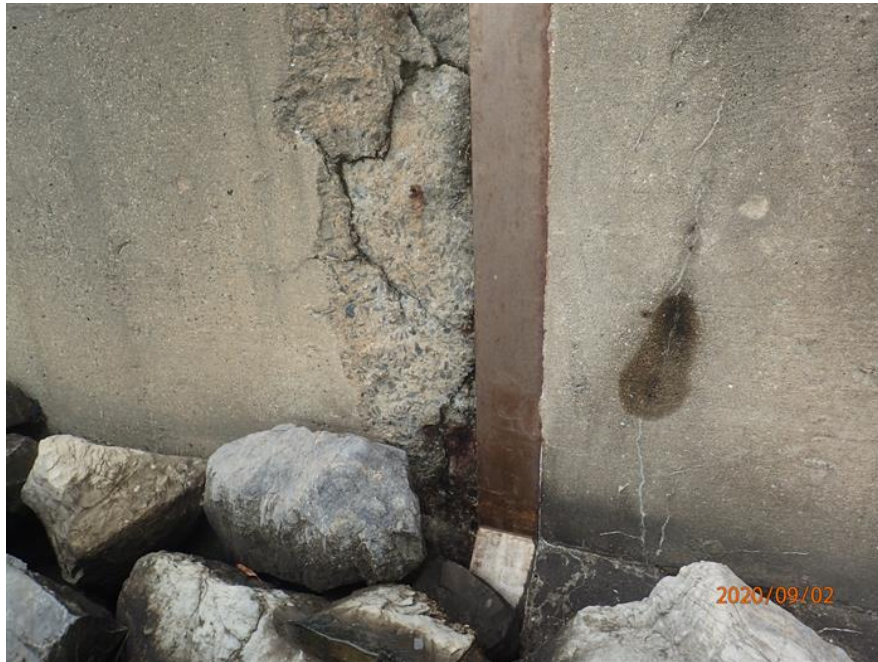
Station 29+62

Direction: Seawall Joint

Comments: Concrete Spalling, Missing Large Section of Concrete, Re-Bar Exposed

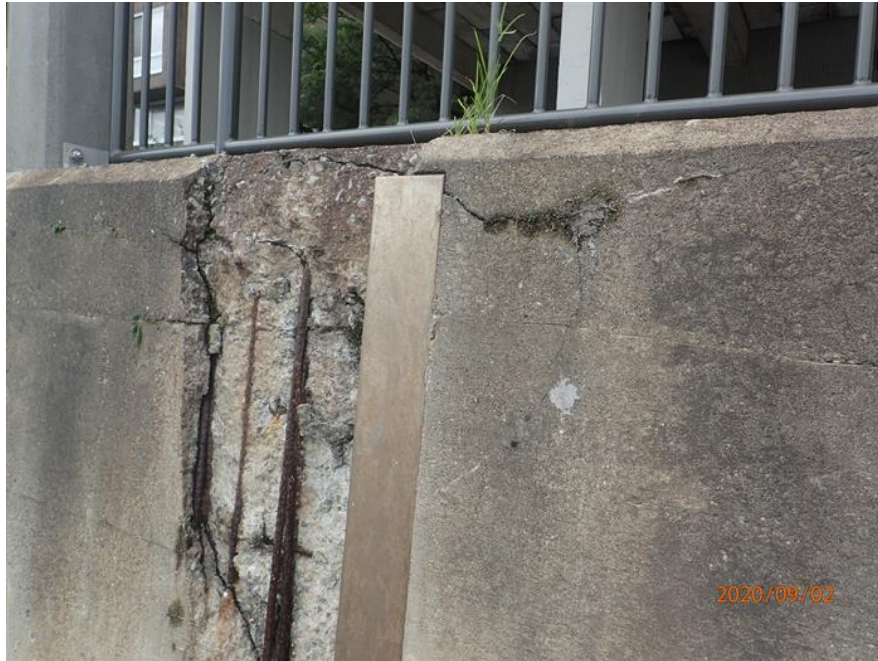
Station 29+62

Direction: Seawall Joint

Comments: Concrete Spalling, Missing Large Section of Concrete, Re-Bar Exposed

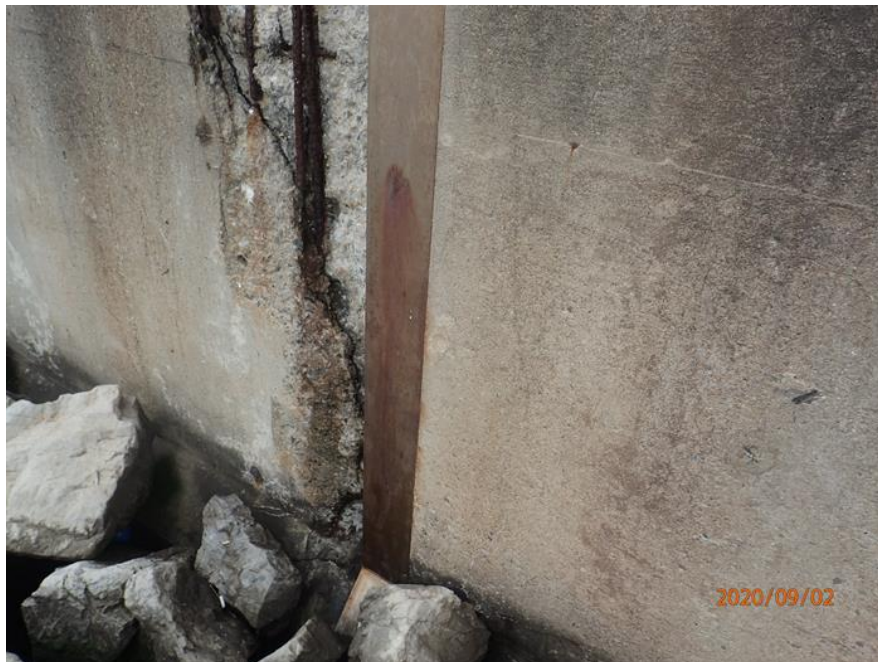
Station 29+62

Direction: Seawall Joint

Comments: Concrete Spalling, Missing Large Section of Concrete, Re-Bar Exposed

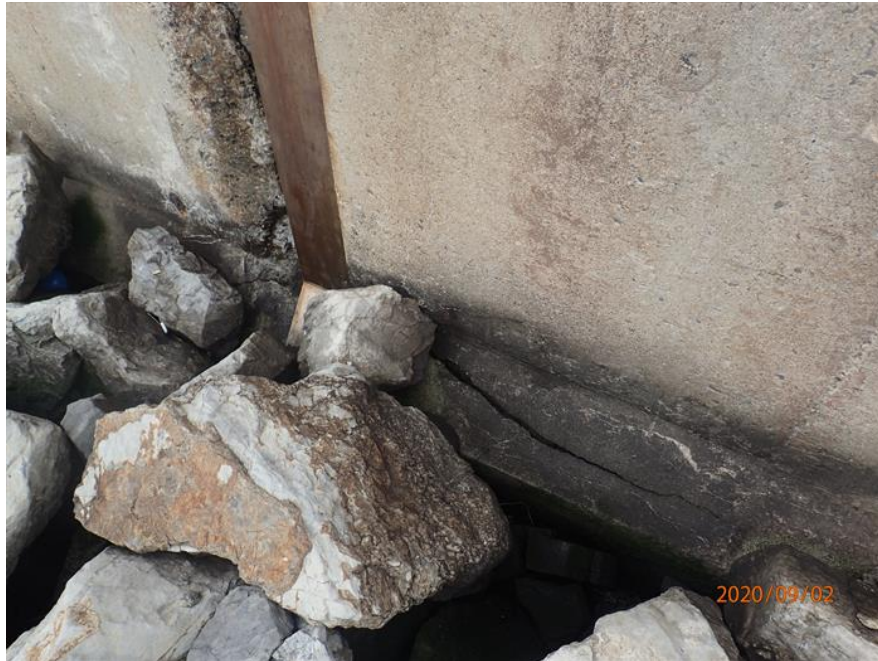
Station 29+62

Comments: Concrete Spalling, Missing Large Section of Concrete, Re-Bar Exposed

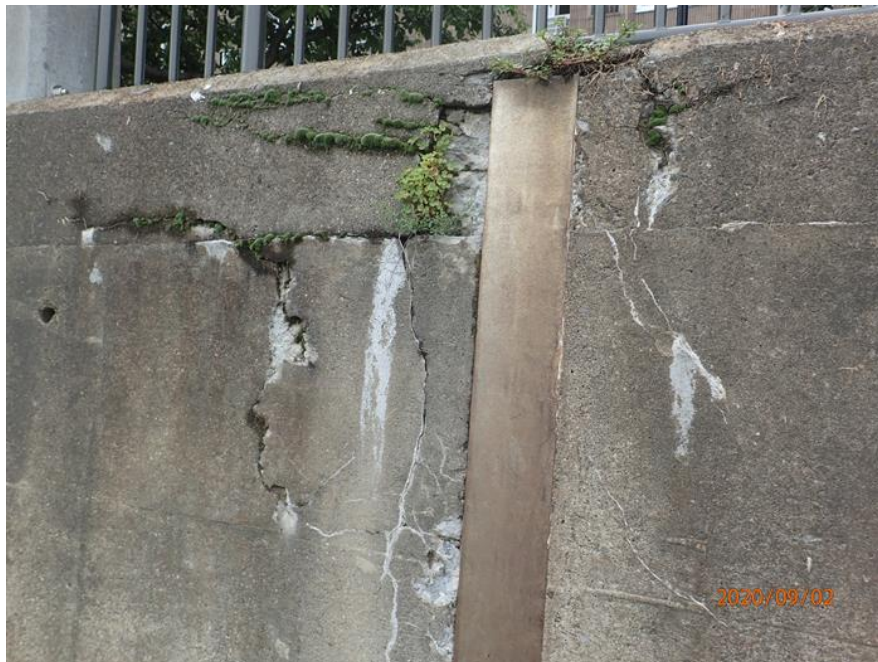
Station 30+24

Comments: Concrete Spalling, Missing Large Section of Concrete, Re-Bar Exposed

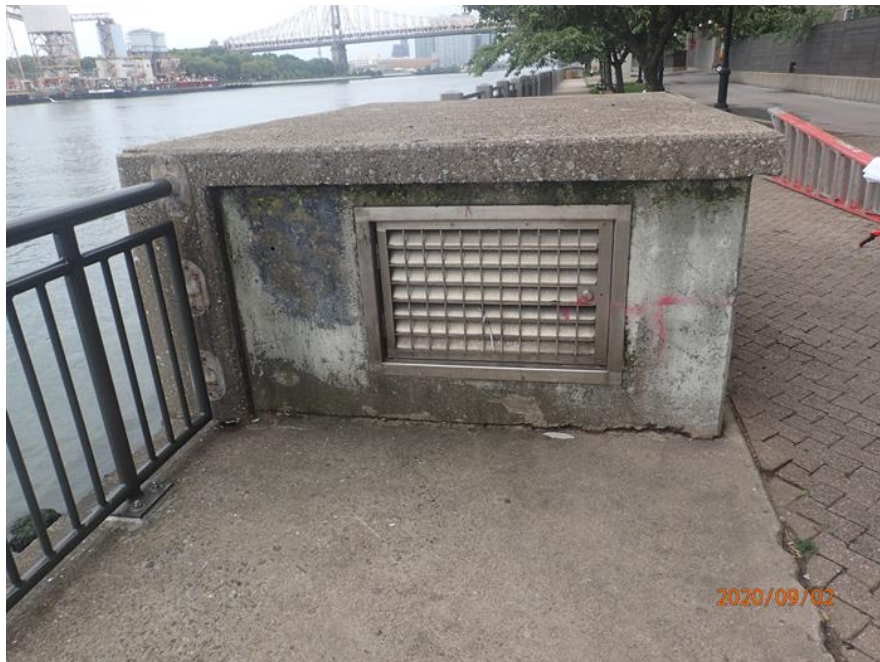
Station 30+46

Comments: Northern Face

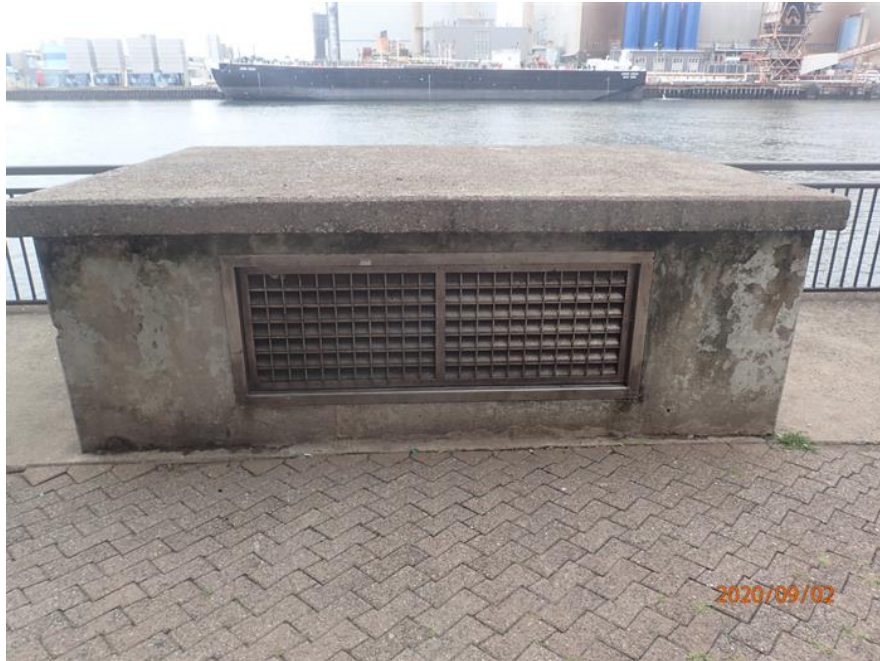
Station 30+46

Comments: Western Face

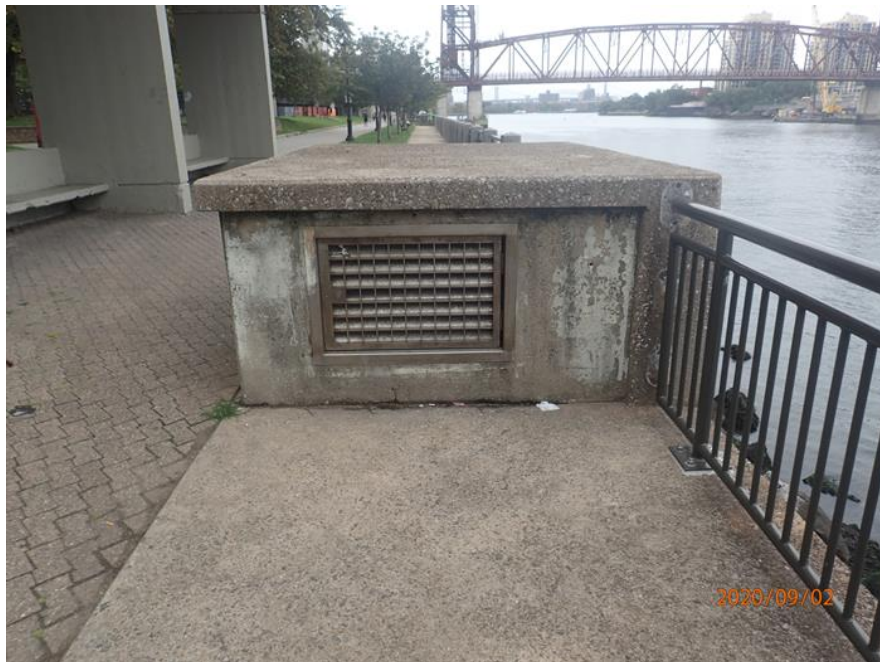
Station 30+46

Comments: Southern Face

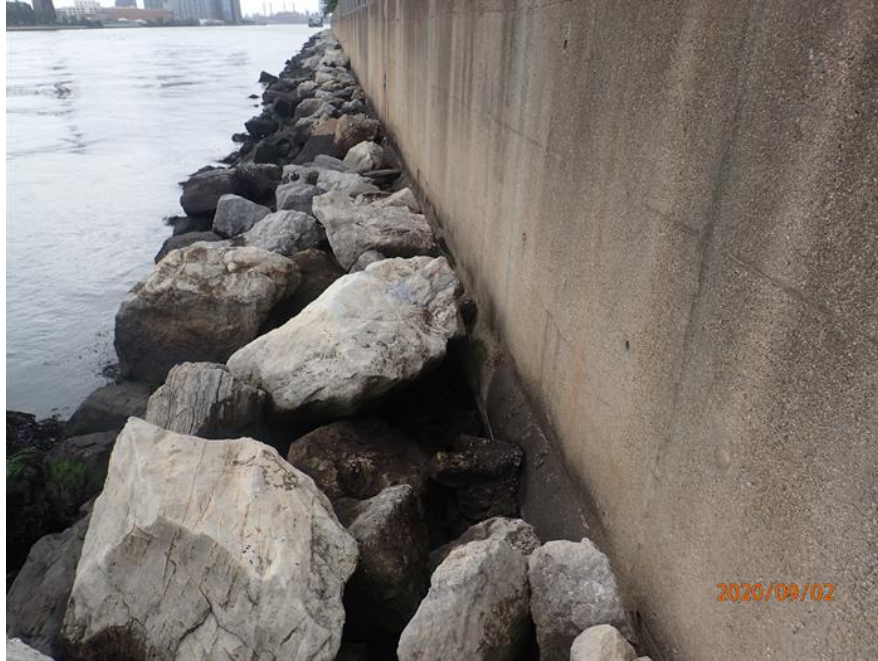
Station 31+10 to 31+20

Comments: Rip-rap Deficiency

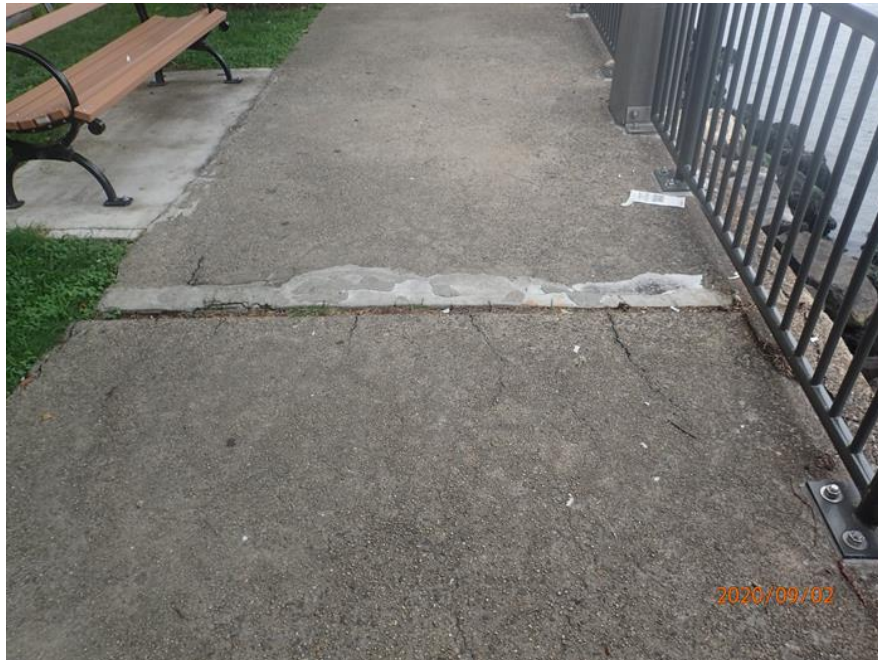
Station 31+52

Comments: Concrete Cracks, Attempt to Repair

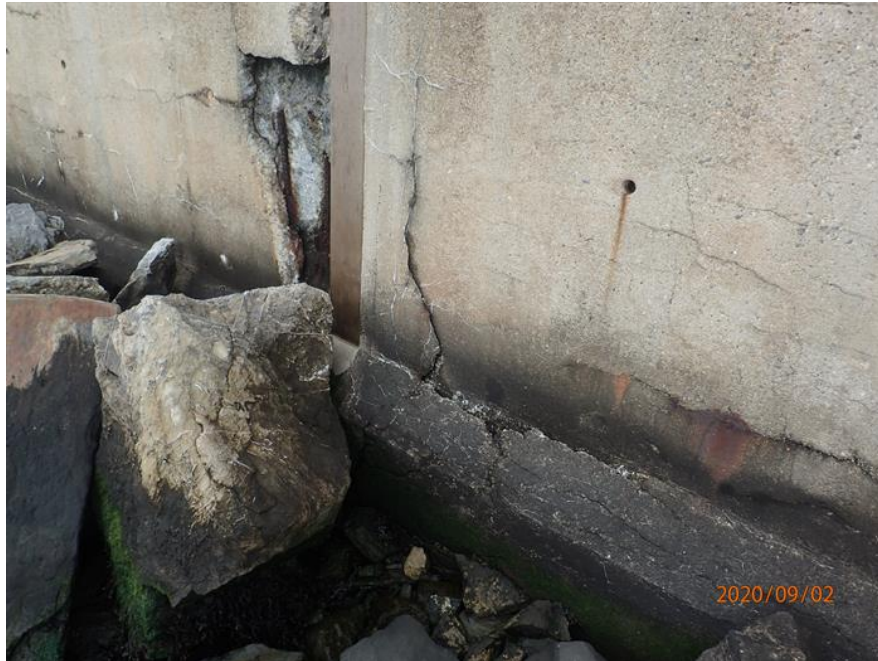
Station 31+52

Comments: Concrete Spalling, Missing Large Section of Concrete, Re-Bar Exposed

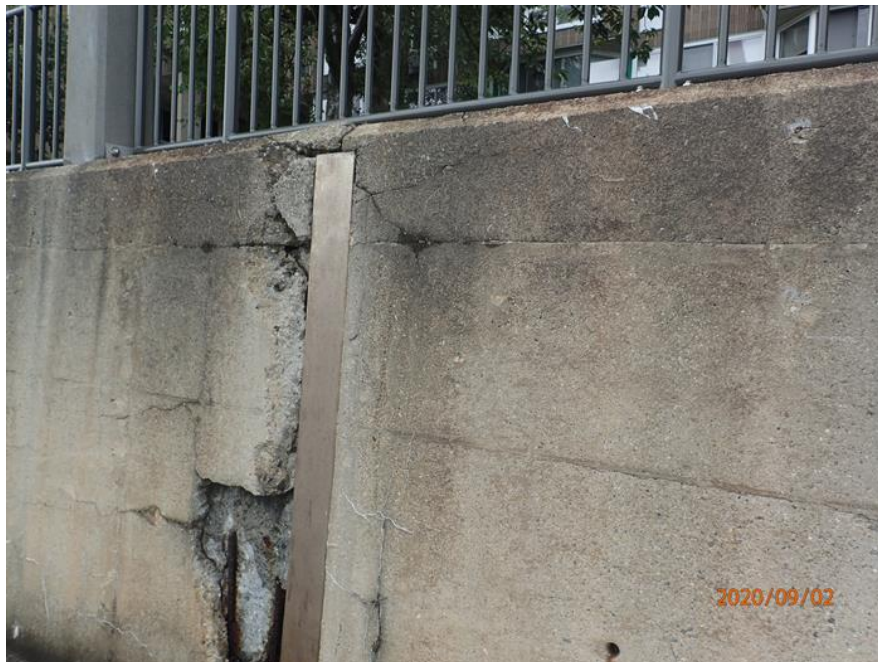
Station 31+52

Comments: Concrete Spalling, Missing Large Section of Concrete, Re-Bar Exposed

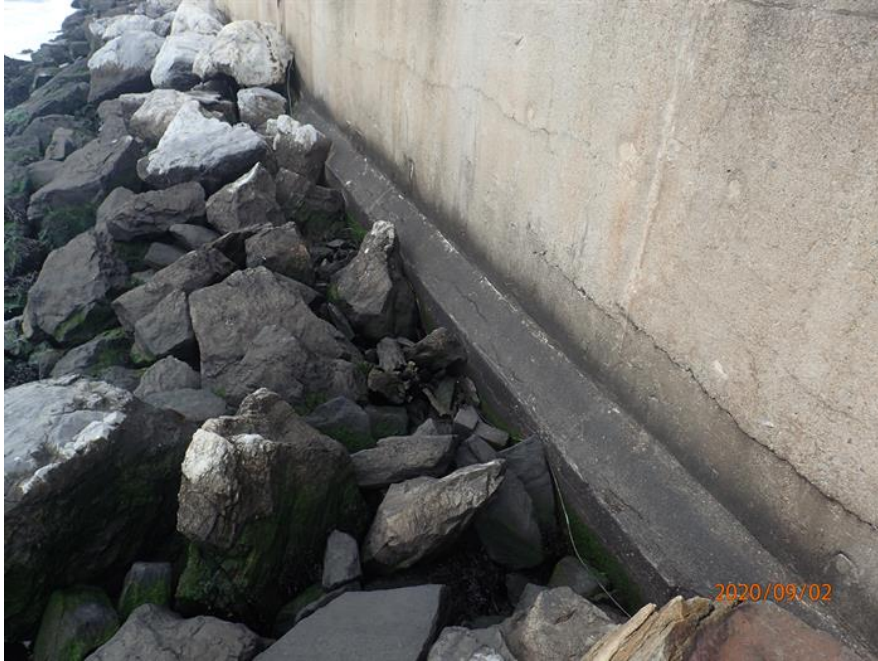
Station 31+80

Comments: Concrete Spalling, Concrete Cracks, Rip-rap Deficiency

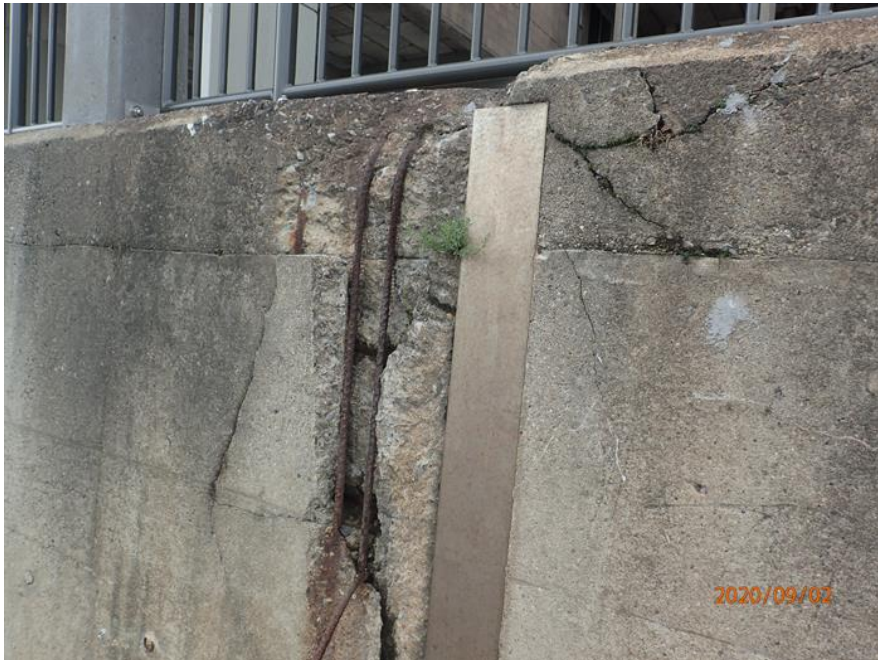
Station 32+16

Comments: Concrete Spalling, Loose Section of Concrete, Re-Bar Exposed

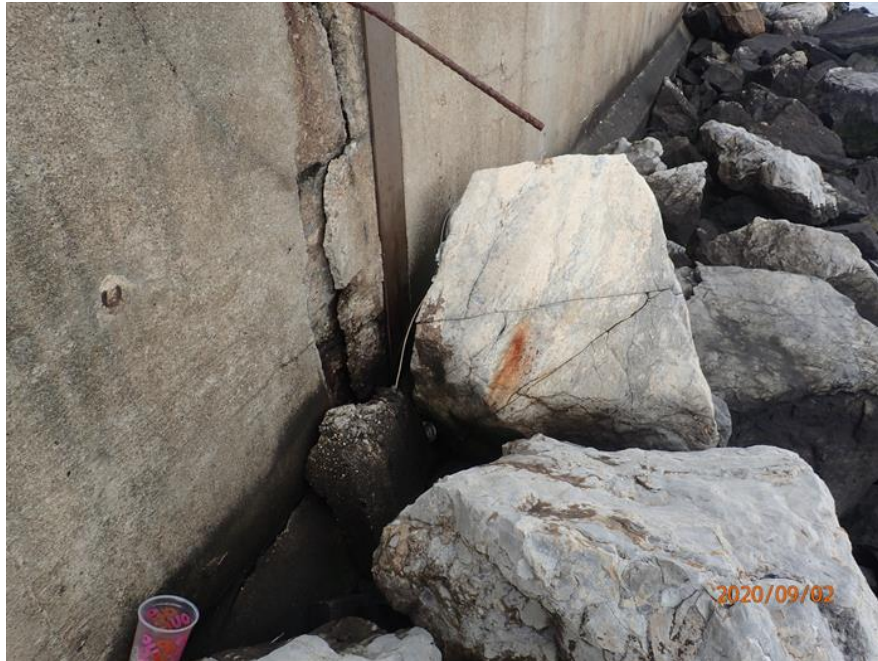
Station 32+16

Comments: Concrete Spalling, Missing Large Section of Concrete, Re-Bar Exposed and Loose

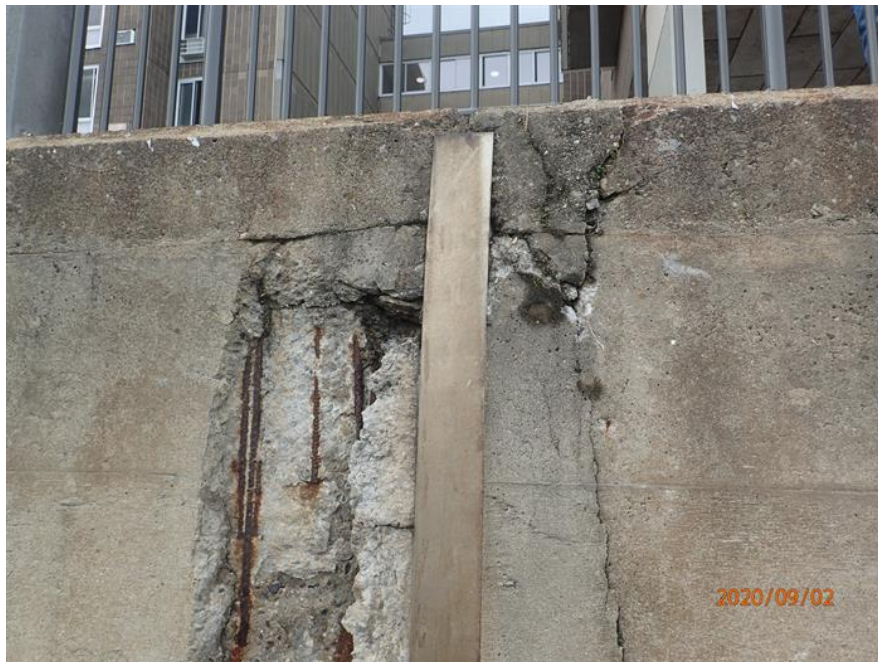
Station 32+79

Comments: Concrete Spalling, Missing Large Section of Concrete, Re-Bar Exposed

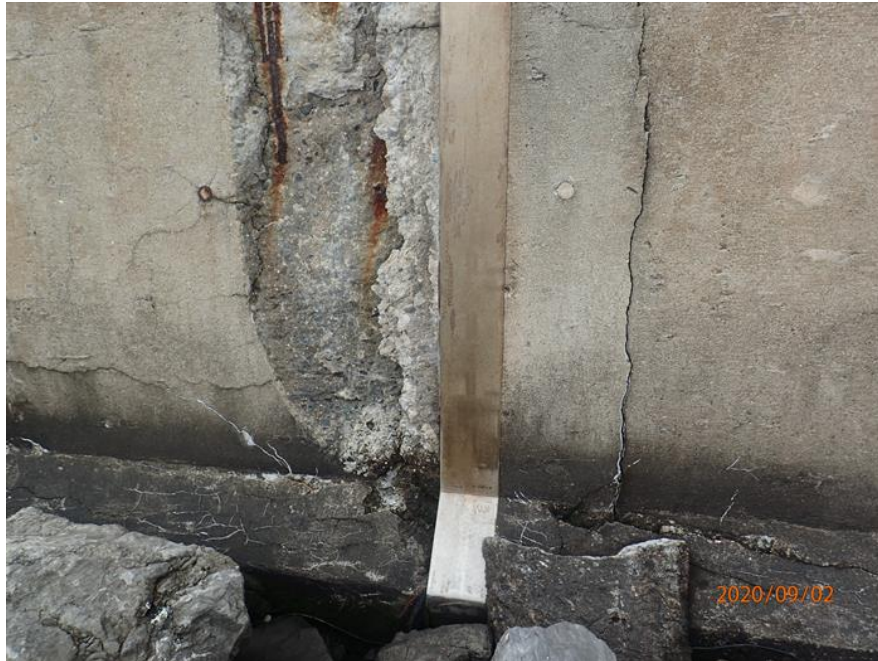
Station 32+79

Comments: Concrete Spalling, Missing Large Section of Concrete, Re-Bar Exposed
