CONDITIONS REPORT & CONCEPTUAL DESIGN MEMORANDUM

STEAM TUNNEL ASSESSMENT

ROOSEVELT ISLAND, NEW YORK

17 November 2014
Revised 28 December 2018
Revised 18 September 2020
Project # 100444601

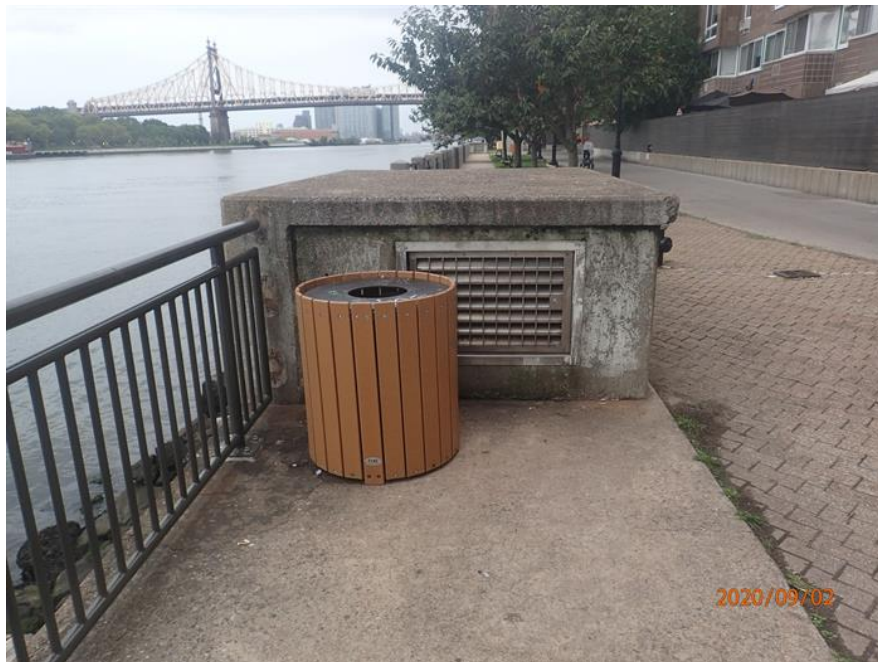
Station 33+00

Comments: Northern Face

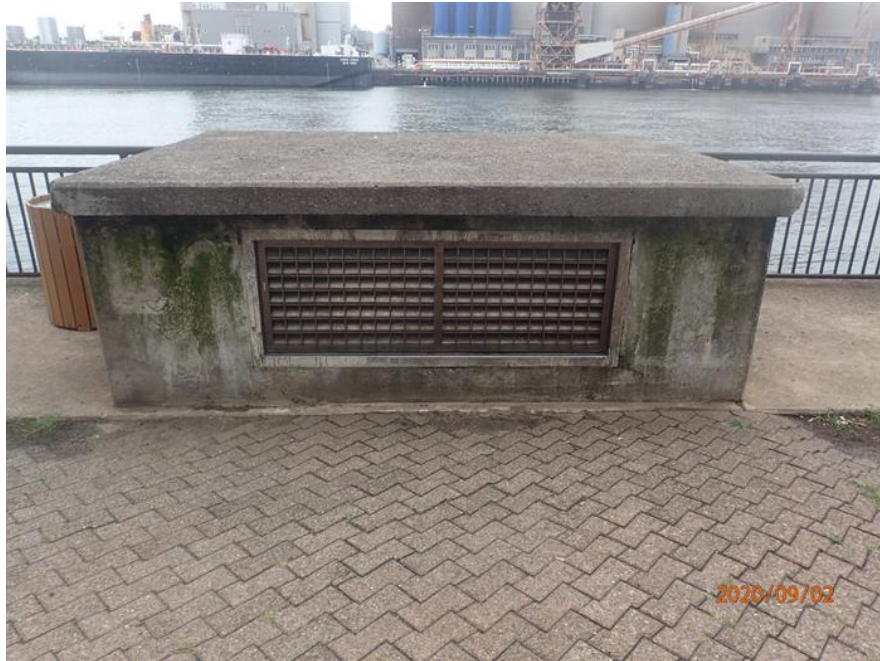
Station 33+00

Comments: Western Face

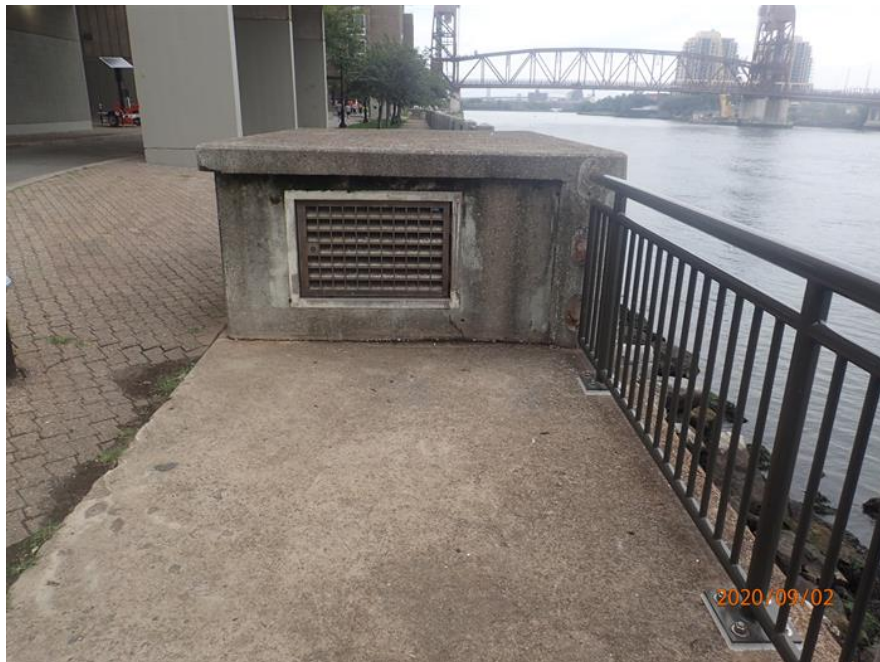
Station 33+00

Comments: Southern Face

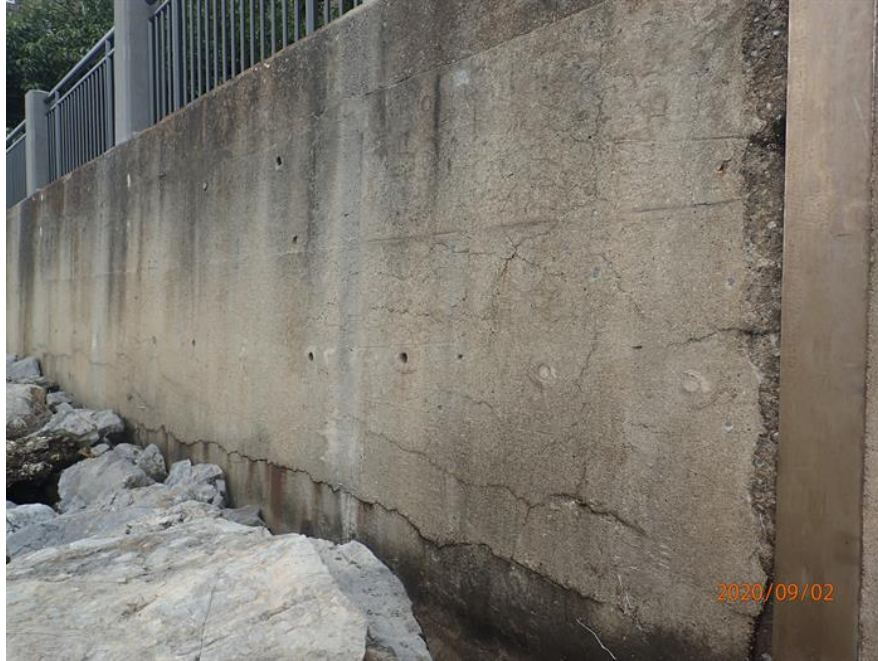
Station 33+36

Comments: Concrete Spalling, Missing Concrete

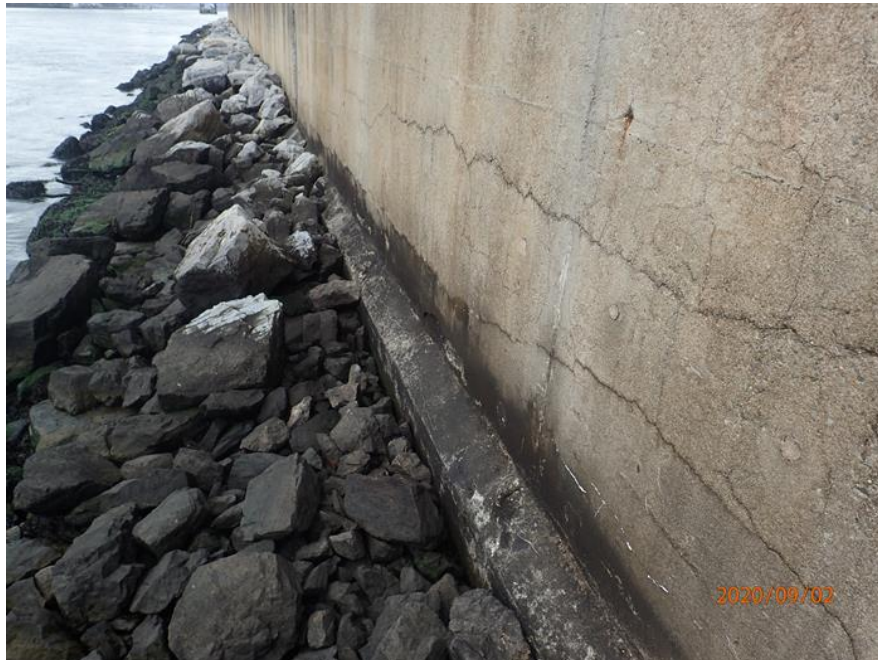
Station 33+84

Comments: Concrete Cracks, Rip-rap Deficiency

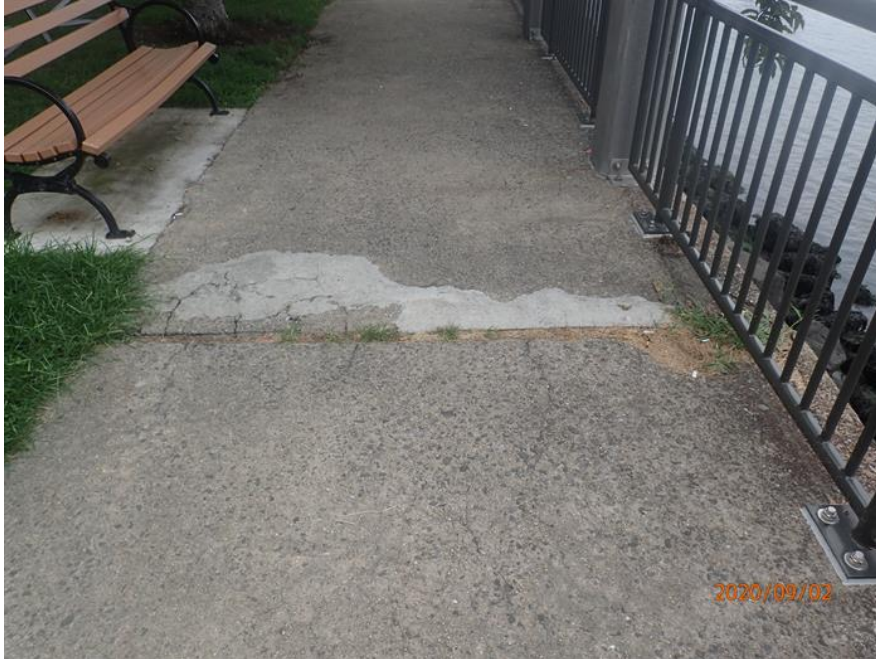
Station 34+06

Comments: Concrete Cracks

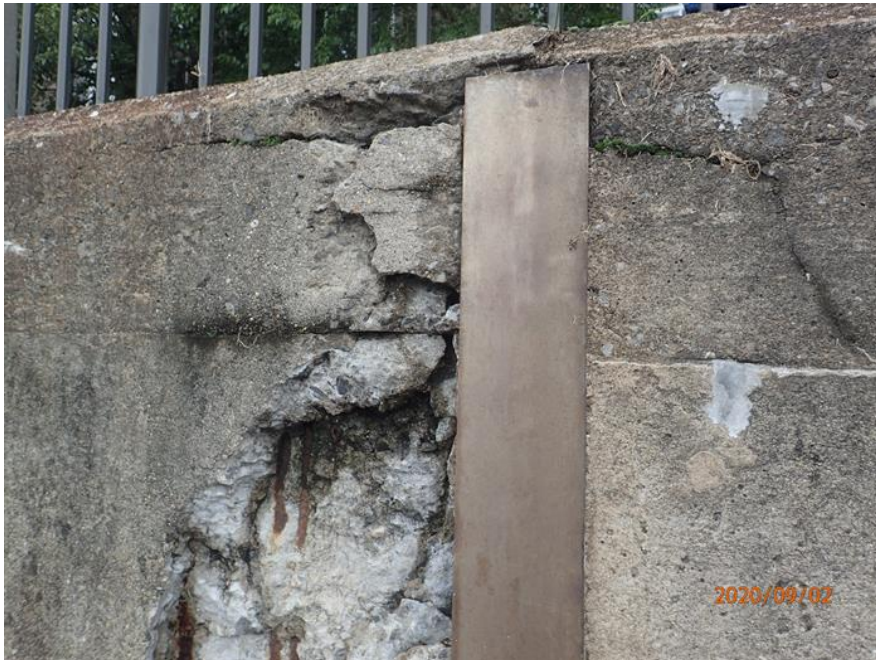
Station 34+06

Comments: Concrete Spalling, Missing Large Section of Concrete, Re-Bar Exposed

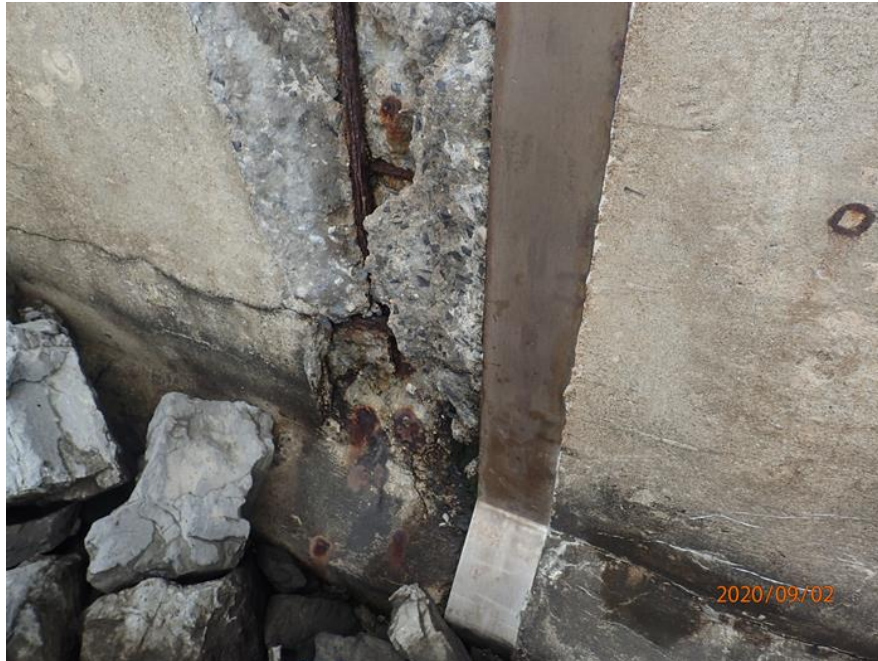
Station 34+06

Comments: Concrete Spalling, Missing Large Section of Concrete, Re-Bar Exposed

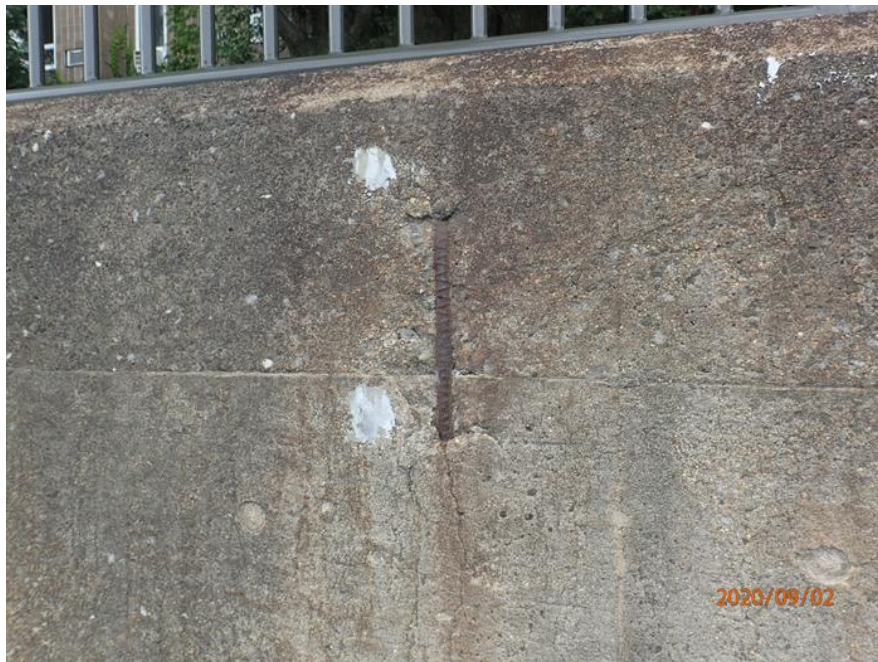
Station 34+30

Comments: Re-Bar Exposed

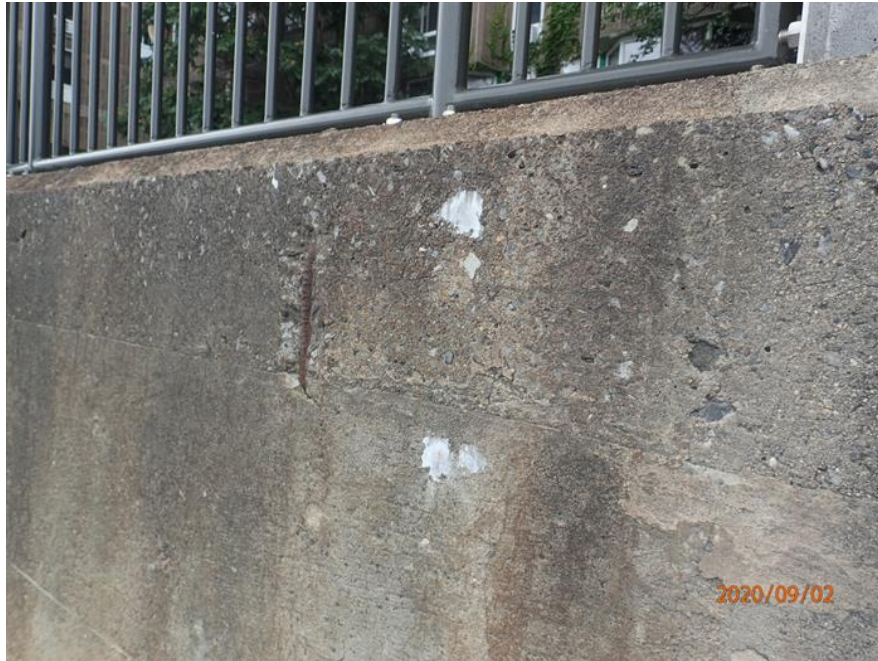
Station 34+40

Comments: Re-Bar Exposed

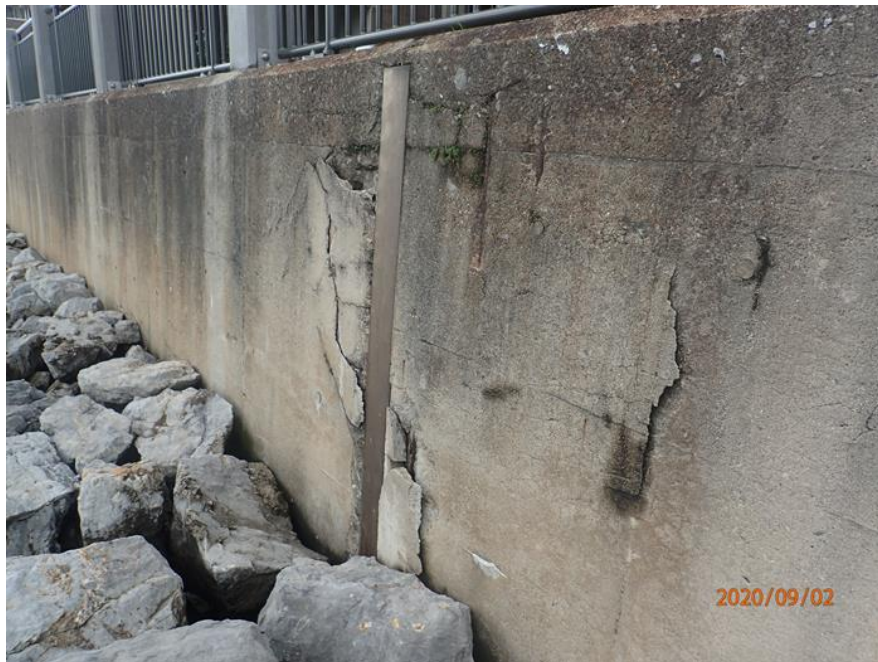
Station 34+70

Comments: Concrete Spalling, Missing Large Section of Concrete, Re-Bar Exposed

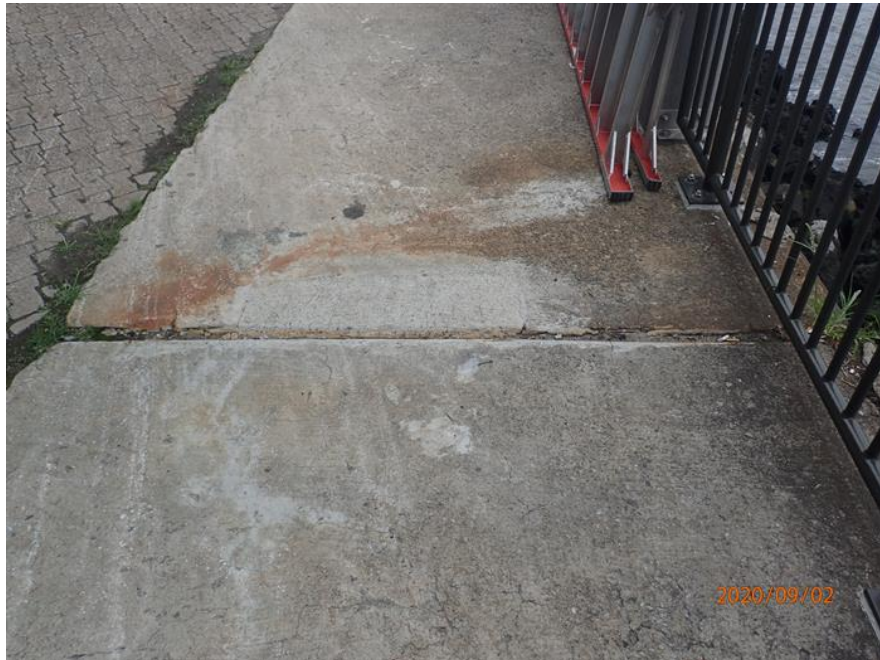
Station 35+38

Comments: Concrete Cracks

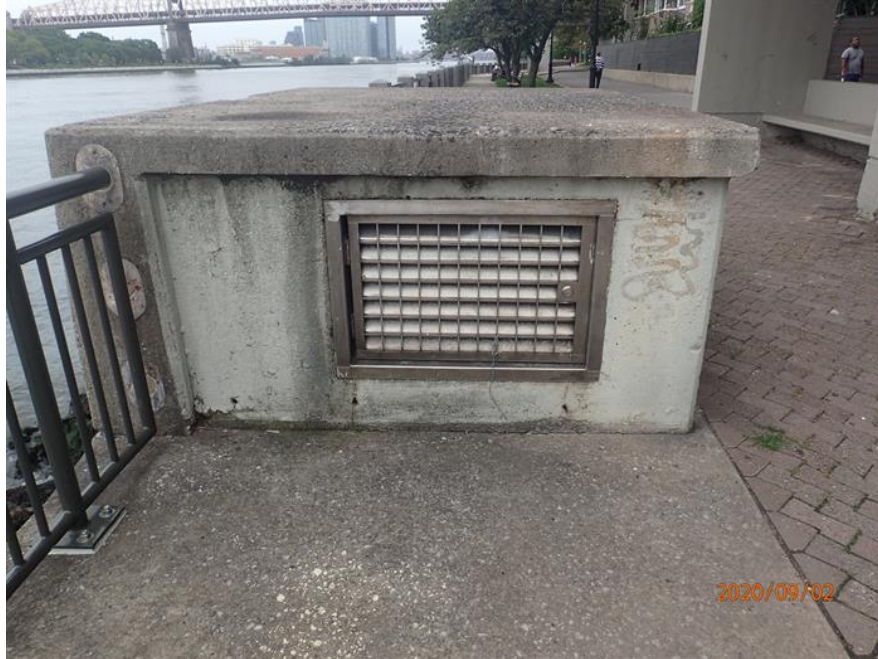
Station 35+54

Comments: Northern Face

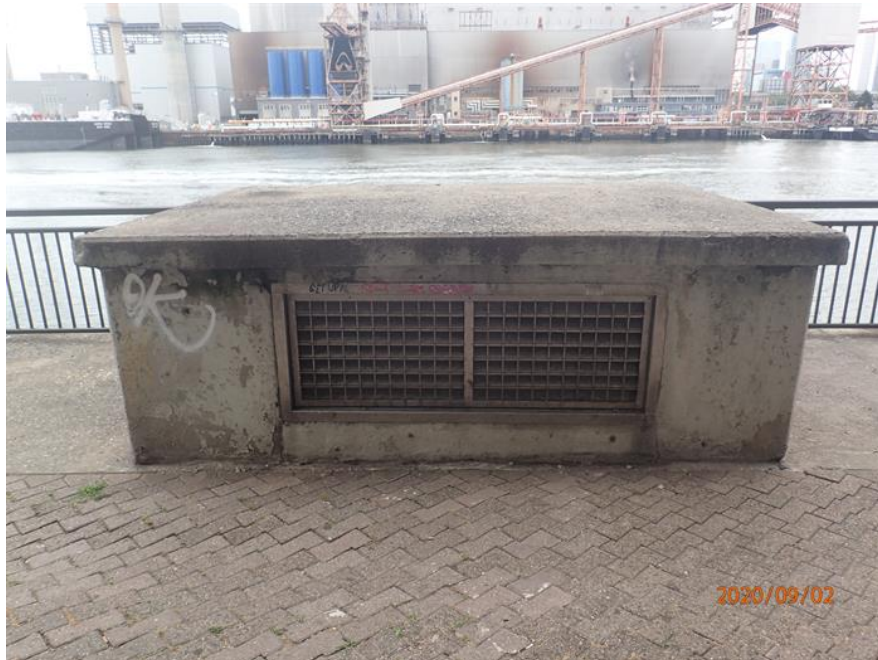
Station 35+54

Comments: Western Face

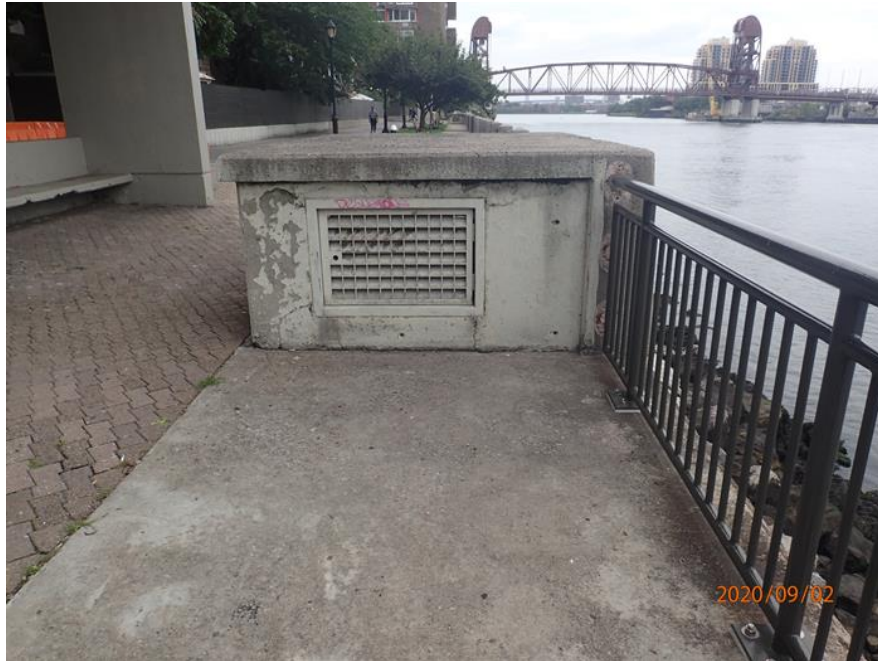
Station 35+54

Comments: Southern Face

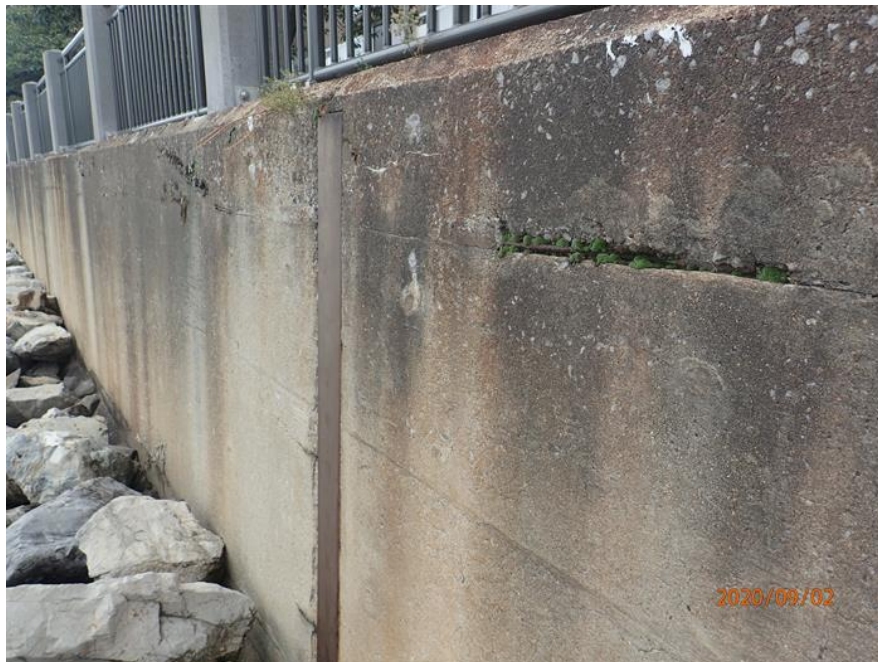
Station 35+93

Comments: Exposed Re-Bar, Concrete Spalling

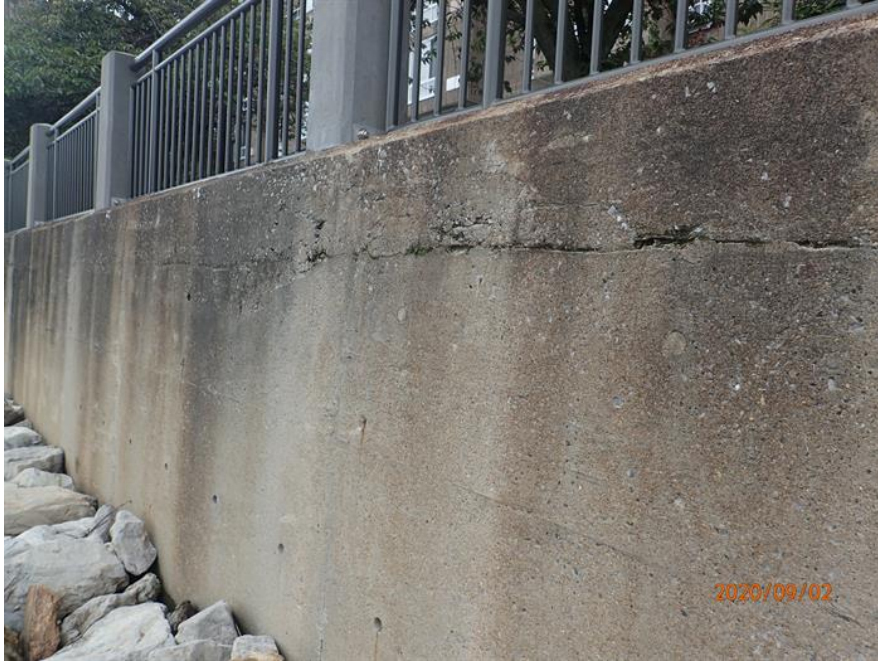
Station 36+20

Comments: Concrete Cracks

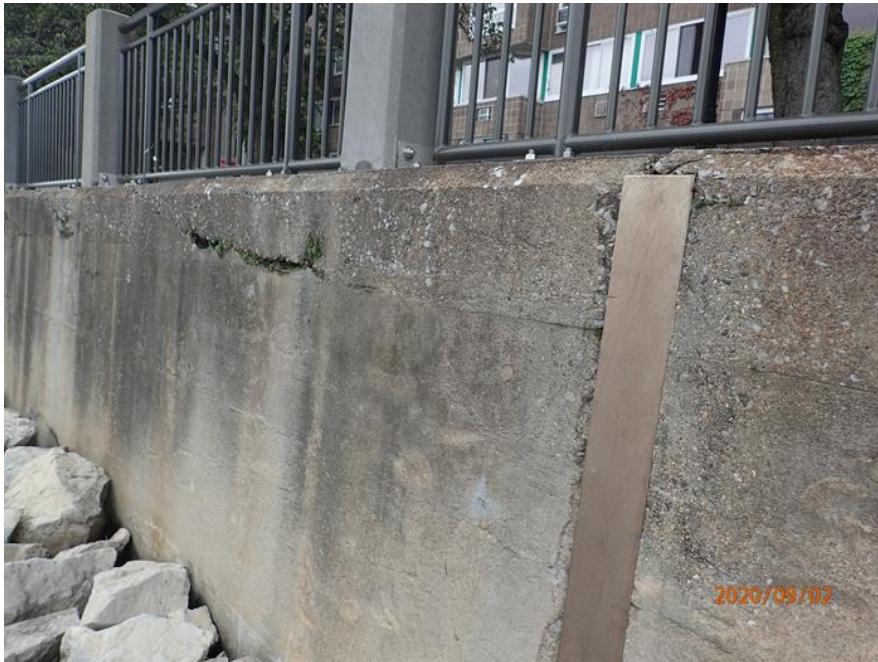
Station 36+56

Comments: Concrete Spalling, Missing Concrete, Concrete Cracks

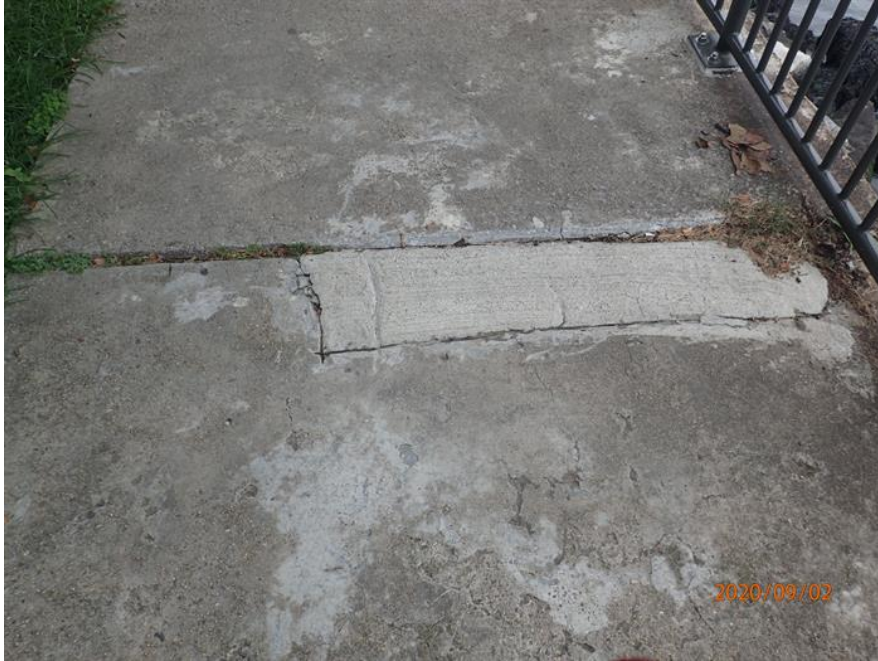
Station 37+22

Comments: Concrete Cracks

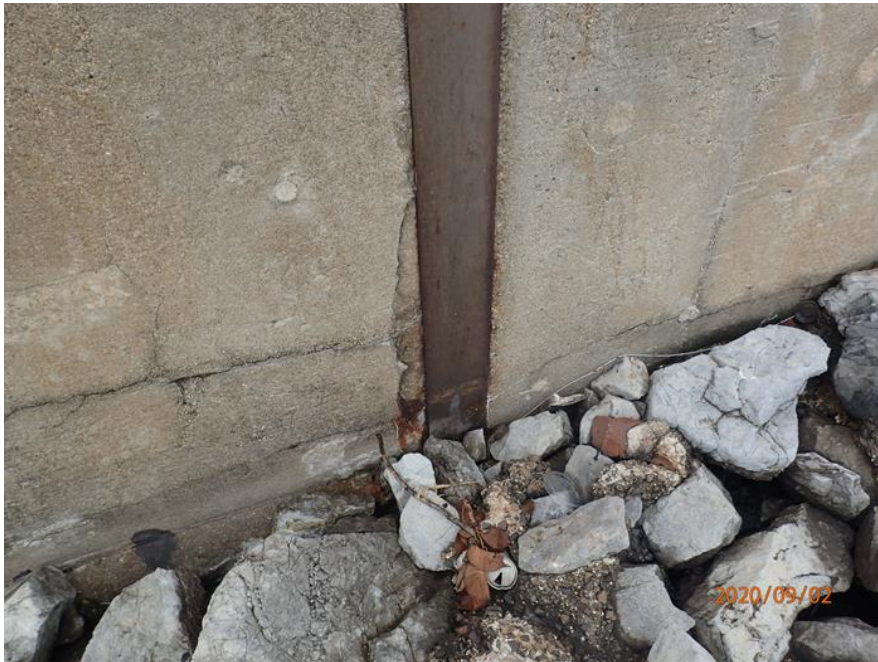
Station 37+22

Comments: Concrete Spalling

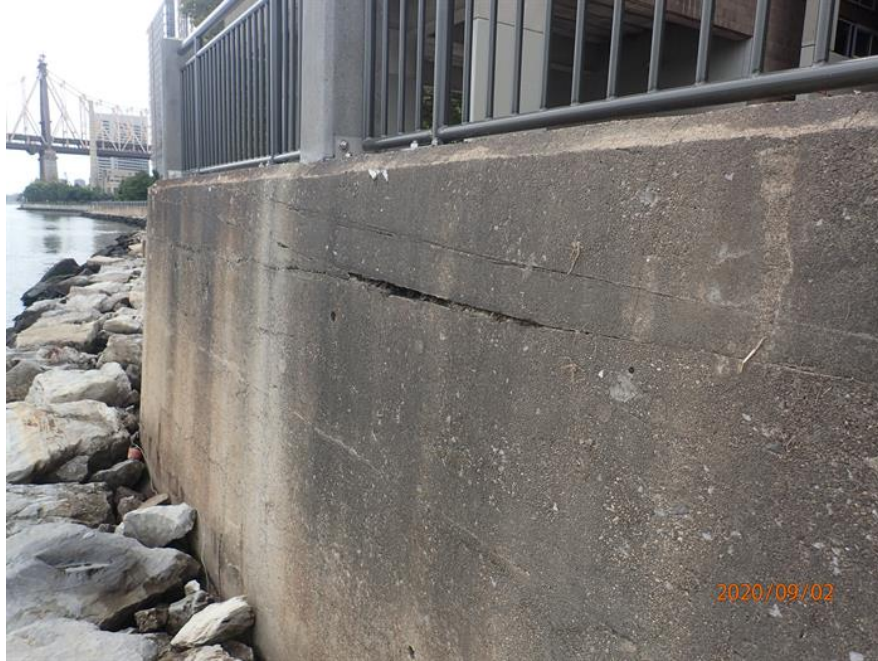
Station 37+40

Comments: Concrete Cracks

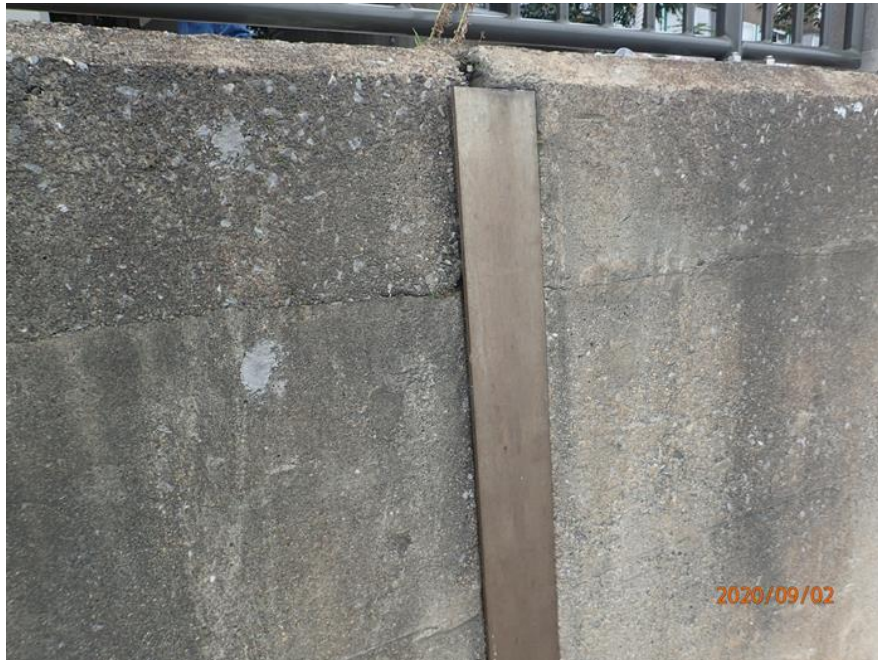
Station 37+62

Comments: Concrete Spalling, Joint Separation

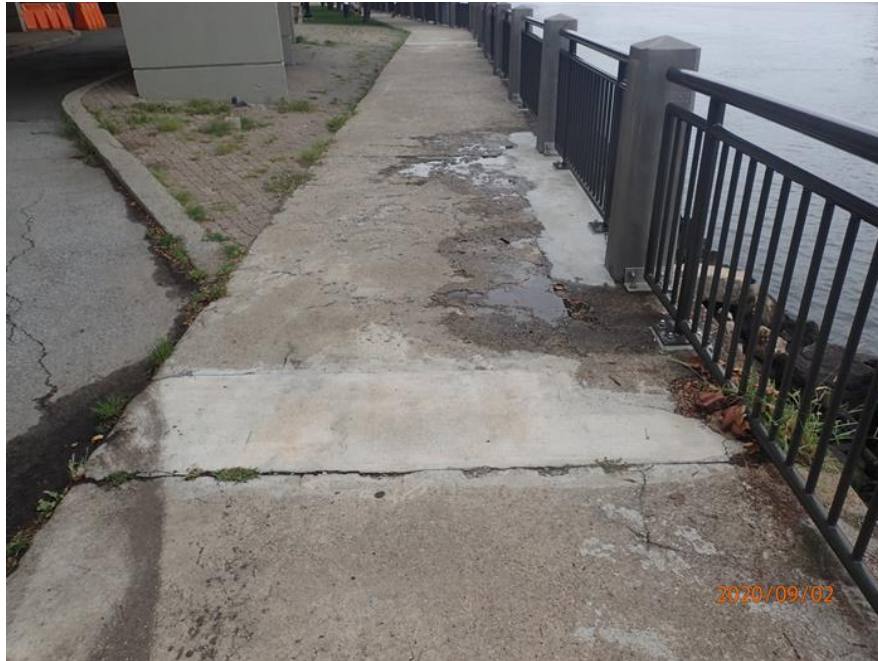
Station 38+42 to 38+52

Comments: Concrete Spalling, Concrete Cracks, Attempt to Repair

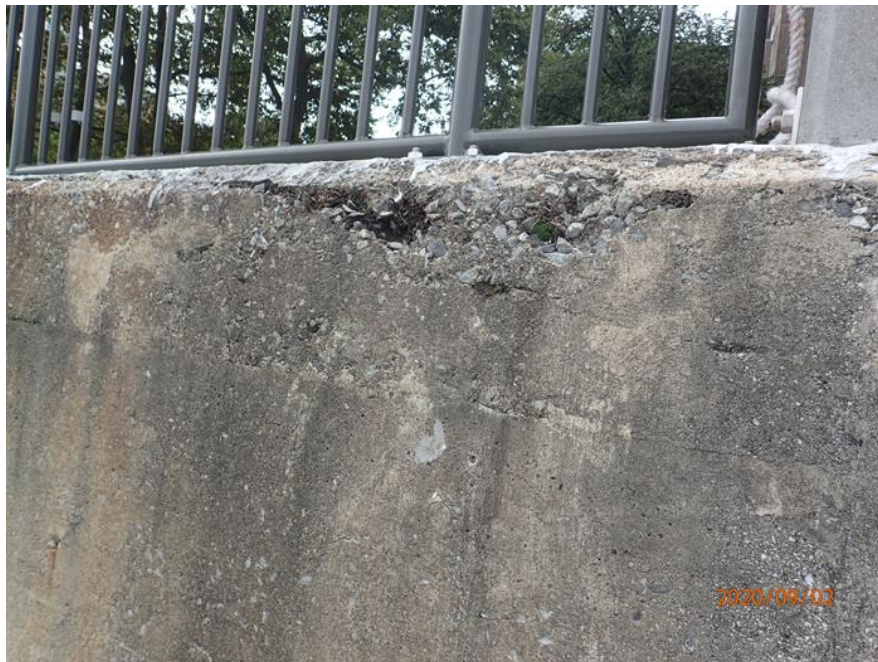
Station 38+42

Comments: Concrete Spalling

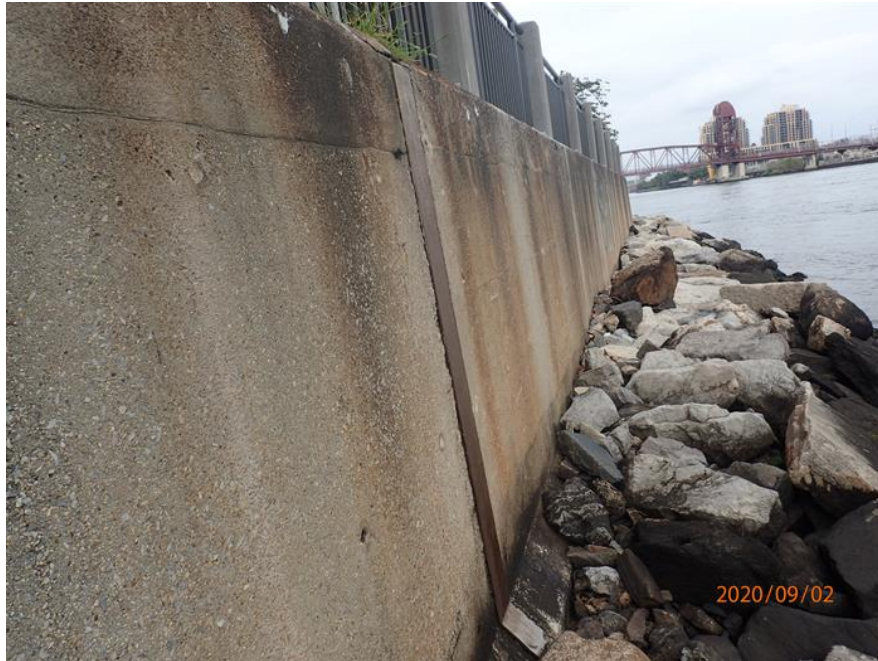
Station 38+52

Comments: Concrete Spalling, Concrete Cracks

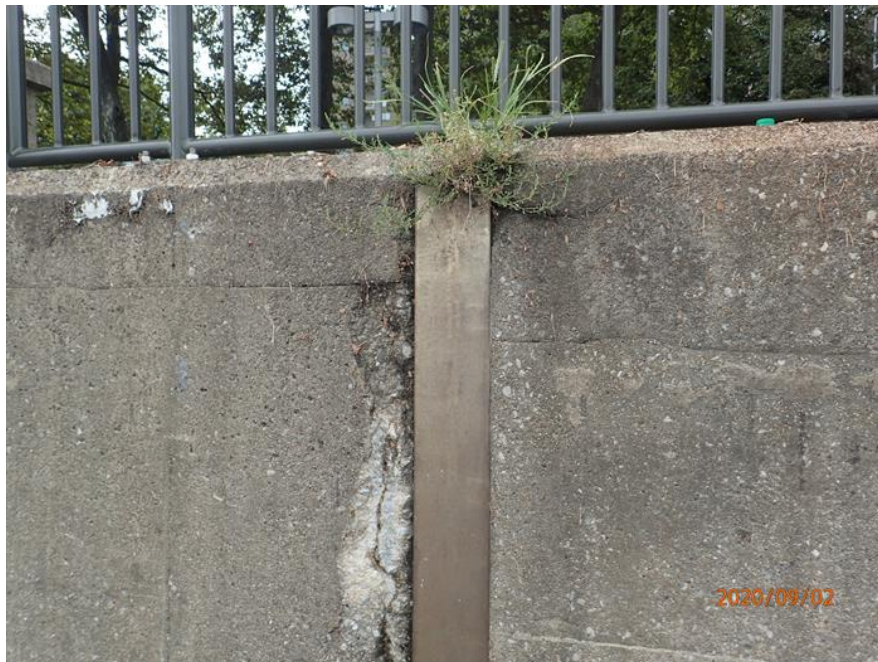
Station 38+82

Comments: Concrete Spalling, Missing Concrete, Concrete Cracks

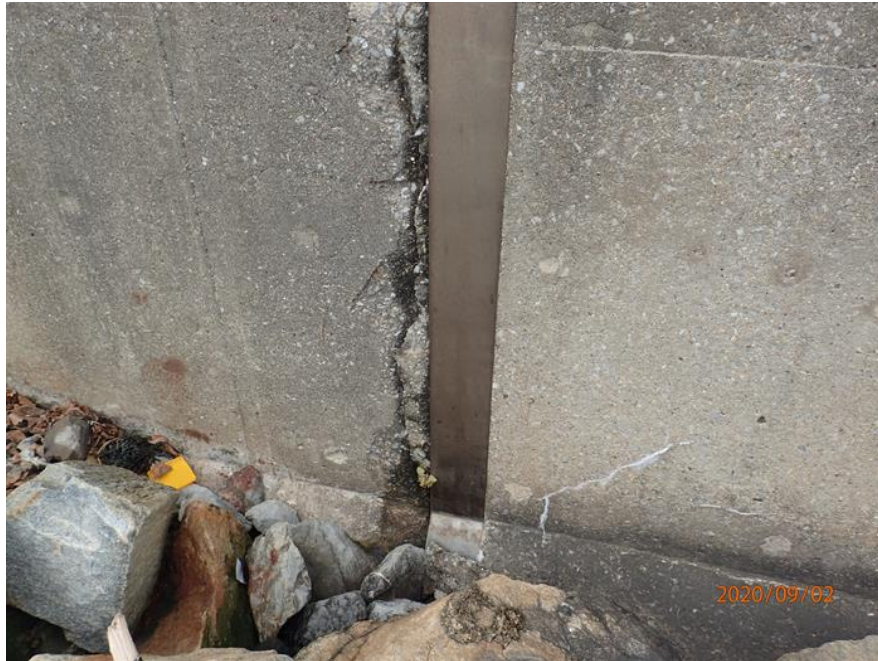
Station 38+82

Direction: Seawall Joint

Comments: Concrete Spalling, Missing Concrete, Concrete Cracks

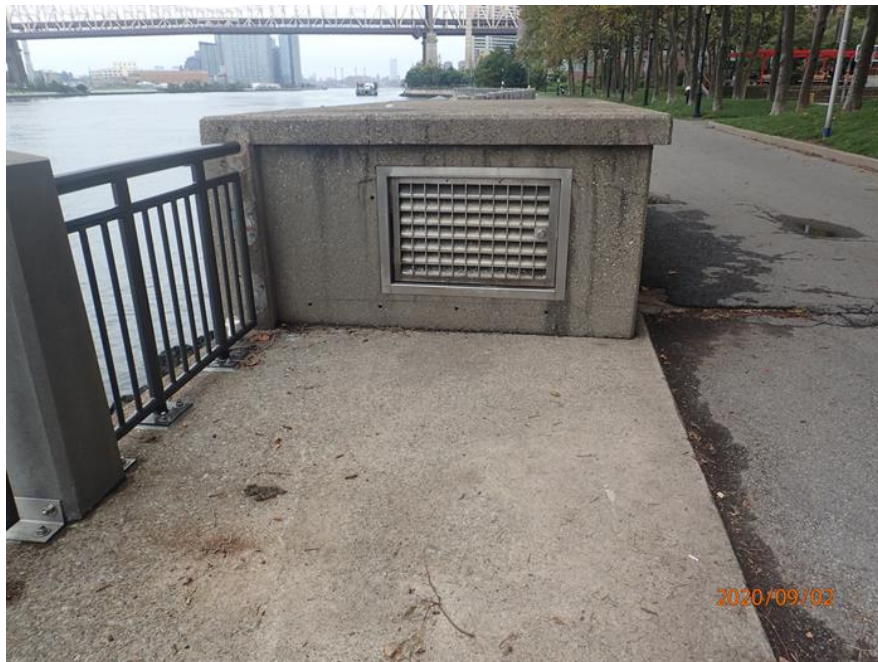
Station 39+03

Direction: Air Vent 3

Comments: Northern Face

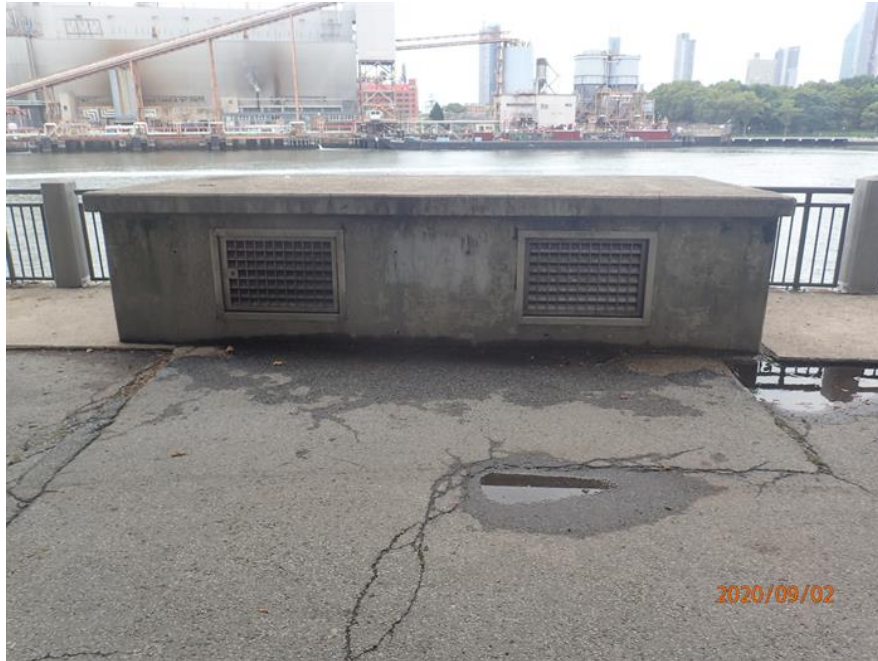
Station 39+03

Direction: Air Vent 3

Comments: Western Face

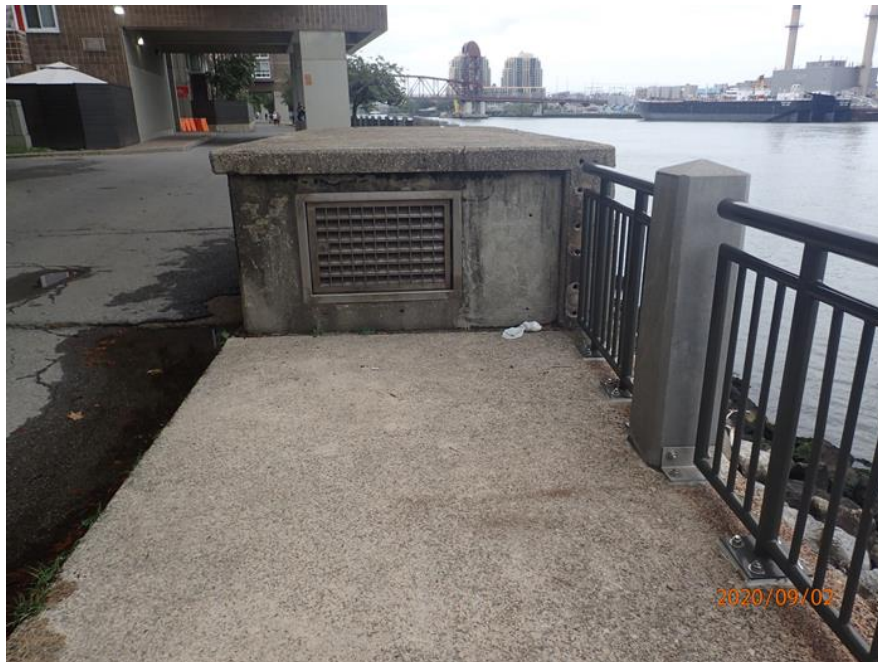
Station 39+03

Direction: Air Vent 3

Comments: Southern Face

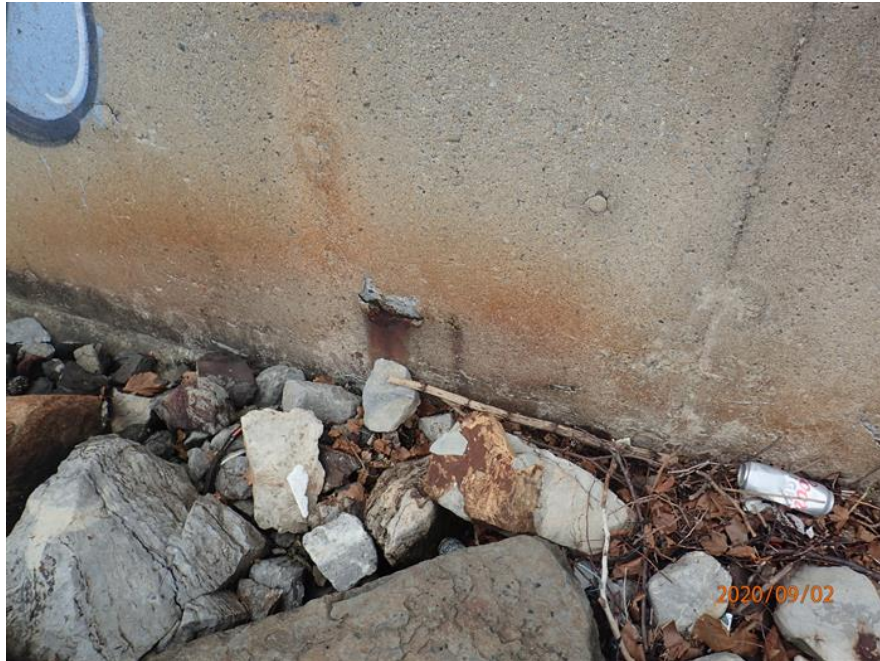
Station 39+03

Direction: Seawall

Comments: Re-Bar Exposed

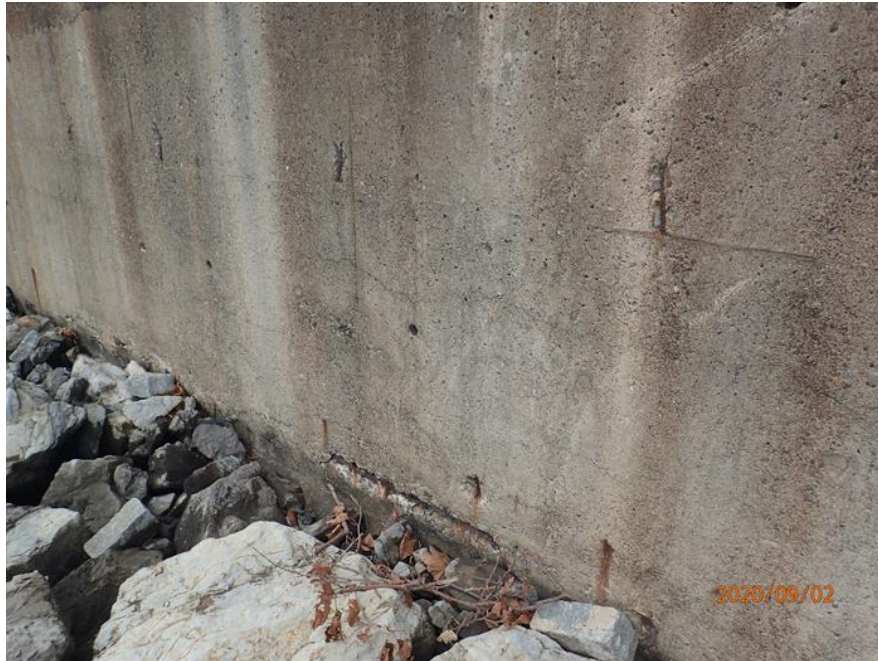
Station 39+22

Direction: Seawall

Comments: Exposed Re-Bar

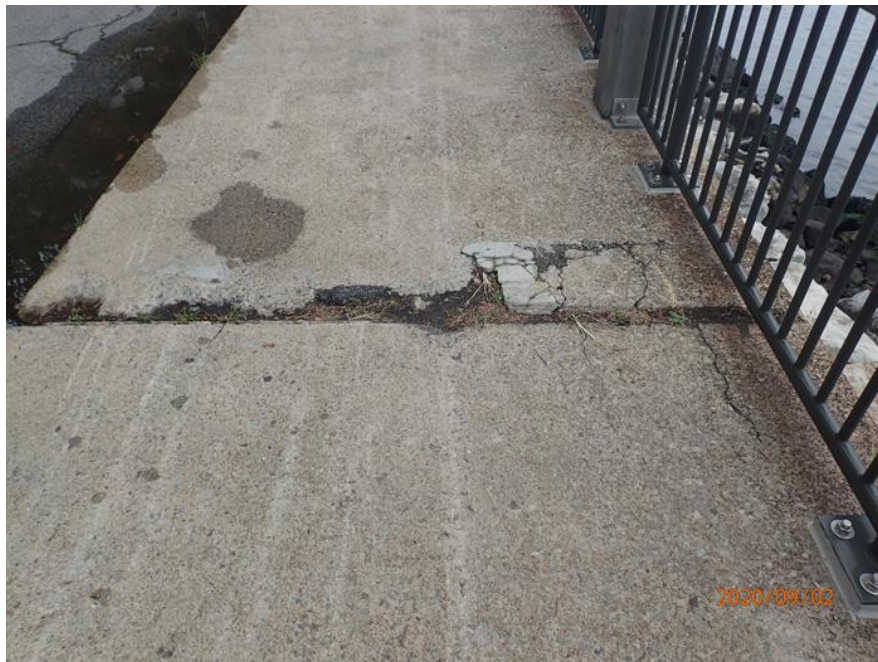
Station 39+66

Direction: Seawall Sidewalk Joint

Comments: Concrete Cracks

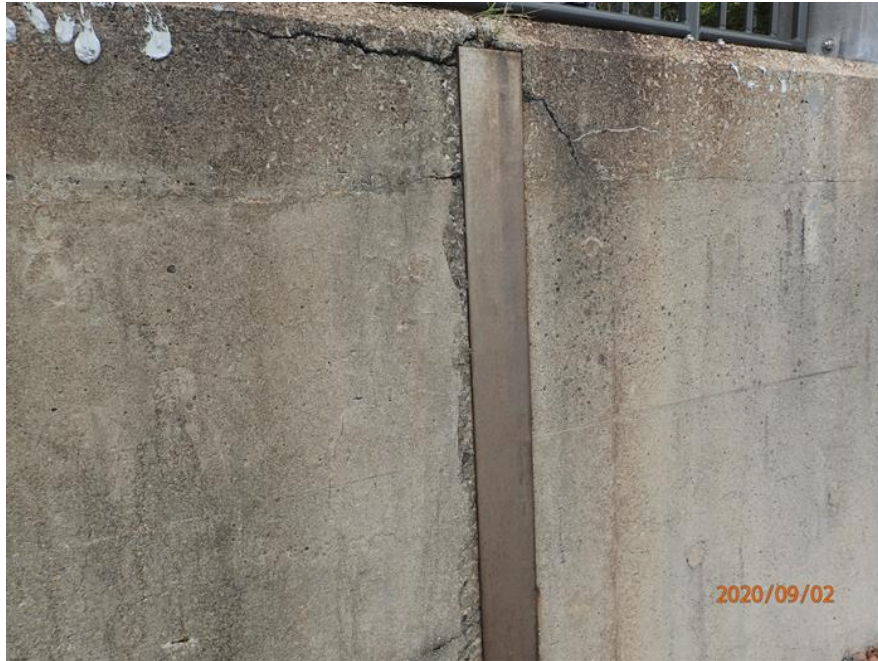
Station 39+66

Direction: Seawall Joint

Comments: Concrete Spalling, Missing Concrete, Concrete Cracks

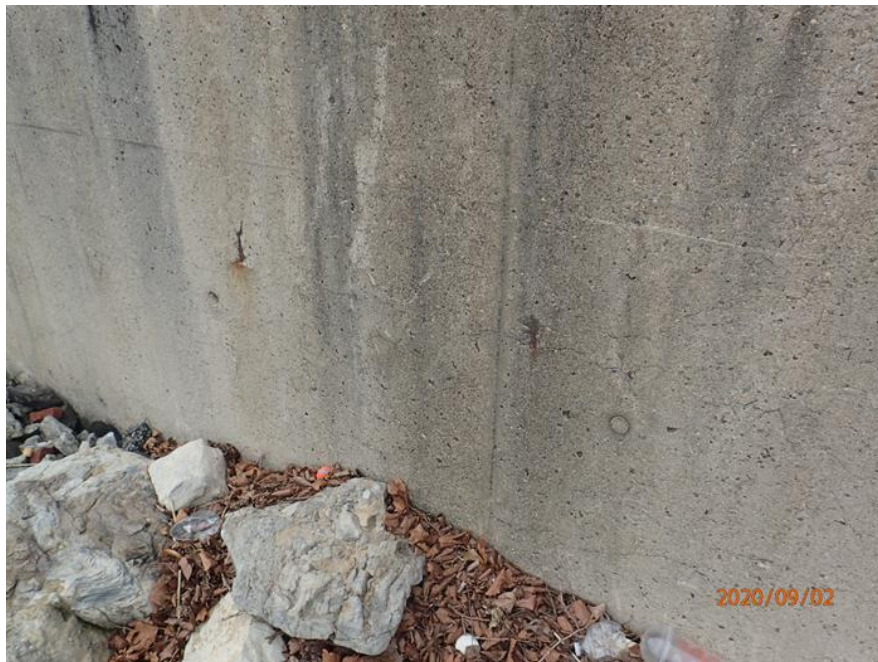
Station 39+70

Direction: Seawall

Comments: Exposed Re-Bar

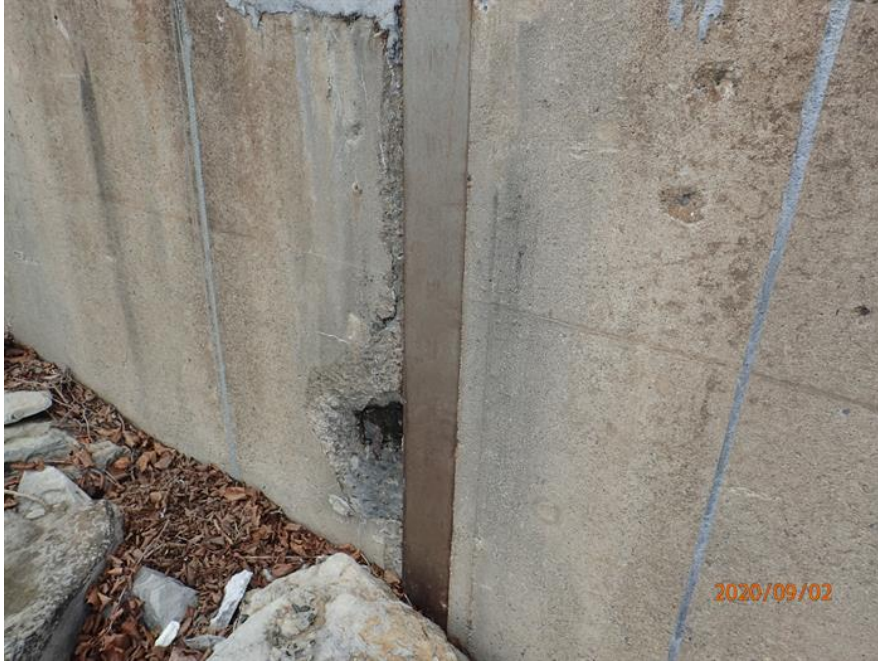
Station 40+15

Direction: Seawall Joint

Comments: Concrete Spalling, Missing Concrete, Re-Bar Exposed

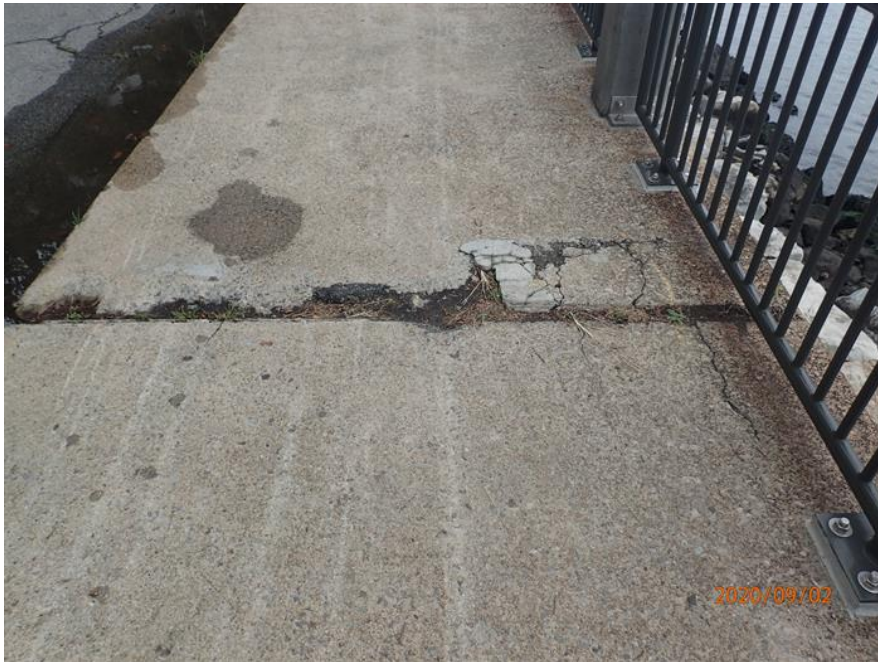
Station 40+39

Direction: Seawall Sidewalk Joint

Comments: Concrete Cracks, Attempt to Repair

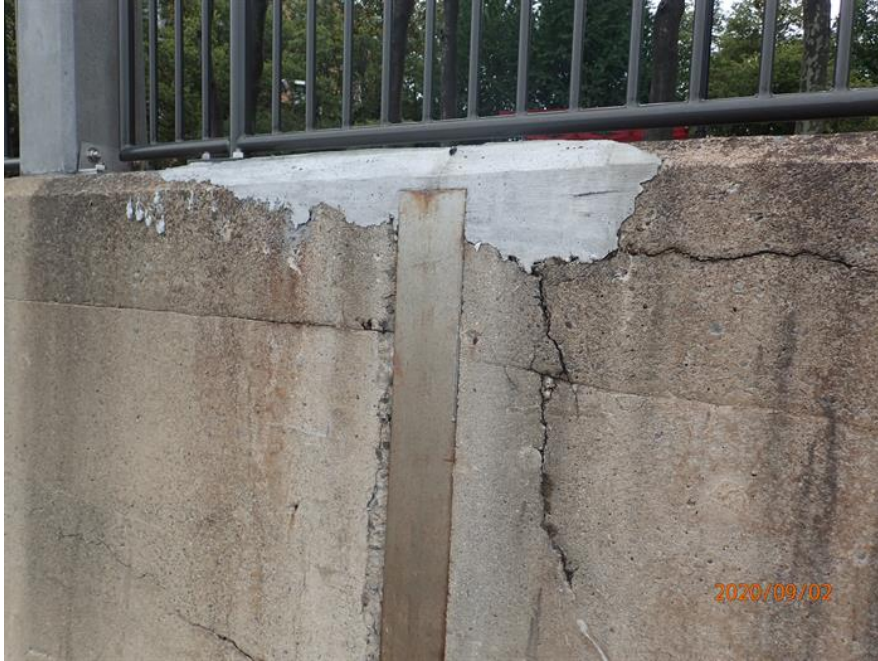
Station 40+39

Direction: Seawall Joint

Comments: Concrete Spalling, Concrete Cracks, Attempt to Repair

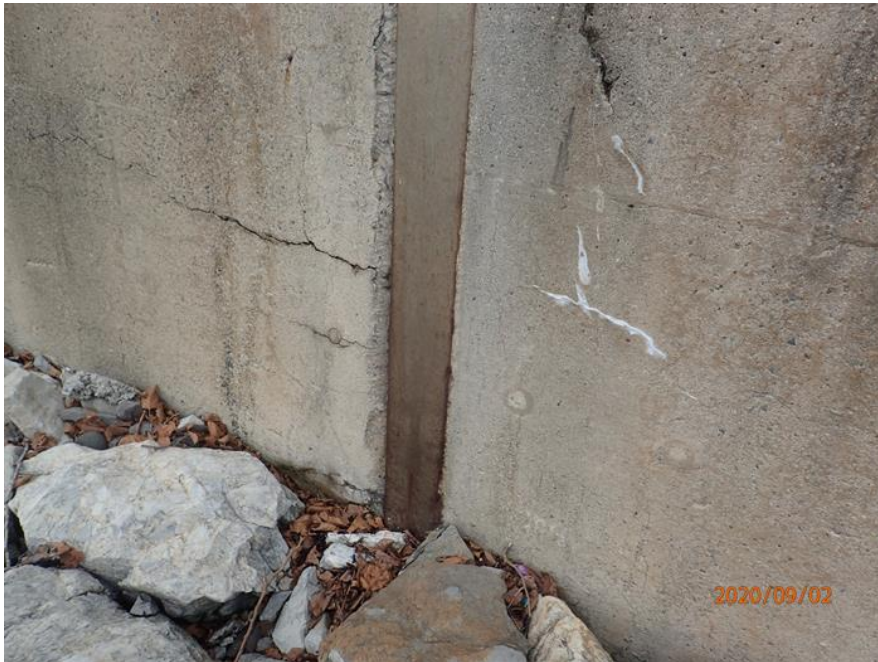
Station 40+39

Direction: Seawall Joint

Comments: Concrete Spalling, Concrete Cracks
