CONDITIONS REPORT & CONCEPTUAL DESIGN MEMORANDUM

STEAM TUNNEL ASSESSMENT

ROOSEVELT ISLAND, NEW YORK

17 November 2014
Revised 28 December 2018
Revised 18 September 2020
Project # 100444601

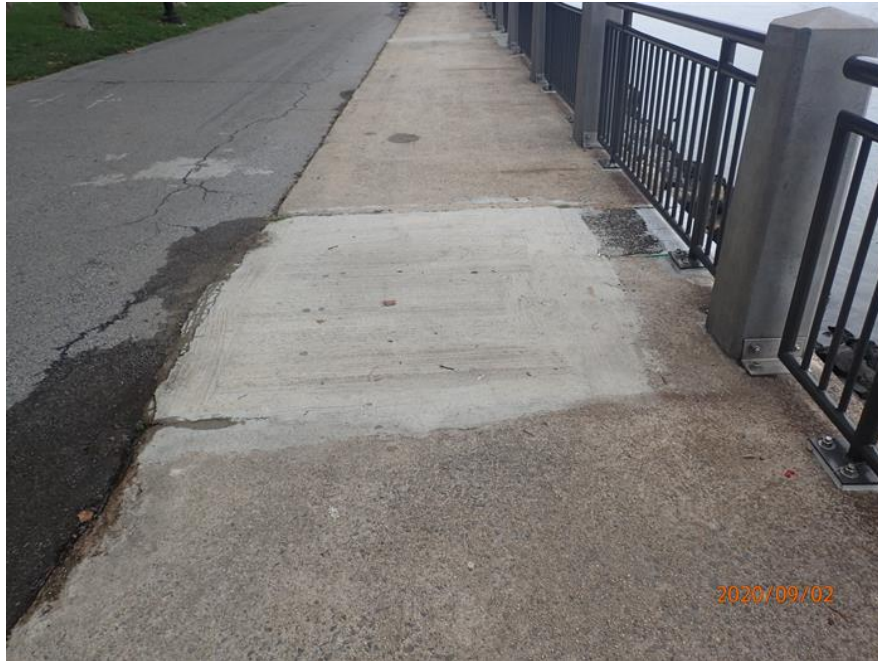
Station 40+61

Direction: Seawall Sidewalk Joint

Comments: Concrete Cracks, Attempt to Repair

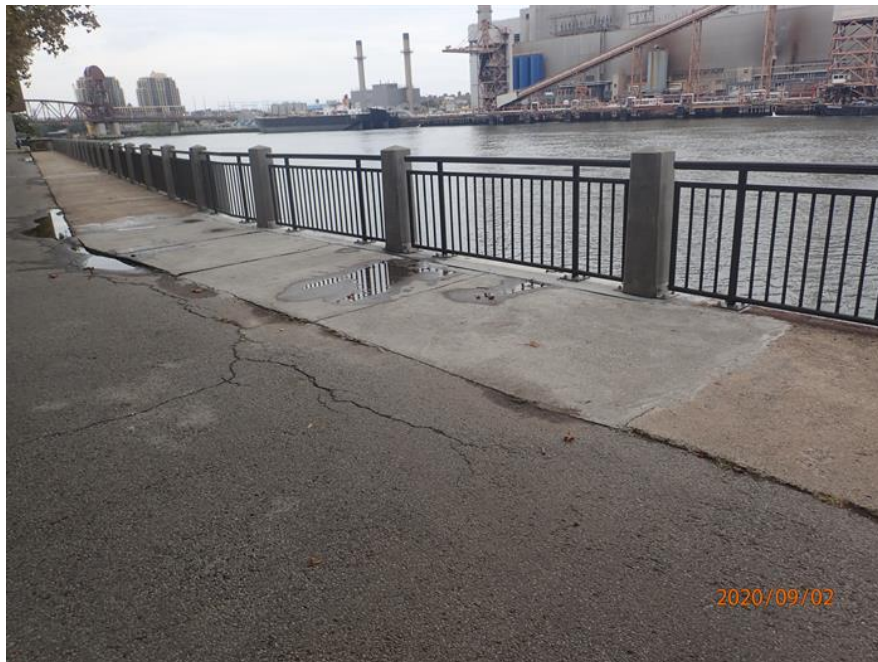
Station 41+22 to 41+54

Direction: Seawall Sidewalk

Comments: Concrete Cracks, Attempt to Repair

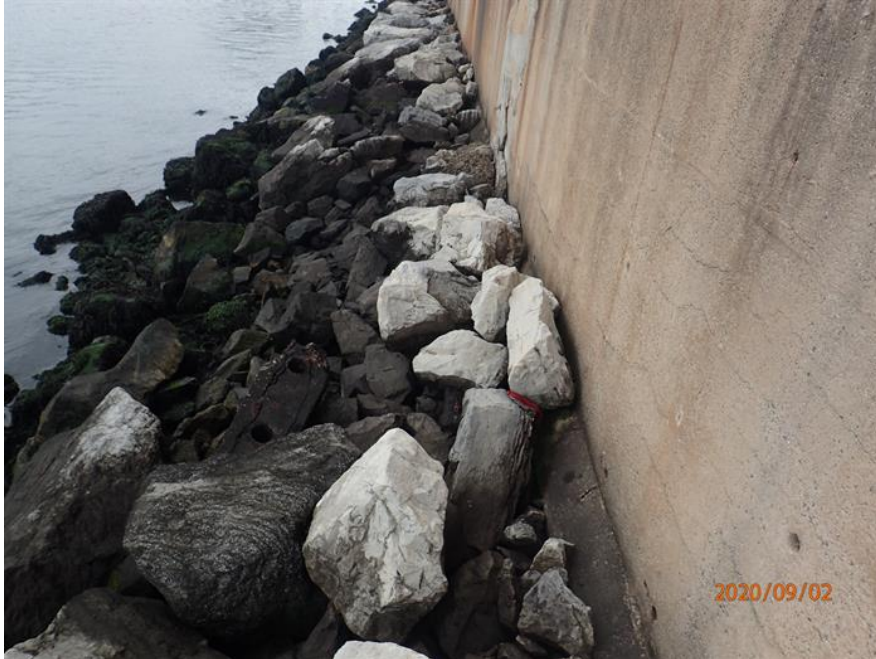
Station 41+31

Direction: Seawall Joint

Comments: Concrete Repair

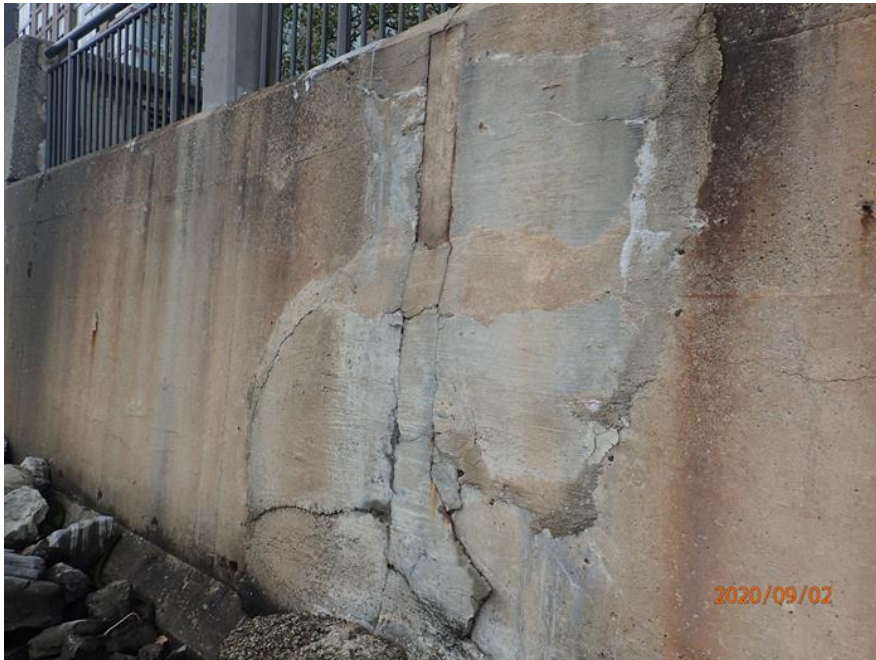
Station 41+97

Direction: Seawall Joint

Comments: Concrete Cracks, Attempt to Repair

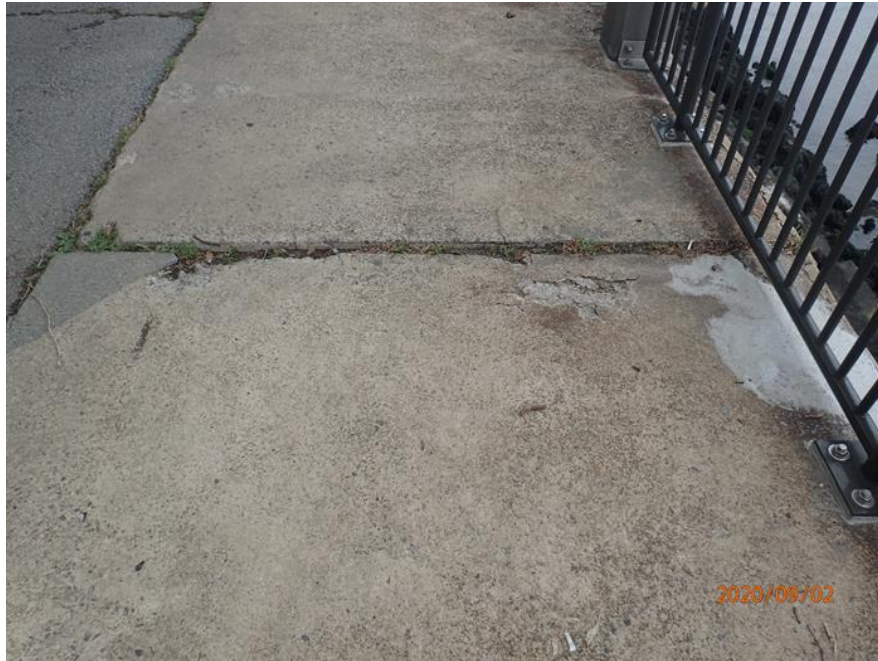
Station 41+97

Direction: Seawall Sidewalk

Comments: Concrete Cracks

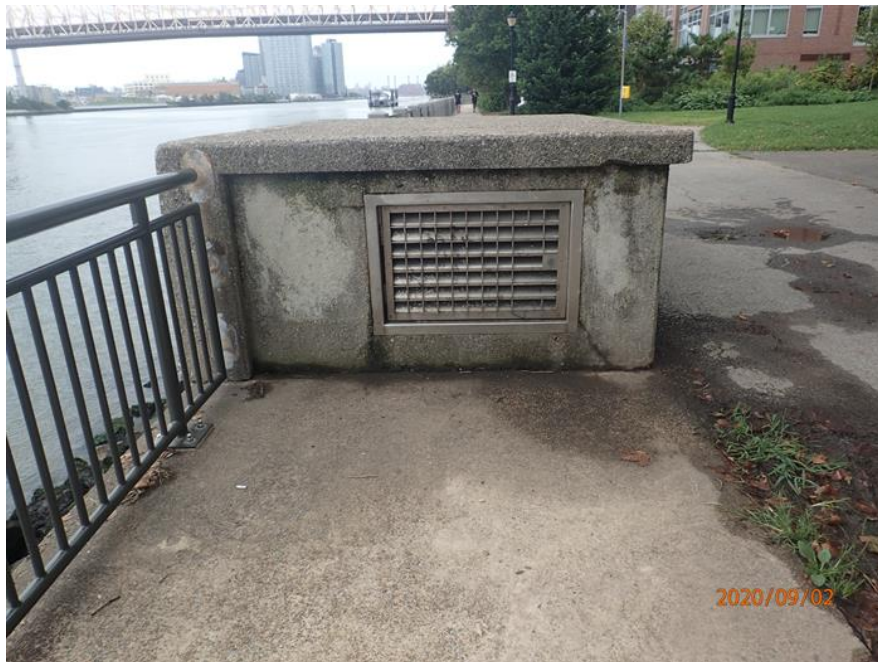
Station 42+18

Direction: Air Vent 2

Comments: Northern Face

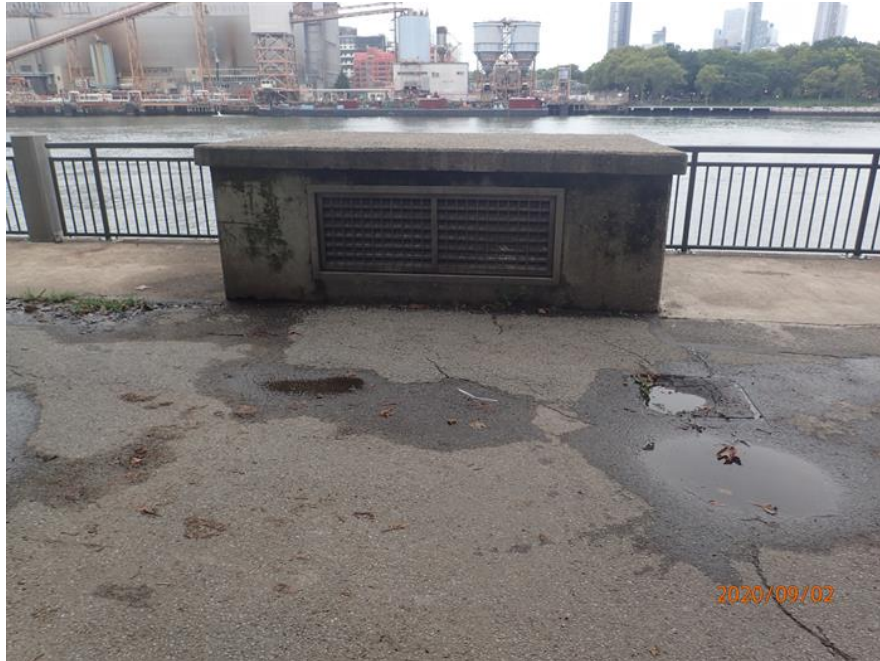
Station 42+18

Direction: Air Vent 2

Comments: Western Face

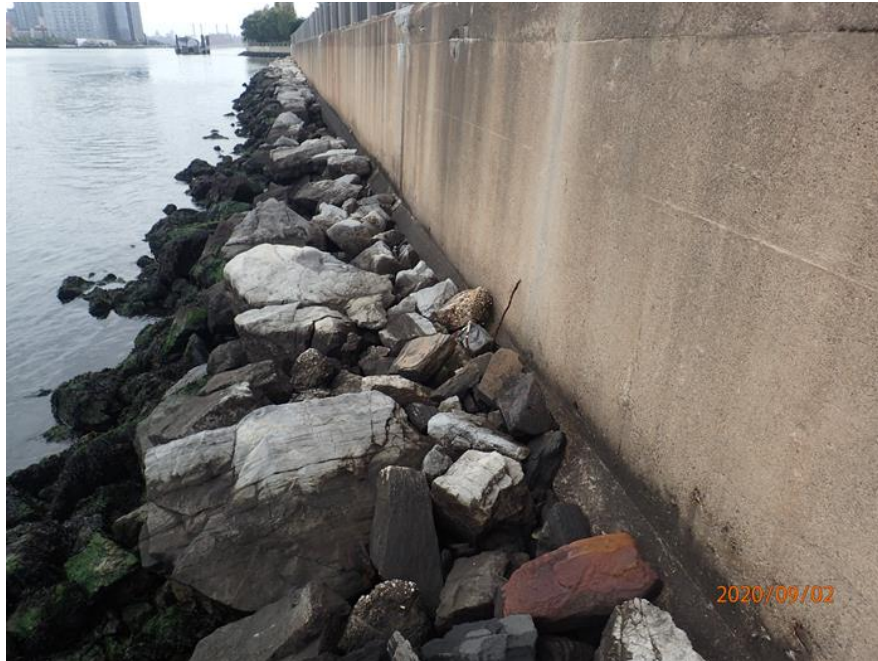
Station 42+28

Direction: Seawall

Comments: Rip-rap Deficiency

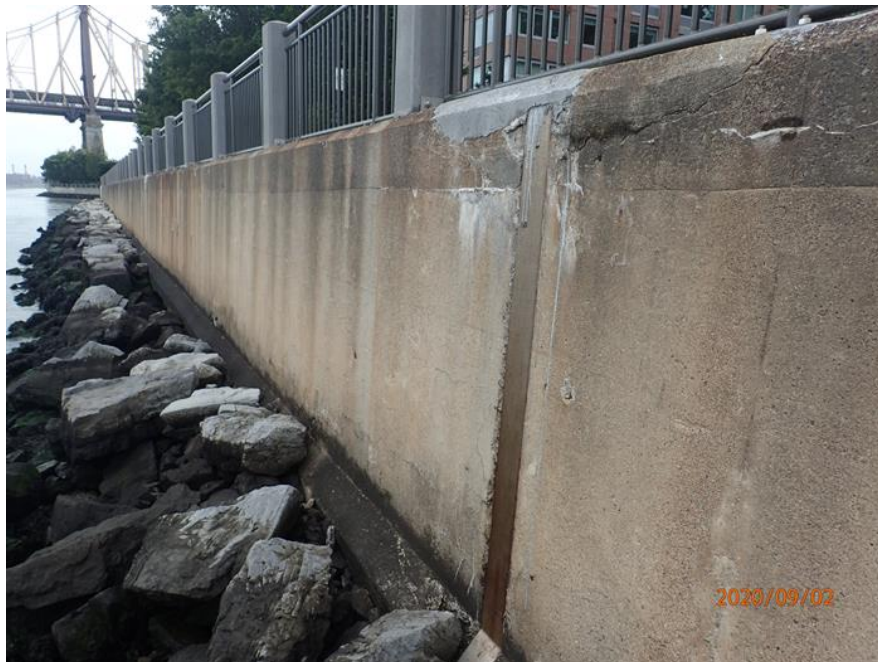
Station 42+39

Direction: Seawall Joint

Comments: Concrete Spalling, Concrete Cracks, Attempt to Repair, Rip-rap Deficiency

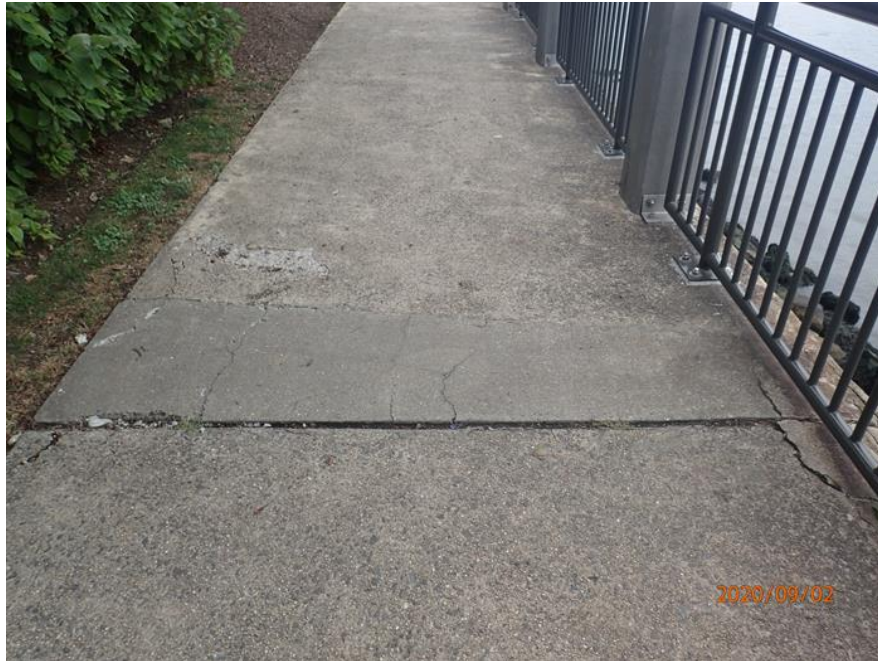
Station 42+54

Direction: Seawall Sidewalk Joint

Comments: Concrete Cracks

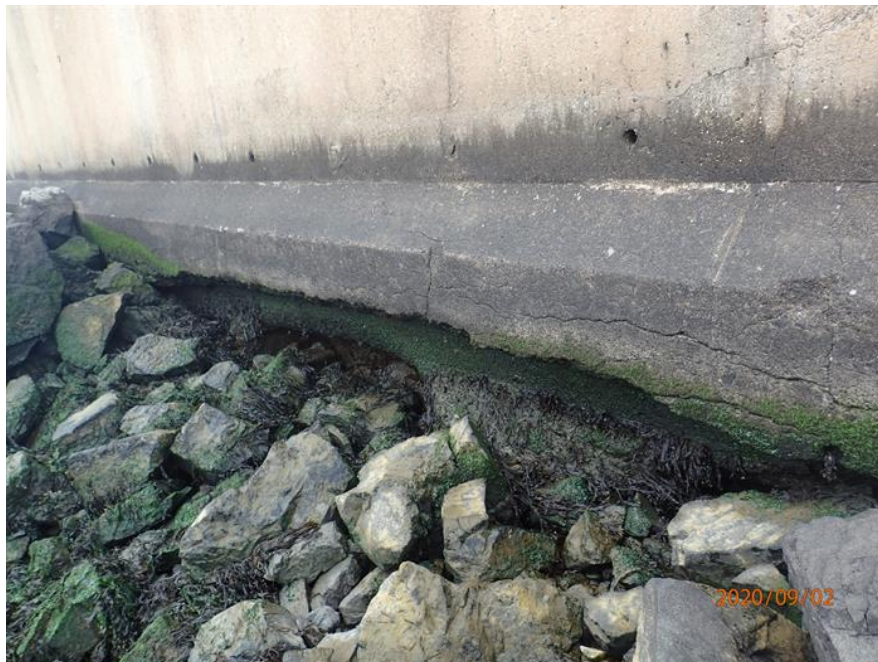
Station 43+04

Direction: Seawall

Comments: Tunnel has been Undermined

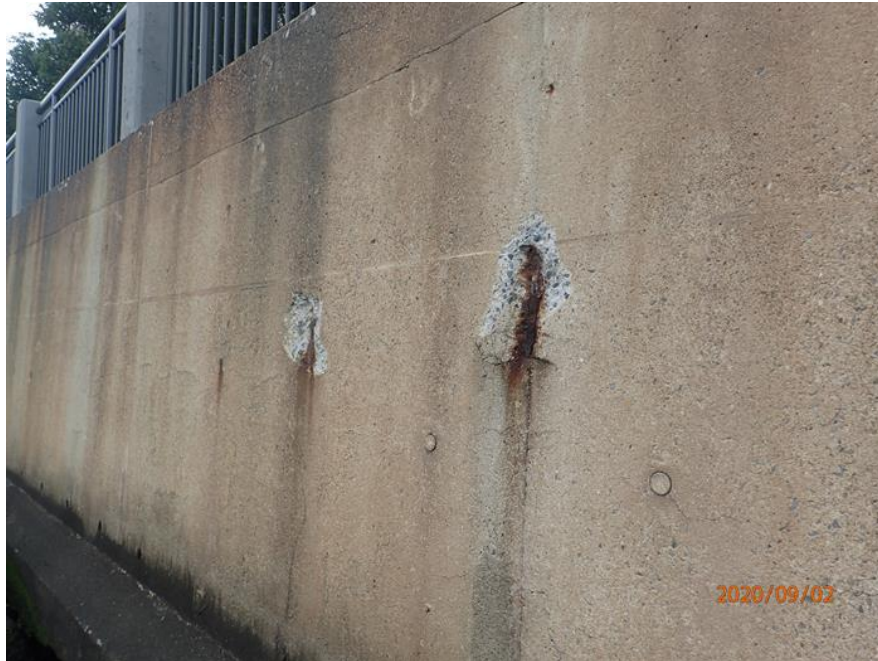
Station 43+14

Direction: Seawall

Comments: Exposed Re-Bar

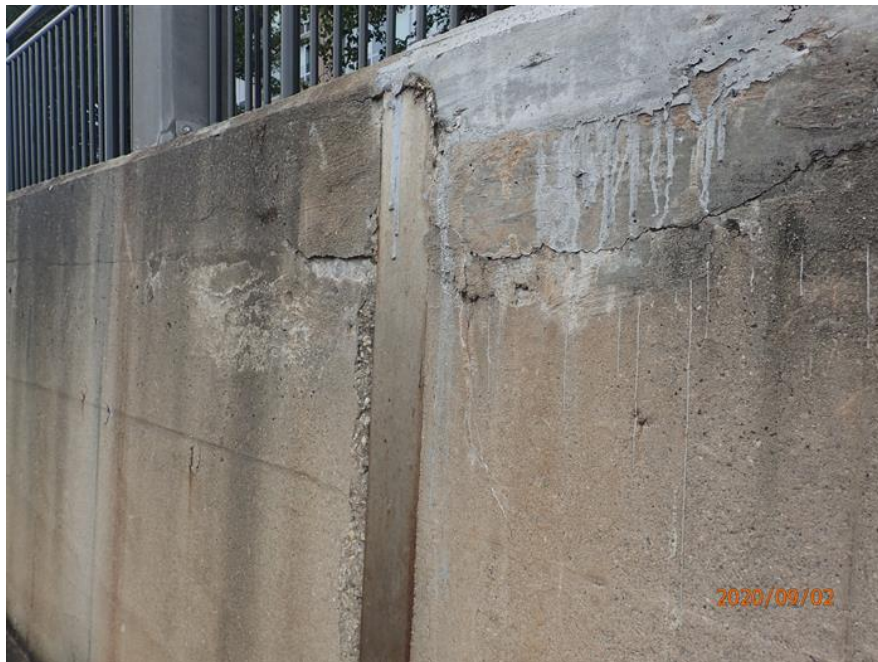
Station 43+30

Direction: Seawall Joint

Comments: Concrete Spalling, Concrete Cracks, Attempt to Repair

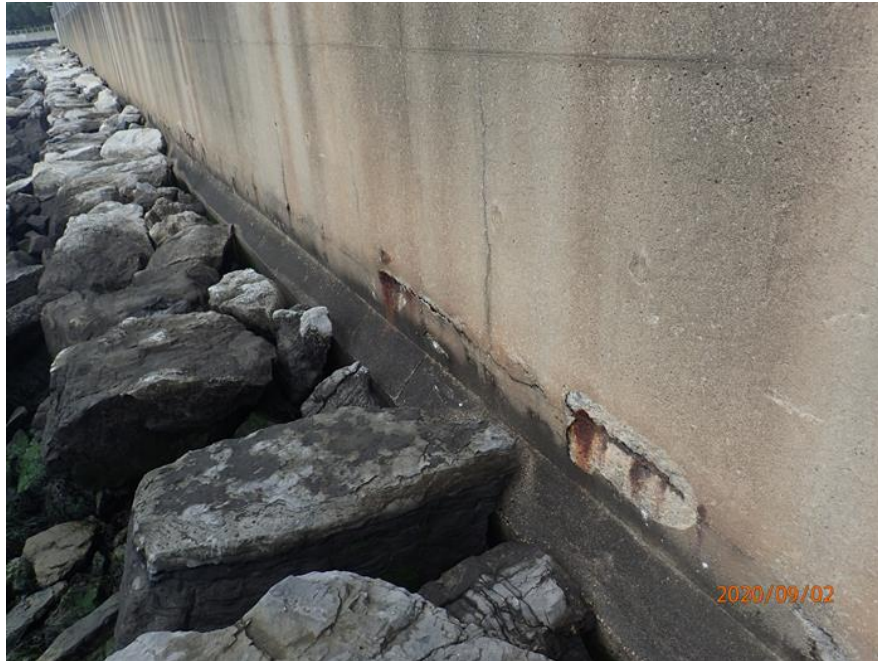
Station 43+44

Direction: Seawall

Comments: Concrete Spalling, Exposed Re-bar

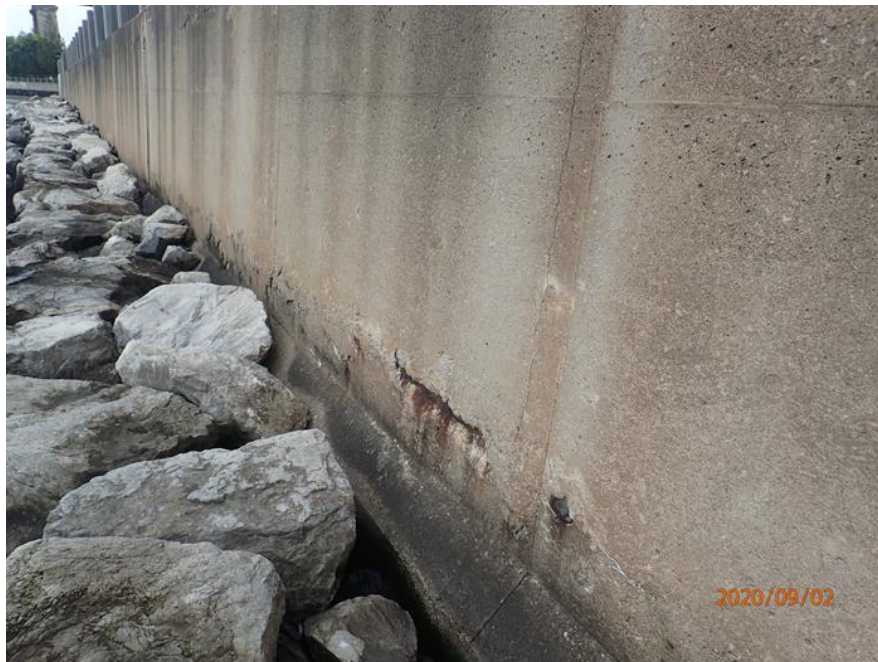
Station 43+66

Direction: Seawall

Comments: Exposed Re-Bar

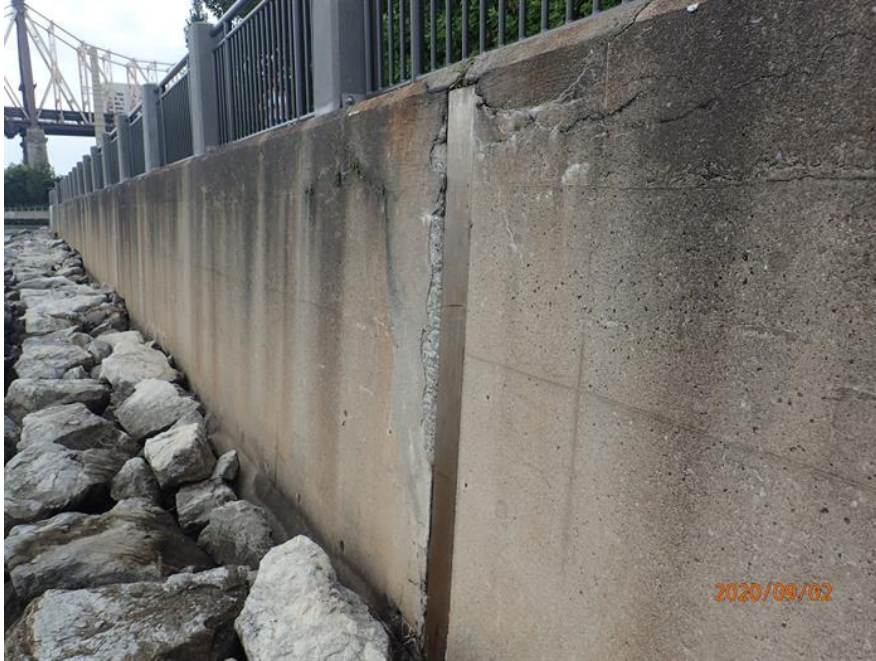
Station 43+87

Direction: Seawall Joint

Comments: Concrete Spalling and Concrete Repairs

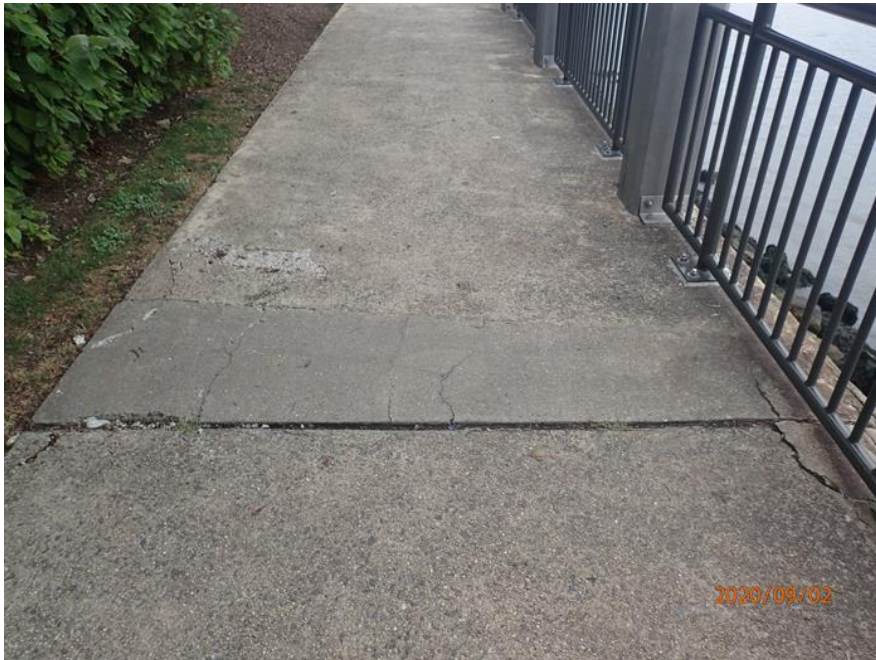
Station 43+57

Direction: Seawall Sidewalk Joint

Comments: Concrete Cracks

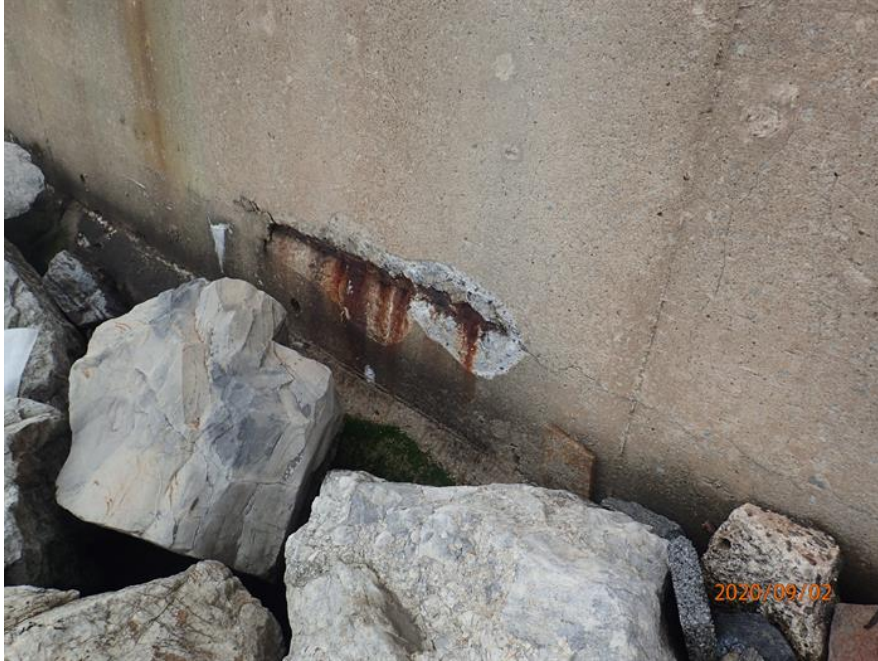
Station 44+65

Direction: Seawall

Comments: Exposed Re-Bar

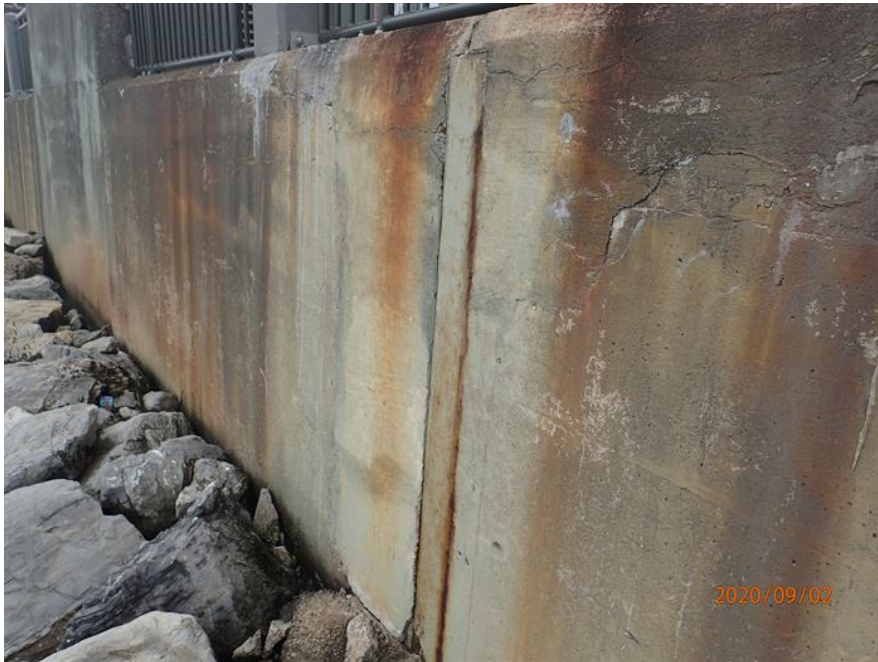
Station 45+77

Direction: Seawall Joint

Comments: Concrete Spalling, Large Concrete Cracks

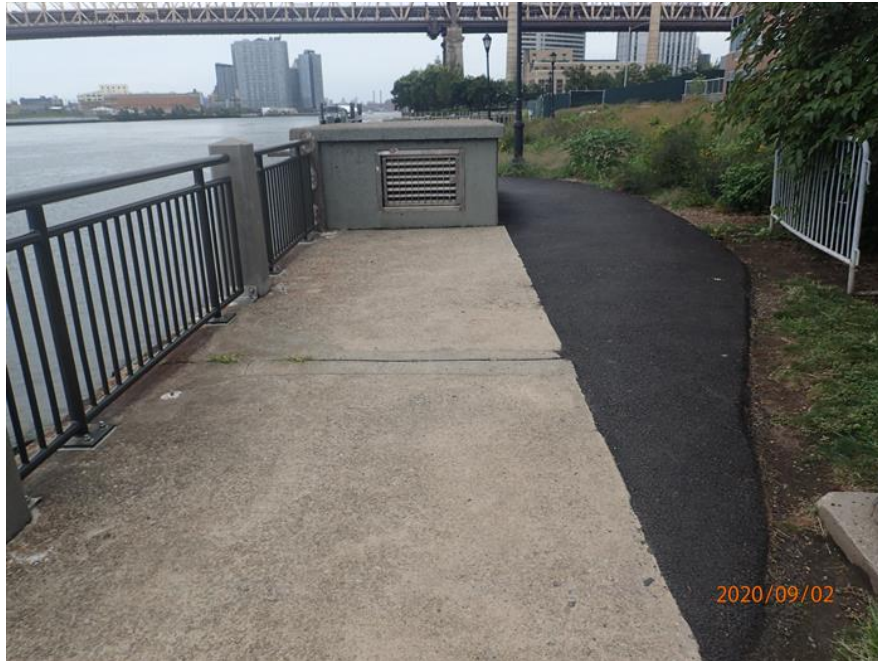
Station 45+34

Direction: Air Vent 1

Comments: Northern Face

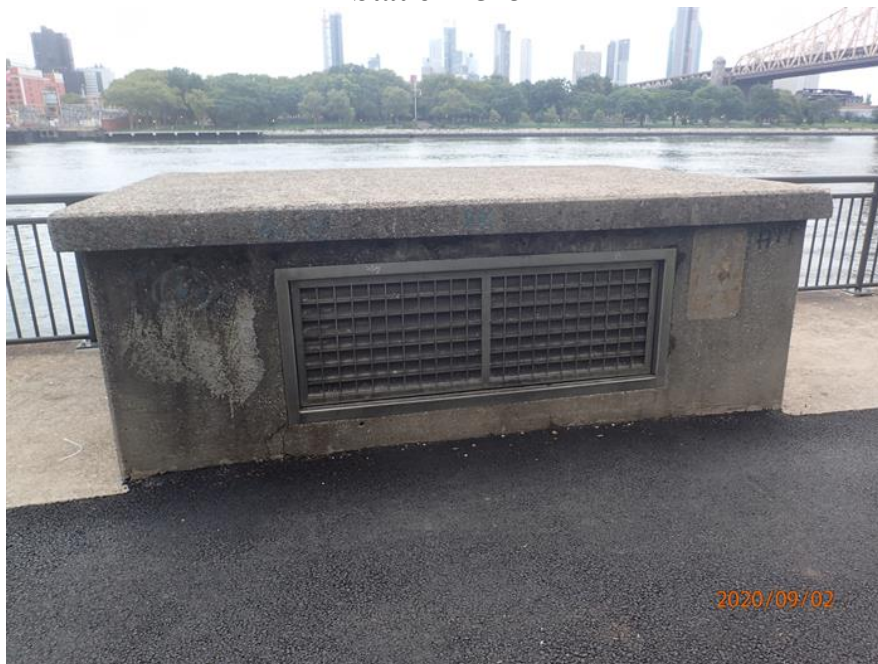
Station 45+34

Direction: Air Vent 1

Comments: Western Face

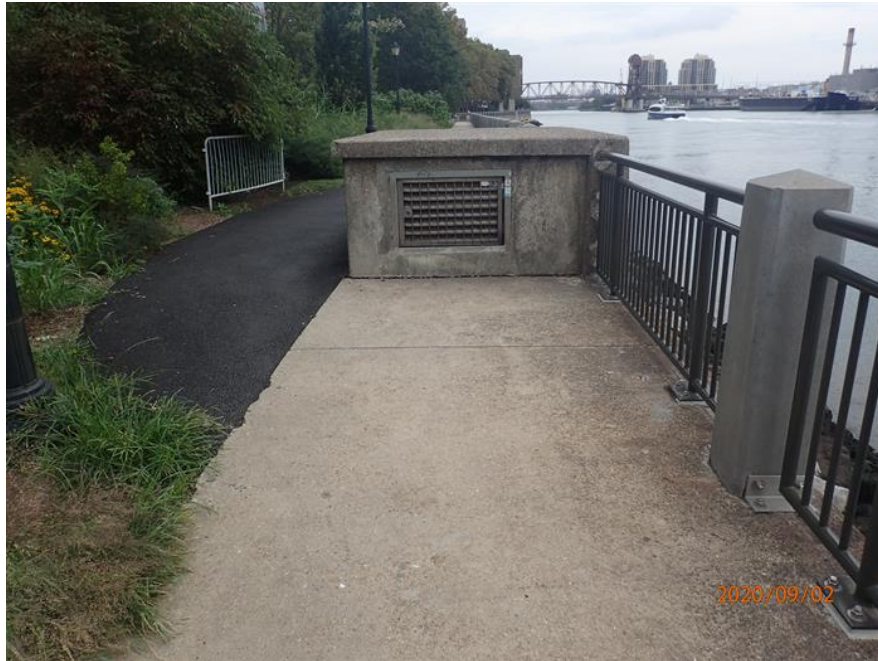
Station 45+34

Direction: Air Vent 1

Comments: Southern Face

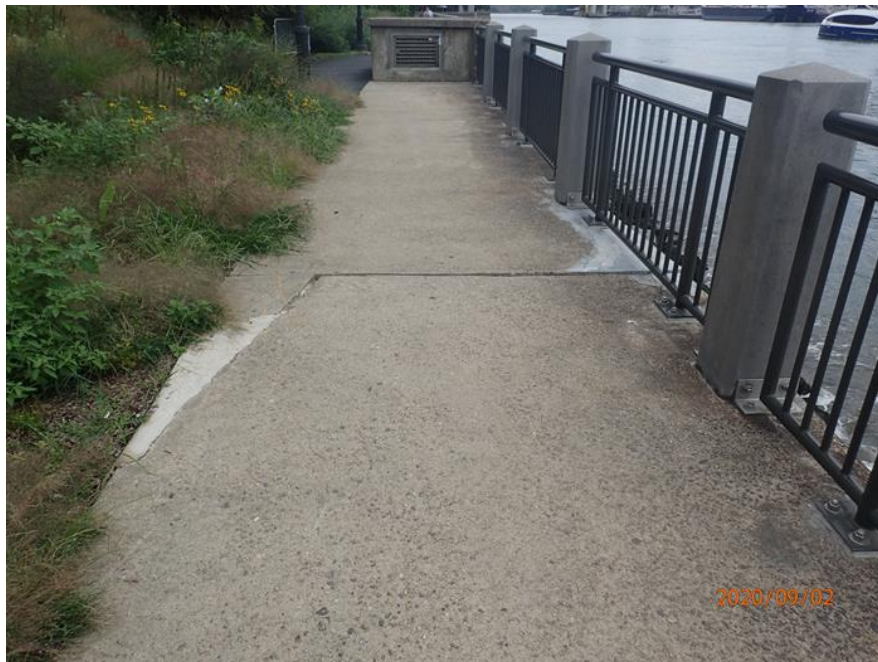
Station 45+77

Direction: Seawall Sidewalk Joint

Comments: Large Concrete Crack, Missing Concrete

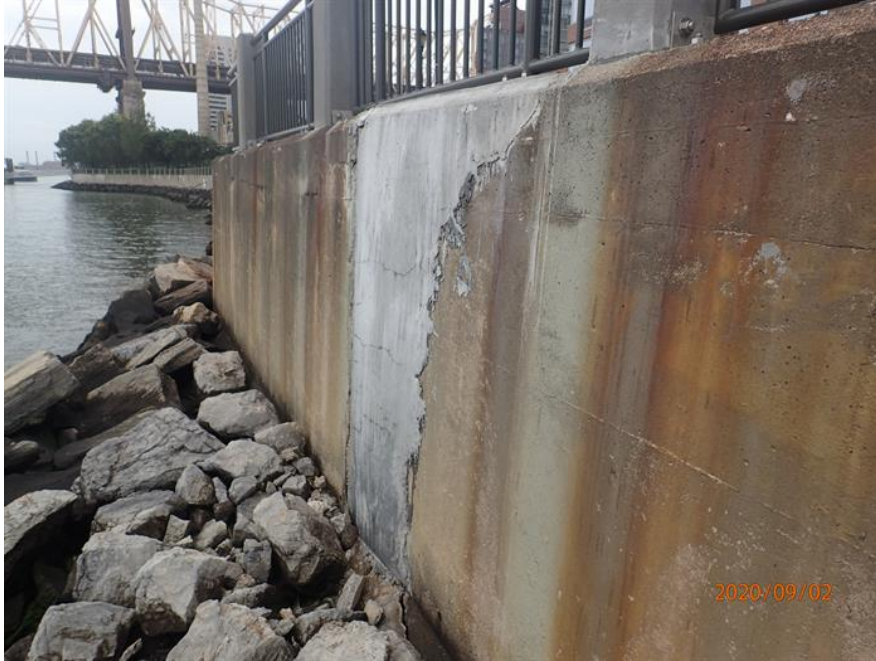
Station 45+77

Direction: Seawall Joint

Comments: Concrete Spalling, Concrete Cracks, Attempt to Repair

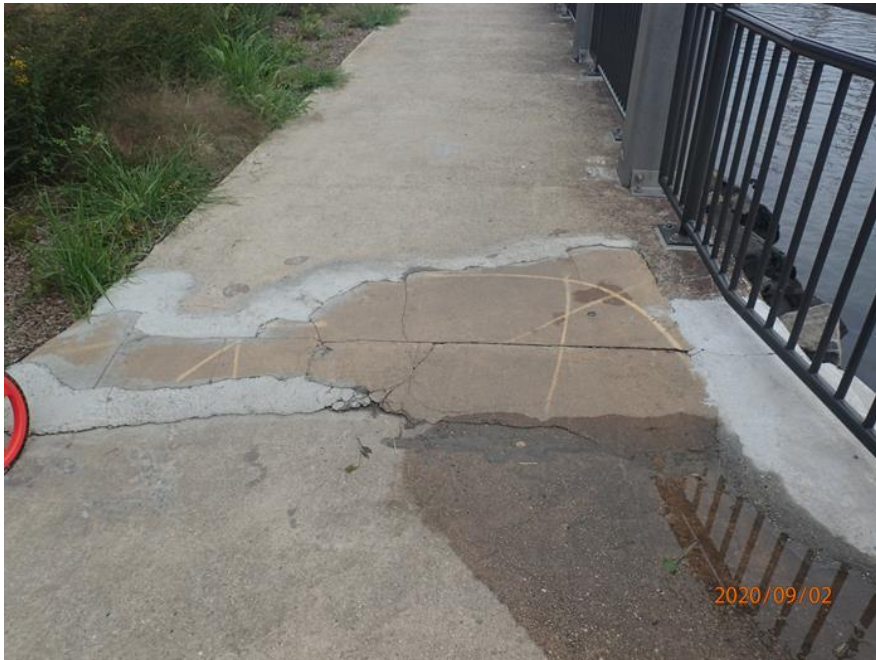
Station 45+97

Direction: Seawall Sidewalk Joint at Terminus

Comments: Concrete Cracks, Attempt to Repair

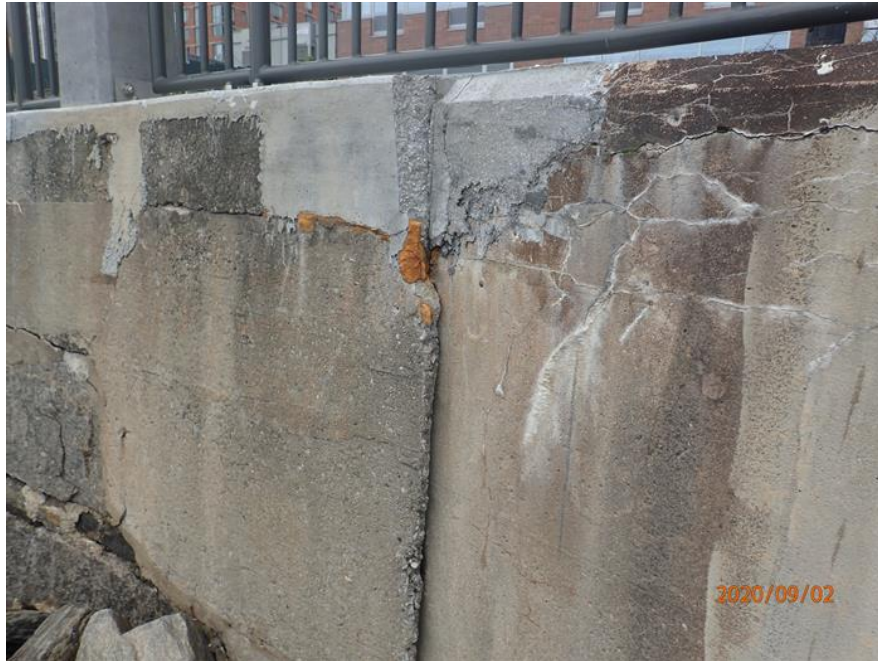
Station 45+97

Direction: Southern Seawall Terminus

Comments: Spalling at Haunch, Concrete Cracks, Attempt to Repair

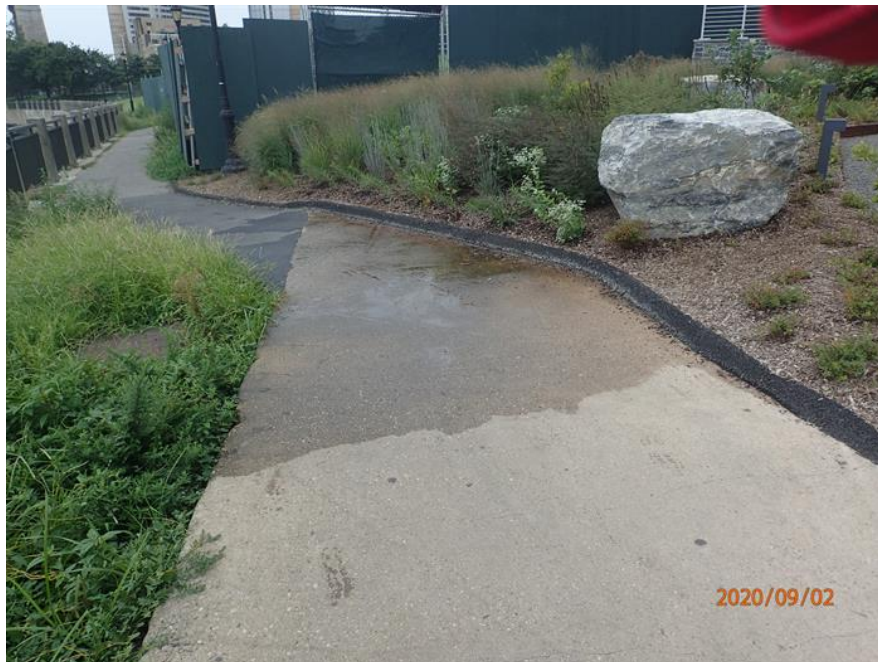
Station 47+00

Direction: Southern Seawall Terminus

Comments: End of Seawall

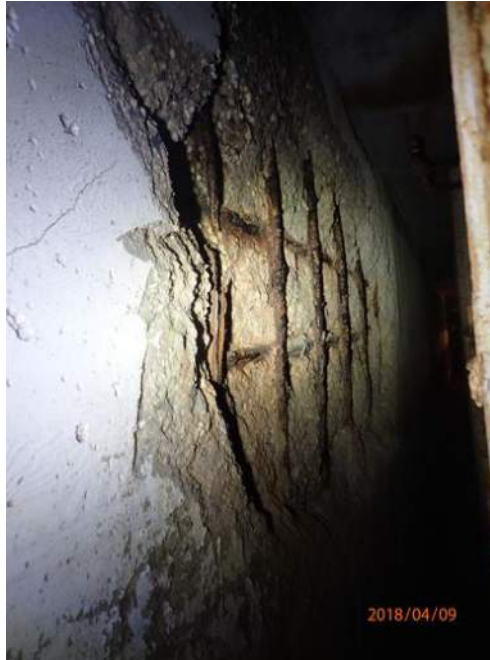
Station 1+95

Direction: Eastern Wall (Seawall)

Comments: Spalling, Loose Concrete, Exposed Rebar

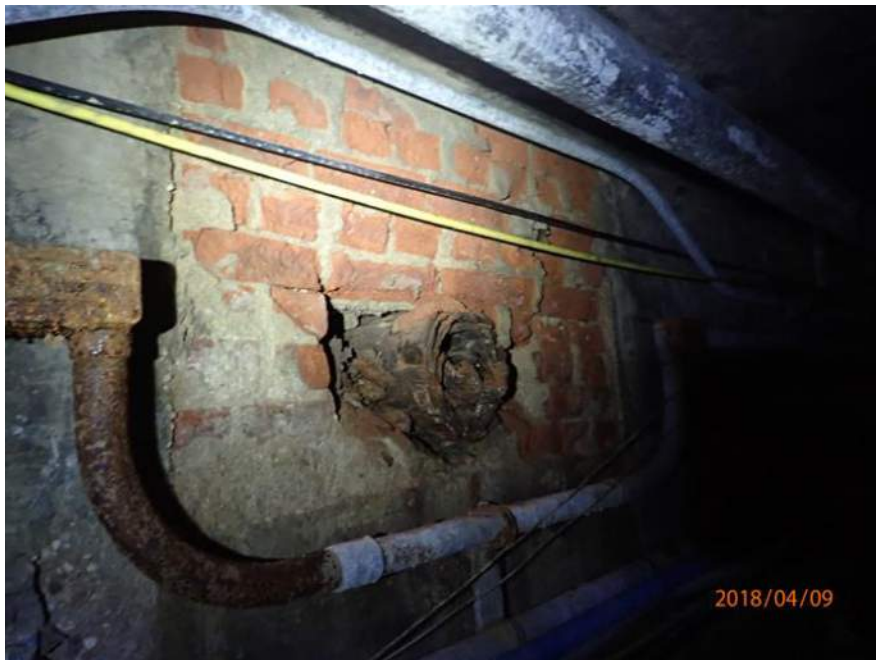
Station 1+95

Direction: Western Wall (In-Land)

Comments: Spalling, Loose Concrete, Exposed Rebar

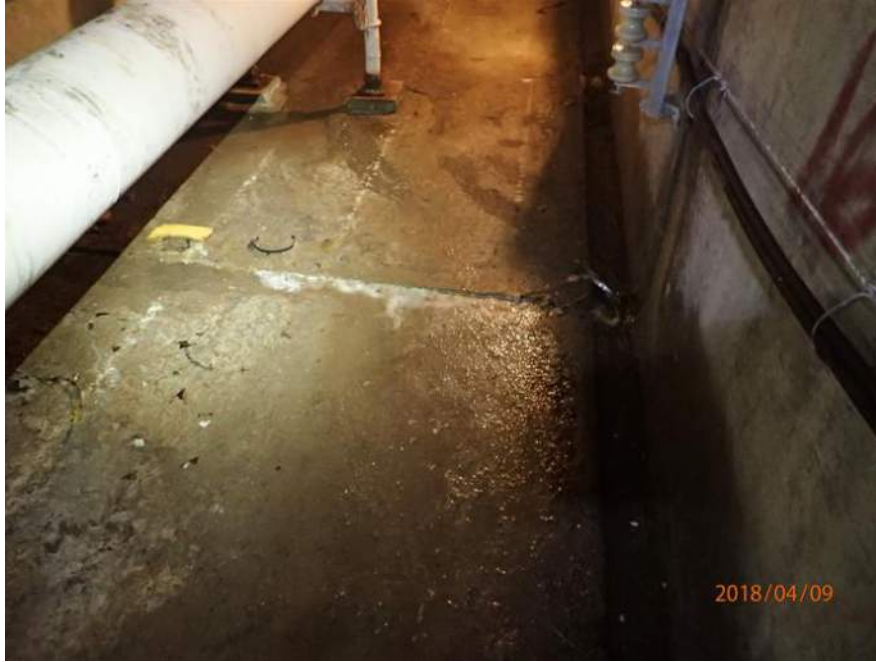
Station 2+60

Direction: Tunnel Floor

Comments: Raised Joint and Separation at Joint

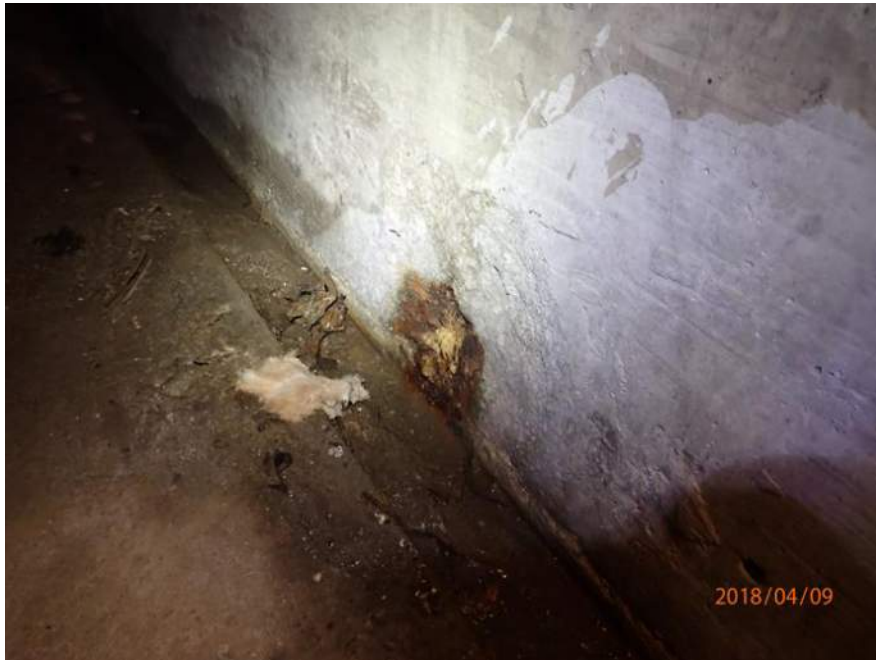
Station 3+60

Direction: Western Wall (In-Land)

Comments: Concrete Spalling

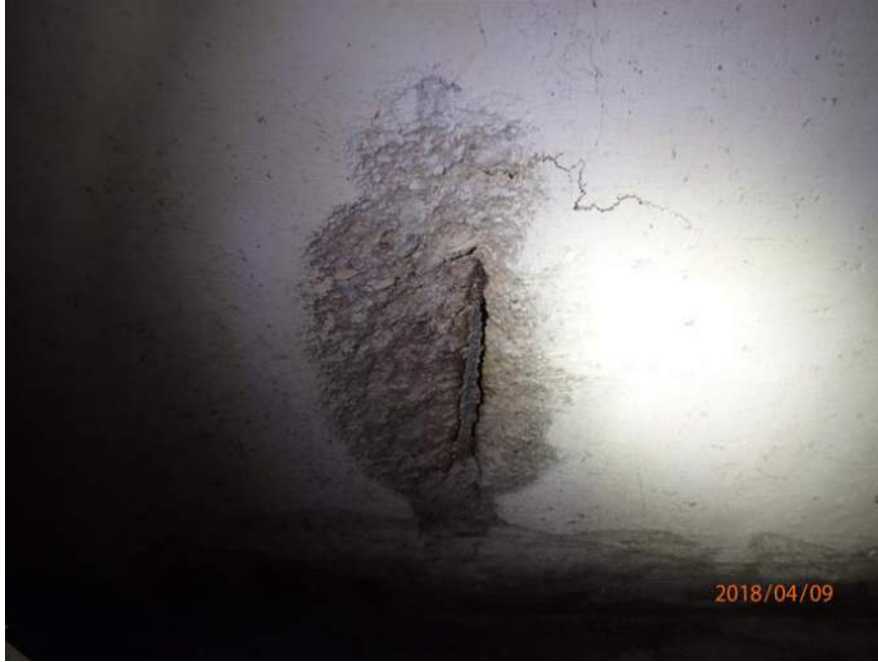
Station 4+50

Direction: Eastern Wall (Seawall)

Comments: Spalling, Re-Bar Exposed and Corroded

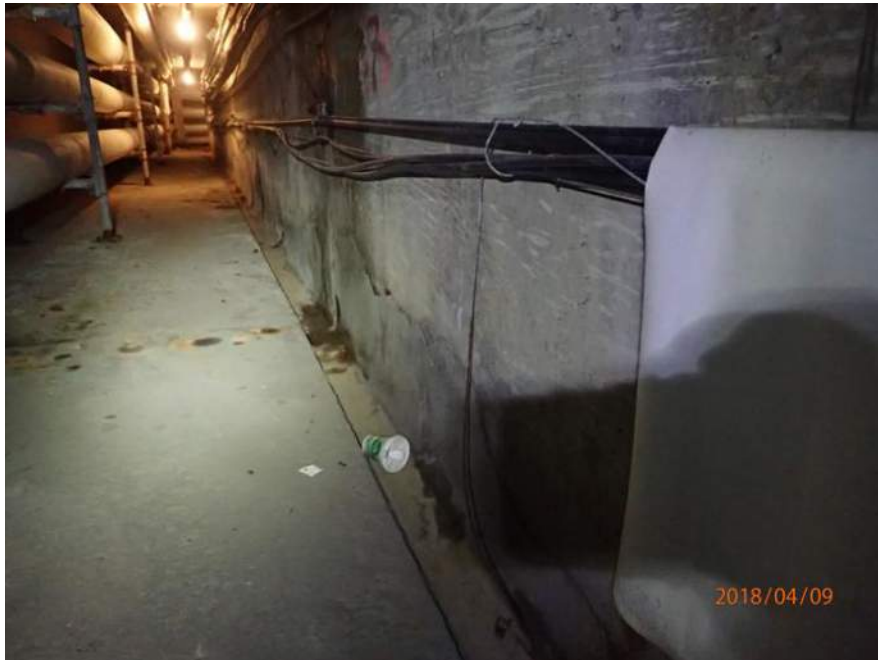
Station 4+50 to 4+55

Direction: Western Wall (In-Land)

Comments: Spalling, Loose Concrete

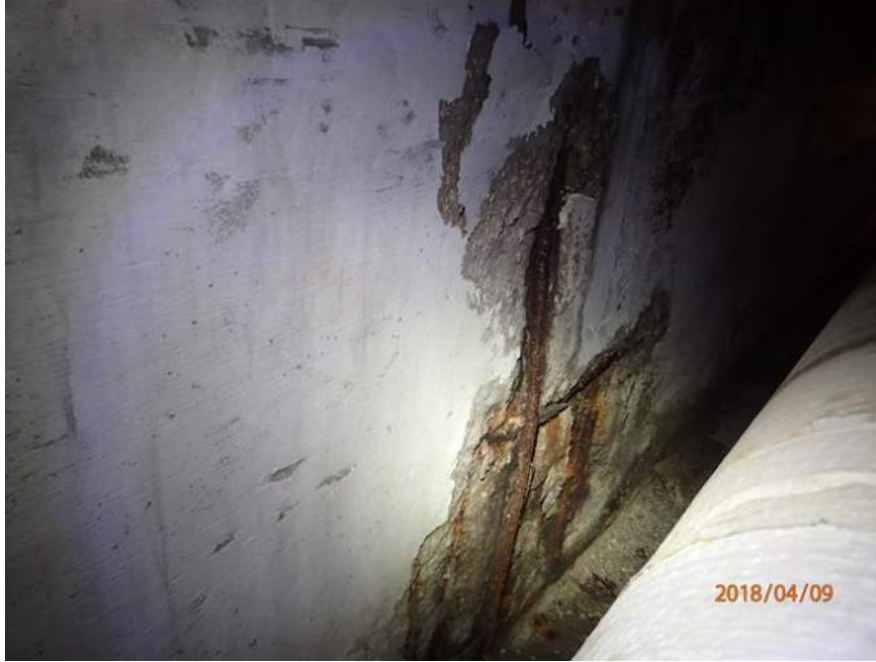
Station 4+50

Direction: Eastern Wall (Seawall)

Comments: Spalling, Re-Bar Exposed and Corroded

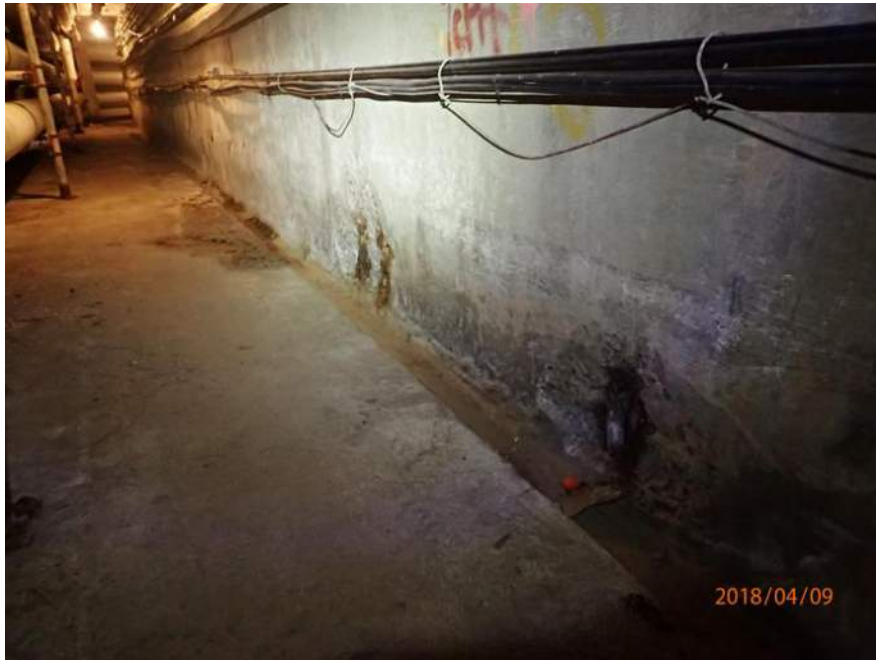
Station 4+50 to 4+85

Direction: Western Wall (In-Land)

Comments: Spalling, Re-Bar Exposed and Corroded

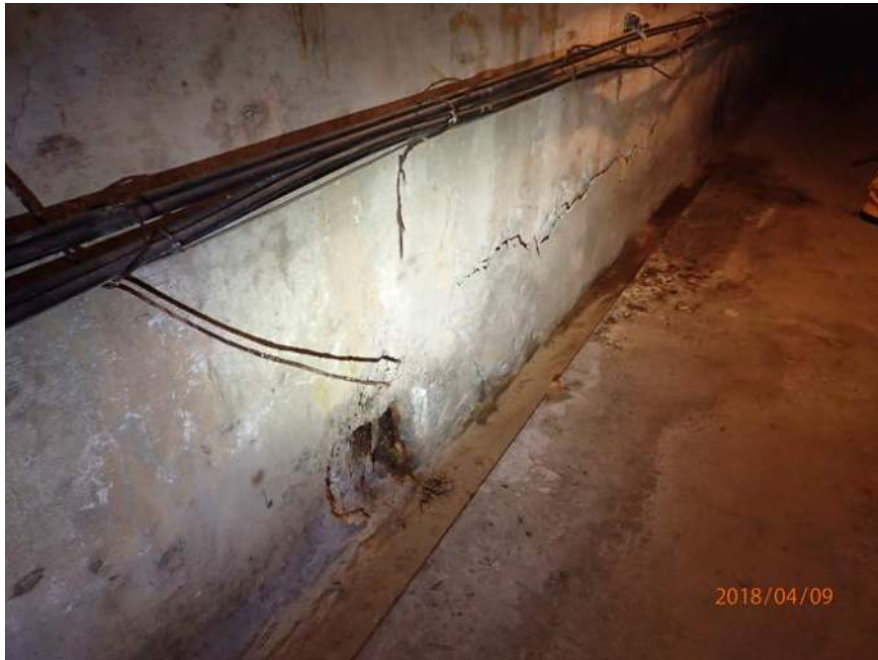
Station 4+50 to 4+85

Direction: Western Wall (In-Land)

Comments: Spalling, Loose Concrete

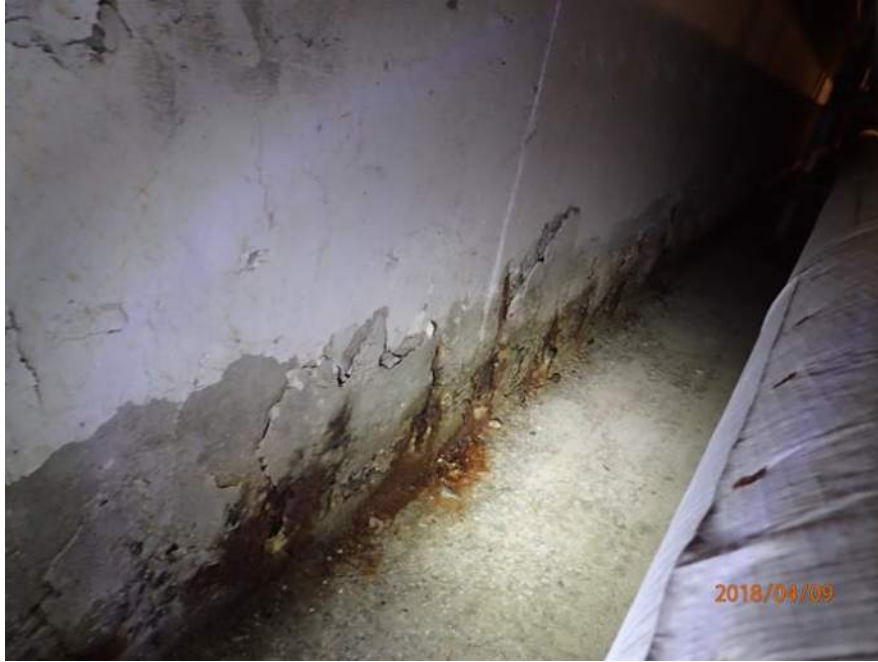
Station 4+80 to 5+15

Direction: Eastern Wall (Seawall)

Comments: Concrete Spalling, Re-Bar Exposed and Corroded

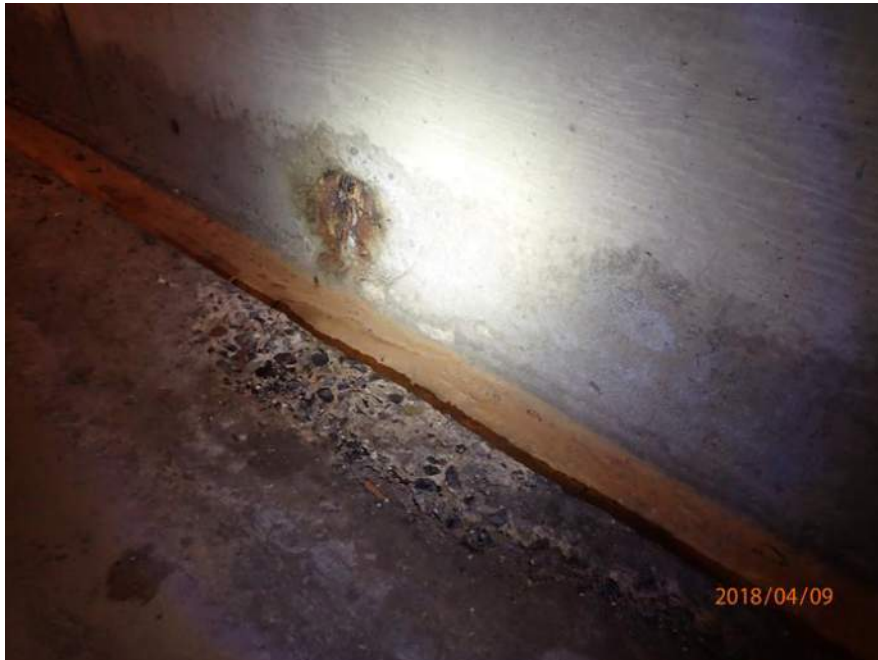
Station 5+08

Direction: Western Wall (In-Land)

Comments: Concrete Spalling

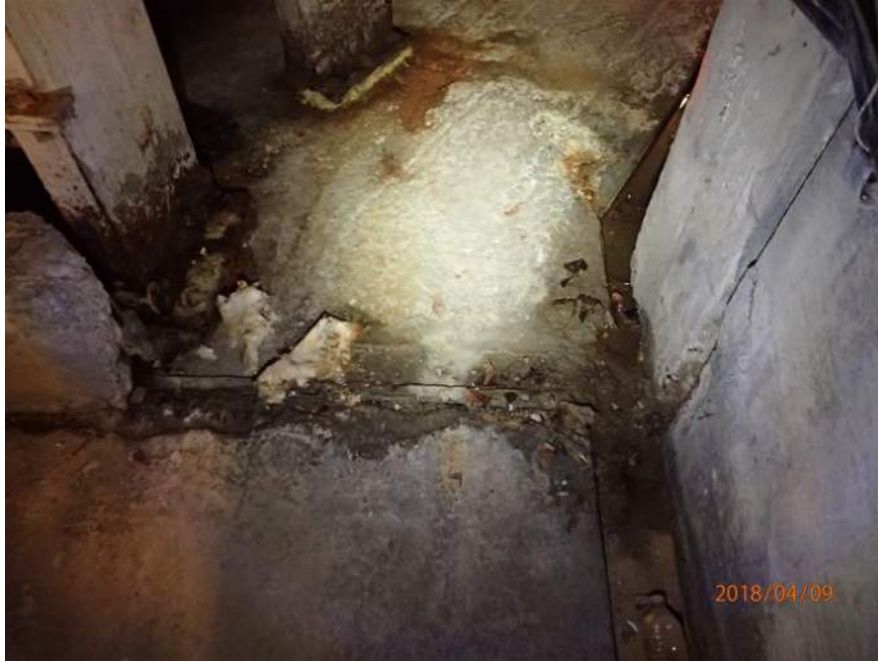
Station 5+30

Direction: Tunnel Floor, Joint

Comments: Floor Slab Raised at Joint, Cracking, Loose Concrete
