CONDITIONS REPORT & CONCEPTUAL DESIGN MEMORANDUM

STEAM TUNNEL ASSESSMENT

ROOSEVELT ISLAND, NEW YORK

17 November 2014
Revised 28 December 2018
Revised 18 September 2020
Project # 100444601

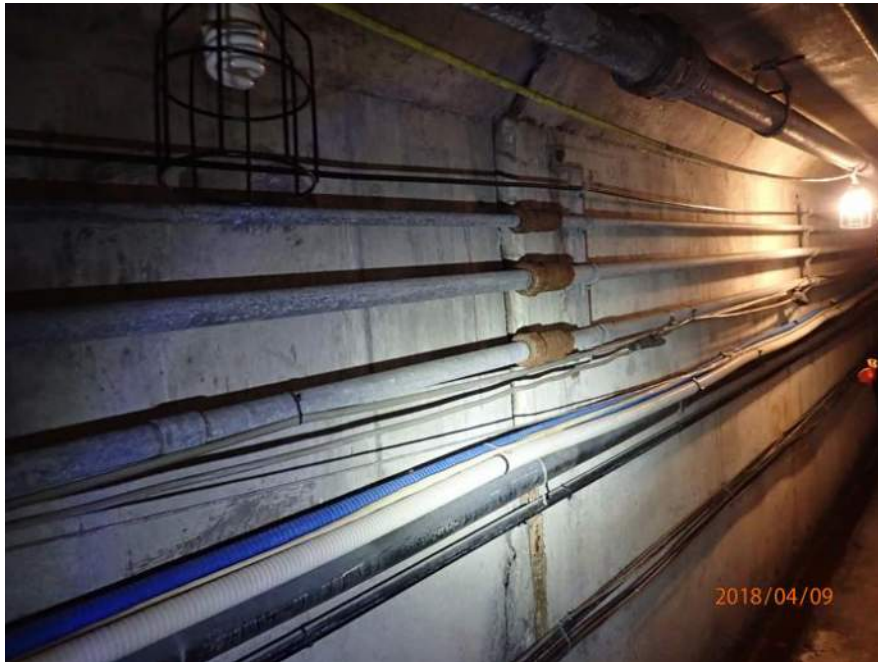
Station 5+40

Direction: Eastern Wall (Seawall)/ Western Wall (In-Land)

Comments: Joint Leaking, Separated

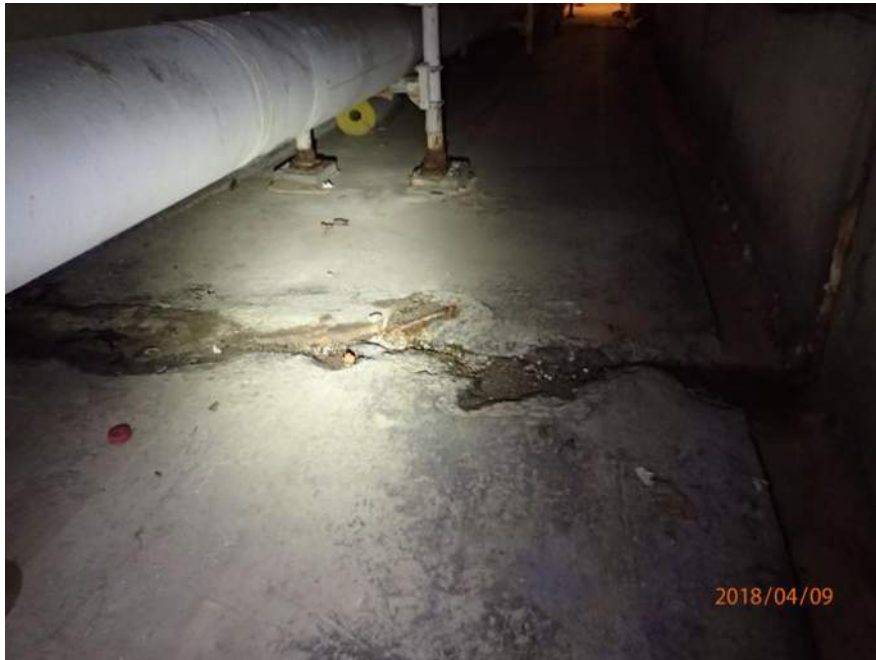
Station 5+90

Direction: Tunnel Floor

Comments: Raised Joint, Loose Concrete and Leaking at Seawall

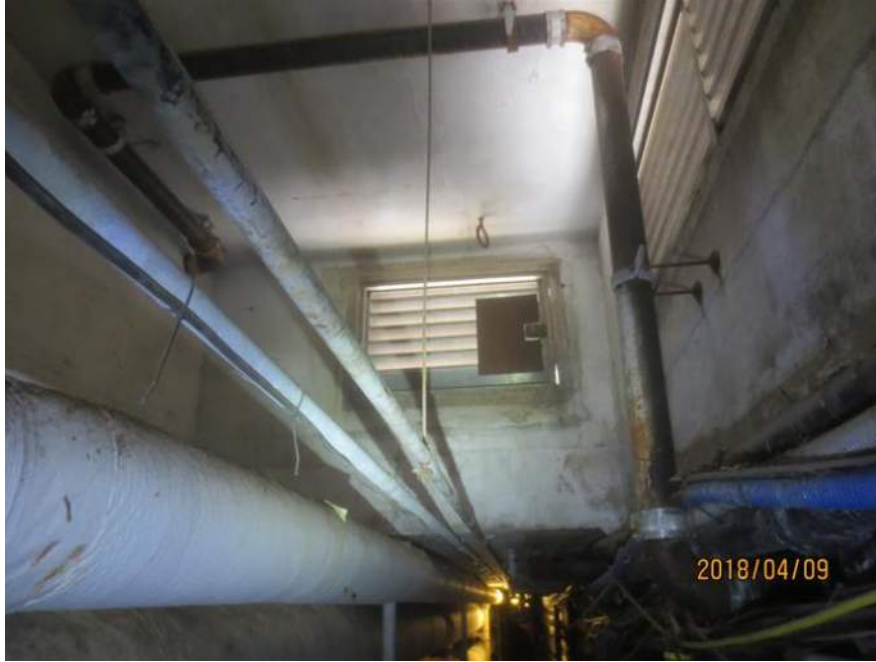
Station 6+16

Direction: Tunnel Floor

Comments: Sump Pump - Not Working

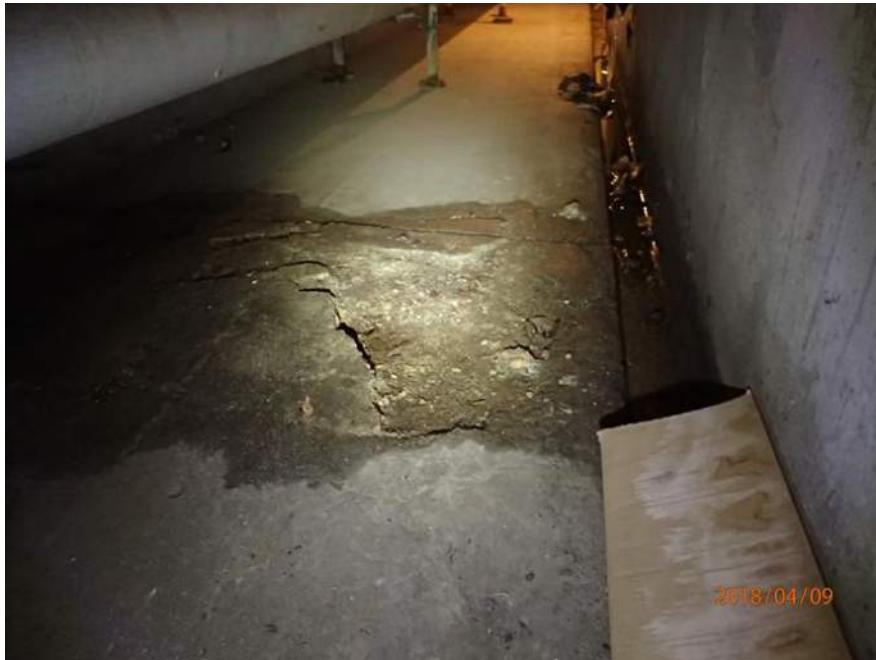
Station 6+20 to 6+26

Direction: Tunnel Floor

Comments: Floor Slab Cracking and Spalling

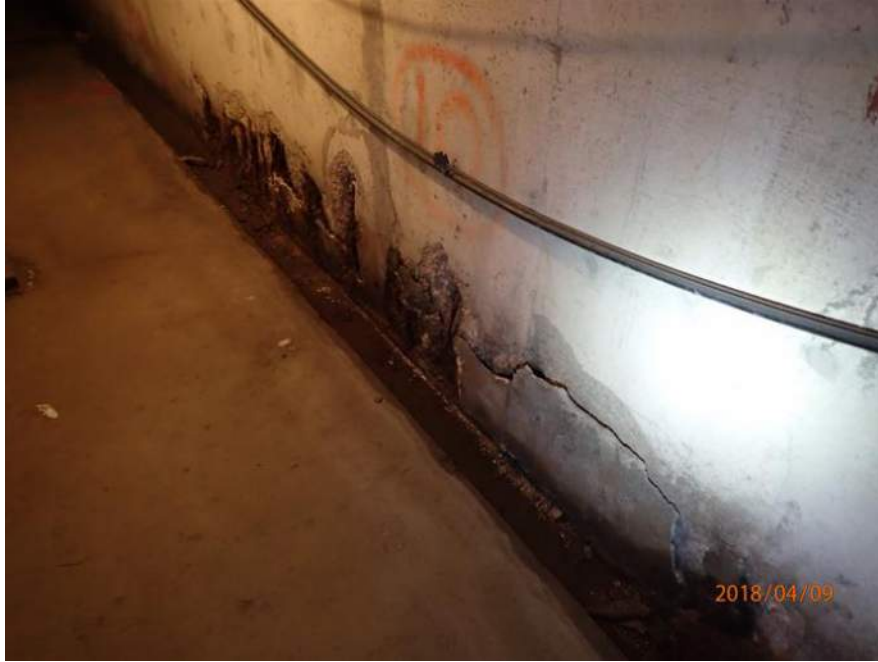
Station 6+30 to 6+47

Direction: Western Wall (In-Land)

Comments: Concrete Spalling, Re-Bar Exposed and Corroded

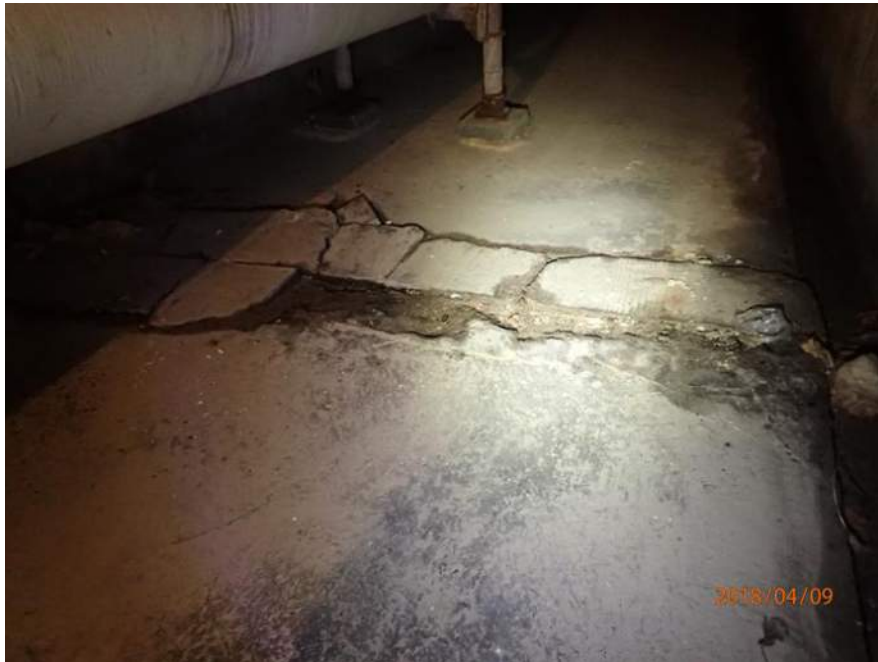
Station 6+56

Direction: Tunnel Floor

Comments: Raised Joint, Loose Concrete and Leaking at Seawall

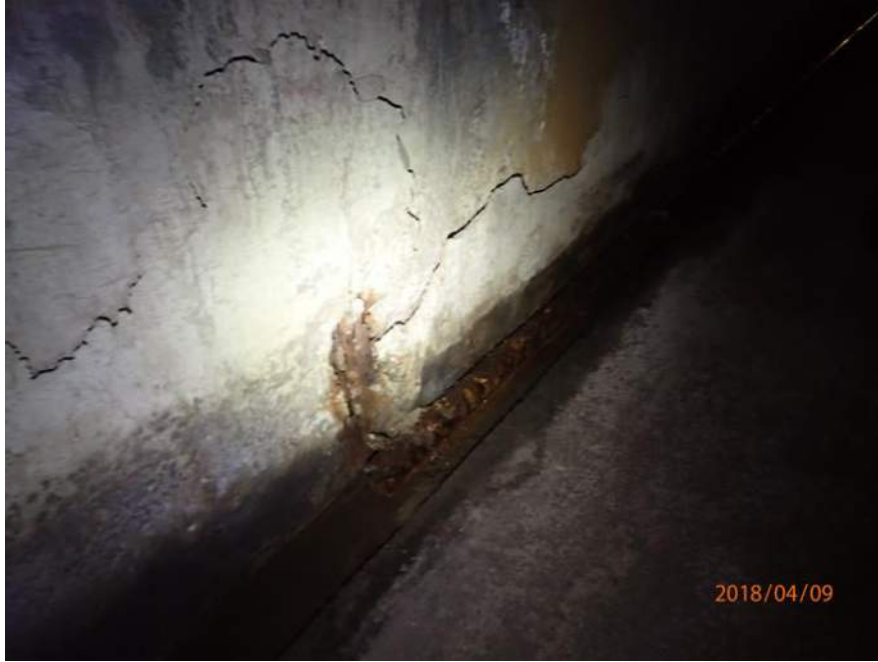
Station 6+90

Direction: Western Wall (In-Land)

Comments: Spalling, Loose Concrete

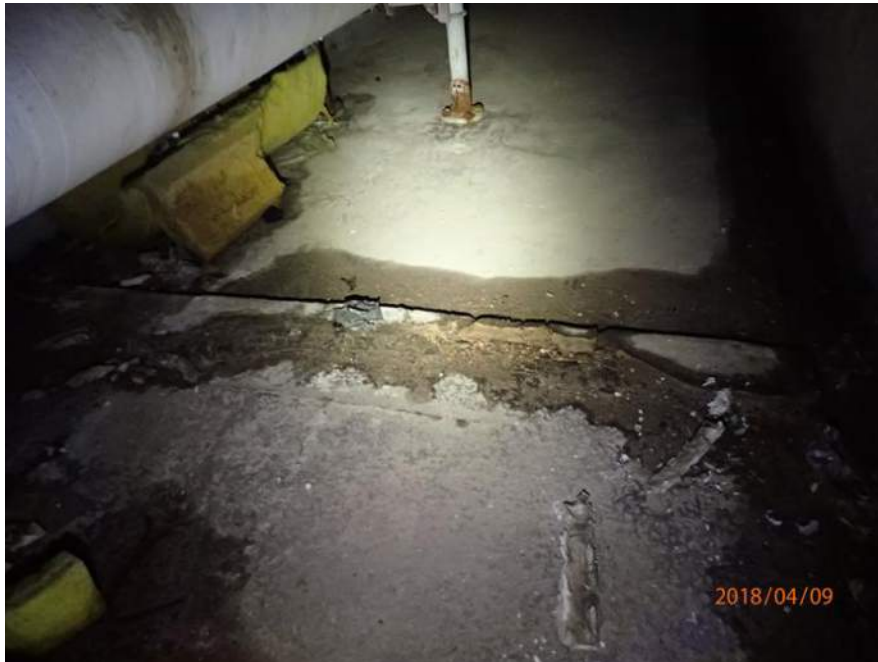
Station 7+21

Direction: Tunnel Floor

Comments: Floor Slab Raised at Joint, Cracking, Loose Concrete

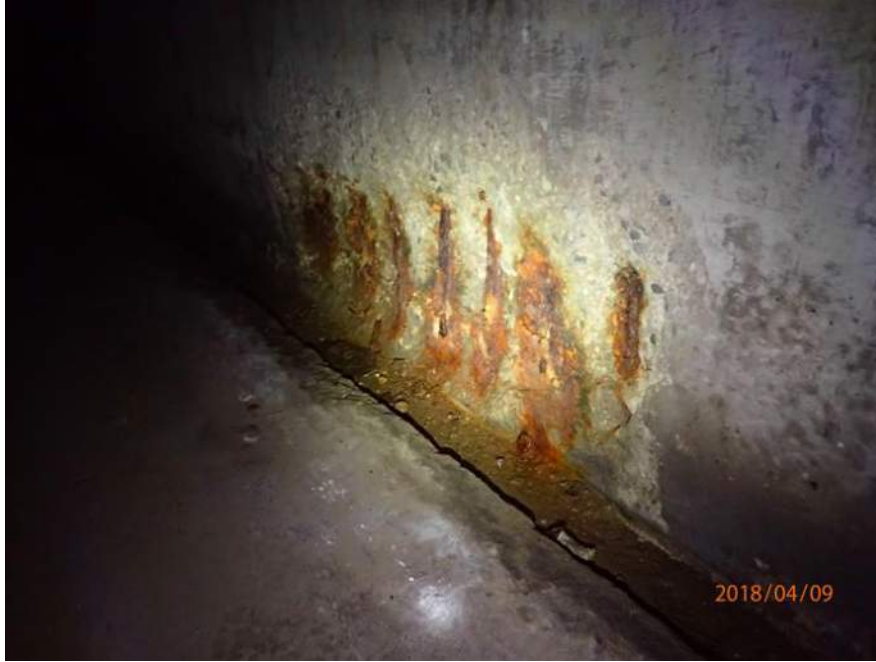
Station 7+23 to 7+40

Direction: Western Wall (In-Land)

Comments: Spalling, Re-Bar Exposed and Corroded

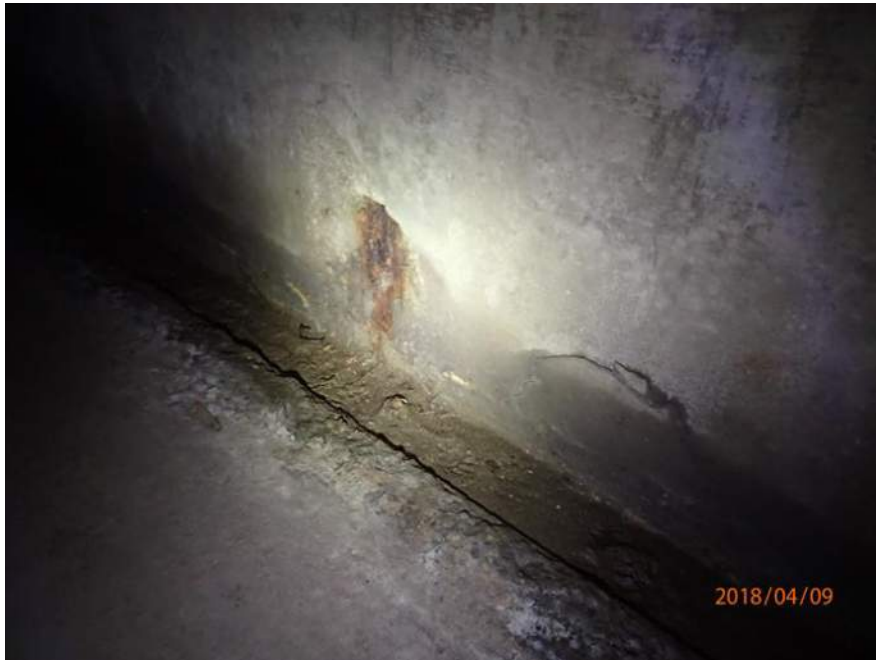
Station 7+53

Direction: Western Wall (In-Land)

Comments: Concrete Spalling

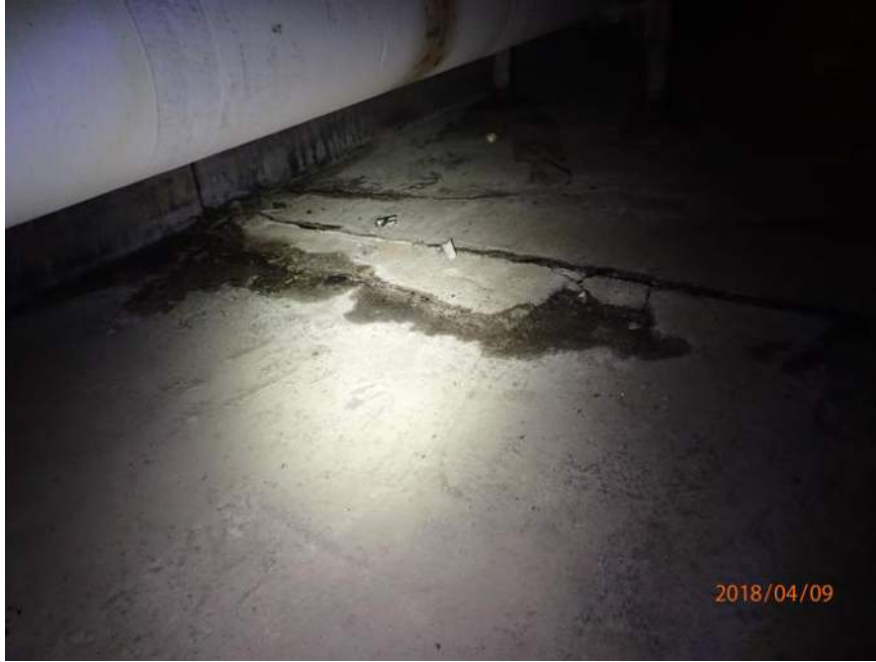
Station 7+75

Direction: Tunnel Floor

Comments: Floor Slab Raised at Joint, Cracking, Loose Concrete

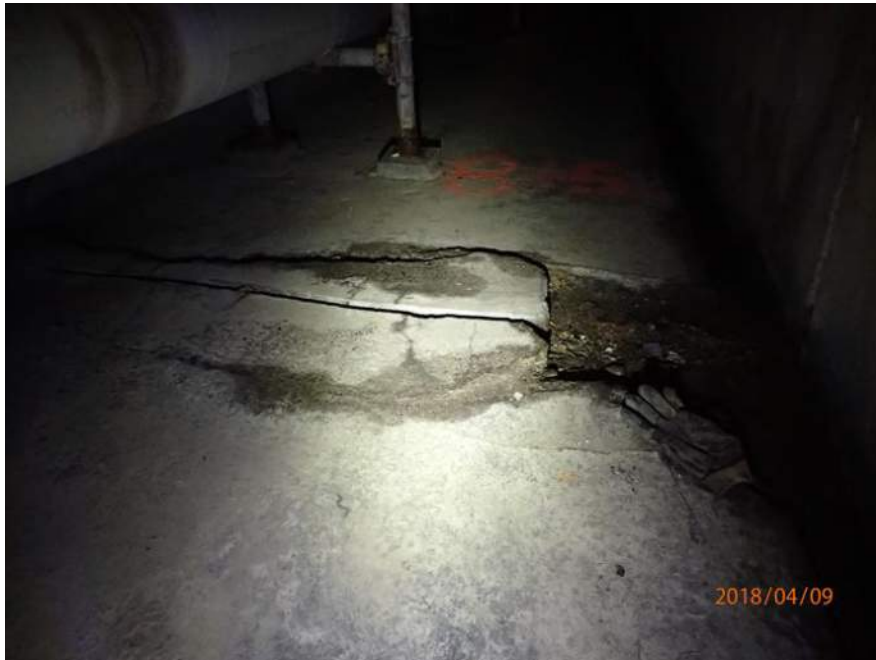
Station 8+47

Direction: Tunnel Floor

Comments: Floor Slab Raised at Joint, Cracking, Loose Concrete

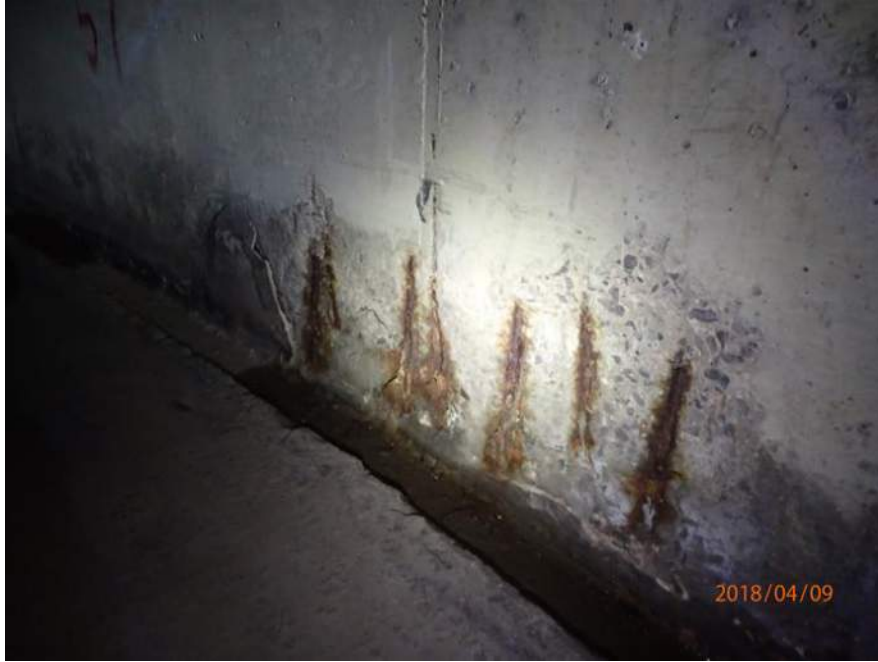
Station 8+72 to 8+88

Direction: Western Wall (In-Land)

Comments: Spalling, Re-Bar Exposed and Corroded

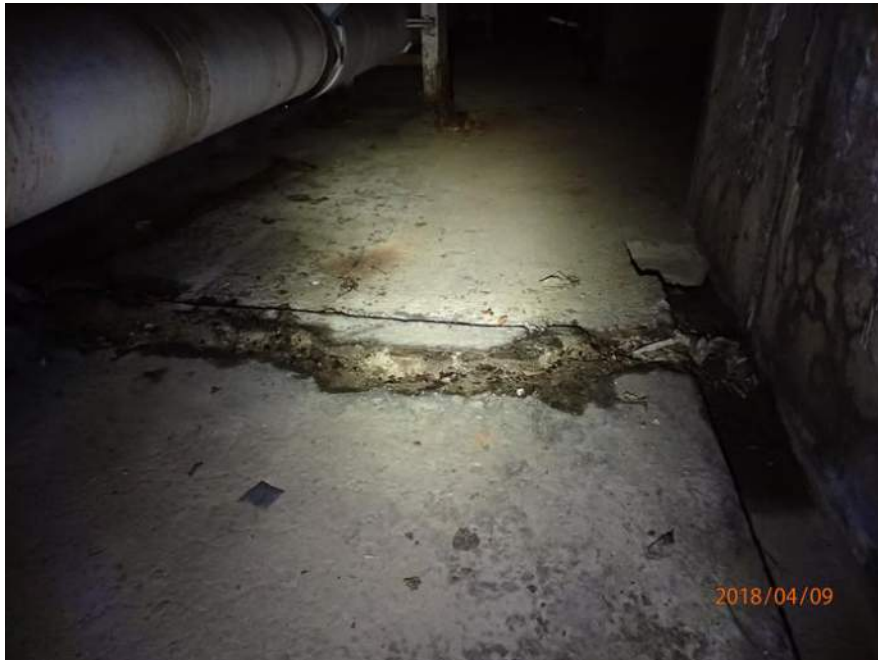
Station 9+09

Direction: Tunnel Floor

Comments: Floor Slab Raised at Joint, Cracking, Loose Concrete

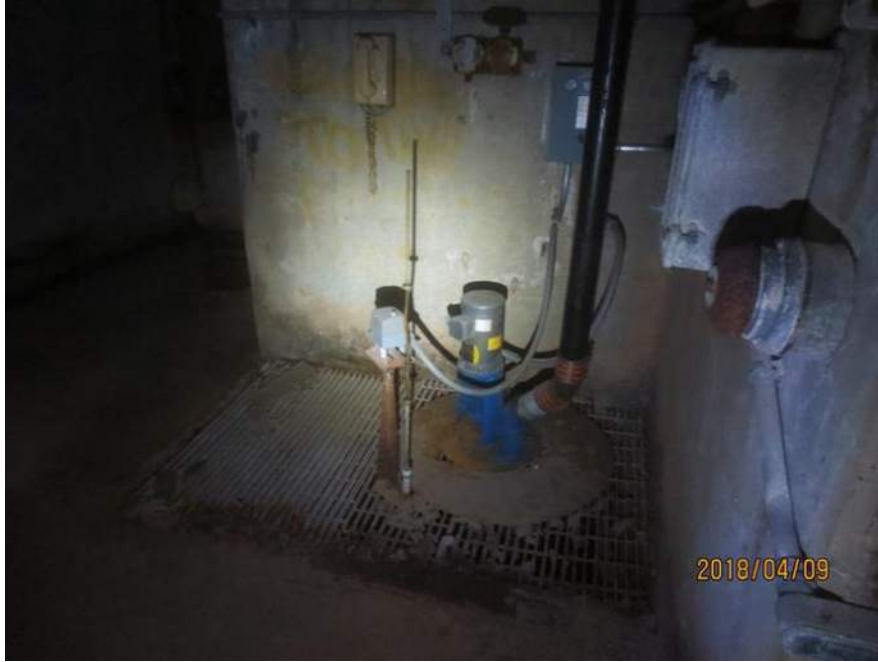
Station 9+21

Direction: Tunnel Floor

Comments: Sump Pump - Not Working

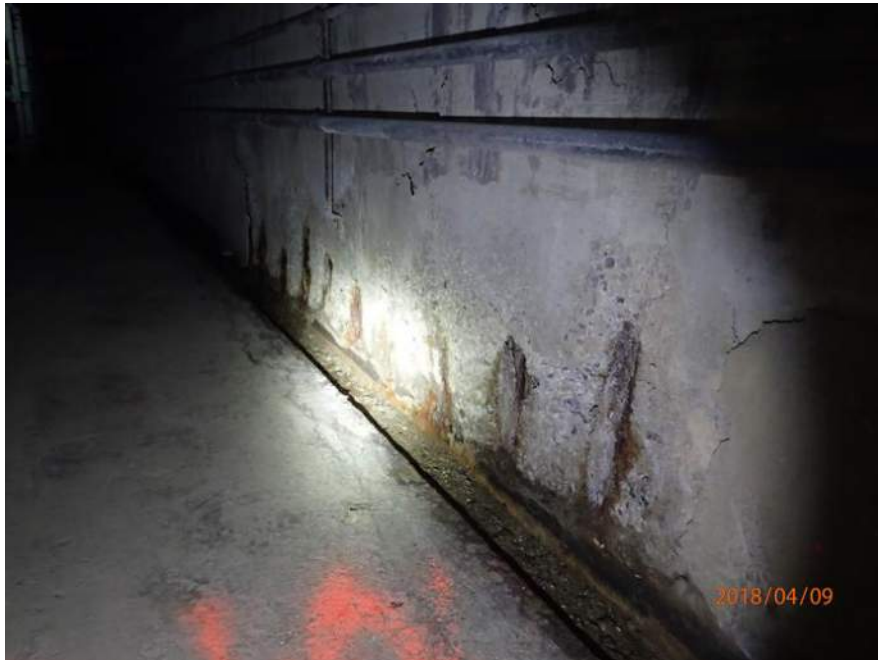
Station 9+95 to 10+15

Direction: Western Wall (In-Land)

Comments: Spalling, Re-Bar Exposed and Corroded

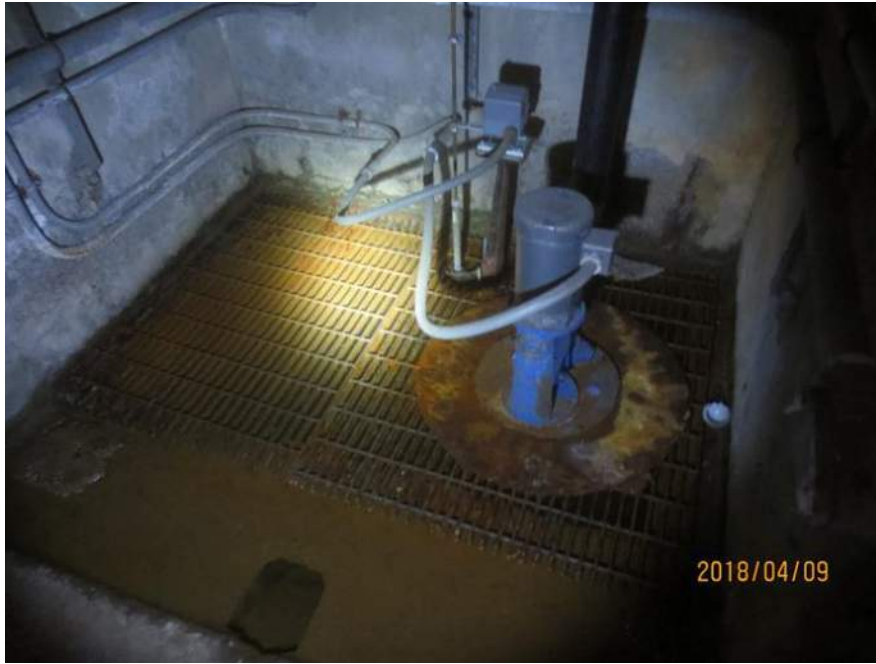
Station 10+77

Direction: Tunnel Floor

Comments: Sump Pump - Not Working

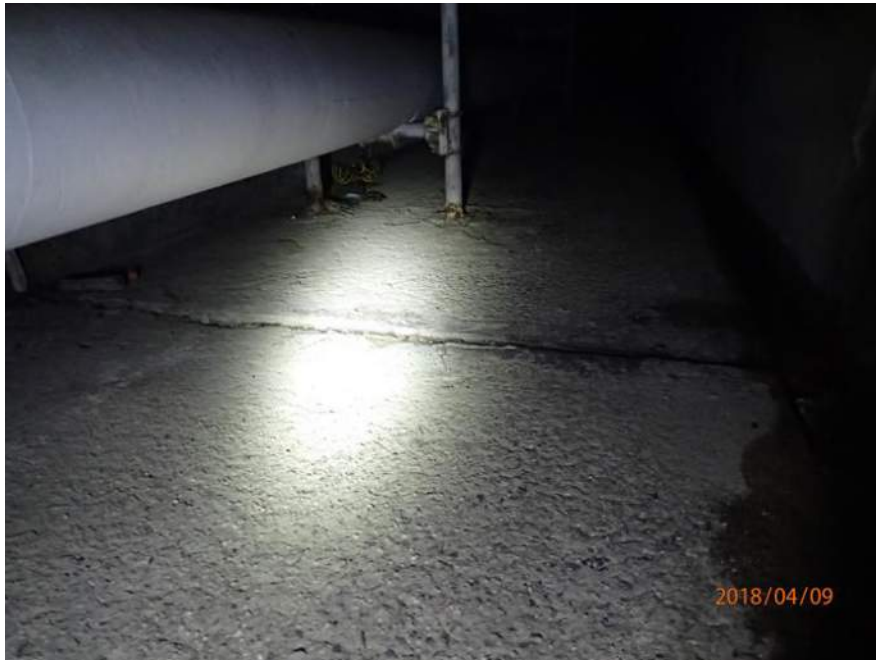
Station 11+18

Direction: Tunnel Floor

Comments: Floor Slab Raised at Joint, Cracking, Loose Concrete

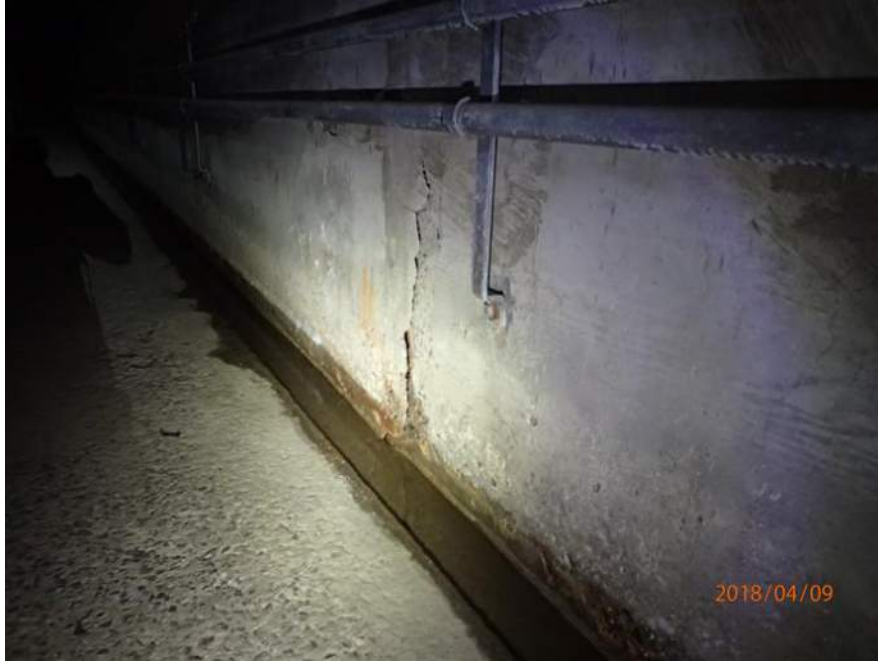
Station 11+29

Direction: Western Wall (In-Land)

Comments: Concrete Spalling

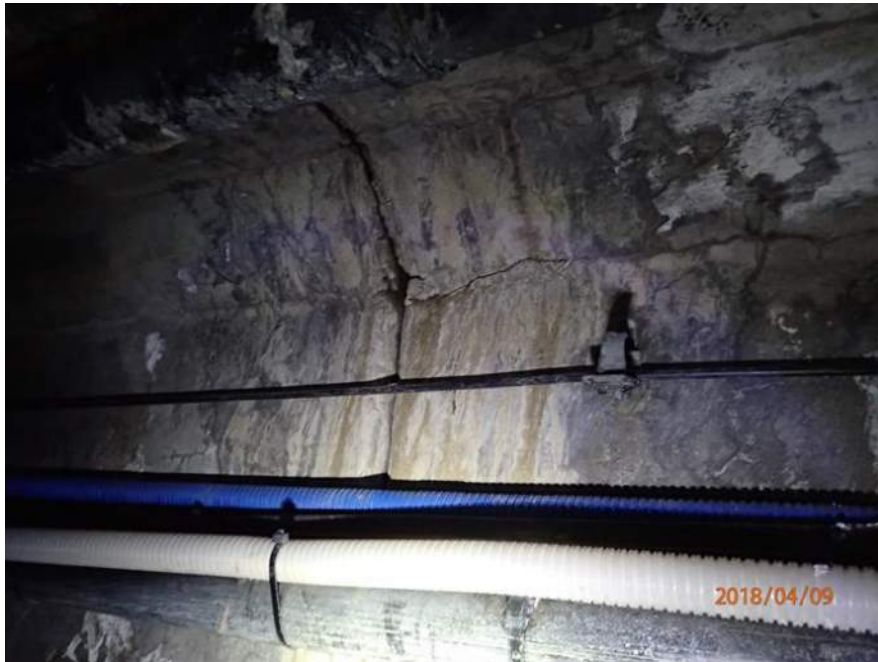
Station 11+80

Direction: Western Wall (In-Land)

Comments: Joint Separation, Missing Concrete

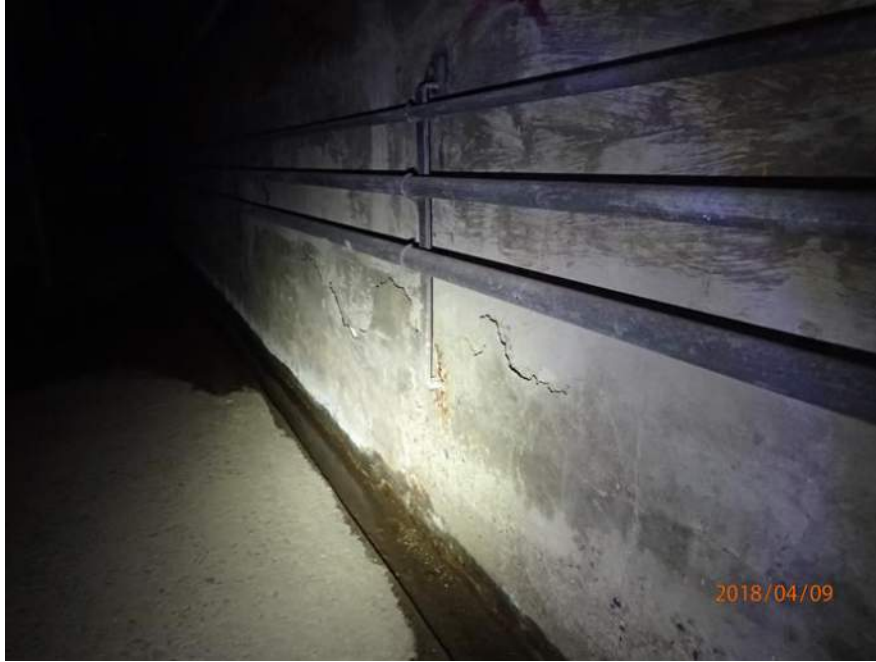
Station 11+85 +12+50

Direction: Western Wall (In-Land)

Comments: Concrete Spalling and Bowing of Wall

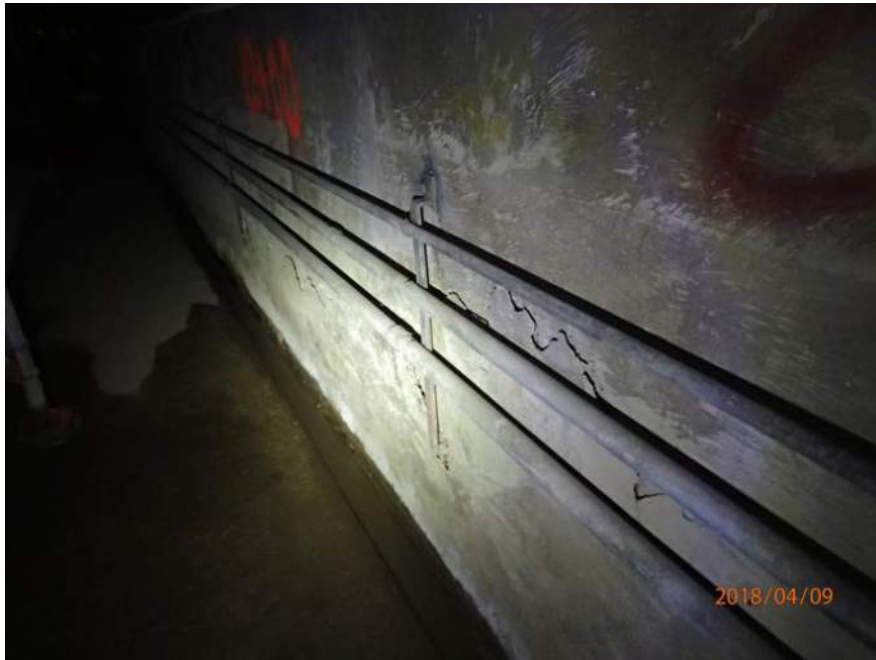
Station 11+85 +12+50

Direction: Western Wall (In-Land)

Comments: Concrete Spalling and Bowing of Wall, Loose Concrete

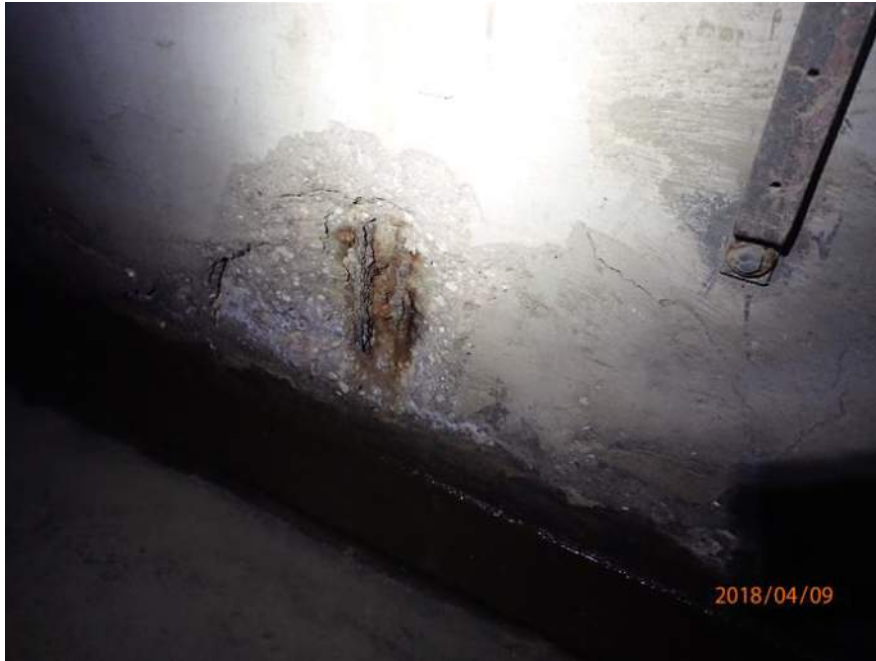
Station 12+53

Direction: Western Wall (In-Land)

Comments: Concrete Spalling, Re-Bar Exposed and Corroded

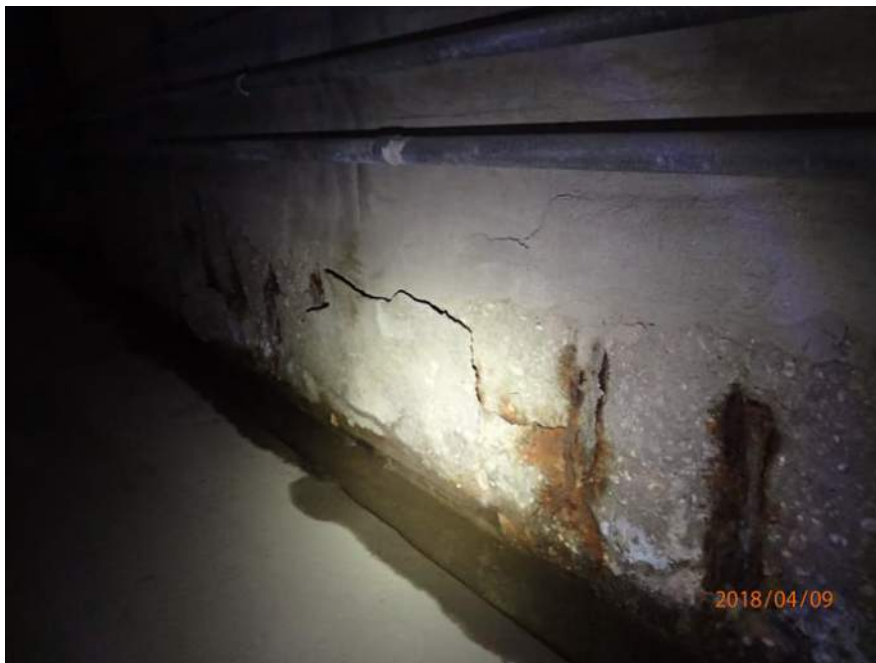
Station 12+65 to 12+85

Direction: Western Wall (In-Land)

Comments: Concrete Spalling, Re-Bar Exposed and Corroded

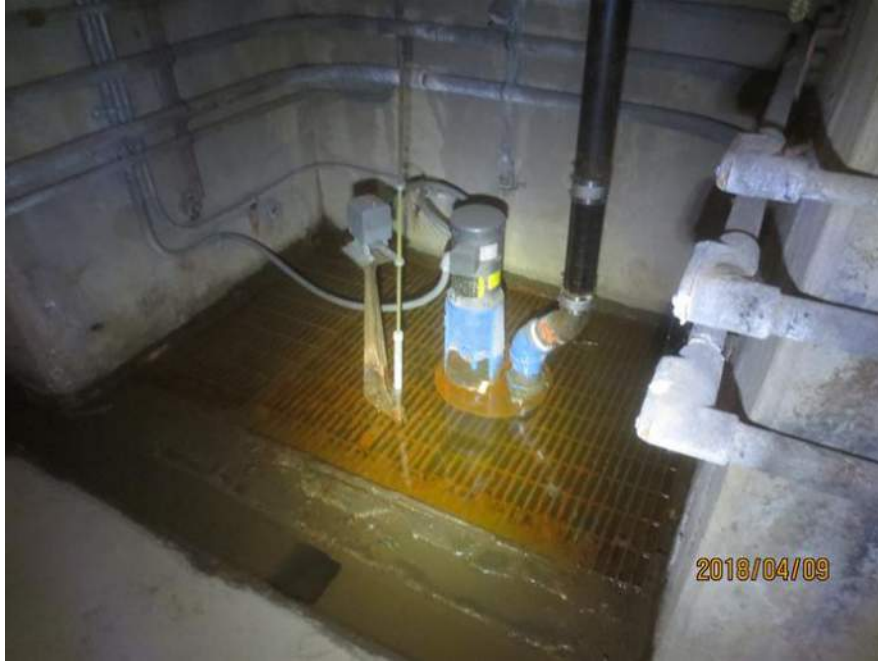
Station 12+84

Direction: Tunnel Floor

Comments: Sump Pump - Not Working

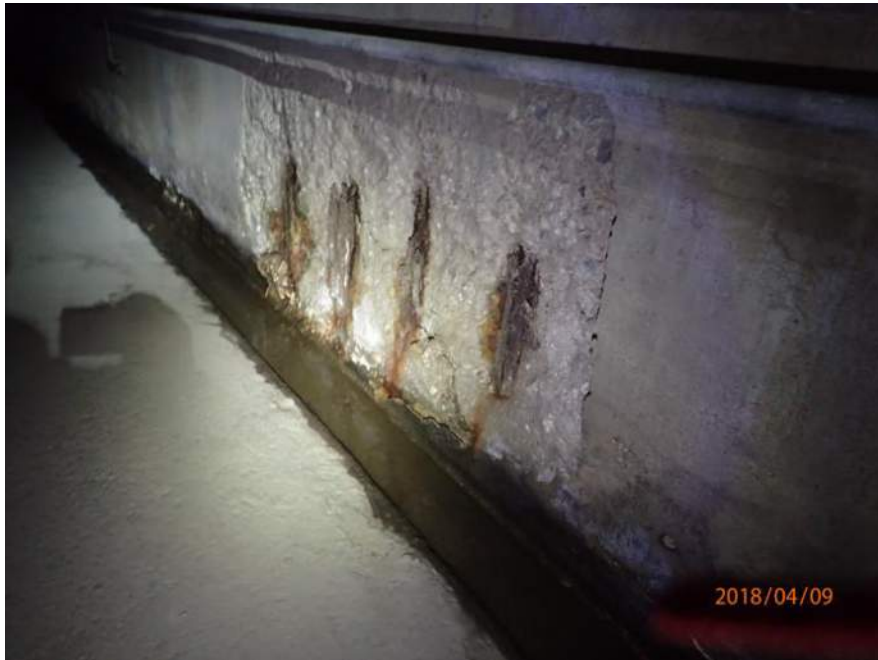
Station 12+90 to 12+96

Direction: Western Wall (In-Land)

Comments: Concrete Spalling, Re-Bar Exposed and Corroded

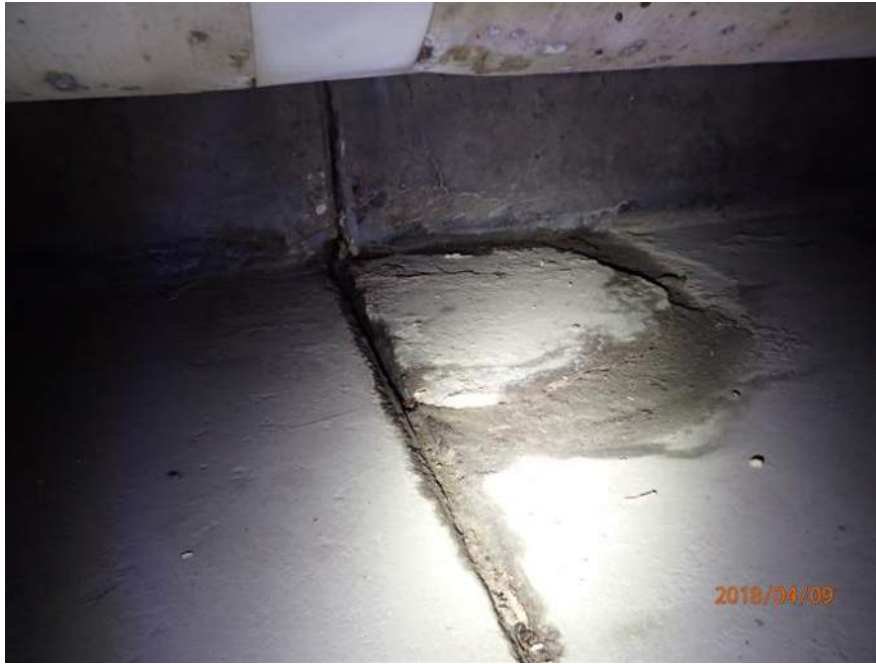
Station 13+25

Direction: Tunnel Floor

Comments: Floor Slab Raised at Joint, Cracking, Loose Concrete

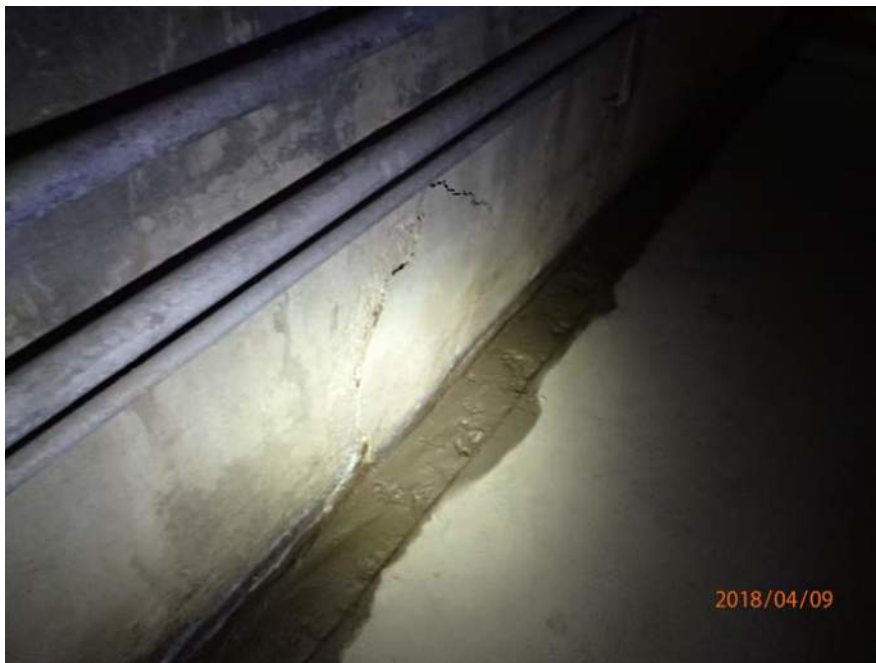
Station 13+31

Direction: Western Wall (In-Land)

Comments: Spalling, Loose Concrete

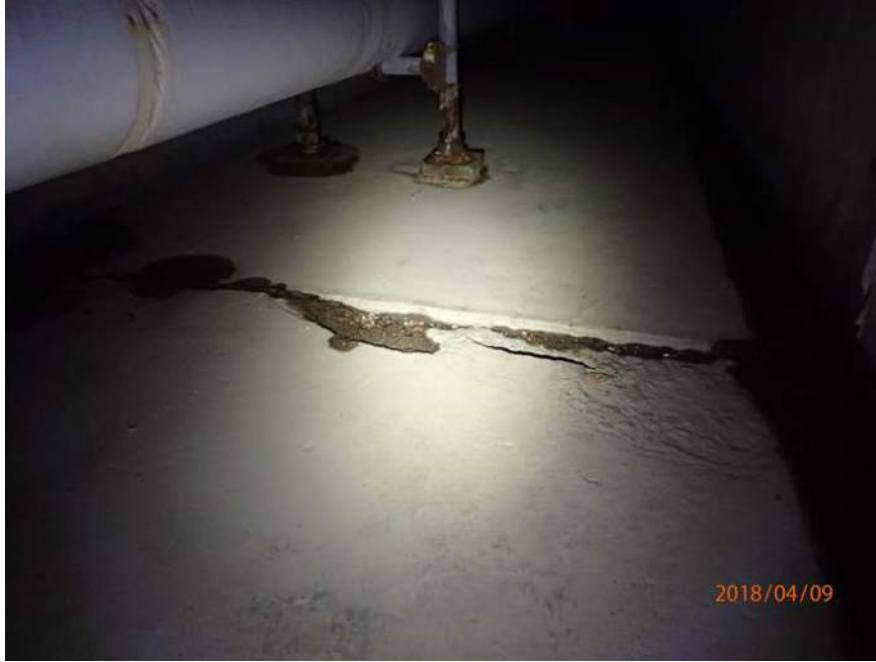
Station 13+70

Direction: Tunnel Floor

Comments: Floor Slab Raised at Joint, Cracking, Loose Concrete

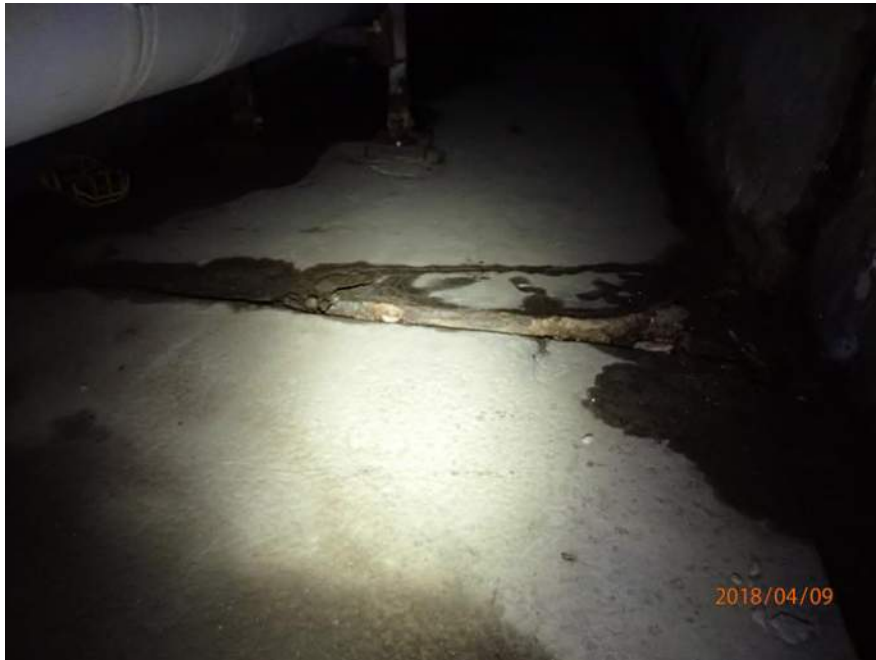
Station 14+30

Direction: Tunnel Floor

Comments: Floor Slab Raised at Joint, Cracking, Loose Concrete

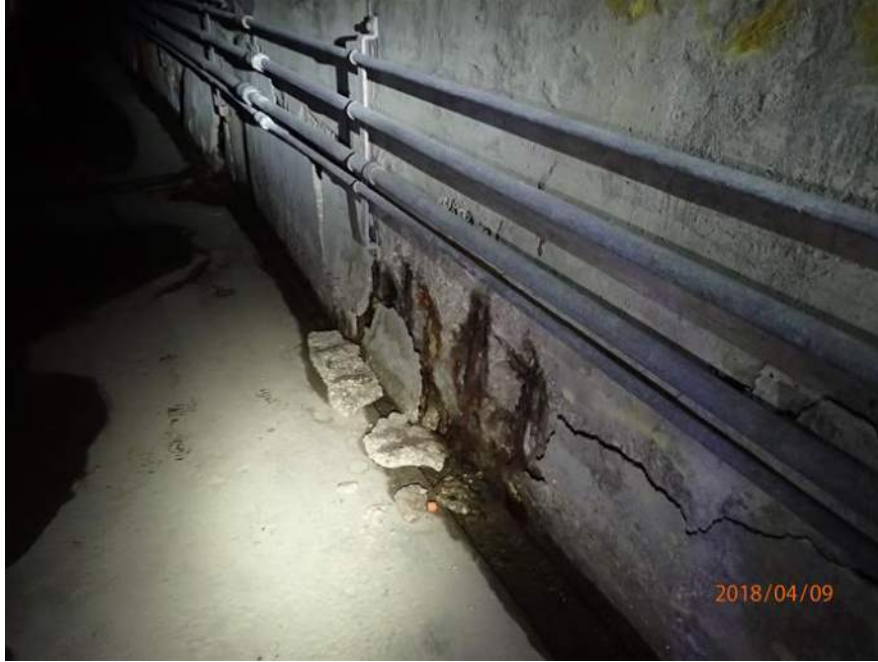
Station 14+24 to 15+00

Direction: Western Wall (In-Land)

Comments: Concrete Spalling, Re-Bar Exposed and Corroded

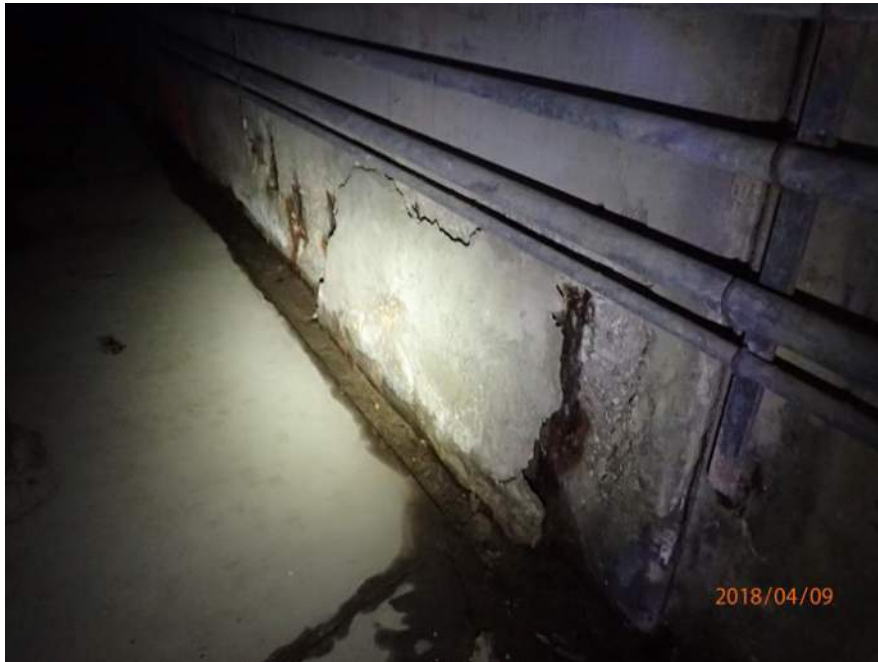
Station 14+24 to 15+00

Direction: Western Wall (In-Land)

Comments: Spalling, Re-Bar Exposed and Corroded, Loose Concrete

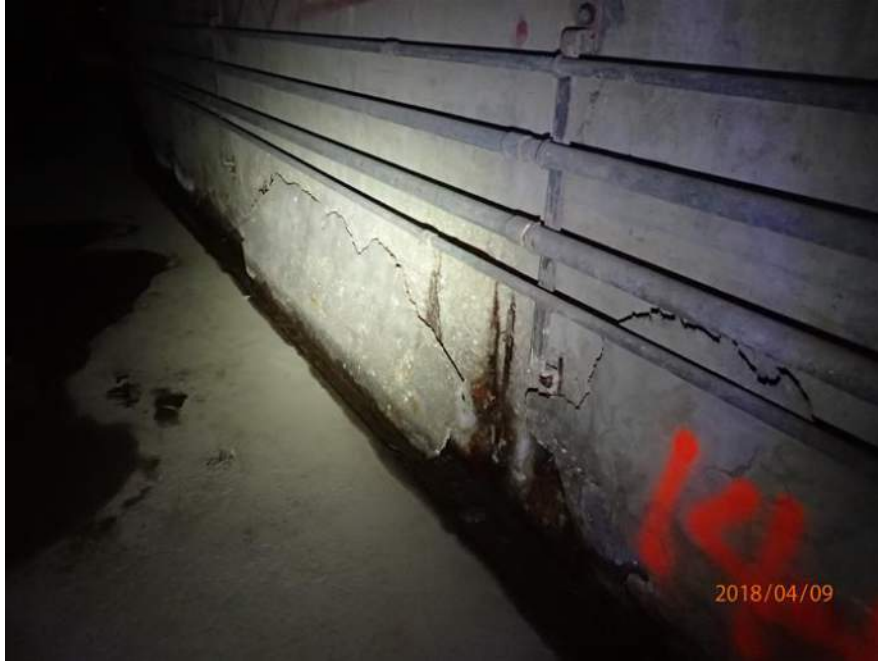
Station 14+24 to 15+00

Direction: Western Wall (In-Land)

Comments: Spalling, Re-Bar Exposed and Corroded

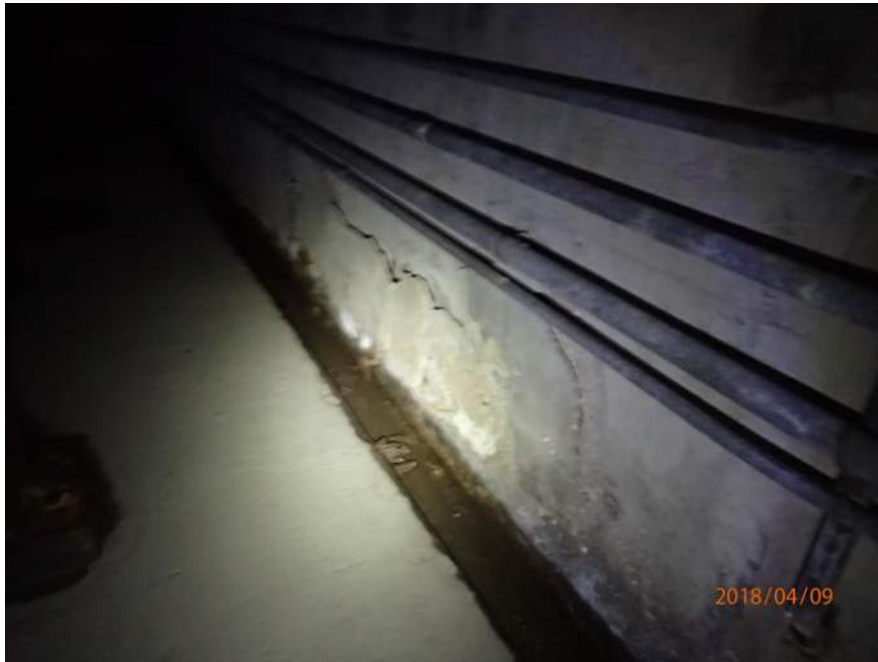
Station 14+24 to 15+00

Direction: Western Wall (In-Land)

Comments: Spalling, Re-Bar Exposed and Corroded

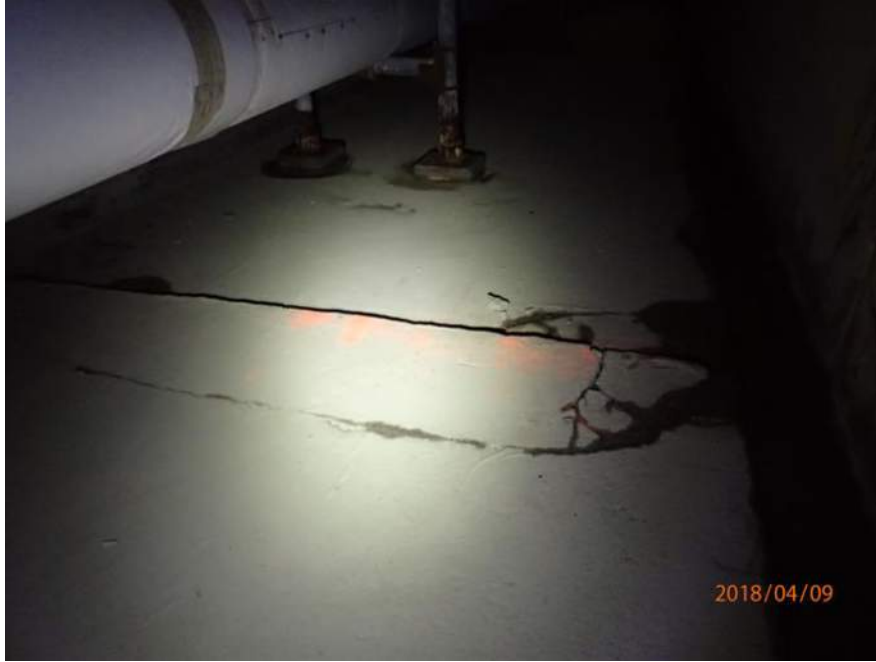
Station 15+00

Direction: Tunnel Floor

Comments: Floor Slab Raised at Joint, Cracking, Loose Concrete

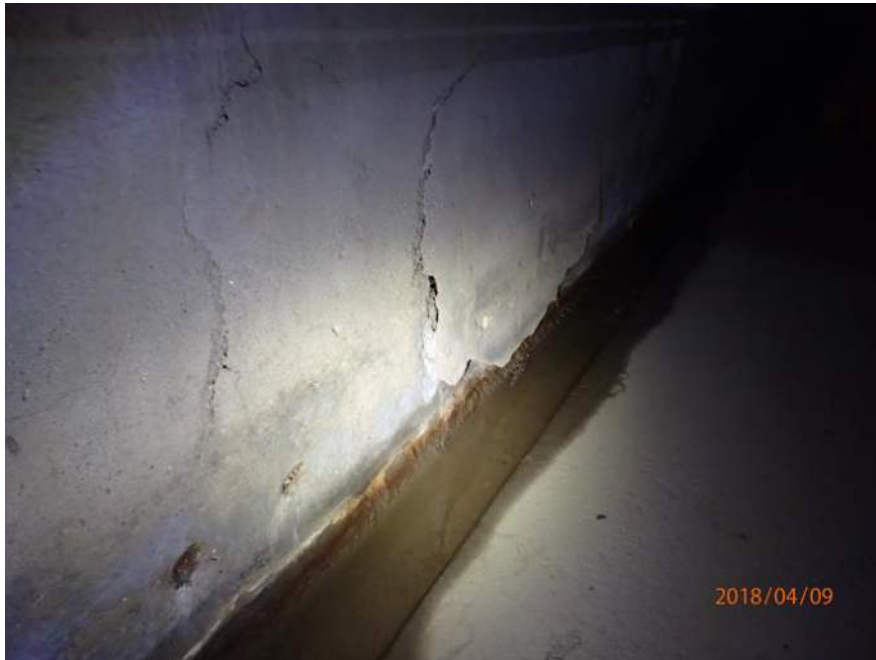
Station 15+09 to 15+20

Direction: Western Wall (In-Land)

Comments: Concrete Spalling

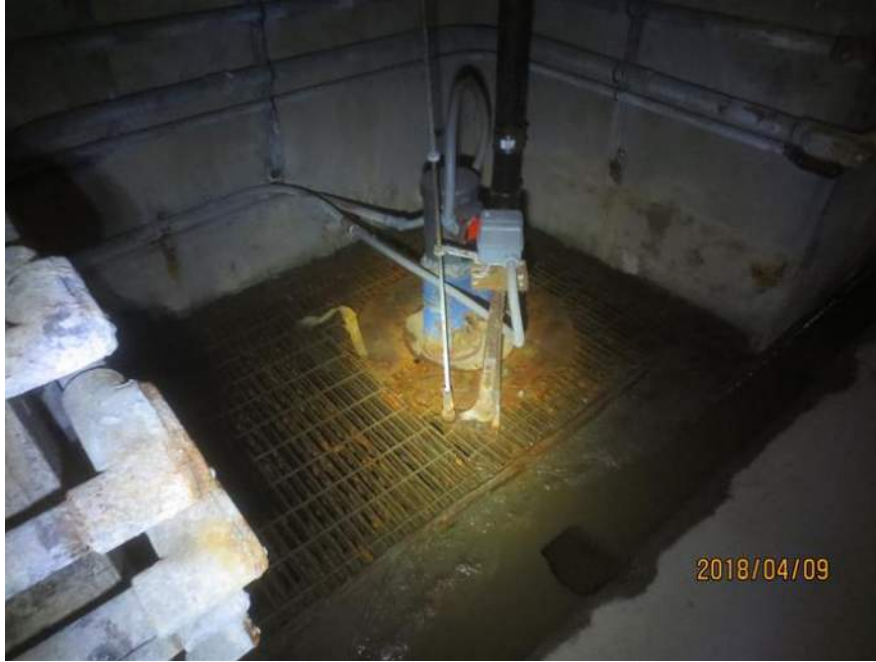
Station 15+22

Direction: Tunnel Floor

Comments: Sump Pump - Not Working

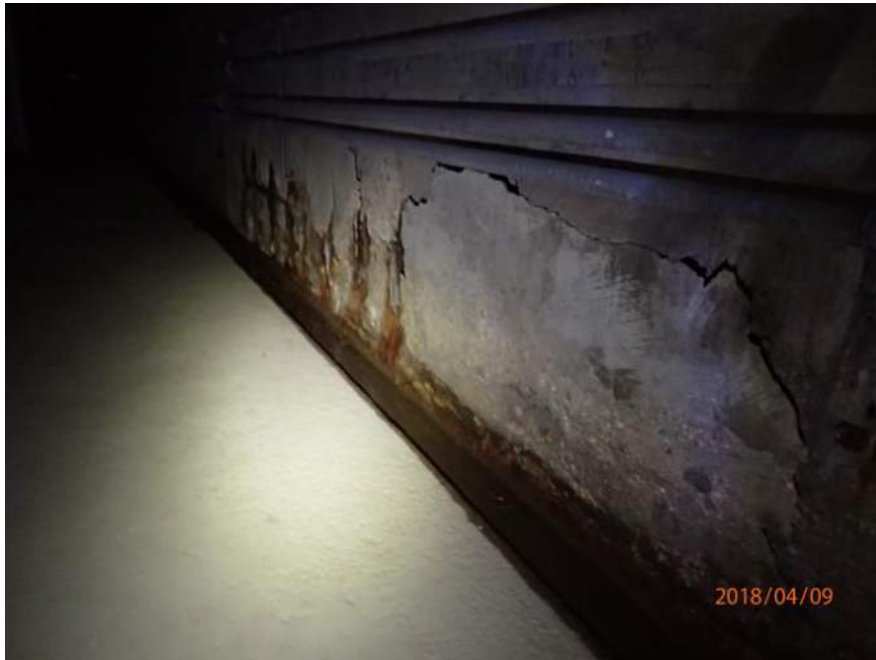
Station 15+50 to 15+75

Direction: Western Wall (In-Land)

Comments: Spalling, Re-Bar Exposed and Corroded
