CONDITIONS REPORT & CONCEPTUAL DESIGN MEMORANDUM

STEAM TUNNEL ASSESSMENT

ROOSEVELT ISLAND, NEW YORK

17 November 2014
Revised 28 December 2018
Revised 18 September 2020
Project # 100444601

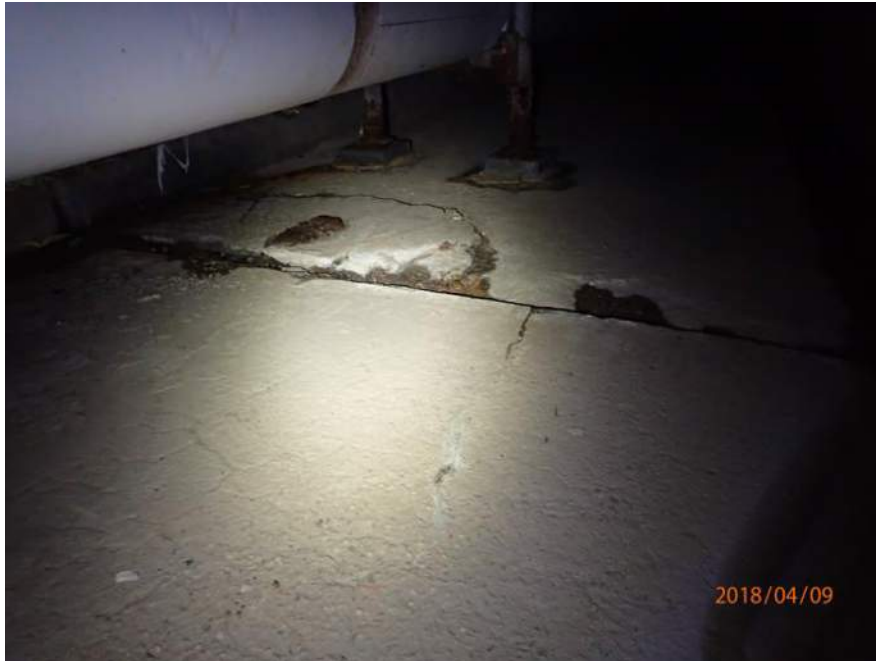
Station 15+75

Direction: Tunnel Floor

Comments: Floor Slab Raised at Joint, Cracking, Loose Concrete

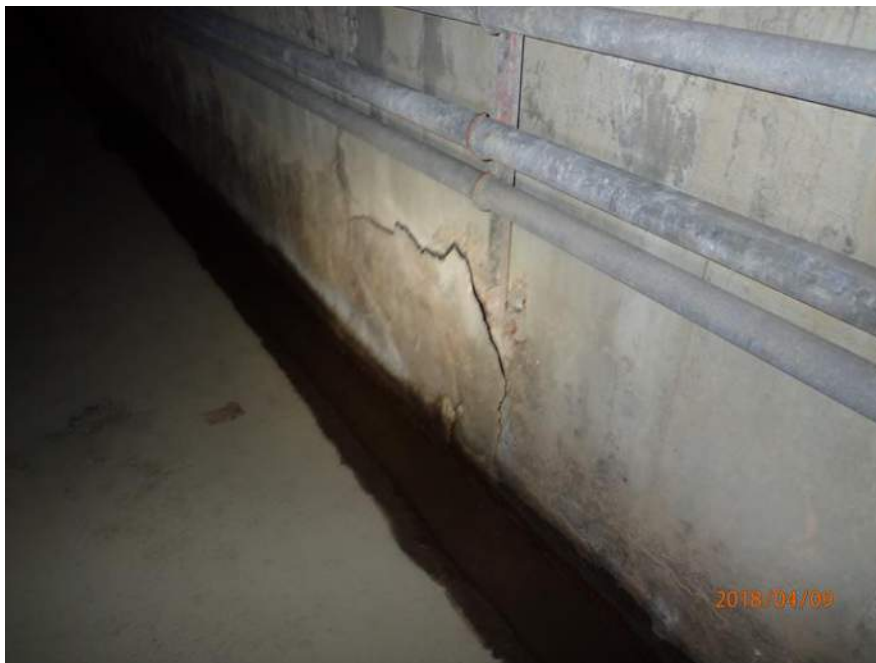
Station 15+88 to 16+00

Direction: Western Wall (In-Land)

Comments: Concrete Spalling

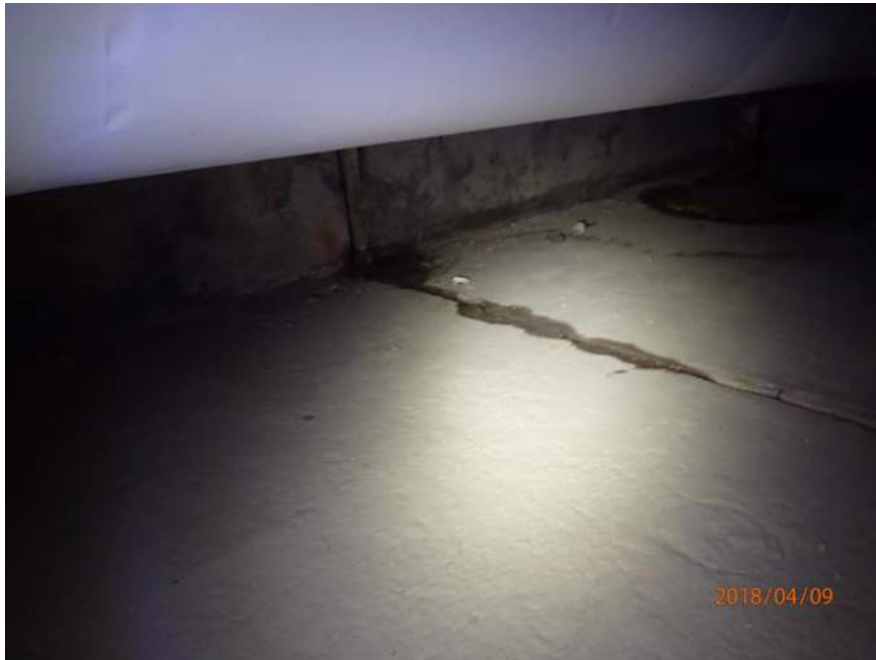
Station 16+95

Direction: Tunnel Joint

Comments: Leaking at Seawall

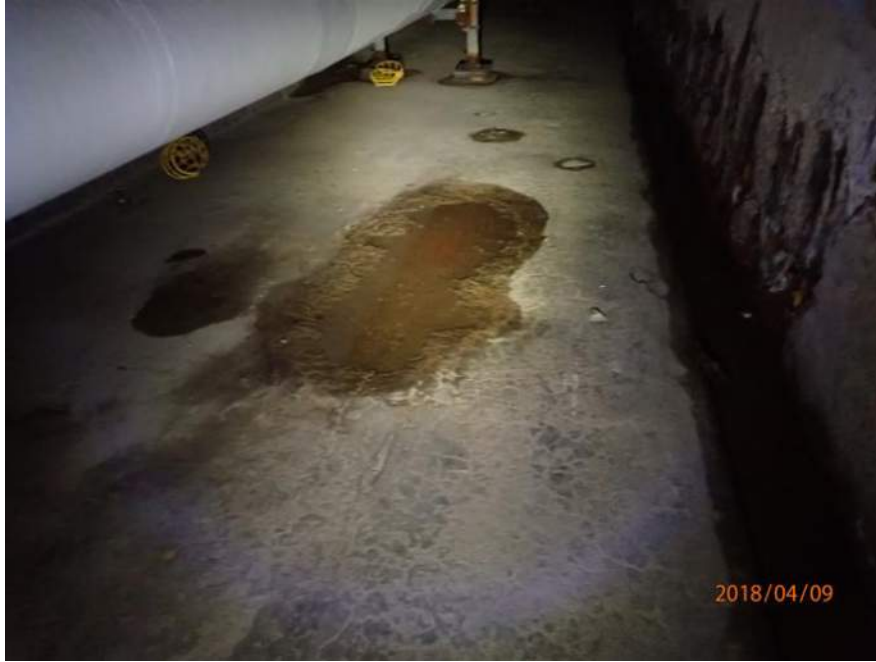
Station 17+35

Direction: Tunnel Floor

Comments: Concrete Spalling

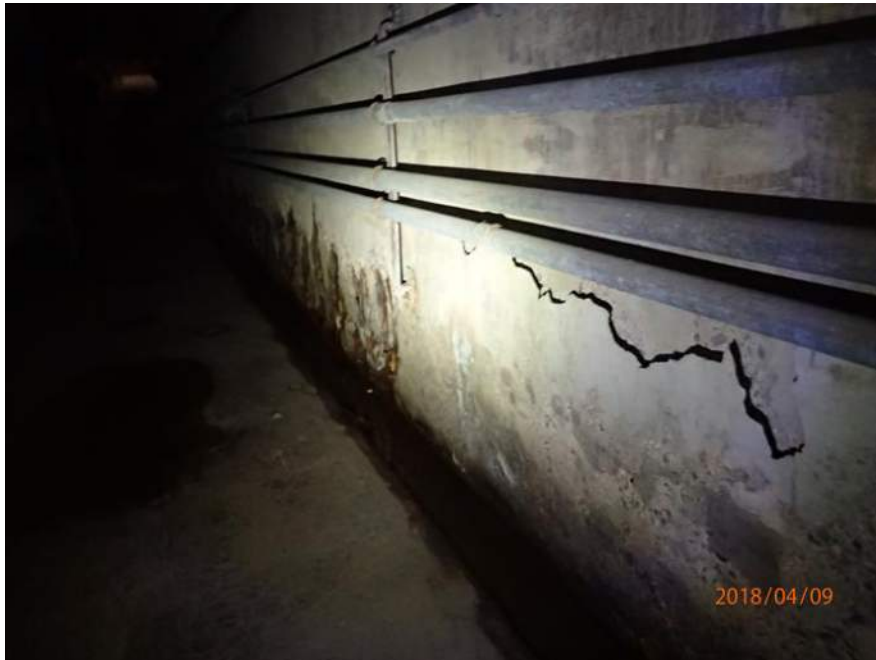
Station 17+10 to 17+61

Direction: Western Wall (In-Land)

Comments: Spalling, Re-Bar Exposed and Corroded

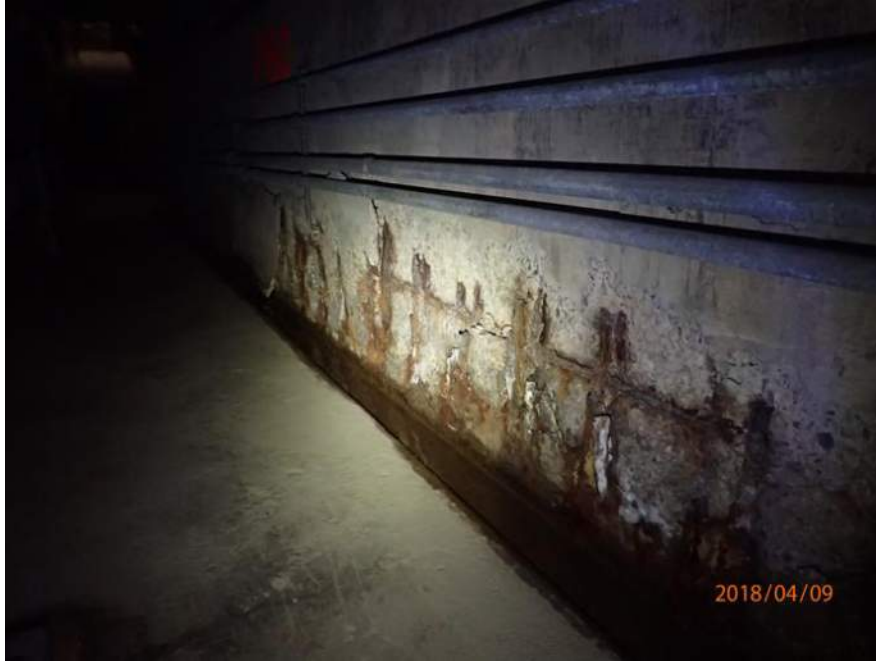
Station 17+10 to 17+61

Direction: Western Wall (In-Land)

Comments: Spalling, Re-Bar Exposed and Corroded

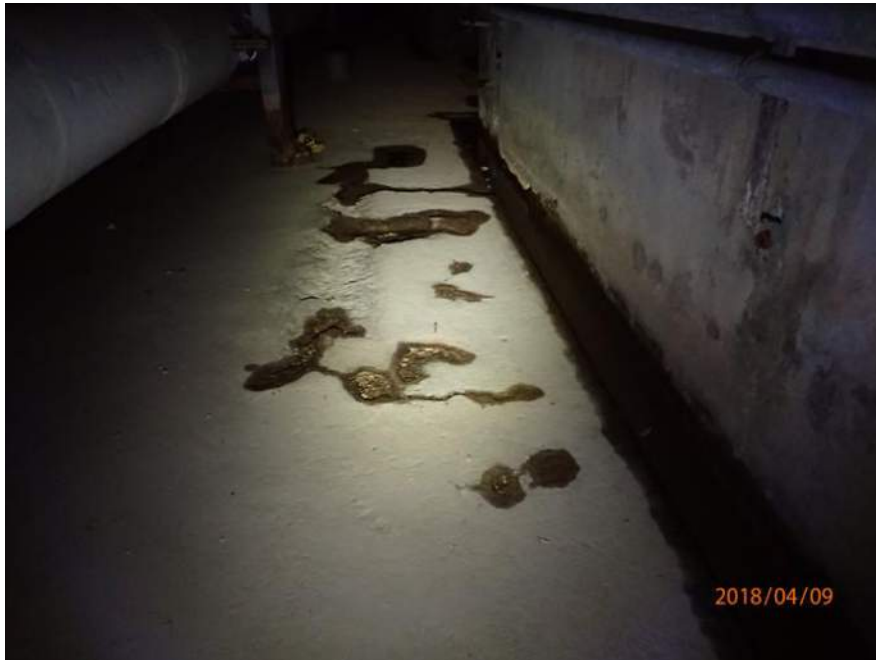
Station 17+70

Direction: Tunnel Floor

Comments: Concrete Spalling

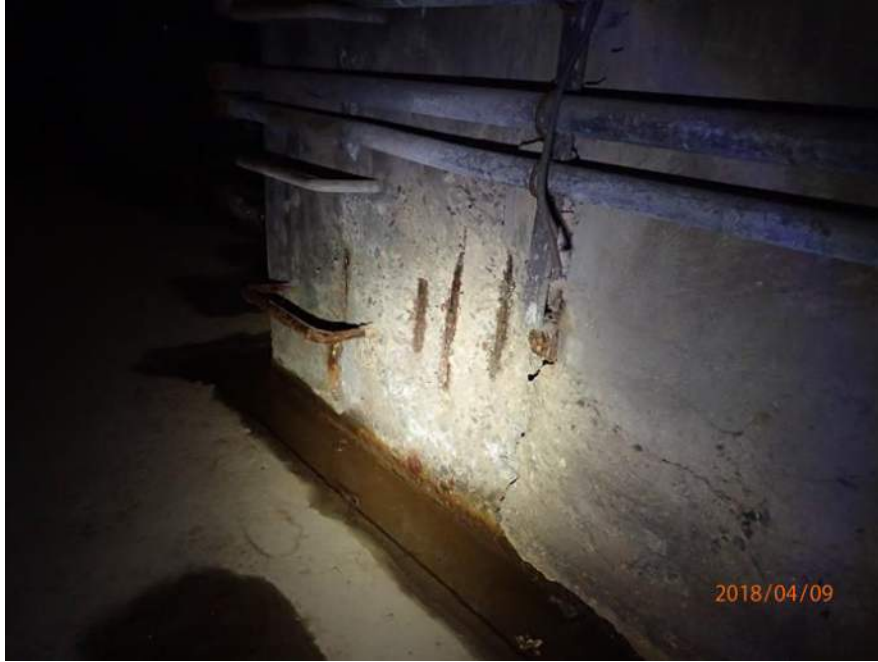
Station 17+68

Direction: Western Wall (In-Land)

Comments: Concrete Spalling

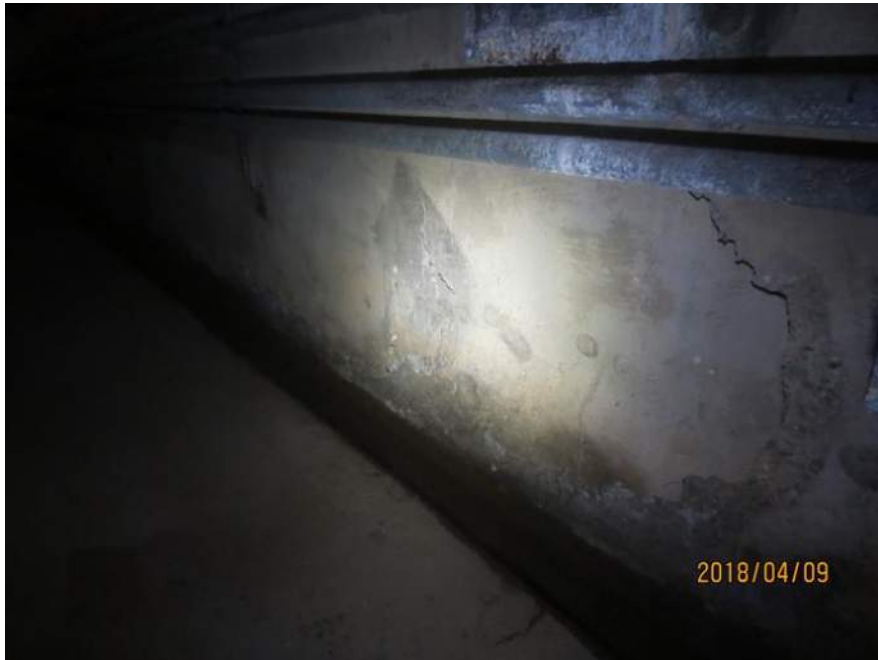
Station 17+68

Direction: Western Wall (In-Land)

Comments: Concrete Spalling

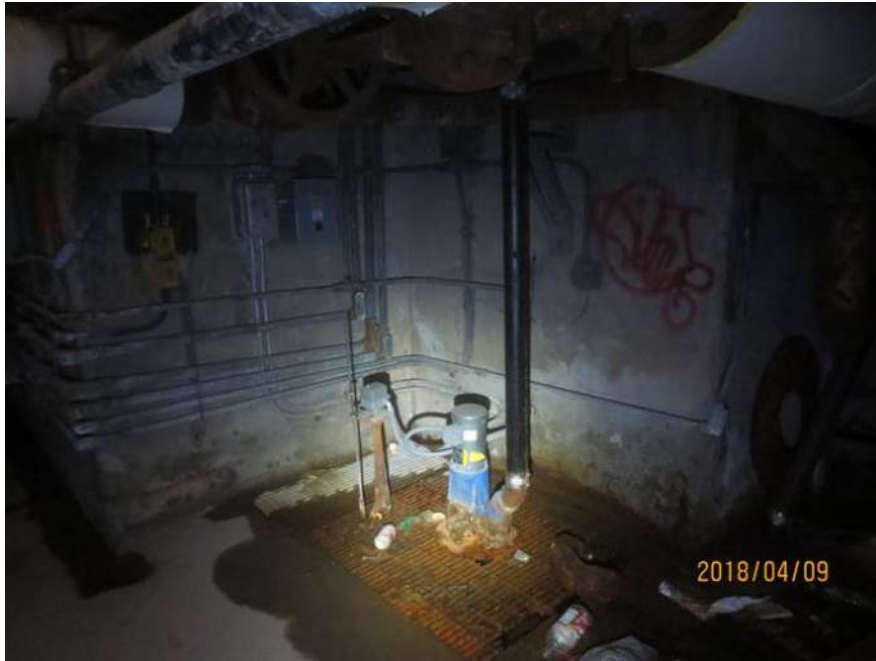
Station 17+76

Direction: Tunnel Floor

Comments: Sump Pump - Not Working

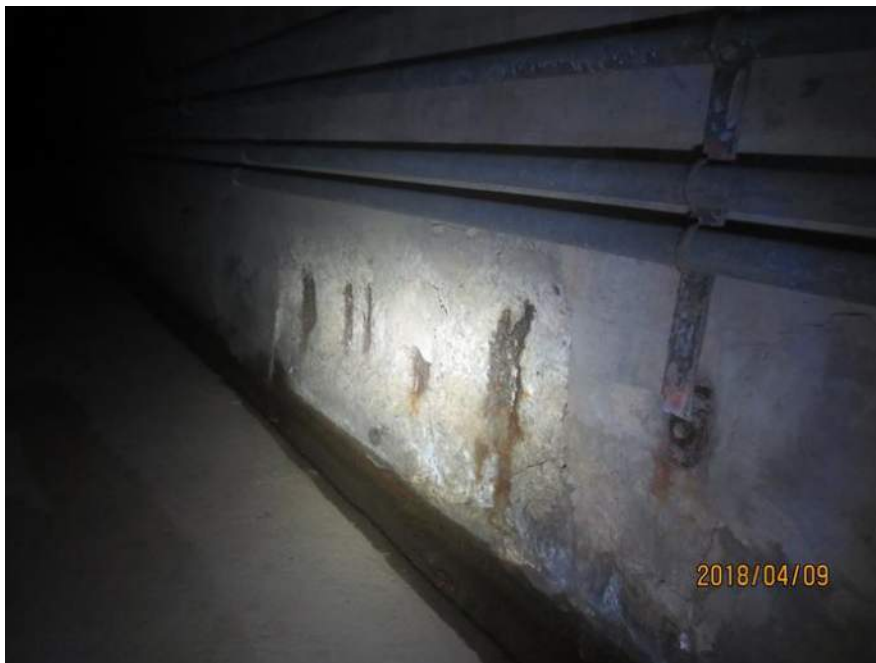
Station 17+85 to 18+10

Direction: Western Wall (In-Land)

Comments: Concrete Spalling, Re-Bar Exposed and Corroded

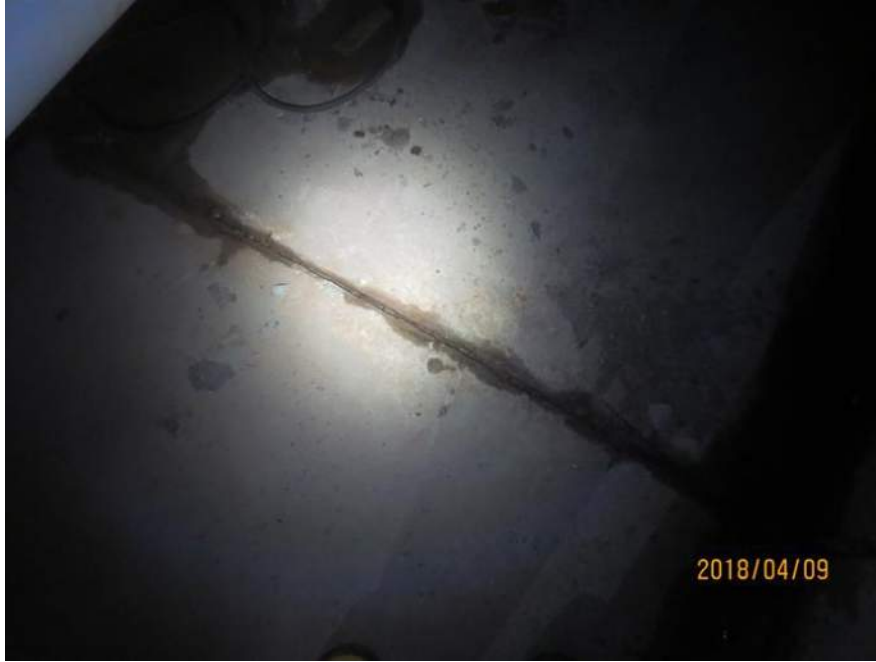
Station 18+20

Direction: Tunnel Floor

Comments: Floor Slab Craking at Joint

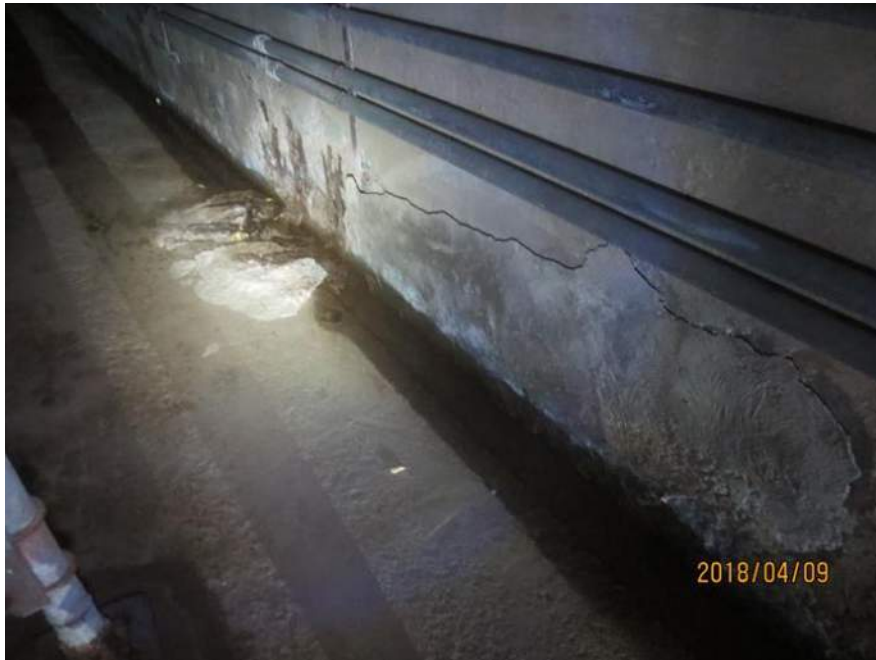
Station 18+30 to 18+50

Direction: Western Wall (In-Land)

Comments: Spalling, Loose Concrete

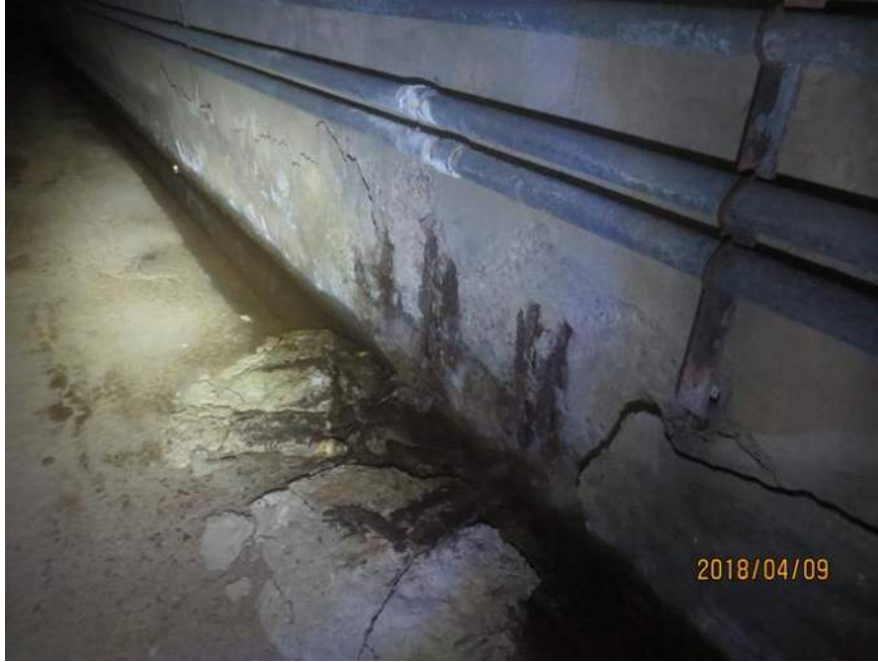
Station 18+80

Direction: Tunnel Floor

Comments: Floor Slab Raised at Joint, Cracking, Loose Concrete

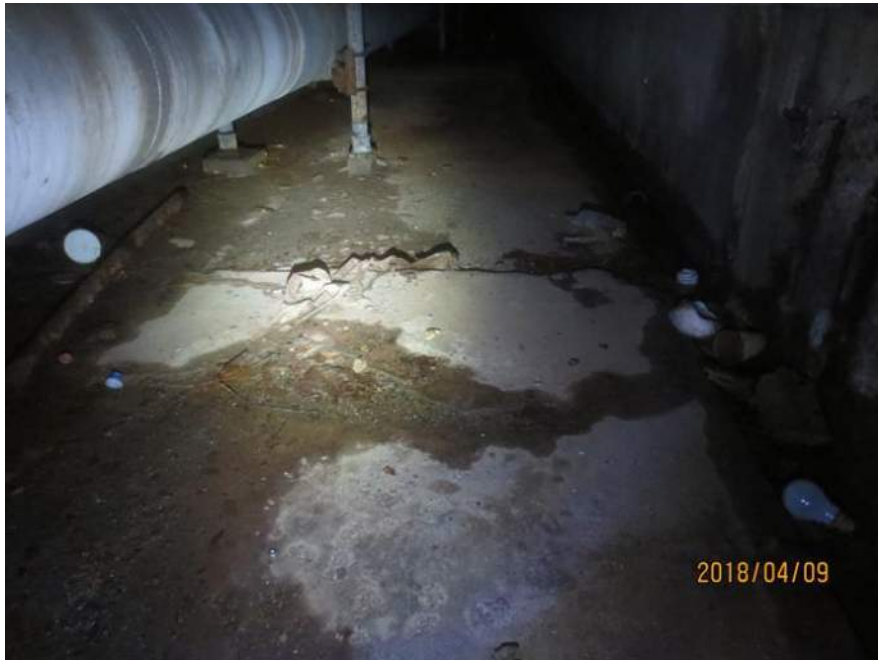
Station 18+75

Direction: Tunnel Floor

Comments: Floor Slab Raised at Joint, Cracking, Loose Concrete

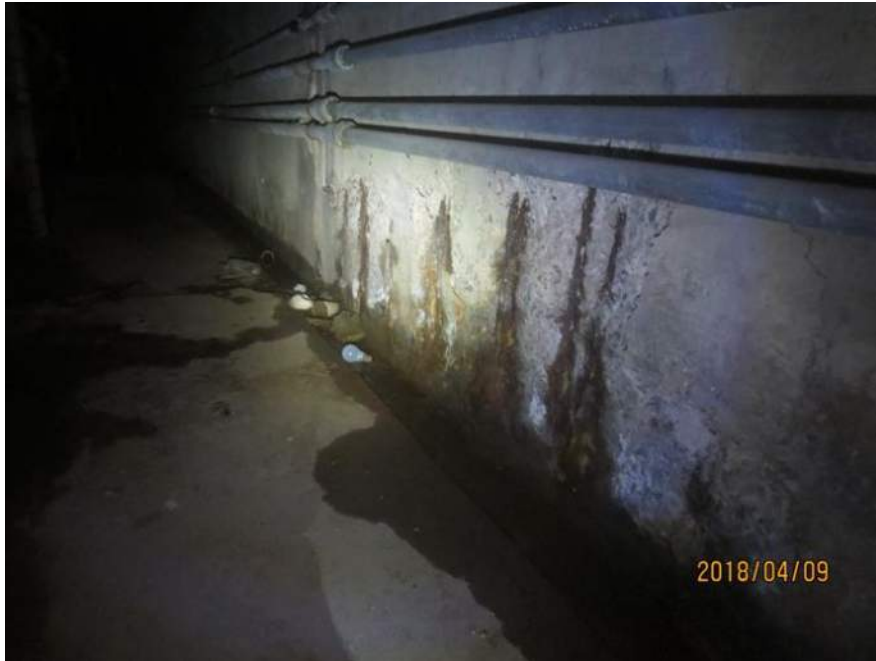
Station 18+75 to 18+80

Direction: Western Wall (In-Land)

Comments: Concrete Spalling and Bowing of Wall, Loose Concrete, Re-Bar Exposed

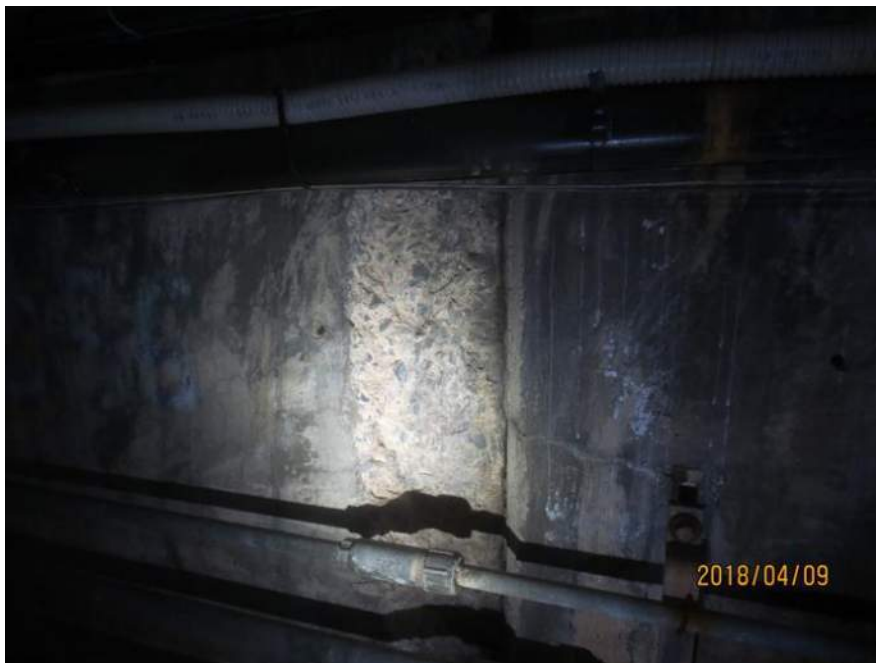
Station 19+45

Comments: Cracking at Joint, Concrete Missing

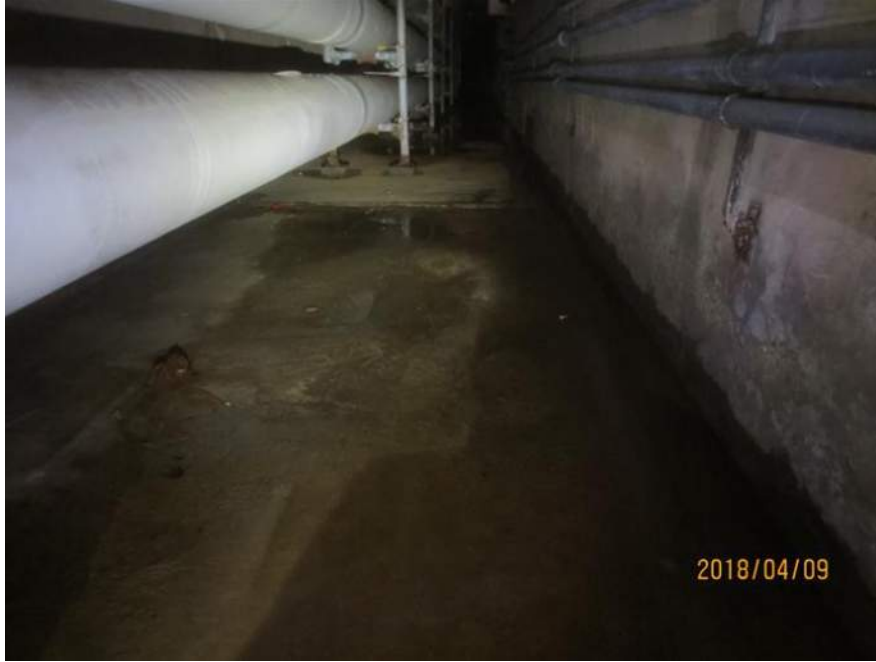
Station 19+50 to 20+00

Comments: Water Observed in the Tunnel

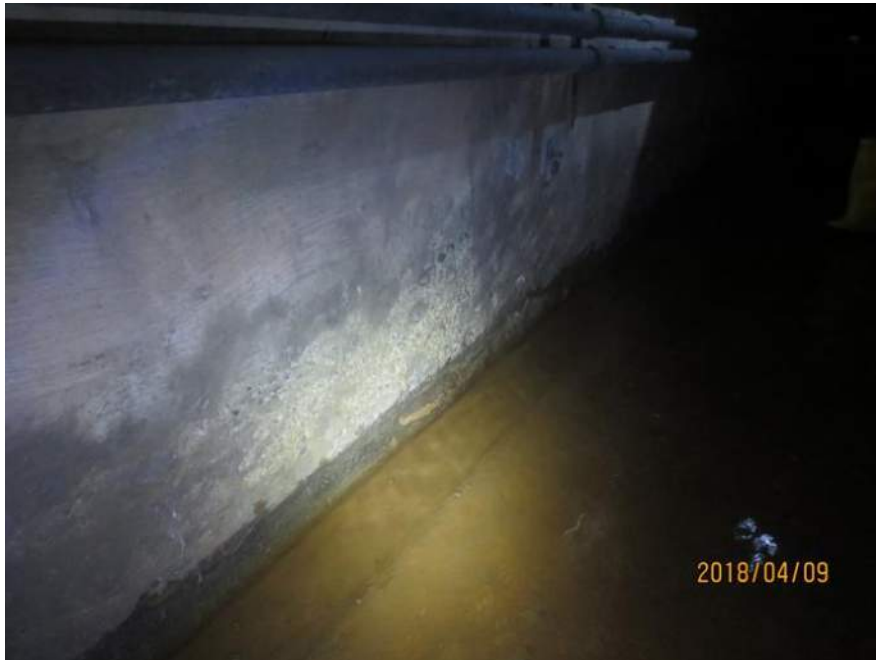
Station 19+90 to 19+72

Comments: Concrete Spalling

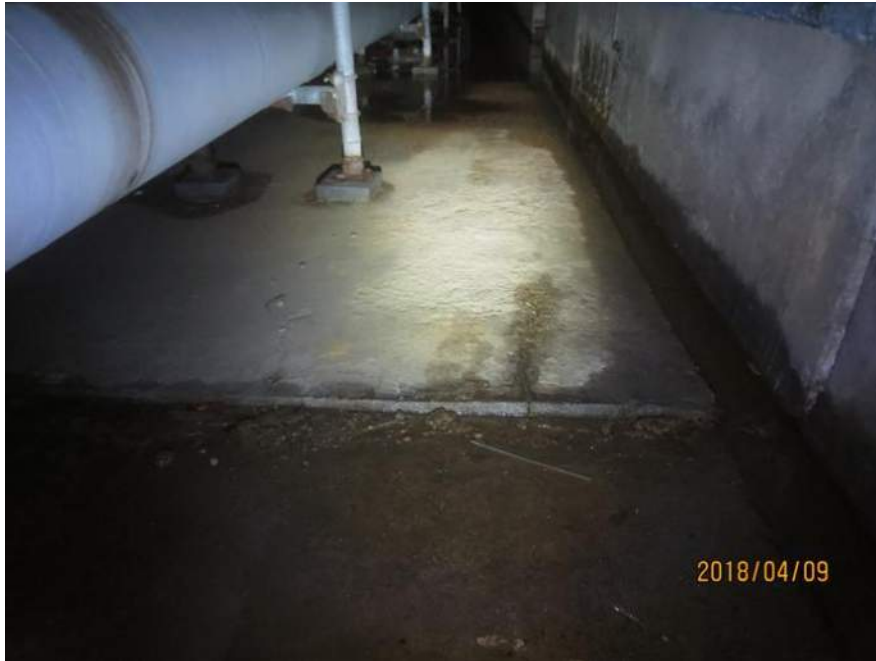
Station 20+10

Comments: Floor Slab Raised at Joint, Cracking, Loose Concrete

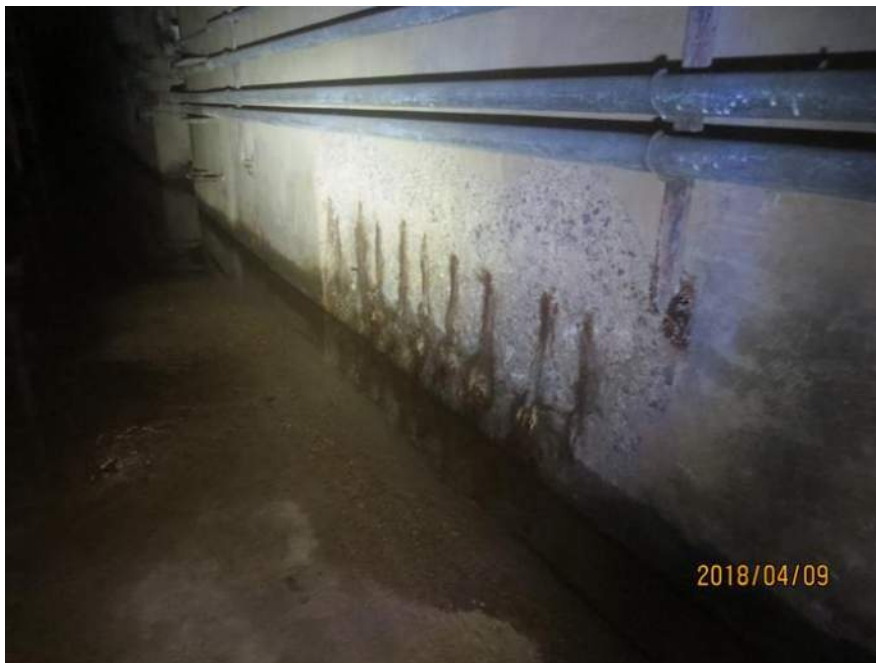
Station 20+15 to 20+22

Comments: Concrete Spalling, Re-Bar Exposed

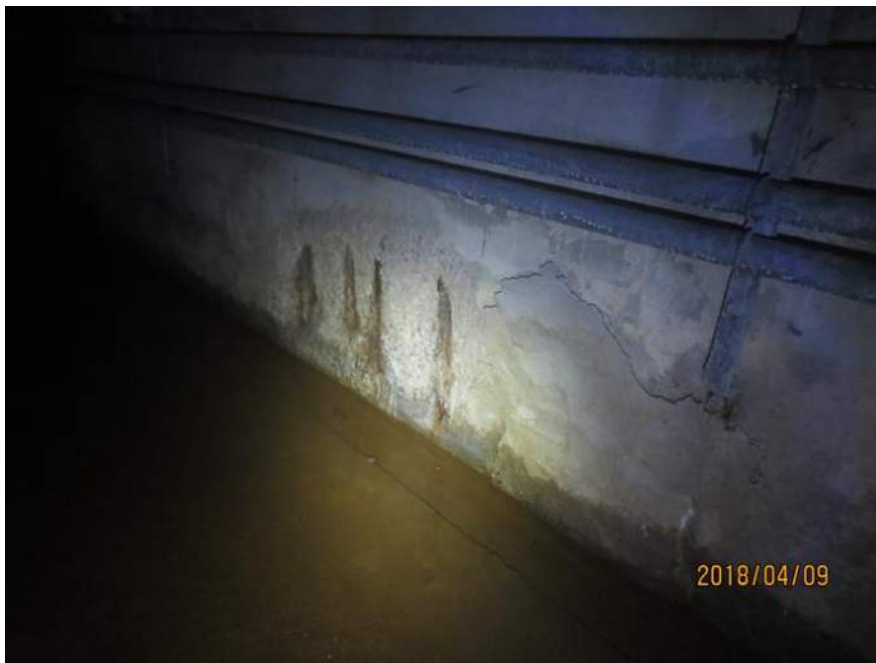
Station 20+74 to 20+80

Comments: Concrete Spalling, Re-Bar Exposed

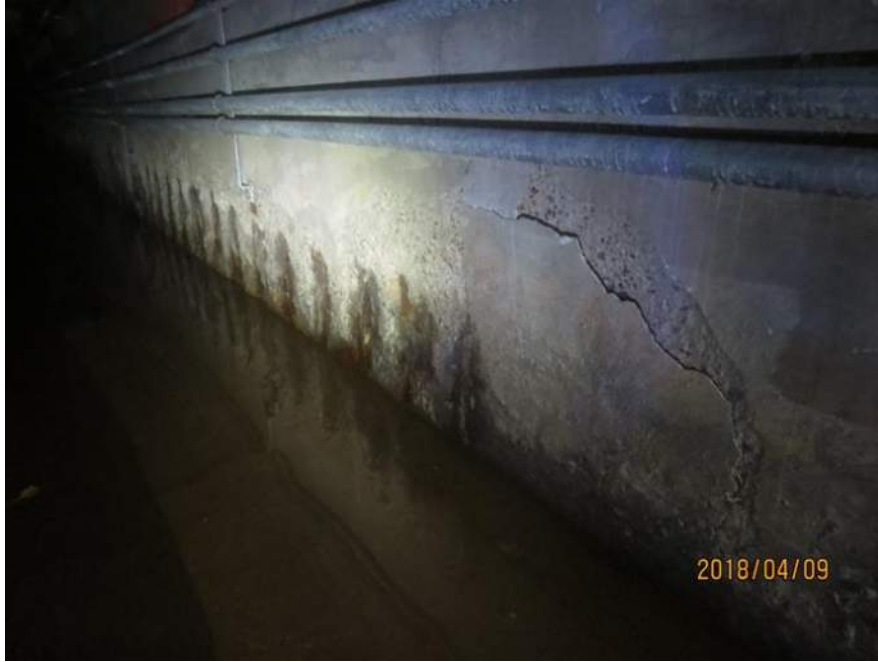
Station 20+90 to 21+30

Comments: Concrete Spalling, Re-Bar Exposed and Corroded

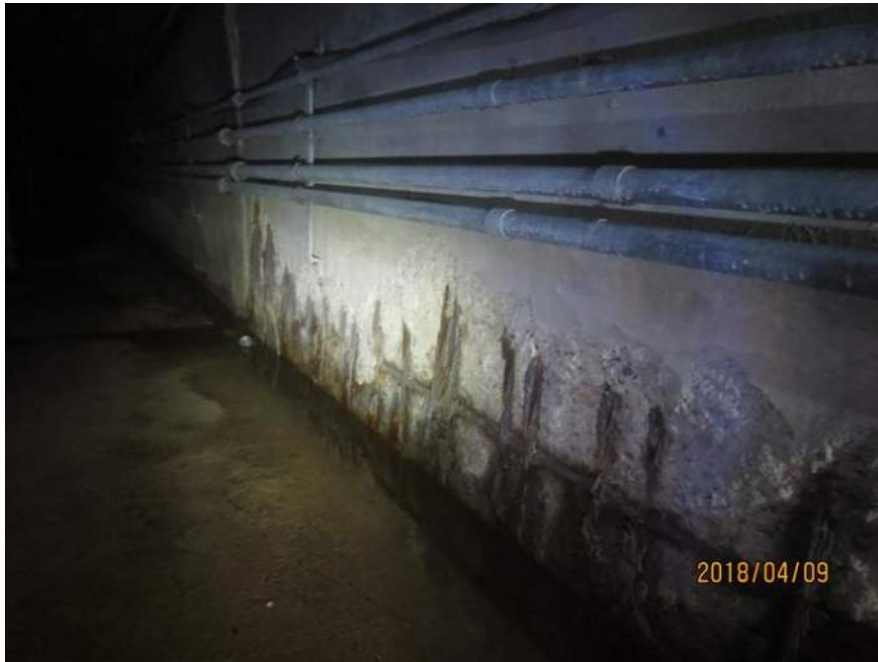
Station 20+90 to 21+30

Comments: Concrete Spalling, Re-Bar Exposed and Corroded

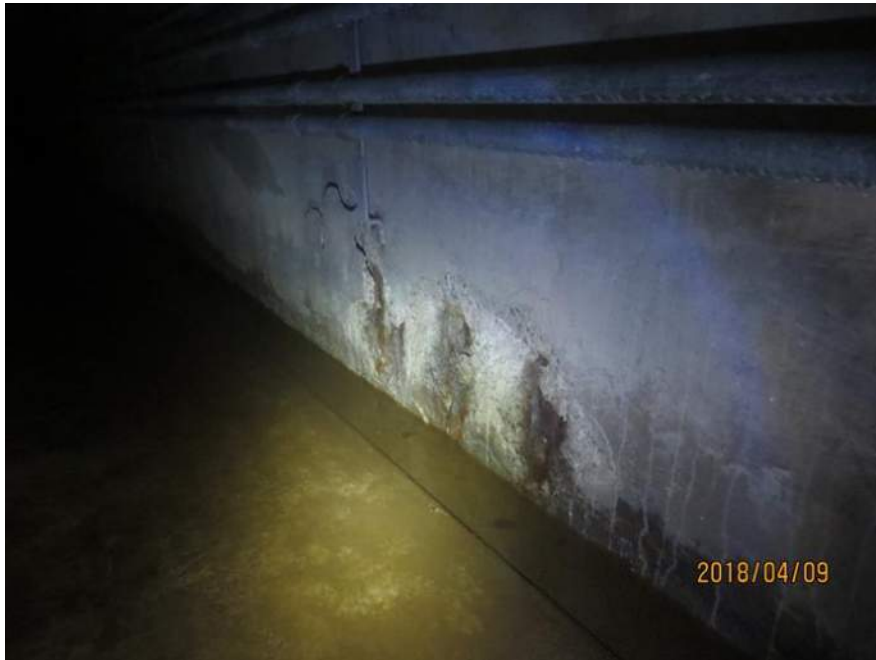
Station 21+68 to 21+75

Comments: Concrete Spalling, Re-Bar Exposed

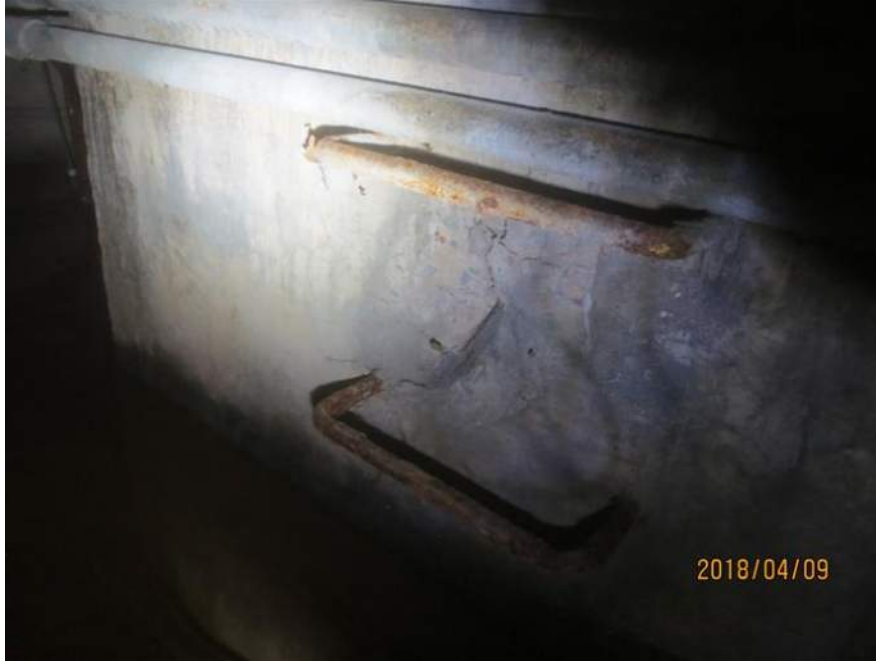
Station 22+70

Comments: Concrete Spalling, Re-Bar Exposed

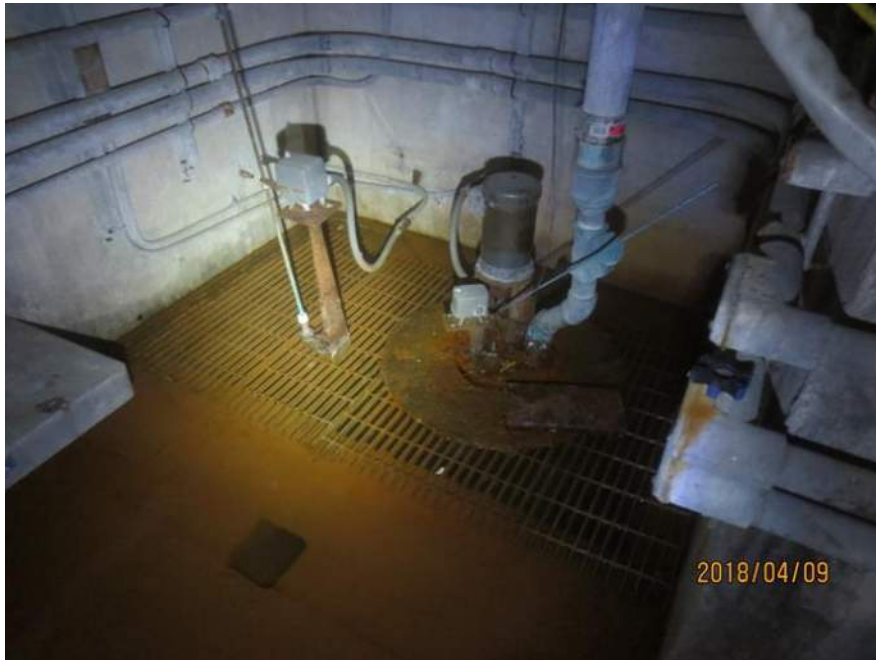
Station 22+84

Comments: Sump Pump - Not Working

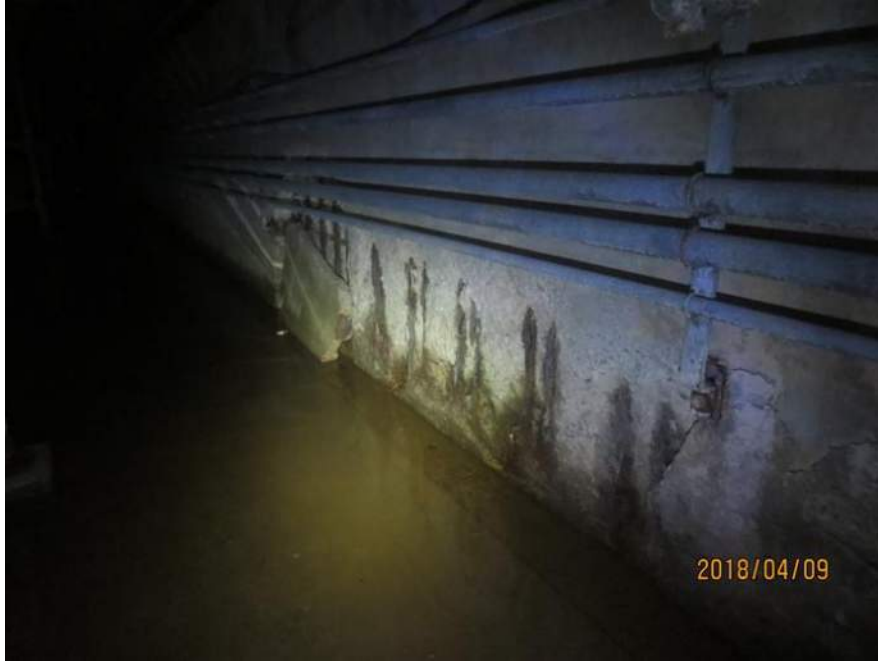
Station 23+44 to 23+63

Comments: Spalling, Re-Bar Exposed and Corroded, Loose Concrete

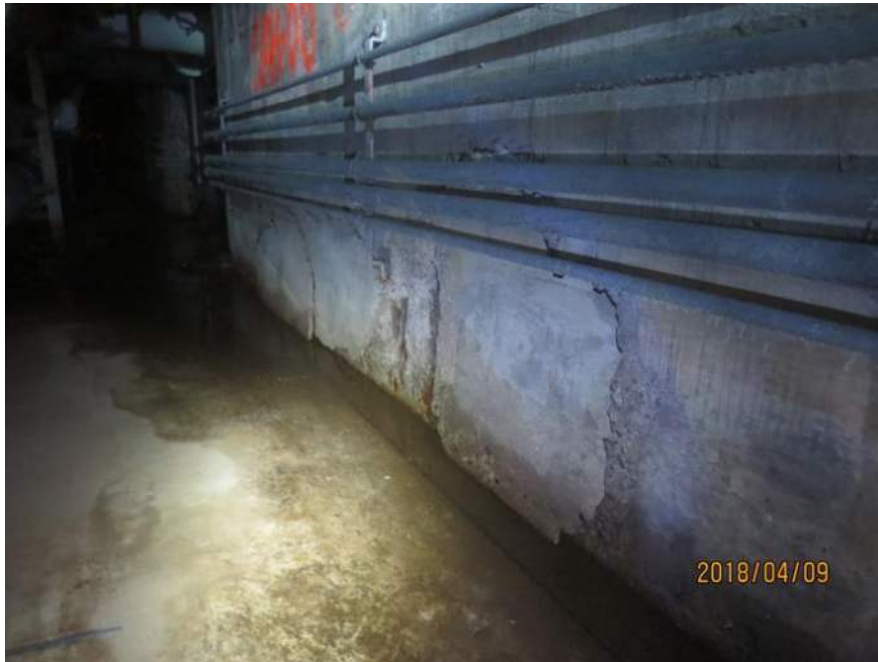
Station 23+90 to 24+03

Comments: Spalling, Loose Concrete

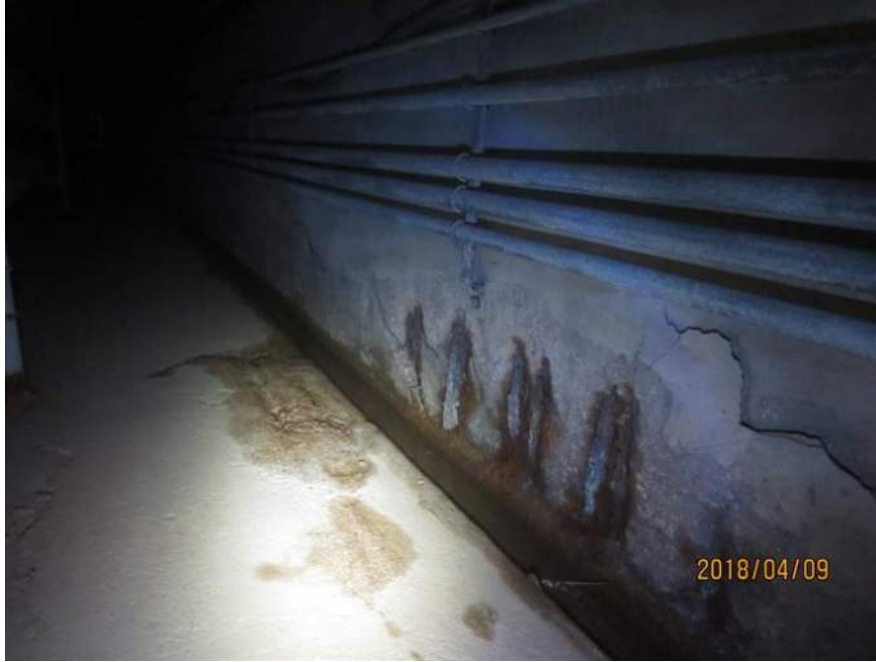
Station 26+03 to 26+20

Comments: Concrete Spalling, Re-Bar Exposed and Corroded

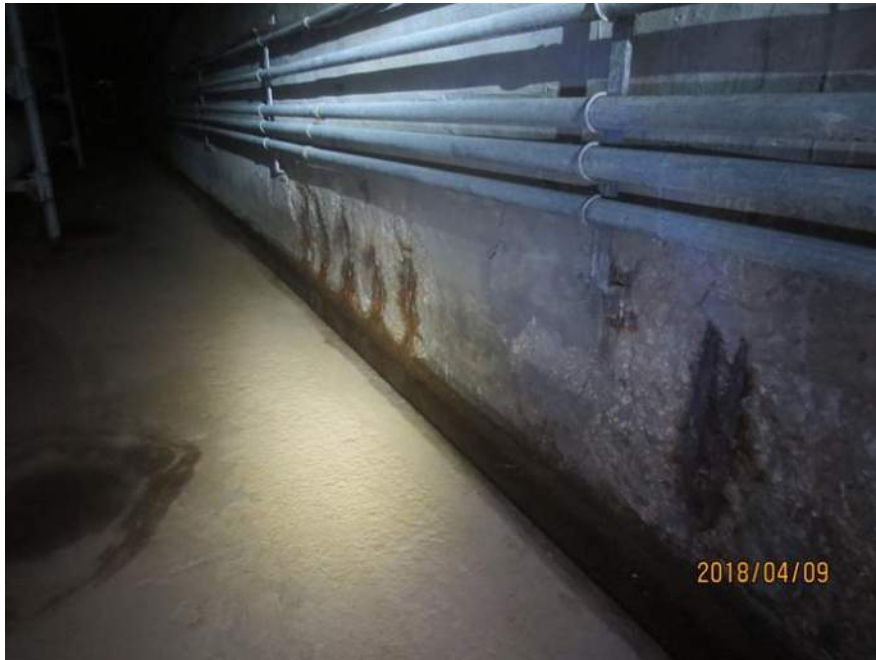
Station 26+50 to 26+62

Comments: Concrete Spalling, Re-Bar Exposed and Corroded

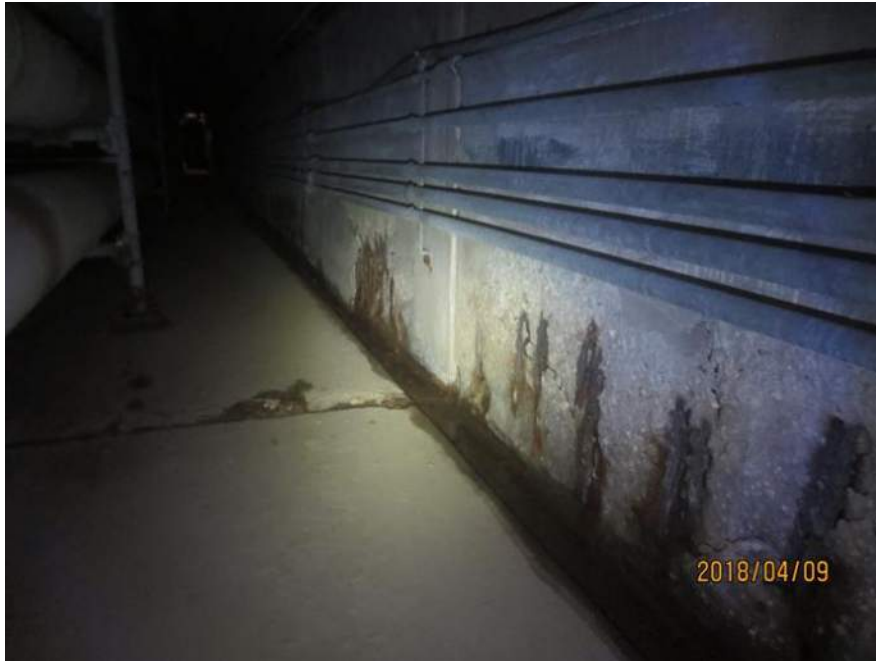
Station 26+90 to 27+25

Comments: Concrete Spalling, Re-Bar Exposed and Corroded

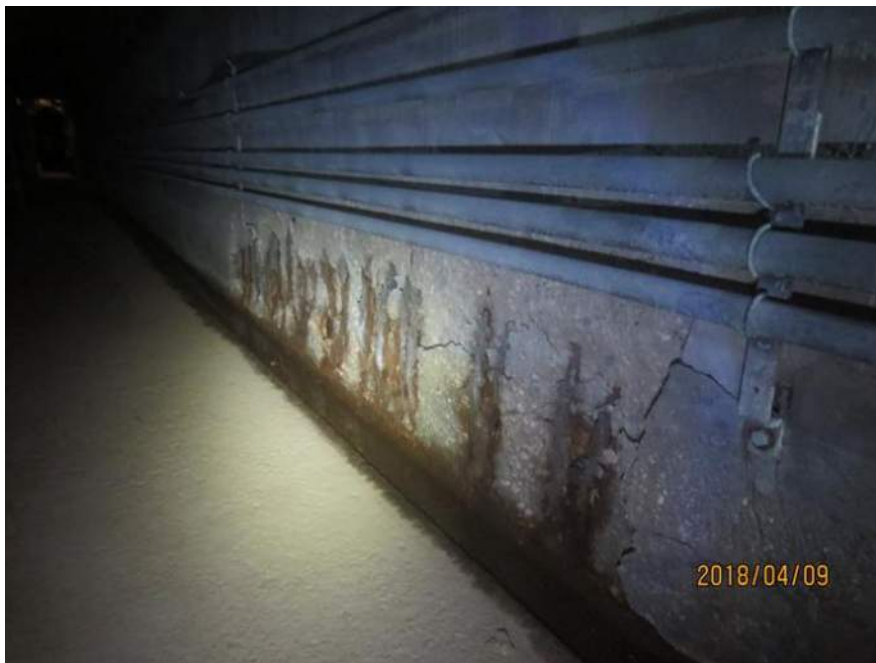
Station 27+25

Comments: Concrete Spalling, Re-Bar Exposed and Corroded

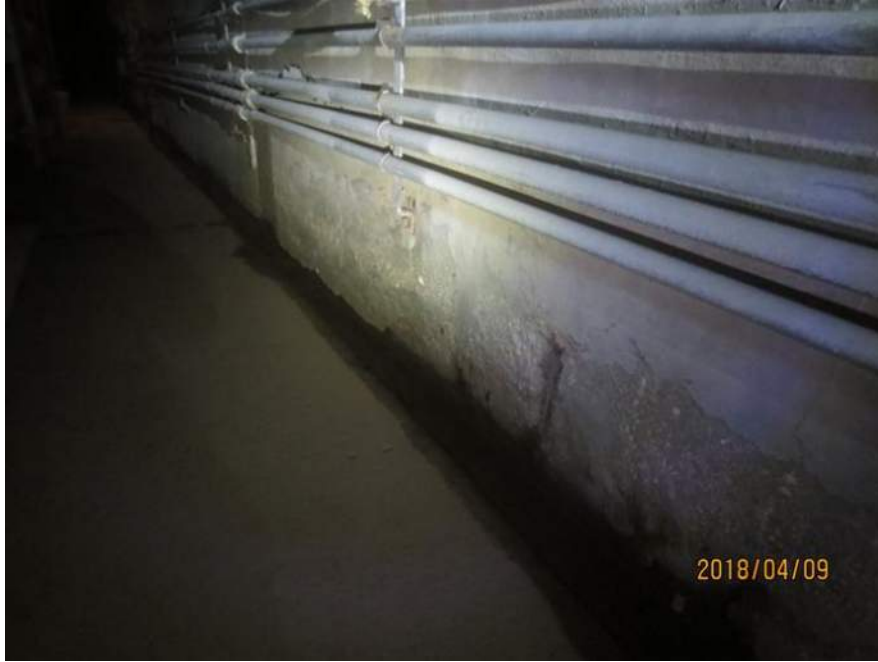
Station 27+51 to 27+69

Comments: Concrete Spalling

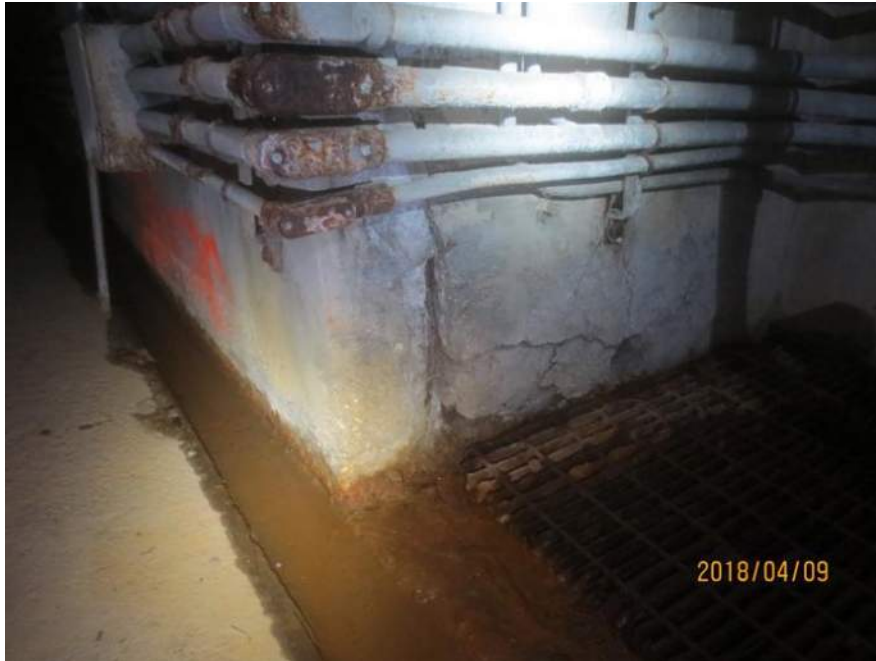
Station 27+94

Comments: Concrete Spalling

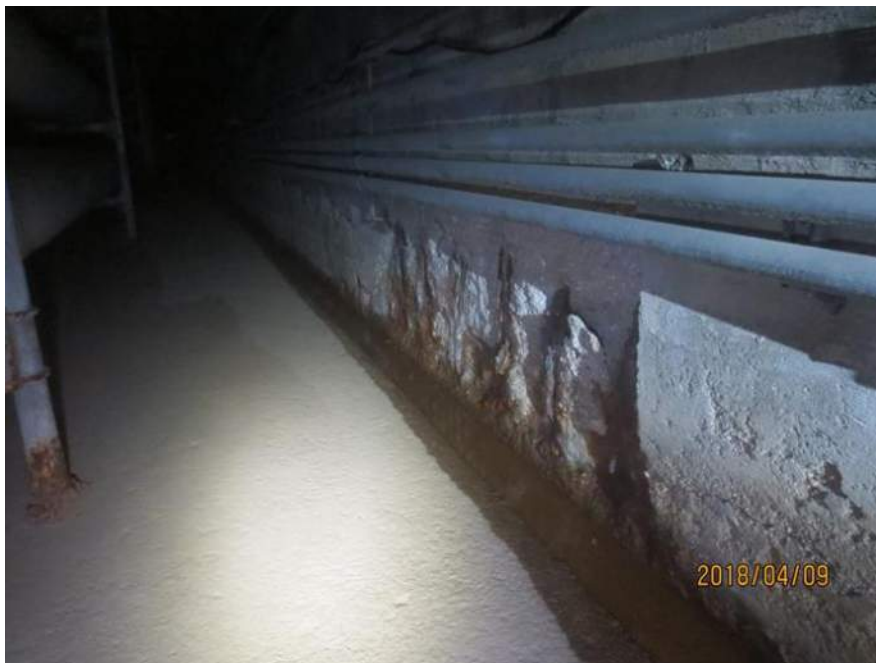
Station 28+02 to 28+27

Comments: Concrete Spalling, Re-Bar Exposed and Corroded

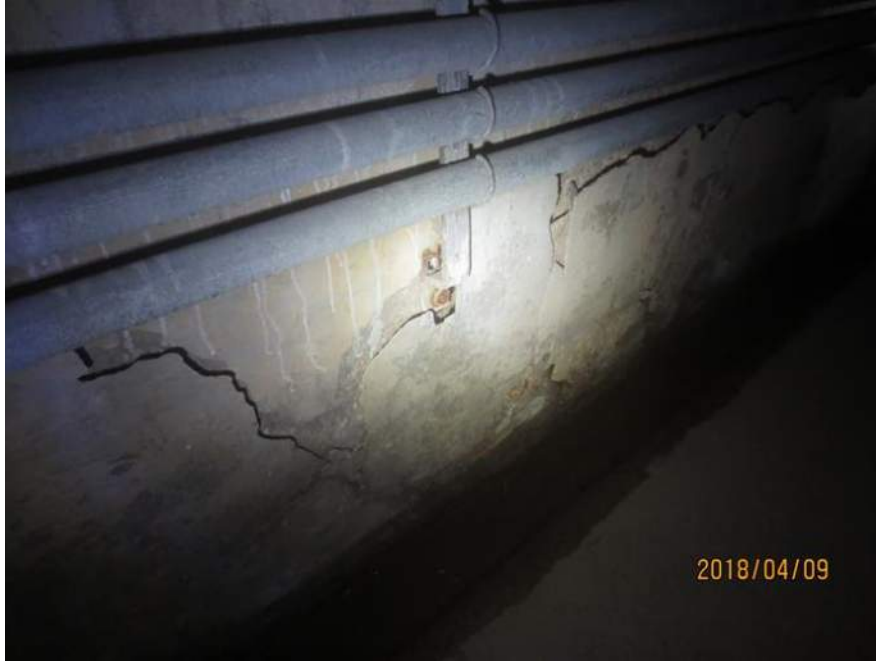
Station 28+62 to 28+86

Comments: Spalling, Re-Bar Exposed and Corroded, Loose Concrete

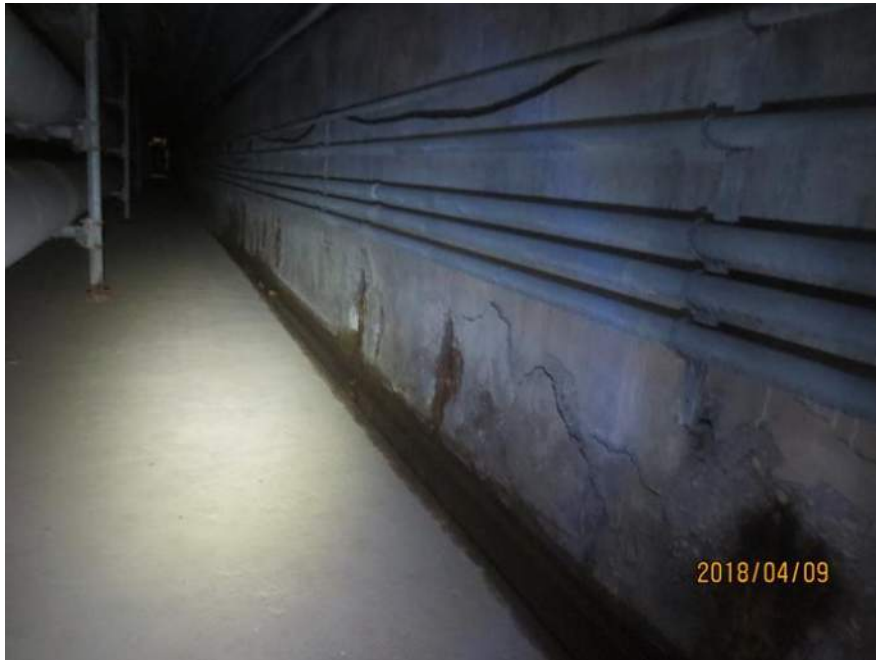
Station 28+94 to 29+32

Comments: Concrete Spalling, Re-Bar Exposed and Corroded
