CONDITIONS REPORT & CONCEPTUAL DESIGN MEMORANDUM

STEAM TUNNEL ASSESSMENT

ROOSEVELT ISLAND, NEW YORK

17 November 2014
Revised 28 December 2018
Revised 18 September 2020
Project # 100444601

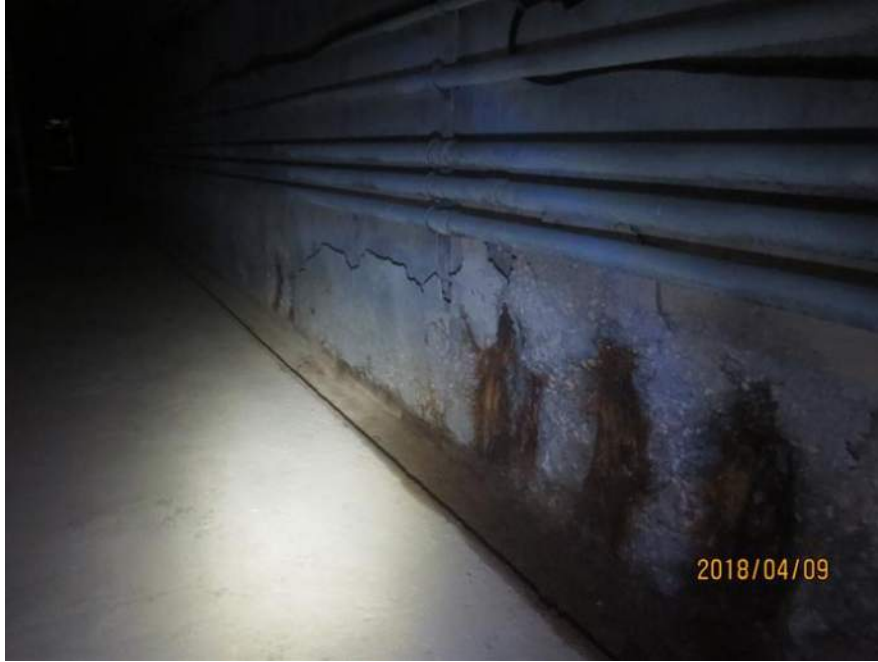
Station 29+45 to 29+70

Comments: Spalling, Re-Bar Exposed and Corroded, Loose Concrete

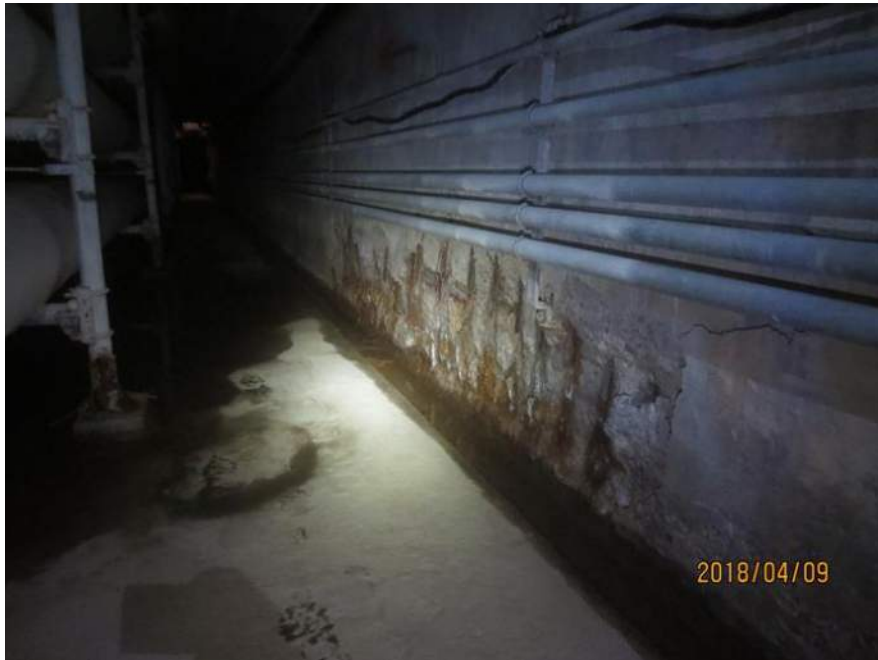
Station 29+76 to 29+96

Comments: Concrete Spalling, Re-Bar Exposed and Corroded

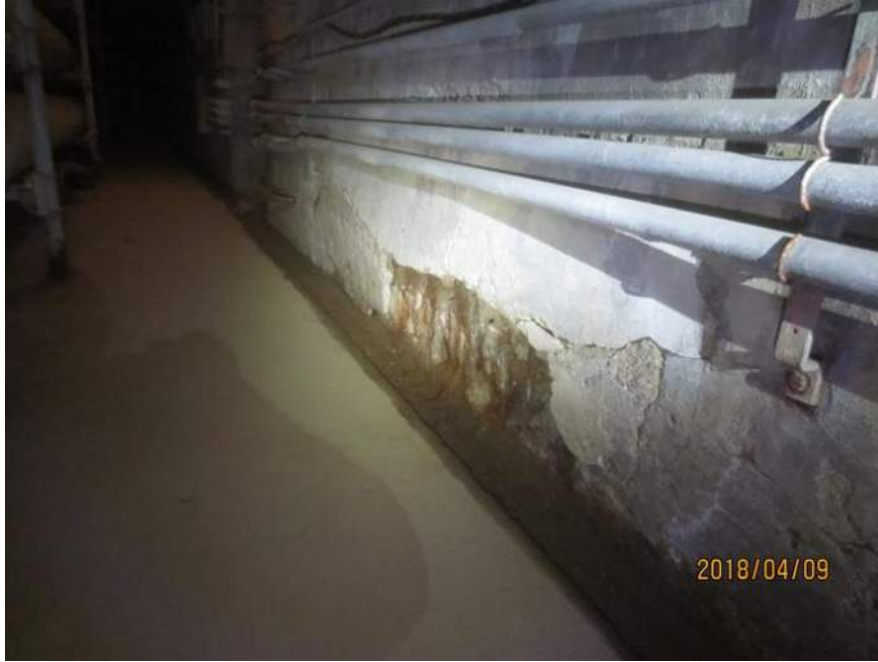
Station 30+31 to 30+41

Comments: Concrete Spalling, Re-Bar Exposed and Corroded

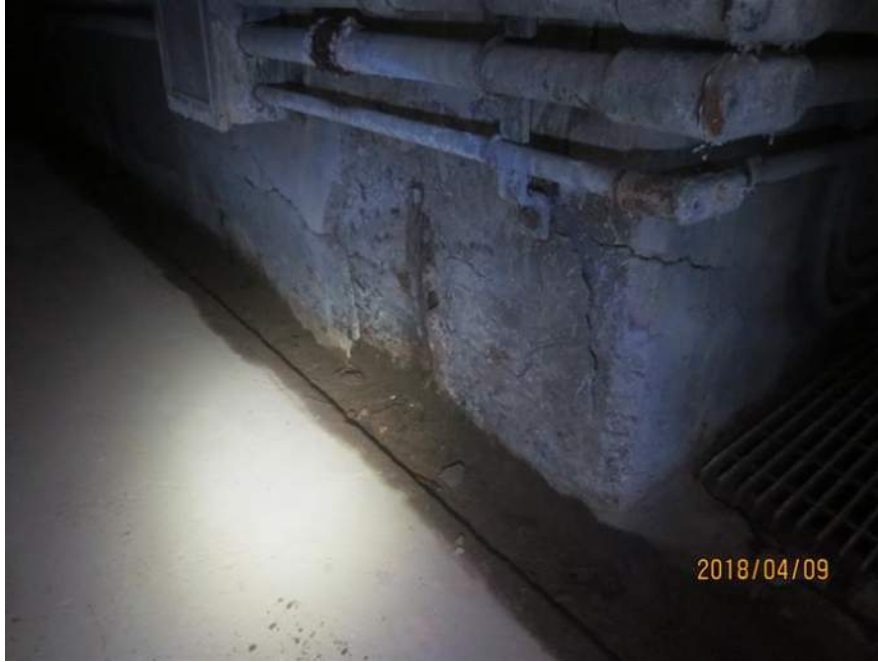
Station 30+50 to 30+65

Comments: Concrete Spalling, Re-Bar Exposed and Corroded

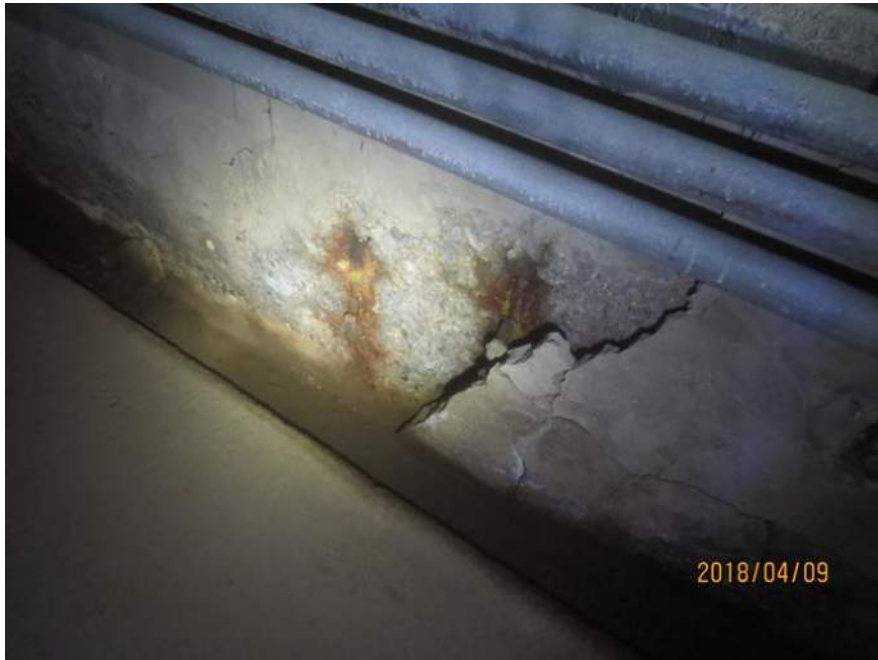
Station 30+77 to 30+85

Direction: Western Wall (In-Land)

Comments: Spalling, Re-Bar Exposed and Corroded, Loose Concrete

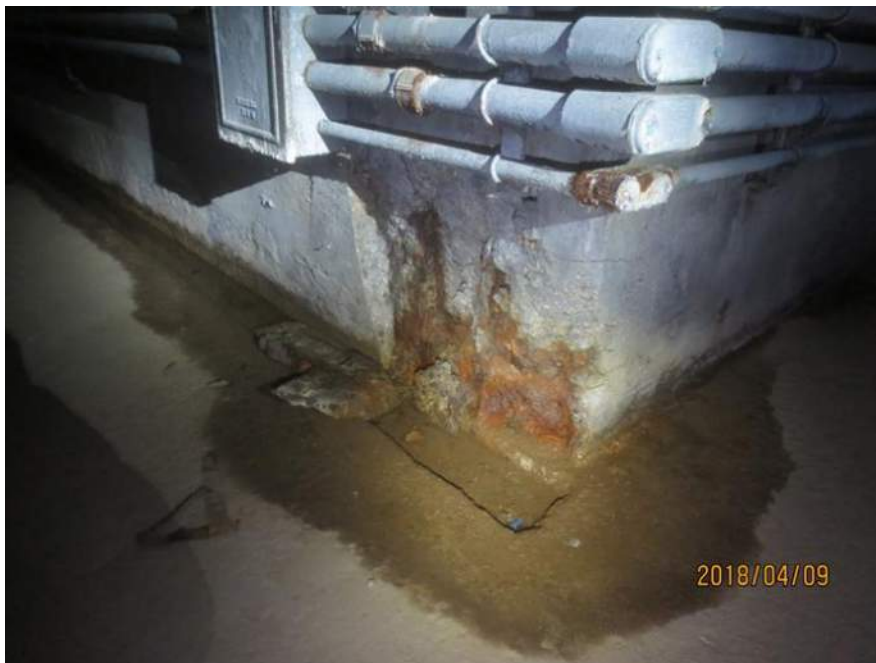
Station 31+83 to 31+85

Direction: Western Wall (In-Land)

Comments: Concrete Spalling, Re-Bar Exposed and Corroded

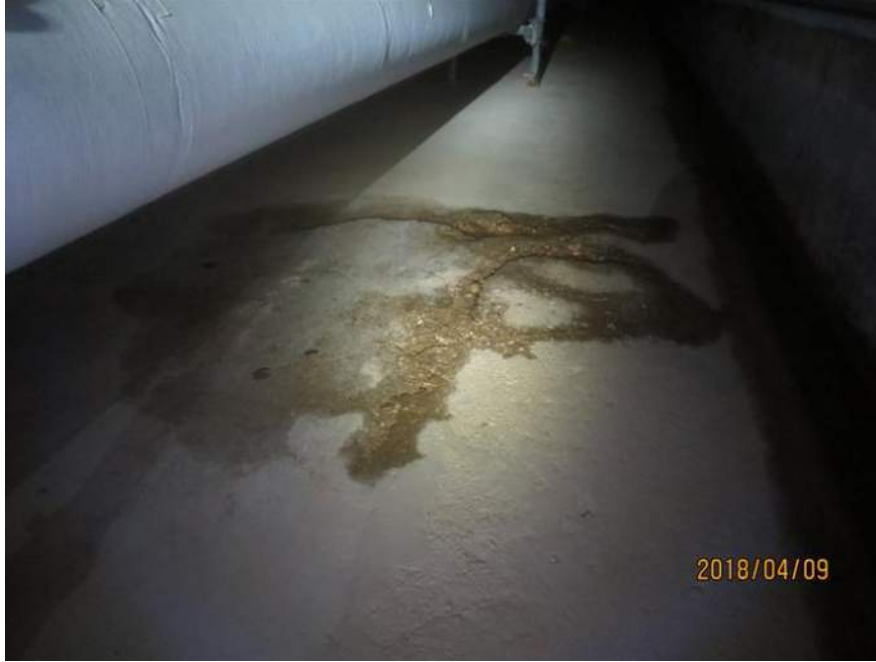
Station 31+94

Direction: Tunnel Floor

Comments: Floor Slab Cracking

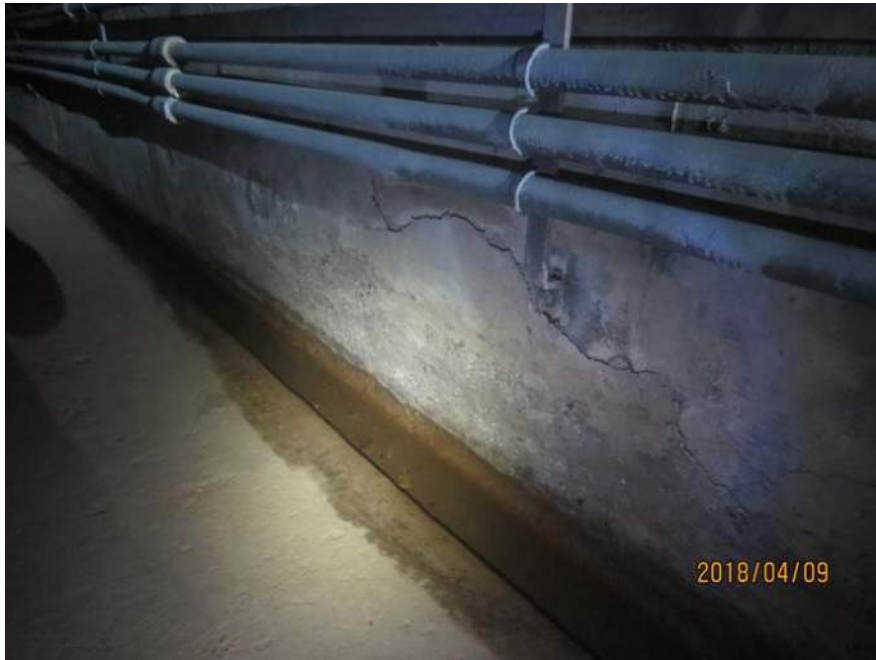
Station 32+00 to 32+02

Direction: Western Wall (In-Land)

Comments: Concrete Spalling

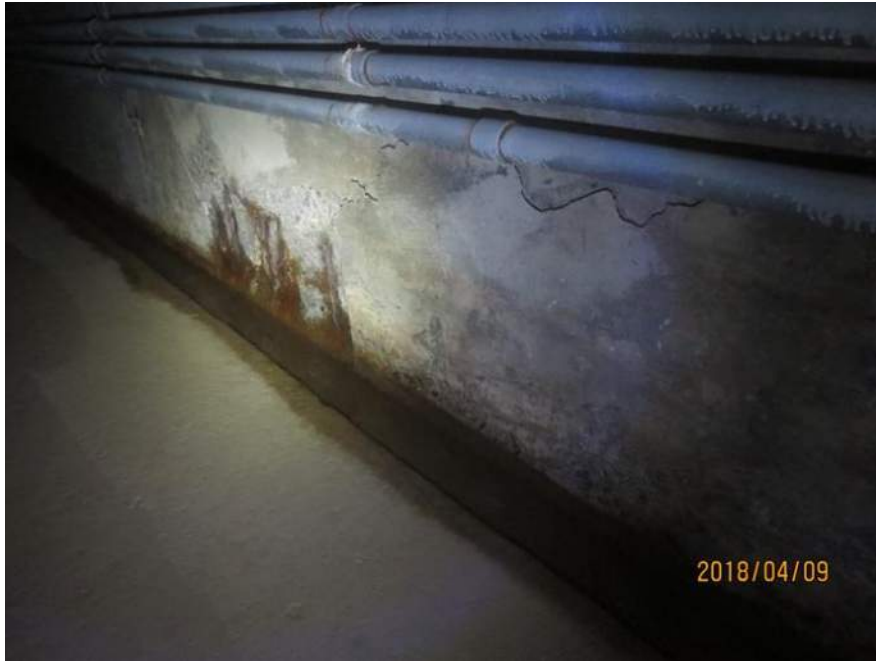
Station 32+43 to 32+49

Direction: Western Wall (In-Land)

Comments: Concrete Spalling, Re-Bar Exposed and Corroded

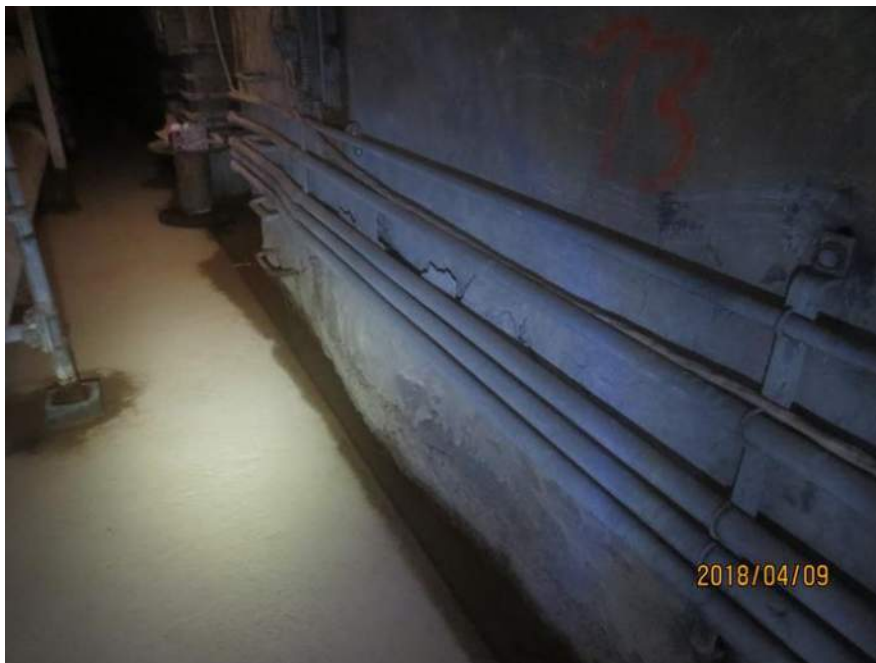
Station 32+77 to 33+00

Direction: Western Wall (In-Land)

Comments: Concrete Spalling, Re-Bar Exposed and Corroded

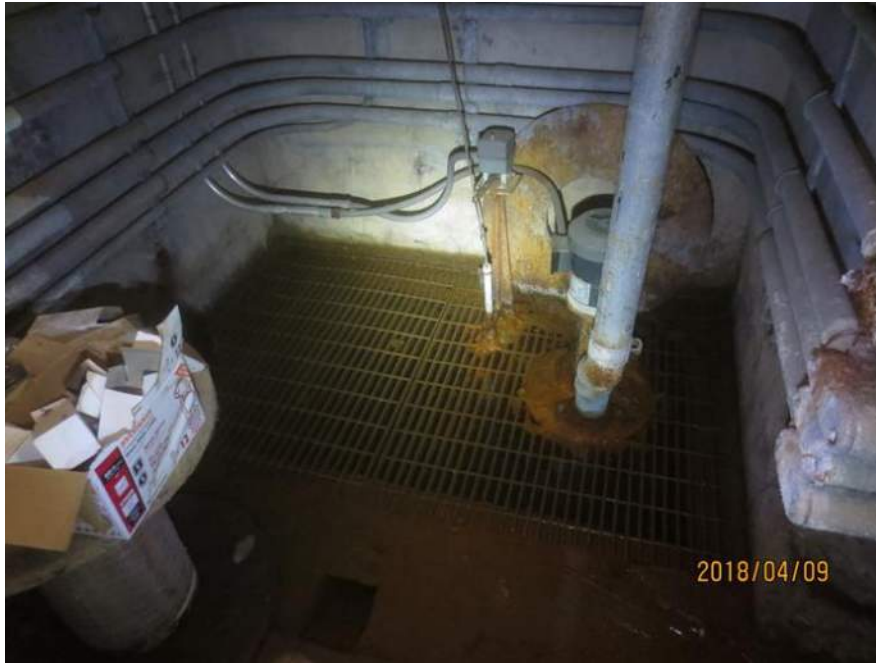
Station 33+00

Direction: Tunnel Floor

Comments: Sump Pump

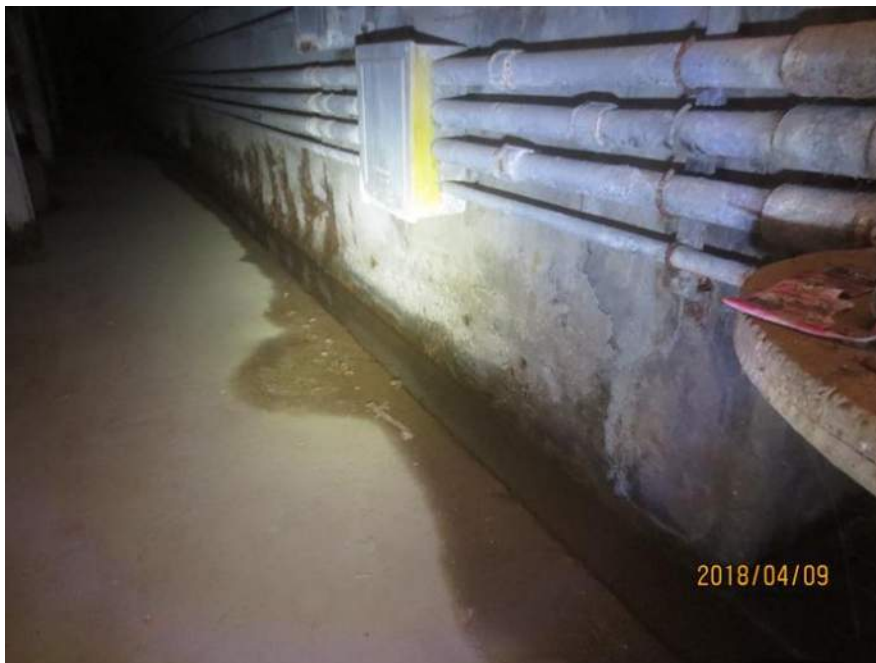
Station 33+02

Direction: Western Wall (In-Land)

Comments: Concrete Spalling

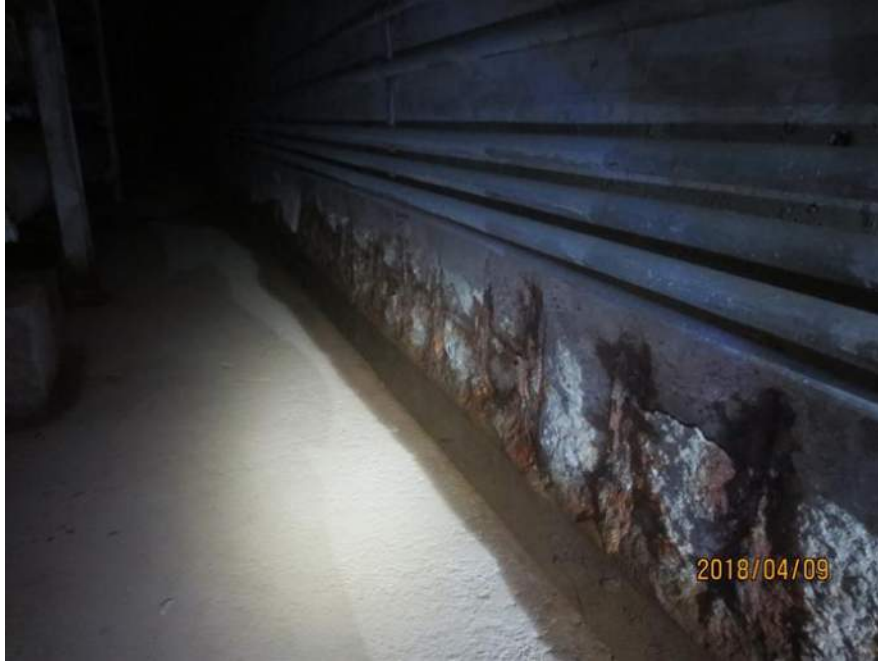
Station 33+04 to 33+71

Direction: Western Wall (In-Land)

Comments: Concrete Spalling, Re-Bar Exposed and Corroded

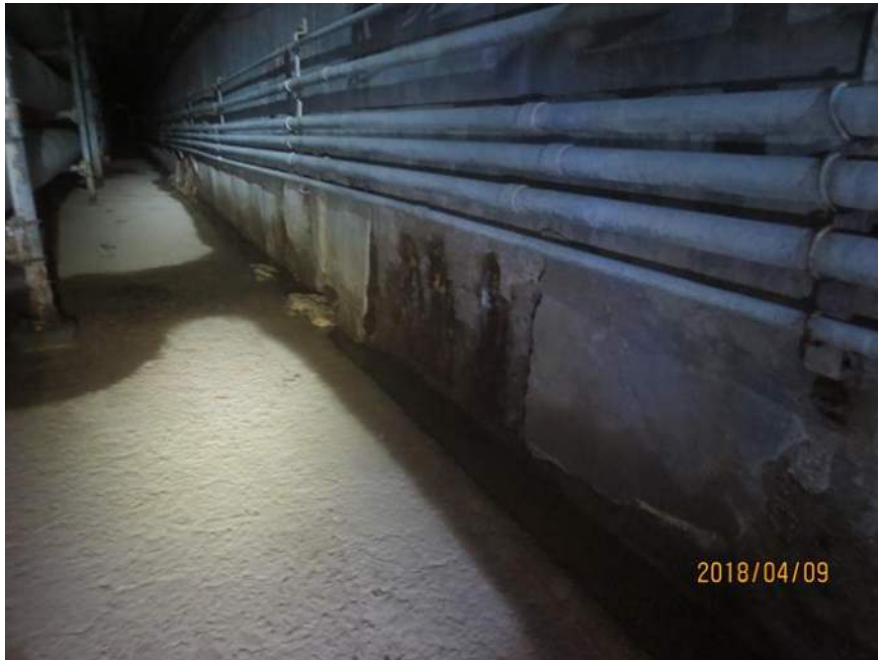
Station 34+23 to 34+75

Direction: Western Wall (In-Land)

Comments: Concrete Spalling, Re-Bar Exposed and Corroded

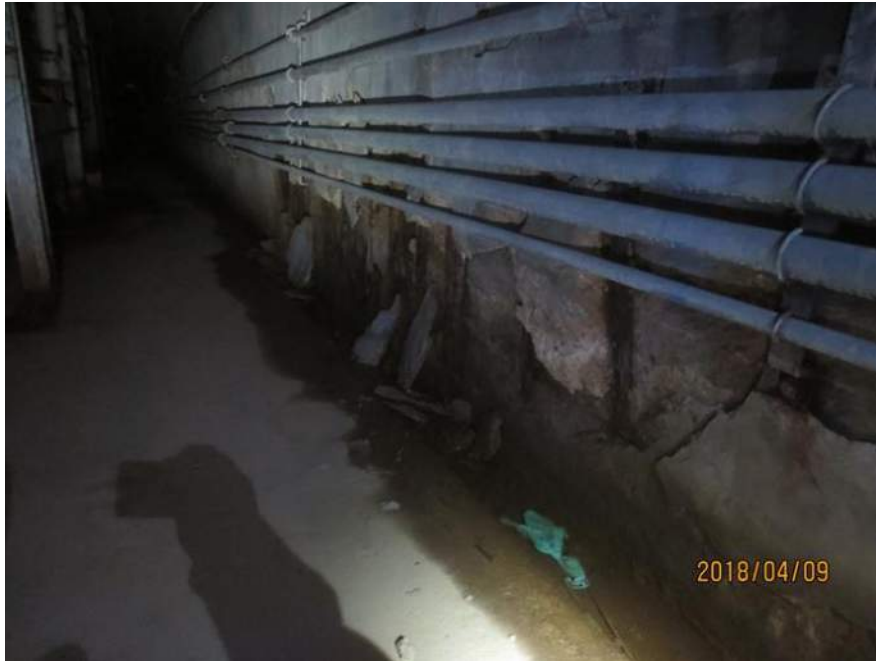
Station 34+23 to 34+75

Direction: Western Wall (In-Land)

Comments: Concrete Spalling, Re-Bar Exposed and Corroded

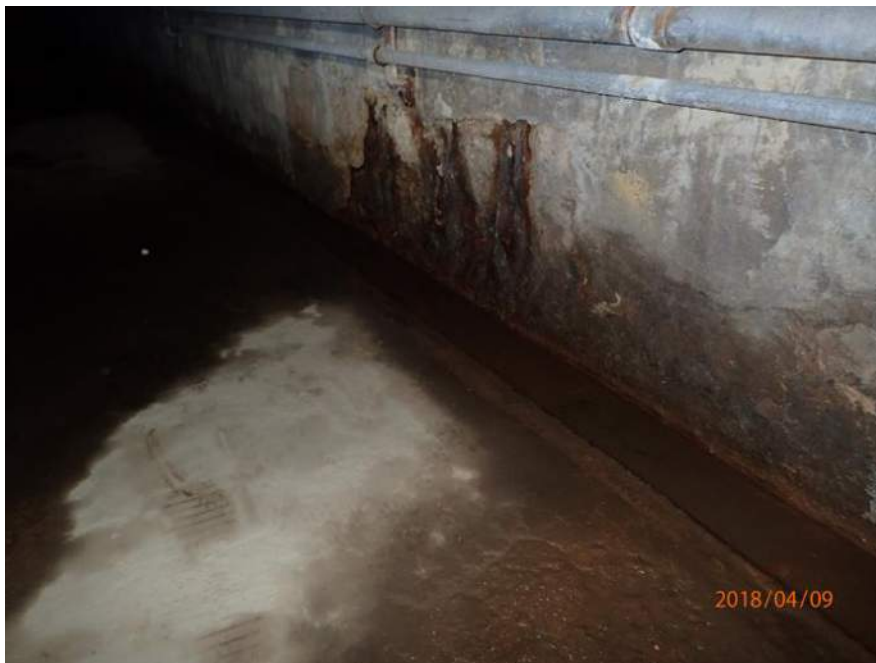
Station 35+00 to 35+08

Direction: Western Wall (In-Land)

Comments: Concrete Spalling, Re-Bar Exposed and Corroded

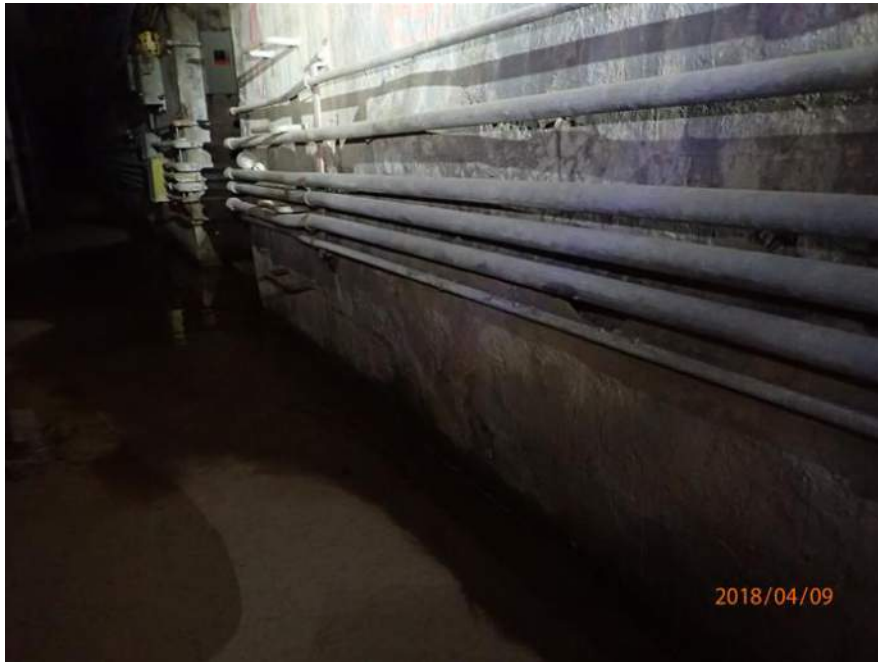
Station 35+52 to 35+63

Direction: Western Wall (In-Land)

Comments: Concrete Spalling

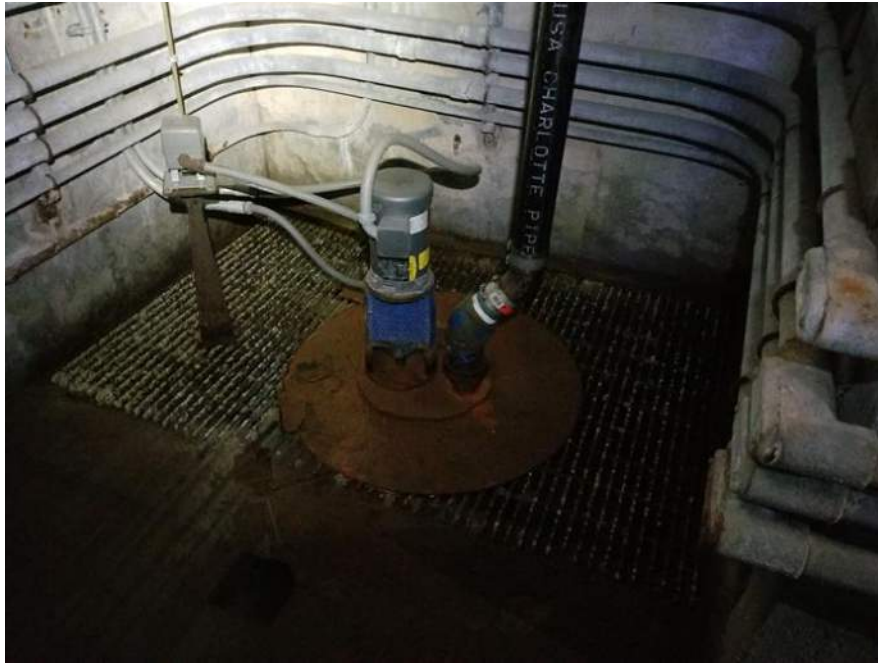
Station 35+54

Direction: Tunnel Floor

Comments: Sump Pump

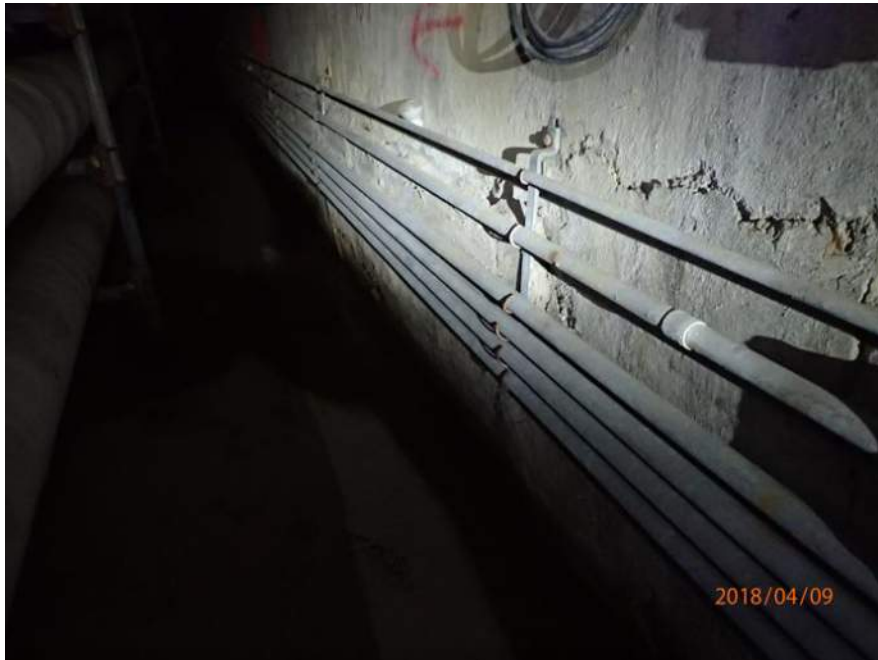
Station 35+75 to 36+29

Direction: Western Wall (In-Land)

Comments: Concrete Spalling up to 5 feet Height

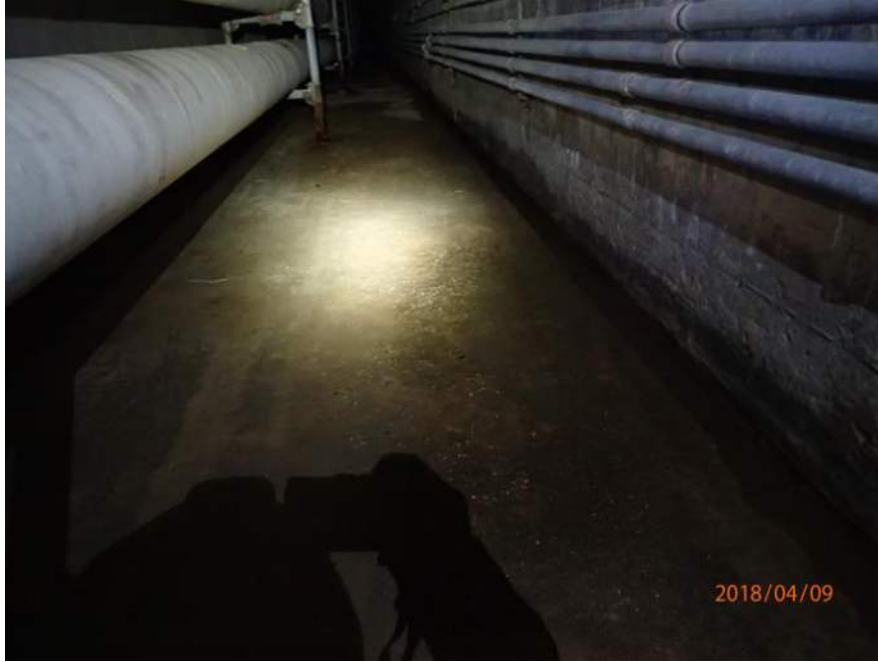
Station 36+57 to 36+62

Direction: Tunnel Floor

Comments: Floor Slab Cracked

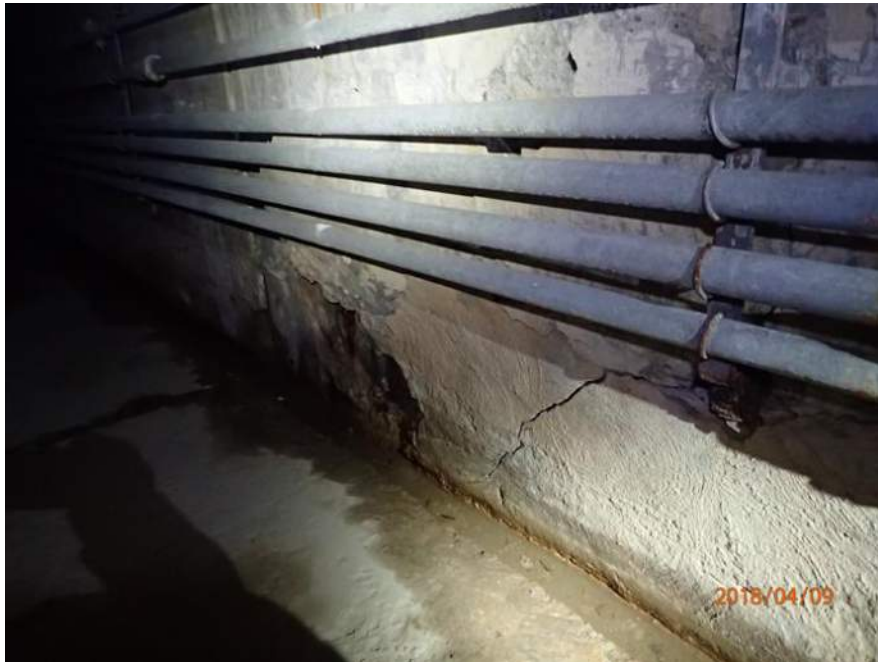
Station 36+57 to 36+90

Direction: Western Wall (In-land)

Comments: Concrete Spalling

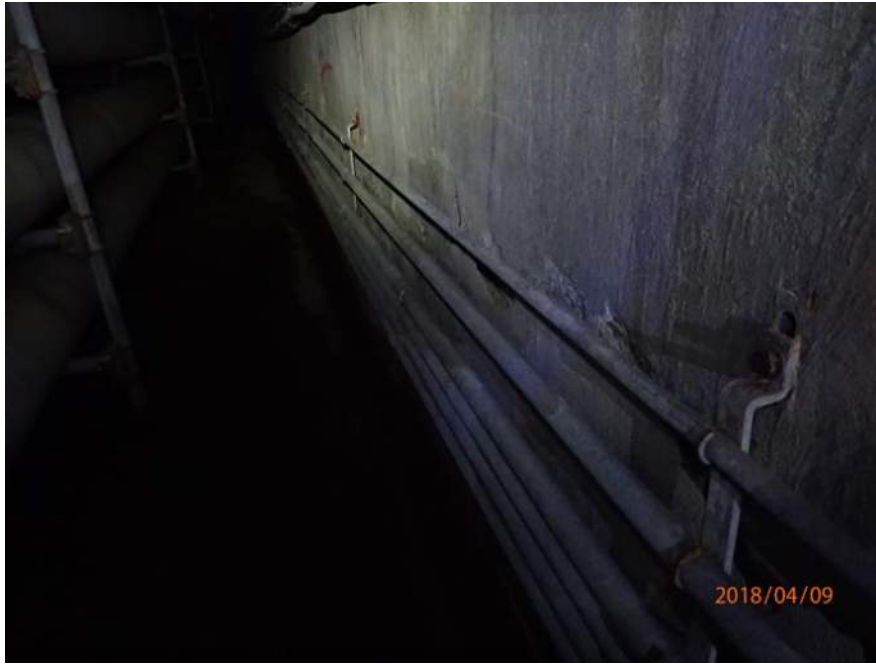
Station 37+00

Direction: Western Wall (In-Land)

Comments: Concrete Spalling up to 5 feet Height

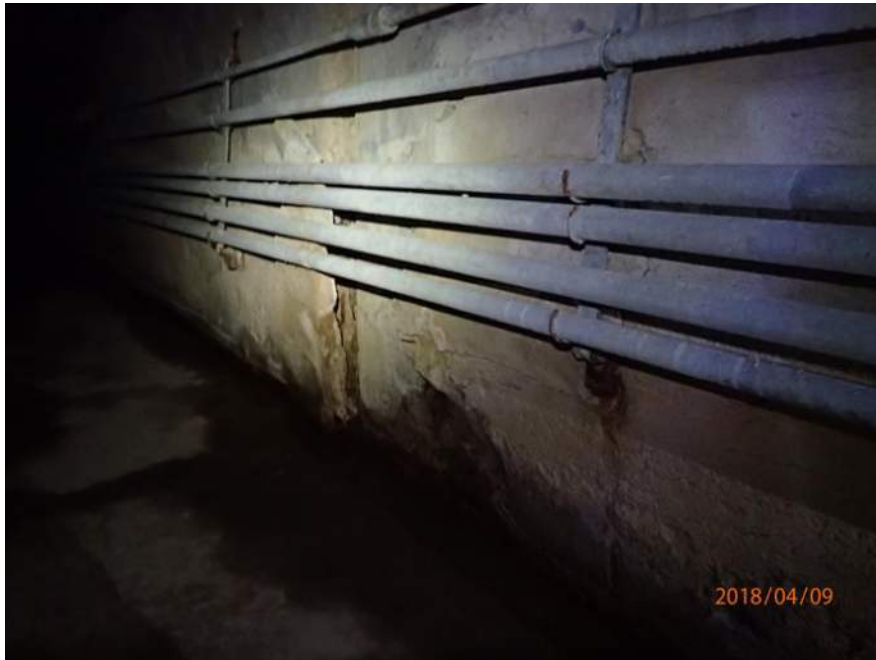
Station 37+35

Direction: Tunnel Joint

Comments: Joint Separation, Missing Concrete

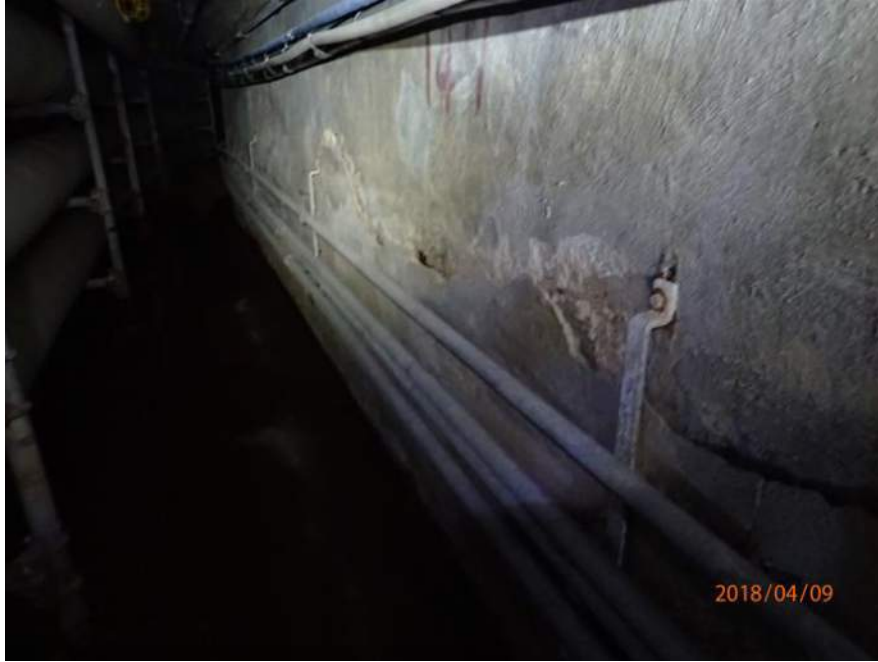
Station 37+50 to 38+00

Direction: Western Wall (In-land)

Comments: Concrete Spalling

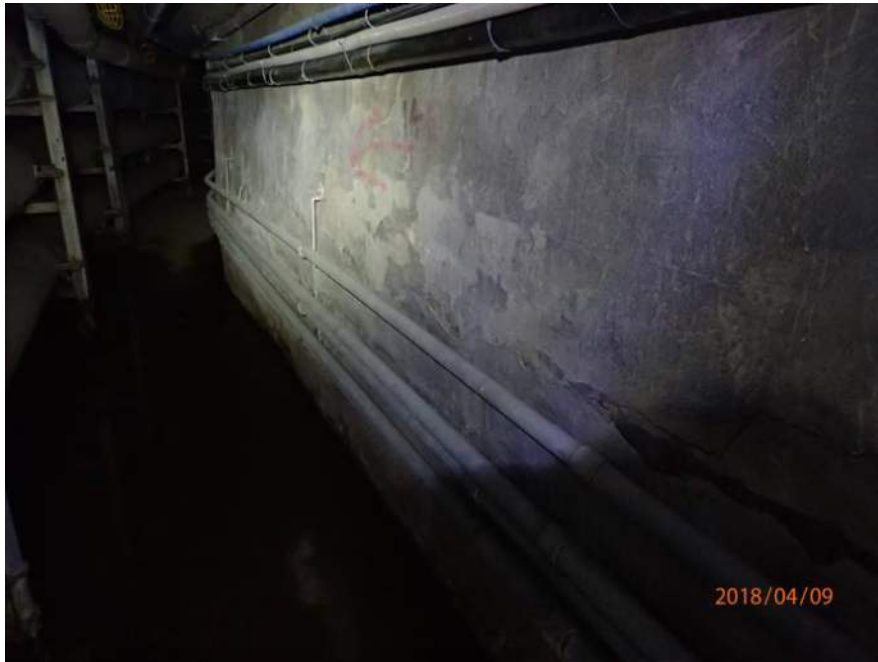
Station 37+50 to 38+00

Direction: Western Wall (In-land)

Comments: Concrete Spalling

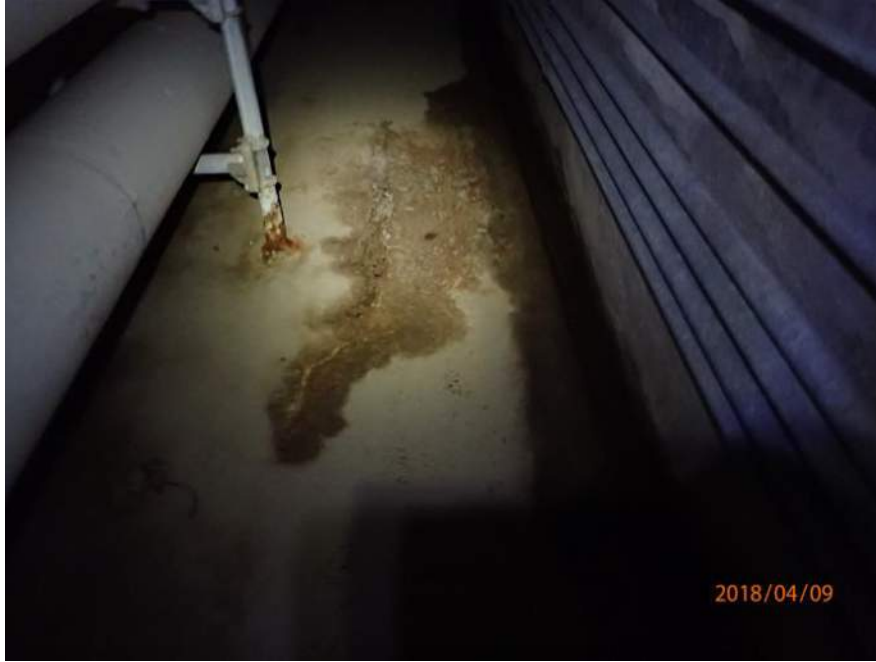
Station 38+13

Direction: Tunnel Floor

Comments: Floor Slab Cracked

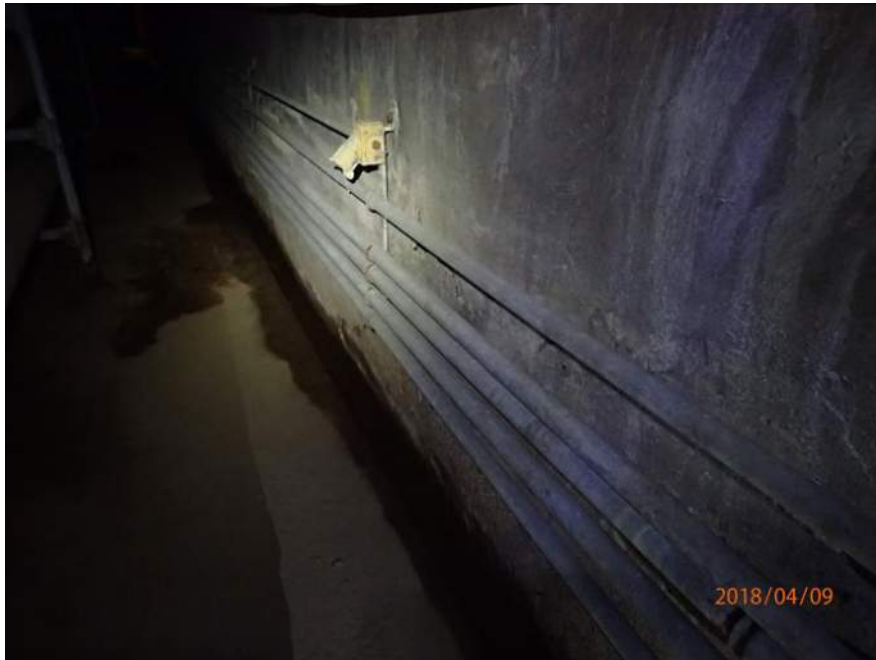
Station 38+03 to 38+55

Direction: Western Wall (In-Land)

Comments: Concrete Spalling

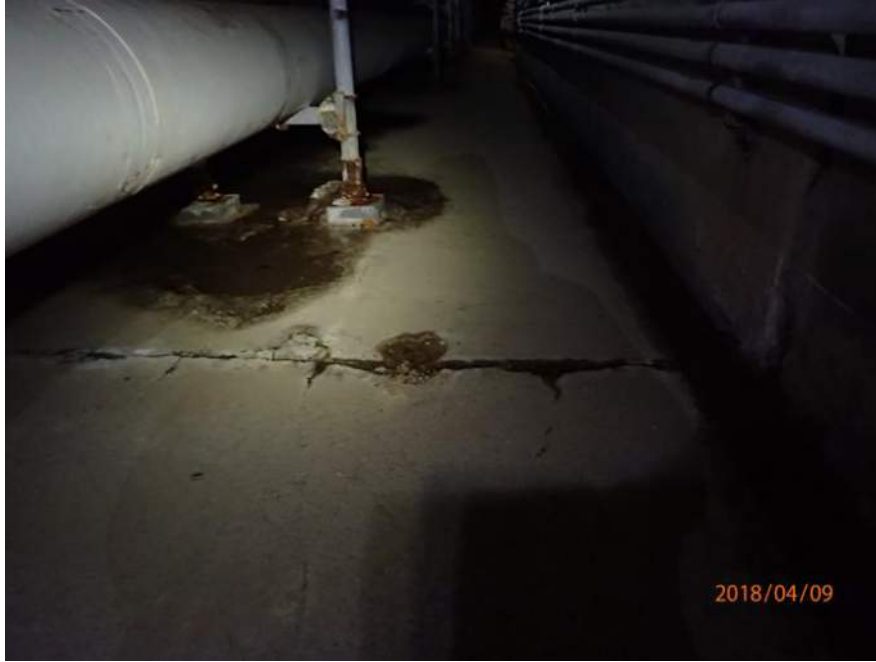
Station 38+64

Direction: Tunnel Floor

Comments: Floor Slab Cracking at Joint

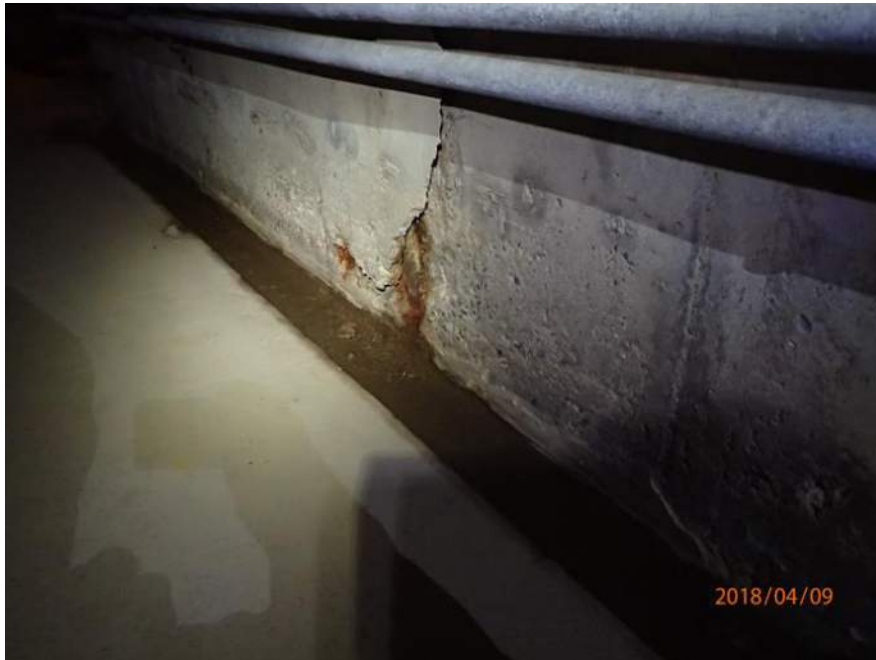
Station 39+00

Direction: Western Wall (In-Land)

Comments: Spalling, Loose Concrete

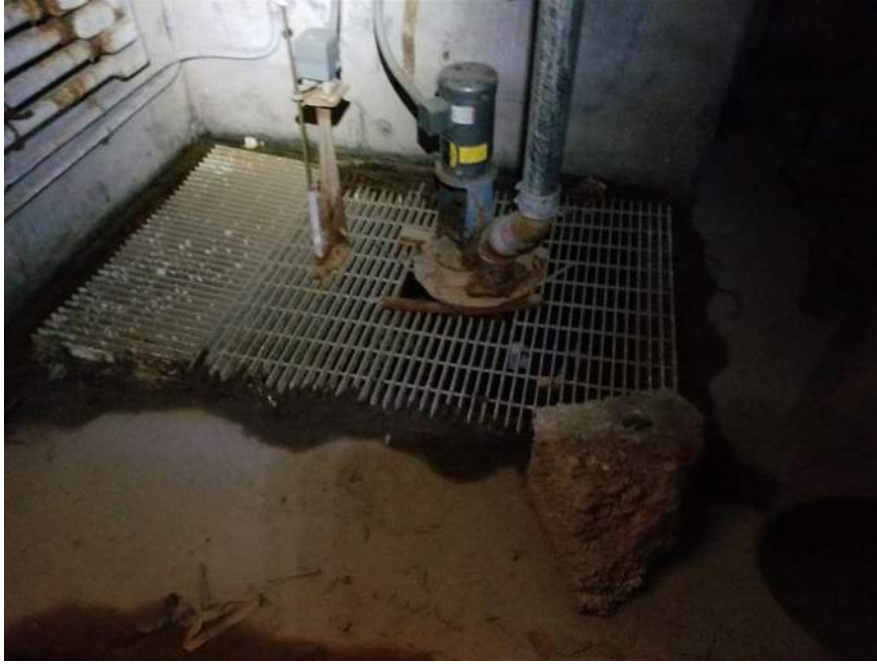
Station 39+03

Direction: Tunnel Floor

Comments: Sump Pump

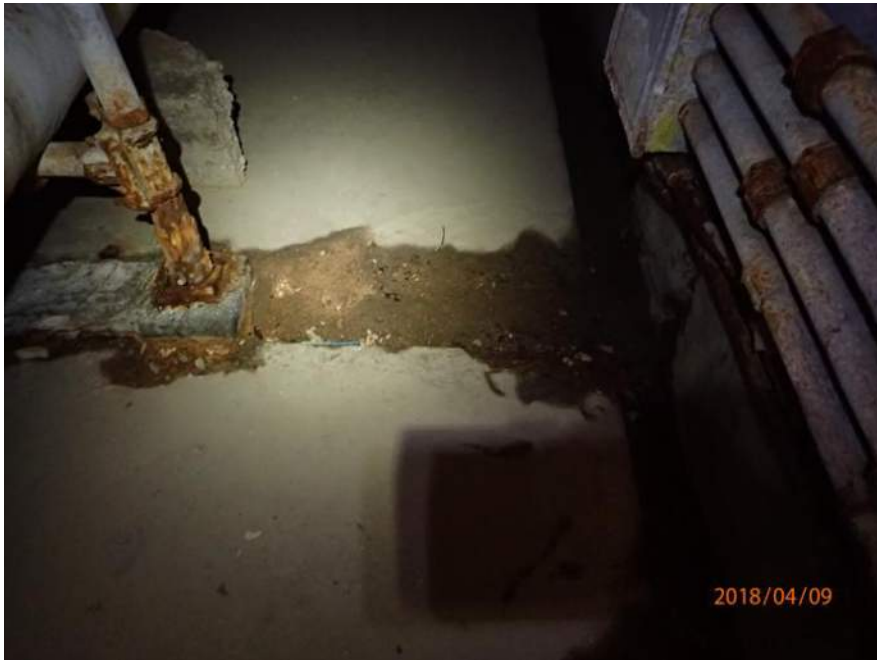
Station 39+23

Direction: Tunnel Floor

Comments: Floor Slab Cracking

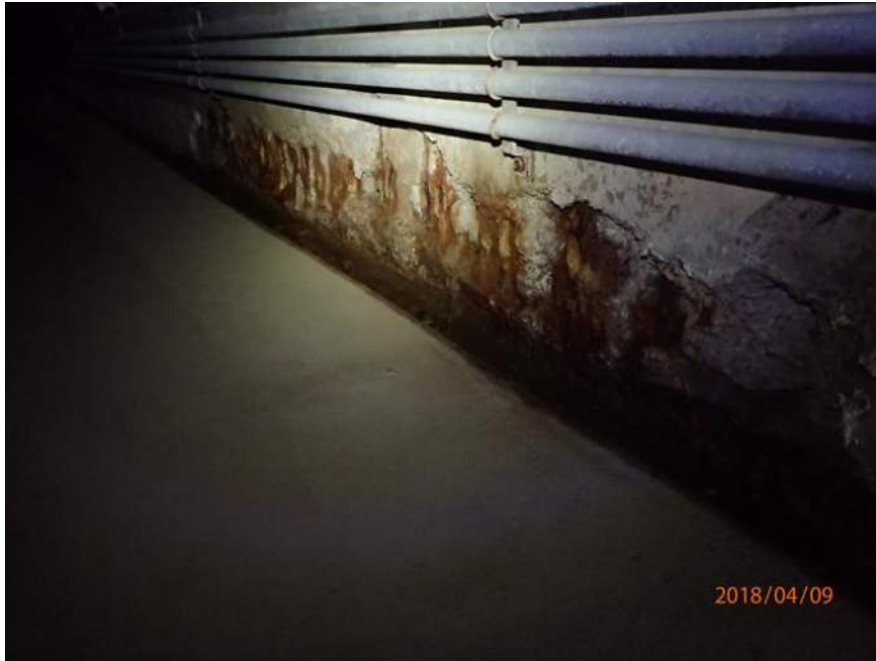
Station 39+58 to 39+74

Direction: Western Wall (In-Land)

Comments: Concrete Spalling, Re-Bar Exposed and Corroded

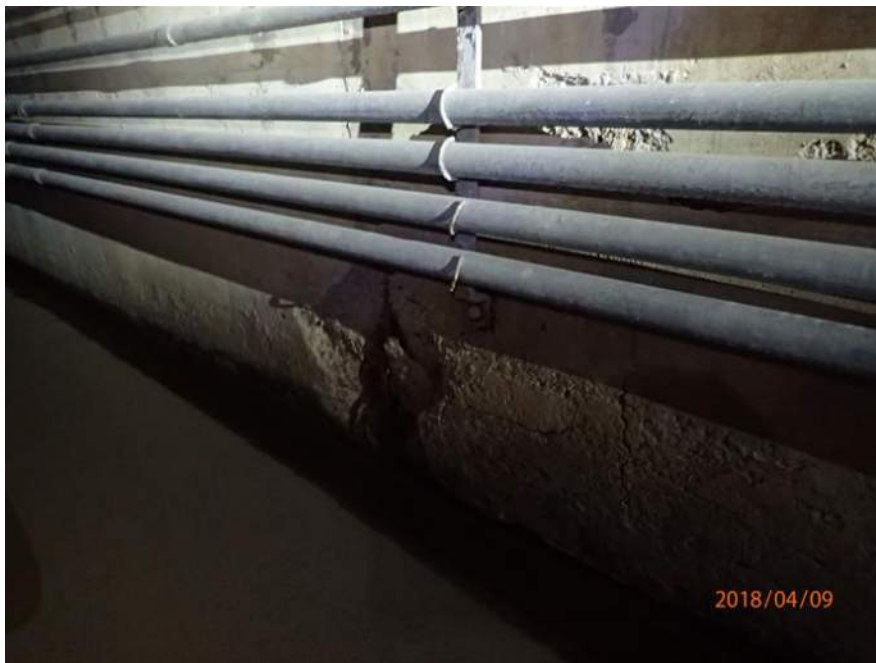
Station 40+02 to 40+03

Direction: Western Wall (In-Land)

Comments: Concrete Spalling, Re-Bar Exposed and Corroded

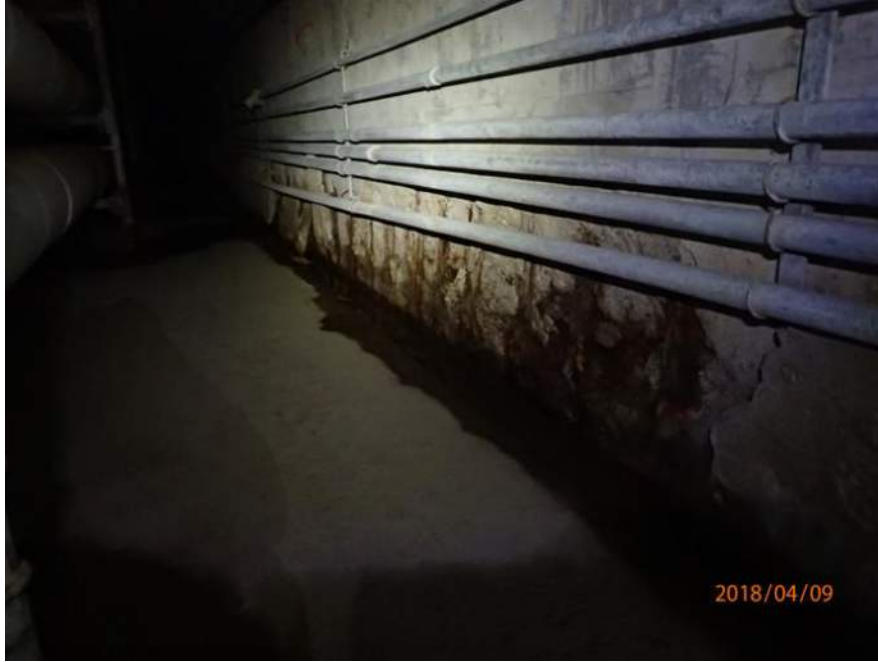
Station 40+50 to 40+90

Direction: Western Wall (In-Land)

Comments: Concrete Spalling

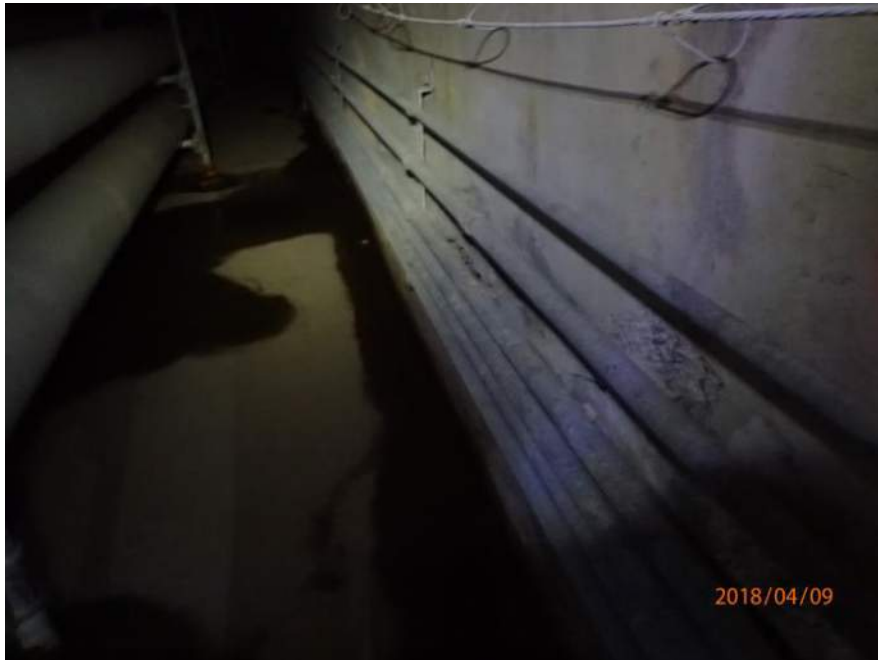
Station 40+98 to 41+45

Direction: Western Wall (In-Land)

Comments: Concrete Spalling

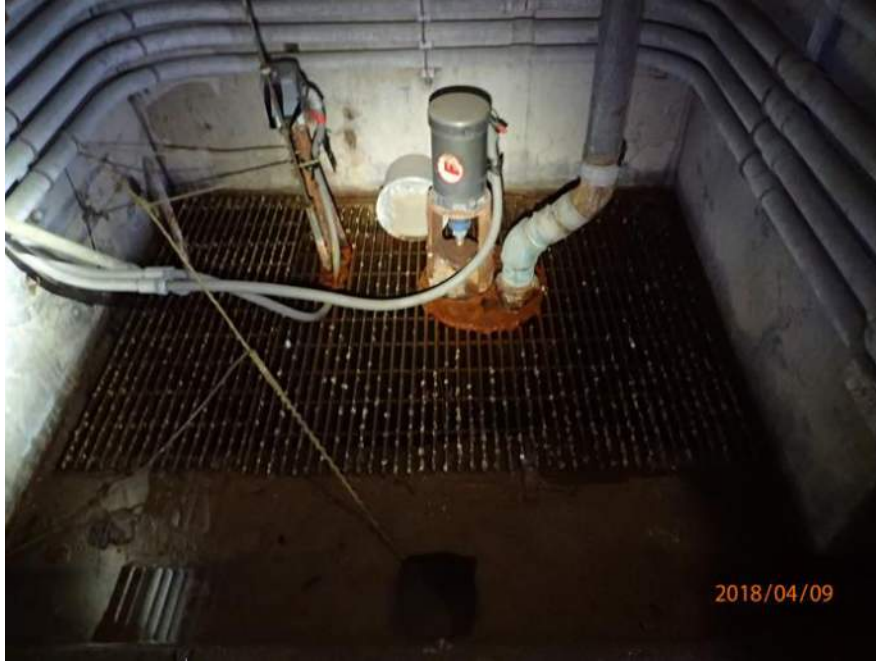
Station 42+18

Direction: Tunnel Floor

Comments: Sump Pump

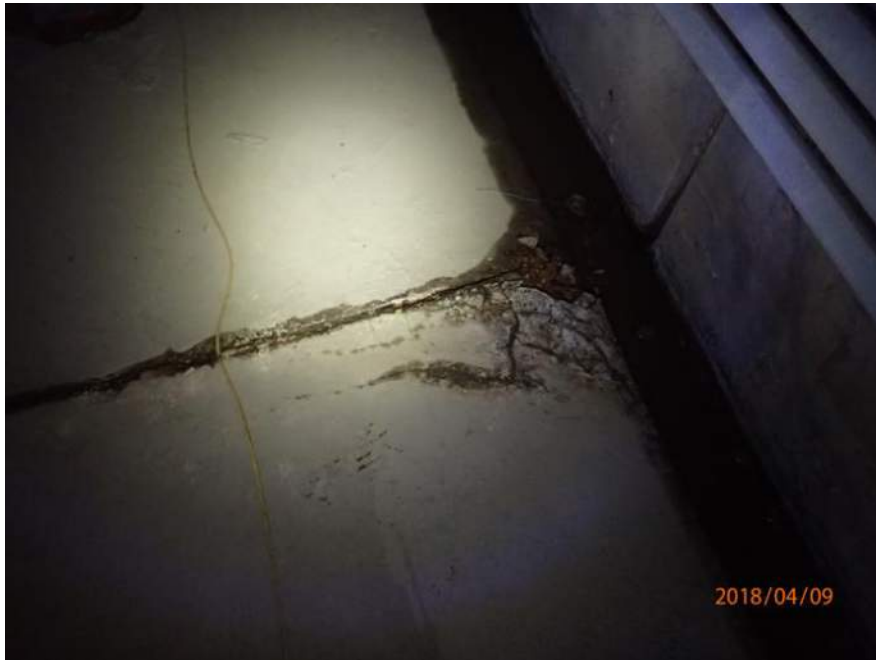
Station 42+75

Comments: Floor Slab Raised at Joint

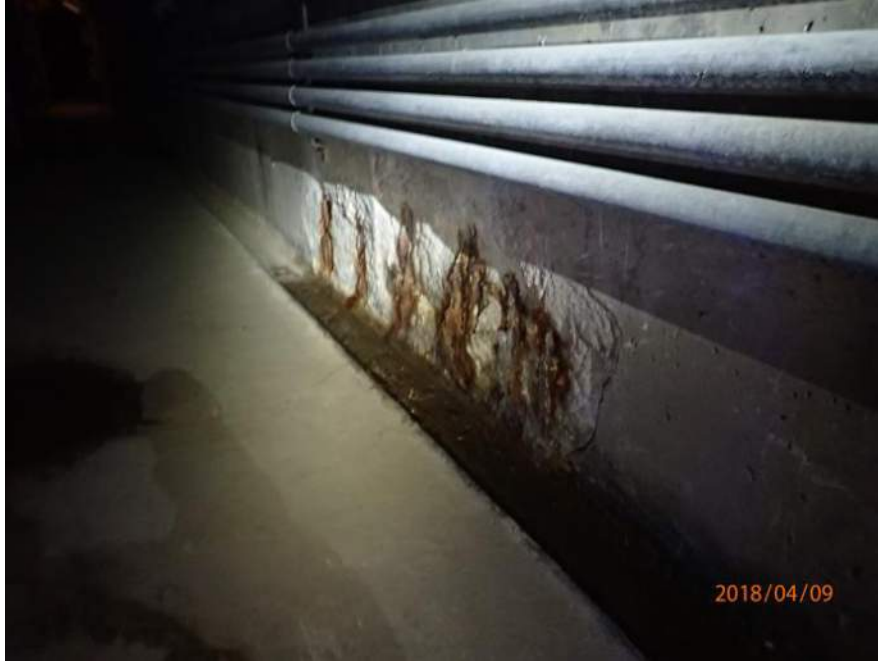
Station 45+00 to 45+05

Comments: Concrete Spalling, Re-Bar Exposed and Corroded
