CONDITIONS REPORT & CONCEPTUAL DESIGN MEMORANDUM

STEAM TUNNEL ASSESSMENT

ROOSEVELT ISLAND, NEW YORK

17 November 2014
Revised 28 December 2018
Revised 18 September 2020
Project # 100444601

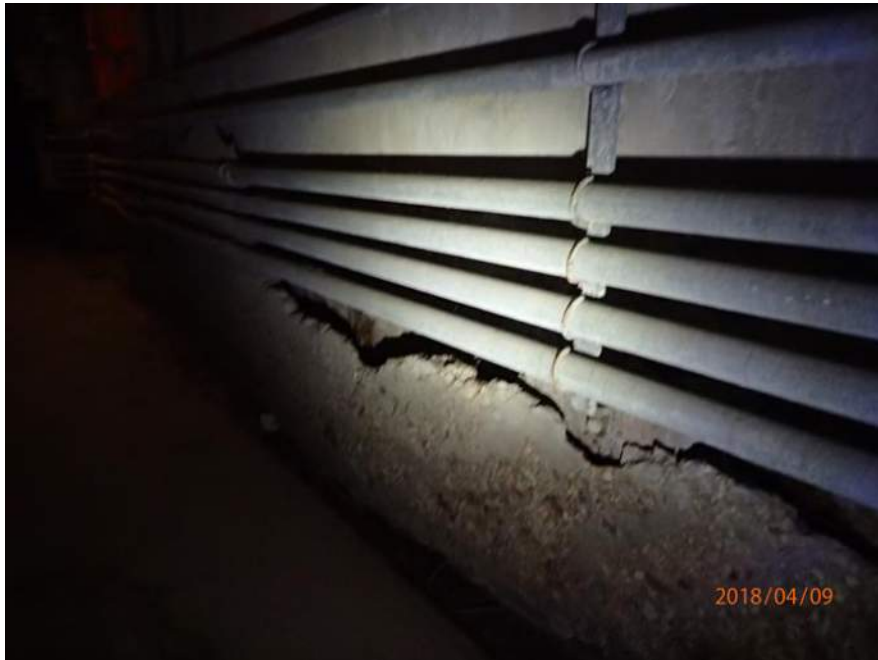
Station 45+34 to 45+47

Comments: Spalling, Loose Concrete

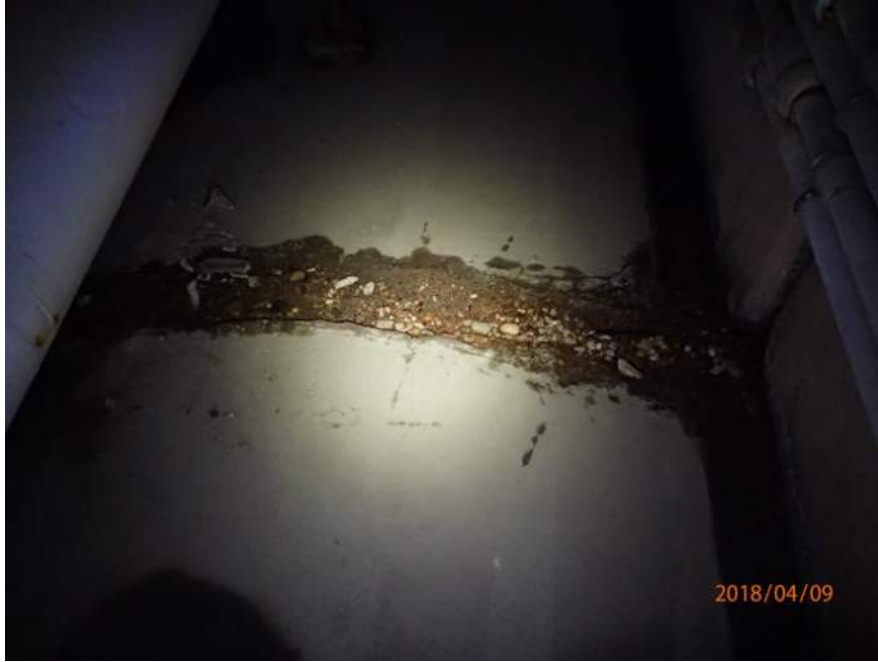
Station 45+94

Comments: Cracks

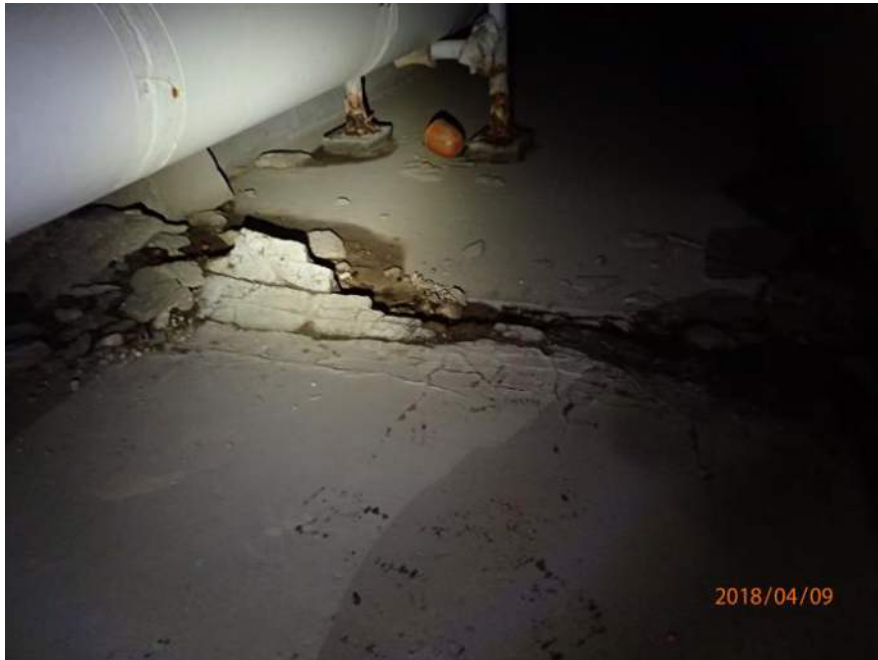
Station 46+60

Comments: Floor Slab Raised at Joint, Cracking, Loose Concrete

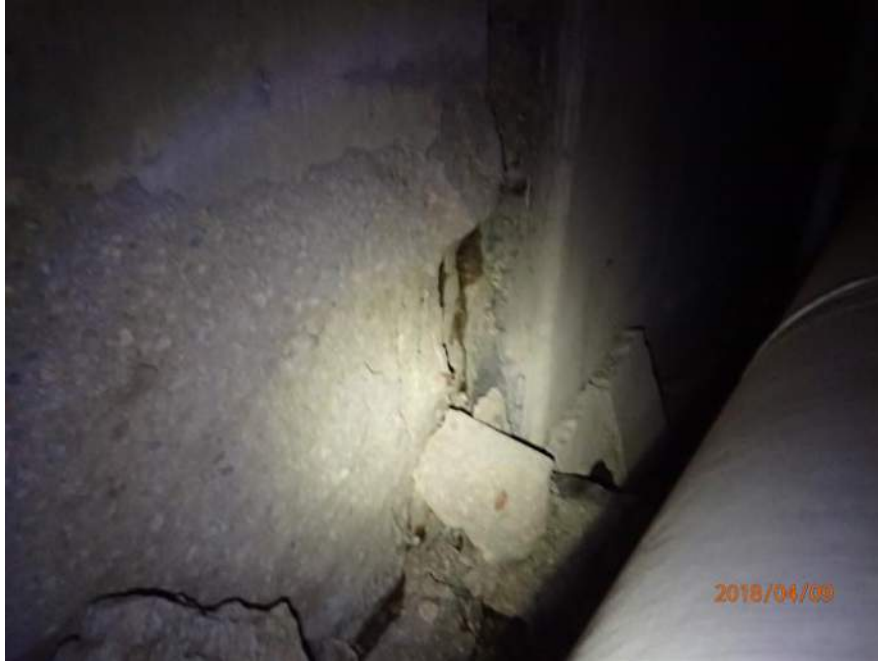
Station 46+60

Comments: Floor Slab Raised at Joint, Cracking, Loose Concrete

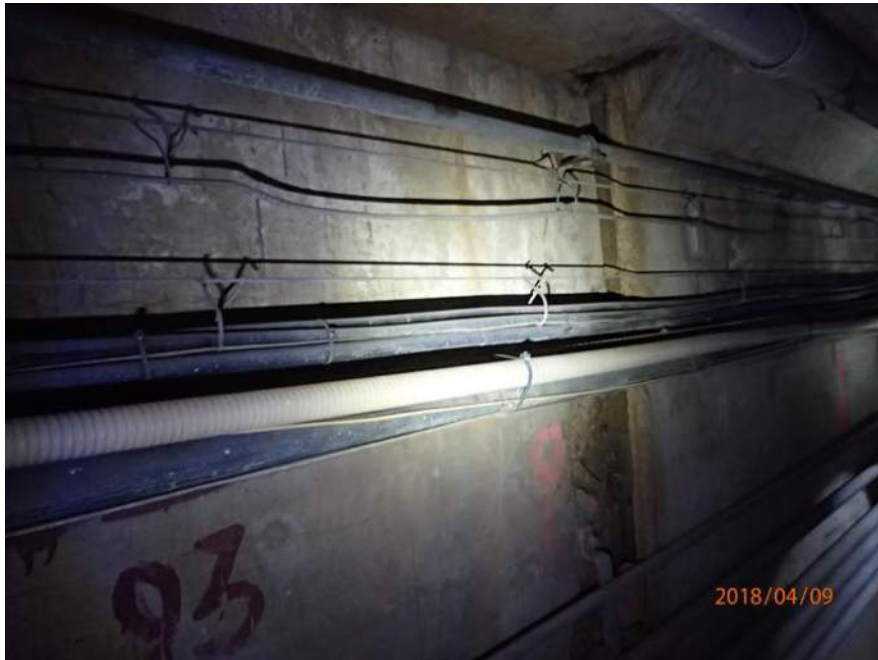
Station 46+60

Comments: Tunnel Displaced

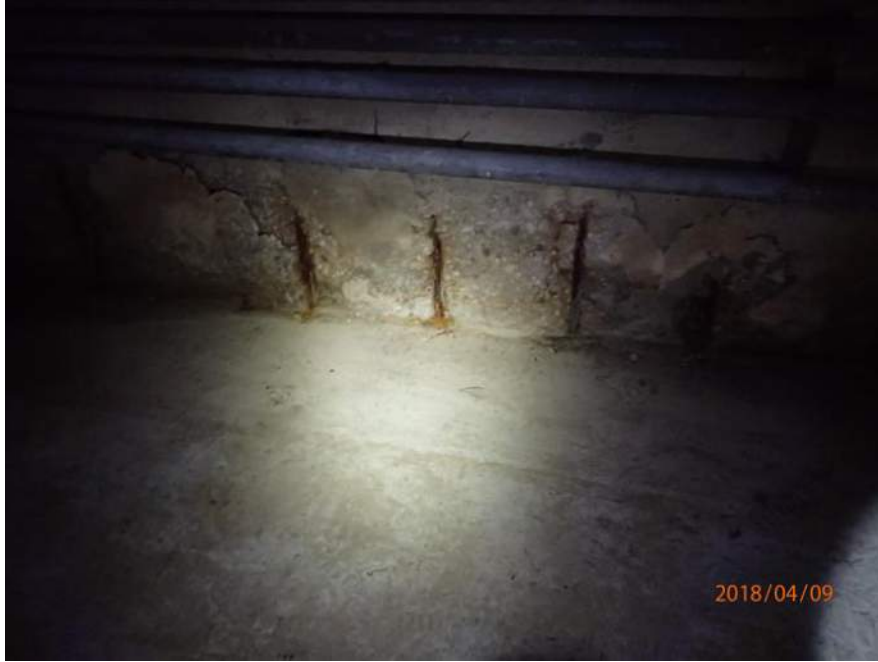
Station 49+09 to 49+23

Comments: Concrete Spalling

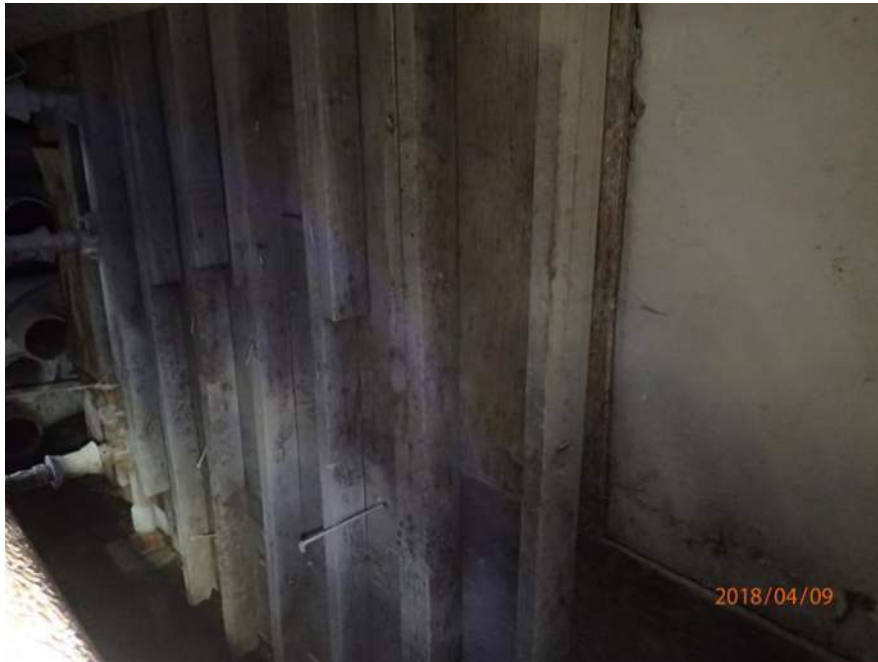
Station 49+09

Comments: Wood Frame Support Structure

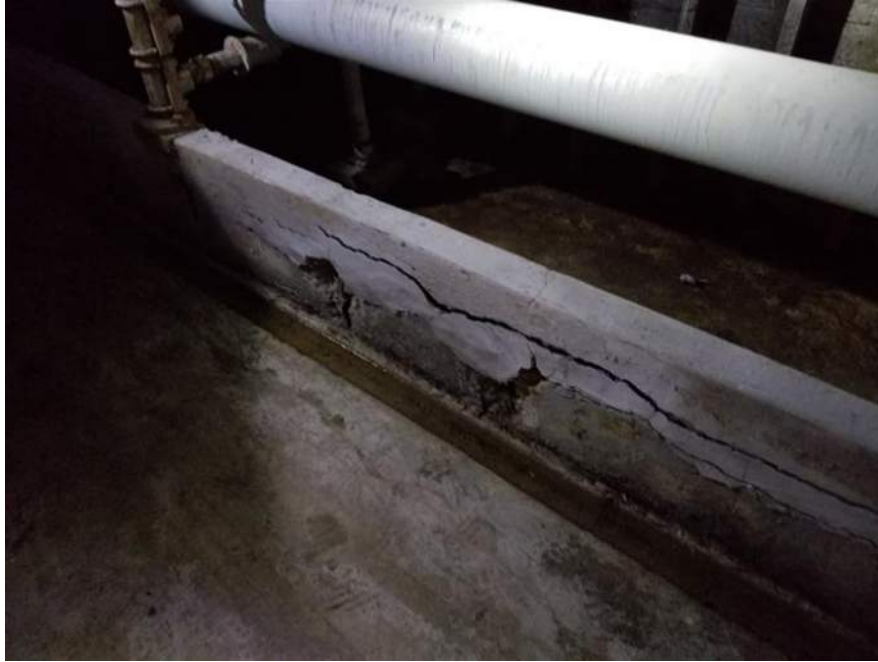
Station 49+10 to 51+75

Comments: Cracked, Missing Concrete on its Entirety

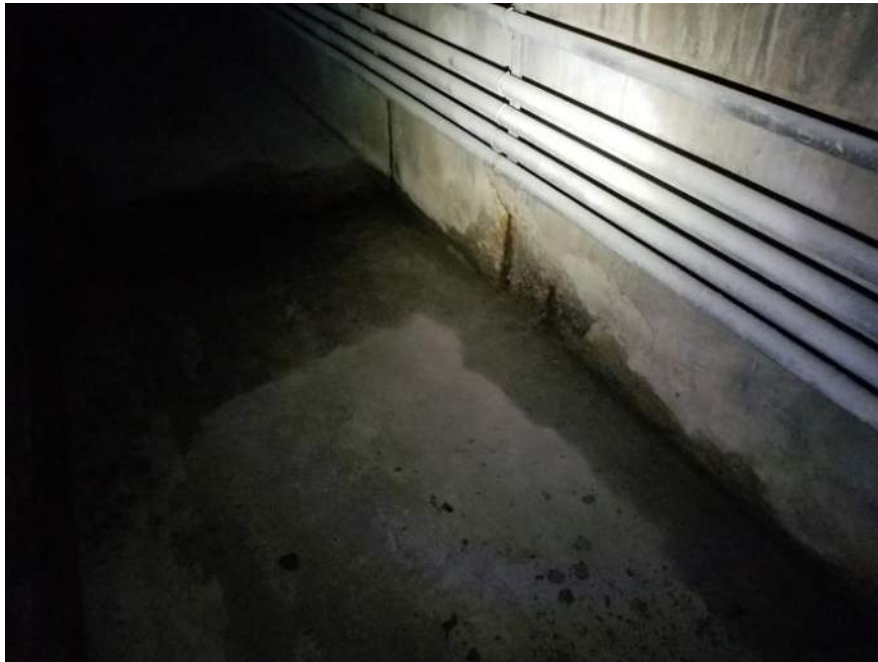
Station 49+60

Comments: Concrete Spalling

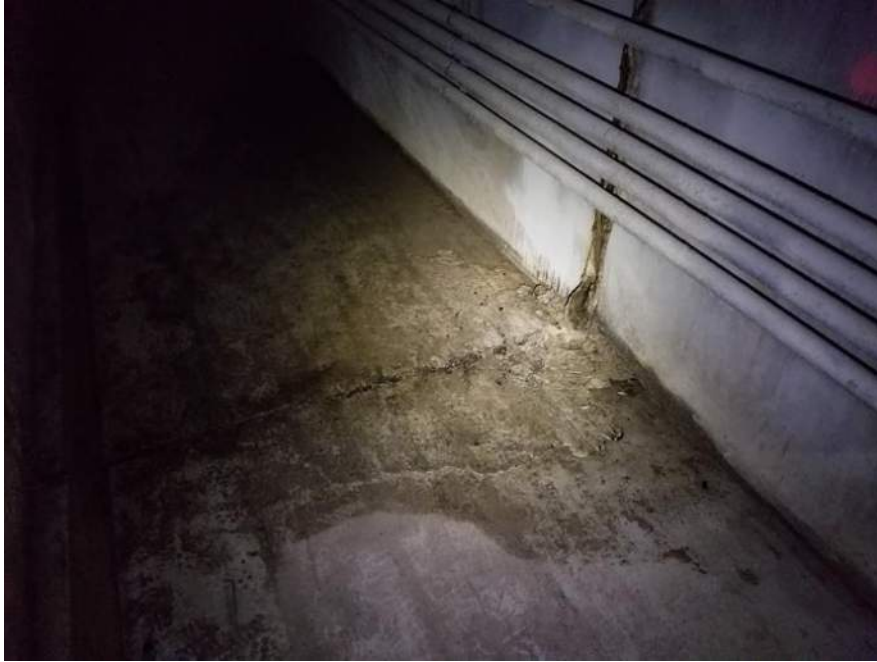
Station 49+17

Comments: Joint Filler

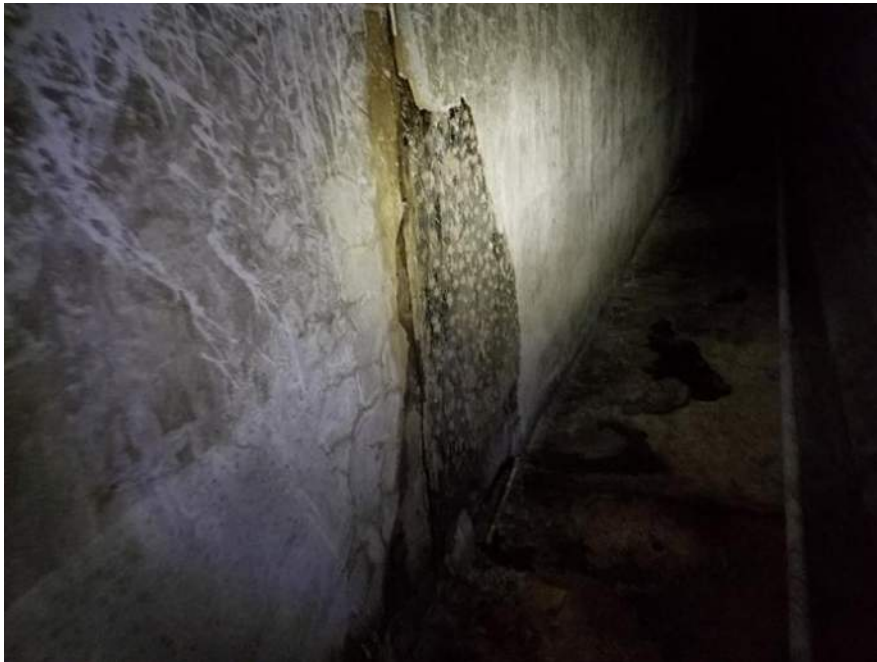
Station 53+50

Comments: Concrete Spalling

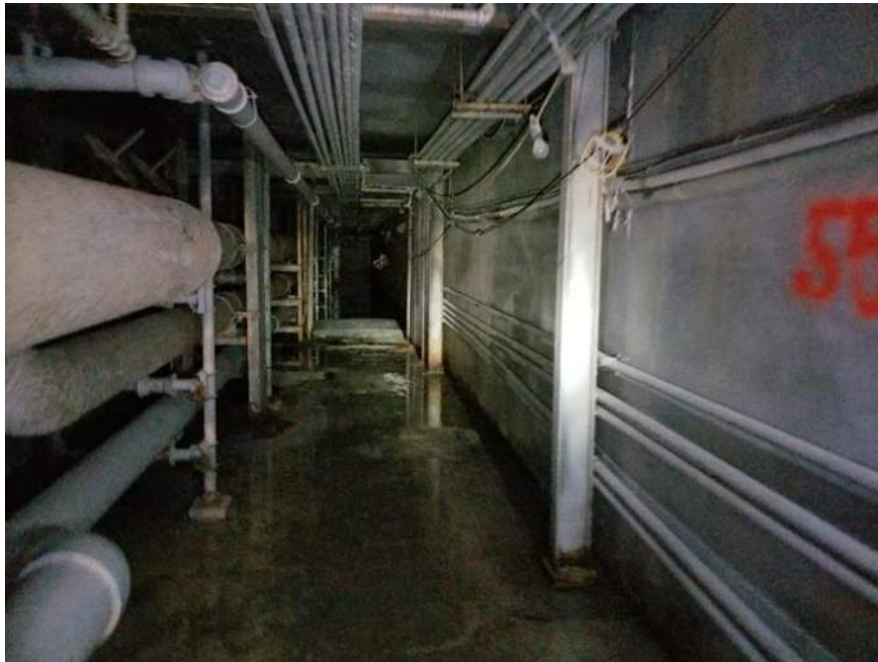
Station 55+52

Comments: "1/8"" Thick Crack running from the Floor to the roof of the Tunnel"

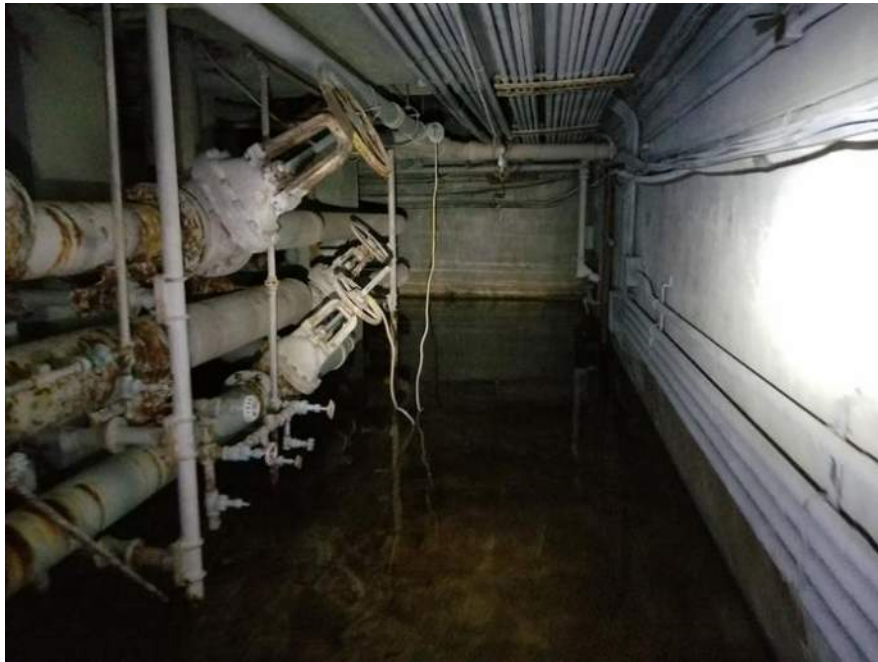
Station 56+00 to 58+50

Comments: Water Observed in the Tunnel

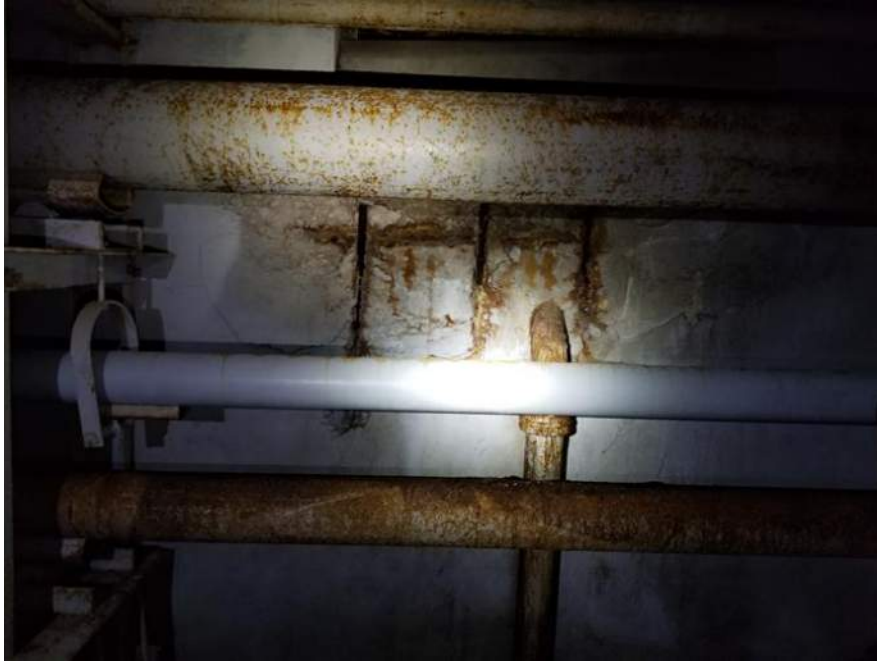
Station 58+53

Comments: Concrete Spalling around pipe opening

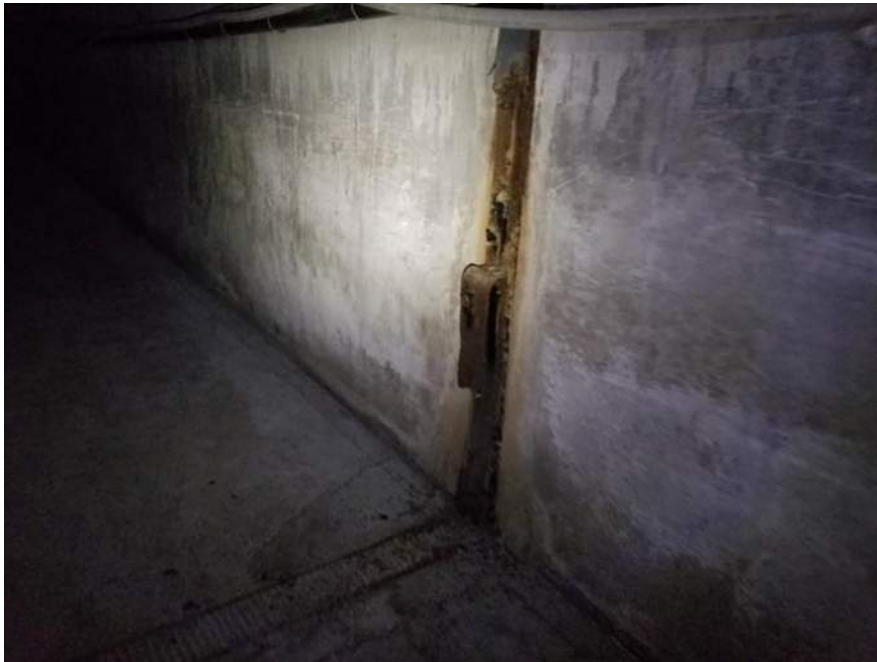
Station 59+25

Comments: Re-Bar Exposed, Corroded

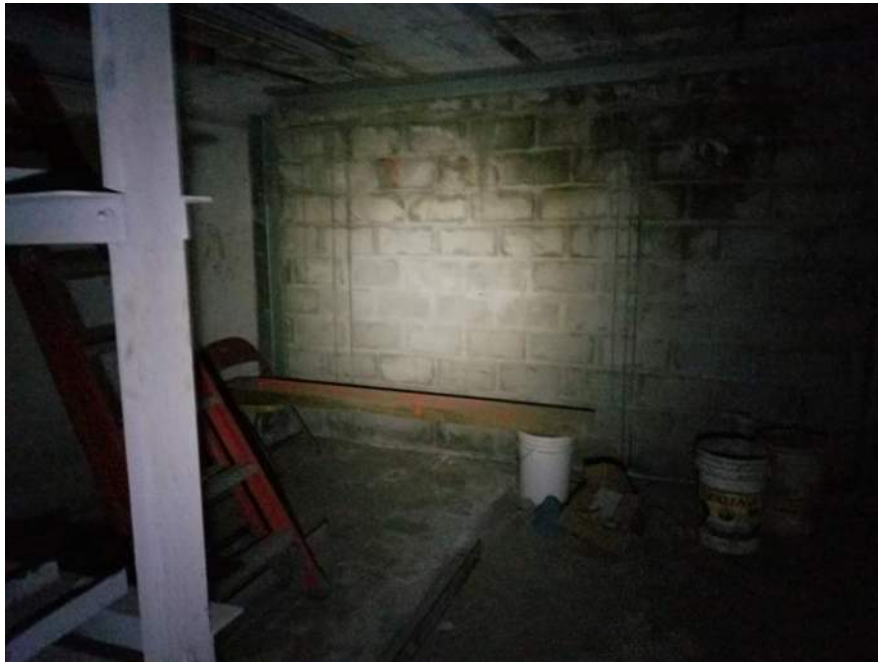
Station 61+50

Comments: Brick Wall

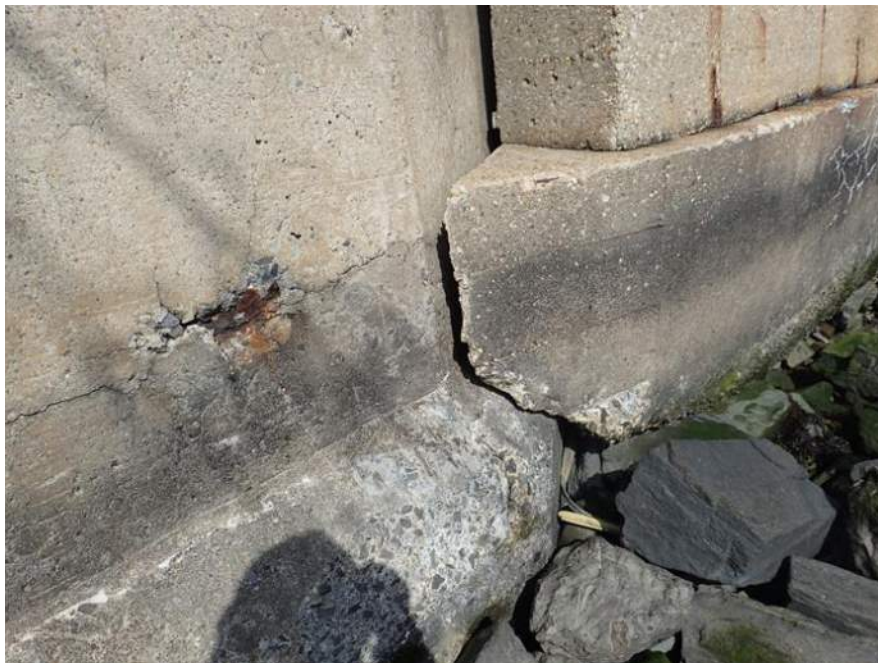
Station 5+18

Comments: Gap Between Steam Tunnel and Seawall

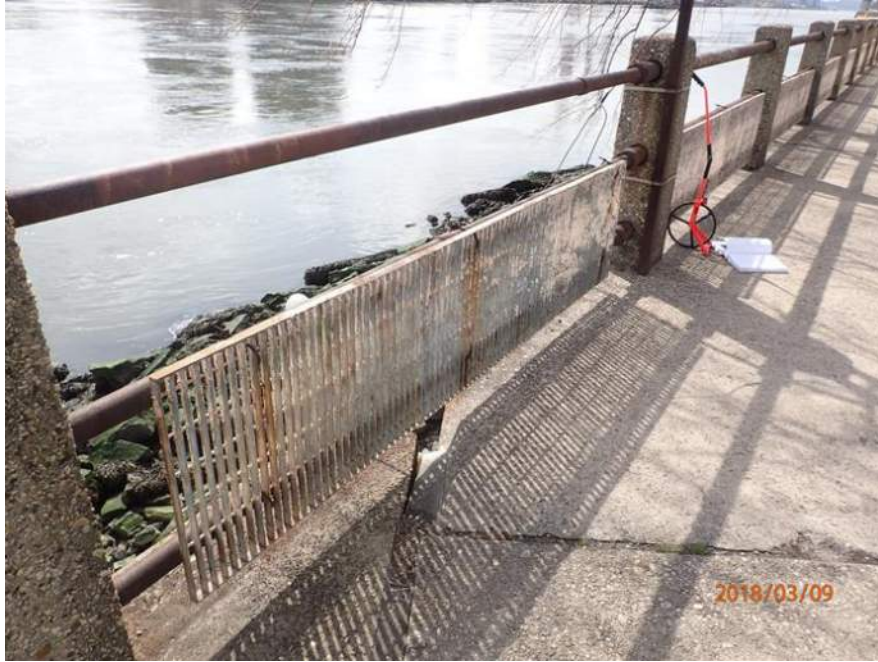
Station 5+18

Comments: Tunnel Terminus from Inland

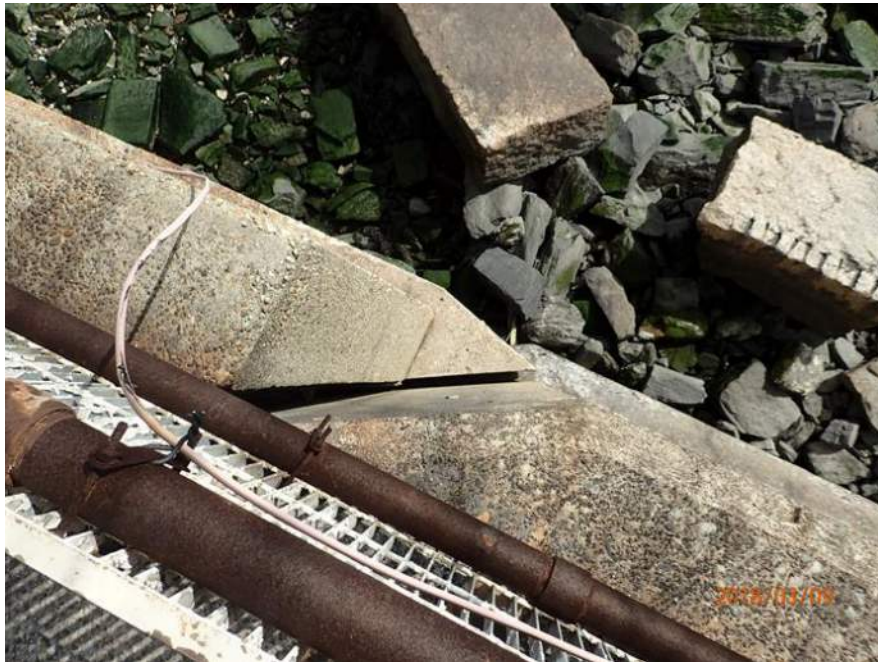
Station 5+18

Comments: Spalling at Haunch

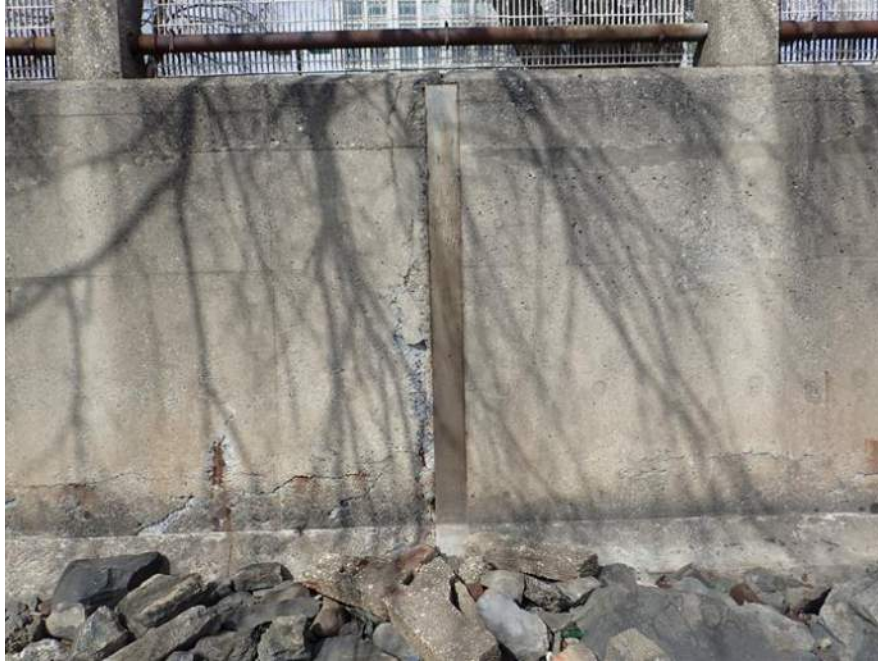
Station 5+40

Comments: Concrete Spalling

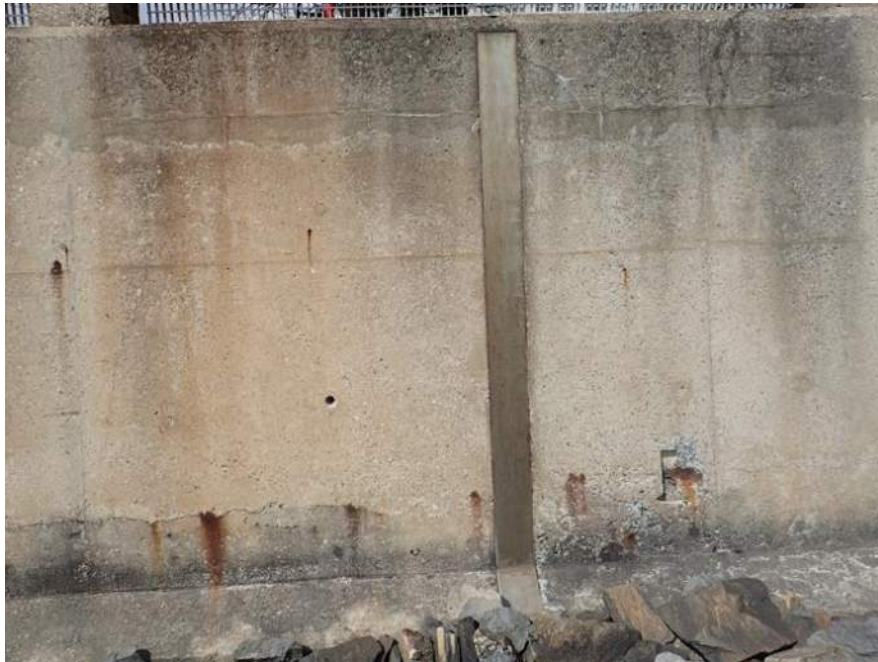
Station 5+60

Comments: Concrete Spalling

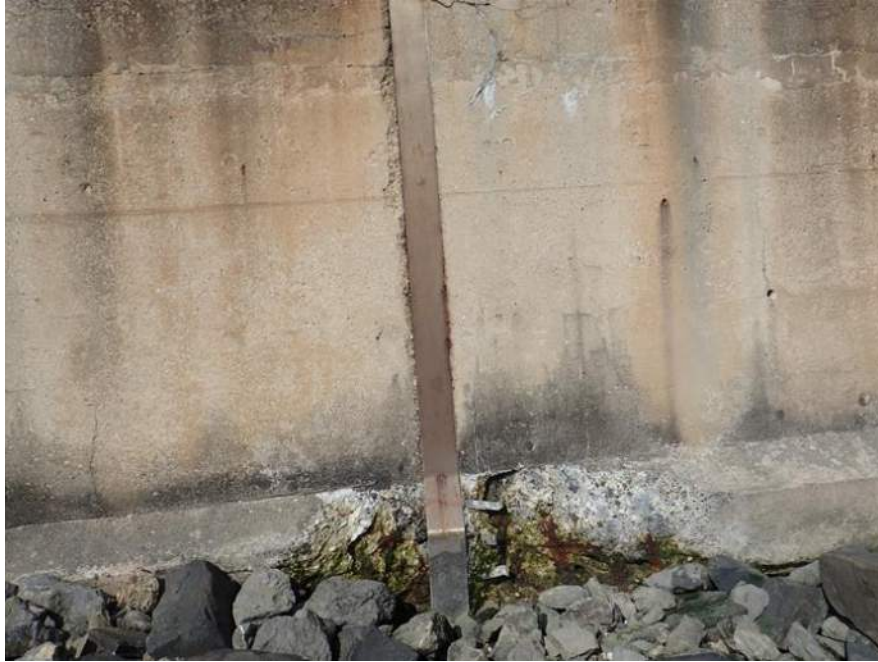
Station 5+94

Comments: Concrete Cracks, Imbedded Wood Missing

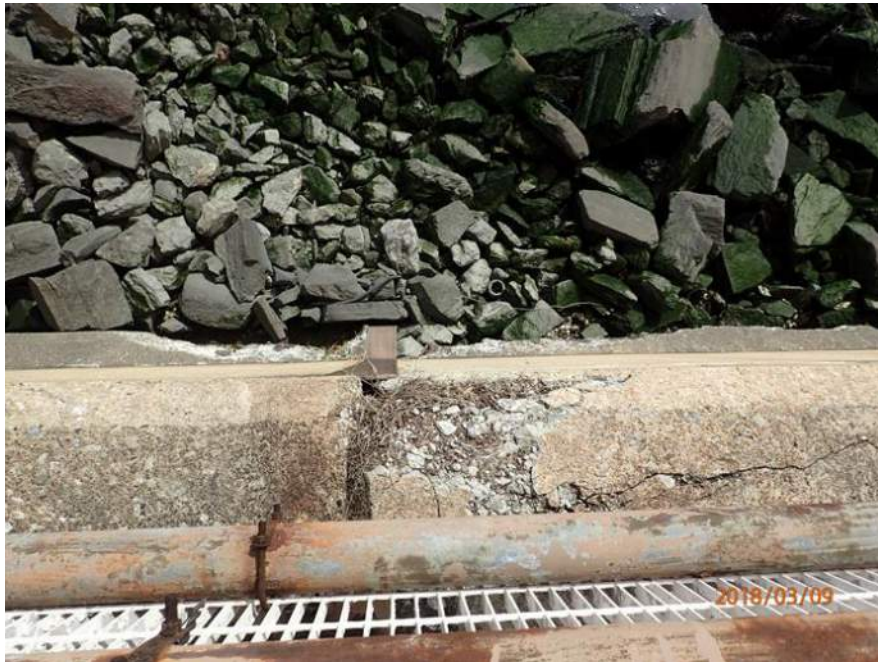
Station 6+60

Comments: Spalling at Haunch, Missing Large Sections of Concrete, Tunnel has been Undermined

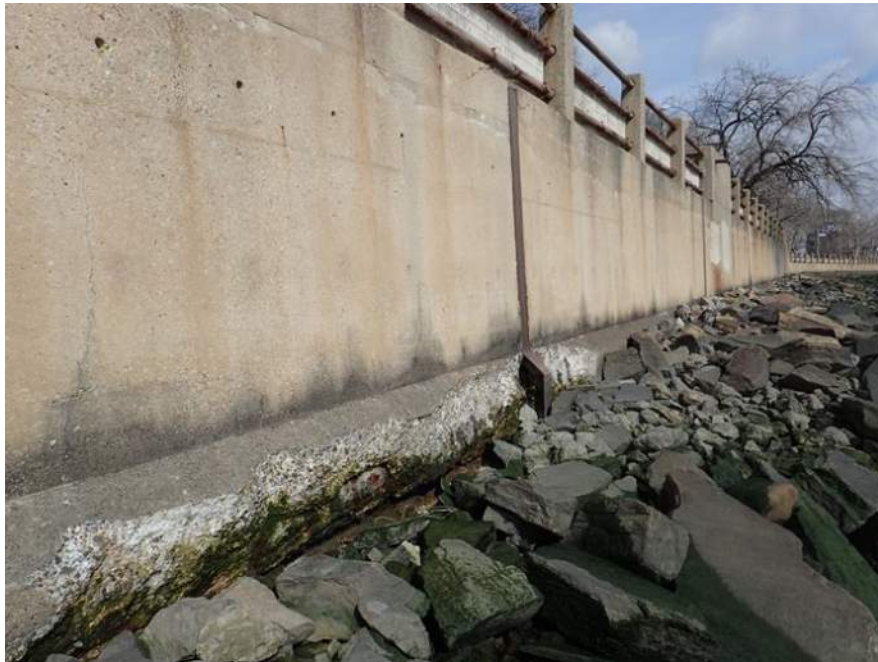
Station 6+60

Comments: Spalling at Haunch, Missing Large Sections of Concrete

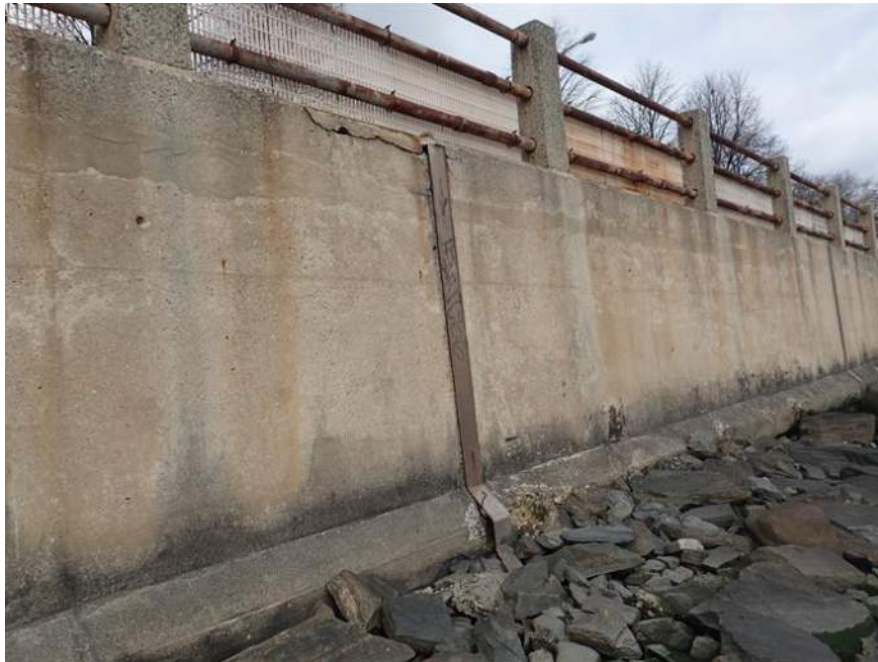
Station 7+26

Comments: Spalling at Haunch, Missing Large Sections of Concrete

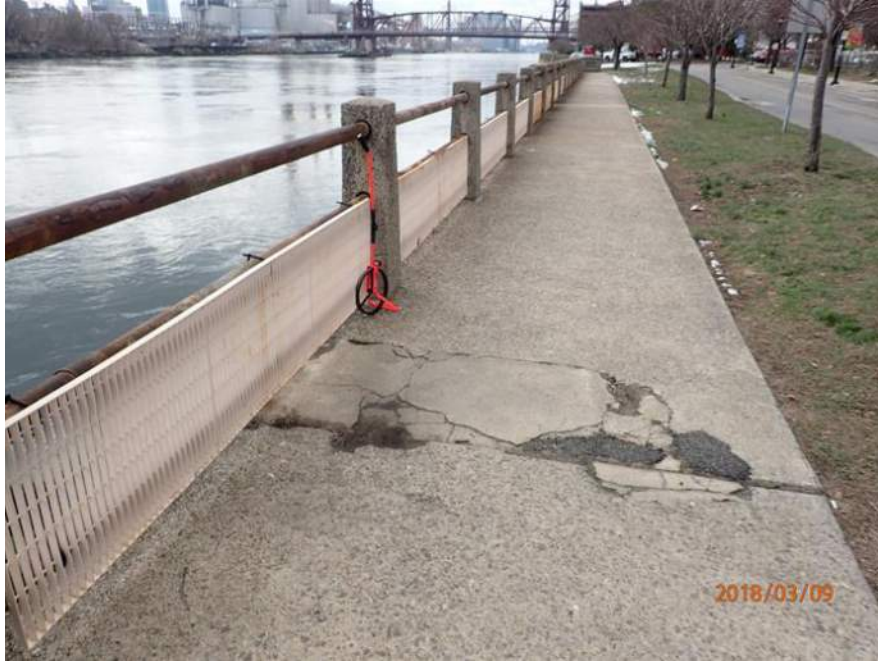
Station 7+26

Comments: Concrete Spalling

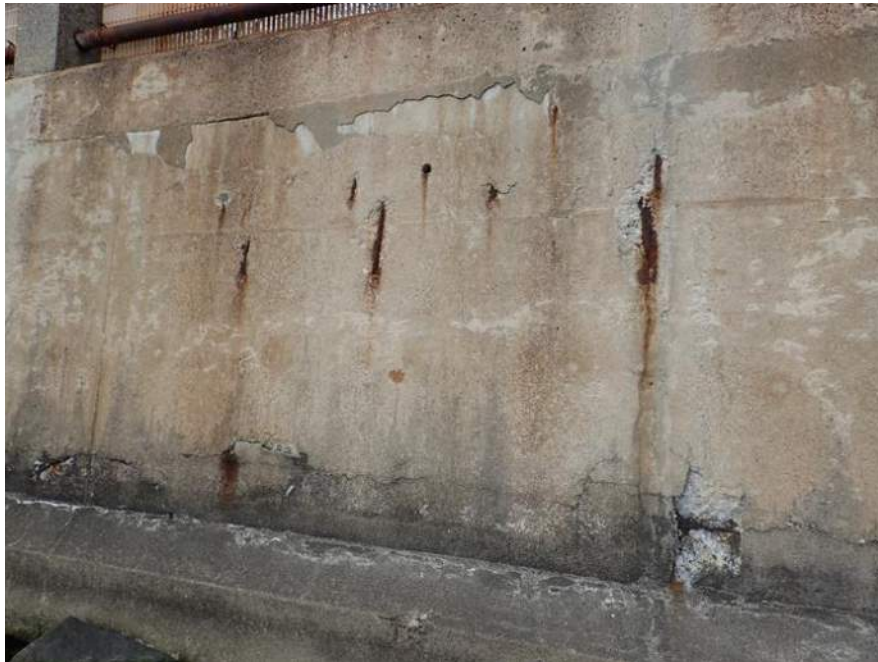
Station 7+68

Comments: Exposed Re-Bar

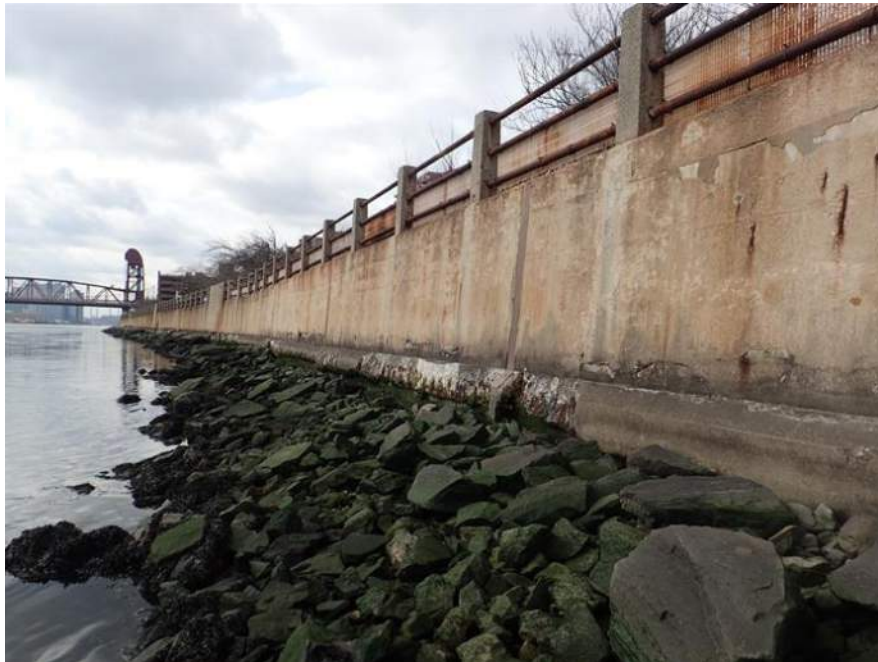
Station 7+99

Comments: Missing Rip-Rap, Tunnel Undermined

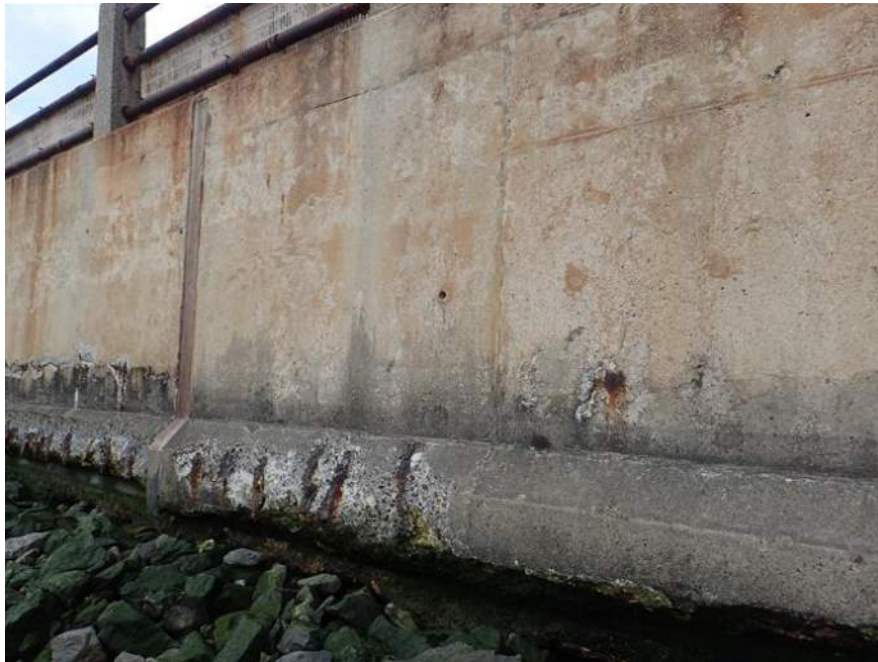
Station 8+28

Direction: Seawall

Comments: Missing Rip-Rap, Tunnel Undermined

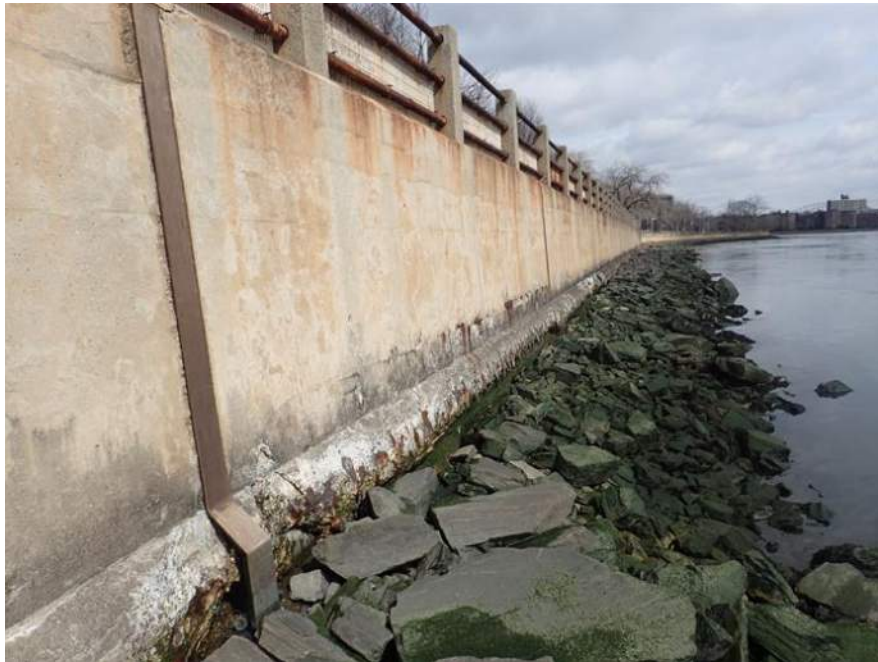
Station 8+49

Direction: Seawall Joint

Comments: Spalling at Haunch, Missing Large Sections of Concrete, Tunnel has been Undermined

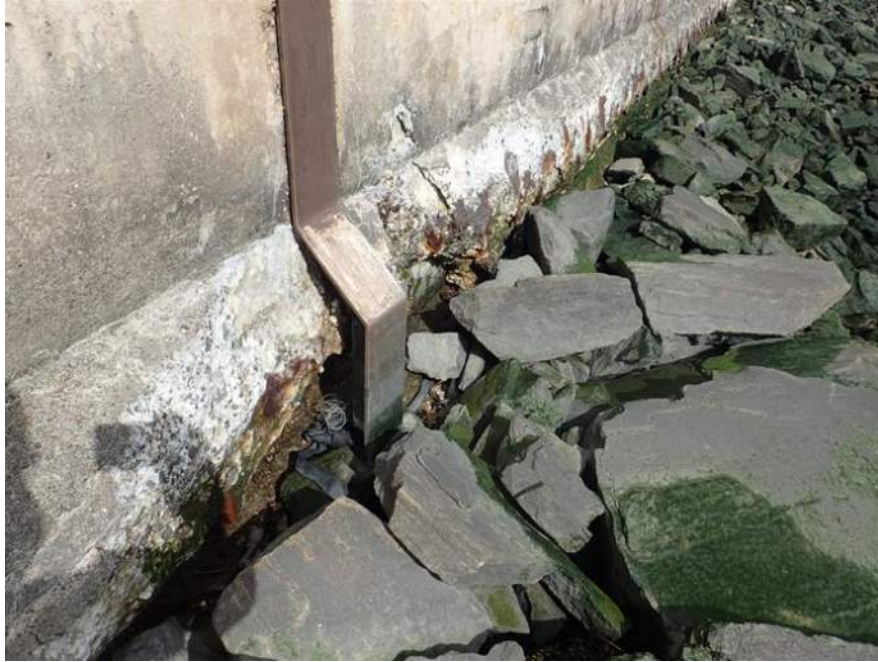
Station 8+49

Direction: Seawall Joint

Comments: Spalling at Haunch, Missing Large Sections of Concrete, Tunnel has been Undermined

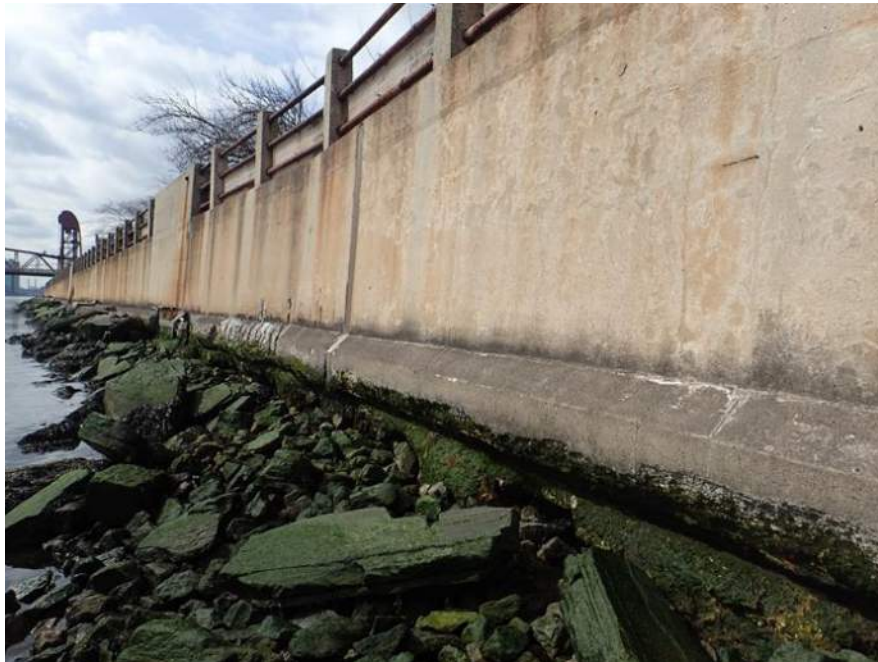
Station 8+80

Direction: Seawall Joint (Looking North)

Comments: Spalling at Haunch, Missing Large Sections of Concrete, Tunnel has been Undermined

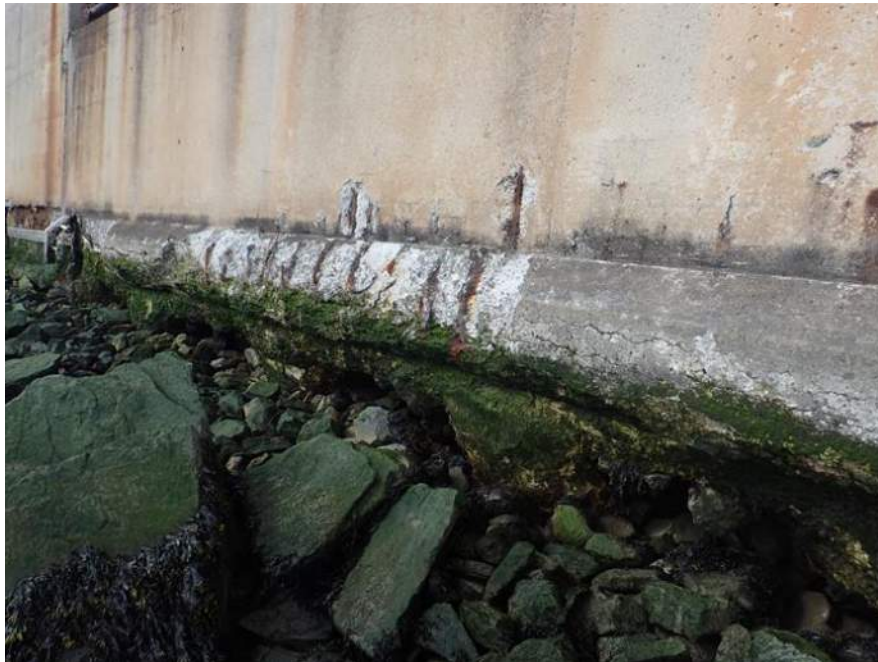
Station 8+97

Direction: Seawall Joint

Comments: Missing Large Concrete Section, Tunnel has been Undermined

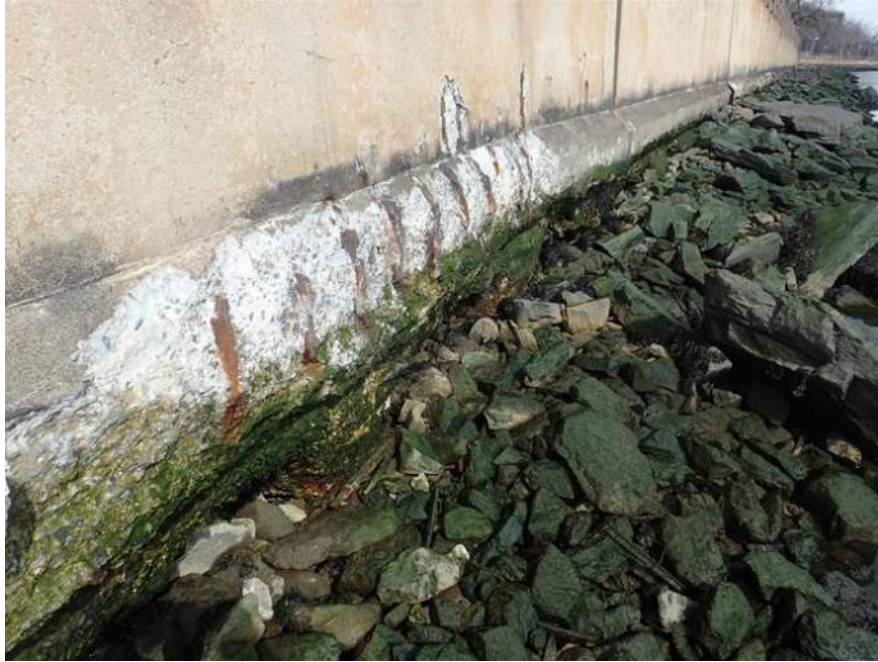
Station 9+10

Direction: Seawall Joint

Comments: Spalling at Haunch, Missing Large Sections of Concrete, Metal Joint Covering Loose

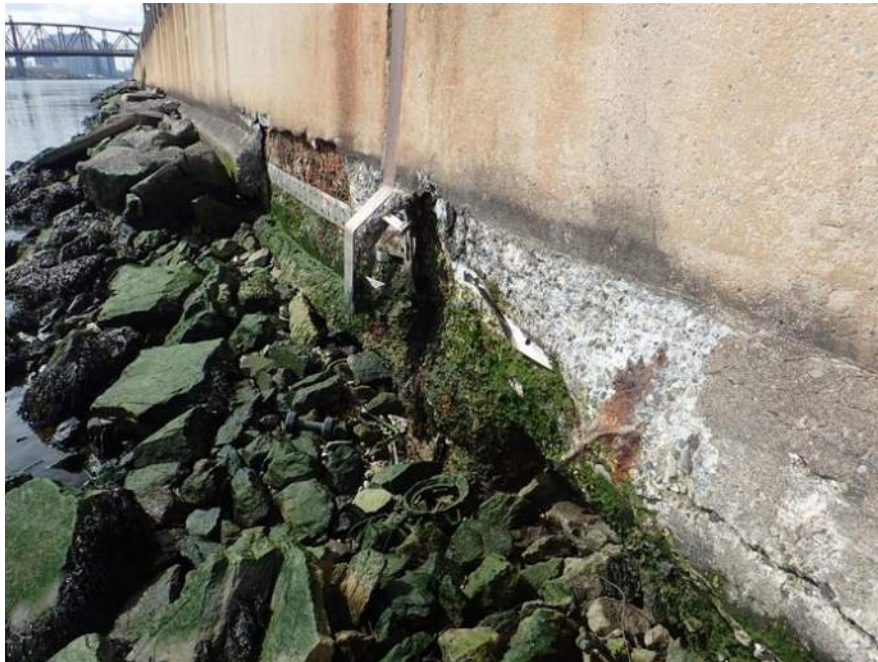
Station 9+21

Direction: Seawall

Comments: Spalling at Haunch, Missing Large Sections of Concrete, Tunnel has been Undermined

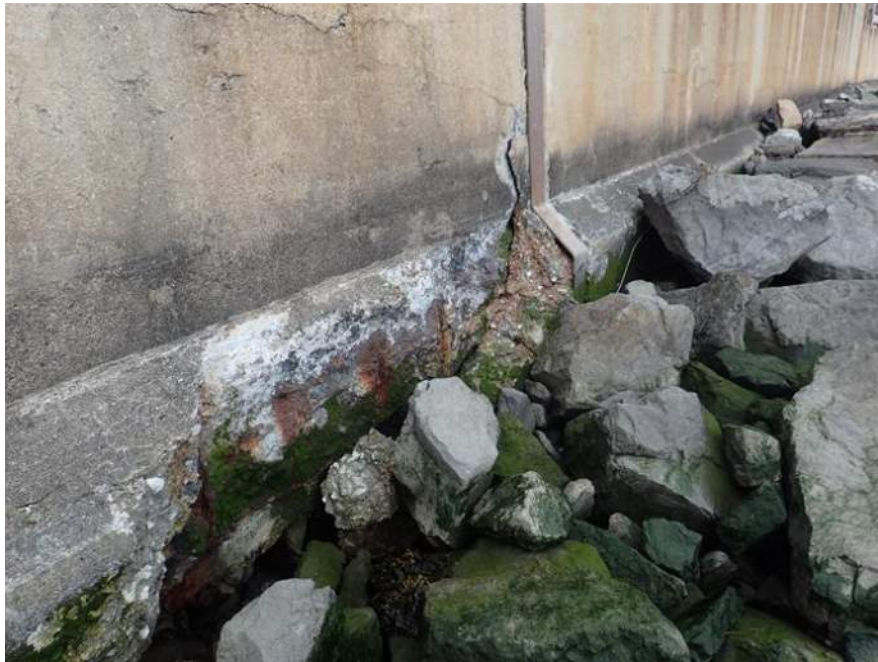
Station 9+82

Direction: Seawall

Comments: Spalling at Haunch, Missing Large Sections of Concrete, Tunnel has been Undermined

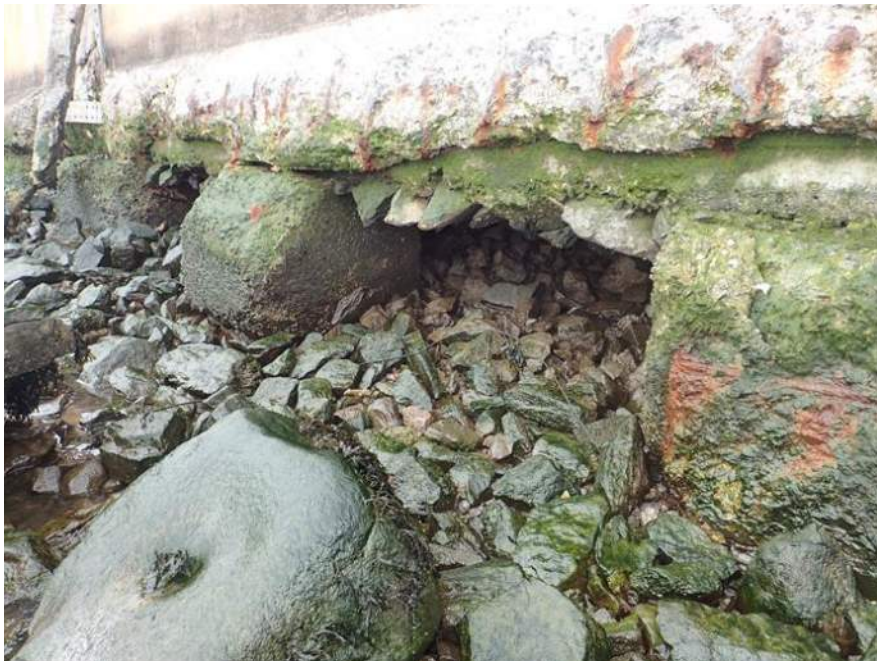
Station 10+43

Direction: Seawall

Comments: Tunnel has been Undermined

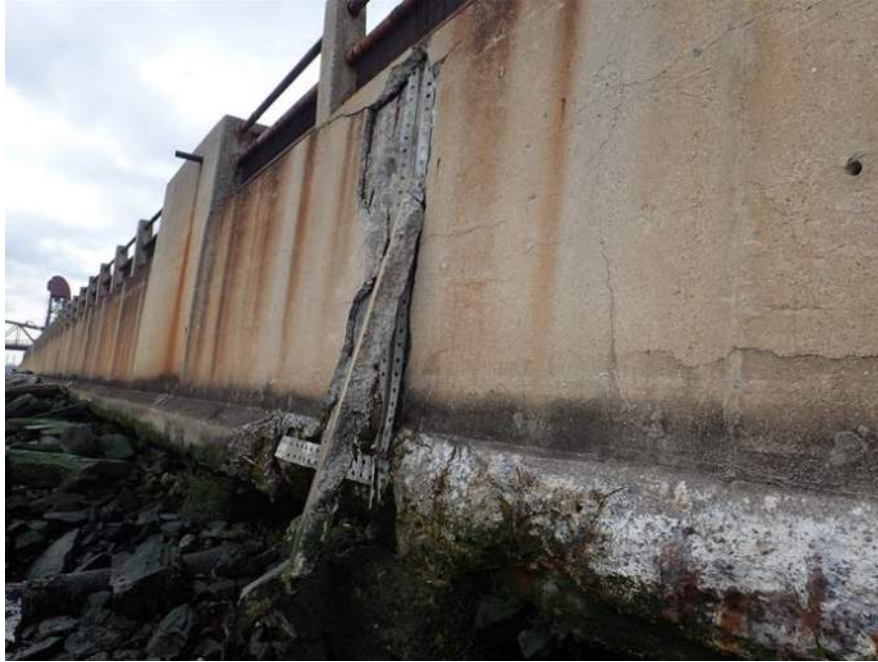
Station 10+57

Direction: Seawall Joint

Comments: Spalling at Haunch, Missing Large Sections of Concrete, Metal Joint Covering Loose
