CONDITIONS REPORT & CONCEPTUAL DESIGN MEMORANDUM

STEAM TUNNEL ASSESSMENT

ROOSEVELT ISLAND, NEW YORK

17 November 2014
Revised 28 December 2018
Revised 18 September 2020
Project # 100444601

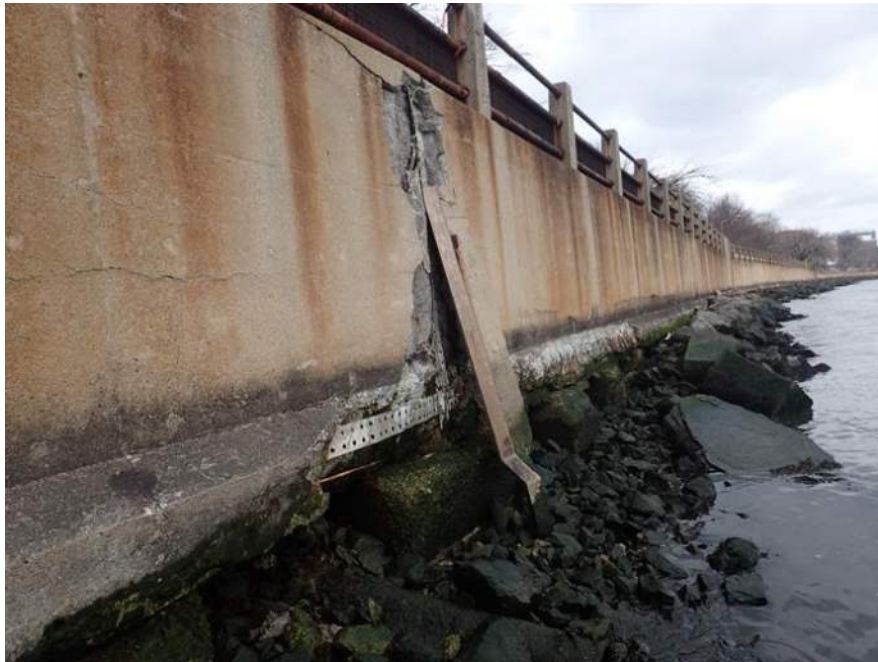
Station 10+57

Direction: Seawall

Comments: Tunnel has been Undermined

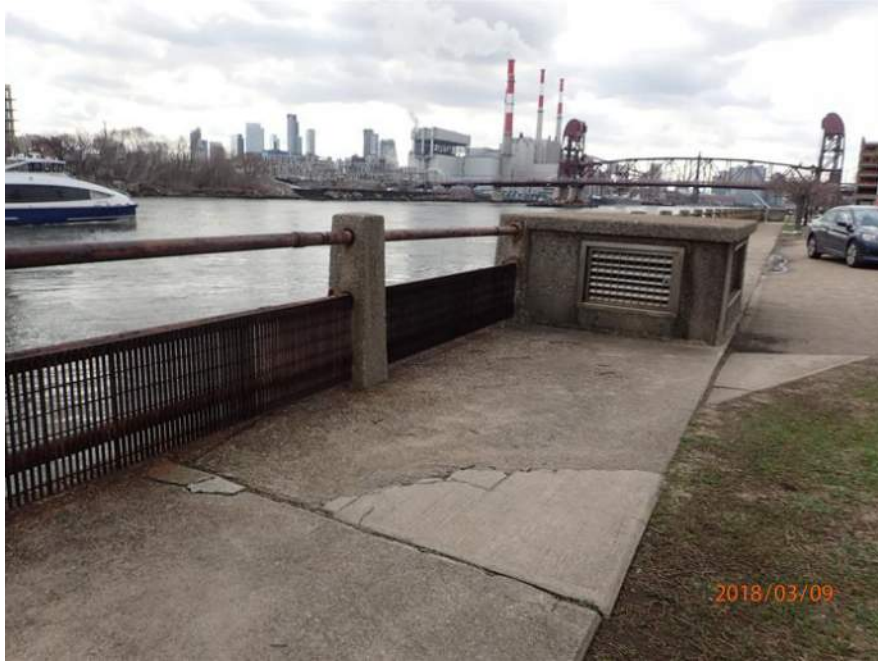
Station 10+57

Direction: Seawall Sidewalk Joint

Comments: Concrete Spalling

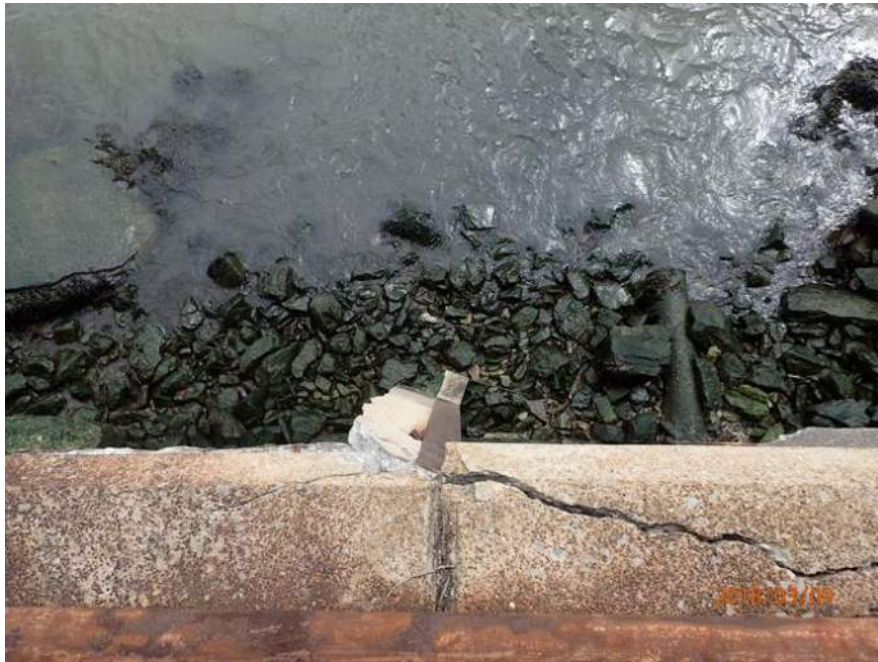
Station 10+57

Direction: Seawall Joint

Comments: Spalling at Haunch, Missing Large Sections of Concrete, Metal Joint Covering Loose

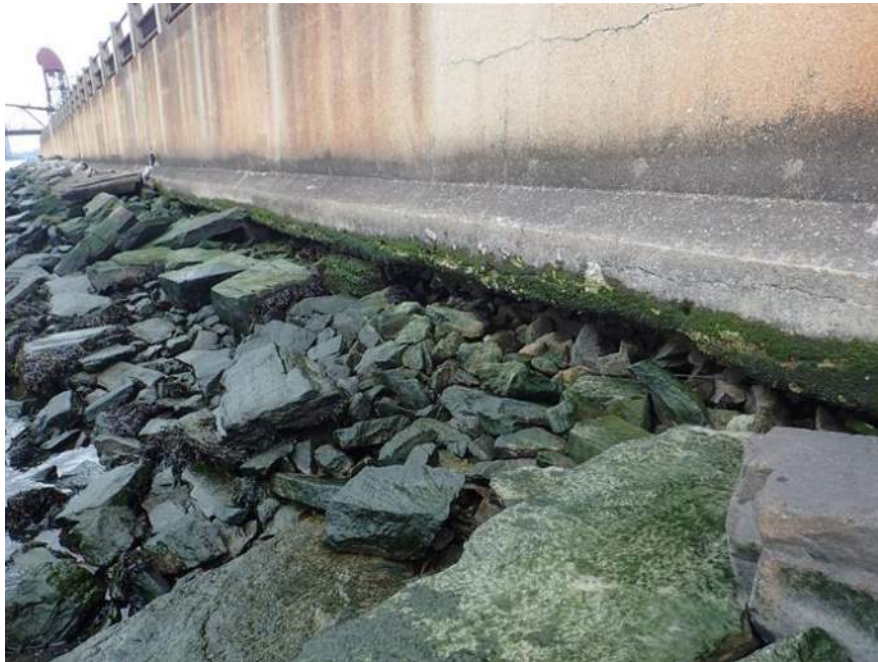
Station 10+63

Direction: Seawall

Comments: Tunnel has been Undermined

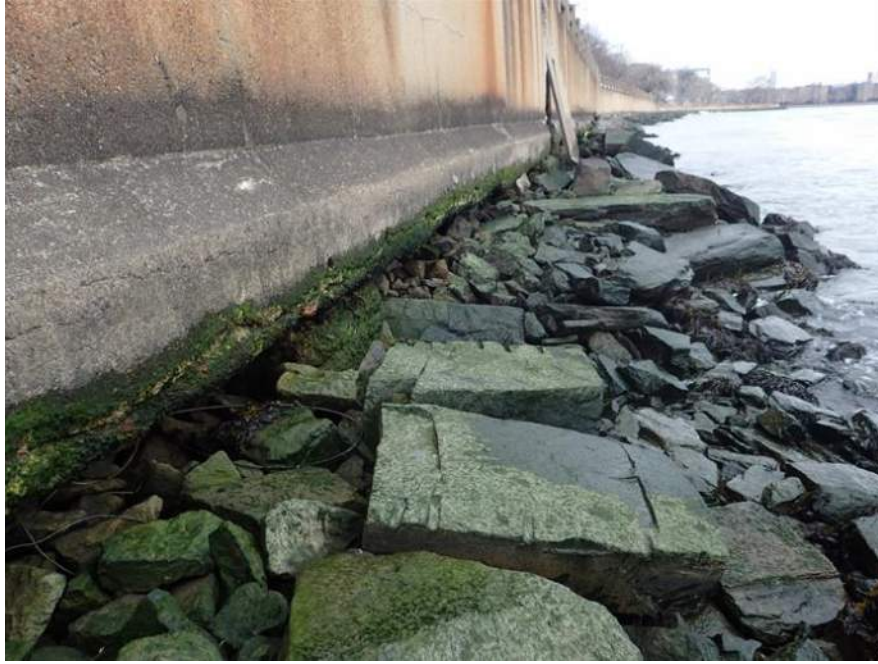
Station 10+72

Direction: Seawall

Comments: Tunnel has been Undermined

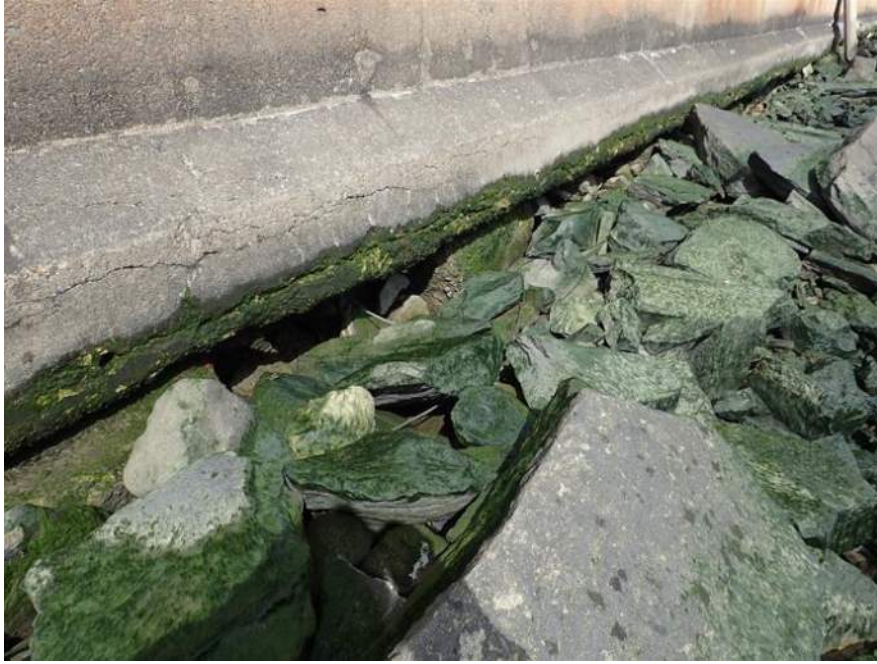
Station 11+06

Direction: Seawall

Comments: Tunnel has been Undermined

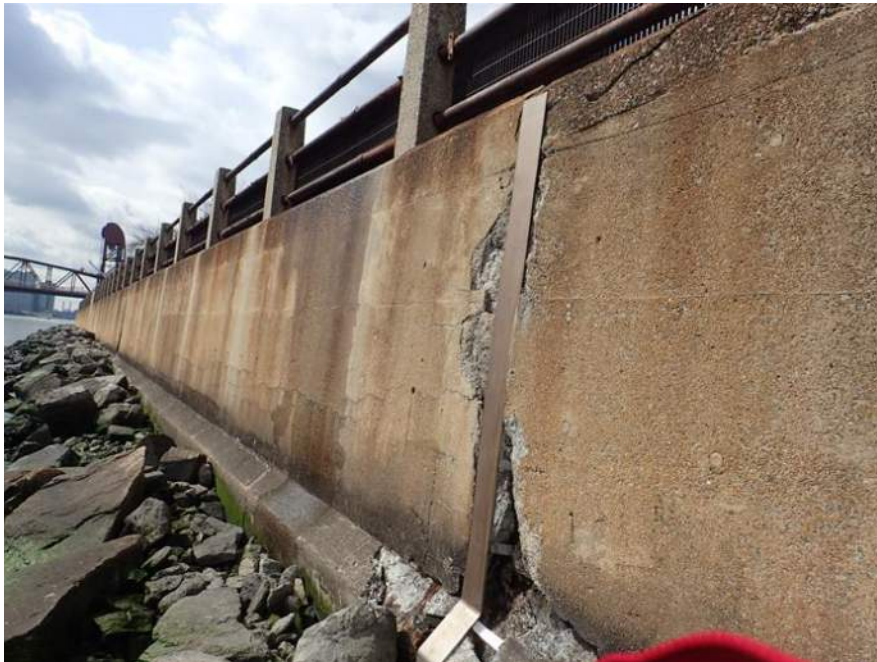
Station 11+19

Direction: Seawall Joint

Comments: Remnant of Timber Formwork

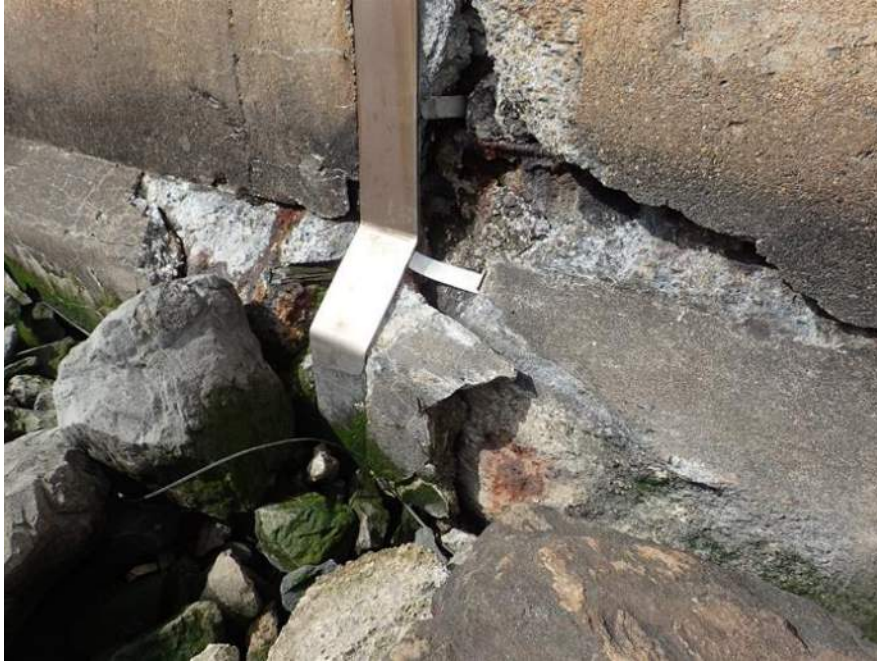
Station 11+19

Direction: Seawall Joint

Comments: Remnant of Timber Formwork

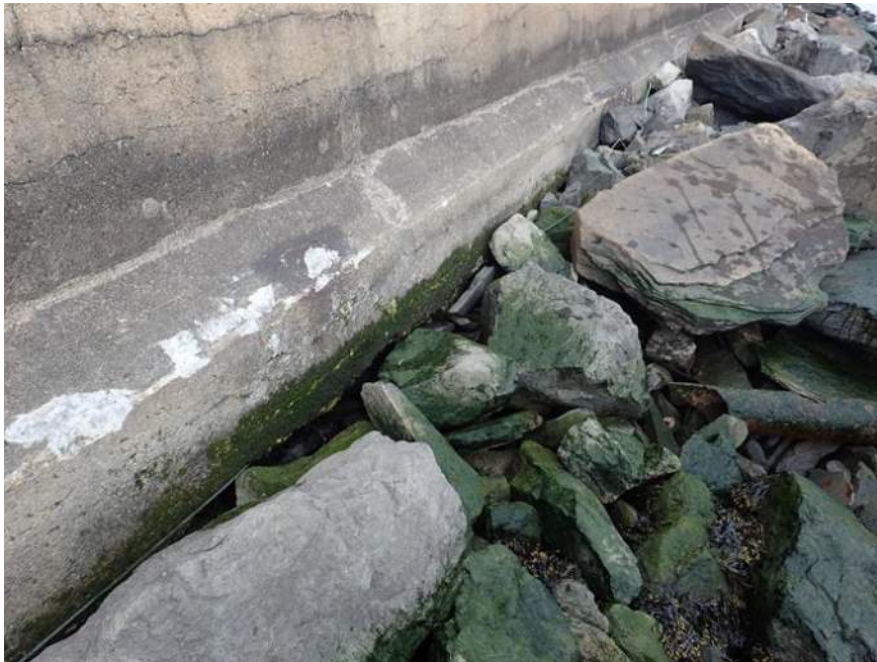
Station 11+66

Direction: Seawall

Comments: Tunnel has been Undermined

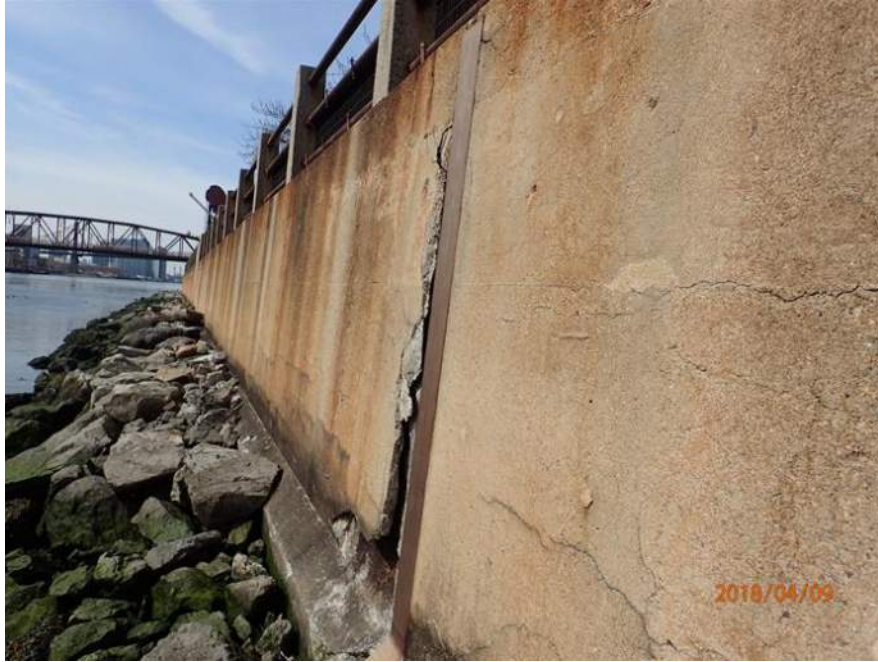
Station 11+83

Direction: Seawall Joint

Comments: Spalling at Haunch, Missing Large Sections of Concrete

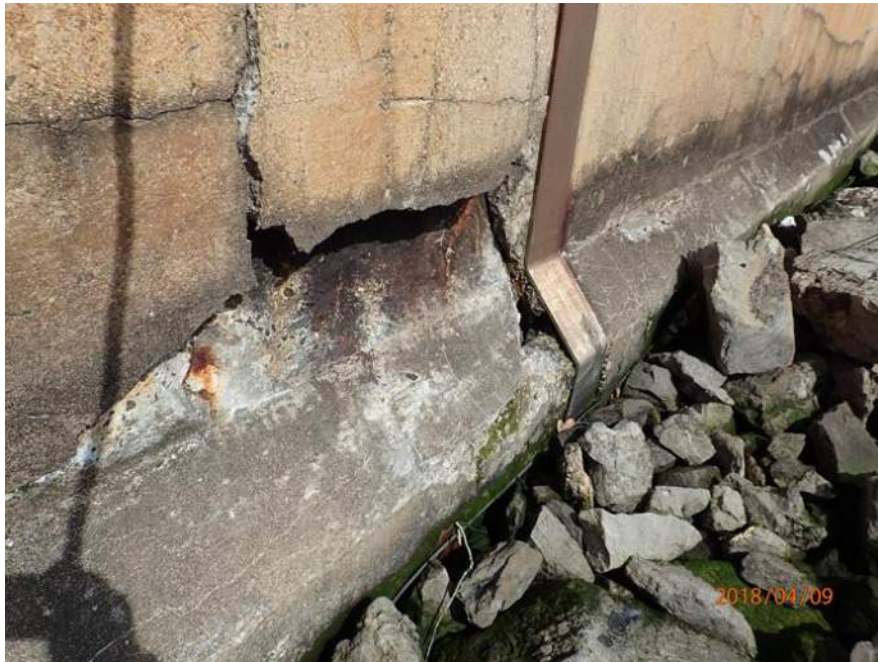
Station 11+83

Direction: Seawall Joint

Comments: Spalling at Haunch, Missing Large Sections of Concrete

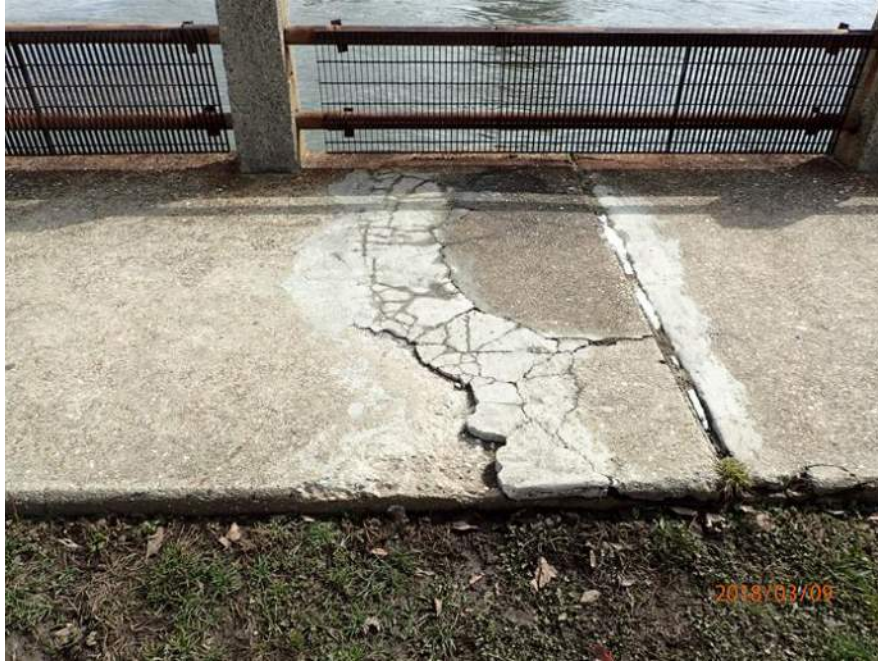
Station 13+03

Direction: Seawall Sidewalk Joint

Comments: Concrete Spalling

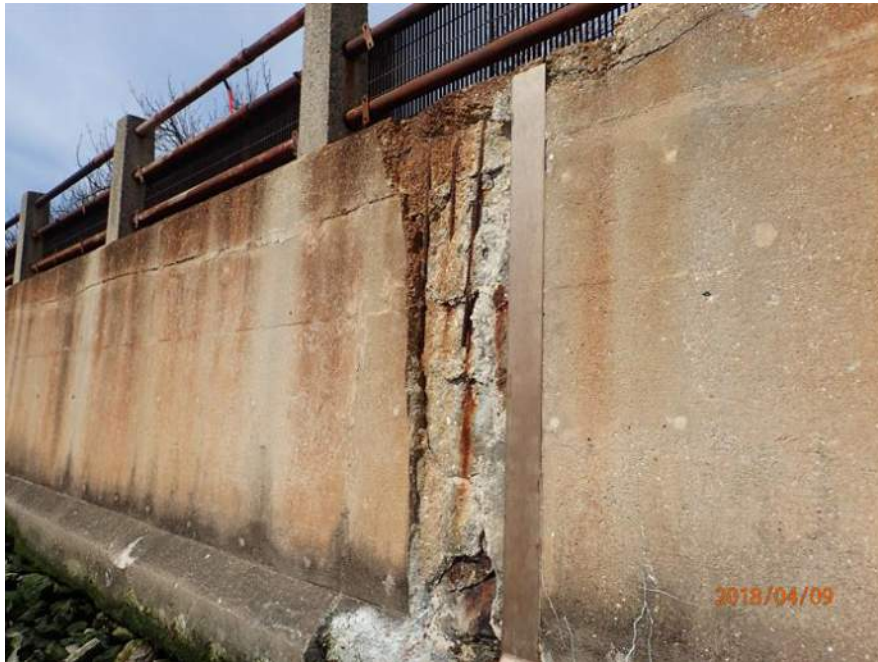
Station 13+10

Direction: Seawall Joint

Comments: Spalling at Haunch, Missing Large Sections of Concrete

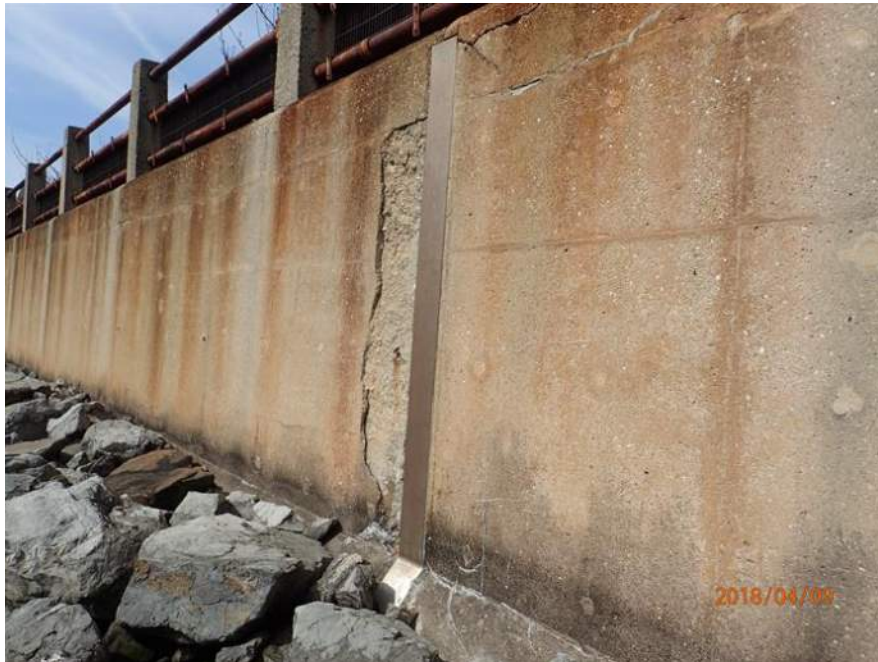
Station 13+27

Direction: Seawall Joint

Comments: Concrete Spalling

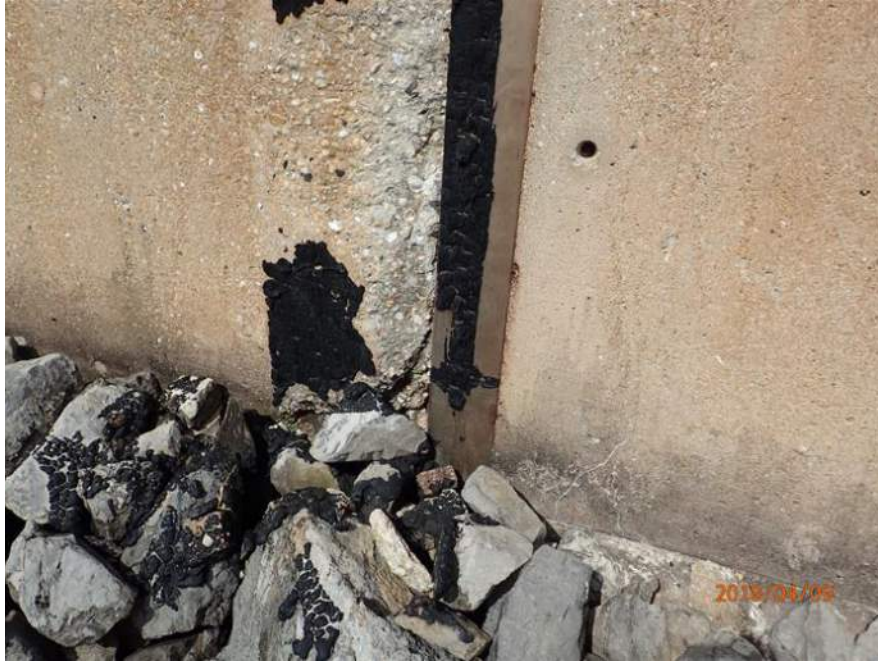
Station 13+74

Direction: Seawall Joint

Comments: Concrete Spalling and Repair

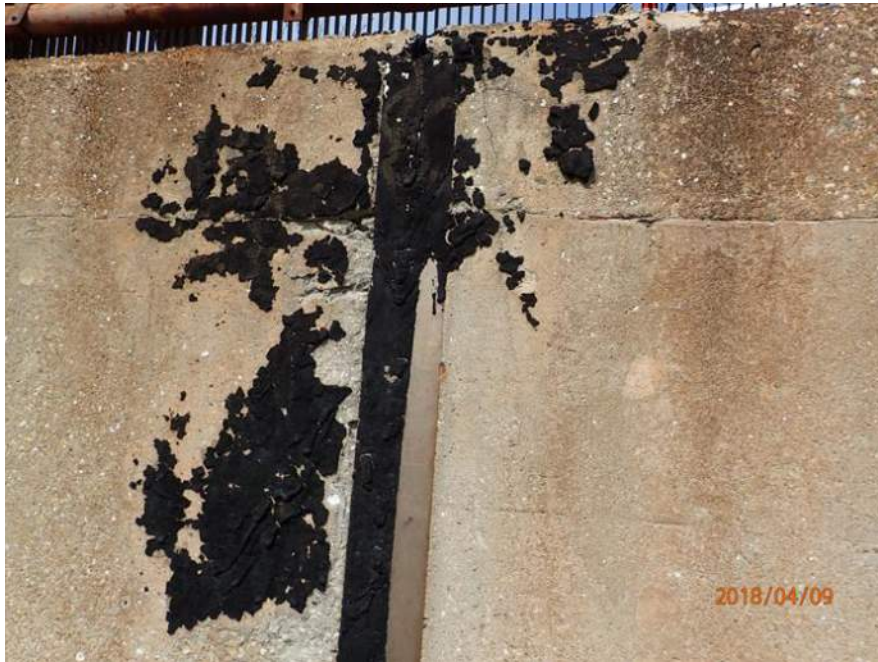
Station 14+37

Direction: Seawall Joint

Comments: Concrete Spalling, Loose Sections of Concrete

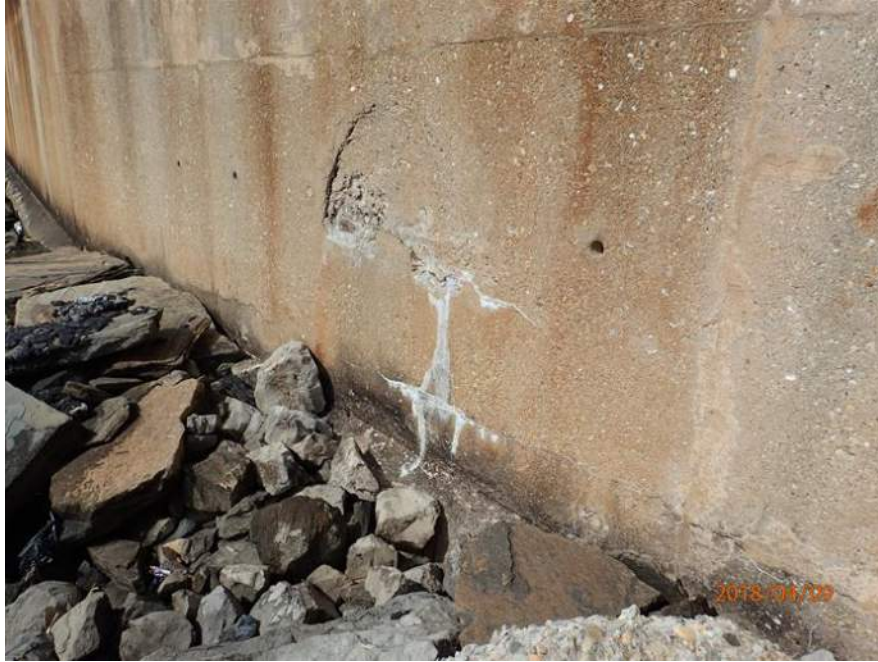
Station 14+50

Direction: Seawall

Comments: Concrete Spalling

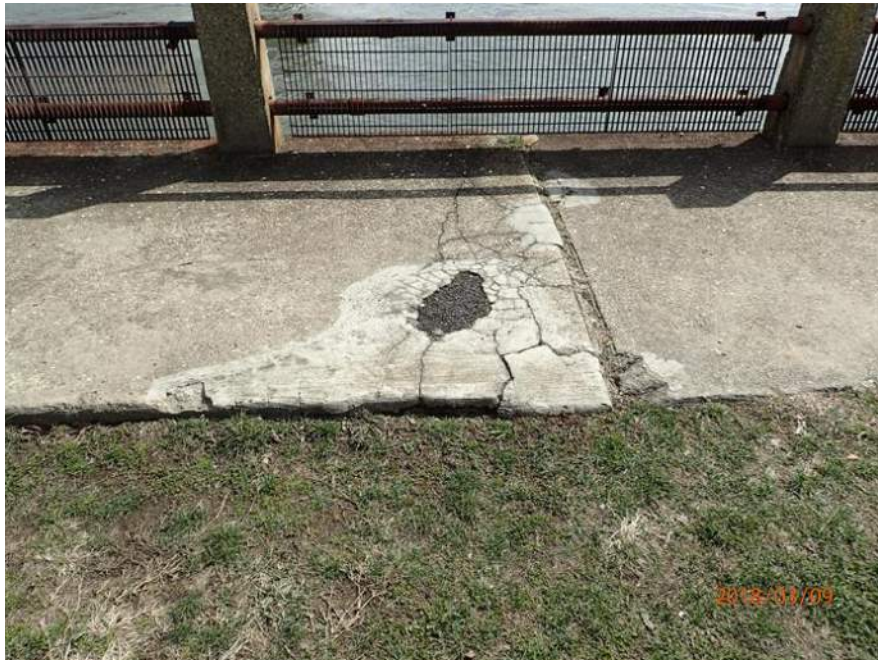
Station 10+57

Direction: Seawall Sidewalk Joint

Comments: Concrete Cracks, Loose Sections of Concrete

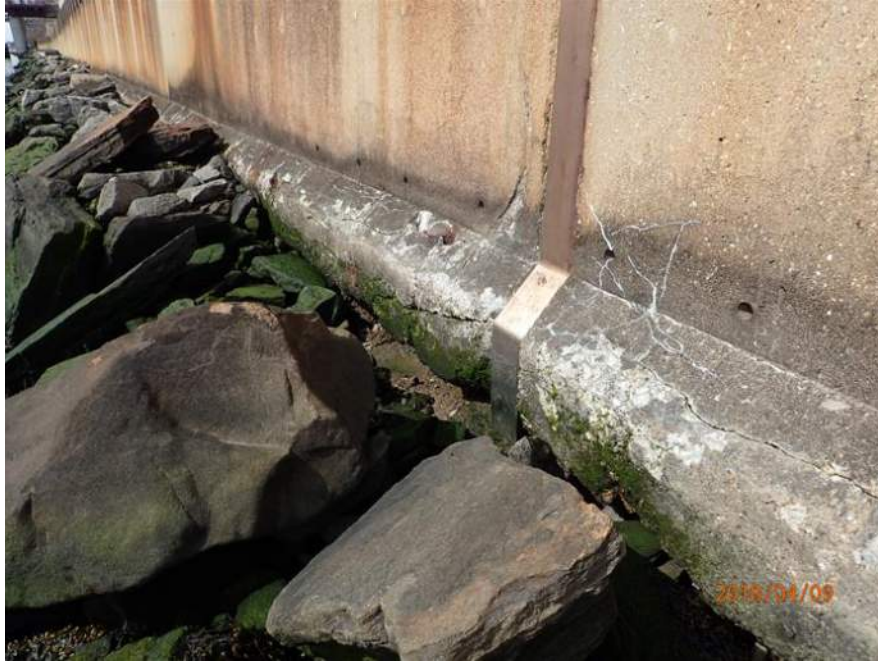
Station 15+06

Direction: Seawall Joint

Comments: "Concrete Spalling, Loose Sections of Concrete, Tunnel has been Undermined."

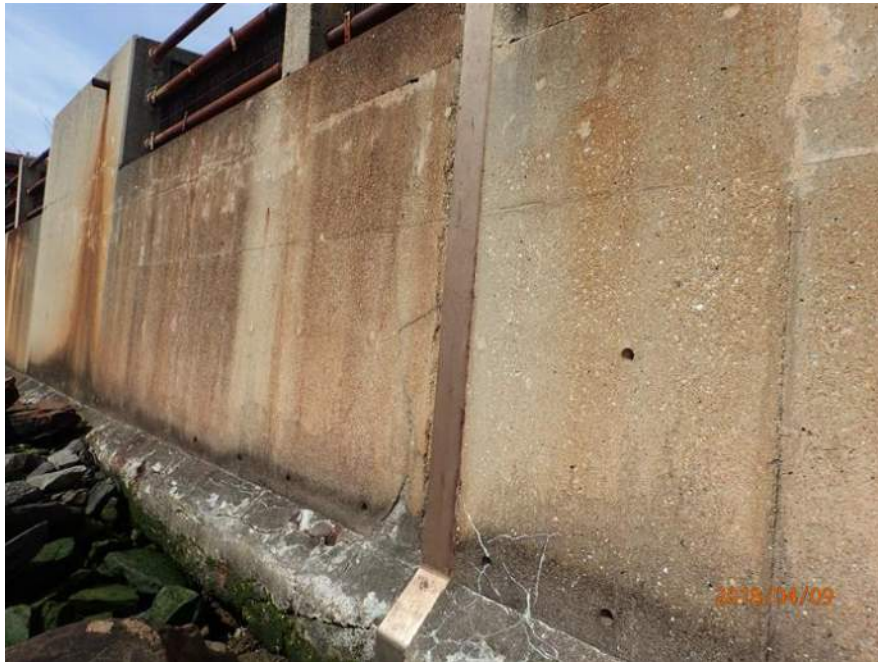
Station 15+06

Direction: Seawall Joint

Comments: Spalling along Joint and Haunch, Loose Concrete

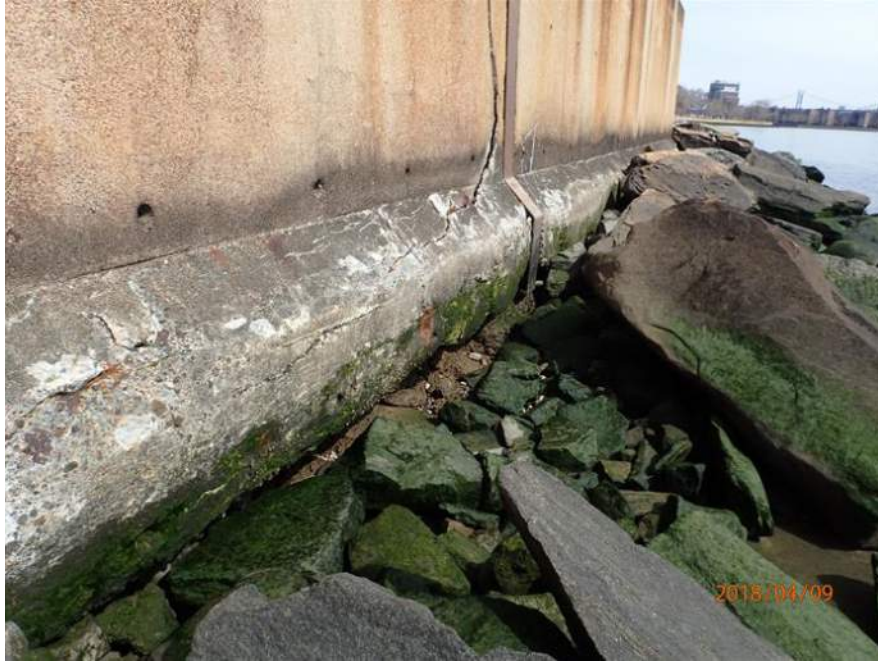
Station 15+06

Direction: Seawall Joint

Comments: Spalling along Joint and Haunch, Loose Concrete

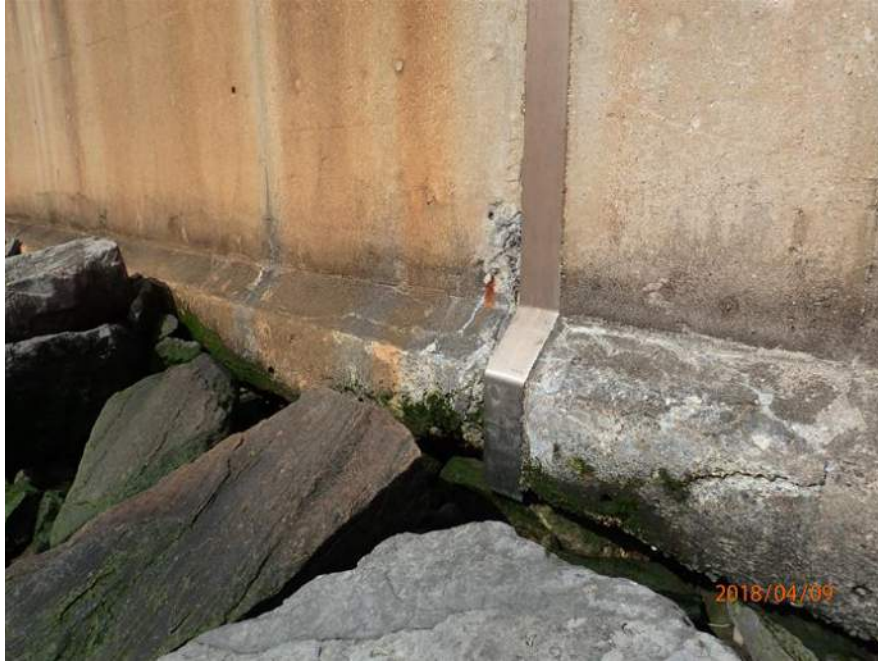
Station 15+40

Direction: Seawall Joint

Comments: Concrete Spalling, Exposed Re-bar

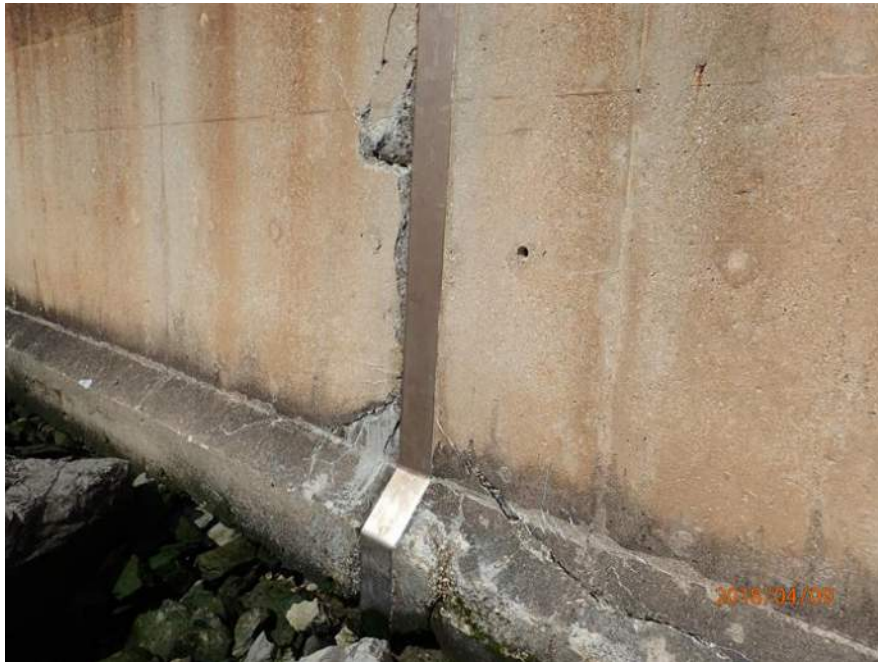
Station 15+63

Direction: Seawall Joint

Comments: Concrete Spalling, Exposed Re-bar

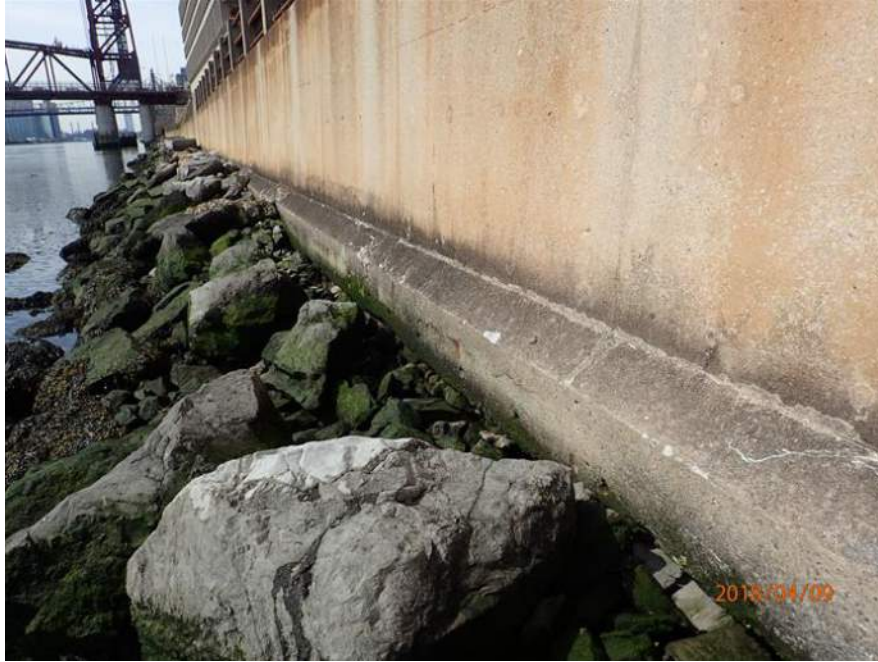
Station 15+63

Direction: Seawall

Comments: Tunnel has been Undermined

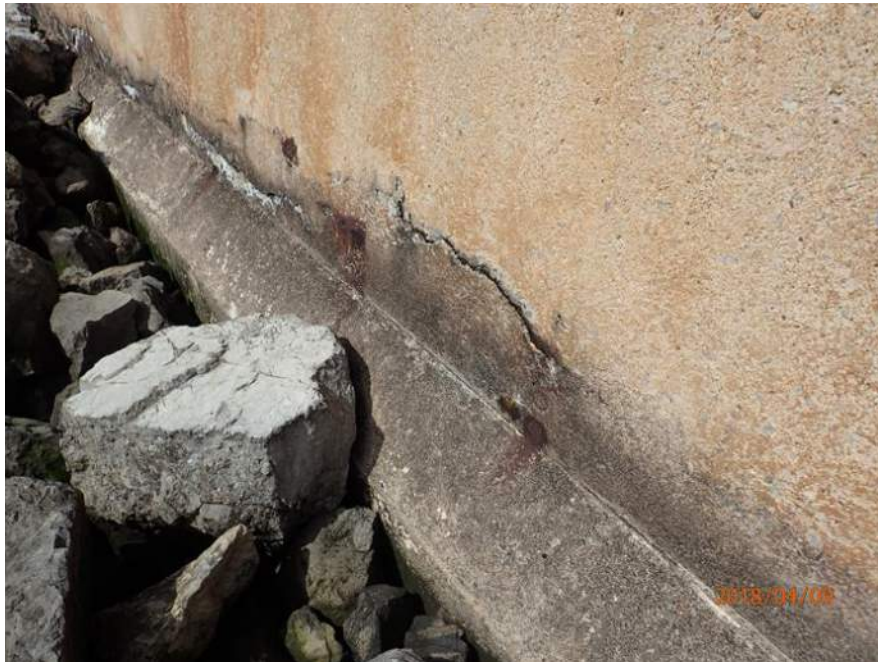
Station 16+00

Direction: Seawall

Comments: Concrete Spalling

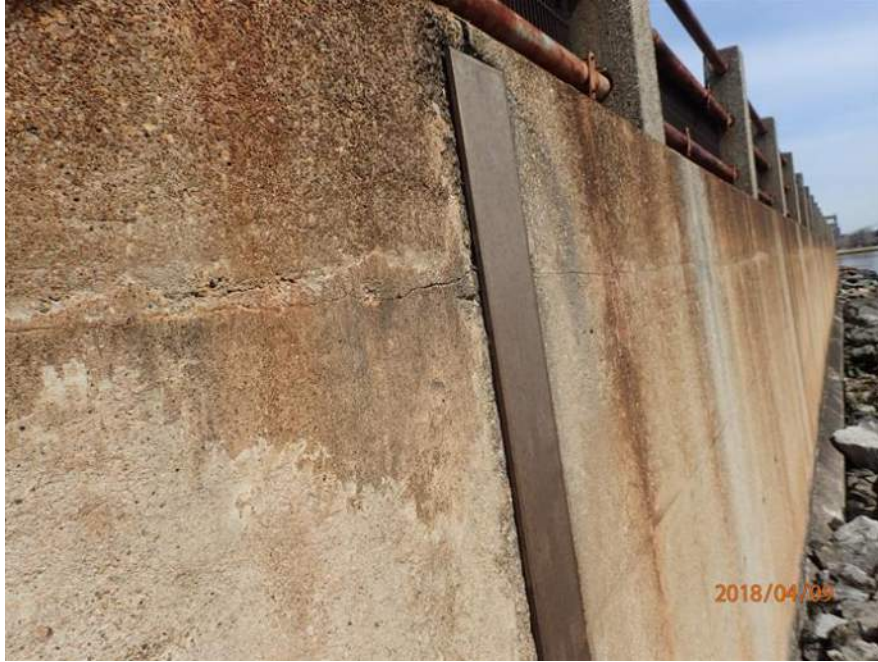
Station 16+23

Direction: Seawall Joint

Comments: Concrete Spalling, Missing Large Section of Concrete, Re-Bar Exposed

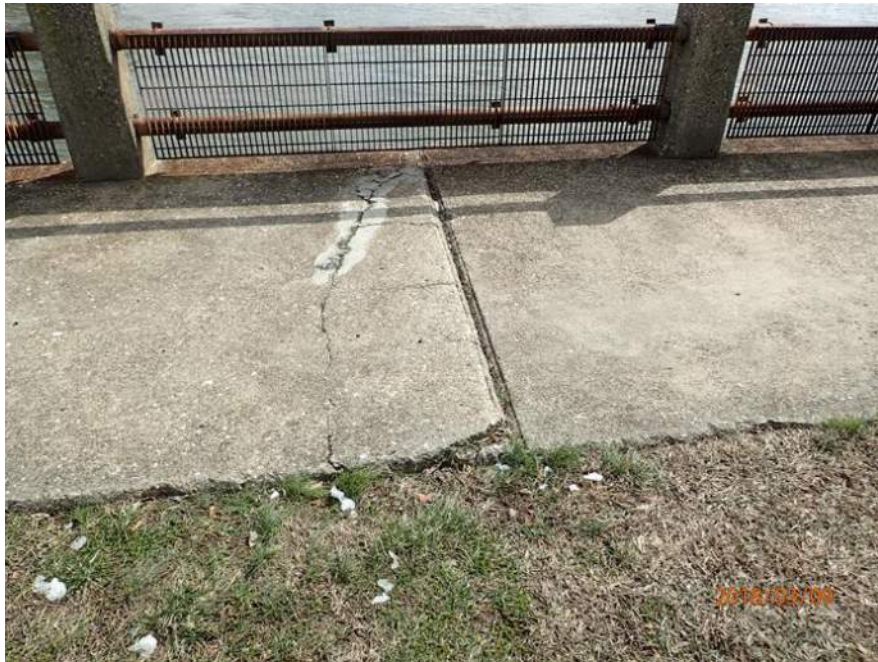
Station 16+37

Direction: Seawall Sidewalk Joint

Comments: Concrete Cracks

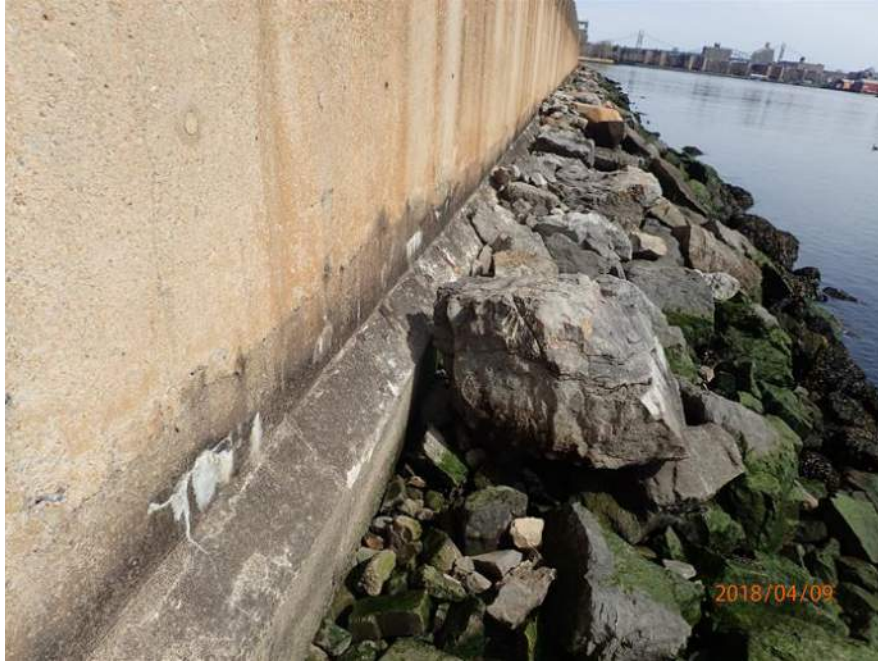
Station 17+55 to 17+65

Direction: Seawall

Comments: Concrete Spalling

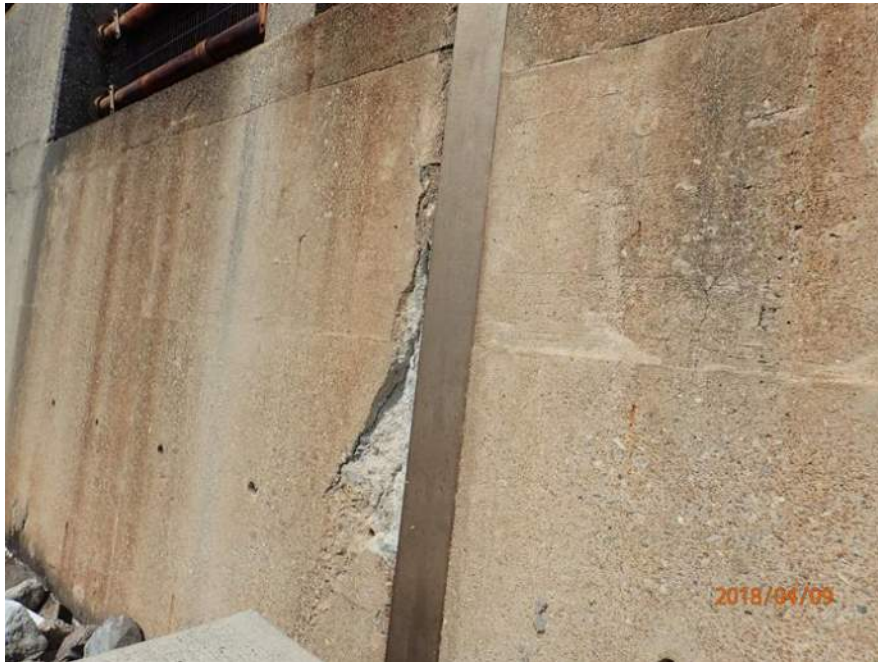
Station 17+66

Direction: Seawall Joint

Comments: Concrete Spalling, Missing Large Section of Concrete, Re-Bar Exposed

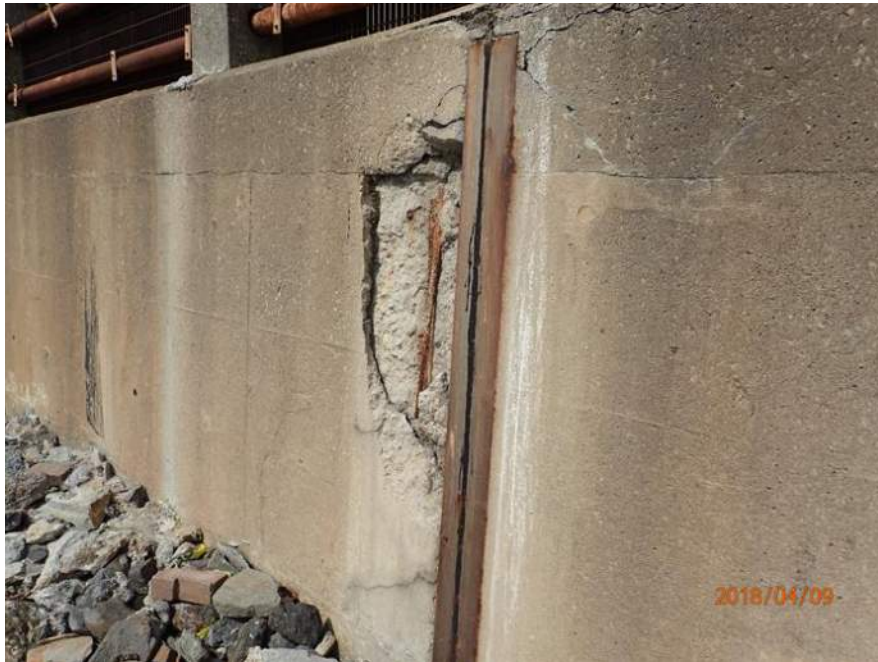
Station 17+85

Direction: Seawall Joint

Comments: Concrete Spalling, Missing Large Section of Concrete, Re-Bar Exposed

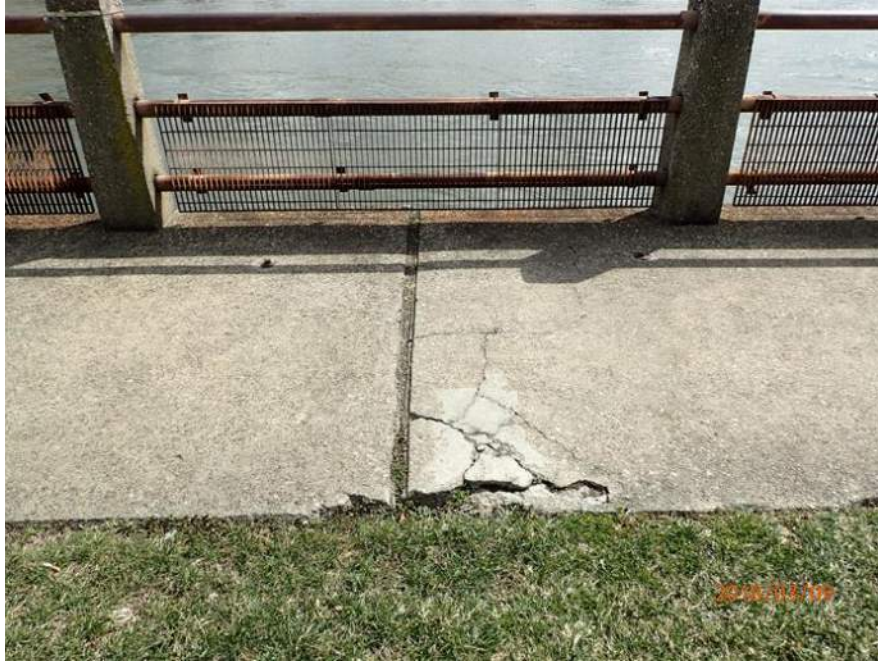
Station 18+10

Direction: Seawall Sidewalk Joint

Comments: Concrete Cracks

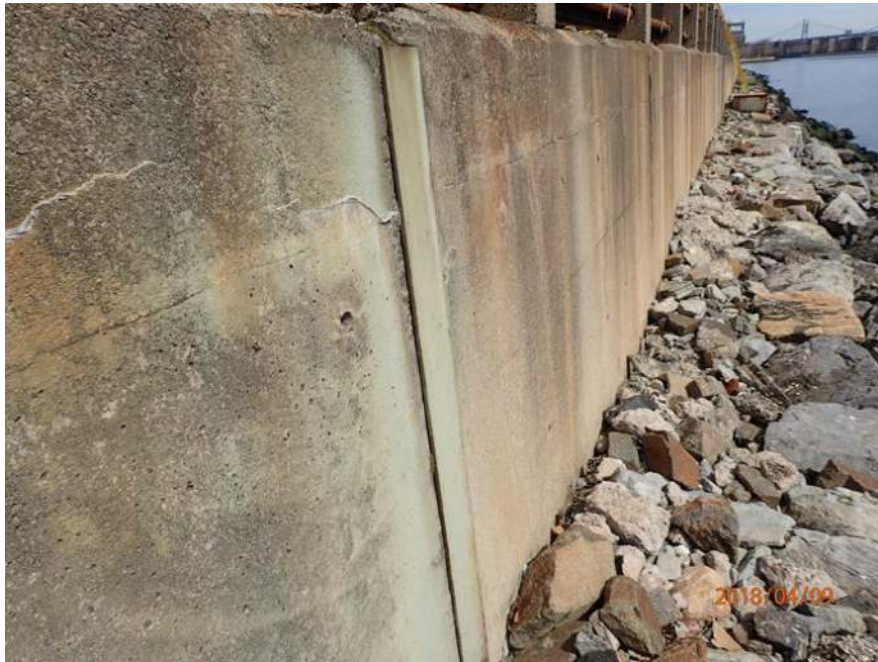
Station 18+82

Direction: Seawall Joint

Comments: Concrete Spalling, Exposed Re-bar, Cracks about 3-inches Deep

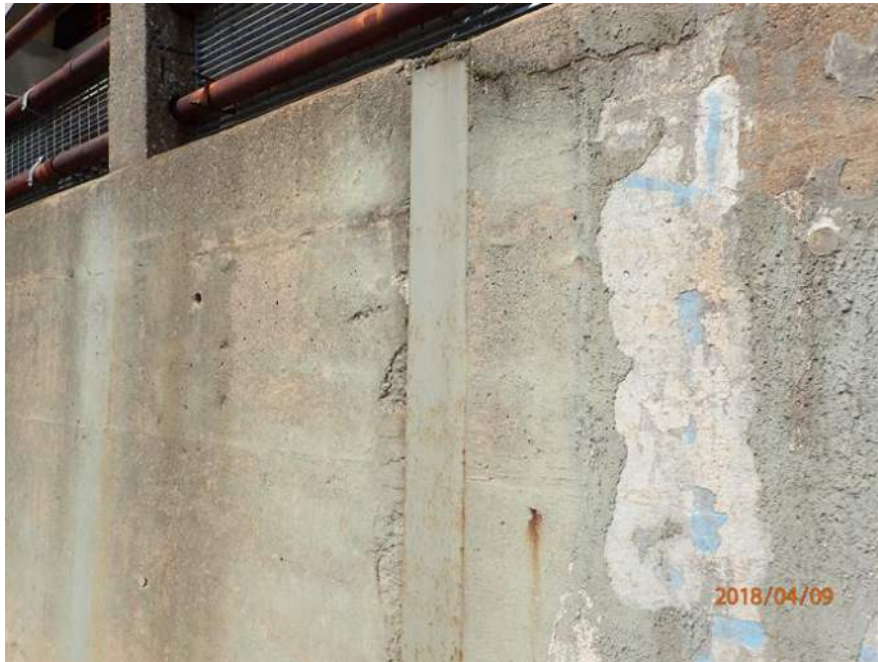
Station 20+09

Direction: Seawall Joint

Comments: Concrete Spalling

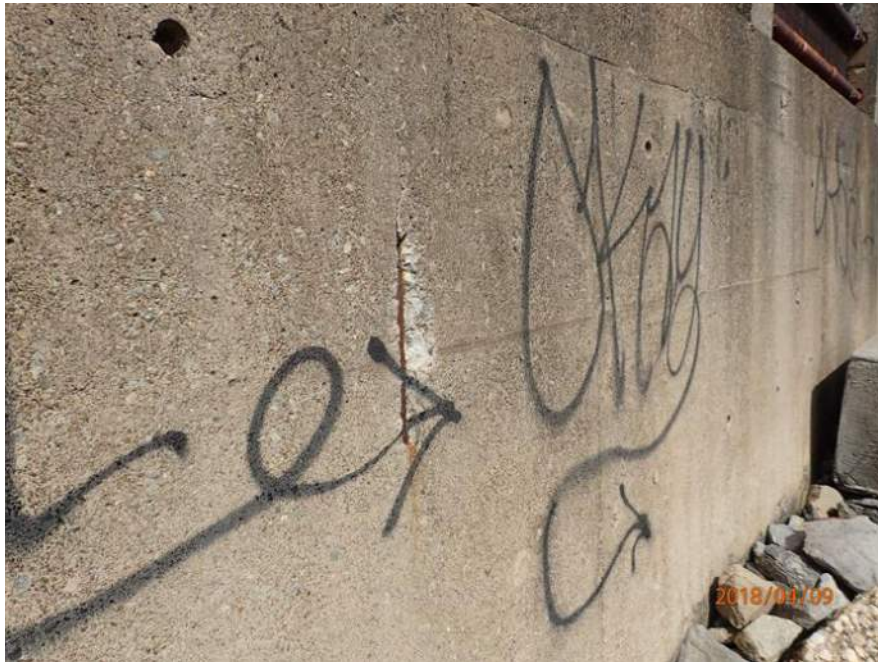
Station 20+45

Direction: Seawall

Comments: Exposed Re-Bar

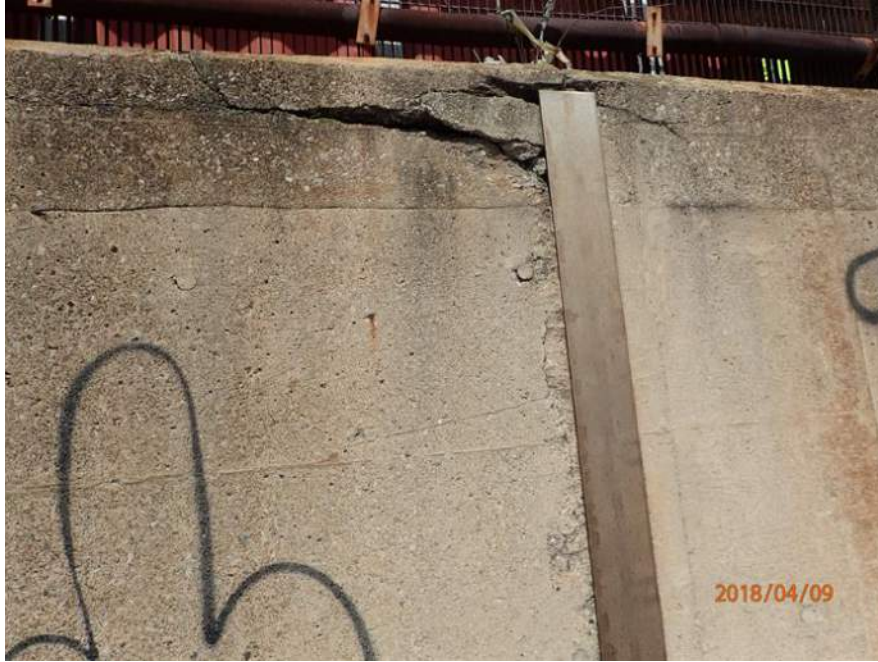
Station 20+73

Direction: Seawall Joint

Comments: Concrete Spalling and repair

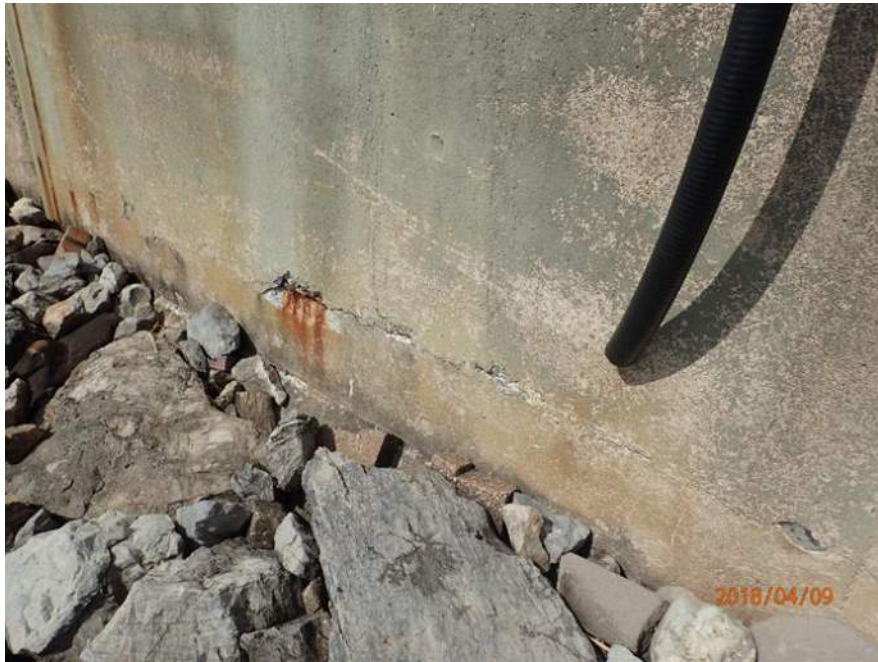
Station 21+23

Direction: Seawall

Comments: Exposed Re-Bar

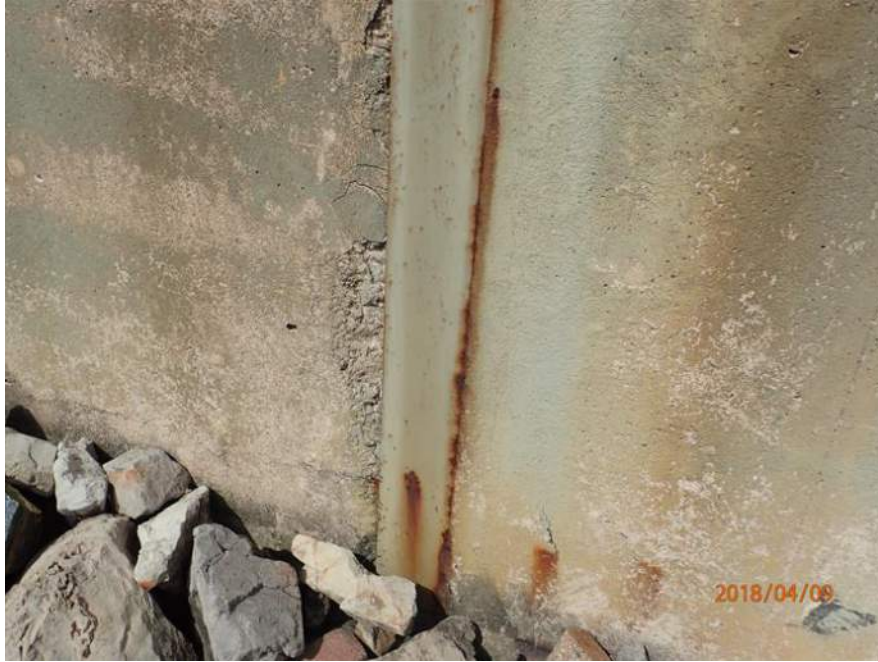
Station 21+33

Direction: Seawall Joint

Comments: Concrete Spalling, Missing Large Section of Concrete, Re-Bar Exposed

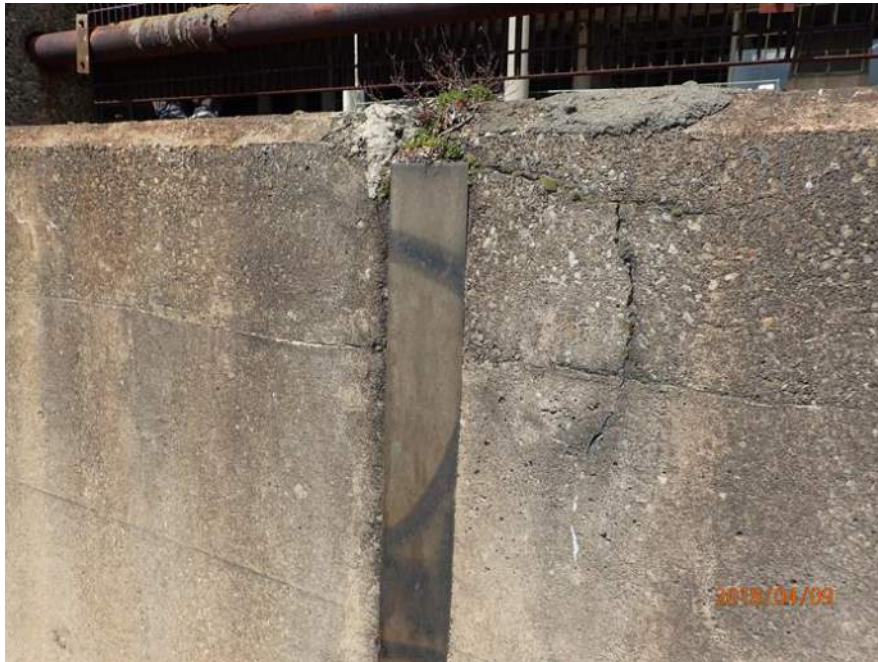
Station 21+33

Direction: Seawall Joint

Comments: Concrete Spalling, Missing Large Section of Concrete, Re-Bar Exposed
