CONDITIONS REPORT & CONCEPTUAL DESIGN MEMORANDUM

STEAM TUNNEL ASSESSMENT

ROOSEVELT ISLAND, NEW YORK

17 November 2014
Revised 28 December 2018
Revised 18 September 2020
Project # 100444601

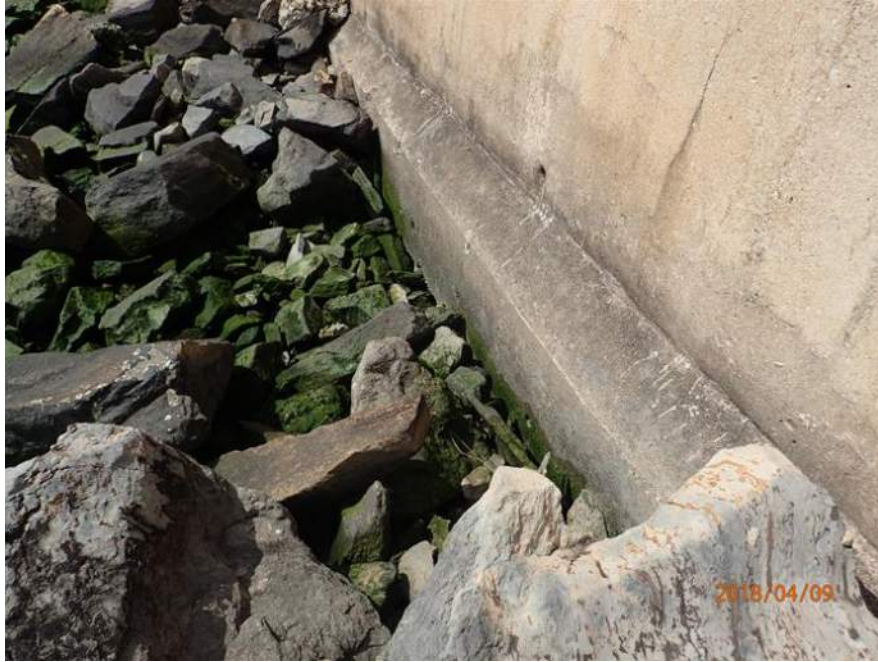
Station 21+43

Direction: Seawall

Comments: Tunnel has been Undermined

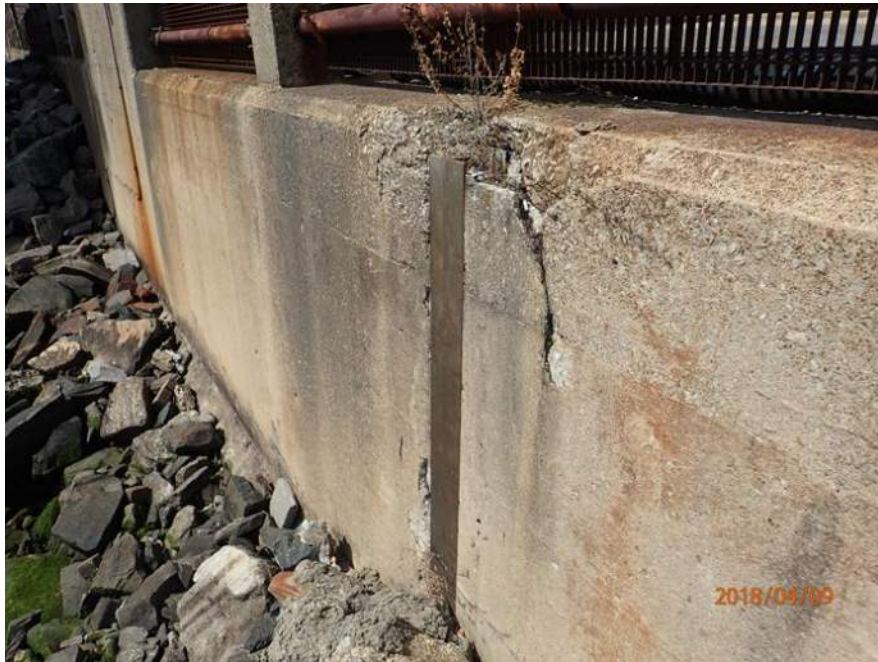
Station 22+64

Direction: Seawall Joint

Comments: Concrete Spalling, Missing Large Section of Concrete

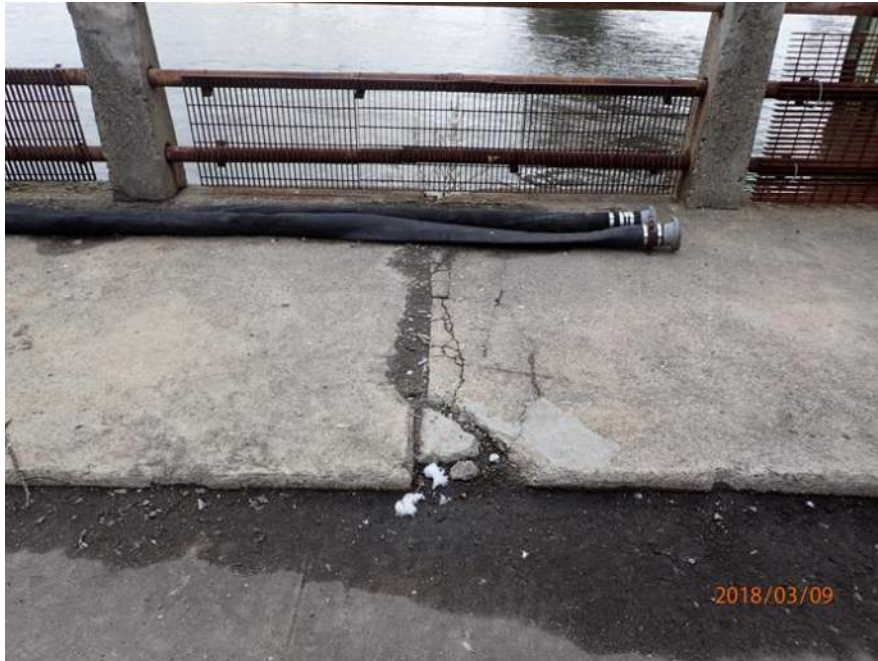
Station 22+57

Direction: Seawall Sidewalk Joint

Comments: Concrete Cracks

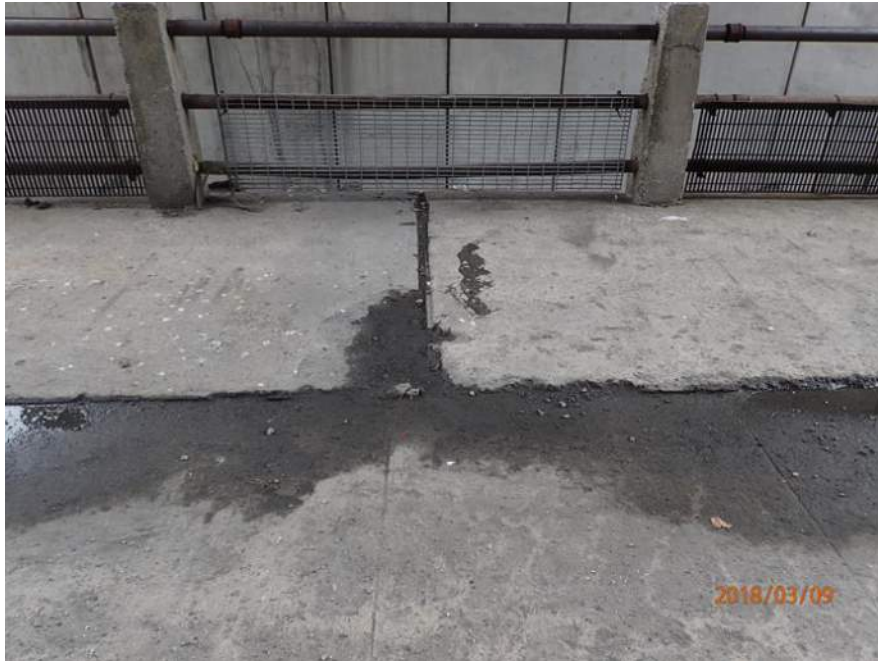
Station 23+20

Direction: Seawall Sidewalk Joint

Comments: Concrete Cracks

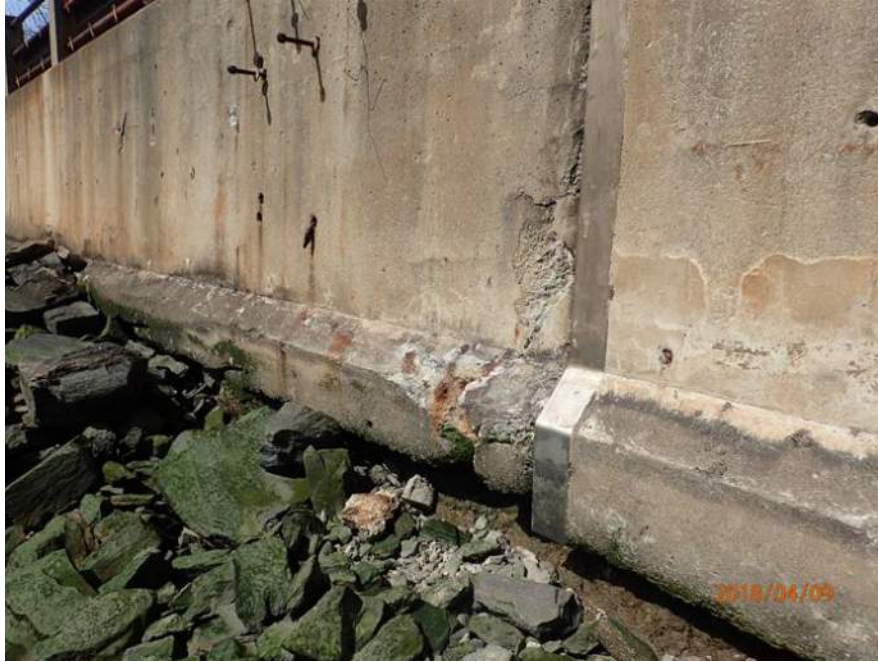
Station 23+88

Direction: Seawall Joint

Comments: Concrete Spalling, Missing Large Section of Concrete

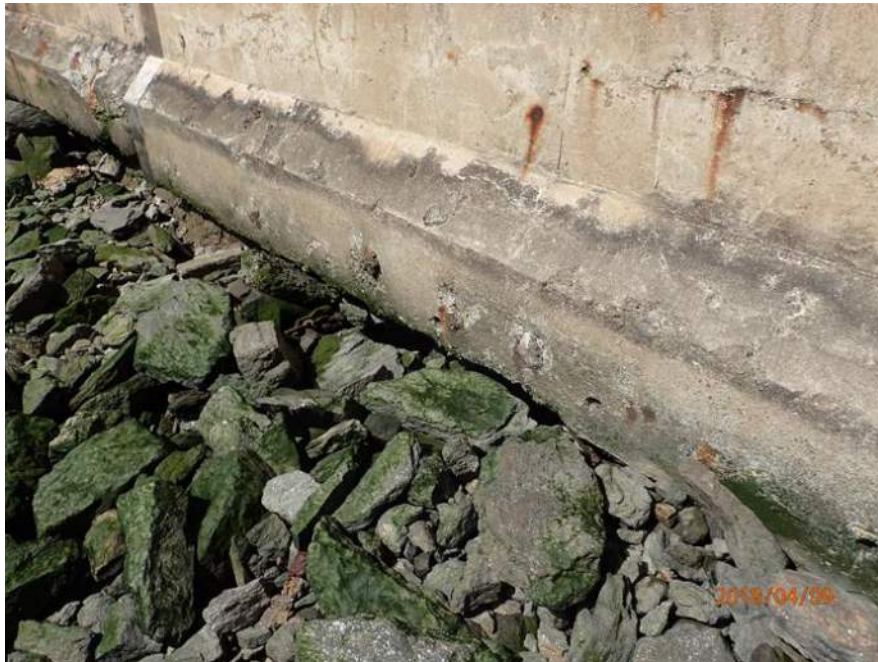
Station 23+78 to 24+00

Direction: Seawall

Comments: Tunnel has been Undermined

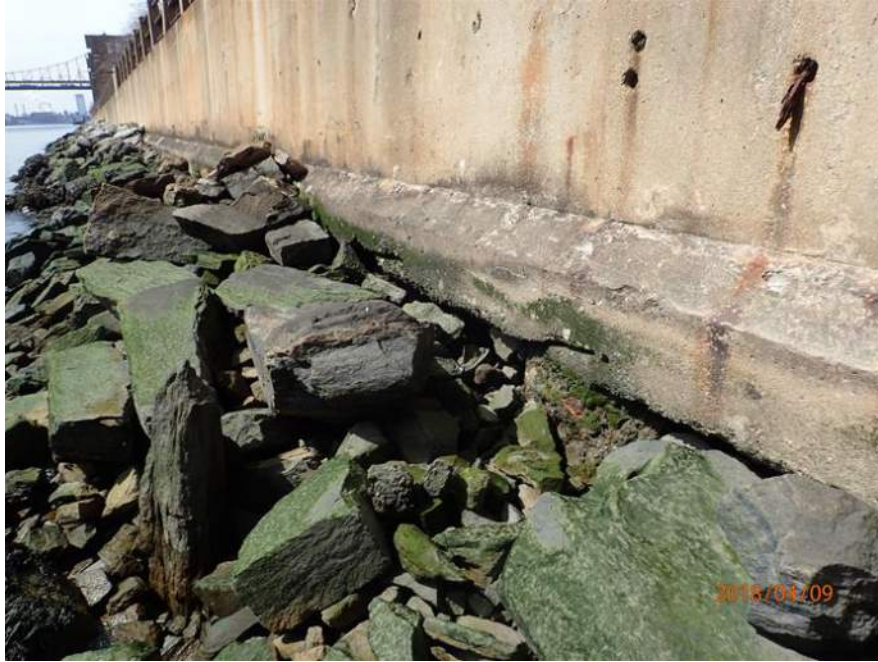
Station 23+78 to 24+00

Direction: Seawall

Comments: Tunnel has been Undermined

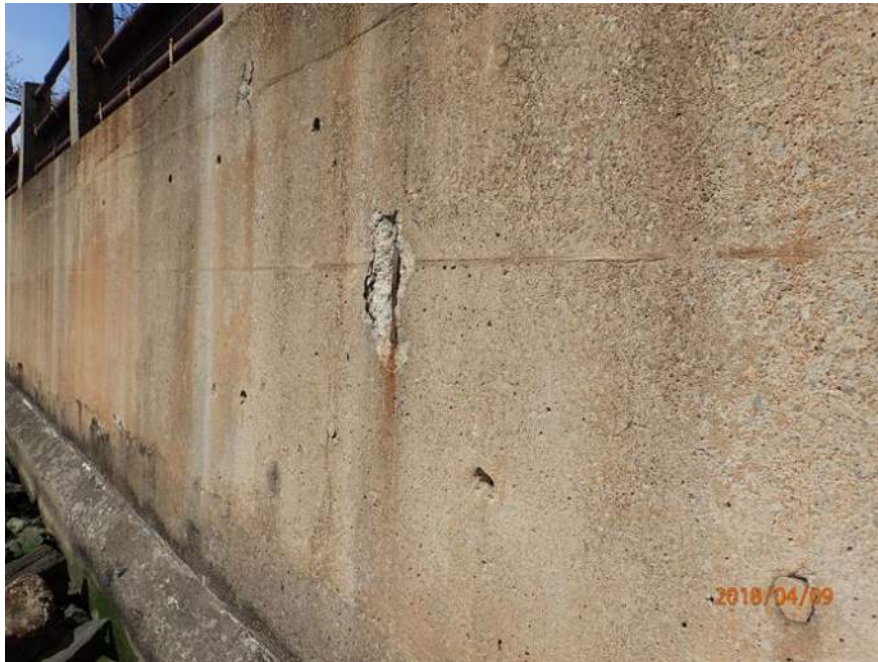
Station 24+10

Direction: Seawall

Comments: Exposed Re-Bar

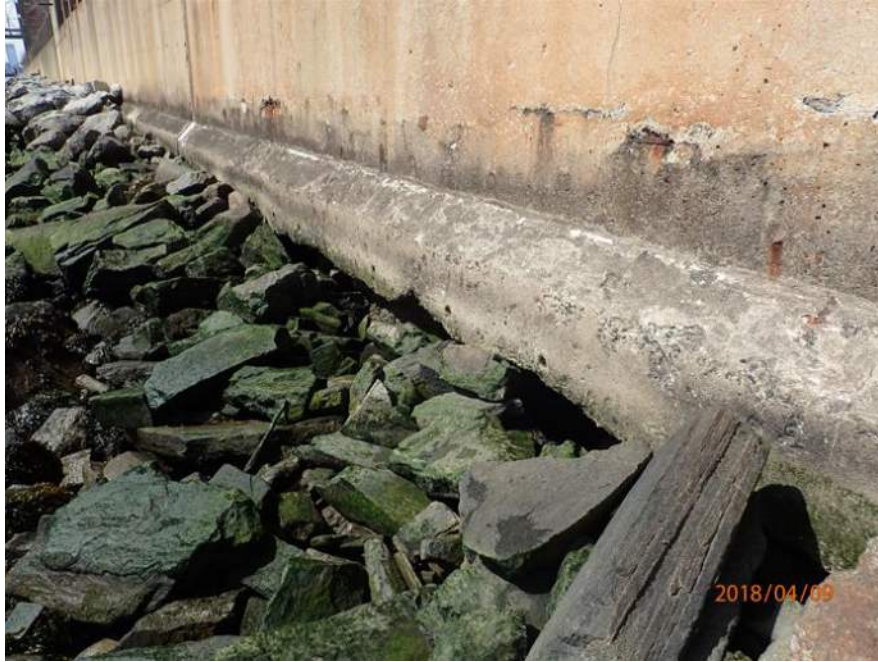
Station 24+00 to 24+20

Direction: Seawall

Comments: Tunnel has been Undermined

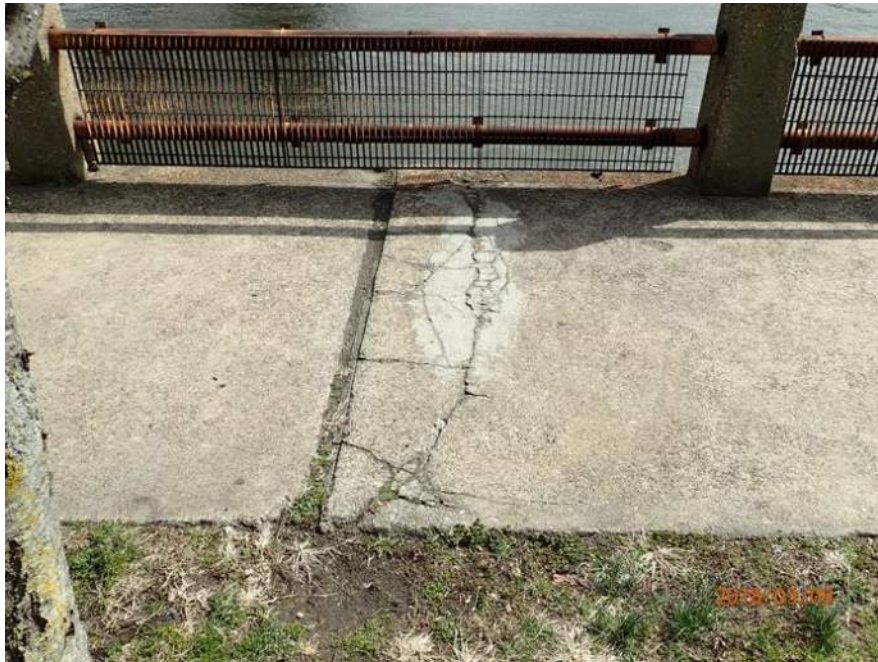
Station 24+48

Direction: Seawall Sidewalk Joint

Comments: Concrete Cracks

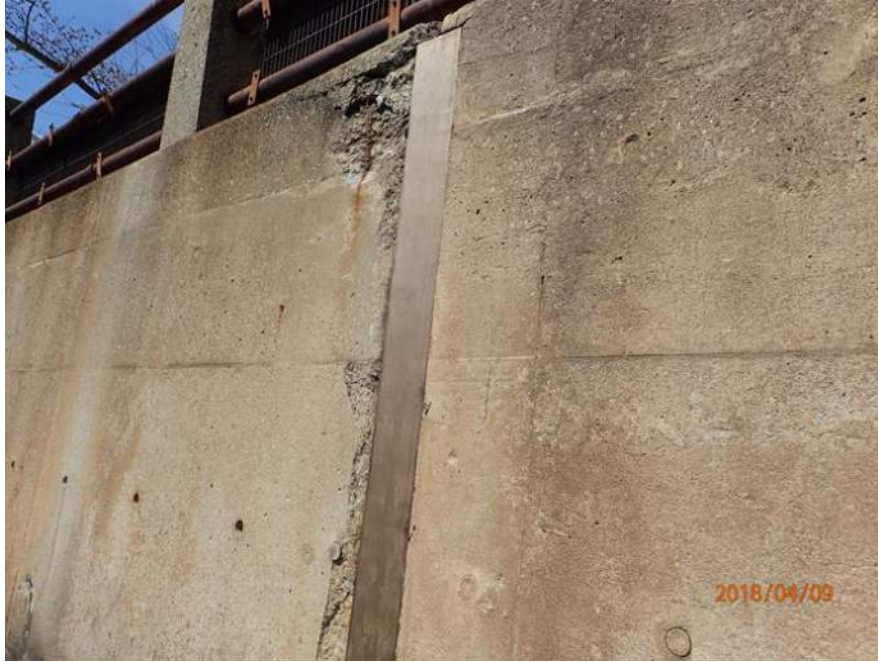
Station 24+53

Direction: Seawall Joint

Comments: Concrete Spalling, Missing Large Section of Concrete, Re-Bar Exposed

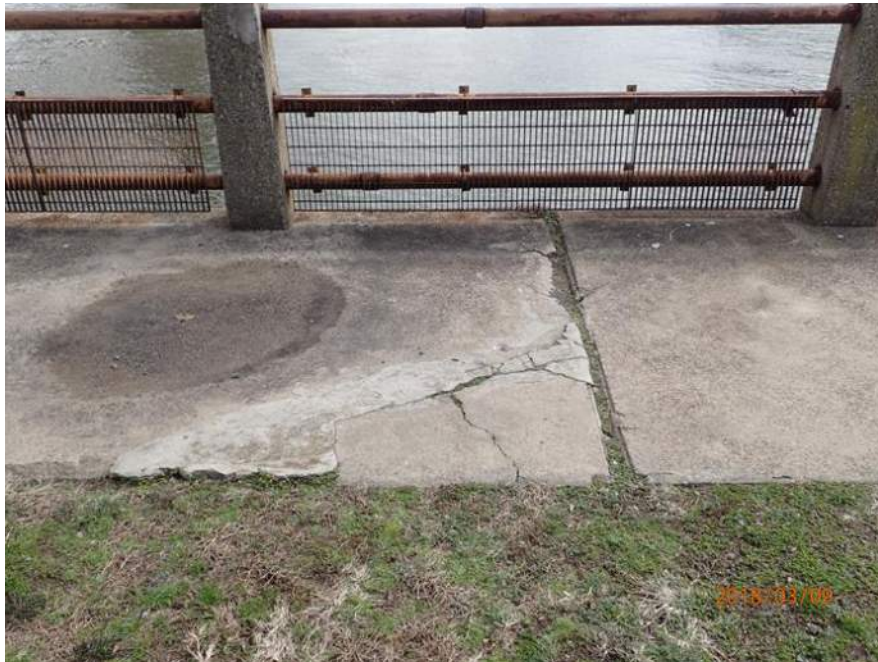
Station 25+10

Direction: Seawall Sidewalk Joint

Comments: Concrete Cracks

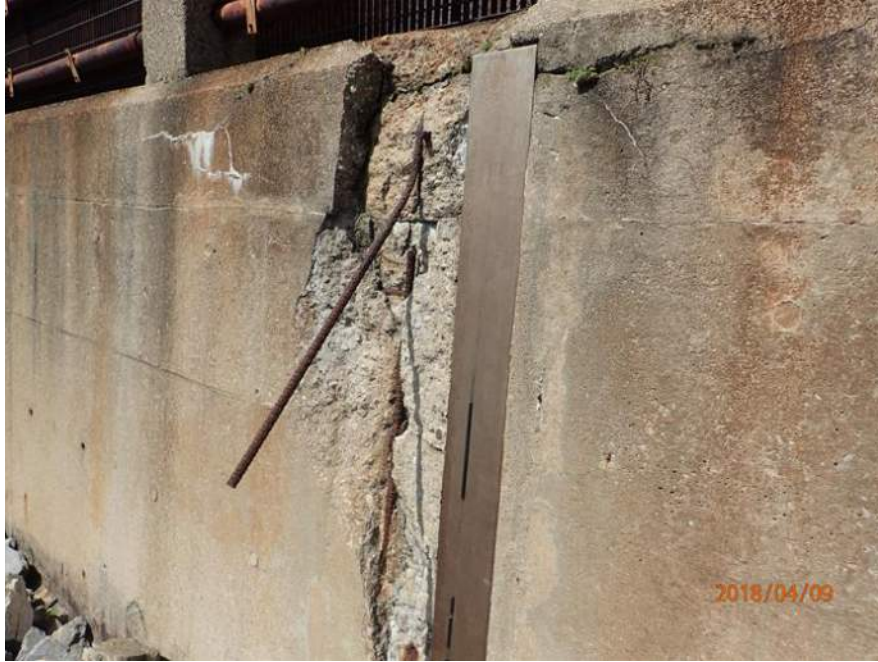
Station 25+17

Direction: Seawall Joint

Comments: Concrete Spalling, Missing Large Section of Concrete, Re-Bar Exposed and Loose

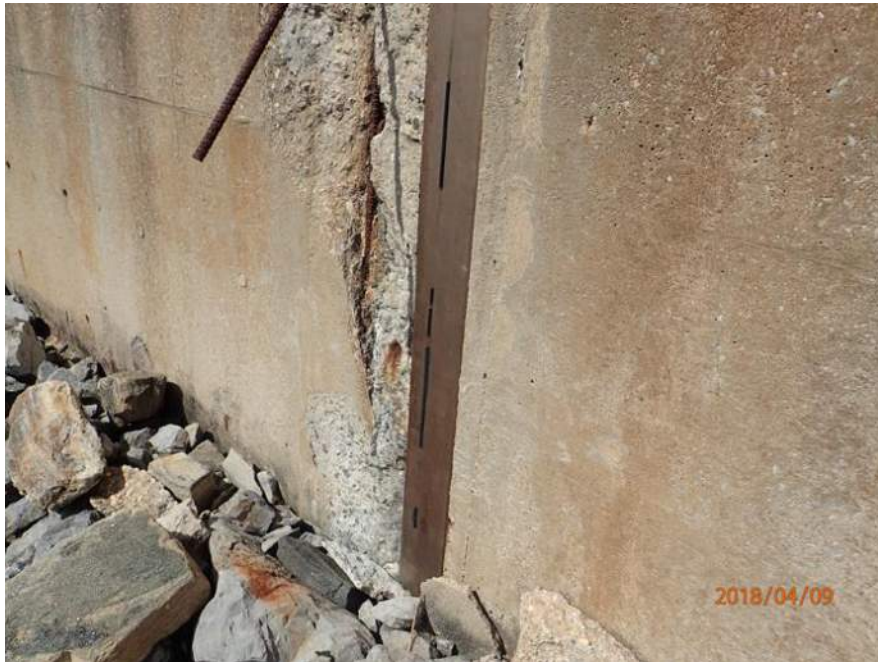
Station 25+17

Direction: Seawall Joint

Comments: Concrete Spalling, Missing Large Section of Concrete, Re-Bar Exposed and Loose

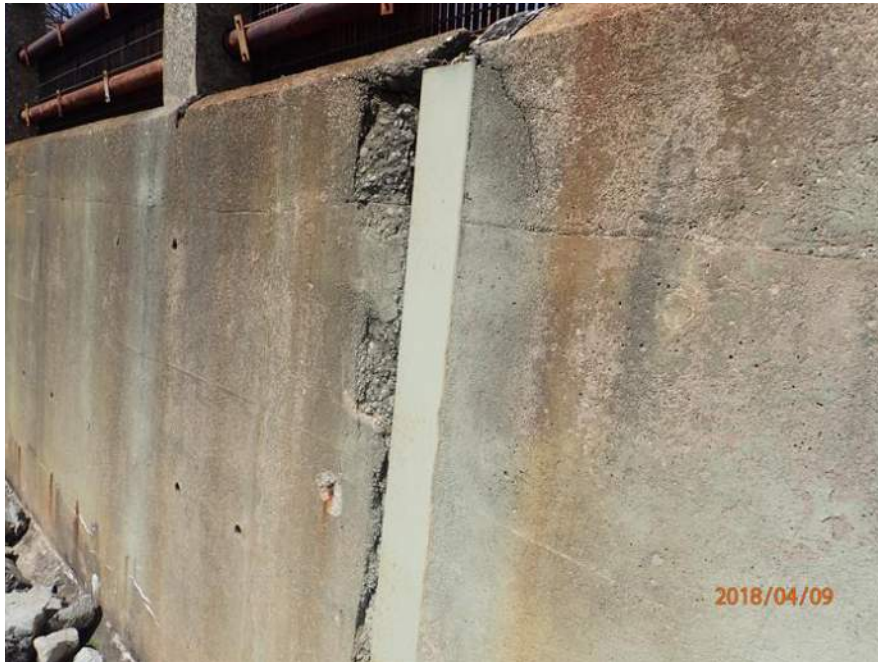
Station 25+82

Direction: Seawall Joint

Comments: Concrete Spalling

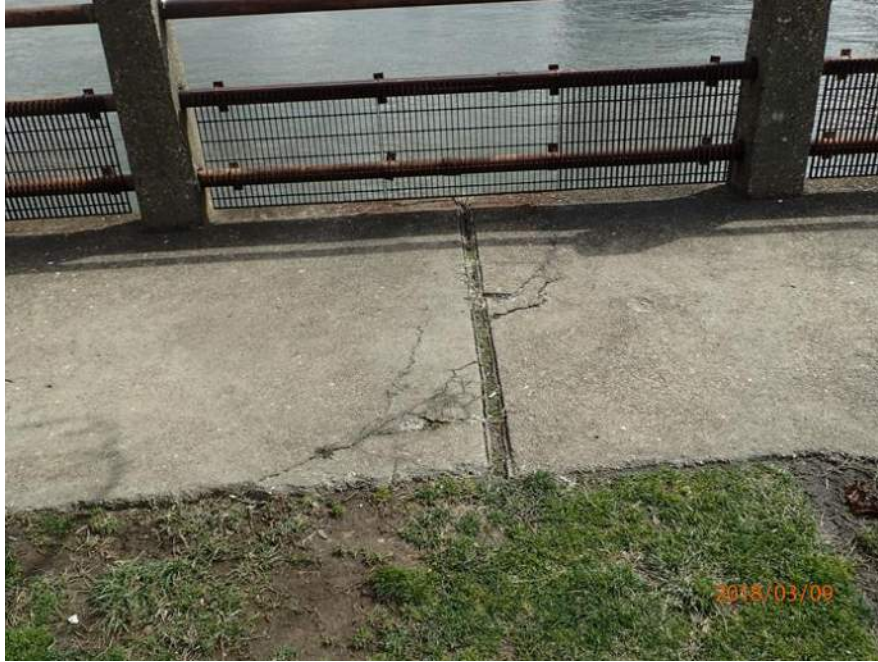
Station 27+07

Direction: Seawall Sidewalk Joint

Comments: Concrete Cracks

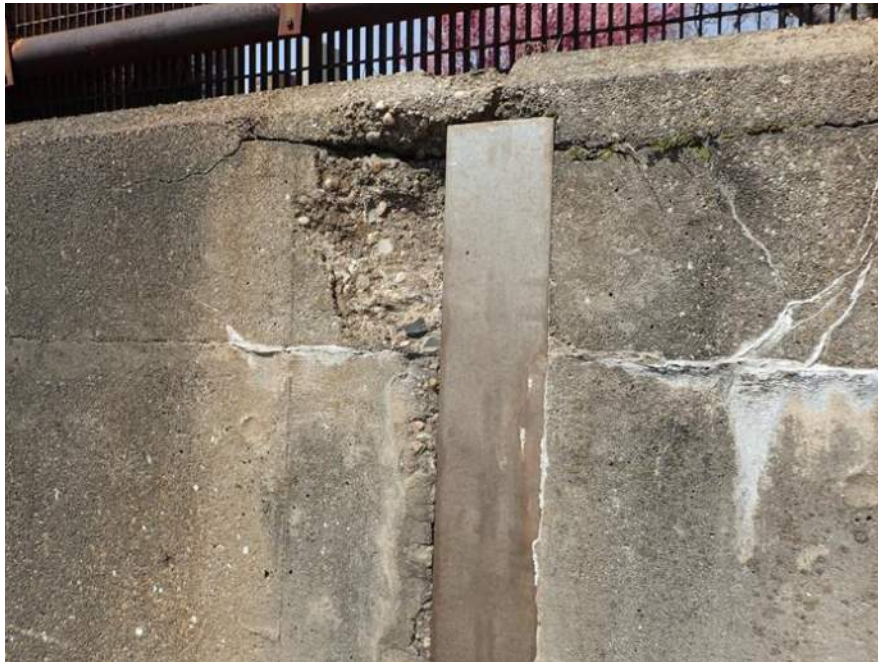
Station 27+07

Direction: Seawall Joint

Comments: Concrete Spalling, Missing Large Section of Concrete, Re-Bar Exposed

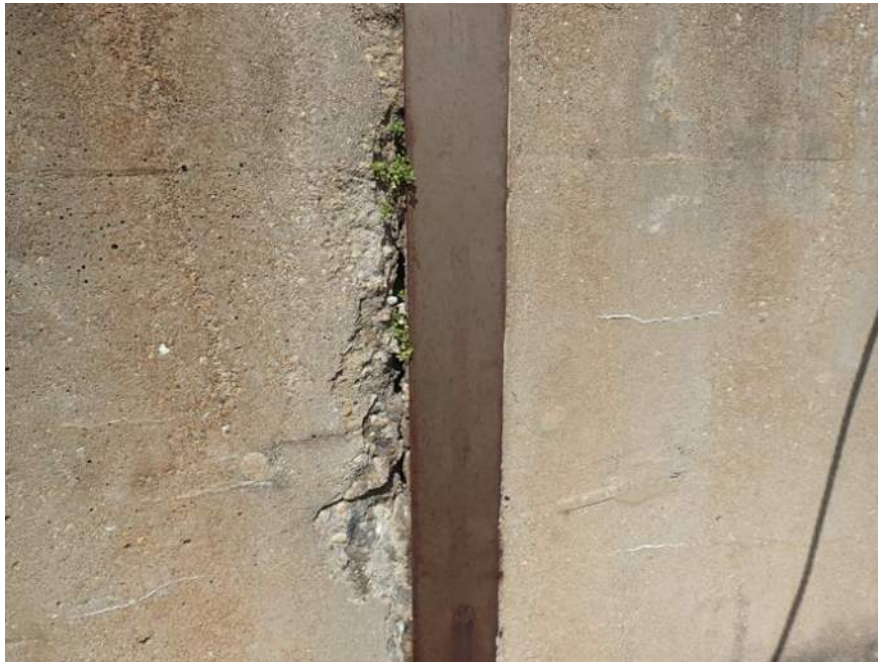
Station 28+02

Direction: Seawall Joint

Comments: Concrete Spalling, Missing Large Section of Concrete, Re-Bar Exposed

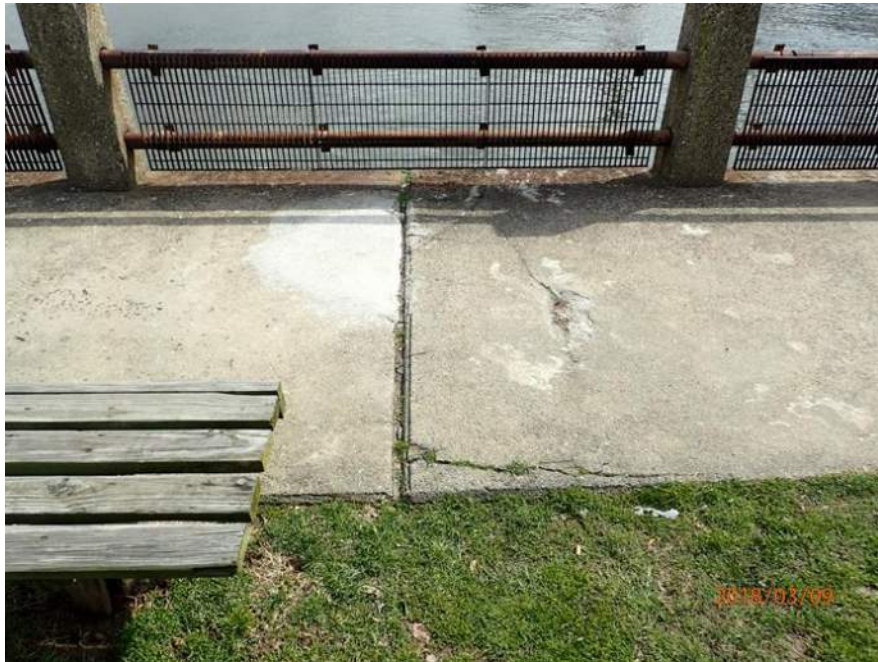
Station 28+34

Direction: Seawall Sidewalk Joint

Comments: Concrete Cracks

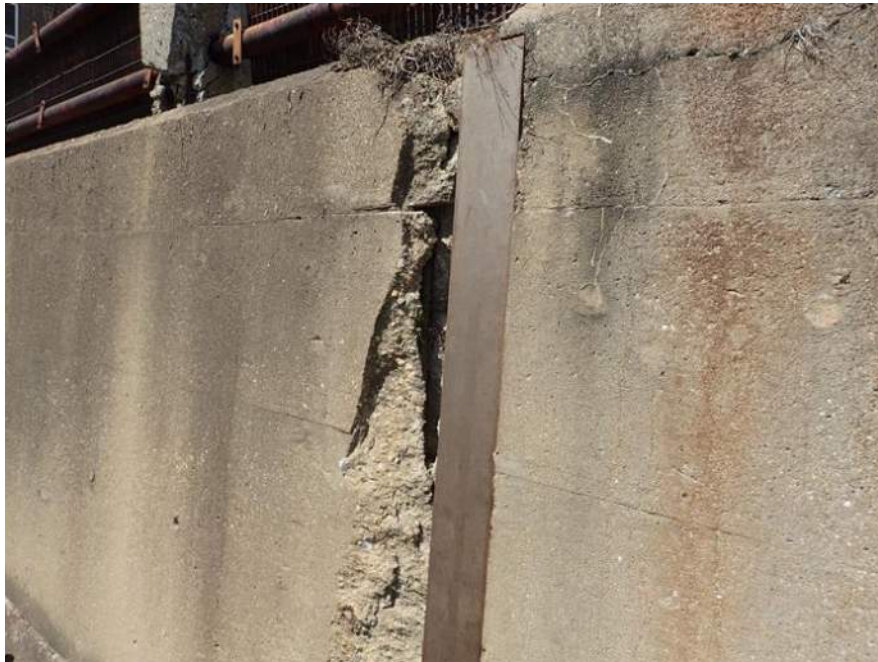
Station 28+34

Direction: Seawall Joint

Comments: Concrete Spalling, Missing Large Section of Concrete, Re-Bar Exposed

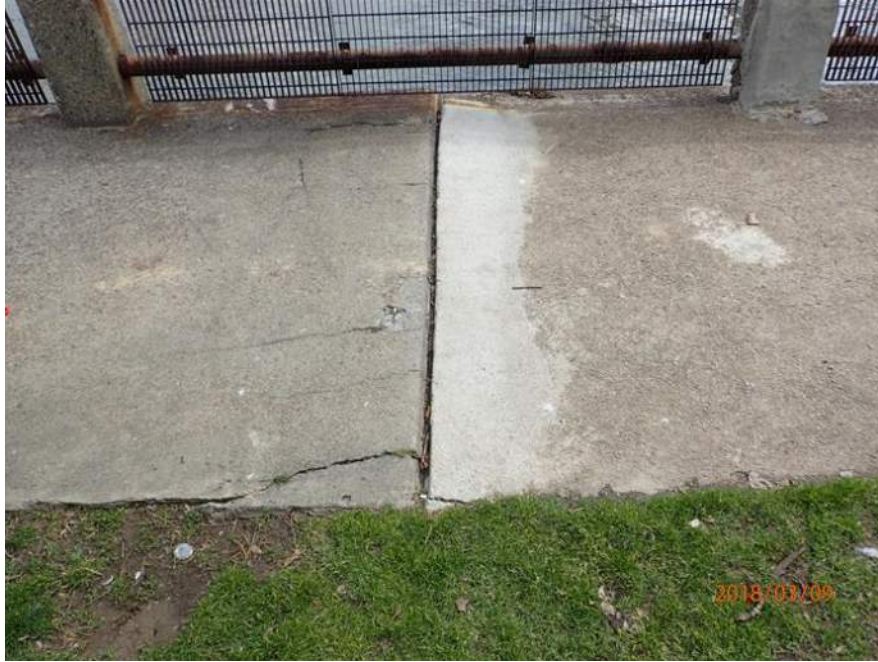
Station 28+91

Direction: Seawall Sidewalk Joint

Comments: Concrete Cracks, Attempt to Repair

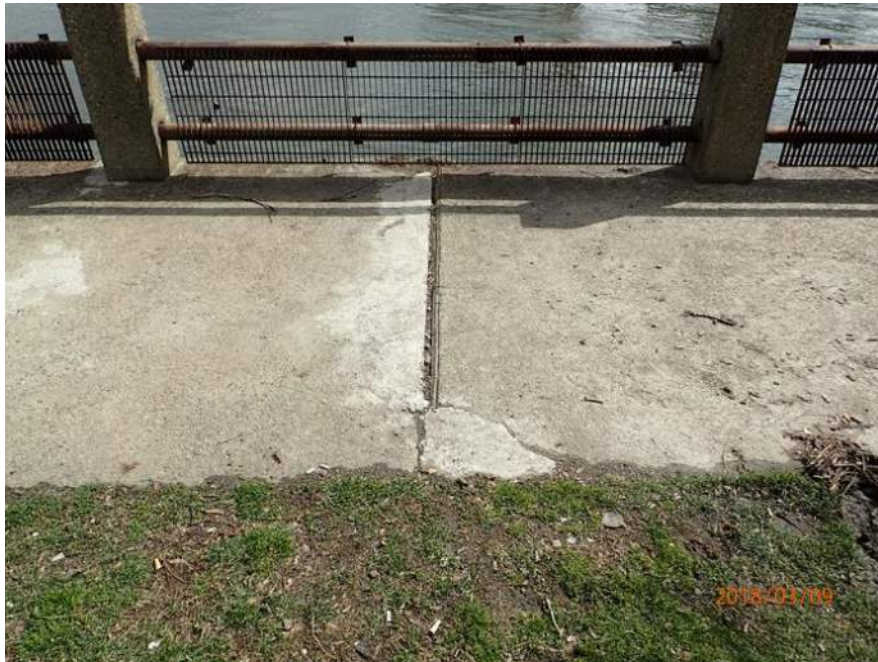
Station 29+62

Direction: Seawall Sidewalk Joint

Comments: Concrete Cracks

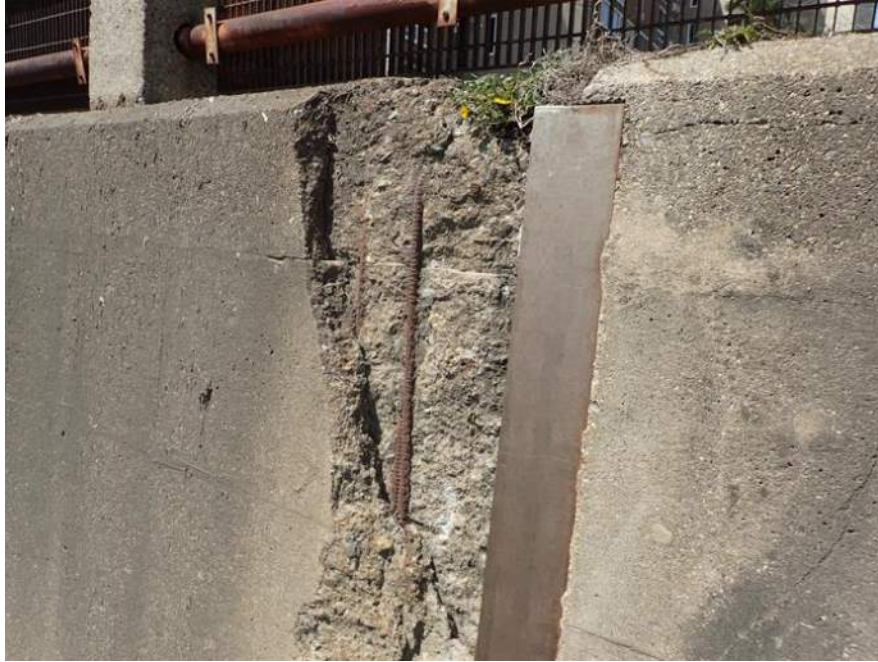
Station 29+62

Direction: Seawall Joint

Comments: Concrete Spalling, Missing Large Section of Concrete, Re-Bar Exposed

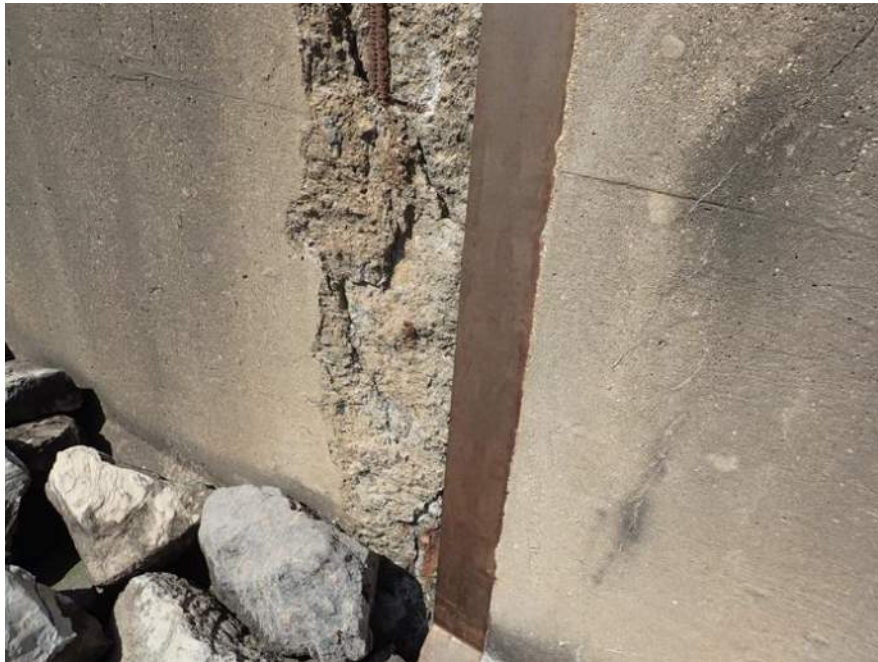
Station 29+62

Direction: Seawall Joint

Comments: Concrete Spalling, Missing Large Section of Concrete, Re-Bar Exposed

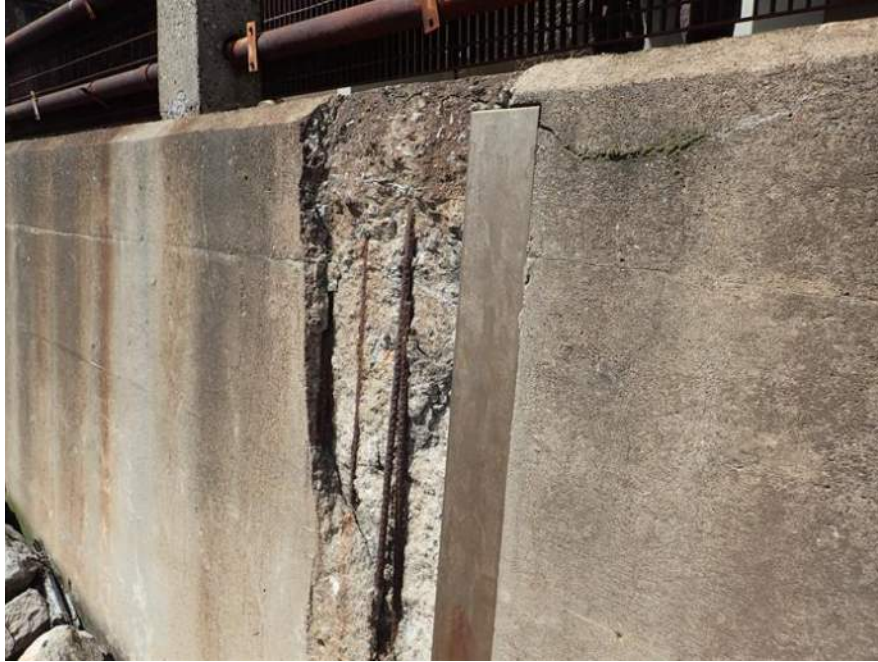
Station 29+62

Direction: Seawall Joint

Comments: Concrete Spalling, Missing Large Section of Concrete, Re-Bar Exposed

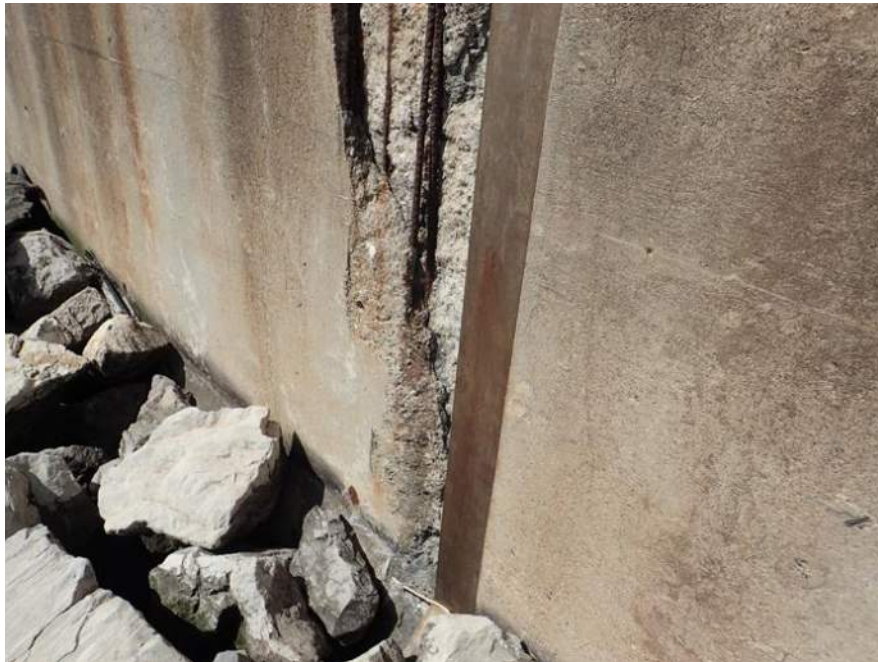
Station 29+62

Direction: Seawall Joint

Comments: Concrete Spalling, Missing Large Section of Concrete, Re-Bar Exposed

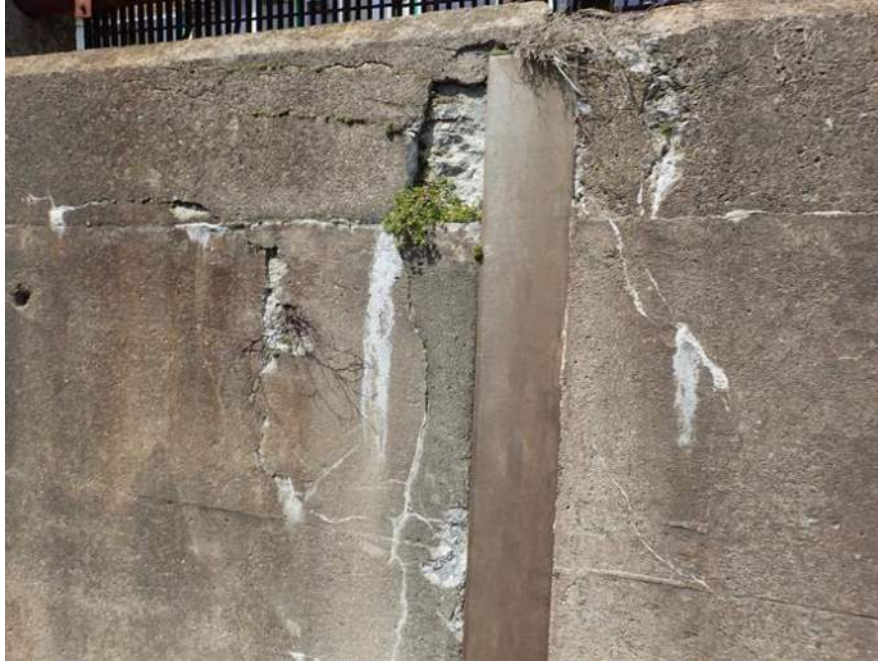
Station 30+24

Direction: Seawall Joint

Comments: Concrete Spalling, Missing Large Section of Concrete, Re-Bar Exposed

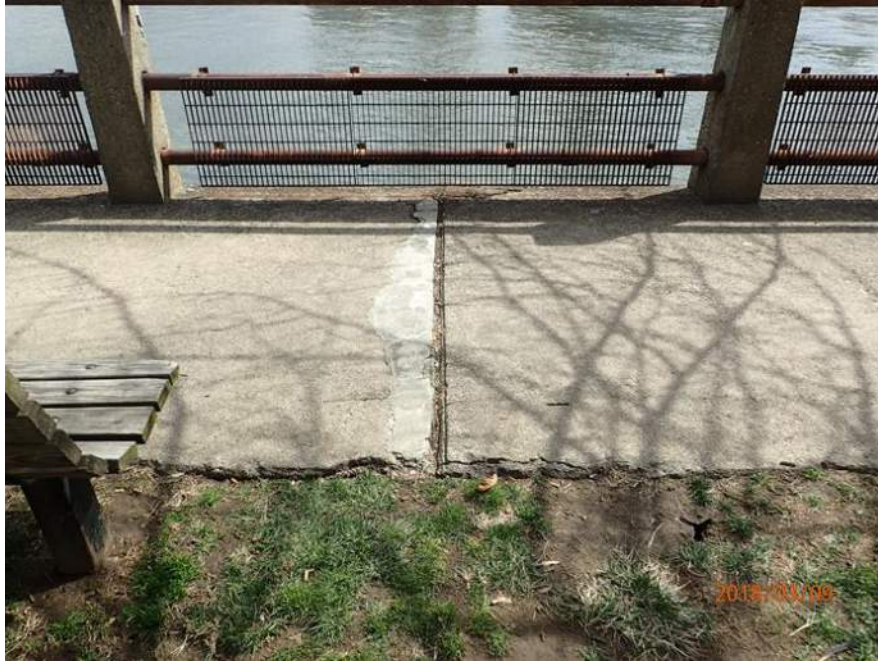
Station 31+52

Direction: Seawall Sidewalk Joint

Comments: Concrete Cracks

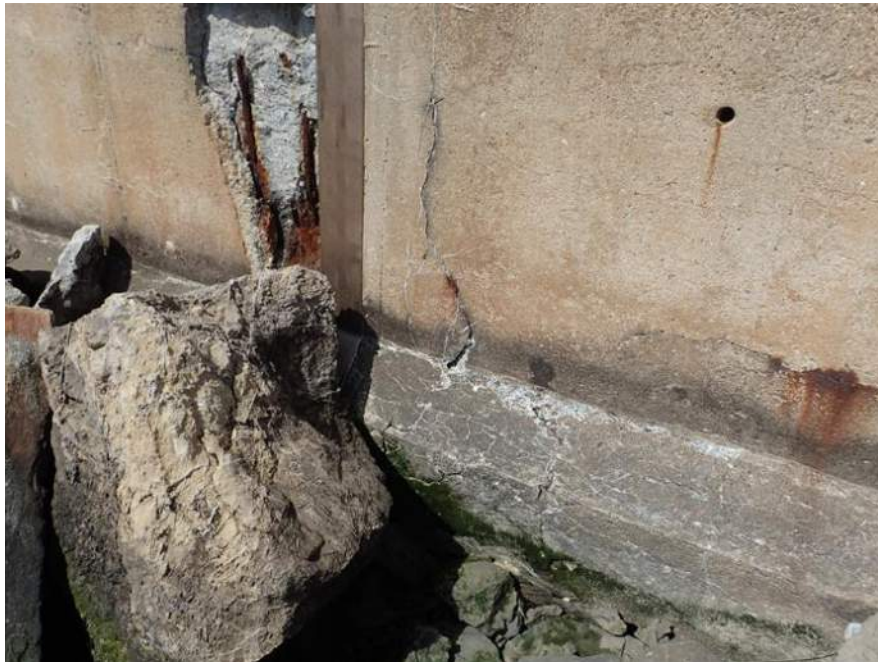
Station 31+52

Direction: Seawall Joint

Comments: Concrete Spalling, Missing Large Section of Concrete, Re-Bar Exposed

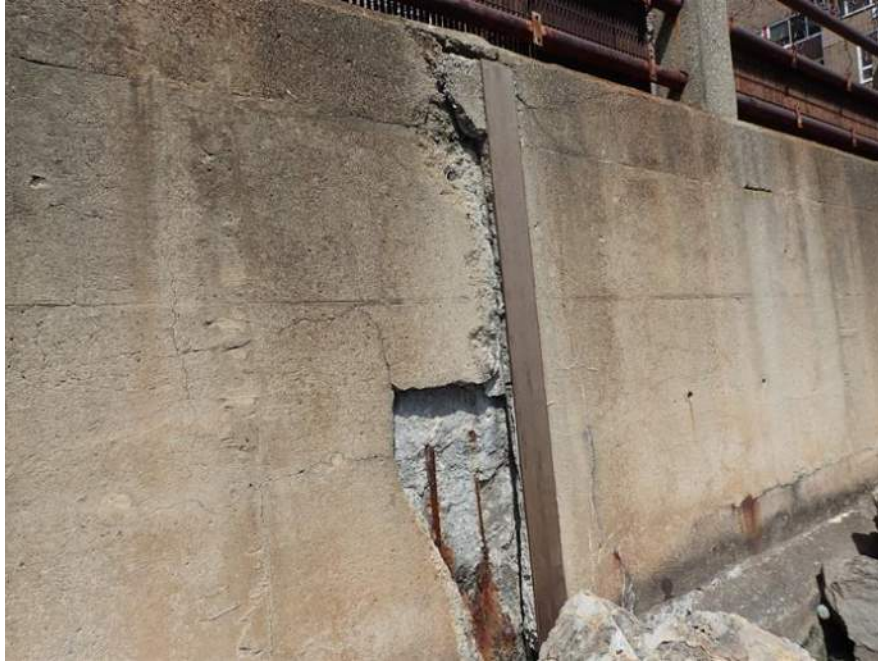
Station 31+52

Direction: Seawall Joint

Comments: Concrete Spalling, Missing Large Section of Concrete, Re-Bar Exposed

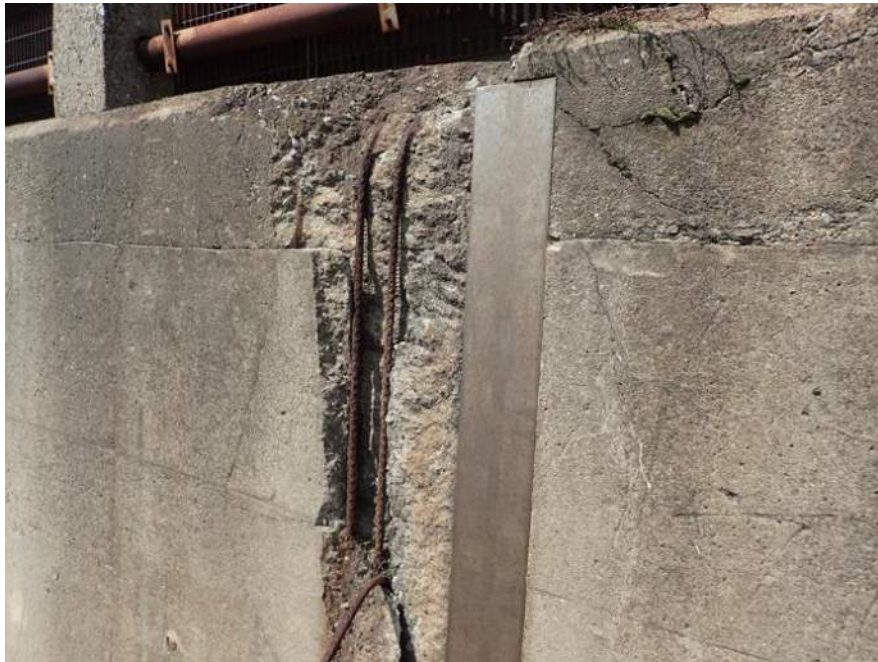
Station 32+16

Direction: Seawall Joint

Comments: Concrete Spalling, Loose Section of Concrete, Re-Bar Exposed

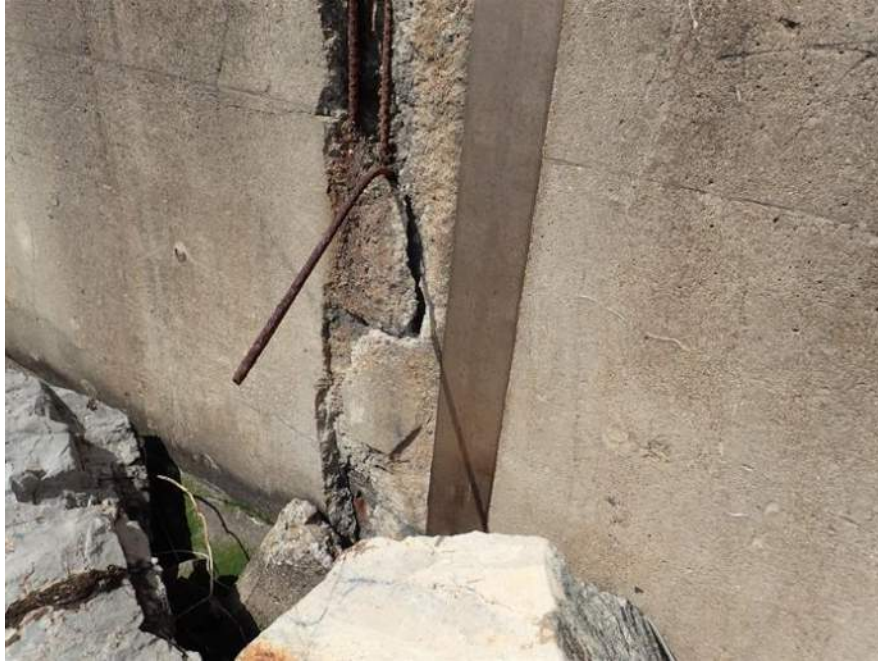
Station 32+16

Direction: Seawall Joint

Comments: Concrete Spalling, Missing Large Section of Concrete, Re-Bar Exposed and Loose

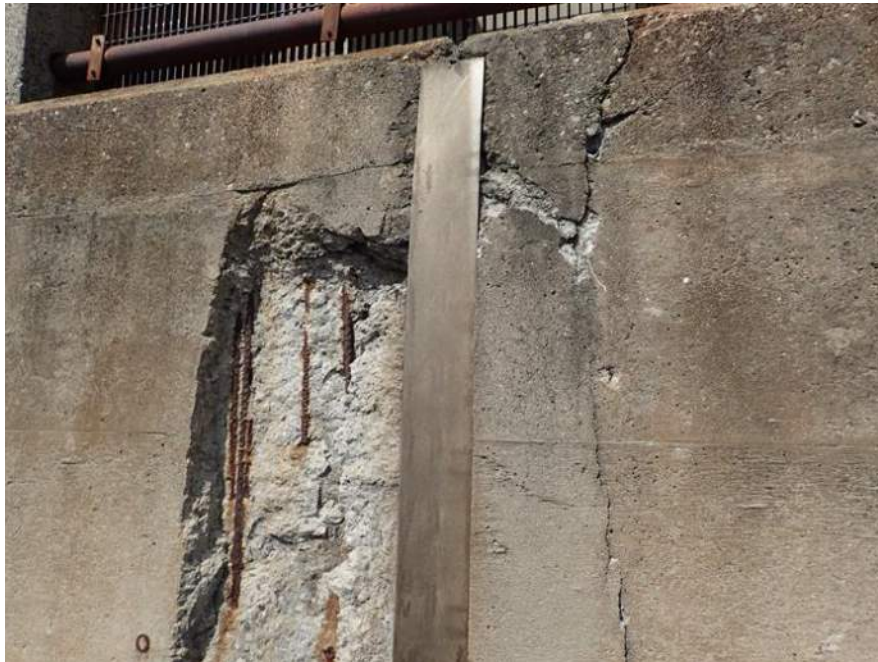
Station 32+79

Direction: Seawall Joint

Comments: Concrete Spalling, Missing Large Section of Concrete, Re-Bar Exposed

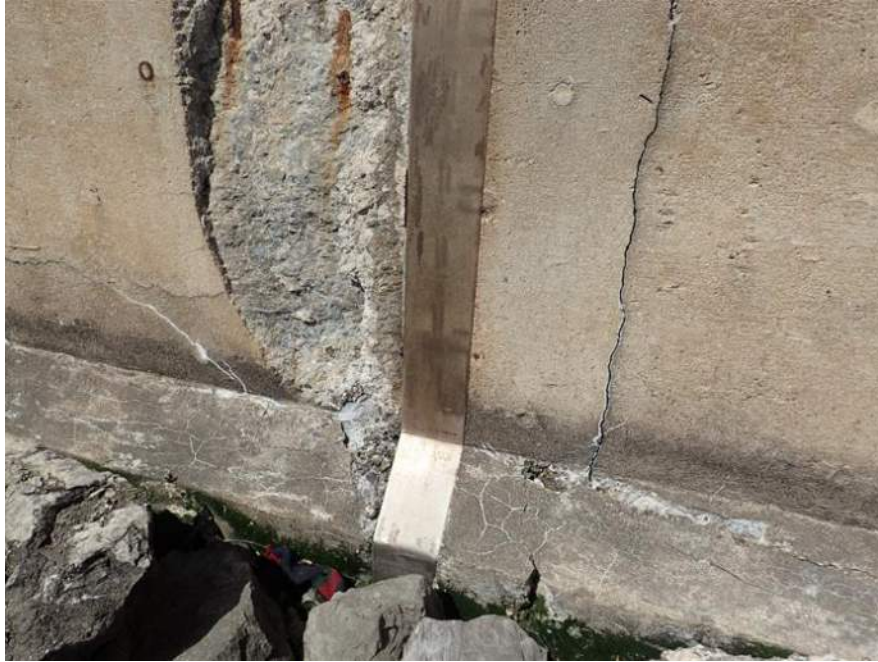
Station 32+79

Direction: Seawall Joint

Comments: Concrete Spalling, Missing Large Section of Concrete, Re-Bar Exposed

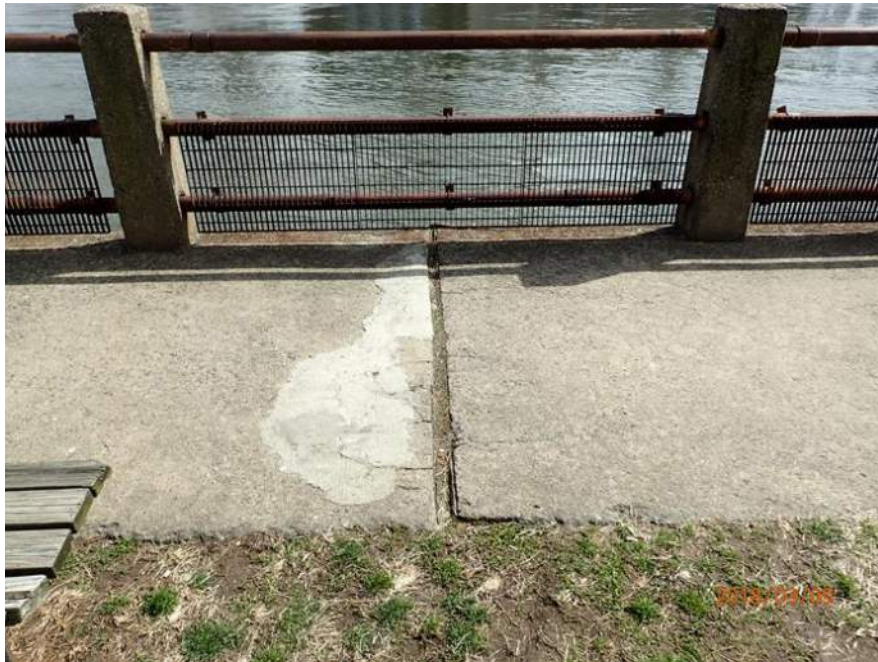
Station 34+06

Direction: Seawall Sidewalk Joint

Comments: Concrete Cracks

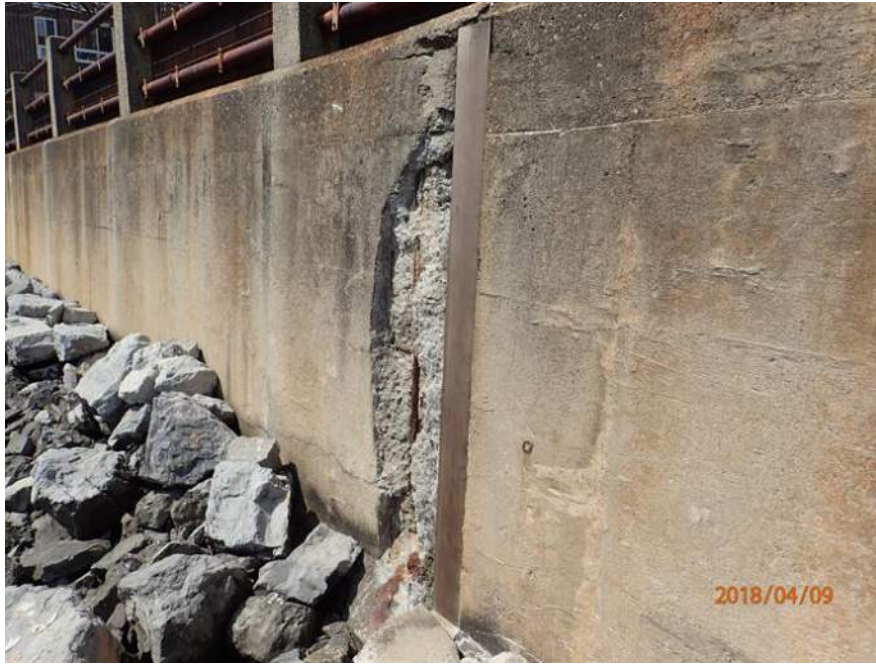
Station 34+06

Direction: Seawall Joint

Comments: Concrete Spalling, Missing Large Section of Concrete, Re-Bar Exposed

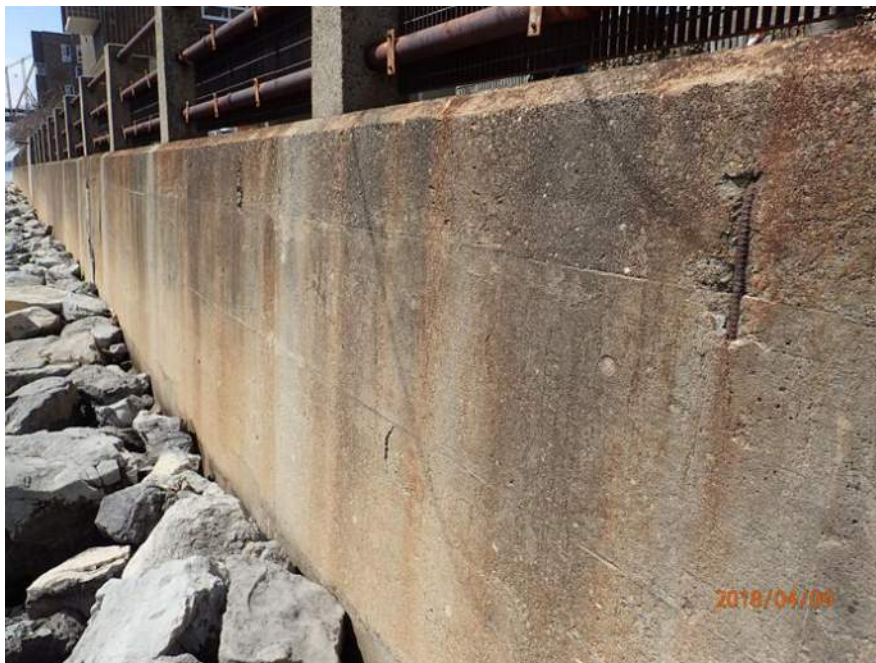
Station 34+30

Direction: Seawall

Comments: Re-Bar Exposed

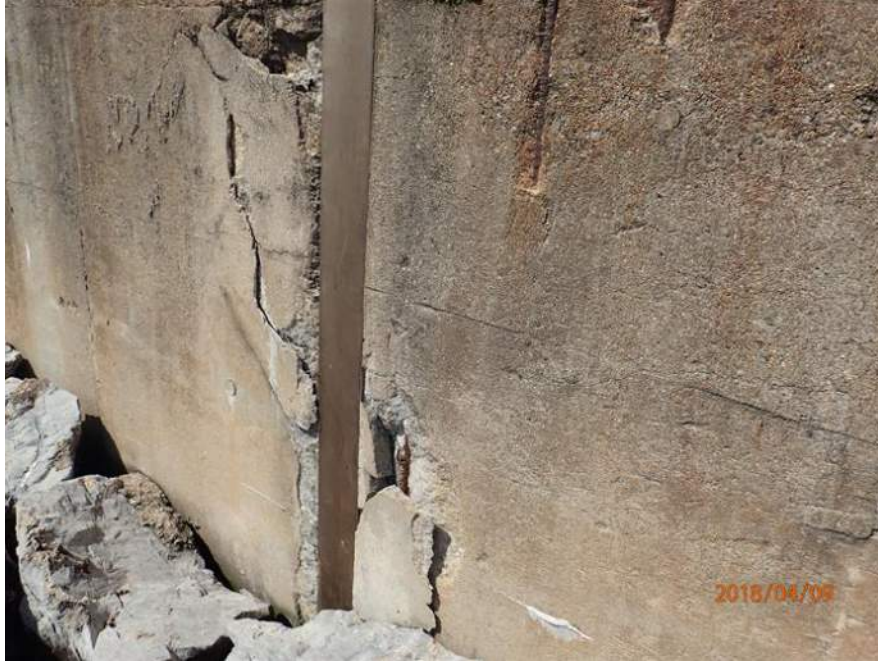
Station 34+70

Direction: Seawall Joint

Comments: Concrete Spalling, Missing Large Section of Concrete, Re-Bar Exposed
