CONDITIONS REPORT & CONCEPTUAL DESIGN MEMORANDUM

STEAM TUNNEL ASSESSMENT

ROOSEVELT ISLAND, NEW YORK

17 November 2014
Revised 28 December 2018
Revised 18 September 2020
Project # 100444601

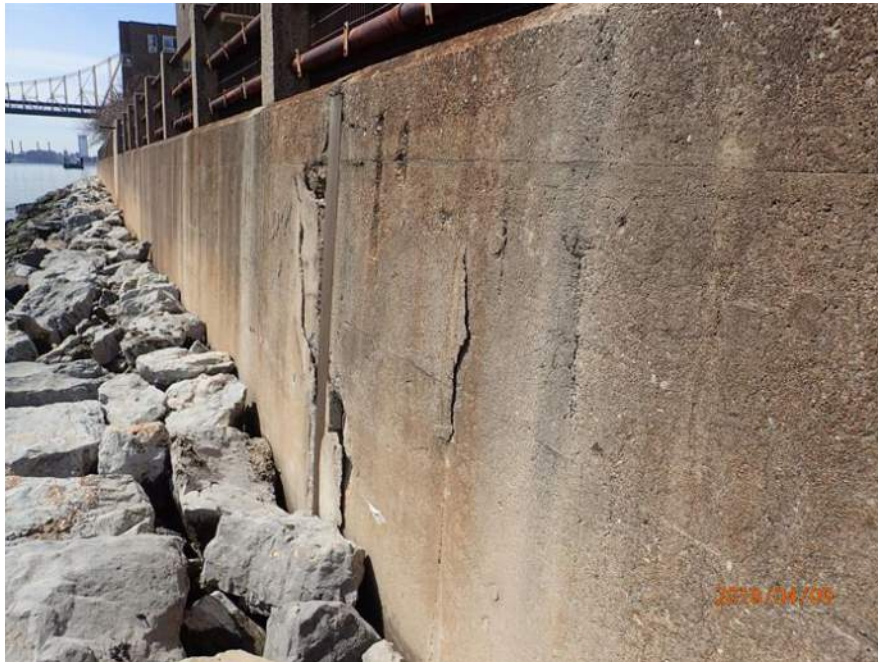
Station 34+70

Direction: Seawall Joint

Comments: Concrete Spalling, Loose Concrete

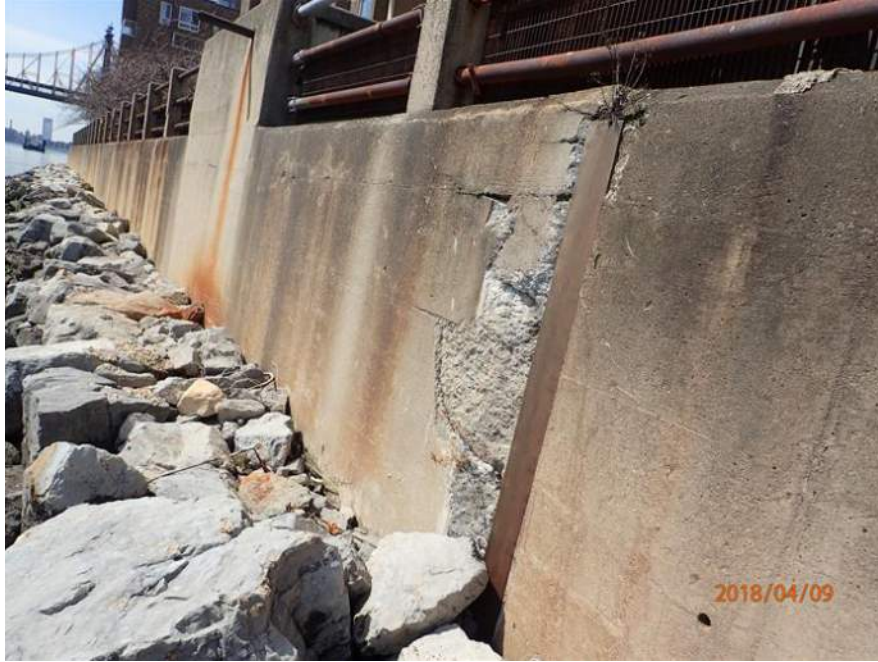
Station 35+38

Direction: Seawall Joint

Comments: Concrete Spalling, Missing Large Section of Concrete, Re-Bar Exposed

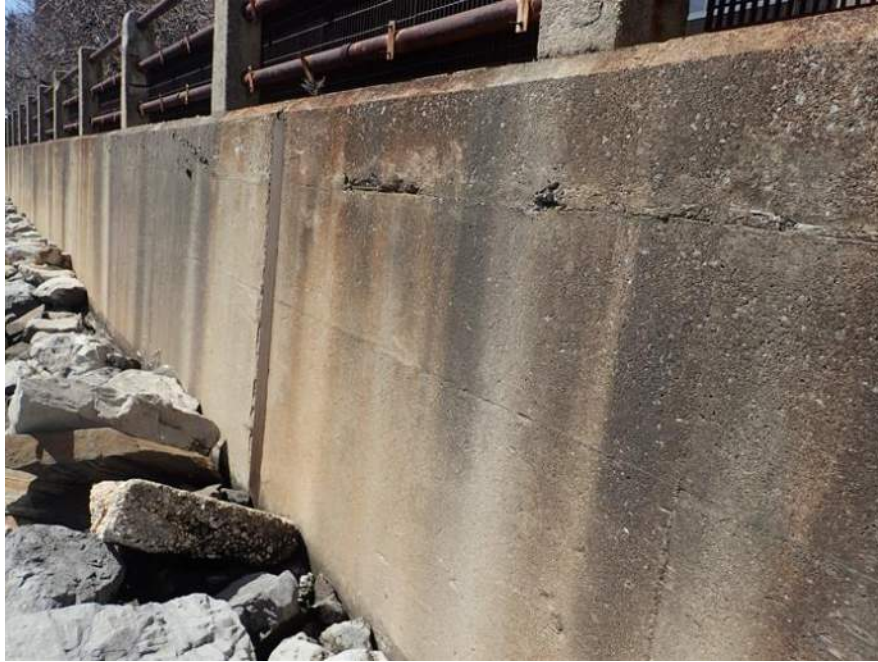
Station 35+93

Direction: Seawall

Comments: Exposed Re-Bar, Concrete Spalling

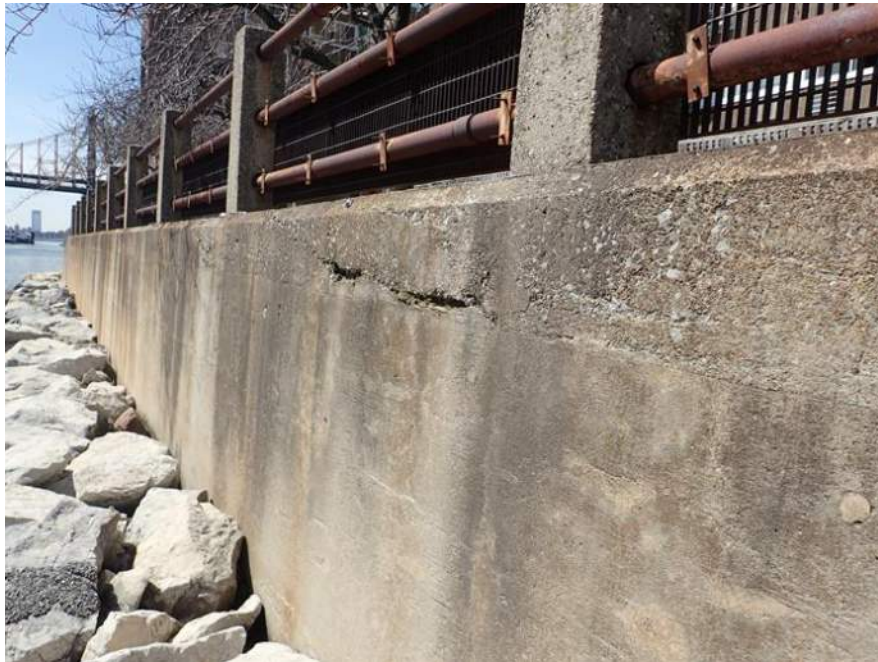
Station 36+20

Direction: Seawall

Comments: Concrete Cracks

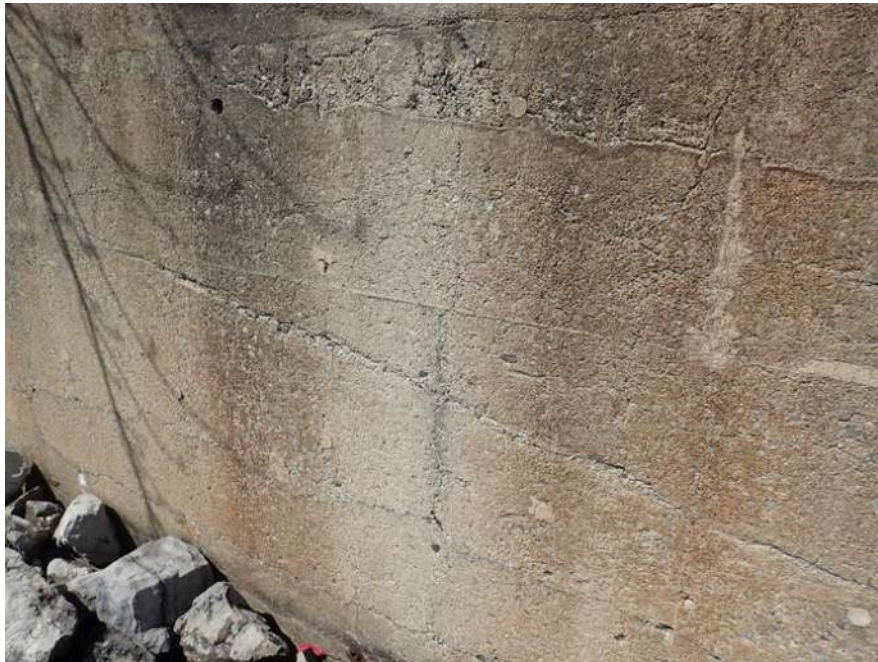
Station 37+40

Direction: Seawall

Comments: Concrete Cracks

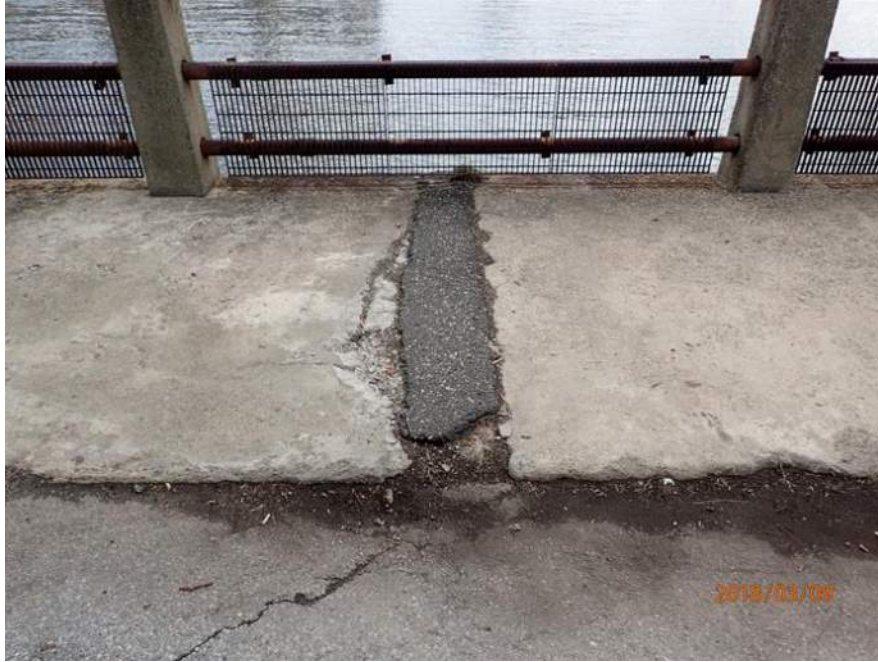
Station 38+44

Direction: Seawall Sidewalk

Comments: Concrete Cracks, Asphalt Repair

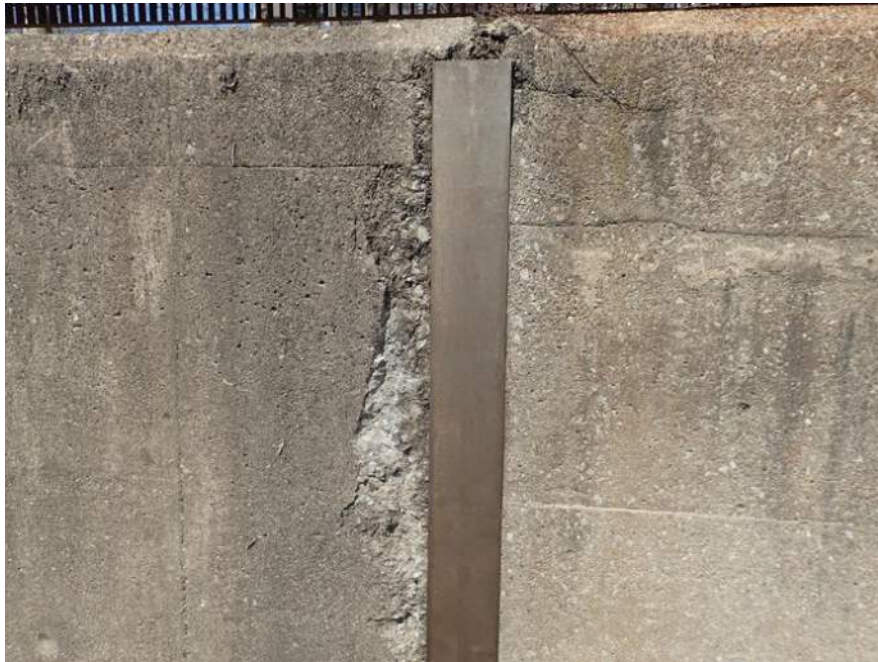
Station 38+82

Direction: Seawall Joint

Comments: Concrete Spalling

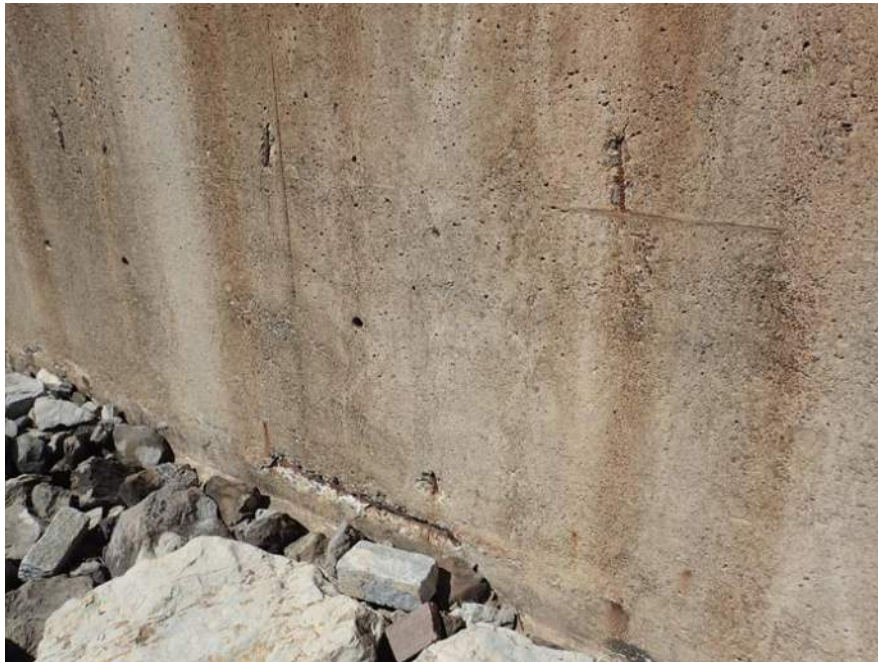
Station 39+22

Direction: Seawall

Comments: Exposed Re-Bar

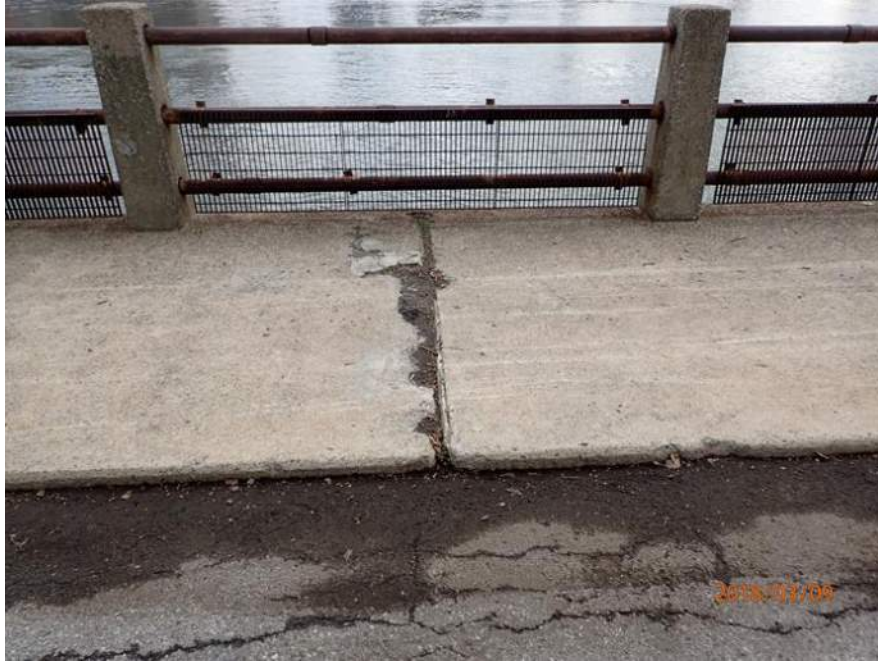
Station 39+66

Direction: Seawall Sidewalk Joint

Comments: Concrete Cracks

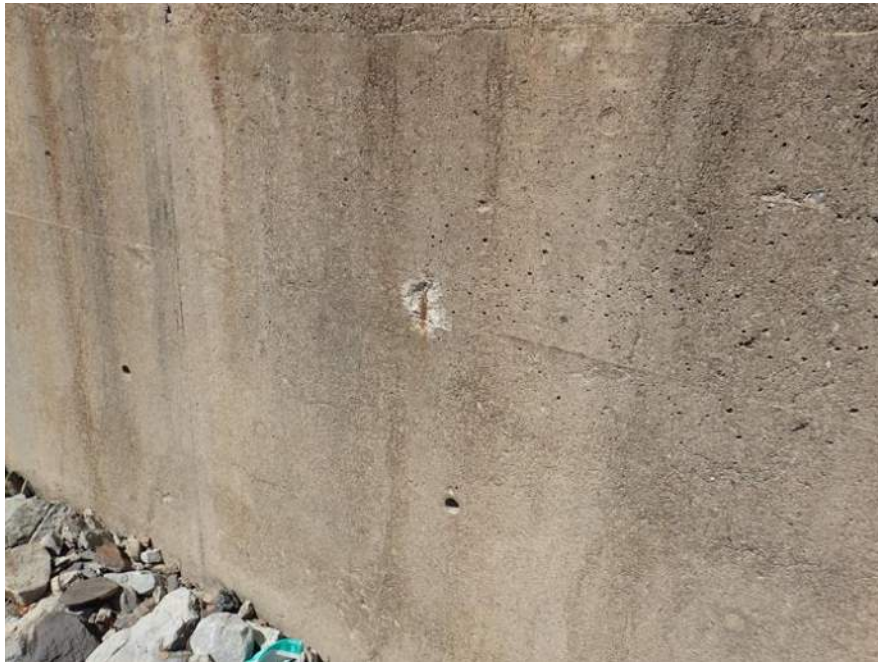
Station 39+70

Direction: Seawall

Comments: Exposed Re-Bar

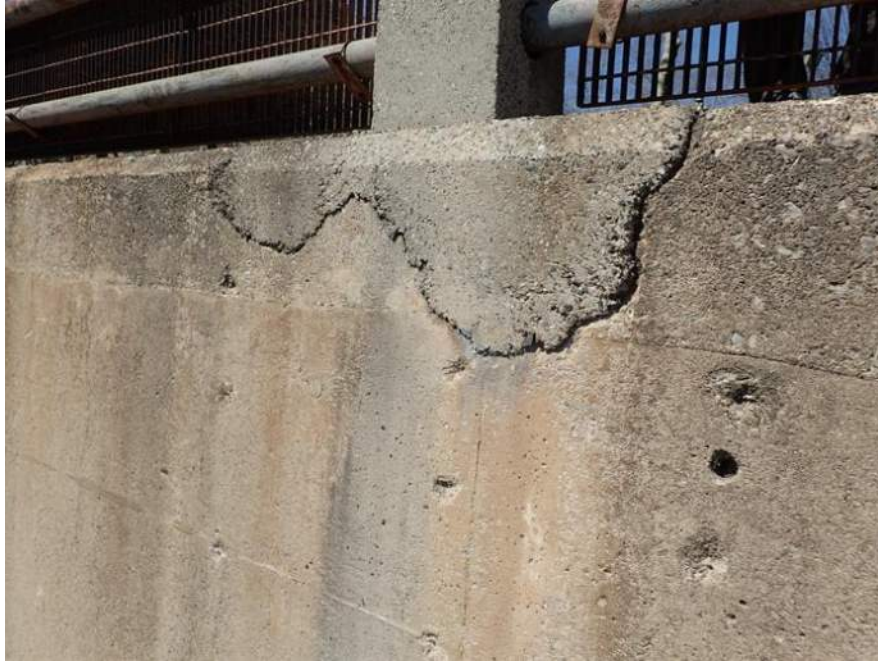
Station 40+00

Direction: Seawall Column

Comments: Concrete Spalling

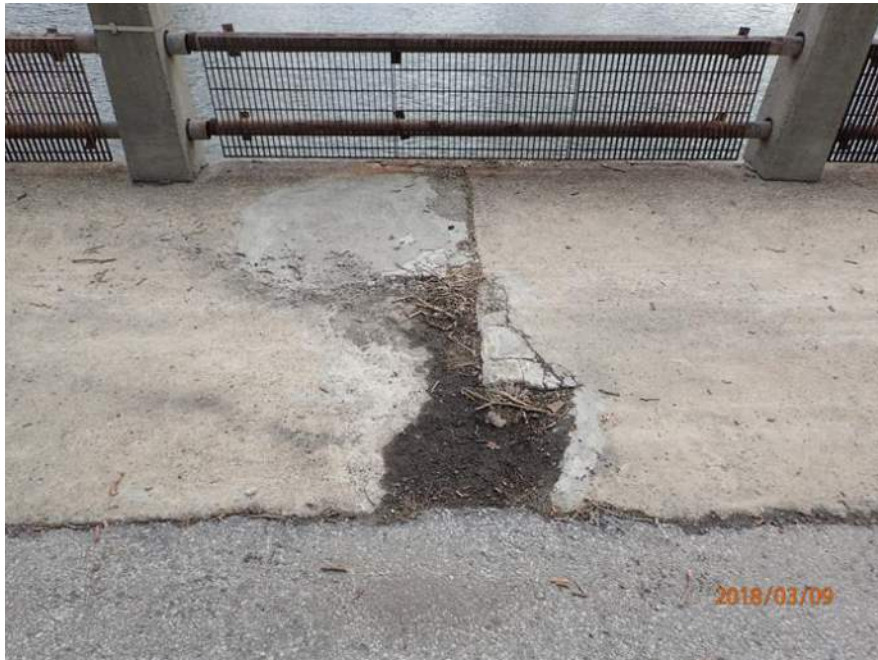
Station 40+39

Direction: Seawall Sidewalk Joint

Comments: Concrete Cracks

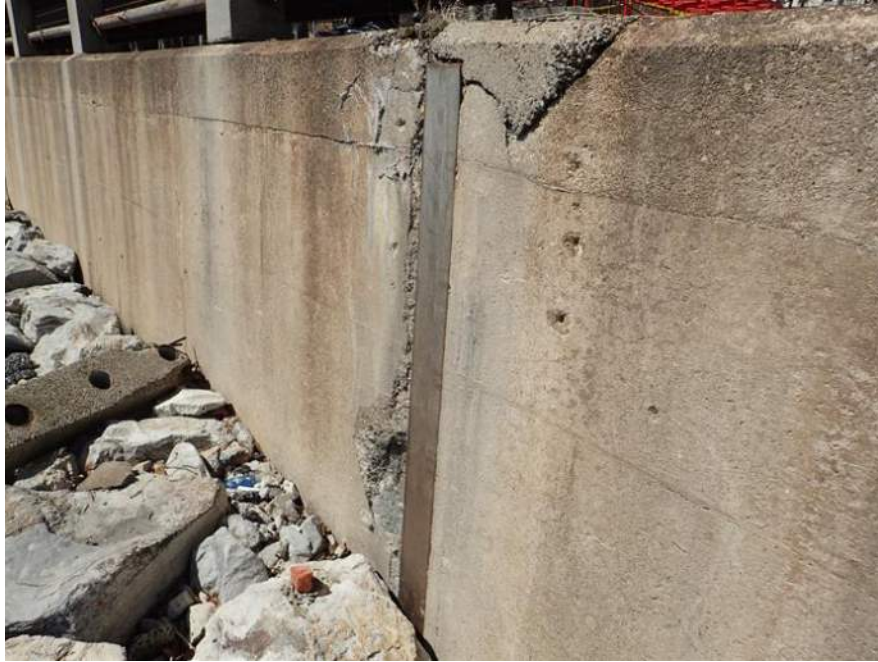
Station 40+39

Direction: Seawall Joint

Comments: Concrete Spalling

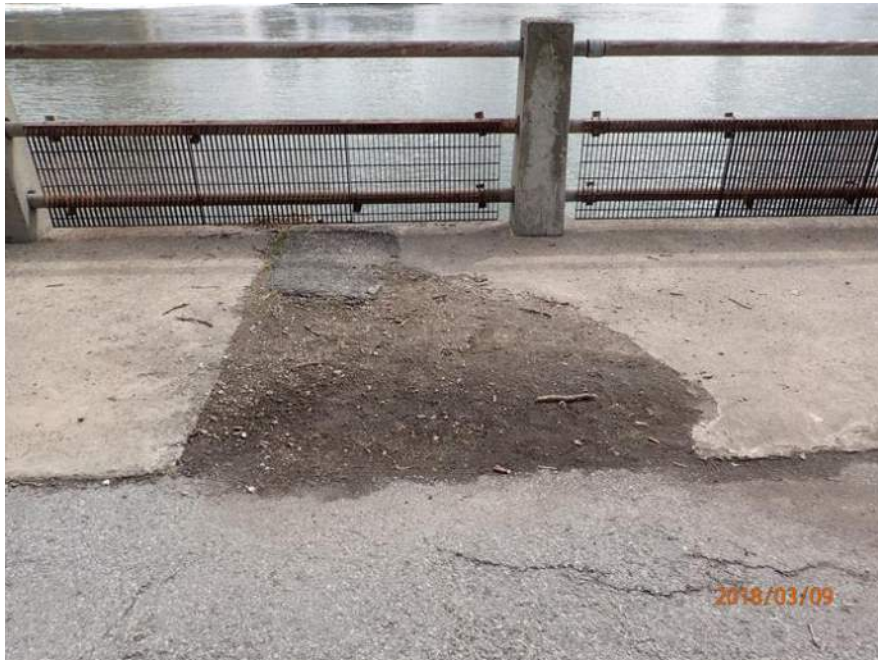
Station 40+61

Direction: Seawall Sidewalk Joint

Comments: Concrete Cracks

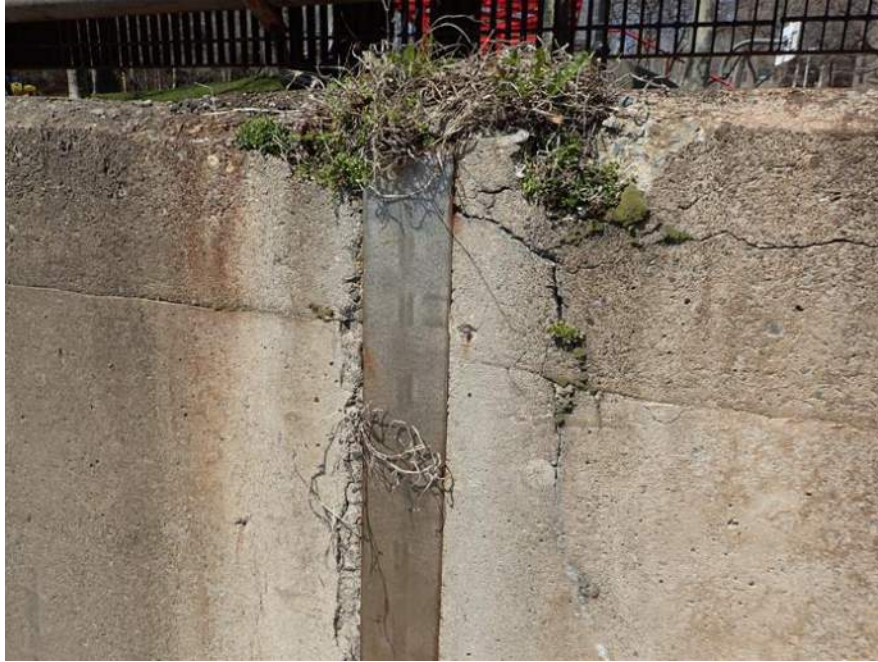
Station 40+80

Direction: Seawall Joint

Comments: Concrete Spalling

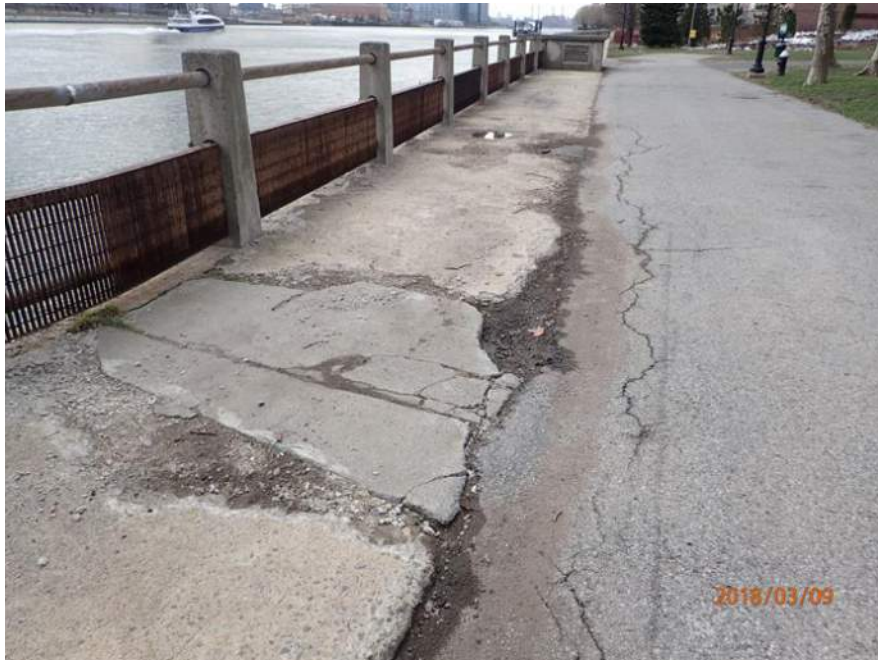
Station 41+22 to 41+54

Direction: Seawall Sidewalk

Comments: Concrete Cracks

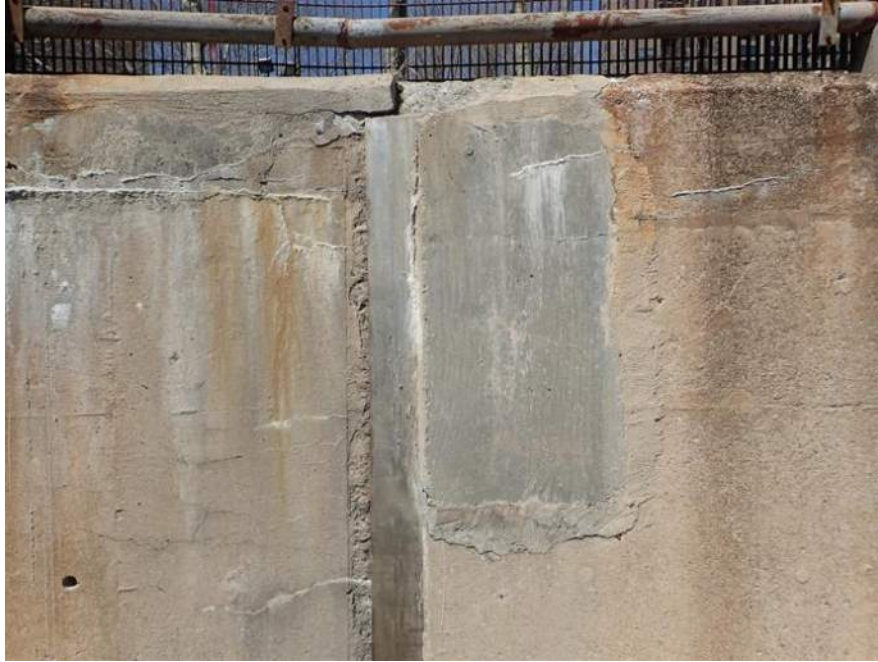
Station 41+31

Direction: Seawall Joint

Comments: Concrete Repair

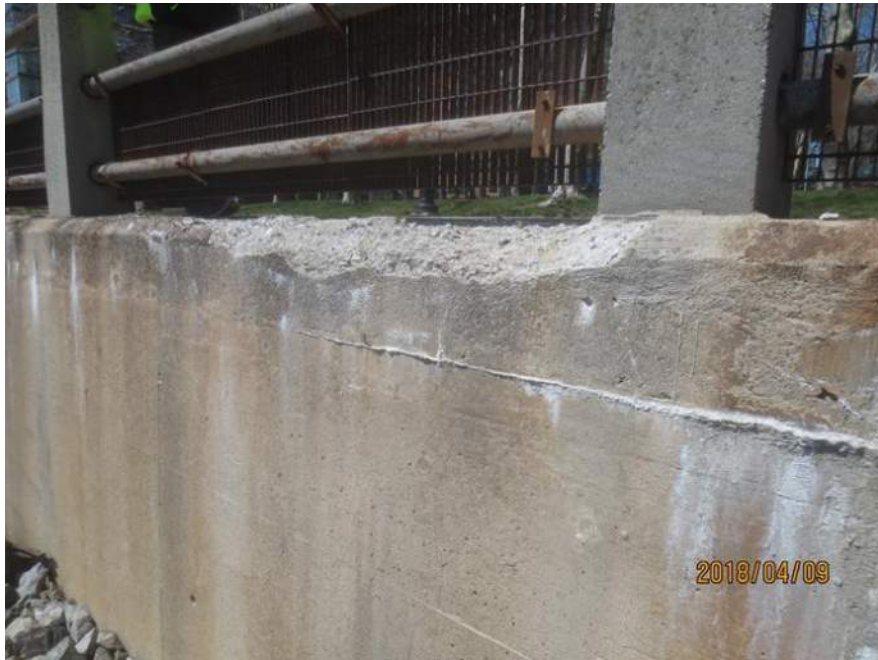
Station 41+50

Direction: Seawall

Comments: Missing Large Section of Concrete

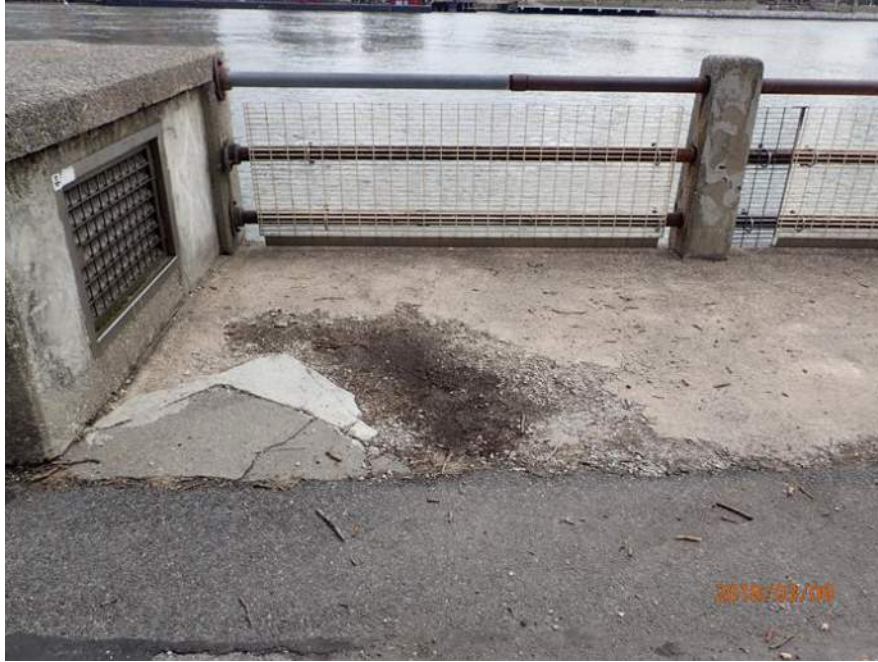
Station 42+22

Direction: Seawall Sidewalk

Comments: Concrete Cracks

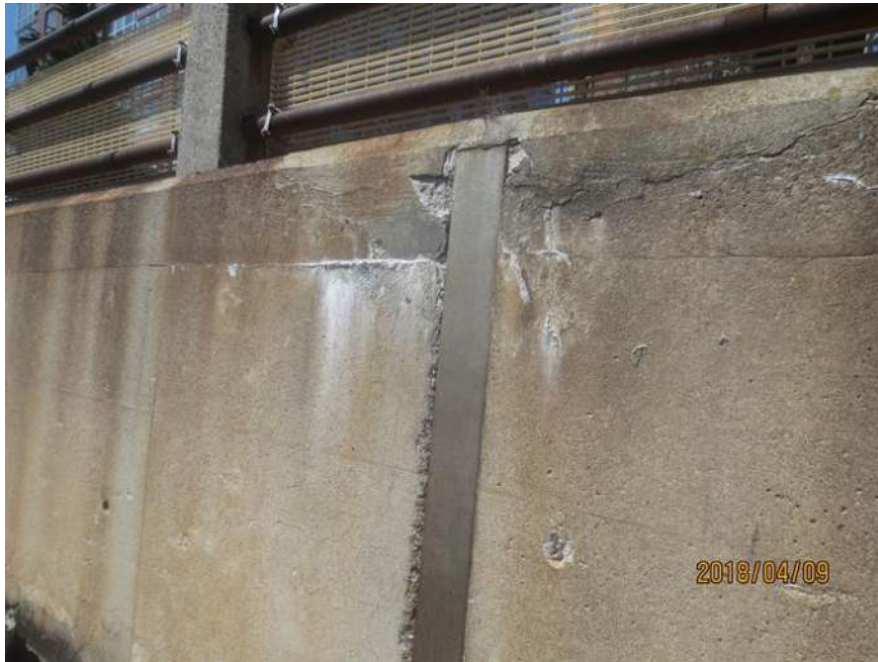
Station 42+39

Direction: Seawall Joint

Comments: Concrete Repair Over Metal Plate, Cracks

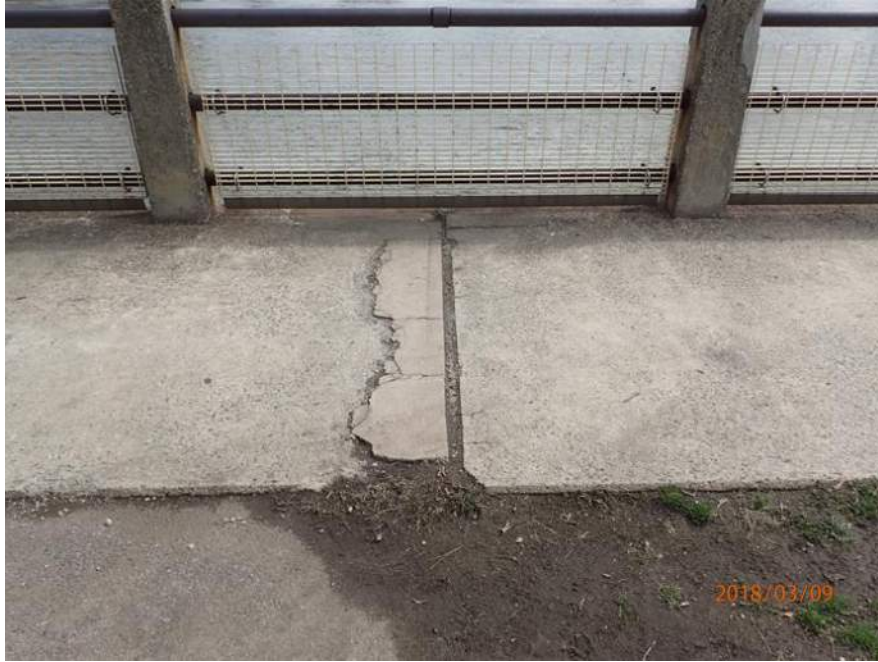
Station 42+54

Direction: Seawall Sidewalk Joint

Comments: Concrete Cracks

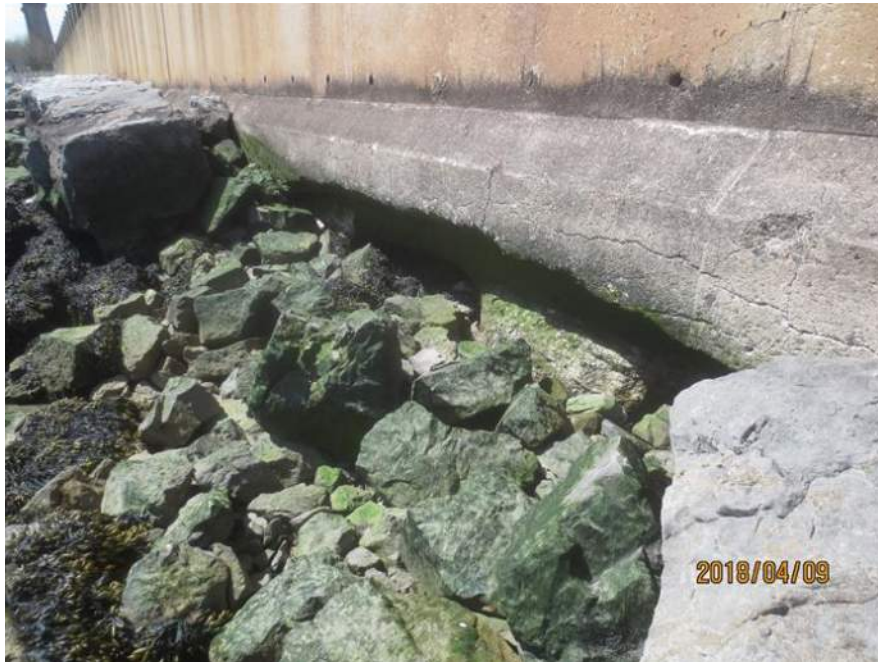
Station 43+04

Direction: Seawall

Comments: Tunnel has been Undermined

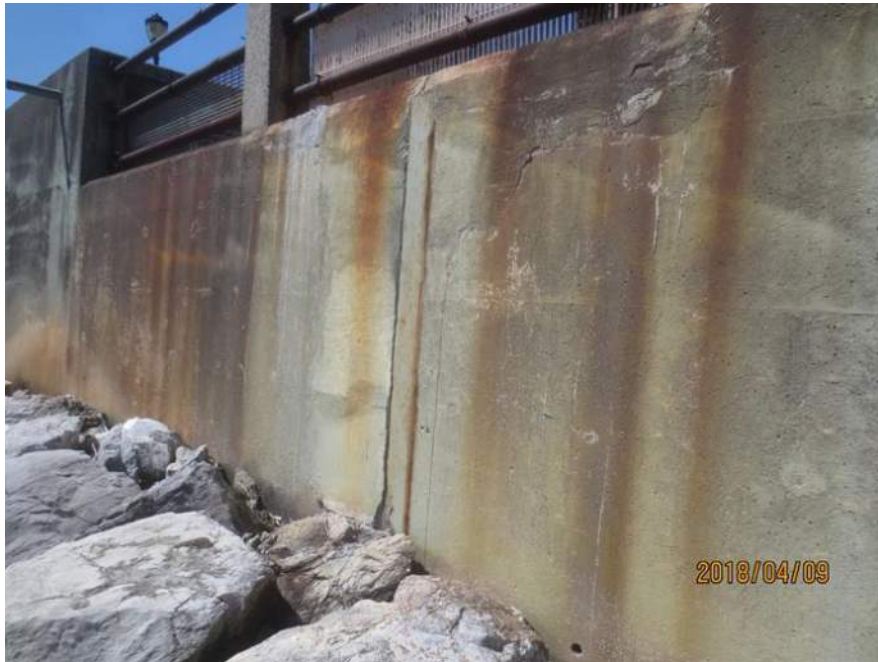
Station 45+77

Direction: Seawall Joint

Comments: Concrete Spalling, Large Concrete Cracks

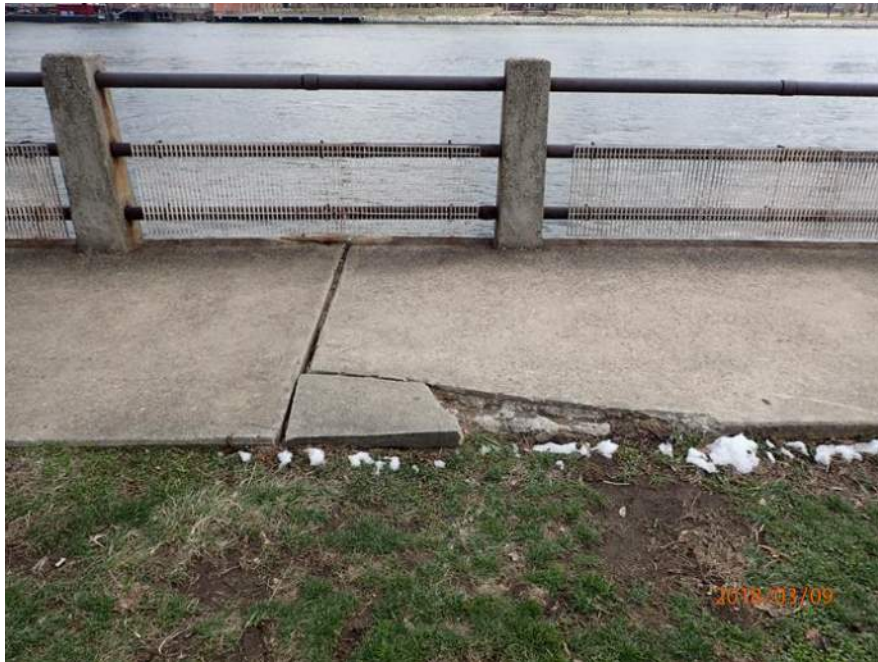
Station 45+77

Direction: Seawall Sidewalk Joint

Comments: Large Concrete Crack, Missing Concrete

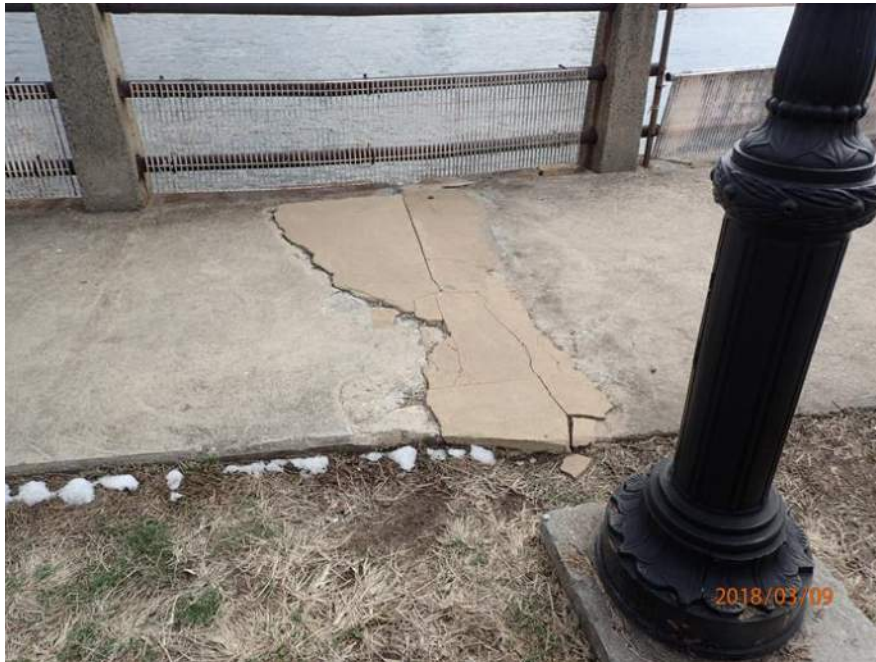
Station 45+97

Direction: Seawall Sidewalk Joint at Terminus

Comments: Concrete Cracks

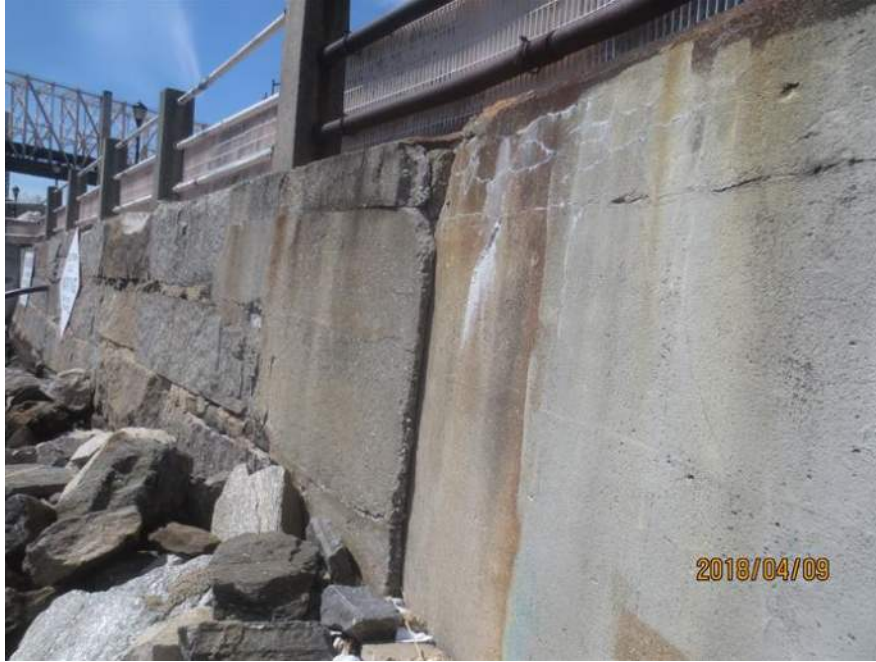
Station 45+97

Direction: Southern Seawall Terminus

Comments: Spalling at Haunch

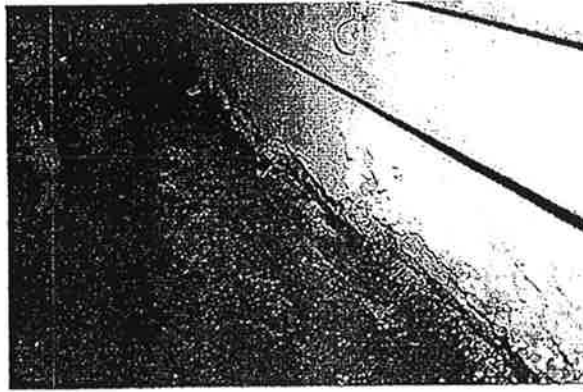
1

Interior wall spalling occurs within this segment as shown in Appendix B, photo 1, pg. 2.

Check tunnel roof for additional crack repair requirements. Check tunnel interior wall waterproofing system. See detail for 1949 waterproofing design in Appendix C. Waterproof as required.

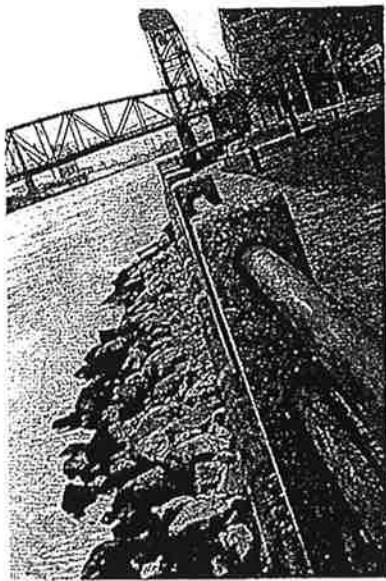
Appendix B, photo 1, pg. 11 shows damage at lower tunnel.

Photo 1 pg. 11 shows missing rip rap which is contributing to the deterioration of the tunnel.

Replace rip rap as required. Check tunnel piers, piles and caps for deterioration. Repair as required. Repair expansion joints.

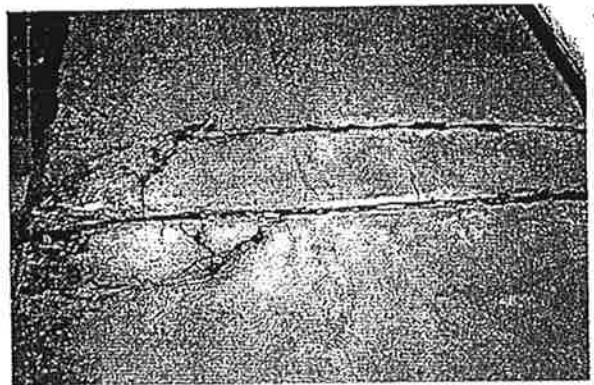
2

Appendix B, photos 2, 3, 4 & 5, pg. 11 show damage below vents 14 and 15 as well as the section between the vents.

Photos 2, 3, 4 & 5 pg. 11 show missing rip rap and deteriorated joints which are contributing to the deterioration of the tunnel.

Replace rip rap as required. Repair expansion joints. Check tunnel piers, piles & caps for deterioration. Repair as required.

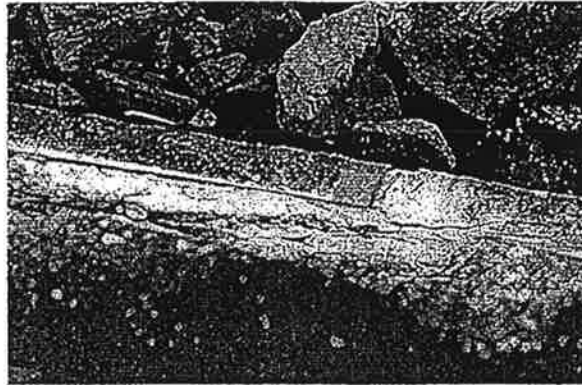
Appendix B, photos 1 & 2, pg. 12 show damage to the tunnel floor. Water infiltrates through the floor.

Replace rip rap as required. Repair expansion joints. Check tunnel piers, piles & caps for deterioration. Repair as required.

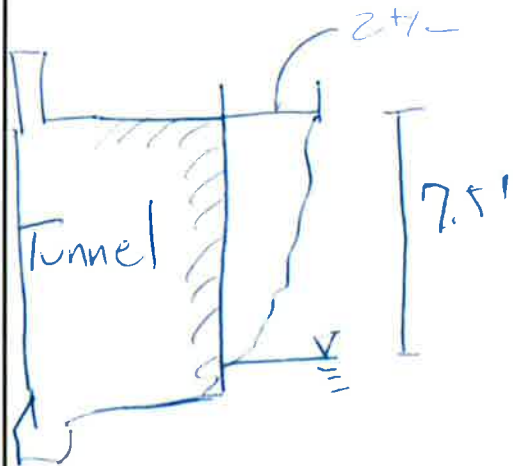
Test Pit 6 - STA: ~~8+92~~ 8+92

- wall in good condition, no cracks visible
- No water proofing
- No stone

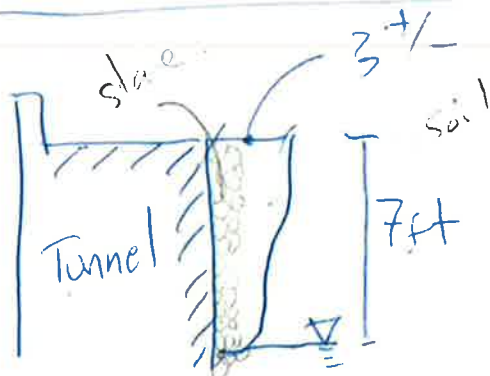
Test Pit 5 - STA: 11+99

- wall in good condition, no cracks visible
- No water proofing
- Crushed stone in the first foot along the wall

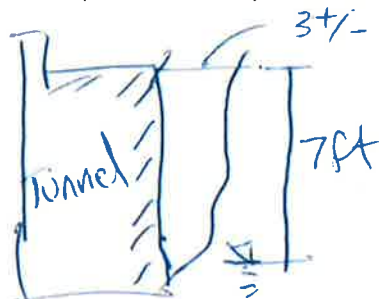
Test Pit 4 STA: 17+13

- wall in good condition, no cracks visible
- No water proofing
- Crushed stone.

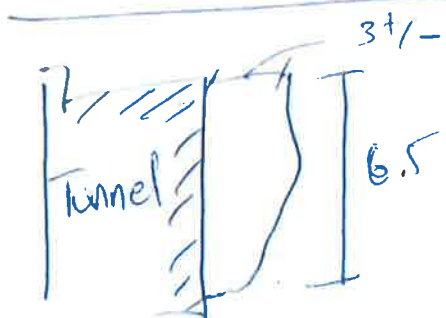
Test Pit 3 STA: 25+90

- Wall in good condition, no cracks visible.
- No water proofing
- Crushed stone.

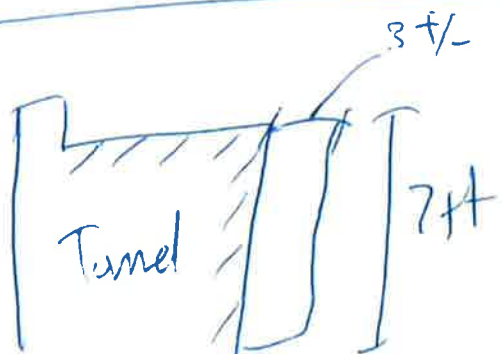
Test Pit 1 STA: 45+60

- Wall in good condition, no visible cracks
- No water proofing
- No stone.

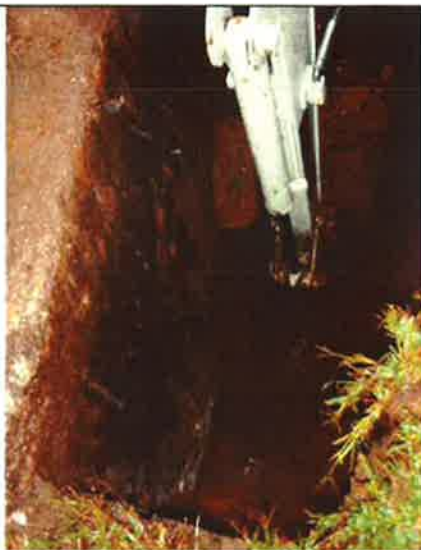
Test Pit 6 – Steam Tunnel exterior wall in good condition

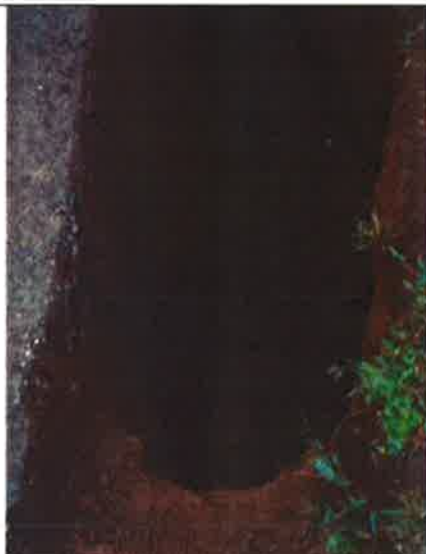
Test Pit 5 – Steam Tunnel exterior wall in good condition
